IMPACT RESISTANCE OF STEEL FIBER REINFORCED CONCRETE SLABS

**A Thesis Submitted to the
Graduate School of Engineering and Sciences of
İzmir Institute of Technology
in Partial Fulfillment of the Requirements for the Degree of
MASTER OF SCIENCE
in Civil Engineering**

**by
Süleyman YAŞAYANLAR**

**July 2015
İZMİR**

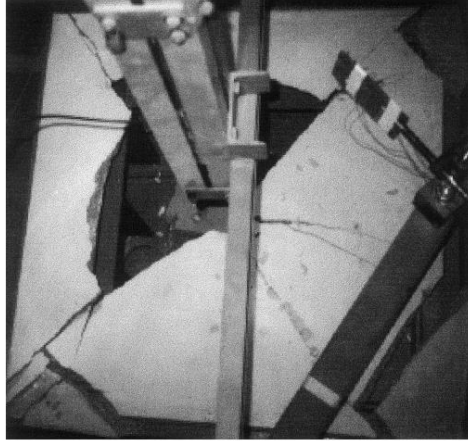
Figure 2.5. Failure of plain concrete slab
(Source: Ong et al., 1999)

In case of plain concrete members, the result of the impact event was catastrophic. As presented in Figure 2.5 the projectile penetrated the slab, and then shear cone shaped fracture was formed. Slab lost its integrity and gained momentum as a result of radial crack formation. As presented in Figure 2.6 Similar results were obtained in the specimens with the fraction of 0.5% for both polyolefin and PVA fibers. But in case of steel fibers, no such catastrophic results were observed; no penetration was occurred in concrete members with steel fibers.

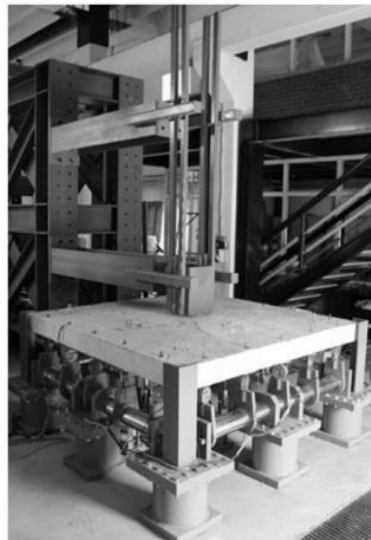
Figure 2.15. Impact test setup
(Source: Batarlar, 2013)

In Batarlar's study, as presented in Figure 2.15, three identical pairs of reinforced concrete slabs with ϕ 8 mm reinforcing bar with different reinforcement ratios were casted. Longitudinal reinforcement spacing was 100, 150 and 200 mm for different ratios. Each specimen had one layer of reinforcement on the top and one layer reinforcement on the bottom face. One member of the pair was used in static test, and the other one used impact test.

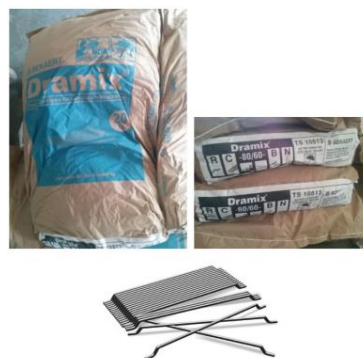
Figure 3.3. Steel fibers

Steel fibers of 60 mm in length and 0.75 mm in diameter which had length diameter ratio of 80 were used in this study (Figure 3.2). Minimum tensile strength of the fibers is 1050 N/mm^2 and it conformed EN 10016-2 – C9D. General views of steel fibers are presented in the Figure 3.3.

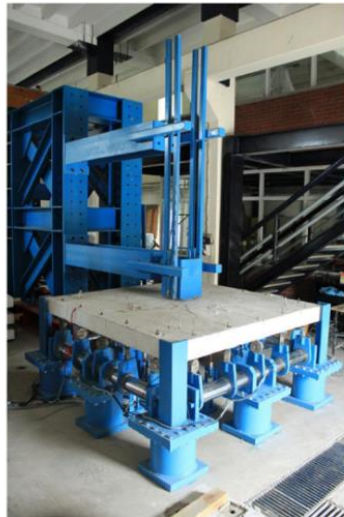
Figure 3.5. Test Setup

Test setup had eight footing and every one of them was fixed to the strong floor. All load cells were placed on a circular shaft. (Figure 3.5) Although the vertical movements of the edges were prevented, their free rotation was allowed. Thus, simply supported boundary conditions were obtained.

The setup was manufactured and mounted at the strong floor at İzmir Institute of Technology as a part of previous studies Batarlar, 2013 and Arsan 2014). (Figure 3.4) With a few modifications both static and dynamic tests were done in this test setup.

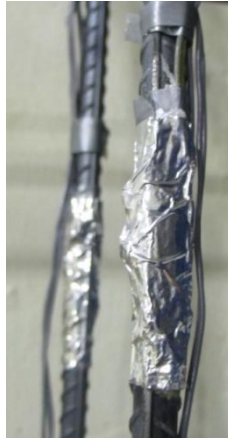
Figure 3.10. Final state of the strain gauge

Reinforcing bars were grinded at the strain gauge locations until a flat and smooth surface was obtained. Then, it was cleaned by basic and acidic solutions. After that, the strain gauges were glued with the special glue provided by the strain gauge manufacturer. Finally, strain gauges were covered with a thick layer of varnish, paraffin wax and insulation tape in order to prevent any external damage. All those procedures were presented in Figure 3.8, Figure 3.9 and Figure 3.10.

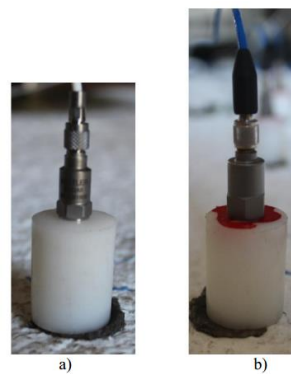
Figure 3.15. Two types of accelerometers; (a) Kistler Group accelerometers, (b) PCB Piezotronics accelerometers

Accelerometers were screwed to the specimen using delrin cylinders in order to prevent noise. These delrin cylinders were fixed to the slab with chemical anchorage to increase stability. (Figure 3.15)

16 accelerometers were used to record acceleration. Two $\pm 50000g$ range, 8742A50 type from Kistler Group were mounted on the drop weight. Four $\pm 5000g$ range 8742A5 type from Kistler Group and ten models 350B04 from PCB Piezotronics with a range of $\pm 5000g$ were mounted on the top of the slab. (Figure 3.14)

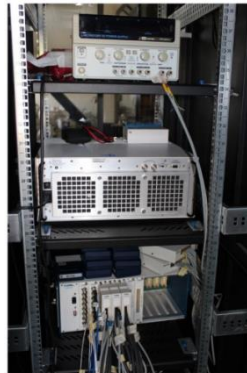
Figure 3.17. General view of Data Acquisition System

In order to collect and record all data from the tests, a high speed data acquisition system with a 250 kS/s/channel sampling rate was employed. (Figure 3.17) Lab VIEW Academic Standard Suite program was used to manipulate and save all data obtained from experiments.

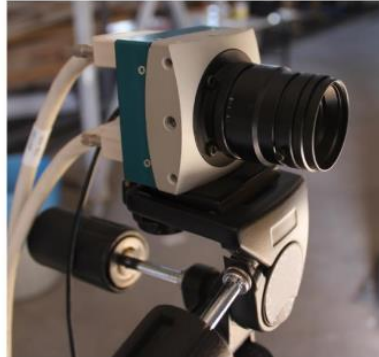
Figure 3.18. Mikroton EoSens high speed camera

A high speed camera was used to record the impact event (Figure 3.18). In order to record the impact event MotionBLITZS high speed camera system, product of Mikroton GmbH, was used. The number of frames per second in this camera was

between 800 and 1262. Once the entire event was recorded, the records were used to calculate the speed of the mass at the impact moment.

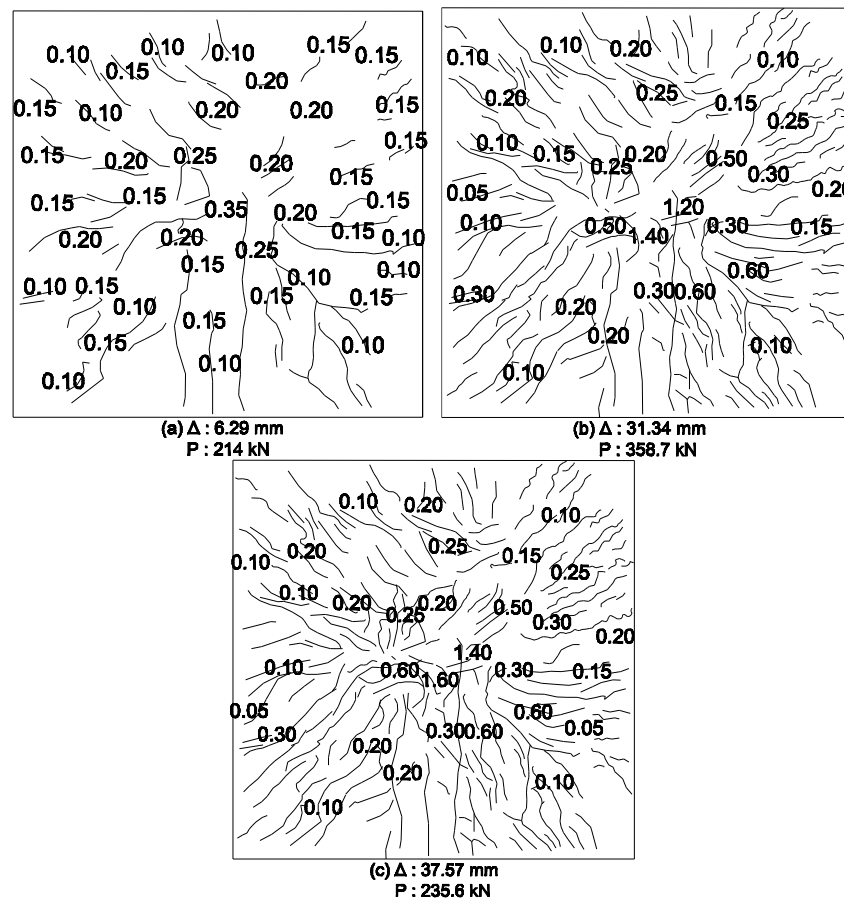
Figure 3.19. Crack patterns at the tension side of specimen SY100f05-a, (a) after 1st stop; (b) after 2nd stop; (c) after 3rd stop (Given numbers are crack widths in millimeter.)

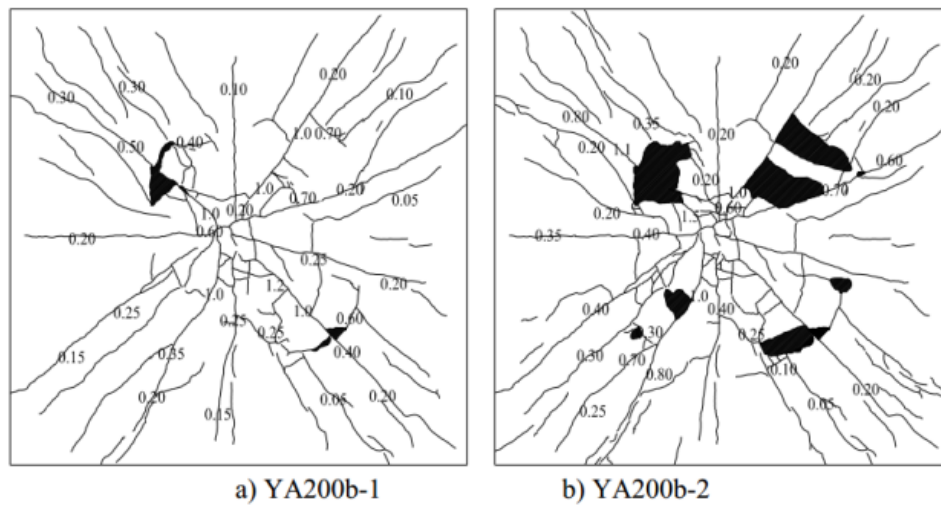
Figure 3.37. Crack patterns at the bottom side of specimen YA200f10-b, after 1st and 2nd drop (Given numbers are crack widths in millimeter.)

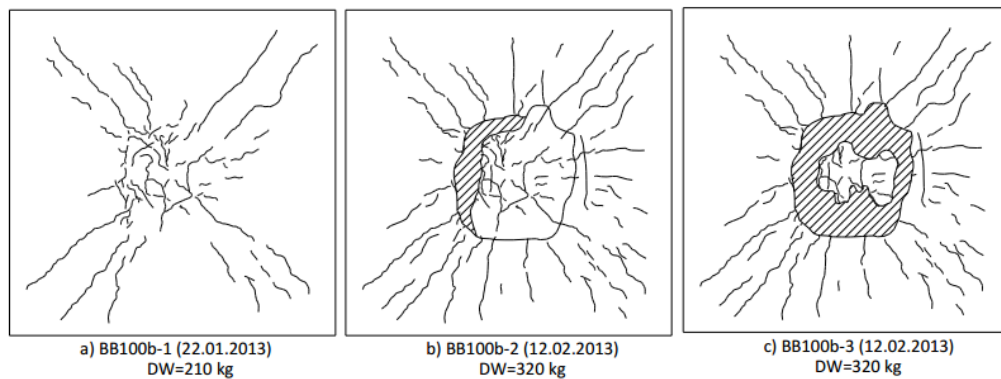
Figure 3.39. Crack patterns at the bottom side of specimen BB100f00-b, (a) after 1st drop; (b) after 2nd drop; (c) after 3rd drop (Given numbers are crack widths in millimeter.)

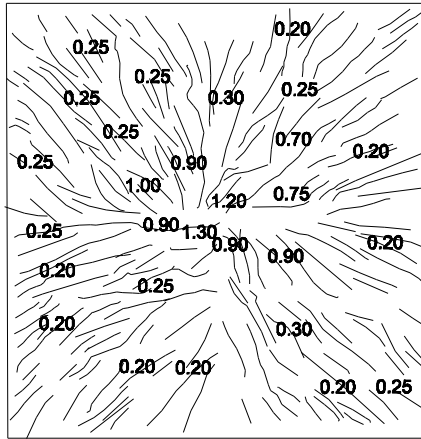
Figure 4.9. Tension face of specimen SY200f15-a after testing (Numbers indicate crack widths in millimeters)

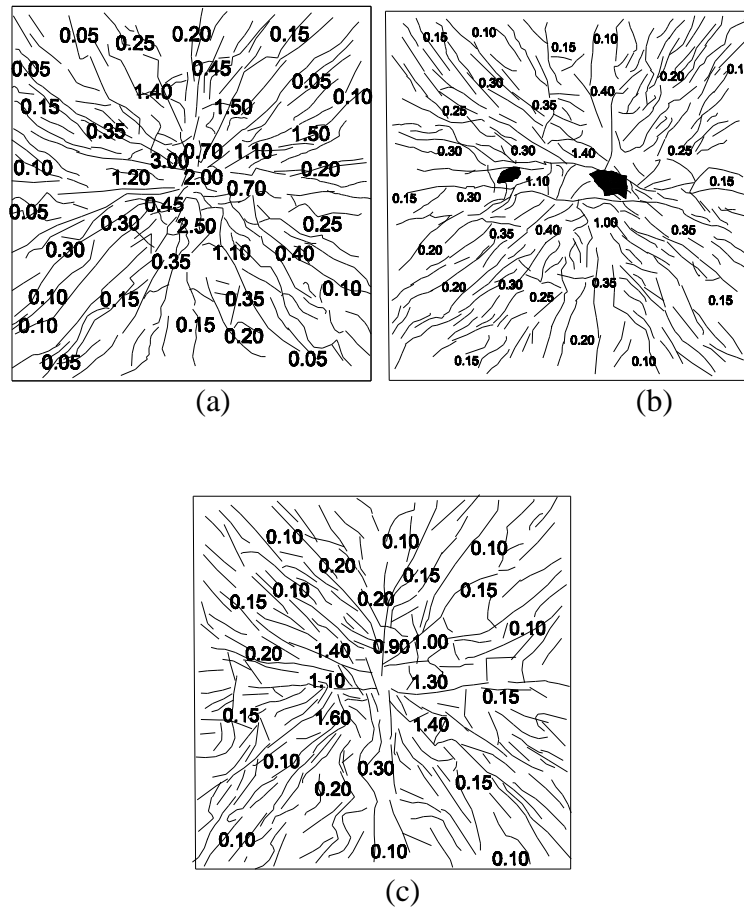
Figure 4.19. Bottom face of (a) SY100f05-b, (b) SY100f10-b and (c) SY100f15-b at final state (Numbers indicate crack widths in millimeters)

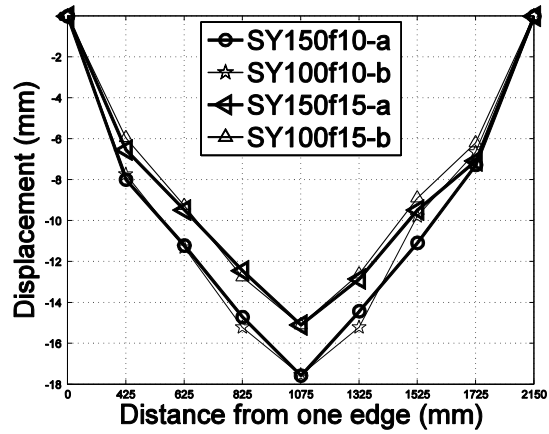
Figure 4.40. Comparison of static and dynamic displacements of specimens for same mid-point displacements

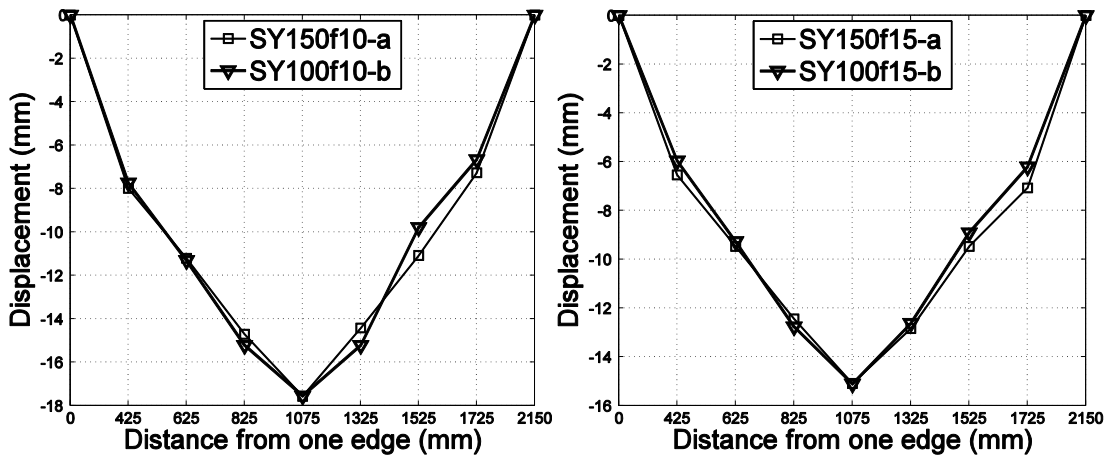
Figure 4.43. Maximum displacements of the specimens with the same longitudinal reinforcements and corresponding static tested control specimens
