**INVESTIGATION OF THE DETERIORATION
PROBLEMS OF EXCAVATED ANDESITE
MONUMENTS IN ARCHAEOLOGICAL SITES FOR
THE PURPOSE OF CONSERVATION**

**A Thesis Submitted to the
the Graduate School of Engineering and Sciences of
İzmir Institute of Technology
in Partial Fulfillment of the Requirements for the Degree of**

**by
Çağlayan Deniz KAPLAN**

**July 2015
İZMİR**

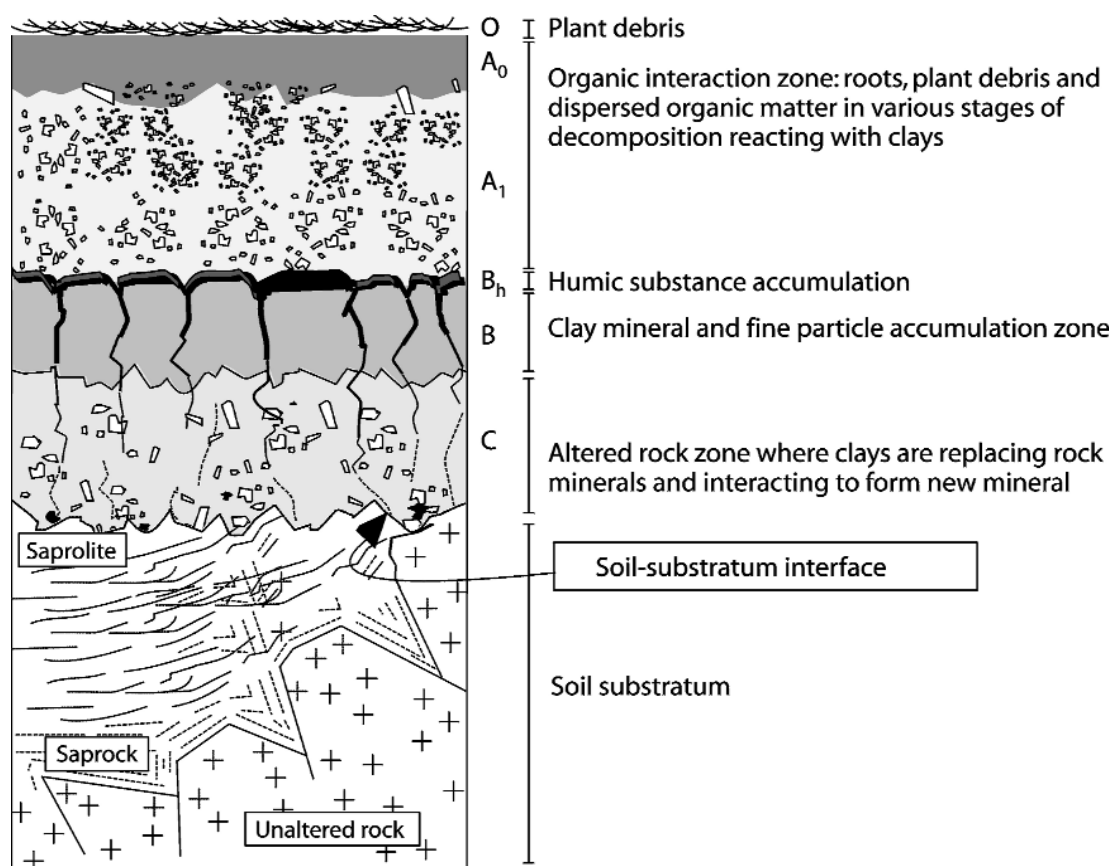
Figure 1.2. The components of subsoil environment
(Source: Velde and Meunier 2008)

The *O horizon* is a surface horizon which is made up mostly of decomposed organic matter and leaf litter. The *A horizon*, which is also called rhizosphere, is the surface layer composed of plant roots and sand, silt, and clay. With the presence of organic materials, clays, water and air coexist in this layer (Amundson 2003, Velde and Meunier 2008). Thus, the horizon creates appropriate environment for physical, chemical and biological deterioration of the buried materials (April and Keller 1990, Colin, et al. 1992, Velde and Meunier 2008). The *E horizon* (shown as B_h in the Figure 1.2) is light in color and mostly composed of sand and silt. It has been heavily leached in which soluble nutrients are lost from the soil due to precipitation or irrigation. The *B horizon* is a subsurface horizon which has accumulated from the layers above and contains clay and mineral deposits which it receives from layers above it when mineralized water drips from the soil above. The *C horizon*, which is also known as the saprolite, is the deteriorated rock zone. Plant roots do not penetrate into this layer and very little organic material is found. The most important process in this zone is that hydration and chemical dissolution of stone minerals. As a chemical deterioration, anhydrous and low hydration state rock minerals are transformed into hydrous (OH) forms in C horizon (Velde and Meunier 2008). The deepest layer of the subsoil environment is the fresh rock (bedrock).

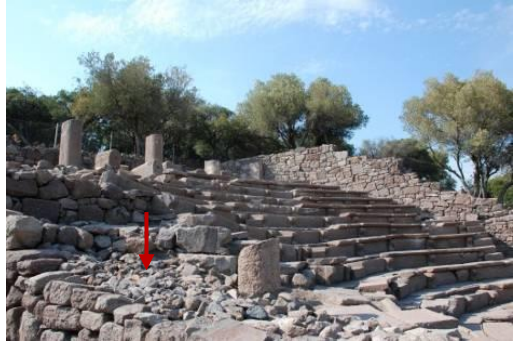
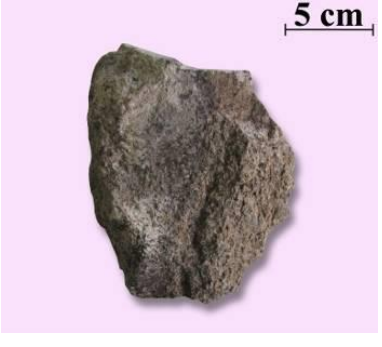
Southern cavea of Bouleuterion Excavation year: 2005 Sampling year: 2010 <u>Burial depth</u> Shallow burial ≈ 200 cm	Ai2_E

Exterior part of the sample approximately 1.5 cm from its surface to the interior part.
					Ai2_I		Core of the sample approximately 2x2 cm in dimensions.
					Ai2_Wd		White deposition on the stone surface.
					Ai2_Cr		Fine grained particles of the stone in the cracks close to the surface.
	Ai3

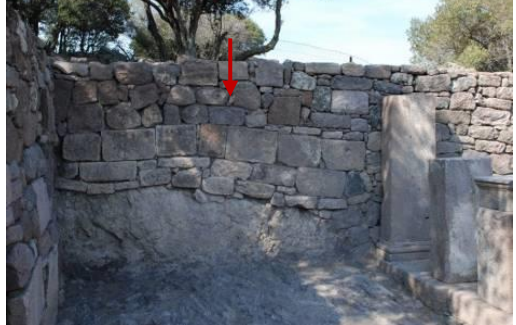
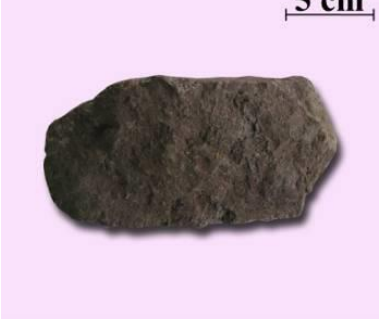
Northern backstage wall of Bouleuterion Excavation year: 2006 Sampling year: 2010 <u>Burial depth</u> Shallow burial ≈ 50 cm	Ai3_E

Exterior part of the sample approximately 1.5 cm from its surface to the interior part.

Ai3_I		Core of the sample approximately 2x2 cm in dimensions.
	Ai4

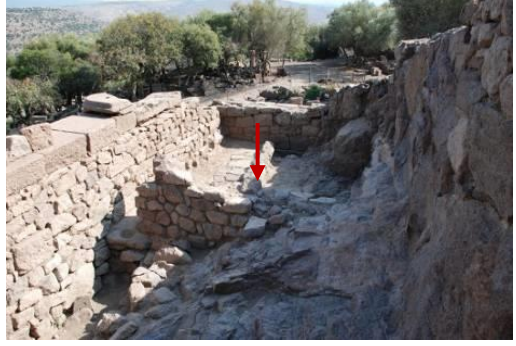
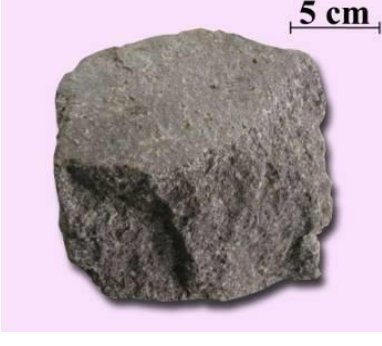
Southern backstage wall of Bouleuterion Excavation year: 2009 Sampling year: 2010 <u>Burial depth</u> Shallow burial ≈ 120 cm	Ai4_E

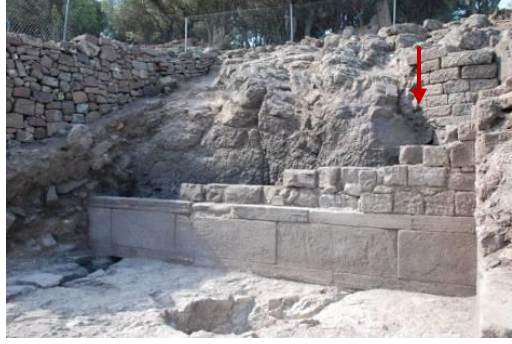
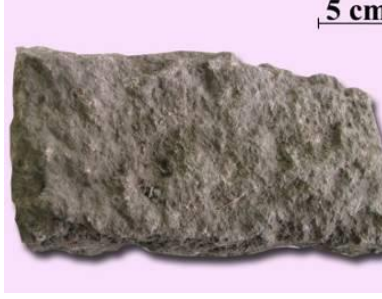
Southern wall of Stoa Excavation year: 2010 Sampling year: 2010 <u>Burial depth</u> Shallow burial ≈ 100 cm	Ai6_E

Exterior part of the sample approximately 1.5 cm from its surface to the interior part.
					Ai6_I		Core of the sample approximately 2x2 cm in dimensions.
	Ai7

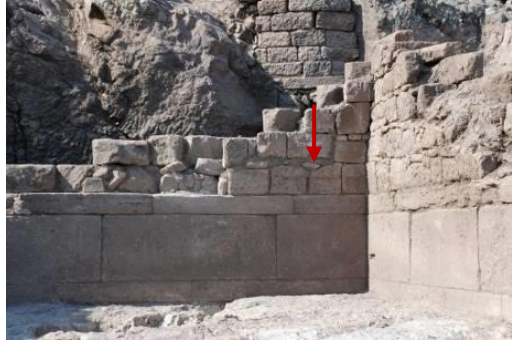
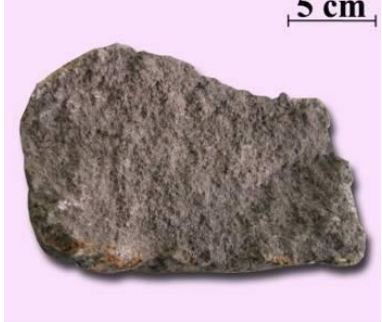
Southern wall of Stoa Excavation year: 2010 Sampling year: 2010 <u>Burial depth</u> Shallow burial ≈ 150 cm	Ai7_E

Exterior part of the sample approximately 1.5 cm from its surface to the interior part.
					Ai7_I		Core of the sample approximately 2x2 cm in dimensions.

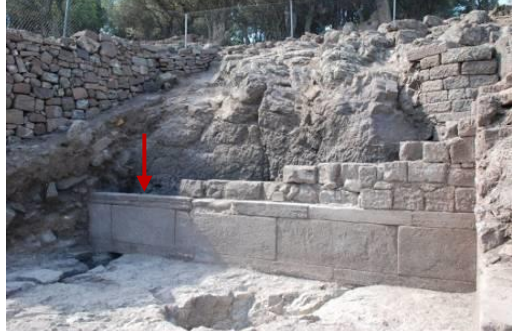
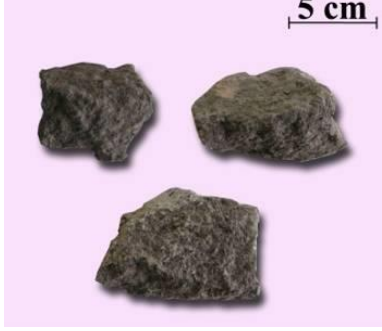
Southern wall of Stoa Excavation year: 2010 Sampling year: 2010 <u>Burial depth</u> Shallow burial ≈ 180 cm	Ai8_E

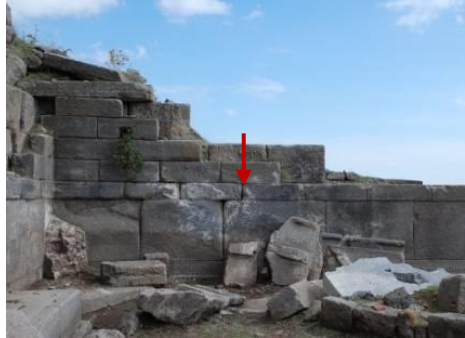
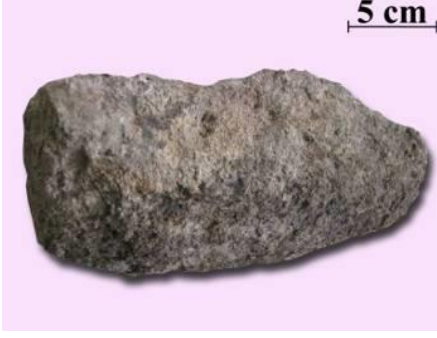
Eastern part of Bouleuterion Excavation year: 2010-2013 Sampling year: 2010 <u>Burial depth</u> Shallow burial ≈ 180 cm	As1_E

Exterior part of the sample approximately 1.5 cm from its surface to the interior part.
					As1_I		Core of the sample approximately 2x2 cm in dimensions.
					As1_Wd		White deposition on the stone surface.
	As2

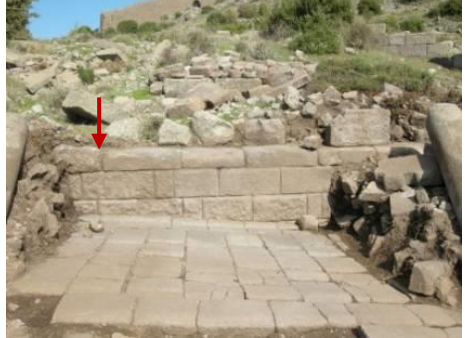
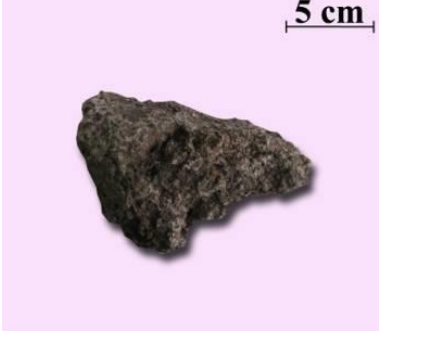
Gymnasium Excavation year: 2010 Sampling year: 2010 <u>Burial depth</u> Shallow burial ≈ 50 cm	As2_E

Exterior part of the sample approximately 1.5 cm from its surface to the interior part.
					As2_I		Core of the sample approximately 2x2 cm in dimensions.
					As2_Wd		White deposition on the stone surface.
					As2_Cr		Fine grained particles of the stone in the cracks close to the surface.
	As3

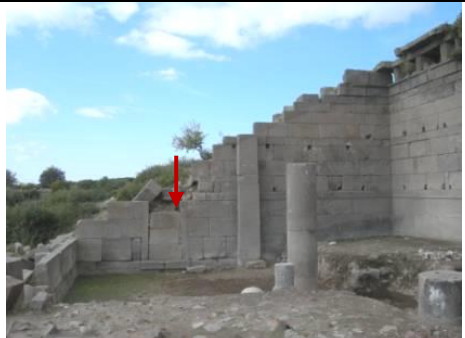
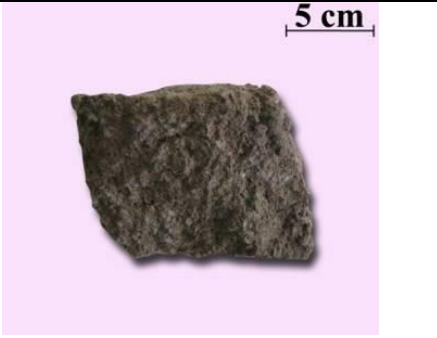
Northern wall of Stoa Excavation year: 2010-2011 Sampling year: 2010 <u>Burial depth</u> Shallow burial ≈ 120 cm	As3_E

Exterior part of the sample approximately 1.5 cm from its surface to the interior part.

As3_I		Core of the sample approximately 2x2 cm in dimensions.
	As4

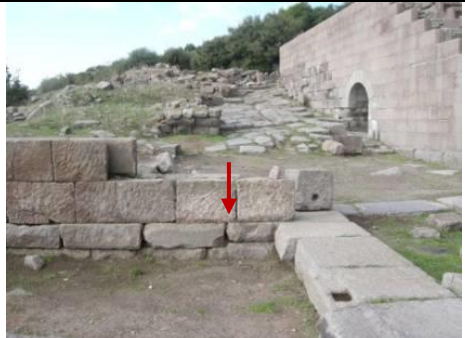
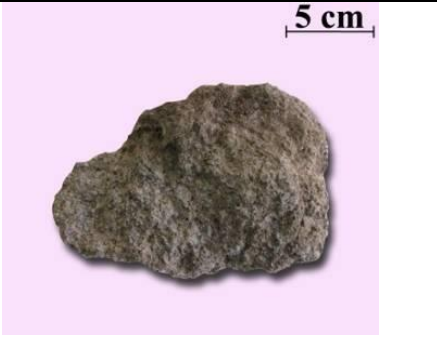
Western part of Theatre Excavation year: 1989 Sampling year: 2010 <u>Burial depth</u> Shallow burial ≈ 50 cm	As4_E

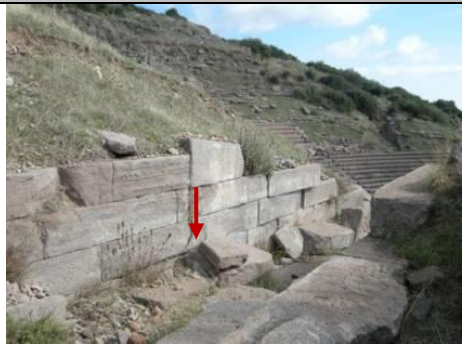
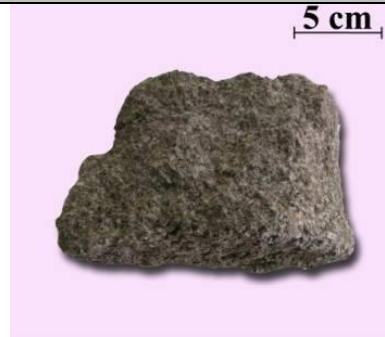
Southern part of Theatre Excavation year: 1989 Sampling year: 2010 Burial depth Shallow burial ≈ 200 cm	As5_E

Exterior part of the sample approximately 1.5 cm from its surface to the interior part.
				As5_I		Core of the sample approximately 2x2 cm in dimensions.
				As5_Cr		Fine grained particles of the stone in the cracks close to the surface.
As6

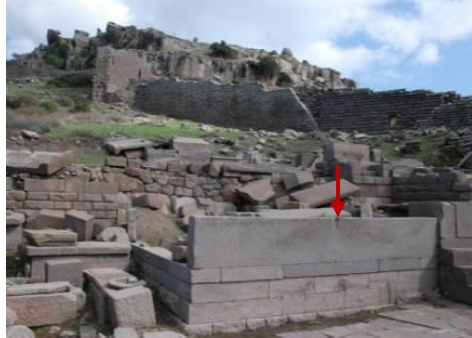
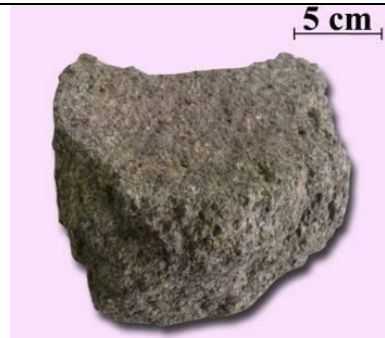
Necropolis Excavation year: 2010 Sampling year: 2010 Burial depth Shallow burial ≈ 50 cm	As6_E

Exterior part of the sample approximately 1.5 cm from its surface to the interior part.
				As6_I		Core of the sample approximately 2x2 cm in dimensions.
As7

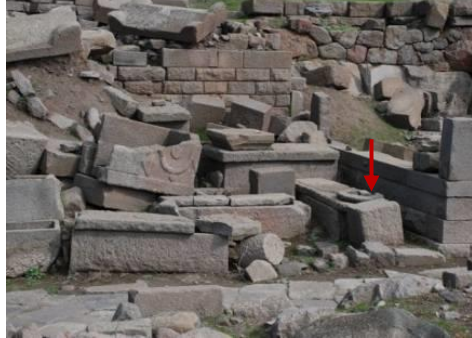
Necropolis Excavation year: 2010 Sampling year: 2010 Burial depth Shallow burial ≈ 100 cm	As7_E

Exterior part of the sample approximately 1.5 cm from its surface to the interior part.
				As7_I		Core of the sample approximately 2x2 cm in dimensions.

As7_Wd		White deposition on the stone surface.
As8

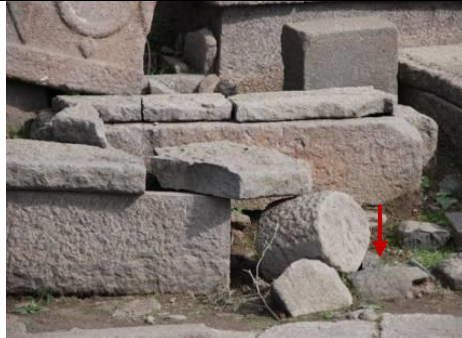
Necropolis Excavation year: 2010 Sampling year: 2010 Burial depth Shallow burial ≈ 150 cm	As8_E

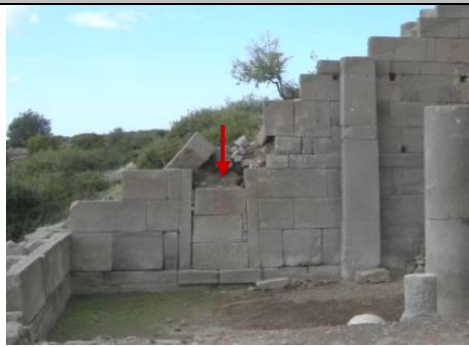
Location	Sample	Definition	Label	Section	Definition
Soil Samples	AsSo1

—	Northern wall of Stoa Excavation year: Sampling year: 2010 <u><i>Burial depth</i></u> Shallow burial ≈ 40 cm	<i>AsSo1_Cl</i>	—	Clay fraction of the soil sample.
	AsSo2

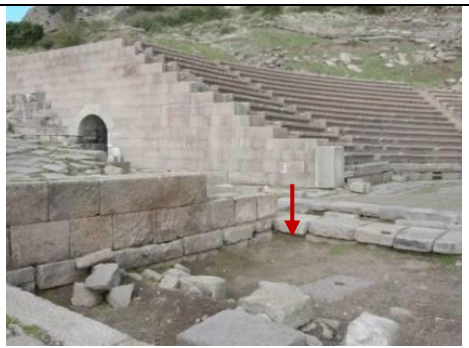
—	Theatre Excavation year: 2010 Sampling year: 2010 <u><i>Burial depth</i></u> Shallow burial ≈ 50 cm	<i>AsSo2_Cl</i>	—	Clay fraction of the soil sample.
	AsSo3

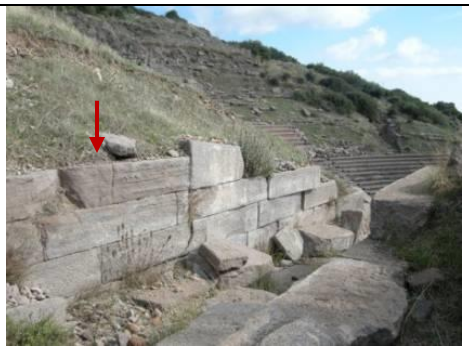
—	Western part of Theatre Excavation year: 1980s Sampling year: 2010 <u><i>Burial depth</i></u> Shallow burial ≈ 100 cm	<i>AsSo3_Cl</i>	—	Clay fraction of the soil sample.
	AsSo4

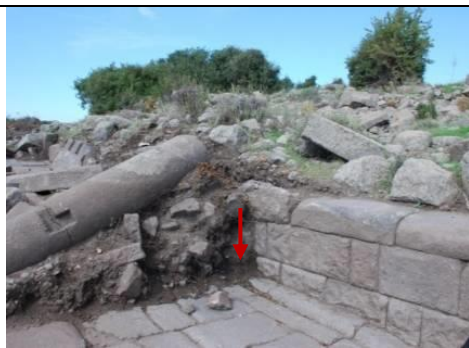
—	Gymnasium Excavation year: 2010 Sampling year: 2010 <u><i>Burial depth</i></u> Shallow burial ≈ 80 cm	<i>AsSo4_Cl</i>	—	Clay fraction of the soil sample.

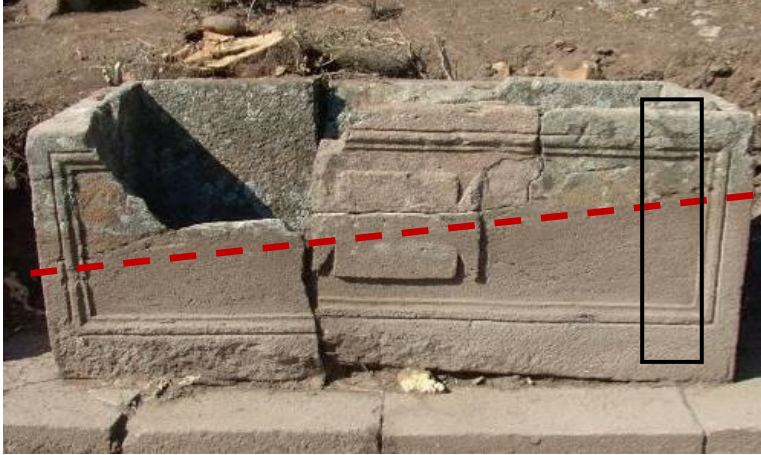
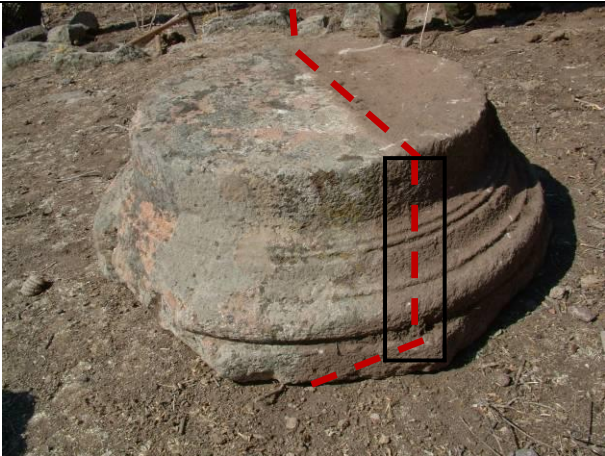
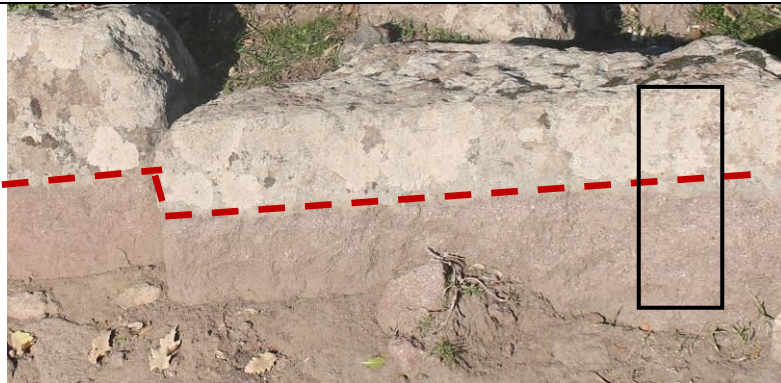
<p>Visible deterioration: Biological growth on exposed standing parts is observed.</p>

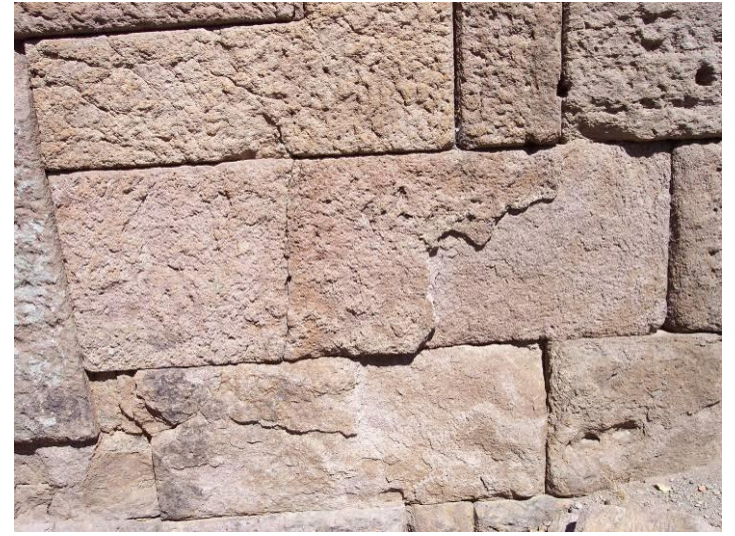
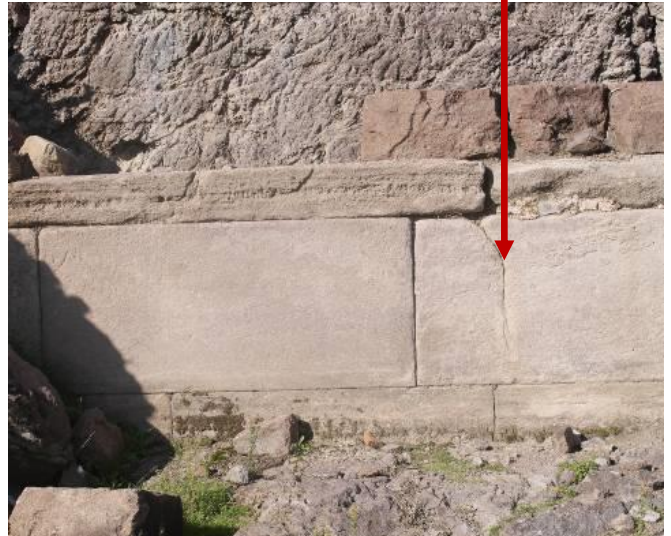
<p style="writing-mode: vertical-rl; transform: rotate(180deg);">Definition</p>	<p>Necropolis: Partially excavated in 2006. Visible deterioration: Collapse of restored piece of the grave and discolouration are observed.</p>	<p>Agora: Completely exposed standing since approximately 2500 years. Visible deterioration: Pitting on the andesite surfaces is observed.</p>	<p>Western Stoa: Completely excavated in 2009. Visible deterioration: Progress of the current crack is observed.</p>

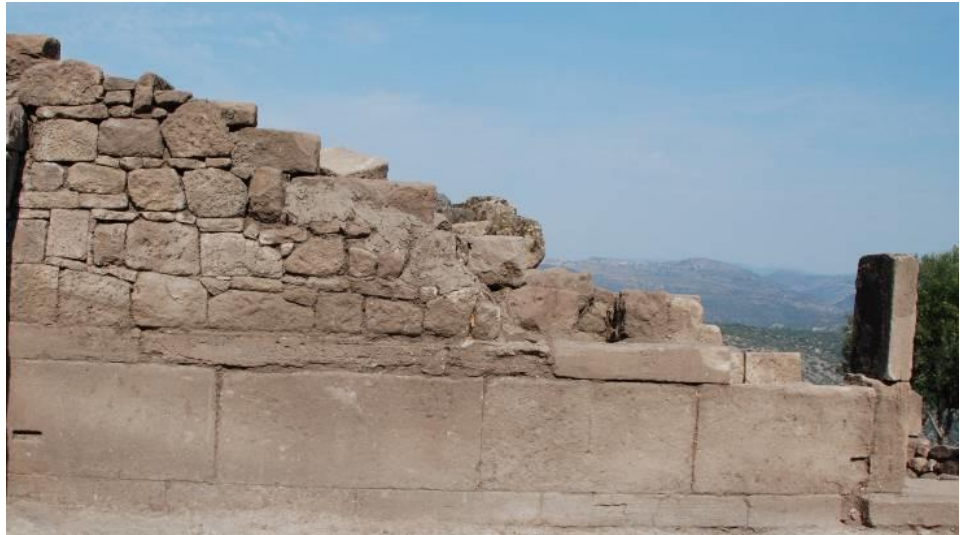
<p>October 2014</p>	 	 	 
<p>Definition</p>	<p>Western Stoa: Completely excavated in 2009. <i>Visible deterioration:</i> Discharge of the soil, which was used to combine the andesites, is observed.</p>

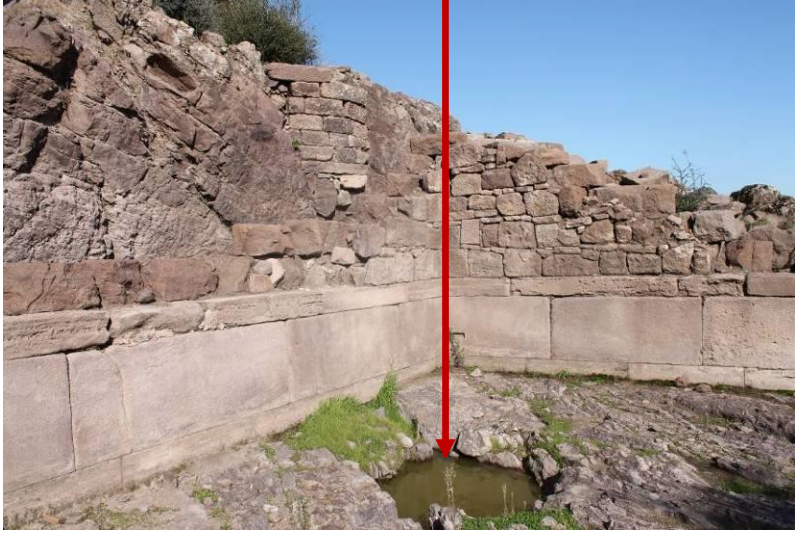
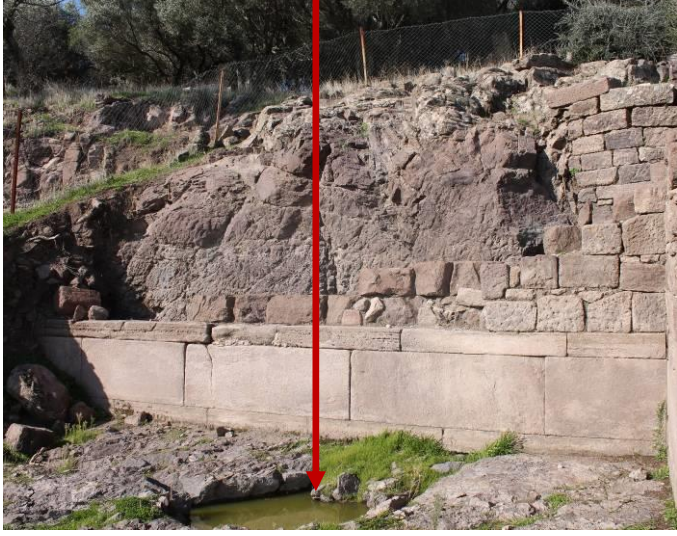
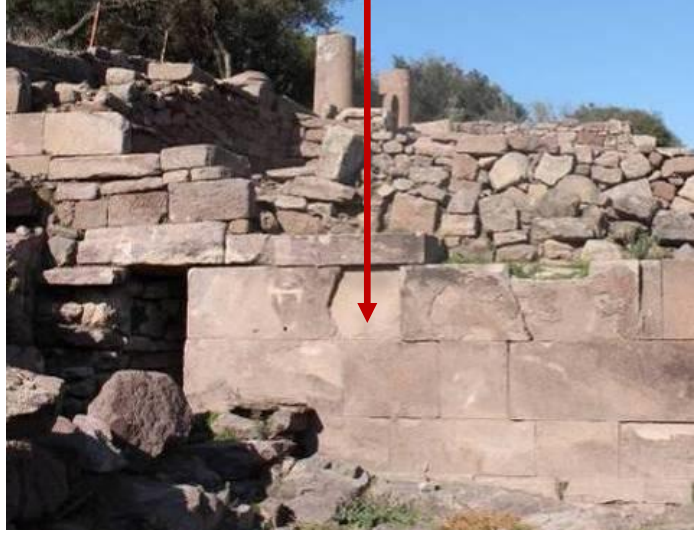
<p>Definition</p>	<p>Western Stoa: Completely excavated in 2009. <i>Visible deterioration:</i> Biological growth and accumulation of water on the ground are observed.</p>		<p>Bouleuterion: Partially excavated between 2004 and 2006. <i>Visible deterioration:</i> Collapse of the andesite surface on the wall is observed.</p>

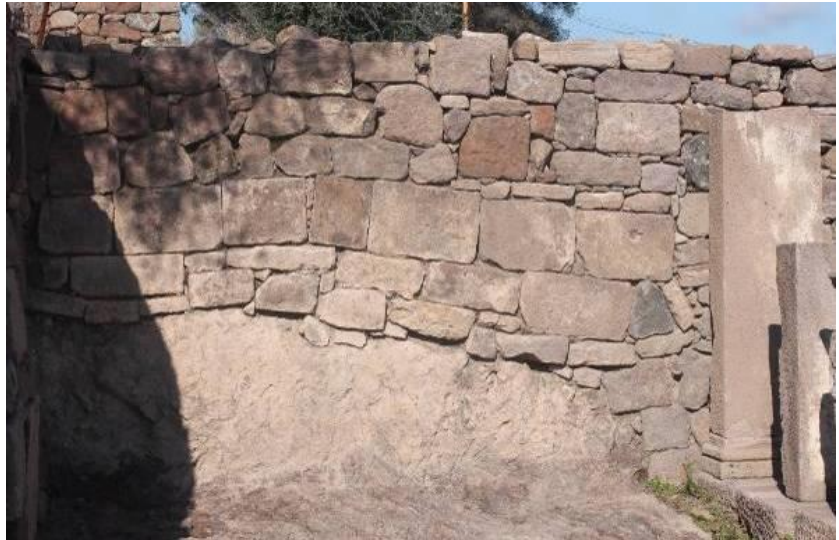
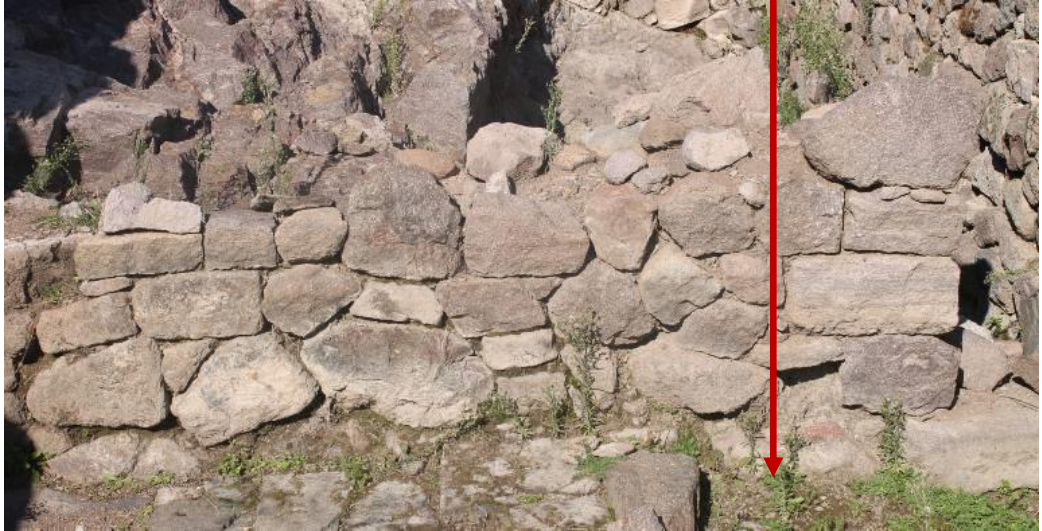
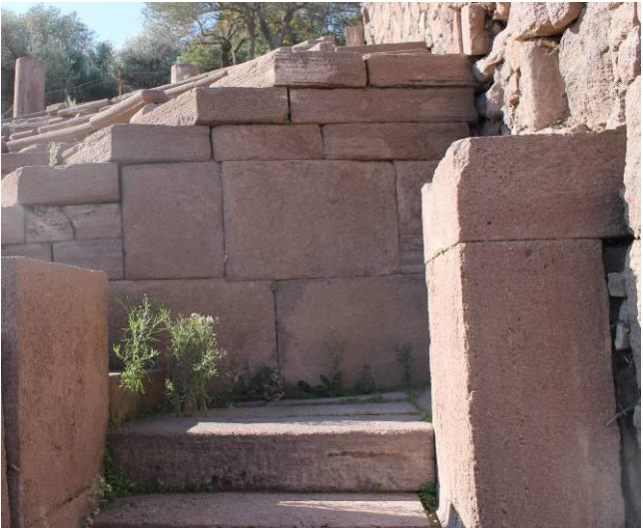
<p style="writing-mode: vertical-rl; transform: rotate(180deg);">Definition</p>	<p>Bouleuterion: Partially excavated between 2004 and 2006. <i>Visible deterioration:</i> Biological growth on the ground is observed.</p>

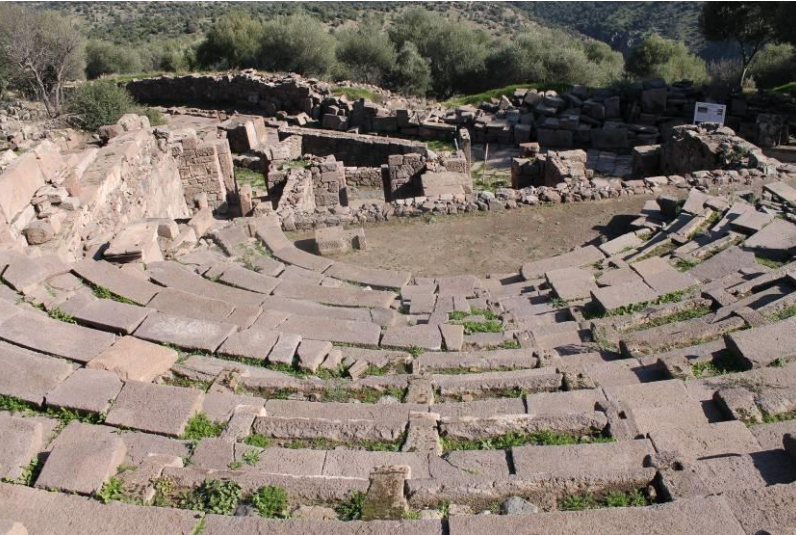
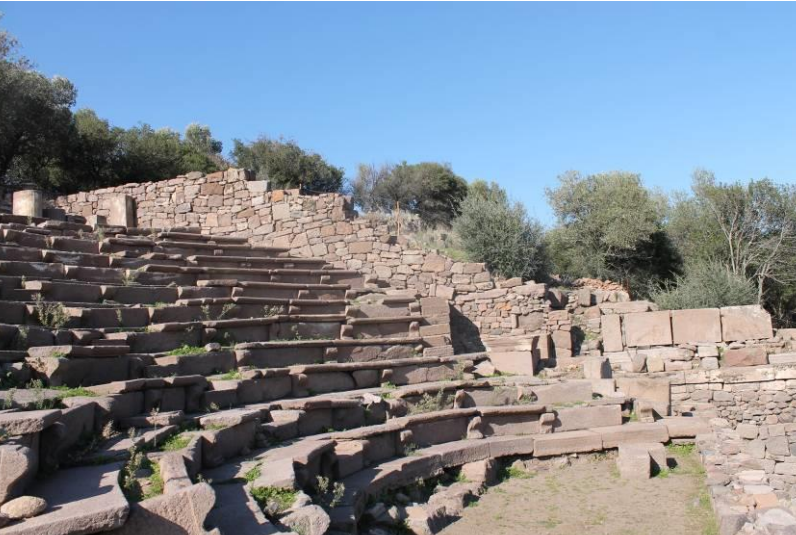
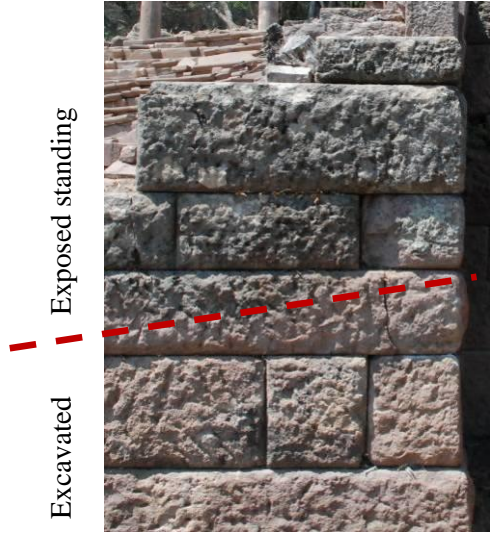
<p>Definition</p>	<p>Bouleuterion: Partially excavated between 2004 and 2006. <i>Visible deterioration:</i> Biological growth and pitting on the ground is observed.</p>

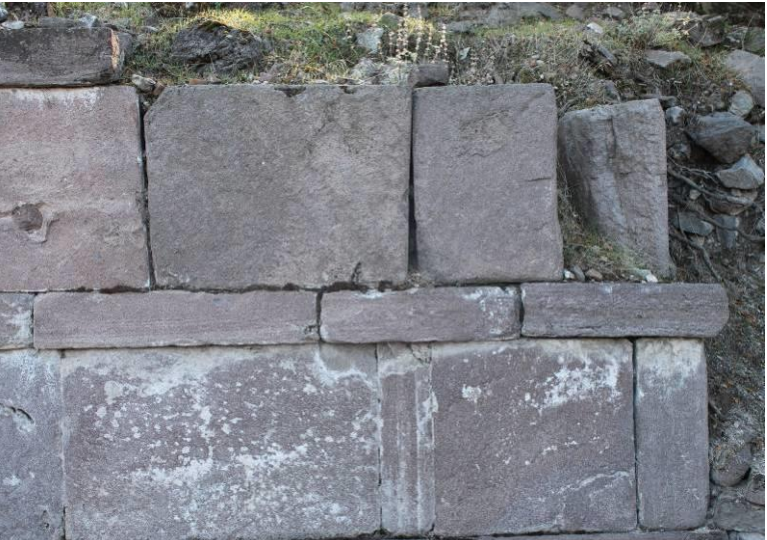
<p>Definition</p>	<p>Shop: Completely excavated in 2008. <i>Visible deterioration:</i> Biological growth on the wall is observed.</p>	<p>Public Bath Wall: Completely excavated in 2008. <i>Visible deterioration:</i> Discharge of the soil, which was used to combine the andesites, is observed.</p>

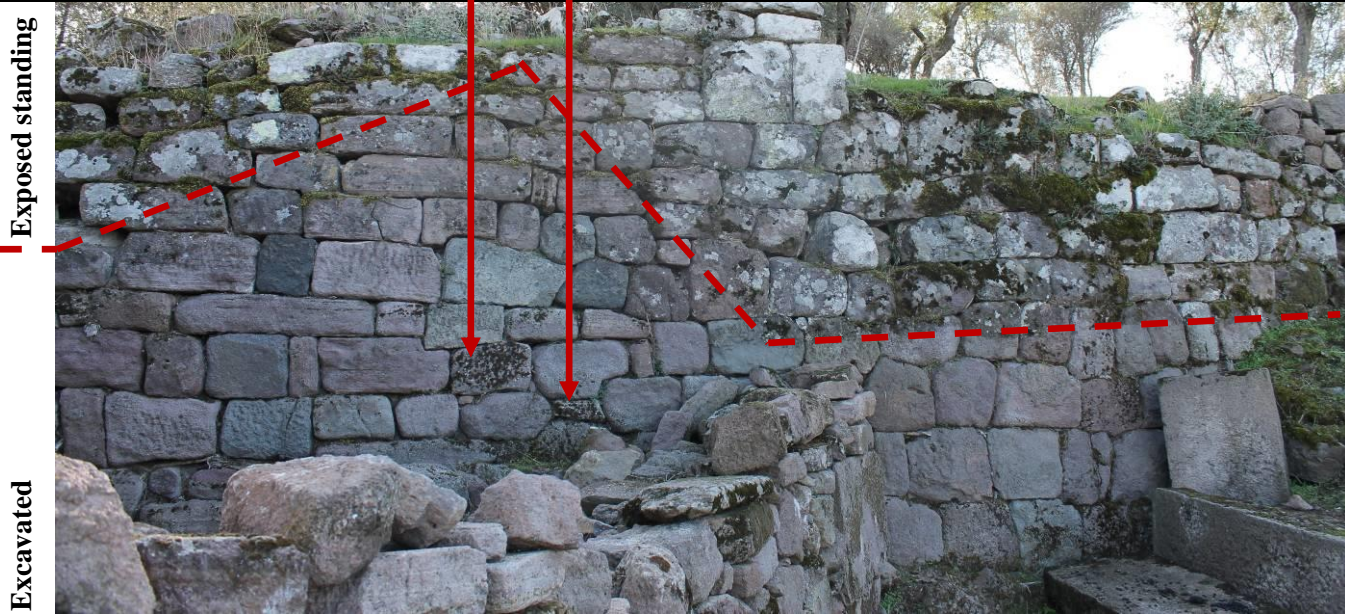
<p>Excavated</p>
<p>Definition</p>	<p>Iron Gate: Partially excavated in 2005 and 2006. <i>Visible deterioration:</i> Biological growth on the excavated parts of the wall is observed.</p>

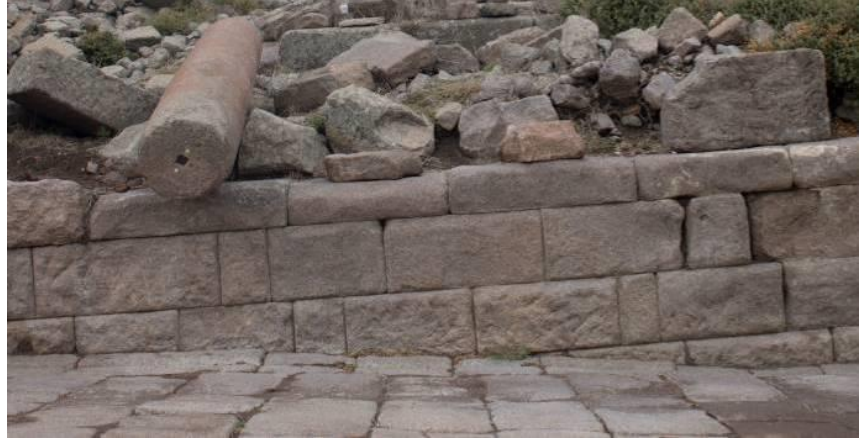
<p style="writing-mode: vertical-rl; transform: rotate(180deg);">Definition</p>	<p>Fortification wall: Exposed standing. <i>Visible deterioration:</i> Deterioration of the andesites was not observed.</p>		<p>Gymnasium wall: Completely excavated in 2014. <i>Visible deterioration:</i> Deterioration of the andesites was not observed.</p>

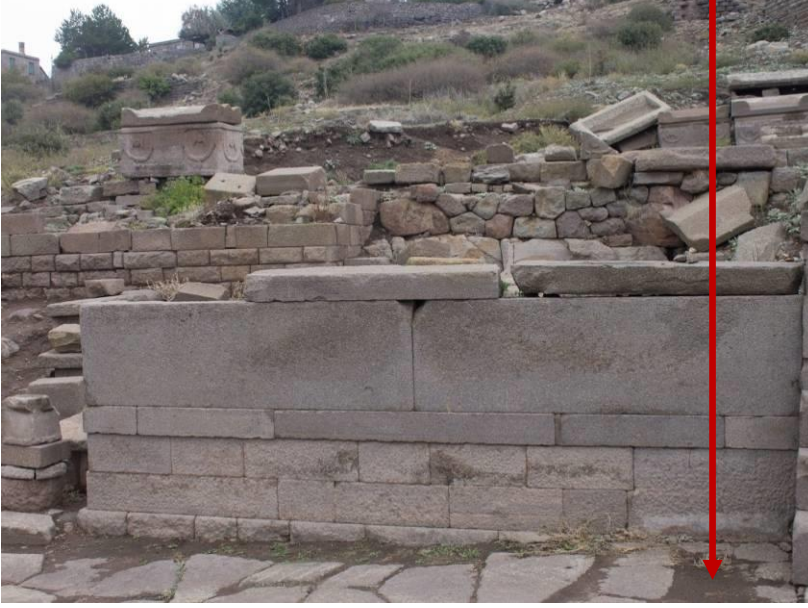
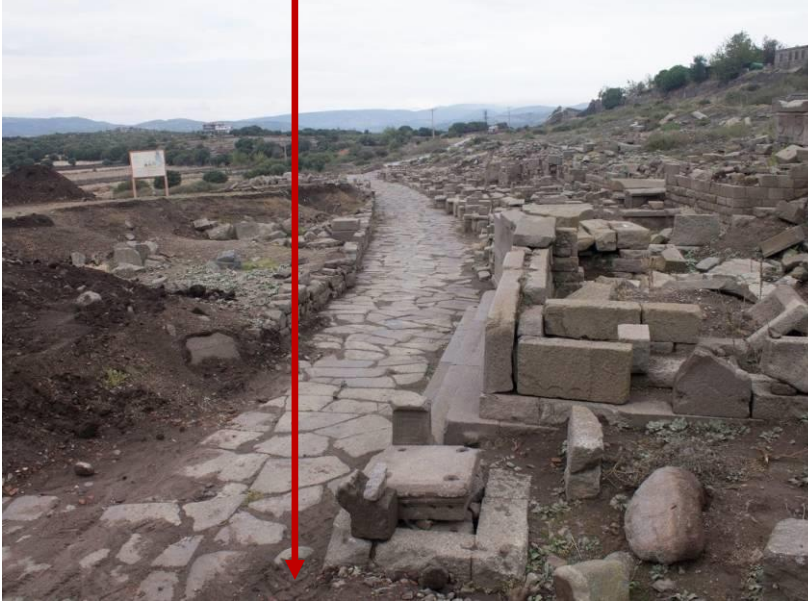
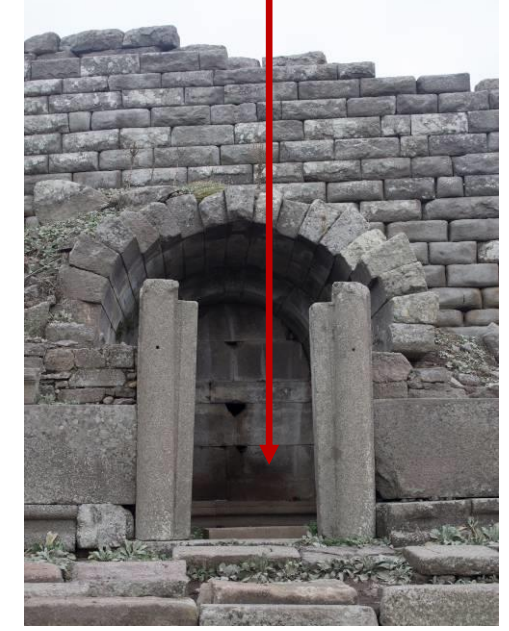
<p>Definition</p>	<p>Necropolis: Completely excavated between 2008 and 2014. <i>Visible deterioration:</i> Loss of andesite street floor coverings is observed.</p>		<p>Monumental tomb: Exposed standing. <i>Visible deterioration:</i> Wet andesite surfaces are observed.</p>

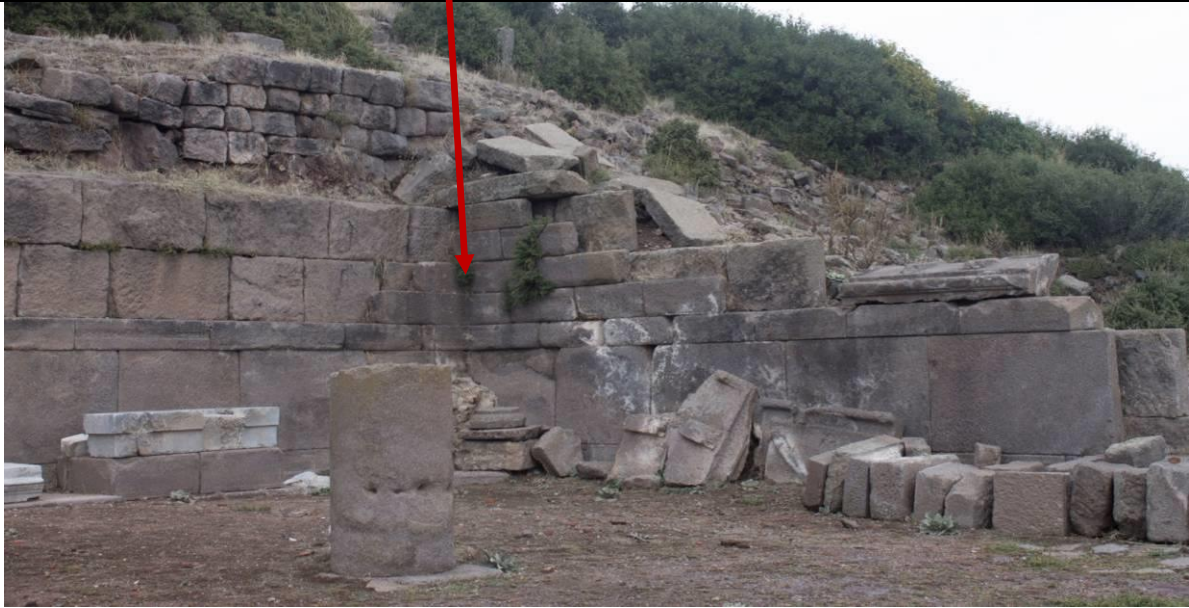
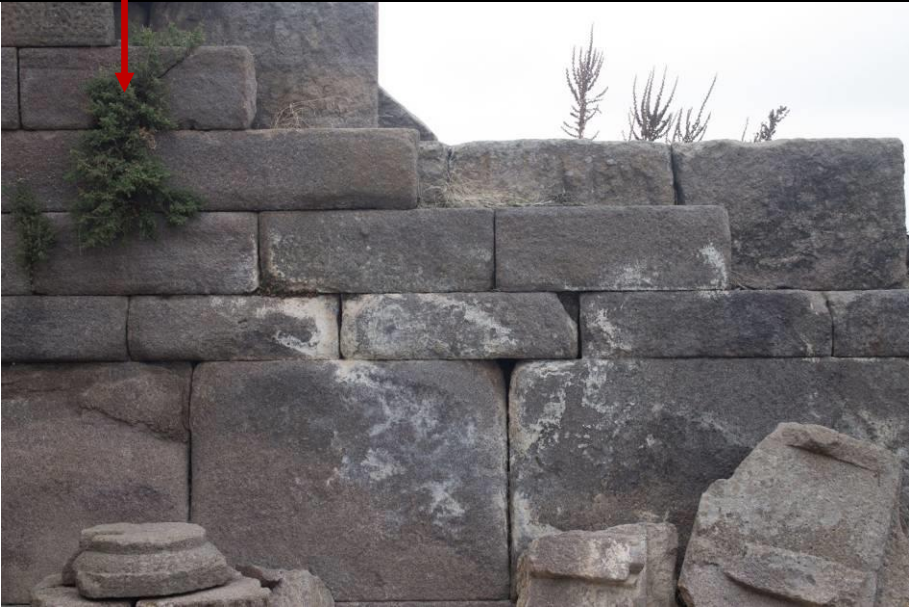
Definition	<p>Bouleuterion: Completely excavated between 2009 and 2013. <i>Visible deterioration:</i> Biological growth on the excavated parts of the wall is observed.</p>

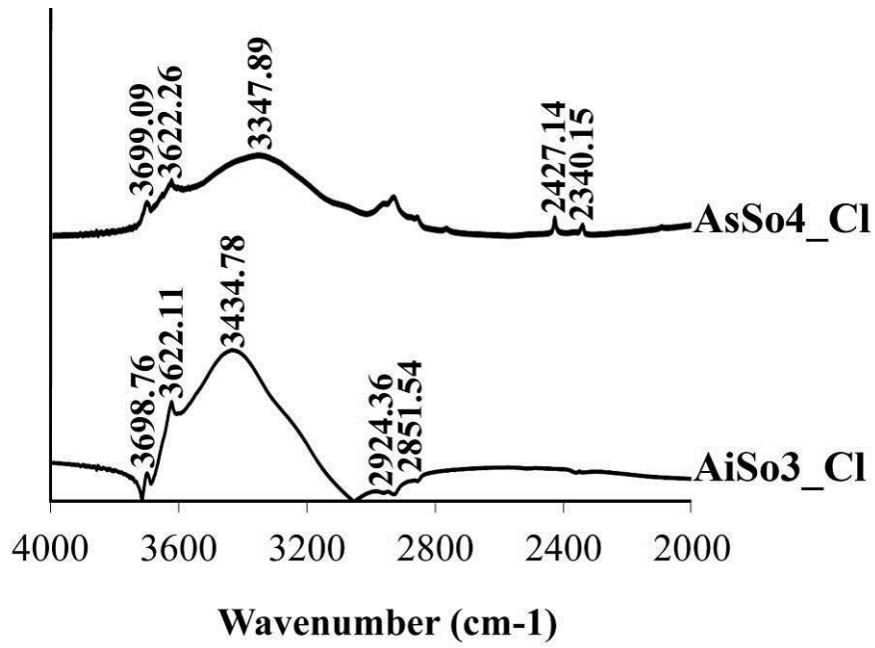
Figure 3.1. FT-IR spectrum of clay fraction of AiSo3 and AsSo4

During burial, clays in the soil structure increase water retention of the subsoil environment and thus chemical deterioration rate increase (Thorn et al. 2002). Besides, they constitute appropriate environment for biological formations which have both physical and chemical effects on the stones as previously mentioned (Press and Siever 2002, Chen et al. 1999). Hence, presence of clay minerals in the soil structure may be one of the reasons of andesite deteriorations during burial. Their presence may also be effective in the generation of biological forms on the andesite surfaces after their excavations as mentioned in visual analysis part.

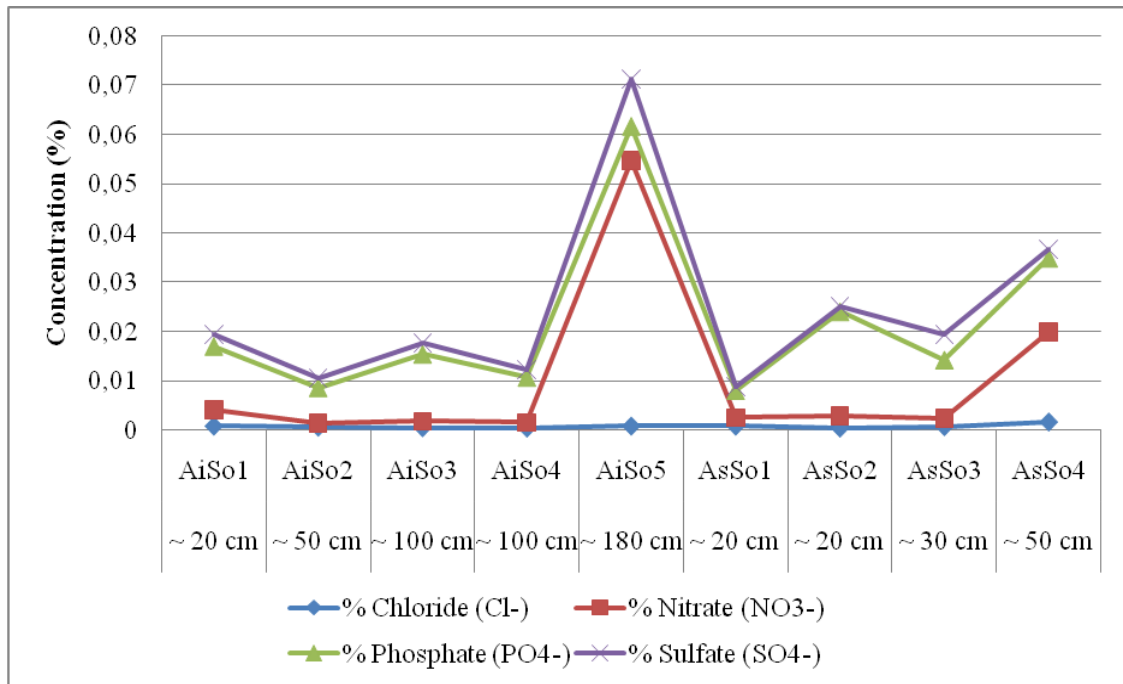
Figure 3.6. % Soluble salt contents of the soil samples

The results of the IC analyses show that studied soil samples which were collected from Aigai and Assos archaeological sites contain trace amounts of soluble salts (Figure 3.6, Appendix A). Although Assos is a coastal archaeological site, soil samples collected from Assos contain trace amounts of soluble salts either. Thus, the results of the analyses show that the soluble salts may be less effective in the deterioration of buried Aigai and Assos andesites.

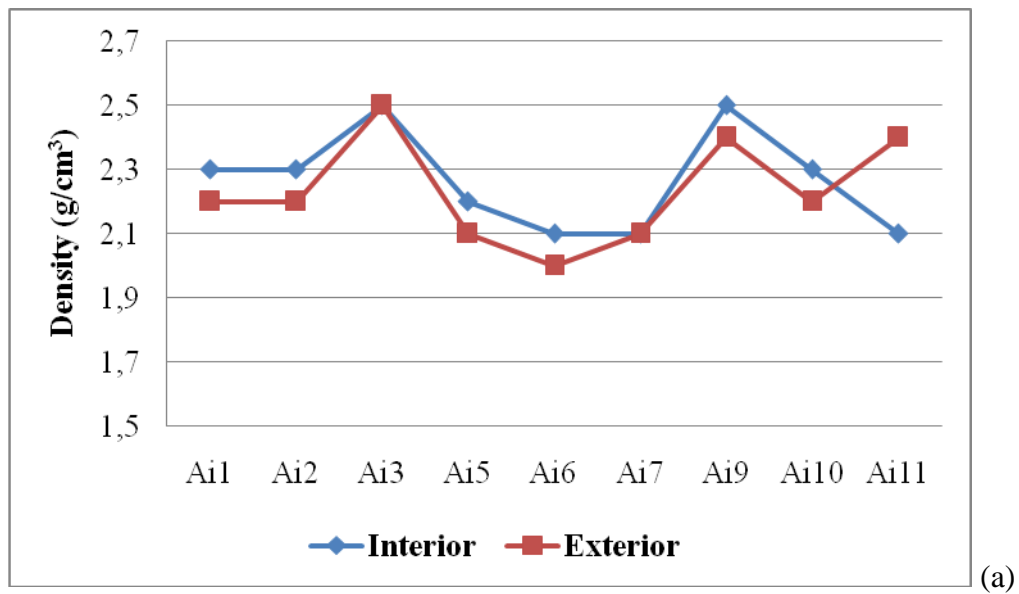
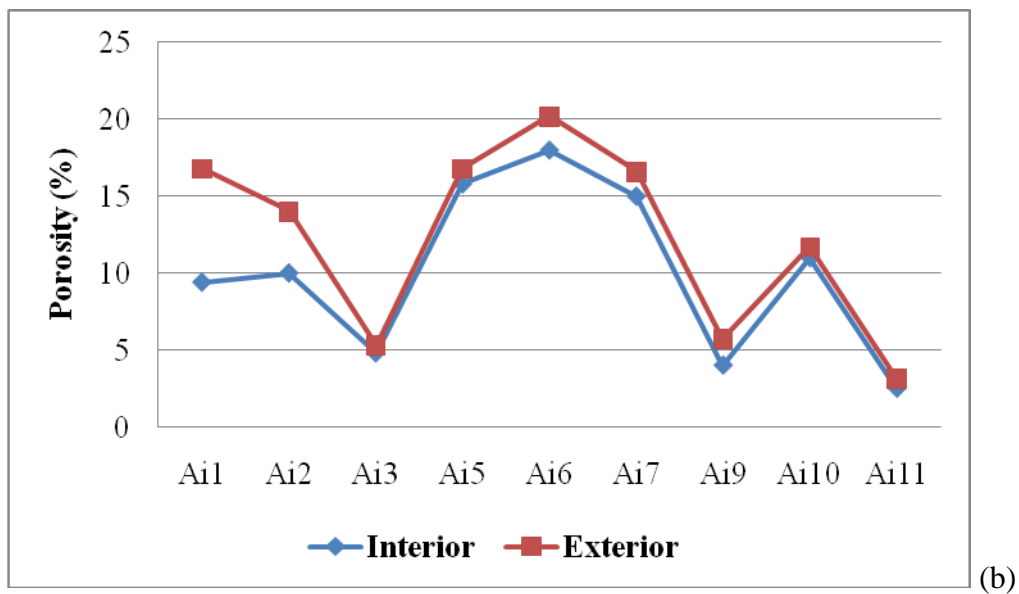
Figure 3.7. Density (g/cm^3) (a) and porosity (%) (b) values of Aigai Andesites

B). Higher porosity and lower density values of the exterior parts of the stones resulted from the crack and pore formations in the stone structures as a physical deterioration and results in the decrease of the stone strength (Jaeger and Cook 1979, Brady and Brown 2004, Arıkan et al. 2007).

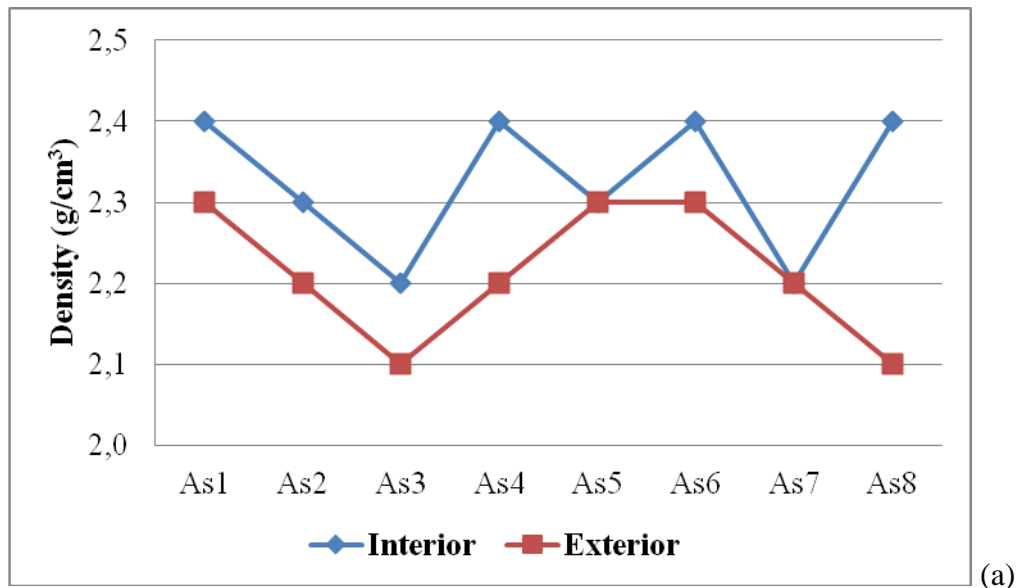
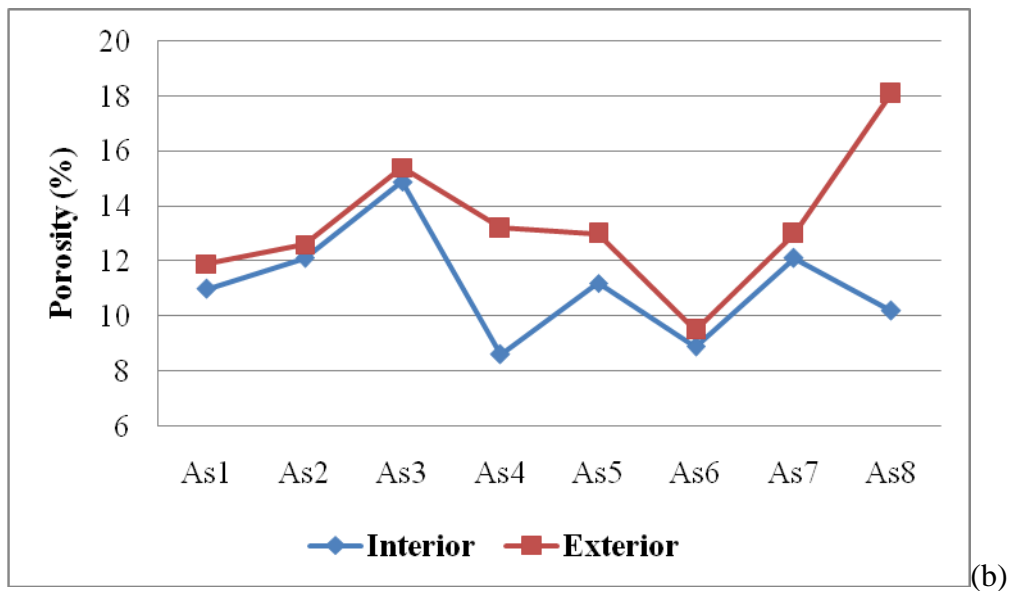
Figure 3.8. Density (g/cm^3) (a) and porosity (%) (b) values of Assos Andesites

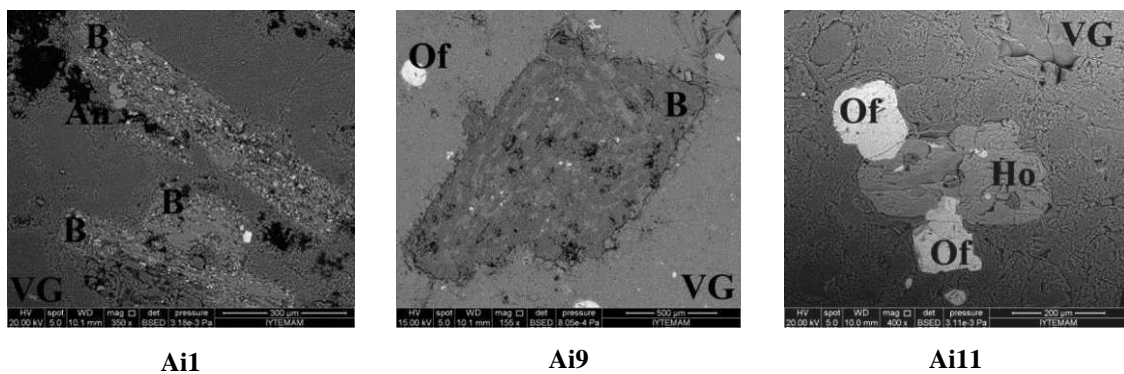
Figure 3.9. BSE images of the minerals in the interior parts of Aigai andesites (VG: volcanic glass, B: biotite, Ho: hornblende, Of: orthoferrosillite)

With the stone-forming minerals, volcanic matrix with the glassy phase of the andesites was also observed in all the samples (Figure 3.9, Figure 3.11, Figure 3.13, Figure 3.14).
