**INVESTIGATION OF THE DETERIORATION
PROBLEMS OF EXCAVATED ANDESITE
MONUMENTS IN ARCHAEOLOGICAL SITES FOR
THE PURPOSE OF CONSERVATION**

**A Thesis Submitted to the
the Graduate School of Engineering and Sciences of
İzmir Institute of Technology
in Partial Fulfillment of the Requirements for the Degree of**

**by
Çağlayan Deniz KAPLAN**

**July 2015
İZMİR**

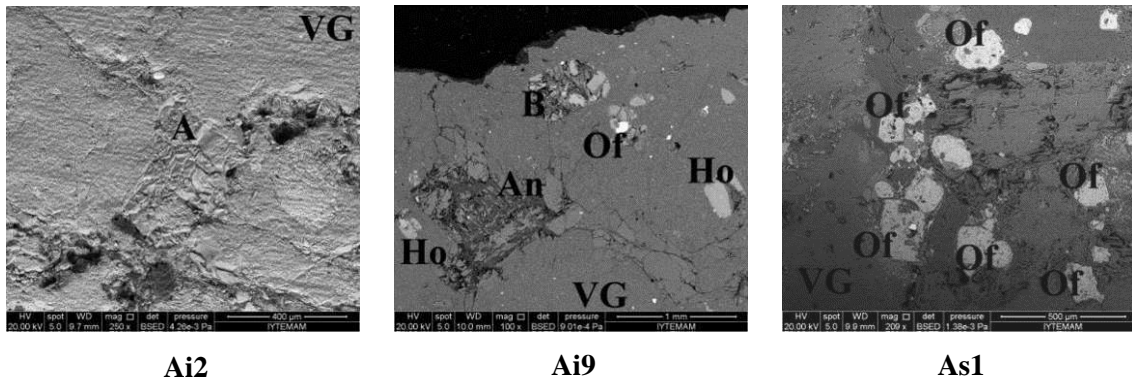
Figure 3.13. BSE images of the single mineral grain observed in Ai2, twinning minerals in Ai9 and oscillatory zoning observed in As1 (VG: volcanic glass, A: albite, B: biotite, Ho: hornblende, Of: orthoferrosillite)

With the stone-forming minerals, volcanic matrix with the glassy phase of the andesites was also observed in all the samples (Figure 3.9, Figure 3.11, Figure 3.13, Figure 3.14).

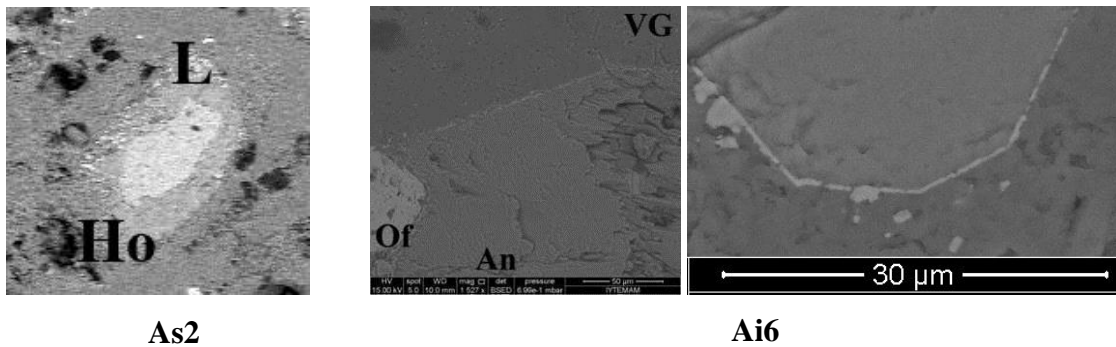
Figure 3.14. BSE images of the corona mineral texture of As2 and Ai6 (VG: volcanic glass, An: andesine, L: labradorite, Ho: hornblende, Of: orthoferrosillite)

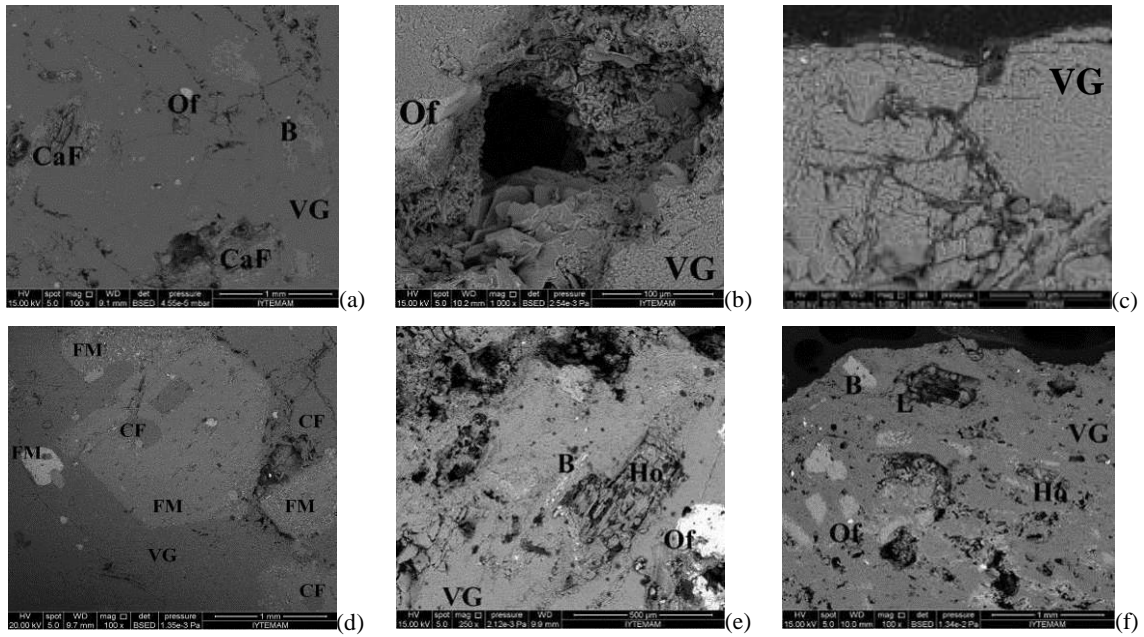
B: Biotite, CaF: Calcium Feldspar, L: Labradorite, Ho: Hornblende,
Of: Orthoferrosilite, VG: Volcanic Glass

Figure 3.15. SEM images of pore formation and micro-cracks of exterior parts of Ai1 (a), Ai2 (b) (c), Ai6 (d), Ai8 (e) and Ai9 (f)

The comparison of microstructural characteristics of interior and exterior parts of the andesites, which was analyzed with SEM analyses show micro-cracks ($\leq 55 \mu\text{m}$) and pore formation in the stone structures by the deterioration of stone forming minerals and volcanic glass as matrix (Figure 3.15, Figure 3.16). Supporting the results of basic physical property analyses, density of the pores and micro-cracks are higher in the sections close to the surface of the stones and they decrease through the inner parts.

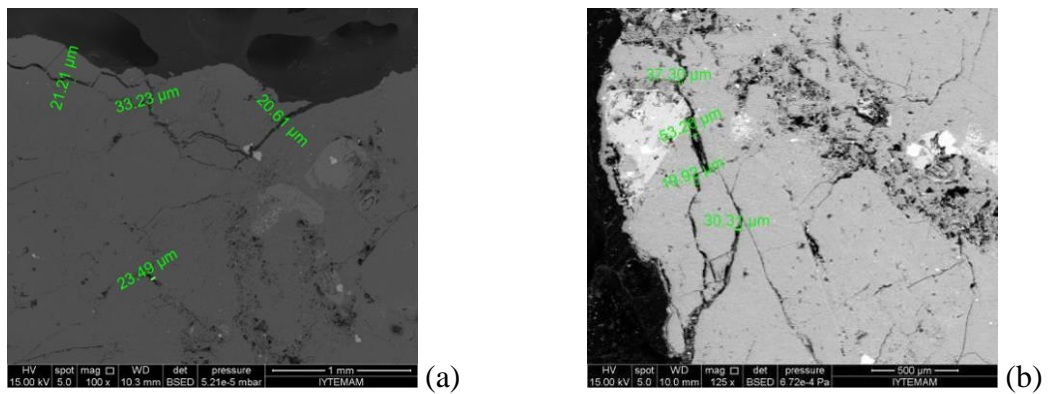
Figure 3.17. BSE images with the dimensions of the cracks observed on Ai1 (a) and As4 (b)

For both Aigai and Assos andesites, the widths of the micro-cracks change between 10 and 55 μm (Figure 3.17). As micro-crack dimensions, the widths of the pores have a great variety changing between 100 μm and 2.5 mm. Having the larger mineral grains, the pores of Assos andesites are larger than the ones of Aigai. While the largest pores observed in Aigai andesites are approximately 1.3 mm (Ai1, Ai11), it increase to 2.5 mm in Assos andesites (As5) (Figure 3.18).

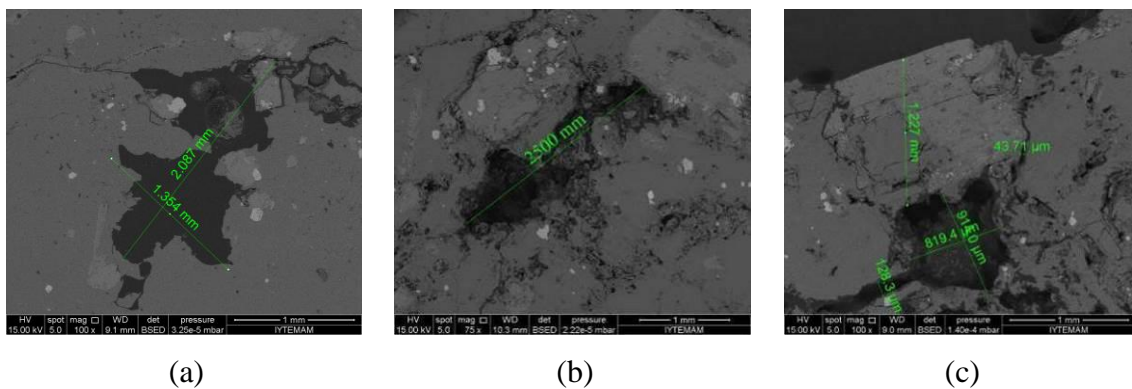
Figure 3.18. BSE images with the dimensions of the pores observed on Ai11 (a), As5 (b) and As7 (c)

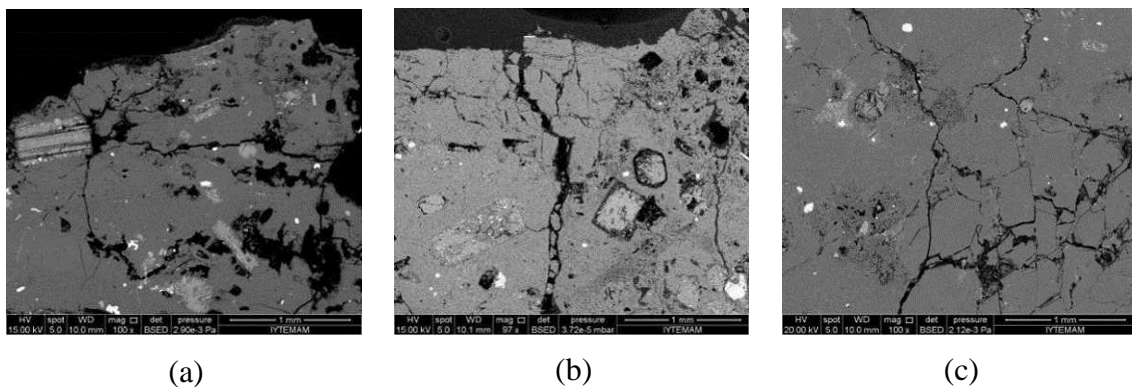
Figure 3.19. BSE images of the cracks observed on Ai2 (a), As3 (b) and As6 (c)

Physical deterioration of the samples was observed by the examination of the andesite sections from their surfaces through interior parts by SEM. As a technical constraint of the SEM, the sections which are longer than 5.3 cm could not analyzed. Visual observation of the combined BSE images of the andesite sections also show the presence of micro-cracks and pore formations in the interior parts of the samples (Figure 3.20, Figure 3.21). As determined in the sections close to the andesite surfaces and mentioned above, micro-crack formations are also generally seen around the mineral boundaries and through the interior parts of the andesites in the interior parts either.

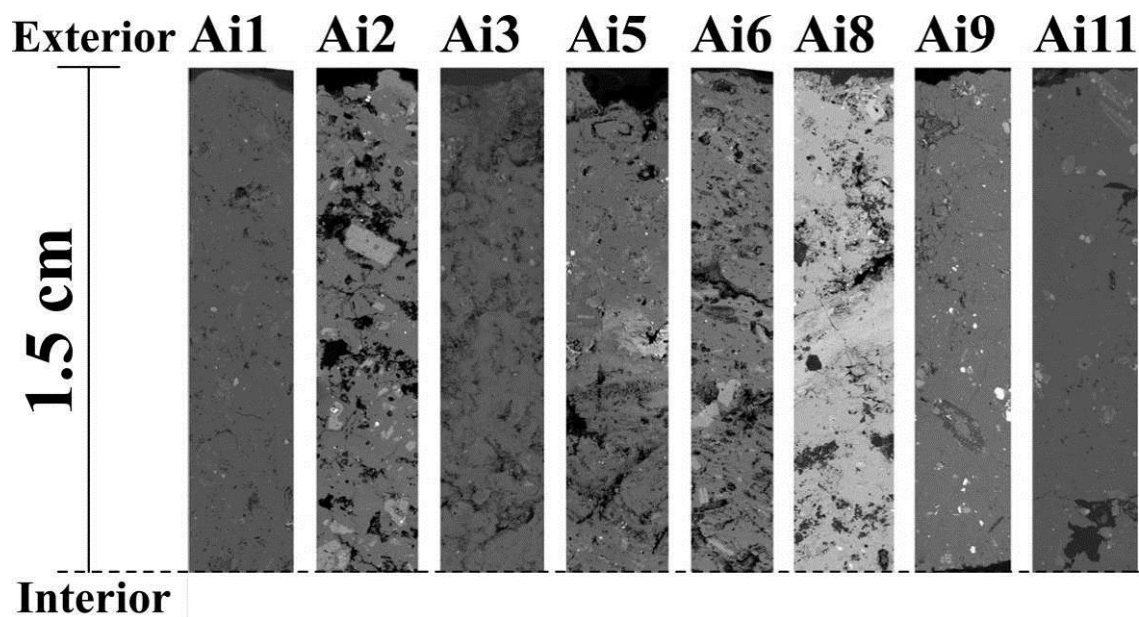
Figure 3.20. BSE images of Aigai andesites from surfaces to the inner cores

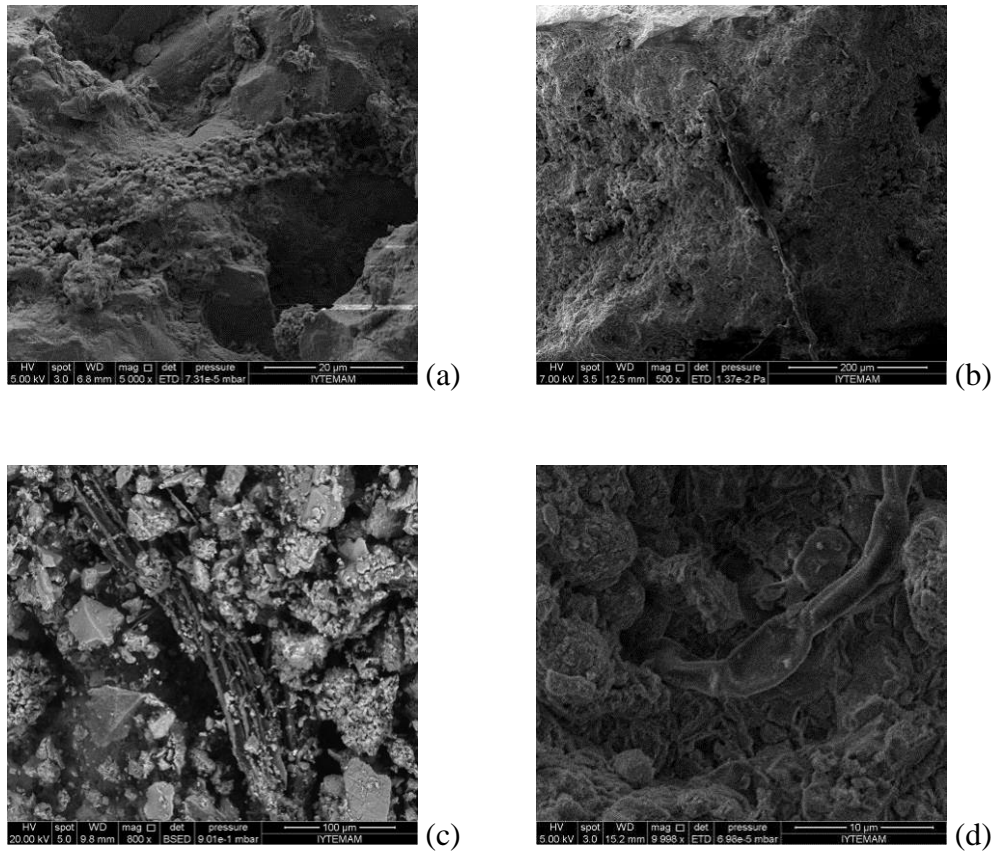
Figure 3.25. SEM images of hyphae observed on Ai2 (a), Ai3(b), As5 (c) and As8 (d)

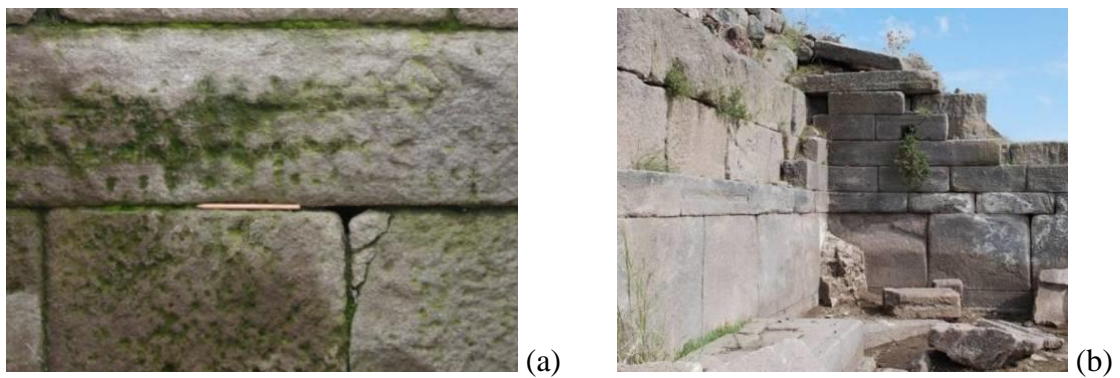
Figure 3.26. Biological forms observed on the walls of bouleuterion of Aigai (a) and stoa Assos (b)

As supported with the experiments, both in Aigai and Assos, biological formations in micro and macro scale can be seen on the excavated stone surfaces (Figure 3.26, Table 3.3, Table 3.4). The comparison of the photographs taken in 2010 and 2014 in Aigai and Assos archaeological sites also show the generation of biological forms on the andesite surfaces and loss of stone materials resulted from the presence of clay minerals and water as mentioned before (Table 3.3, Table 3.4).

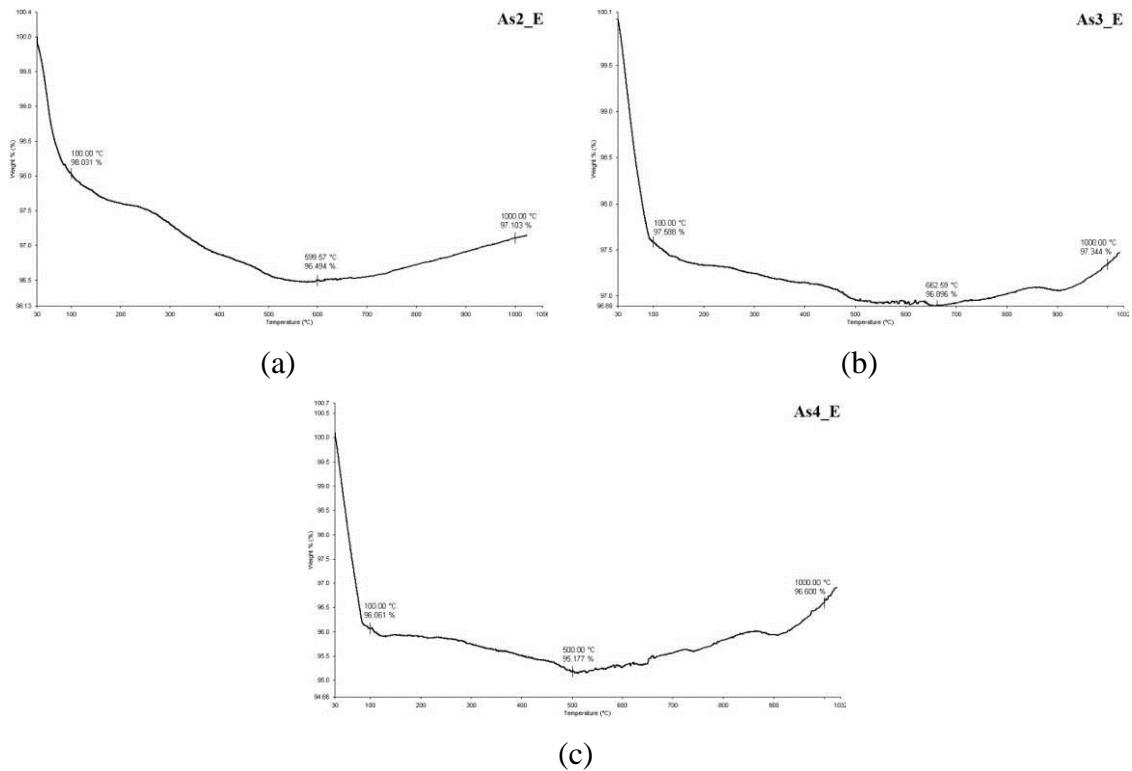
Figure 3.36. TGA graphs of exterior surfaces of As2 (a), As3 (b) and As4 (c)

The analysis for the average values of the organic material proportions shows low amounts of organic material values for both Aigai and Assos andesites. Organic material content is lower than 2.62 % and 2.24 % for Aigai and Assos andesites respectively (Figure 3.34, Appendix C). TGA curves of the stone samples show similar weight losses on the whole. The weight losses of the first and second period samples within a temperature range from 25°C to 550°C are 3.27, 1.71 and 2.74 % respectively for the exterior parts of Aigai andesites and 3.51, 3.1 and 4.8 % for the exterior parts of Assos andesites (Figure 3.35, Figure 3.36, Appendix C).

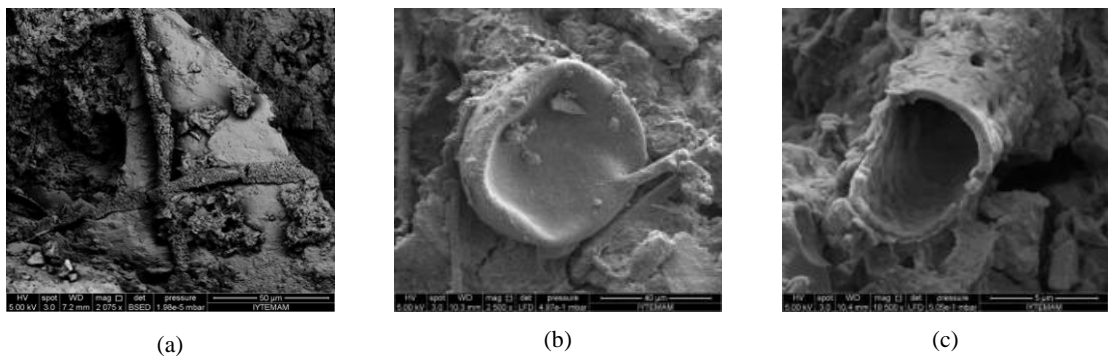
Figure 3.37. SEM images of organic materials on the surface of Ai2 (a) and Ai5 (b) (c)

The presence of organic materials was observed on the andesite surfaces by SEM analysis (Figure 3.37, Figure 3.38). Thus, although the amounts of organic materials in both Aigai and Assos andesites are low, their presence may have affected the deterioration of the andesites. Because they promote chemical deterioration by increasing acidity on the andesite surfaces and also physical deterioration by hyphae penetration through the voids of the stones (Chen et al. 1999, Cronyn 2002, Mortatti and Probst 2003)

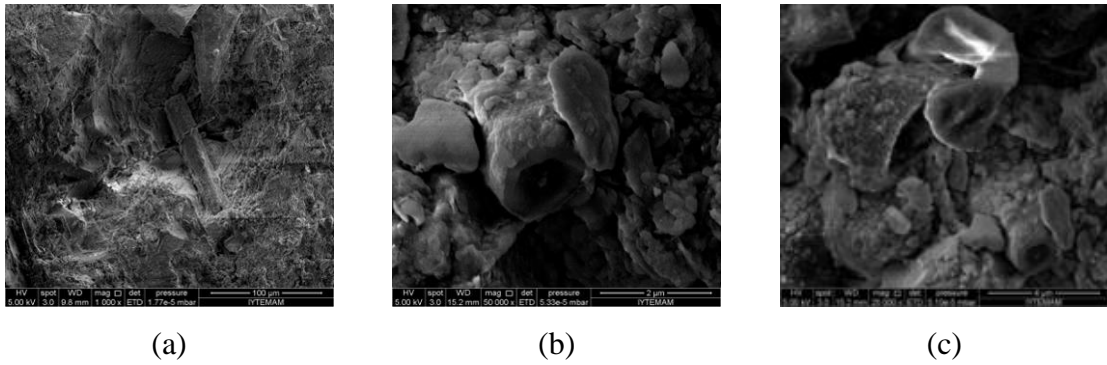
Figure 3.38. SEM images of organic materials on the surface of As7 (a) and As8 (b) (c)

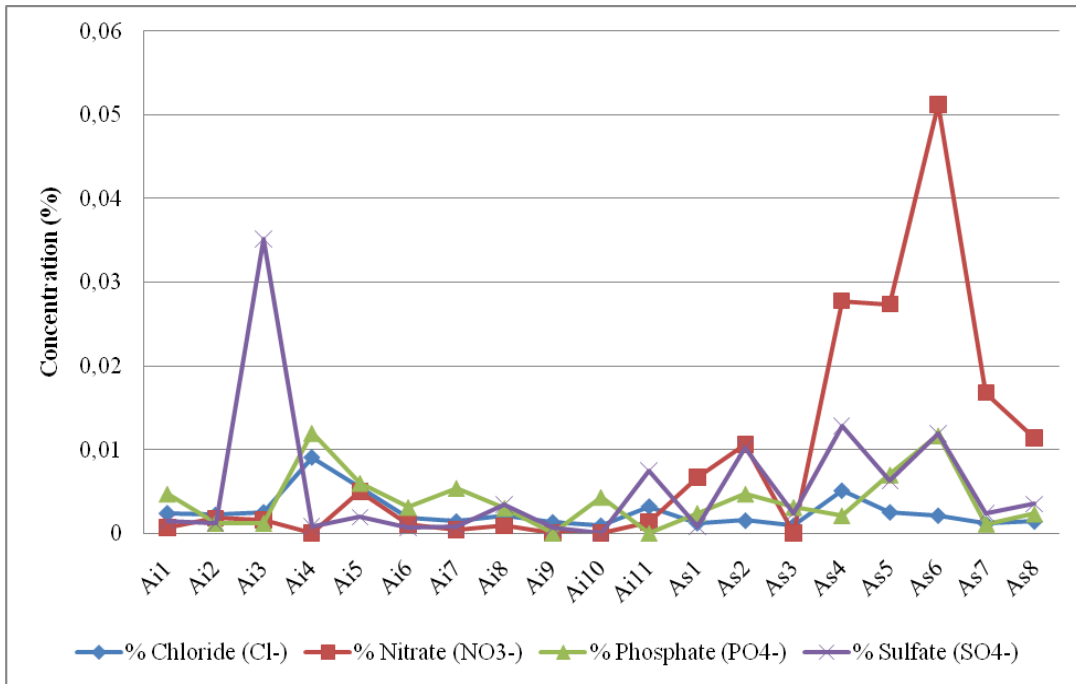
Figure 3.39. % Soluble salt contents of the andesite samples

Assos is a coastal archaeological site, soil samples collected from Assos contain trace amounts of soluble salts either. Thus, the results of the analyses show that the soluble salts are less effective in the deterioration of buried Aigai and Assos andesites.

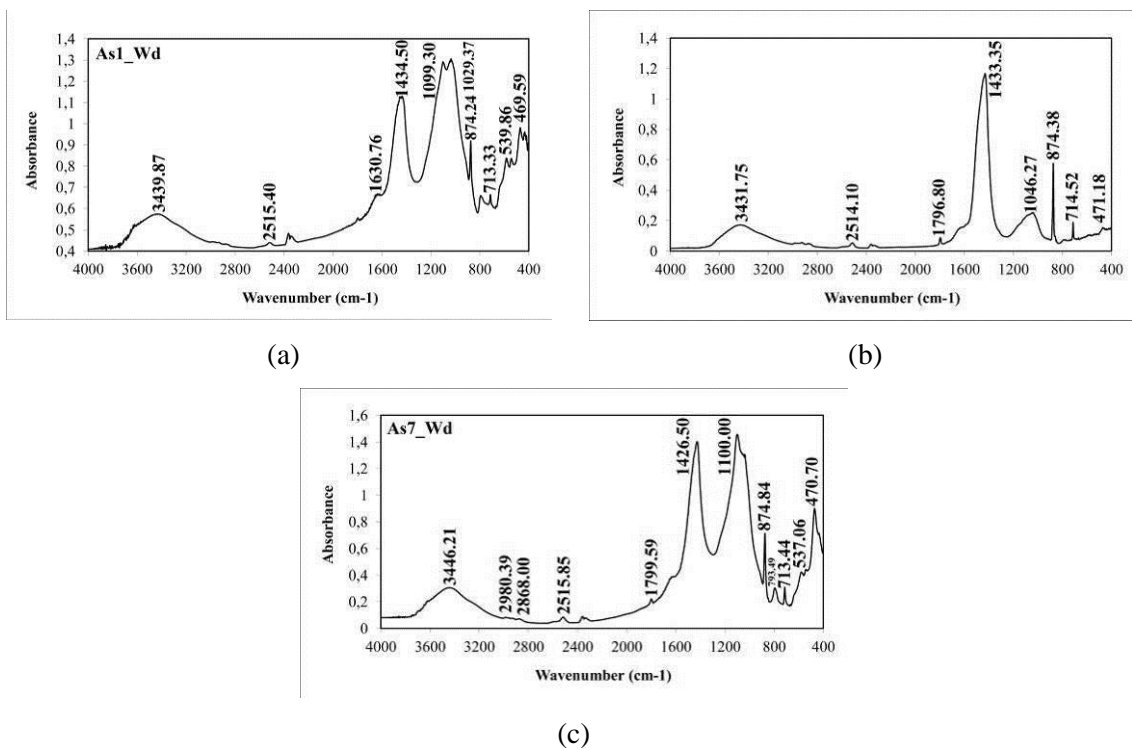
Figure 3.43. FT-IR spectra of white deposits of Assos: 1 (a), 2(b) and 7 (c)

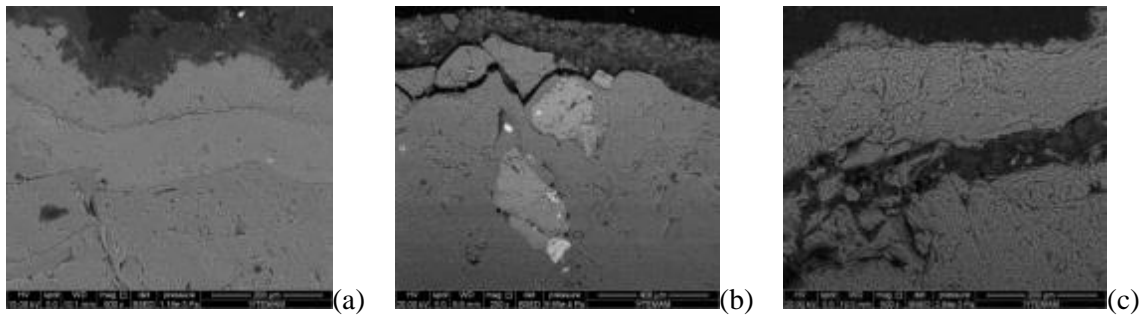
Figure 3.44. SEM images of white deposits of stone sections: Ai2 (a), Ai11 (b) and As1 (c)

Microstructural analyses of insoluble white deposits were carried out by SEM analysis of andesite sections and surfaces. SEM analyses of the sections show that the deposition is formed only on the surface of the andesites. The formation could not be observed interior parts of the studied andesites (Ai1, 2, 9, 11 and As1, 2 and 7) (Figure 3.44). This may be because of the movement of the calcium bicarbonate ions to the surface of the andesites and precipitation of the CaCO_3 layer on the andesite surfaces, which will be explained in more detail in the following parts. Thickness of the deposition is between 15 μm (Ai9) and 300 μm (Ai11) for Aigai andesites and 10 μm (As2) and 50 μm (As1) for Assos andesites.

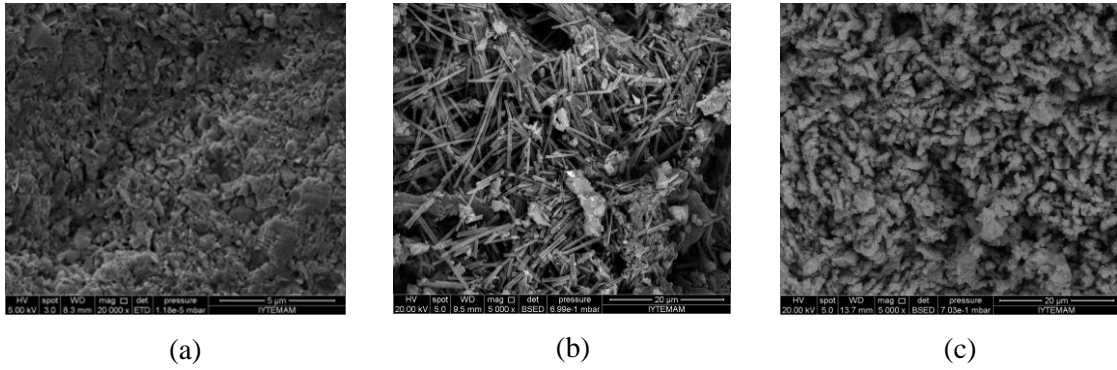
Figure 3.45. SEM images of white deposits of Ai2 (a), Ai9 (b) and Ai11(c)

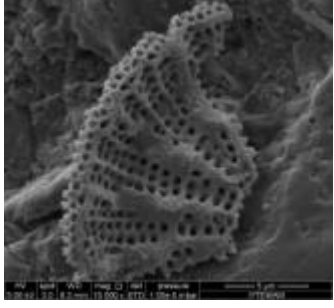
Centric	Cylotella	Deteriorated diatom sample.
Ai9

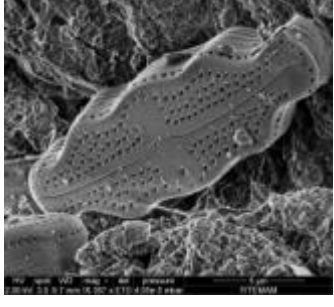
Pennate	Naviculoid	–
Ai9

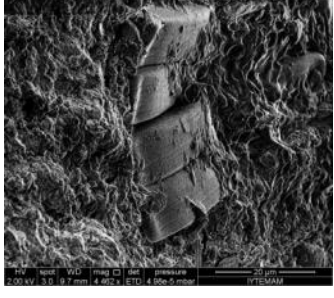
Pennate	Eunotia	–

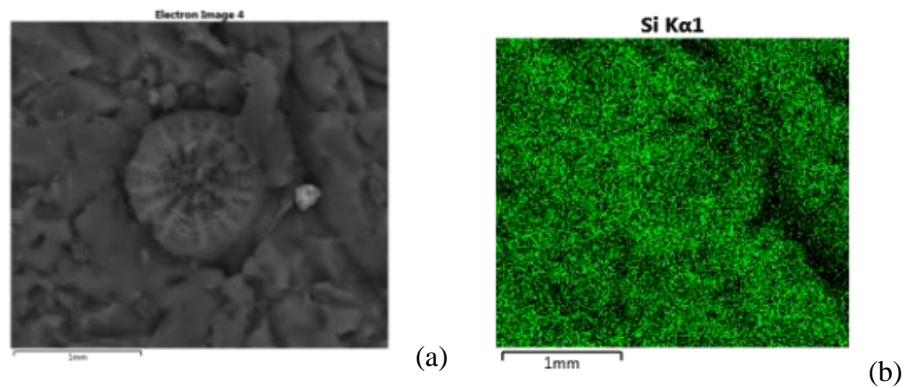
Figure 3.53. Diatom specie observed in Ai11 (a) and mapping of the diatom based on chemical composition (b)

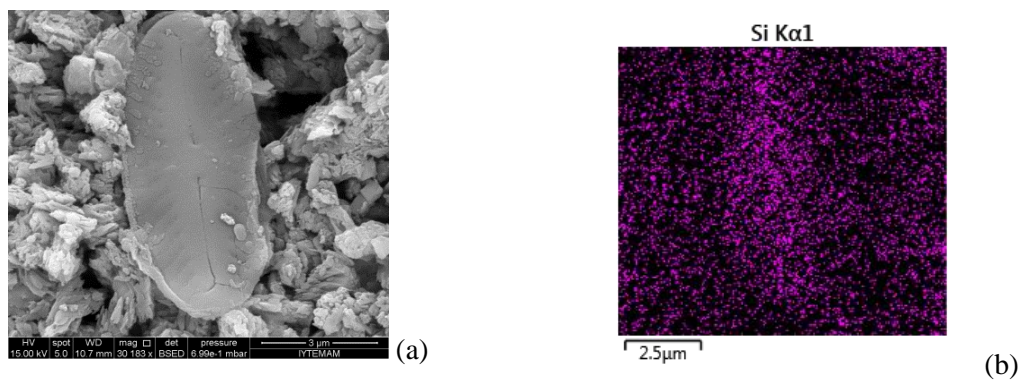
Figure 3.54. Diatom specie observed in Ai2 (a) and mapping of the diatom based on chemical composition (b)

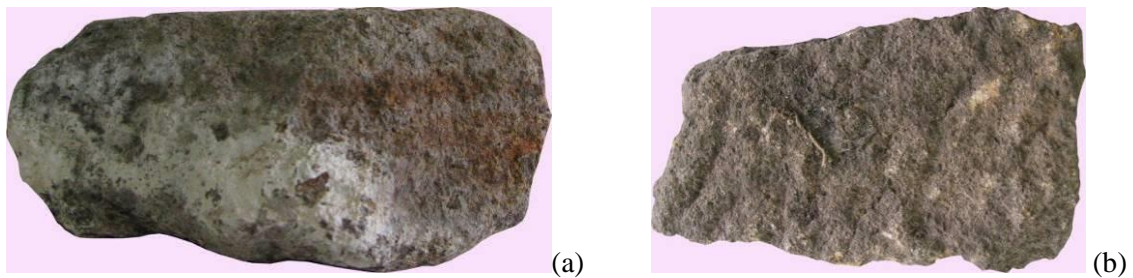
Figure 3.55. Orange-brown deposits on Ai1 (a) and Ai6 (b)

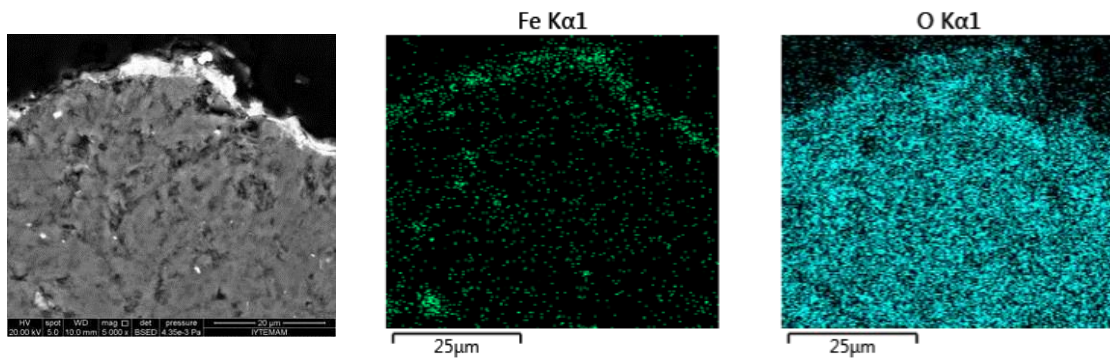
Figure 3.57. Mapping of Ai6 based on chemical composition
