# Thermal Analysis of the Domed Vernacular Houses of Harran, Turkey

Tahsin Başaran

Department of Mechanical Engineering, Dokuz Eylül University, Bornova, İzmir, Turkey

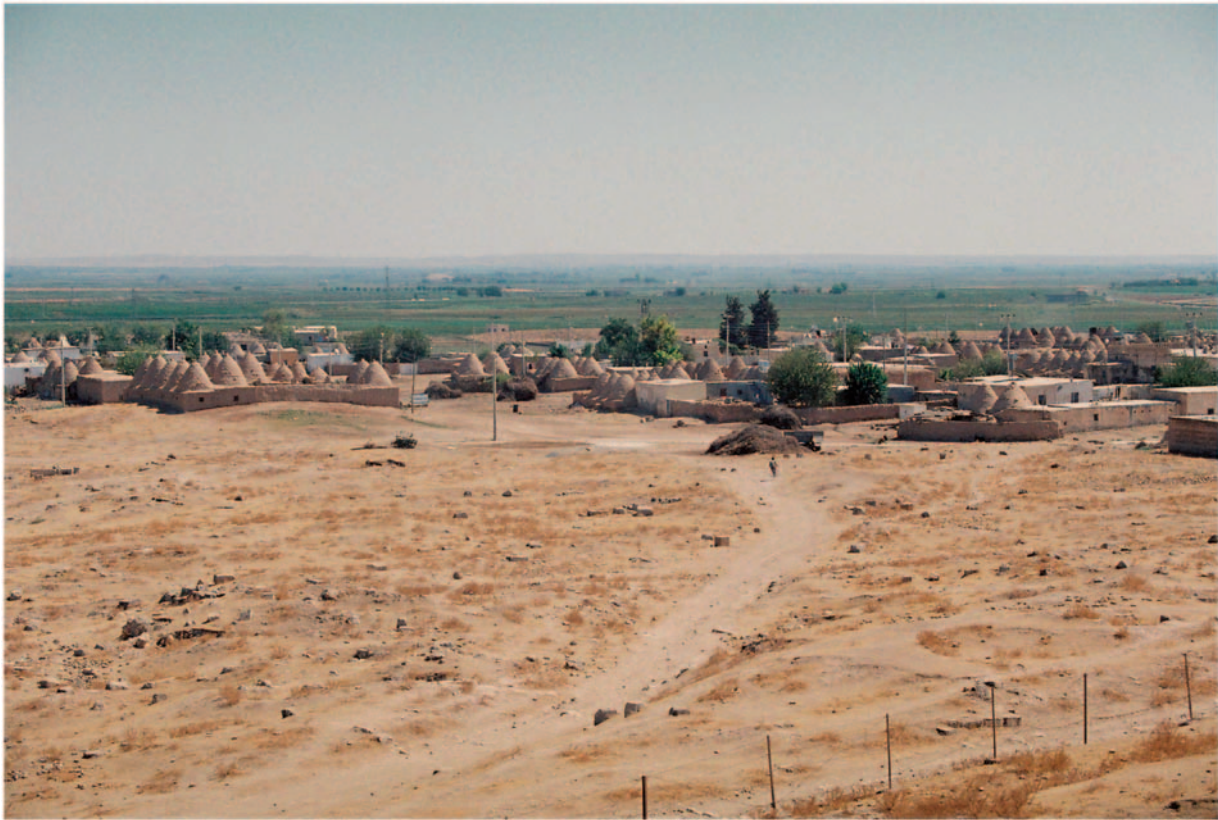
**Fig. 1.** A part of Harran town with domed houses.

level, which is the lowest among the lowlands in the region. The town of Harran (Figure 1) is surrounded by 5-m high ancient city walls approximately 4.5 km long, which are in rather good condition. Inside the city wall, there are two wards of domed houses which were built in [7]. The main distinguishing feature of these houses is the dome, which is constructed by means of overlapping bricks. The average wall thickness of Harran houses is around 50–60 cm, and they are built out of stone, brick, and mud for mortar. The dome is usually 20–30 cm thick with an opening at the top. The opening provides natural ventilation/air circulation inside the house, and the thick-walled structure both thermal insulation and storage. These special features provide relatively good indoor conditions during the year.

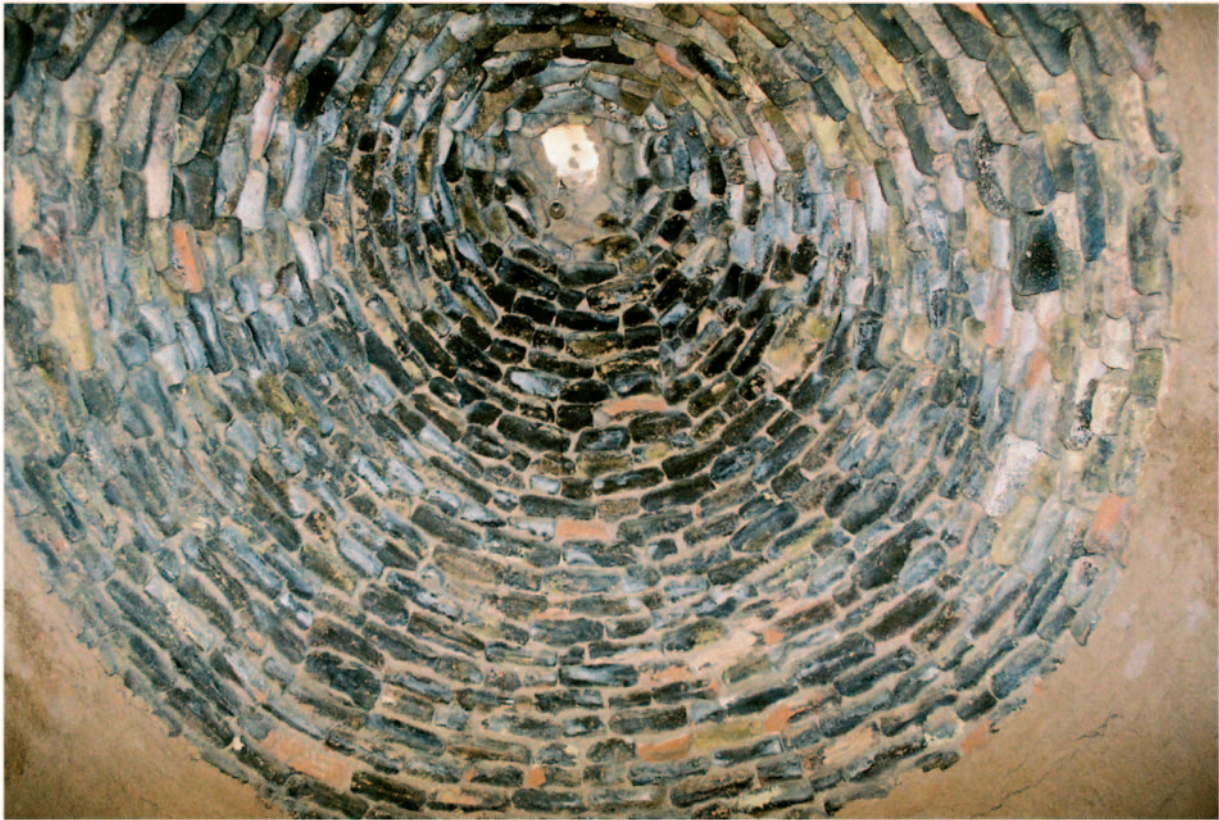
**Fig. 2.** Internal view of the dome in a Harran house.

filled up using randomly sized rubble. On top of the masonry base, a parabolic cone was erected in overlapping brick recycled from ancient ruins joined by a black sand mortar (Figure 2). Plaster is used only at the bottom part of the cone, approximately to a height of 0.5 m, and the upper part of the cone is left without plaster. The outside is completely plastered. Approximately, 1650 bricks were used for the cone of the domed house. The number of bricks required would depend on the height of the house which could vary between 3.5 and 5 m. A hole of about 20 cm diameter is left at the top of the dome, where a simple “roof” over the hole is constructed using bricks to provide protection against rain. Usually, the domed units are connected to each other by means of brick arches which link one space to the other in creating the planimetric layout of the house.

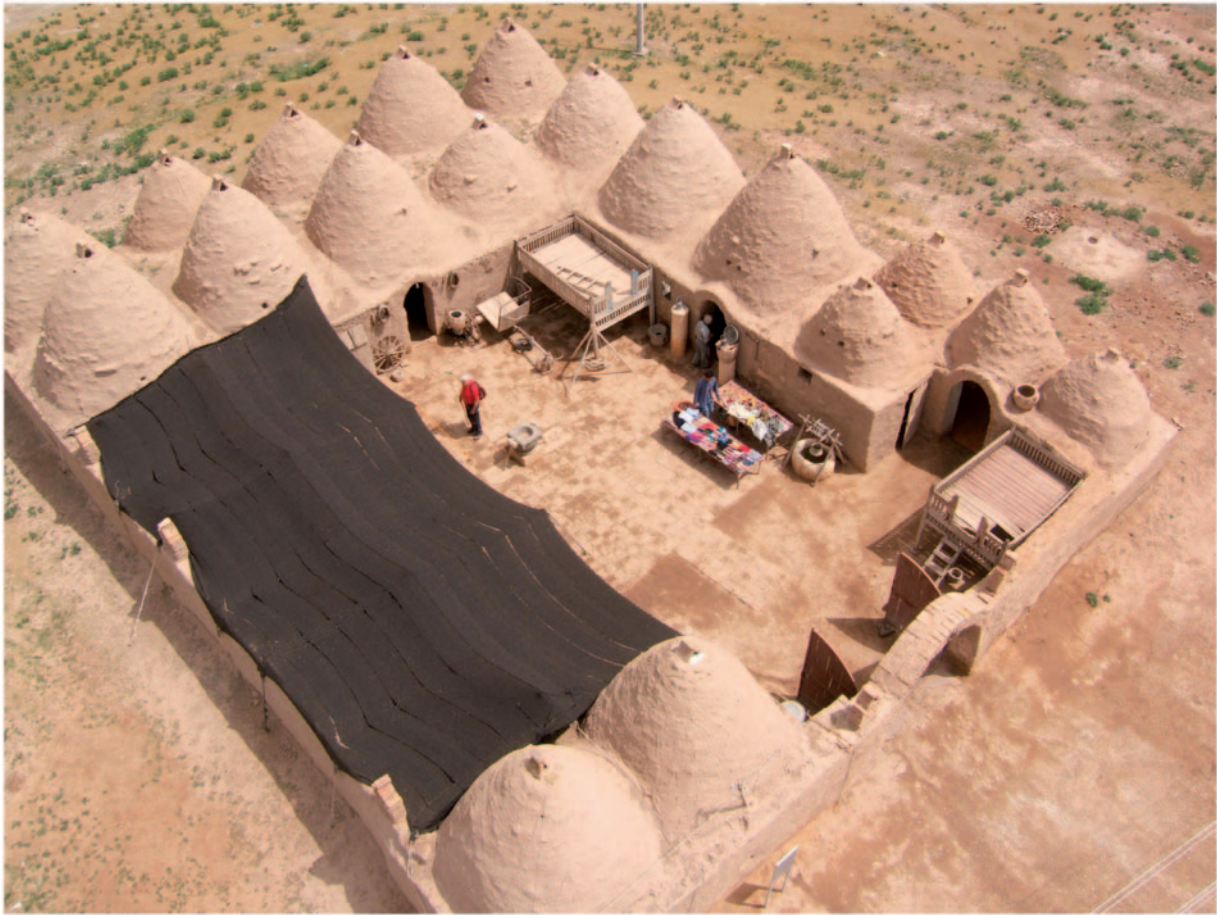
**Fig. 3.** Halil Özyavuz Harran House.

A domed house complex named “Halil Özyavuz Harran House” was chosen for the experimental study after carrying out a pre-research in Harran town centre (Figure 3). This house complex, approximately 210 years

Two SATO SK-L200THIII $\alpha$  data loggers were also used for recording inside and outside temperatures and relative humidity. One of them was located in the courtyard in the shadow under a tent (Figure 3), and the other recorded the data in room Number 7 at head height level (indicated using a quadrangle with S in Figure 7). The total uncertainty of the calibrated probes and the data loggers was estimated as  $\pm 1^{\circ}\text{C}$  for the temperature measurements and  $\pm 3\%$  for the relative humidity measurements.

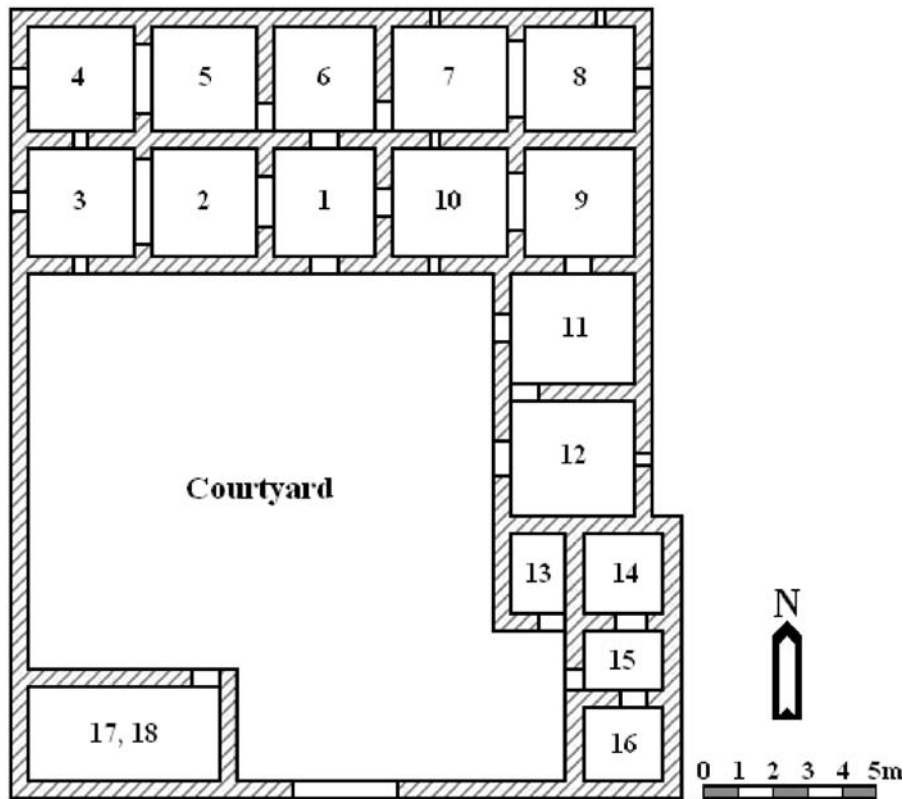
**Fig. 4.** Plan of “Halil Özyavuz Harran House”.

The entrance of the house, located at the south side of the complex, opens to a courtyard, and the domed units are placed on the northern and eastern sides of the courtyard, as shown in Figure 4.

The Number 1 unit is the main entrance where an open fire would be burnt in a  $1 \times 1 \text{ m}^2$  hole of 15 cm depth in winter when necessary (Figure 4). Numbers 2 and 3 are joined by an arch, which constitute the living room (Figure 5). The oldest married son of the family occupies the two domed sections numbered 4 and 5. The storage room is the Number 6 unit and is another connection point to the next section. The domed sections numbered 7 and 8 are used by women. This section was used for the research study. Sections 9 and 10 are utilised as kitchen and connected to number 11 with a door. Two domes numbered 11 and 12 are used by the house owners. Small-sized domes numbered 13–16 are utilised as toilets and baths. Two separated domed sections numbered 17 and 18

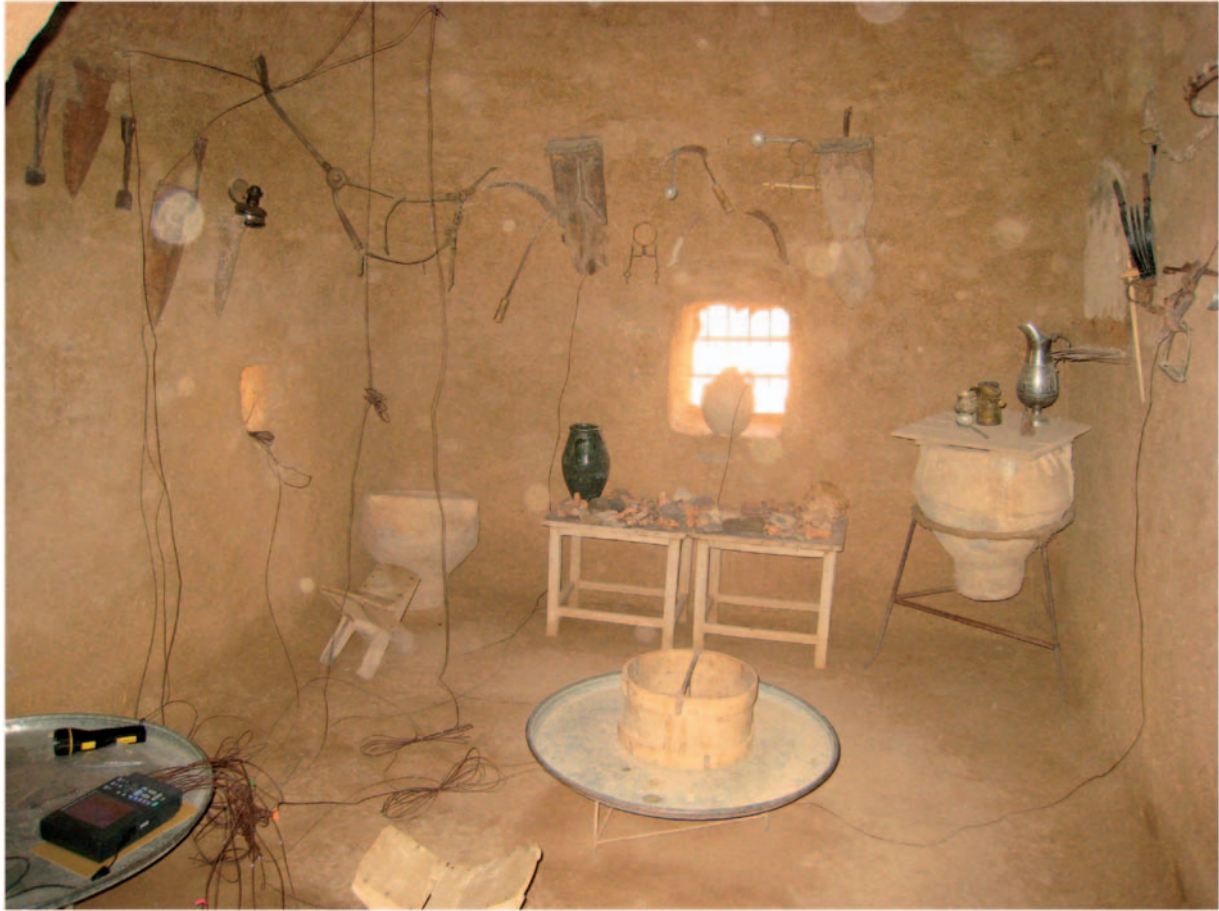
**Fig. 6.** Inside view of the domed house numbered 8 showing some of the placed thermocouples and HIOKI 8421-51 memory hilogger unit.

The domed sections numbered 7 and 8 were the most suitable places to collect the data and were reserved for the research study by the owners. For the thermal analysis, temperatures were recorded on a HIOKI 8421-51 memory hilogger unit using 20 T-type thermocouples (Figure 6). The locations of the thermocouples are shown in Figure 7. Thermocouples numbered 1–6 measured the air temperature inside the two domes at different levels at 2 m (#3 and 6), 3.5 m (#2 and 5), and 5 m (#1 and 4) from the ground. The temperatures of air entering or leaving from the windows and the door were recorded using thermocouples numbered 8–12. Temperatures of different surfaces were measured by thermocouples numbered 13–20. Simultaneously, outside temperature was recorded by thermocouple 7, as indicated in Figure 7. Calibration of the thermocouples was performed using a PT100

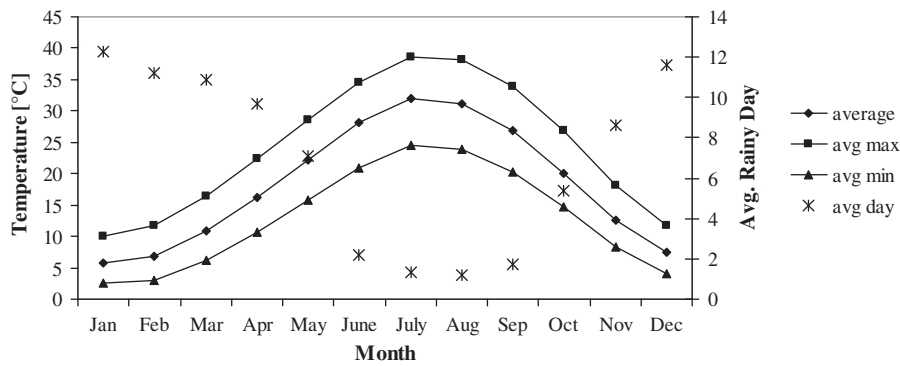
**Fig. 8.** Average temperatures and number of average rainy day variations [10].

Harran lies in a hot-dry climatic zone with a significant temperature difference between day and night in summer time. To investigate the effect of this extreme condition experimentally, data were collected in July, which has the highest monthly average temperature given as 31.9°C (Figure 8) by the Turkish State Meteorological Service [10]. In addition to monthly average temperature values between 1975 and 2006, average minimum and maximum temperatures with average number of rainy days are shown in Figure 8. Since the solar gain is an important factor, the experimental study was started at night time on July 15th, 2008 and completed in the early morning of July 19th [11].

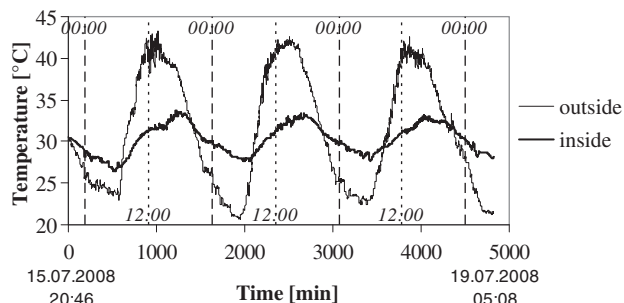
**Fig. 9.** Temperature variations inside and outside of the domed house.

Inside and outside temperature and humidity values were recorded at 2-min intervals using SATO data logger from the 15th of July at 20:46 to 19th of July at 05:08 in 2008. The experimental results are presented in Figures 9 and 10, indicating mid-night and noon periods. The great outside temperature difference between night and day measured in shadows in the courtyard are shown in Figure 9. Although the temperature reached 42°C in the

afternoons and dropped to 22°C approximately at night, the inside temperature was not much affected by these fluctuations; it was observed to change only  $\pm 3^{\circ}\text{C}$  and stayed around 30°C due to the thermal behaviour of the structure. Time difference between the highest and lowest temperature values of the inside and outside is shown in Figure 9. Inside temperature reached its highest value approximately 2h after outside temperature started decreasing. The phase difference was only 1h for the lowest temperature degrees between outside and inside.

possible to stay under the sun, which was very hot during daytime; the indoor conditions were comfortable in the house. On the other hand, although sleeping outside is common in this region, the night time temperatures inside the house was not so high, as seen in Figure 9. Nevertheless, people prefer to sleep outside on a wide and high bed called “throne” with thick quilts because of the respectively cold weather (two of them can be seen in the courtyard in Figure 3), as the first rays of the sun are very effective in waking them up early in the morning.

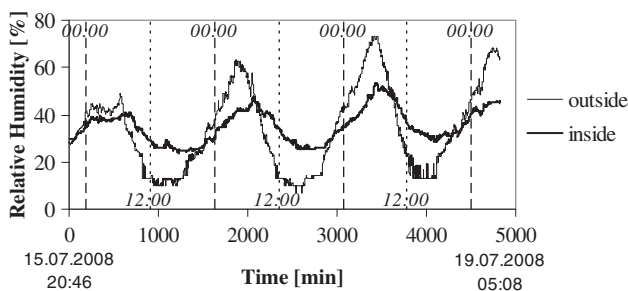
**Fig. 10.** Relative humidity variations inside and outside of the domed house.

Similar behaviour is also shown for the relative humidity, as illustrated in Figure 10. Although the humidity of the outside fluctuated with a great difference, the inside humidity was within the relatively comfortable condition, which was between 30% and 50% during the monitoring periods. Outside relative humidity reached its top value just before daybreak and decreased in the afternoon hours. Figures 9 and 10 illustrate a contrasting behaviour of temperature and relative humidity variations during a time period.

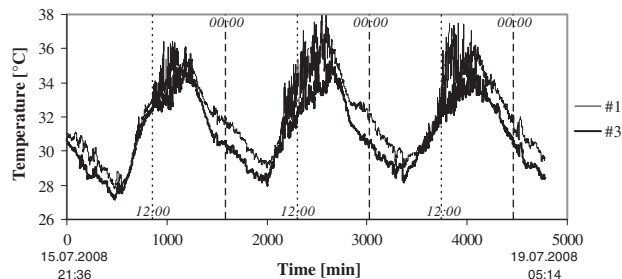
**Fig. 11.** Temperature variations at two different levels of the dome.

Exit air temperatures from the dome, as measured at 8, and 2m high level using two thermocouples numbered 1 and 3, respectively, are shown in Figure 11. In the morning hours (06:00 am to 12:00), there was no significant difference between these two temperature values due to the thermal equilibrium between outside and inside temperatures (Figure 9), and no windy conditions outside were noticed. The two temperature values fluctuated during afternoon hours under an unstable wind velocity and chimney effect conditions, when significant temperature difference could be detected. After sunset,

temperature values decreased gradually, giving relatively stable conditions during the night hours. Approximately, 1.5°C temperature difference occurred inside the two levels of the dome and the air flow was mainly created by the buoyancy forces that evolve from density gradients induced by this temperature difference inside the dome. Similar behaviour was observed for the other dome numbered 7.

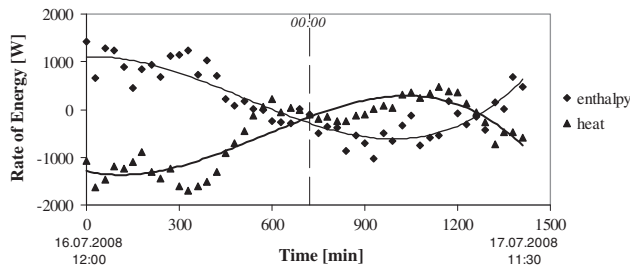
**Fig. 12.** Rate of energy transport by inlet/outlet air, and heat transfer from/to the inside sections from the surfaces of the walls.

properties of air were taken from reference [12]. On the other hand, heat transfer rates along walls between inside surfaces to air were determined using the thermocouples numbered 2, 3, 5, 6 (for air) and 13–18 (for surfaces). Convection heat transfer coefficient was assumed to be  $5 \text{ W}\cdot\text{m}^{-2} \text{ K}^{-1}$  for inside surfaces, whereas  $10 \text{ W}\cdot\text{m}^{-2} \text{ K}^{-1}$  was used for the outside surface of the domes. Results are drawn for every half-an-hour, and indicated by “heat” in Figure 12. Again, a third-degree polynomial was matched with these data. Electrical power gain from the data loggers and the computer and the rate of heat gain from people who visited the sections were neglected because they were small quantities. Internal energy of air inside the sections varied little between  $-20$  and  $30 \text{ W}$  approximately during the day. These values completed the energy balance in Equation (2), and the two polynomial lines in Figure 12 had dampened each other with these results. These values did not match at every time step since the inside condition

was sensitive in calculating the rate of energy. Air flow was unstable and the calculation results were quite rough. However, these polynomial lines in Figure 12 give an idea, mainly about the heat transfer mechanism of the inside conditions.

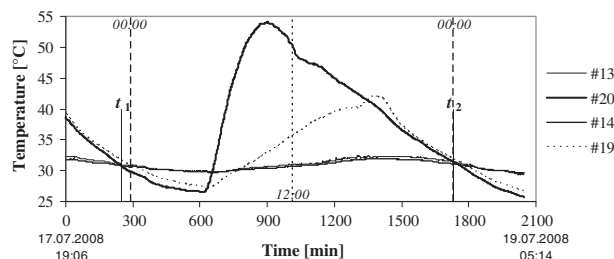
**Fig. 13.** Inside and outside surface temperature variations.

Surface temperature values at the outside and inside were recorded for the north and east walls, respectively, of the domed sections numbered 8, as seen in Figure 13. Inside surface temperature values measured using thermocouples numbered 13 and 14 were almost stable during the monitoring. On the other hand, outside surface temperatures reached high values due to the sun. Especially, the exterior surface temperature of the east wall increased sharply under the influence of the sun and reached  $54^\circ\text{C}$  before noon. After that, the temperature decreased gradually since the surface was not exposed to direct sunlight. Also, the north side of the wall was not directly influenced by the sun. Because of that, surface temperature

first increased gradually and decreased with the same slope and did not reach high values like the east side of the wall. However, these fluctuations did not affect the inside surface temperatures, which changed only by  $\pm 1^\circ\text{C}$ . The thick structure and thermophysical properties of the wall yielded these results.

The computer program was run approximately for 1 day starting from the equality of the inside and outside temperatures, as indicated by  $t_1$  in Figure 13. Although the initial condition was defined as uniform inside the wall as a first assumption, temperature distribution of the last time step (indicated as  $t_2$  when inside and outside surface temperatures were the same, as shown in Figure 13) was used as input for the initial condition during the second run of the program. This variation is shown as 0 h in Figure 14. Other time steps can also be followed in the same figure. For 12 h, although the outside surface temperature reached over  $50^\circ\text{C}$ , more than half the thickness of the wall temperature was not affected by this. On the other hand, the inside surface temperature was somewhat higher at 16 and 20 h.

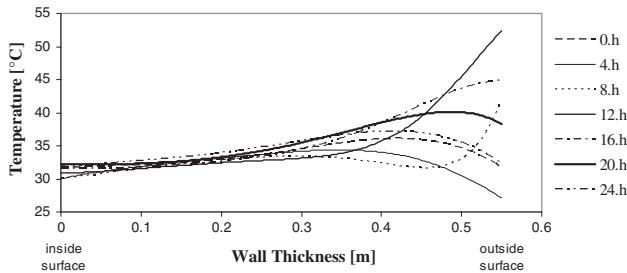
**Fig. 14.** Temperature distributions in the east wall of section 8 for different time steps.

from the inside and outside surface temperatures. 1D, time-dependent heat conduction equation was expressed by the finite difference method, and a computer program was written using the implicit method. The results for different time steps indicated by 0 h (initial condition) to 24 h (24th hour) are shown in Figure 14. Since the wall thickness of the structure was not the same at every section and varied within 50–60 cm, an average value of 55 cm was considered. Wall material was not homogenous. Although generally local stone was used for erecting the walls, bricks and sand were also utilised as complementary materials. For this reason, weighted average values of thermophysical properties, namely thermal diffusivity,  $\alpha = 4.14\text{E-}07\text{ m}^2\cdot\text{s}^{-1}$  and thermal conductivity,  $k = 0.975\text{ W}\cdot\text{m}^{-1}\text{K}^{-1}$  were determined by the computer program.

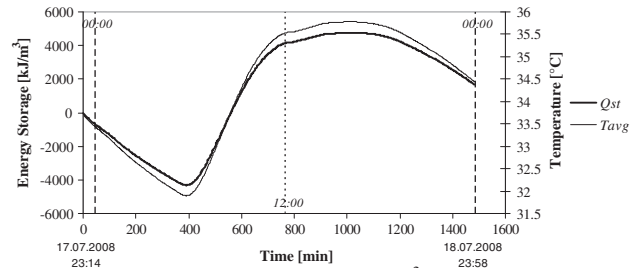
**Fig. 15.** Thermal energy storage per  $\text{m}^3$  and weighted average temperature of the east wall of section 8.

Weighted average temperature ( $T_{avg}$ ) and energy storage ( $Q_{st}$ ) per  $\text{m}^3$  of section 8's east wall is shown in Figure 15 approximately for a day starting from 17th of July at 23:14 (it is also indicated as  $t_1$  in Figure 13). Weighted average temperature and energy storage variations by time showed a harmonic behaviour, as expected. At the end of the 1-day period, because the weighted average temperature did not reach the initial condition, energy storage could not complete the period, since 0 and 24 h temperature distributions in the wall do not match exactly, as seen in Figure 14. Because of the huge thermal mass of the wall, weighted average temperature varied approximately  $\pm 2^\circ\text{C}$  around  $33.7^\circ\text{C}$  mean value.
