A transdisciplinary approach on the energy efficient retrofitting of a historic building in the Aegean Region of Turkey

2. The case building: Basmane neighborhood centre (Basmane Semt Merkezi)

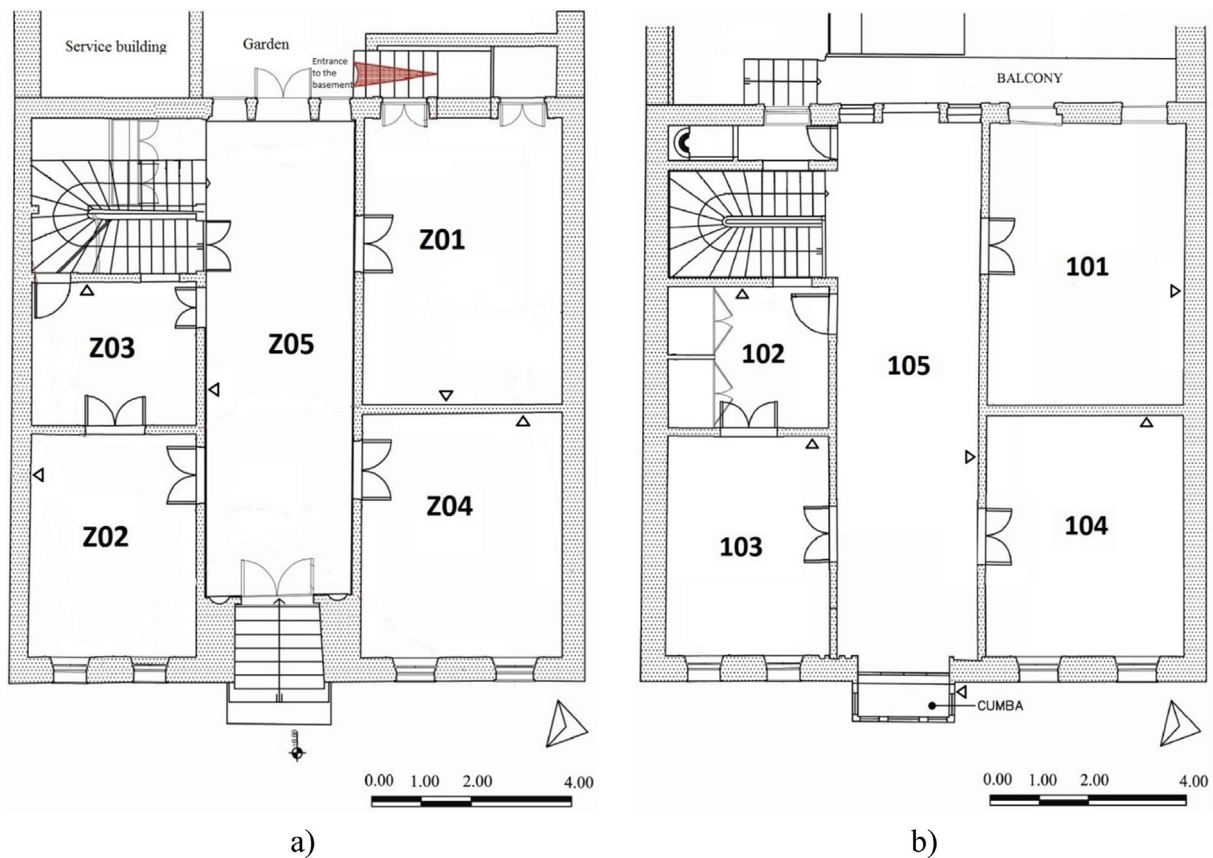
Fig. 2. (a) Ground floor and (b) first floor plan.

Basmane Semt Merkezi is a three-story building including the basement. It was built in East–West direction. The west façade faces the garden. There is a service building adjacent to the house at the southeast part of the garden. The connection between the house and the service building is provided only at the ground floor level (see Fig. 2).

The rooms are symmetrically located at the either sides of a longitudinal corridor, at both floors. The wooden stair on the southwest end of house is the only connection between the ground and first floors. Entrance to the basement is provided by the stairs from the garden (see Fig. 2a). Besides, there is a bay window (called *cumba*) on the east and a balcony on the west edge of the first floor (see Fig. 2b).

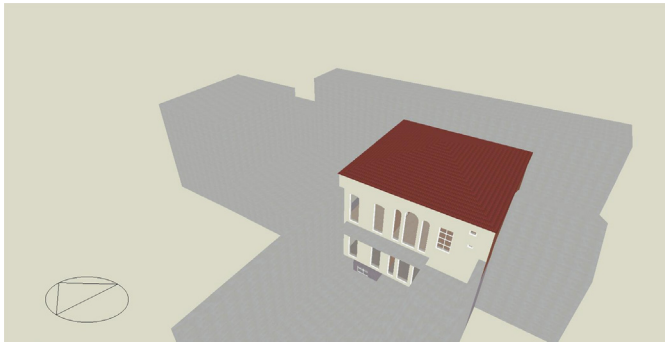
Fig. 3. BES Model of the building and the surroundings.

For a traditional building, the building has a relatively regular geometry as compared to many others with irregular shapes and volumes. Fig. 3 shows the building and its surroundings drawn on the BES tool [15]. Grey colored items illustrate the neighbor buildings. The temperature difference between the adjacent buildings and the case building is assumed to be zero or negligible (adiabatic). The reasons to assume the buildings as adiabatic are to reduce the run time of simulation and those buildings on the north and south sides are also occupied and conditioned.

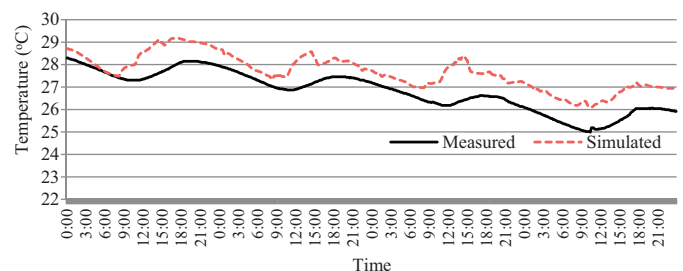
Fig. 7. Comparison of measured and simulated data (Room 102).

It can be seen from Fig. 7 that measured and simulated data show parallel pattern with small temperature differences throughout the period. For each room, the errors, which are mean bias error (MBE) and coefficient of variance of root-mean-squared-error (CV(RMSE)), between the measured and simulated hourly DBTs are given in Table 1.

Measured outdoor temperature data was integrated with the simulation weather data. For the measurement period, the simulation was run and the results were compared to the measured temperatures of each room. Fig. 7 illustrates the comparison of measured and simulated indoor DBTs for 96 h period in a sequence within the measured period.

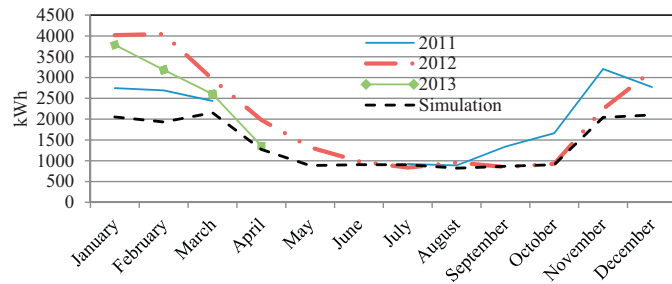
Fig. 8. Comparison of electricity utility bills and simulation results.

According to Table 1, none of the spaces exceeded neither MBE nor CV(RMSE) limits of ASHRAE Guideline–14. Moreover, energy consumptions regarding electricity and fuel-oil were also compared. Fig. 8 shows the calibration results of the electricity consumption of the building consist of lighting, electrical appliances and auxiliary heating. The comparison denotes that simulation results show similar trend with the energy consumption figures of 2011–2013 on a monthly basis.

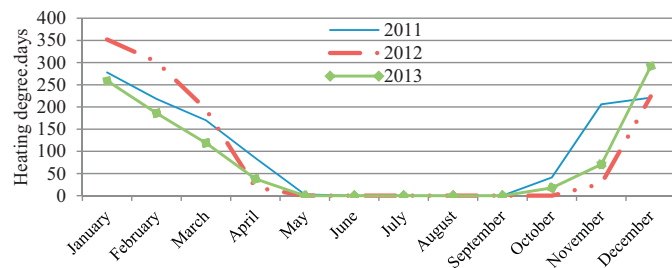
Fig. 9. Heating degree days of İzmir.

Variations in the actual yearly usage figures may be related to the heating degree days (HDD) since the electricity consumption is highly dependent on auxiliary heating. Fig. 9 illustrates the HDD of İzmir for the given years [23]. According to the figure, it is

possible to say that HDD shows similar pattern with the electricity consumption on both annual and monthly basis. Therefore, the electricity consumption out of the heating season can be interrelated to the lighting and the electrical appliances.

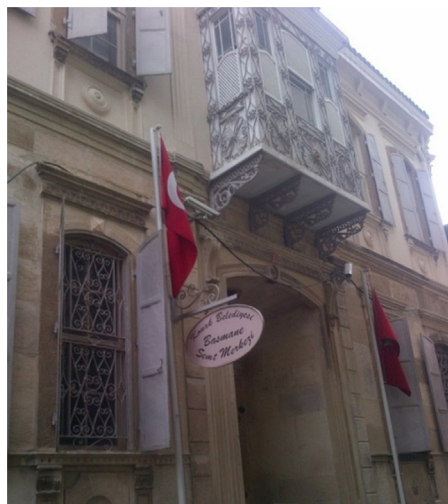
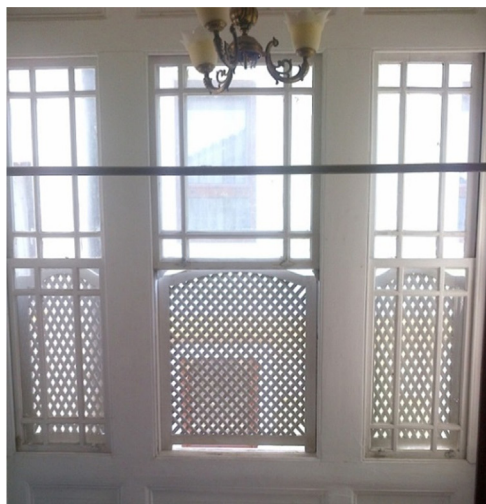
Fig. 10. (a) East façade of the building and (b) the east windows in detail.

The rich details of plasterwork and stone claddings with ornamentalations on the east façade (Fig. 10a) show that the building was originally built as a typical home for a noble family. The elaborate east façade played an important role in the streetscape. On the contrary, west façade consists of relatively plain texture except the stone casings around the windows and doors (see Fig. 4b). The north and south walls, on the other hand, are rather simply built using either bricks or andesite rubble stone coursed with brick without plaster.

The wooden windows are tangible elements that enrich the building appearance. Wooden frame and single glazed windows with horizontal and vertical dividers all in original materials and forms make them worth to preserve. Fig. 10b illustrates a window example from the building.

The *cumba*, which is at the east end of first floor, is a traditional Turkish architectural element with typical wooden framed windows supported and ornamented by iron framework. This is a particular component which adds aesthetic value to the building's main façade (see Fig. 10a).

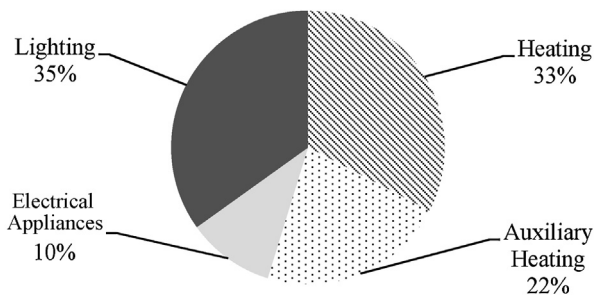
Fig. 11. Shares of total annual primary energy consumption.

Fig. 11 shows that, the share of lighting accounts for 35% while heating of the building by fuel-oil is 33%, auxiliary heating is 22%

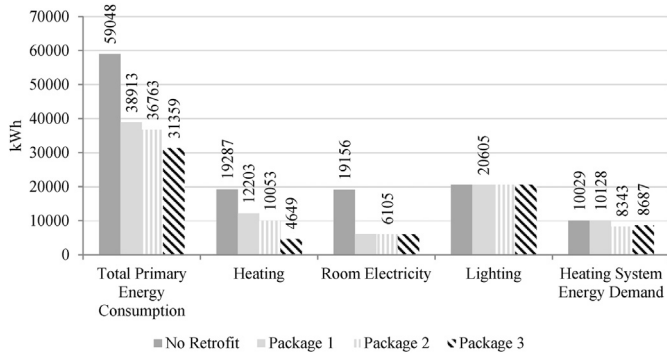
Fig. 12. Comparison of the EER results on package basis.

Fig. 12 shows the comparison of the heating system energy demand, total annual primary energy consumption and its

components of heating, lighting and room electricity (electrical appliances + auxiliary heating), on package basis. At this point, it is necessary to give the definition of heating system energy demand for better understanding. Basically, heating system energy demand is the amount of energy which should be supplied by the heating system to the building in order to keep the indoor environment under the desired conditions.

The results of Package 2 show that the heating energy demand and total annual primary energy consumption were reduced with respect to the Package 1. The main reason for this is the interior insulation, which causes approximately 5% reduction in energy consumption. According to the results, the minor energy target, 20%, can easily be accomplished while the TS825 standard [3] is partially satisfied. Even the small, reversible constructional changes, the package did not unavoidably affect the building appearance and heritage value so that the conservation targets were also reached.

Package 3 was intended to show the effect of maximizing the energy saving without considering the heritage value, even tangible elements having significant role on building's character were changed such as windows were replaced with ones having double glazing and PVC frame and insulation was applied to the outer walls. The other significant change in the 3rd retrofit package is the use of

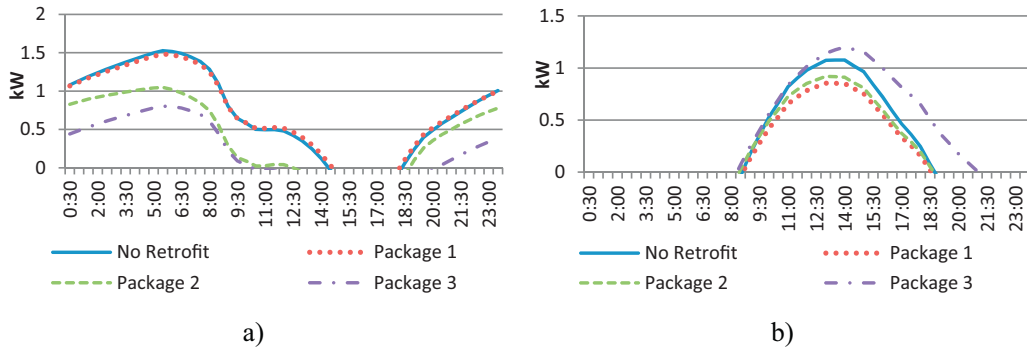
Fig. 15. Effect of EER packages on cooling load; (a) heat gains from the walls, (b) heat gain via infiltration (for July, 15).

In Aegean Region, cooling is of consideration during summer season. Therefore, EER should be assessed both taking into account of heating and cooling energy consumption. Although heating energy consumption is the primary interest of this study, it is favorable to show the impact of EER on cooling load. Fig. 15a and b illustrates the effect of EER packages on heat gains through walls and infiltration, respectively. Hence, it can be said that external insulation (Package 3) reduces the heat gains by 63% which is more than that of including internal insulation (Package 2) even though they have the same insulation thickness. However, Package 3 increases the heat gain via infiltration by 31% though the same air-tightness value with Package 2.

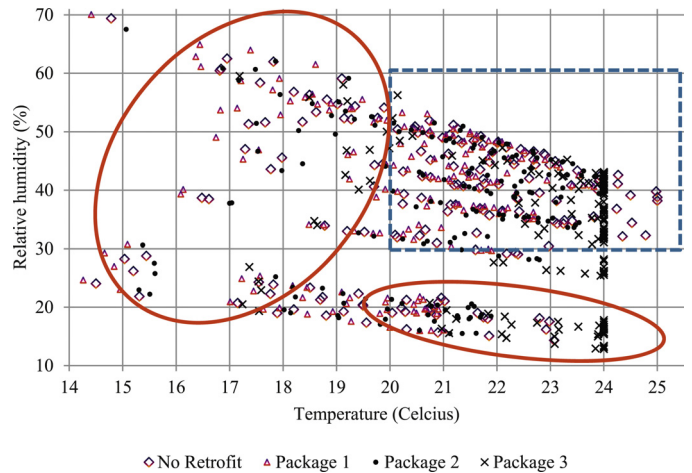
Fig. 16. Change of thermal comfort on package basis (for the space, 105).

Thermal comfort is another important parameter to be considered when the EER is of interest in historic buildings. Fig. 16 shows the change of thermal comfort (within the heating season) of the space 105 (see Fig. 2b) due to the effect of EER packages, where the comfort zone was shown with a dashed rectangle.

In the given space, which is used for an educational purpose, thermal comfort zone is defined as the area where the relative humidity and temperature are between 30–60% and 20–25.5 °C, respectively [28].

According to Fig. 16, the rate of points within the comfort zone were calculated for each EER packages are 44% for no retrofit case, 44% for Package 1, 49% for Package 2 and 51% for Package 3. Hence, it can be said that the thermal comfort within the heating season was improved through the EER packages. Nevertheless, it is seen that some points, which are indicated within two circles, dropped out of the comfort zone. The reason behind the points highlighted within the big circle is that the building has an intermittent heating regime. Thus the indoor air needs to be reheated from the lower temperatures rather than 20 °C, which is the lowest threshold based on ASHRAE Standard-55 [28]. On the other hand, the points in the small circle indicate that the indoor air can be conditioned to acceptable temperature but relative humidity since none of the proposed heating systems have humidity control.
