DOCUMENTATION OF HISTORIC STRUCTURES FOR THE ASSESSMENT OF HERITAGE CHARACTERISTICS

Mine Hamamcioglu-Turan

Ipek Akbaylar

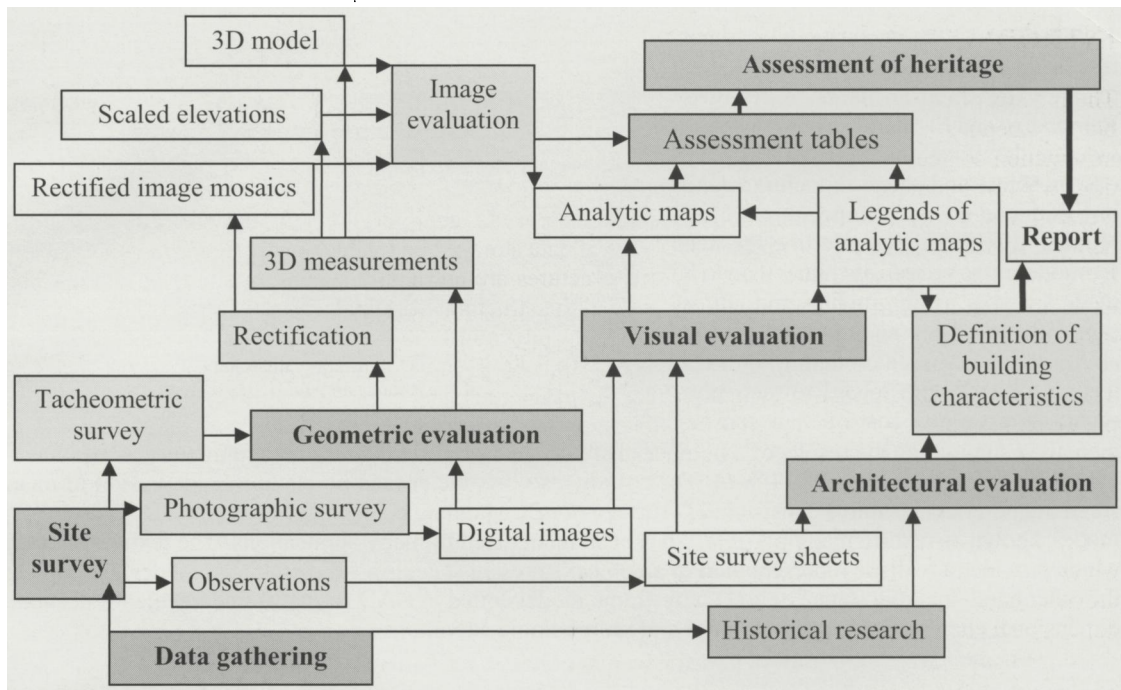
FIGURE 1. Flow diagram illustrating the types of work and their relations.

The methodology used in this study is illustrated in Figure 1. First, we selected a historical building, Ildiri Church in Izmir, Turkey, as the structure to be documented. We measured the point clouds with Pictran and transferred them in DXF format into AutoCAD. Then, we produced a 3D model and 2D scaled elevations in 1/50 scale. Next, we rectified the images of the building facades in Pictran and mapped the heritage characteristics on the rectified image mosaic of each facade in 1/50 scale (Hamamcioglu-Turan and Akbaylar, 2007). Finally, we evaluated the visual data along with past research results so the original characteristics and alterations within the historical timeline of the architectural heritage site could be clarified. We considered the following factors in the assessment of the architectural heritage site: spatial components, architectural elements, construction techniques, and damages. Definite characteristics attached to each factor set make up the column headings of the assessment tables (Tables 1-4). The column headings "Element Name" and "ID" (*i.e.*, building element ID) are kept constant for all tables; however, only building elements that are relevant to the theme of each specific table appear in that table. Building elements are taken as the core of the assessment.

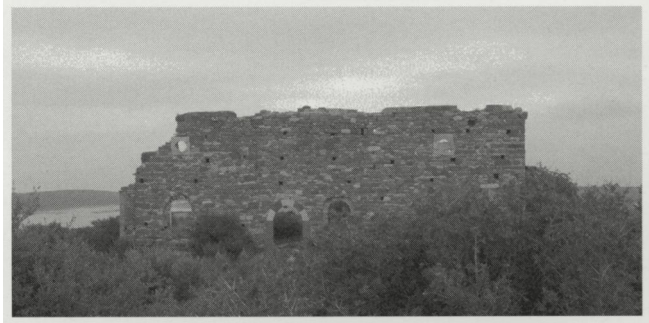
FIGURE 2. Photo illustrating the southern exterior wall of the church and Ildiri Bay behind.

The structure chosen for this case study is the Ildiri (Erythrai) Church (Figure 2) at the acropolis of the archaeological site of Erythrai on the western coast of Turkey. Erythrai was one of the important cities in antique Ionia (Akurgal, 1993a, 1993b; Bean, 1989). During the Byzantine period, it was demolished extensively (Akurgal, 1993b; Bayburtluoglu, 1975). During the Emirates and Ottoman periods, it was known as a coastal village with a dense Greek population (Akurgal, 1993a, 1993b; Budun, 2003). The village of Ildiri presents a potential for tourism because of its archaeological and natural values. Ildiri was declared a first-degree archaeological site in 1981 (Ministry of Culture of Turkey, 1981), and the outstanding perceptual value of the acropolis on the Ildiri plane was underlined. The church was declared a cultural heritage site in 1992 (*ibid.*, 1992).

Due to its distinguished position, the monument can be seen in all directions from the Ildiri plain and serves as a cultural landmark in the region (Table 1 and Figure 2). It is a typical late Ottoman church with a three-aisled naos (11.2 m x 17.1 m) organized around an east-west axis and a semi-domed apse (2 m in radius) (Figure 5). The central aisle (4.95 m) is slightly wider than the side

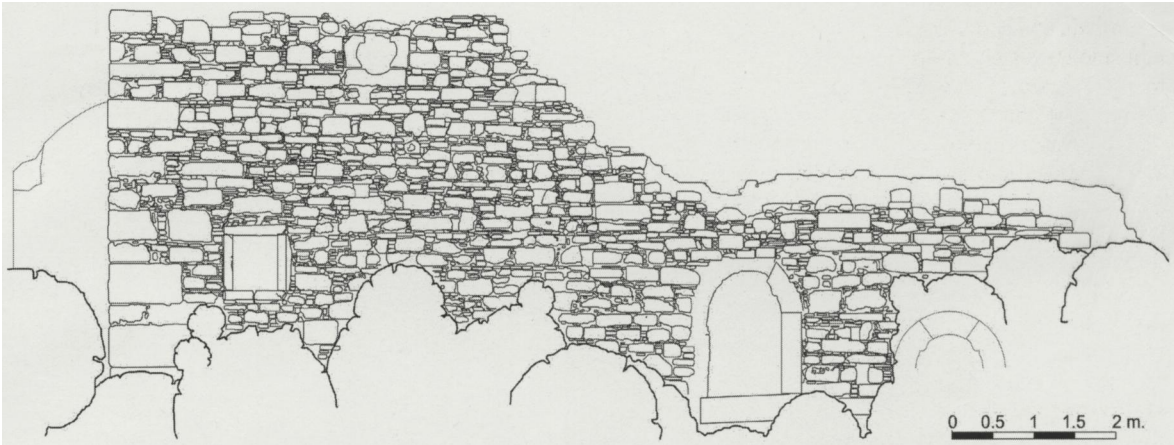
FIGURE 3. Scaled drawing illustrating the exterior facade of the northern wall.

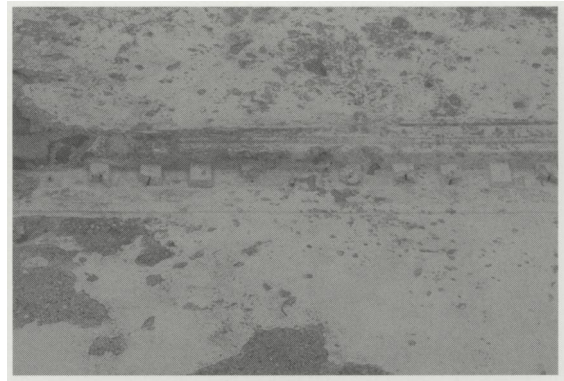
FIGURE 9. Photo illustrating the construction of the cornice on the interior facade of the southern wall.

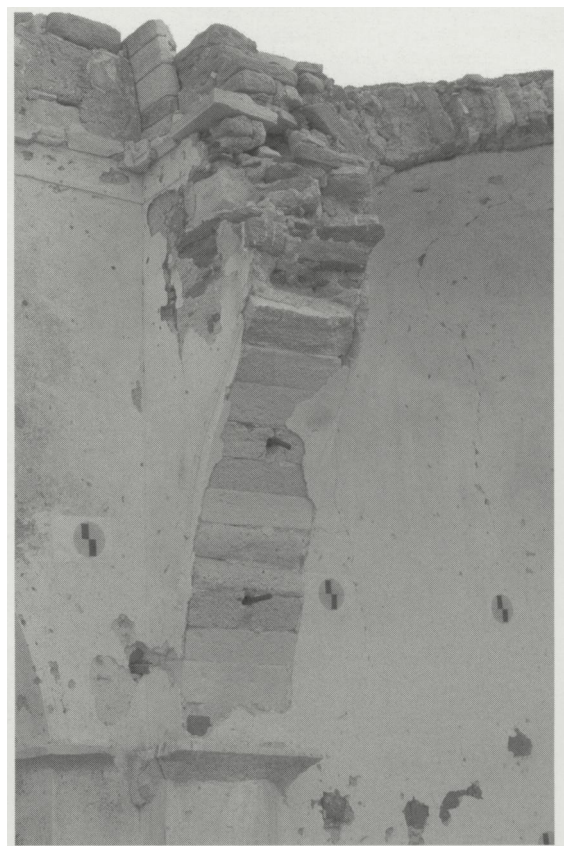
FIGURE 10. Photo illustrating the relation of the vault, arch, and pilaster on the southern part of the apse wall.

the springing line of the vaults (Figures 7 and 10) and the other just below the window openings (Figure 8). The corner wall plates that reinforce the walls are made of timber (8 cm in diameter) and located diagonally at the middle level of the walls. Cut stone, some of which is gathered from the ancient site, is used to reinforce the outer surfaces of the arches (Figure 10) and the corners of the walls (Figure 3). Four rows of holes (each 15 cm x 15 cm x 70 cm) belonging to the scaffolding that was used to construct the church appear on each wall (Figures 2 and 4). The distance between them is nearly 2.5 m. Stone lintels (15-20 cm thick) span the window, door, and niche openings. The double tie rods of the arches (Figure 10) are almost completely lost, but small pieces of iron (each 2-3 cm in diameter) or stains of iron can be seen around the double holes close to the springing lines of the arches. These tie rods continue throughout the walls and are anchored to the exterior with linear iron elements, each around 80 cm in height (Figure 11).
