**UNDERSTANDING
CULTURAL LANDSCAPE CHARACTERISTICS:
THE CASE OF BARBAROS SETTLEMENT,
URLA-İZMİR**

**A Thesis Submitted to
the Graduate School of Engineering and Sciences of
İzmir Institute of Technology
in Partial Fulfillment of Requirements for Degree of**

in Architectural Restoration

**by
Şeyma SARİBEKİROĞLU**

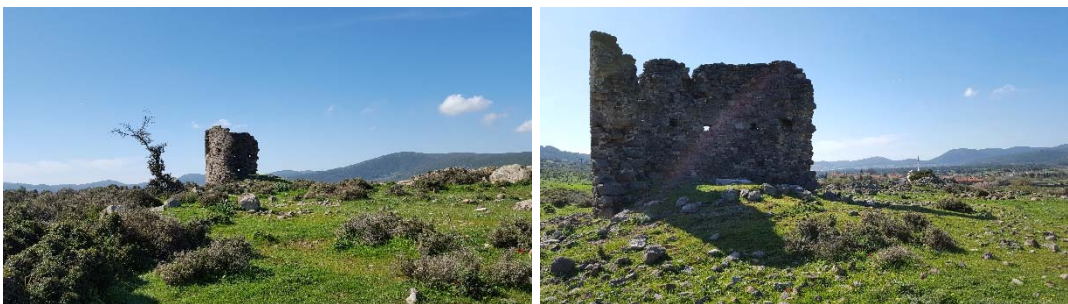
Figure 26. Windmill at north of settlement. February 27, 2016.

More than these activities and uses, natural land hosts structures that are using the wind and an unfinished laboratory building, which belongs to IZTECH. The wind-driven structures are traditional windmills and recently constructed wind power plants. There are two spots having windmills. One of them is at the north side of the settlement and the second one is at the Değirentepe Hill, which is close to Birgi. The first spot hosts one mill and the second spot at Değirmentepe Hill has three windmills. All four mills are unused and in ruined condition. None of them has a roof structure and they all lost their top parts of walls. The one at the north also lost its wall at north side. It was constructed with pink and gray andesite stones. Small andesite stones, slate stones and brick pieces were used in between bigger andesite. The wall bond is similar to the structures in Barbaros settlement. That mill has trace of its stairs. Interviewed locals know neither the construction date nor its period of use. However, mills at the Değirmentepe hill used to be used by Barbaros locals as they told. The three mills on that hill were made out of white stone and small brick pieces. That type of bond is not seen at any other examined structure in the content of the thesis. One of the three mill has an arched niche (Figure 28). The hill and its surroundings are registered as first-degree archaeological site and mills are listed as second-degree immovable cultural assets. Electricity pylons on the hill give visual harm to the hill and mills. Other than windmills, there are windpower plants¹⁰ as wind-driven structures (Figure 29). They produce electricity since 2016. They were constructed in Qualified Natural Preservation Area at Çıtlık Mountain. One other structure located in natural land is a laboratory building whose construction phase did not finished (Figure 29).

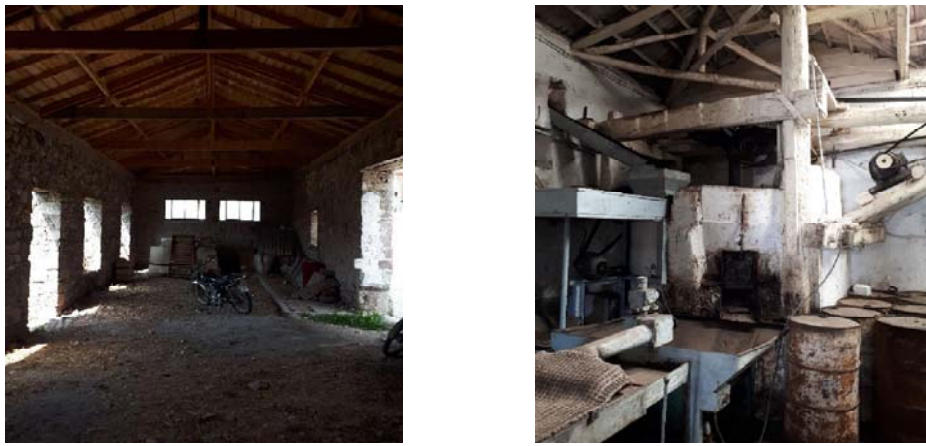
Figure 36. a) Rendering Plant in parcel no: 1528. March 27, 2017. b) Rendering plant in parcel no: 47. May 25, 2017.

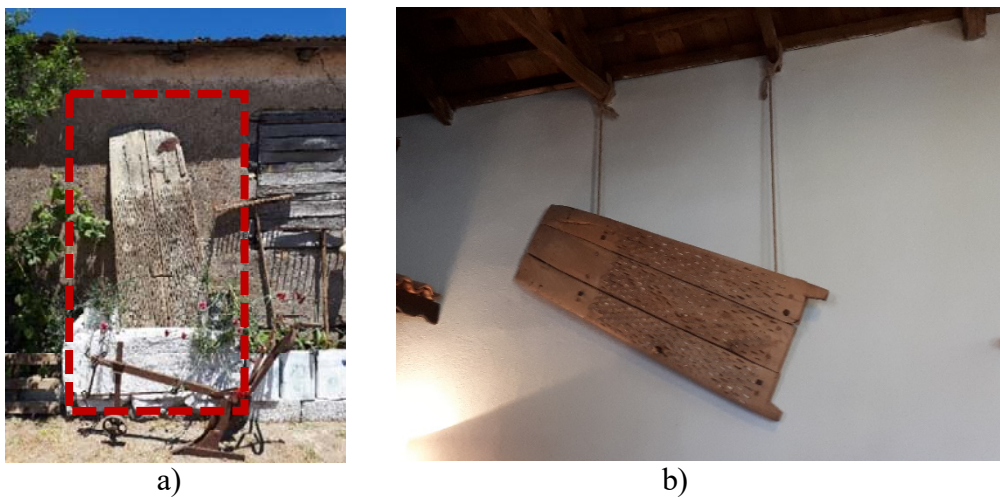
Figure 39. a) Threshing slender in parcel no: 1494. May 20, 2017. b) Threshing slender in Çınaraltı Café. November 25, 2017

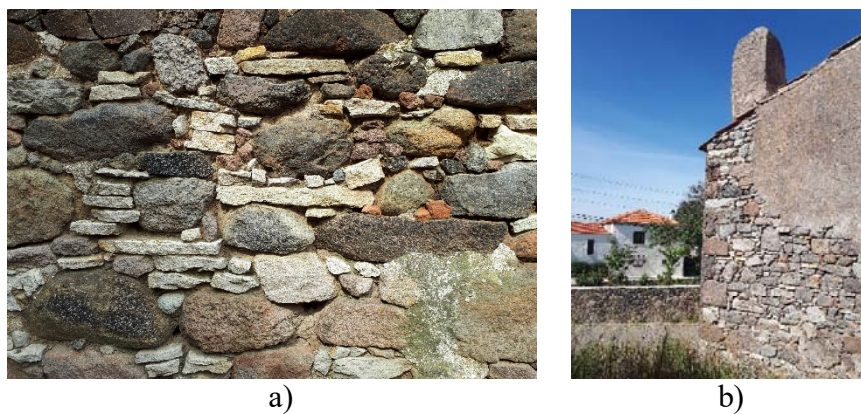
Figure 60. Wall bondings. a) March 13, 2017. b) April 25, 2017.

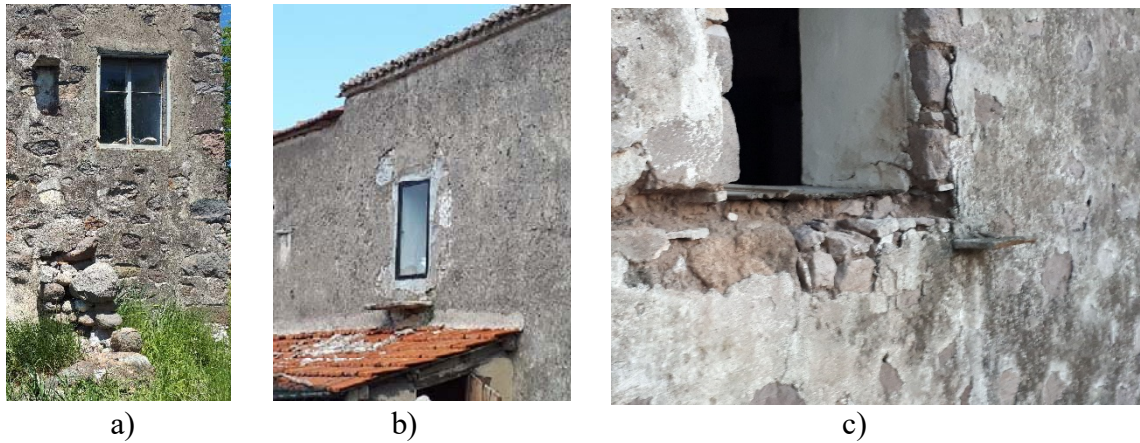
Figure 71. Exterior cantilever slate stones a) April 27, 2017. b) April 23, 2017. c) June 6, 2017.

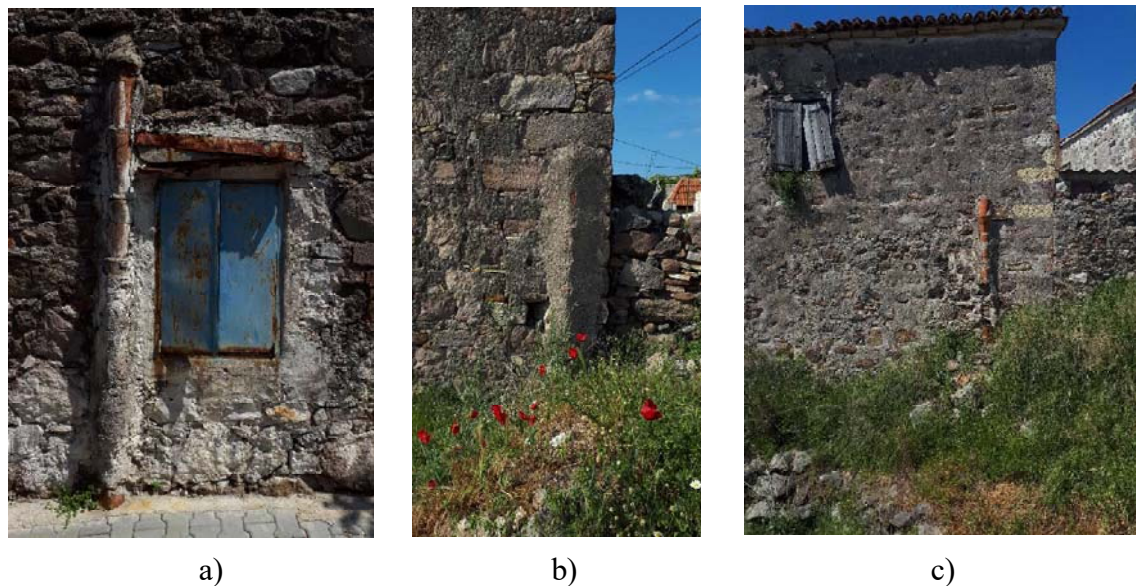
Figure 72. Water outlets a) April 23 2017 b) April 23, 2017. c) April 23, 2017

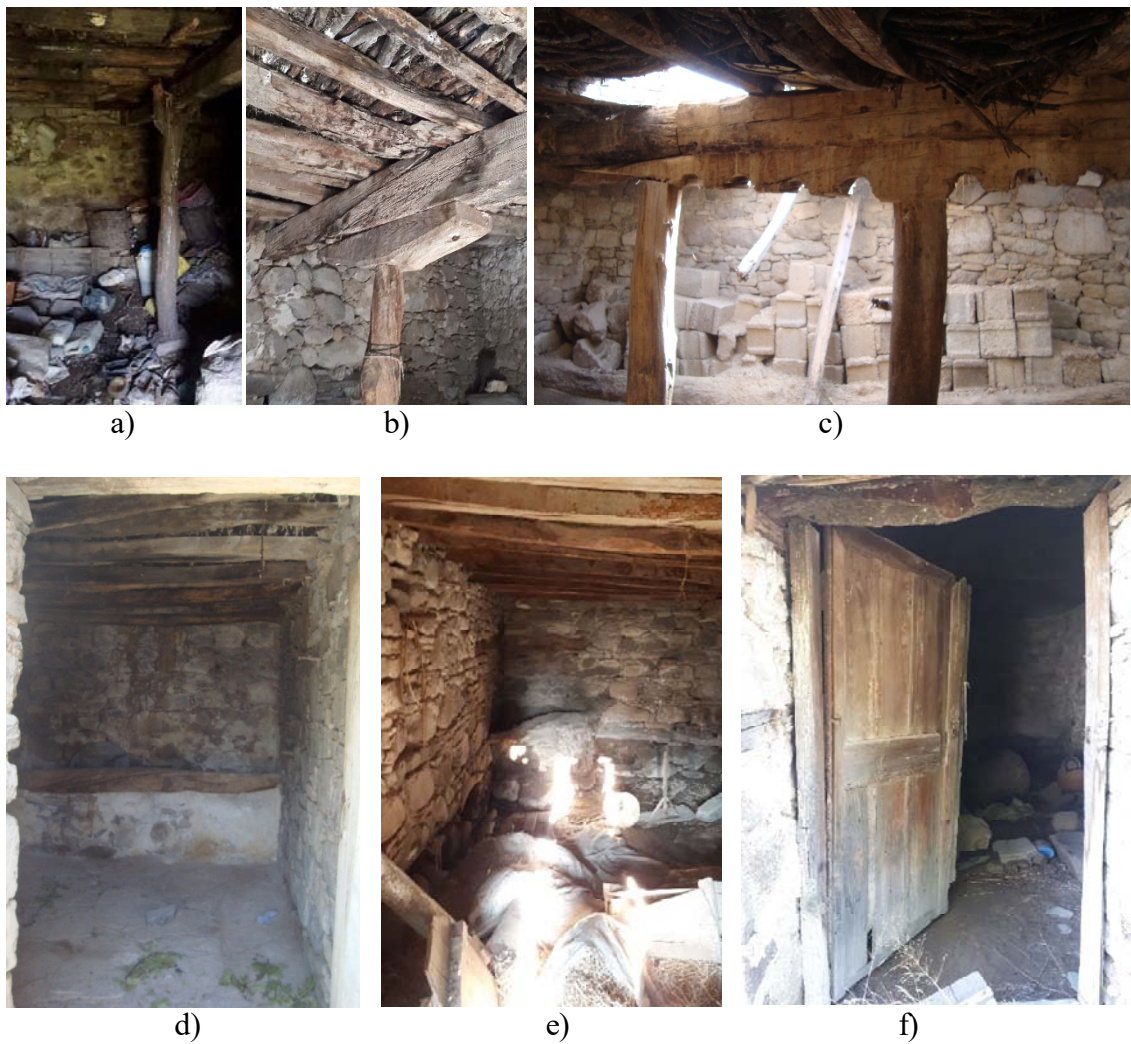
Figure 73. a) Padstone, Y shaped column. April 30, 2017. b) Column, transition element, main beam, joists, *seren*. April 26, 2017. c) Ornamented transition element. May, 2016. d) Slate stone ground covering, rectangular manger, wooden joists. May, 2016. E) Triangular manger at corner. April 24, 2017. f) Wooden door. April 24, 2017.

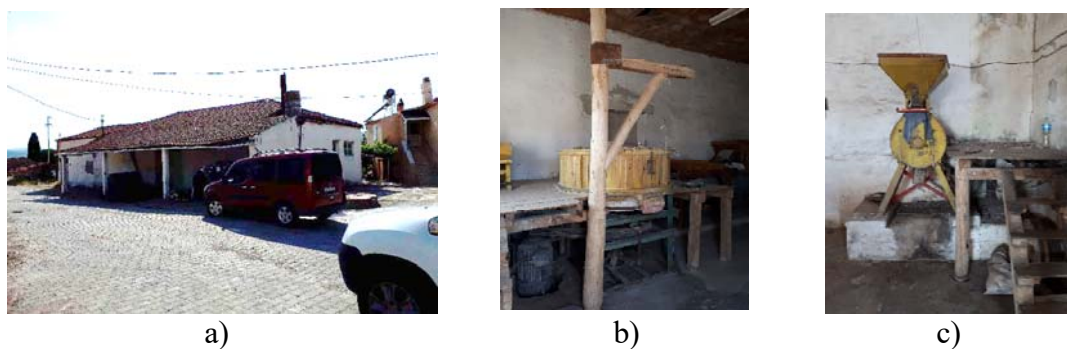
Figure 99. a) Flourmill and rendering plant in parcel no: 47. May 25, 2017. b) Flormill. May 25, 2017. c) Machine in the flourmill. May 25, 2017.
