Execution technique and pigment characteristics of Byzantine wall paintings of Anaia Church in Western Anatolia

Serap Demir, Kerem Şerifaki*, Hasan Böke

Architectural Restoration Department, İzmir Institute of Technology, 35430 İzmir, Turkey

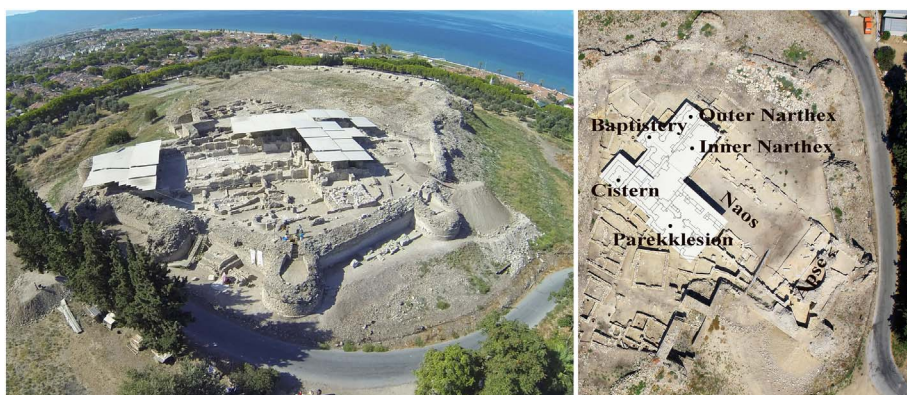
Fig. 1. Aerial views of Church and Monastery complex in Anaia (Anaia excavation archive, 2013).

Western Anatolia has had rich historical buildings and monuments from ancient times. In this study, material characteristics of historic paintings executed in a Byzantine church located in archaeological site of Anaia (Kadikalesi) were determined (Fig. 1). Anaia was an upstate castle situated at the northwest of Davutlar Village in Kuşadası, Aydın. The fortress was erected on a 25 m high hill from the sea level and 250 m away from the sea. Scientific excavations and surface investigations of the site were started at 2001. Archaeological findings during the excavations demonstrated that the castle was erected on a tumulus composed of six archaeological strata. The first settlement on the tumulus is dated to Late Chalcolithic Age (4000 BCE) (Akdeniz, 2007).

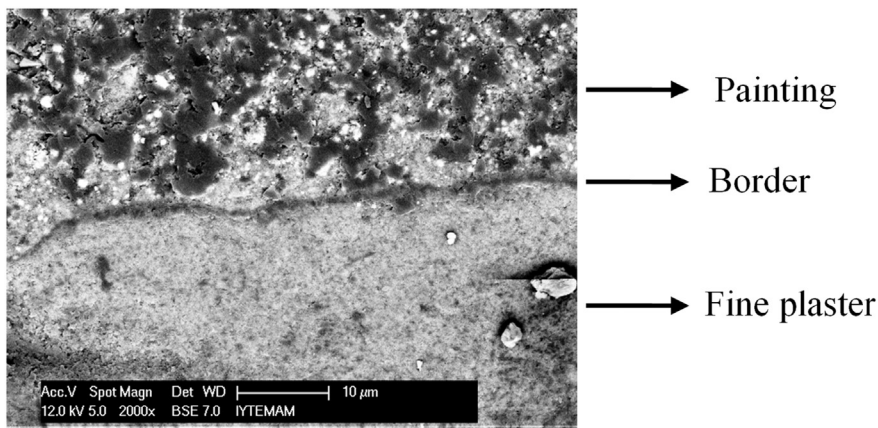
Fig. 3. BSE image of painting layers (S.2).

SEM analysis on cross-sectional samples indicated that paintings were composed of a fine plaster and a thin paint layer over the plaster layer. The execution techniques of the paintings were identified by examining the boundaries between fine plaster and paint layers. In most of the samples, plaster and paint layers are distinguishable with border

lines (Fig. 3). Distinguishable border lines may show that pigments were mixed with lime and then applied on dry plaster surfaces which can be called secco technique.

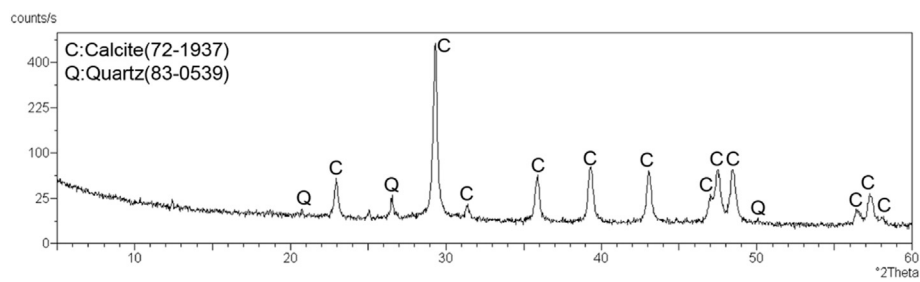
Fig. 4. XRD pattern of fine plaster layer (S.1).

Fine plaster layer has a smooth surface, a low density and high porosity values. Its density and porosity values were about 1.2 g/cm³ and 40% by volume respectively. Its thickness was in the range from 1 to 1.5 cm. The mineralogical composition of plaster layer was indicated by X-ray Diffraction (XRD) and FT-IR analyses. In the XRD pattern of the fine plaster layer, calcite and quartz peaks were observed (Fig. 4).

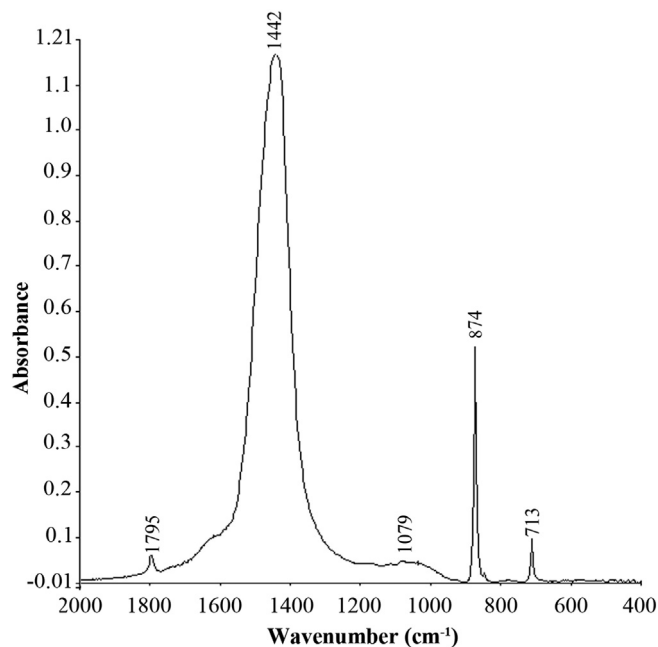
Fig. 5. FT-IR spectrum of fine plaster layer (S.1).

In its FT-IR spectrum, calcite bands at 1442, 874, 713, 1795 cm⁻¹ and a weak silica band at

1079 cm⁻¹ are observed (Fig. 5) (De Benedetto et al., 2002; Gadsden, 1975). These results indicated that fine plaster layer was mainly composed of calcium carbonate (CaCO₃) and quartz.

Observation of calcium carbonate is assigned to calcium lime and the weak silica band may be due to the quartz present in the calcite rock that the lime is produced from.

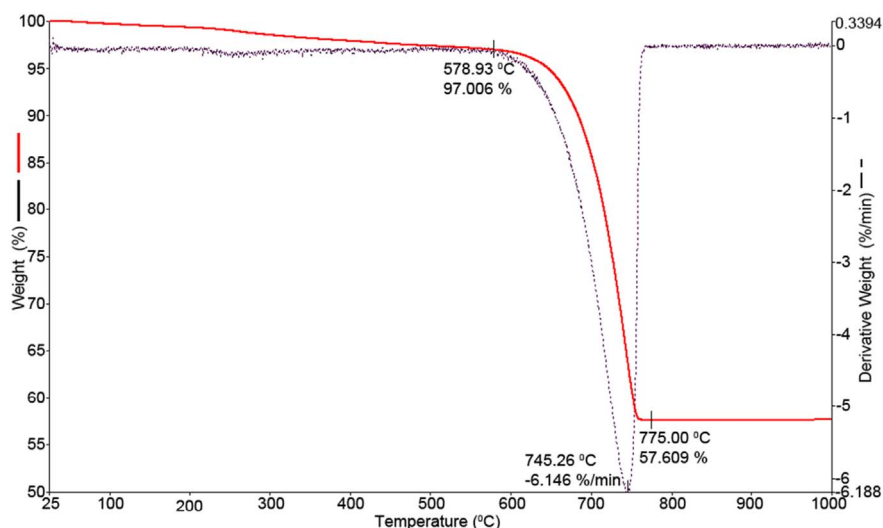
Fig. 6. TGA graph of fine plaster layer (S.1).

High amounts of calcium and low amounts of magnesium shows the use of calcium lime containing low amounts of magnesium as a binder in the preparation of the plaster. TGA analysis supported the SEM-EDS result. In the TGA graph, a 40% weight loss was observed at temperatures between 580 °C and 775 °C due to carbon dioxide driven from the carbonated lime (Fig. 6). This loss shows the use of nearly 90% lime in the preparation of plaster. The use of lime as binder in plaster layer was

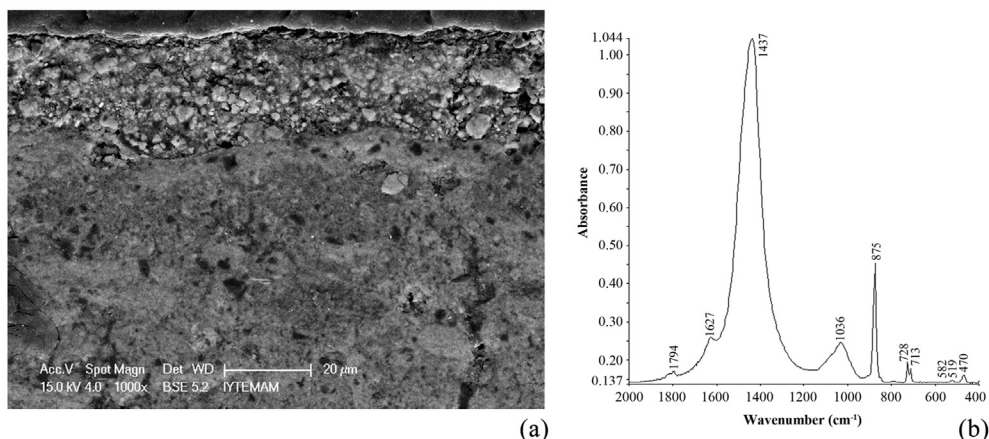
Fig. 8. BSE image (a), FT-IR spectrum (b) and XRD pattern (c) of yellow painting layers (S.3). (For interpretation of the references to colour in this figure legend, the reader is referred to the web version of this article.)

SEM analysis indicated that yellow painting was executed in the secco technique with lime solution (Fig. 8a). The thickness of the paint layer was about 25 μm. In the FT-IR spectrum of the yellow colored paintings, calcite bands at 2518, 1794, 1437, 875, 713 cm⁻¹, HCO₃⁻ band at 1627 cm⁻¹, a distinctive peak of magnesite (MgCO₃) from calcite at 728 cm⁻¹, silica at 1036 cm⁻¹, hematite at 470 cm⁻¹ and 519 cm⁻¹ were observed (Fig. 8b). In their XRD patterns, the strong

peaks of calcite, dolomite, and quartz and weak peaks of hematite and illite were observed (Fig. 8c).

The elemental composition of yellow paint layer indicated that it was mainly composed of calcium (Ca), magnesium (Mg), silicon (Si), aluminium (Al) and moderate amounts of iron (Fe) (Table 2). It is known that yellow ochre consisted of iron oxide, silica and clay has been used as yellow pigment since ancient times (Hradil et al., 2003). Based on the XRD, FT-IR and SEM-EDS analysis results, it can be said that in the execution of the yellow painting, yellow ochre was used as pigment and mixed with dolomitic lime and then applied to the dry fine plaster layer.

In a recent study, the use of dolomitic lime in the binding medium of paintings has also been determined in Byzantine wall paintings (Hein et al., 2009). The use of dolomitic lime can be explained by its less shrinkage cracking properties than most of the common lime (Chever et al., 2010).

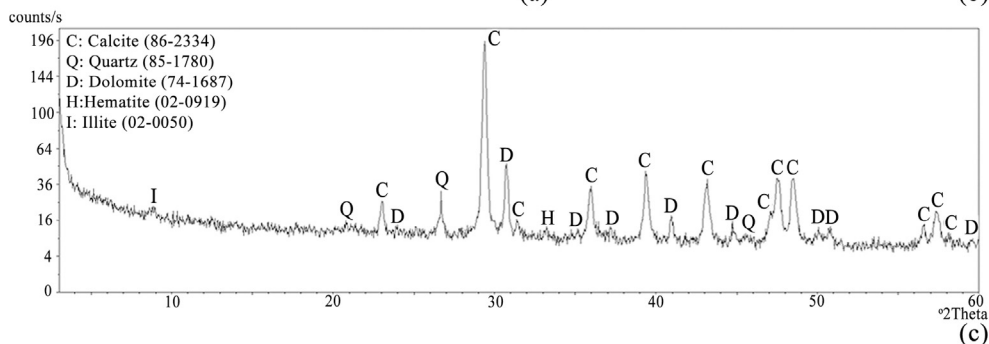
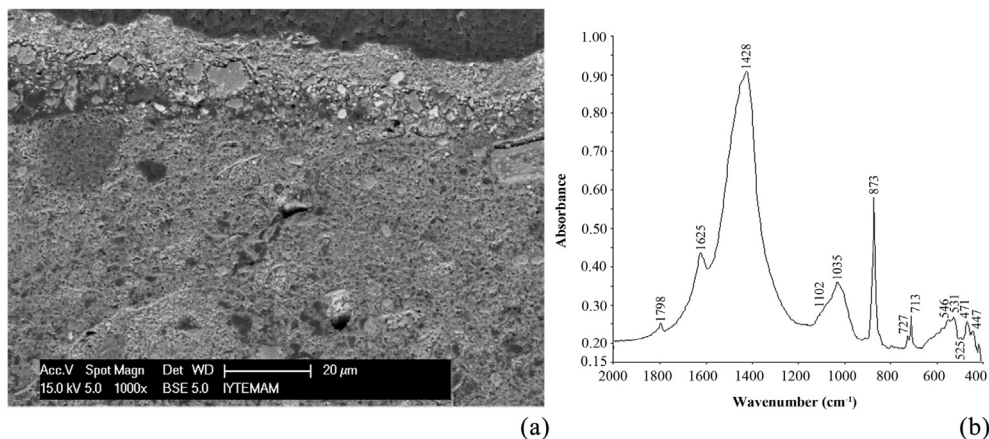
Fig. 9. BSE image (a), FT-IR spectrum (b) and XRD pattern (c) of purple painting layers (S.4). (For interpretation of the references to colour in this figure legend, the reader is referred to the web version of this article.)

SEM analysis indicated that purple painting was executed in the secco technique on dry plaster surface with thickness of roughly 10 μm (Fig. 9a). FT-IR analysis of the purple paint layer showed typical bands of the calcite and dolomite at 2515, 1798, 1625, 1428, 873, 727 and 713 cm⁻¹ (Fig. 9b) (Gadsden, 1975). They can be differentiated by their characteristic bands observed at 727 cm⁻¹ for dolomite and at 713 cm⁻¹ for calcite (Mazzocchin et al., 2006). The infrared absorption band at 1035 cm⁻¹ was due to silicate minerals and two characteristics bands of hematite at 471 cm⁻¹ and 546 cm⁻¹ were also indicated. The mineralogical composition of the purple paint determined by XRD analysis demonstrated that it was mainly composed of calcite, dolomite, quartz and hematite (Fig. 9c).

The elemental composition of paint layer was determined by SEM-EDS analysis. In the SEM-EDS analyses, calcium (Ca) and magnesium (Mg) due to carbonated lime binder, iron (Fe) due to pigments and Al,

Si, Na, and K due to presence of clay minerals were determined (Table 2).

The presence of iron in the composition of paint may indicate the use of iron-based purple ochre such as caput mortuum (Fe₂O₃). Caput mortuum, most commonly used pigments in Byzantine wall paintings, was rare and expensive (Bikiaris et al., 2000; Daniilia et al., 2000; Marshall et al., 2005).
