# Construction Techniques of *Hayat* Houses: Two Case Studies in the Vicinity of *İzmir*

**Abstract:** This study aims to contribute to the analytic studies on constructional aspects of the *hayat* house typology with an eye on its historical evolution for conservation purposes. The method used included a review of the surviving examples of the typology in *İzmir* and its vicinity and the selection of two intact examples whose structural components are legible: one from the earliest period and the other from the latest period. The examples selected are *Kerimağa Konağı* in *Birgi, Ödemiş, İzmir* and a house in *Kırkağaç, Soma, Manisa*. The early example (probably eighteenth century, constructed over the remains of an older house) sustains the traditional box system in its wooden upper story that integrates with the roof. The provision of level differences on the upper floor, the traditional relationship of the sitting level—window design, and masonry base are its authentic features. The late example (probably early twentieth century) presents signs of modernization, such as the establishment of a systematic wooden roof and wall frames in relation to each other, lack of diagonals i

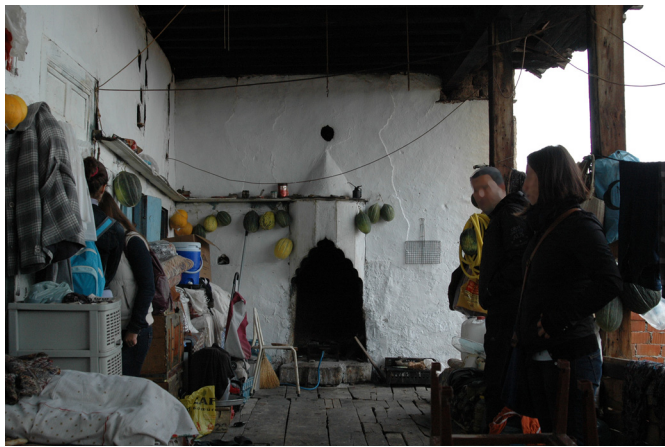
**Fig. 2.** View of a *hayat*, the house in *Kadriye* neighborhood, *Kırkağaç*.

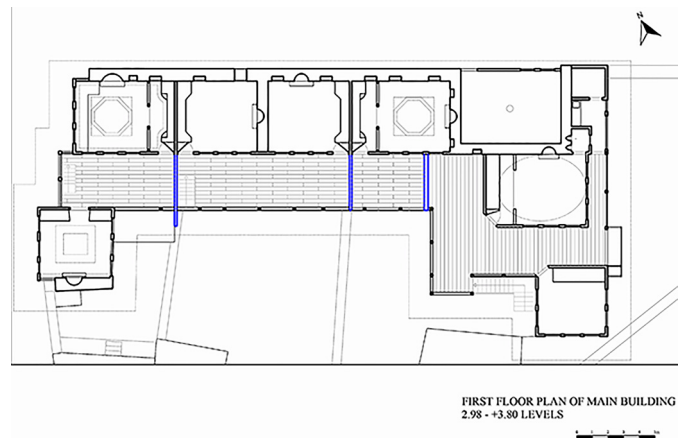
**Fig. 3.** *Bekirbeyler* house, *Kula*, first-floor plan. (Adapted from E. Kırtas unpublished master's thesis, *İzmir* 2013.)

In the eighteenth century, the *hayat* house reached its classical expression. As seen in surviving examples in western Anatolia and the Balkans (Eldem 1955; Kuban 1995b), an open gallery with varying numbers of rooms added to one another on both floors had become a standard for houses in the cities and provinces. Timber had definitely replaced stone in the first-floor walls and became the major building material. The houses, with their large numbers of façades, were well illuminated. The rooms and the alcoves between them projected over the ground floor walls and were oriented to the surroundings rather than to other houses. In more restricted lots and for those with fewer requirements related to their rural settings, houses with more rooms along a long or U-formed *hayat* and an intermediate floor for winter usage became possible. The distinctive features of the examples in the *İzmir* region that are datable to the eighteenth century are well illuminated and volumetrically complex. Presence of an intermediate/half story, preference for U- or L-planned, long *hayats* with small kiosks projecting to the courtyard for large houses, and stone bases with timber-frame main stories filled in with mudbrick, brick, or stone are also characteristic. As revealed in the very limited surviving examples of *hayat* houses in the center of *İzmir*, the type was a standard there in this time interval, for example, *Selvili masjid*, No. 86. There are a number of examples in nearby small cities. Some exciting ones are *Çakrağa* and *Kerimağa* in *Birgi* and *Bekirbeyler* in *Kula* (Fig. 3).

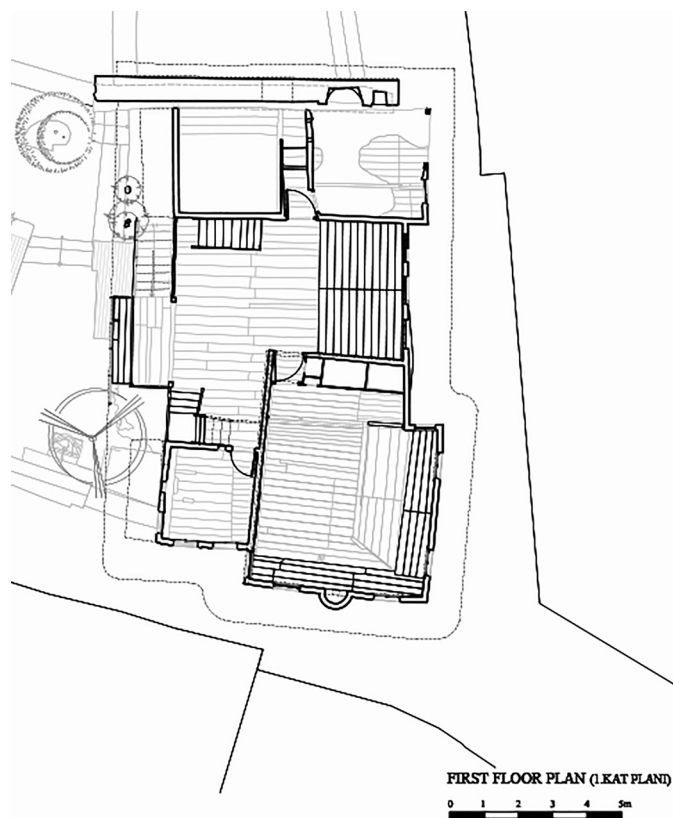
Fig. 5. *Kerimağa* House, *Birgi*, first-floor plan.

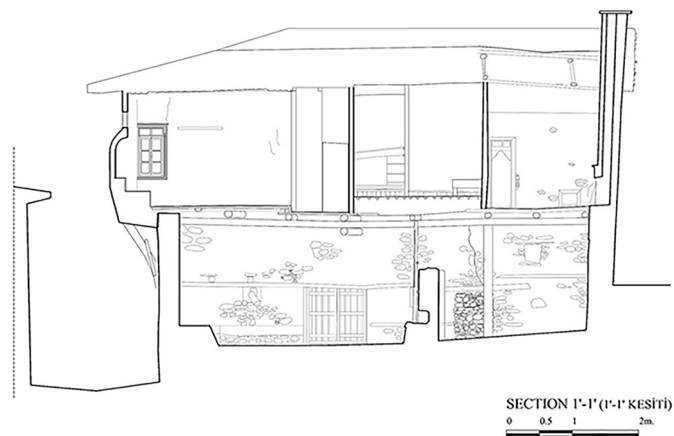
Fig. 6. *Kerimağa* House, *Birgi*, longitudinal section.

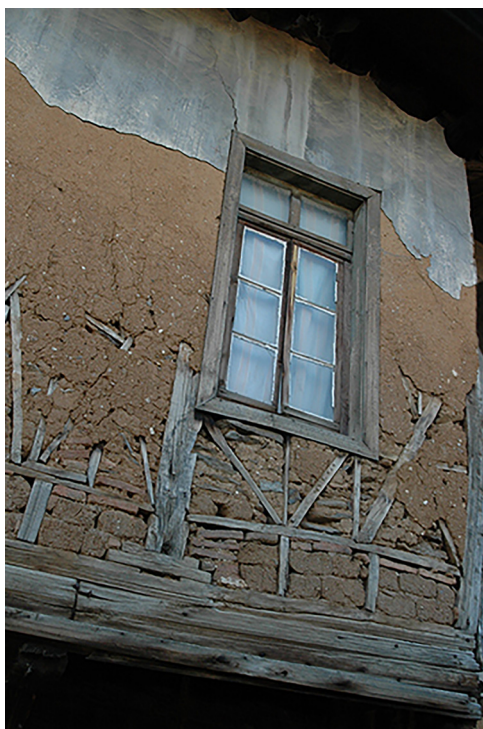
**Fig. 7.** *Kerimağa House, Birgi*, exterior of the eastern wall of the main room.

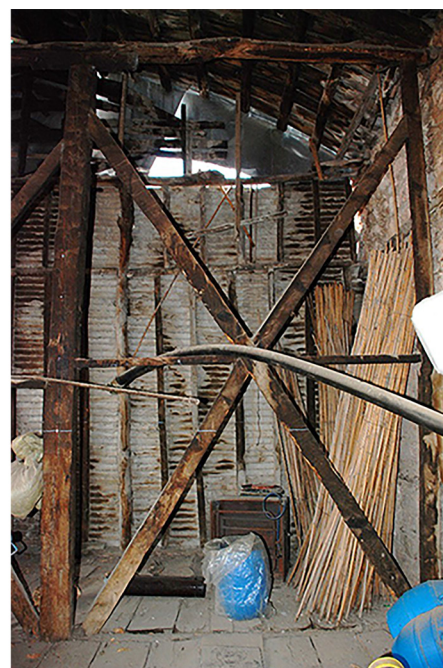
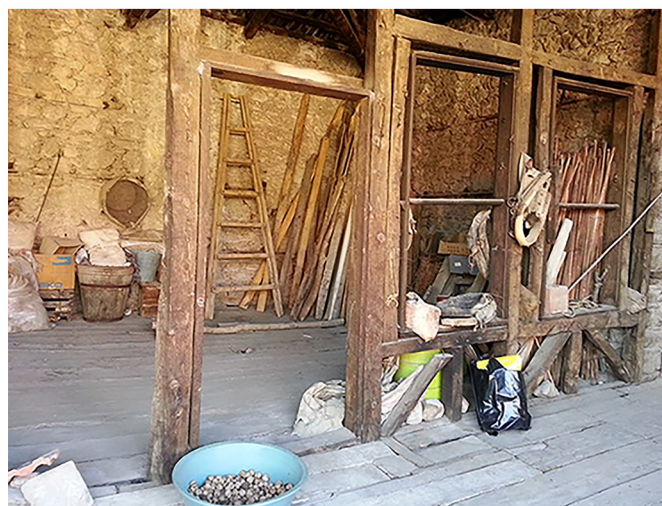
**Fig. 9.** Eker House, Kırkağaç (a) timber frame wall with diagonals; and (b) timber frame wall with voids.

The interior walls are wooden on both floors. Thicknesses of 18 cm and 15 cm are recorded for the upper and ground floors, respectively. As observed on the upper floor, two different types of wooden frame walls are used [Figs. 9 and 10(a)]. Those in the north-south direction that connect the two ends of the U-formed masonry wall and improve the stiffness of the masonry wall system have no diagonal elements but comprehend rhythmic door and window openings supported with sills. The others are perpendicular to this system and are reinforced with wooden braces and sills at the intersection axes of the diagonals. They are all parallel to each other, generally overlap with the roof frames above, and increase the lateral stability in an east-west direction. The posts are placed every two meters or more frequently where openings are needed. The unfinished upper floor has no infill or wooden laths; the

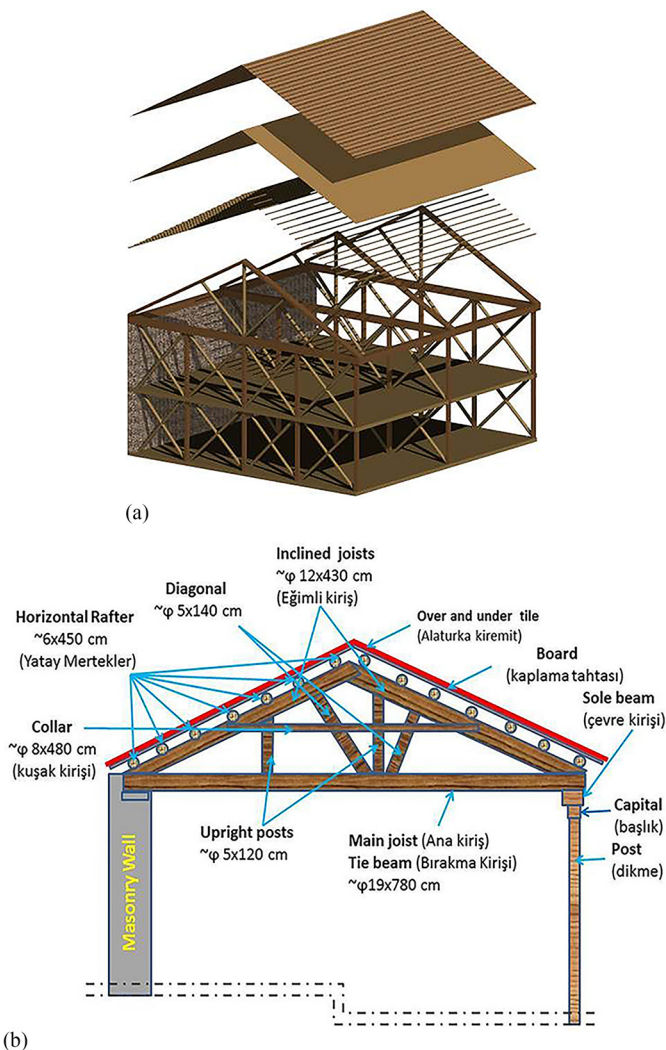
**Fig. 10.** Eker House, *Kırkağaç* (a) axonometric view; and (b) a typical roof frame.

The wooden roof of the main building is hipped, and its south portion is partially demolished. A series of full roof frames separated by distances of 215 cm and half roof planes at the hipped portions are covered with roof boards (180 × 18 × 2 cm) and finished with over and under tiles at their exterior. The same roof system comprised of frames is repeated in the gable roof of the gateway, which is known as *saya*. The diameters of the frame elements vary between 5 and 19 cm. The horizontal rafter (5 × 230 cm), inclined joist (7 × 5 × 230 cm), king post (10 × 85 cm), stud (5 × 140 cm),

collar (8 × 9 × 480 cm), and tie beam (5 × 7 × 370 cm) [Fig. 10(b)] compose the frame elements. The roof water flows to the courtyard without a conduit.

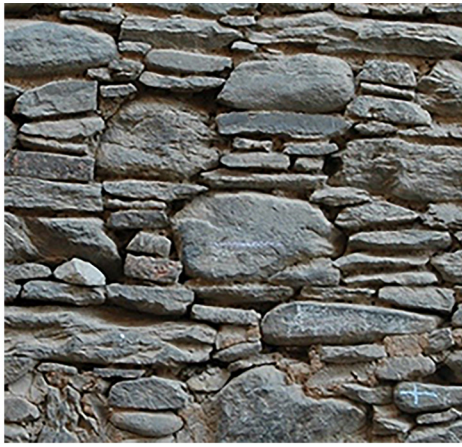
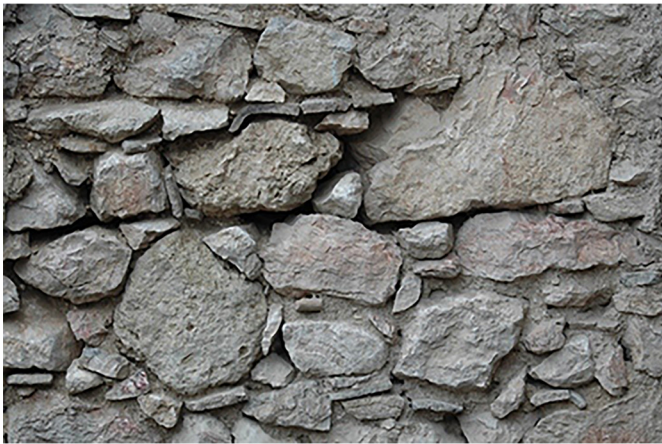
**Fig. 11.** Bonding in masonry walls: (a) *Kerimağa House, Birgi*; and (b) *Eker House, Kırkağaç*.

In both examples, as a typical characteristic of *hayat* houses, wooden posts are observed at the transparent *hayat* façades. In *Birgi*, they also support the intersection points of interior wooden frame walls at the ground level. The masonry walls of the case studies, in terms of bonding, present qualities in parallel with their

construction dates (Fig. 11). In *Birgi*, *Tarhala*, and *Kırkağaç*, early examples use rubble stones that alternate with slate stone, brick, and tile pieces at their masonry bases. In *Birgi* and *Tarhala*, this technique is observed on the upper floor masonry walls, whereas in *Kırkağaç*, mudbrick can be seen at the upper floor. Late examples have coursed rubble stone masonry. In terms of their finishing, the exteriors of masonry walls are left exposed without plastering in a majority of the examples in *Birgi*, *Tarhala*, and *Kırkağaç*, independent of their dates. This characteristic is repeated in *Kerimağa Konağı* and the house in *Kırkağaç*. In terms of thickness, the same width is sustained throughout the same floor in the majority of *Birgi* and *Tarhala* examples. This was also recorded in the case studies. The usage of symbols on masonry walls is a characteristic seen in relatively early houses in western Anatolia. *Kerimağa Konağı* has a sun symbol. *Spolia* are recorded for *Tarhala* houses (Tayla 2007, F. Diri, unpublished M.S. thesis, Metu 2010; A. Etlacakuş, unpublished MS thesis, Iztech 2015) but are not observed in *Kırkağaç*.

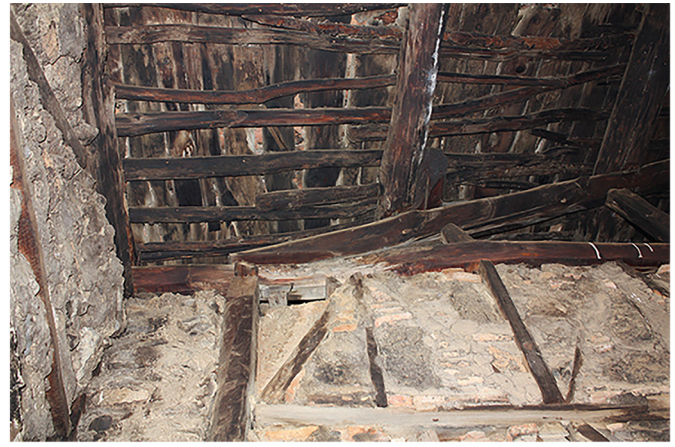
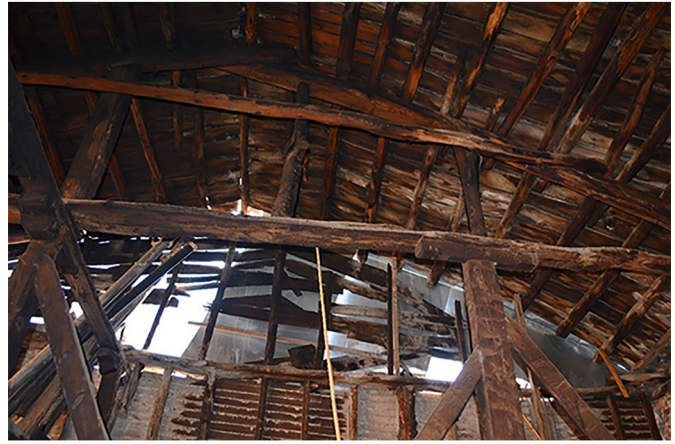
**Fig. 12.** Relationship of roof and wall frames in cross section: (a) *Kerimağa House, Birgi*; and (b) *Eker House, Kırkağaç*.

The roof forms of both houses are in line with the characteristics of the *hayat* house: a combination of hipped and gable in *Kerimağa* and hipped in the house in *Kirkağaç* (Fig. 12). The structural

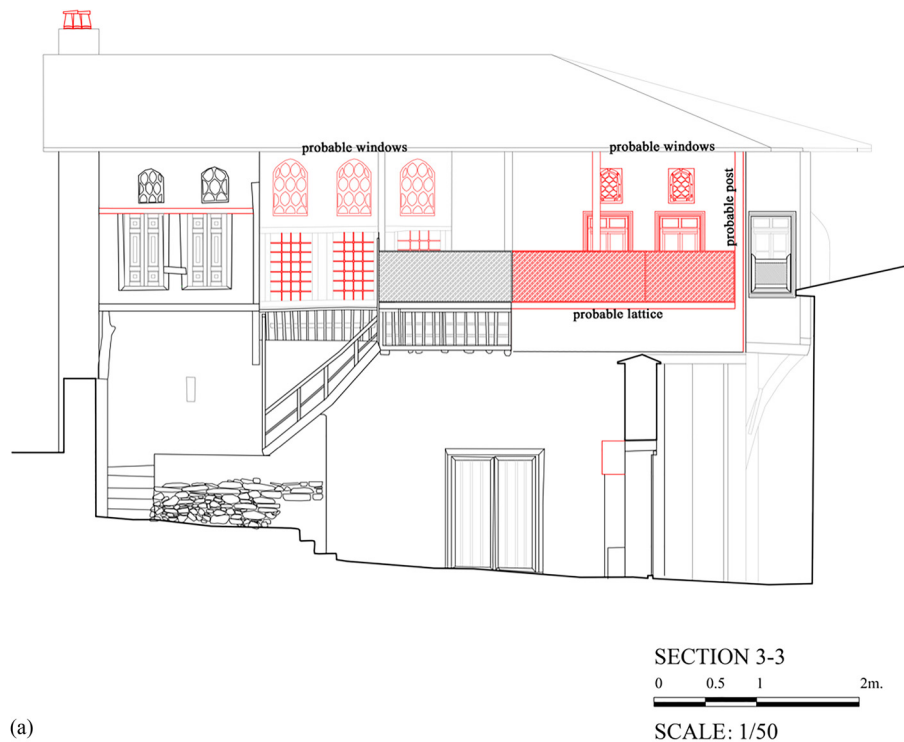
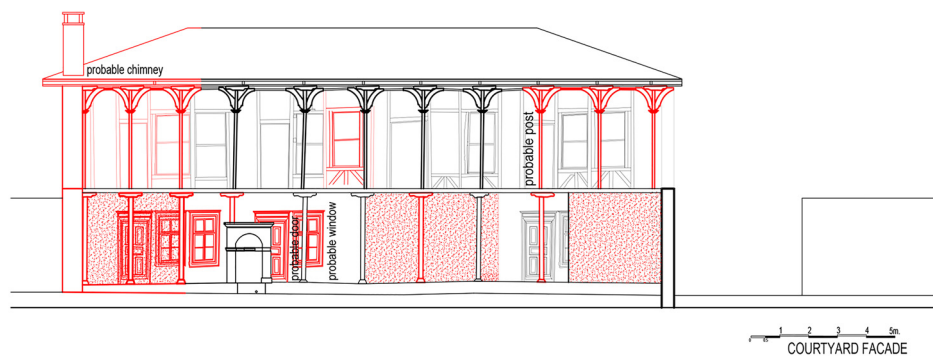
**Fig. 13.** Reconstructions of *hayat* elevations: (a) *Kerimağa House, Birgi*; and (b) *Eker House, Kirkağaç*.
