**CONSERVATION AIMED EVALUATION OF THE
BATH RUIN IN GÜLBAHÇE, URLA, İZMİR**

**A Thesis Submitted to
The Graduate School of Engineering and Sciences of
İzmir Institute of Technology
In Partial Fulfillment of the Requirements for the Degree of**

in Architectural Restoration

**by
Aslı ÇAĞLIYURT**

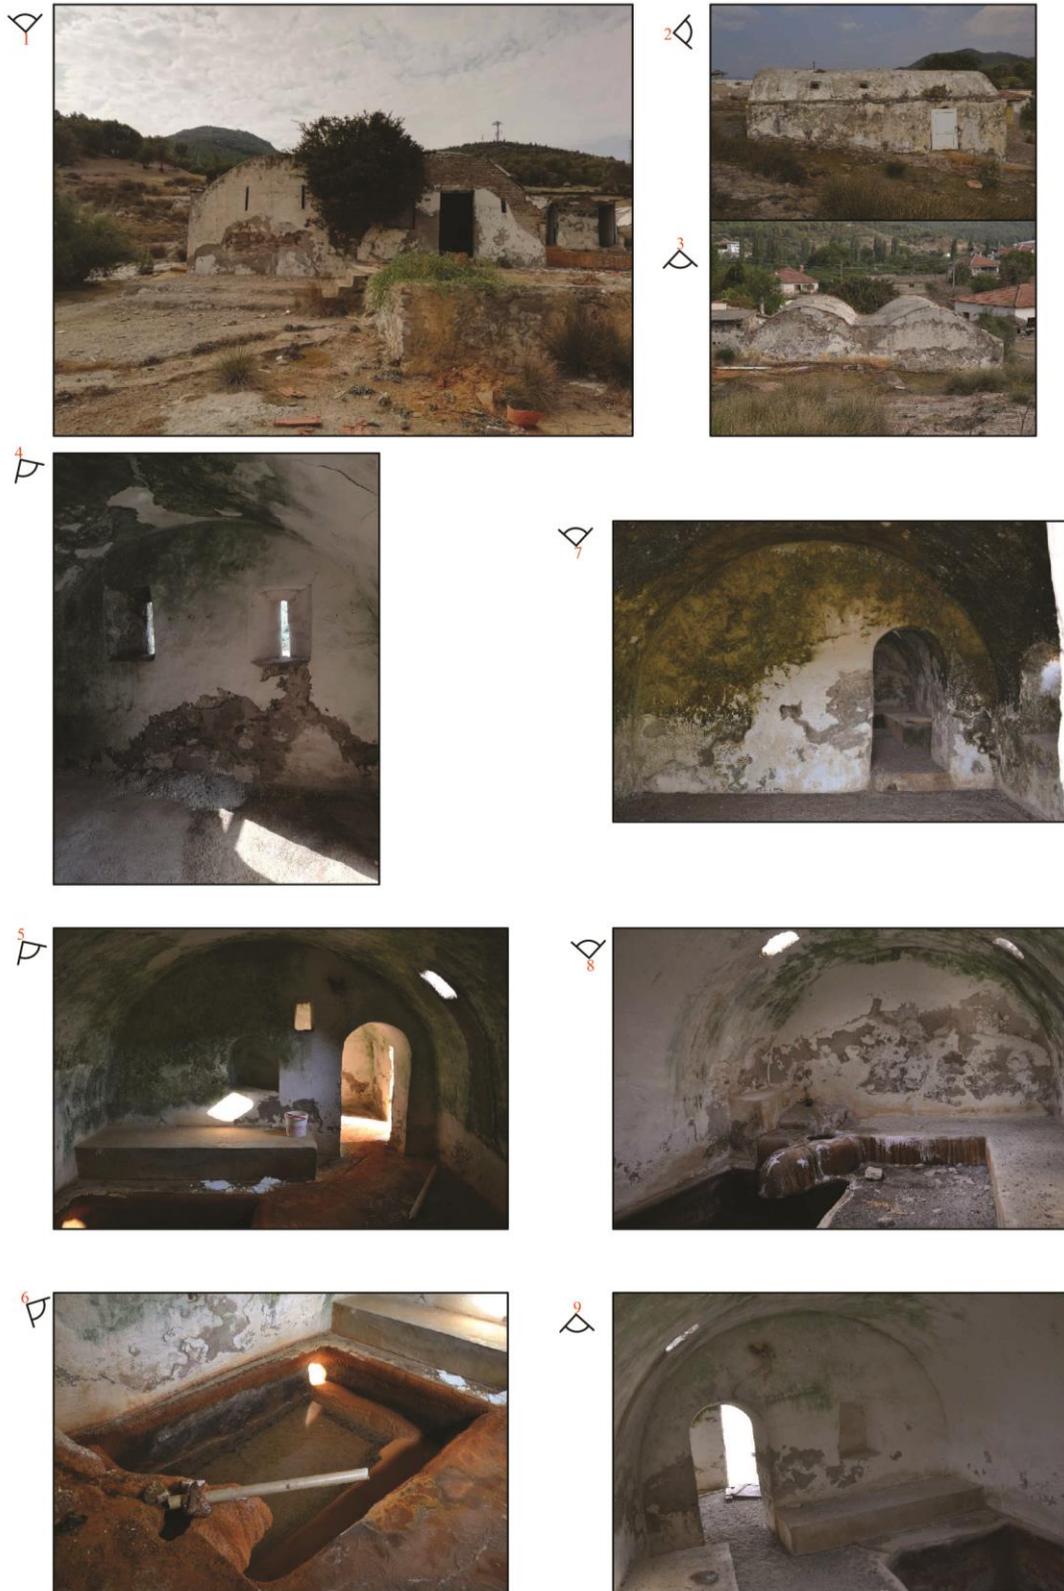
Figure 2.23. Cumalı Thermal Spring Bath Houses, A and B, Photographs

The construction material of the vaults is not visible since there is cement plaster and white wash on the surfaces. The walls of the bath houses A, B and C are rubble stone masonry finished with cement plaster and whitewash. They are 68 cm in thickness

at A and B. Some wall portions corresponding to the changing room of bath B are out of brick and finished with cement plaster and whitewash. So, a repair was realized after partial collapse of these wall portions. The interior surfaces of the walls, the sitting platforms and the floors inside the pools are all finished with cement plaster and whitewash (Figure 2.25, 2.26). Because of precipitation of the minerals in the spring water, there is a brownish layer observed on the surfaces of the floors and pools.

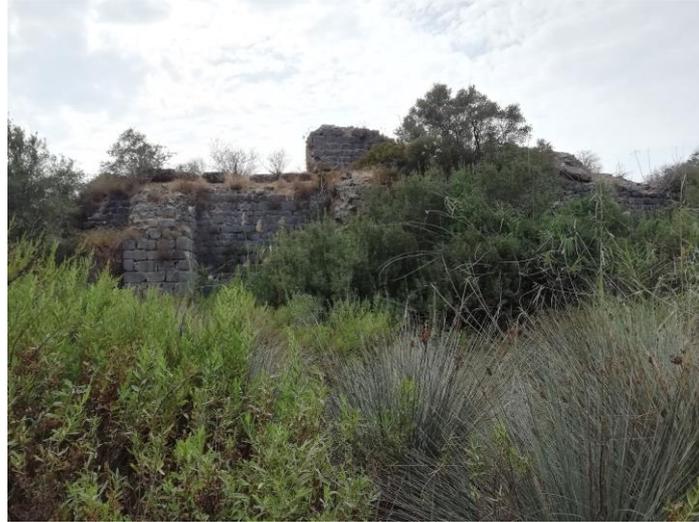
Figure 2.28. Thermal Spring Bath Ruin dating to the Roman period, view from the north

The ruin of the Roman bath is hardly perceived among the vegetation. The entrance through a vaulted opening at the western side. The form of plan and architectural elements cannot be understood due to the vegetation inside the building at

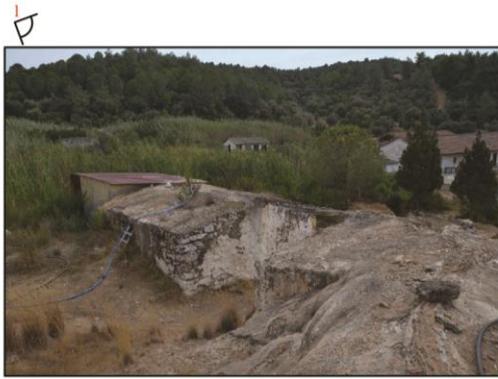
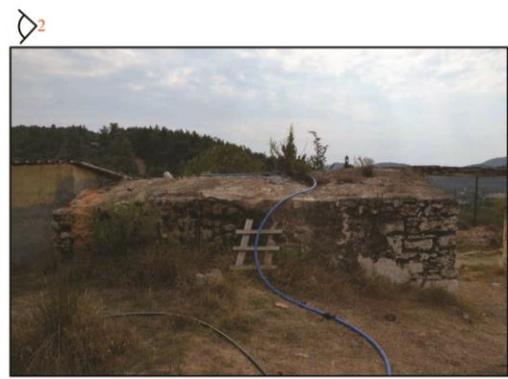
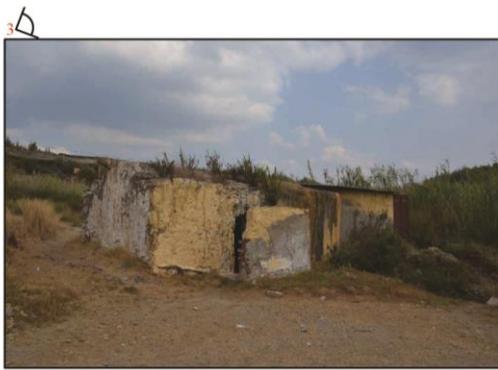
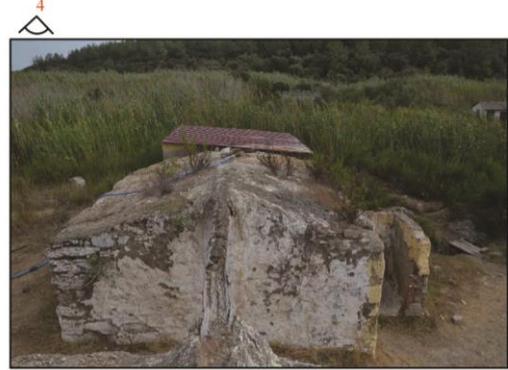
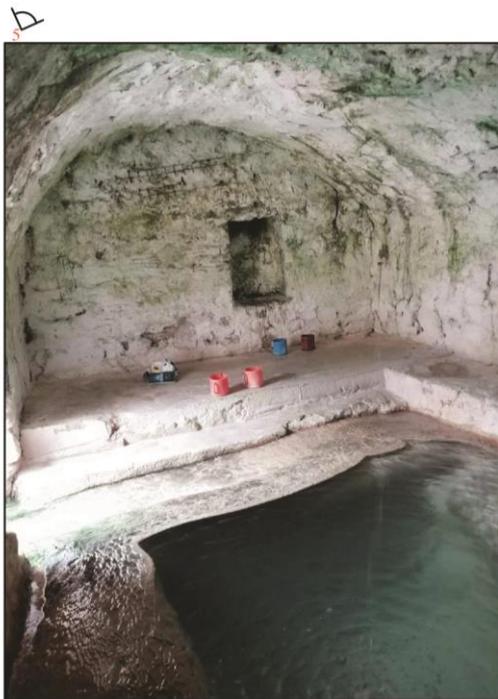
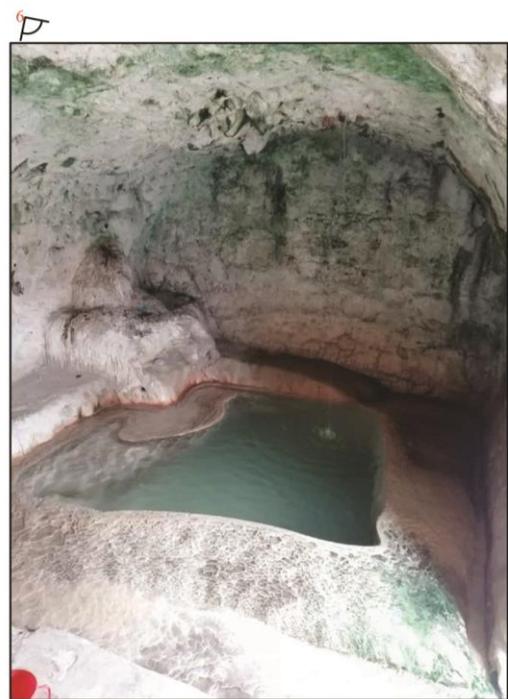
Figure 2.34. Karakoç Thermal Spring Bath B, Photographs

Both the vault and the walls (thickness: ~70 cm) are out of rubble stone and mortar. At the exterior, the vault is plastered, while there are patches of plastering on the walls. The precipitation of minerals in the spring water have formed a sedimentary layer on the roof. Higher plants and microorganism are seen here as well. The interior surfaces are finished with cement plaster and whitewash (Figure 2.34). The floor is covered with screed.

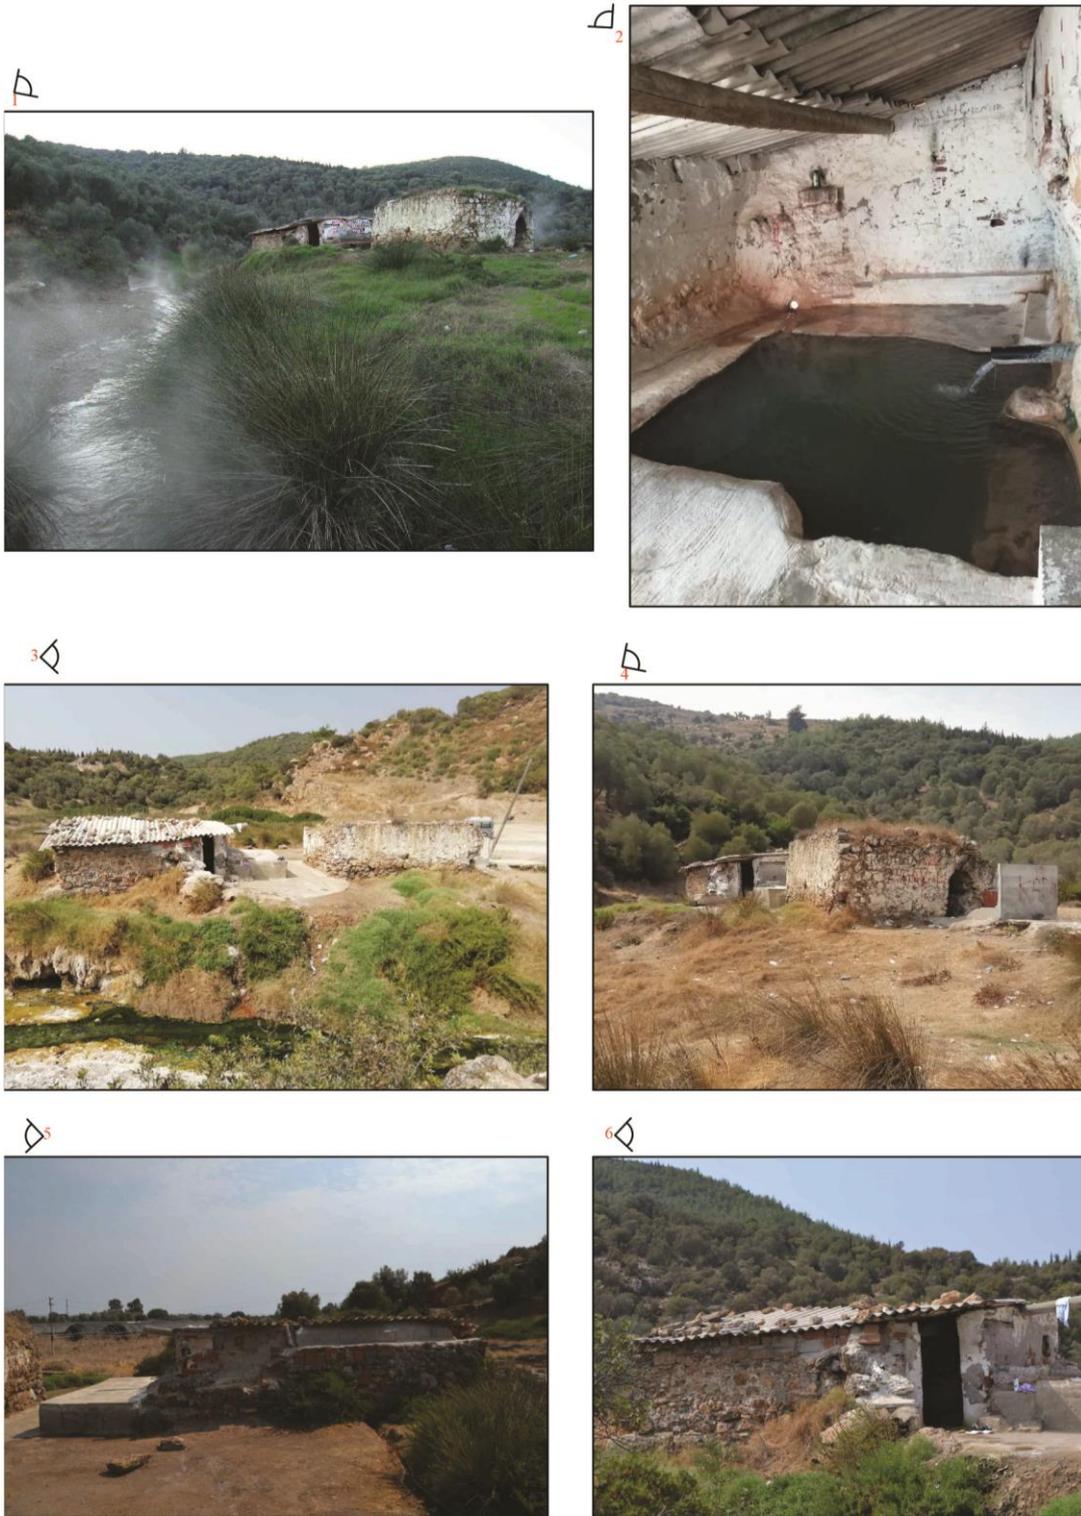
Figure 2.37. Kelalan Thermal Spring Bath House A, Photographs

The renewed roof of A is out of timber and covered with corrugated sheets. The original walls are rubble stone masonry. The exterior is exposed without plastering, but there is repair mortar, plaster and whitewash, observed at various locations. The interior surfaces are plastered and whitewashed. The upper portions of the walls are renewed with hollow bricks and mortar. The floor of the bathing space is screed. The vicinity of the bath house has sustained its natural earth surface (Figure 2.36, 2.37).

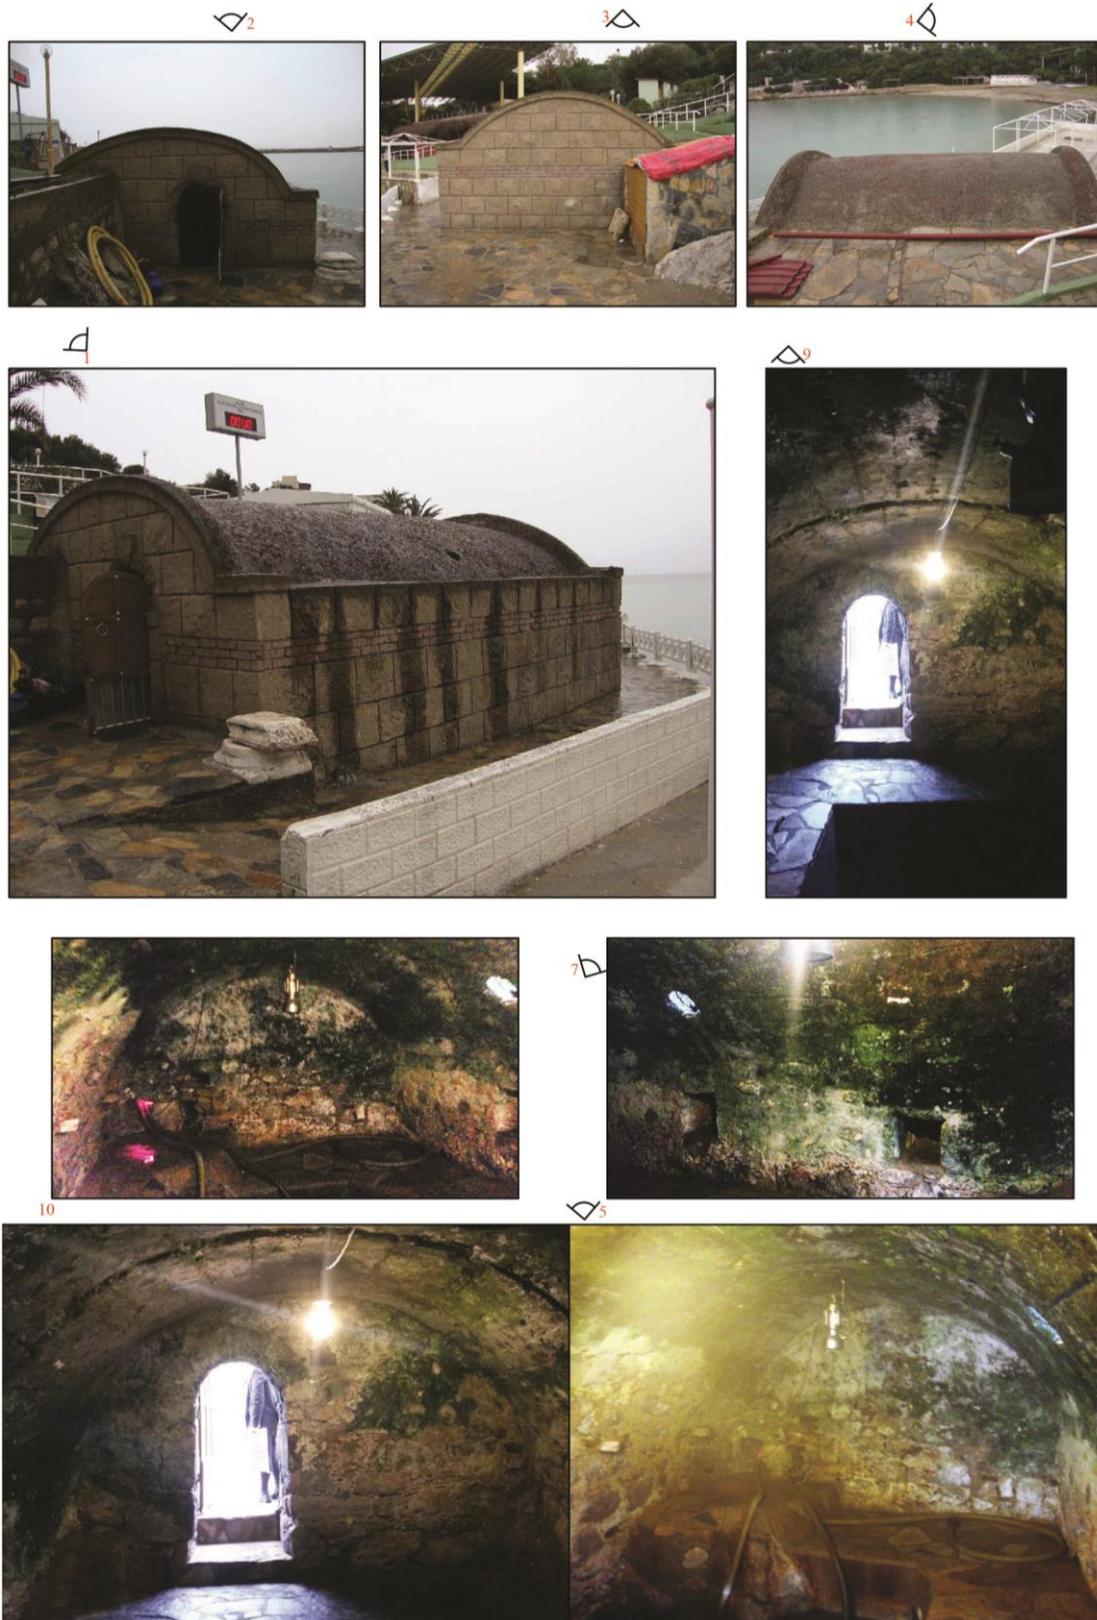
Figure 2.43. Ilıksu Geothermal Spring Bath Photographs

The walls of the bath house are out of rubble stone (thickness: ~70 cm) and the corners are reinforced with cut stone. The exterior surface of the vault was plastered, while those of the walls were exposed without plastering (Yaman, 1999:53) (Figure 2.41). Today, the walls are cement plastered, imitating cut stone covering (Figure 2.43). The bath house was repaired in 1932 and after 1999 by the army (oral source). So, this facade treatment is thought to belong to the renewal after 1999. About the inside; the interior surfaces of the walls are used cement plaster with whitewash. The vault is out of rubble stone with cement grout as plaster that has been seen scaffolding mould mark and covering whitewash. The water temperature is 17°C (Figure 2.42, 2.43).

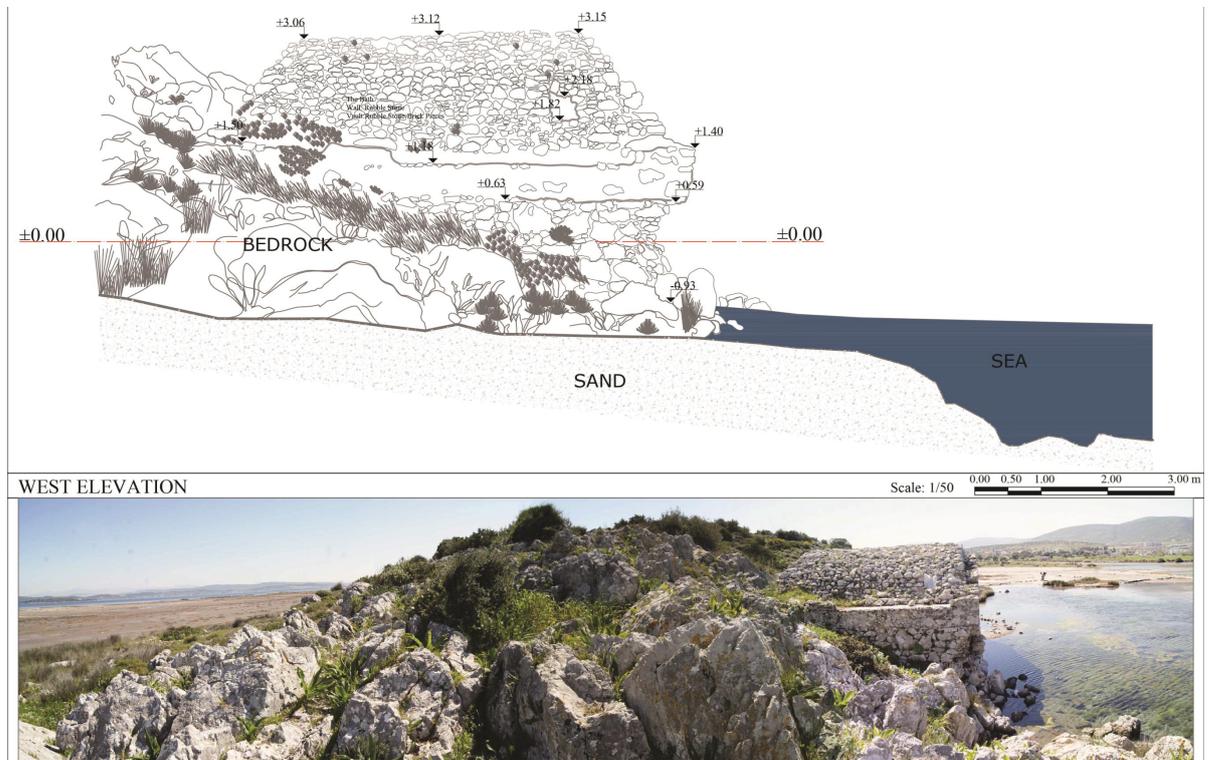
Figure 3.5 The Western Facade of The Case Study

The vault and wall are constructed with rubble stone and mortar. For vault and walls, there are not used any special binding technique. Even the edge of wall collapsed

still understanding the wall's arrangement on building. The portion in contact with the sea had eroded inwards. There is an opening where its right side on the vaults created as a result of vandalism at 25 cm in width, 35 cm in height of the vault (Figure 3.5).

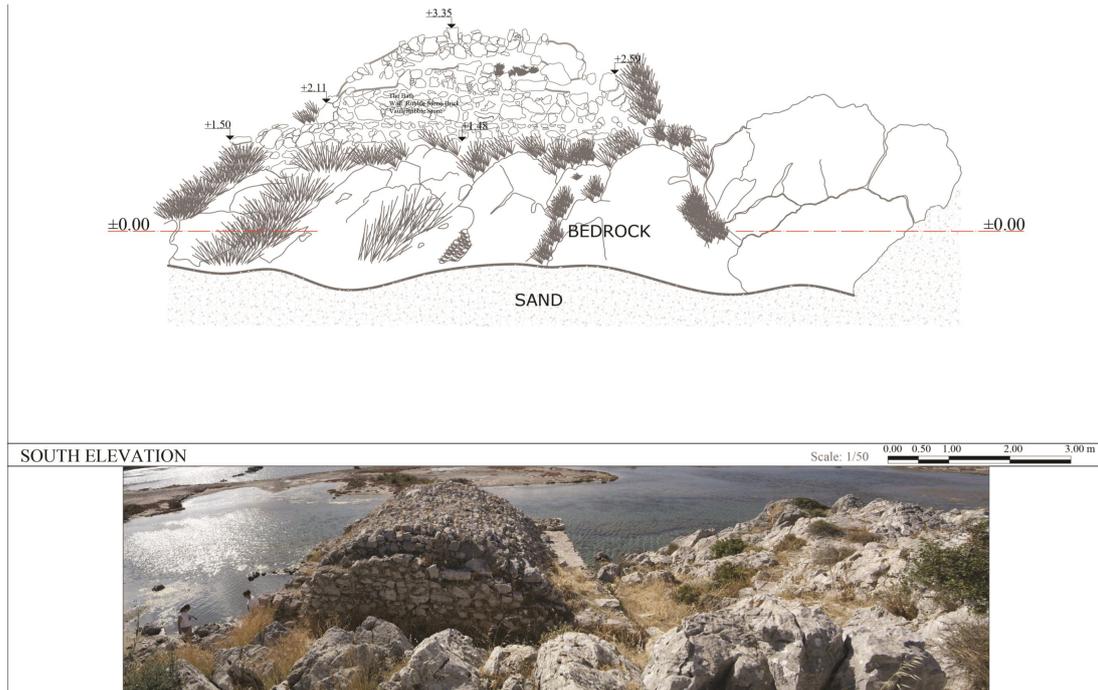
Figure 3.6 The Southern Facade of the Case Study

This is the rear facade (669 cm in width and 246 cm in height), juxtaposing the mount at its north. It is composed of south face of the barrel vault (~156 cm in height) and the upper portion of the south wall (~90 cm in height). There is not any opening at its surface. The facade is out of rubble stone in random order and exposed without plastering. The vault is ruined at its bottom portion while the wall is ruined at its west corner (Figure 3.6).

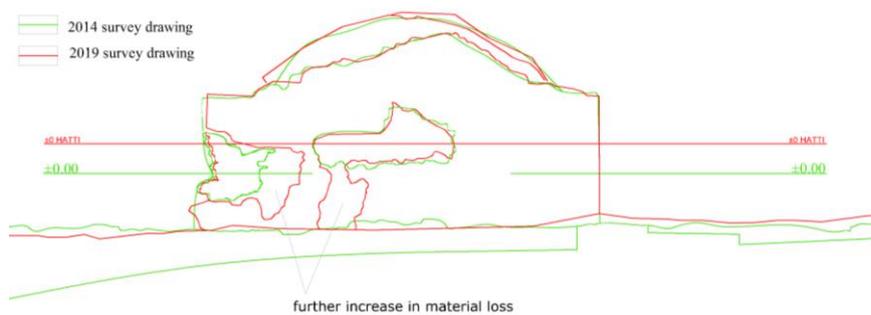
Figure 5.2. Northern Facade

When a comparison is made between both March 2014 and 2019 survey drawings it is seen that sea is the major cause of failures and deteriorations. The northwestern wall facing the sea has eroded much more compared to the other portions of the bath house in the mentioned five years (Figure 5.1, 5.2). The material loss at the sea façade has probably given way to a movement of the related wall towards the sea direction. In turn, the structural crack at the west side of the entrance façade has become longer and the hole above it has enlarged (Figure 5.3). The most apparent material loss in the other portions is at the south corner of the mass. In addition, the arch of the spring has further eroded. This may be explained with the discharge of the mortar in the joints

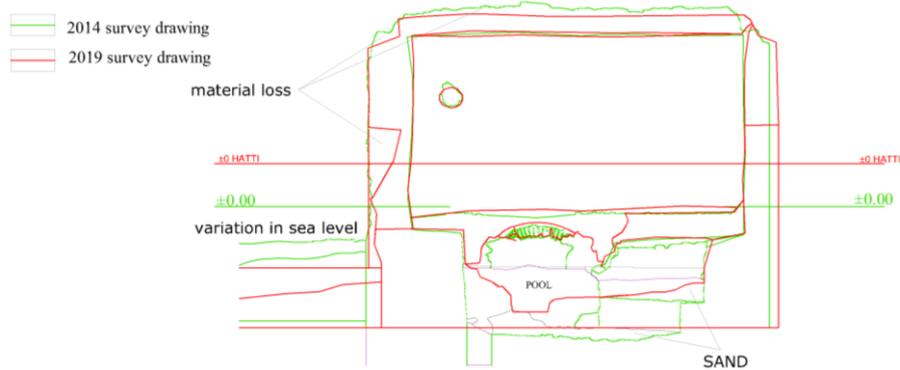
Figure 5.4. Eastern Facade

in close connection with geothermal water at highest temperature (Figure 5.4). The variation in level differences of sea water may be related with seasonal changes, tide turns and heaviness of rains.
