Geotechnical reconnaissance findings of the October 30 2020, Mw7.0 Samos Island (Aegean Sea) earthquake

Abstract

Keywords Reconnaissance · Samos earthquake · Liquefaction · Lateral spreading · Slopes · Retaining structures · Foundations · Seismic performance

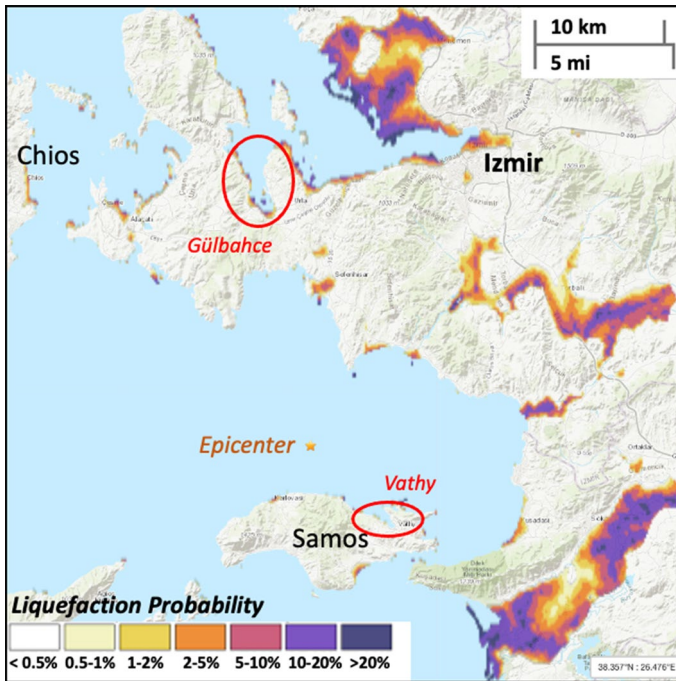
Fig. 5 USGS liquefaction susceptibility map released after the event showing liquefaction probability in the region surrounding the epicenter (not necessarily associated with the source at hand). The red ellipses indicate the only locations where evidence of liquefaction manifestation was identified

Starting with the Anatolian side, as presented in Fig. 5, potentially liquefiable sites and shores were visited, and the lack of surface manifestation of soil liquefaction triggering was documented as no sand boils or displacements were identified. However, a number of surface manifestations were documented in Gulbahce-Izmir and Samos Island indicating the triggering of soil liquefaction, which will be discussed next (Fig. 6).

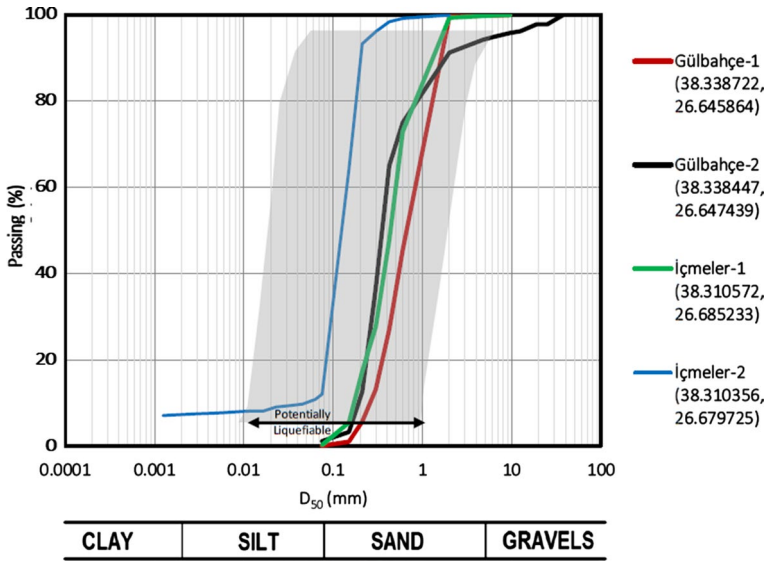
Consistent with the USGS susceptibility predictions, 45–50 km away from the rupture, along the shores of the Icmeler and Gulbahce districts, sand boils were observed, as shown in Fig. 7a through d. These sites were close to the Gulbahce fault zone, and documented artesian pressures along with hot water springs which are known to be present at these sites, which are also believed to have contributed to the observed soil ejecta formation. Figure 8 illustrates the results of grain size distribution analyses performed on soil samples retrieved from the sand ejecta. As can be seen, all samples were uniform and within the bounds typically delineated as liquefiable uniform soils.

Fig. 8 Grain size distribution curves of sand ejecta obtained from Gülbahçe, along with the bounds of typically liquefiable non-uniform soils

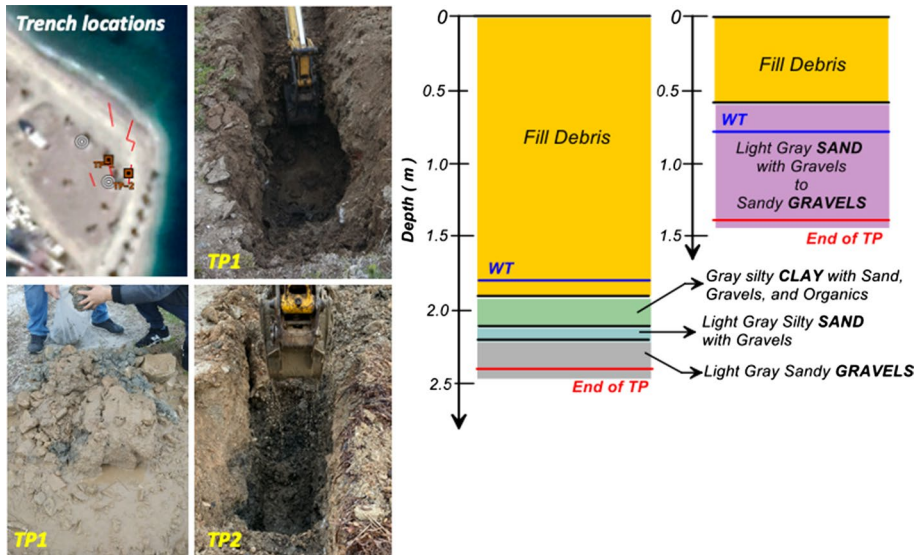
Fig. 11 Trenching at the Malagari liquefaction site and rough stratigraphy resulting from it

their broader extent were still easily visible and distinguishable. In the same area, ground cracks compatible with a lateral spreading mode of failure were observed and are emphasized in the inset of Fig. 10. The combination of the aforementioned with a free face to water, like in Malagari, eases the process, but lateral spreading has been manifested also in case histories with no free face (e.g. Balboa Boulevard failure during the 1994 Northridge earthquake—e.g. Stewart et al. 1996, Pretell et al. 2020). Trenching and soil sampling at two locations at the Malagari site were performed, which yielded two rough cross-sections and three grain size distributions for samples at three distinct depth intervals at the site illustrated in Figs. 11 and 12 respectively. The fines portion in all three samples was found to be non-plastic.

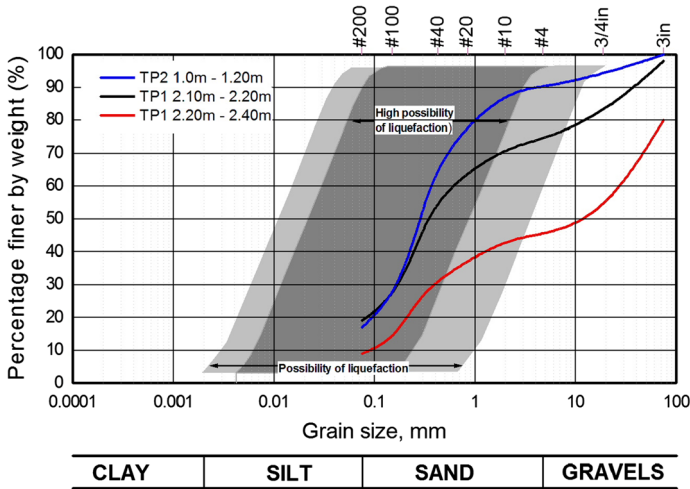
Fig. 12 Grain size distributions of three samples retrieved from different depths at the two trenching locations at the Malagari liquefaction site, along with the bounds of typically liquefiable non-uniform soils. The fines were found to be non-plastic (NP). (Geographic coordinates are provided in Fig. 10)

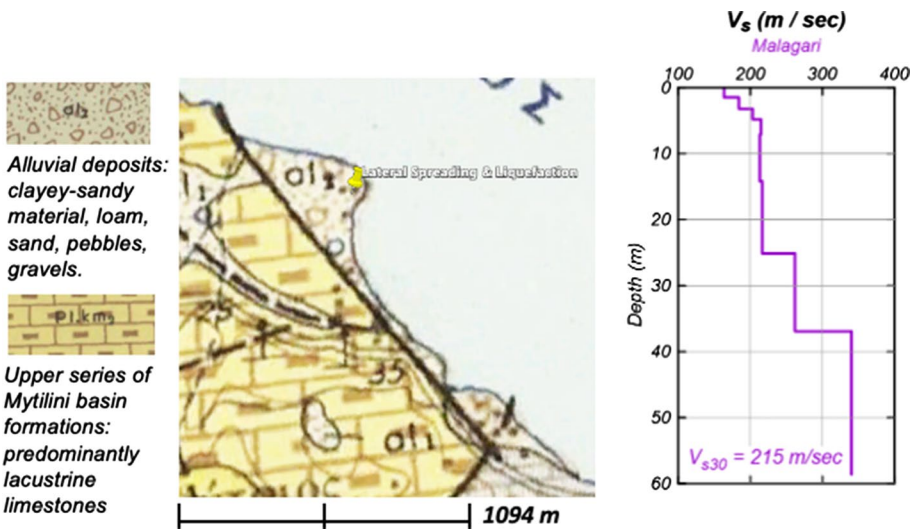
Shear wave velocity measurements performed after the earthquake using geophysical methods such as MASW (Professor Panagiotis Pelekis—20th December 2020) in the Malagari area that was affected by liquefaction yielded a time-averaged shear-wave velocity in the upper 30 m of the site $V_{s30}=215$ m/sec. The distribution of shear wave velocity V_s with depth is shown in Fig. 13. There are no borehole SPT or CPT data available at this site and the only relevant information is that from the Port of Malagari (West side of Vathy gulf) and borehole BH5 (Fig. 33). The geologic map of Samos (Fig. 13, but also Fig. 32) indicates that the Malagari site has alluvial deposits featuring plain deposits of clayey-sandy material, loam, sand, pebbles and gravels, which are potentially liquefiable when saturated. This particular site, where liquefaction was undoubtedly manifested, can be studied as a case history of either True Negative or True Positive liquefaction manifestation after more data are obtained and processed.

Fig. 13 Geologic map of Malagari indicating alluvial deposits and shear wave velocity profile at Malagari down to a depth of 60 m. (Geographic coordinates are provided in Fig. 10)

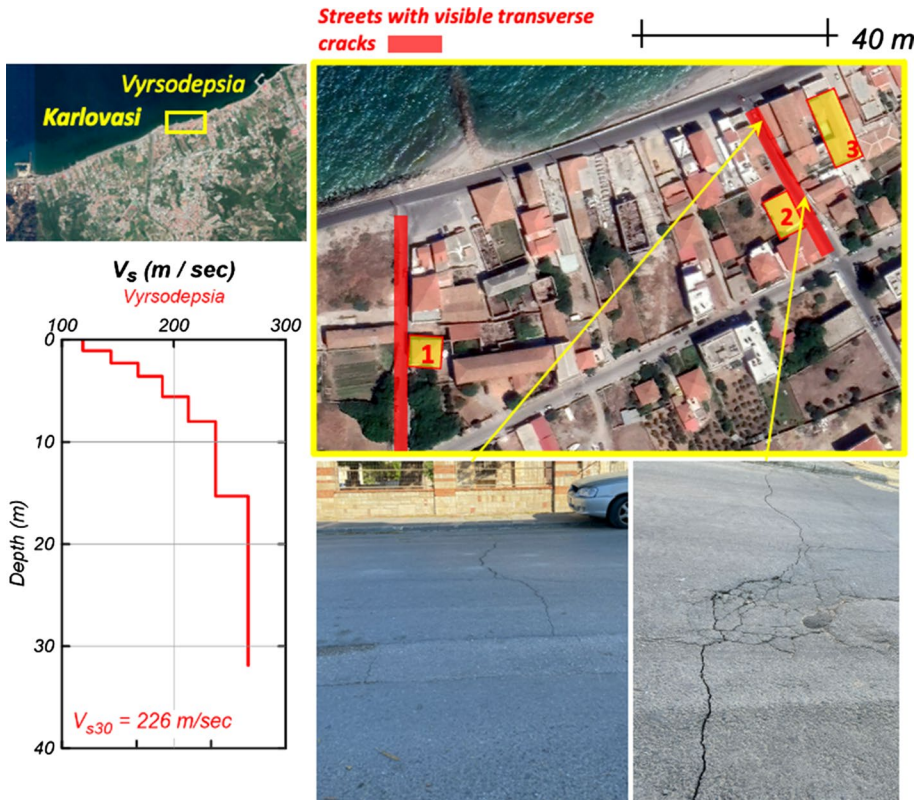
Lateral spreading effects were also evident through structural damage at other nearshore locations in the northern part of the island. Specifically, Figs. 14 and 15 illustrate three buildings and their location close to the north shore of the island, in the neighborhood Vyrsodepsia in Karlovasi. No surface manifestation of liquefaction was identified nearby, but the ground cracking crossing the street pavement and running through the buildings (the two in Fig. 16 are about 70 m inland and the one in Fig. 17 is about 20 m inland), in combination with the level/mildly sloping ground, the shallow water table, and the free face to the sea are all compatible with the hypothesis of lateral spreading.

Fig. 14 Plan view of Karlovasi and the Vyrsodepsia neighborhood with buildings likely affected by lateral spreading towards the seafront alongside with shear wave velocity profile of the area down to a depth of 30 m (aerial close up at 1382 ft, 37o47'57.94" N, 26o42'23.27" E). The enumerated buildings are individually shown in Figs. 16 and 17

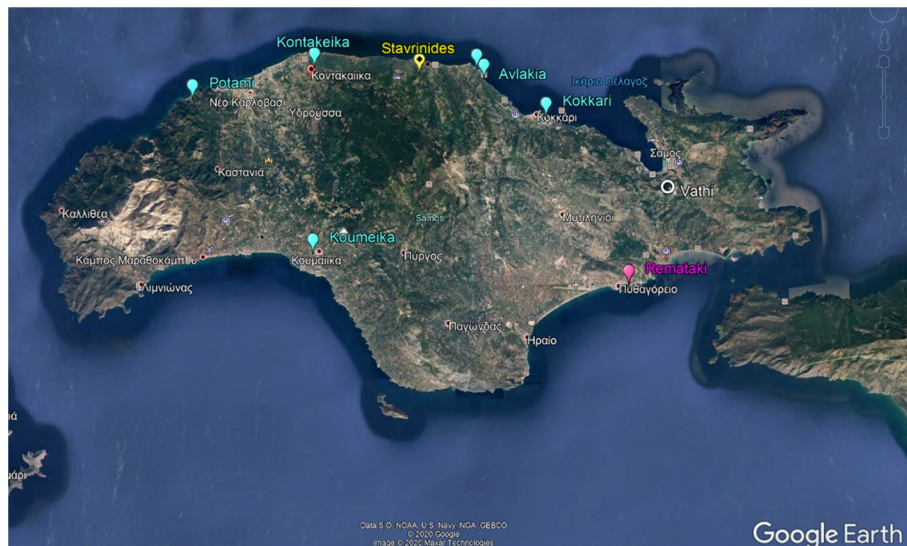
A series of minor-to-moderate slope failures and rockfalls were identified during the earthquake reconnaissance, mainly in the northern part of the island of Samos. The areas with nearby slope failures which are marked in a Google Earth map (Fig. 20) were located mainly by the reconnaissance team of HAEE/ETAM. The exact coordinates of these failures are also listed in Table 1, while some additional cases reported in Lekkas et al. (2020) and HSMGE (2020) are also shown. A brief description and representative photos are given below for some of these cases.

Fig. 20 Geographical distribution of slope-type failures located by the HAEE/ETAM reconnaissance team during the visit on 7th November, 2020 (cyan pins). Additional sites with light slope failures recorded by Lekkas et al. (2020) (magenta pin) and HSGME (2020) (yellow pin) are also shown

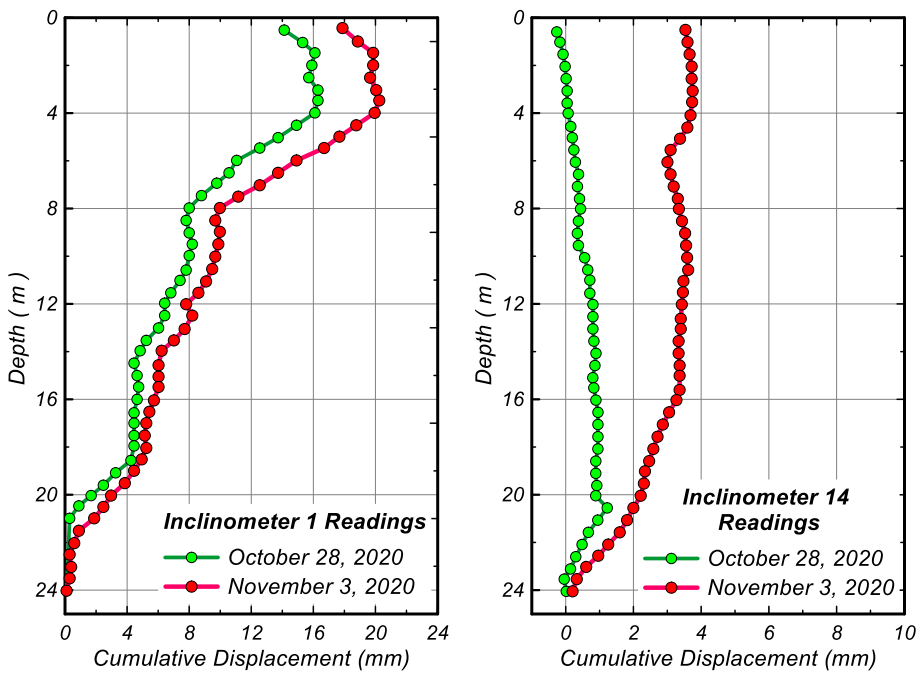
the installed monitoring system (Fig. 26). No failure or relaxation of pre-stressing loads on anchors was measured/observed. These observations are also supported by inclinometer measurements taken before and after the earthquake. The measurements suggest that the lateral displacements (illustrated in Fig. 26) accumulated during the earthquake were less than 2 mm. No relevant data are available from Samos (or any of the nearby islands) in Greece, since there are no similarly deep excavations constructed.

Fig. 26 Inclinometer data covering the period of earthquake shaking, at a 9 m-deep excavation in Izmir, Turkey, supported by diaphragm walls

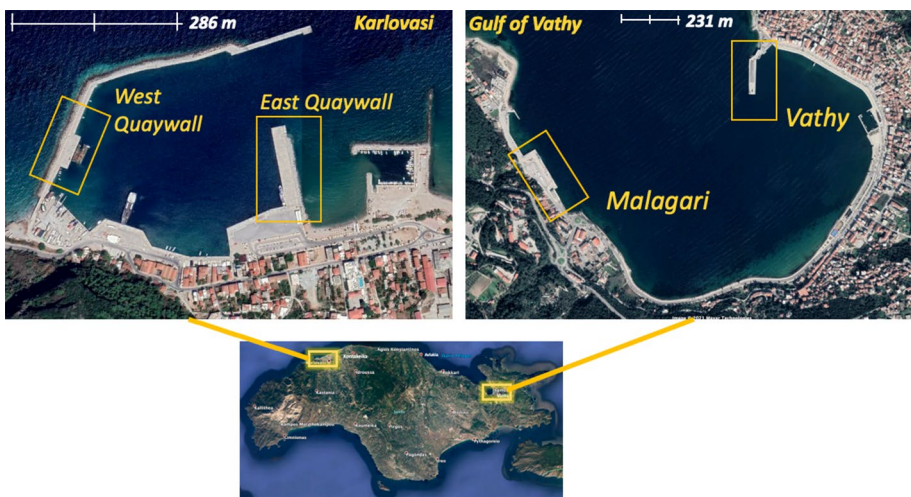
Sea and the Dodecanese islands. Both ports are situated at the northern part of Samos and suffered damage due to the earthquake. There is also a smaller port, Kokkari, which is located in-between the Vathy and Karlovasi ports. That port was also affected by the earthquake; however, the economic impact of the damage was less important relative to that of the other two ports. At the southern part of the island, there are some other ports, at Pythagorio, Iraion, and Marathokampos bay, that were less affected by the earthquake (HAEE/ETAM 2020).

Fig. 31 Satellite images providing an overview of ports of interest in Samos where significant earthquake damage was observed. Annotations indicate the names assigned for ease of reporting herein

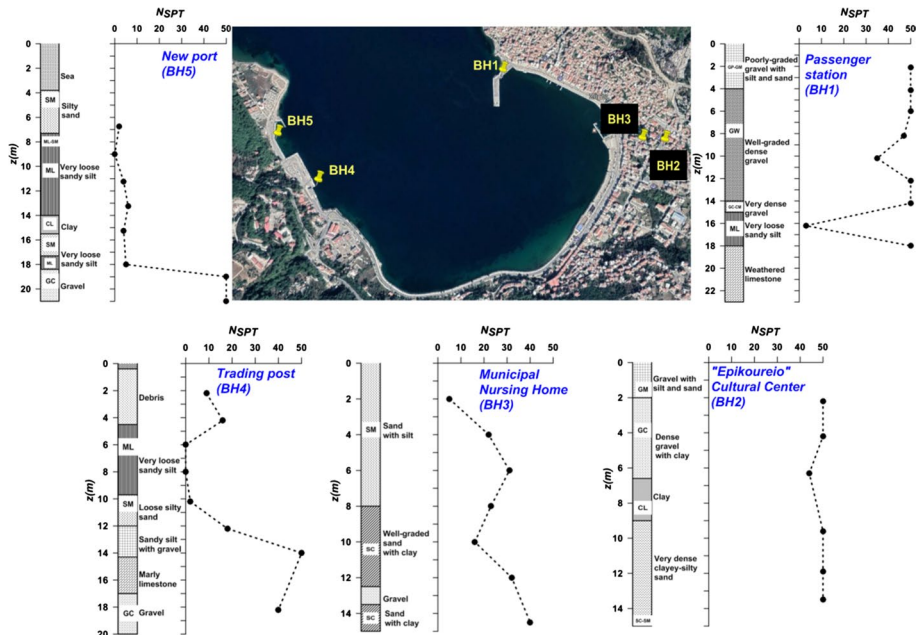
Fig. 33 Four geotechnical borehole logs (BH1, BH2, BH3, BH4) alongshore from the eastern (old) port to the western (new) port at Vathy (courtesy of G. Milionis—modified by Em. Rovithis). One offshore borehole (BH5) at the NW edge of the new port (kindly provided by the Ministry for the Environment, Physical Planning and Public Works of Greece – modified by Em. Rovithis)

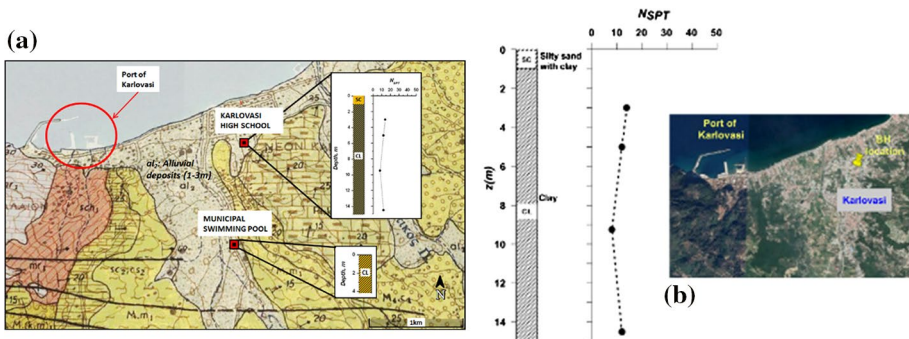
from a borehole close to the high school of Karlovasi indicate that the soil consists of grey to grey-brownish medium stiff to stiff sandy clay of medium plasticity (excluding the top 1 m that consists of silty sand with a few gravels). The distance to the closest part of Karlovasi port (east quay wall) is about 2 km; therefore, it is difficult to extrapolate as to the subsoil in the port. However, based on the soil layering at Vathy, there is a possibility that the surficial layer of silty sand gets thicker near the seashore. This however, albeit generally true, cannot be reliably deduced without geotechnical data.

Fig. 37 **a** Part of the detailed geological map of Samos Island, published by the Hellenic Survey of Geology and Mineral Exploration (HSGME 2020) with the location of two (2) geotechnical boreholes on the same geological formation (a12). **b** Borehole log next to the High School of Karlovasi (Gymnasium), at a distance of about 2 km from the east quay wall of the port and 550 m from the seafront
