## ASSESSMENT OF STRUCTURAL DAMAGE IN ADIYAMAN AND CALIBRATION OF RAPID VISUAL SCREENING METHODS AFTER KAHRAMANMARAŞ EARTHQUAKE SEQUENCE

A Thesis Submitted to the Graduate School of Engineering and Sciences of İzmir Institute of Technology in Partial Fulfillment of the Requirements for the Degree of

by Yusuf EKİNCİ

December 2024 İZMİR We approve the thesis of Yusuf EKİNCİ

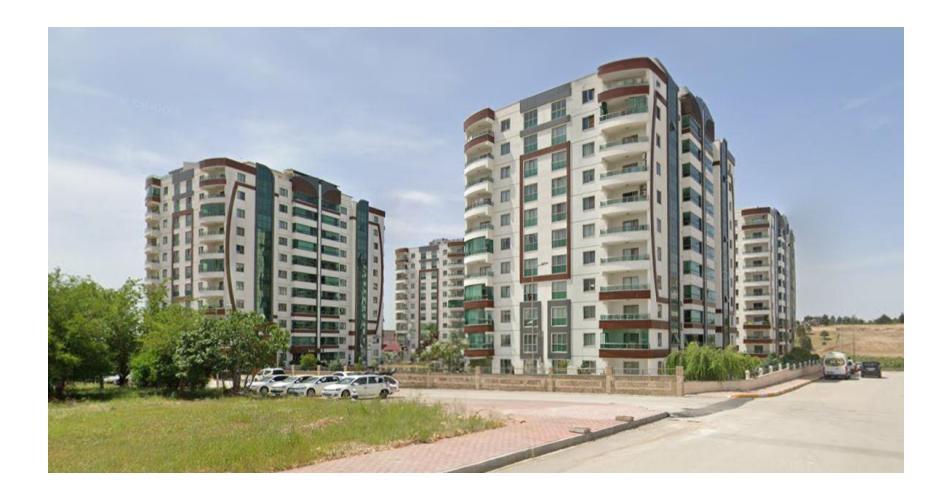
Figure 3.29. 11-storey complex from database. (Courtesy of Google Street view).

One of the 11-storey complex from database, consisting of 4 blocks and constructed in 2015 in the center of Adıyaman, sustained heavy damage during the earthquake. For safety reasons, all four buildings were subsequently demolished following the earthquake (Figure 3.29). These buildings had one of the most expensive house prices at Adıyaman
