**CONSERVATION OF
KUSEYRİ SOAP FACTORY
AS AN INDUSTRIAL HERITAGE IN ANTAKYA**

**A Thesis Submitted to
the Graduate School of Engineering and Sciences of
İzmir Institute of Technology
in Partial Fulfillment of the Requirements for the Degree of**

in Architectural Restoration

**by
Derya CAMUZ**

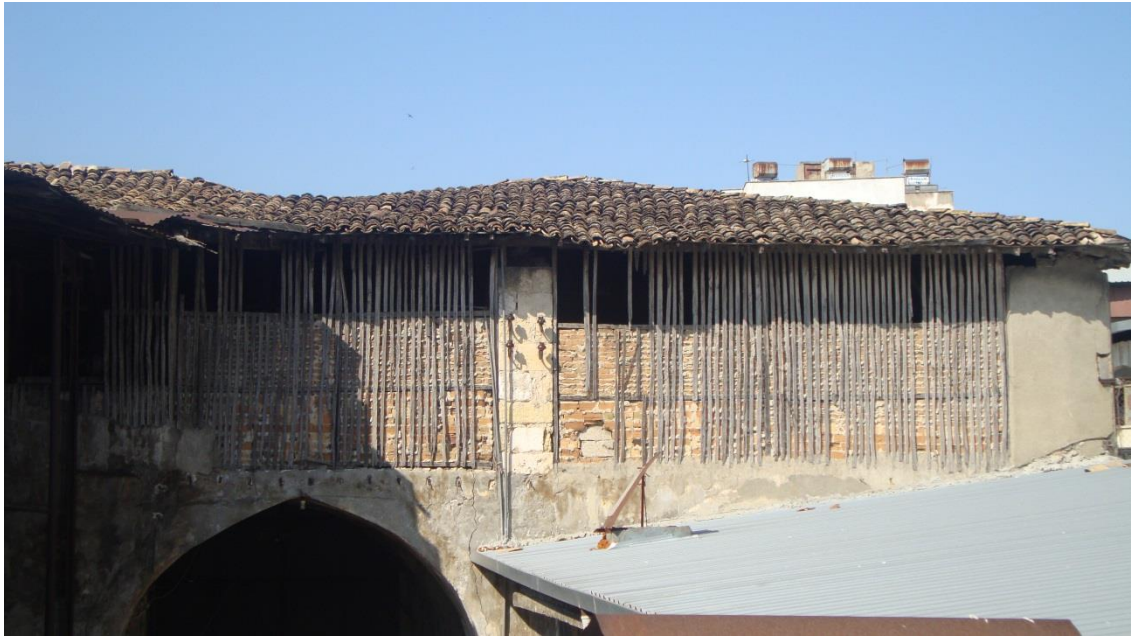
Figure 4.40. The original wooden screen and later added low partition brick masonry walls between the original cut stone masonry columns on the south part of the drying area

The missing parts of the building are the western part of the renewed hipped roof on the north (Figure 4.141), the wooden laths of the floor on the west part of the spreading areas on the first floor (Figure 4.142) and the vertical wooden laths on a part of the wooden screen on the courtyard facade of the drying area on the first floor (see Figure 4.40).

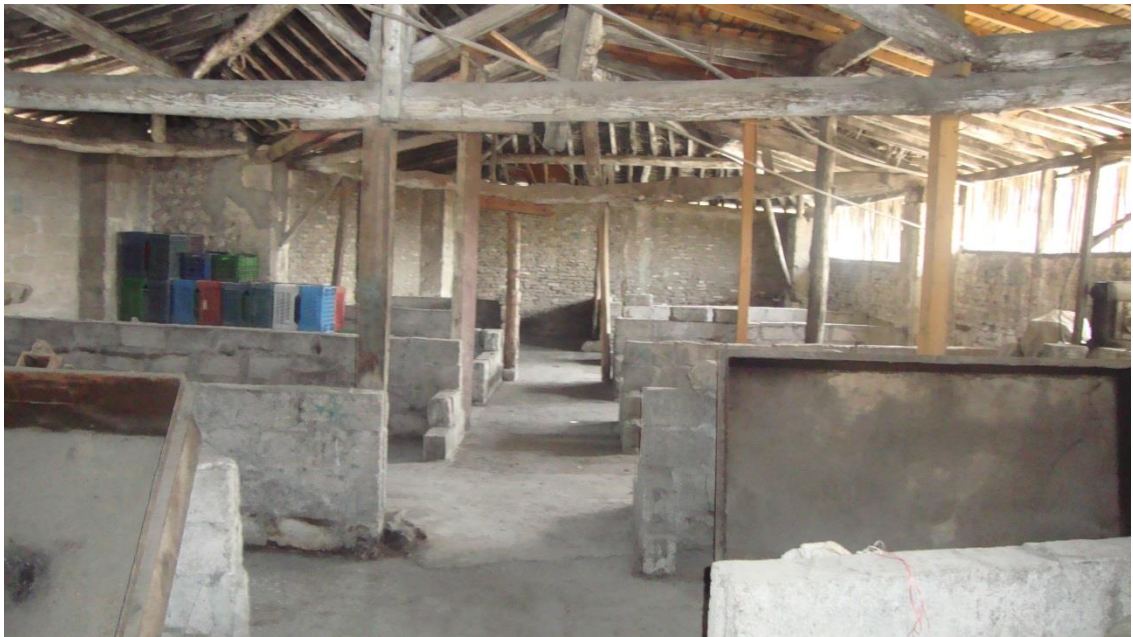
Figure 4.41. Later added low partition cinder blok walls on the drying area

The most important addition observed on the building is the mass additions. These mass additions are the rooms and toilet that are later arranged on the west part of the building and the later arranged toilet located above the original stone stairway provide to get off from the courtyard to the fireplace room (Figure 4.134, Figure 4.135). The building element additions are the partition brick, cinder block and stone masonry walls on the ground floor and first floor, two reinforced concrete stairs one of which is quarter landing on the south of the courtyard and the other is half landing on the west part of the building, reinforced concrete columns on the northern facade, the doors on the ground floor and first floor, wooden platforms and pedestals of these platforms located on the closed and semi-open galleries on the south of the building on the ground floor, electrical installations of the ground floor, eaves and shutters on the northern and eastern facades (Figure 4.136, see Figure 4.41, Figure 4.137, see Figure 4.35, see Figure 4.59, Figure 4.138, see Figure 4.88).

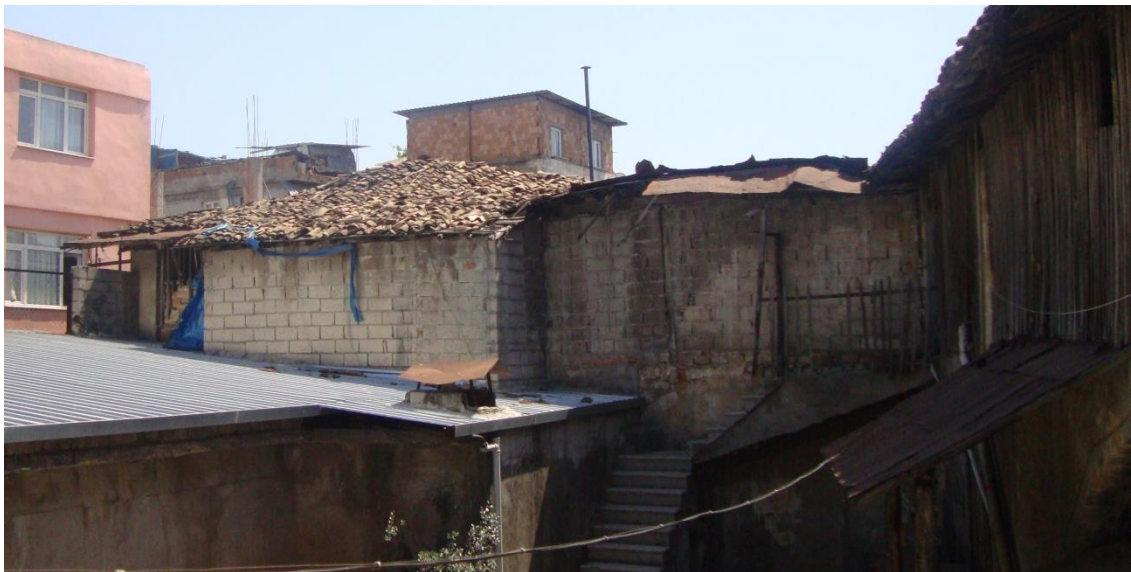
Figure 4.49. The later added cinder block masonry wall of the unoccupied space on the south of the courtyard

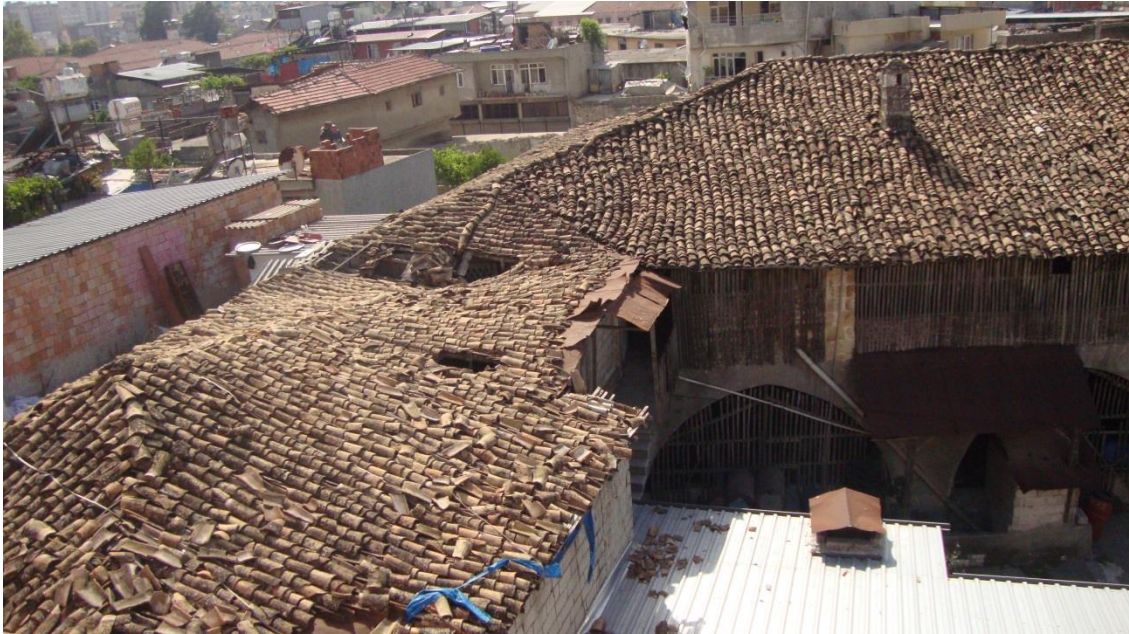
The first floor is covered with wooden hipped roof (Figure 4.50). The north part of the hipped roof was later renewed (Figure 4.51). At present, the west of the renewed part of the roof is collapsed. The original part of the hipped roof has later added wooden structural elements on its south. The southeastern part of the hipped roof is partially collapsed (Figure 4.52). The first floor is covered with later added cement screed on its entire floor.

Figure 4.52. Partially collapsed part of the roof

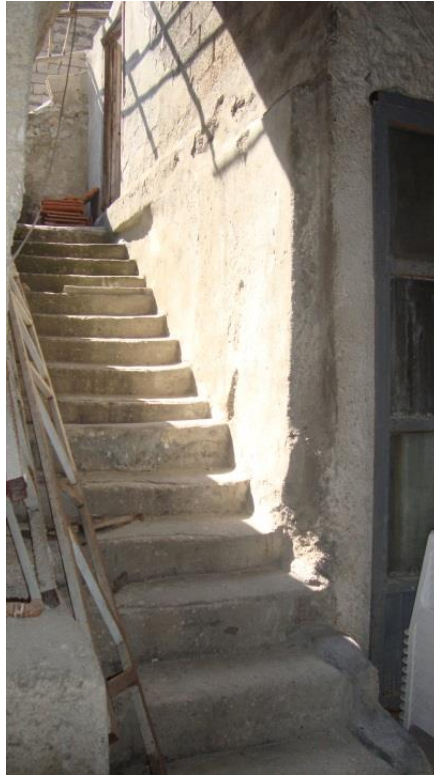
Figure 4.59. The later arranged half-space landing reinforced concrete stair on the west of the distribution space

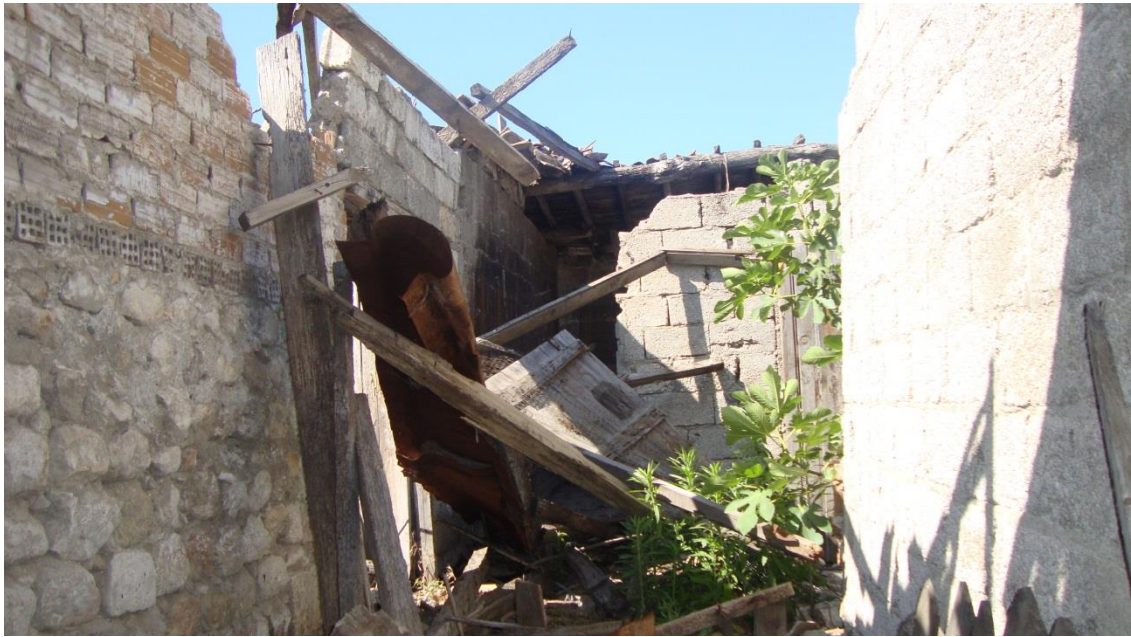
Figure 4.71. The later arranged ruined unoccupied space on the north of the entrance and distribution space

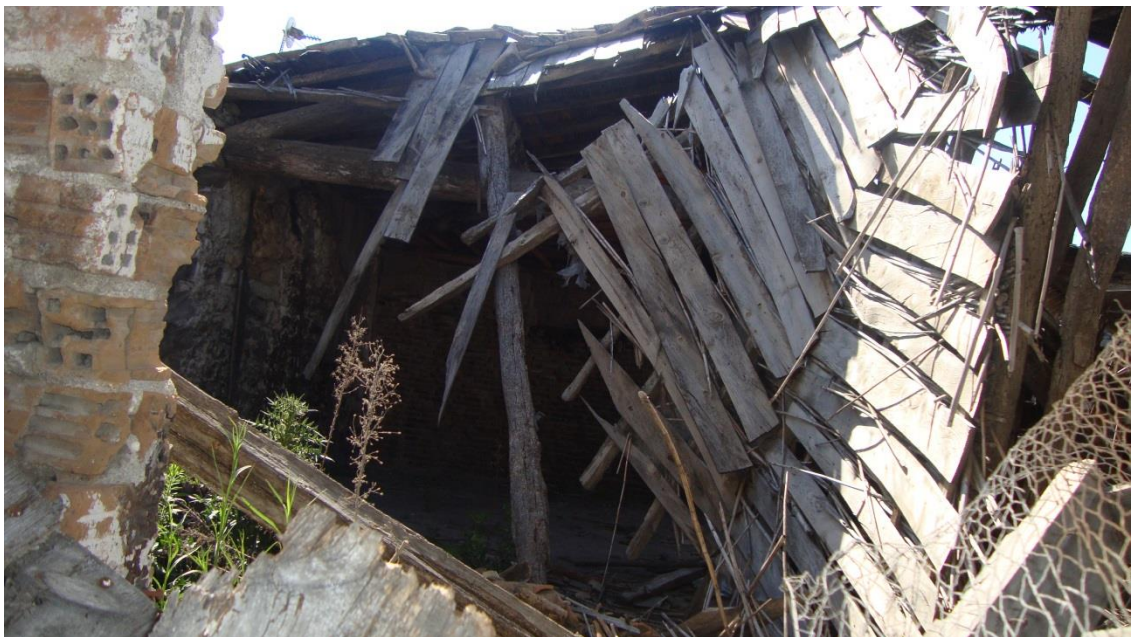
Figure 4.72. The later arranged ruined unoccupied on the northwest of the entrance and distribution space

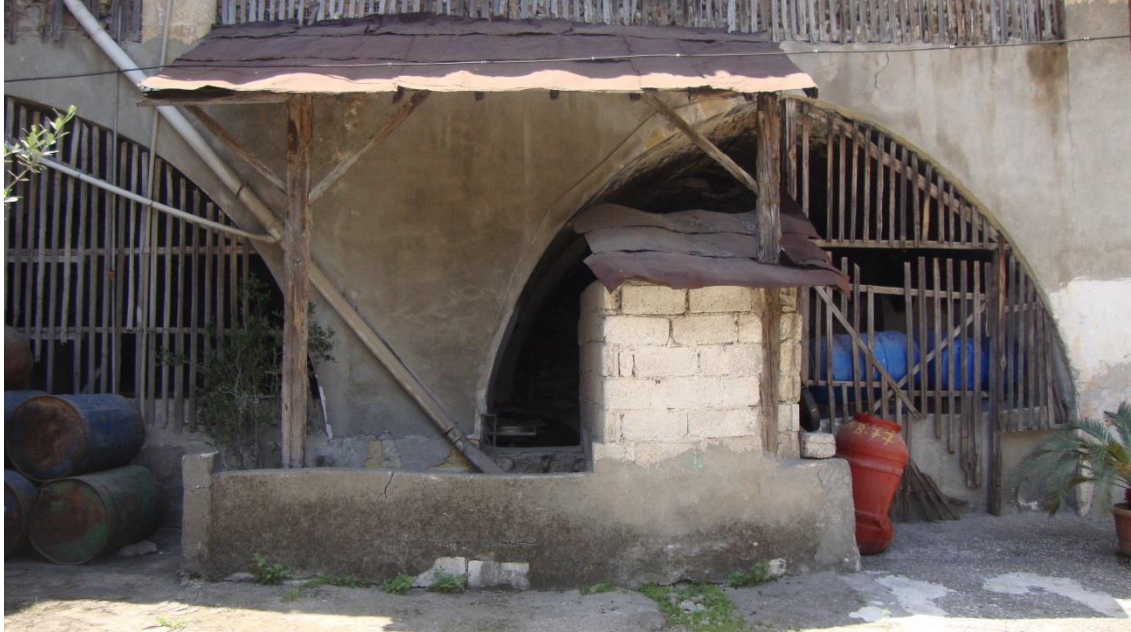
Figure 4.74. Partially removed wooden screen in the depressed pointed arch and mass addition on the western courtyard facade

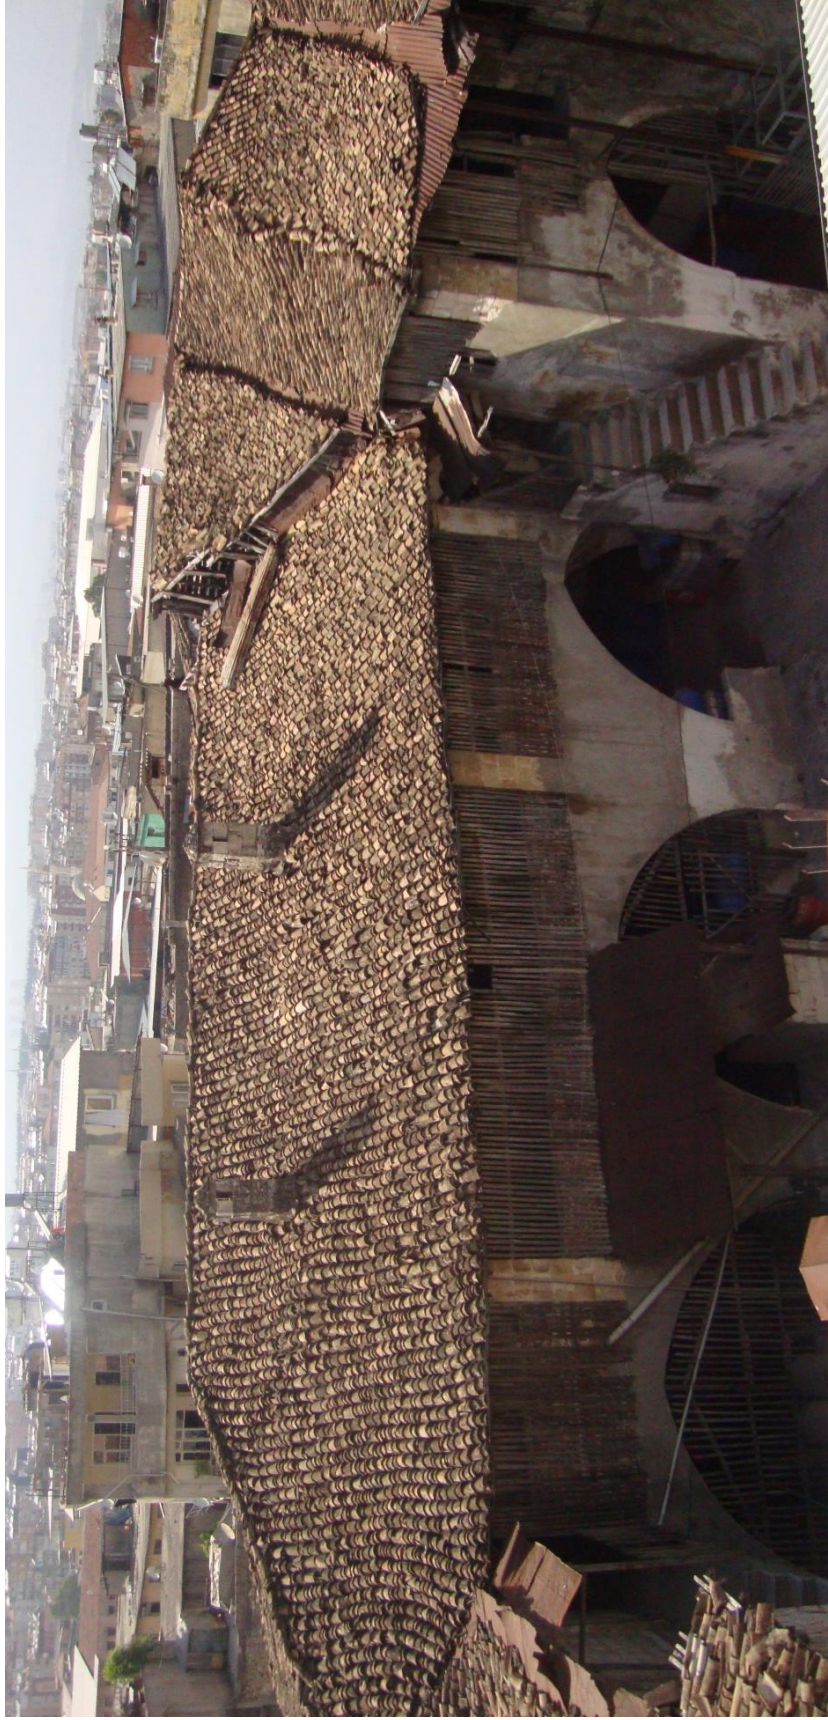
Figure 4.79. The original and renewed part of the hipped roof

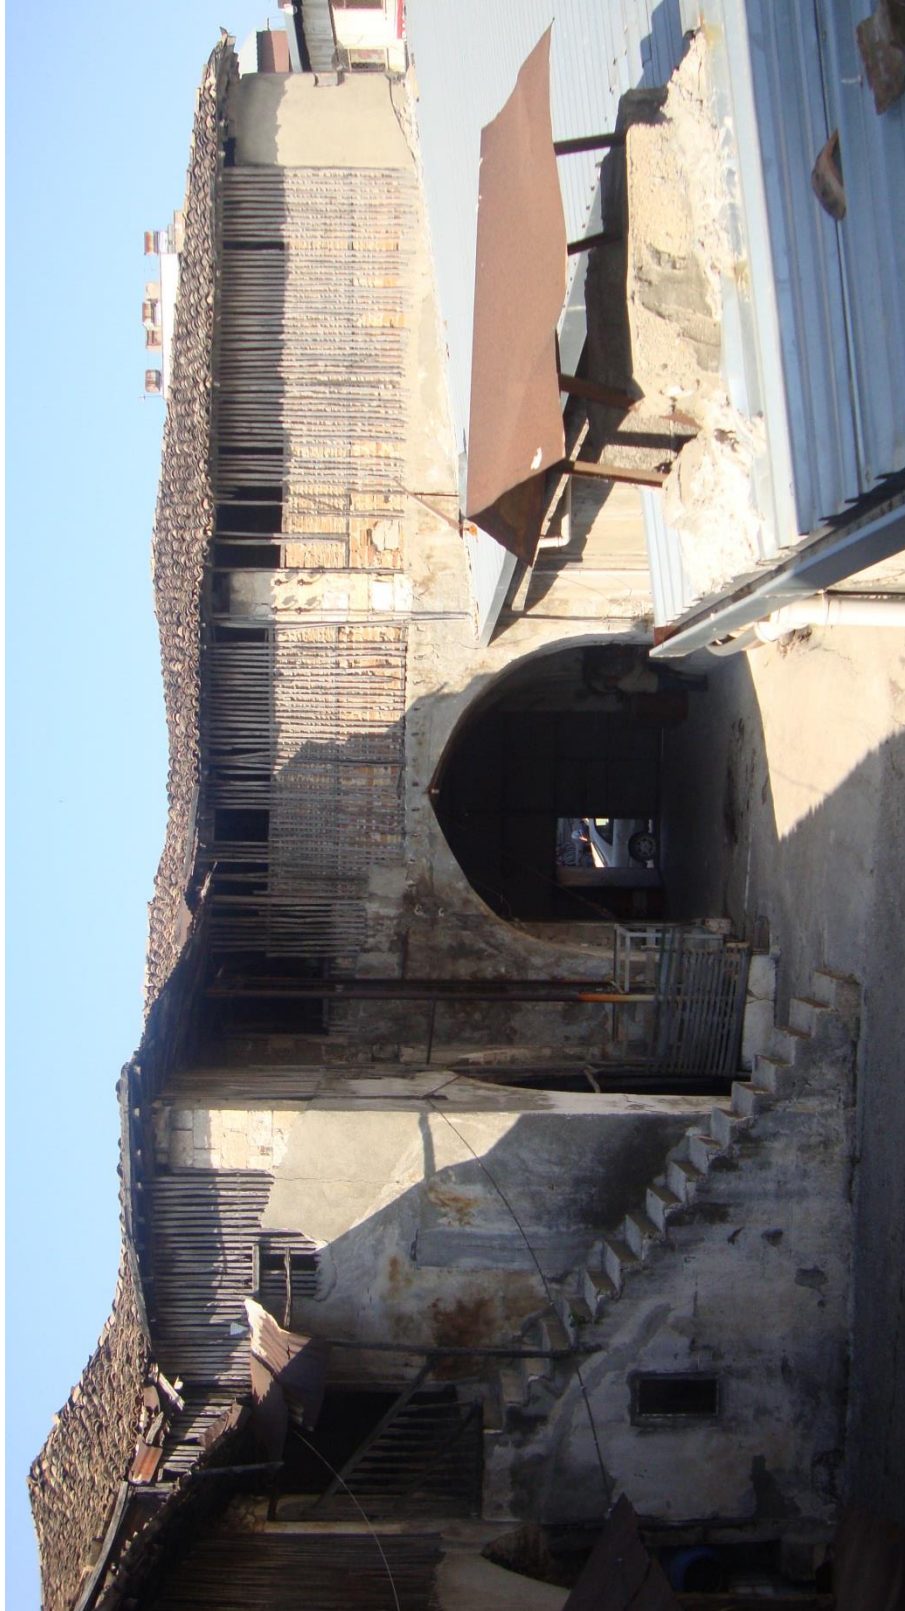
The northern facade of the courtyard consists of depressed pointed arch of the semi-open entrance space, original straight stair lead to the first floor and the first part extends in the east-west direction of the L shaped semi-open gallery on the ground floor (Figure 4.80, Figure 4.81). This facade is covered with later added cement plaster until the first floor level. On the west of the facade, the first part of the L shaped semi-open gallery and the original stone stair situated in front of the gallery are projected towards the front of the building line. At the behind, the depressed pointed arch of the entrance space is directly opened to the courtyard (Figure 4.82). This facade is restricted by the shops looking onto Tayfur Sökmen Street on the east. The surface of the wall that supports the original stone stair is covered with cement plaster. A vertical rectangular unqualified window with wooden joinery is observed on this plastered wall. The wall of the L shaped semi-open gallery, situated behind the original stone stair, is also covered with cement plaster. On the first floor, original cut stone masonry columns and original wooden screens consist of vertical wooden laths between these columns constitute the northern facade of the courtyard. On the east part that situated behind of the façade, low partition brick masonry wall is added in the front of the wooden screen and some parts are removed (Figure 4.87). On the projected part of the facade towards the front of the building line, the original wooden screen is removed behind of the original stone stair on the alignment of the landing and an unqualified door opening without joinery is arranged in this part (see Figure 4.37). The facade is completed with the renewed wooden hipped roof covered with over and under tiles.

Figure 4.80. The northern courtyard facade

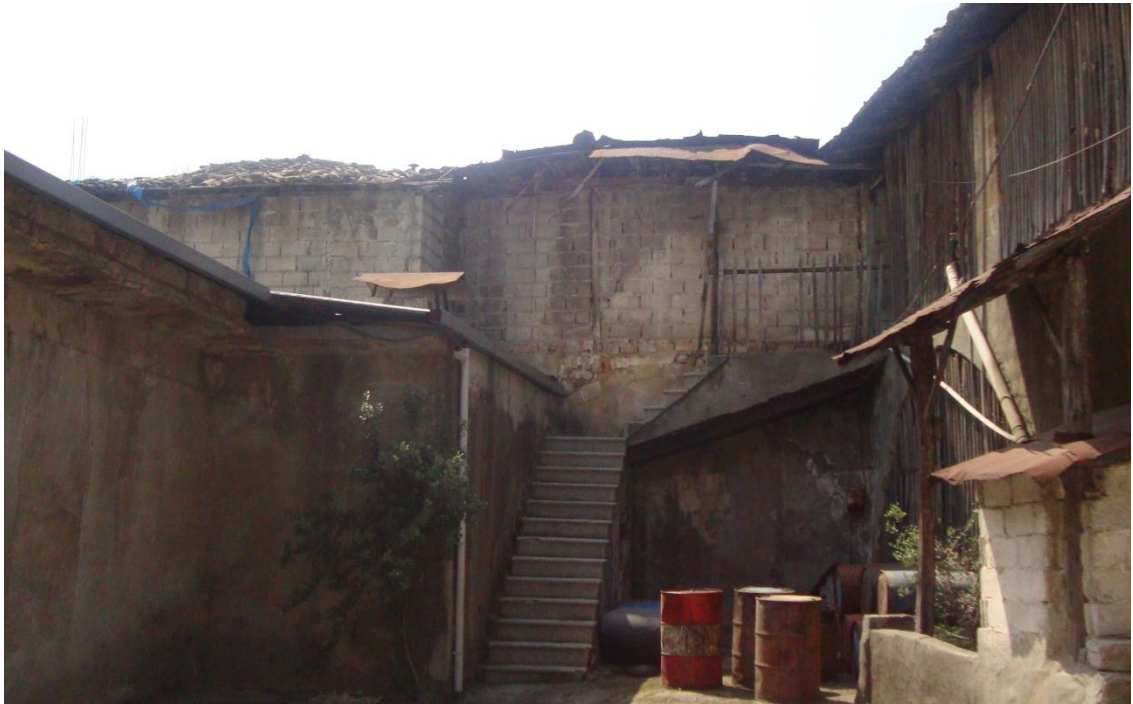
The southern facade of the courtyard consists of a later added reinforced concrete quarter-space landing stair lead to the first floor and the cement plastered wall of the southern shop located behind of the stair on the ground floor (Figure 4.83). On the east of the facade, an unqualified shop looking onto the Tayfur Sökmen Street is observed. The rear walls of this shop are projected towards the front of the building line on the south facade of the courtyard. On the first floor, a later added cinder block wall is observed on the west of the facade. This wall isolates the storage space located on the south part of the building from the courtyard. In the middle of the facade, a later added cinder block wall that defines the border of the later added reinforced concrete stairway lead to the storage space from the street on the south part of the building. This wall also projects towards the front of the building line (see Figure 4.49). On the east of the facade, the original cut stone masonry columns covered with cement plaster and a later added cinder block wall positioned in the front of the column and the original wooden screen are observed. A part of the wooden screen is removed and a later added brick wall is observed in this part (Figure 4.84). The south facade of the courtyard is completed with original wooden hipped roof covered with over and under tiles.

Figure 4.83. The southern facade of the courtyard

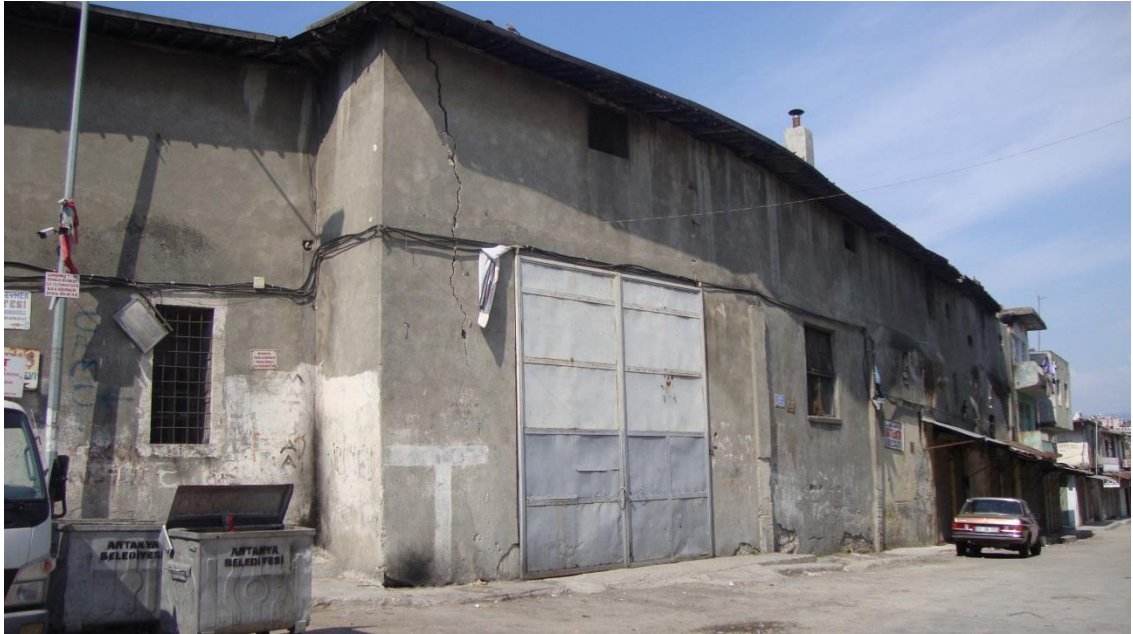
The northern facade of the building is 40.95 m long from the east to the west and average 7 m high to the level of the eave (Figure 4.85). The west part is 1.81 m in front of the 5.40 m east part. The entire surface of the facade is covered with cement plaster (Figure 4.86). An unqualified double winged iron entrance door (3.93 m x 4.48 m) is observed on the east of the front part of the facade (Figure 4.87). A later arranged square wooden top window with wire mesh is observed above the entrance door on the first floor level. The later arranged entrance opening with roller shutters, the later arranged entrances of the shop and two storage spaces accessed from the street, the corrugated iron sheet eaves are observed on the west of the facade (Figure 4.88). Two later arranged top windows, one of which is square with iron bars and the other is vertical rectangular without joinery, are observed above the openings with roller shutters. A later arranged square sash window with wooden joinery and 12 glass grills is observed between two reinforced concrete columns located on the right side of the entrance door (Figure 4.89). The window openings without joinery that are later arranged in a random order are observed on the upper part of the facade (Figure 4.90, Figure 4.91). On the east part, which is 1.81 m behind the west part, the original vertical rectangular double-winged window with grilled iron bars, stone casing and inner wooden shutter is observed (Figure 4.92). The northern facade of the building is completed with renewed wooden hipped roof covered with over and under tiles. At present, a large part of the roof is collapsed on the west part of the facade.

Figure 4.86. The northern facade

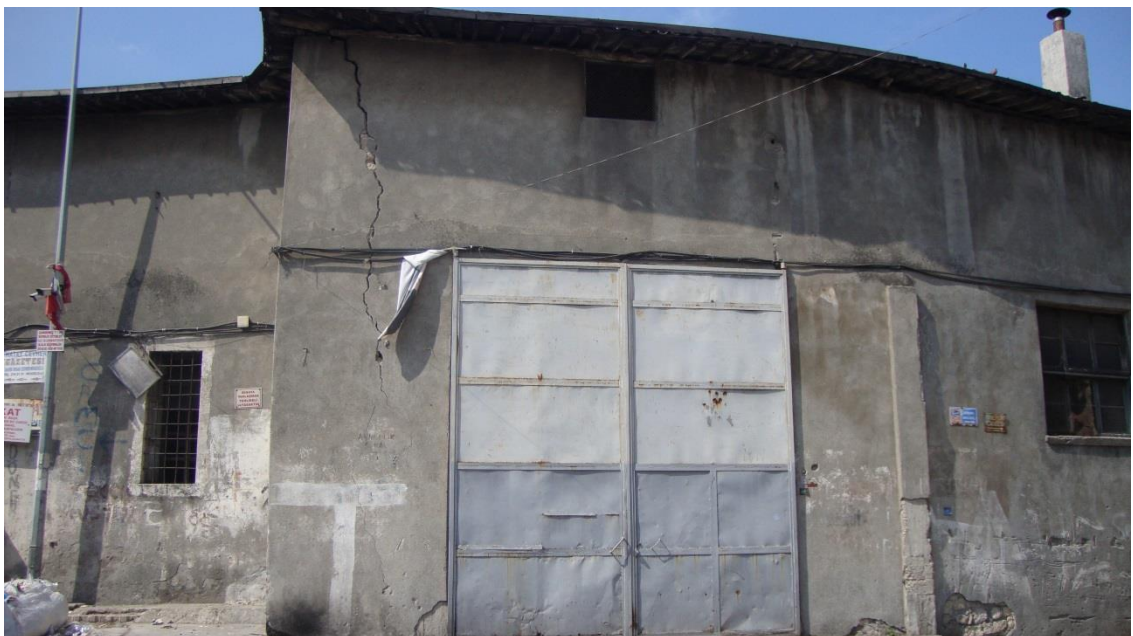
Figure 4.87. The later added double-winged iron door

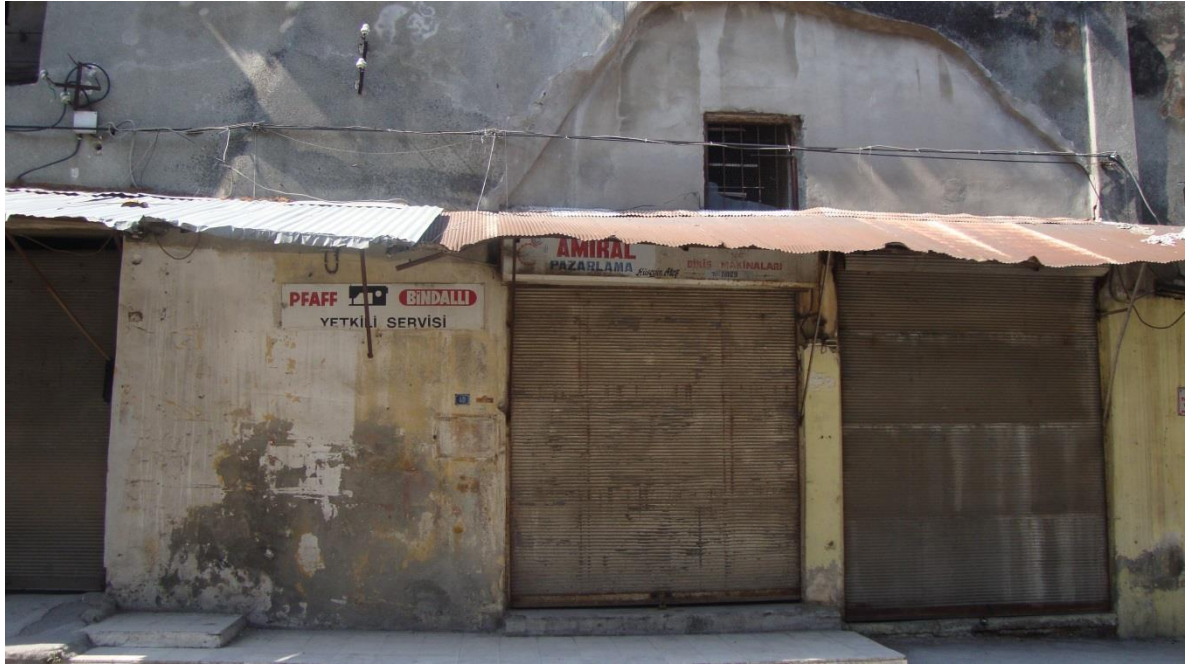
Figure 4.88. Later arranged openings with roller shutters on the west of the northern facade

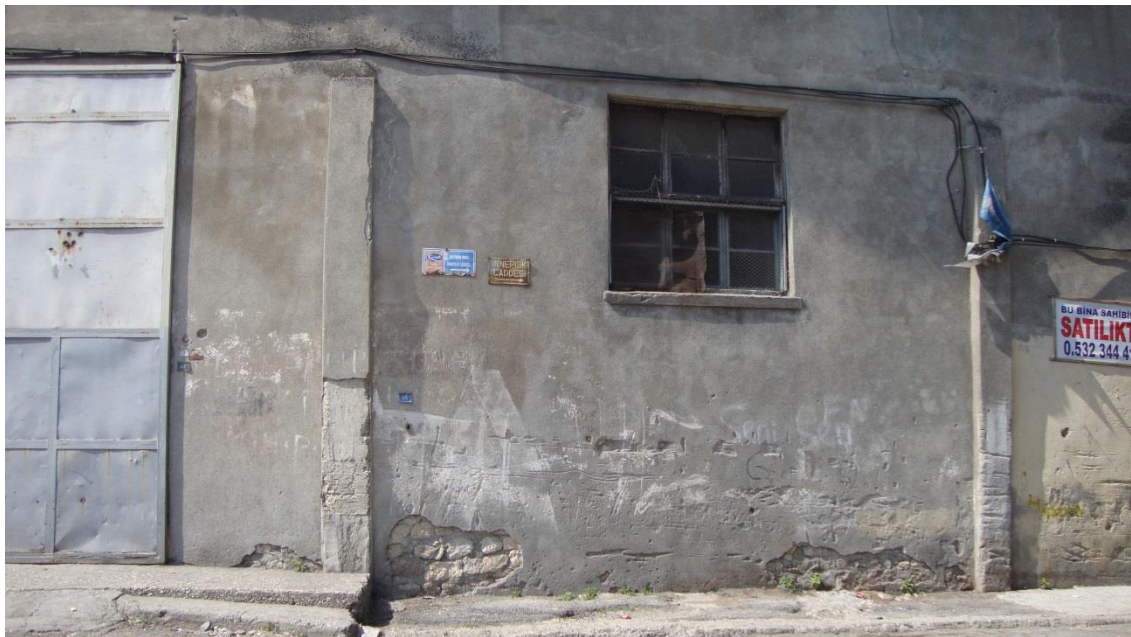
Figure 4.89. The later arranged square wooden sash window and reinforced concrete columns on the northern facade

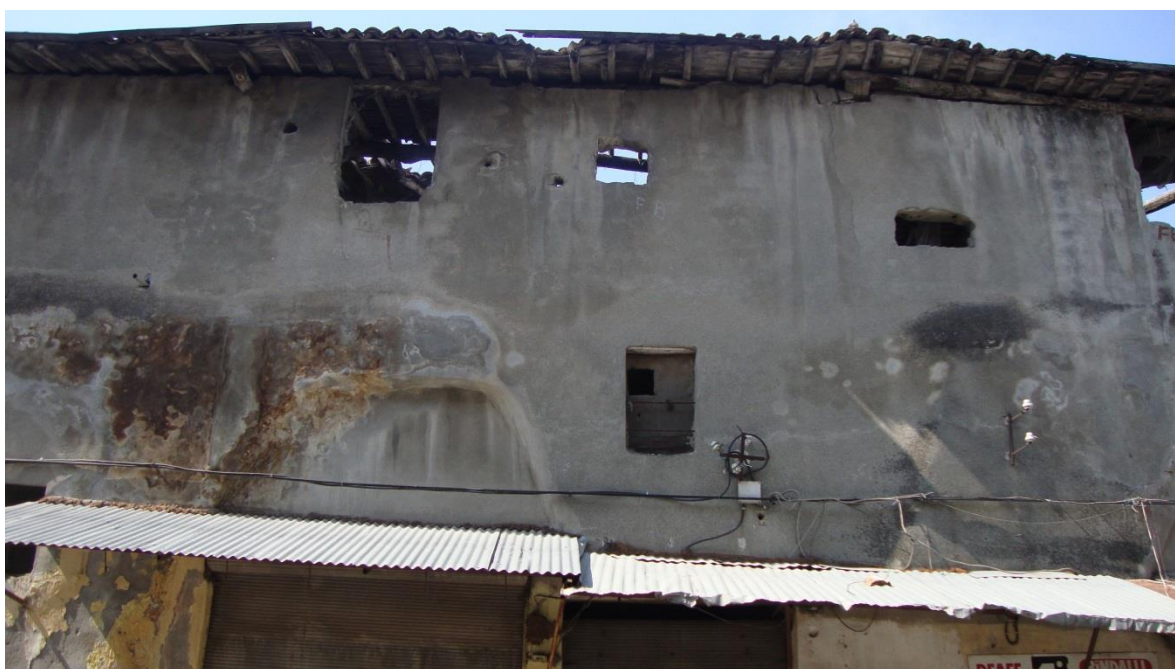
Figure 4.90. Later arranged window openings without joinery on the upper part of the northern facade

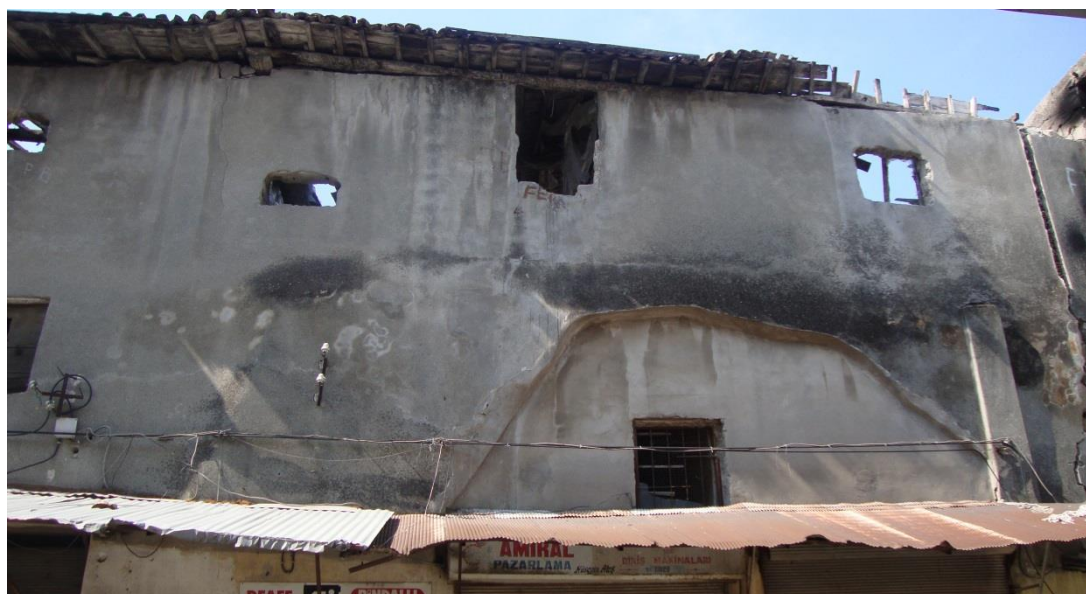
Figure 4.91. Later arranged window openings without joinery on the upper part of the northern facade

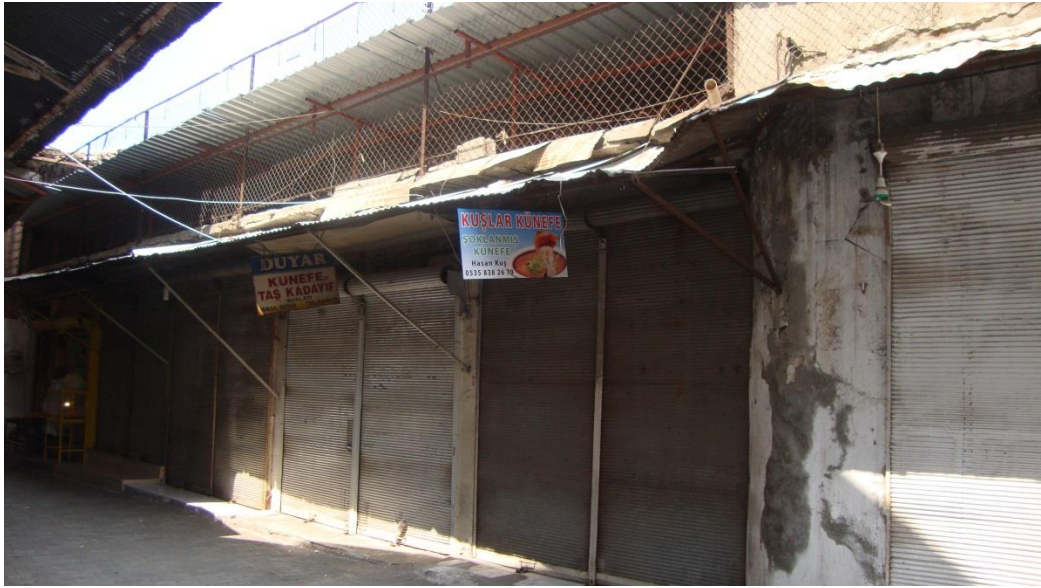
Between the north and south parts of the facade, the unqualified openings of the later arranged six shops have roller shutters and corrugated iron sheet eaves on the ground floor (Figure 4.97). The northern one of these shops is constituted by the arrangement of the original entrance space as a shop. The surface of this shop and the original stone casing of the entrance opening are covered with later added cement plaster (Figure 4.98, Figure 4.99). The other five shops are converted spaces constituted by the conversion of the original stone masonry section opening to the courtyard into the brick masonry section opening to the street. An unqualified double winged iron door of the later arranged stairway that is accessed from the street and lead up to the first floor is observed on the southern of the shops. On the first floor level, a later added cinder block wall part is observed above the iron door. The shops are covered with corrugated iron sheet eaves on the first floor level (Figure 100). Behind this part, the original cut stone masonry columns, the original wooden screen between these columns and the original wooden hipped roof of the western courtyard facade of the soap factory are observed.

Figure 4.97. Later arranged shops between the north and south parts of the east facade

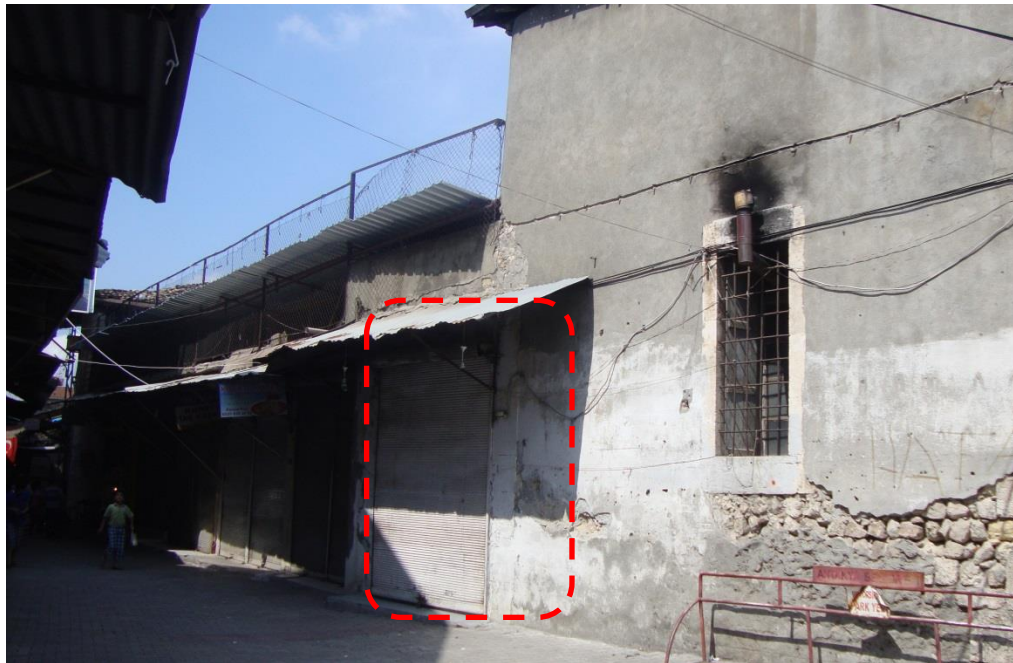
Figure 4.98. The original entrance space arranged as a shop at present

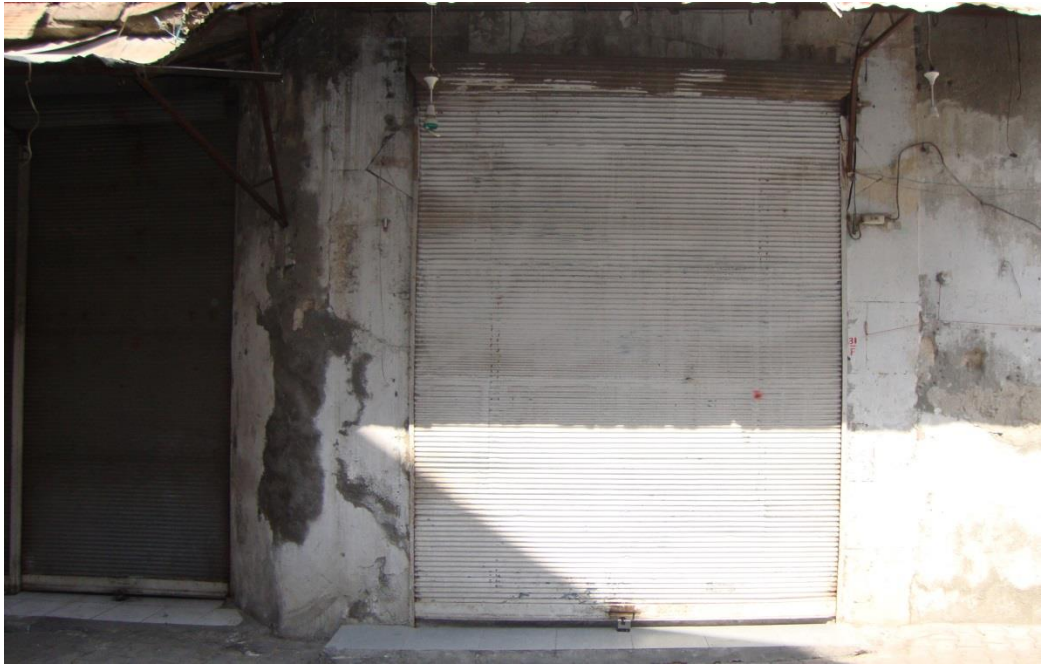
Figure 4.99. The original depressed arched door opening of the original entrance space

The original entrance door opening of the building is depressed arched with stone casing on the east of the building (see Figure 4.99). The door joinery was removed and a roller shutter was added since the original entrance space was arranged as a shop. The original entrance door opening of the spreading and drying area on the first floor is depressed arched with stone casing (Figure 4.113). The door joinery of the original door opening is altered at present. Furthermore, an original door opening is located on the west part of the building on the ground floor (Figure 4.114).

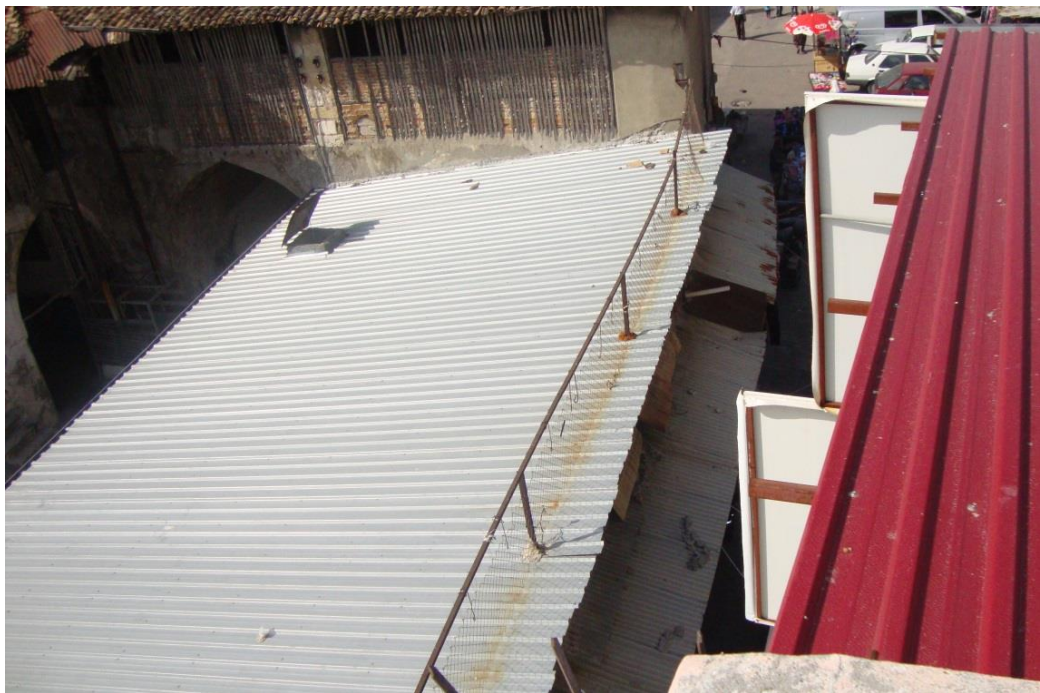
Figure 4.100. View of the later arranged shops from the first floor level

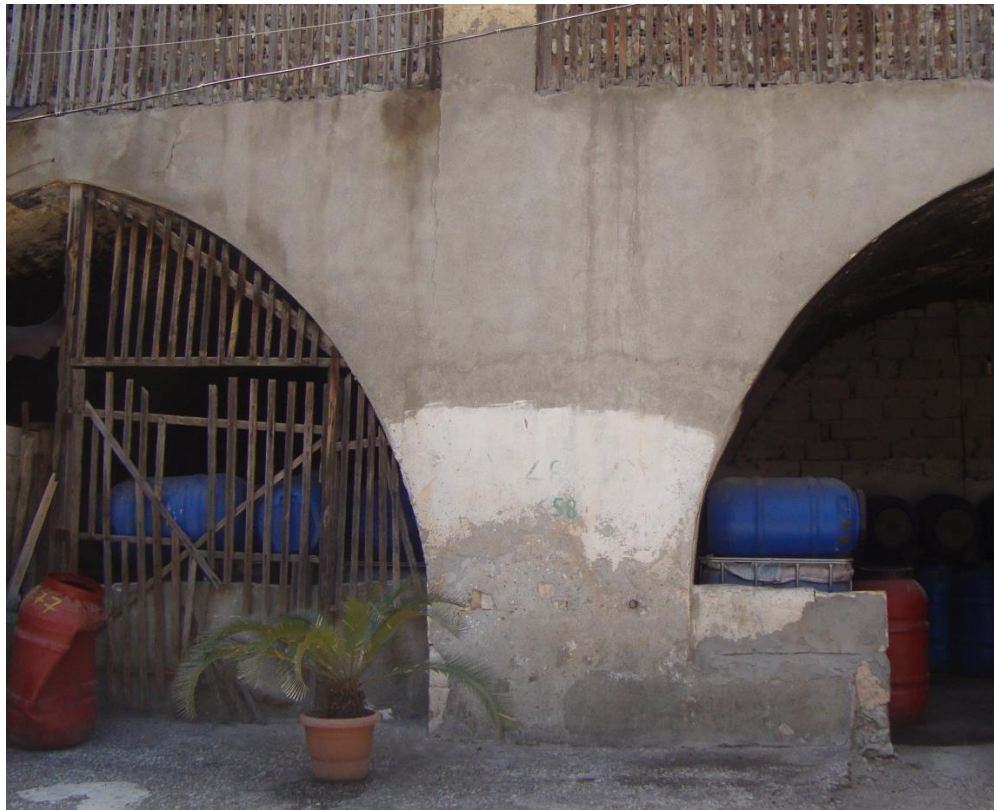
The vertical elements are the load bearing elements and partition walls. The vertical load bearing elements are the piers, walls and columns. The cut stone masonry piers are covered with cement plaster (Figure 4.101). The square or rectangular piers have dimensions of 146 cm x 187 cm. However, edge dimensions vary between 91 cm and 361 cm (pier located on the southwest corner).

Figure 4.101. The cut stone masonry piers covered with cement plaster

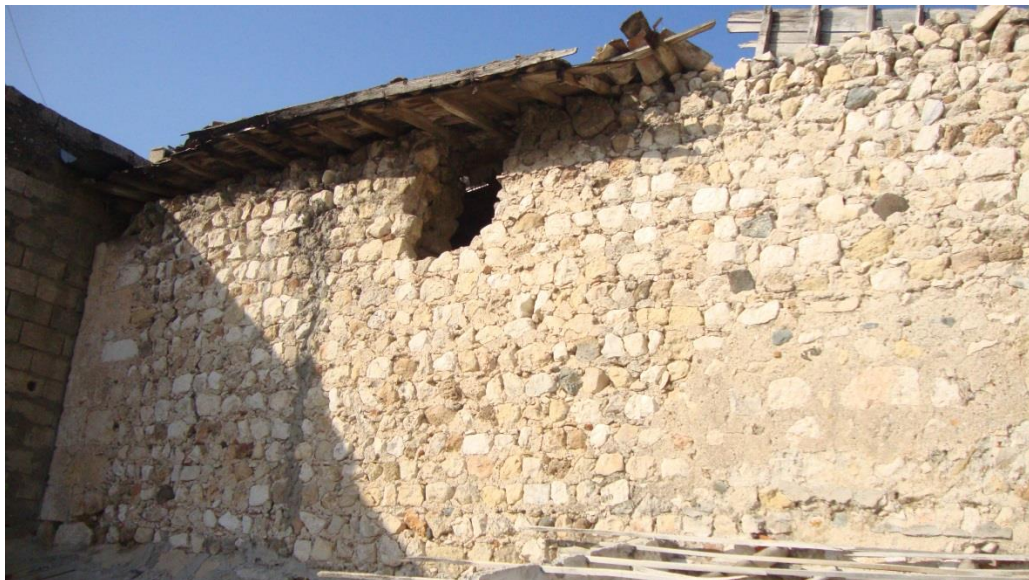
The rubble stone masonry walls (75 cm) are located on the ground floor and on the west part of the first floor (Figure 4.102). The surfaces of the walls on the ground floor are covered with later added cement plaster.

Figure 4.102. The rubble stone masonry wall on the west part of the building

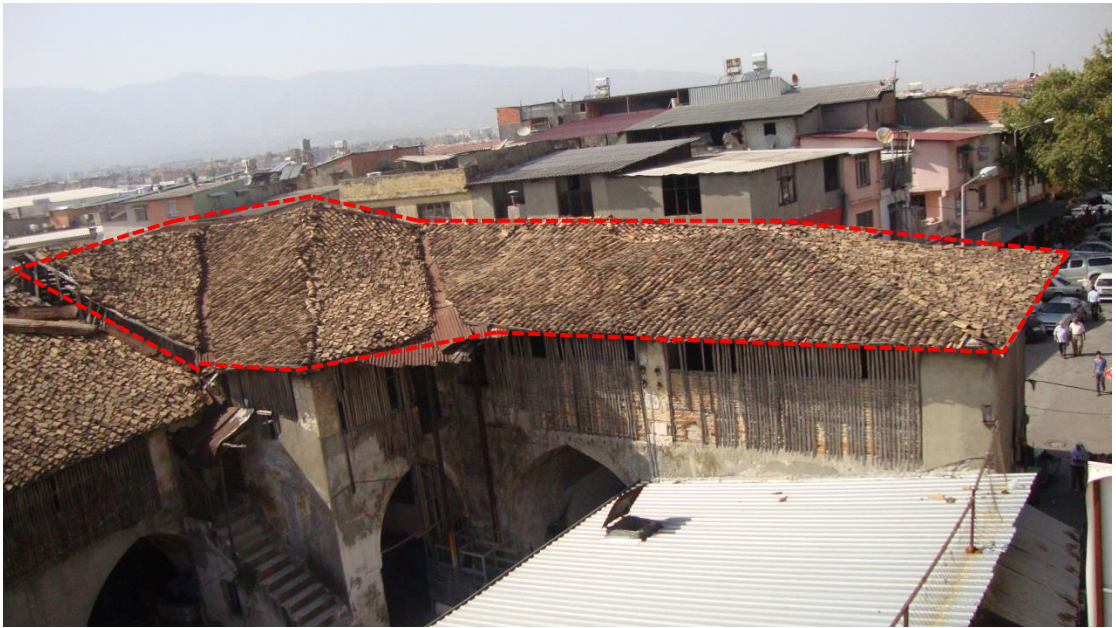
The surmounting element is the wooden hipped roof on the first floor. The north part of the roof is renewed (Figure 4.106).

Figure 4.106. The renewed part of the hipped roof on the north of the building

The blind arches on the northern facade and the wooden hipped roof on the north part of the building collapsed during the widening of İnneplik Street. The collapsed part of the roof (see Figure 4.106) and two blind arches on the northern facade are renewed (Figure 4.139). Furthermore, the wooden screen that is located on the courtyard facades of the southern semi-open gallery on the ground floor is renewed (Figure 4.140).

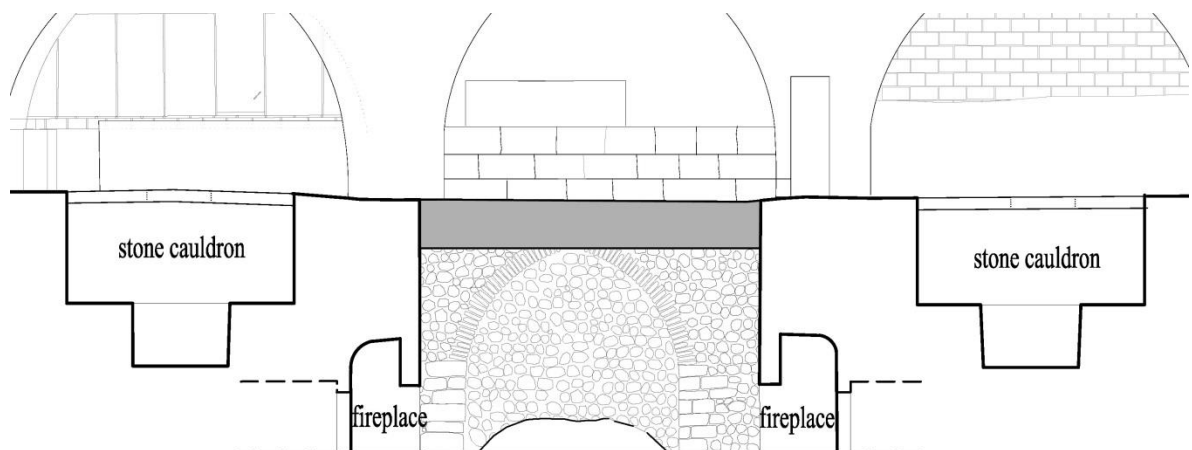
Two original fireplaces with depressed semicircular arches are located below the circular cauldrons on two walls of the fireplace room on the basement floor. The fireplaces, located on the opposite walls of the fireplace room, are related to the stone cauldrons with a fire hole (Figure 4.119, see Figure 4.32). In the original case, the fire, required to heat the stone cauldrons for cooking the soap, was made in these two original fireplaces. A later added furnace is also located below the later added stone cauldron on the ground floor (see Figure 4.27, Figure 4.28).

Figure 4.119. The measured drawings of the original stone cauldrons and fireplaces

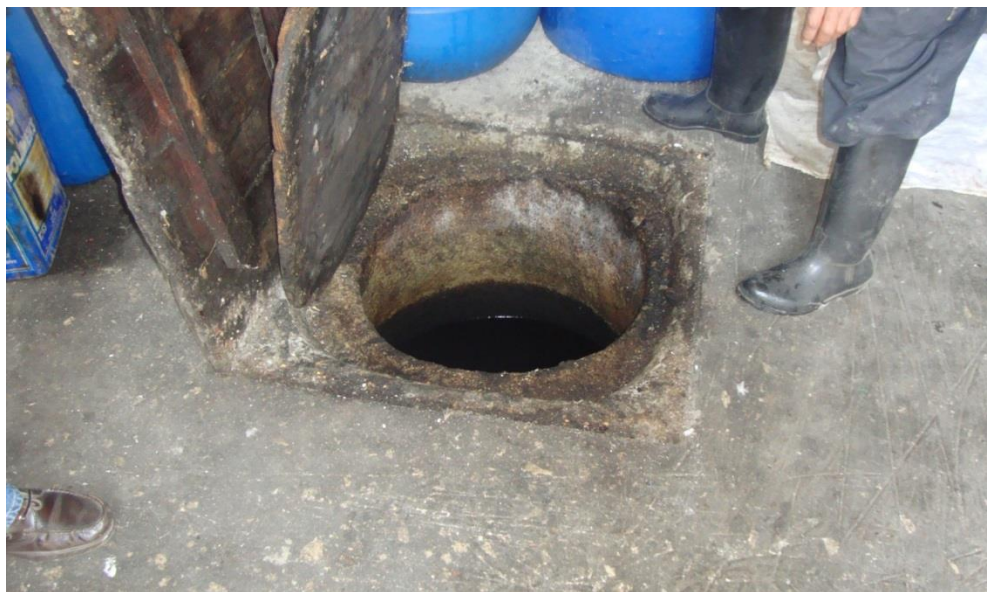
Six olive oil wells are buried beneath the ground floor of the northern one of the semi-open galleries located on the west of the courtyard and a water well is located on the south of the courtyard (Figure 4.120, Figure 4.121). The depths of the circular olive oil and water wells are average 3 m. The tracks of the later added wooden shutter of the olive oil wells are observed on the floor of the semi-open gallery (see Figure 4.16, see Figure 4.17).

Figure 4.120. The original circular olive oil well buried beneath the ground of the semi-open gallery on the ground floor
