**CONSERVATION OF
KUSEYRİ SOAP FACTORY
AS AN INDUSTRIAL HERITAGE IN ANTAKYA**

**A Thesis Submitted to
the Graduate School of Engineering and Sciences of
İzmir Institute of Technology
in Partial Fulfillment of the Requirements for the Degree of**

in Architectural Restoration

**by
Derya CAMUZ**

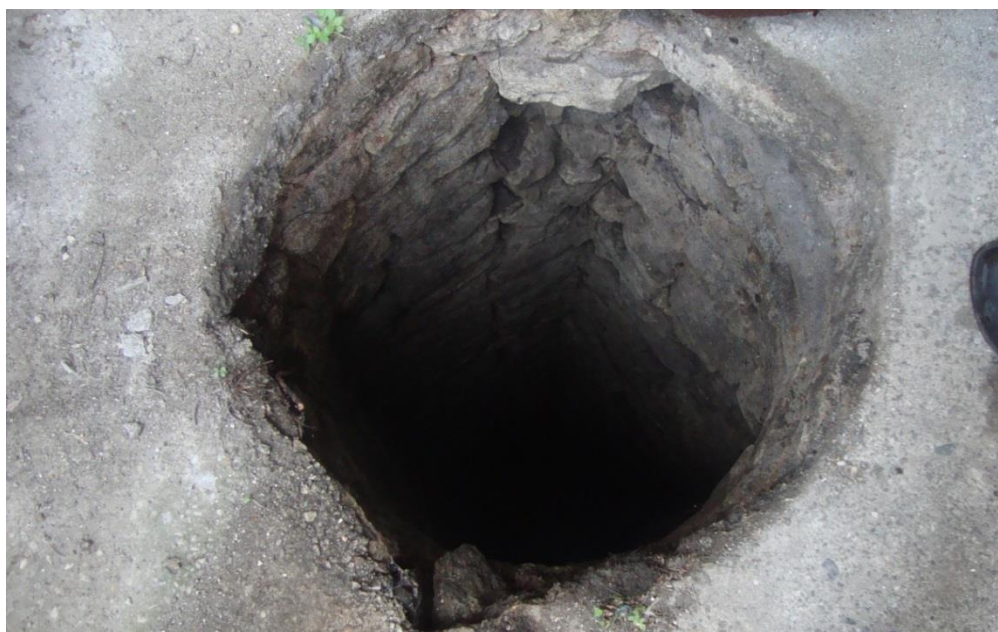
Six olive oil wells are buried beneath the ground floor of the northern one of the semi-open galleries located on the west of the courtyard and a water well is located on the south of the courtyard (Figure 4.120, Figure 4.121). The depths of the circular olive oil and water wells are average 3 m. The tracks of the later added wooden shutter of the olive oil wells are observed on the floor of the semi-open gallery (see Figure 4.16, see Figure 4.17).

Figure 4.121. The circular water well buried beneath the ground on the south of the courtyard

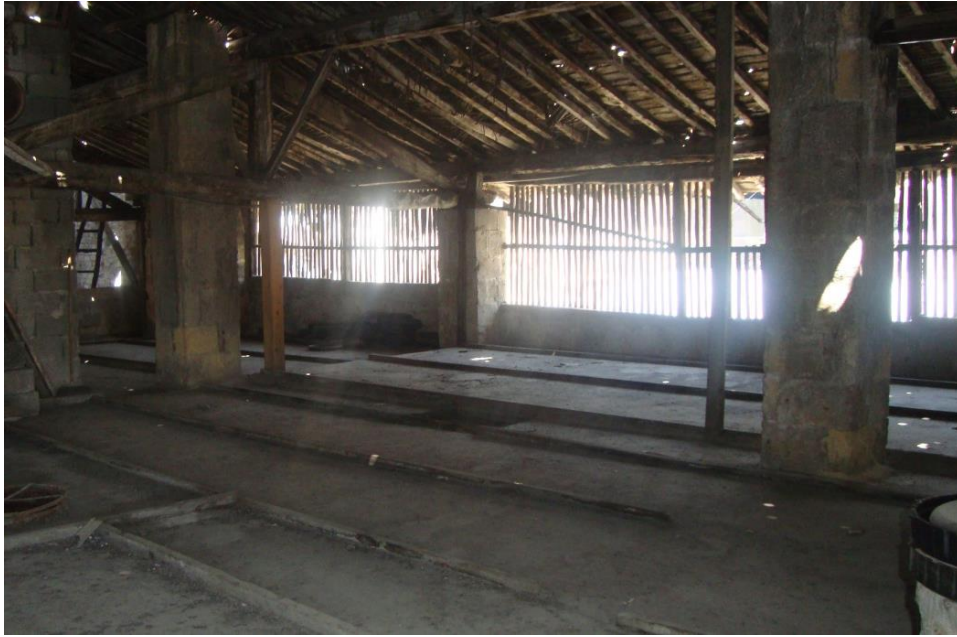
Two original cut stone masonry, square (60 cm x 63 cm; 50 cm x 58 cm) chimneys rise from the alignment of the fireplaces located on the fireplace room on the basement floor to the spreading and drying areas on the first floor and to the roof (Figure 4.122, Figure 4.123).

Figure 4.122. The cut stone masonry chimneys rising from the fireplace room and from the spreading and drying area

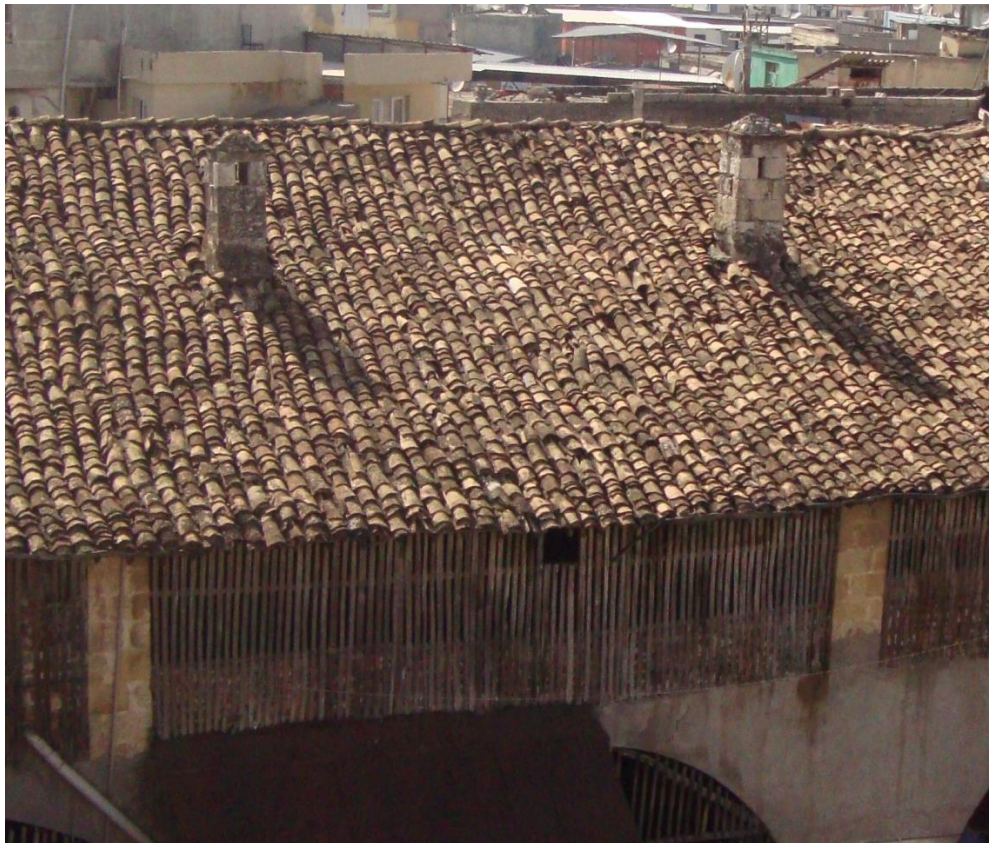
Figure 4.123. The original cut stone masonry chimney rising from the fireplace room to the roof

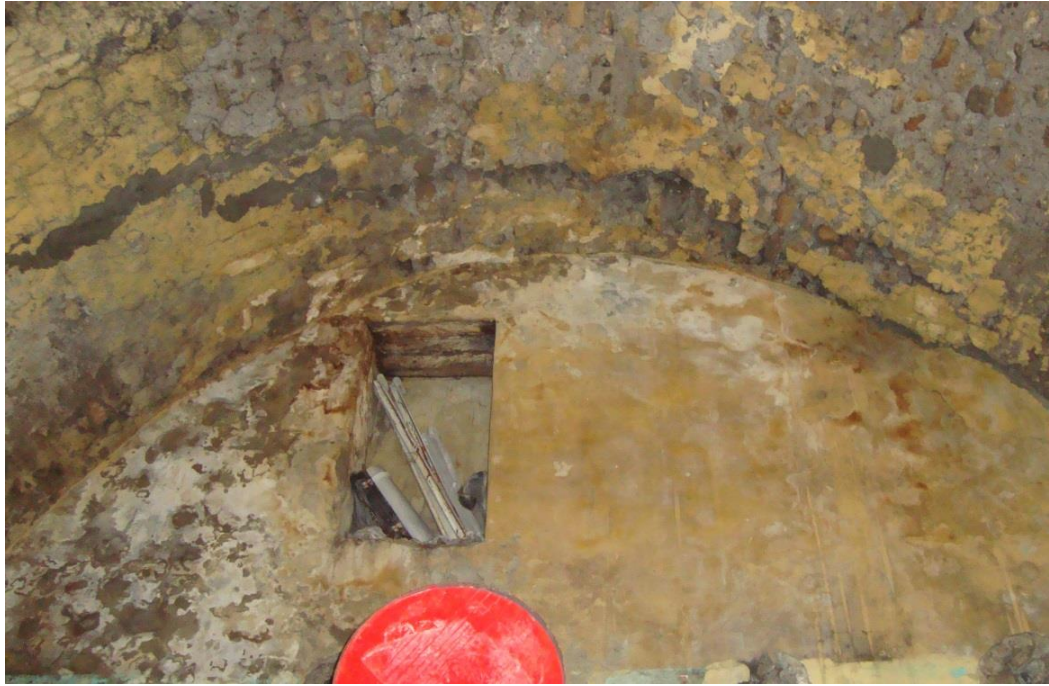
A rectangular niche (46 cm x 72 cm x 85 cm) is located on the north wall of the office on the northeast of the building. Furthermore, another rectangular niche (20 cm x 45 cm x 65 cm) is located on the west wall of the storage space looking onto the street on the north facade of the building. The height of the niche is 426 cm from the floor of the storage space (Figure 4.124).

Figure 4.124. The vertical rectangular niche on the west part of the building

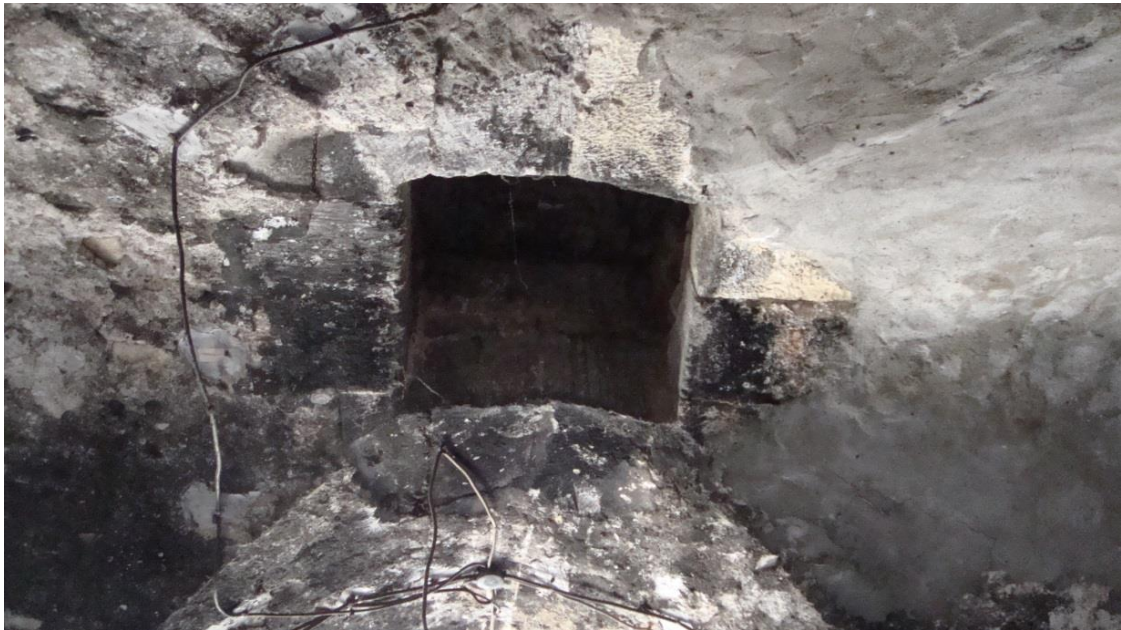
A rectangular hole for transferring the liquid soap to the first floor is located on the center of the vault of the semi-open gallery on the west of the courtyard on the ground floor (Figure 4.125). Furthermore, a later arranged circular hole is located above the later arranged stone furnace platform and stone cauldron, on the vault of the galleries on the west of the courtyard (Figure 4.126).

Figure 4.125. The original rectangular hole for transferring the liquid soap to the first floor on the center of the vault on the semi-open gallery

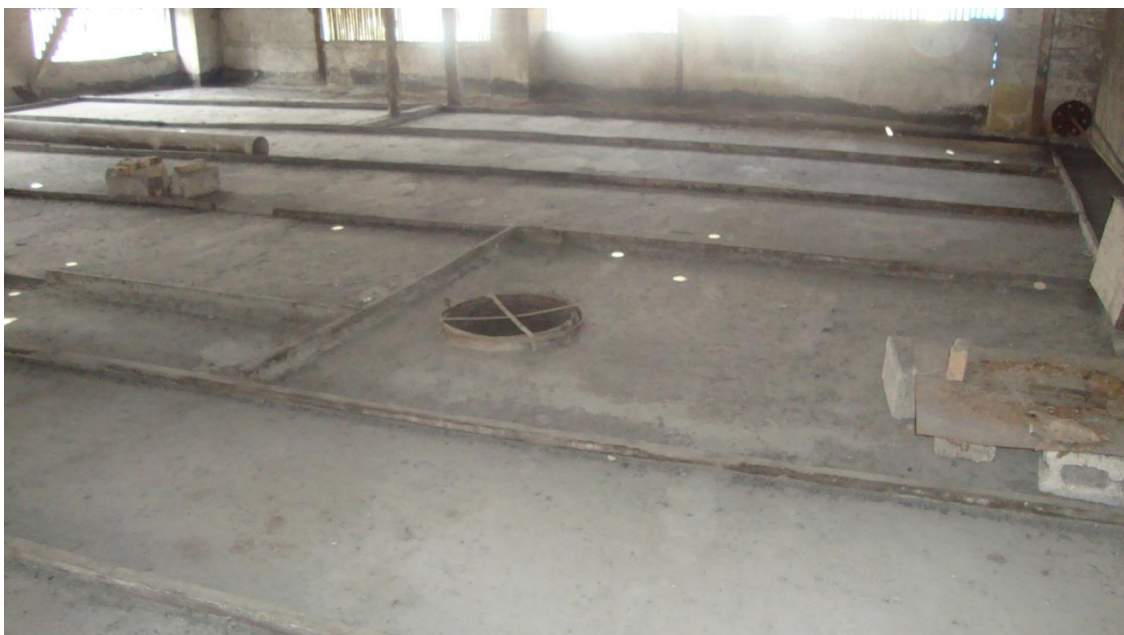
Figure 4.126. View of the later arranged circular hole from the floor of the spreading area on the first floor

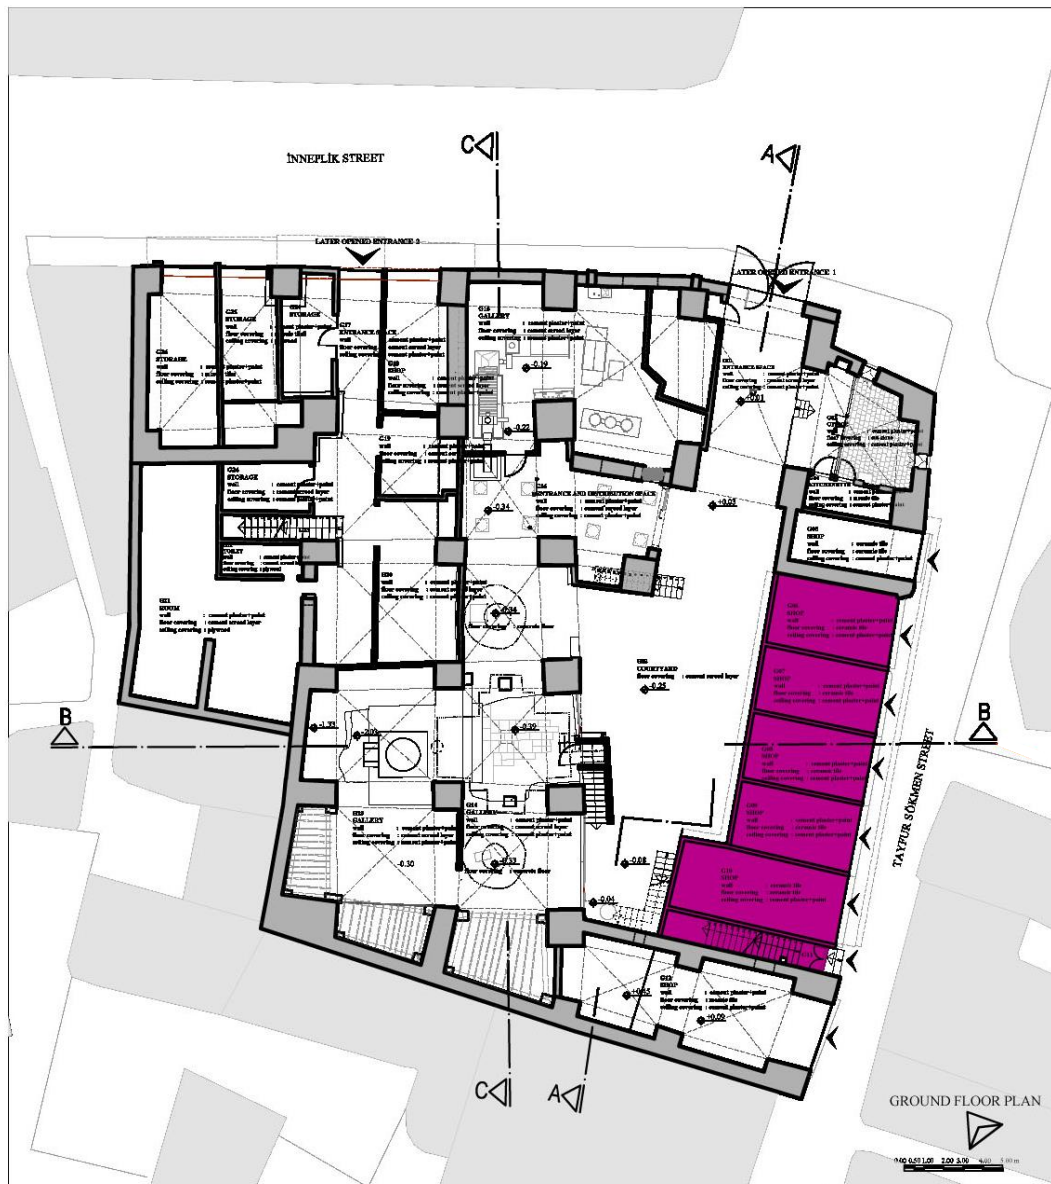
The most important alteration of the building is the conversion of the original stone masonry section, opening to the courtyard, into brick masonry section opening to the street on the east of the building (Figure 4.127, Figure 4.128). The original entrance space of the building located on the east of the building is converted into a shop and the easternmost blind arches on the north facade of the building are converted into a new entrance door opening (Figure 4.129, see Figure 4.98). The original wooden screen, constituted of vertical wooden laths to provide ventilation and shade for speeding up the drying of the soap, is converted into brick or cinder block walls on the northern and eastern street facades of the building (Figure 4.130, see Figure 4.39). In addition, the original wooden screen on the southern courtyard facade and a part of the southern facade of the building is converted into cinder block masonry walls (Figure 4.131). Moreover, the original cross vault that is located on a part of the L shaped semi-open gallery on the ground floor, is converted into reinforced concrete floor (Figure 4.132). A part of the original floor of the office, located on the northeast of the building on the ground floor, is converted into stone steps (Figure 4.133).

Figure 4.127. The converted part on the east of the building

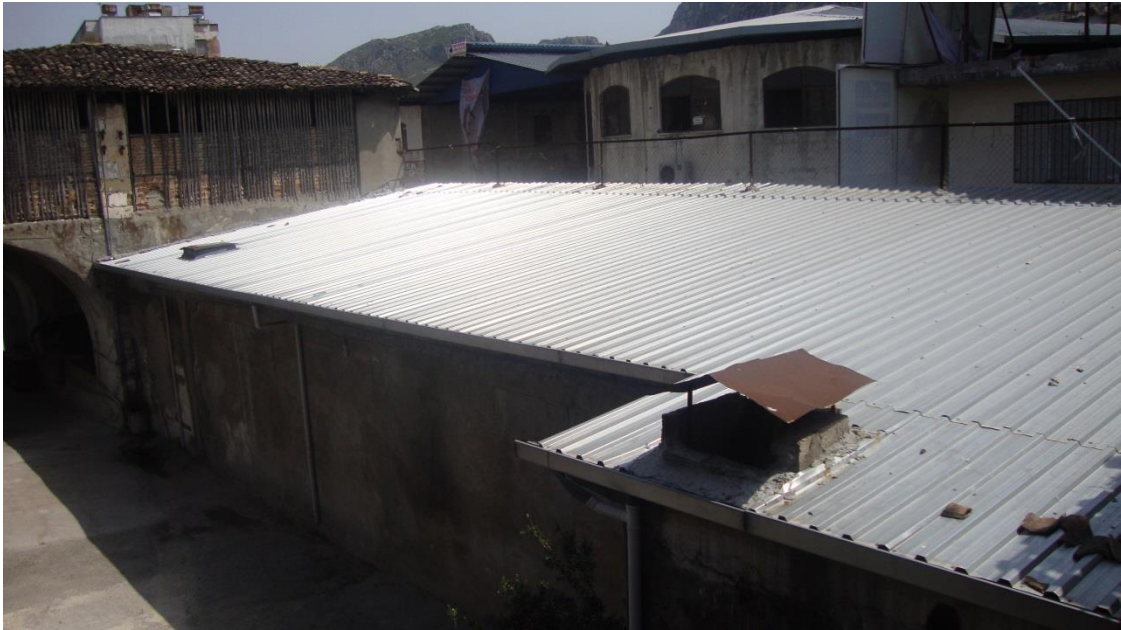
Figure 4.128. The converted brick masonry section opening to the street on the east of the building

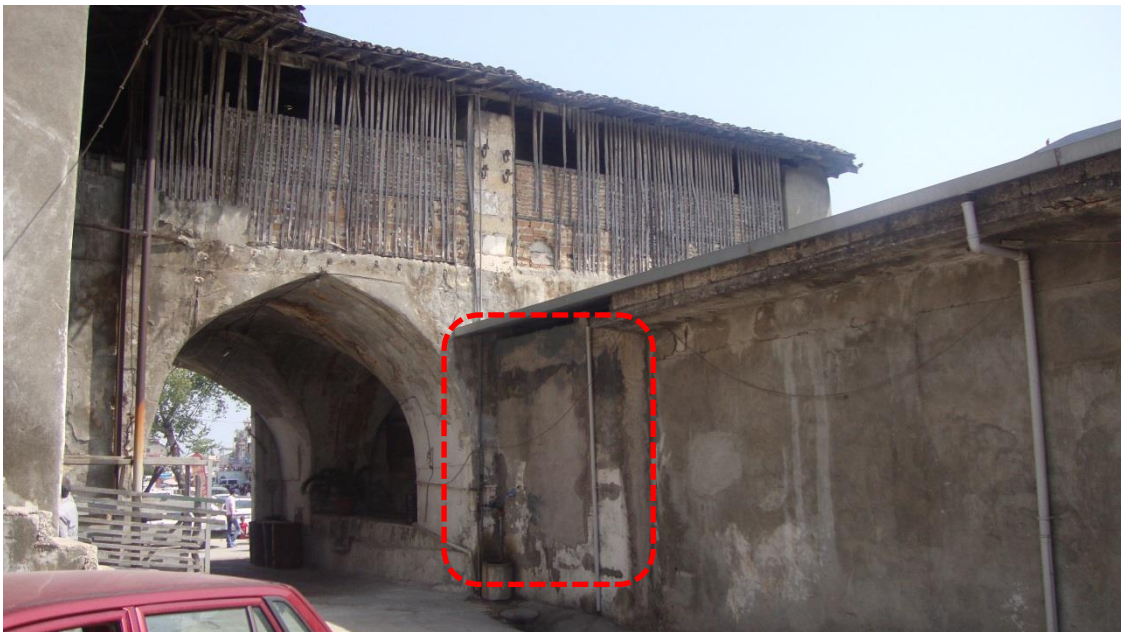
Figure 4.129. View of the original entrance space, converted into a shop, from the courtyard

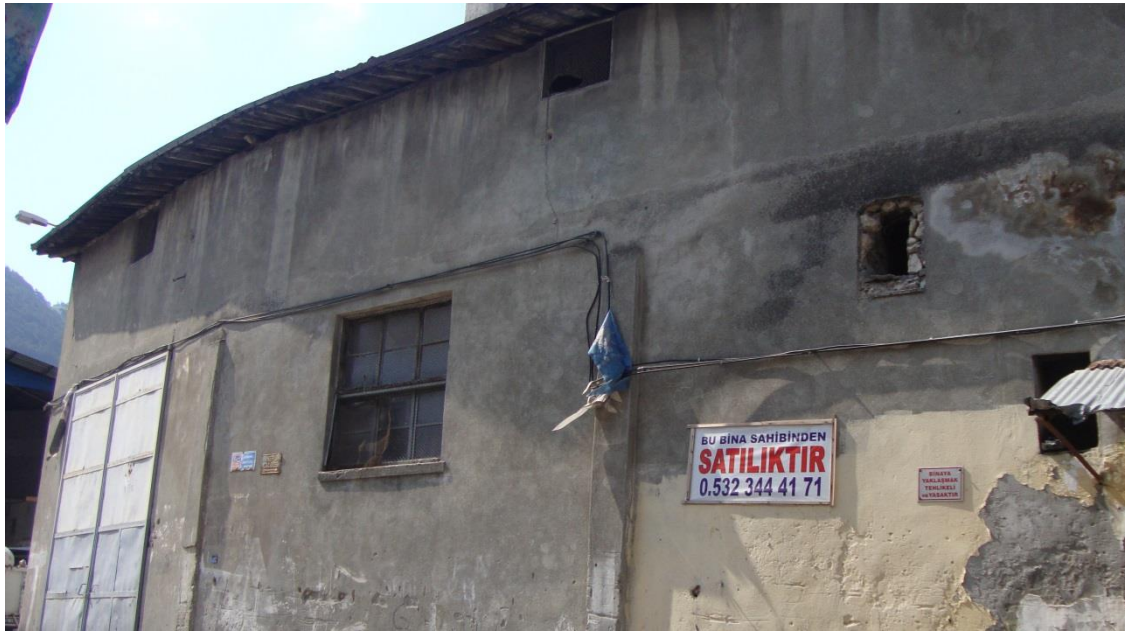
Figure 4.130. The later arranged cinder block walls on the northern facade of the spreading and drying are on the first floor

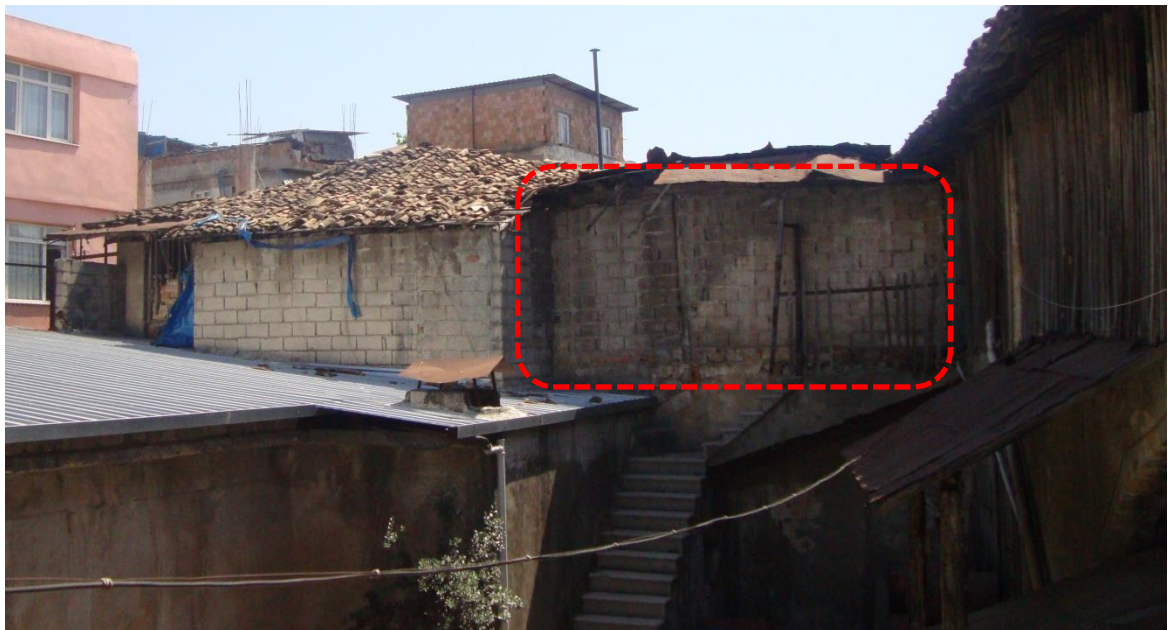
Figure 4.131. The later arranged cinder block masonry wall on the southern courtyard facade on the first floor

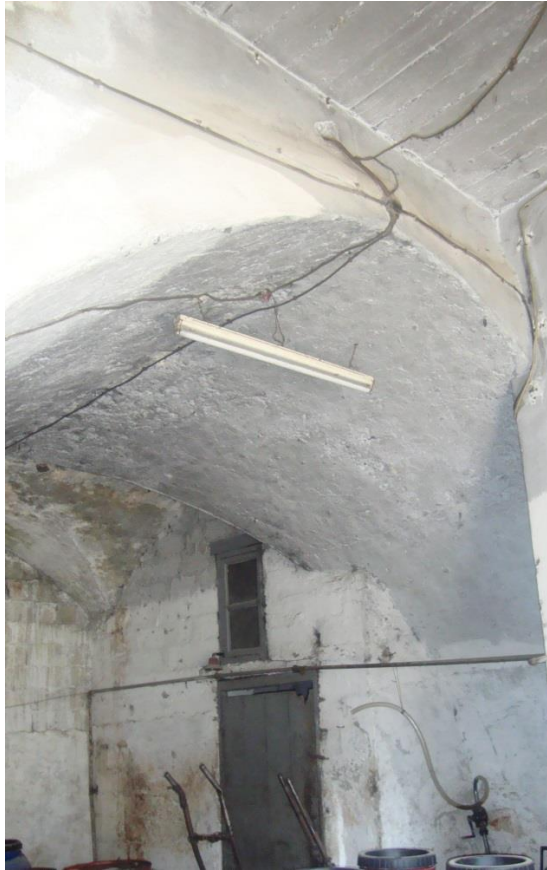
Figure 4.132. The converted part of the original cross vault into the reinforced concrete floor on the L shaped semi-open gallery on the ground floor

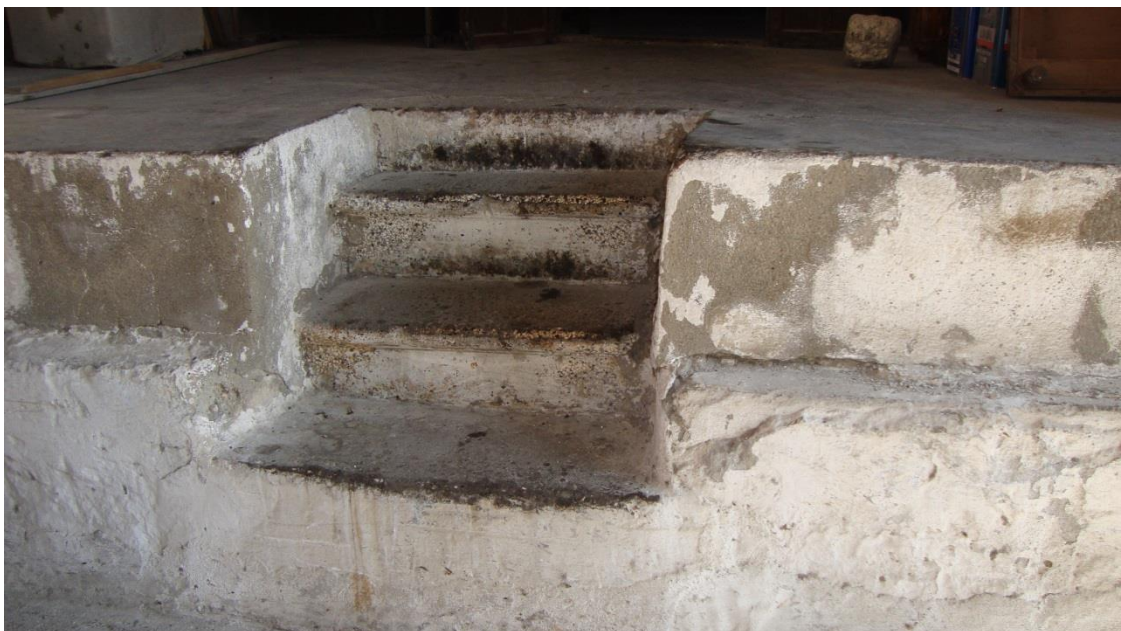
Figure 4.133. The later arranged stone steps of the office on the northeast of the building

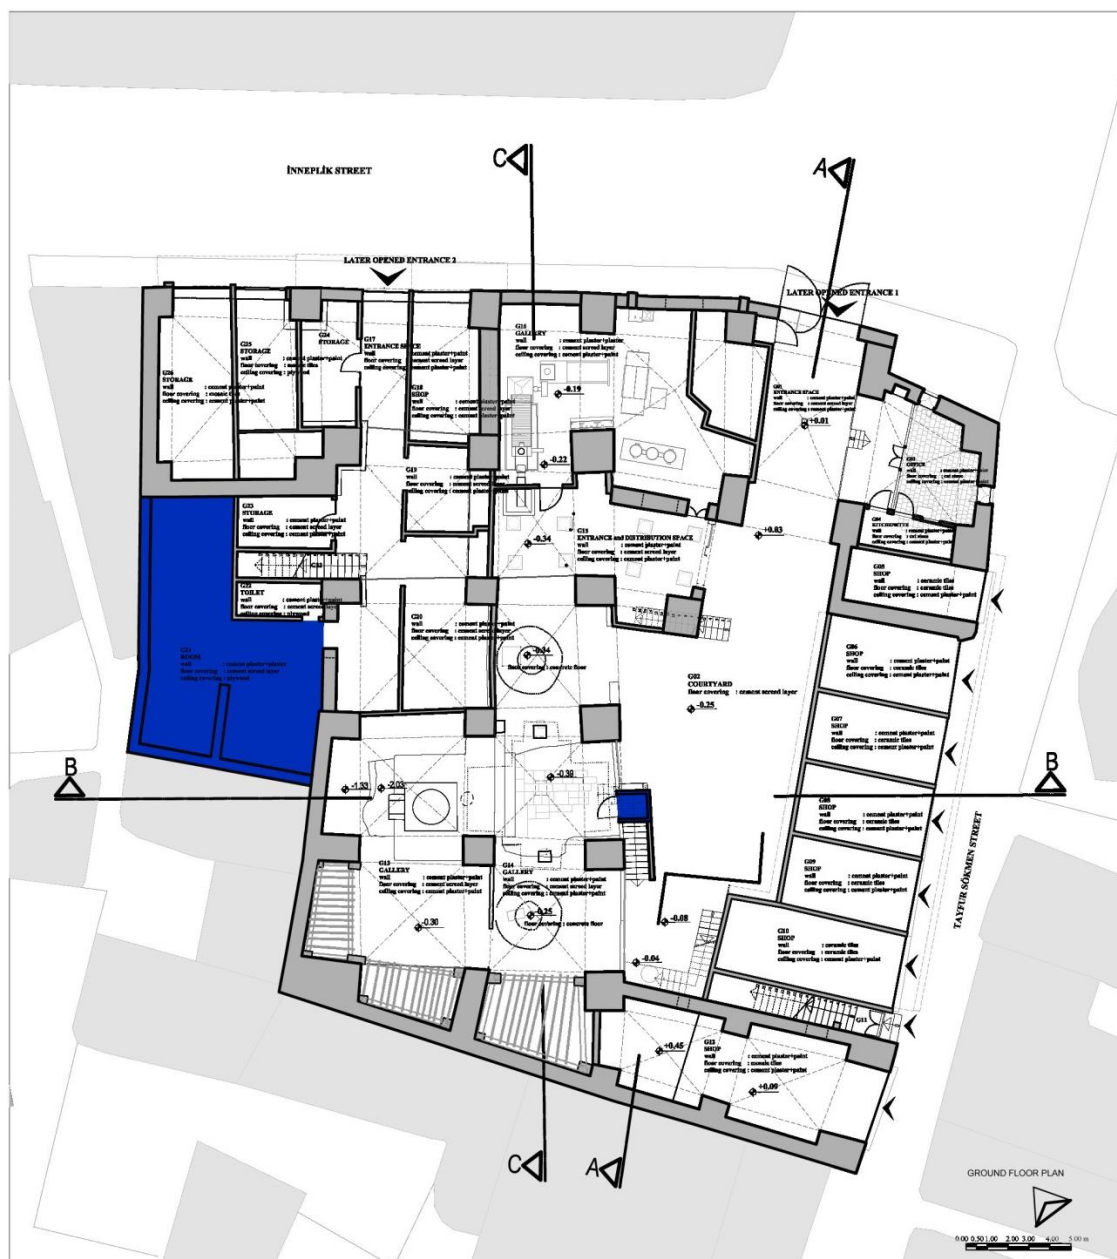
The most important addition observed on the building is the mass additions. These mass additions are the rooms and toilet that are later arranged on the west part of the building and the later arranged toilet located above the original stone stairway provide to get off from the courtyard to the fireplace room (Figure 4.134, Figure 4.135). The building element additions are the partition brick, cinder block and stone masonry walls on the ground floor and first floor, two reinforced concrete stairs one of which is quarter landing on the south of the courtyard and the other is half landing on the west part of the building, reinforced concrete columns on the northern facade, the doors on the ground floor and first floor, wooden platforms and pedestals of these platforms located on the closed and semi-open galleries on the south of the building on the ground floor, electrical installations of the ground floor, eaves and shutters on the northern and eastern facades (Figure 4.136, see Figure 4.41, Figure 4.137, see Figure 4.35, see Figure 4.59, Figure 4.138, see Figure 4.88).

Figure 4.134. The mass additions of the building

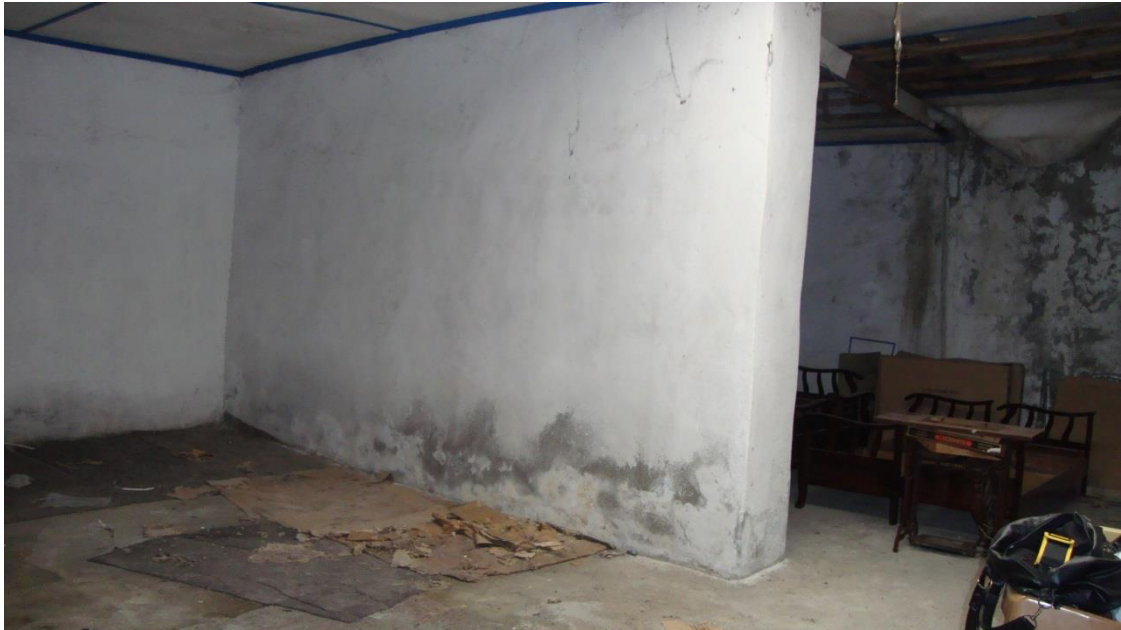
Figure 4.135. View of the mass addition on the west part of the building

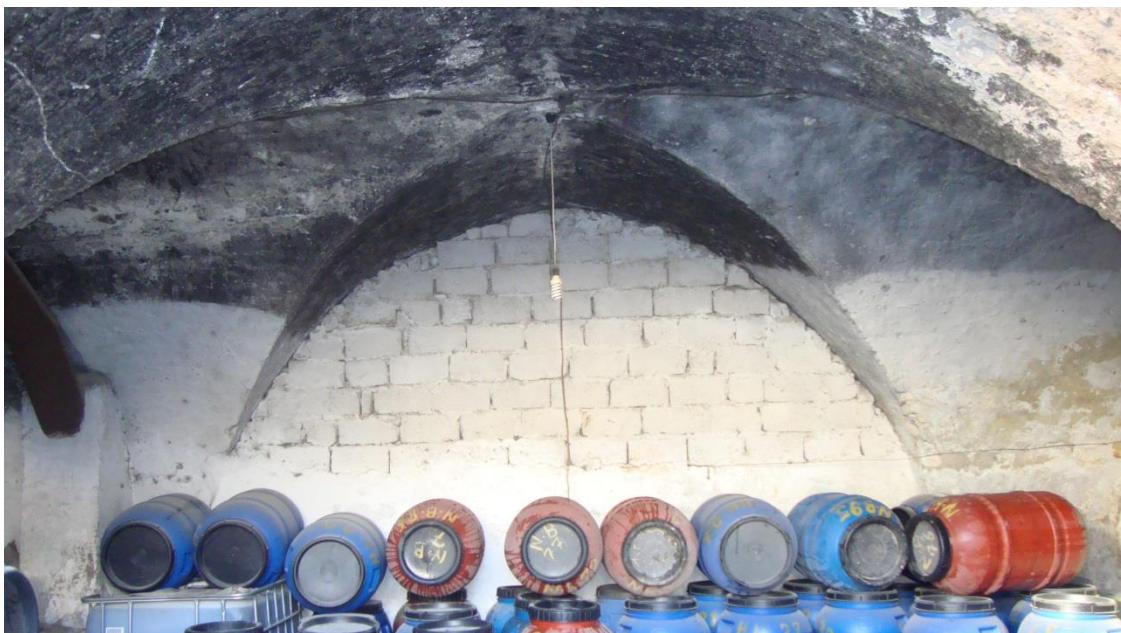
Figure 4.136. One of the later added cinder block masonry wall that divide the building into two parts on the ground floor

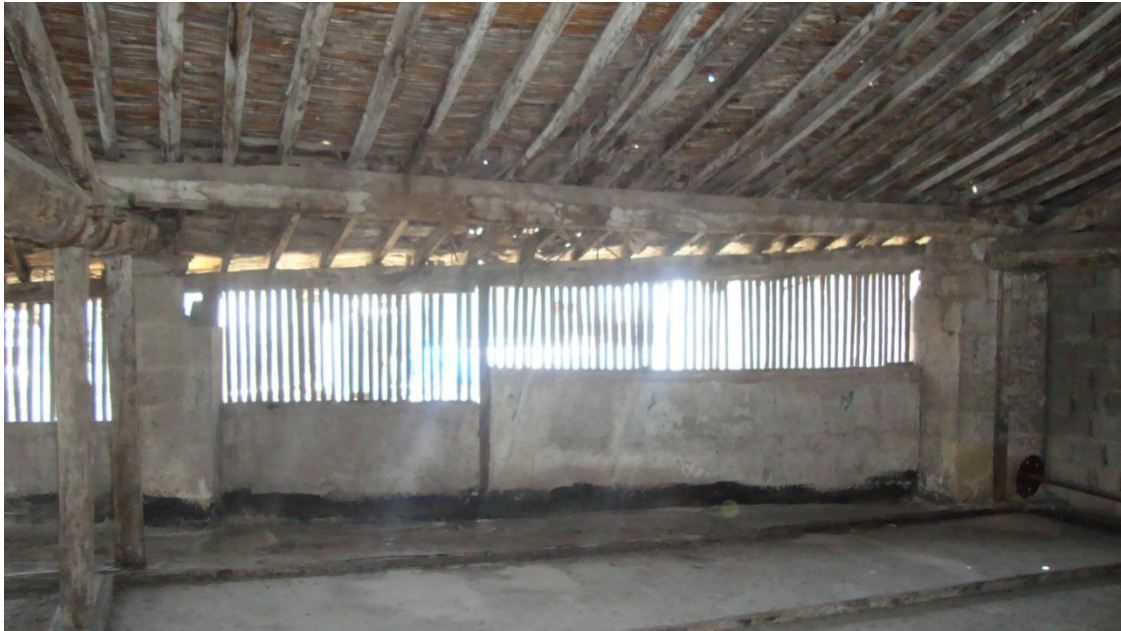
Figure 4.137. The later added low partition brick masonry wall in front of the original wooden screen on the adjacent facade of the spreading area

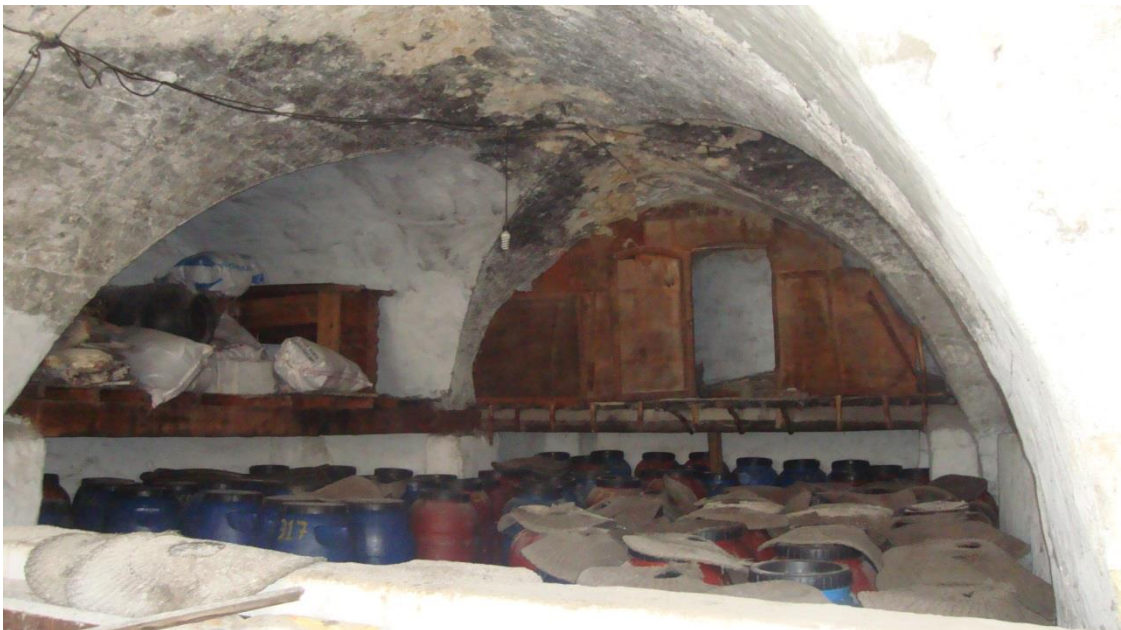
Figure 4.138. The later added wooden platforms and their pedestals on the closed gallery on the ground floor

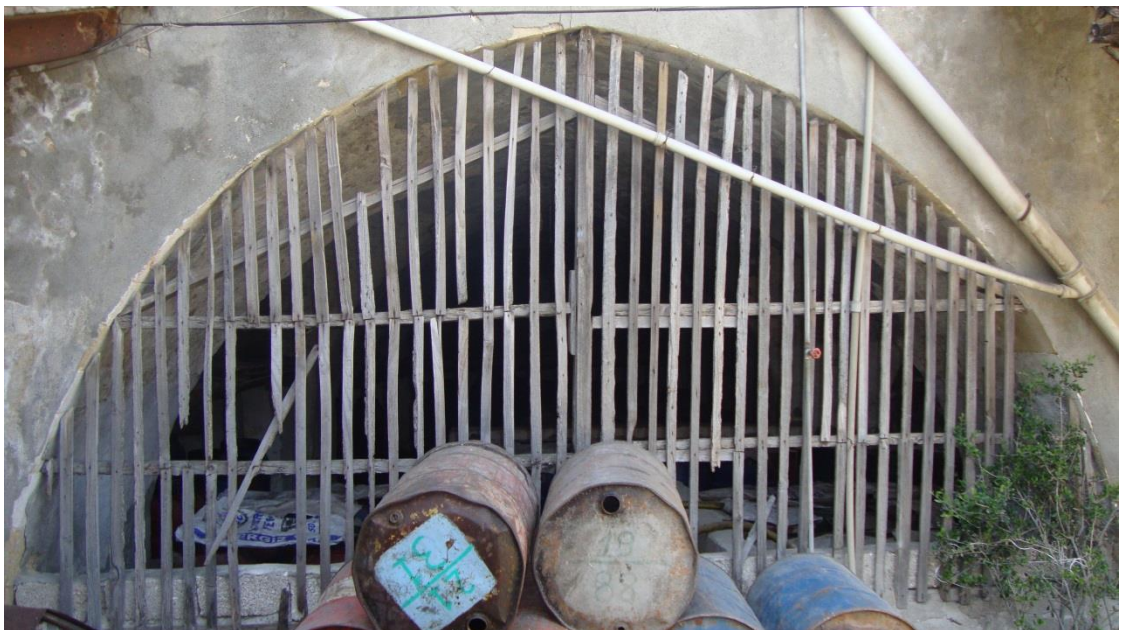
The blind arches on the northern facade and the wooden hipped roof on the north part of the building collapsed during the widening of İnneplik Street. The collapsed part of the roof (see Figure 4.106) and two blind arches on the northern facade are renewed (Figure 4.139). Furthermore, the wooden screen that is located on the courtyard facades of the southern semi-open gallery on the ground floor is renewed (Figure 4.140).

Figure 4.140. The renewed wooden screen between depressed pointed arch of the semi-open gallery on the courtyard facade

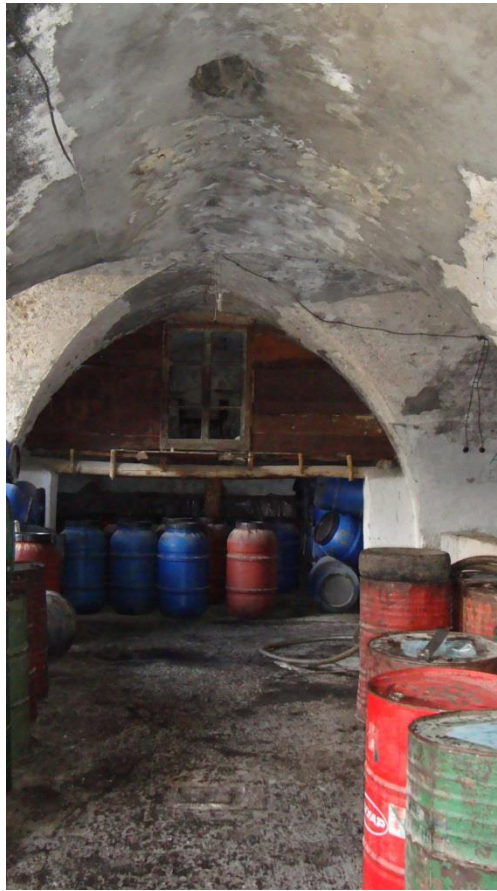
- The ground floor parts of two original stone masonry chimneys rise from the fireplace room on the basement floor and from the southern semi-open gallery located on the west of the courtyard on the ground floor to the roof (Figure 4.143, Figure 4.144),
- A part of the wooden screen on the arch of the northern semi-open gallery located on the west of the courtyard (Figure 4.145),
- The low partition stone wall and the wooden screen on the arch of the northern L shaped semi-open gallery located on the west of the courtyard (Figure 4.146),
- The stone masonry wall on the west part of the office,

Figure 4.143. The traces of the cut stone masonry chimney on the floor and cross vault of the semi-open gallery on the ground floor

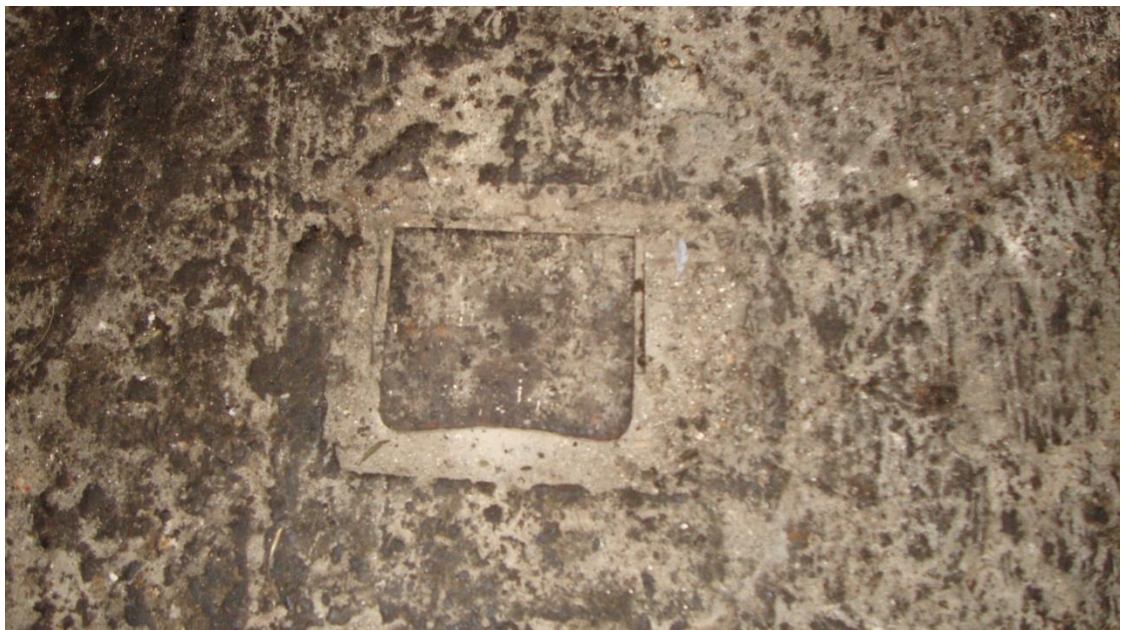
Figure 4.144. The trace of the cut stone masonry chimney on the floor of the semi-open gallery on the ground floor

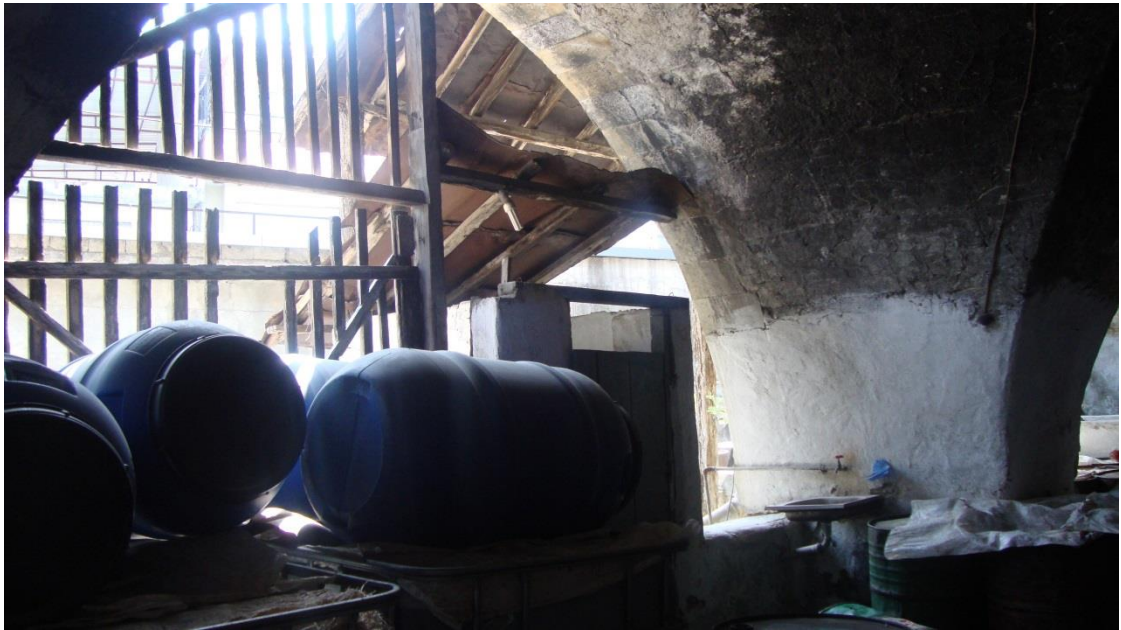
Figure 4.145. The removed part of the wooden screen on the courtyard facade of the semi-open gallery on the ground floor

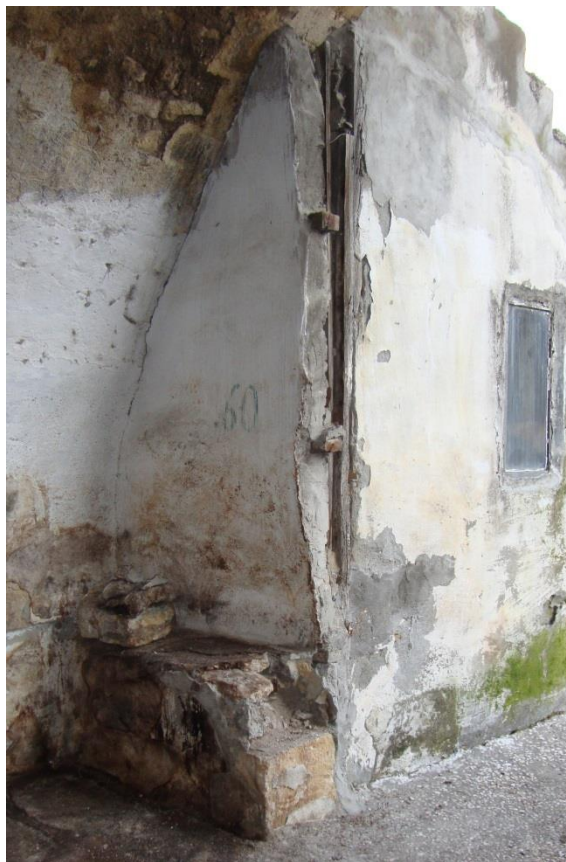
Figure 4.146. The traces of the removed low partition stone wall and wooden screen on the depressed pointed arch of the northern semi-open gallery

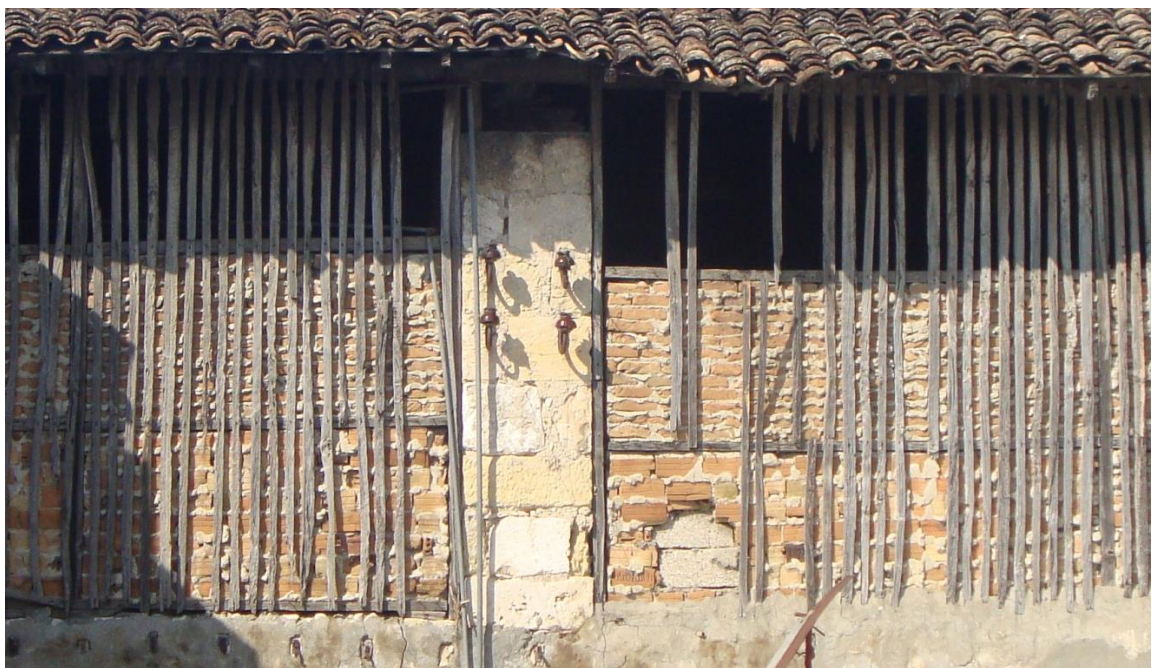
- Granular disintegration (Figure 4.147),
- Crumbling (Figure 4.148),
- Detachment of a light colored crust changing the surface (Figure 4.149),
- Soiling (Figure 4.150),
- Efflorescences (Figure 4.151),
- Coloration to colored crust tracing the surface (Figure 4.152),
- Microbiological colonization (Figure 4.153),
- Colonization by higher plants (Figure 4.154),
- Loss of material (Figure 4.155),
- Decay (Figure 4.156),
- Natural aging (see Figure 4.77, Figure 4.157)

Figure 4.148. Crumbling on the cut stone masonry column on the northern courtyard facade

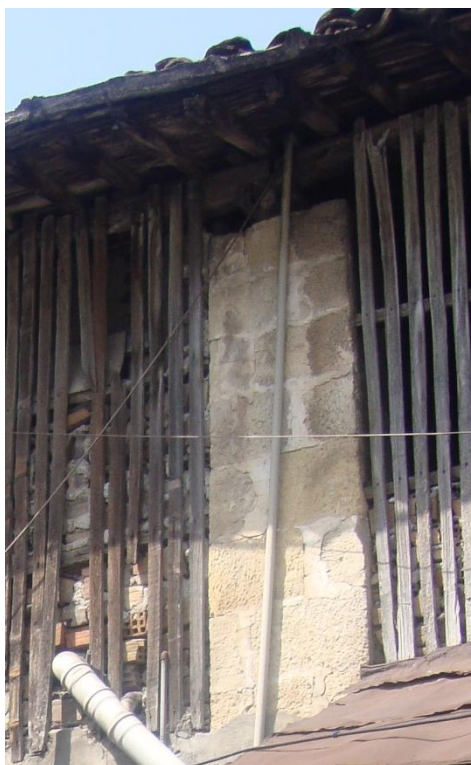
Figure 4.149. Detachment of a light colored crust changing the surface on the cut stone masonry column on the western courtyard facade

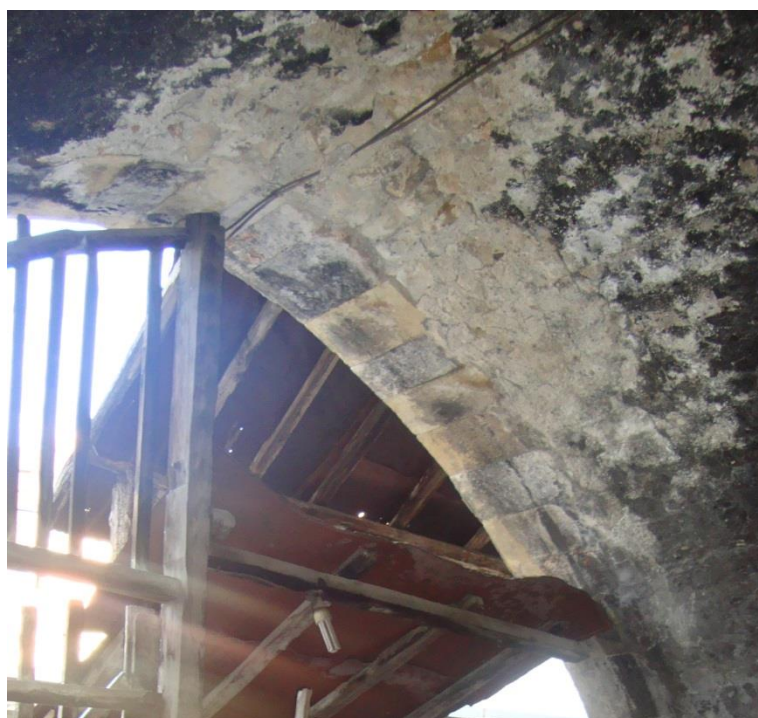
Figure 4.150. Soiling on the vault of the semi-open galleries on the ground floor

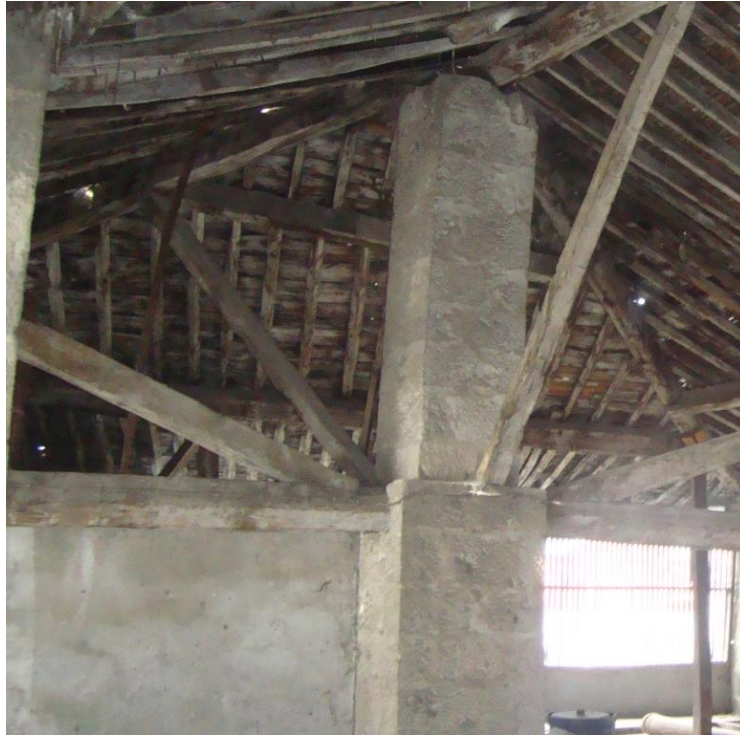
Figure 4.151. Efflorescences on the cut stone masonry columns on the spreading area

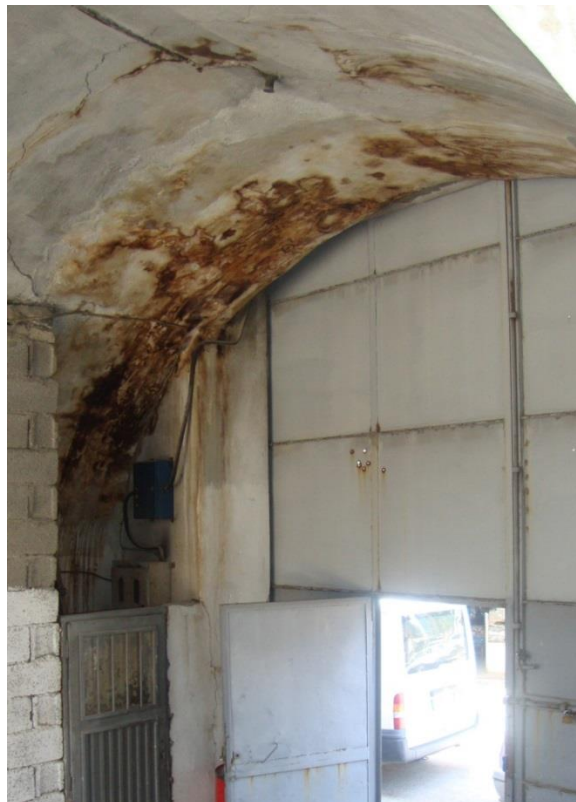
Figure 4.152. Coloration to colored crust tracing the surface

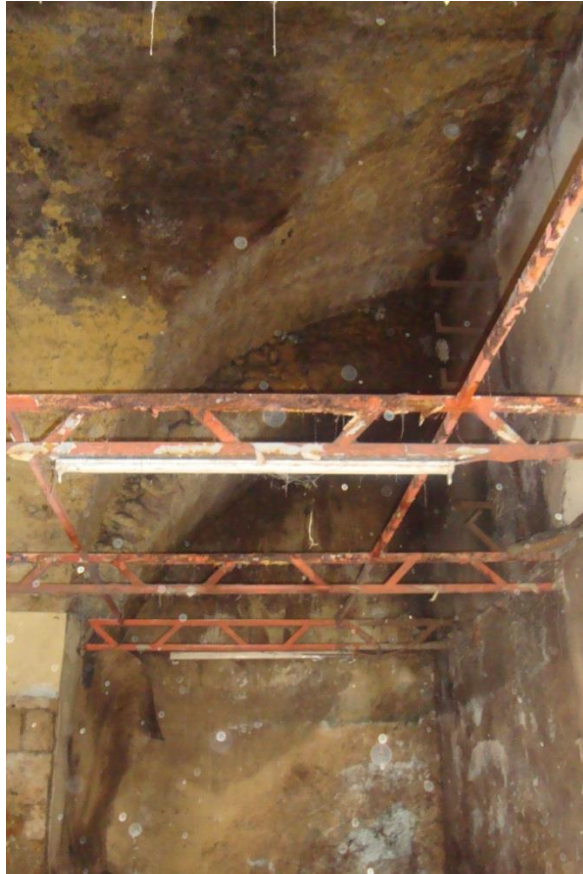
Figure 4.153. Microbiological colonization on the vault

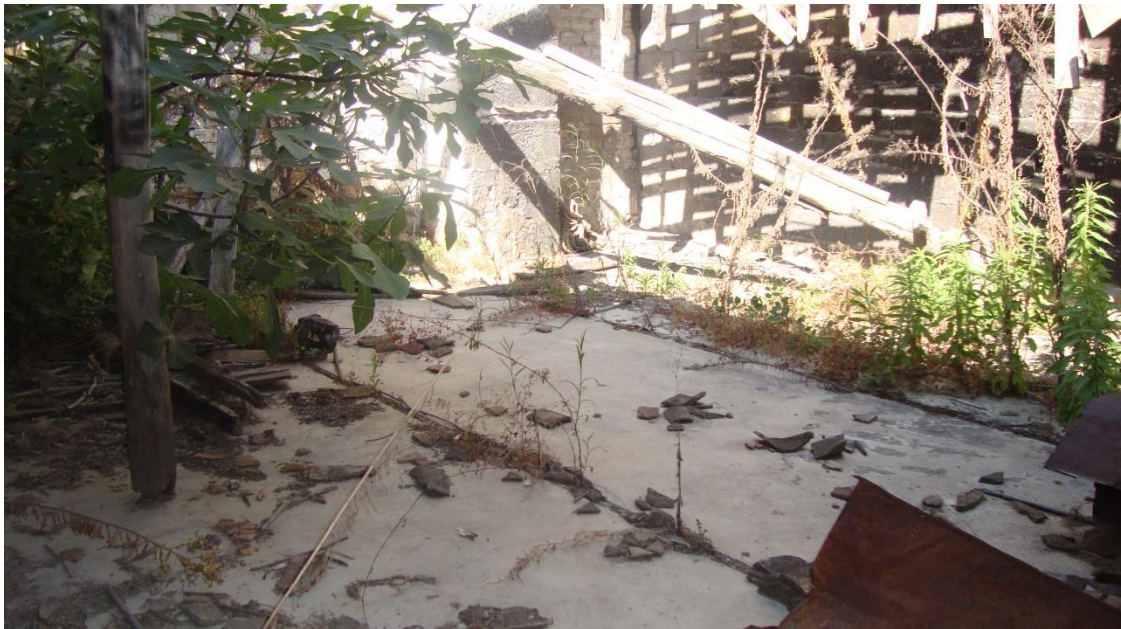
Figure 4.154. Colonization by higher plants on the first floor on the west part of the building
