**CONSERVATION OF
KUSEYRİ SOAP FACTORY
AS AN INDUSTRIAL HERITAGE IN ANTAKYA**

**A Thesis Submitted to
the Graduate School of Engineering and Sciences of
İzmir Institute of Technology
in Partial Fulfillment of the Requirements for the Degree of**

in Architectural Restoration

**by
Derya CAMUZ**

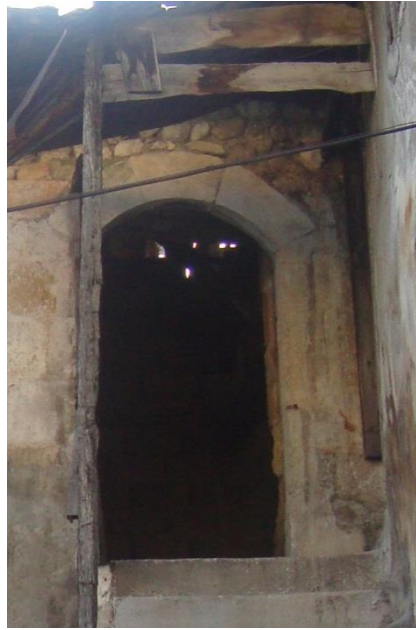
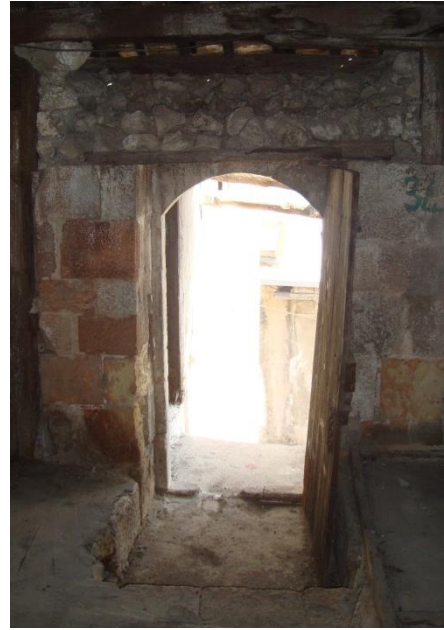
In Antakya Kuseyri Soap Factory, the original depressed arched door opening with stone casing of the original entrance space is observed on the east facade of the building (see Figure 5.14). A depressed arched entrance door opening with stone casing is located on the western courtyard facade of the spreading area on the first floor (Figure 5.88). Furthermore, an original door opening is observed on the stone masonry wall on the west part of the building on the ground floor (Figure 5.89).

a) b)
 Figure 5.88. The depressed arched entrance door opening with stone casing on the courtyard facade on the first floor:
 a) View from the outside;
 b) View from the inside;

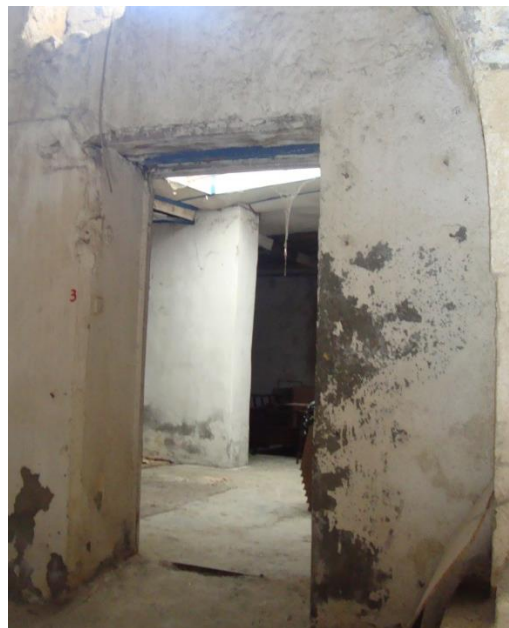
Figure 5.89. The original door opening on the stone masonry wall on the west part of the building in Kuseyri Soap Factory, Antakya

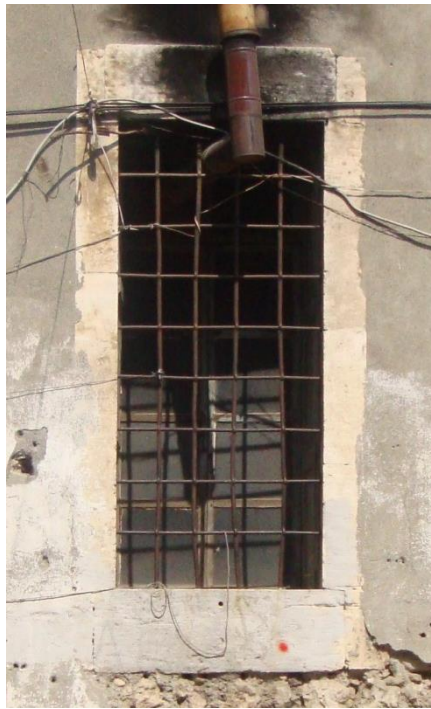
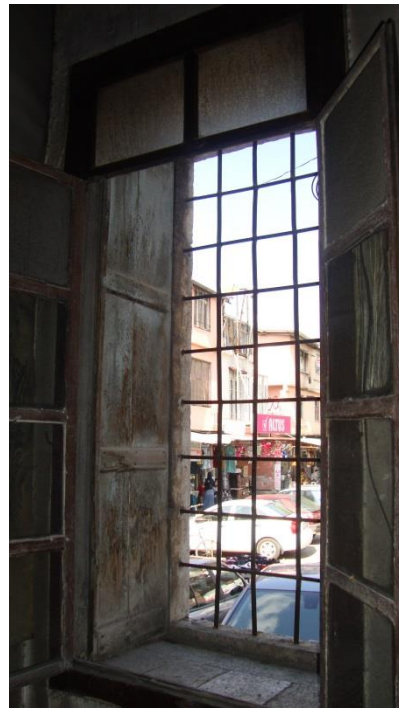
The office windows of Kuseyri Soap Factory are similar with Aselci Soap Factory. The original vertical rectangular (91 cm x 172 cm) windows, which open to the street on the northern and eastern walls of the office located on the northeast on the ground floor, are double winged with stone casing, wooden joinery, grilled iron bars and inner wooden shutter (Figure 5.96). The original vertical rectangular top windows are located on the west part of the building and on the courtyard wall of the shop, opening to the street on the south of the building on the ground floor.

Figure 5.96. The original vertical rectangular double winged window opening looking onto the street with stone casing, wooden joinery, grilled iron bars and inner wooden shutter in Kuseyri Soap Factory, Antakya:

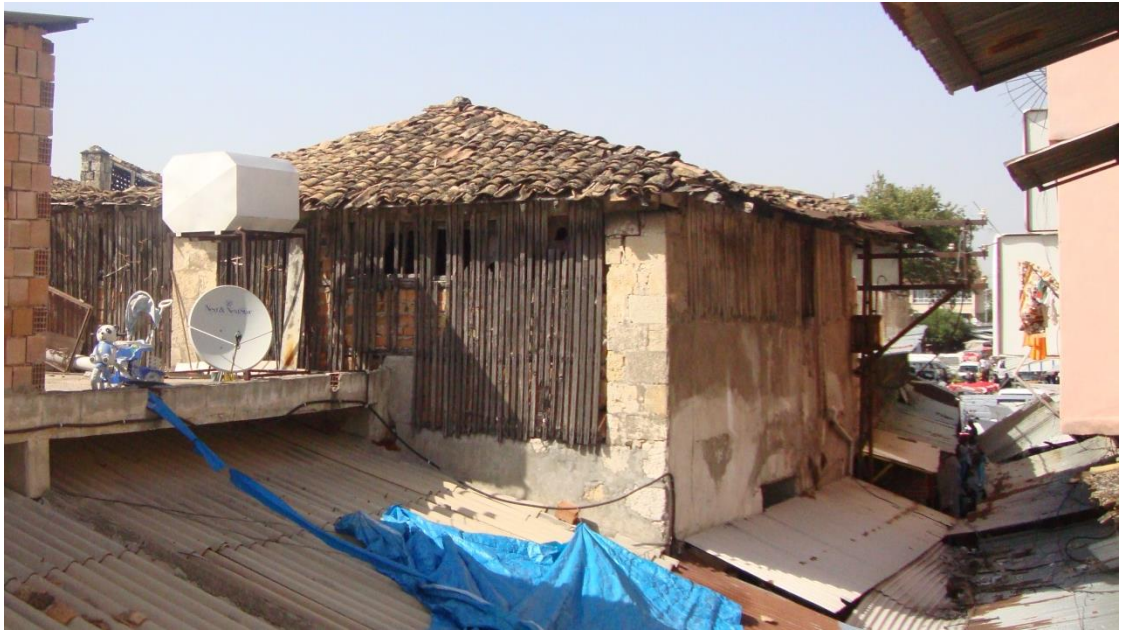
In Antakya, Aselci Soap Factory (see Figure 5.35, Figure 5.98), Selahattin Ökten Soap Factory (Figure 5.99, see Figure 5.21, Figure 5.37) and Şeyhoğlu Soap Factory (see Figure 5.36), the wooden screens are observed between pointed depressed arches on the courtyard facade on the ground floor, between cut stone masonry columns on the courtyard, street and adjacent facades of the spreading and drying areas on the first floor. This scheme is a general feature observed in all of the soap factories located in Antakya, including Kuseyri Soap Factory (see Figure 5.37, Figure 5.100).

Figure 5.100. The wooden screen on the street and adjacent facades of the spreading and drying area in Kuseyri Soap Factory, Antakya

- The renewed wooden screen between depressed pointed arch openings on the ground floor of the western courtyard facade will be renewed by using the similar material and detail since it is exposed to natural aging and decay. It is proposed to refunctione this part as a cafe. The frameless folding insulated glass units will be arranged in the front of the wooden screen providing ventilation and isolation required for the new function (APPENDIX F).

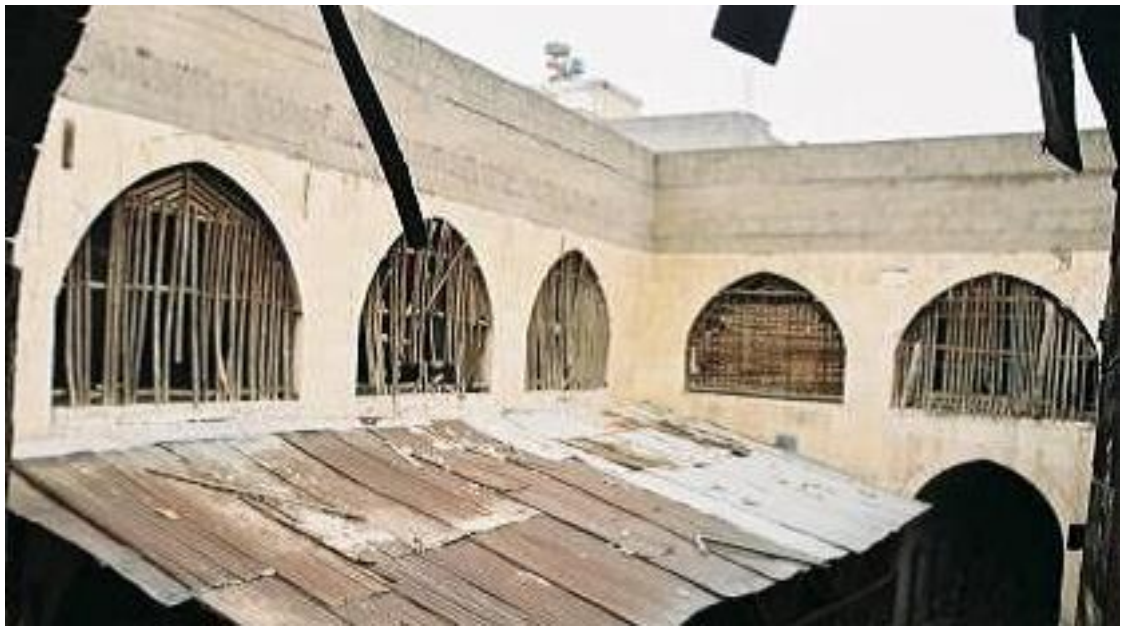
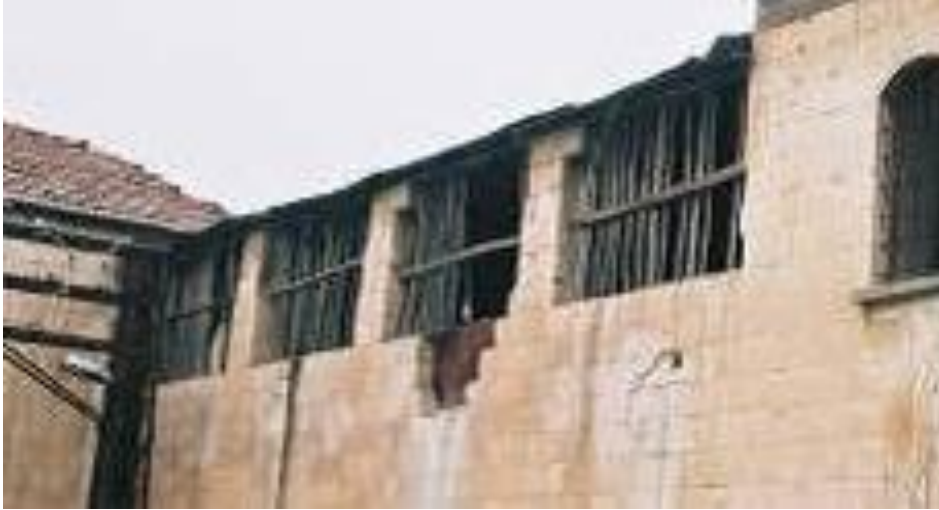
In Nizip, Sayınlar Soap Factory, the wooden screens are observed between pointed depressed arches on the courtyard facade of the spreading and drying areas on the first floor. On the other hand, the wooden screens arranged on the courtyard facade on the first floor of Nizip Sayınlar Soap Factory are removed at present (Figure 5.101, Figure 5.102).

Figure 5.101. The wooden screen between depressed pointed arches on the courtyard facades of the spreading and drying area in Sayınlar Soap Factory, Nizip

Figure 5.102. The wooden screen between cut stone masonry columns on the street facades of the spreading and drying area in Sayınlar Soap Factory, Nizip

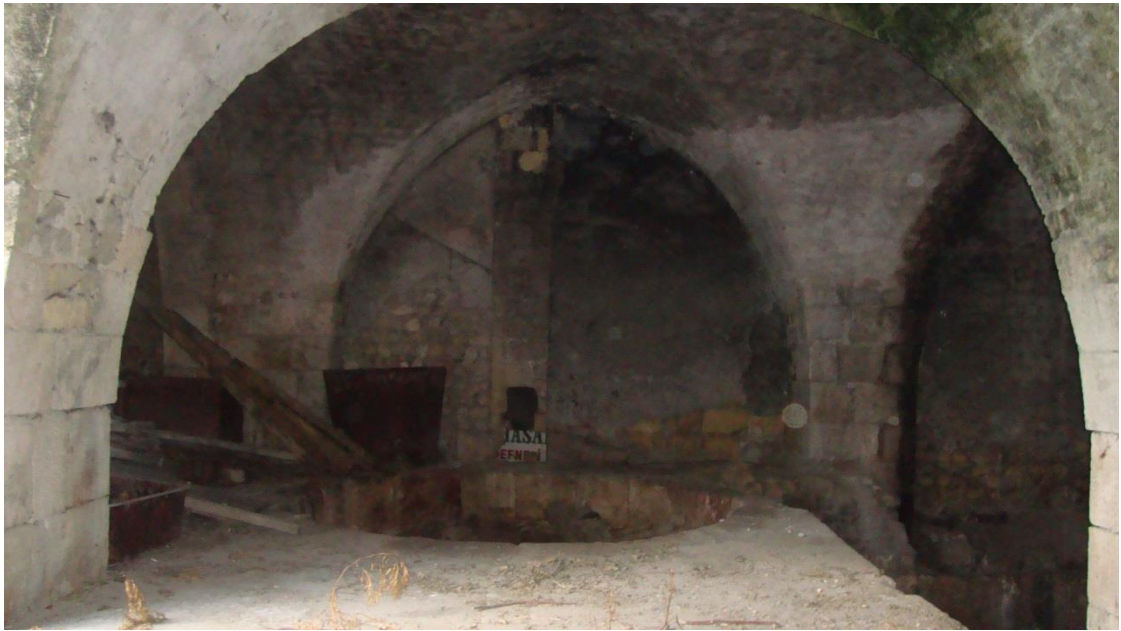
Kuseyri Soap Factory has two original stone cauldrons below the ground floor that are covered with a reinforced concrete floor on the semi-open galleries on the ground floor (see Figure 4.23). As revealed from an old book written by Fatin Kuseyri⁴ who is the previous owner of the soap factory, titled “Türkiye’de Sabun Sanayii” in 1952, the lower parts of the stone cauldrons related with the fire hall of the fireplaces and known as *kake* were made of copper. As revealed from the old sketches drawn by Fatin Kuseyri, the causticizing pits known as *samda* are located on the west part of the stone cauldrons (Figure 5.109). The causticizing pits are infilled at present. Furthermore, a later added stone cauldron is located above the later added furnace platform on the closed gallery on the ground floor (see Figure 4.26).

Figure 5.106. The stone cauldron on the semi-open gallery on the ground floor in Kuseyri Soap Factory, Antakya

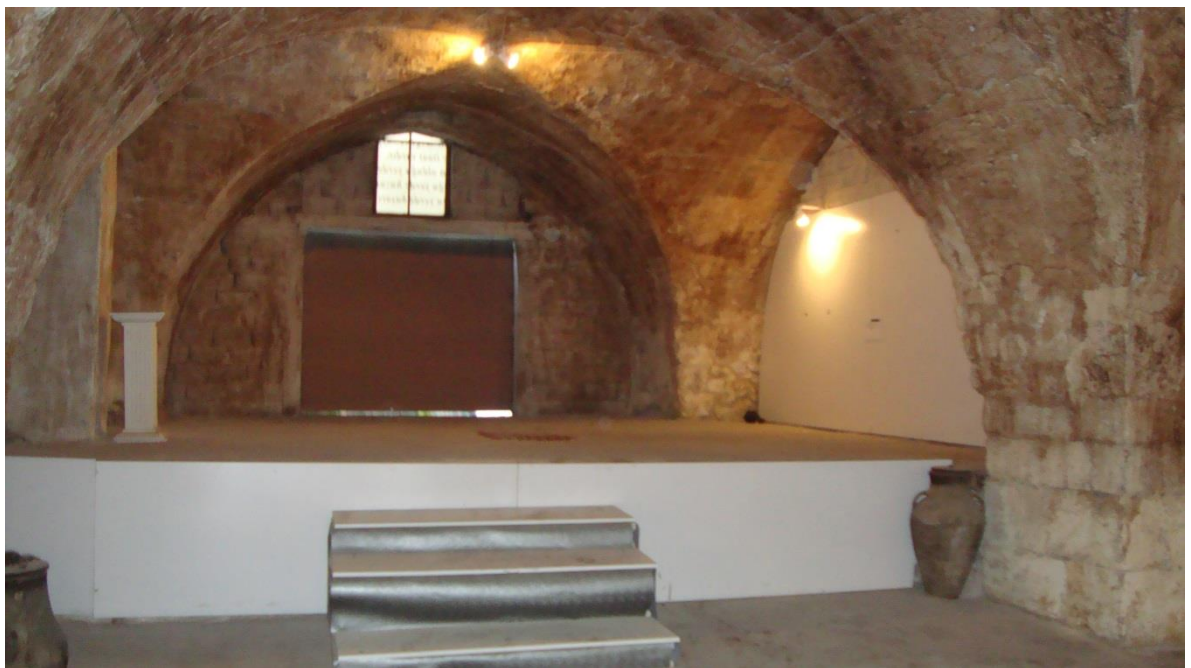
Antakya Aselci Soap Factory, Selahattin Ökten Soap Factory and Hasan Ökten Soap Factory, Antakya have stone cauldrons on the galleries on the ground floors (Figure 5.106). In Selahattin Ökten Soap Factory, the stone cauldron is covered with plywood at present (Figure 5.107). Aselci Soap Factory has causticizing pits known as *samda* adjacent to the stone cauldron. Furthermore, Aselci Soap Factory has a later added copper vat on the first floor (Figure 5.108).

Figure 5.107. View of the stone cauldron covered with plywood in the gallery on the ground floor in Selahattin Ökten Soap Factory, Antakya

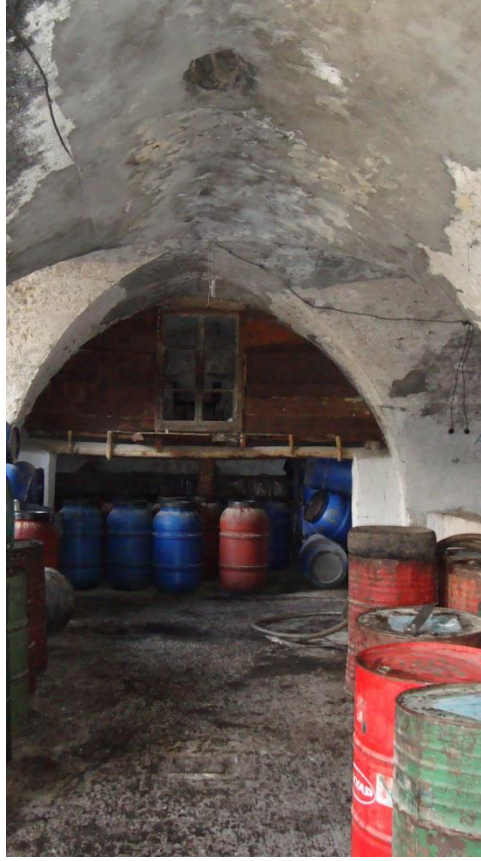
Figure 5.121. The traces of the removed part of the cut stone masonry chimney on the floor and cross vault of the semi-open gallery in Kuseyri Soap Factory, Antakya

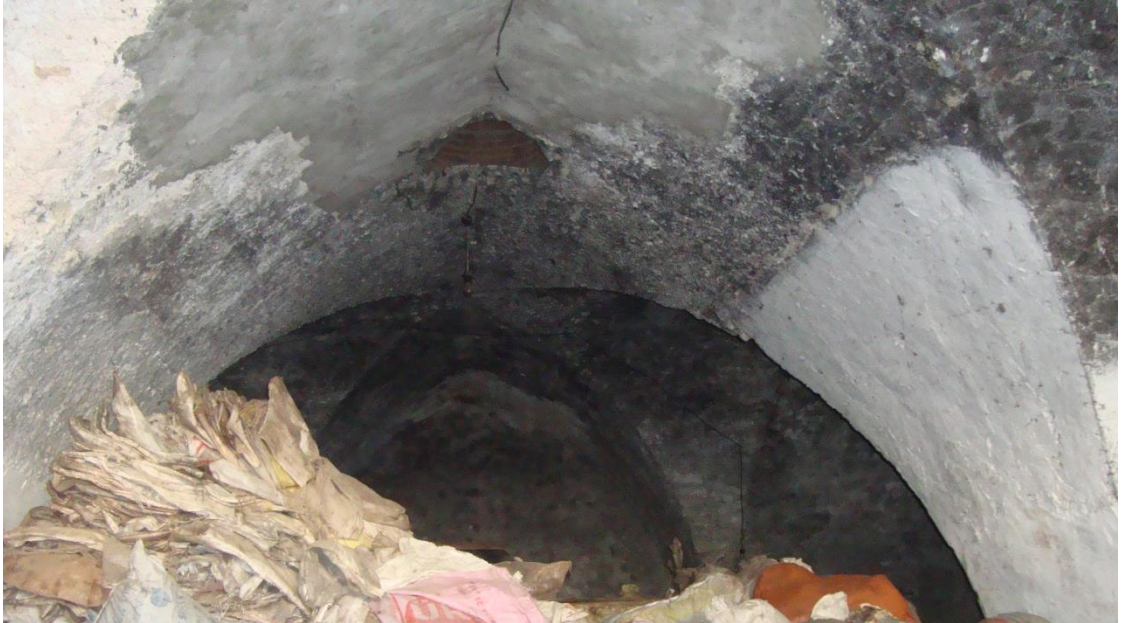
Figure 5.122. The later arranged circular hole for carrying the liquid soap on the vault of the closed gallery in Kuseyri Soap Factory, Antakya
