**RESTORATION OF A TRADITIONAL
RESIDENTIAL BUILDING IN ŞANLIURFA**

**A Thesis Submitted to
the Graduate School of Engineering and Sciences of
İzmir Institute of Technology
in Partial Fulfillment of the Requirements for the Degree of**

in Architectural Restoration

**by
Keziban ÇELİK**

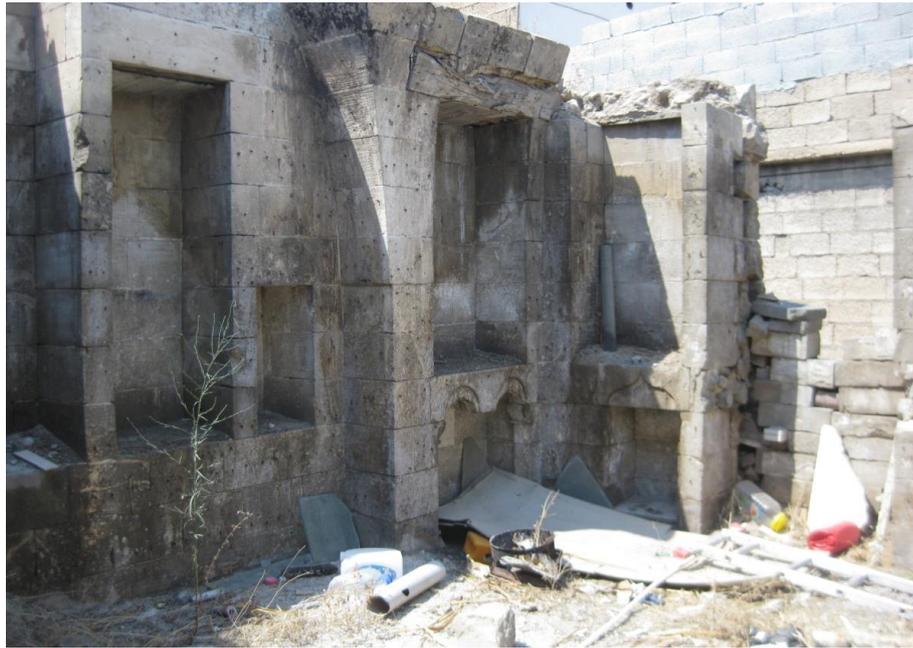
Figure 4.20. The room (F04) on the west of south wing

The room (F04) located on west part of the south wing of the first floor is not accessed because of the demolished entrance. The ceiling of the rectangular planned space (25.1 m²) is ruined, too. The room is consisted of two parts as *gedemeç* and main living area. *Gedemeç* floor level is 1.33 m higher than the courtyard, and the floor of the main living space is 10 cm higher than *gedemeç*. The floor covering is collapsed partly and covered with dust. It has three niches (78x175 cm; 101x273 cm; 78x175 cm) on the east wall, seven niches (50x75 cm; 64x178 cm; 152x255; 70x105 cm; 38x78 cm; 88x75 cm; 85x132 cm) on the south wall, a niche (66x100 cm) on the west wall, in order (Figure 4.20). Room (F04) has four windows opening on the long side of the room, north of the room and one window opening to street, on the short side of the room, on west. These windows are opening to courtyard. Various niches in different dimensions are organized on other three sides of the room not opening to courtyard which south, east and west.

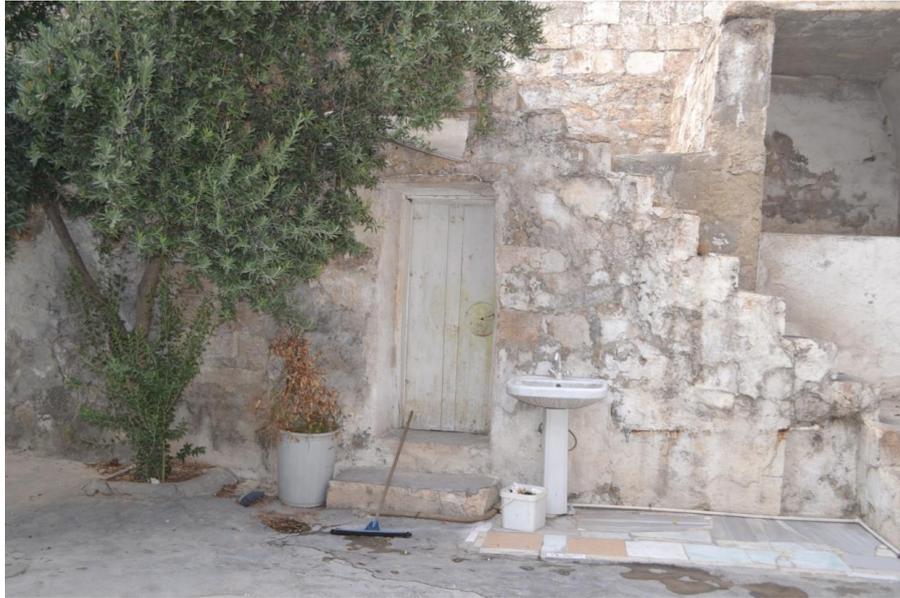
Figure 4.40. Stone step covered with screed (G03)

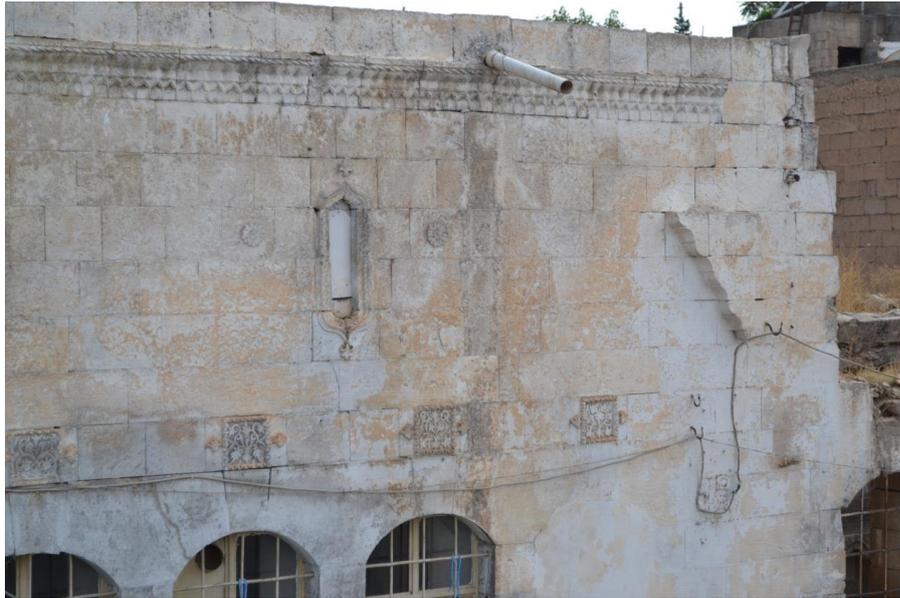
The ornamentations on the building are ornamented stones seen above doors and windows. Stones above doors are depressed arched formed with floral motives. Ornamented stones rectangular formed with fretwork floral motives are located above windows (Figure 4.42). These stones, where the open portions are covered today, originally provide ventilation for the rooms. There are double rose formed ornamented reliefs above ornamented stones on both facades. There is an ornamented stone with fretwork floral motives located in front of *eyvan* arch. It is designed to hide the pulley system located behind. The pulley is a unique architectural element designed to keep food raised in the past in order to protect from animals such as cat, dog. Spiral moulding is arranged along two walls of *eyvan*. This spiral moulding is integrated into the transition to the vault with ornamentations of the niche in the south wall (Figure 4.43).

Figure 4.42. Ornamented stones above windows

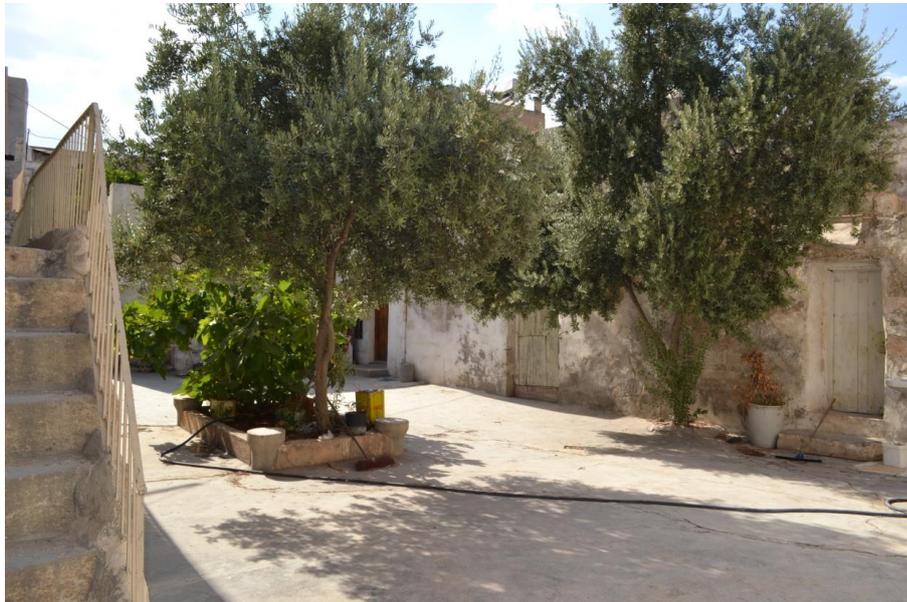
There are two flowerbeds in the courtyard of the building. One is in the center of the courtyard, while the other is located in front of the *develik*. The flowerbed in the middle of the courtyard has edges of cut stone, the corner stone was changed later (Figure 4.44). Stone curbs of flowerbed in front of the *develik* are covered with screed.

Figure 4.44. Flowerbeds

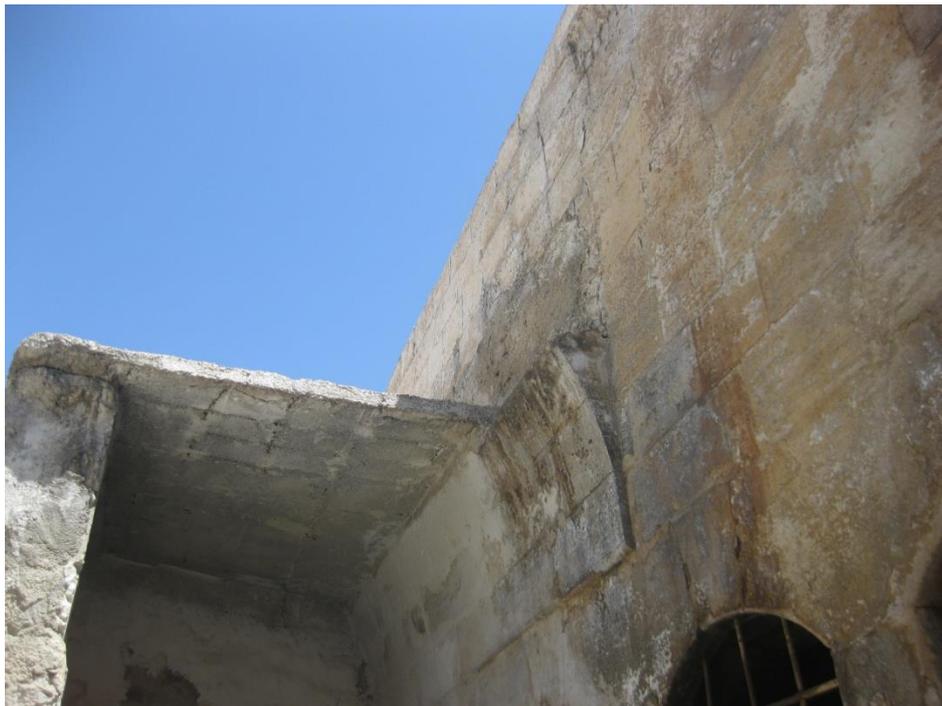
Figure 4.52. Reinforced concrete slab of water storage

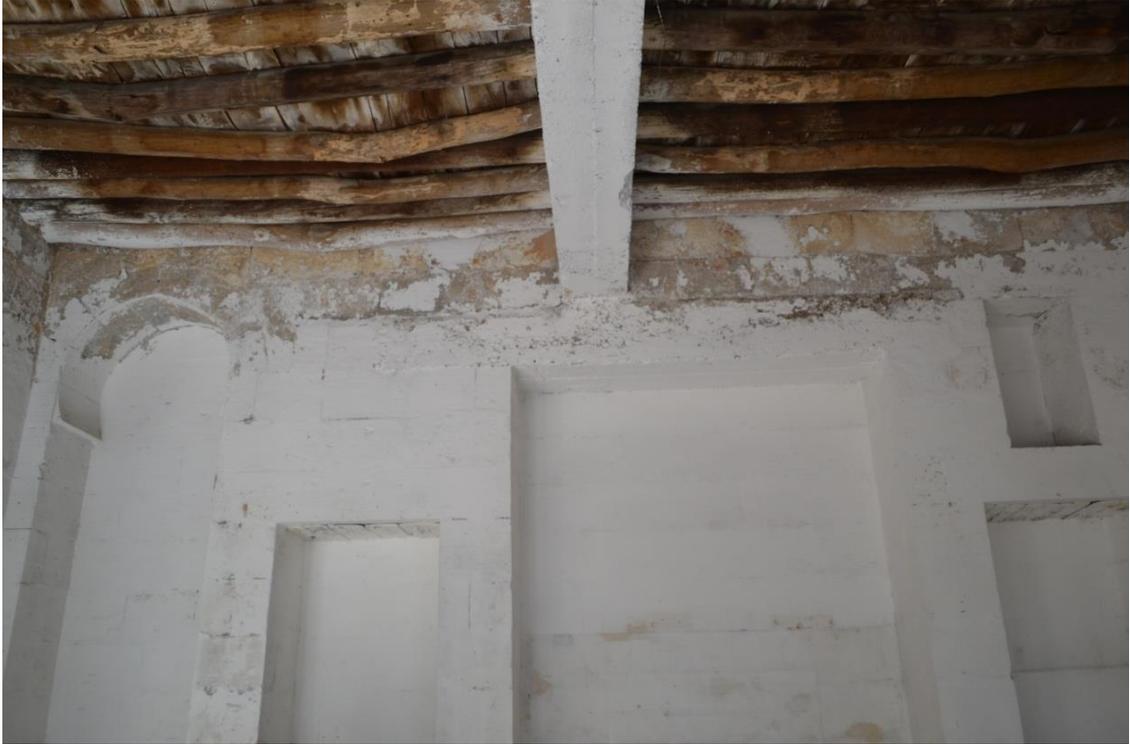
Spanning elements are wood beams and reinforced concrete beams. Wood beams are in the ceiling system of the room in the southeast of the building. The reinforced concrete beams were added to support this system (Figure 4.53). There is also a concrete lintel above the main entrance.

Figure 4.53. Reinforced concrete beam in the room on southeast

Improper additions were made with the purpose of structural requirements and use. On the ground floor, a reinforced concrete beam was added to support the wooden ceiling system of the room in the southeast. A sink was added in front of the bathroom in the northeast of the courtyard (Figure 4.68). Earth was added to the floor of *zerzembe* space in the middle of the south wing, on the ground floor. Also the door and window

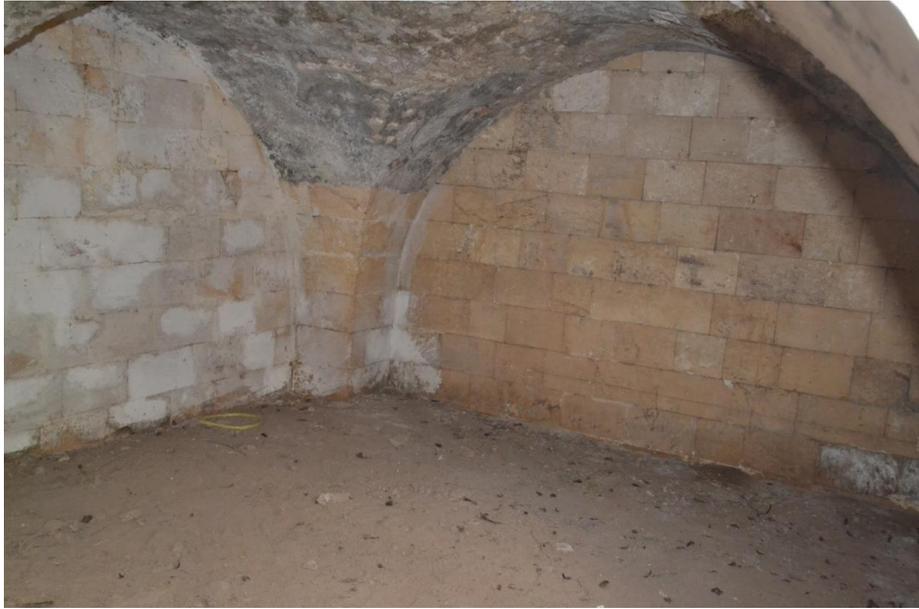
zerzembe spaces and the room on the ground floor in the southeast. *Develik* floor is earth. The original floor of *zerzembe* space located in the middle of the south wing was filled with earth (Figure 4.55). The floors in the courtyard, *zerzembe* space on the south, kitchen, bathroom and rooms are covered with screed (Figure 4.56). The floor in front of the sink in the southwest of the courtyard is later added ceramic coating (Figure 4.57).

Figure 4.55. Earth floor of *zerzembe* space in the middle of south wing

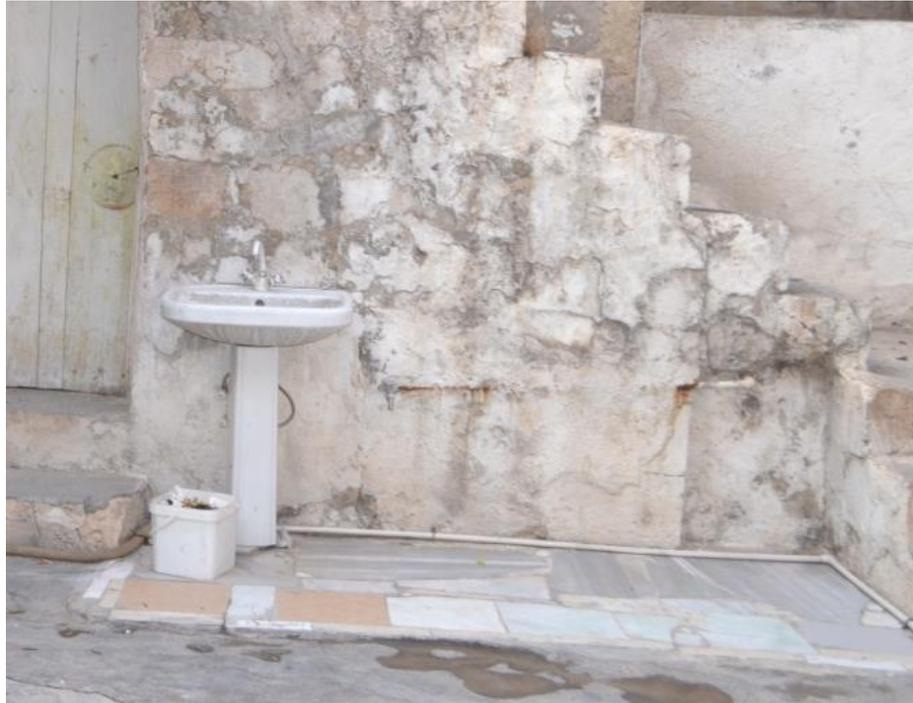
Figure 4.57. Ceramic material on courtyard

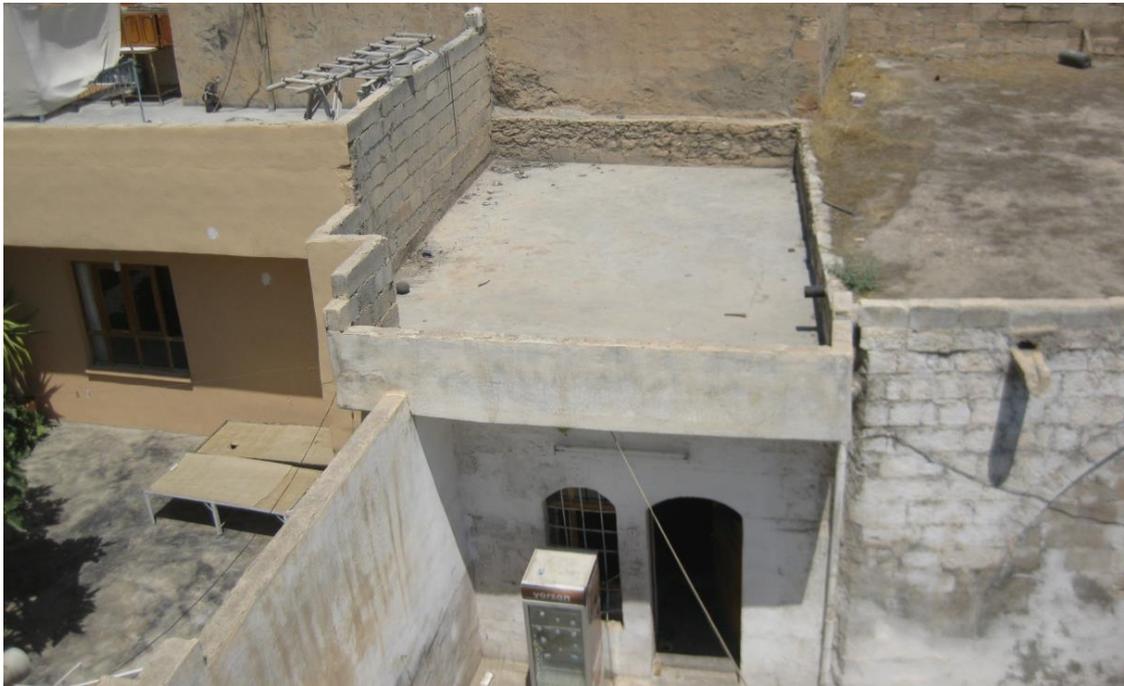
Plot was divided with the organization of a new housing on west by dividing the original layout of the building. Division is provided by a portion of the wall that separates the *selamlık* section of the traditional house from *haremlık* section (Figure 4.67).

Figure 4.67. Wall providing division

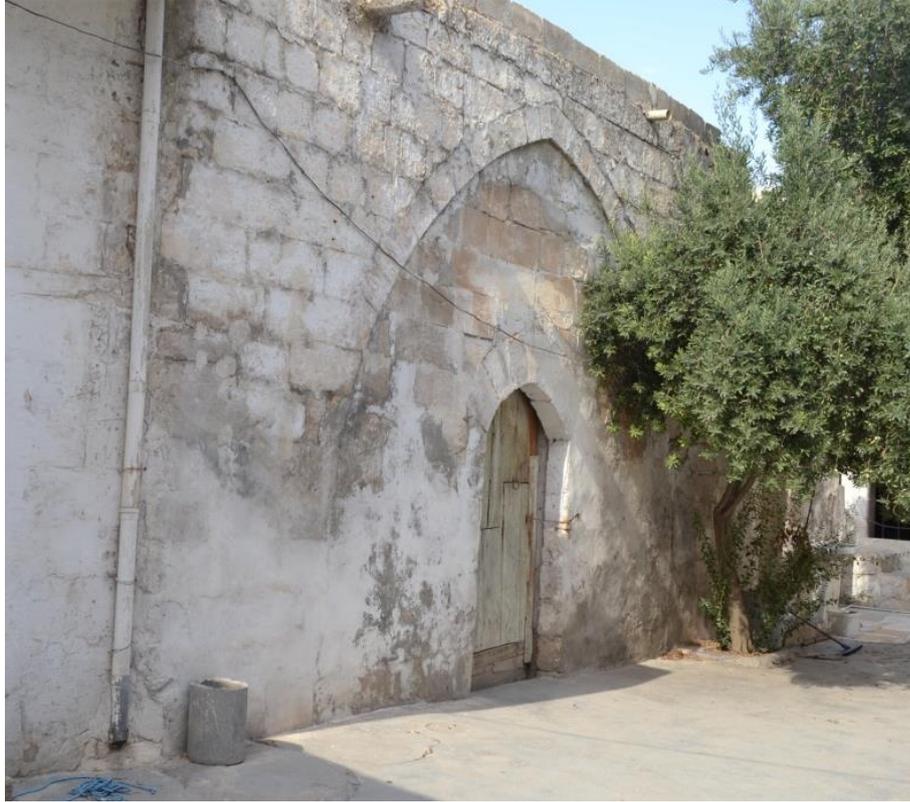
Original entrance of the *develik* space has been reduced by the addition of a wall (Figure 4.69). Cut stone walls of the courtyard, the rooms and *zerzembe* spaces were coated with whitewash later.

Figure 4.69. Wall added in front of *develik*

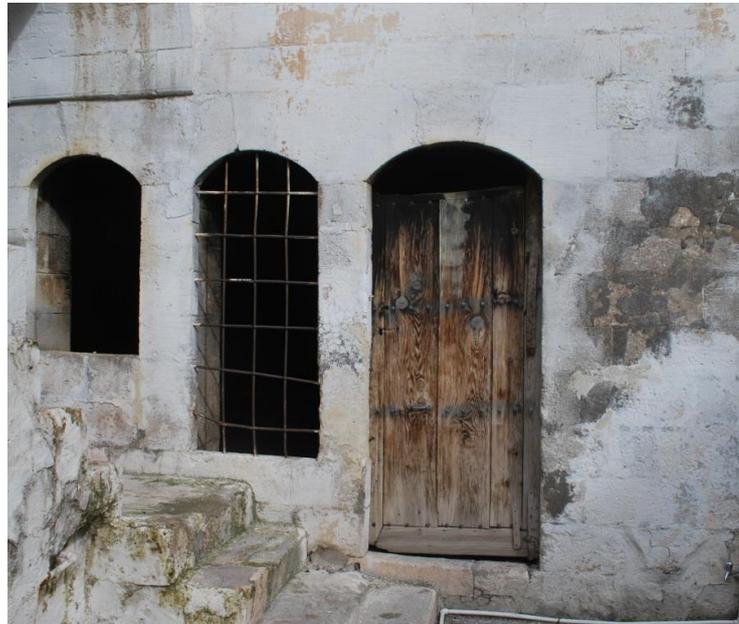
Figure 6.3. Old photographs belonging to *tandırılık* entrance in 2012
(Source: Collection of Hüseyin Arslan, 2014)

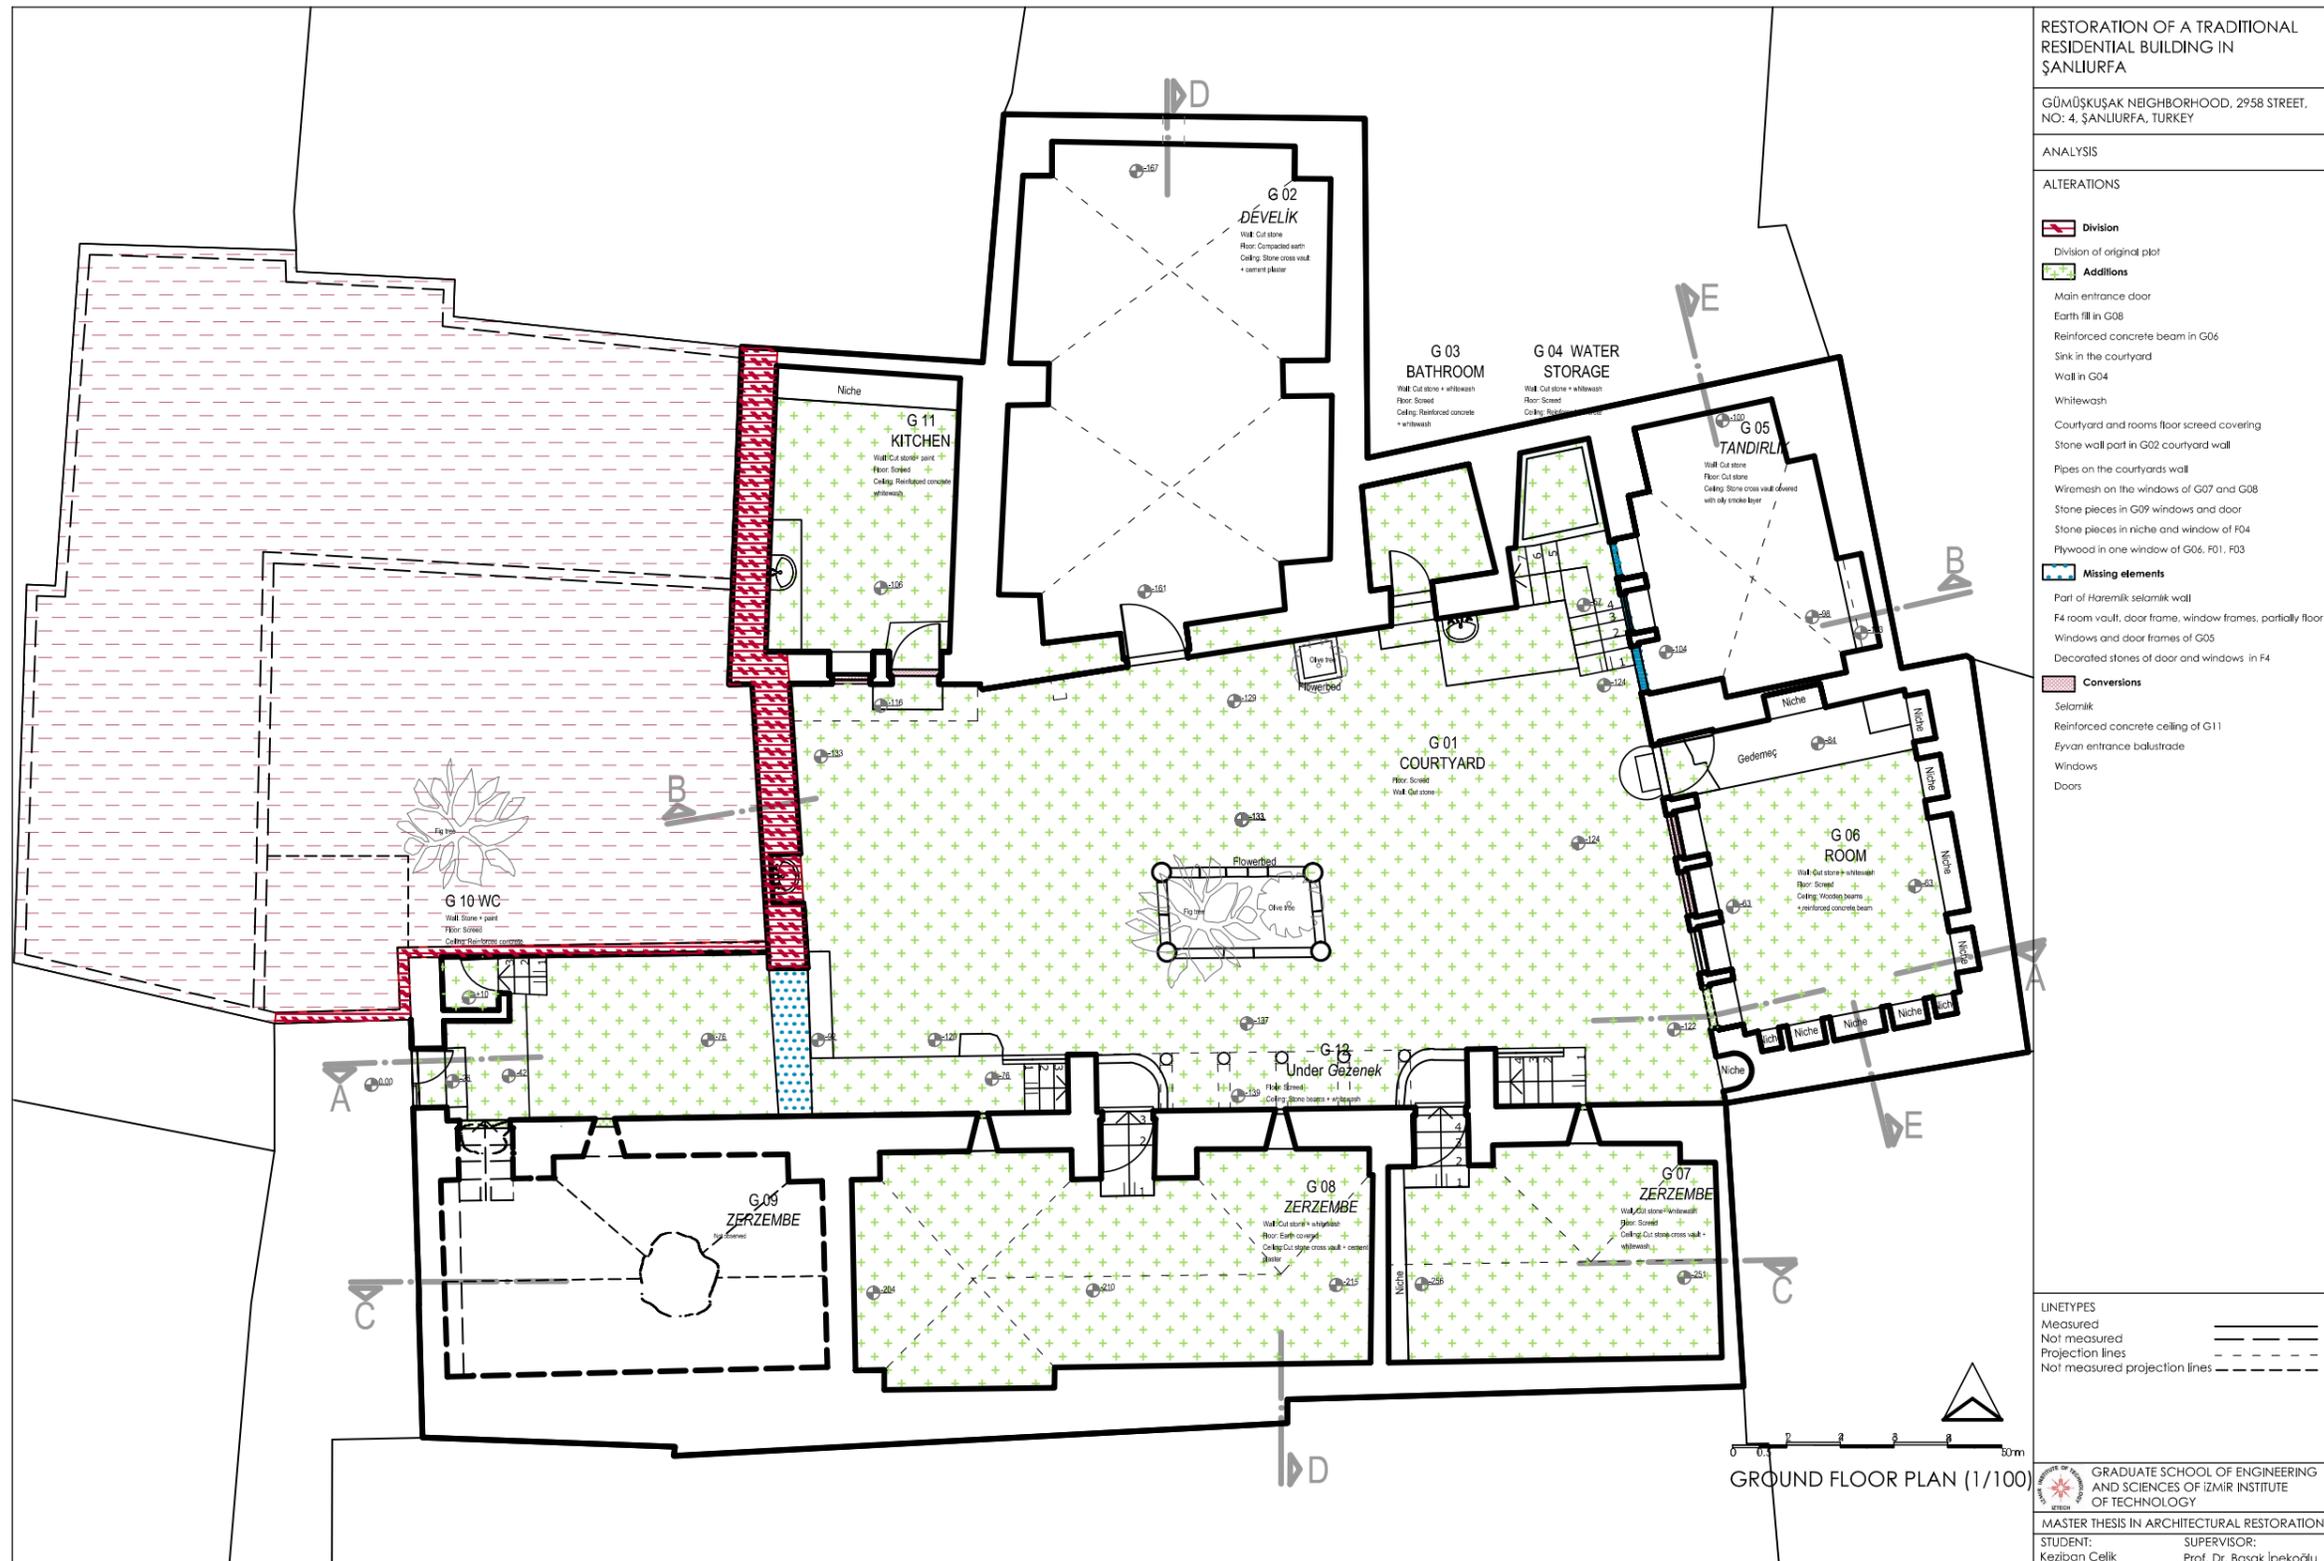
B.11. Alterations - Ground floor plan

Door and window joineries of the *tandırılık* space have been removed, original doors and windows of building have been replaced with new metal joineries. Original stone balustrade has been replaced with a metal balustrade. Balustrade of stair reaching the roof has been removed.

- Metal balustrade of stairs leading to *gezenek* will be renewed with stone material as in restoration project.
- Metal doors and windows will be replaced with wooden doors and windows.

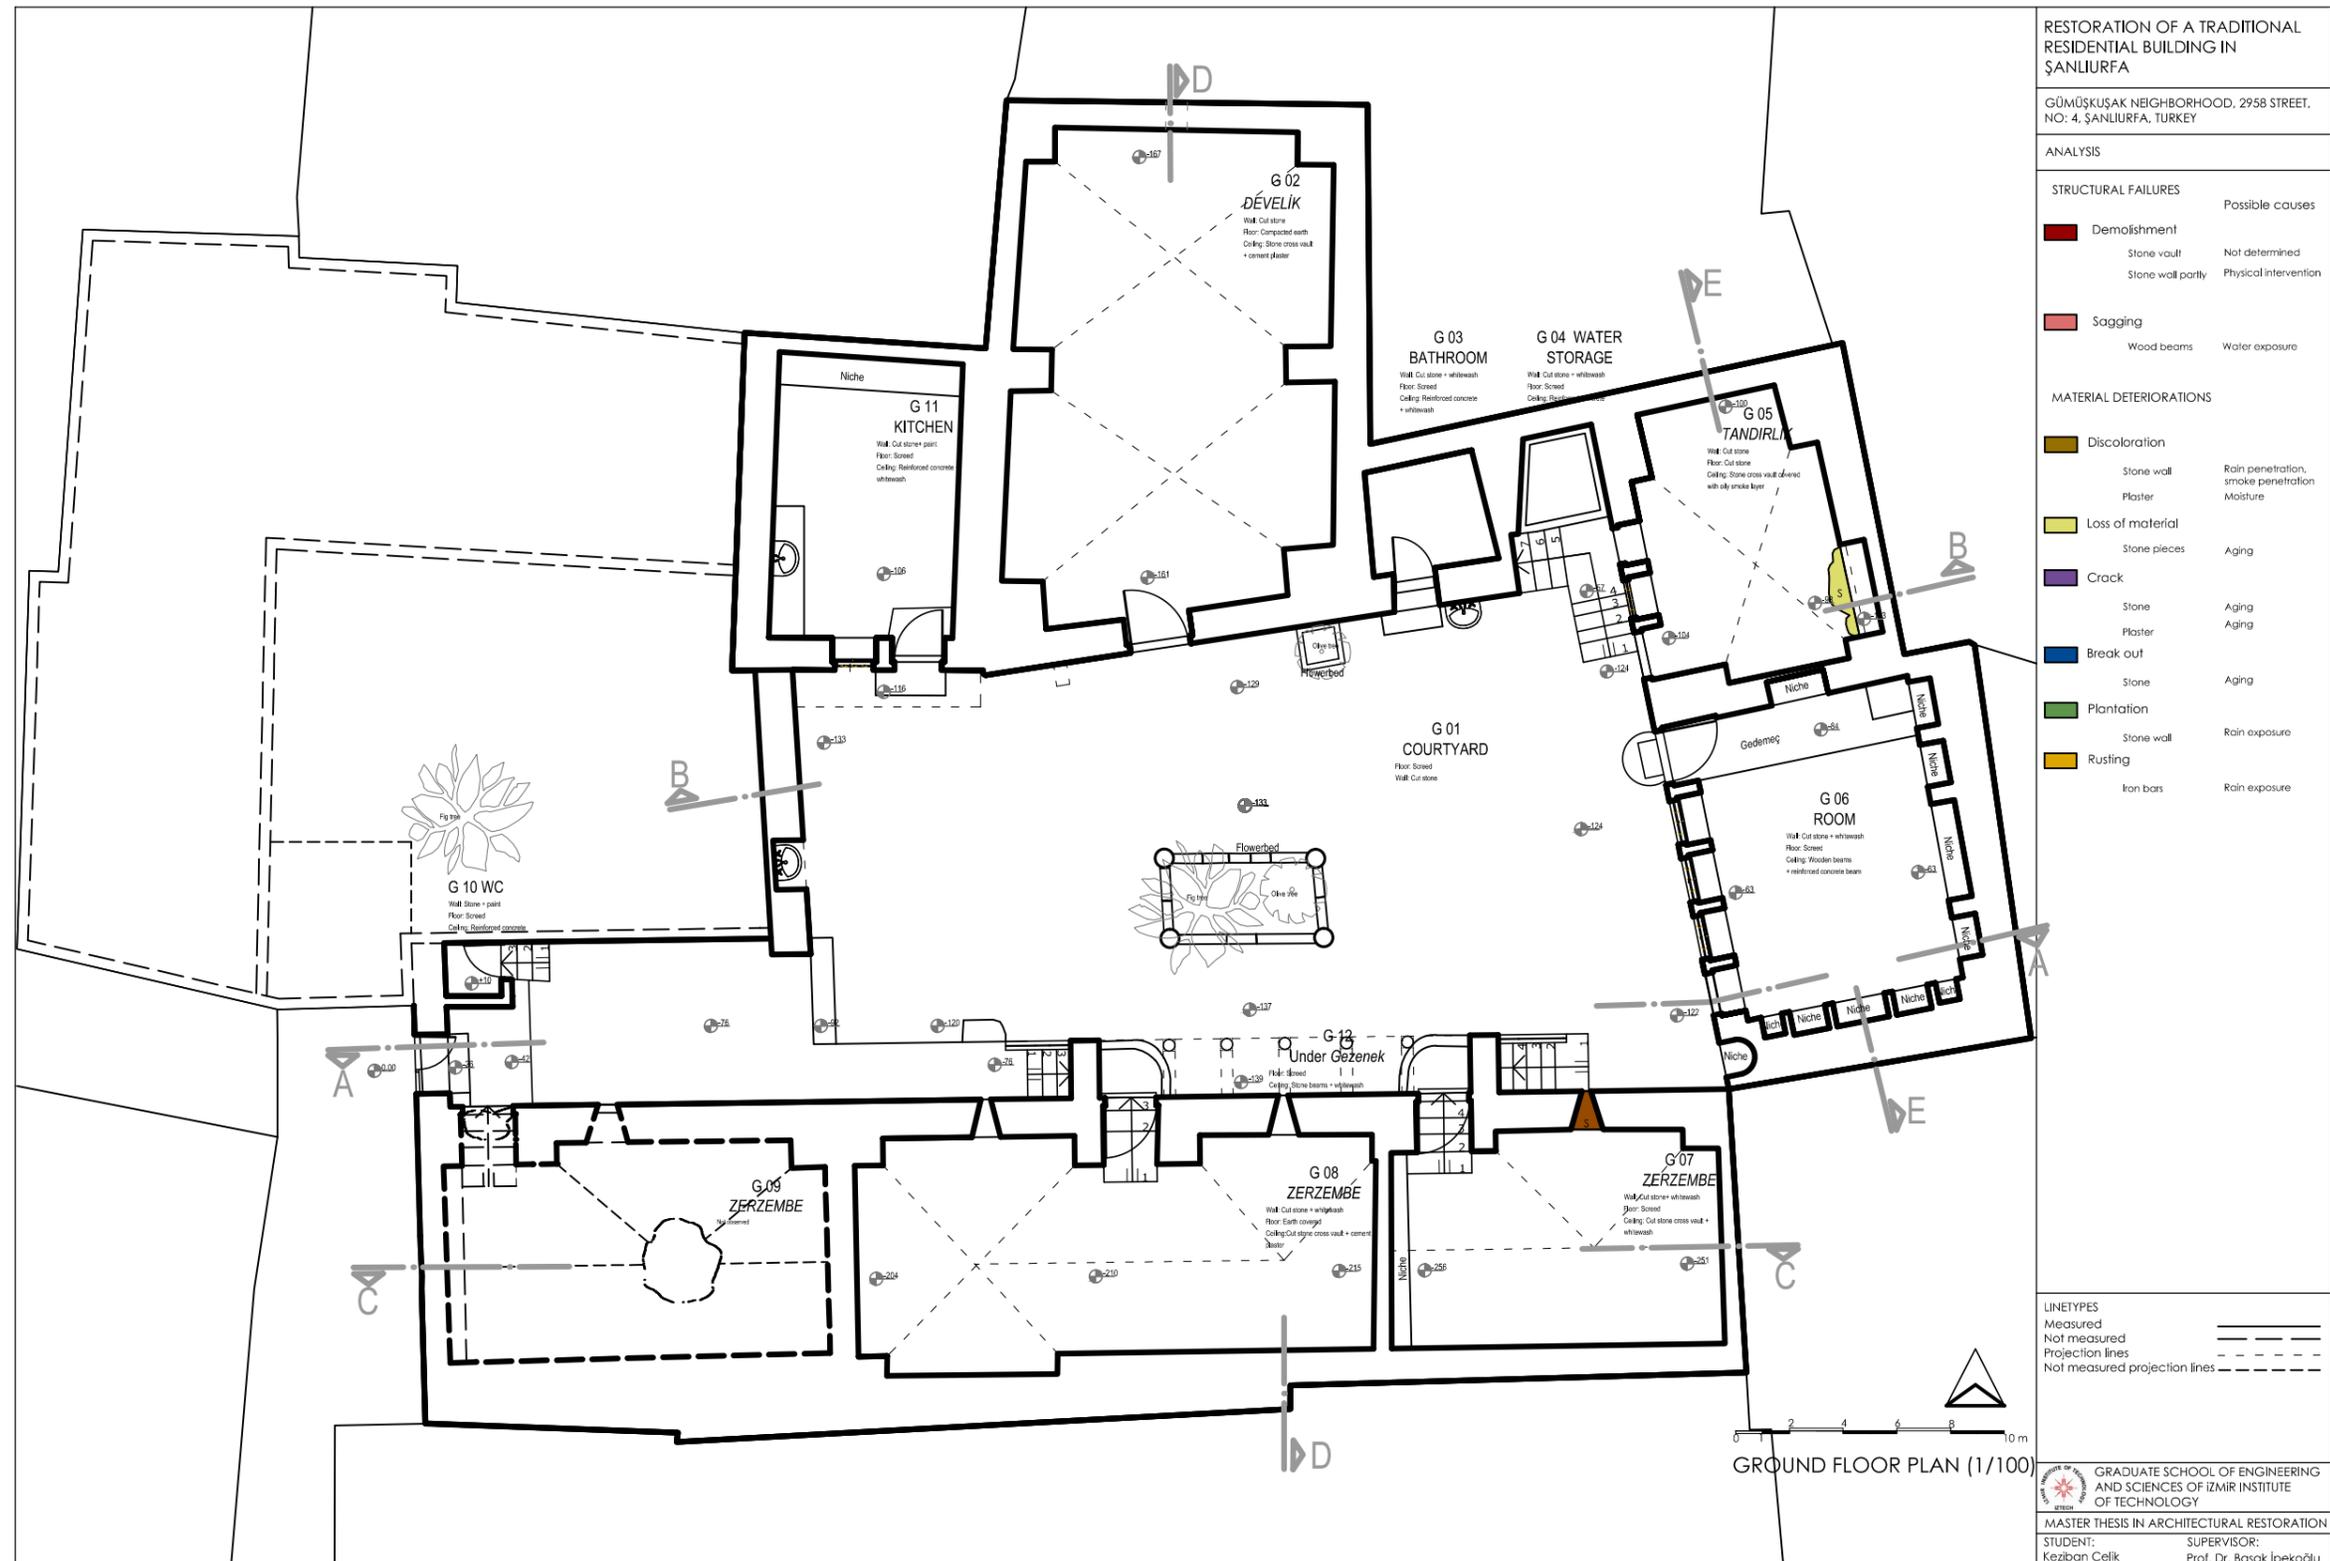
B.16. Structural failures and material deteriorations - Ground floor plan

Structural problems are loss of structural integrity with collapse of vault and walls of room in southwest first floor. In addition, sagging seen in wood ceiling system of room on southeast ground floor owing to lack of maintenance is another structural problem. Small scale material deteriorations in stone and wood material, occurred because of inappropriate use and lack of maintenance are other problems.

- Vault of room on southwest upstairs and *zerzembe* on southwest on ground floor will be reconstructed with stone material similar to original material type and dimensions. Metal profile will be added at the point where reconstruction begins to make the new material identifiable from original material. Stone material upper profile will be emphasized in the reconstructed section.
- Stair, *gezenek* and balustrade, used for access to room on the first floor in the southwest, will be reconstructed as in form and dimension suggested in restitution. Stair, *gezenek* and balustrade will be replaced using stone.
- Reinforced concrete beam added to wooden ceiling system of room in the southeast on the ground floor will be removed, beams of wooden ceiling system will be replaced.

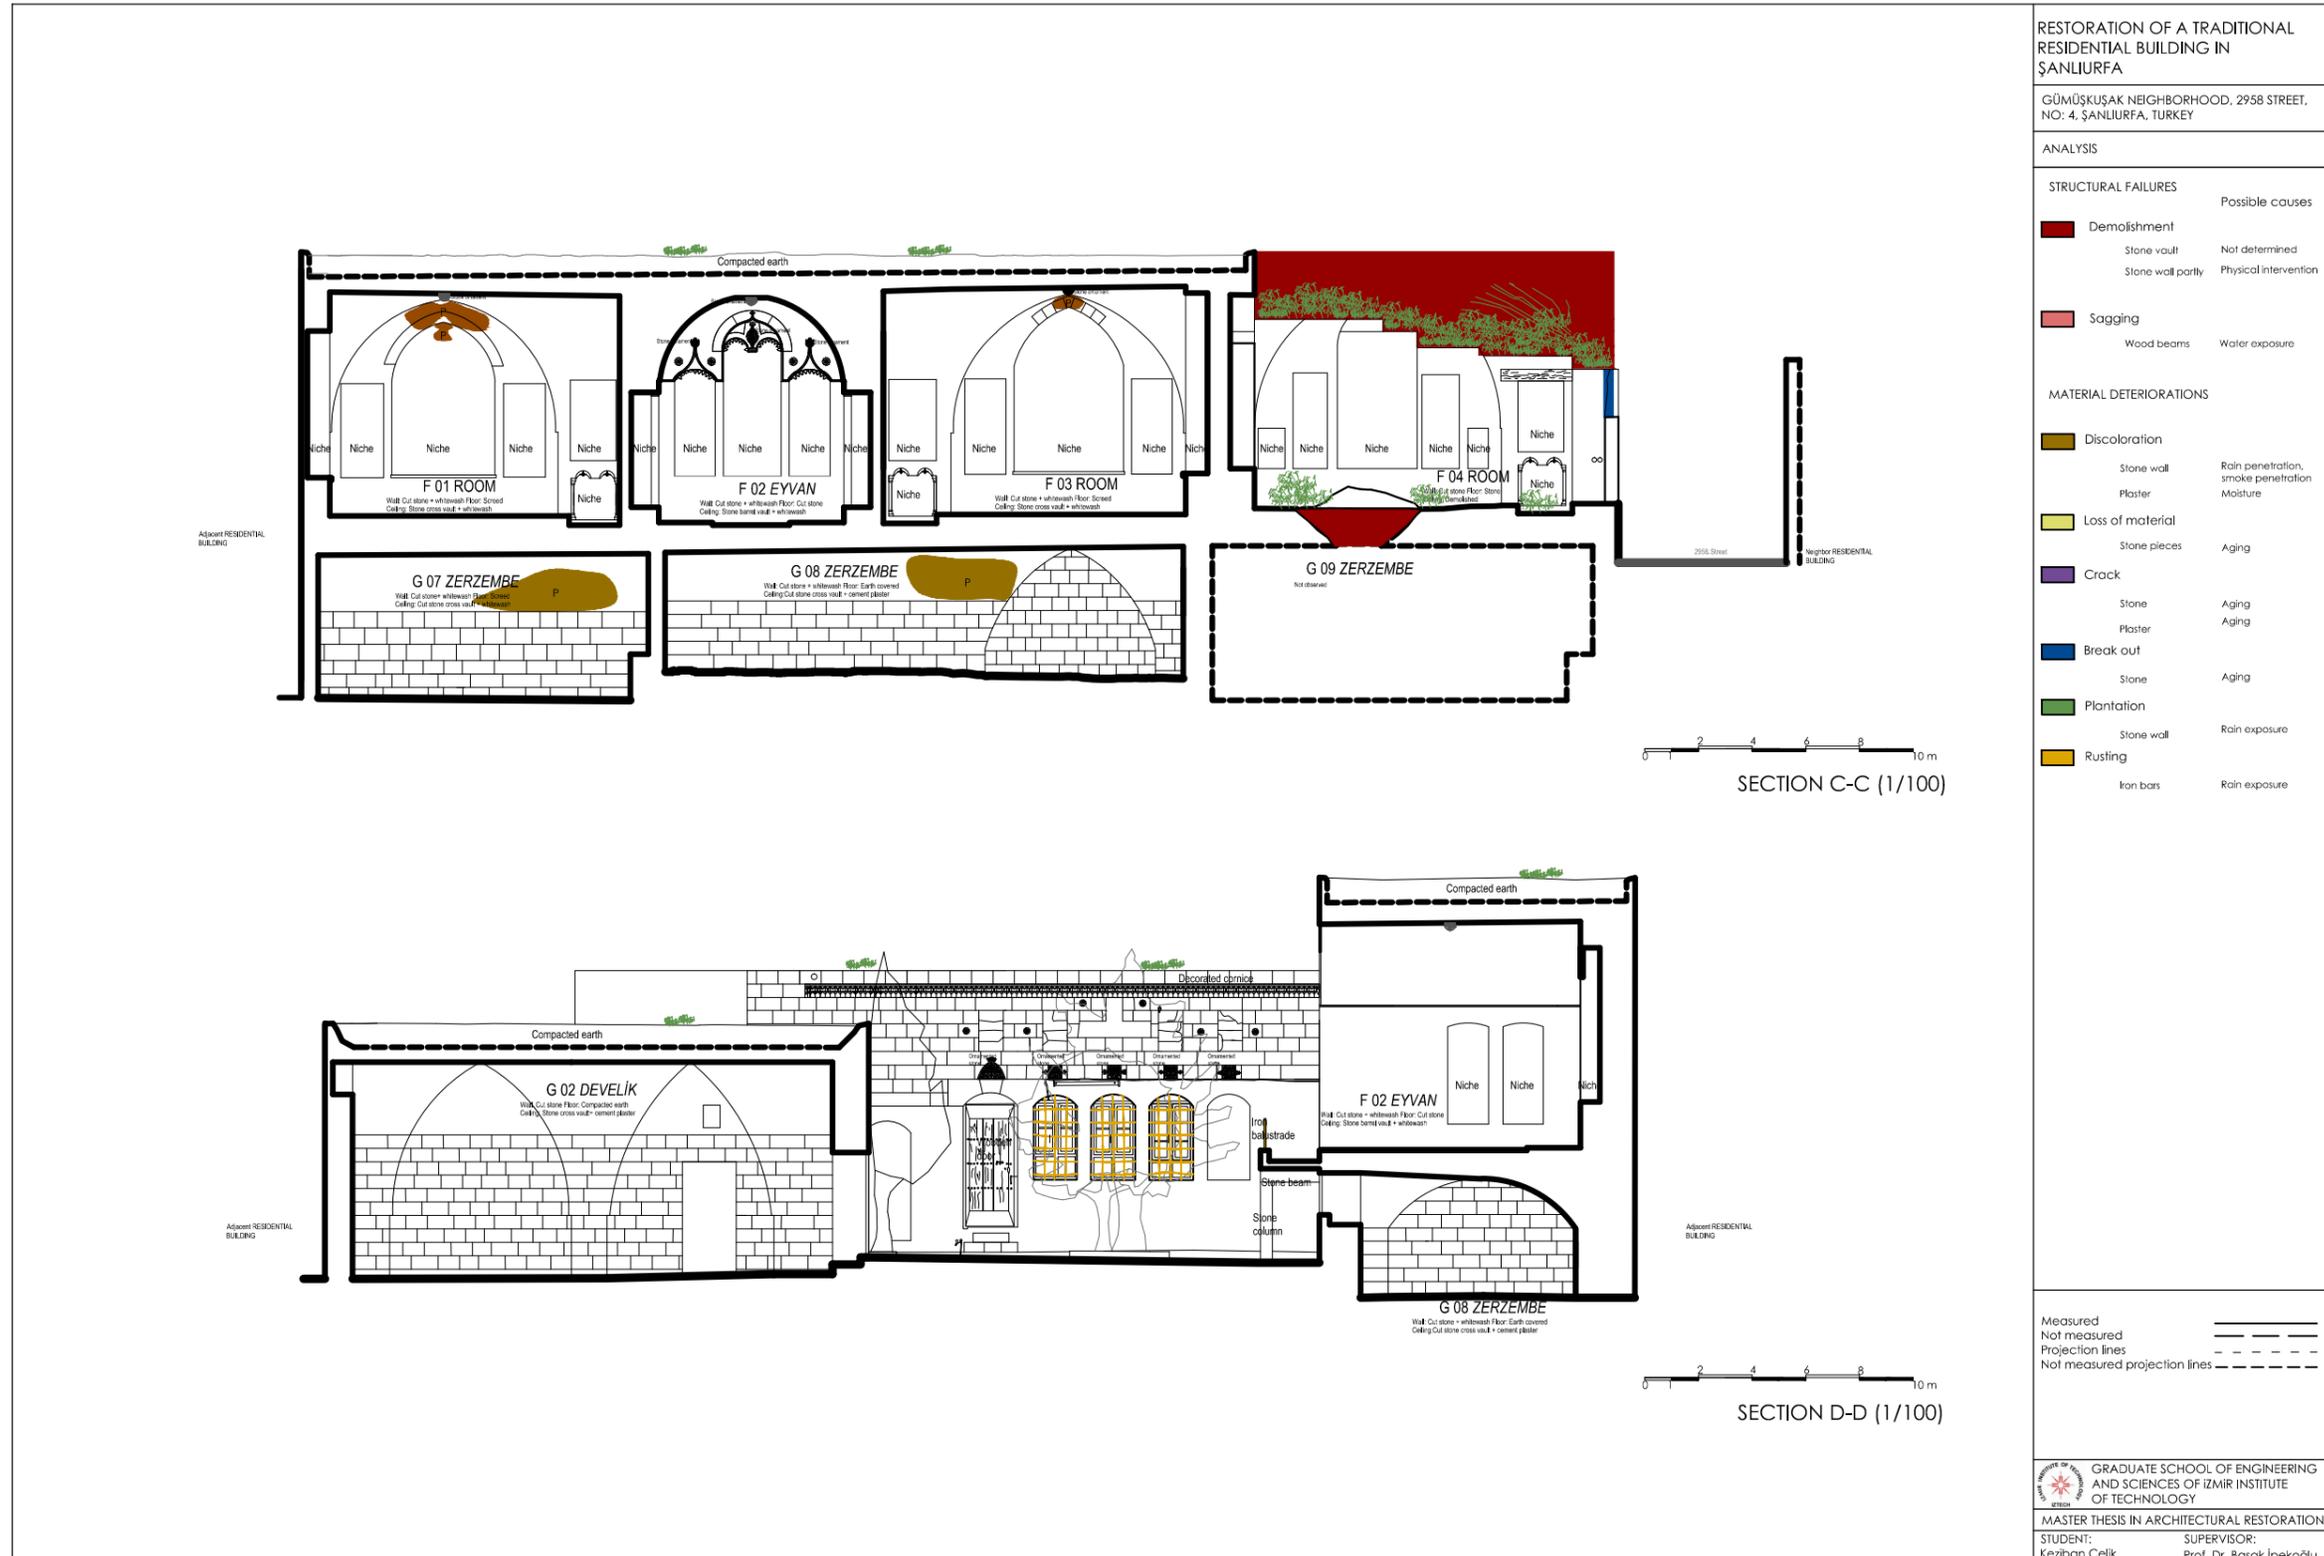
B.19. Structural failures and material deteriorations - Section C-C, Section D-D

STRUCTURAL FAILURES		Possible causes
Demolishment	Stone vault	Not determined
	Stone wall partly	Physical intervention
	Sagging	Water exposure
MATERIAL DETERIORATIONS		
Discoloration	Stone wall	Rain penetration, smoke penetration
	Plaster	Moisture
Loss of material	Stone pieces	Aging
	Crack	Stone
Plaster		Aging
Break out	Stone	Aging
	Plantation	Stone wall
Rusting		Iron bars
