**INVESTIGATION OF THE OTTOMAN PERIOD
FOUNTAINS IN İZMİR/ÇEŞME FOR THEIR
PRESERVATION**

**A Thesis Submitted to
the Graduate School of Engineering and Sciences of
İzmir Institute of Technology
in Partial Fulfillment of the Requirements for the Degree of**

in Architectural Restoration

**by
Ahmet KARAÇÖL**

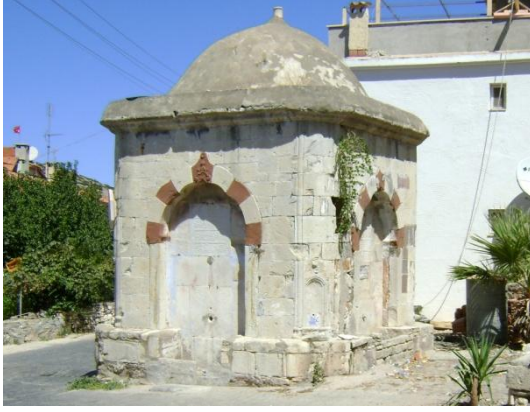
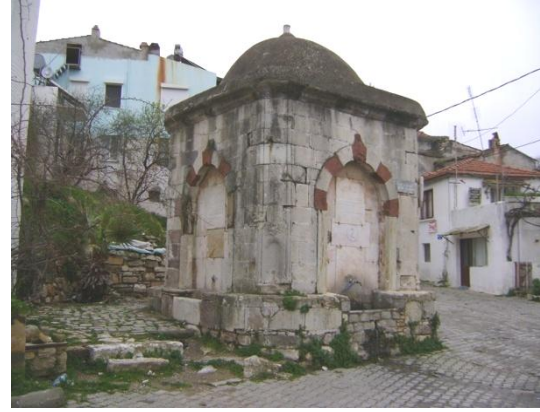
Conservation problems: Spalling on the surfaces of voussoirs in red, darkening on cut stones in white. According the records dated 1976, basins and the plaster of the dome renewed. Water collecting chamber filled with garbage due to the missing shutter blinds of maintenance window at the rear façade.

Figure 4.3. İlyaszade Fountain; a) southern and eastern façades in summer 2010, b) western and northern façades in winter

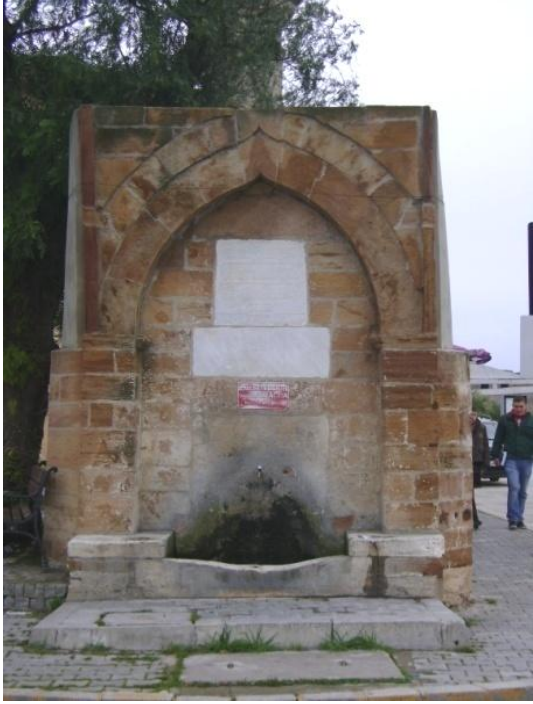
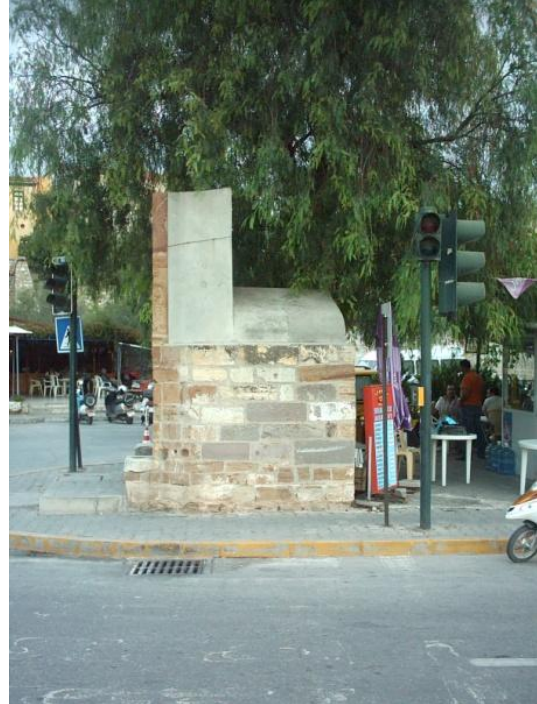
Conservation problems: Salt crystallization due to the application of cement mortar. Reduction in the length of water collecting chamber, absence of maintenance window originally existed, not constructed after transfer.

Figure 4.12. Saliha Fountain; a) front façade, b) right façade

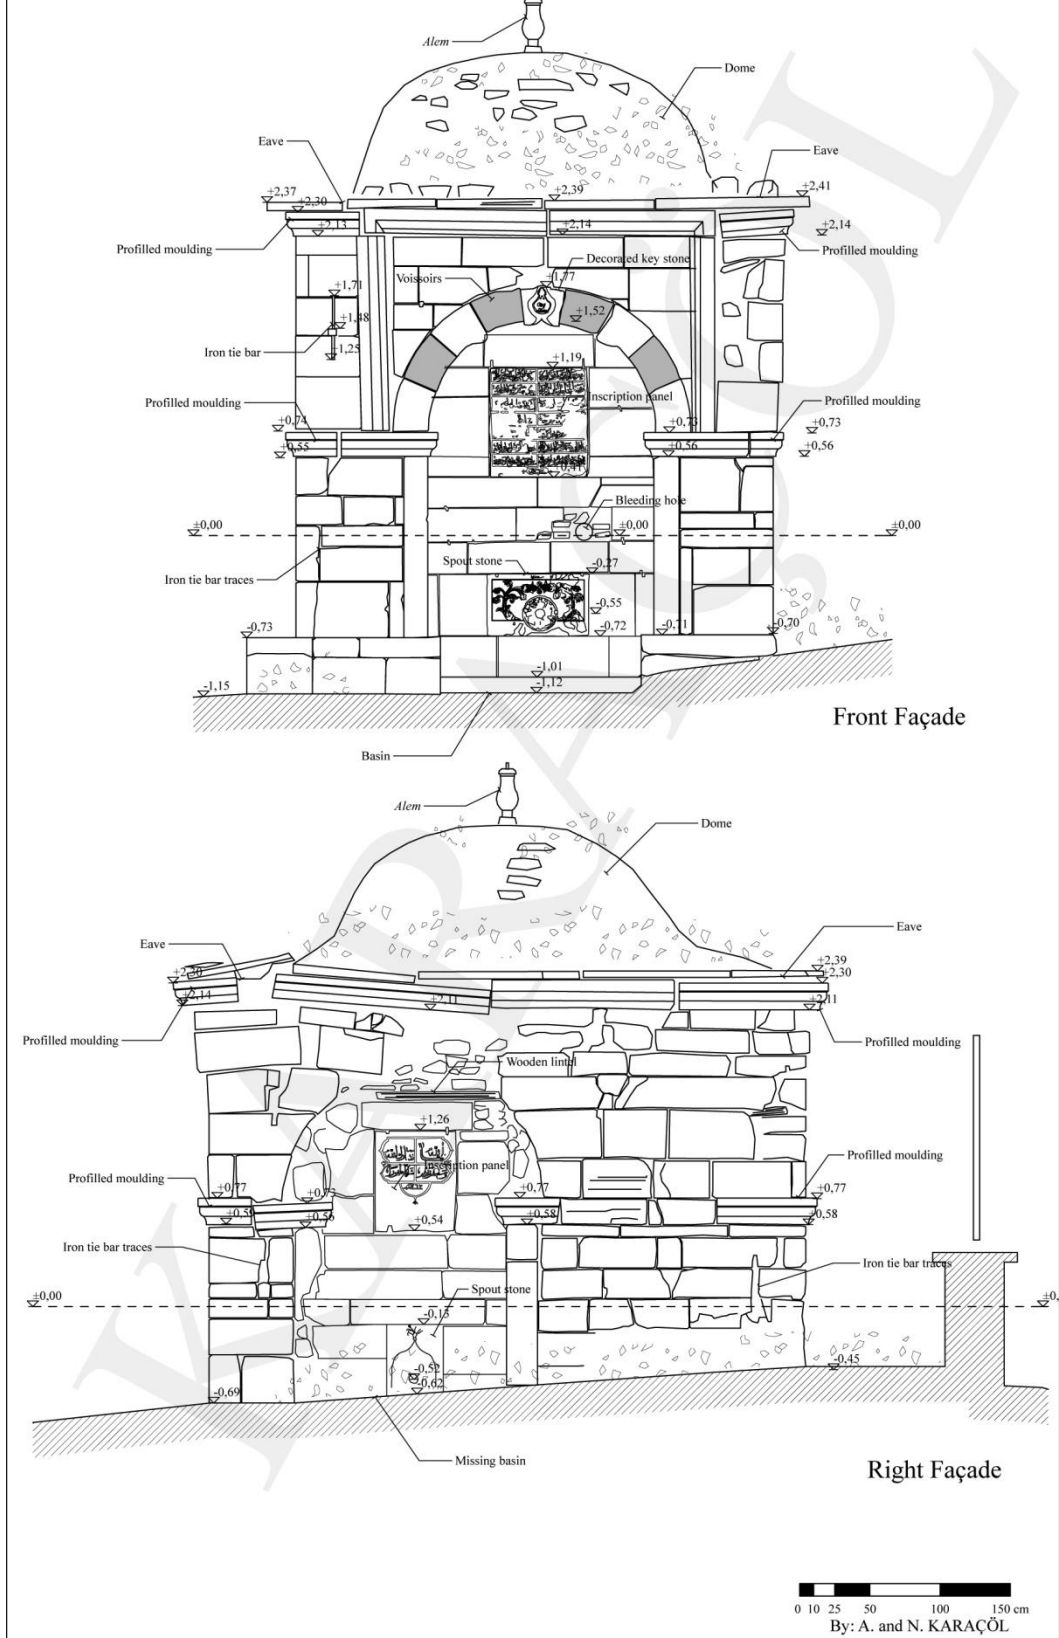
Conservation problems: Weakening in front and right façade walls due to the stolen iron bars, partial collapses at the eaves due to the missing pilaster and some of the voussoirs stones at the right façade (Figure 4.18), partial losses of plaster on the dome and plant growths in the joints of stone bonds.

Figure 4. 18. Hamaloğlu Fountain front and right façade drawings

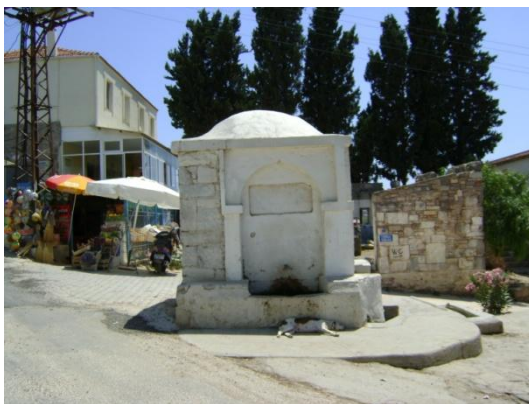
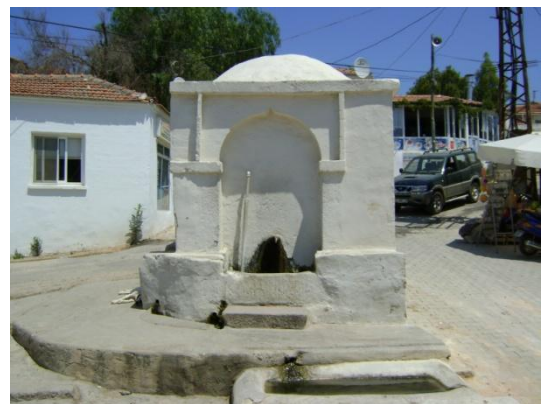
Conservation problems: Damage due to cement plaster application. Lack of land and parcel records.

Figure 4.23. Sadık Paşa Fountain, a) front façade, b) right façade

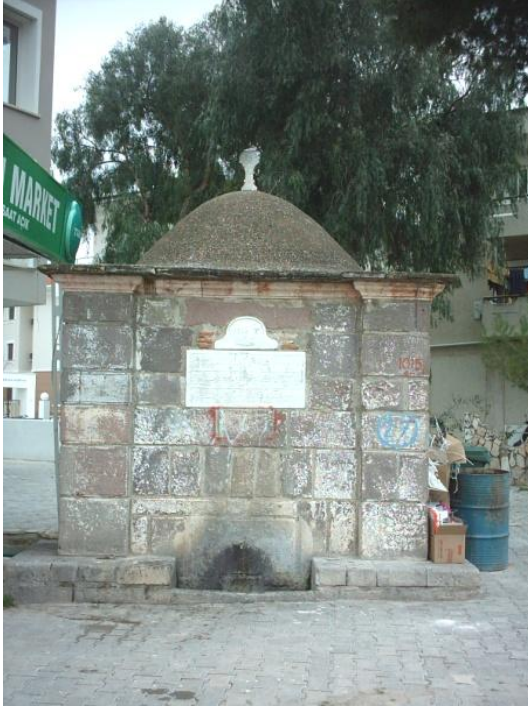
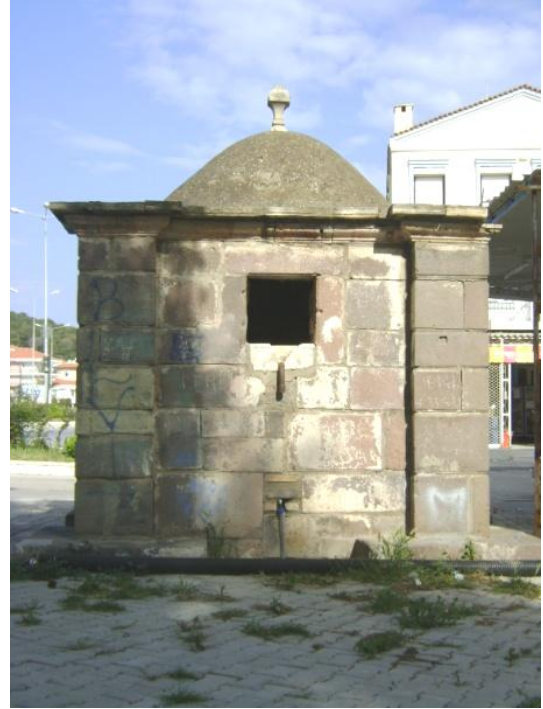
Figure 4.27. Kaymakam fountain, a) front façade, b) rear façade

Conservation problems: Ground raised with newly applied concrete parquet. Salt problems due to cement application.

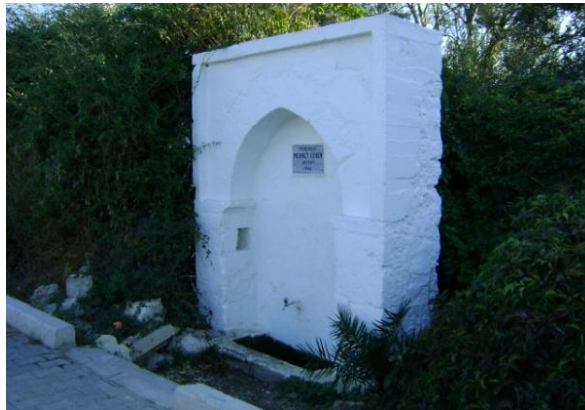
Figure 4.34. Tenekeci Fountain front and right façades

Conservation problems: Necessity of cleaning bushes, reconstruction of jug shelves.

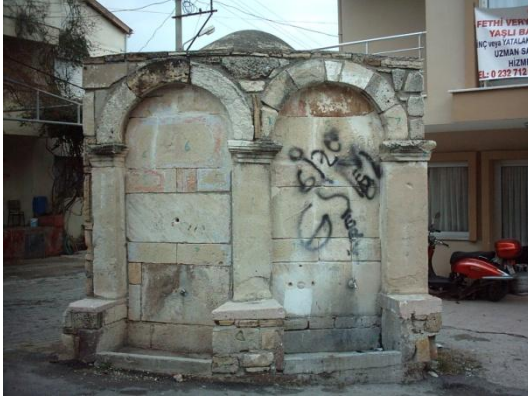
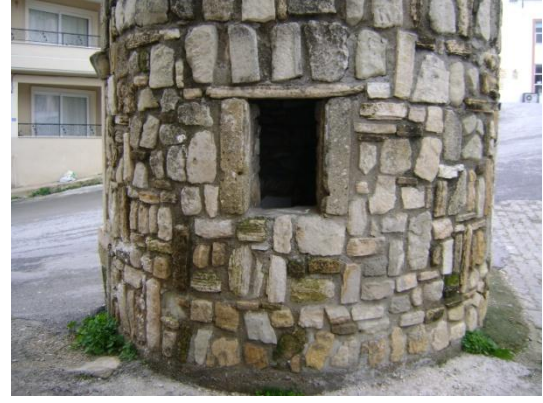
Figure 4.36. Çatal Fountain; a) front façade, b) rear façade

Conservation problems: Missing original features after transfer. Became an independent fountain misleadingly. Water collecting chamber filled with garbage, dirt done with spray paint.

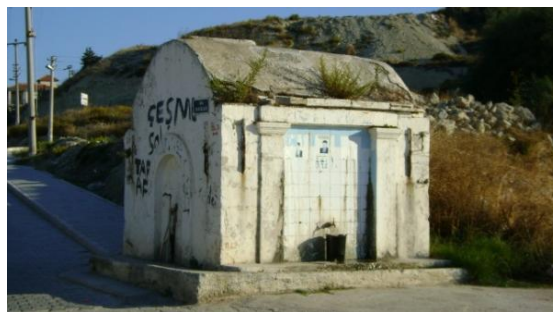
Figure 4.40. Çiftlik Fountain front façade

Conservation problems: Water collecting chamber filled with garbage, cement plaster application on the façades, screed cover in the basin.

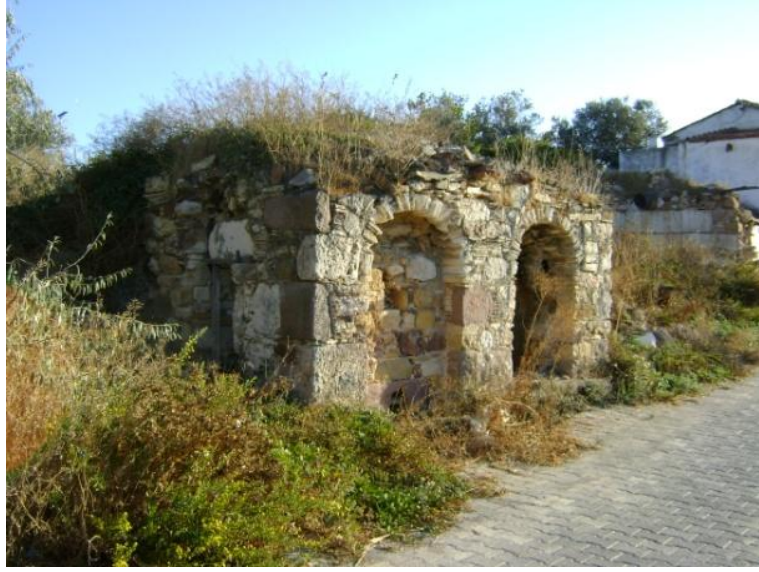
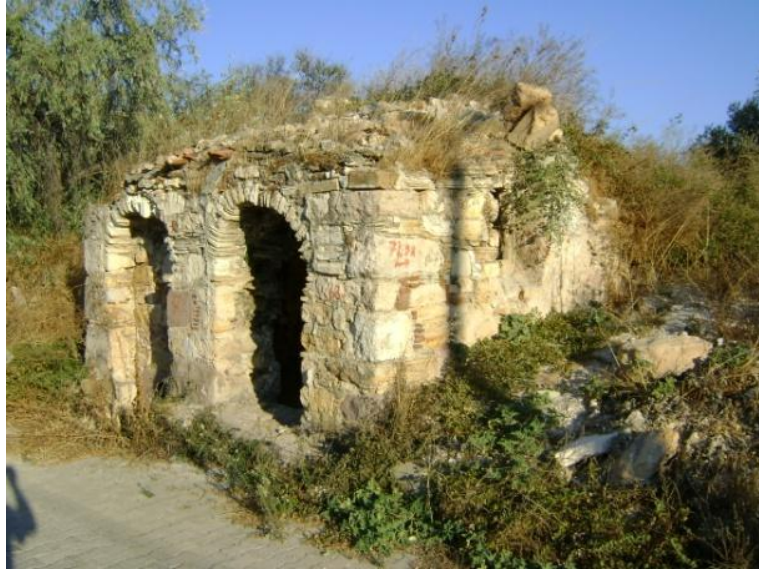
Figure 4.44. Çiftlik Çatal Fountain; a) front and left façades, b) front and right façades

Façade composition: Two niches framed with two semicircular arches side by side rested on impost stones inserted into the wall at the front façade. Inner portion of the niche in the right collapsed. A door with a stone lintel below the traces of a missing arch. Rear façade leaned against a hill.

Conservation problems: Weakening in the joints, determination of missing water supply system.

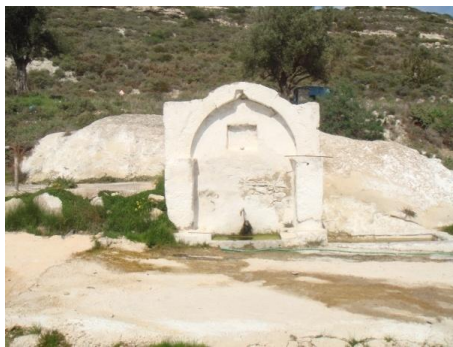
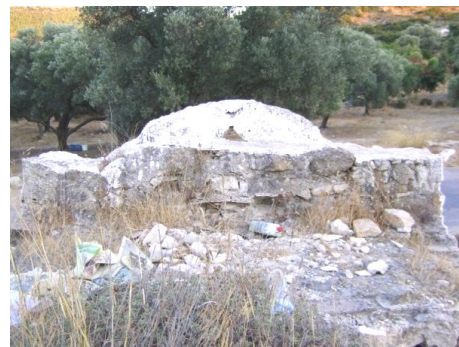
Conservation problems: Partially buried basin. Missing original spout. Replacement of original installation pipes with galvanized ones. Cement application and whitewash on the front façade. Invalidated water collecting chamber and its bleed hole. Partial collapse at left façade wall. Plant growth on the roof, *namazgâh* in the past.

Figure 4.51. Helleki Fountain; a) front façade, b) view from the *namazgâh*

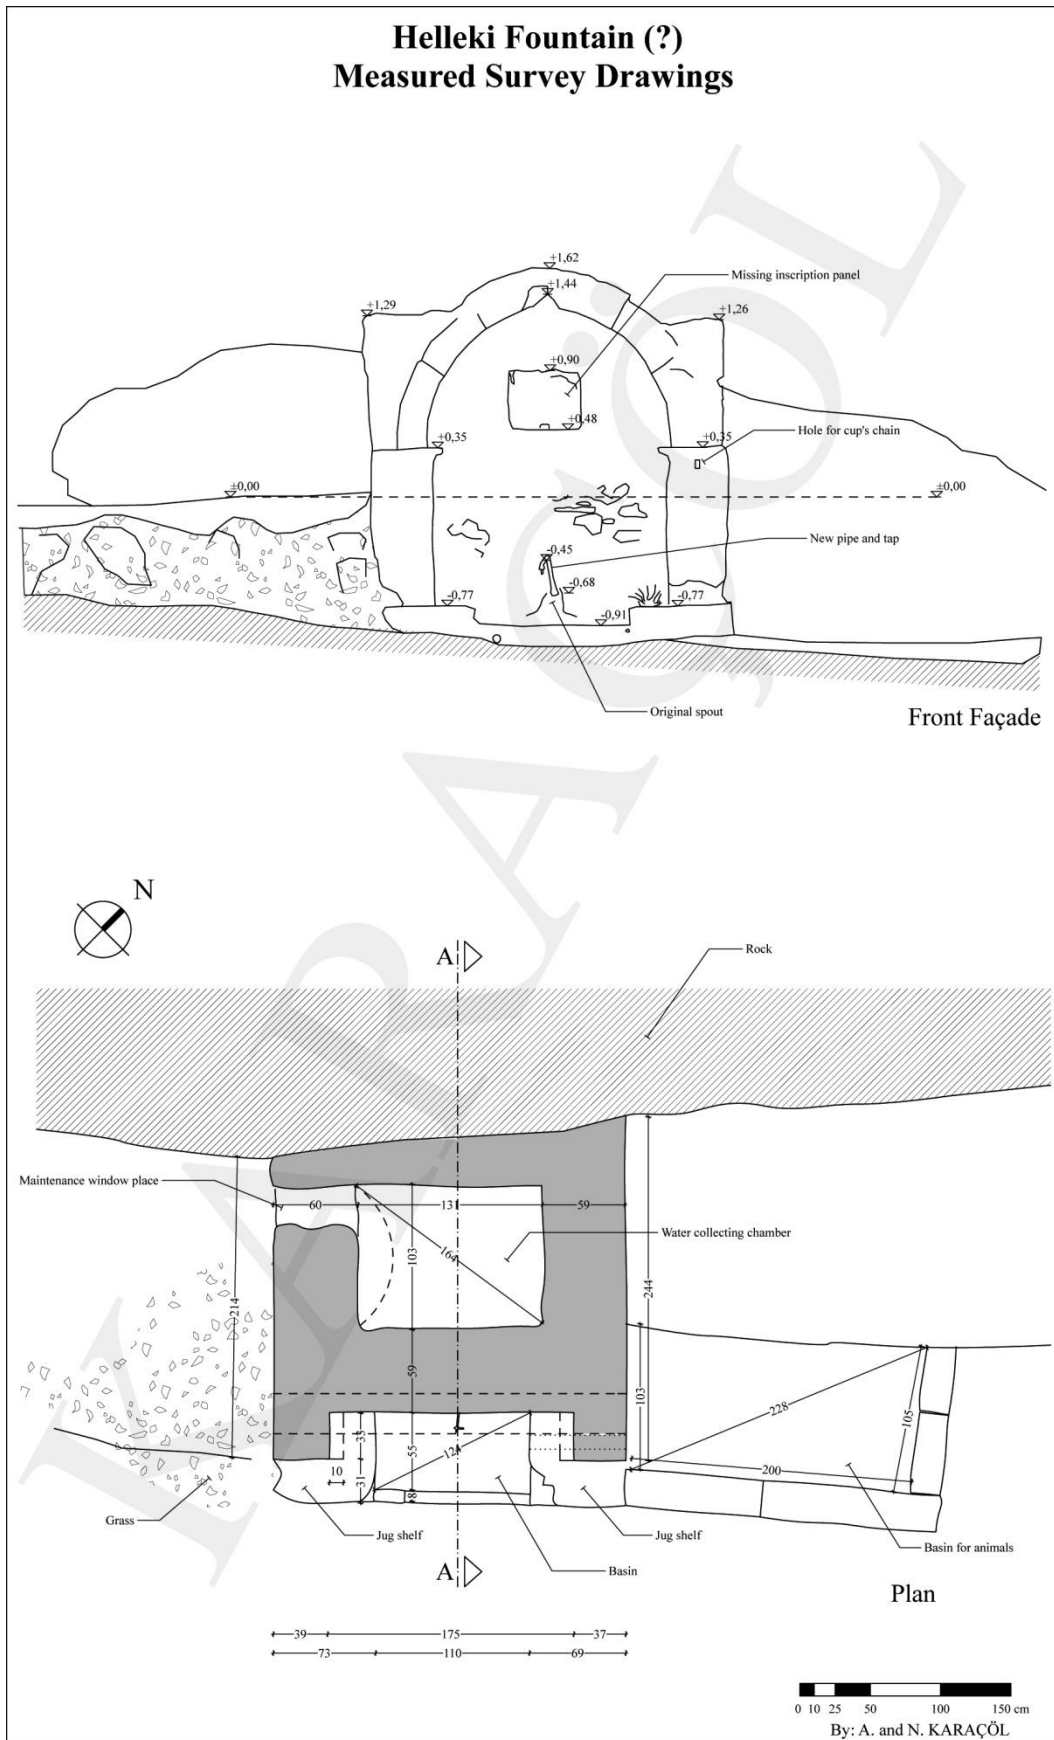
Figure 4.52. Helleki Fountain front façade and plan drawings

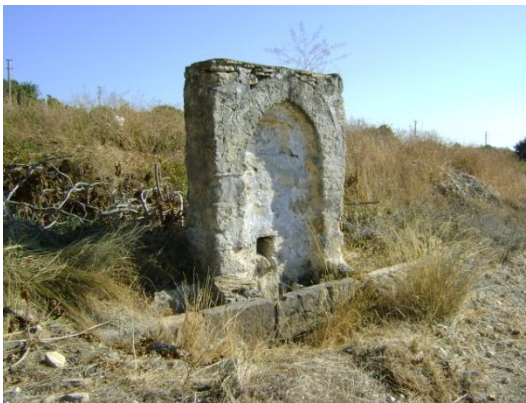
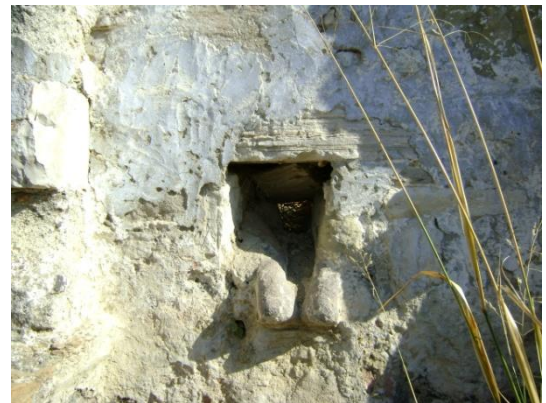
Conservation problems: Missing inscription panel, replacement of original terracotta pipes with metal pipes, application of cement pilaster and damage on jug shelves.

Figure 4.54. İki Çeşmelik Fountain; a) front façade, b) stone spout

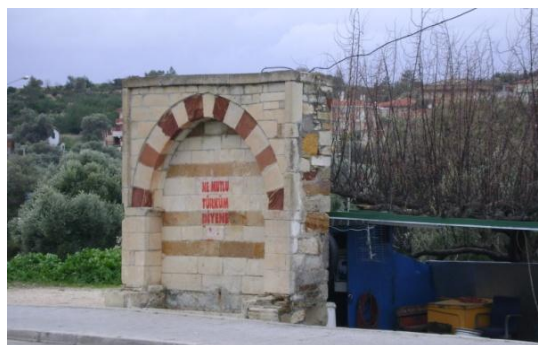
Conservation problems: Listing, reactivation, cleaning from dirt needed.

Figure 4.56. Ilıca Road Fountain front façade

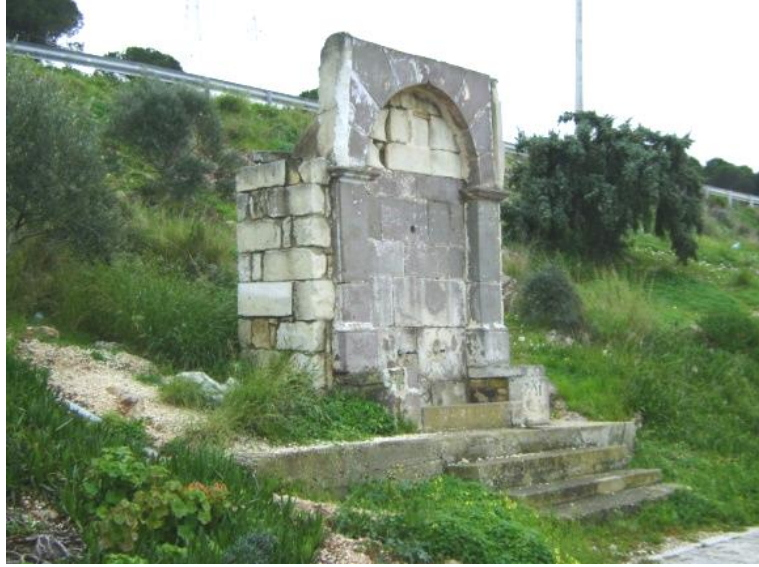
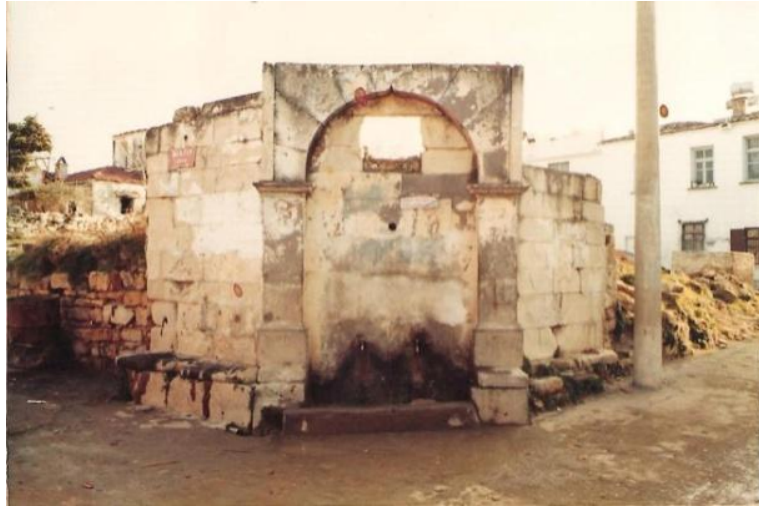
Conservation problems: Reconstruction of left and right side walls, water collecting chamber and activation needed.

Figure 4.58. İskele Fountain a) front, left side façades, b) an old photograph
(Source: İzmir Number 1 Regional Board for the Conservation of Cultural and Natural Assets)

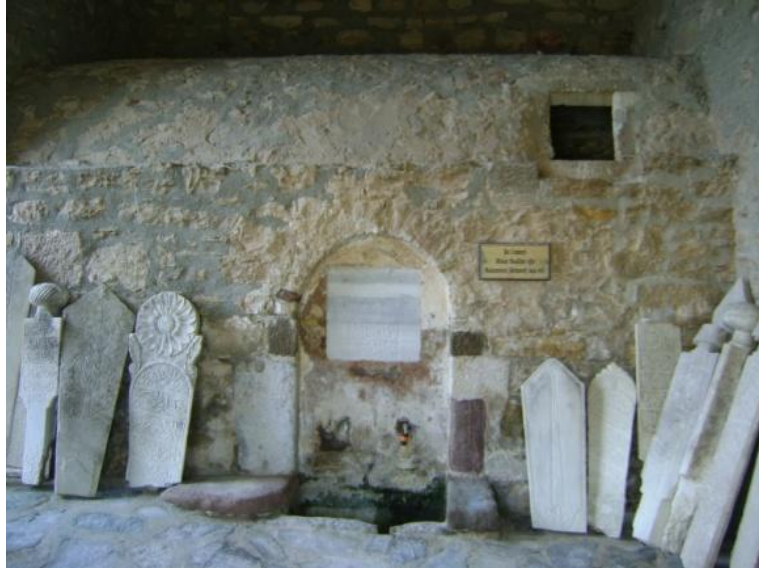
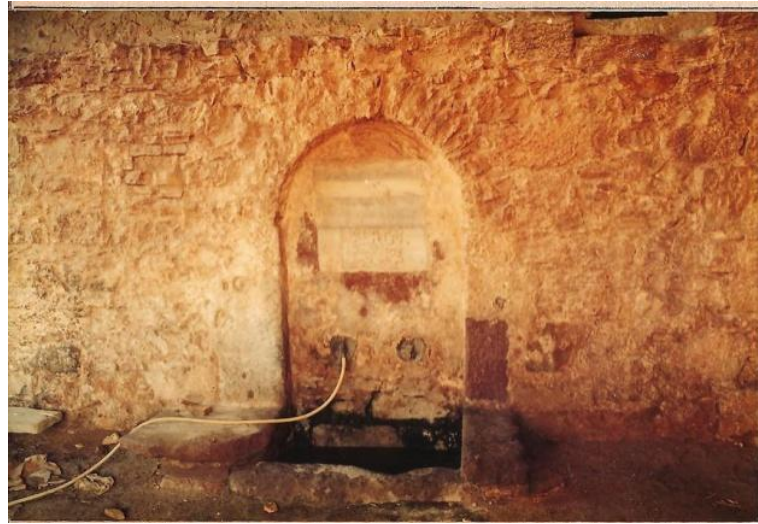
Conservation problems: Remained below the ground, necessity of placement a note stating that inscription panel belonged to and other unit in the castle, cement plaster application.

Figure 4.62. Castle Fountain; a) front façade, b) an old photograph
(Source: İzmir Number 1 Regional Board for the Conservation of Cultural and Natural Assets)

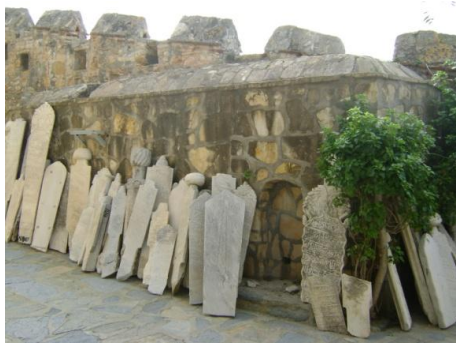
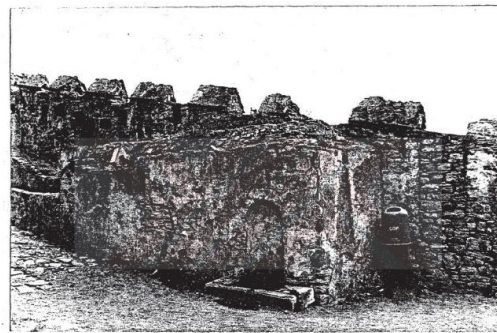
Conservation problems: Damaged caused by cement use, slate stone cover on basin.

Figure 4.65. Castle Rampart Wall Fountain; a) front façade, b) an old photograph (Source: Kayın 1988)

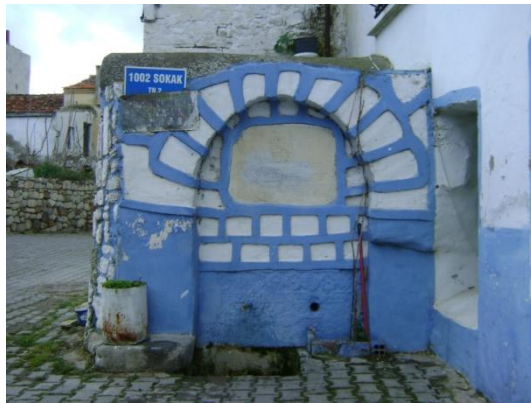
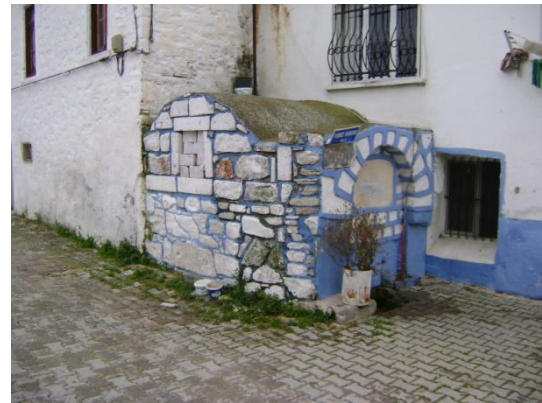
Conservation problems: Embossed cement jointing's, broken pile of the arch, cleaning the chamber.

Figure 4.67. Castle Street Fountain; a) front façade, b) front and left façades

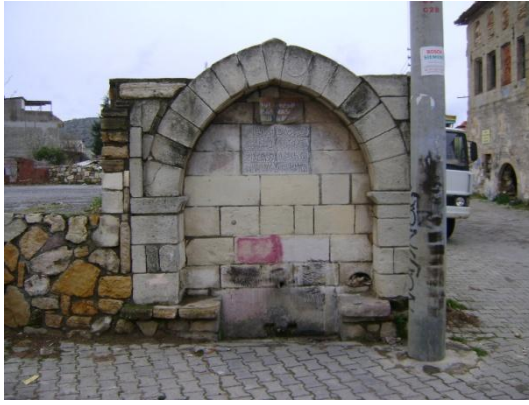
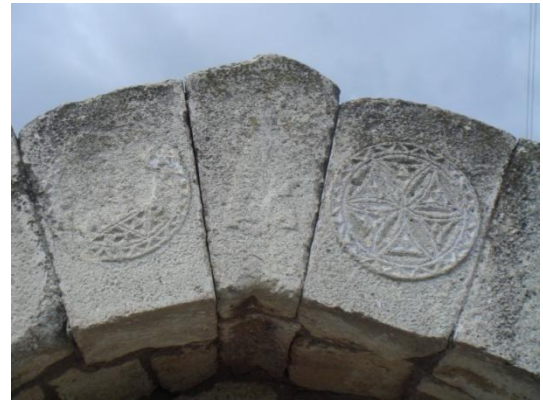
Conservation problems: Default orientation, cement used during reconstruction.

Figure 4.72. Kethüda Fountain; a) front façade, b) carved voussoirs

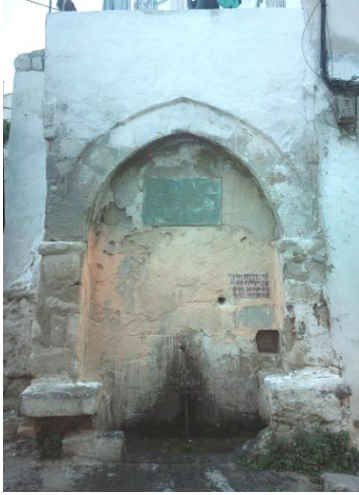
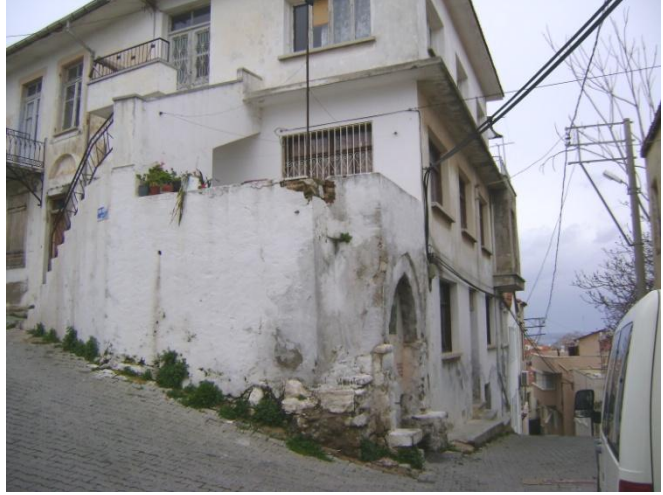
Conservation problems: Improper use due to the terrace above, excessive use of cement, spalling on stone surface.

Figure 4.75. Murabutzade Fountain; a) front façade, b) left side façade

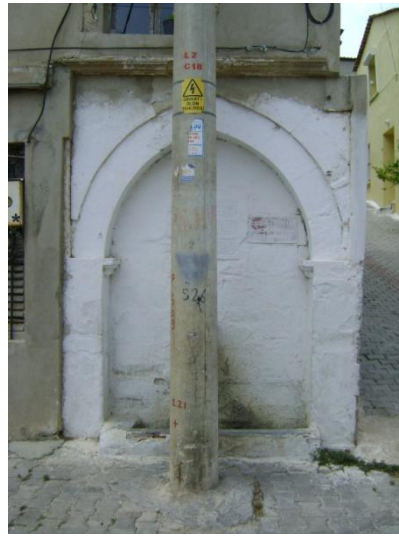
Figure 4.78. Memiş Ağa House and its fountain; a) front and right façades, b) front façade

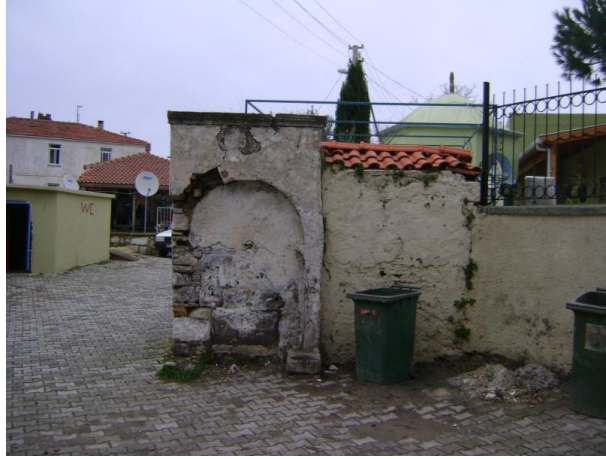
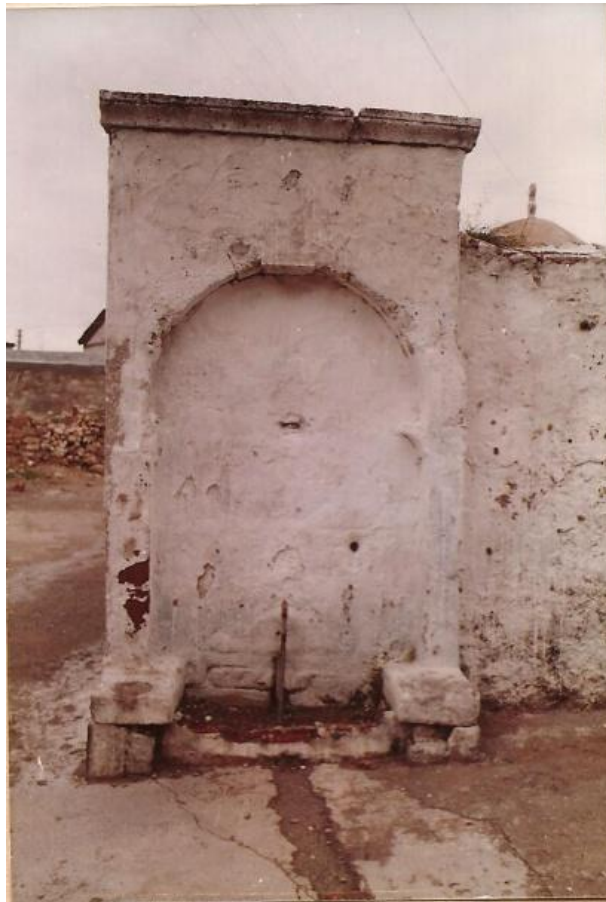
Conservation problems: Cement plaster application, missing voussoirs and pilaster in the left, basin remained below the ground level, inactive spout.

Figure 4.82. Hacı Mehmet Ağa Mosque Fountain; a) front façade, b) an old photograph
(Source: İzmir Number 1 Regional Board for the Conservation of Cultural and Natural Assets)

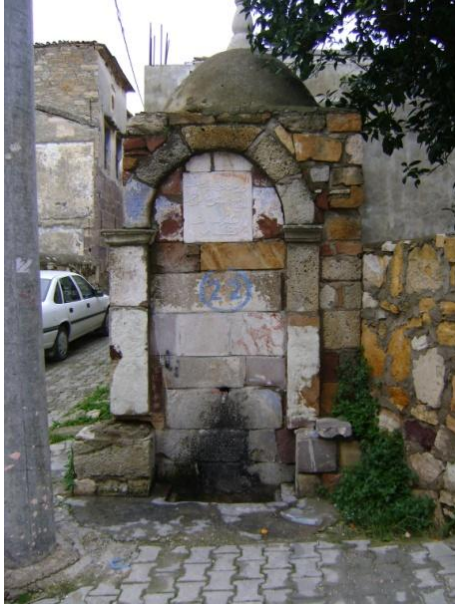
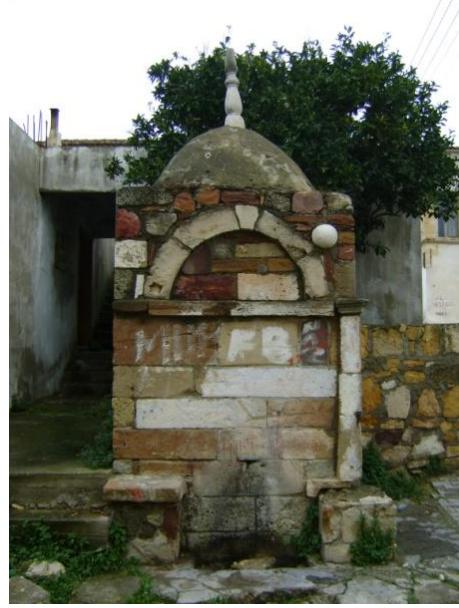
Conservation problems: Misleading feature in classification, requires transfer to former location as in the past.

Figure 4.84. Memiş Ağa Fountain; a) front façade, b) left façade

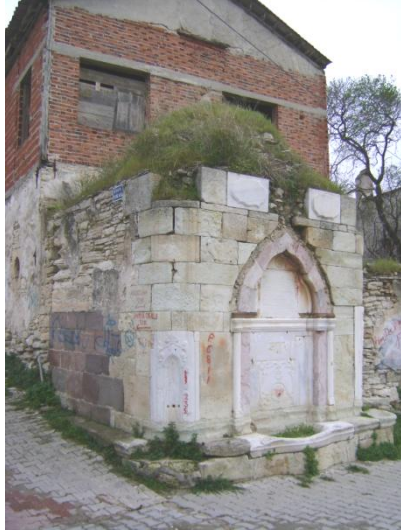
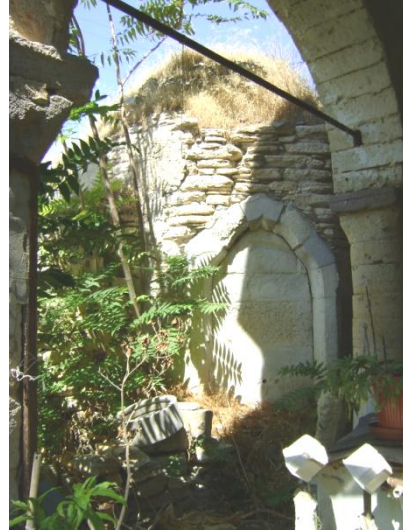
Conservation problems: Necessity of; update according to the new parcel, repair of pilasters, iron stretching bars and renewal of missing left side jug shelf.

Figure 4.87. Kabadayı Fountain; a) front façade, b) rear façade

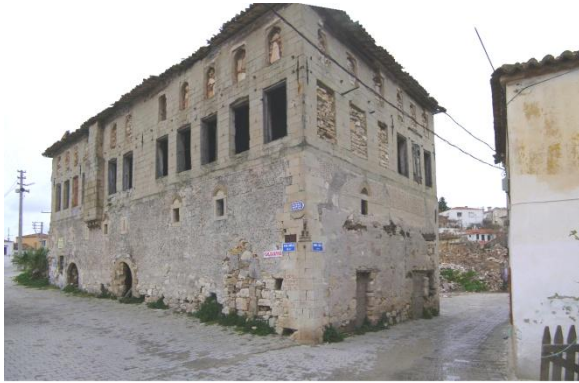
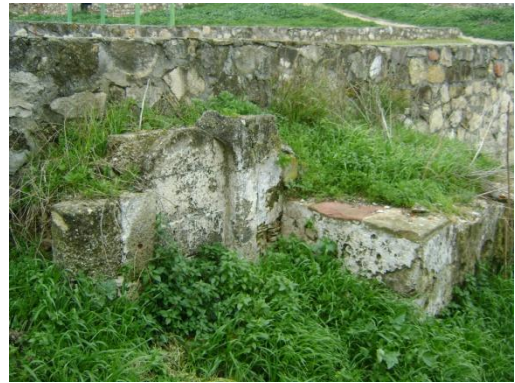
Conservation problems: Small excavation for the missing basin, replacement for missing voussoirs of the arch.

Figure 4.93. Osman Ağa House and its fountain; a) front façade of house, b) front façade of fountain

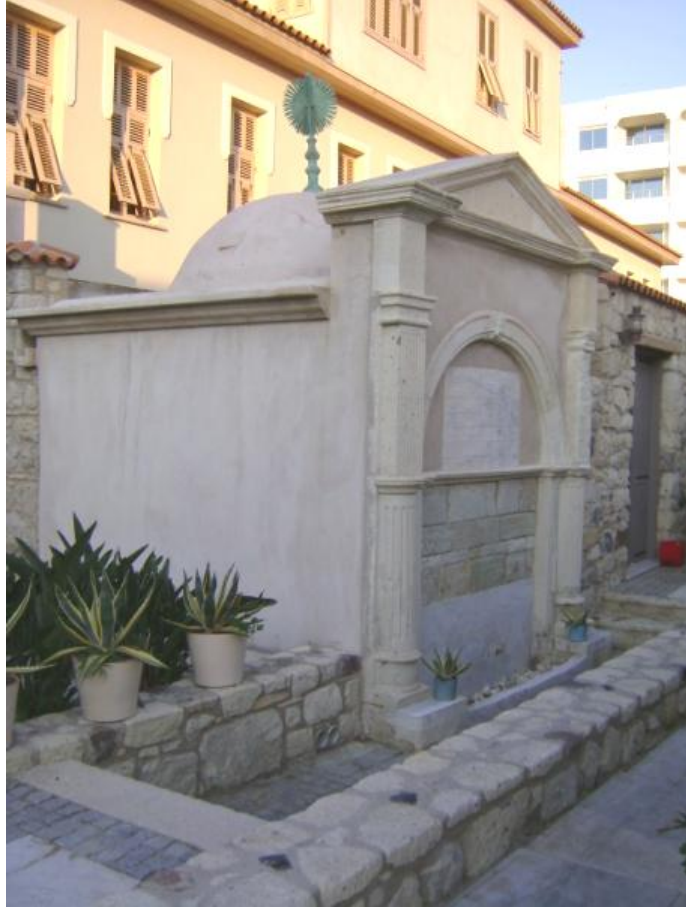
Conservation problems: Loss of original value due to excessive renewals.

Figure 4.96. Tosun Paşa Fountain front and left façades

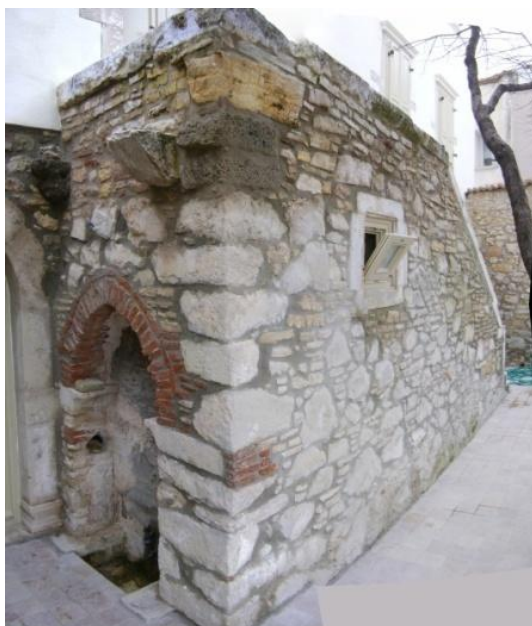
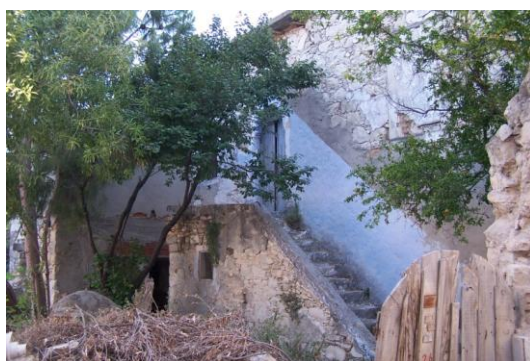
Conservation problems: Application of cement plaster in the niche, lack of louvered window provide ventilation, display of the basin remained below the ground.

Figure 4.101. 249 land 1 parcel house fountain a) front and right façades in 2010, b) right side façade in 2007

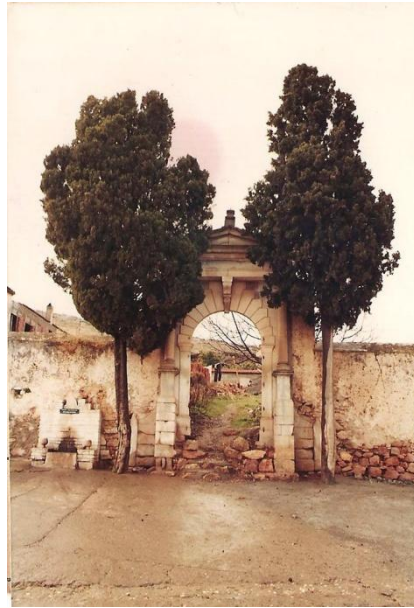
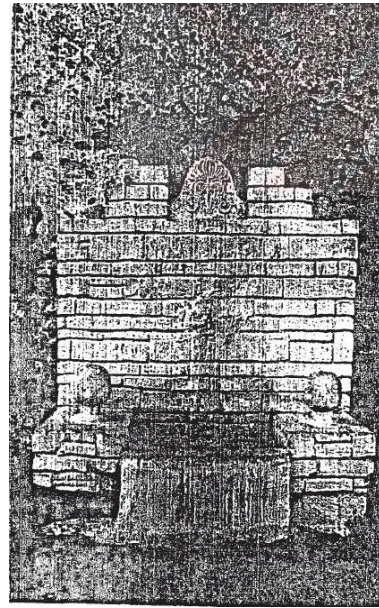
Conservation problems: All original properties and missing. Requires reconstruction according to old photograph.

Figure 4.106. Old photographs of; a) the gate of the church and the fountain (Source: İzmir Number 1 Regional Board for the Conservation of Cultural and Natural Assets), b) front façade of the fountain (Source: Kayın 1988)

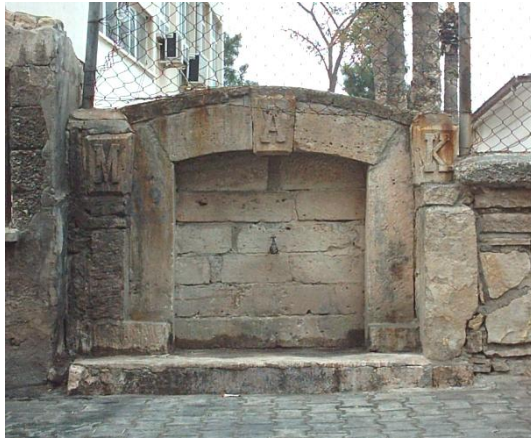
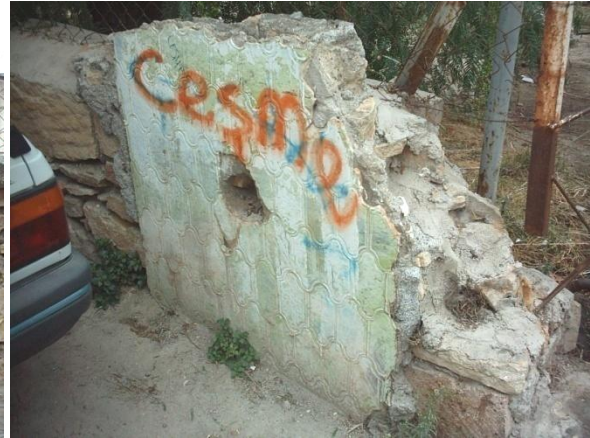
Conservation problems: Transfer to former place still available, requires listing.

Figure 4.109. Ice Fabric Fountain; a) front façade, b) the ceramic tiles exist in the former place

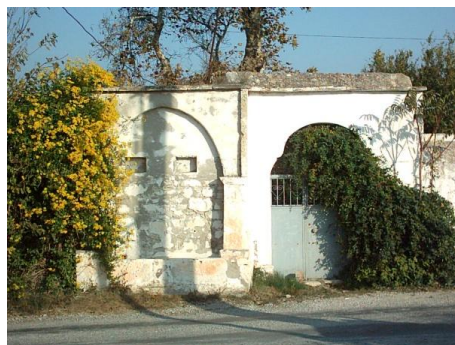
Conservation problems: Cement plaster application, in filled maintenance window. Listing required.

Figure 4.112. İmam Fountain and garden gate front façade

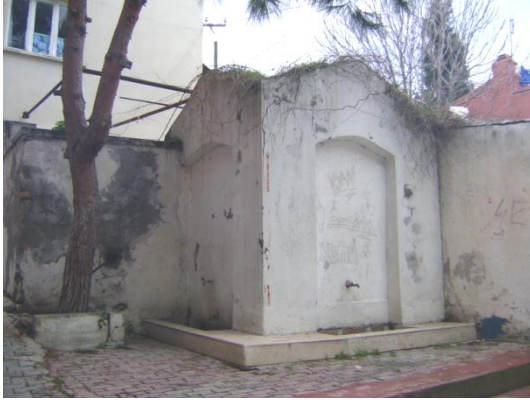
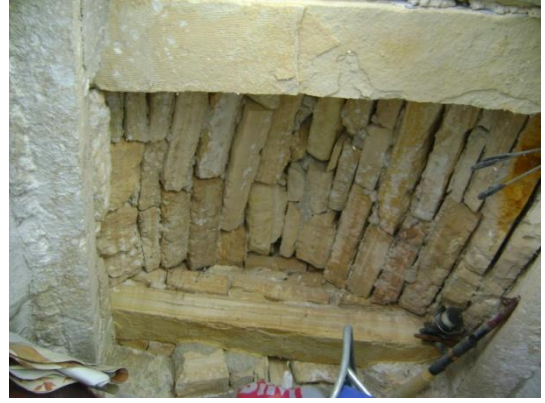
Conservation problems: Addition of a neighbor garden wall, demolished rear wall, cement application on façades, screed covering on the vault, invalidated water chamber and bleeding hole, missing original spouts and abusive graffiti on façades.

Figure 4.114. Köste Street Fountain; a) front and left façades, b) bottom view of the vault

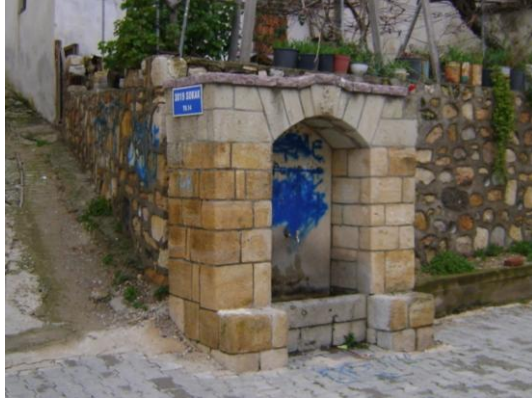
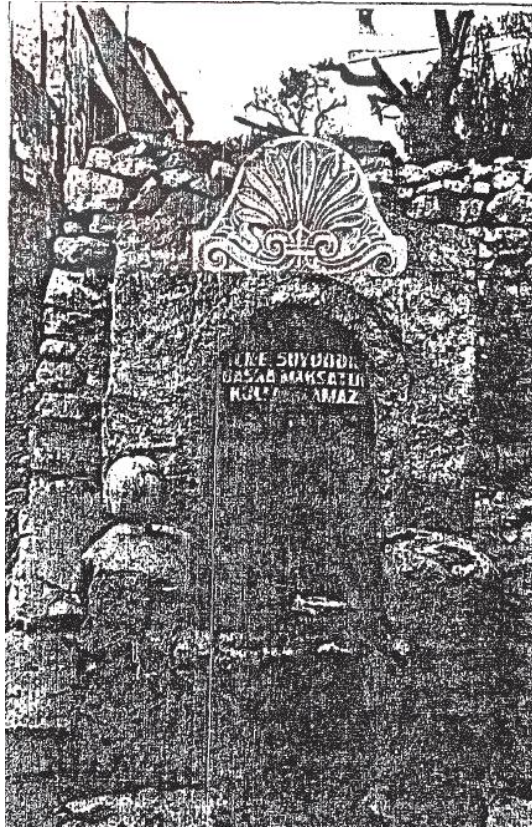
Conservation problems: Entirely changed, a plate giving information about original features needed.

Figure 4.119. Köste Street Wall Fountain; a) front façade, b) an old photograph (Source: Kayın 1988)

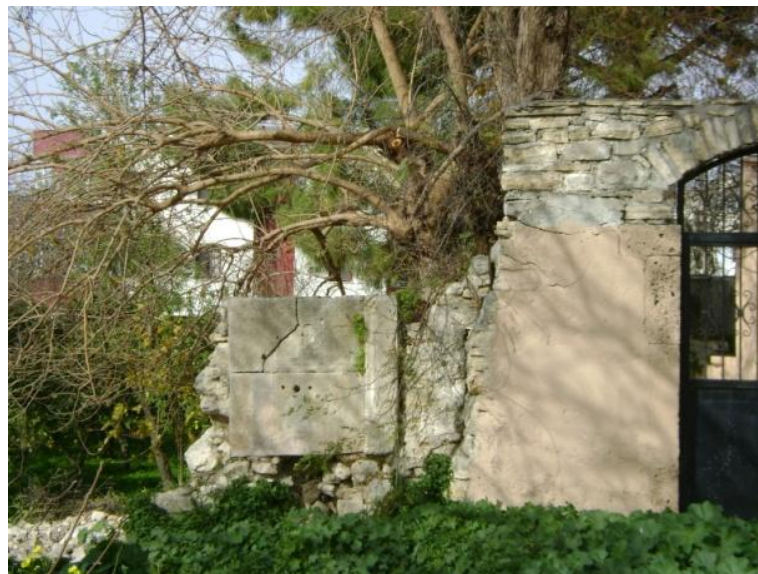
Façade composition: Except for spout stone and a part of pilaster, all parts missing (Figures 4.121-122).

Conservation problems: Transferred to original location.

Figure 4.121. Reşid Ağa Fountain front façade

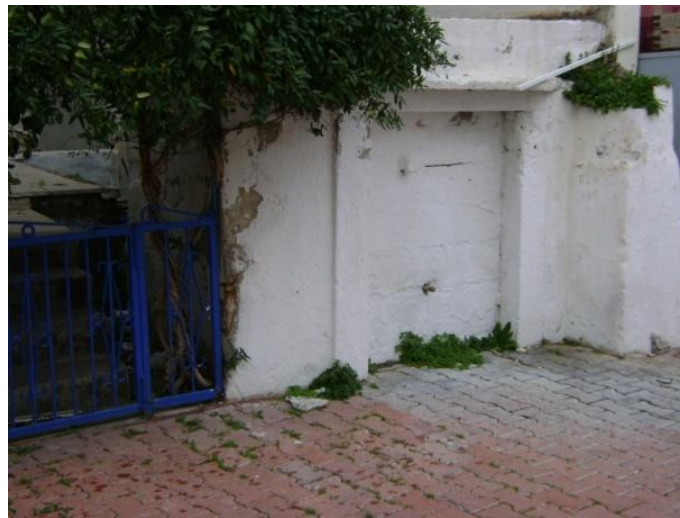
Conservation problems: Reinforced concrete slab and cement plaster application, missing basin and jug shelves remain under existing ground.

Figure 4.123. Şeyh Ziya Fountain front façade

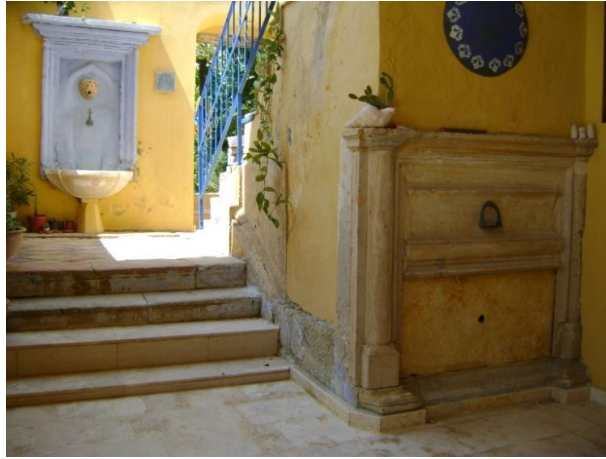
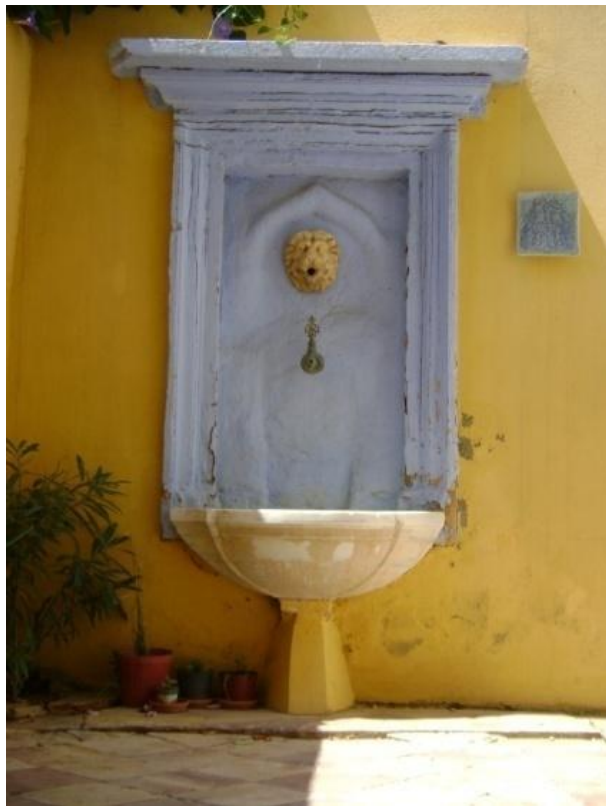
Conservation problems: Cement plaster and thick layers of acrylic based whitewashed application.

Figure 4.125. Tekke Fountain; a) the entrance hall of Müftü Street Numbered 2 House (previously used as *tekke*), b) front façade

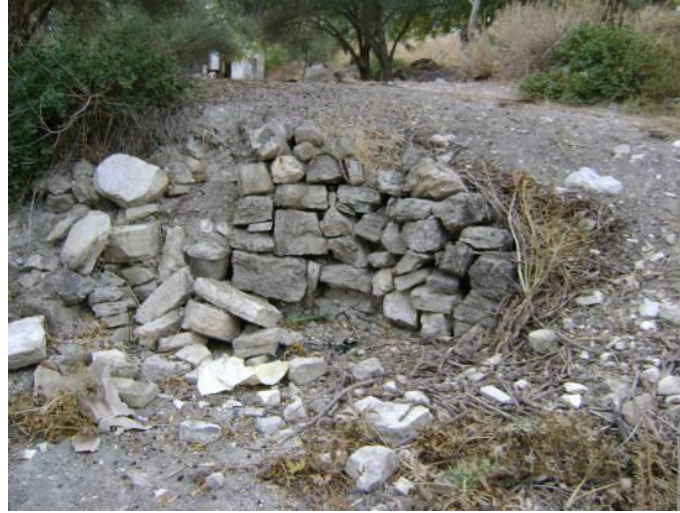
It is informed that a *hamam* and three fountains were built in the area following the capture of Anatolia by the Turks. When the area was left by the people, only a fountain survived after plundering. There is no more information about the fountain (Figures 4.2, 4.130) (Saatli 2009).

Figure 4.130. Location of Çeşmeköy Fountain and its remnants

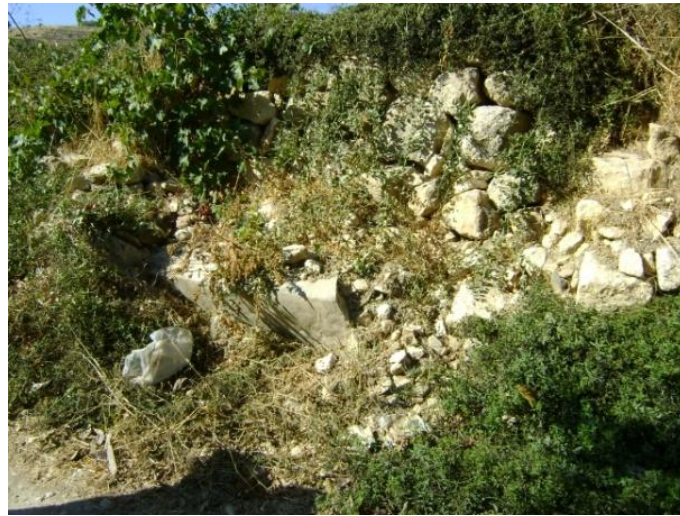
The stones of this fountain, which was located at Manastır area of Ovacık Village and built against a hill, were stolen recently. A well, situated at the distance of 200 m to the west of the hill, which was used to supply water for a monastery (missing today) and the fountain respectively, has been widened, deepened and used with irrigation purpose at present (Kaya 2009) (Figures 4.2, 4.132).

Figure 4.132. Manastır Fountain, the location and the remnants
