**EVALUATION OF INTERVENTIONS
IN WESTERN STOA OF AGORA
IN İZMİR**

**A Thesis Submitted to
the Graduate School of Engineering and Sciences of
İzmir Institute of Technology
in Partial Fullfilment of the Requirements for the Degree of**

in Architectural Restoration

**by
Necmiye Funda YAKA**

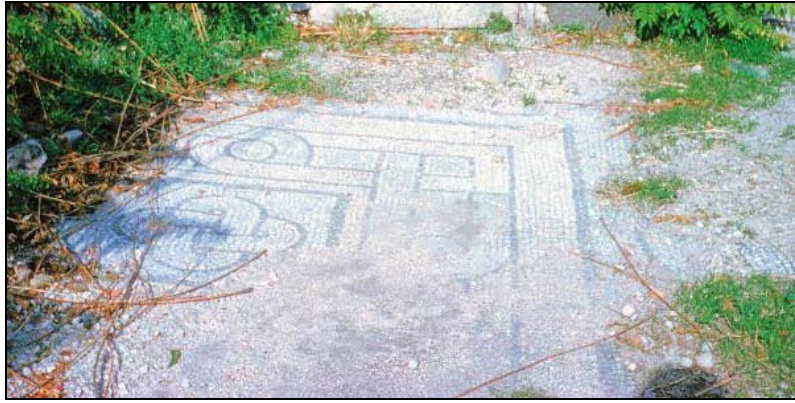
The mosaic hall found and documented in the 1940s was left uncovered. It was still present in 1969 however, is completely destroyed today, except for some parts which were left unexcavated (Figure 3.46, Figure 3.47, Figure 3.42)

Figure 3.46. A photo of the “Mosaic Hall” taken in December 1961.
(Source: WEB_23 2006)

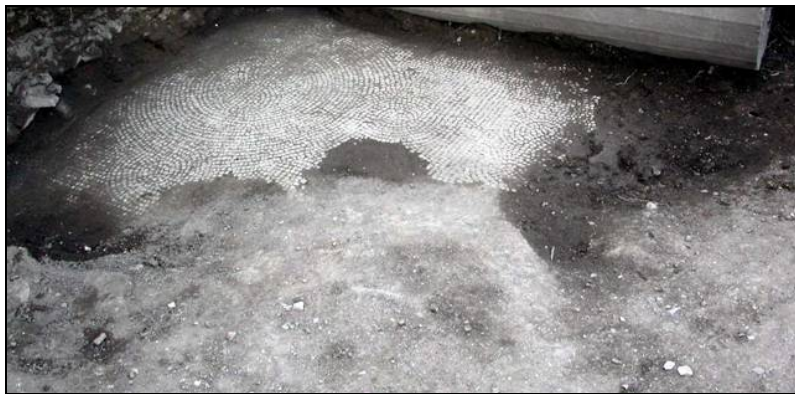
Figure 3.47. The remains of mosaics in 2005.

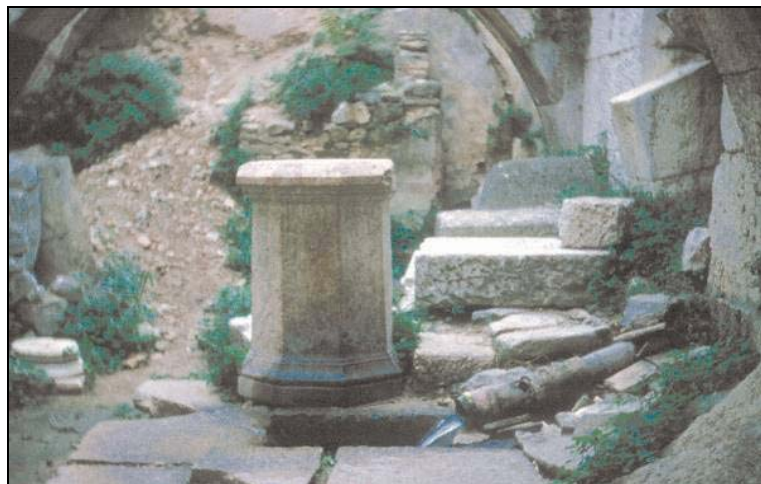
In the second place, an altar found in the northwest basement gallery that was left exposed to weathering does not exist today. Built with rubble stone masonry, plastered and painted with plant and animal figures, the altar collapsed after some years. Many photos taken by visitors of the site reveal the phases of the destruction of the monument (Figure 3.48, Figure 3.49, Figure 3.16).

Figure 3.48. A view of the altar in December 1961.
(Source: WEB_24 2006)

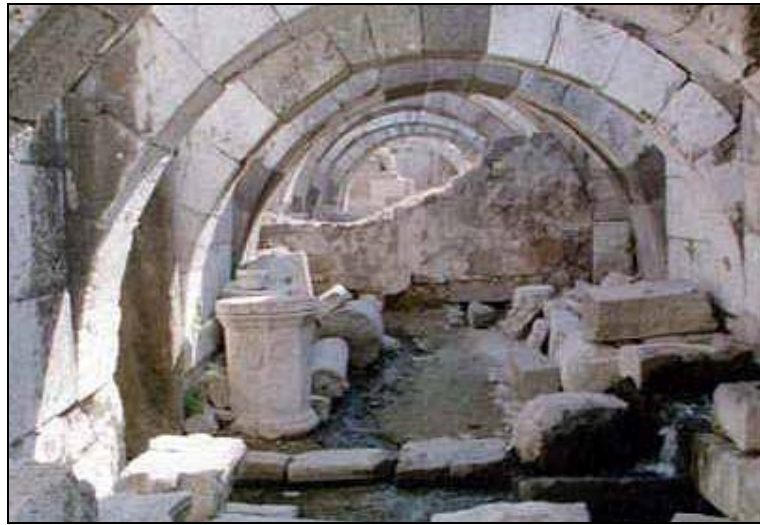
Figure 3.49 The altar does not exist anymore around 1990.
(Source: WEB_25 2006)

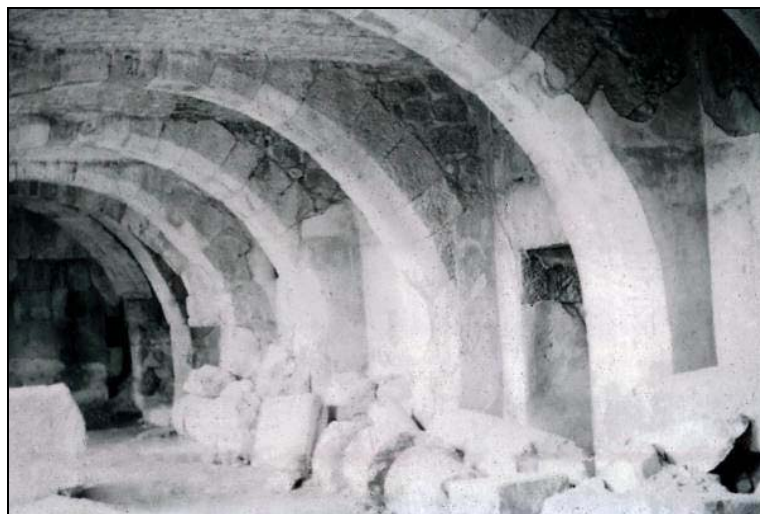
Thirdly, the plasters found in the lower galleries do not exist today. These plasters became detached from the walls due to weathering problems (Figure 3.50).

Figure 3.50. The plasters seen on the walls in December 1961 do not exist today.
(Source: WEB_24 2006)

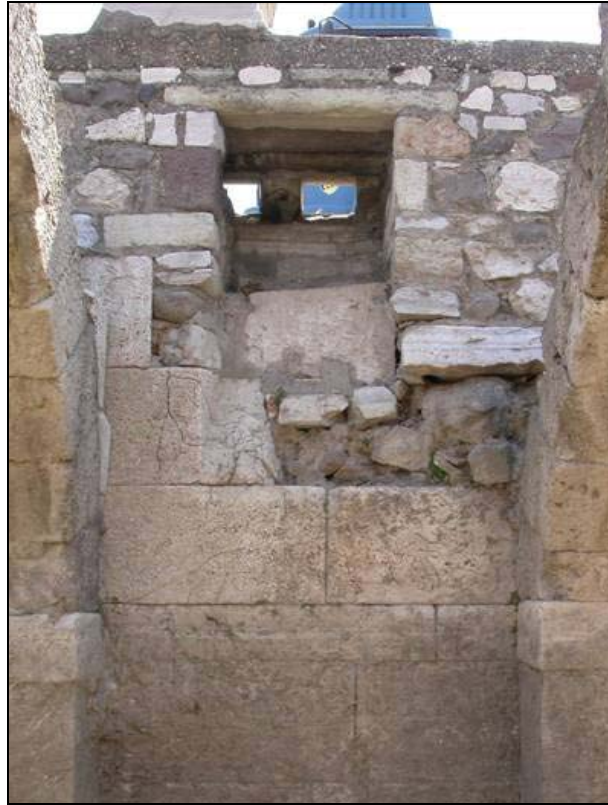
It is observed that the construction system and details do not match with the original parts. That is, reconstructions started before the excavations were completed in the West Stoa also were applied without much analyses of the structure. In brief, implementations comprise many faults at the details of the windows and mouldings. To start with, mouldings seen in Figure 3.52 were not applied in the reconstructions. As stated under heading 3.3.2. mouldings reflect the earlier construction system of the West Stoa. Considering their importance, they should be placed in the former implementation.

The original windows were opened to the steps of stylobate with narrowing section both in horizontal and vertical line. The windows opened to the riser of the steps with only one space. However, reconstructions were applied as seen in the figure without regards to the original (Figure 3.53).

Figure 3.53. The present situation of the east wall and the windows.

To sum up, the reconstruction of the east wall and stylobate is distinguishable from the original fabric since it is not compatible to the original structure in materials as well as the construction techniques and details. The state of the wall and stylobate is not available for future reconstructions due to static reasons but they are reversible for future implementations.

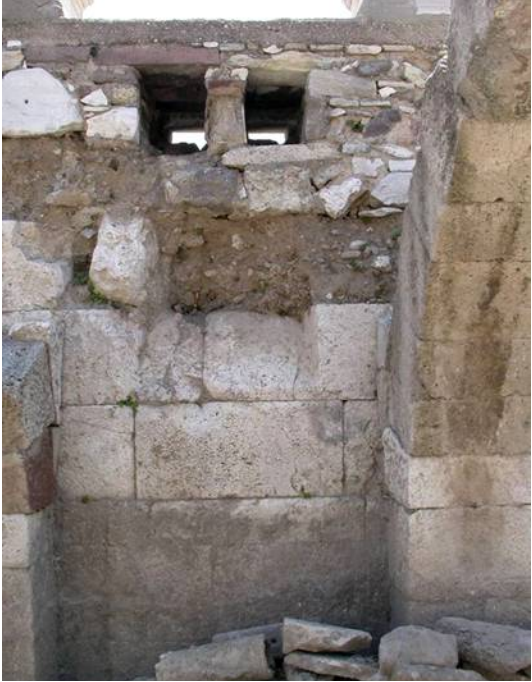
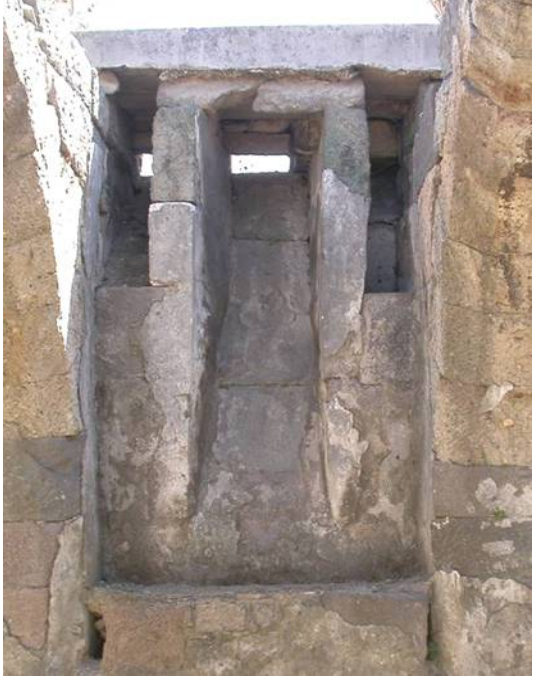
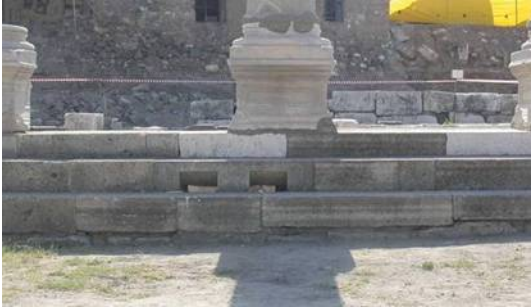
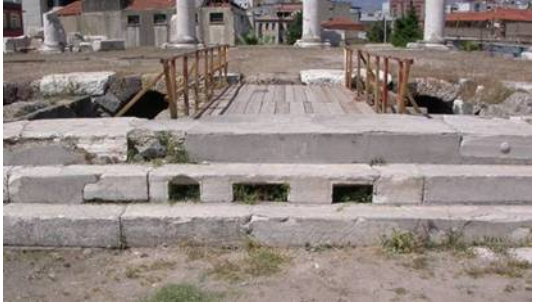
Besides, the reconstruction implementation resembled not the windows of the West Stoa but the Basilica. When windows of the two buildings are examined in the Figure 3.54, the Basilica's windows consist of three parts both inside and outside. However, West Stoa's windows consist of one division inside and two outside.

That is not so strange because when the implementations started, a part of the lower gallery was excavated in the Basilica in contrast to the West Stoa. Next, there was no original piece of stylobate with window openings in the West Stoa, as in the Basilica. On the other hand, that was an incorrect choice because the Basilica was built in different era with different function so the structure of the windows was not the same. Further, the Basilica was located at the lowest point of the terrace, which may cause further drainage problems.

<p data-bbox="320 1796 778 1825">Window of the West Stoa (reconstruction)</p>

Figure 3.54. Analyses of the windows opening to the stylobate. The Basilica windows were imitated for the reconstruction of the windows of the West Stoa.

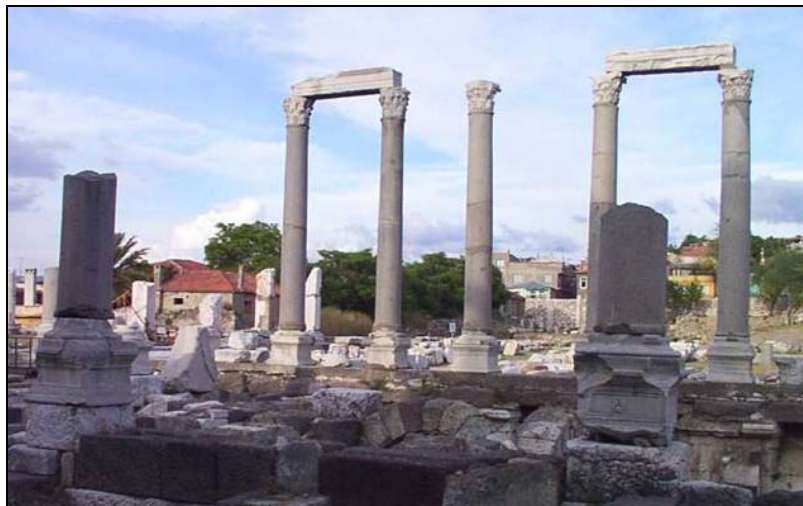
Figure 3.59. The distances vary between the columns and the longest ones are with the architraves.

Column capitals are similar in characteristics but different orientations when compared to each other. However, two architraves were placed over the capitals which do not belong to the West Stoa because they are longer than the original column axes (Figure 3.59). In order to place these architraves, columns were lined with longer distance than the others.

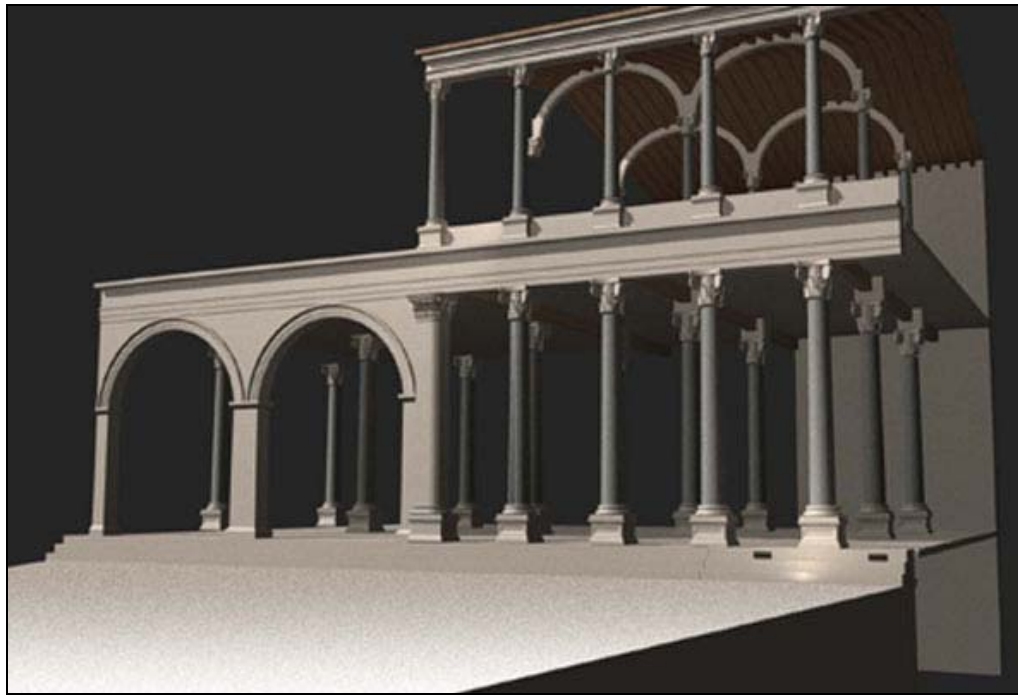
The West Stoa was illustrated as two arches in the reconstruction, which was an accurate decision. Even so, the beginning of the second arch was placed through the north, conversely it should be through the south because the West Stoa is placed on the north but a Roman road is on the south under the 816 Street (Figure 3.61).

Figure 3.61. The reconstruction of the southern east façade of the West Stoa and the West Gate.
(Source: The archives of the Agora excavation, 2005)

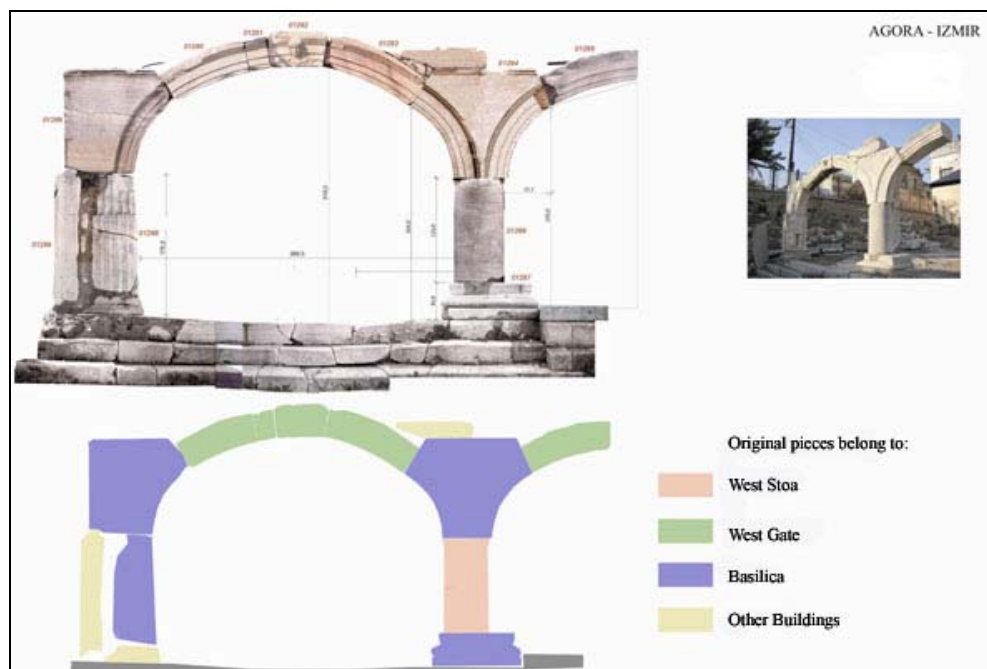
Last, it is necessary to mention, the extant original materials were used in the reconstruction. The voussoirs and the keystone do not match each other from the point of the profile and arch lines. That reveals, some pieces used in the anastylosis do not belong to the structure. As illustrated in the figure springers on two sides thought probably belong to the Basilica (restitution studies not completed yet), further half columns reveal the original characteristics of the West Gate (Figure 3.62).

Figure 3.62. The figure illustrates the materials of the reconstruction regarding the original structure.
(Source: The archives of the Agora excavation, 2004)

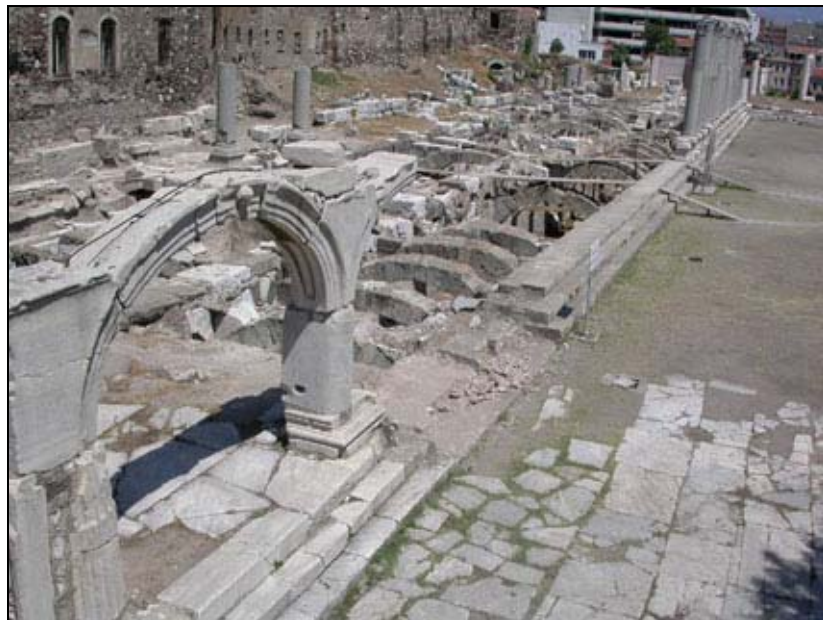
The recent situation of the gate has been analyzed and evaluated under heading 3.5.1.2.3 (Figure 4.5). In summary, the reconstruction of the structure includes mistakes which resulted in the wrong impression of the monument. To illustrate, initially, incorrect pieces which belong to other building parts were used in the reconstruction, secondly, the horizontal and vertical proportions of the arch are not correct, eventually the placement of the second section had been presented in the wrong direction (Figure 3.60), (Figure 3.62). Because of these mistakes, the existing reconstruction needed to be disassembled and a new reconstruction project was decided upon that must be applied.

Figure 4.5. Reconstruction of the West Gate.
(Source: The archives of the Agora excavation, 2004)

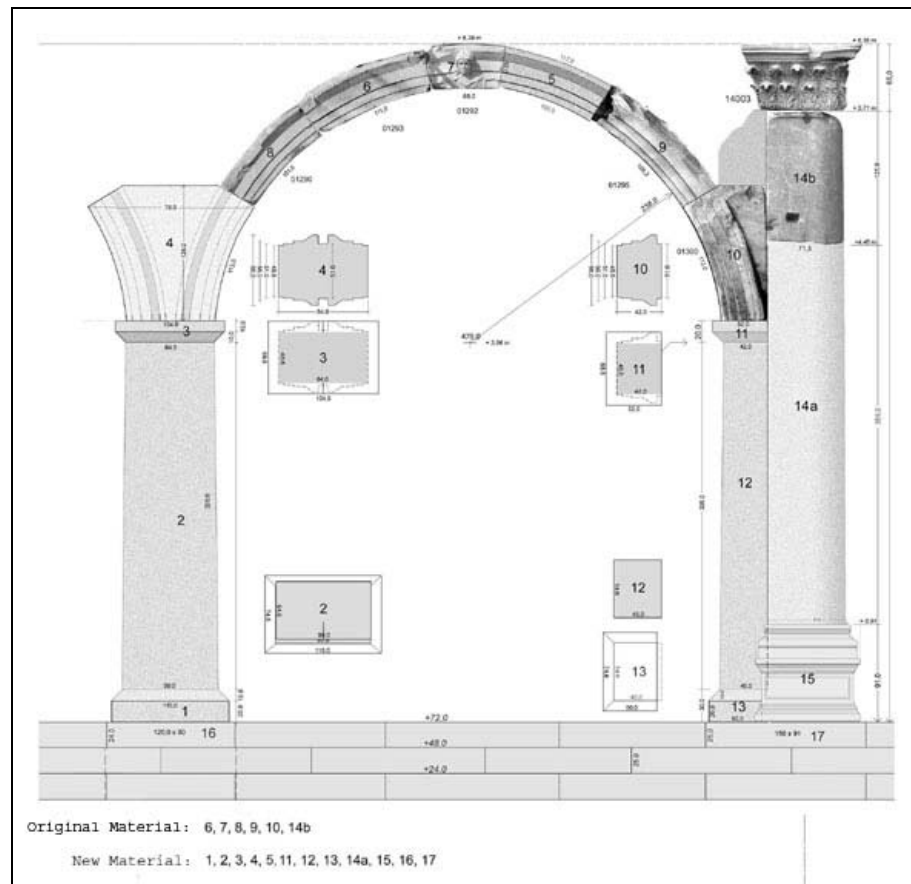
Figure 4.6. Reconstruction project of the West Gate.
 (Source: Archives of the Agora excavations, 2004)

According to the reconstruction proposal, the extant architectural pieces should be used initially. The lacking parts would be constructed with similar properties of material to the original. Although experimental investigation of the materials was not executed, Marmara marble was found to be the most similar to the original material (by the stone experts). In addition to the 7 original pieces, 9 more pieces are needed in order to reconstruct the arch (Figure 4.6). All pieces should be montaged with bronze clamps and enclosed with lead and epoxy.

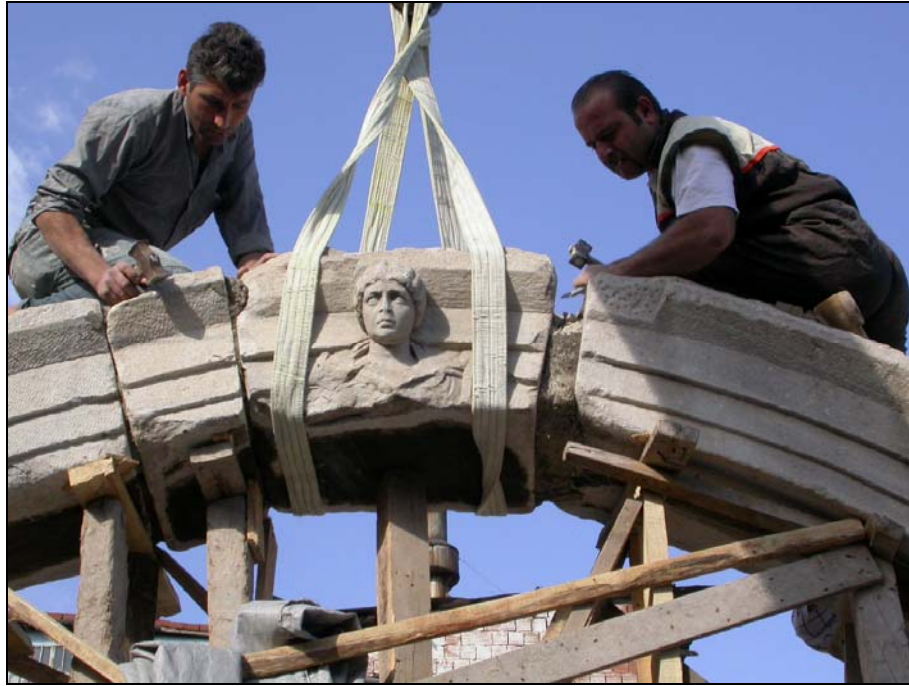
Figure 4.10. The disassembling process of the West Gate.
(Source: Archives of the Agora excavations, 2004)

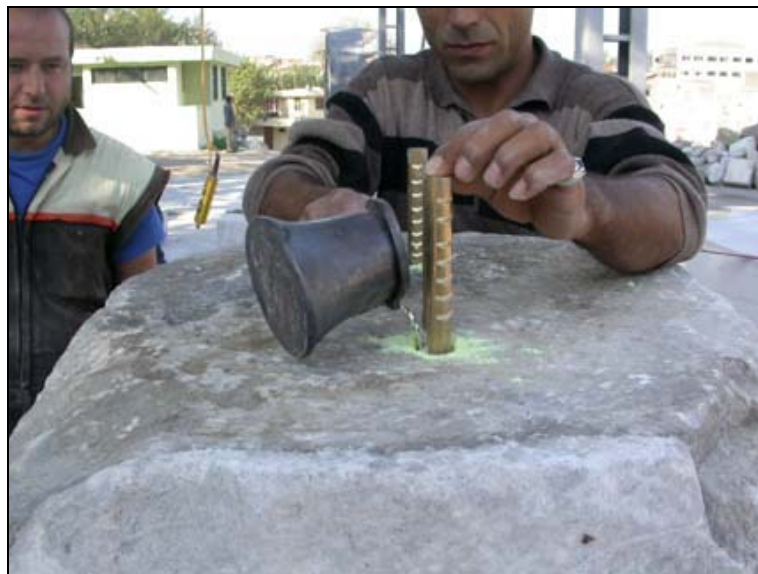
Figure 4.11. Bronze cylindrical clamps applied to the architectural pieces and surrounded with lead.
(Source: Archives of the Agora excavations, 2004)

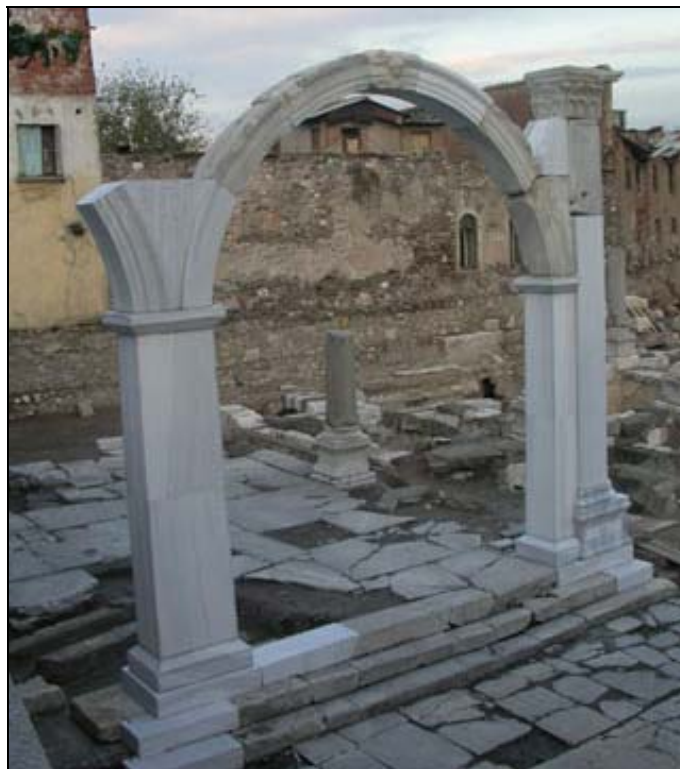
Figure 4.13. The West Gate after reconstruction implementation, 2005.

The reconstruction of West Gate is available for the future studies since no original components have been damaged and the structure is stable enough in order to allow for further necessary interventions.

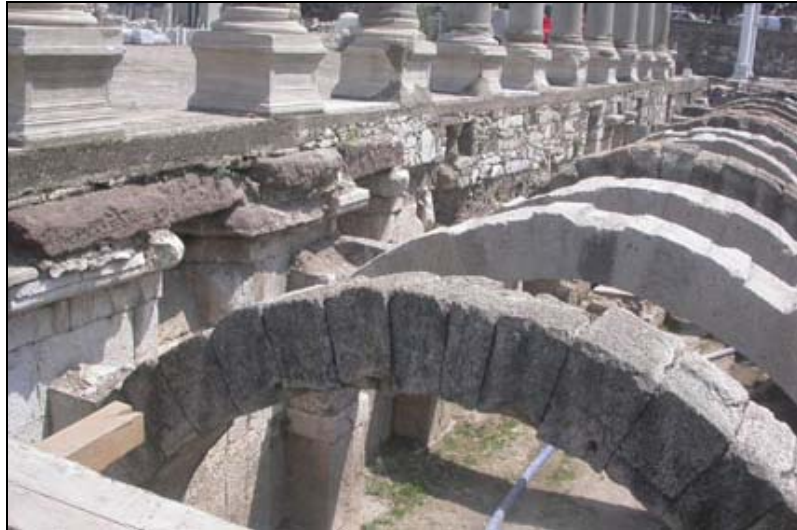
Three periods of the structure are observed on the east border of the West Stoa. These are, the primary construction in Hellenistic era, second is the addition of abutments bearing to the wall and the final is the latest implementations dated between 1932 and 1943 (Figure 4.15). Today the recent situation of the structure reveals the previous alterations (Figure 4.16). In the Roman era, 30 arch abutments had been added to the structure with various distances. The stairs climbing to the ground floor were constructed on the north side occupying the wall between the 1st and 3rd axes. A 55 cm thick wall was constructed in front of the wall between the 24th and 30th axes in order to build cistern 1. Additionally partial flooring at -3.25 m, dating to the Roman era was found between the 12th and 14th axes the aim of which is not defined yet

The latest implementations were due to reconstruction of the stylobate. Although reconstructed with concrete material (as stated under heading 3.5.1.2.1) it includes a few extant pieces on the north side as well. To do the reconstruction, destroyed parts of the east wall had been completed with rubble. Infact, the masonry wall reveals the original characteristics of the structure except for the implemented sections. To illustrate, the most preserved part with the elevation of -0.87 m is observed between the 4th and 10th and between the 14th and 15th axes. Afterwards elevated until -1.27 m it comes between the 15th and 24th axes. Subsequently, the surface between the 10th and 13th axes displays the most destroyed part which is until -1.78 m (Figure 4.16).

Figure 4.15. The east side of the West Stoa.

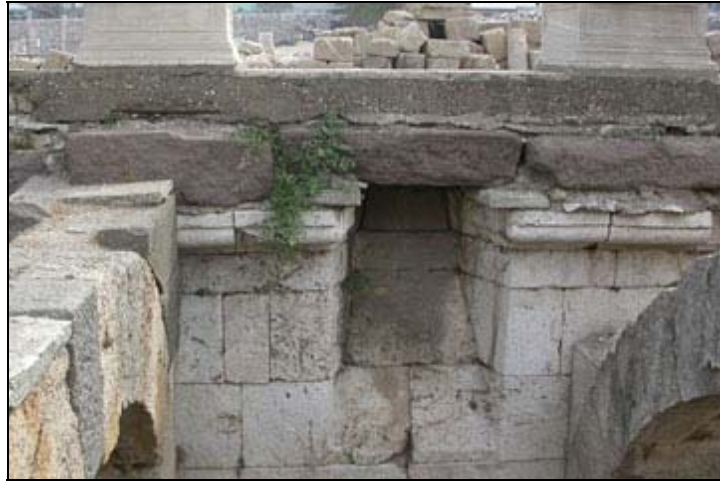
Built in pseudoisidomum²⁶ technique the wall starts from -4.41 m and rises up to -0.12 m which is the level of the stylobate. However, these codes differ in 10 cm between the north and south of the wall (Figure 4.17). To examine the wall, architectural elements and traces will be evaluated in this section. It is consisted of 12 courses of stones, the first three of which constitute the stylobate. Fourth course of the structure is the most distinguished one since it is placed with a 15 cm console to the wall (Figure 4.18). This console is ornamented with cyma reversa moulding²⁷ along the wall except for the windows, it is cut off at the windows with a profiled corner. As stated under heading 3.3.2, the fourth course was constructed to carry the bearing load of timber beams (Figure 4.19).

Figure 4.18. Fourth course of the wall with cyma reversa moulding is displayed in a restricted area.

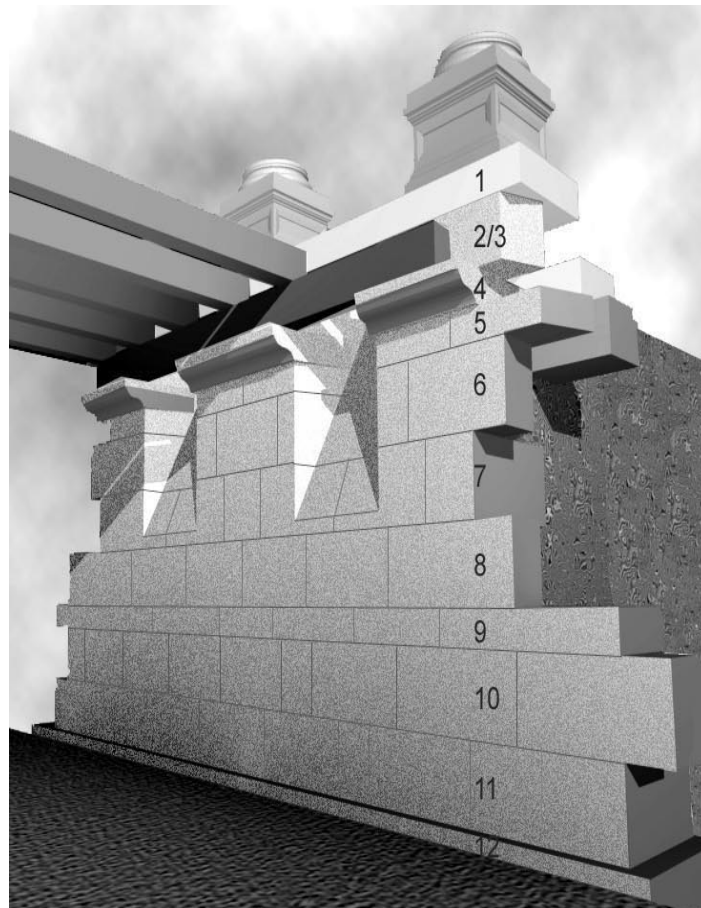
Figure 4.19. The restitution drawing of the stone courses of the east wall.
(Source: Archives of the Agora excavations, 2005)

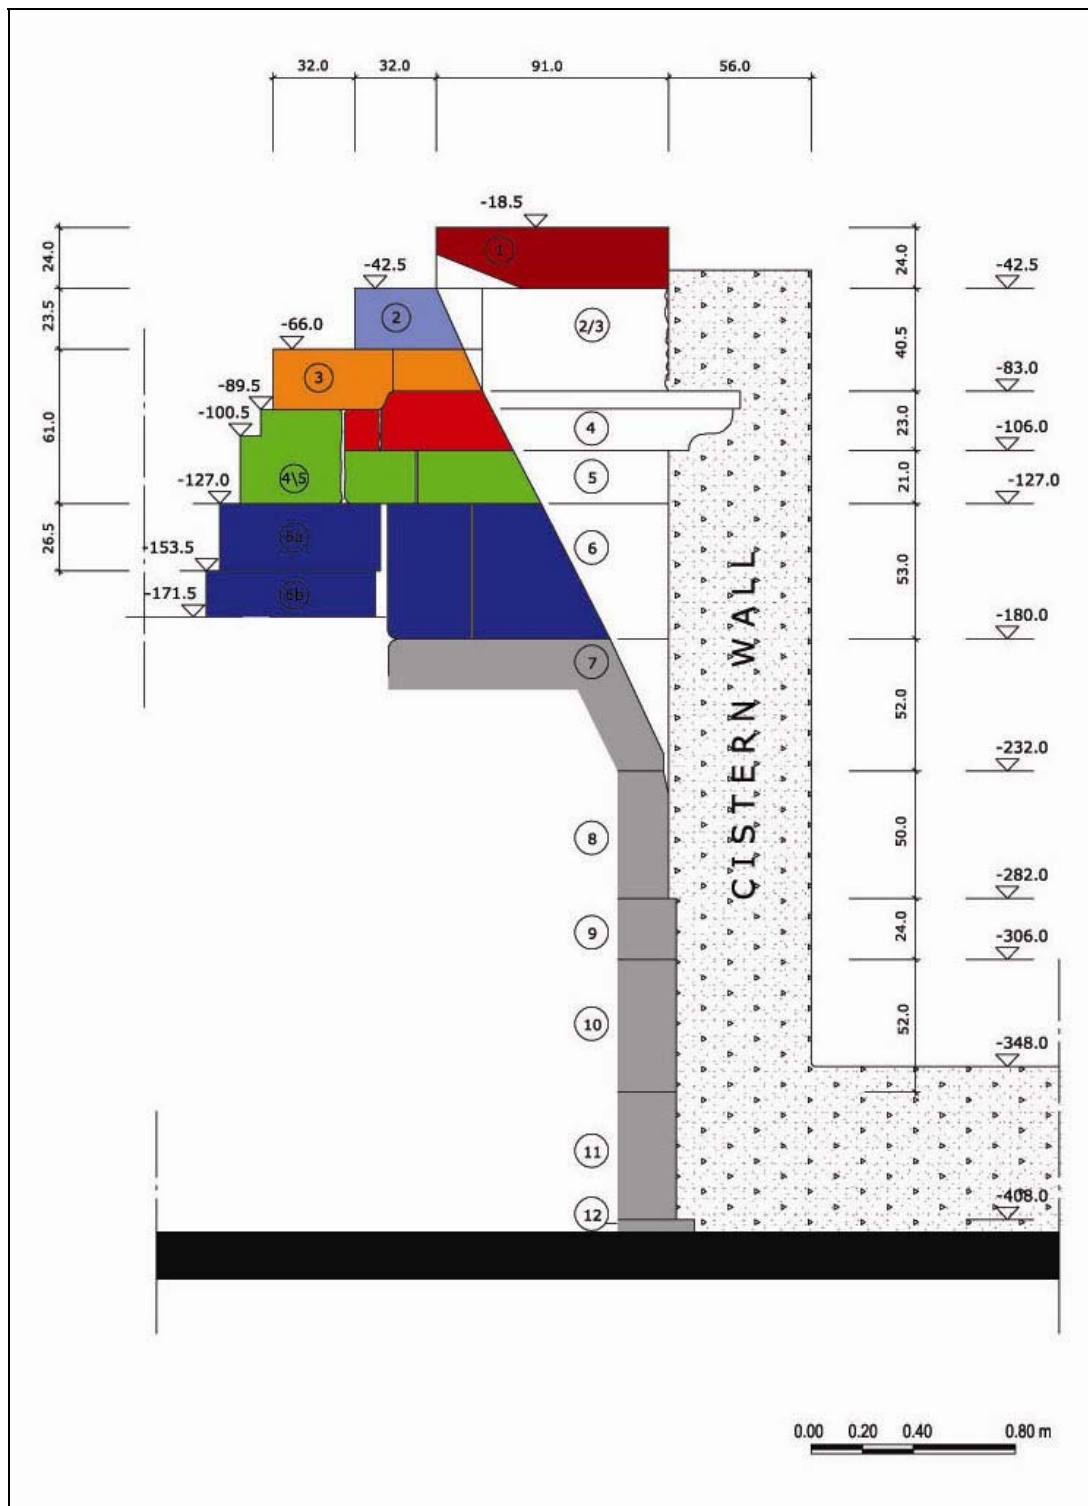
Figure 4.23. The restitution section of the east wall and the stylobate.
(Source: Archives of the Agora excavations, 2004)

The third and second steps of the stylobate should be placed in this course as seen in the figures (Figure 4.23), (Figure 4.26). The height of the stylobate steps were decided regarding the existing steps on the north side of the West Stoa and the steps of the West Gate. The horizontal measure of existing stylobate steps were varied, but certain measures of 135 cm, 115 cm and 90 cm were the most significant ones. Accordingly, the reconstruction project was planned regarding these measures. On the other hand there should be a regular method to implement the window constructions. The survey studies showed the measure of the windows varied as well as the measures between them. Therefore it was decided to construct windows with a regular measure

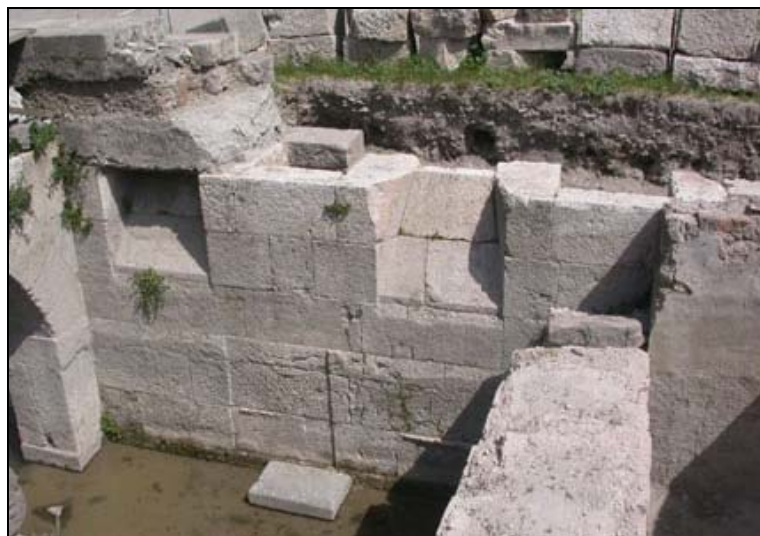
Figure 4.25. The east wall of the West Stoa, after the removal of the stylobate at 23rd axis.

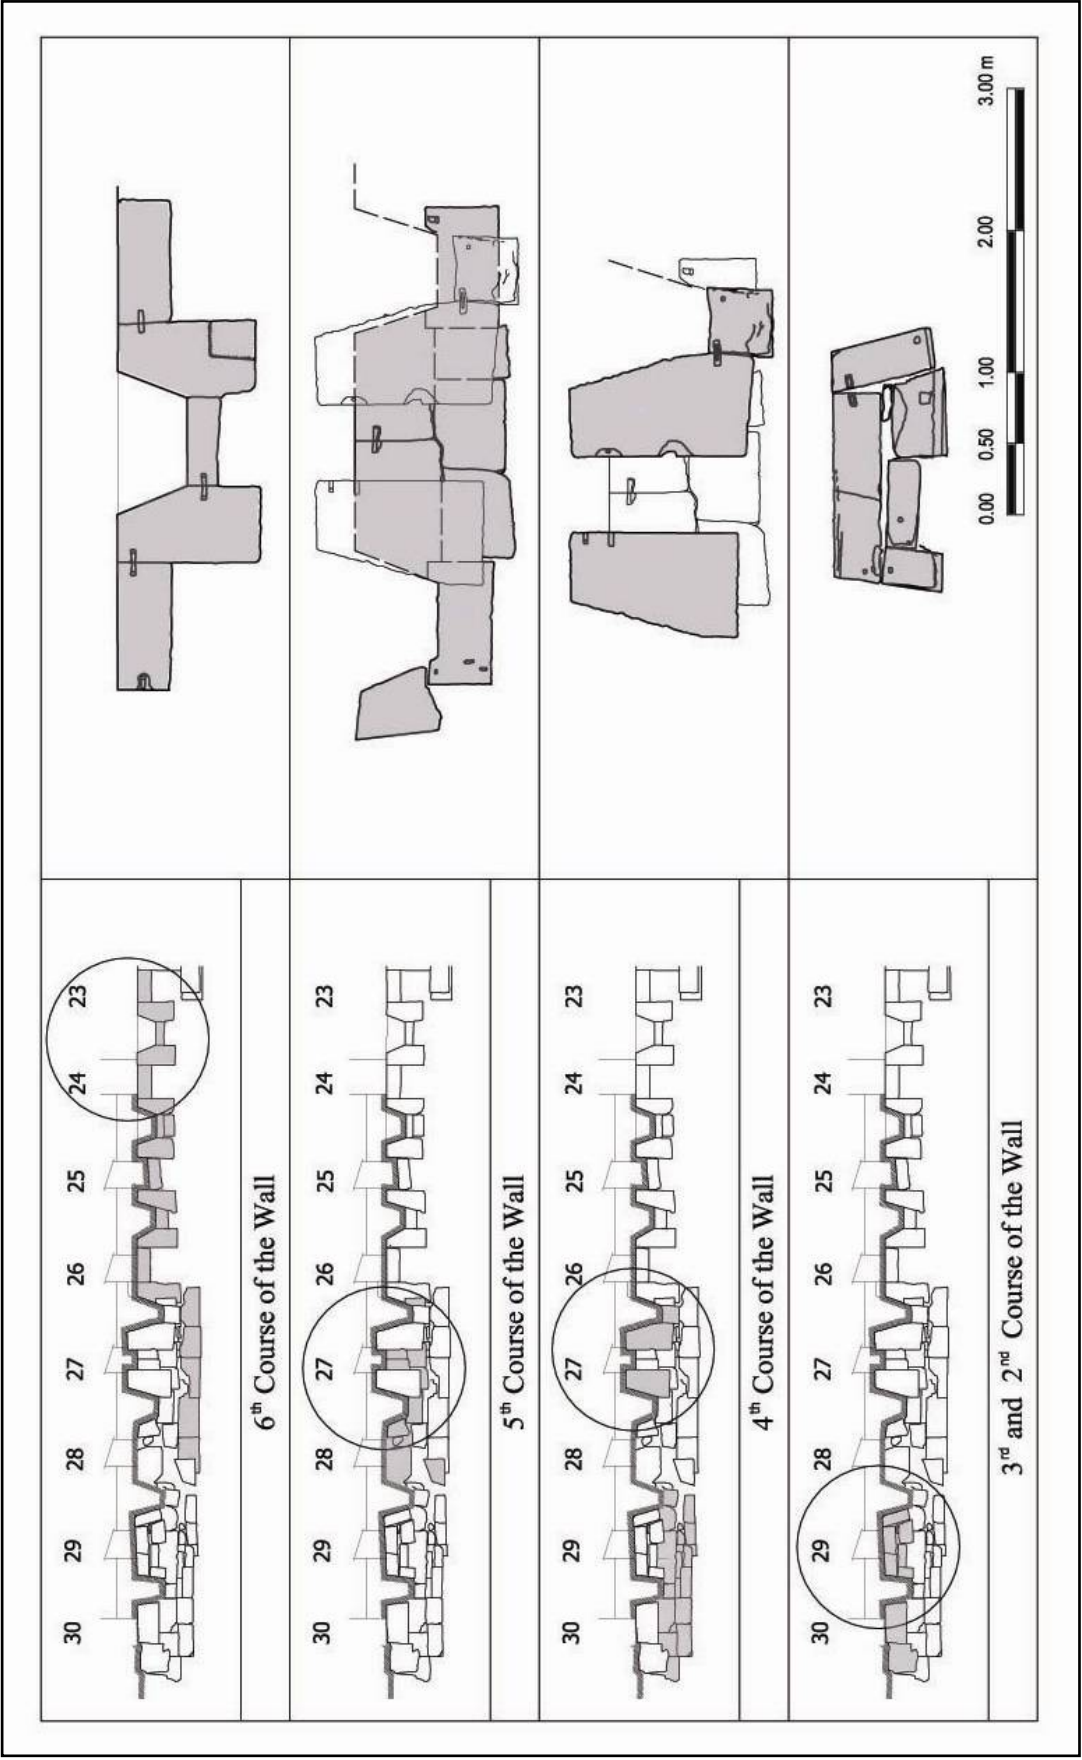
Figure 4. 26. Construction system of the courses.

Secondly, the 5th course was observed between the 26th and 28th axes, however, not completely open due to the existence of the 4th course. It is possible to understand the forms of the stones constituting the 5th course with careful inspection. To illustrate, four stretchers and a header belonging to two windows are observed here, which assisted to find out the construction system of the course (Figure 4.26).

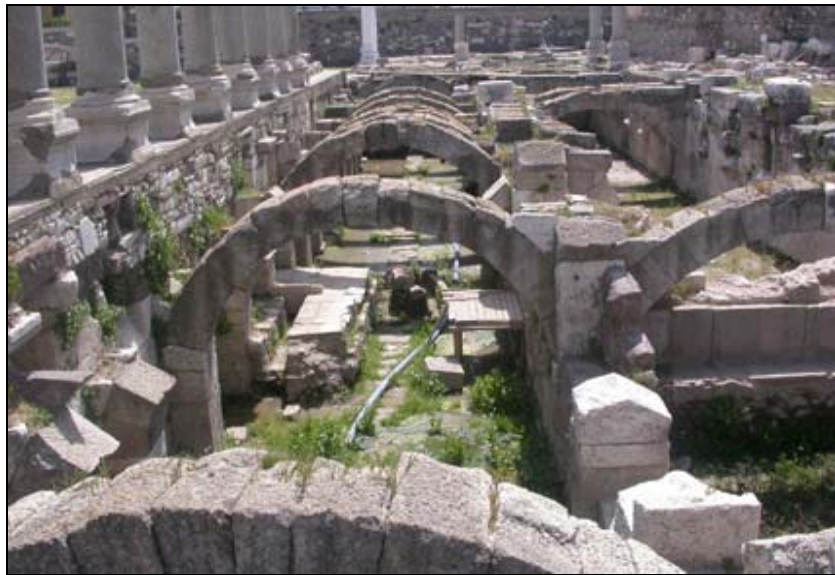
The arches constitute the grid plan of the West Stoa placed one next to the other in each nave. Therefore they supported each other against the lateral thrusts. According to this planning each nave was constituted of 29 arches placed with irregular distances from north to south. These arches connected to each other with smaller arches from north to south as stated under heading 3.3.2. However, many of them are broken today. There are 8 arches on the south nave, 10 arches on the middle nave and 10 arches missing on the west nave (Figure 4. 37). The existing arches do not have many apparent structural problems but some material problems which can result in structural problems soon.

Figure 4.36. The Roman arches of the West Stoa.

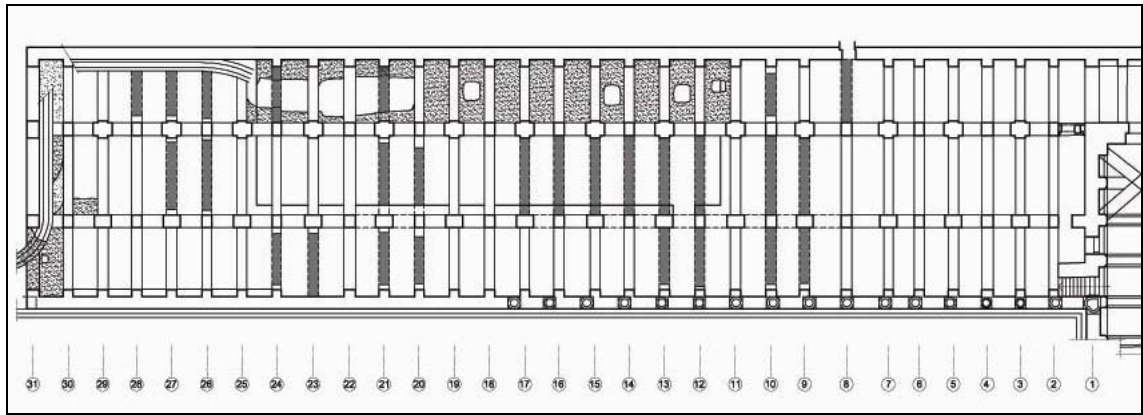
Figure 4. 37. The collapsed arches are shown in grey.

Although not planned among the intervention decisions concerning the Agora, the reconstruction of the ruined arches were decided by the administration of the excavation. These reconstructions were planned to make the anastylosis of the arches which were destroyed (collapsed) during the recent excavations and the arch components had been kept to be re-erected later on.

The aim of the reconstruction study is to replace the collapsed voussoirs and to consolidate the structure of the West Stoa. Although the aim of this implementation had been stated due to consolidation of the structure, the necessity of it should be discussed from the point of the structural system. As stated under the heading 3.3.2 the arches had been constructed subsequently in order to carry the bearing load of the ground flooring system. Further they do not support any walls but the arch in the next gallery. In the scope of the reconstruction proposal, reconstruction of the arches placed in the east lower gallery would be implemented first. However, the implementation should be done at each arch by axis since they support each other against the lateral thrusts.

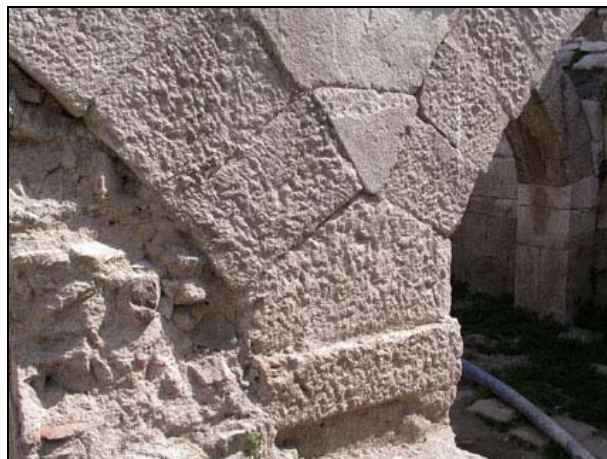
The arches bear on the abutments composed of 16 voussoirs, 2 springers and a keystone. Most of the voussoirs have the same width, however, some are smaller due to repair implementations in ancient times. The east abutments bear on the wall while the west abutments separate the east and middle lower galleries. Since the arched system continues through the west, that springer was formed for two arches. Not all, but some of the arches reveal the use of andesite at the keystones and the springers (Figure 4.39). On the other hand, other components of the arches were made of tufa “(Taşlıalan 2005b)”.

Figure 4.39. The west springer of the arches was for loading two arches.

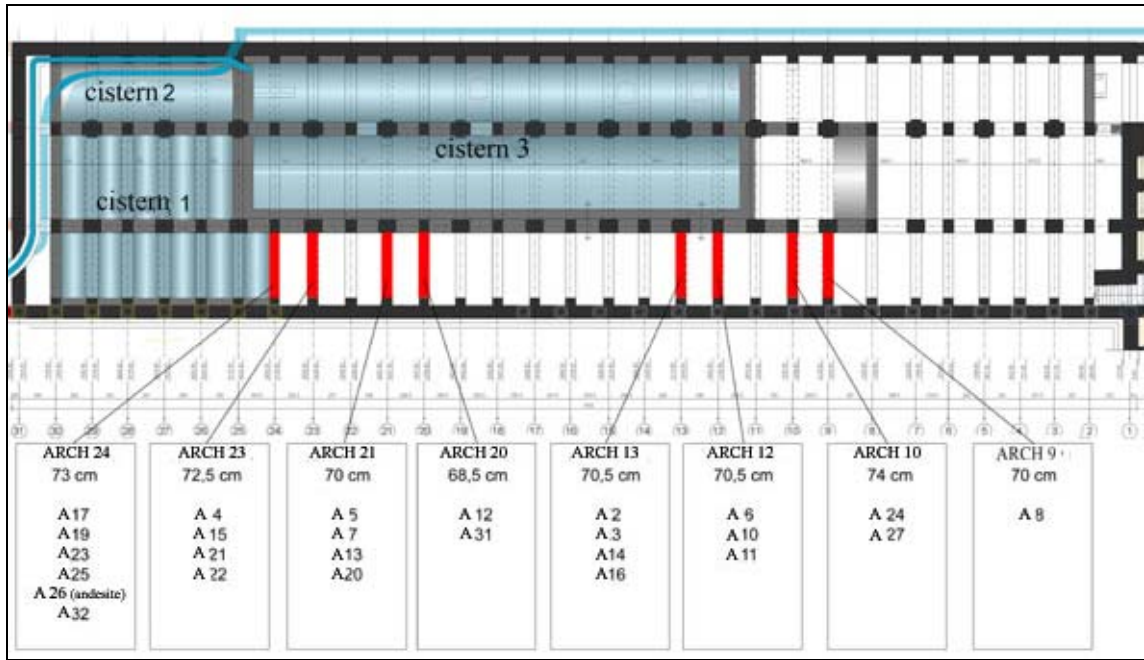
Figure 4.40. The figure shows the implemented arches and the extant voussoirs to be used in the reconstruction. (Source: Archives of the Agora excavations, 2005).

The reconstruction project was prepared regarding the theoretical drawings. A total of 8 arches of the east nave were planned to be reconstructed in this study. In total 24 extant voussoirs were decided to be used in appropriate places of the reconstruction. The voussoirs were classified according to the sizes to be reused in Figure 4.40. Since the span of the arches varied, the voussoirs would be used in the exact measure but the keystones would be adjusted “(Taşlıalan 2005b)”.

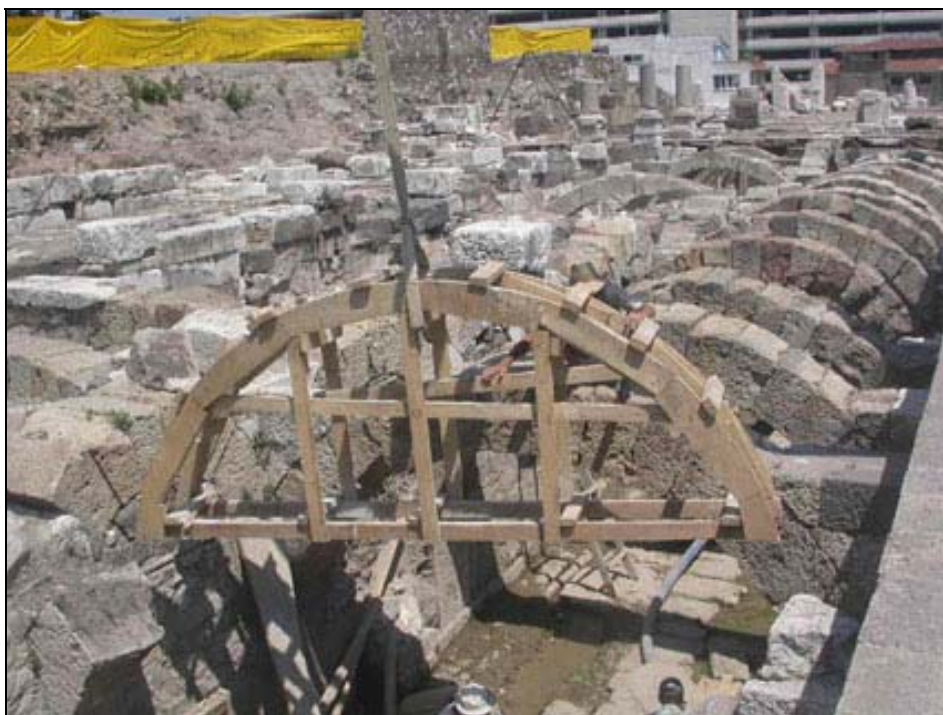
Figure 4.41. The timber staging is placed initially.
(Source: Archives of the Agora excavations, 2005)

A timber staging with the arch for the reconstruction implementation was built initially (Figure 4.41). Then the voussoirs were placed on the staging. Each voussoir was constructed with similar measures but not identical. The extant voussoirs were used in the reconstruction process initially (Figure 4.42). Finally the keystone was placed on the arch. The voussoirs implemented were in divesting measures in order to have the similar appearance with the extant arches which are dated to Roman era (Figure 4.43). Tufa was used to construct new voussoirs since they reveal similar properties with the Roman arches.

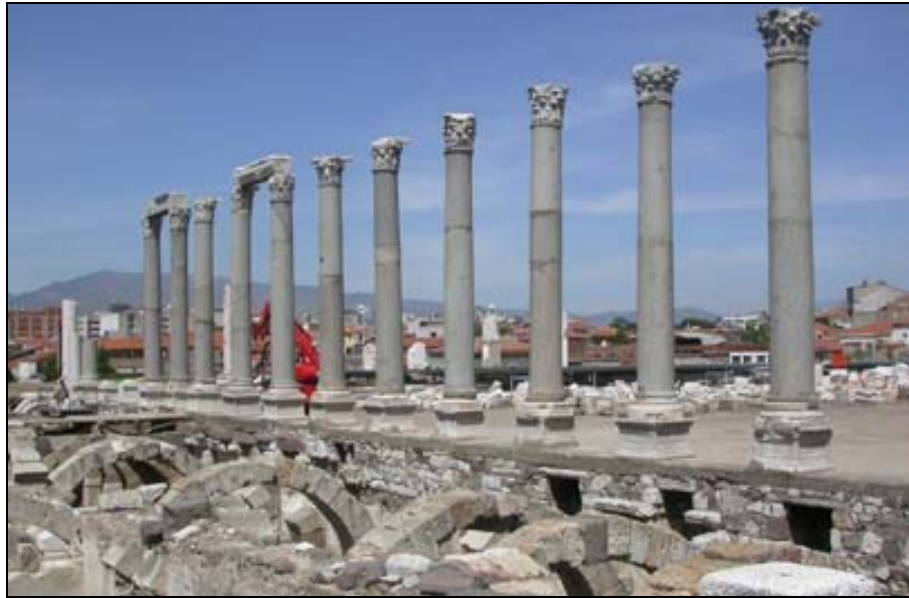
The east façade of the West Stoa partially stands on the north side including the anastylosis of 13 columns, capitals and two architraves (Figure 4.44). This state of the structure was due to a prior implementation which was stated under heading 3.5.1.2.2. The anastylosis of the 5 columns were implemented by unification of two pieces and 8 columns were implemented with three pieces of columns. The joint edges of the pieces reveal that concrete material was used during the implementations. Further some ancient reconstruction marks are also displayed at the edges of the column pieces (Figure 4.45). This leads to the idea that, the West Stoa was destroyed in an earthquake and repaired at least once. Further, fractured columns were reused after being reunified with the clamps.

Figure 4.44. Recent state of the West Stoa east facade columns.

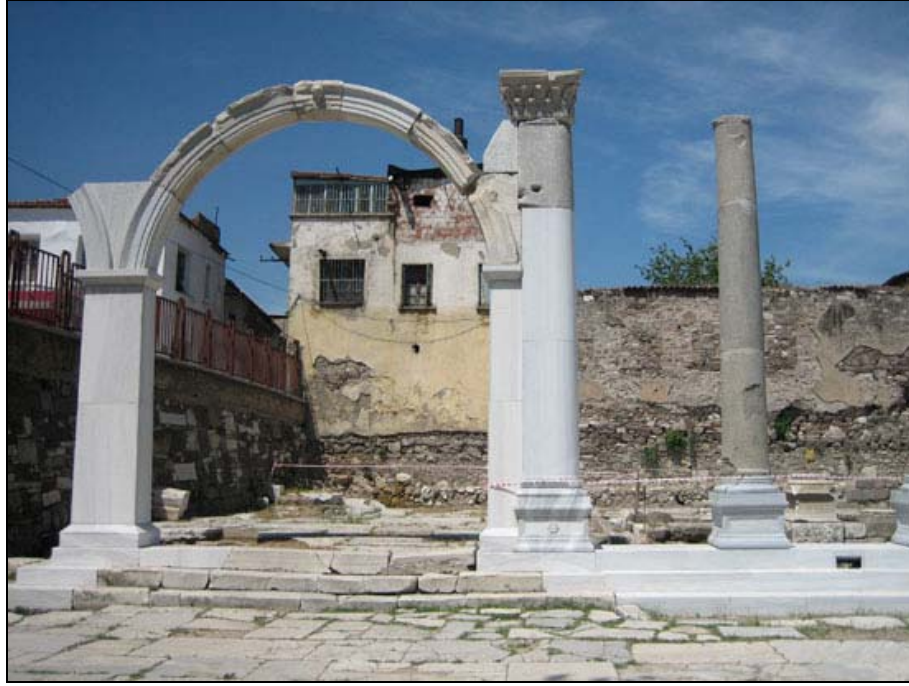
Figure 4.46. Reconstruction implementation of the West Gate and the 30th column of the West Soa.

After the reconstruction of the stylobate, column bases were constructed in the atelier from the Marmara marble. Seven bases were constructed and placed on the first step of the stylobate with 3 clamps and lead applied around the clamps. Later on the implementation of the columns started. First 30th column was unified from the pieces shown in the project, afterwards placed on the newly constructed bases. It was montaged with three clamps as stated in the proposal of project (Figure 4.46). The implementation studies had been stopped when the re-erection of the columns started. As stated under heading 4.2, the aim of this process was to acquire the unity of the West Gate and the West Stoa as in the Roman era. On the contrary, the recent state of the West Stoa presents a discontinuous and artificial structure due to unfinished implementations.
