**EVALUATION OF INTERVENTIONS
IN WESTERN STOA OF AGORA
IN İZMİR**

**A Thesis Submitted to
the Graduate School of Engineering and Sciences of
İzmir Institute of Technology
in Partial Fullfilment of the Requirements for the Degree of**

in Architectural Restoration

**by
Necmiye Funda YAKA**

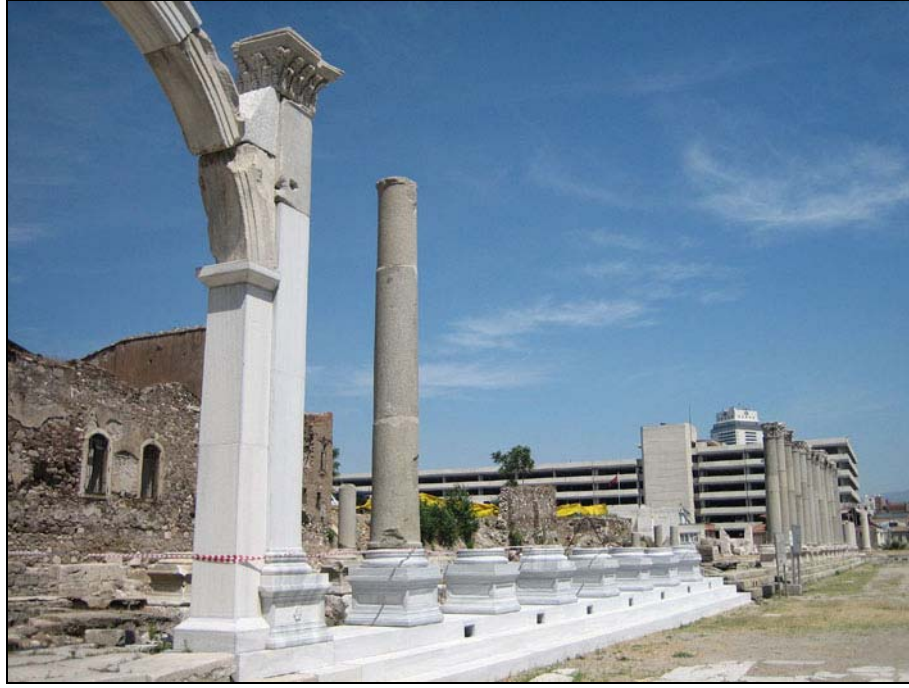
After the reconstruction of the stylobate, column bases were constructed in the atelier from the Marmara marble. Seven bases were constructed and placed on the first step of the stylobate with 3 clamps and lead applied around the clamps. Later on the implementation of the columns started. First 30th column was unified from the pieces shown in the project, afterwards placed on the newly constructed bases. It was montaged with three clamps as stated in the proposal of project (Figure 4.46). The implementation studies had been stopped when the re-erection of the columns started. As stated under heading 4.2, the aim of this process was to acquire the unity of the West Gate and the West Stoa as in the Roman era. On the contrary, the recent state of the West Stoa presents a discontinuous and artificial structure due to unfinished implementations.

Figure 4.48. The present appearance of the West Stoa, 2006.
