**DOCUMENTATION OF THE LOWER BATH IN  
METROPOLIS, TORBALI, İZMİR FOR THE  
ASSESSMENT OF HERITAGE  
CHARACTERISTICS**

**A Thesis Submitted to  
The Graduate School of Engineering and Sciences of  
İzmir Institute of Technology  
in Partial Fulfillment of the Requirements for the Degree of**

**in Architectural Restoration**

**by  
Suna BÜYÜKKILIÇ**

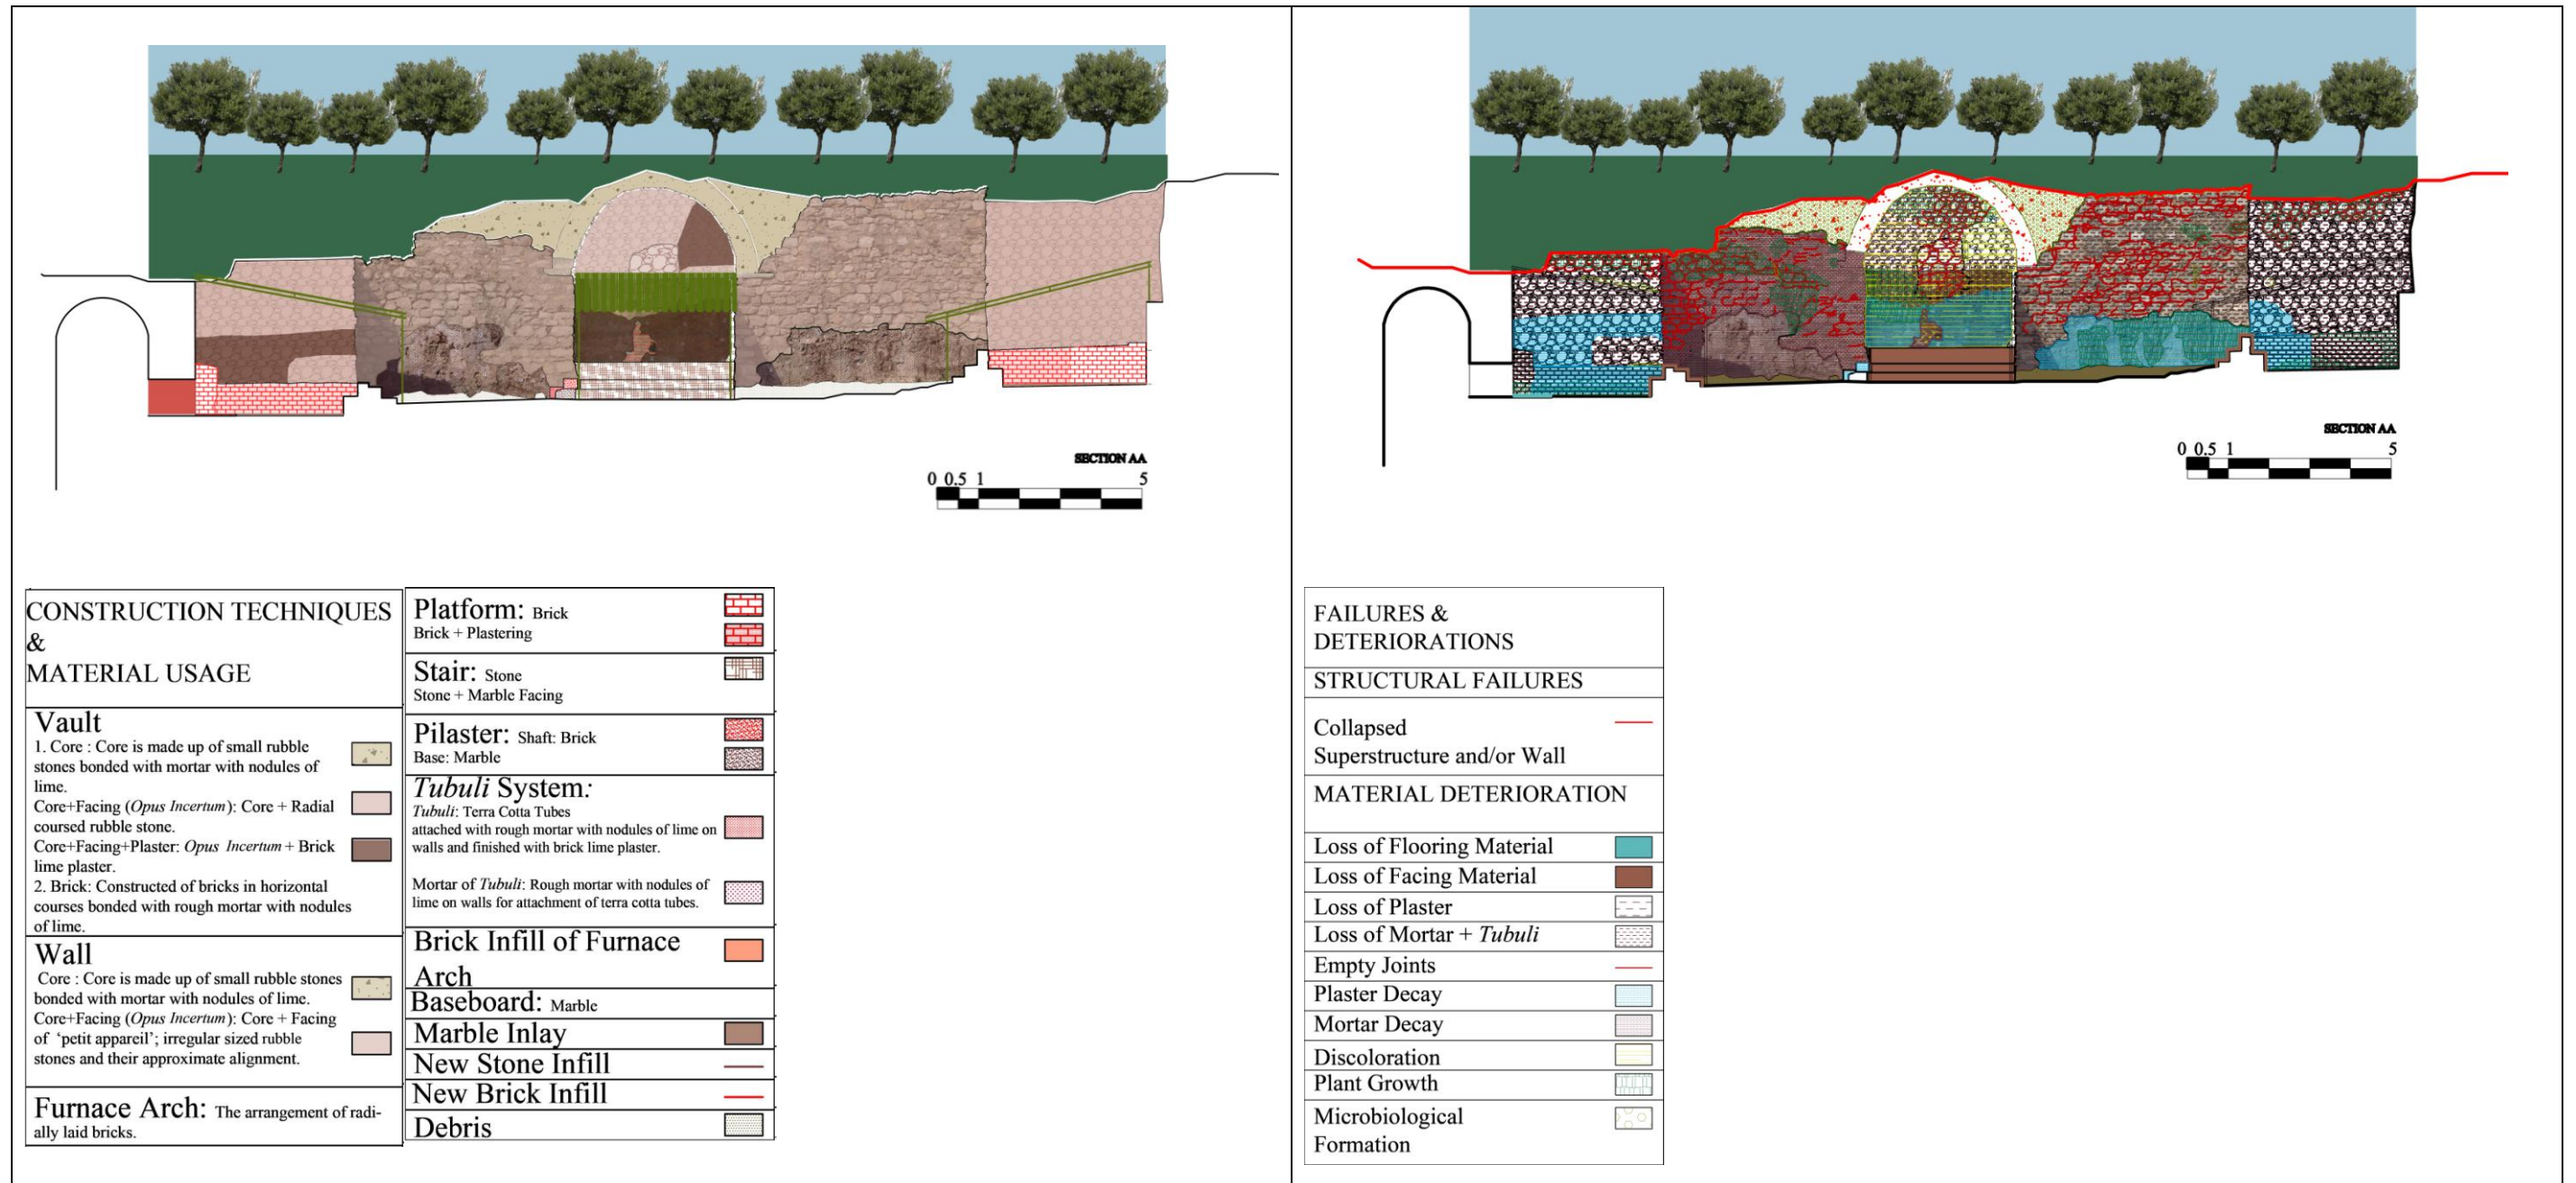
Figure J.1. Structural Characteristics, and Failures and Deteriorations

<p>Appendix J</p>
10	Vault - service corridor, west, south corner.	Structural	Barrel (could not be measured), brick (~30x5) in isodomic order + mortar (t horizontal: ~3, t vertical:1).	Overloading due to earth covering; plant, lichen, algae growth.	
11	Protective roof - <i>caldarium</i> 2, south.	Structural	Metal guttered sheet carried by metal posts.	Slight rusting.

<p>Appendix J.</p>
12	Protective roof - <i>caldarium</i> 2, west.	Structural	Metal guttered sheet carried by metal posts.	Slight rusting.	
13	Protective roof - <i>caldarium</i> 2, north.	Structural	Metal guttered sheet carried by metal posts.	Slight rusting.

<p>Appendix J</p>
16	Arch - <i>caldarium</i> 1, northern wall, western niche.	Structural	Semicircular arch (r:86, cs:175), rubble stone (~16x6x25) embedded in lime mortar (t: 6-7); core; irregular sized rough cut stone facing (~43x19x12).	Extensively damaged facing: only four rough cut stone remaining, plaster totally lost.

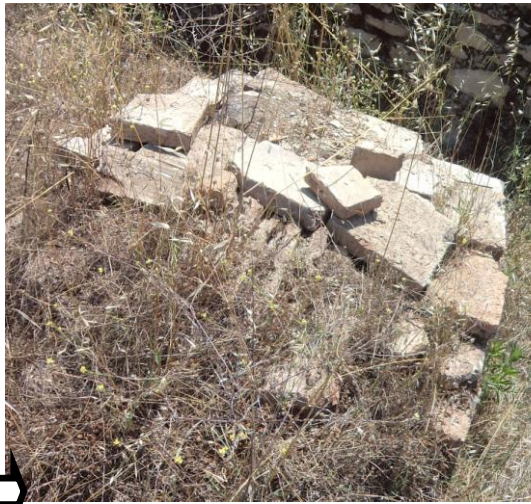
ID	Element Name	Morphological Characteristics	Alteration	Graphic
55	Flue - service corridor, western part, south.	Providing hot gas a draught through a tube with quadrilateral cross section and projecting from the superstructure of service corridor, ~w: 109, l: 180	Loss of function with debris covering the output.

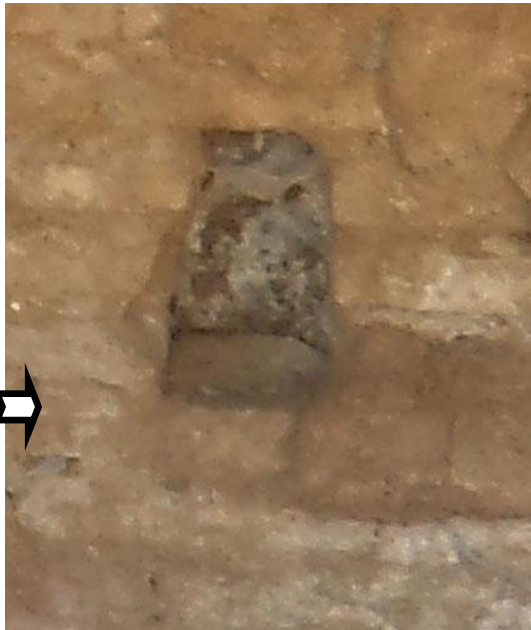
59	Fountain spout - <i>caldarium</i> 1, western plunge pool.	A quadrilateral hole (~17x30) in the wall forming the mouth of the probable outlet pipe controlling the flow of water into the plunge pool.	-

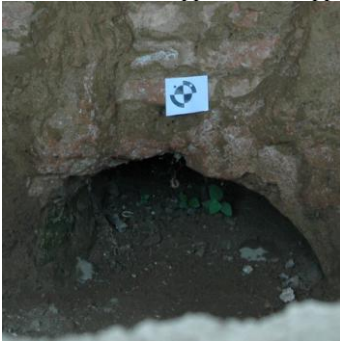
<p>Appendix H, Appendix I</p>
64	Furnace opening - <i>caldarium</i> 2, southern <i>alveus</i> , southern wall.	Semicircular, arched opening in the middle of the wall: furnace opening directly underneath, so the tank receiving the greatest heat, (r: 35, cs: 40).	Total loss of infill.	
65	Furnace opening - <i>caldarium</i> 2, western <i>alveus</i> , western wall.	Semicircular, arched opening in the middle of the wall infill, furnace opening directly underneath, so the tank receiving the greatest heat, (r: 30, cs: 40).	New infill in the wall with an arched opening.

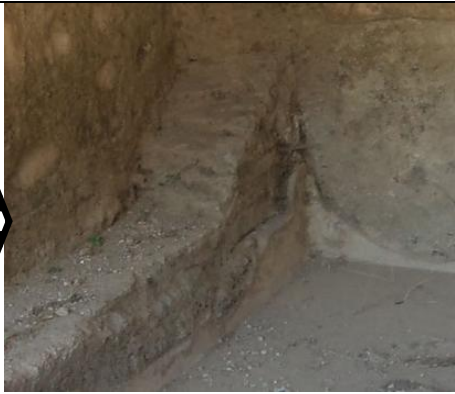
<p>Appendix H, Appendix I</p>
68	Platform - <i>caldarium</i> 2, southern <i>alveus</i> , eastern wall.	Sitting element extending throughout the short edge of <i>alveus</i> , finishing with a baseboard, (w: 35-, ~hmax: 30)	Partial loss of the element, extensive loss of hydraulic lime plaster covering.	
69	Platform - <i>caldarium</i> 2, northern <i>alveus</i> , western wall.	Sitting element extending throughout the wall behind, finishing with a baseboard, (w: 37, ~h: 82)	Partial loss of the element, total loss of lime plaster covering.

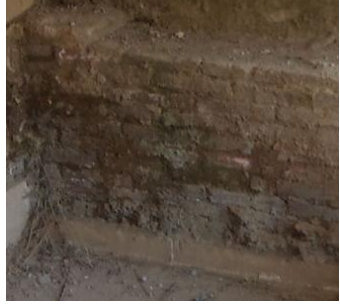
70	Platform - <i>caldarium</i> 2, northern <i>alveus</i> , eastern wall.	Sitting element extending throughout the short edge of <i>alveus</i> , finishing with a baseboard, (w: 29, ~h: 88)	Partial loss of the element, total loss of plaster covering.

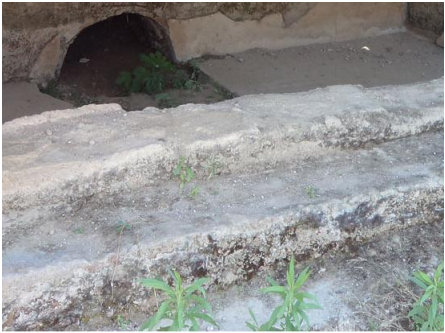
<p>Appendix H, Appendix I</p>
74	Stairs - <i>caldarium</i> 2, southern <i>alveus</i> .	Three steps providing access to the <i>alveus</i> (each w~30, h~15) and one step for sitting (w~35, h~40) in the <i>alveus</i> , all extending throughout the pool long edge.	Extensive loss of marble covering.

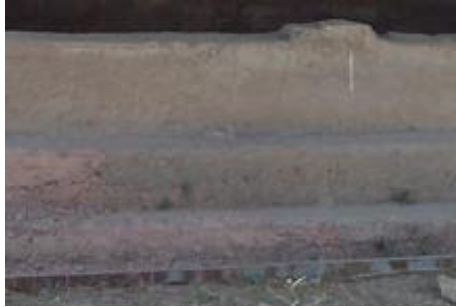
<p>Appendix H, Appendix I</p>
78	Pilaster - <i>caldarium</i> 1, western wall, southern part.	Decorative element, slightly projecting from the wall ... cm, quadrilateral shaft (w: 18, l: 69, h: 152).	Partial loss of shaft, total loss of base, total loss of covering.

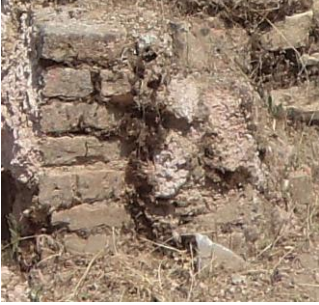
Appendix H, Appendix I
83	Pilaster - <i>caldarium</i> 2, eastern wall, southern part.	Decorative element, slightly projecting from the wall ... cm, quadrilateral shaft (w: 18, l: 35, h: 43).	Partial loss of shaft, total loss of base, total loss of covering.	
84	Niche - <i>caldarium</i> 1, northern wall, west.	Rectangular (w:48, l:170), arched recess in the wall with a pedestal (h:30).	Total loss of plastering.

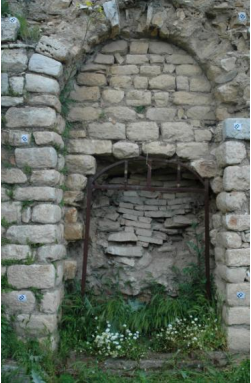
85	Niche - <i>caldarium</i> 1, northern wall, east.	Rectangular (w:50, l:184), arched recess in the wall with a pedestal (h:33).	Partial loss of pedestal, additional infill on the original pedestal remain.	
86	Niche - <i>caldarium</i> 3, western wall.	Square recess in the wall (w: 43, l: 38, d:32), being higher level from the ground (gc: 241).	-	
87	<i>Tubuli</i> system - <i>caldarium</i> 1, <i>alveus</i> , western wall.	Voids in form of series of rectangular prisms, running vertically parallel to the wall surface, providing circulation for gases, 4 <i>tubuli</i> only, w: 15, l: 30, h: 30, t: 2.	3 of 4 <i>tubuli</i> remains partially lost, others completely lost.

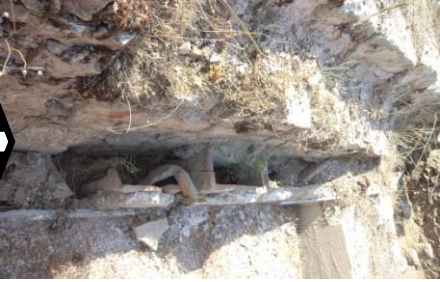
Appendix H, Appendix I
88	<i>Tubuli</i> system - <i>caldarium</i> 2, western wall.	Voids in form of rectangular prism, running vertically parallel to the wall surface, providing circulation for gases, 1 <i>tubulus</i> only, w: 15, l: 30, h: 30, t: 2.	Almost complete loss of <i>tubuli</i> system.

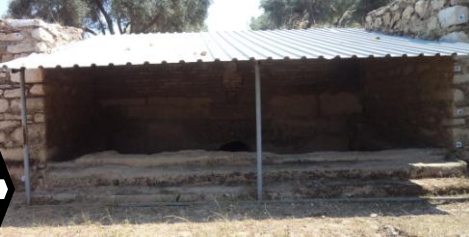
Appendix H, Appendix I
90	<i>Alveus</i> - <i>caldarium</i> 2, south.	Bathing pool (w: 334, l: 541, ~d: 55) heated with a <i>praeurnium</i> , enriched with platforms on 2 sides, entered with a 4 steps.	-

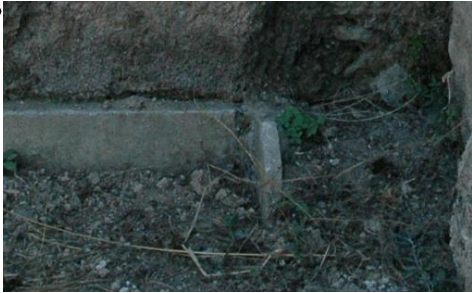
<p>Appendix H, Appendix I</p>
97	Baseboard - <i>caldarium</i> 2, northern wall.	Linear transition element between wall and floor surfaces, extending throughout the wall, h: 15, t: 1.5.	Partial embedding into the earth.	
98	Baseboard - <i>caldarium</i> 2, eastern wall.	Linear transition element between wall and floor surfaces, extending throughout the wall, h: 12, t: 1.5.	Partial loss of the element.	
99	Baseboard - <i>caldarium</i> 2, southern <i>alveus</i> , eastern wall.	Linear transition element between wall and floor surfaces, extending throughout the wall, h: 17, t: 1.5.	-

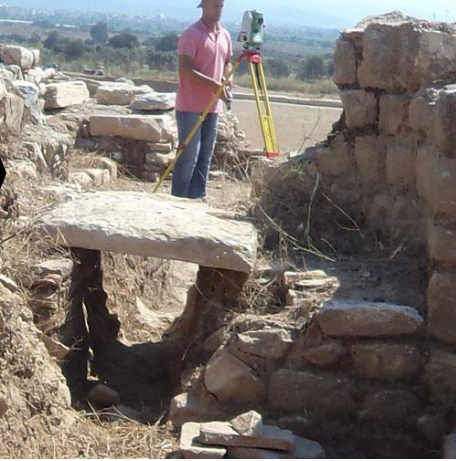
<p>Appendix H, Appendix I</p>
107	Door - <i>caldarium</i> 2, east.	Rectangular (w:221, l:226) planned opening enriched with pilasters on its two sides + a recess (~50x15) on its <i>caldarium</i> 2 face, on its two sides + marble inlay, providing circulation between <i>caldarium</i> 1 and <i>caldarium</i> 2, small in size to control heat loss.	Extensive loss of wall bounding the opening, total loss of finishing elements.

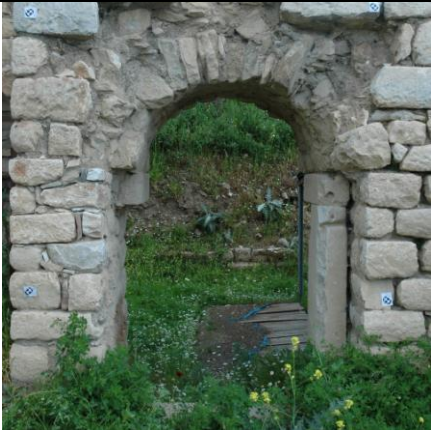
<p>Appendix H, Appendix I</p>
109	Door - <i>caldarium</i> 3, north.	Opening (w:136, l:50) providing circulation between <i>caldarium</i> 3 and an unexcavated space, enriched with recesses (~36x15) on its two sides + 3 marble steps leading to the opening, small in size to control heat loss.	Extensive loss of wall bounding the opening, total loss of finishing elements.	
110	Marble inlay - <i>caldarium</i> 2, east.	Horizontal marble pieces in different sizes lying on the bottom of the door opening only (~w:221, l:262).	Slight embedding into the earth.

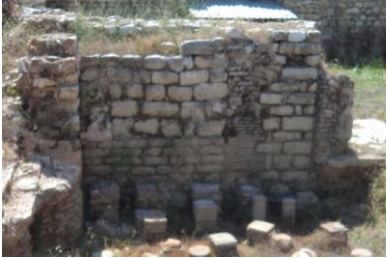
26	Wall - <i>caldarium</i> 1, west, northern part.	Structural	Rubble stone (~16x6x25) + embedded in lime mortar (t: 6-7): core; facing with irregular sized rough cut stones (~43x19x12), brick lime mortar (t: 3): <i>opus vittatum</i> , hmax: ~332.	Loss of height: partial collapse, total loss of plastering.

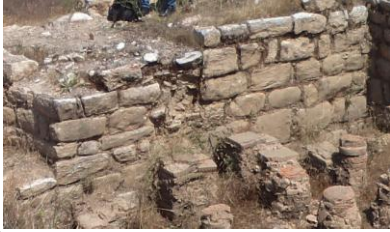
<p style="text-align: right;">Appendix J</p>
29	Wall - <i>caldarium</i> 1, east, southern part.	Structural	Rubble stone (~16x6x25) + embedded in lime mortar (t: 6-7): core; facing with irregular sized rough cut stones (~43x19x12), brick lime mortar (t: 3): <i>opus vittatum</i> , hmax: ~241.	Loss of height: partial collapse, total loss of plastering.

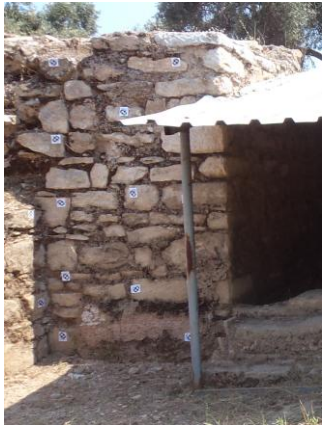
34	Wall - <i>caldarium</i> 2, south, western part.	Structural	Rubble stone (~16x6x25) + embedded in lime mortar (t: 6-7): core; facing with irregular sized rubble stones (~43x19x12), brick lime mortar (t: 3): <i>opus incertum</i> , hmax: ~311.	Loss of height: partial collapse, total loss of plastering.

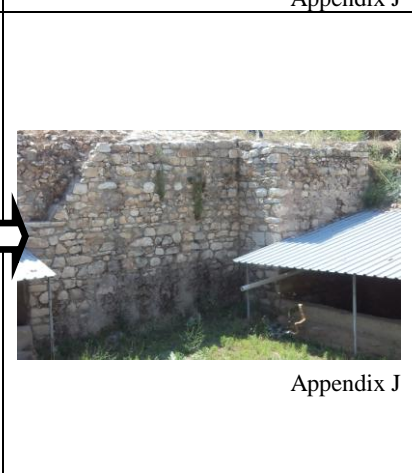
37	Wall - <i>caldarium</i> 2, north, western part.	Structural	Rubble stone (~16x6x25) + embedded in lime mortar (t: 6-7): core; facing with irregular sized rubble stones (~43x19x12), brick lime mortar (t: 3): <i>opus incertum</i> , hmax: ~377.	Loss of height: slight collapse, total loss of plastering, empty joints.

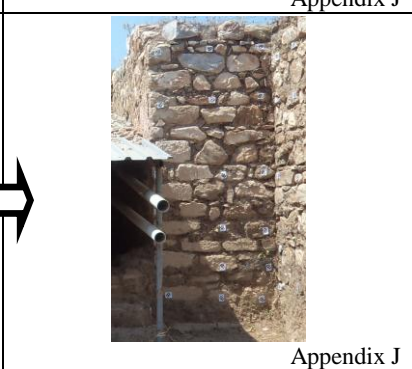
Appendix J
38	Wall - <i>caldarium</i> 2, north, eastern part.	Structural	Rubble stone (~16x6x25) + embedded in lime mortar (t: 6-7): core; facing with irregular sized rubble stones (~43x19x12), brick lime mortar (t: 3): <i>opus incertum</i> , hmax: ~299.	Loss of height: slight collapse, total loss of plastering, empty joints.

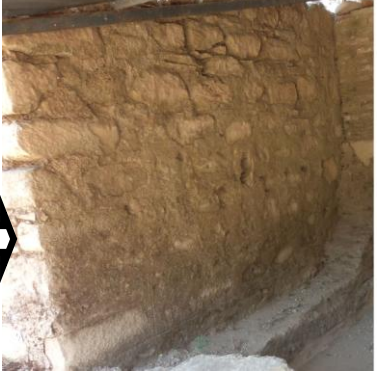
<p>Appendix J</p>
40	Wall - <i>caldarium</i> 2, east, southern part.	Structural	Rubble stone (~16x6x25) + embedded in lime mortar (t: 6-7): core; facing with irregular sized rubble stones (~43x19x12), brick lime mortar (t: 3): <i>opus incertum</i> , hmax: ~125.	Loss of height: extensive collapse, total loss of plastering, empty joints.	<p>Appendix J</p>
41	Wall - <i>caldarium</i> 2, southern <i>alveus</i> , east.	Structural	Rubble stone (~16x6x25) + embedded in lime mortar (t: 6-7): core; facing with irregular sized rubble stones (~43x19x12), brick lime mortar (t: 3): <i>opus incertum</i> , lime plaster (t: ~3.5), h: ~284.	Loss of height: partial collapse, partial loss of plastering, empty joints.

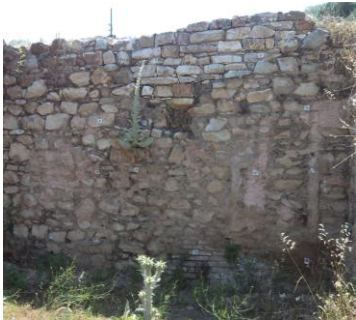
<p>Appendix J</p>
51	Wall - <i>caldarium</i> 3, west.	Structural	Rubble stone (~16x6x25) + embedded in lime mortar (t: 6-7): core; facing with irregular sized rubble stones (~43x19x12), brick lime mortar (t: 3): <i>opus incertum</i> , repair brick at central bottom part, brick lime plaster (t: ~4), hmax: ~404.	Loss of height: partial collapse, extensive loss of plastering, empty joints.

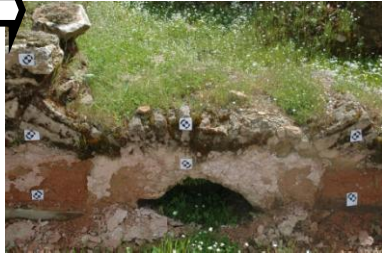
Appendix J
63	Furnace opening - <i>caldarium</i> 1, southern <i>alveus</i> , southern wall.	Architectural	Opening with a wall piece covered brick lime plaster, covered a brick arch system.	Partial loss of the infill.

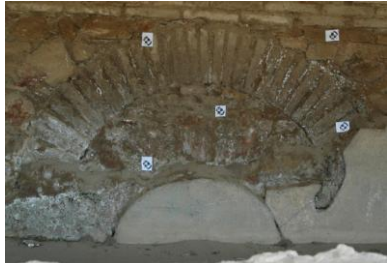
Appendix J
64	Furnace opening - <i>caldarium</i> 2, southern <i>alveus</i> , southern wall.	Architectural	Opening covered with an arch covered with double layered plastering: brick lime under-layer, hydraulic lime top-layer.	Mortar pieces on the intrados surface of arch, partial loss of double-layered plastering, loss of integrity, deposit formation.

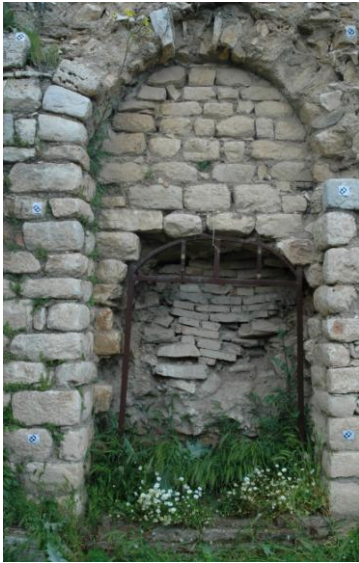
<p style="text-align: right;">Appendix J</p>
83	Pilaster - <i>caldarium</i> 2, eastern wall, southern part.	Architectural	Bricks (~15 or 30x5x30) + lime mortar (t: ~3); brick lime plaster (t: ~5).	Extensive loss of the element: extensive loss of shaft, extensive loss of plastering, deposit formation.	
84	Niche - <i>caldarium</i> 1, northern wall, west.	Architectural	Rubble stone (~16x6x25) + embedded in lime mortar (t: 6-7): core; facing with irregular sized rough cut stones (~43x19x12), brick lime mortar (t: 3): <i>opus vittatum</i> , repair brick and stone at central part, metal supporting elements.	Partial loss of the element, total loss of plastering, deposit formation, plant growth.

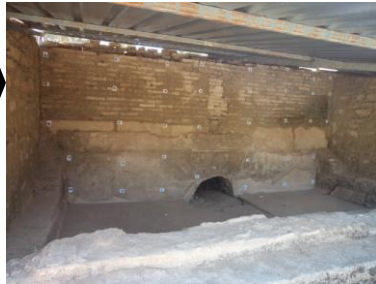
<p>Appendix J</p>
88	<i>Tubuli</i> system - <i>caldarium</i> 2, western wall.	Architectural	A single terra cotta element attached to the wall with lime mortar.	Loss of integrity, deposit formation.	
89	<i>Alveus</i> - <i>caldarium</i> 1, south.	Architectural	Surrounded by three walls, a stair on its sides, marble inlay on the ground.	Loss of the superstructure.
