**CONSERVATION PROJECT OF LATİFE HANIM
HOUSE IN KARŞIYAKA, İZMİR**

**A Thesis Submitted to
the Graduate School of Engineering and Sciences of
İzmir Institute of Technology
in Partial Fulfillment of the Requirements for the Degree of**

in Architectural Restoration

**by
Esra DİPBURUN**

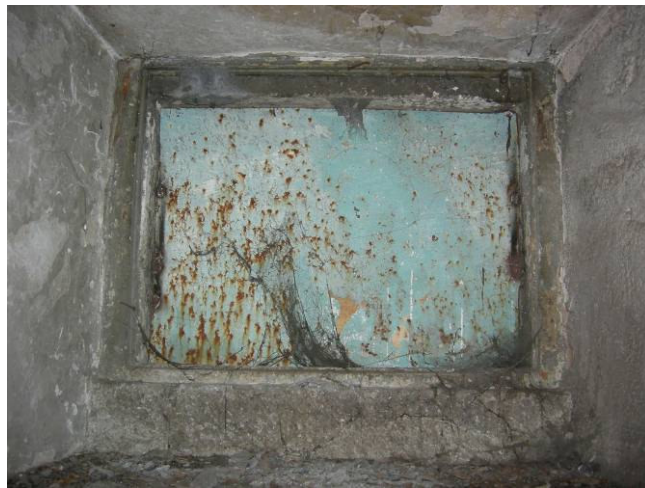
Figure 2.15. The window of wet space 1 at the basement floor.

Wet space 1, at the northern side of the corridor, is rectangle in plan (4.45 by 2.90m.) and entered through a door opening (0.90 by 2.00 m.) that has no leaf at present. From the trace on the wall, it is observed that the frame of the door is missing at the western side. Its ceiling is covered with wood lath (Figure A.3). There are gypsum moldings at the sides where the ceiling and the walls connect. The walls of the space are plastered. The northern wall of the space extends to the garden with a window opening (0.75 by 0.60m.). Its joinery is timber, but has no window leaf at present (Figure 2.15). The plaster on the bottom part of the walls is lost (Figure 2.16). On the eastern wall of the space, there is a door opening which connects this space to the bathroom. The floor of the wet space 1 can not be observed because of the rubble waste on it.

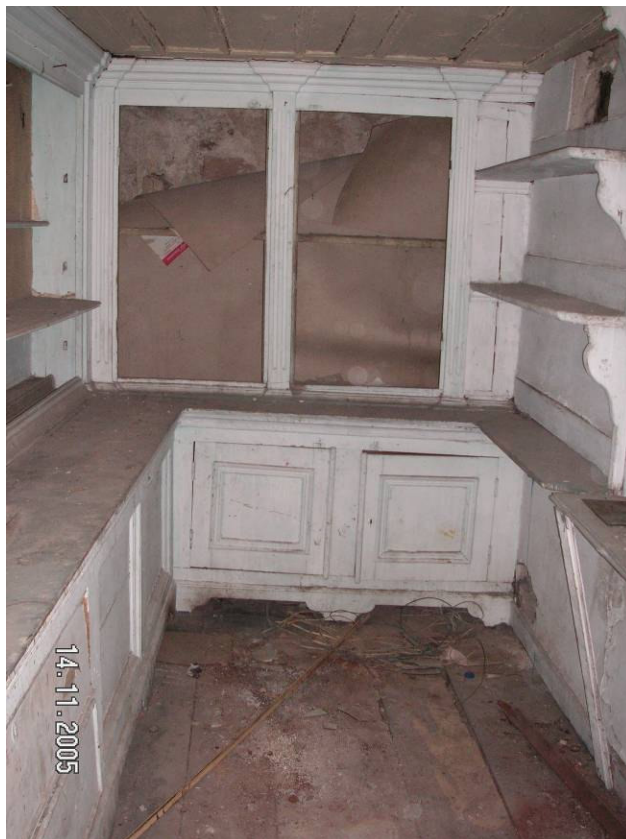
Figure 2.101. The east wall of the kitchenette.

The loss elements are observed at various spaces in the building. All the window shutters of the ground and first floor windows are missing. Door leaves of the wet space 1 and 2 at the basement, door leaves of the rooms at the mezzanine floor (Figure 2.114, Figure D.5), door leaf of the wet space at the first floor, and window leaves of wet space 1 and 2 at the basement and window leaves of room 6 (Figure 2.76) at the first floor are missing. The lids of the kitchenette cupboards are lost as well (Figure 2.101).

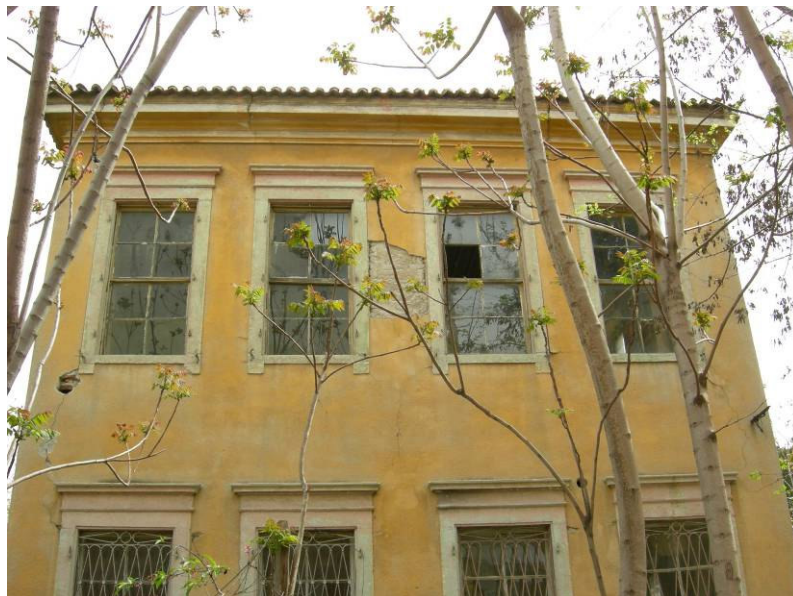
It is observed that Latife Hanım House in Karşıyaka has limited structural problems (Appendix E). The cracks observed at the western wall, emerged after the earthquakes in November 2005¹ (Figure 2.117). Especially those at the northern corner of the western wall are the most important structural failures in the building. These are detachments in the mentioned wall starting from the cornice level and continuing uptil to the starting zone of the ground floor level. (Figure 2.118). When the distribution of the cracks on this western wall are considered, it is understood that the excess number of openings create a great load on the masonry wall piece between the ground and the first floor opening series (Figure 2.119). The majority of the cracks are located at this area. A long, but thinner crack is observed at the southern corner of this wall as well (Figure E.12). It is assumed that the link between the floor and this western wall is not strong enough. In turn, cracks are have formed².

Figure 2.119. The distribution of openings on the western wall.

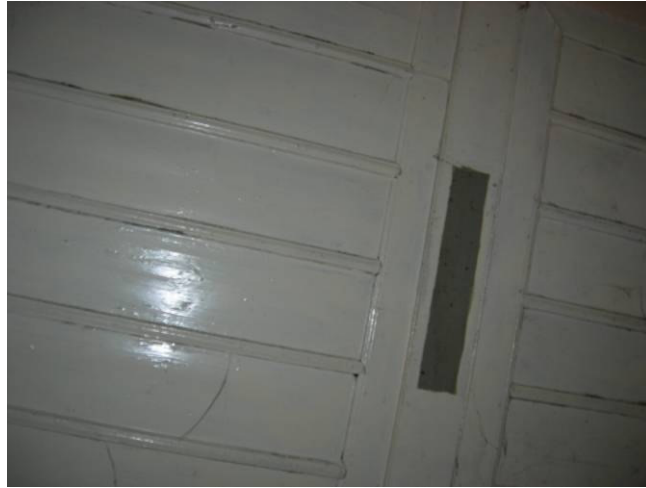
Figure 4.14. The trace of a separator on the ceiling of wet space at the first floor.

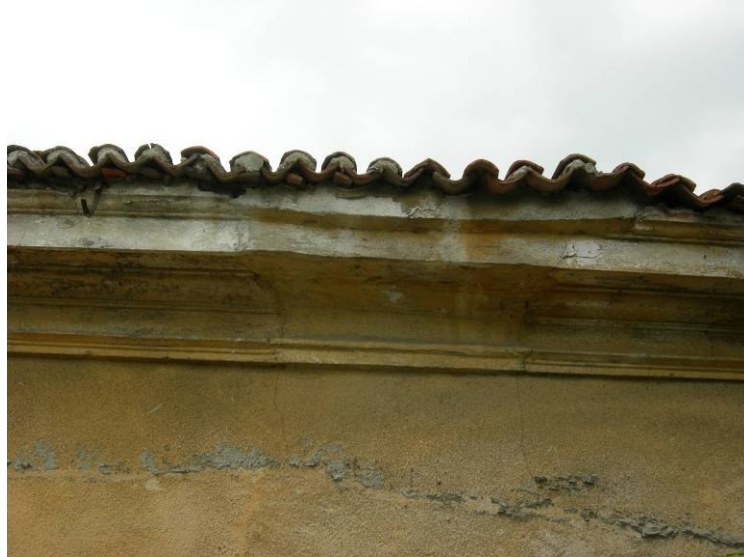
Figure 4.16. The trace of the fireplace at the eastern facade of the house.

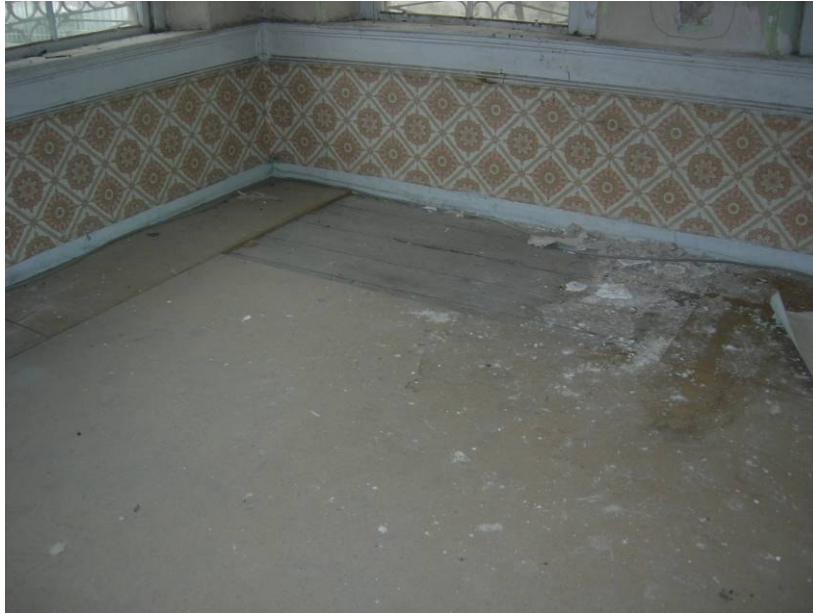
Figure 5.1. The additional chipboard coverings on the floor of room 1, 2 and 3 which should be removed.

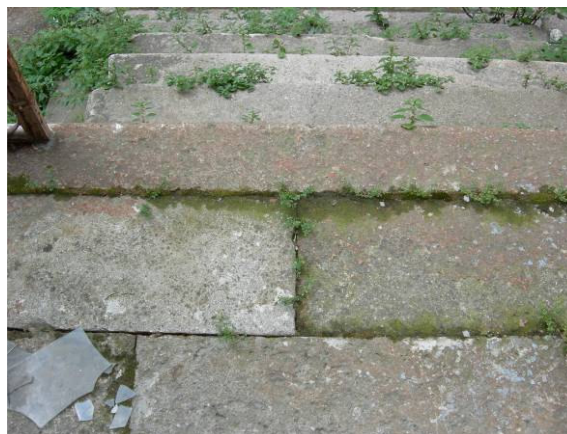
The cleanings are suggested: The soluble salts on the walls of the basement should be cleaned with the aid of leaching packs or poultices¹² (Figure I.1, Figure I. 9). On some of the stones covering the terrace, there are rust stains due to corrosion of iron balustrade (Figure 5.13). These stains should be removed.¹³ The crust on the stone

Figure 5.13. The rust stains on the stone that are suggested to be cleaned.
