**IMPORTANCE OF CONDITION SURVEY AND
REPORT OF BUILT CULTURAL HERITAGE:
DÜZCE (HEREKE) BATH**

in Architectural Restoration

IMPORTANCE OF CONDITION SURVEY AND REPORT OF BUILT CULTURAL HERITAGE: DÜZCE (HEREKE) BATH

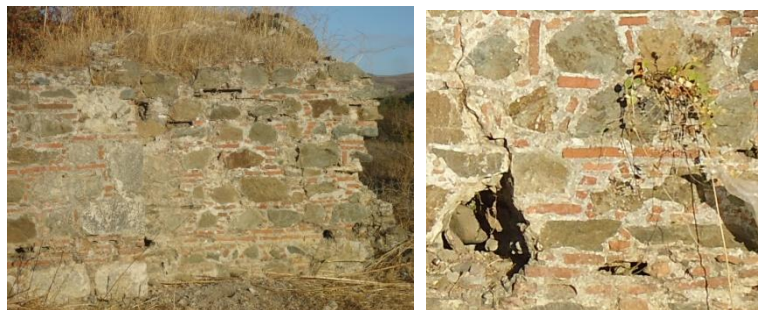
West wall of the bath (Figure 4.4) has sustained loss. It is the entrance door behind metal sheet. Observed structural failures are missing (collapsed) part of the wall on the right part of wall (~20 cm. behind); missing roughly cut stone on the left edge; missing bricks in the middle (*Sıcaklık* and *Halvet* walls) part; splitting on the middle (*Halvet* wall) and the right (water reservoir wall) parts, also small plants were observed

Figure 4.5.A. Missing part of West wall

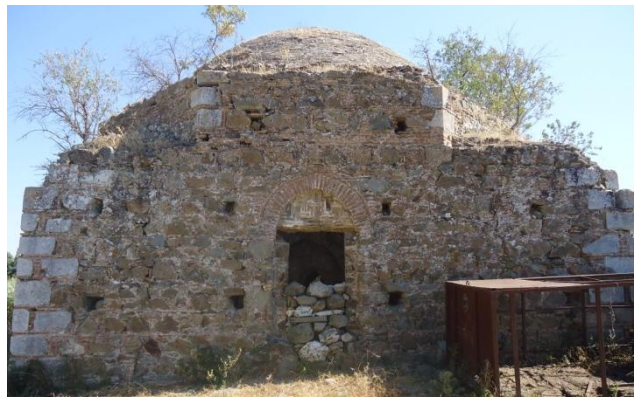
Figure 4.6. North wall - 1 of Düzce Bath

stones in the middle part, and splitting (Figure 4.7) on the left of wall. Observed material deteriorations are microbiological colonizations, black crusts (especially on the left and right of the wall), efflorescences (Figure 4.7) (especially on the left and right of the wall), pittings, discolorations and hair cracks on the whole wall.

According to the findings, North wall - 1 displays moderate symptoms and condition class of the wall is CC2, recommendation class of the wall is RC2, and urgency class of the wall is UC2 (Appendix.B, Appendix.C).

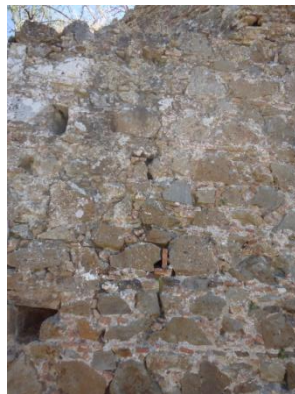
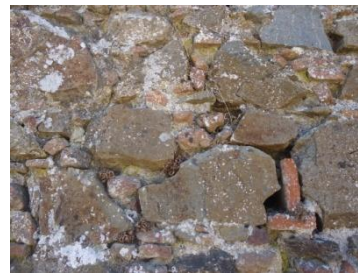
Figure 4.7.A. Splitting on the North wall - 1
B. Efflorescences on the North wall - 1

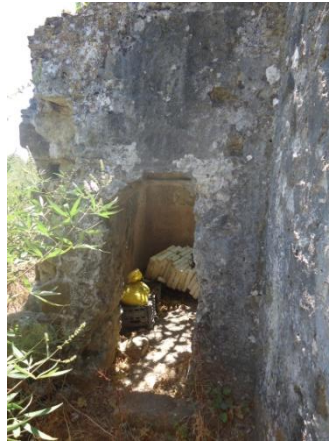
Figure 4.8. North wall - 2 of Düzce Bath

North wall - 2 of the bath has sustained loss. It is the window. Observed structural failures are missing (collapsed) part of wall below the window trace, missing stones in the left part, and splitting on the left of wall. Observed material deteriorations are microbiological colonizations, black crusts (especially above the wall), efflorescences (especially around window trace), discolourations, and pittings on the whole wall.

According to the findings, North wall - 2 displays moderate symptoms and condition class of the wall is CC2, recommendation class of the wall is RC2, and urgency class of the wall is UC2 (Appendix.B, Appendix.C).

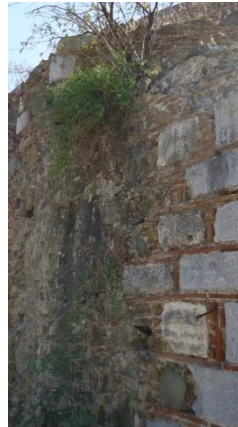
Figure 4.9. Plants on East wall - 1

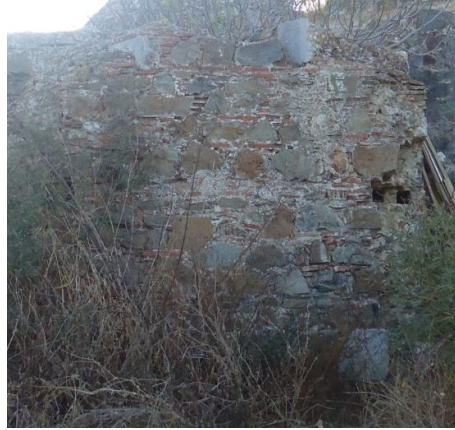
Figure 4.10. East wall - 2 of Düzce Bath

Observed structural failure involves missing (collapsed) part on the right part of the wall. Observed material deteriorations are microbiological colonizations, black crusts, efflorescences, and discolourations on the whole wall.

According to the findings, East wall - 2 displays moderate symptoms and condition class of the wall is CC2, recommendation class of the wall is RC2, and urgency class of the wall is UC2 (Appendix.B, Appendix.C).

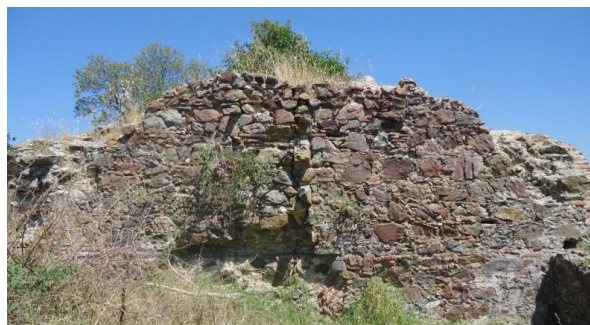
Figure 4.11. South wall - 1 of Düzce Bath

Observed structural failures are missing part of the wall, splitting, and plants in the middle of the wall. Observed material deteriorations involve discolourations on stones, bricks and mortars.

According to the findings, South wall - 1 displays moderate symptoms and condition class of the wall is CC2, recommendation class of the wall is RC2, and urgency class of the wall is UC2 (Appendix.B, Appendix.C).

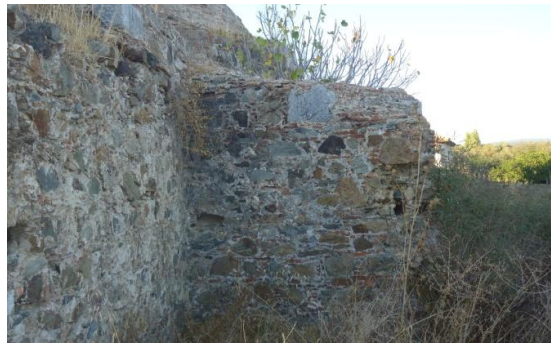
Figure 4.12. South wall - 2 of Düzce Bath

Observed structural failure involves missing stone on the left part of wall. Observed material deteriorations are microbiological colonizations, black crusts, efflorescences, and discolourations on the whole wall.

According to the findings, South wall - 1 displays moderate symptoms and condition class of the wall is CC2, recommendation class of the wall is RC2, and urgency class of the wall is UC2 (Appendix.B, Appendix.C).

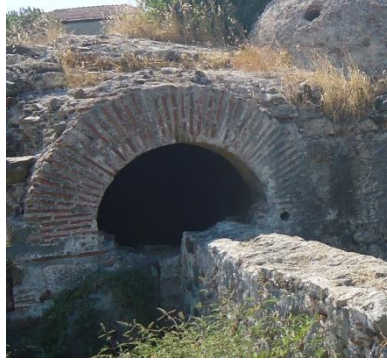
Figure 4.13. Arch of Düzce (Hereke) Bath

No structural failure was observed on the arch. Observed material deteriorations are black crusts, efflorescences, discolourations, pittings and microbiological colonizations on the whole arch surface. Microbiological colonizations were seen on the right part of the wall intensely.

According to the findings, the arch displays minor symptoms and condition class of the arch is CC1, recommendation class of the arch is RC1, and urgency class of the arch is UC1 (Appendix.B, Appendix.C).

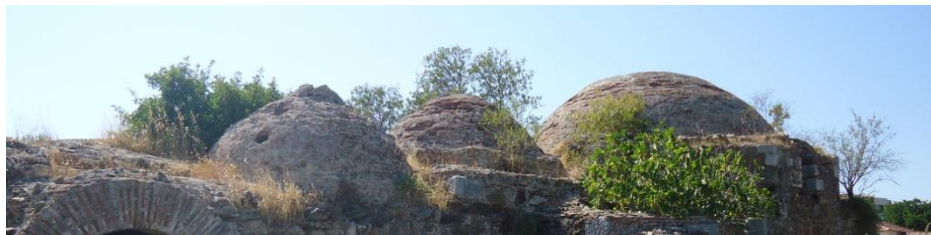
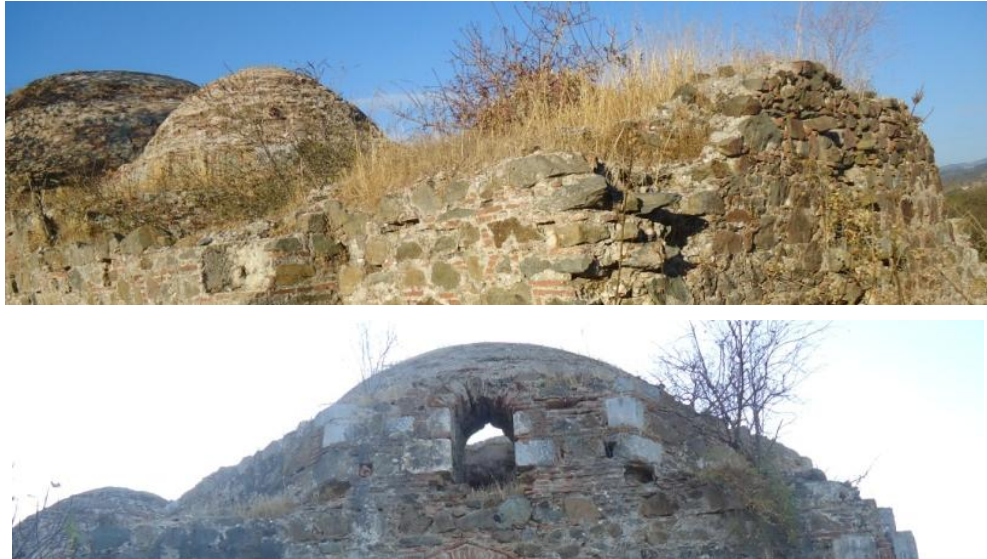
Figure 4.14. Superstructure of Düzce Bath

Superstructure of the bath has sustained losses. They are top windows on *Soyunmalık* dome; top skylight on *Sıcaklık* dome; and oculis. Observed structural failures are widely missing (collapsed) part of dome of *Soyunmalık*, Cleaning Cell (*tıraşlık*) and South East *Halvets*; missing central small dome of *Sıcaklık* (top skylight); missing bricks in *Soyunmalık* dome; splitting in *Soyunmalık* dome and barrel vault (water reservoir's superstructure); broken bricks around colapsed areas; plants on all drums and begginings of the domes and barrel vaults, and all superstructures surfaces. Observed material deteriorations are black crusts, especially on drums' roughly cut stones; efflorescences, discolorations, and pittings on the whole superstructure.

According to the findings, superstructure of bath displays major symptoms and condition class of the superstructure is CC3, recommendation class of the superstructure is RC3, and urgency class of the superstructure is UC3 (Appendix.B, Appendix.C).

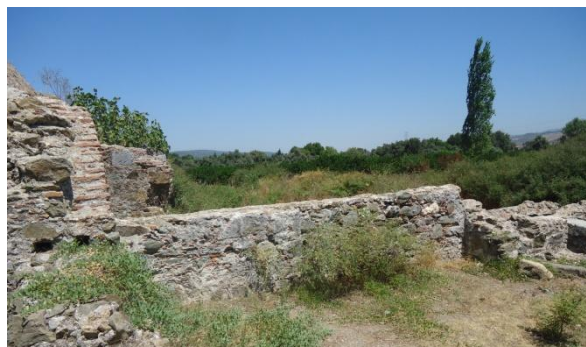
Figure 4.15. The wall (between cistern and water reservoir)

Observed structural failure involves joint discharge which is close to cistern. Efflorescences and discolourations were observed as material deteriorations on the wall.

According to the findings, the wall displays moderate symptoms and condition class of the wall is CC2, recommendation class of the wall is RC2, and urgency class of the wall is UC2 (Appendix.B).

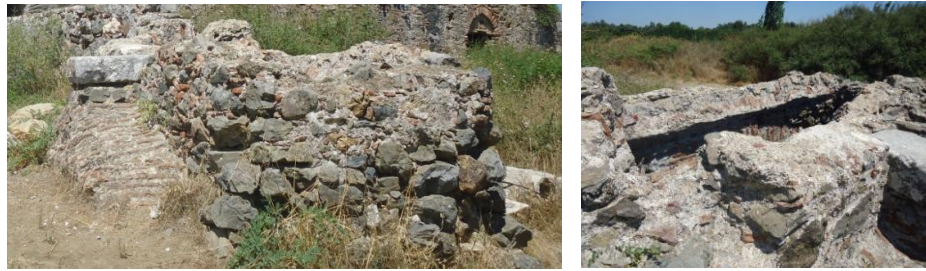
Figure 4.16. The cistern

The walls of cistern have missing (collapsed) parts and joint discharges as structural failures. Observed material deteriorations are efflorescences, discolourations, and pittings.

According to the findings, the cistern walls display major symptoms and condition class of the wall is CC3, recommendation class of the wall is RC3, and urgency class of the wall is UC3 (Appendix.B, Appendix.C).

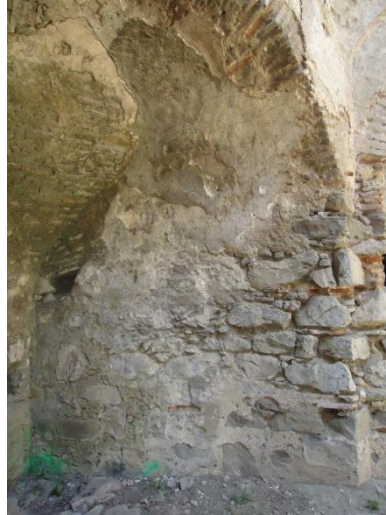
Figure 4.18. Left part of the West wall

No severe damage was observed in the left part of the wall (Figure 4.18). Observed structural failures are joint discharges (Figure 4.19) in unplastered area and missing small parts on bricks and stones. Observed material deteriorations are green graffiti on the corner of wall (Figure 4.19), black crusts that was observed near the graffiti, pittings and efflorescences on mortar below the plastered area, and discolourations on bricks and stones. All findings were evaluated and condition class of the left part of the wall was defined as CC1.

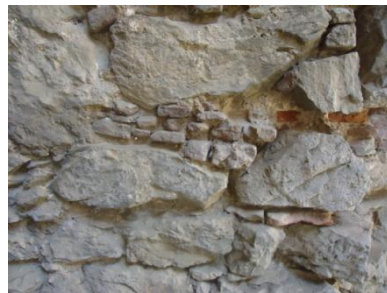
Figure 4.19.A. Joint discharge on the left part of wall
B. Graffiti on the left part of wall

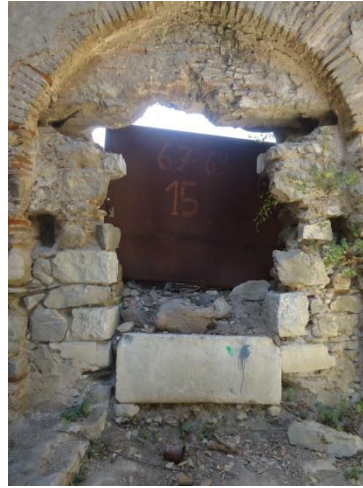
Figure 4.20. Middle part of the West wall

The middle part of wall (Figure 4.20) has sustained losses. They are entrance door and timber beam. Observed structural failures are missing (collapsed) parts and joint discharges (Figure 4.21) around missing elements' boundaries. Apart from these, missing part of the roughly cut stone is at the upper right of the altered floor level and alveolizations were seen on stones below the beam trace. Observed material deteriorations are white crusts below the wall; efflorescences above the left space; pittings (Figure 4.21) on mortars under the arch. All findings were evaluated and condition class of middle part of wall was defined as CC3.

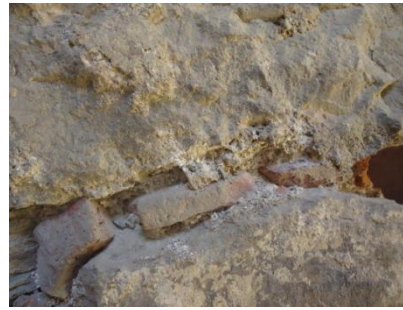
Figure 4.21.A. Joint discharges on the middle part of the wall
B. Pittings on the middle part of the wall

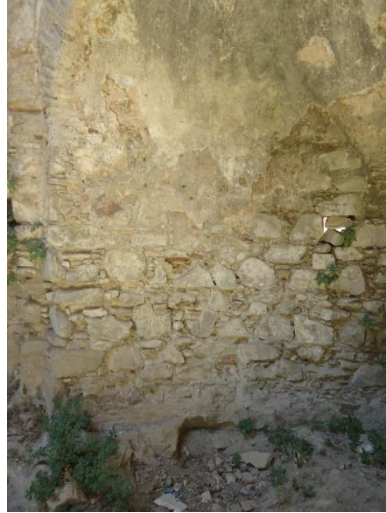
Figure 4.22. Right part of the West wall

No severe damage was seen in the right part of the wall (Figure 4.22). The most severe structural failure is joint discharge from ground up to 60 - 70 centimeters height. Alveolizations (Figure 4.23) were seen on stones and mortars upper part of wall. Observed material deteriorations are pittings and discolourations (Figure 4.23) on most stones and mortars and some bricks. All findings were evaluated and condition class of right part of wall was defined as CC2.

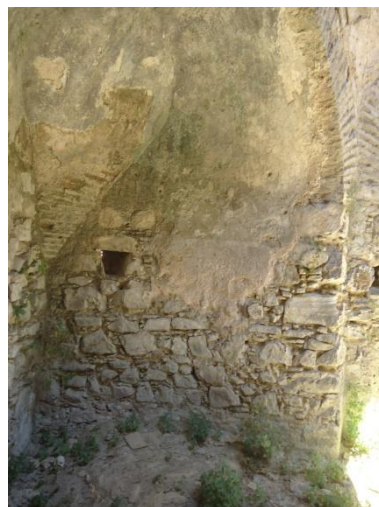
Figure 4.25. Left part of the North wall

No severe damage was observed in the left part of the wall (Figure 4.25). Observed structural failures are joint discharges from ground to plastered area and missing small parts on bricks and stones. Observed material deteriorations are hair cracks; pittings; black crusts from ground to plastered area; and efflorescences on stones and bricks. Also discolourations are widespread. All findings were evaluated and condition class of left part of the wall was defined as CC1.

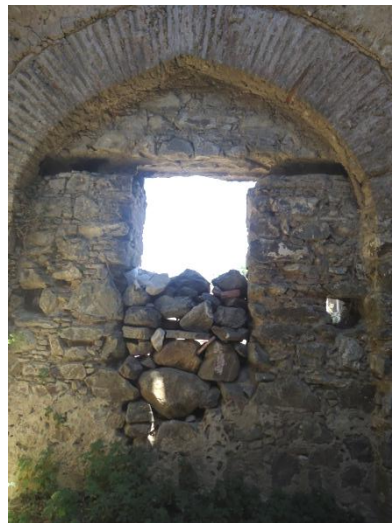
Figure 4.26. Middle part of the North wall

The middle part of the wall (Figure 4.26) has sustained losses. They are window and timber beam. From 40 centimeters height to window trace, the missing (collapsed) part was observed. Missing stone was observed below the timber beam trace. Under the beam trace joint discharges; above the beam trace star crack (Figure 4.27) were seen. Observed material deteriorations are pittings above beam trace; efflorescences and black crusts (Figure 4.27) on the whole wall. Also discolourations are widespread. All findings were evaluated and condition class of the middle part of the wall was defined as CC3.

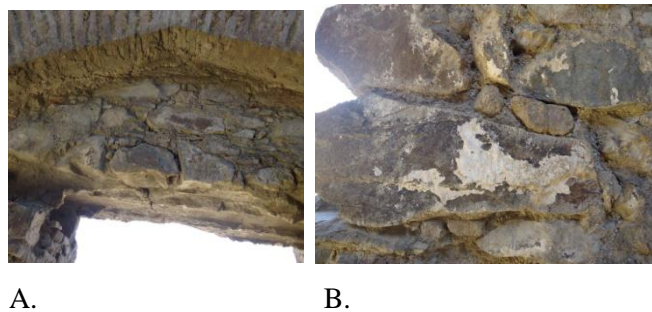
Figure 4.27.A. Star crack on the middle part of the wall
B. Black crusts on the middle part of the wall

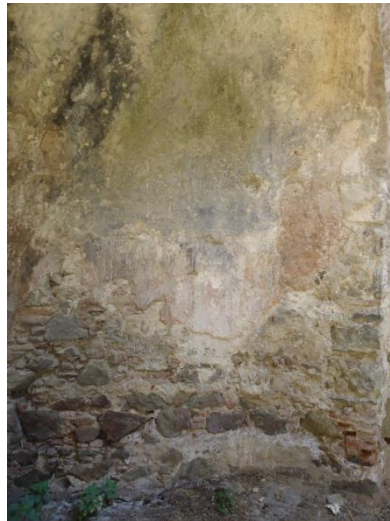
Figure 4.30. Left part of the East wall

No severe damage was seen in the left part of the wall (Figure 4.30). In the unplastered small area, no structural failure was observed. Observed material deteriorations are pittings on bricks, stones and mortars, and discolourations on surface. All the findings were evaluated and condition class of left part of the wall was defined as CC0.

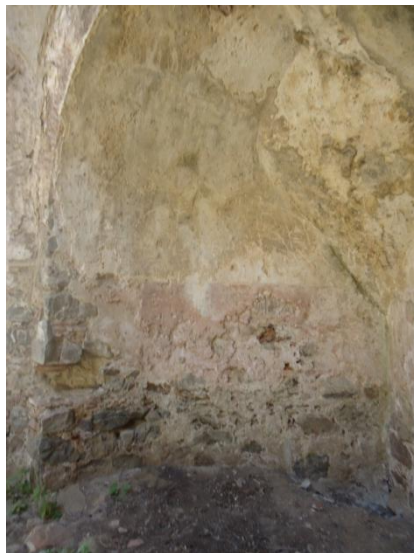
Figure 4.32. Right part of the East wall

No visual deterioration was observed in the right part of the wall (Figure 4.32). All the findings were evaluated and condition class of the middle part of the wall was defined as CC0.

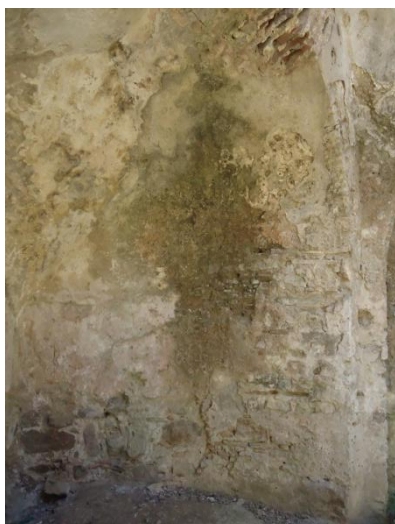
Figure 4.34. Left part of the South wall

No severe damage was observed in the left part of the wall (Figure 4.34). In the unplastered small area, no structural failure was observed. Observed material deteriorations are small pittings on bricks and mortars. All the findings were evaluated and condition class of left part of wall was defined as CC0.

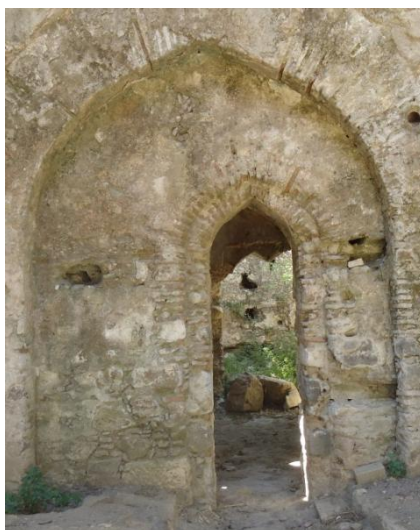
Figure 4.35. Middle part of the South wall

The middle part of the wall (Figure 4.35) has sustained losses. They are the door and the flue. Observed structural failures involve joint discharges (Figure 4.36) around the door trace. Observed material deteriorations are efflorescences and pittings (Figure 4.36). Also discolourations were observed on the bricks and stones. All findings were evaluated and condition class of the middle part of the wall was defined as CC2.

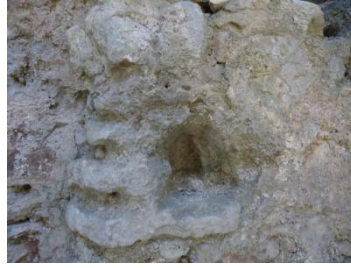
Figure 4.36.A. Joint discharge in the middle part of wall
B. Pittings on the middle part of wall

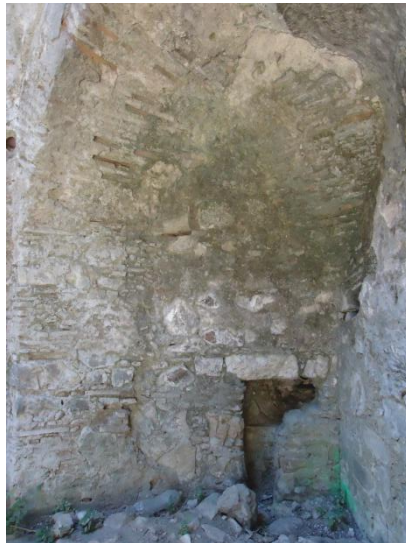
Figure 4.37. Right part of the South wall

No severe damage was observed in the right part of the wall (Figure 4.37). The general condition assessment revealed that the wall has sustained losses. They are the basin and the flue. No structural failure was observed. Observed material deteriorations are small pittings on the mortars (Figure 4.38); efflorescences; microbiological colonizations (Figure 4.38) on semi part of the wall; and green graffiti. All findings were evaluated and condition class of the right part of the wall was defined as CC1.

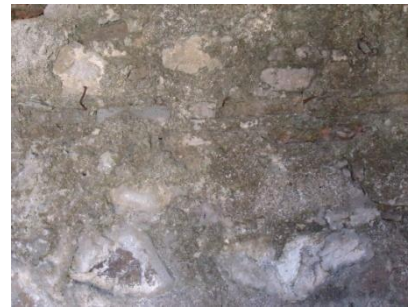
Figure 4.38. Pittings and microbiological colonizations on the right part

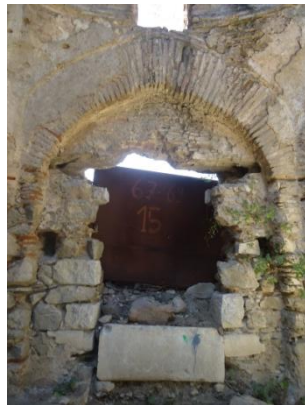
Figure 4.39. West arch of *Soyunmalik*

The general condition assessment revealed that the arch is in a good condition. Observed structural failures are joint discharges on left and right of the door trace; convex deformation (Figure 4.40) below the right of the top point of the arch, and missing parts below the timber beam trace. Observed material deteriorations are pittings on the mortars and black crusts. Black crusts were observed on middle part of arch (~20 centimeters) intensely. Also discolourations were observed on the bricks.

According to the findings, the arch displays minor symptoms and condition class of the arch is CC1, recommendation class of the arch is RC1, and urgency class of the arch is UC1 (Appendix.B, Appendix.C).

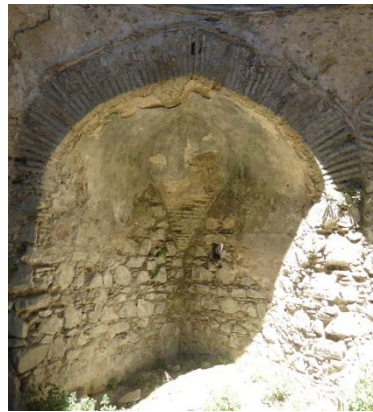
Figure 4.41. North West arch of *Soyunmalik*

The general condition assessment revealed that the arch is in a good condition. Observed structural failures are joint discharges on the base; and missing bricks on the top point and left of the arch. Observed material deteriorations are pittings on the mortars and black crusts. Black crusts were observed on mortars and stones from

plastered area to ground, especially inner surface of niches. Also discolourations were observed in components in different intensities.

According to the findings, North West arch displays minor symptoms and condition class of the arch is CC1, recommendation class of the arch is RC1, and urgency class of the arch is UC1 (Appendix.B).

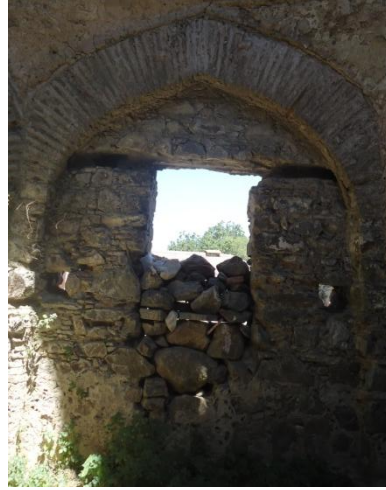
Figure 4.42. North arch of *Soyunmalik*

The general condition assessment revealed that the arch is in a good condition. Observed structural failures are joint discharges from ground up to 50 - 60 centimeters, and missing brick on the right of arch on the timber beam level. Observed material deteriorations are pittings on the mortars, efflorescences near the empty square space, black crusts, and discolourations on the base of arch up to window's middle height.

According to the findings, North arch displays minor symptoms and condition class of the arch is CC1, recommendation class of the arch is RC1, and urgency class of the arch is UC1 (Appendix.B).

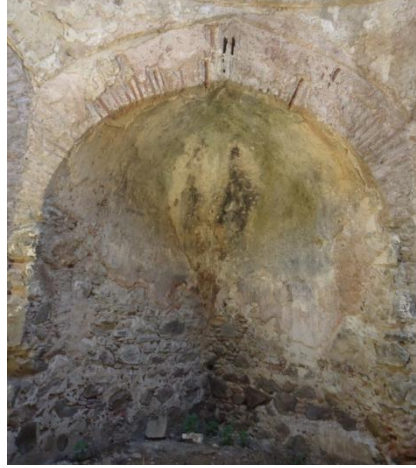
Figure 4.43. North East arch of *Soyunmalik*

The general condition assessment revealed that the arch is in a good condition. Observed structural failures are missing bricks on the top point of the arch and alveolization on the stone which is located inner part of the arch, on the 15 centimeters height from ground. Observed material deteriorations are pittings on mortars, widespread efflorescences and discolourations, and rarely seen black crusts below the wall.

According to the findings, North East arch displays minor symptoms and condition class of the arch is CC1, recommendation class of the arch is RC1, and urgency class of the arch is UC1 (Appendix.B).

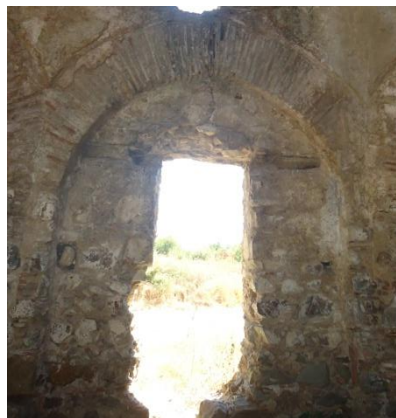
Figure 4.44. East arch of *Soyunmalik*

The general condition assessment revealed that the arch is in a good condition. Observed structural failures are missing part of brick in the right of the top point and below the arch. Observed material deteriorations are pittings, black crusts on the mortar, efflorescences, and discolourations which were seen widespread and homogenously.

According to the findings, East arch displays minor symptoms and condition class of the arch is CC1, recommendation class of the arch is RC1, and urgency class of the arch is UC1 (Appendix.B).

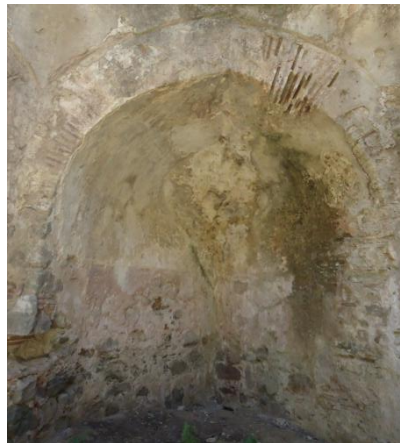
Figure 4.45. South East arch of *Soyunmalık*

The general condition assessment revealed that the arch is in a good condition. Observed structural failures are missing bricks in the right part of the arch. Observed material deteriorations are pittings on the mortars, black crusts on the upper part of the arch, small efflorescences, and discolourations on the bricks and stones on the base of the arch.

According to the findings, South East arch displays minor symptoms and condition class of the arch is CC1, recommendation class of the arch is RC1, and urgency class of the arch is UC1 (Appendix.B).

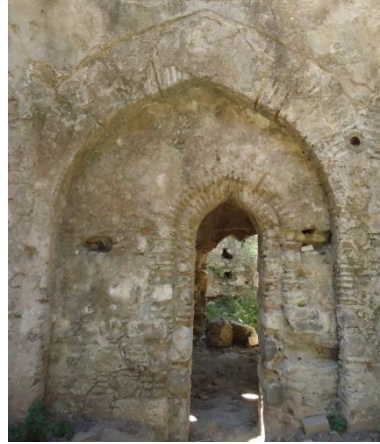
Figure 4.46. South arch of *Soyunmalik*

The general condition assessment revealed that the arch is in a good condition. No structural failure was observed. Observed material deteriorations are pittings, black crusts on the right of top point of the arch, microbiological colonizations on the right part of the arch, and discolourations on the bases.

According to the findings, East arch displays minor symptoms and condition class of the arch is CC1, recommendation class of the arch is RC1, and urgency class of the arch is UC1 (Appendix.B).

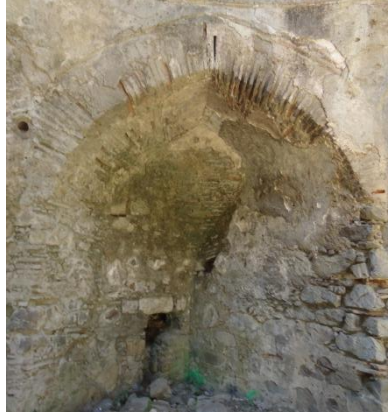
Figure 4.47. South West arch of *Soyunmalik*

The general condition assessment revealed that the arch is in a good condition. Observed structural failures are missing bricks in the right part of top point of arch and joint discharges inner surface and upper part of the arch. Observed material deteriorations are white crusts on the upper part of the arch, pittings on mortars, and discolourations.

According to the findings, South West arch displays minor symptoms and condition class of the arch is CC1, recommendation class of the arch is RC1, and urgency class of the arch is UC1 (Appendix.B, Appendix.C).

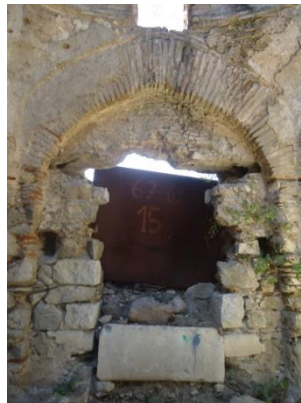
Figure 4.66. West arch plaster of *Soyunmalık*

Loss of plaster was observed on the arch bases. On the left part of the current plaster, discolourations; black crusts and pittings were observed. On the right part of arch, two small areas are plastered and they have discolourations; delaminations and pittings.

According to the findings, the plaster displays major symptoms and condition class of the plaster is CC3, recommendation class of the plaster is RC3, and urgency class of the plaster is UC3 (Appendix.B).

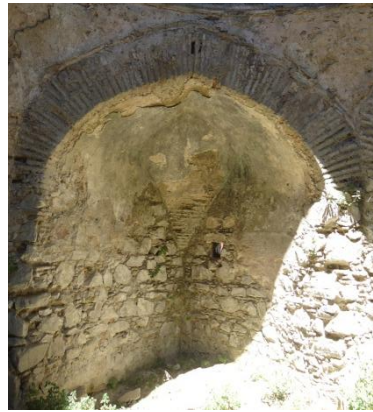
Figure 4.67. North West arch plaster of *Soyunmalık*

Loss of plaster was observed on the arch bases. Widely missing part of plaster was observed. On current plaster parts, peelings; pittings and white crusts were observed.

According to the findings, the plaster displays major symptoms and condition class of the plaster is CC3, recommendation class of the plaster is RC3, and urgency class of the plaster is UC3 (Appendix.B).

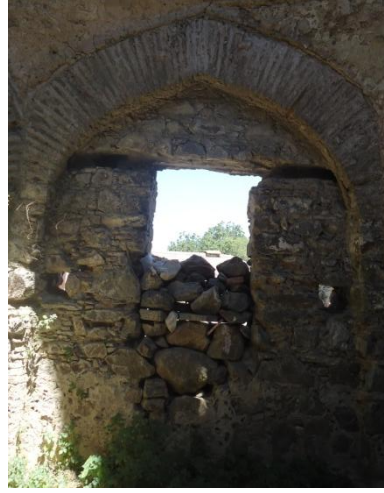
Figure 4.68. North arch plaster of *Soyunmalık*

Loss of plaster was observed on the arch bases. The arch has only two small plaster parts and they have pittings and white crusts.

According to the findings, the plaster displays major symptoms and condition class of the plaster is CC3, recommendation class of the plaster is RC3, and urgency

class of the plaster is UC3 (Appendix.B).

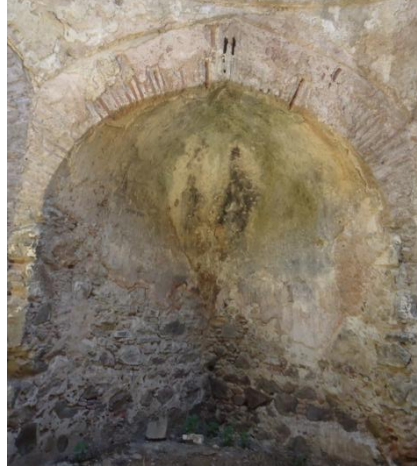
Figure 4.69. North East arch plaster of *Soyunmalık*

Loss of plaster was observed on the arch bases. The arch has only two small plaster parts on outer surface and they have pittings and delaminations. Plasters which are on inner surfaces the arch is present in large quantities and they have microbiological colonizations, black and white crusts, and hair cracks.

According to the findings, the plaster displays moderate symptoms and condition class of the plaster is CC2, recommendation class of the plaster is RC2, and urgency class of the plaster is UC2 (Appendix.B).

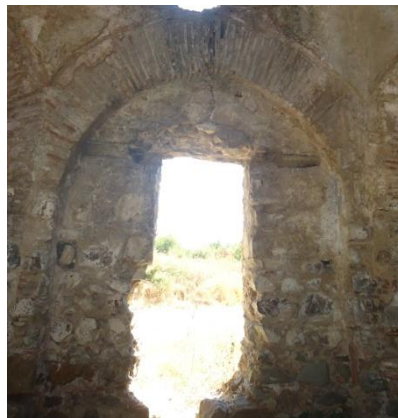
Figure 4.70. East arch plaster of *Soyunmalık*

Loss of plaster was observed on the arch bases. The arch has only two small plaster parts on the right and left of the arch and they have discolourations, pittings, peelings, and white crusts.

According to the findings, the plaster displays major symptoms and condition class of the plaster is CC3, recommendation class of the plaster is RC3, and urgency class of the plaster is UC3 (Appendix.B).

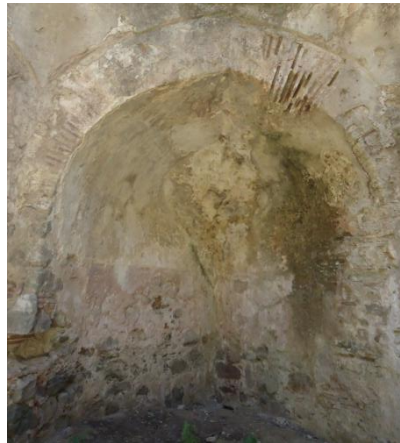
Figure 4.71. South East arch plaster of *Soyunmalık*

The plaster is present in large quantities on the surfaces. Missing parts of plaster is on the arch bases; the left of inner surfaces and the upper part. On the left part, delaminations, pittings, and white crusts were observed. On the other parts have black crusts intensely and microbiological colonizations, pittings, and discolourations were observed inner surface of plaster.

According to the findings, the plaster displays moderate symptoms and condition class of the plaster is CC2, recommendation class of the plaster is RC2, and urgency class of the plaster is UC2 (Appendix.B).

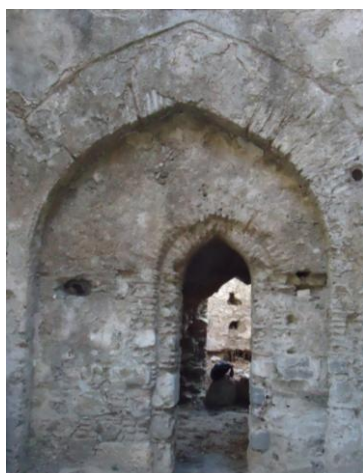
Figure 4.72. South arch plaster of *Soyunmalik*

The plaster is present in large quantities on south arch surfaces. Missing parts

are inner left and 20 centimeters right of the top point, and the right base of the arch. Pittings, black crusts, and discolourations were observed on the current plasters.

According to the findings, the plaster displays moderate symptoms and condition class of the plaster is CC2, recommendation class of the plaster is RC2, and urgency class of the plaster is UC2 (Appendix.B).

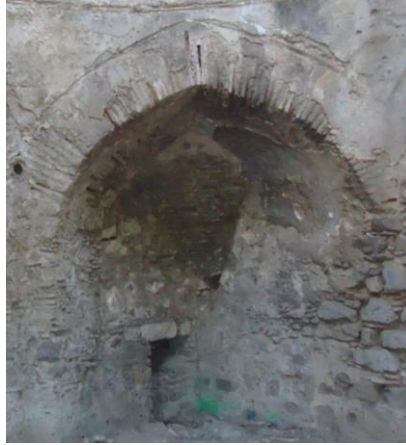
Figure 4.73. South West arch plaster of *Soyunmalik*

The plaster is semi preserved on the arch surfaces. On the upper left part of the arch, the plasters have pittings; peelings; delaminations; white crusts and intense black crusts were observed. On the upper right part of the arch, plasters have pittings; peelings; delaminations; black crusts and intense white crusts were observed. Inner surface of plasters have pittings, peelings, delaminations, black crusts, and intensely white crusts.

According to the findings, the plaster displays moderate symptoms and condition class of the plaster is CC2, recommendation class of the plaster is RC2, and urgency class of the plaster is UC2 (Appendix.B).

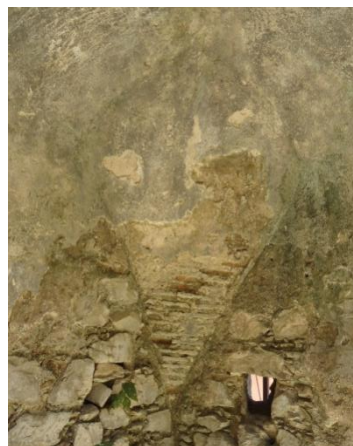
Figure 4.74. North West squinch plaster of *Soyunmalik*

North West squinch plaster has no missing part. But peelings and delaminations were observed rarely. The plaster is covered with microbiological colonizations, black and white crusts, and pittings.

According to the findings, the plaster displays moderate symptoms and condition class of the plaster is CC2, recommendation class of the plaster is RC2, and urgency class of the plaster is UC2 (Appendix.B).

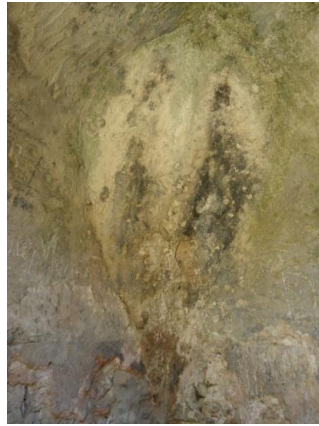
Figure 4.75. North East squinch plaster of *Soyunmalık*

North East squinch plaster has no missing part. Microbiological colonizations, black crusts, white crusts on the middle part, and pittings were observed rarely.

According to the findings, the plaster displays minor symptoms and condition class of the plaster is CC1, recommendation class of the plaster is RC1, and urgency class of the plaster is UC1 (Appendix.B).

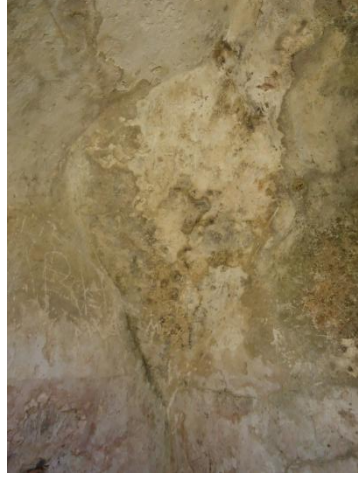
Figure 4.76. South East squinch plaster of *Soyunmalik*

South East squinch plaster has no missing part. Microbiological colonizations were seen on the line. Black crusts were seen on the line intensely and they are widespread on whole plaster. White crusts and pittings are widespread on the whole plaster.

According to the findings, the plaster displays minor symptoms and condition class of the plaster is CC1, recommendation class of the plaster is RC1, and urgency class of the plaster is UC1 (Appendix.B).

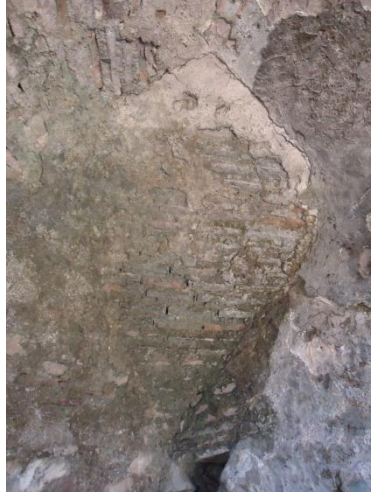
Figure 4.77. South West squinch plaster of *Soyunmalik*

South West squinch plaster has no missing part. But peelings and delaminations were observed on the plaster rarely. The plaster is covered with microbiological colonizations; black and white crusts; and pittings.

According to the findings, the plaster displays moderate symptoms and condition class of the plaster is CC2, recommendation class of the plaster is RC2, and urgency class of the plaster is UC2 (Appendix.B).

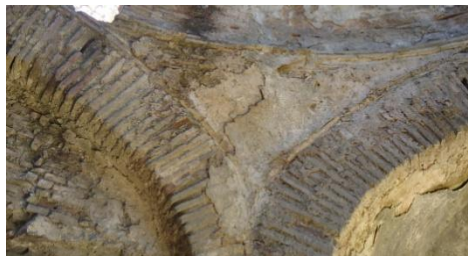
Figure 4.78. North West plane triangle plaster - 1 of *Soyunmalik*

On the plaster, black crusts were observed on the left and between the arches intensely. Peelings and pittings are widespread.

According to the findings, the plaster displays minor symptoms and condition class of the plaster is CC1, recommendation class of the plaster is RC1, and urgency class of the plaster is UC1 (Appendix.B).

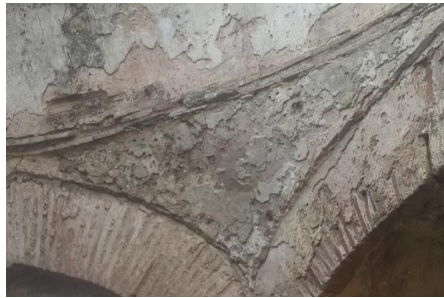
Figure 4.80. North East plane triangle - 1 plaster of *Soyunmalık*

On the plaster, black crusts were observed on the left part. Microbiological colonizations were observed on the middle part. Peelings and pittings are widespread.

According to the findings, the plaster displays minor symptoms and condition class of the plaster is CC1, recommendation class of the plaster is RC1, and urgency class of the plaster is UC1 (Appendix.B).

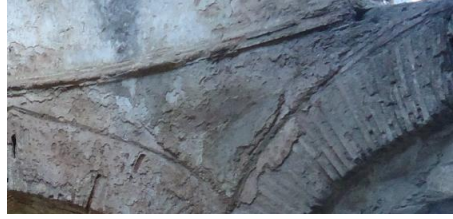
Figure 4.81. North East plane triangle - 2 plaster of *Soyunmalık*

On the plaster, microbiological colonizations were observed on the middle part. Peelings, delaminations, pittings, and white crusts are widespread.

According to the findings, the plaster displays moderate symptoms and condition class of the plaster is CC2, recommendation class of the plaster is RC2, and urgency class of the plaster is UC2 (Appendix.B).

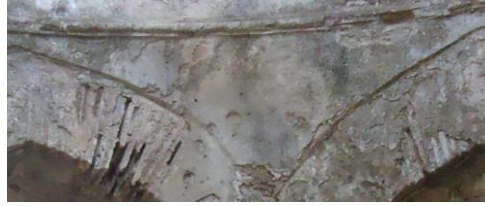
Figure 4.83. South East plane triangle - 2 plaster of *Soyunmalik*

On the plaster, delaminations and peelings were seen rarely. Black crusts; microbiological colonizations; white crusts; discolourations were observed on the plaster. Efflorescences were observed on the corners. Pittings are widespread.

According to the findings, the plaster displays minor symptoms and condition class of the plaster is CC1, recommendation class of the plaster is RC1, and urgency class of the plaster is UC1 (Appendix.B).

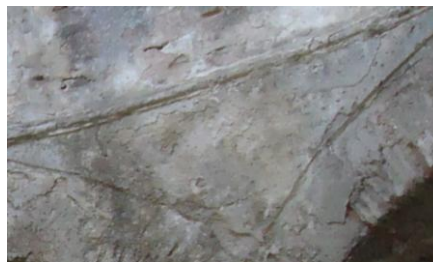
Figure 4.84. South West plane triangle - 1 plaster of *Soyunmalik*

On plaster, delaminations and peelings were seen rarely around the edges. Microbiological colonizations; white and black crusts; discolourations were observed. Microbiological colonizations were seen on the left part intensely. Pittings are widespread.

According to the findings the plaster displays minor symptoms and condition class of the plaster is CC1, recommendation class of the plaster is RC1, and urgency class of the plaster is UC1 (Appendix.B).

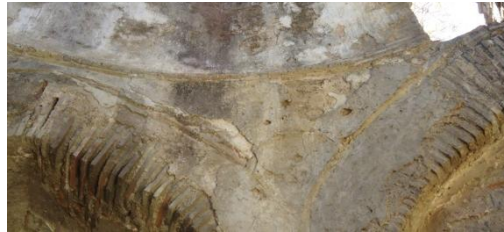
Figure 4.85. South West plane triangle - 2 plaster of *Soyunmalık*

On the plaster, delaminations and peelings were seen rarely on the left. Microbiological colonizations; white and black crusts; discolourations were observed. Microbiological colonizations were seen on the left part intensely. Pittings are widespread. Missing small parts of the plaster were observed.

According to the findings, the plaster displays minor symptoms and condition class of the plaster is CC1, recommendation class of the plaster is RC1, and urgency class of the plaster is UC1 (Appendix.B).

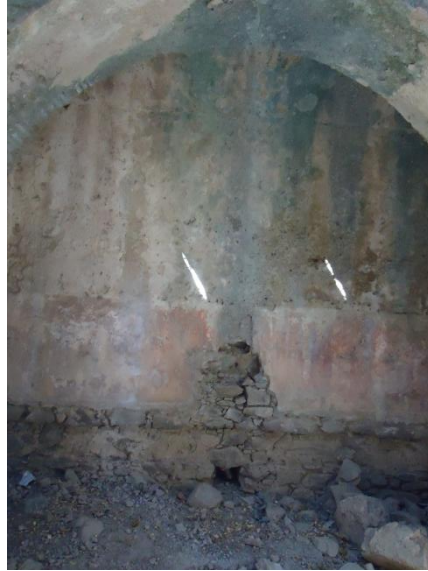
Figure 4.87. West Wall of *Sicaklık*

The general condition assessment revealed that the wall is in a good condition. Losses are *seki* and basin. Broken flue was observed, the height of which is 40 centimetres above the ground. Observed structural failures involve missing stones on the basin trace and bottom of the wall (Figure 4.88).

According to the findings, west wall displays minor symptoms and condition class of the wall is CC1, recommendation class of the wall is RC1, and urgency class of the wall is UC1 (Appendix.B, Appendix.C).

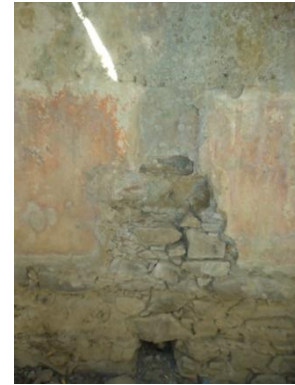
Figure 4.88. Missing part of the wall

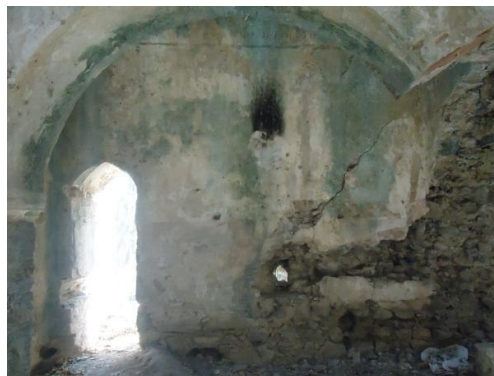
Figure 4.90. East Wall of *Sicaklık*

The general condition assessment revealed that the wall has sustained losses and severe structural failures. Losses are *seki*, flue and, basin, the height of which is 40 centimetres above the ground. Observed structural failures are the widely missing parts (collapsed) on right part of wall; splitting from middle to the right; and joint discharges. Observed material deteriorations are pittings and black crusts.

According to findings, the wall displays major symptoms and condition class of the wall is CC3, recommendation class of the wall is RC3, and urgency class of the wall is UC3 (Appendix.B, Appendix.C).

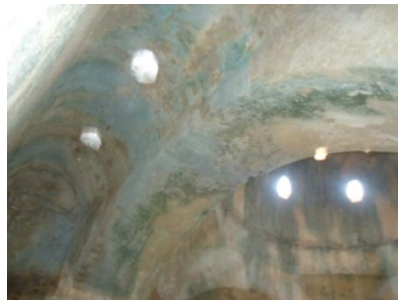
Figure 4.94. East Arch of *Sicaklık*

Losses are *seki* and the basin the height of which is 40 centimetres above the ground. Right base of the arch is totally collapsed (missing). On the right base, no structural failure was observed on unplastered areas. Observed material deteriorations are black crusts; efflorescences; and discolourations.

According to findings, arch displays major symptoms and condition class of the arch is CC3, recommendation class of the arch is RC3, and urgency class of the arch is UC3 (Appendix.B, Appendix.C).

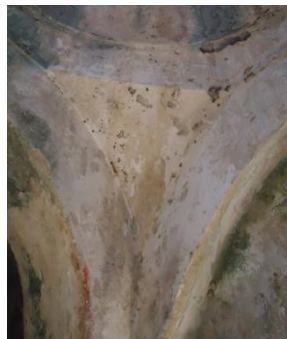
Figure 4.96. North West Pendentive of *Sicaklık*

North West pendentive is plastered and no visual deterioration can be observed. No symptoms can be seen and condition class of the pendentive is CC0, recommendation class of the pendentive is RC0, and urgency class of the pendentive is UC0 (Appendix.B).

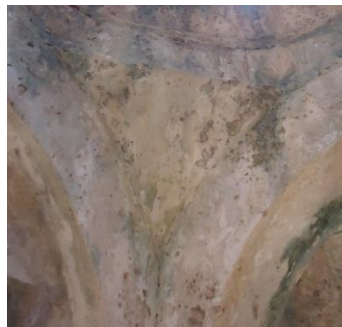
Figure 4.97. North East Pendentive of *Sıcaklık*

North East pendentive is plastered and no visual deterioration can be observed. No symptoms can be seen and condition class of the pendentive is CC0, recommendation class of the pendentive is RC0, and urgency class of the pendentive is UC0 (Appendix.B).

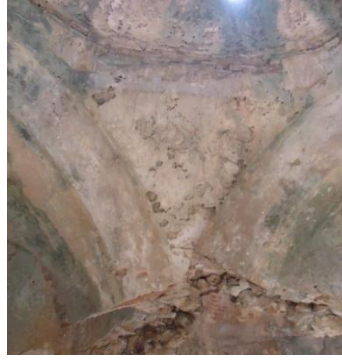
Figure 4.98. South East Pendentive of *Sıcaklık*

South East pendentive is plastered and no visual deterioration can be observed. No symptoms can be seen and condition class of the pendentive is CC0, recommendation class of the pendentive is RC0, and urgency class of the pendentive is UC0 (Appendix.B).

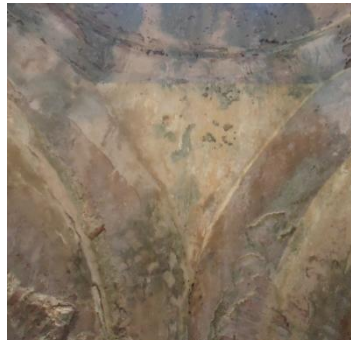
Figure 4.99. South West Pendentive of *Sıcaklık*

South West pendentive is plastered and no visual deterioration can be observed. No symptoms can be seen and condition class of the pendentive is CC0, recommendation class of the pendentive is RC0, and urgency class of the pendentive is UC0 (Appendix.B).

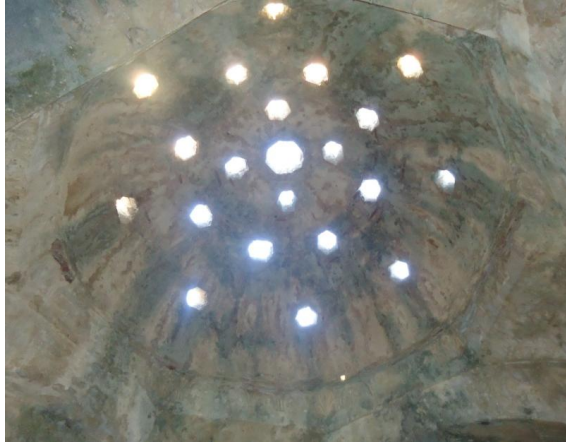
Figure 4.100. Drum of *Sicaklık*

The drum is plastered and no visual deterioration can be observed. No symptoms can be seen and condition class of the drum is CC0, recommendation class of the drum is RC0, and urgency class of the drum is UC0 (Appendix.B).

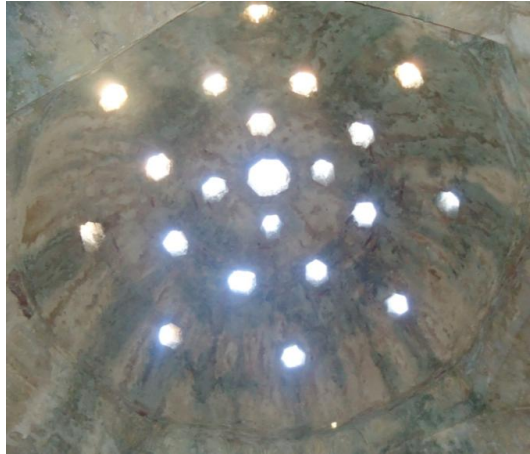
Figure 4.102. Dome of *Sıcaklık*

Losses of dome are small dome on center which is called top skylight, and oculis. The dome is plastered and no visual deterioration can be observed.

According to findings, dome displays moderate symptoms and condition class of the dome is CC2, recommendation class of the dome is RC2, and urgency class of the dome is UC2 (Appendix.B, Appendix.C).

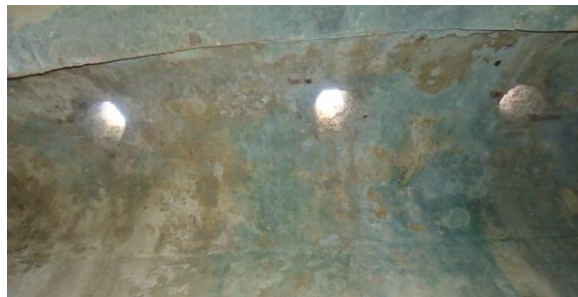
Figure 4.103. West Barrel Vault of *Sıcaklık*

Barrel vault of West *Eyvan/Iwan* of *Sıcaklık* (Figure 4.103) is brick - lime mortar barrel vault which has three oculis. Surface is plastered.

Losses of barrel vault are three oculis. The barrel vault is plastered and no visual deterioration can be observed.

According to the findings, the barrel vault displays minor symptoms and condition class of the barrel vault is CC1, recommendation class of the barrel vault is RC1, and urgency class of the barrel vault is UC1 (Appendix.B, Appendix.C).

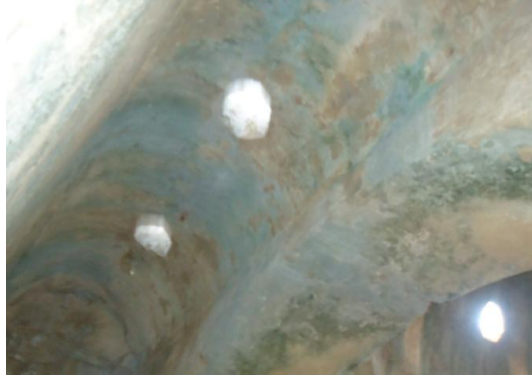
Figure 4.104. East Barrel Vault of *Sicaklık*

Barrel vault of East *Eyvan/Iwan* of *Sıcaklık* (Figure 4.104) is brick - lime mortar barrel vault which has three oculis. Surface is plastered.

deterioration can be observed.

According to the findings, the barrel vault displays minor symptoms and condition class of the barrel vault is CC1, recommendation class of the barrel vault is RC1, and urgency class of the barrel vault is UC1 (Appendix.B).

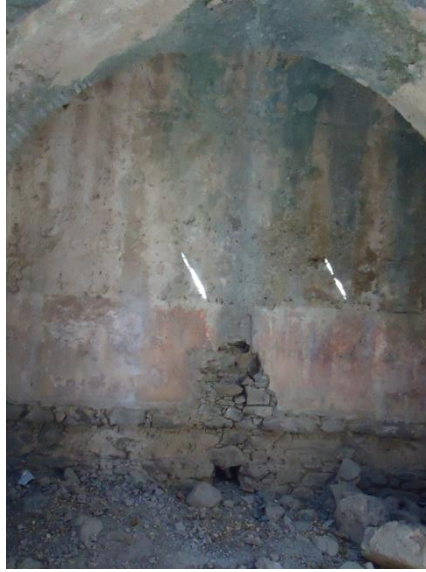
Figure 4.105. West Wall Plaster of *Sicaklık*

On the West wall plaster, microbiological colonizations are widespread, especially it was observed on the right part of surface. Pittings, delaminations and peelings were observed on the left part of wall. Black and white crust; efflorescences; and hair cracks were seen on the whole plaster.

According to the findings, plaster displays moderate symptoms and condition class of the plaster is CC2, recommendation class of the plaster is RC2, and urgency class of the plaster is UC2 (Appendix.B).

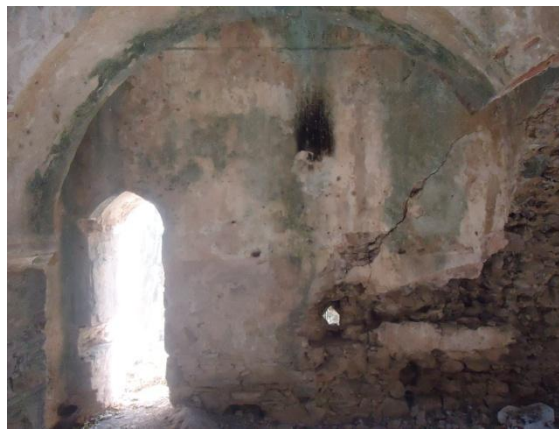
Figure 4.107. East Wall plaster of *Sicaklık*

On the East wall plaster, microbiological colonizations were seen more on the upper surface than bottom of the wall. Efflorescences; pittings; discolourations; black - white crusts and hair cracks were observed on the whole plaster.

According to findings, plaster displays moderate symptoms and condition class of the plaster is CC2, recommendation class of the plaster is RC2, and urgency class of the plaster is UC2 (Appendix.B).

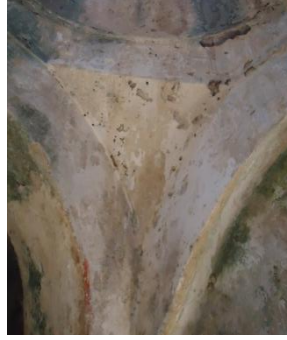
Figure 4.113. North West Pendentive plaster of *Sıcaklık*

On the North West pendentive plaster, black crusts were observed rarely. Pittings and discolourations are widespread.

According to the findings, plaster displays minor symptoms and condition class of the plaster is CC1, recommendation class of the plaster is RC1, and urgency class of the plaster is UC1 (Appendix.B).

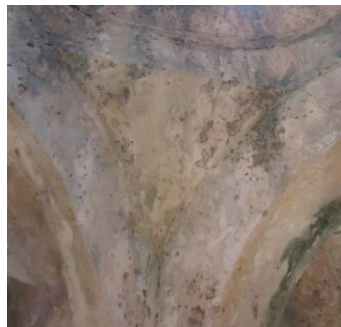
Figure 4.114. North East Pendentive plaster of *Sıcaklık*

On the North West pendentive plaster, microbiological colonizations were observed on the right and the left corners intensely. Black and white crusts were observed around the edges. Pittings and discolourations were seen on the whole plaster.

According to the findings, plaster displays minor symptoms and condition class of the plaster is CC1, recommendation class of the plaster is RC1, and urgency class of the plaster is UC1 (Appendix.B, Appendix.C).

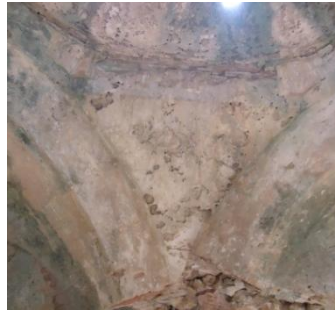
Figure 4.115. South East Pendentive of *Sıcaklık*

On the South East pendentive plaster, microbiological colonizations; black and white crusts; hair cracks; pittings and discolourations were observed on the whole.

According to the findings, plaster displays moderate symptoms and condition class of the plaster is CC2, recommendation class of the plaster is RC2, and urgency class of the plaster is UC2 (Appendix.B).

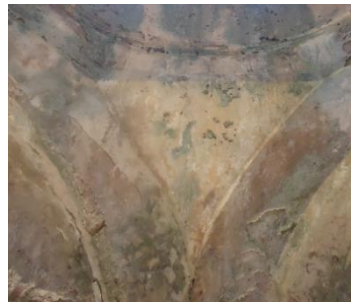
Figure 4.116. South West Pendentive plaster of *Sıcaklık*

On the South West pendentive plaster, microbiological colonizations were observed from the intersection points of archs to the middle part of the surface. Black and white crusts; hair cracks; pittings and discolourations were seen on the whole plaster.

According to the findings, plaster displays moderate symptoms and condition class of the plaster is CC2, recommendation class of the plaster is RC2, and urgency class of the plaster is UC2 (Appendix.B).

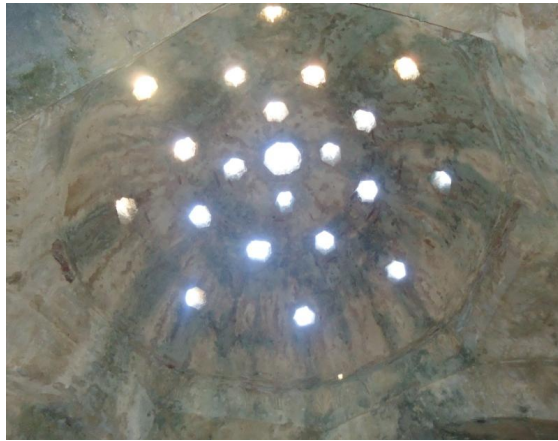
Figure 4.117. Drum plaster of *Sıcaklık*

On the drum plaster, microbiological colonizations; black and white crusts; hair cracks; pittings and discolourations were observed. Muqarnas patterns could not be seen clearly because of microbiological colonizations and black crusts (Figure 4.118).

According to the findings, plaster displays moderate symptoms and condition class of the plaster is CC2, recommendation class of the plaster is RC2, and urgency class of the plaster is UC2 (Appendix.B).
