**IMPORTANCE OF CONDITION SURVEY AND
REPORT OF BUILT CULTURAL HERITAGE:
DÜZCE (HEREKE) BATH**

in Architectural Restoration

IMPORTANCE OF CONDITION SURVEY AND REPORT OF BUILT CULTURAL HERITAGE: DÜZCE (HEREKE) BATH

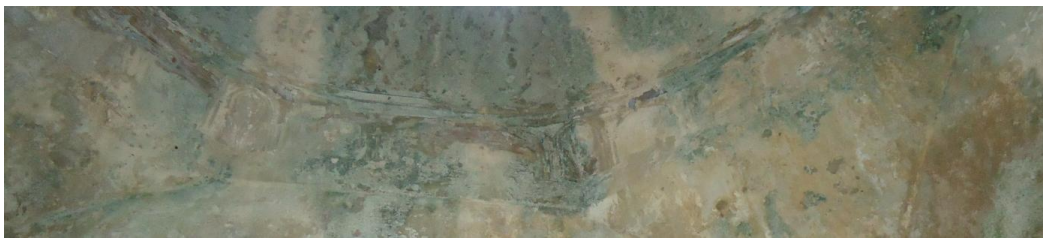
Figure 4.118. Muqarnas plaster of Drum plaster in *Sıcaklık*

On the drum plaster, microbiological colonizations; black and white crusts; hair cracks; pittings and discolourations were observed. Muqarnas patterns could not be seen clearly because of microbiological colonizations and black crusts (Figure 4.118).

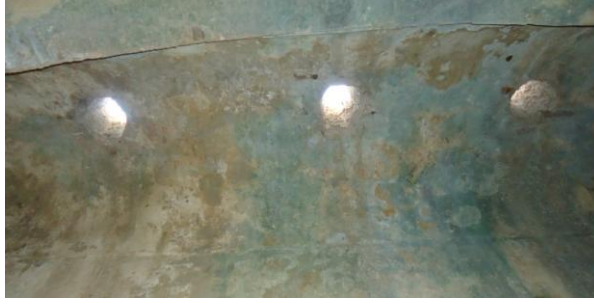
Figure 4.120. West Barrel Vault plaster of *Sıcaklık*

On the West barrel vault plaster, microbiological colonizations, especially on the right part; black and white crusts; hair cracks; pittings and discolourations were observed.

According to the findings, plaster displays moderate symptoms and condition class of the plaster is CC2, recommendation class of the plaster is RC2, and urgency class of the plaster is UC2 (Appendix.B).

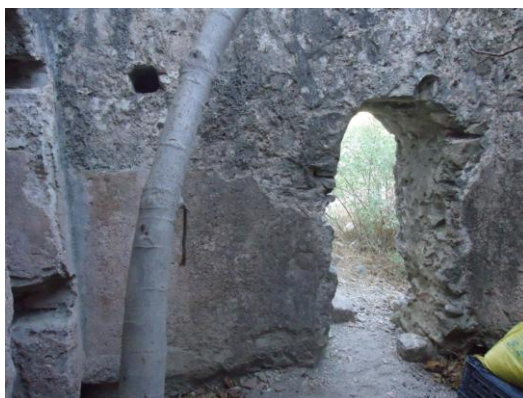
Figure 4.123. North wall of Cleaning Cell

On the North wall, losses are window, and flue bottom of the wall. Observed structural failures involve missing part of the wall below the window trace.

According to the findings, the wall displays moderate symptoms and condition class of the wall is CC2, recommendation class of the wall is RC2, and urgency class of the wall is UC2 (Appendix.B, Appendix.C).

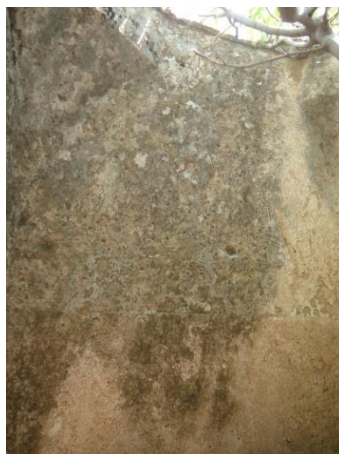
Figure 4.124. East wall of Cleaning Cell

On the East wall, loss of flue was observed which is above the ground. Surface of the wall is plastered and no deterioration was observed.

No symptoms can be seen and condition class of the wall is CC0, recommendation class of the wall is RC0, and urgency class of the wall is UC0 (Appendix.B, Appendix.C).

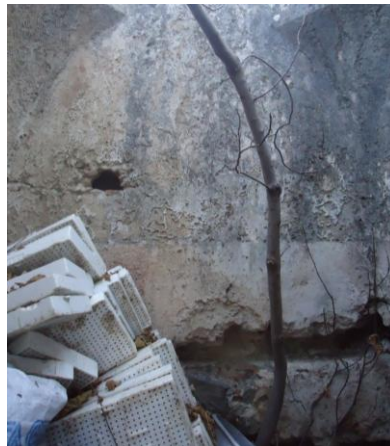
Figure 4.125. South wall of Cleaning Cell

On the South wall, losses involve flues, the height of which is 40 and 150 centimeters above ground. Observed structural failure is missing part of the wall above the upper flue trace.

According to the findings, the wall displays moderate symptoms and condition class of the wall is CC2, recommendation class of the wall is RC2, and urgency class of the wall is UC2 (Appendix.B).

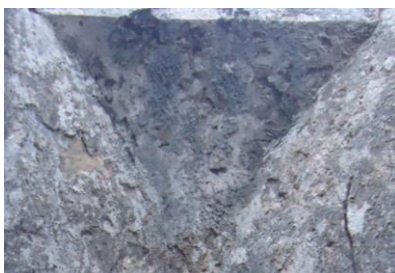
Figure 4.127. North East pendentive of Cleaning Cell

North East pendentive is plastered and no visual deterioration can be observed. No symptoms can be seen and condition class of the pendentive is CC0, recommendation class of the pendentive is RC0, and urgency class of the pendentive is UC0 (Appendix.B).

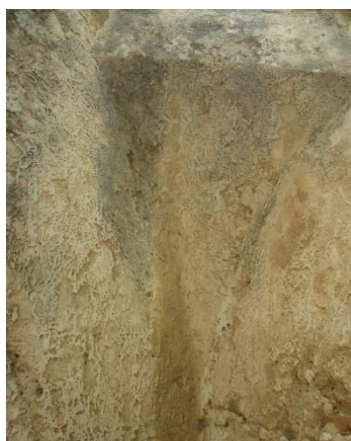
Figure 4.128. South East pendentive of the Cleaning Cell

South East pendentive is plastered and no visual deterioration can be observed. No symptoms can be seen and condition class of the pendentive is CC0, recommendation class of the pendentive is RC0, and urgency class of the pendentive is UC0 (Appendix.B).

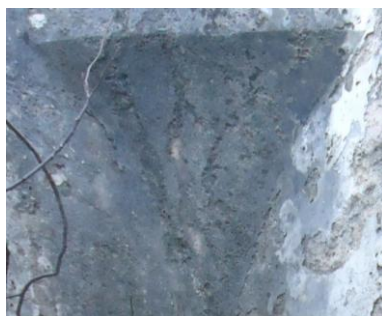
Figure 4.129. South West pendentive of Cleaning Cell

South West pendentive is plastered and no visual deterioration can be observed. No symptoms can be seen and condition class of the pendentive is CC0, recommendation class of the pendentive is RC0, and urgency class of the pendentive is UC0 (Appendix.B, Appendix.C).

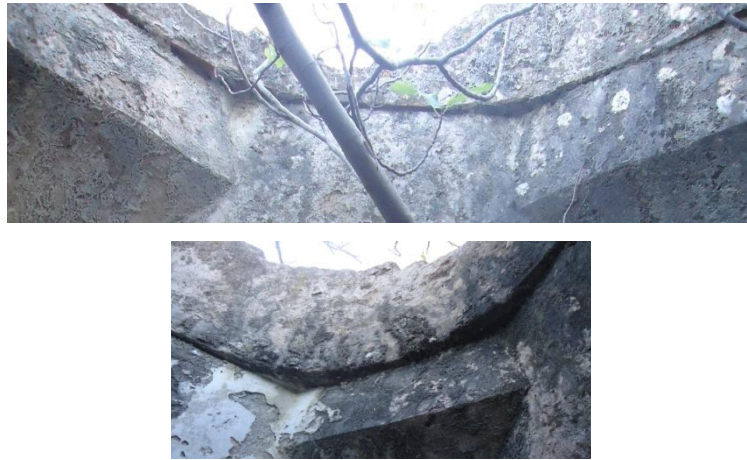
Figure 4.130. Drum of Cleaning Cell

Drum is plastered and no visual deterioration can be observed. No symptoms can be seen and condition class of the pendentive is CC0, recommendation class of the

pendentive is RC0, and urgency class of the pendentive is UC0 (Appendix.B).

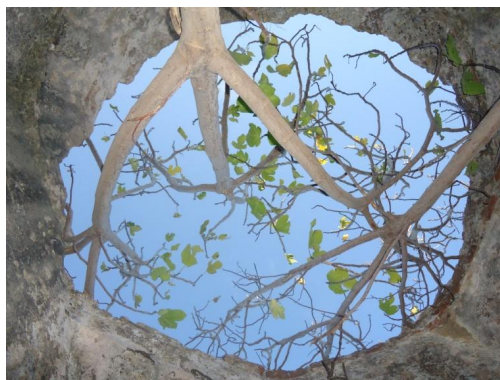
Figure 4.131. Dome of Cleaning Cell

Dome has missing wide part (almost collapsed) as structural failure. Existing dome is plastered and no deteriorations were observed.

According to the findings, the dome displays major symptoms and condition class of the dome is CC3, recommendation class of the dome is RC3, and urgency class of the dome is UC3 (Appendix.B, Appendix.C).

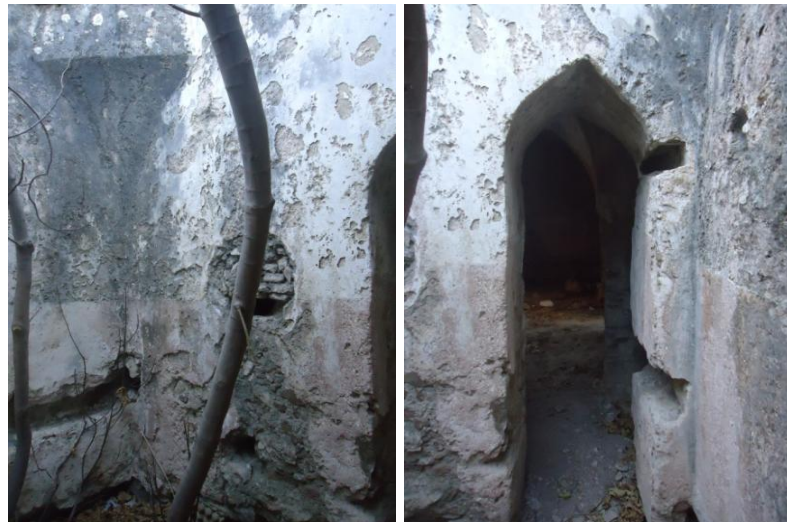
Figure 4.132. West wall plaster of Cleaning Cell

On the West wall plaster, peelings and pittings are widespread. Black crusts and microbiological colonizations are widespread on the right and the left part of the surface.

According to the findings, plaster displays moderate symptoms and condition class of the plaster is CC2, recommendation class of the plaster is RC2, and urgency class of the plaster is UC2 (Appendix.B).

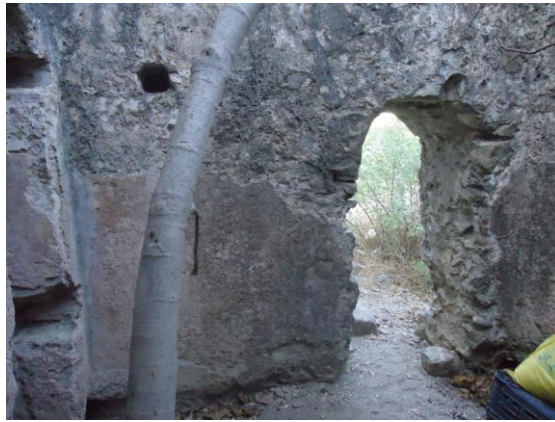
Figure 4.133. North wall plaster of Cleaning Cell

According to the findings, plaster displays moderate symptoms and condition

class of the plaster is CC2, recommendation class of the plaster is RC2, and urgency class of the plaster is UC2 (Appendix.B).

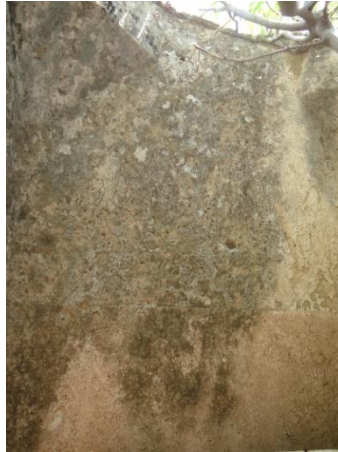
Figure 4.134. East wall plaster of Cleaning Cell

On the East wall plaster, microbiological colonizations are widespread except the left and bottom of the wall. Efflorescences were observed between the pendentives. Peelings; black crusts; and pittings were seen on the whole plaster.

According to the findings, plaster displays moderate symptoms and condition class of the plaster is CC2, recommendation class of the plaster is RC2, and urgency class of the plaster is UC2 (Appendix.B).

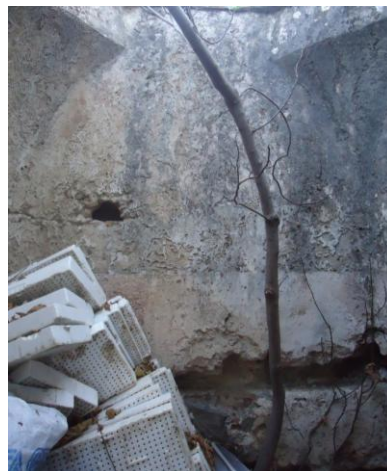
Figure 4.135. South wall plaster of Cleaning Cell

On the South wall plaster, microbiological colonizations are widespread except the left of the wall. Efflorescences were observed upper part of the wall. Peelings; black crusts; and pittings were observed on the whole plaster.

According to the findings, plaster displays moderate symptoms and condition class of the plaster is CC2, recommendation class of the plaster is RC2, and urgency class of the plaster is UC2 (Appendix.B).

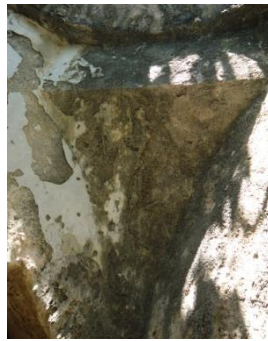
Figure 4.136. North West pendentive plaster of Cleaning Cell

On the North West pendentive plaster, microbiological colonizations; delaminations and peelings were observed. Also, white crusts and pittings were seen rarely.

According to the findings, plaster displays moderate symptoms and condition class of the plaster is CC2, recommendation class of the plaster is RC2, and urgency class of the plaster is UC2 (Appendix.B).

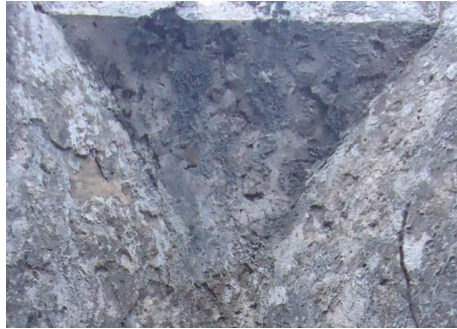
Figure 4.137. North East pendentive plaster of Cleaning Cell

On the North East pendentive plaster, pittings are widespread. Black crusts were observed upper part and the left edge of the surface. Efflorescences were seen rarely on the middle part, up to drum level.

According to the findings, plaster displays moderate symptoms and condition class of the plaster is CC2, recommendation class of the plaster is RC2, and urgency class of the plaster is UC2 (Appendix.B).

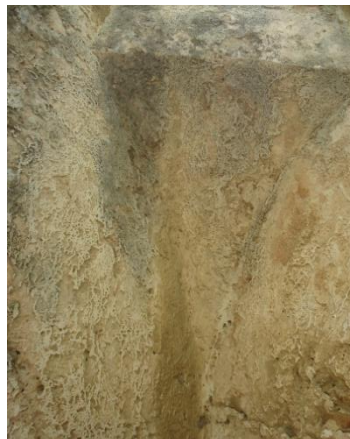
Figure 4.138. South East pendentive plaster of Cleaning Cell

On the South East pendentive plaster, black crusts are widespread on the drum edge. Peelings; delaminations; and pittings were observed on the whole plaster.

According to the findings, plaster displays moderate symptoms and condition class of the plaster is CC2, recommendation class of the plaster is RC2, and urgency class of the plaster is UC2 (Appendix.B).

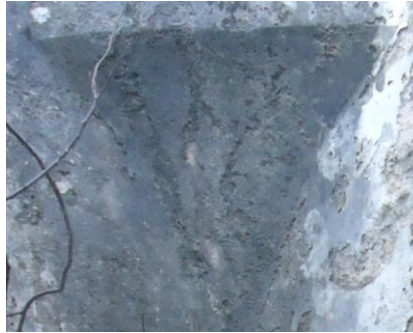
Figure 4.139. South West pendentive plaster of Cleaning Cell

On the South West pendentive plaster, peelings were observed, and black crusts were observed peeled areas' inner layers. Efflorescences were seen partially on the left part. Pittings were observed on the whole plaster.

According to the findings, the plaster displays moderate symptoms and condition class of the plaster is CC2, recommendation class of the plaster is RC2, and urgency class of the plaster is UC2 (Appendix.B).

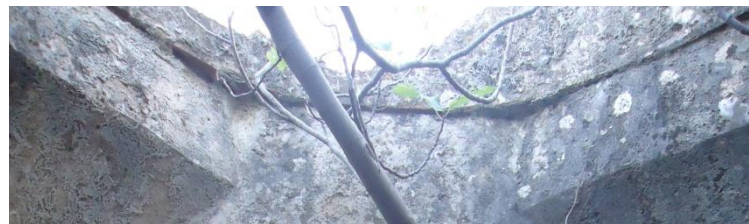
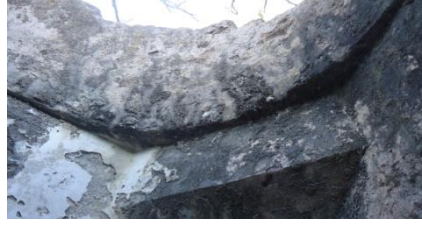
Figure 4.140. Drum plaster of Cleaning Cell

On the drum plaster, efflorescences were observed on the West and the South surfaces Black crusts and microbiological colonizations were observed on the whole plaster, especially on the North surfaces of the drum. Peelings; delaminations; pittings are widespread.

According to the findings, the plaster displays moderate symptoms and condition class of the plaster is CC2, recommendation class of the plaster is RC2, and urgency class of the plaster is UC2 (Appendix.B).

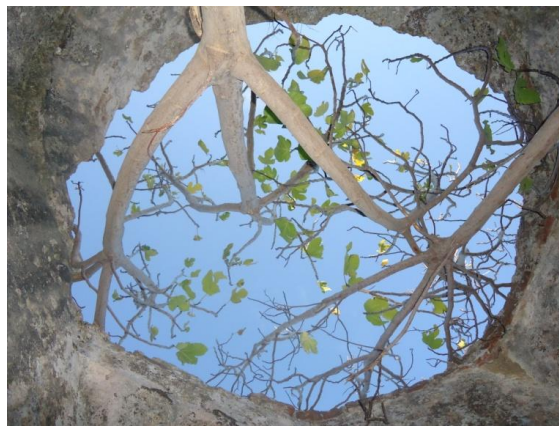
Figure 4.141. Dome plaster of Cleaning Cell

On the dome of the Cleaning Cell, lime plaster was observed (Figure 4.141). Plant, which was seen in figure, has grown on the ground (Figure 4.141).

On the dome plaster, missing part of plaster was observed. Current plaster has microbiological colonizations; pittings; efflorescences; and black crusts.

According to the findings, the plaster displays major symptoms and condition class of the plaster is CC3, recommendation class of the plaster is RC3, and urgency class of the plaster is UC3 (Appendix.B).

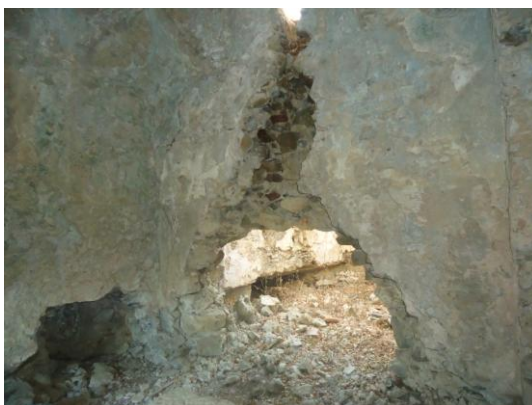
Figure 4.142. West wall of the South East *Halvet*

West wall of the South East *Halvet* (Figure 4.142) is a stone masonry wall which was constructed through bonding technique with rubble stone and brick components in lime mortar (Reyhan, 2004). Surface is plastered.

Observed structural failure is widely missing (collapsed) part in the middle part of the wall. Observed material deteriorations are pittings and discolourations on the mortars and stones.

According to the findings, the wall displays major symptoms and condition class of the wall is CC3, recommendation class of the wall is RC3, and urgency class of the wall is UC3 (Appendix.B, Appendix.C).

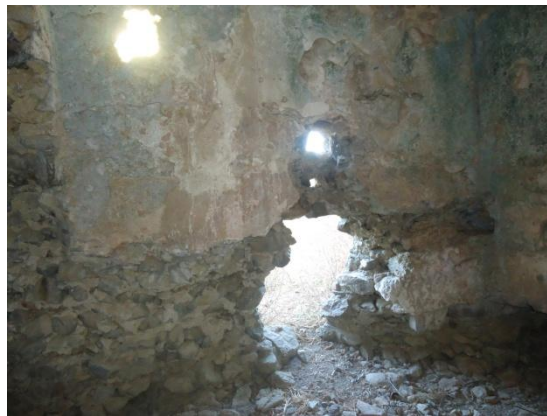
Figure 4.145. East wall of the South East *Halvet*

East wall of the South East *Halvet* (Figure 4.145) is a stone masonry wall which was constructed through bonding technique with rubble stone and brick components in lime mortar (Reyhan, 2004). Surface is plastered.

Losses are the flue and the basin on East wall. The widely missing (collapsed) part and joint discharges were observed in the current wall as structural failures. Observed material deteriorations are pittings and discolourations on the mortars and the stones.

According to the findings, the wall displays major symptoms and condition class of the wall is CC3, recommendation class of the wall is RC3, and urgency class of the wall is UC3 (Appendix.B, Appendix.C).

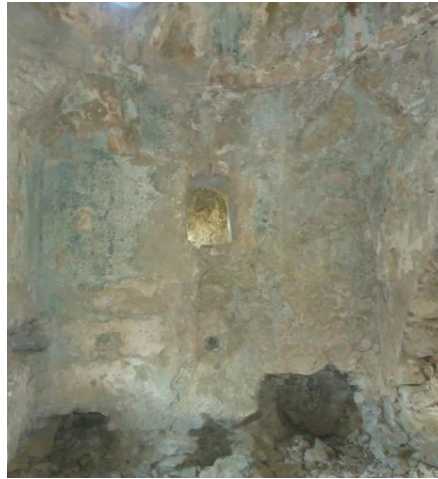
Figure 4.146. South wall of the South East *Halvet*

South wall of the South East *Halvet* (Figure 4.146) is a stone masonry wall which was constructed through bonding technique with rubble stone and brick components in lime mortar (Reyhan, 2004). Surface is plastered.

Losses are the window, the flue and the basin on the East wall. Observed structural failures are the widely missing (collapsed) part bottom of the wall; joint discharges; splitting from ground up to the window; star crack from the window to the dome. Observed material deteriorations are pittings and discolourations on mortars and stones.

According to the findings, the wall displays major symptoms and condition class of the wall is CC3, recommendation class of the wall is RC3, and urgency class of the wall is UC3 (Appendix.B).

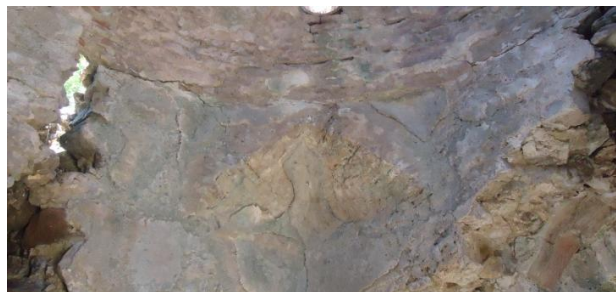
Figure 4.147. North West plane triangles of the South East *Halvet*

North West plane triangles of the South East *Halvet* (Figure 4.147) are brick and lime mortar plane triangles. Surfaces are plastered.

North West plane triangles are plastered and no visual deterioration can be observed. No symptoms can be seen and condition class of the plane triangle is CC0, recommendation class of the plane triangle is RC0, and urgency class of the plane triangle is UC0 (Appendix.B).

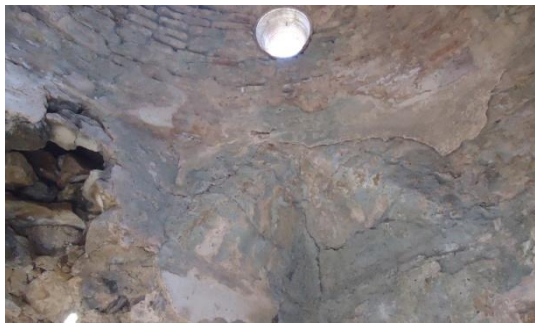
Figure 4.148. North East plane triangles of the South East *Halvet*

North East plane triangles of the South East *Halvet* (Figure 4.148) are brick and lime mortar plane triangles. Surfaces are plastered.

North East plane triangles are plastered and no visual deterioration can be observed. No symptoms can be seen and condition class of the plane triangle is CC0, recommendation class of the plane triangle is RC0, and urgency class of the plane triangle is UC0 (Appendix.B).

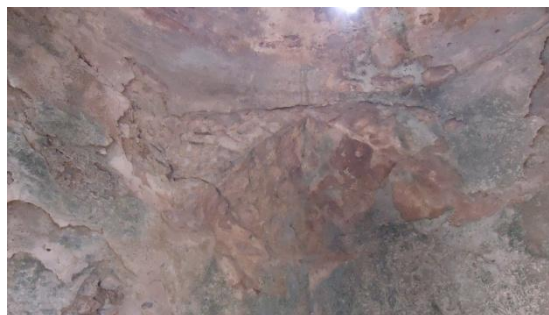
Figure 4.149. South East plane triangles of the South East *Halvet*

South East plane triangles of the South East *Halvet* (Figure 4.149) are brick and lime mortar plane triangles. Surfaces are plastered.

South East plane triangles are plastered and no visual deterioration can be observed. No symptoms can be seen and condition class of the plane triangle is CC0, recommendation class of the plane triangle is RC0, and urgency class of the plane triangle is UC0 (Appendix.B).

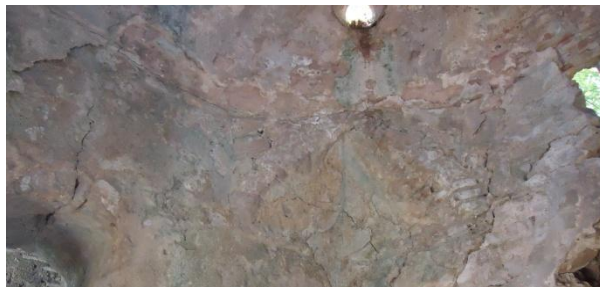
Figure 4.150.South West plane triangles of the South East *Halvet*

South West plane triangles of the South East *Halvet* (Figure 4.150) are brick and lime mortar plane triangles. Surfaces are plastered.

South West plane triangles are plastered and no visual deterioration can be observed. No symptoms can be seen and condition class of the plane triangle is CC0, recommendation class of the plane triangle is RC0, and urgency class of the plane triangle is UC0 (Appendix.B).

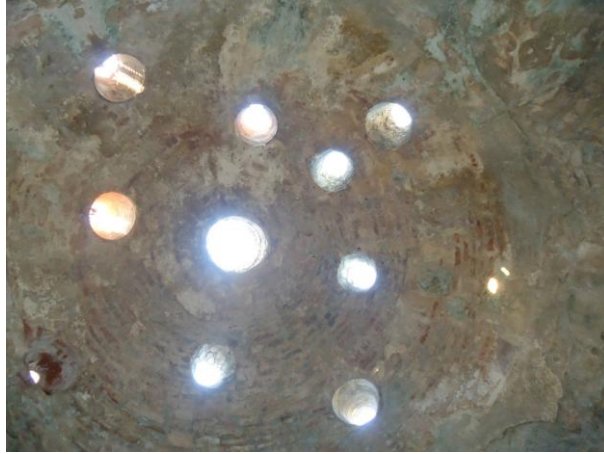
Figure 4.151. Dome of South East *Halvet*

Dome of South East *Halvet* (Figure 4.151) is brick - lime mortar dome which has central oculi and nine oculis around center on two rows. Surface is plastered.

Losses of dome are 10 oculis, and six terracotta pipes of oculis. No structural failure was observed. On unplastered areas, bricks and mortars have microbiological colonizations and discolourations.

According to the findings, the dome displays moderate symptoms and condition class of the dome is CC2, recommendation class of the dome is RC2, and urgency class of the dome is UC2 (Appendix.B, Appendix.C).

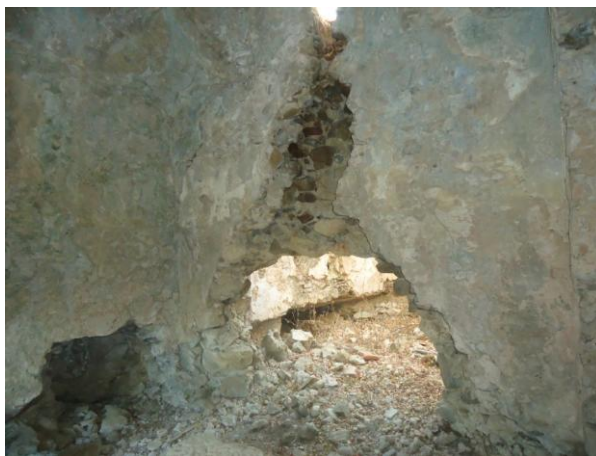
Figure 4.152. West wall plaster of the South East *Halvet*

On the West wall of the South East *Halvet*, three layers horasan plaster were used up to 150 cm. From 150 cm up to dome, two layers horasan plaster layer were used and lime plaster were used as finishing layer (Uğurlu, 2005) (Figure 4.152).

On the West wall plaster, peelings; pittings; black crusts; efflorescences; and microbiological colonizations were observed. Hair crack was observed from the left part of wall to the South wall.

According to the findings, the plaster displays moderate symptoms and condition class of the plaster is CC2, recommendation class of the plaster is RC2, and urgency class of the plaster is UC2 (Appendix.B).

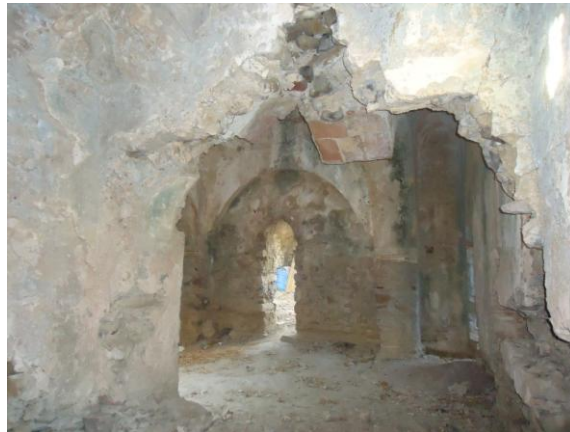
Figure 4.153. North wall plaster of the South East *Halvet*

On the North wall of the South East *Halvet*, three layers horasan plaster were used up to 150 cm. From 150 cm up to dome, two layers horasan plaster layer were used and lime plaster were used as finishing layer (Uğurlu, 2005) (Figure 4.153).

On the North wall plaster, peelings; pittings; black crusts; efflorescences; and microbiological colonizations were observed. Microbiological colonizations were seen upper part of the wall intensely. Hair crack was seen on the right part of the wall, close to the plane triangle.

According to the findings, the plaster displays moderate symptoms and condition class of the plaster is CC2, recommendation class of the plaster is RC2, and urgency class of the plaster is UC2 (Appendix.B).

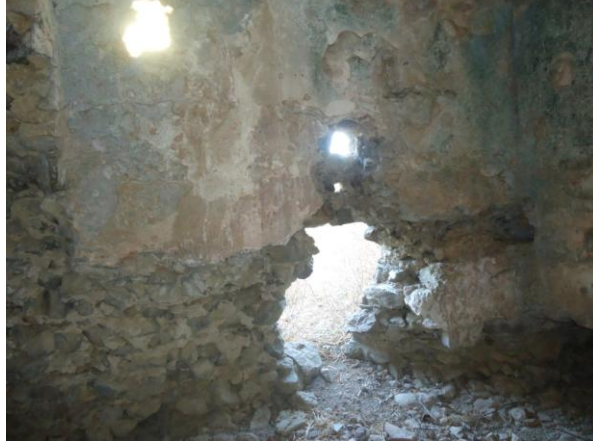
Figure 4.154. East wall plaster of the South East *Halvet*

On the East wall of the South East *Halvet*, three layers horasan plaster were used up to 150 cm. From 150 cm up to dome, two layers horasan plaster layer were used and lime plaster were used as finishing layer (Uğurlu, 2005) (Figure 4.154).

On the East wall plaster, peelings; pittings; black crusts; efflorescences; and microbiological colonizations were observed. Microbiological colonizations were seen on the left and the right of surface intensely. Delamination was seen on the middle part of the current plaster.

According to the findings, the plaster displays moderate symptoms and condition class of the plaster is CC2, recommendation class of the plaster is RC2, and urgency class of the plaster is UC2 (Appendix.B).

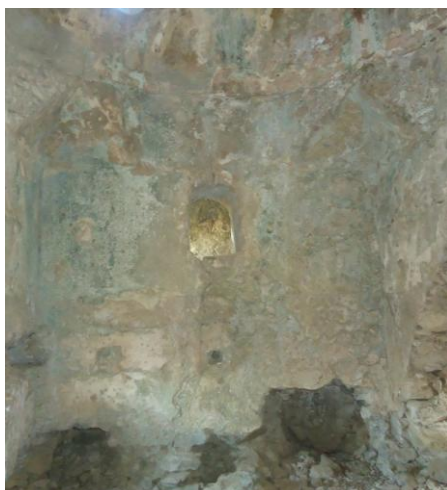
Figure 4.155. South wall plaster of the South East *Halvet*

On the South wall of the South East *Halvet*, three layers horasan plaster was used up to 150 cm. From 150 cm up to dome, two layers horasan plaster layer were used and lime plaster were used as finishing layer (Uğurlu, 2005) (Figure 4.155).

On the South wall plaster, peelings; pittings; black crusts; efflorescences; and microbiological colonizations were observed. Microbiological colonizations were seen around the edges intensely. Delamination was observed below the window trace.

According to the findings, the plaster displays moderate symptoms and condition class of the plaster is CC2, recommendation class of the plaster is RC2, and urgency class of the plaster is UC2 (Appendix.B).

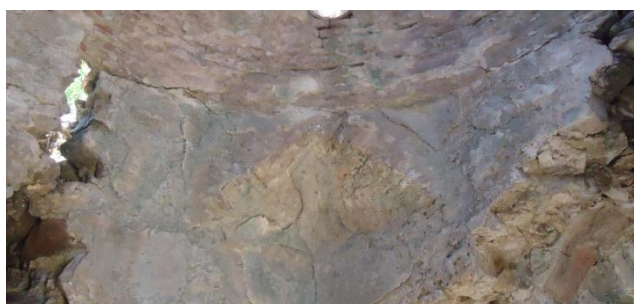
Figure 4.156. North West plane triangles plaster of the South East *Halvet*

On the North West plane triangles of the South East *Halvet*, two layers horasan plaster layer were used and lime plaster were used as finishing layer (Uğurlu, 2005) (Figure 4.156).

On the North West plane triangles plasters, delaminations were observed on the left one. Microbiological colonizations; peelings; pittings; black crusts and efflorescences were observed on the whole plasters.

According to the findings, the plaster displays moderate symptoms and condition class of the plaster is CC2, recommendation class of the plaster is RC2, and urgency class of the plaster is UC2 (Appendix.B, Appendix.C).

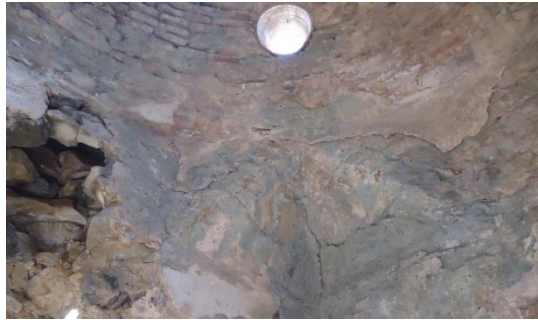
Figure 4.157. North East plane triangles plaster of the South East *Halvet*

On the North East plane triangles of the South East *Halvet*, two layers horasan plaster layer were used and lime plaster were used as finishing layer (Uğurlu, 2005) (Figure 4.157).

On the North East plane triangles plasters, delaminations were observed on the upper parts. Microbiological colonizations; peelings; pittings; black crusts and efflorescenes were observed on the whole surfaces.

According to the findings, the plaster displays moderate symptoms and condition class of the plaster is CC2, recommendation class of the plaster is RC2, and urgency class of the plaster is UC2 (Appendix.B).

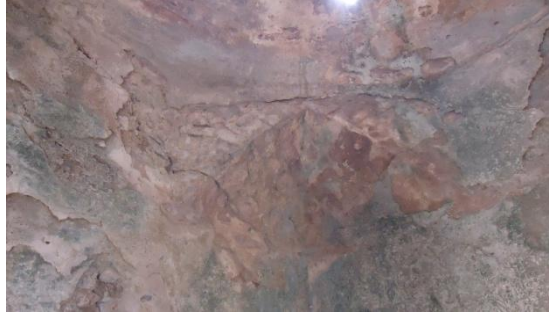
Figure 4.158. South East plane triangles plaster of the South East *Halvet*

On the South East plane triangles of the South East *Halvet*, two layers horasan plaster layer were used and lime plaster were used as finishing layer (Uğurlu, 2005) (Figure 4.158).

On the South East plane triangles plasters, microbiological colonizations especially on the right plane triangle; peelings; pittings; black crusts and efflorescenes were observed.

According to the findings, the plaster displays moderate symptoms and condition class of the plaster is CC2, recommendation class of the plaster is RC2, and urgency class of the plaster is UC2 (Appendix.B).

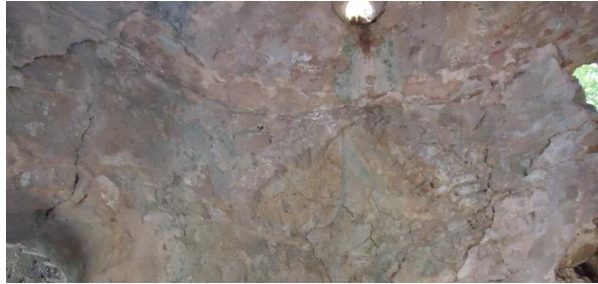
Figure 4.159. South West plane triangles plaster of the South East *Halvet*

On the South West plane triangles of the South East *Halvet*, two layers horasan plaster layer were used and lime plaster were used as finishing layer (Uğurlu, 2005) (Figure 4.159).

On the South West plane triangles plasters, microbiological colonizations; peelings; pittings; black crusts and efflorescenes were observed.

According to the findings, the plaster displays moderate symptoms and condition class of the plaster is CC2, recommendation class of the plaster is RC2, and urgency class of the plaster is UC2 (Appendix.B).

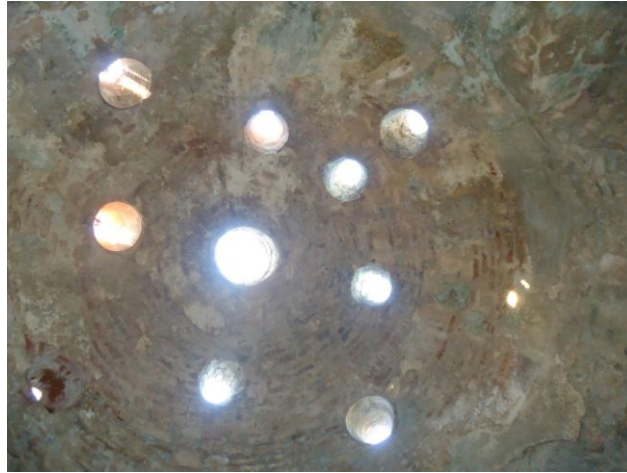
Figure 4.160. Dome plaster of the South East *Halvet*

On dome of the South East *Halvet*, two layers horasan plaster layer were used and lime plaster were used as finishing layer (Uğurlu, 2005) (Figure 4.160).

Plaster of the South East *Halvet* dome has missing parts. Microbiological colonizations; peelings; pittings; black crusts and efflorescenes were observed on the

existing plaster.

According to the findings, the plaster displays moderate symptoms and condition class of the plaster is CC2, recommendation class of the plaster is RC2, and urgency class of the plaster is UC2 (Appendix.B).

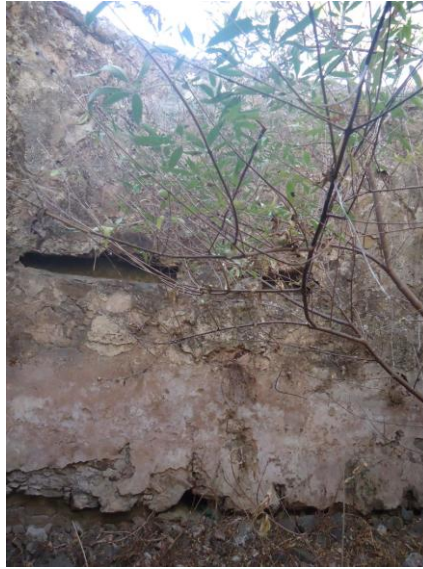
Figure 4.161. West wall of the South West *Halvet*

West wall of the South West *Halvet* (Figure 4.161) is a stone masonry wall which was constructed through bonding technique with rubble stone and brick which is different from other walls. In horizontal joints, one or two rows of brick bonds lie between rubble stones, while in vertical joints, large pieces of bricks are mixed into the lime mortar and they are parallel to the horizontal joints (Reyhan, 2004). Surface is plastered.

Losses of wall are flue and basin. Observed structural failures are missing stones and bricks around the basin trace. Observed material deteriorations are discolourations and pittings on the components of the wall.

According to the findings, the wall displays moderate symptoms and condition class of the wall is CC2, recommendation class of the wall is RC2, and urgency class of the wall is UC2 (Appendix.B, Appendix.C).

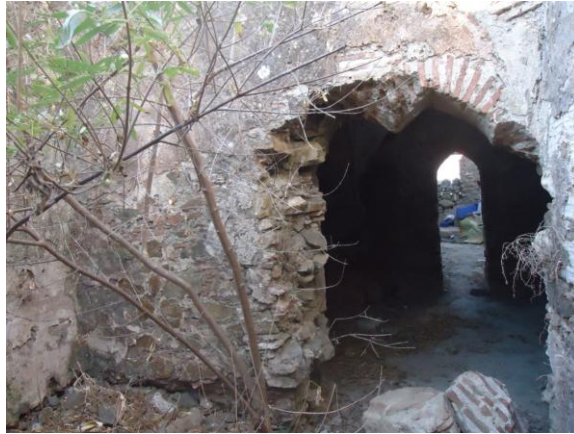
Figure 4.162. North wall of the South West *Halvet*

North wall of the South West *Halvet* (Figure 4.162) is stone masonry wall which was constructed with bonding technique with rubble stone and brick components in lime mortar (Reyhan, 2004). Surface is plastered.

On the North wall, losses are door, flue and seki. Observed structural failures are missing (collapsed) part around the door trace, the plants inner surfaces of the collapsed area's mortars and joint discharges. Observed material deteriorations involve pittings on mortars.

According to the findings, the wall displays major symptoms and condition class of the wall is CC3, recommendation class of the wall is RC3, and urgency class of the wall is UC3 (Appendix.B, Appendix.C).

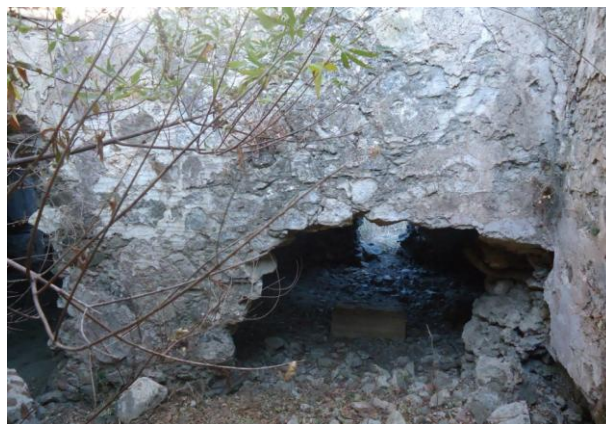
Figure 4.163. East wall of the South West *Halvet*

East wall of the South West *Halvet* (Figure 4.163) is a stone masonry wall which was constructed through bonding technique with rubble stone and brick components in lime mortar (Reyhan, 2004). Surface is plastered.

Observed structural failures are missing part of the wall around one squaremeter; joint discharges and small plants inner the surfaces of the missing part. Observed material deteriorations are pittings on mortars; black crusts and discolourations on unplastered surfaces.

According to the findings, the wall displays major symptoms and condition class of the wall is CC3, recommendation class of the wall is RC3, and urgency class of the wall is UC3 (Appendix.B, Appendix.C).

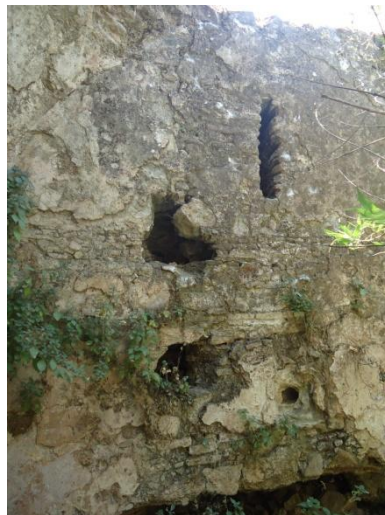
Figure 4.164. South wall of the South West *Halvet*

South wall of the South West *Halvet* (Figure 4.164) is a stone masonry wall which was constructed through bonding technique with rubble stone and brick components in lime mortar (Reyhan, 2004). Surface is plastered.

On the South wall, losses are window, flue and basin. Observed structural failures are missing parts around the basin trace and joint discharges. Observed material deteriorations are discolorations; black crusts; efflorescences; and pittings on the unplastered surfaces.

According to the findings, the wall displays moderate symptoms and condition class of the wall is CC2, recommendation class of the wall is RC2, and urgency class of the wall is UC2 (Appendix.B).

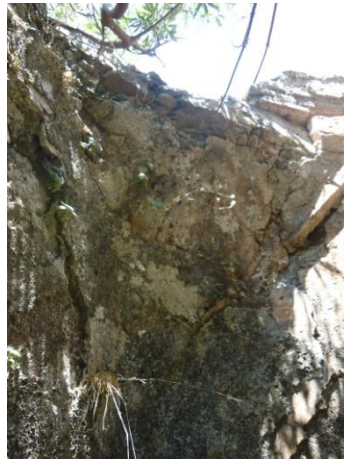
Figure 4.165. North West pendentive of the South West *Halvet*

North West pendentive of the South West *Halvet* (Figure 4.165) is brick - lime mortar pendentive. Surface is plastered.

North West pendentive is plastered and no visual deterioration can be observed. No symptoms can be seen and condition class of the pendentive is CC0, recommendation class of the pendentive is RC0, and urgency class of the pendentive is UC0 (Appendix.B).

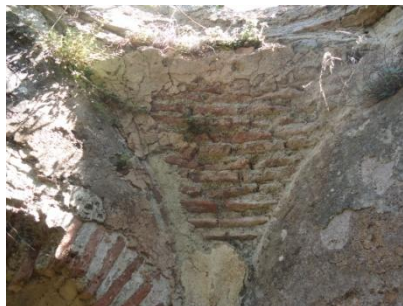
Figure 4.166. North East pendentive of the South West *Halvet*

North East pendentive of the South West *Halvet* (Figure 4.166) is brick - lime mortar pendentive. Surface is plastered.

North East pendentive is plastered and no visual deterioration can be observed. No symptoms can be seen and condition class of the pendentive is CC0, recommendation class of the pendentive is RC0, and urgency class of the pendentive is UC0 (Appendix.B).

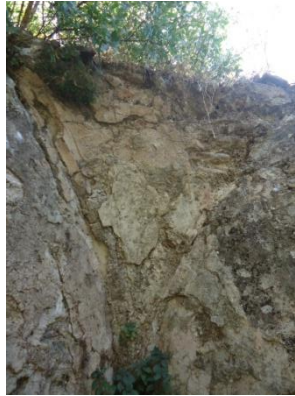
Figure 4.167. South East pendentive of the South West *Halvet*

South East pendentive of the South West *Halvet* (Figure 4.167) is brick - lime mortar pendentive. Surface is plastered.

South East pendentive is plastered and no visual deterioration can be observed. No symptoms can be seen and condition class of the pendentive is CC0, recommendation class of the pendentive is RC0, and urgency class of the pendentive is UC0 (Appendix.B).

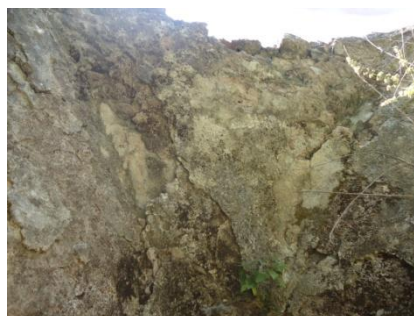
Figure 4.168. South West pendentive of the South West *Halvet*

South West pendentive of the South West *Halvet* (Figure 4.168) is brick - lime mortar pendentive. Surface is plastered.

South West pendentive is plastered and no visual deterioration can be observed. No symptoms can be seen and condition class of the pendentive is CC0, recommendation class of the pendentive is RC0, and urgency class of the pendentive is UC0 (Appendix.B).

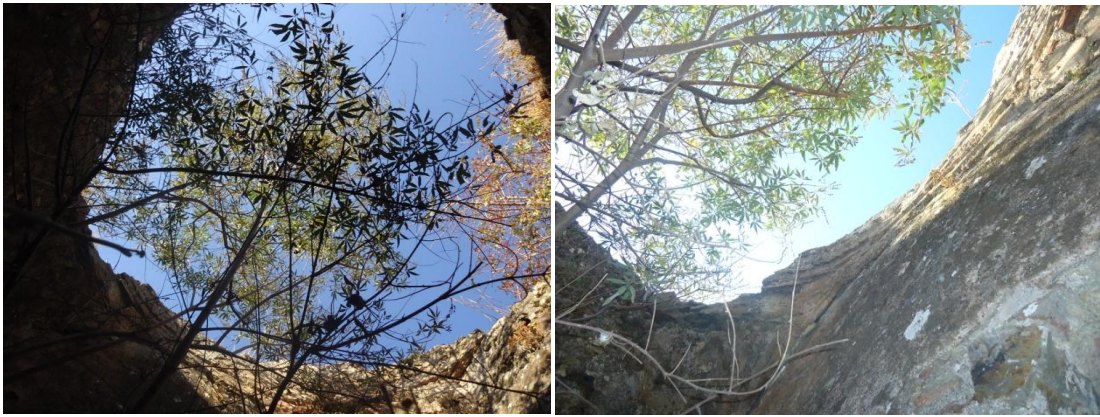
Figure 4.169. Dome of the South West *Halvet*

Dome of the South West Halvet (Figure 4.169) is brick - lime mortar dome. Surface is plastered.

Observed structural failure is widely missing part (almost collapsed). Observed material deteriorations involve small plants and pittings were observed on mortars of existing dome.

According to the findings, the dome displays major symptoms and condition class of the dome is CC3, recommendation class of the dome is RC3, and urgency class of the dome is UC3 (Appendix.B, Appendix.C).

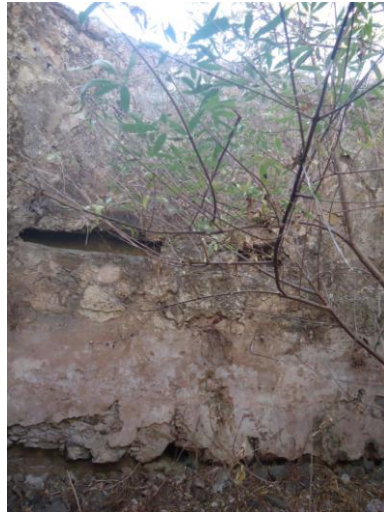
Figure 4.170. West wall plaster of the South West *Halvet*

On the West wall plaster, delaminations and peelings were observed from ground up to 150 cm height intensely. Pittings; black crusts; efflorescences; and microbiological colonizations were observed on the whole plaster, but they are widespread from 150 cm height up to dome.

According to the findings, the plaster displays moderate symptoms and condition class of the plaster is CC2, recommendation class of the plaster is RC2, and

urgency class of the plaster is UC2 (Appendix.B).

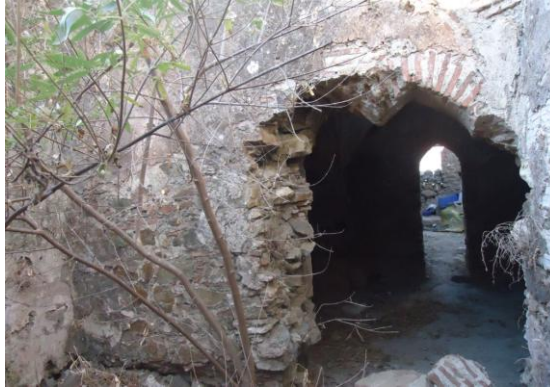
Figure 4.171. North wall plaster of the South West *Halvet*

On the North wall plaster, missing parts were seen intensely. Microbiological colonizations were observed on the whole plaster, but they are widespread on the left part of the wall.

According to the findings, the plaster displays major symptoms and condition class of the plaster is CC3, recommendation class of the plaster is RC3, and urgency class of the plaster is UC3 (Appendix.B).

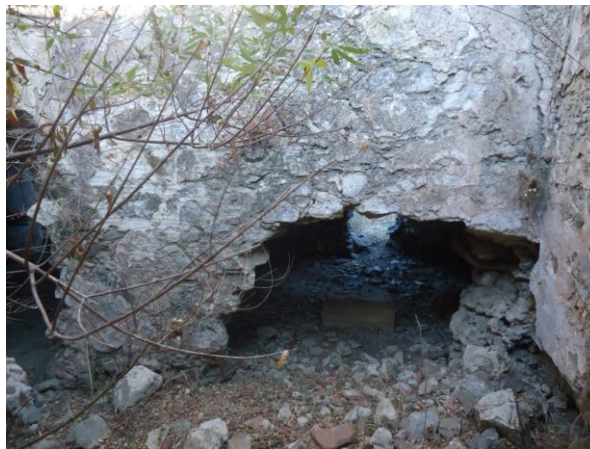
Figure 4.172. East wall plaster of the South West *Halvet*

On the East wall plaster, missing small parts of the plaster were observed. Pittings; black crusts; efflorescences; peelings and microbiological colonizations were observed on the whole plaster.

According to the findings, the plaster displays moderate symptoms and condition class of the plaster is CC2, recommendation class of the plaster is RC2, and urgency class of the plaster is UC2 (Appendix.B).

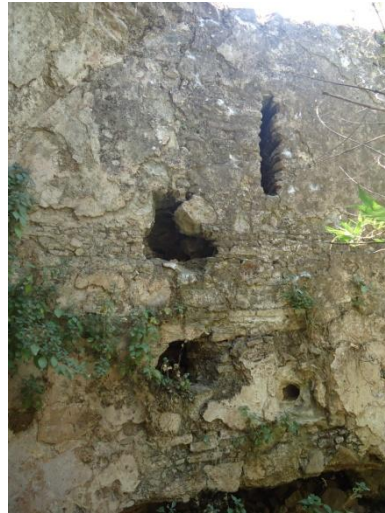
Figure 4.173. South wall plaster of the South West *Halvet*

On the South wall plaster, pittings; black crusts; efflorescences; peelings and microbiological colonizations were observed.

According to the findings, the plaster displays moderate symptoms and condition class of the plaster is CC2, recommendation class of the plaster is RC2, and urgency class of the plaster is UC2 (Appendix.B).

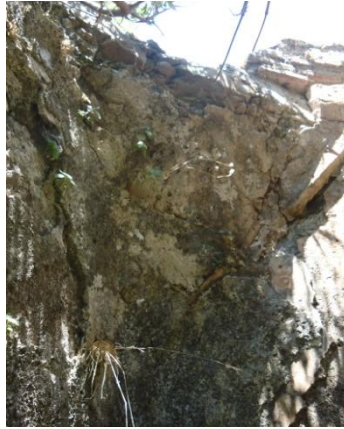
Figure 4.174. North West pendentive plaster of the South West *Halvet*

On the North West pendentive plaster, microbiological colonizations and black crusts were observed intensely. Peelings and discolourations are other deteriorations of plaster.

According to the findings, the plaster displays moderate symptoms and

condition class of the plaster is CC2, recommendation class of the plaster is RC2, and urgency class of the plaster is UC2 (Appendix.B).

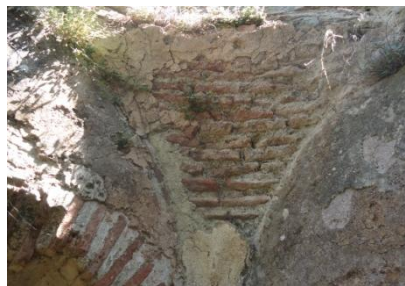
Figure 4.175. North East pendentive plaster of the South West *Halvet*

On the North East pendentive plaster, pittings and delaminations were observed.

According to the findings, the plaster displays moderate symptoms and condition class of the plaster is CC2, recommendation class of the plaster is RC2, and urgency class of the plaster is UC2 (Appendix.B).

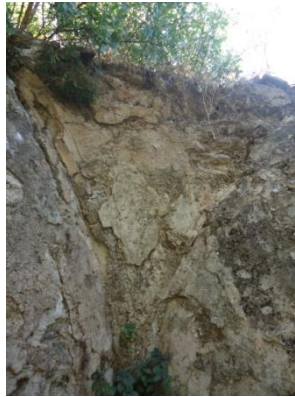
Figure 4.176. South East pendentive plaster of the South West *Halvet*

On the South East pendentive plaster, pittings; black crusts; efflorescences; and microbiological colonizations were observed. Delaminations were seen on the plaster except the upper right of the surface.

According to the findings, the plaster displays moderate symptoms and condition class of the plaster is CC2, recommendation class of the plaster is RC2, and urgency class of the plaster is UC2 (Appendix.B).

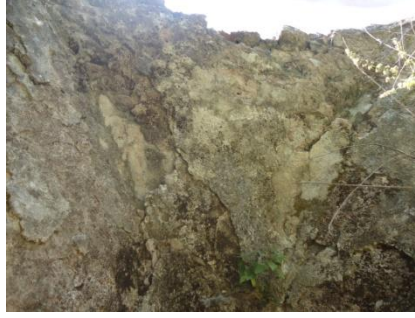
Figure 4.177. South West pendentive plaster of the South West *Halvet*

On the South West pendentive plaster, discolourations and pittings were observed.

According to the findings, the plaster displays minor symptoms and condition class of the plaster is CC1, recommendation class of the plaster is RC1, and urgency class of the plaster is UC1 (Appendix.B).

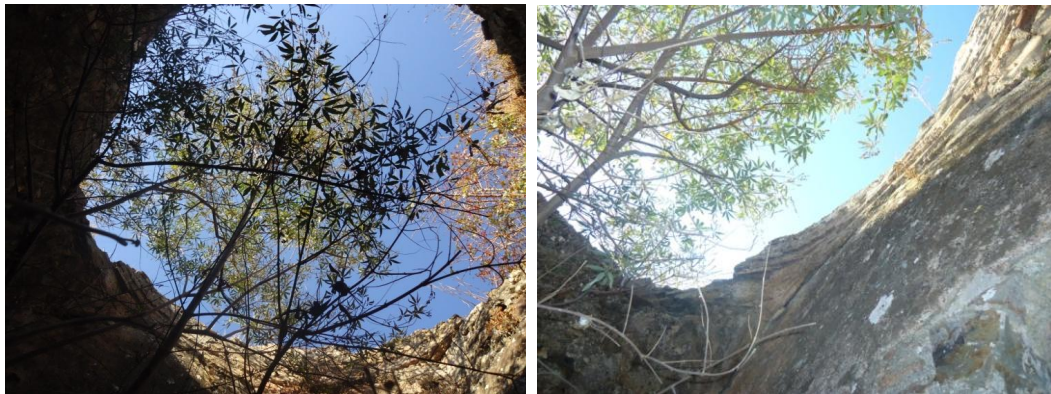
Figure 4.178. Dome plaster of the South West *Halvet*

On the dome plaster, widely missing plaster part was observed. Current plaster has microbiological colonizations; pittings; efflorescences; and black crusts.

According to the findings, the plaster displays major symptoms and condition class of the plaster is CC3, recommendation class of the plaster is RC3, and urgency class of the plaster is UC3 (Appendix.B).

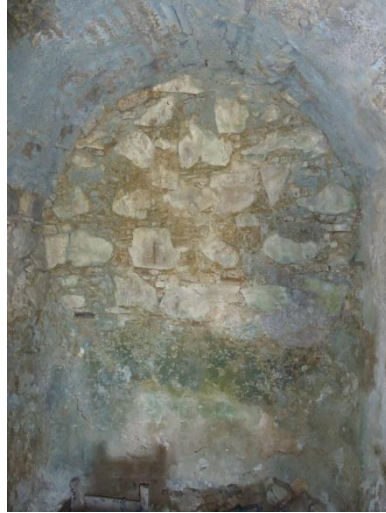
Figure 4.179. West wall of the water reservoir

No structural failure was observed. Observed material deteriorations are microbiological colonization, discolourations and pittings on the unplastered areas. Black crusts are widespread on the middle and the right areas.

According to the findings, the wall displays moderate symptoms and condition class of the wall is CC2, recommendation class of the wall is RC2, and urgency class of the wall is UC2 (Appendix.B, Appendix.C).

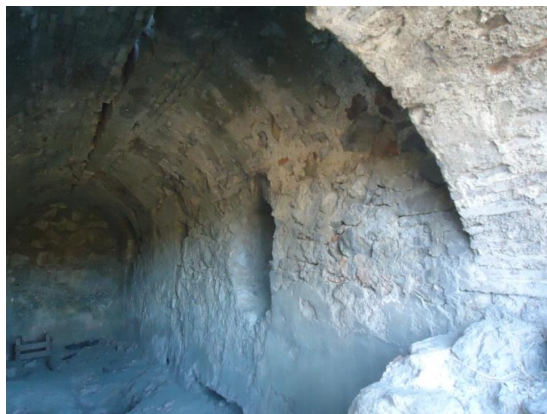
Figure 4.180. North wall of the water reservoir

Losses of the wall involve the windows. Discolourations were observed on the all unplastered areas. Microbiological crusts were seen the upper right of the wall.

According to the findings, the wall displays moderate symptoms and condition class of the wall is CC2, recommendation class of the wall is RC2, and urgency class of the wall is UC2 (Appendix.B).

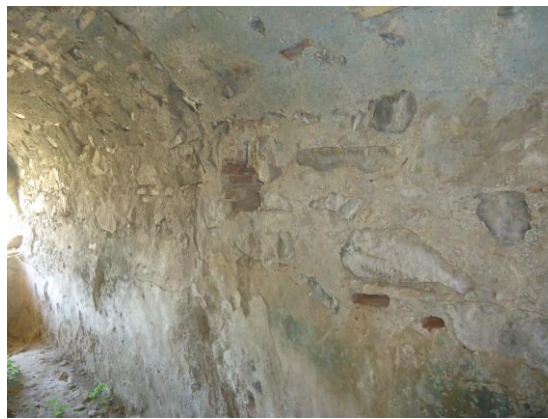
Figure 4.181. South wall of water reservoir

No structural failure was observed. Observed material deteriorations are discolourations and pittings on the all unplastered areas.

According to the findings, the wall displays minor symptoms and condition class of the wall is CC1, recommendation class of the wall is RC1, and urgency class of the wall is UC1 (Appendix.B).

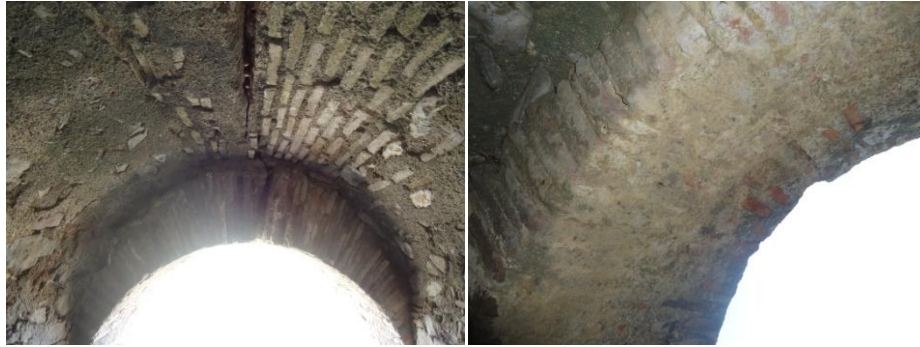
Figure 4.182. East arch of water reservoir

The general condition assessment revealed that the arch is in a good condition. No structural failure was observed. Observed material deteriorations are pittings and microbiological colonizations.

According to the findings, the arch displays minor symptoms and condition class of the arch is CC1, recommendation class of the arch is RC1, and urgency class of the arch is UC1 (Appendix.B).

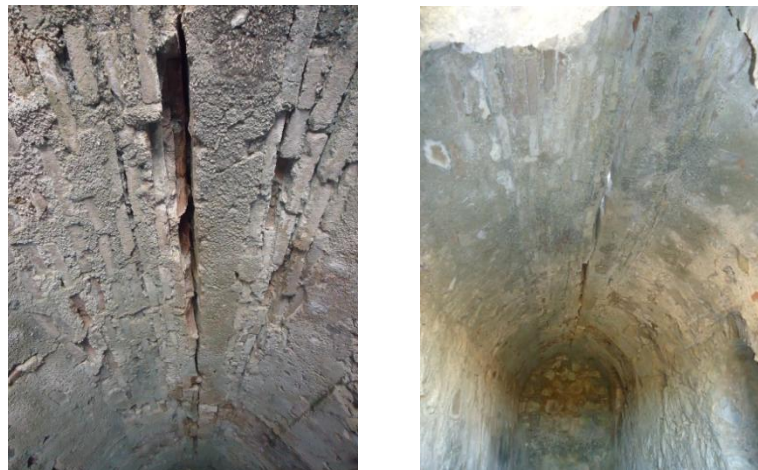
Figure 4.183. Barrel vault of the water reservoir

Observed structural failures of barrel vault are splitting in the middle and loss of bricks. Observed material deteriorations involve discolorations on unplastered bricks.

According to the findings, the barrel vault displays moderate symptoms and condition class of the barrel vault is CC2, recommendation class of the barrel vault is RC2, and urgency class of the barrel vault is UC2 (Appendix.B, Appendix.C).

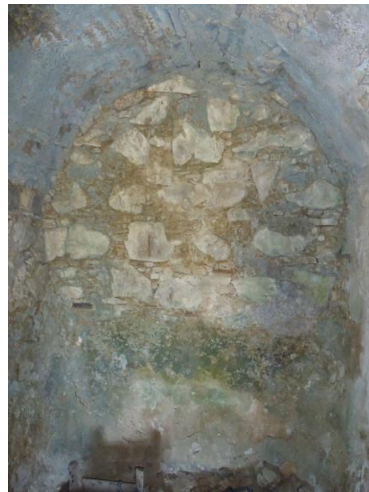
Figure 4.184. West wall plaster of the water reservoir

On the West wall plaster (Figure 4.184), widely missing part of the plaster was

observed from the middle height of the wall to the barrel vault level. Microbiological colonizations, efflorescences and discolorations were observed on the current plaster.

According to the findings, the plaster displays major symptoms and condition class of the plaster is CC3, recommendation class of the plaster is RC3, and urgency class of the plaster is UC3 (Appendix.B).

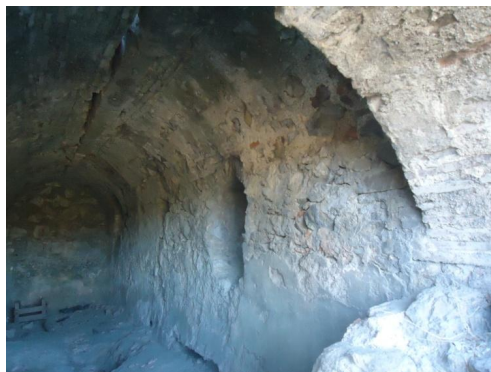
Figure 4.185. North wall plaster of the water reservoir

On the North wall plaster (Figure 4.185), missing parts of the plasters are widespread and delaminations were observed from the window trace to the barrel vault.

According to findings, the plaster displays moderate symptoms and condition class of the plaster is CC2, recommendation class of the plaster is RC2, and urgency class of the plaster is UC2 (Appendix.B).

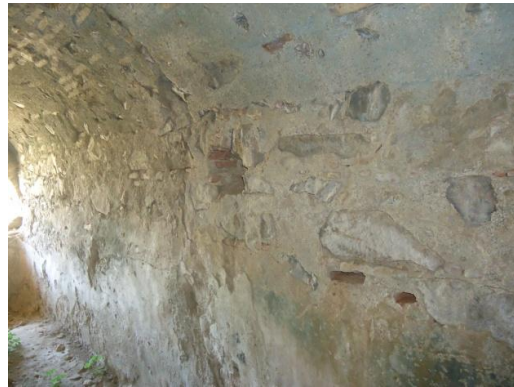
Figure 4.186. South wall plaster of the water reservoir

On the South wall plaster (Figure 4.186), missing parts of the plasters are widespread and microbiological colonizations were observed below the wall.

According to the findings, the plaster displays moderate symptoms and condition class of the plaster is CC2, recommendation class of the plaster is RC2, and urgency class of the plaster is UC2 (Appendix.B).
