**IMPORTANCE OF CONDITION SURVEY AND
REPORT OF BUILT CULTURAL HERITAGE:
DÜZCE (HEREKE) BATH**

in Architectural Restoration

IMPORTANCE OF CONDITION SURVEY AND REPORT OF BUILT CULTURAL HERITAGE: DÜZCE (HEREKE) BATH

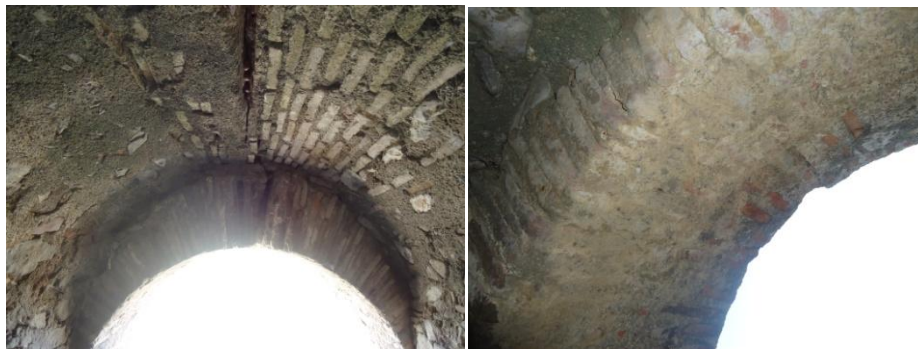
Figure 4.187. East arch plaster of the water reservoir

On the East arch plaster (Figure 4.187), inner surface has missing wide part of the plaster. Microbiological colonizations were seen on the existing small areas.

According to the findings, plaster has major symptoms and condition class of the plaster is CC3, recommendation class of the plaster is RC3, and urgency class of the plaster is UC3 (Appendix.B).

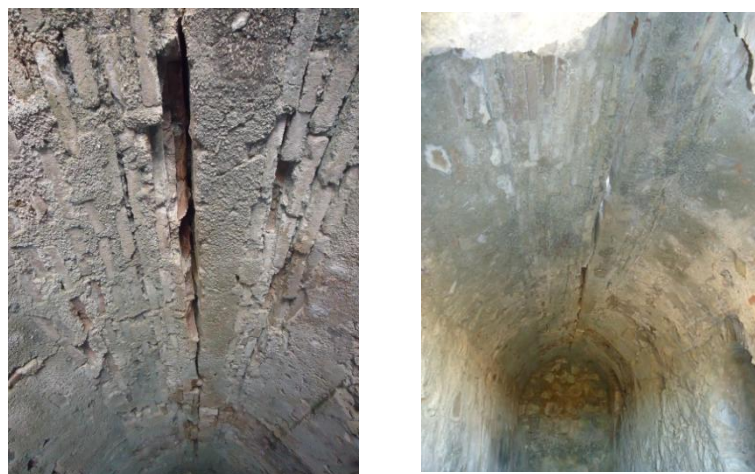
Figure 4.188. Barrel vault plaster of the water reservoir

On the barrel vault plaster (Figure 4.188), delamination was observed on the right corner of the surface. Microbiological colonizations are widespread. Efflorescences were observed rarely.

According to the findings, the plaster displays moderate symptoms and condition class of the plaster is CC2, recommendation class of the plaster is RC2, and urgency class of the plaster is UC2 (Appendix.B).

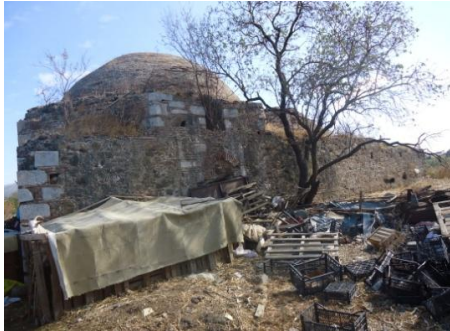
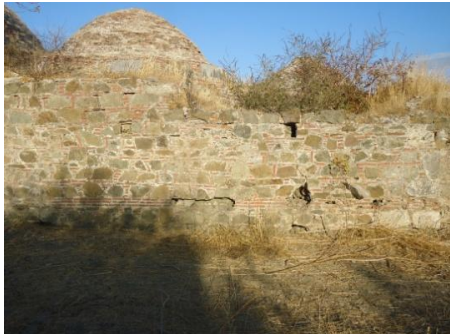
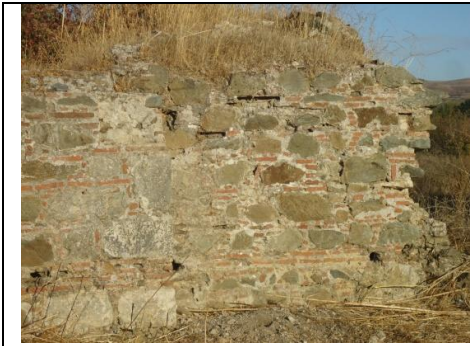
Stone masonry wall which was constructed through bonding technique with rubble stone and brick, which is different from other walls. In horizontal joints, one or two rows of brick bonds lie between rubble stones, while in vertical joints, large pieces of bricks are mixed into the lime mortar and they are parallel to the horizontal joints. Roughly cut stones were used on the left edge. Surface is unplastered.	<u>Losses</u> -Entrance door <u>Structural failures</u> -Missing part of wall on the right -Missing roughly cut stone on left edge -Missing bricks in the middle (<i>Sıcaklık, Halvet</i>) part -Splitting on the middle (<i>Halvet</i>) and right (water reservoir) part -Plants on the left (<i>Soyunmalık</i>) and middle (<i>Halvet</i>) part of wall <u>Material deteriorations</u> -Black crusts on the left (<i>Soyunmalık</i>) part of wall -Microbiological colonizations on	Moderately strong symptoms	2	Moderate repair and further investigation	2	Short Term	2

the left (*Soyunmalık*) part of wall
 -Black crusts are widespread
 -Efflorescences are widespread
 -Discolourations are widespread
 -Hair cracks are widespread
 -Pittings are widespread

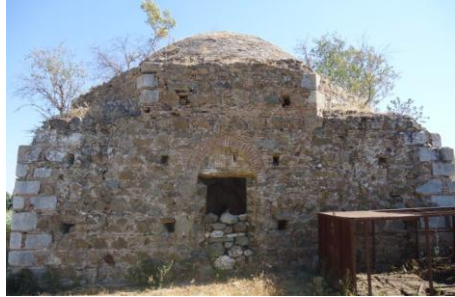
North wall - 1

Stone masonry wall which was constructed through bonding technique with rubble stone and brick components in lime mortar. Roughly cut stones were used on edges. Surface is unplastered.

Losses
 -Window
Structural failures
 -Missing part of wall below the window trace
 -Missing stones in the middle part
 -Splitting on the left of wall
Material deteriorations
 -Microbiological colonizations
 -Black crusts are widespread, especially on the

left and right of the wall
 -Efflorescences are widespread, especially on the left and right of the wall
 -Pittings
 -Discolourations are widespread
 -Hair cracks are widespread

Moderate repair and further investigation

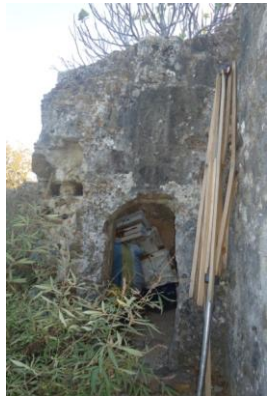
North wall - 2

Stone masonry wall which was constructed through bonding technique with rubble stone and brick components in lime mortar. Surface is unplastered.

Losses
 -Window
Structural failures
 -Missing part of wall below window trace
 -Missing stones in the left part
 -Splitting on the left of wall
Material deteriorations
 -Microbiological

Moderate repair and further investigation

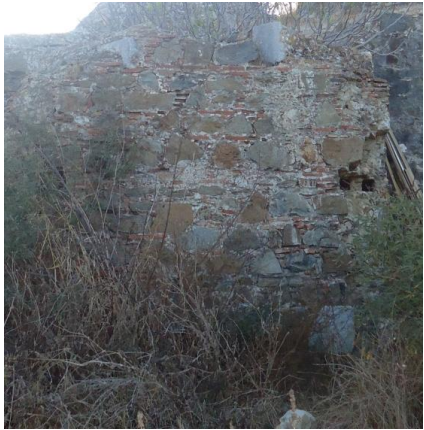
<p>Stone - brick bonding technique with lime mortar. In horizontal joints, one or two rows of brick bonds lie between rubble stones, while in vertical joints, large pieces of bricks are mixed into the lime mortar and they are parallel to the horizontal joints. Surface is unplastered.</p>	<p><u>Structural failures</u></p> <ul style="list-style-type: none"> -Missing part on right part of wall <p><u>Material deteriorations</u></p> <ul style="list-style-type: none"> -Microbiological colonizations -Black crusts are widespread -Efflorescences are widespread -Discolourations are widespread 	<p>Moderately strong symptoms</p>	2	<p>Moderate repair and further investigation</p>	2	<p>Short Term</p>	2

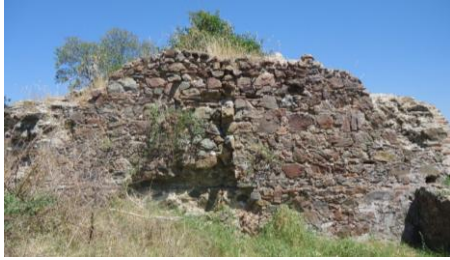
<p>South wall - 1</p>	<p>Stone masonry wall which was constructed through bonding technique</p>	<p><u>Structural failures</u></p> <ul style="list-style-type: none"> -Missing part of wall -Splitting in the 	<p>Moderately strong symptoms</p>	2	<p>Moderate repair and further investigation</p>	2	<p>Short Term</p>	2

<p>with rubble stone and brick components in lime mortar. Surface is unplastered.</p>	<p>middle -Plants <u>Material deteriorations</u> -Discolourations in components</p>						
<p>South wall - 2</p>

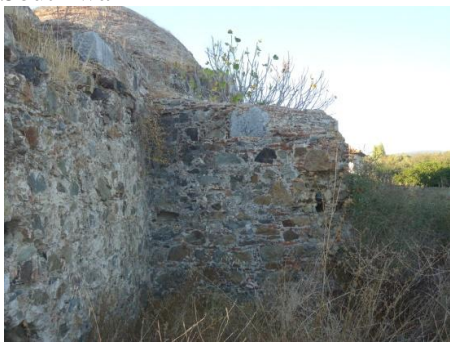
<p>Stone masonry wall which were constructed with bonding technique with rubble stone and brick components in lime mortar. Surface is unplastered</p>	<p><u>Structural failures</u> -Missing stone on the left <u>Material deteriorations</u> -Microbiological colonizations -Black crusts are widespread -Efflorescences are widespread -Discolourations are widespread</p>	<p>Moderately strong symptoms</p>	<p>2</p>	<p>Moderate repair and further investigation</p>	<p>2</p>	<p>Short Term</p>	<p>2</p>
<p>Arch</p>	<p>Brick - lime mortar arch. Surface is unplastered.</p>	<p><u>Material deteriorations</u> -Microbiological colonizations, especially on the right -Black crusts -Efflorescences -Discolourations</p>	<p>Minor symptoms</p>	<p>1</p>	<p>Maintenance / Preventive conservation</p>	<p>1</p>	<p>Intermediate term</p>	<p>1</p>

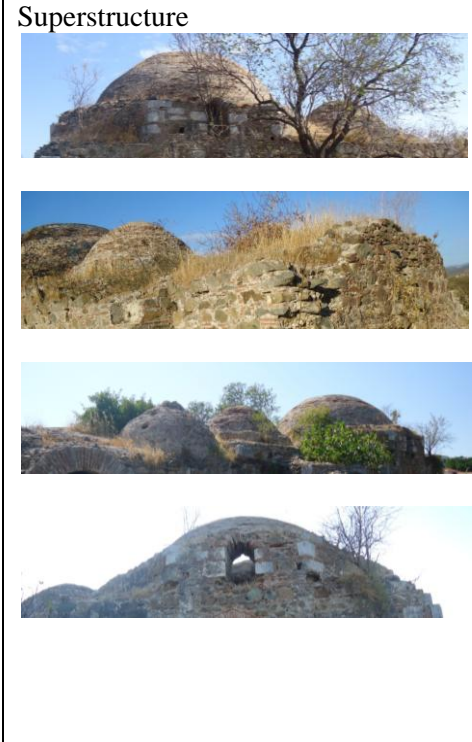
Superstructure of five domes and barrel vault. All of them are brick - lime mortar superstructures which have oculis. Domes are stand on octogonal drums.

Losses
 -Top windows of Soyunmalık dome
 -Top skylight
 -Oculis

Structural failures
 -Missing wide (collapsed) part of dome of Soyunmalık, East and South East Halvets.
 -Missing central small dome of Sıcaklık
 -Missing bricks in Soyunmalık dome
 -Splitting in Soyunmalık dome and barrel vault (water reservoir's

<p>superstructure) -Broken bricks around collapsed areas -Plants on all drums and beginnings of domes and barrel vaults and all superstructures surfaces</p> <p><u>Material deteriorations</u> -Black crusts were seen, especially on drums' roughly cut stones -Efflorescences are widespread -Discolourations are widespread -Pittings in components</p>						
Wall between cistern and water reservoir	Stone masonry wall which were constructed with bonding technique with rubble stone and brick components in lime mortar. Surface is	<p><u>Structural failures</u> -Joint discharges close to the cistern</p> <p><u>Material deteriorations</u> -Efflorescences -Discolourations</p>	Moderately strong symptoms	2	Moderate repair and further investigation	2	Short Term	2

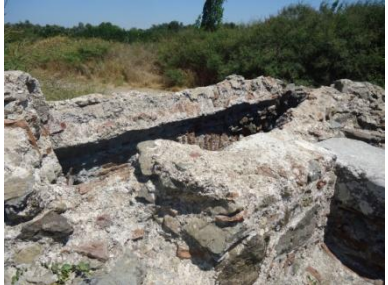
<p>Has stone masonry walls which were constructed with bonding technique with rubble stone and brick components in lime mortar. Surfaces are unplastered</p>	<p><u>Structural failures</u> -Missing wide parts of the walls -Joint discharges</p> <p><u>Material deteriorations</u> -Efflorescences are widespread -Discolourations -Pittings</p>	<p>Major symptoms</p>	<p>3</p>	<p>Major intervention based on diagnosis</p>	<p>3</p>	<p>Urgent and immediate</p>	<p>3</p>

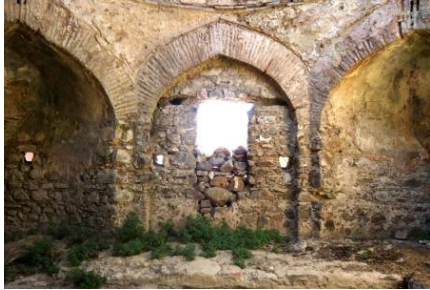
Stone masonry wall that was constructed through bonding technique with rubble stone and brick components in lime mortar. Surface is plastered.	<u>Losses</u> -Window -Timber beam <u>Structural Failures</u> -Missing part (partial collapse) below the window trace -Joint discharge on the left of wall -Missing parts of bricks and stones in the left of wall -Missing stone below the timber beam trace -Alveolizations on components of right part of wall -Hair cracks on left of wall -Star crack above timber beam trace <u>Material Deteriorations</u> -Discoloration in components	Moderately strong symptoms	2	Moderate repair and further investigation	2	Short Term	2

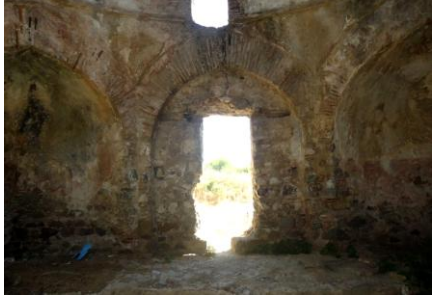
<p>Stone masonry wall that was constructed through bonding technique with rubble stone and brick components in lime mortar. Surface is plastered.</p>	<p><u>Losses</u></p> <ul style="list-style-type: none"> -Window -Timber beam <p><u>Structural Failures</u></p> <ul style="list-style-type: none"> -Partial Collapse below the window trace and between timber beam trace and window trace -Joint discharge around the window trace -Star crack splitting above the timber beam trace <p><u>Material Deteriorations</u></p> <ul style="list-style-type: none"> -Discoloration in components -Black crusts on the middle part of the wall -Efflorescences on 	<p>Moderately strong symptoms</p>	2	<p>Moderate repair and further investigation</p>	2	<p>Short Term</p>	2

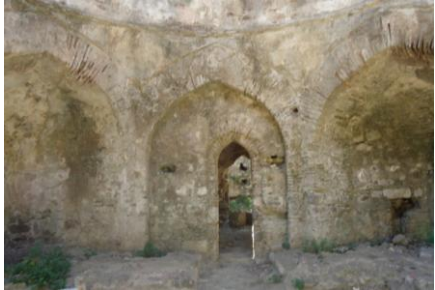
Stone masonry wall that was constructed through bonding technique with rubble stone and brick components in lime mortar. Surface is plastered.	<u>Losses</u> -Door -Flue -Basin <u>Structural Failures</u> -Joint discharge around the door trace <u>Material Deteriorations</u> -Discoloration in components -Efflorescences on the middle and the right part of the wall -Microbiological colonization on the right part of the wall -Graffiti on the right part of the wall -Pittings on the mortars	Moderately strong symptoms	2	Moderate repair and further investigation	2	Short Term	2

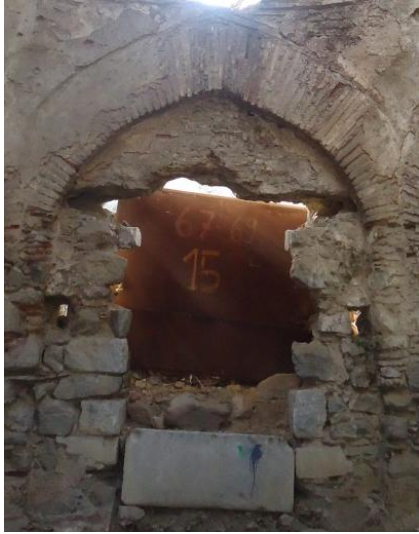
<p>Brick and lime mortar lowered pointed arch. Arch bases made with stone, brick and lime mortar. Surface is plastered.</p>	<p><u>Structural Failures</u> -Convex deformation on the right -Joint discharge on the bases -Broken bricks on the top point and the right of arch -Missing parts of bricks around the timber beam trace</p> <p><u>Material Deteriorations</u> -Discoloration in components -Black crusts on the mortars -Pittings on the mortars</p>	<p>Minor symptoms</p>	<p>1</p>	<p>Maintenance / Preventive conservation</p>	<p>1</p>	<p>Intermediate term</p>	<p>1</p>
<p>North West arch</p>	<p>Brick and lime mortar lowered pointed arch. Arch bases made with stone, brick and lime mortar. It made up niche with</p>	<p><u>Structural Failures</u> -Joint discharge on the bases -Missing bricks on the top point and the left of arch</p>	<p>Minor symptoms</p>	<p>1</p>	<p>Maintenance / Preventive conservation</p>	<p>1</p>	<p>Intermediate term</p>	<p>1</p>

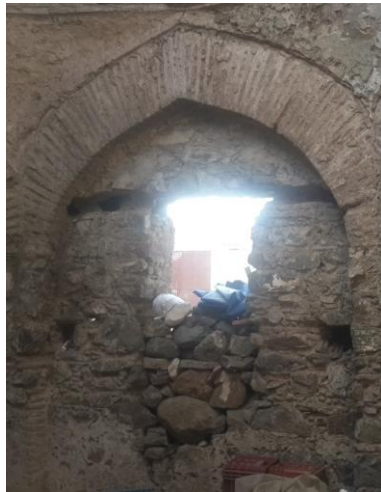
North arch

Brick and lime mortar lowered pointed arch. Arch bases made with stone, brick and lime mortar. Surface is plastered.

Structural Failures
 -Joint discharge on the bases
 -Missing bricks around the timber beam trace

Material Deteriorations
 -Discoloration in components
 -Black crusts on bases
 -Efflorescences on bases
 -Pittings on mortars

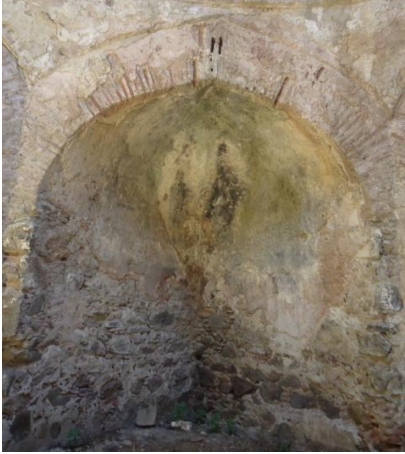
<p>North East arch</p>

<p>Brick and lime mortar lowered pointed arch. Arch bases made with stone, brick and lime mortar. It made up niche with squinch and part of the wall. Surface is plastered.</p>	<p><u>Structural Failures</u> -Missing bricks on the top point of the arch -Alveolization on the stone inner part of the arch</p> <p><u>Material Deteriorations</u> -Discoloration in components -Black crusts on the bases -Efflorescences -Pittings on mortars</p>	<p>Minor symptoms</p>	<p>1</p>	<p>Maintenance / Preventive conservation</p>	<p>1</p>	<p>Intermediate term</p>	<p>1</p>
<p>East arch</p>

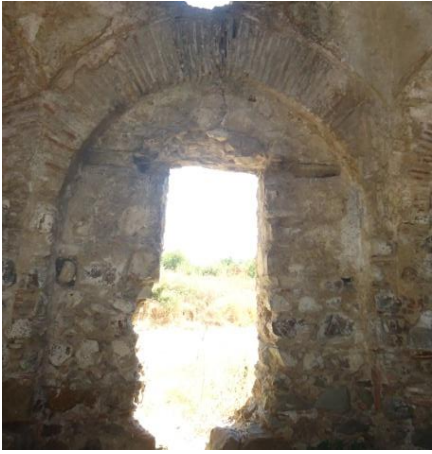
<p>Brick and lime mortar lowered pointed arch. Arch bases made with stone, brick and lime mortar. Surface is plastered.</p>	<p><u>Structural Failures</u> -Missing bricks near the top point of the arch</p> <p><u>Material Deteriorations</u> -Discoloration in components -Black crusts on mortars -Efflorescences on mortars -Pittings</p>	<p>Minor symptoms</p>	<p>1</p>	<p>Maintenance / Preventive conservation</p>	<p>1</p>	<p>Intermediate term</p>	<p>1</p>

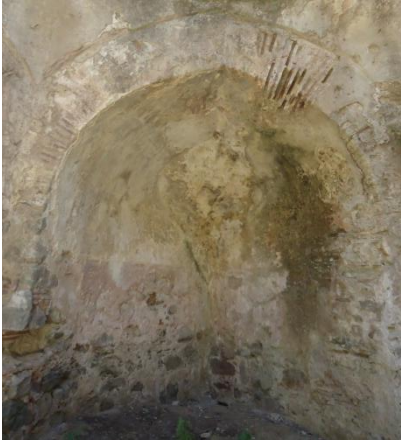
<p>South East arch</p>	<p>Brick and lime mortar lowered</p>	<p><u>Structural Failures</u> -Missing bricks in</p>	<p>Minor symptoms</p>	<p>1</p>	<p>Maintenance / Preventive</p>	<p>1</p>	<p>Intermediate term</p>	<p>1</p>

<p>pointed arch. Arch bases made with stone, brick and lime mortar. It made up niche with squinch and part of the wall. Surface is plastered.</p>	<p>the right part of the arch</p> <p><u>Material</u> <u>Deteriorations</u></p> <ul style="list-style-type: none"> -Discoloration in components -Black crusts on the upper part of the arch -Efflorescences in components -Pittings on mortars 			<p>conservation</p>			
<p>South arch</p>

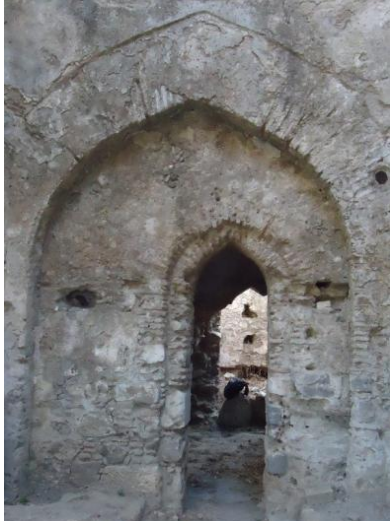
<p>Brick and lime mortar lowered pointed arch. Arch bases made with stone, brick and lime mortar. Surface is plastered.</p>	<p><u>Material</u> <u>Deteriorations</u></p> <ul style="list-style-type: none"> -Discoloration on the bases -Black crusts on right of top part of the arch - Microbiological colonizations on right top part of the arch -Pittings on components 	<p>Minor symptoms</p>	<p>1</p>	<p>Maintenance / Preventive conservation</p>	<p>1</p>	<p>Intermediate term</p>	<p>1</p>

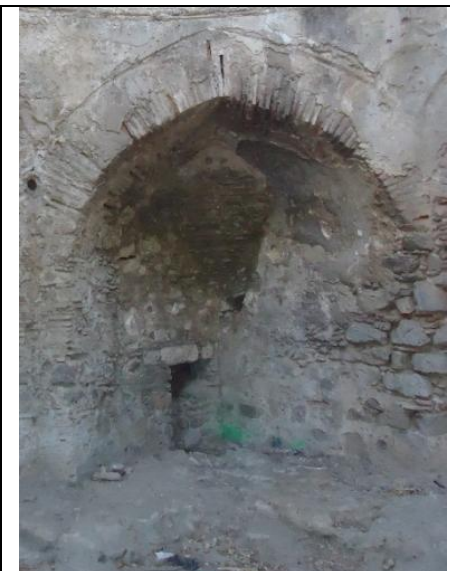
<p>South West arch</p>	<p>Brick and lime mortar lowered</p>	<p><u>Structural Failures</u></p> <ul style="list-style-type: none"> -Joint discharges 	<p>Minor symptoms</p>	<p>1</p>	<p>Maintenance / Preventive</p>	<p>1</p>	<p>Intermediate term</p>	<p>1</p>

<p>pointed arch. Arch bases made with stone, brick and lime mortar. It made up niche with squinch and part of the wall. Surface is plastered.</p>	<p>inner surface and upper part of the arch -Missing brick in the right part of top point of arch</p> <p><u>Material</u> <u>Deteriorations</u> -Discoloration in components -White crusts on the upper part of the arch -Pittings on mortars</p>			<p>conservation</p>			
---	---	---	--	--	---------------------	--	--	--

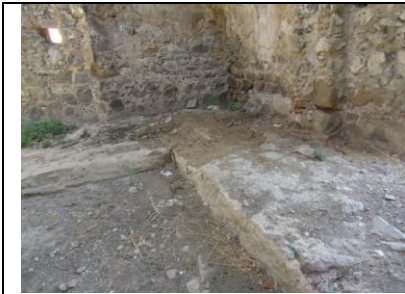
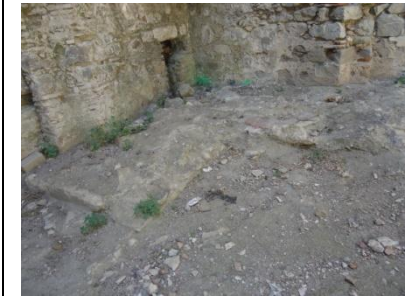
<u>Seki</u>								
Building Component	Component Description	Condition Description	Symptoms	CC	Recomended Measure	RC	Risk Assessment	UC
	Square-formed stone <i>seki</i> .	<p><u>Structural Failures</u> -Missing parts of the stones -Mechanical damage - impact damage</p>	Moderately strong symptoms	2	Moderate repair and further investigation	2	Short Term	2

Material Deteriorations
 -Discoloration in components
 -White crusts
 -Pittings on components

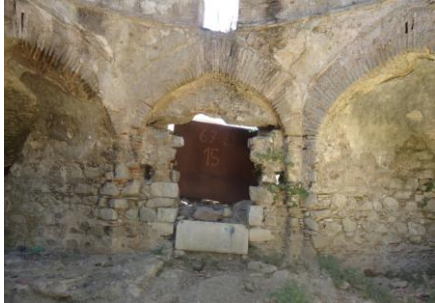
Building Component	Component Description	Condition Description	Symptoms	CC	Recomended Measure	RC	Risk Assessment	UC
West wall plaster	Up to 150 cm, 2 layers horasan plaster were used as plaster and thin red plaster used as finishing layer. From 150 cm up to	-Missing wide part of the plaster -Microbiological colonisation on the left part of the wall -Graffiti on the left part of the wall	Major symptoms	3	Major intervention based on diagnosis	3	Urgent and immediate	3

<p>dome, horasan plaster layer and 2 layers lime plaster were used</p>	<ul style="list-style-type: none"> -Delamination on the middle part of the wall -Black and white crusts under the timber beam trace -Black crusts on the right part of the wall -Pittings 						
<p>North wall plaster</p>

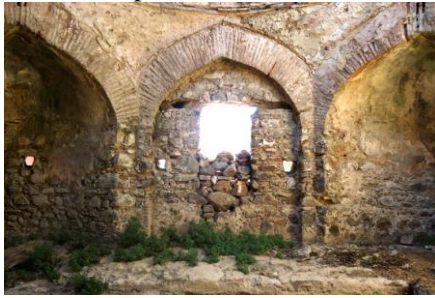
<p>Up to 150 cm, 2 layers horasan plaster were used as plaster and thin red plaster used as finishing layer. From 150 cm up to dome, horasan plaster layer and 2 layers lime plaster were used</p>	<ul style="list-style-type: none"> -Missing semi part of the plaster -Black crusts, discolourations and efflorescences on the left part and middle part of the wall -Delamination and peeling below the middle arch and the right part of the wall 	Moderately strong symptoms	2	Moderate repair and further investigation	2	Short Term	2
<p>East wall plaster</p>	<p>Up to 150 cm, 2 layers horasan plaster were used as plaster and thin red plaster used as finishing layer. From 150 cm up to dome, horasan plaster layer and 2</p>	<ul style="list-style-type: none"> -Missing part of plaster on middle part of wall - Black crusts -White crusts below the timber beam trace in the middle part -Discolourations 	Moderately strong symptoms	2	Moderate repair and further investigation	2	Short Term	2

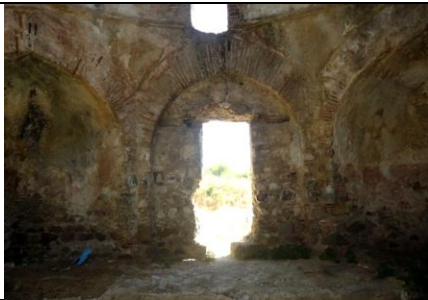
<p>layers lime plaster were used</p>	<p>-Microbiological colonizations on the right part of the wall near squinch</p>						
<p>South wall plaster</p>

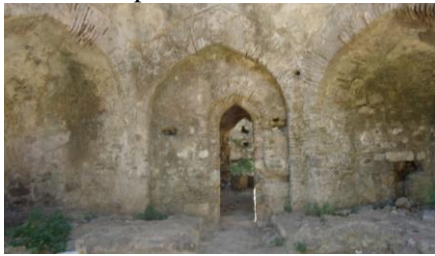
<p>Up to 150 cm, 2 layers horasan plaster were used as plaster and thin red plaster used as finishing layer. From 150 cm up to dome, horasan plaster layer and 2 layers lime plaster were used</p>	<p>-Missing part of the plaster on the middle and the right part of the wall - Microbiological colonizations on the left and right part of wall -Pittings on the right and the middle part of the wall -Discolourations -Black and white crusts on middle and right part of wall</p>	<p>Moderately strong symptoms</p>	<p>2</p>	<p>Moderate repair and further investigation</p>	<p>2</p>	<p>Short Term</p>	<p>2</p>
<p>West arch plaster</p>	<p>Up to 150 cm, 2 layers horasan plaster were used as plaster and thin red plaster used as finishing layer.</p>	<p>-Loss of plaster on the arch bases -Missing wide part of the plaster of arch -Discolourations on</p>	<p>Major symptoms</p>	<p>3</p>	<p>Major intervention based on diagnosis</p>	<p>3</p>	<p>Urgent and immediate</p>	<p>3</p>

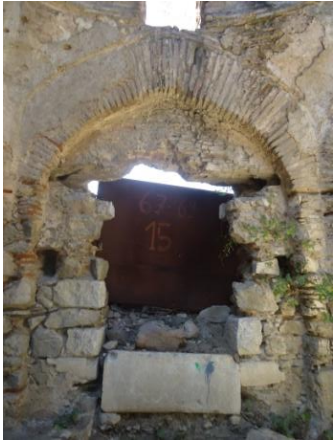
<p>From 150 cm up to dome, horasan plaster layer and 2 layers lime plaster were used.</p>	<p>the left and right plaster parts -Black crusts on the left plaster part -Pittings on the left and the right plaster parts -Delaminations on the right plaster part</p>						
<p>North West arch plaster</p>

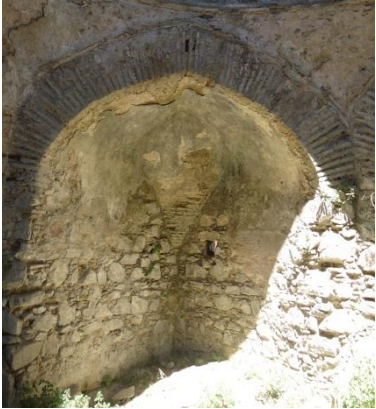
<p>Up to 150 cm, 2 layers horasan plaster were used as plaster and thin red plaster used as finishing layer. From 150 cm up to dome, horasan plaster layer and 2 layers lime plaster were used.</p>	<p>-Loss of plaster on the arch bases -Missing wide part of the plaster of arch -Peelings -Pittings -White crusts</p>	<p>Major symptoms</p>	<p>3</p>	<p>Major intervention based on diagnosis</p>	<p>3</p>	<p>Urgent and immediate</p>	<p>3</p>
<p>North arch plaster</p>	<p>Up to 150 cm, 2 layers horasan plaster were used as plaster and thin red plaster used as</p>	<p>-Loss of plaster on the arch bases -Missing wide part of the plaster of arch</p>	<p>Major symptoms</p>	<p>3</p>	<p>Major intervention based on diagnosis</p>	<p>3</p>	<p>Urgent and immediate</p>	<p>3</p>

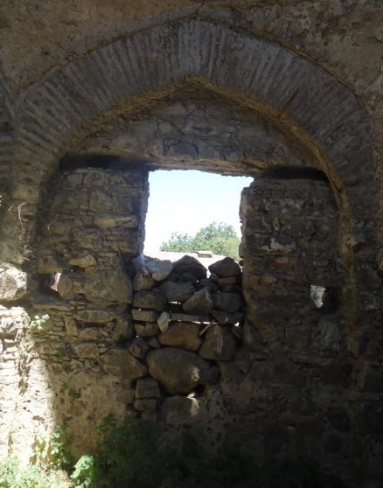
<p>finishing layer. From 150 cm up to dome, horasan plaster layer and 2 layers lime plaster were used.</p>	<ul style="list-style-type: none"> -Pittings -White crusts 						
<p>North East arch plaster</p>

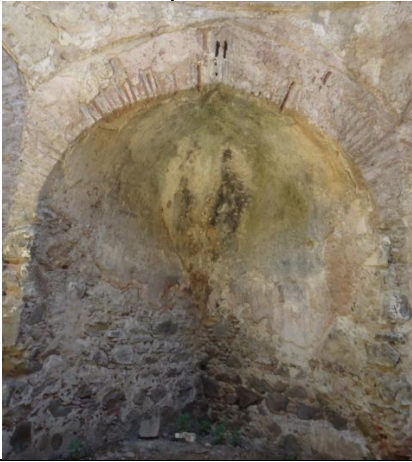
<p>Up to 150 cm, 2 layers horasan plaster were used as plaster and thin red plaster used as finishing layer. From 150 cm up to dome, horasan plaster layer and 2 layers lime plaster were used.</p>	<ul style="list-style-type: none"> -Loss of plaster on the arch bases -Missing wide part of the plaster of the arch -Delaminations -Pittings -Microbiological colonizations inner surface -Hair cracks inner surface -White and black crusts inner surface 	Moderately strong symptoms	2	Moderate repair and further investigation	2	Short Term	2
<p>East arch plaster</p>	<p>Up to 150 cm, 2 layers horasan plaster were used</p>	<ul style="list-style-type: none"> -Missing wide part of plaster on the arch bases 	Major symptoms	3	Major intervention based on	3	Urgent and immediate	3

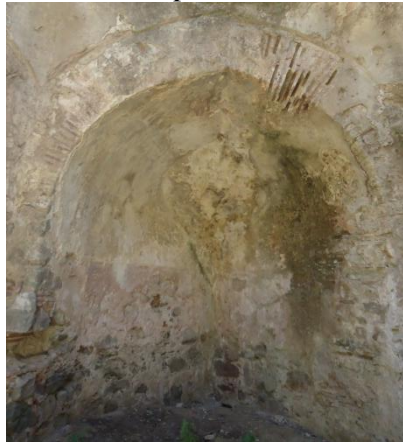
Sourt East arch plaster

Up to 150 cm, 2 layers horasan plaster were used as plaster and thin red plaster used as finishing layer. From 150 cm up to dome, horasan plaster layer and 2 layers lime plaster were used.

- Missing parts of plaster on the arch bases; the left of inner surfaces and the upper part
- Delamination on the left part of arch
- Pittings on the left part of arch
- White crusts on the left part of arch
- Black crusts
- Microbiological colonizations inner surface
- Pittings inner surface
- Discoloration inner surface

Moderate repair and further investigation

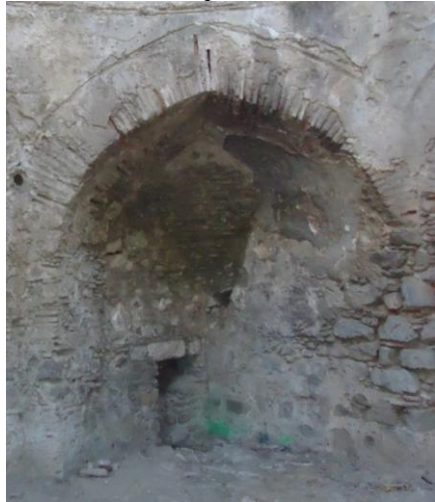
South West arch plaster

Up to 150 cm, 2 layers horasan plaster were used as plaster and thin red plaster used as finishing layer. From 150 cm up to dome, horasan plaster layer and 2 layers lime plaster were used.

-Missing parts of the plaster on arch and inner surface
 -Delamination on the left part of the arch
 -Pittings on the left part of the arch
 -White crusts on the left part of the arch
 -Black crusts
 White crusts

Moderate repair and further investigation

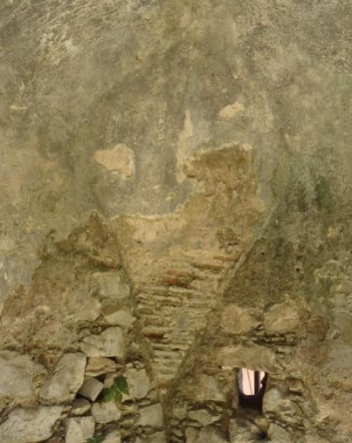
<p>North West squinch plaster</p>

<p>Up to 150 cm, 2 layers horasan plaster were used as plaster and thin red plaster used as finishing layer. From 150 cm up to dome, horasan plaster layer and 2 layers lime plaster were used.</p>	<p>-Peelings were seen rarely -Delaminations were seen rarely - Microbiological colonizations are widespread -Black - white crusts are widespread -Pittings are widespread</p>	<p>Moderately strong symptoms</p>	<p>2</p>	<p>Moderate repair and further investigation</p>	<p>2</p>	<p>Short Term</p>	<p>2</p>
<p>North East squinch plaster</p>

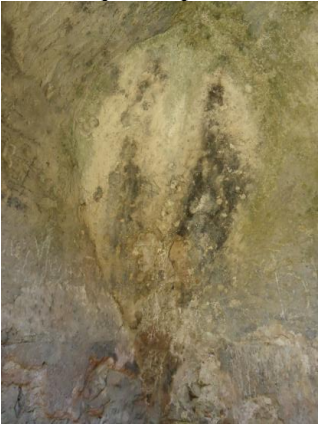
<p>Up to 150 cm, 2 layers horasan plaster were used as plaster and thin red plaster used as finishing layer. From 150 cm up to dome, horasan plaster layer and 2 layers lime plaster were used.</p>	<p>-Microbiological colonizations were seen rarely -Black - white crusts were seen rarely -Pittings were seen rarely</p>	<p>Minor symptoms</p>	<p>1</p>	<p>Maintenance / Preventive conservation</p>	<p>1</p>	<p>Intermediate term</p>	<p>1</p>

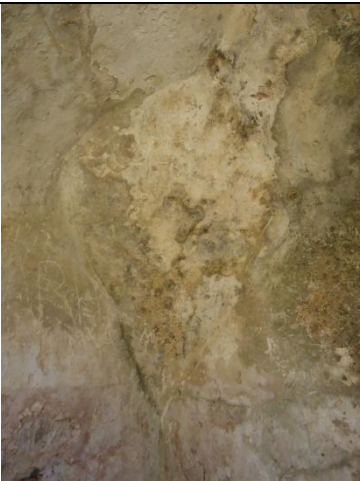
<p>South East squinch plaster</p>	<p>Up to 150 cm, 2 layers horasan</p>	<p>-Microbiological colonizations were</p>	<p>Minor symptoms</p>	<p>1</p>	<p>Maintenance / Preventive</p>	<p>1</p>	<p>Intermediate term</p>	<p>1</p>

<p>plaster were used as plaster and thin red plaster used as finishing layer. From 150 cm up to dome, horasan plaster layer and 2 layers lime plaster were used.</p>	<p>seen on the line -Black crusts were seen on the line and widespread on the whole plaster -White and black crusts are widespread -Pittings are widespread</p>			<p>conservation</p>			
<p>South West squinch plaster</p>

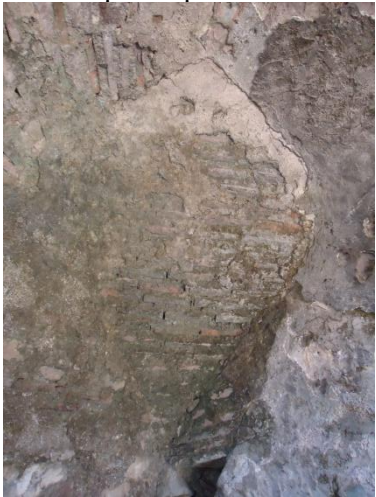
<p>Up to 150 cm, 2 layers horasan plaster were used as plaster and thin red plaster used as finishing layer. From 150 cm up to dome, horasan plaster layer and 2 layers lime plaster were used.</p>	<p>-Delaminations -Peelings - Microbiological colonizations are widespread -White and black crusts are widespread -Pittings are widespread</p>	<p>Moderately strong symptoms</p>	<p>2</p>	<p>Moderate repair and further investigation</p>	<p>2</p>	<p>Short Term</p>	<p>2</p>
<p>North West plane triangle - 1 plaster</p>	<p>Horasan plaster</p>	<p>-Black crusts on the</p>	<p>Minor</p>	<p>1</p>	<p>Maintenance /</p>	<p>1</p>	<p>Intermediate</p>	<p>1</p>

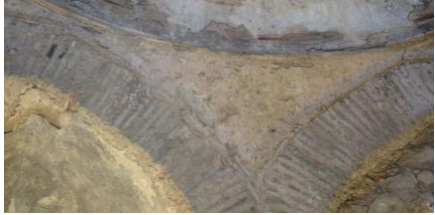
Horasan plaster layer and 2 layers lime plaster were used.	-Black crusts on the upper right part -Peelings -Pittings	Minor symptoms	1	Maintenance / Preventive conservation	1	Intermediate term	1
North East plane triangle - 1 plaster

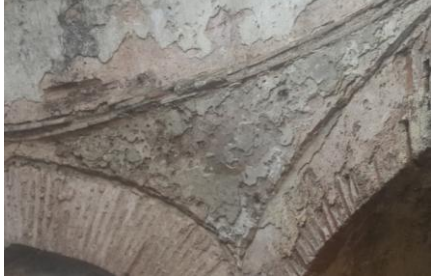
Horasan plaster layer and 2 layers lime plaster were used.	-Black crusts on the left part - Microbiological colonizations on the middle -Peelings -Pittings	Minor symptoms	1	Maintenance / Preventive conservation	1	Intermediate term	1
North East plane triangle - 2 plaster	Horasan plaster layer and 2 layers lime plaster were used.	-Delaminations -Peelings - Microbiological colonizations on the middle -White crusts	Moderately strong symptoms	2	Moderate repair and further investigation	2	Short Term	2

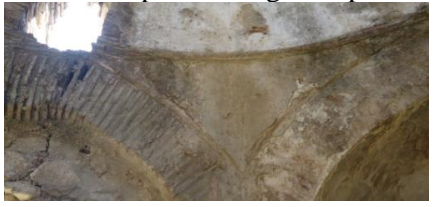
Horasan plaster layer and 2 layers lime plaster were used.	-Delaminations were seen rarely -Peelings were seen rarely -Black crusts -Pittings	Minor symptoms	1	Maintenance / Preventive conservation	1	Intermediate term	1
South East plane triangle - 2 plaster

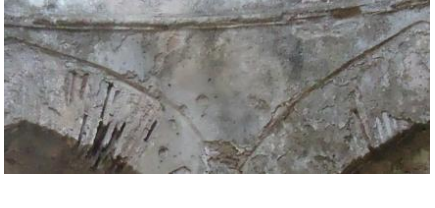
Horasan plaster layer and 2 layers lime plaster were used.	-Delaminations were seen rarely -Peelings were seen rarely -Black and white crusts -Pittings -Discolourations -Efflorescences on the corners	Minor symptoms	1	Maintenance / Preventive conservation	1	Intermediate term	1
South West plane triangle - 1 plaster

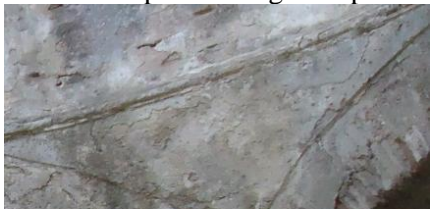
Horasan plaster layer and 2 layers lime plaster were used.	-Delaminations were seen rarely on the edges -Peelings were seen rarely on the edges - Microbiological colonizations on the left part	Minor symptoms	1	Maintenance / Preventive conservation	1	Intermediate term	1

<ul style="list-style-type: none"> -Pittings -Black and white crusts -Discolourations 						
<p>South West plane triangle - 2 plaster</p>

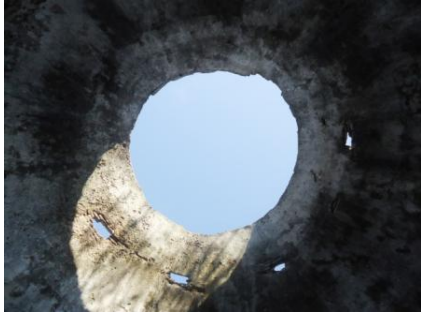
<p>Horasan plaster layer and 2 layers lime plaster were used.</p>	<ul style="list-style-type: none"> -Delamination -Peeling -Hair crack -Microbiological colonizations -Black and white crusts - Pittings 	<p>Moderately strong symptoms</p>	<p>2</p>	<p>Moderate repair and further investigation</p>	<p>2</p>	<p>Short Term</p>	<p>2</p>

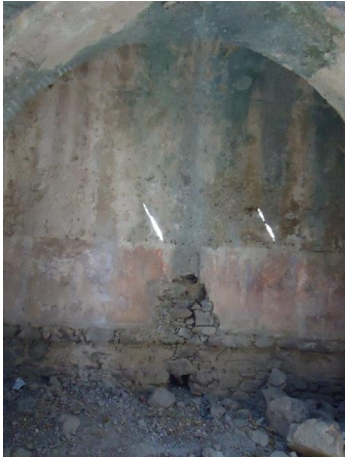
Stone masonry wall which was constructed through bonding technique with rubble stone and brick which is different from other walls. In horizontal joints, one or two rows of brick bonds lie between rubble stones, while in vertical joints, large pieces of bricks are mixed into the lime mortar and they are parallel to the horizontal joints.	<u>Losses</u> -Seki -Basin <u>Structural Failures</u> -Broken flue -Missing stones on the basin trace and below the wall	Minor symptoms	1	Maintenance / Preventive conservation	1	Intermediate term	1

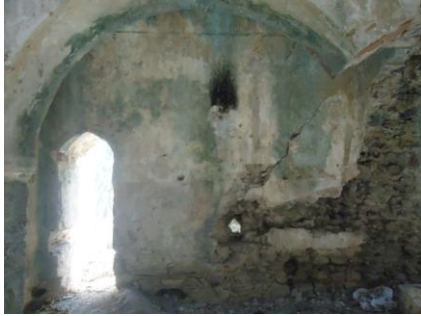
<p>and brick components in lime mortar. Surface is plastered.</p>	<p><u>Structural Failures</u> -Missing part of wall - partial collapse in the right part of the wall -Joint discharges -Splitting</p> <p><u>Material Deteriorations</u> -Black crusts -Pitting</p>						
<p>South wall</p>

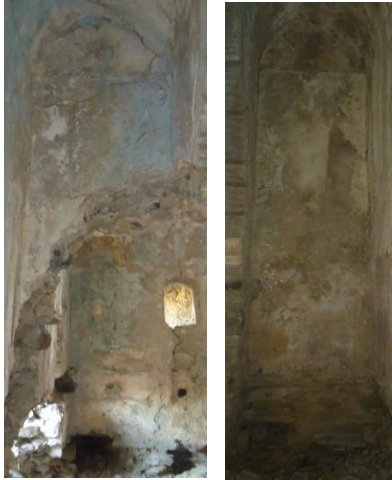
<p>Stone masonry wall which was constructed through bonding technique with rubble stone and brick components in lime mortar. Surface is plastered.</p>	<p><u>Losses</u> -Seki -Basin</p> <p><u>Structural Failures</u> -Missing part of wall (collapsed) in the left iwan part and the middle part of the wall -Joint discharges</p> <p><u>Material Deteriorations</u> -Pittings</p>	<p>Major symptoms</p>	<p>3</p>	<p>Major intervention based on diagnosis</p>	<p>3</p>	<p>Urgent and immediate</p>	<p>3</p>

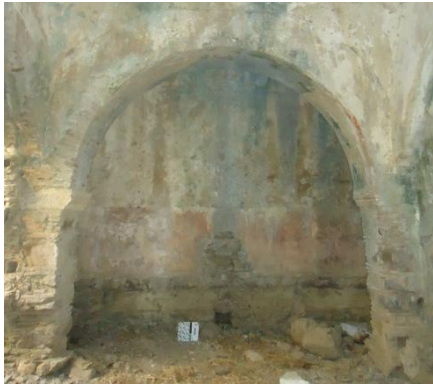
Brick - lime mortar round arch. Roughly cut stone and brick were used in arch bases. Surfaces are plastered.	<u>Losses</u> -Seki -Basin <u>Material</u> <u>Deteriorations</u> -Black crusts -Efflorescences -Discolourations	Minor symptoms	1	Maintenance / Preventive conservation	1	Intermediate term	1

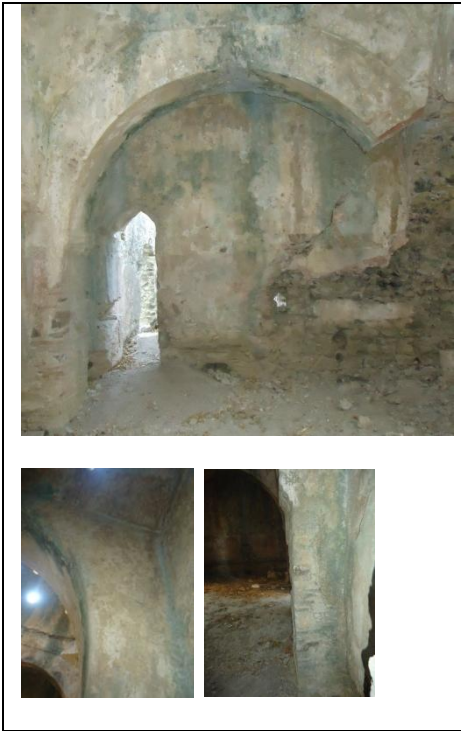
<p>Brick - lime mortar round arch. There is no arch base. Surfaces are plastered.</p>	<p>No visual deterioration</p>	<p>No symptoms</p>	<p>0</p>	<p>Observation</p>	<p>0</p>	<p>Long term</p>	<p>0</p>
<p>East arch</p>	<p>Brick - lime mortar round arch. Roughly cut stone and brick were used in arch bases. Surfaces are plastered.</p>	<p><u>Losses</u> -Seki -Basin</p> <p><u>Structural Failures</u> -Missing part of the arch - totally collapse of right part of the arch</p> <p><u>Material Deteriorations</u> -Black crusts</p>	<p>Major symptoms</p>	<p>3</p>	<p>Major intervention based on diagnosis</p>	<p>3</p>	<p>Urgent and immediate</p>	<p>3</p>

<ul style="list-style-type: none"> -Efflorescences -Discoloration 						
<p>South arch</p>

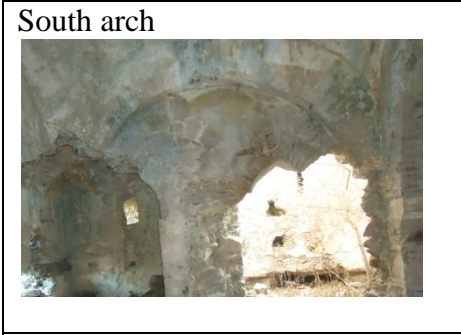
<p>Brick - lime mortar round arch. There is no arch base. Surfaces are plastered.</p>	<p><u>Structural Failures</u></p> <ul style="list-style-type: none"> -Missing part of arch - collapse in left part of arch 	<p>Moderately strong symptoms</p>	<p>2</p>	<p>Moderate repair and further investigation</p>	<p>2</p>	<p>Short Term</p>	<p>2</p>
<p><u>Pendentives</u></p>

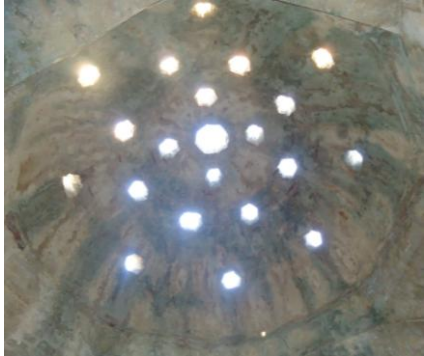
Building Component	Component Description	Condition Description	Symptoms	CC	Recomended Measure	RC	Risk Assessment	UC
Dome

Brick - lime mortar dome. Has top skylight and oculi on 3 rows. Surface is plastered.	<u>Losses</u> -Oculis -Top skylight (small dome)	Moderately strong symptoms	2	Moderate repair and further investigation	2	Short Term	2
West barrel vault	Brick - lime mortar barrel vault. Has 3 oculis. Surface is plastered.	<u>Losses</u> -Oculis	Minor symptoms	1	Maintenance / Preventive conservation	1	Intermediate term	1

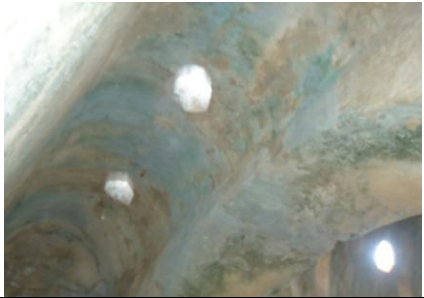
East barrel vault

Brick - lime mortar barrel vault. Has 3 oculis. Surface is plastered.	<u>Losses</u> -Oculis	Minor symptoms	1	Maintenance / Preventive conservation	1	Intermediate term	1
<u>Plasters</u>								
Building Component	Component Description	Condition Description	Symptoms	CC	Recomended Measure	RC	Risk Assessment	UC
West wall plaster

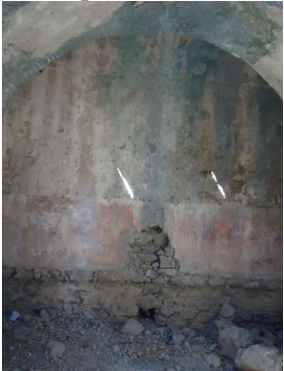
Horasan plaster were used as plaster up to 150 cm, and thin red plaster used as finishing layer. From 150 cm up to dome, 2 layers horasan plaster layer were used and lime plaster were used as finishing layer	-Microbiological colonizations are widespread, especially on the right part of the surface -Pittings on the left part of the surface -Delaminations and peelings on the left part of the surface -Black and white	Moderately strong symptoms	2	Moderate repair and further investigation	2	Short Term	2

<ul style="list-style-type: none"> crusts -Eflorescences -Hair cracks 						
<p>North wall plaster</p>

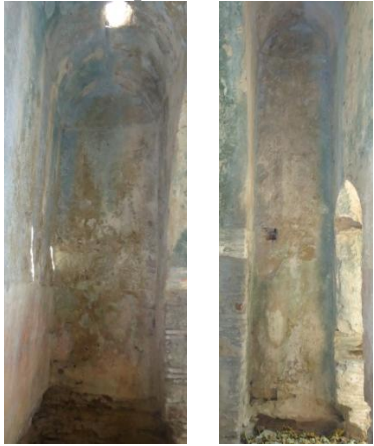
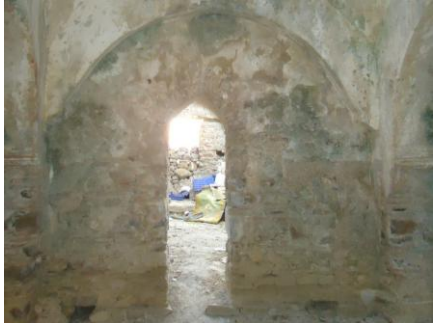
<p>Horasan plaster were used as plaster up to 150 cm, and thin red plaster used as finishing layer. From 150 cm up to dome, 2 layers horasan plaster layer were used and lime plaster were used as finishing layer</p>	<ul style="list-style-type: none"> -Missing parts of plasters below the wall - Microbiological colonizations are widespread on iwans - Eflorescences on the left part -Pittings -Discolourations -Hair cracks 	Moderately strong symptoms	2	Moderate repair and further investigation	2	Short Term	2
<p>East wall plaster</p>	<p>Horasan plaster were used as plaster up to 150 cm, and thin red plaster used as finishing layer.</p>	<ul style="list-style-type: none"> - Microbiological colonizations are widespread from the ground to the drum 	Moderately strong symptoms	2	Moderate repair and further investigation	2	Short Term	2

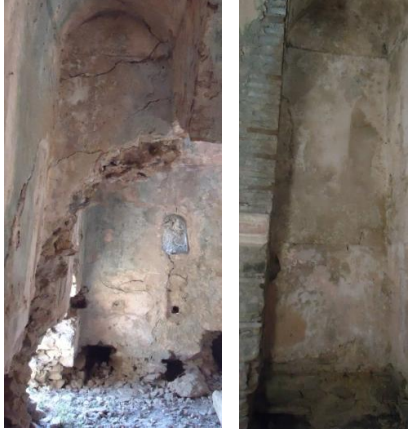
<p>Horasan plaster were used as plaster up to 150 cm, and thin red plaster used as finishing layer. From 150 cm up to dome, 2 layers horasan plaster layer were used lime plaster were used as finishing layer</p>	<ul style="list-style-type: none"> - Microbiological colonizations are seen more on the upper surface than below the wall -Pittings -Black and white crusts -Eflorescences, especially on the left part of the surface -Hair cracks, especially on the left part of the surface 	<p>Moderately strong symptoms</p>	<p>2</p>	<p>Moderate repair and further investigation</p>	<p>2</p>	<p>Short Term</p>	<p>2</p>

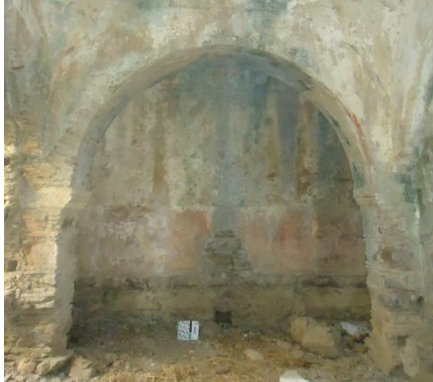
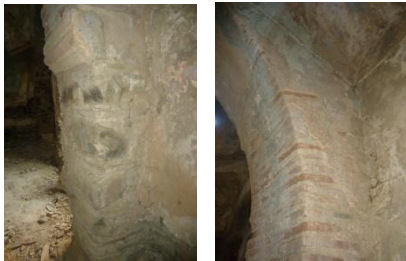
<p>West arch plaster</p>

<p>Horasan plaster were used as plaster up to 150 cm, and thin red plaster used as finishing layer. From 150 cm up to dome, 2 layers horasan plaster layer were used and lime plaster were used as finishing layer</p>	<ul style="list-style-type: none"> -Missing parts of plasters on the arch bases -Microbiological colonizations are observed the upper points of the inner surface intensely -Pittings -Black and white crusts -Eflorescences -Hair cracks -Discolourations 	<p>Moderately strong symptoms</p>	<p>2</p>	<p>Moderate repair and further investigation</p>	<p>2</p>	<p>Short Term</p>	<p>2</p>
<p>North arch plaster</p>	<p>2 layers horasan</p>	<p>-Microbiological</p>	<p>Minor</p>	<p>1</p>	<p>Maintenance /</p>	<p>1</p>	<p>Intermediate</p>	<p>1</p>

<p>plaster layer were used lime plaster were used as finishing layer.</p>	<p>colonizations are widespread from the middle part to the left part of surface -Pittings -Black and white crusts -Eflorescences -Hair cracks -Discolourations</p>	<p>symptoms</p>		<p>Preventive conservation</p>		<p>term</p>	
<p>East arch plaster</p>

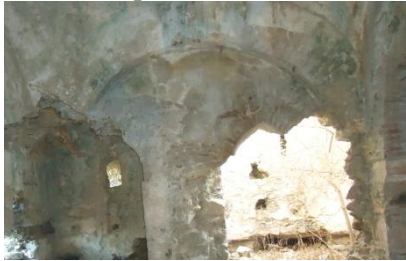
<p>South arch plaster</p>

<p>2 layers horasan plaster layer were used lime plaster were used as finishing layer.</p>	<ul style="list-style-type: none"> -Microbiological colonizations were seen intensely areas middle, left and right part of surface -Eflorescences on the left part of surface -Pittings -Black and white crusts -Discolourations -Hair cracks 	<p>Moderately strong symptoms</p>	<p>2</p>	<p>Moderate repair and further investigation</p>	<p>2</p>	<p>Short Term</p>	<p>2</p>
<p>North West pendentive plaster</p>	<p>2 layers horasan plaster layer were used and lime plaster were used as finishing layer.</p>	<ul style="list-style-type: none"> -Black crusts were seen rarely -Pittings -Discolourations 	<p>Minor symptoms</p>	<p>1</p>	<p>Maintenance / Preventive conservation</p>	<p>1</p>	<p>Intermediate term</p>	<p>1</p>

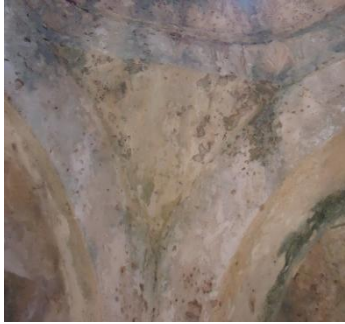
<p>North East pendentive plaster</p>

<p>2 layers horasan plaster layer were used and lime plaster were used as finishing layer.</p>	<ul style="list-style-type: none"> -Microbiological colonizations on the left and right corners - Black crusts were seen rarely on the edges -Pittings -Discolourations 	<p>Minor symptoms</p>	<p>1</p>	<p>Maintenance / Preventive conservation</p>	<p>1</p>	<p>Intermediate term</p>	<p>1</p>
<p>South East pendentive plaster</p>

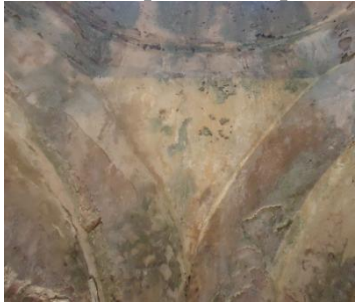
<p>South West pendentive plaster</p>

<p>2 layers horasan plaster layer were used and lime plaster were used as finishing layer.</p>	<p>- Microbiological colonizations from the intersection points of the archs to the middle part of surface -Black and white crusts -Pittings -Discolourations -Hair cracks</p>	<p>Moderately strong symptoms</p>	<p>2</p>	<p>Moderate repair and further investigation</p>	<p>2</p>	<p>Short Term</p>	<p>2</p>
<p>Drum plaster</p>

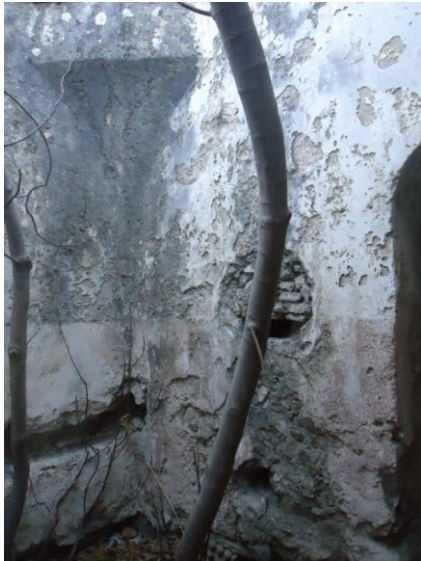
<p>Stone masonry wall which was constructed through bonding technique with rubble stone and brick components in lime mortar. Surface is plastered.</p>	<p><u>Losses</u> -Door -Flues</p> <p><u>Structural Failures</u> -Missing components above flue trace on the left part of wall -Joint discharges above flue trace on the left part of wall</p> <p><u>Material Deteriorations</u> -Discolourations</p>	<p>Moderately strong symptoms</p>	<p>2</p>	<p>Moderate repair and further investigation</p>	<p>2</p>	<p>Short Term</p>	<p>2</p>

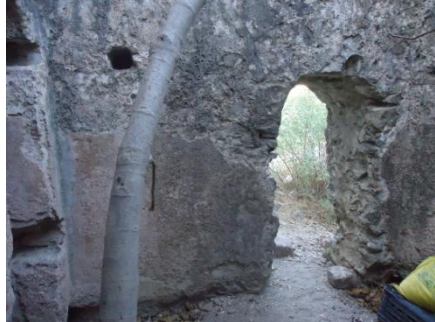
North wall

Stone masonry wall which was constructed through bonding technique with rubble stone and brick components in lime mortar. Surface is plastered.

Losses
-Window
-Flue

Structural Failures
-Missing wide part (collapsed) below the window trace

Moderate repair and further investigation

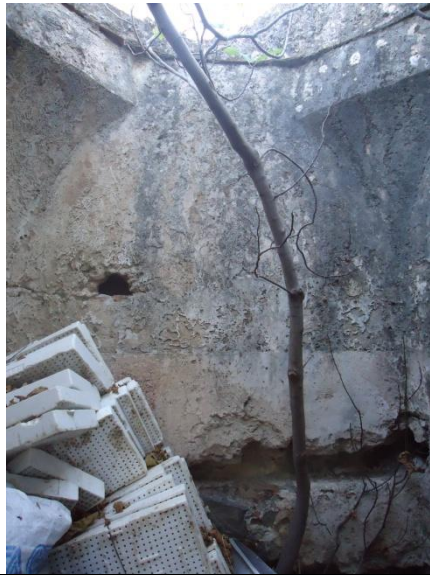
South wall

Stone masonry wall which was constructed through bonding technique with rubble stone and brick components in lime mortar. Surface is plastered.

Losses
-Flues
Structural Failures
-Missing components around the flue trace

Moderate repair and further investigation

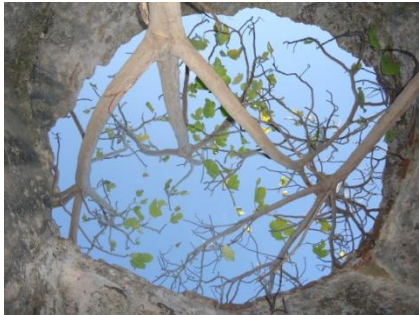
Building Component	Component Description	Condition Description	Symptoms	CC	Recomended Measure	RC	Risk Assessment	UC
Dome

Brick - lime mortar drum. Surface is plastered.	-Missing wide part (collapsed) on the middle part of the dome	Major symptoms	3	Major intervention based on diagnosis	3	Urgent and immediate	3

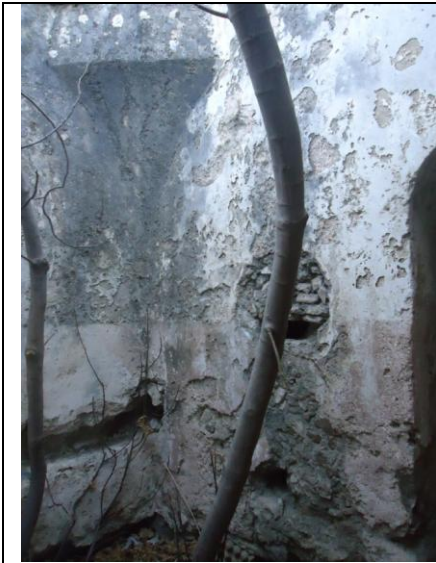
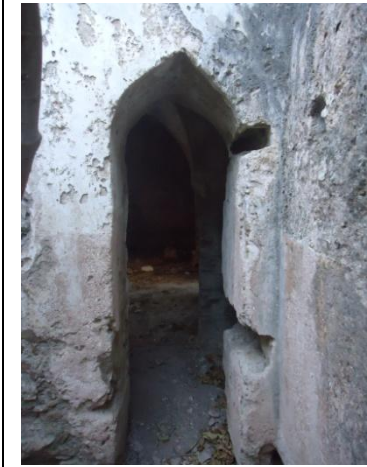
Building Component	Component Description	Condition Description	Symptoms	CC	Recomended Measure	RC	Risk Assessment	UC
West wall plaster	Horasan plaster was observed from the ground up to a height of 150 centimeters. After a	-Pittings -Peelings -Black crusts and microbiological colonizations are	Major symptoms	2	Moderate repair and further investigation	2	Short Term	2

height of 150 centimeters, lime plaster was observed

widespread on the right and the left part of the surface

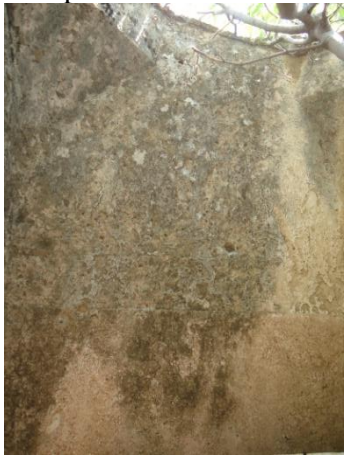
<p>Horasan plaster was observed from the ground up to a height of 150 centimeters. After a height of 150 centimeters, lime plaster was observed</p>	<ul style="list-style-type: none"> -Microbiological colonizations -Efflorescences between the pendentives -Pittings -Peelings -Black crusts 	<p>Moderately strong symptoms</p>	<p>2</p>	<p>Moderate repair and further investigation</p>	<p>2</p>	<p>Short Term</p>	<p>2</p>
<p>South wall plaster</p>	<p>Horasan plaster was observed from the ground up to a height of 150 centimeters. After a height of 150 centimeters, lime</p>	<ul style="list-style-type: none"> -Microbiological colonizations -Efflorescences above the wall -Pittings -Peelings -Black crusts 	<p>Moderately strong symptoms</p>	<p>2</p>	<p>Moderate repair and further investigation</p>	<p>2</p>	<p>Short Term</p>	<p>2</p>

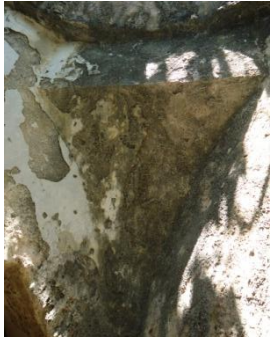
<p>Lime plaster was observed.</p>	<ul style="list-style-type: none"> -Delaminations are widespread -Peelings are widespread -Microbiological colonizations are widespread -Pittings were seen rarely -Efflorescences were seen rarely 	<p>Moderately strong symptoms</p>	<p>2</p>	<p>Moderate repair and further investigation</p>	<p>2</p>	<p>Short Term</p>	<p>2</p>
<p>North East pendentive plaster</p>	<p>Lime plaster was observed.</p>	<ul style="list-style-type: none"> -Pittings are widespread -Black crusts above and the left edge of surface -Efflorescences 	<p>Moderately strong symptoms</p>	<p>2</p>	<p>Moderate repair and further investigation</p>	<p>2</p>	<p>Short Term</p>	<p>2</p>

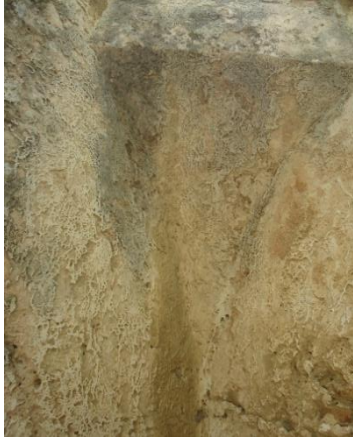
<p>Lime plaster was observed..</p>	<ul style="list-style-type: none"> -Black crusts on the drum edge of the surface -Pittings -Peelings -Delaminations 	<p>Moderately strong symptoms</p>	<p>2</p>	<p>Moderate repair and further investigation</p>	<p>2</p>	<p>Short Term</p>	<p>2</p>
<p>South West pendentive plaster</p>	<p>Lime plaster was observed.</p>	<ul style="list-style-type: none"> -Peelings -Black crusts inner layers -Efflorescences were seen partially on the left -Pittings 	<p>Moderately strong symptoms</p>	<p>2</p>	<p>Moderate repair and further investigation</p>	<p>2</p>	<p>Short Term</p>	<p>2</p>

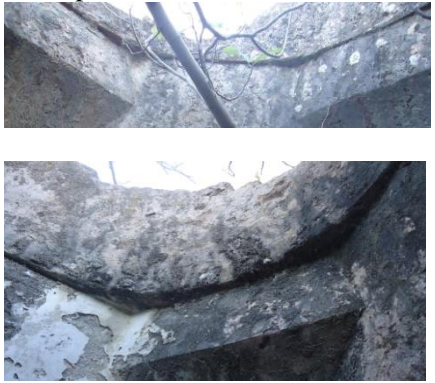
<p>Drum plaster</p>

<p>Lime plaster was observed.</p>	<ul style="list-style-type: none"> -Efflorescences on the West and the South surfaces of the drum -Black crusts and microbiological colonizations, especially on the North surfaces of the drum -Peelings -Delaminations -Pittings 	<p>Moderately strong symptoms</p>	<p>2</p>	<p>Moderate repair and further investigation</p>	<p>2</p>	<p>Short Term</p>	<p>2</p>
<p>Dome plaster</p>	<p>Lime plaster was observed. (Plant, which were seen in figure, has grown on ground.)</p>	<ul style="list-style-type: none"> -Missing the wide part -Pittings -Black crusts -Microbiological colonizations -Efflorescences 	<p>Major symptoms</p>	<p>3</p>	<p>Major intervention based on diagnosis</p>	<p>3</p>	<p>Urgent and immediate</p>	<p>3</p>
