**IMPORTANCE OF CONDITION SURVEY AND
REPORT OF BUILT CULTURAL HERITAGE:
DÜZCE (HEREKE) BATH**

in Architectural Restoration

IMPORTANCE OF CONDITION SURVEY AND REPORT OF BUILT CULTURAL HERITAGE: DÜZCE (HEREKE) BATH

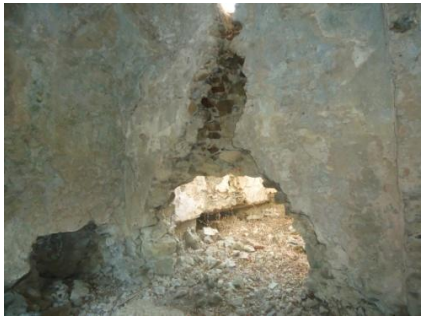
Building Component	Component Description	Condition Description	Symptoms	CC	Recomended Measure	RC	Risk Assessment	UC
West wall

Stone masonry wall which was constructed through bonding technique with rubble stone and brick components in lime mortar. Surface is plastered.	<u>Structural Failures</u> -Missing wide part (collapsed) in the middle part <u>Material Deteriorations</u> -Discolourations -Pittings	Major symptoms	3	Major intervention based on diagnosis	3	Urgent and immediate	3
North wall	Stone masonry wall which was constructed through bonding technique with rubble stone and brick	<u>Structural Failures</u> -Missing (collapsed) wide part -Joint discharges	Major symptoms	3	Major intervention based on diagnosis	3	Urgent and immediate	3

Structural Failures
 -Missing wide part (collapsed) in the middle part

Material Deteriorations
 -Discolorations
 -Pittings

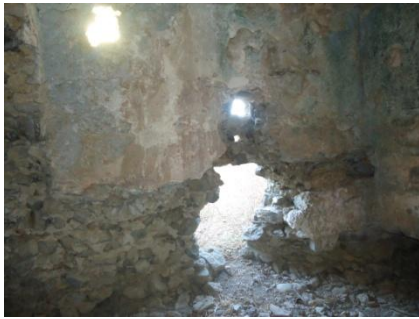
<p>components in lime mortar. Surface is plastered.</p>	<p><u>Material Deteriorations</u> -Discolourations -Pittings</p>						
<p>East wall</p>

<p>Stone masonry wall which was constructed through bonding technique with rubble stone and brick components in lime mortar. Surface is plastered.</p>	<p><u>Losses</u> -Flue -Basin</p> <p><u>Structural Failures</u> -Missing wide part - Joint discharges</p> <p><u>Material Deteriorations</u> -Discolourations -Pittings</p>	<p>Major symptoms</p>	<p>3</p>	<p>Major intervention based on diagnosis</p>	<p>3</p>	<p>Urgent and immediate</p>	<p>3</p>
<p>South wall</p>	<p>Stone masonry wall which was constructed through bonding technique with rubble stone and brick components in lime mortar. Surface is plastered.</p>	<p><u>Losses</u> -Window -Flue -Basin</p> <p><u>Structural Failures</u> -Missing wide part -Joint discharges -Star crack around window trace</p>	<p>Major symptoms</p>	<p>3</p>	<p>Major intervention based on diagnosis</p>	<p>3</p>	<p>Urgent and immediate</p>	<p>3</p>

Structural Failures
 -Missing wide part

Material Deteriorations
 -Discolorations
 -Pittings
 -Joint discharges

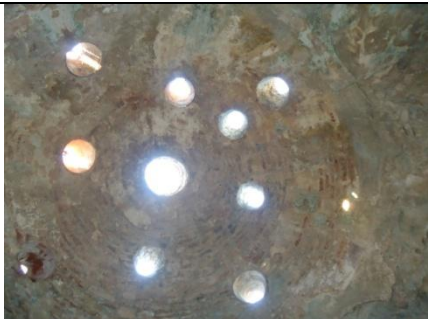
<p>Brick - lime mortar dome have 10 oculis. Surfaces have plaster.</p>	<p><u>Losses</u> -10 oculis -6 terrakotta pipes of oculis</p> <p><u>Material Deteriorations</u> -Discolourations -Microbiological colonizations on unplastered areas</p>	<p>Moderately strong symptoms</p>	<p>2</p>	<p>Moderate repair and further investigation</p>	<p>2</p>	<p>Short Term</p>	<p>2</p>
---	--	--	-----------------------------------	----------	--	----------	-------------------	----------

Material Deteriorations
 -Discolorations
 -Microbiological colonizations

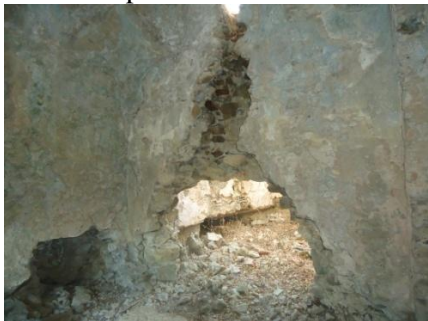
Building Component	Component Description	Condition Description	Symptoms	CC	Recomended Measure	RC	Risk Assessment	UC
<p>West wall plaster</p>

<p>Three layers horasan plaster were used up to 150 cm. From 150 cm up to dome, two layers horasan plaster layer were used and lime plaster were used as finishing layer</p>	<p>-Peelings -Pittings -Black crusts -Microbiological colonizations -Efflorescences -Hair crack on the left part of surface</p>	<p>Moderately strong symptoms</p>	<p>2</p>	<p>Moderate repair and further investigation</p>	<p>2</p>	<p>Short Term</p>	<p>2</p>
<p>North wall plaster</p>	<p>Three layers horasan plaster were used up to 150 cm. From 150 cm up to dome, two layers horasan plaster layer</p>	<p>-Peelings -Pittings -Black crusts -Microbiological colonizations, especially above the</p>	<p>Moderately strong symptoms</p>	<p>2</p>	<p>Moderate repair and further investigation</p>	<p>2</p>	<p>Short Term</p>	<p>2</p>

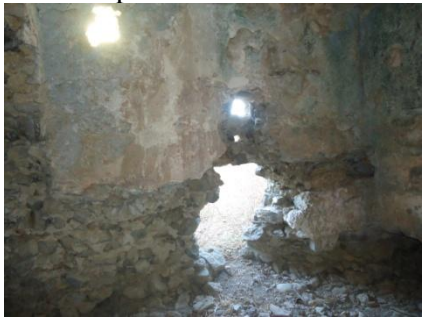
<p>were used and lime plaster were used as finishing layer</p>	<p>wall -Efflorescences -Hair crack on the right, close to the plane triangle</p>						
<p>East wall plaster</p>

<p>Three layers horasan plaster were used up to 150 cm. From 150 cm up to dome, two layers horasan plaster layer were used and lime plaster were used as finishing layer</p>	<p>-Delaminations on the middle part -Peelings -Pittings -Microbiological colonizations, especially on the right and the left parts -Efflorescences</p>	<p>Moderately strong symptoms</p>	<p>2</p>	<p>Moderate repair and further investigation</p>	<p>2</p>	<p>Short Term</p>	<p>2</p>
<p>South wall plaster</p>	<p>Three layers horasan plaster were used up to 150 cm. From 150 cm up to dome, two layers horasan plaster layer were used and lime plaster were used as finishing layer</p>	<p>-Delaminations below the window trace -Peelings -Pittings -Microbiological colonizations, especially on right and left parts -Efflorescences -Black crusts</p>	<p>Moderately strong symptoms</p>	<p>2</p>	<p>Moderate repair and further investigation</p>	<p>2</p>	<p>Short Term</p>	<p>2</p>

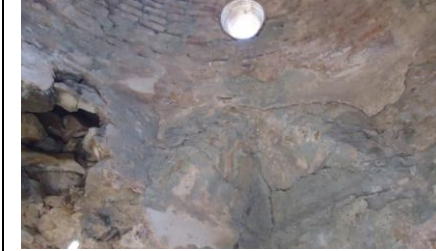
North East plane triangles plasters

Two layers horasan plaster layer were used and lime plaster were used as finishing layer	-Delaminations on the left plane triangle -Peelings -Pittings -Microbiological colonizations -Efflorescences -Black crusts	Moderately strong symptoms	2	Moderate repair and further investigation	2	Short Term	2	
Two layers horasan plaster layer were used and lime plaster were used as finishing layer	-Delaminations on the upper parts -Peelings -Pittings -Microbiological colonizations -Black crusts -Efflorescences	Moderately strong symptoms	2	Moderate repair and further investigation	2	Short Term	2

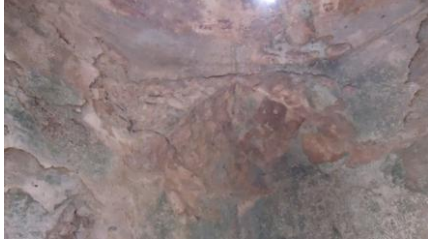
<p>South East plane triangles plasters</p>

<p>Two layers horasan plaster layer were used and lime plaster were used as finishing layer</p>	<ul style="list-style-type: none"> -Peelings -Pittings -Microbiological colonizations, especially on right plane triangle -Black crusts -Efflorescences 	<p>Moderately strong symptoms</p>	<p>2</p>	<p>Moderate repair and further investigation</p>	<p>2</p>	<p>Short Term</p>	<p>2</p>
<p>South West plane triangles plasters</p>

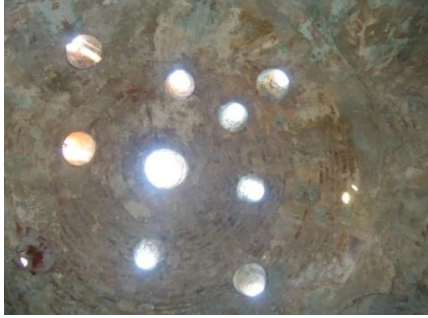
<p>Two layers horasan plaster layer were used and lime plaster were used as finishing layer</p>	<ul style="list-style-type: none"> -Missing parts of plaster were observed from central oculi to below the dome -Peelings -Pittings -Microbiological colonizations -Black crusts -Efflorescences 	<p>Moderately strong symptoms</p>	<p>2</p>	<p>Moderate repair and further investigation</p>	<p>2</p>	<p>Short Term</p>	<p>2</p>

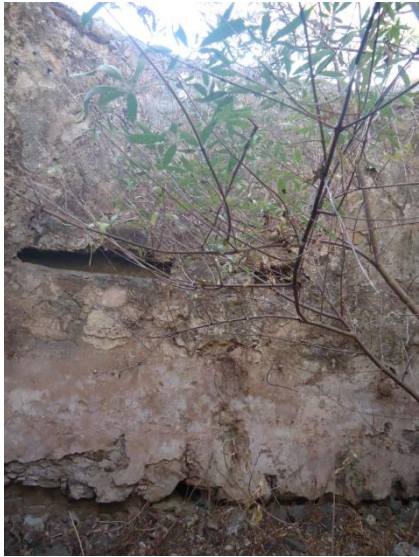
Building Component	Component Description	Condition Description	Symptoms	CC	Recomended Measure	RC	Risk Assessment	UC
West wall

Stone masonry wall which was constructed through bonding technique with rubble stone and brick which is different from other walls. In horizontal joints, one or two rows of brick bonds lie between rubble stones, while in vertical joints, large pieces of bricks are mixed into the lime mortar and they are parallel to the horizontal joints. Surface is plastered.	<u>Losses</u> -Flue -Basin <u>Structural Failures</u> -Missing components around the basin trace <u>Material Deteriorations</u> -Discolourations -Pittings	Moderately strong symptoms	2	Moderate repair and further investigation	2	Short Term	2
North wall

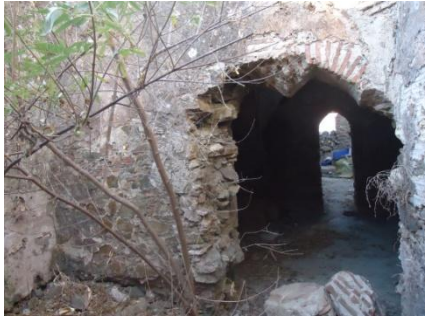
Stone masonry wall which was constructed through bonding technique with rubble stone and brick components in lime mortar. Surface is plastered.	<u>Losses</u> -Door -Flue -Seki <u>Structural Failures</u> -Collapsed (missing) part around the door trace -Plants in the surfaces of the	Major symptoms	3	Major intervention based on diagnosis	3	Urgent and immediate	3

<p>collapsed area's mortars</p> <p>-Joint discharges</p> <p><u>Material Deteriorations</u></p> <p>-Pittings</p>						
<p>East wall</p>

Structural Failures
 -Collapsed part around door trace
 -Plants on surfaces of collapsed area
 -Joint discharges

Material Deteriorations
 -Pittings

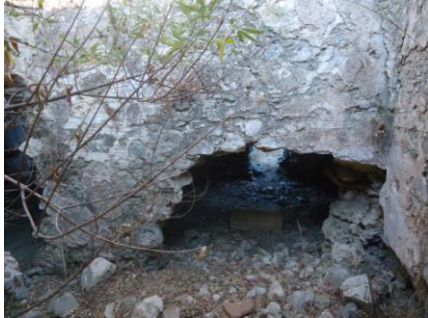
<p>Stone masonry wall which was constructed through bonding technique with rubble stone and brick components in lime mortar. Surface is plastered.</p>	<p><u>Structural Failures</u></p> <p>-Missing wide part below the wall</p> <p>-Plants inner surface of missing part</p> <p>-Joint discharges</p> <p><u>Material Deteriorations</u></p> <p>-Discolourations</p> <p>-Black crusts</p> <p>-Pittings</p>	Major symptoms	3	Major intervention based on diagnosis	3	Urgent and immediate	3
<p>South wall</p>	<p>Stone masonry wall which was constructed through bonding technique with rubble stone and brick components in lime mortar. Surface is plastered.</p>	<p><u>Losses</u></p> <p>-Window</p> <p>-Flue</p> <p>-Basin</p> <p><u>Structural Failures</u></p> <p>-Missing components around the basin trace</p> <p>-Joint discharges</p>	Moderately strong symptoms	2	Moderate repair and further investigation	2	Short Term	2

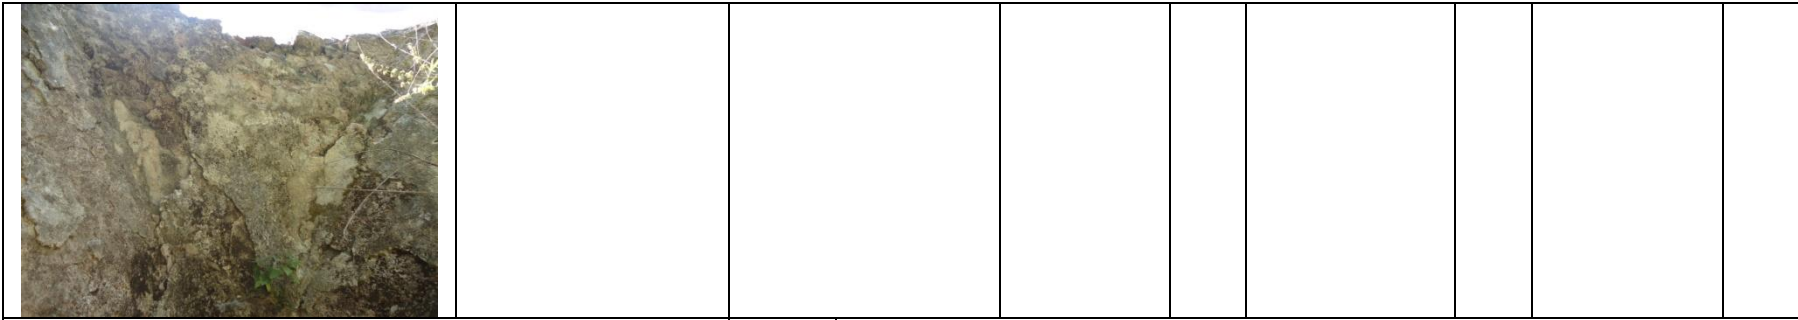
Dome

Building Component	Component Description	Condition Description	Symptoms	CC	Recomended Measure	RC	Risk Assessment	UC
	Brick - lime mortar dome. Surface is plastered.	<u>Structural Failures</u> -Missing wide (collapsed) part of dome -Plants	Major symptoms	3	Major intervention based on diagnosis	3	Urgent and immediate	3

Structural Failures
 -Missing wide (collapsed) part of dome
 -Plants

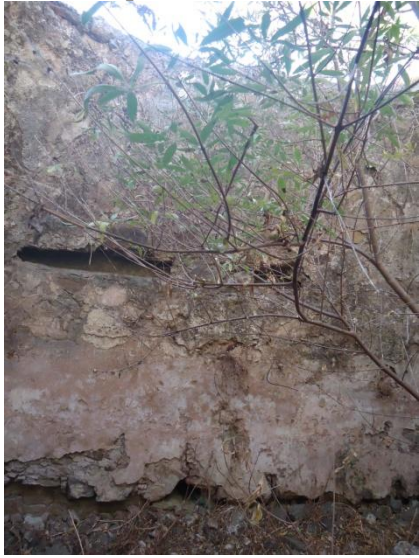
Plasters								
Building Component	Component Description	Condition Description	Symptoms	CC	Recomended Measure	RC	Risk Assessment	UC
West wall plaster

Three layers horasan plaster was used up to a height of 150 centimeters from the floor in the walls. After a height of 150 centimeters, two layers horasan plaster was applied, and lime plaster were used	-Delaminations and peelings up to 150 cm -Pittings , especially from 150 cm up to the dome -Black crusts , especially from 150 cm up to dome -Efflorescences, especially from 150 cm up to the dome -Microbiological colonizations, especially from 150 cm up to the dome	Moderately strong symptoms	2	Moderate repair and further investigation	2	Short Term	2
North wall plaster	Three layers horasan plaster was used up to a height of 150 centimeters from the floor in the walls. After a height of 150 centimeters, two layers horasan	-Missing parts of plasters are widespread -Microbiological colonizations, especially on the left part of the surface	Major symptoms	3	Major intervention based on diagnosis	3	Urgent and immediate	3

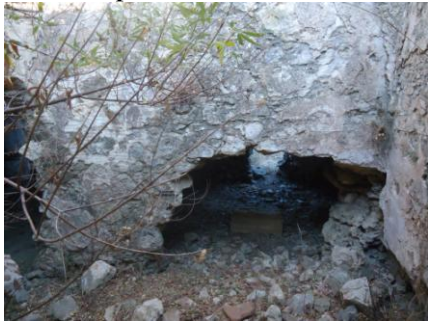
<p>plaster was applied, and lime plaster were used</p>							
<p>East wall plaster</p>

<p>Three layers horasan plaster was used up to a height of 150 centimeters from the floor in the walls. After a height of 150 centimeters, two layers horasan plaster was applied, and lime plaster were used</p>	<ul style="list-style-type: none"> -Missing parts of plasters -Peelings -Pittings -Black crusts -Efflorescences -Microbiological colonizations 	<p>Moderately strong symptoms</p>	<p>2</p>	<p>Moderate repair and further investigation</p>	<p>2</p>	<p>Short Term</p>	<p>2</p>
<p>South wall plaster</p>	<p>Three layers horasan plaster was used up to a height of 150 centimeters from the floor in the walls. After a height of 150 centimeters, two layers horasan plaster was applied,</p>	<ul style="list-style-type: none"> -Pittings - Black crusts -Efflorescences -Microbiological colonizations 	<p>Moderately strong symptoms</p>	<p>2</p>	<p>Moderate repair and further investigation</p>	<p>2</p>	<p>Short Term</p>	<p>2</p>

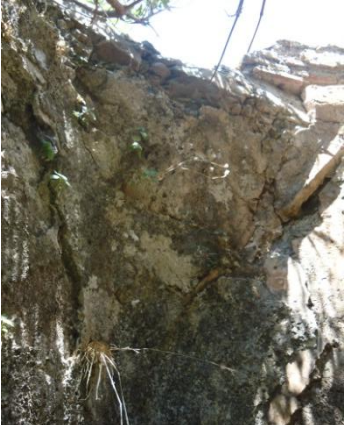
<p>and lime plaster were used</p>							
<p>North West pendentive</p>

<p>Two layers horasan plaster layer were used and lime plaster were used as finishing layer</p>	<ul style="list-style-type: none"> - Black crusts -Microbiological colonizations -Peelings -Discolourations 	<p>Moderately strong symptoms</p>	<p>2</p>	<p>Moderate repair and further investigation</p>	<p>2</p>	<p>Short Term</p>	<p>2</p>

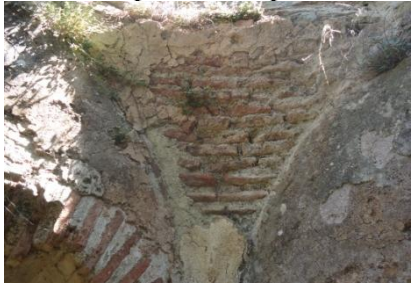
<p>North East pendentive plaster</p>

<p>Two layers horasan plaster layer were used and lime plaster were used as finishing layer</p>	<ul style="list-style-type: none"> -Delaminations -Pittings 	<p>Moderately strong symptoms</p>	<p>2</p>	<p>Moderate repair and further investigation</p>	<p>2</p>	<p>Short Term</p>	<p>2</p>
<p>South East pendentive plaster</p>

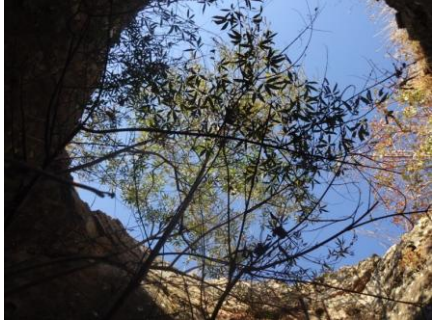
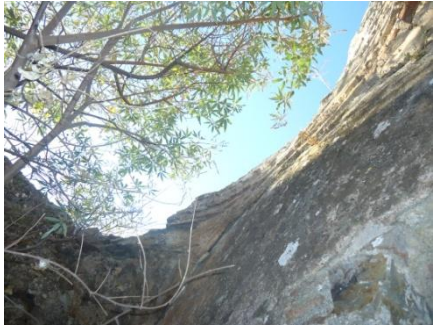
<p data-bbox="235 619 403 646">Dome plaster</p>

<p data-bbox="683 619 929 790">Two layers horasan plaster layer were used and lime plaster were used as finishing layer</p>	<ul style="list-style-type: none"> <li data-bbox="958 619 1198 678">-Missing wide part of plaster <li data-bbox="958 686 1064 715">-Pittings <li data-bbox="958 722 1120 751">-Black crusts <li data-bbox="958 759 1153 788">-Efflorescences <li data-bbox="958 796 1176 855">- Microbiological colonizations 	<p data-bbox="1234 619 1355 678">Major symptoms</p>	<p data-bbox="1400 619 1422 646">3</p>	<p data-bbox="1476 619 1624 758">Major intervention based on diagnosis</p>	<p data-bbox="1684 619 1706 646">3</p>	<p data-bbox="1760 619 1892 678">Urgent and immediate</p>	<p data-bbox="1951 619 1973 646">3</p>

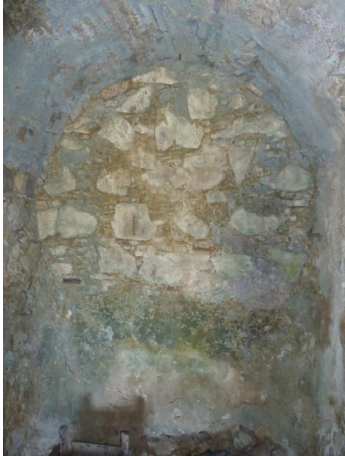
Building Component	Component Description	Condition Description	Symptoms	CC	Recomended Measure	RC	Risk Assessment	UC
West wall

Stone masonry wall which was constructed through bonding technique with rubble stone and brick components in lime mortar. Surface is plastered.	<u>Material deteriorations</u> - Microbiological colonizations -Discolourations -Black crusts, especially on the middle and the right part of the wall	Moderately strong symptoms	2	Moderate repair and further investigation	2	Short Term	2
North wall

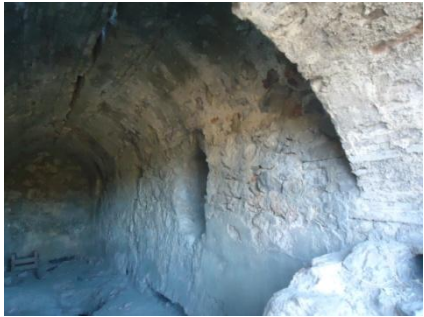
Stone masonry wall which was constructed through bonding technique with rubble stone and brick components in lime mortar. Surface is plastered.	<u>Losses</u> -Windows <u>Material deteriorations</u> - Microbiological colonizations -Discolourations	Moderately strong symptoms	2	Moderate repair and further investigation	2	Short Term	2
South wall	Stone masonry wall	<u>Material</u>	Minor	1	Maintenance /	1	Intermediate	1

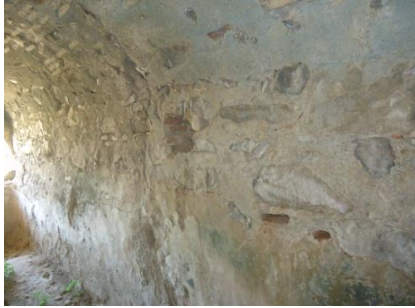
<p>which was constructed through bonding technique with rubble stone and brick components in lime mortar. Surface is plastered.</p>	<p><u>deteriorations</u> - Pittings -Discolourations</p>	<p>symptoms</p>		<p>Preventive conservation</p>		<p>term</p>	
---	---	--	-----------------	--	--------------------------------	--	-------------	--

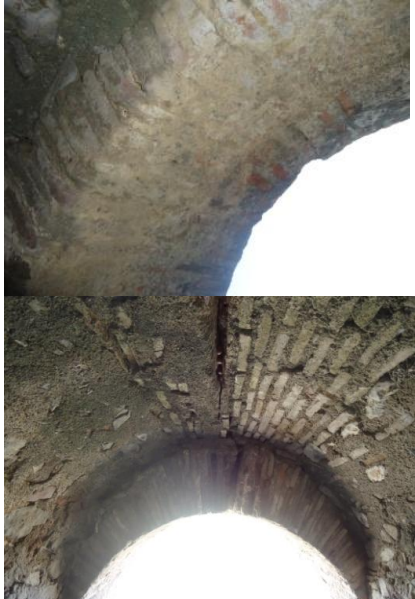
Building Component	Component Description	Condition Description	Symptoms	CC	Recomended Measure	RC	Risk Assessment	UC
<p>East arch</p>

<p>Brick - lime mortar round arch. Surface has plaster.</p>	<p><u>Material deteriorations</u> - Microbiological colonizations -Pittings</p>	<p>Minor symptoms</p>	<p>1</p>	<p>Maintenance / Preventive conservation</p>	<p>1</p>	<p>Intermediate term</p>	<p>1</p>

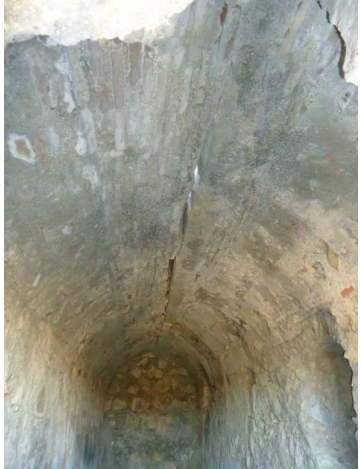
Barrel Vault								
Building Component	Component Description	Condition Description	Symptoms	CC	Recomended Measure	RC	Risk Assessment	UC

Brick - lime mortar barrel vault, has no oculi. Surface has plaster.	<u>Structural failures</u> -Small splitting in the middle -Loss of bricks <u>Material deteriorations</u> - Discolourations	Moderately strong symptoms	2	Moderate repair and further investigation	2	Short Term	2
Plasters								
Building Component	Component Description	Condition Description	Symptoms	CC	Recomended Measure	RC	Risk Assessment	UC
West wall plaster		-Missing wide part of plasters from the middle height of the wall to the barrel vault level - Microbiological colonizations -Efflorescences	Major symptoms	3	Major intervention based on diagnosis	3	Urgent and immediate	3

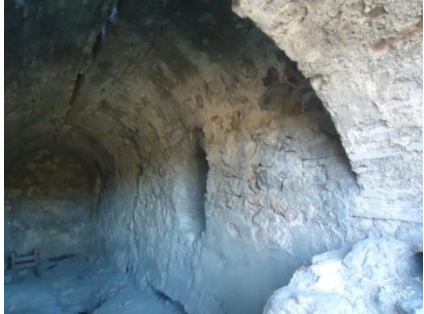
<p>- Discolourations</p>						
<p>North wall plaster</p>

<p>-Delaminations from the window trace to the barrel vault -Missing parts of the plasters</p>	<p>Moderately strong symptoms</p>	<p>2</p>	<p>Moderate repair and further investigation</p>	<p>2</p>	<p>Short Term</p>	<p>2</p>
<p>South wall plaster</p>		<p>-Missing parts of the plasters -Microbiological colonizations below the wall</p>	<p>Moderately strong symptoms</p>	<p>2</p>	<p>Moderate repair and further investigation</p>	<p>2</p>	<p>Short Term</p>	<p>2</p>

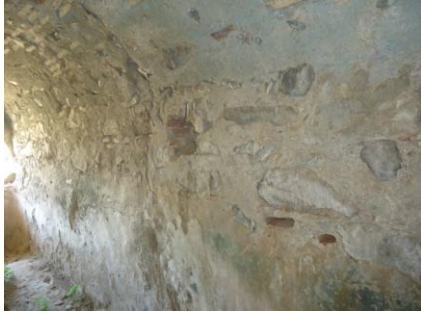
<p>East arch plaster</p>

<p>-Missing wide part of the plaster inner surface -Microbiological colonizations were seen on the existing small areas</p>	<p>Major symptoms</p>	<p>3</p>	<p>Major intervention based on diagnosis</p>	<p>3</p>	<p>Urgent and immediate</p>	<p>3</p>
<p>Barrel vault plaster</p>		<p>-Delamination on the right corner of</p>	<p>Moderately strong</p>	<p>2</p>	<p>Moderate repair and</p>	<p>2</p>	<p>Short Term</p>	<p>2</p>

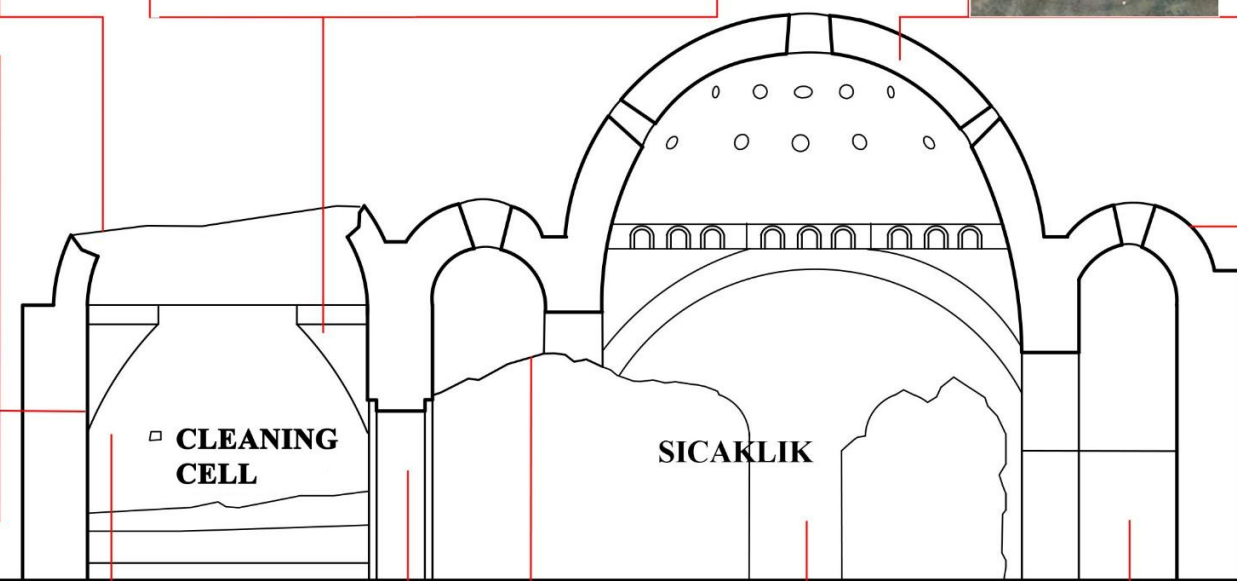
BARREL VAULT OF WEST IWAN

CONDITION CLASS: **1**

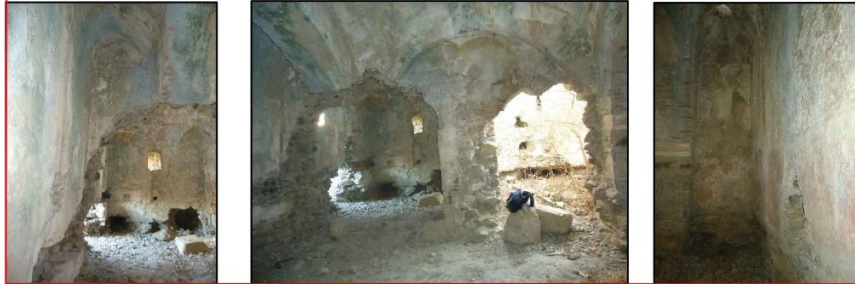
SECTION BB

DOMES OF SOUTH WEST HALVET
 CONDITION CLASS: **3**
 RECOMMENDATION CLASS:
 URGENCY CLASS:

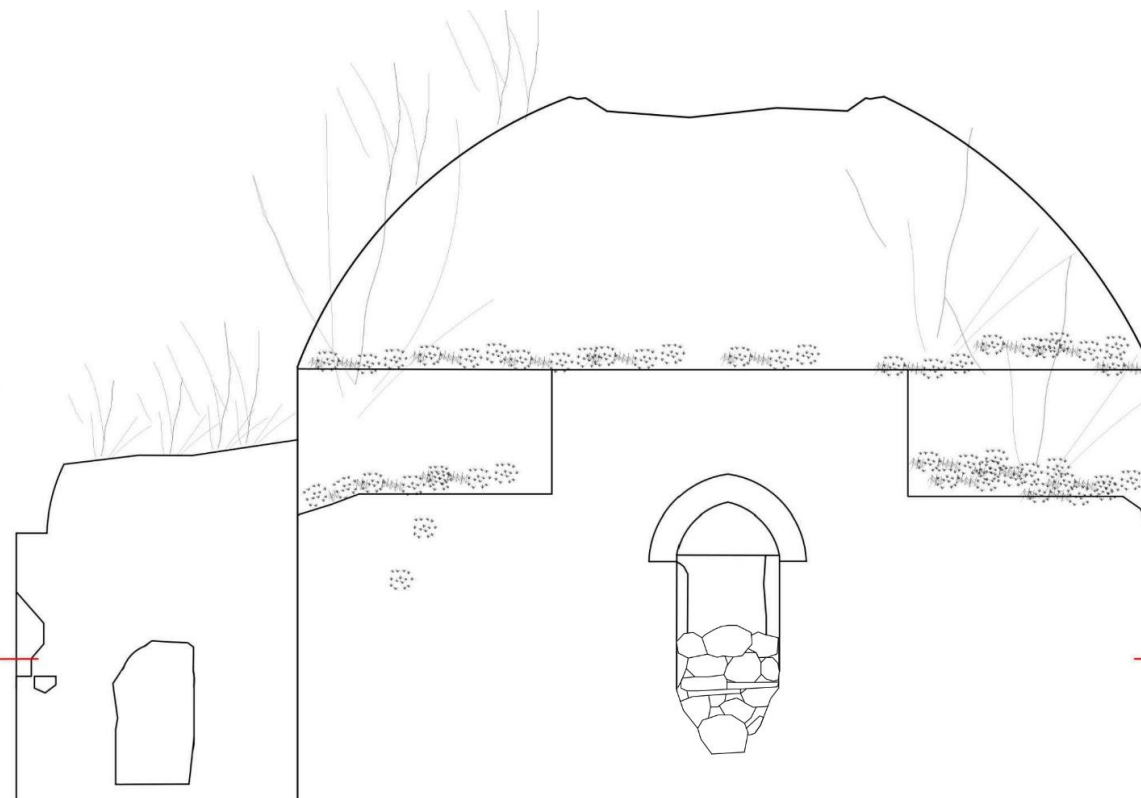
NORTH WALL - 1

CONDITION CLASS: **2**

Structural failures

- Missing part (collapsed) of wall below window trace
- Missing stones in the middle part
- Splitting on the left of wall

Material deteriorations

- Microbiological colonizations
- Black crusts are widespread, especially on the left and right of the wall
- Efflorescences are widespread, especially on the left and right of the wall
- Pittings
- Discolorations are widespread
- Hair cracks are widespread
