**STRUCTURAL MODEL BASED ROOT CAUSE  
INVESTIGATION OF DAMAGE IN URLA  
HELVACILAR MOSQUE AND A PROPOSAL FOR  
STRENGTHENING**

**A Thesis Submitted to  
the Graduate School of Engineering and Sciences of  
İzmir Institute of Technology  
in Partial Fulfillment of the Requirements for the Degree of**

**in Architectural Restoration**

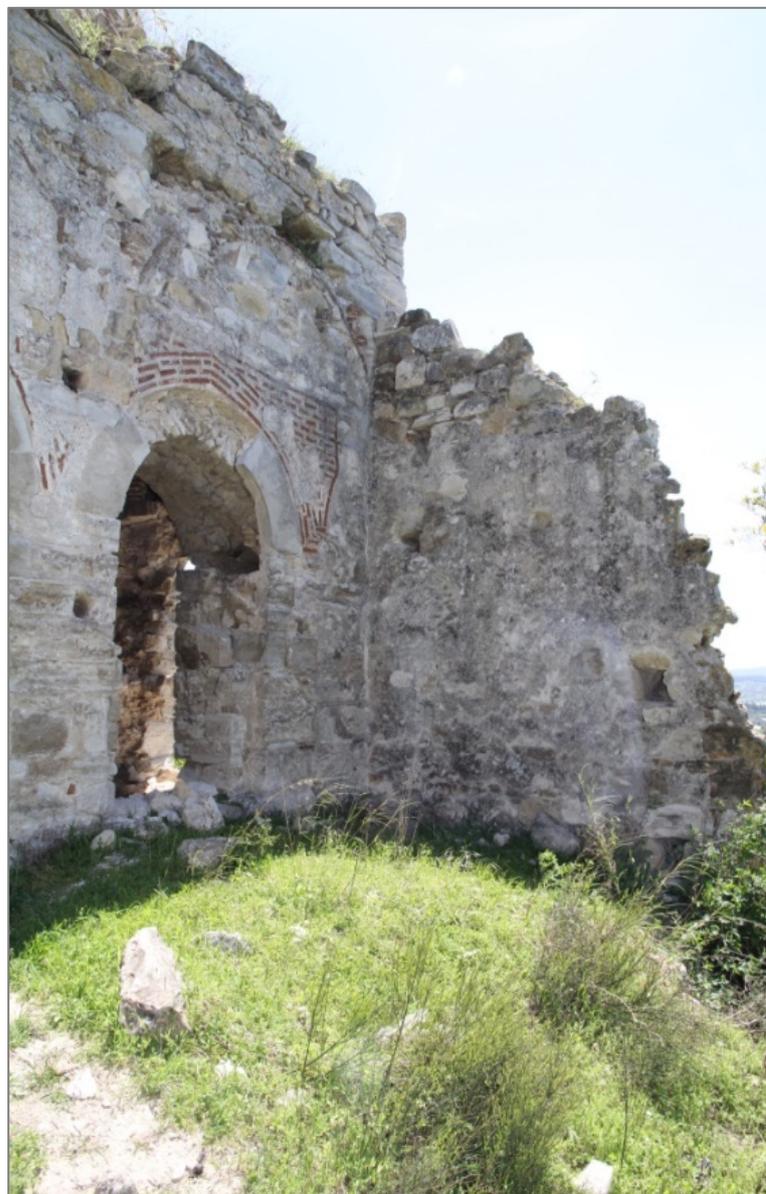
Figure 3.5. South wall of last comers' praying hall

present and there is no superstructure. However, the traces on the western wall of the portico suggest that the superstructure of the portico consisted of three identical domes. The thickness of the walls of the portico ranges from 64 to 67 centimeters and the walls are built of rubble. The length of the south wall is 3.65 meters at the bottom but decreases along the height of the wall and becomes 0.30 meters at the top. The length of the north wall is 3.23 meters at the bottom but drops to 1.65 meters along the height of the wall (Figure 3.5, Figure 3.6).

The north and south walls of the portico differ in masonry techniques and materials used, thereby suggesting that they might have been built later.

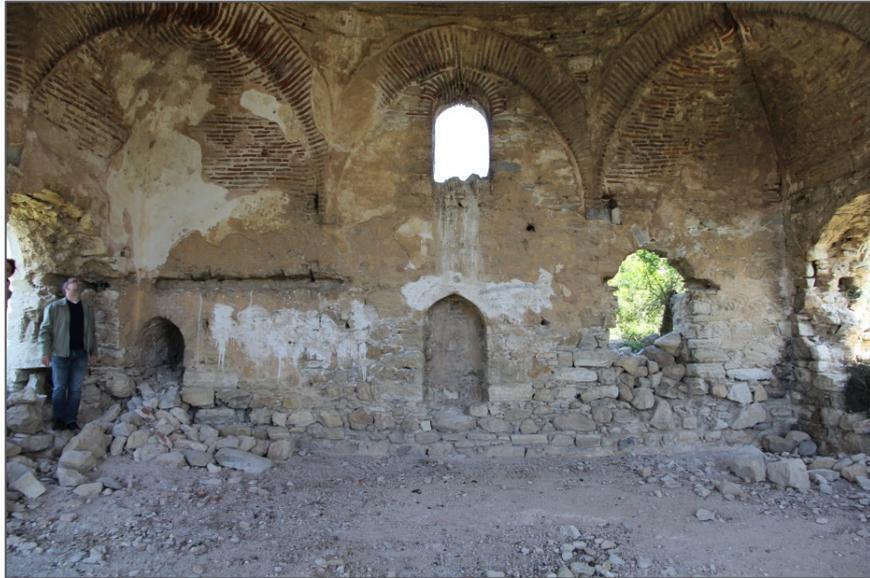
Figure 3.8. North wall of the prayer hall (Harim)

In the middle of the north wall, there is a niche with a depth of nearly 60 centimeters. The entrance door of the minaret is situated in the west corner of the north wall. The debris of rubble walls at the bottom of and inside the minaret door hinders the entrance through the minaret. There is a window opening on the east side of the northern facade. The wall parts below the arch and the window are damaged. The north wall is the least damaged part of the building compared to the other walls (Figure 3.8)

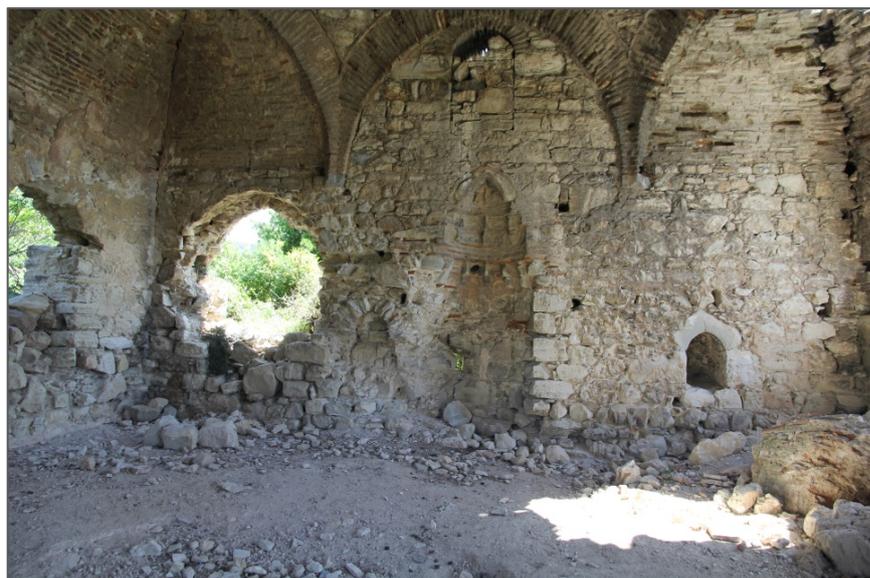
Figure 3.9. East wall of the prayer hall (Harim)

In the middle of the east wall of the prayer hall, there is a mihrab which extends to 3.6 meters above the ground and has a depth of 55 centimeters. There is a small niche on both sides of the mihrab and a window opening on the north side of the east wall. The depth of the niche on the left side of the mihrab is 25 centimeters and that of the niche on the right side is 55 centimeters. There is a window opening on the left side of the mihrab, which starts at a height of nearly 1.2 meters above the ground. The masonry materials below the window and the borders of the window opening are disintegrated (Figure 3.9).

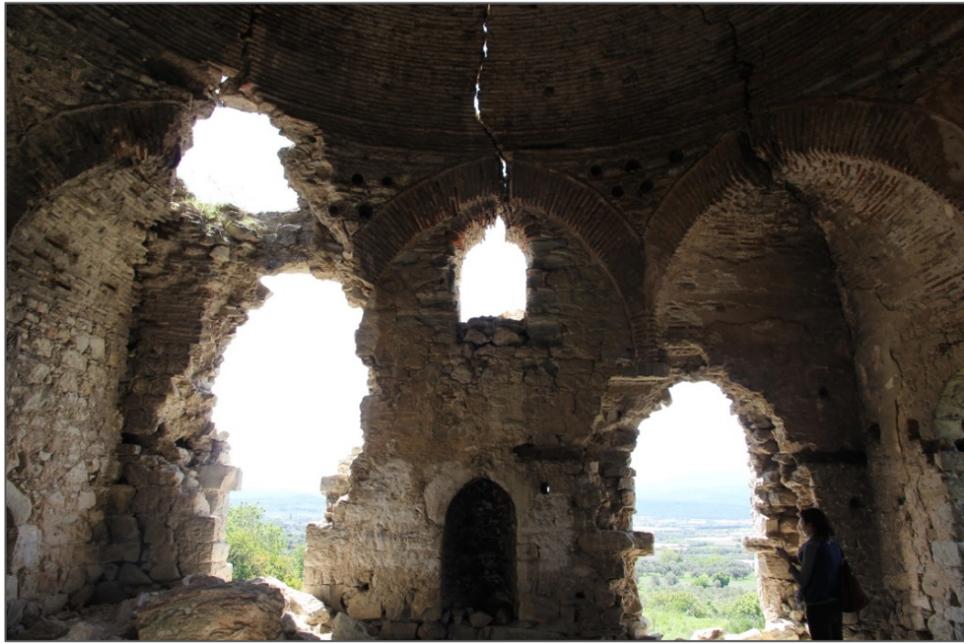
Figure 3.10. South wall of the prayer hall (Harim)

In the middle of the south wall, there is a niche with a depth of nearly 60 centimeters. There are two window openings on the right and left sides of the niche. The walls parts below the windows are not present. Window openings start at ground level as they stand. The biggest structural problems of the building are seen in the south wall of the prayer hall (Figure 3.10).

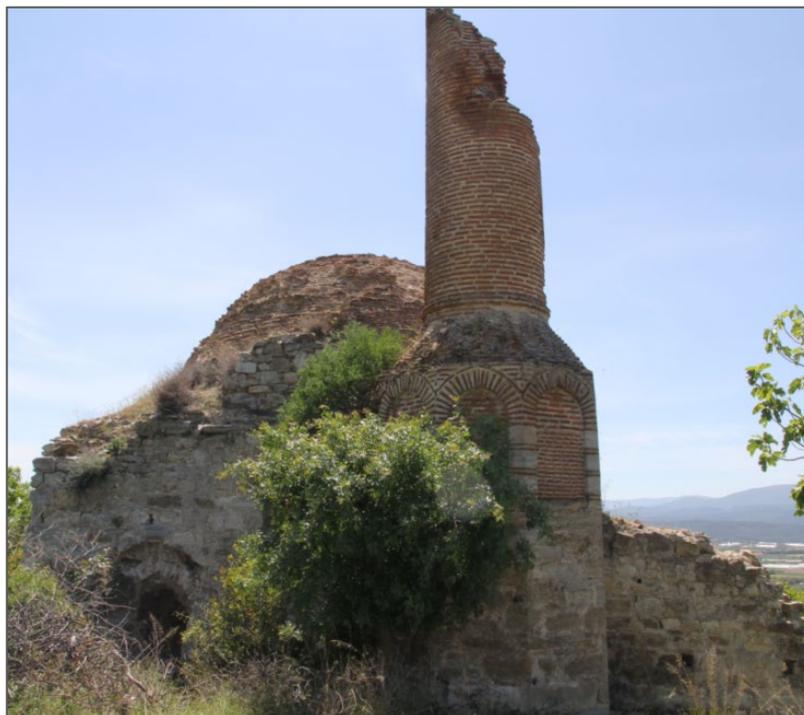
Figure 3.11. Minaret of the mosque

Almost half of the minaret body is ruined. As it can be understood from the registration form, until recently, the minaret had a top balcony and the underside of the top balcony was decorated with brick motifs (Figure 3.11).

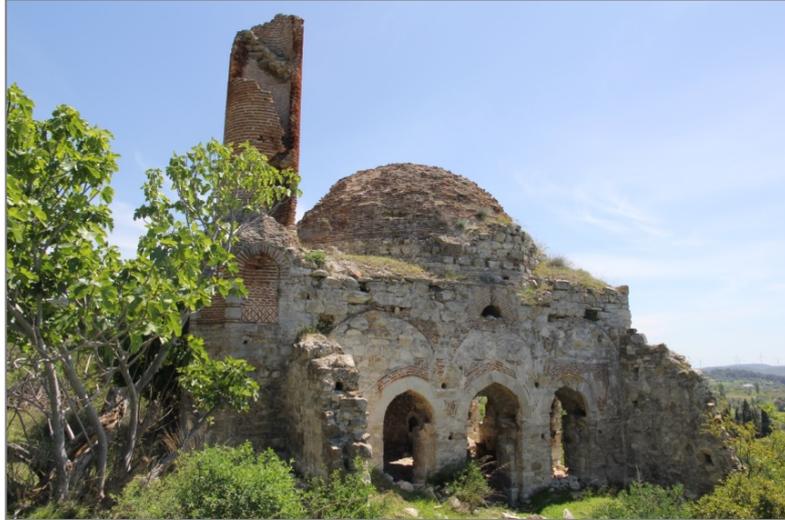
Figure 3.12. West facade of the mosque

The east wall of the portico is the western facade of the building (Figure 3.12). The minaret located to the north side of the facade is adjacent to the facade. The standing parts of the north and south walls of the portico are in the wall borders of the facade. There are four openings on the facade. In the lower row, there is the entrance door of the prayer hall, which is an arched opening in the middle of the western facade. There are large window openings on both sides of the door, which have disintegrated stones at the bottom. The width of the middle entrance door is greater than that of the windows. The traces of the lintels above indicate that the door and window openings are rectangular. There are the pediments of marble arches over the openings, which are highlighted by four courses of bricks. Simple brick decorations over the four courses of bricks are evident from the remains of plaster. The decoration on the window on the southern facade is clearly visible (Figure 3.13). The masonry of pitch-faced stone starts where the brick decoration ends. Circular holes at the level of marble jambs are the holes of timber beams. There is a piece of timber lintel, which is the only timber remnant of the building, in the space in the upper left corner of the door. Above the decorations, there are symmetrically arch-shaped moldings in the masonry of pitch-faced stone over the door and window openings. There is a brick wall above the moldings. The inside of the arch over the door entrance to the prayer hall, which is likely to hold the inscription panel, is empty today. In the upper row, there is a window with a brick arch in the center of the facade, and half of its opening is closed with the wall material. There are plants intensively growing on the border of the drum.

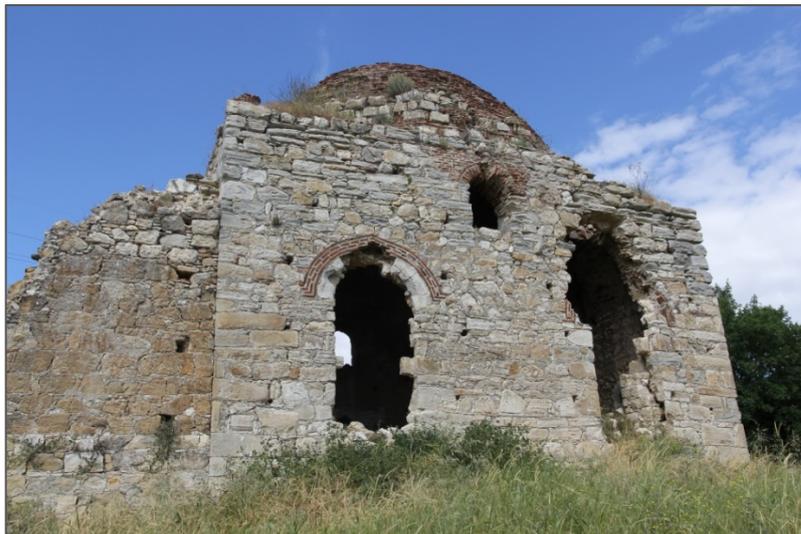
Figure 3.14. South facade of the mosque

There are three openings in the southern facade, including two lower-row windows and one upper-row window (Figure 3.14). The lower rows of windows are the same in size and the easternmost window is destroyed. The traces of the timber lintel above indicate that both windows are rectangular. The pediments of both windows are highlighted by four courses of bricks (Figure 3.15). There are two stone corbels at a similar level with the upper level of the lower row windows. The last opening in the facade is an upper-row window with a brick arch in the center of the facade. The upper-row window has brick decorations similar to those in the lower-row windows on the western facade.

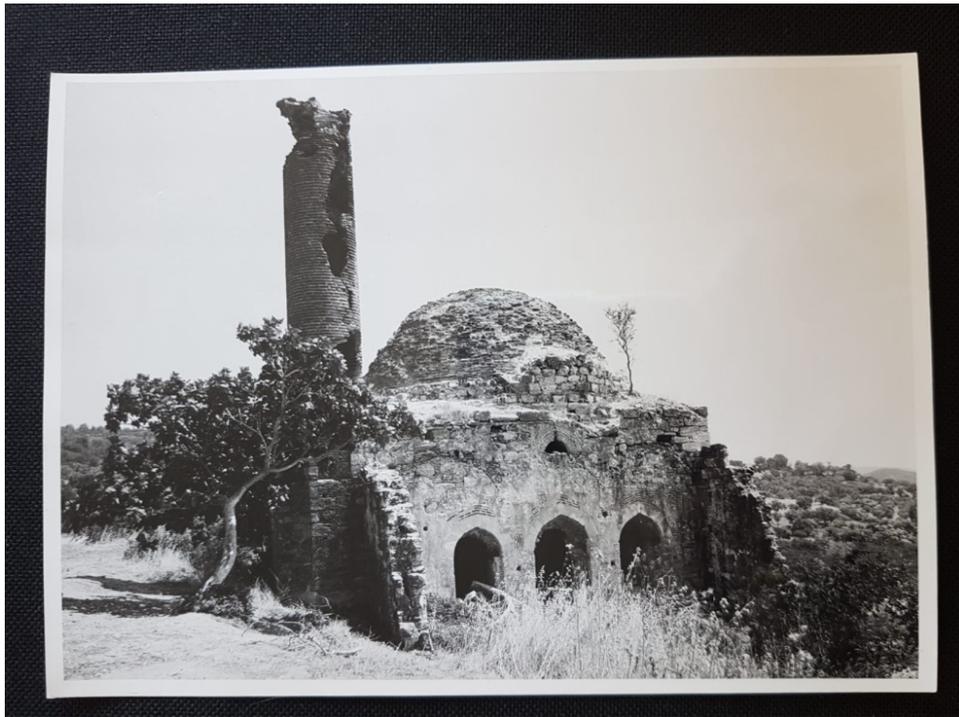
The southern portion of the minaret body, which comprises nearly one-third of the minaret body, is missing. Because the original height of the body is unknown, there is no precise information about how much mass collapse there is on the body over the top level. The structural integrity of the minaret is impaired by these losses and the deterioration mechanism continues to increase (Figure 3.22, Figure 3.23, Figure 3.24).

Figure 3.22. Mass collapse of minaret (dated on 1985)  
(Source: Ünal R. H personal archive)

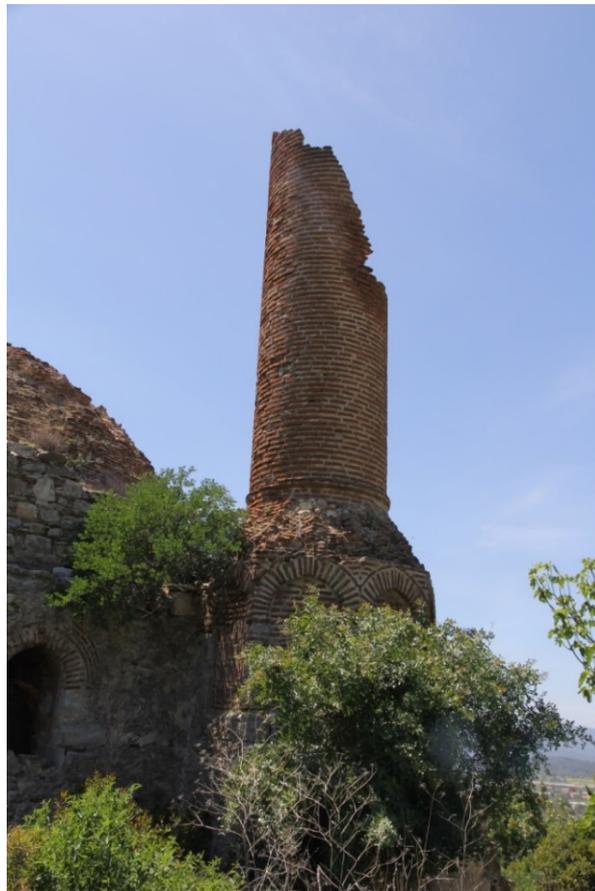
Figure 3.23. Mass collapse of minaret (dated on 2016)

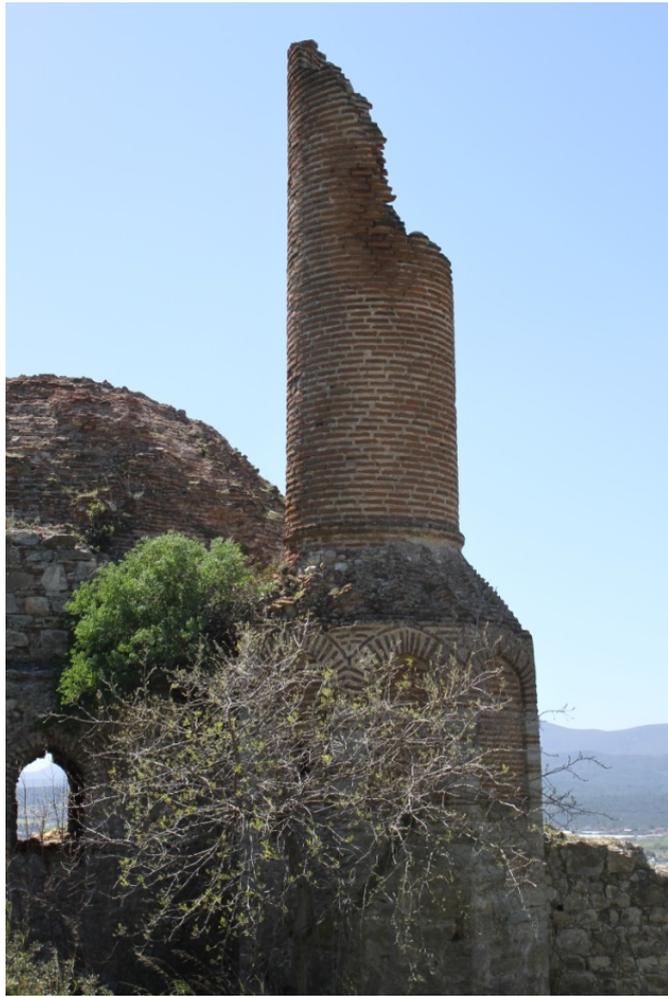
Figure 3.24. Mass collapse of minaret (dated on 2019)

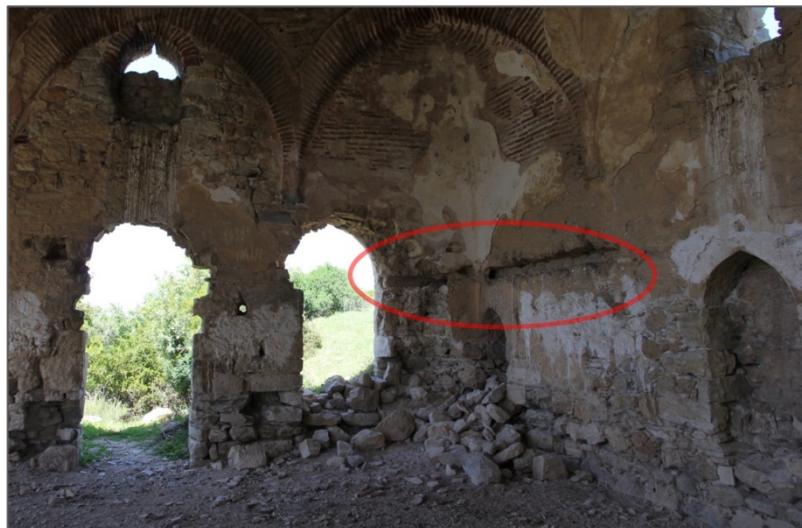
The wooden lintels embedded into the walls of the prayer hall at a height of 2 meters above the ground and the wooden lintels over the window openings are not visible in any wall or window. Lintel holes are clearly seen in the north, south and west walls of the prayer hall (Figure 3.28).

Figure 3.28. Loss of timber elements on north and west walls of harim

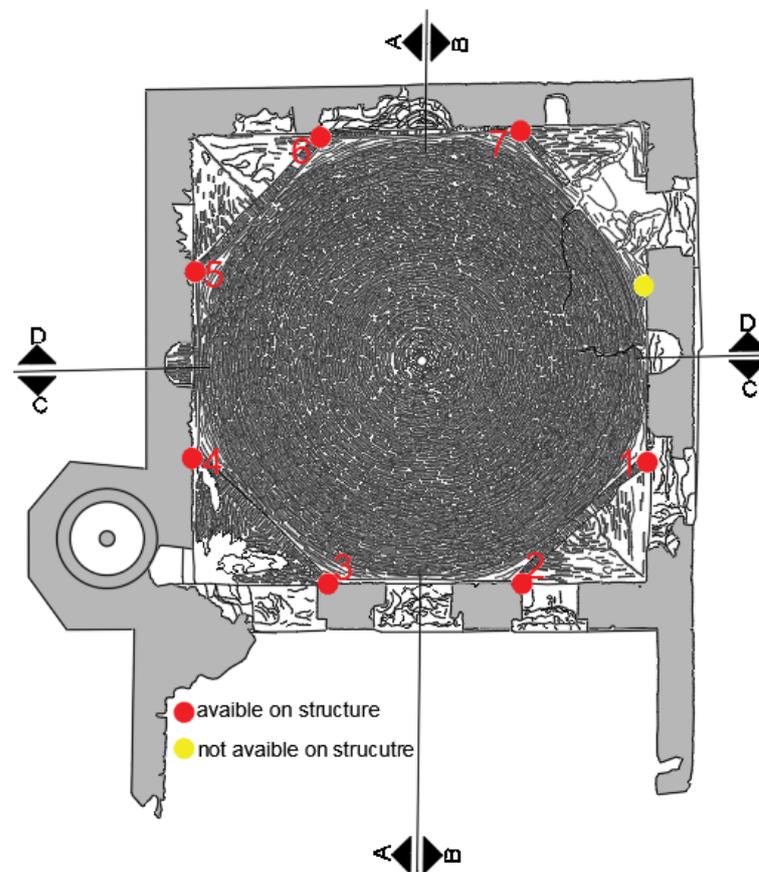
Figure 3.30. Location of abutments on plan

laser line and the beginning levels of the seven abutments in the structure was manually measured and compared with the measures on the measured drawings. The thicknesses of abutment stones also vary (Figure 3.30) (Table 3.2).

In brief, the settlement in the structure reaches a maximum degree in the southwest corner of the south and west walls caused by ground settlement. Additionally, this settlement concurrently led to the rotation of the eastern wall of the building. Starting from the north corner of the eastern wall of the prayer hall and increasing along the length of the wall, there is a rotation of about 20 centimeters in the south corner.

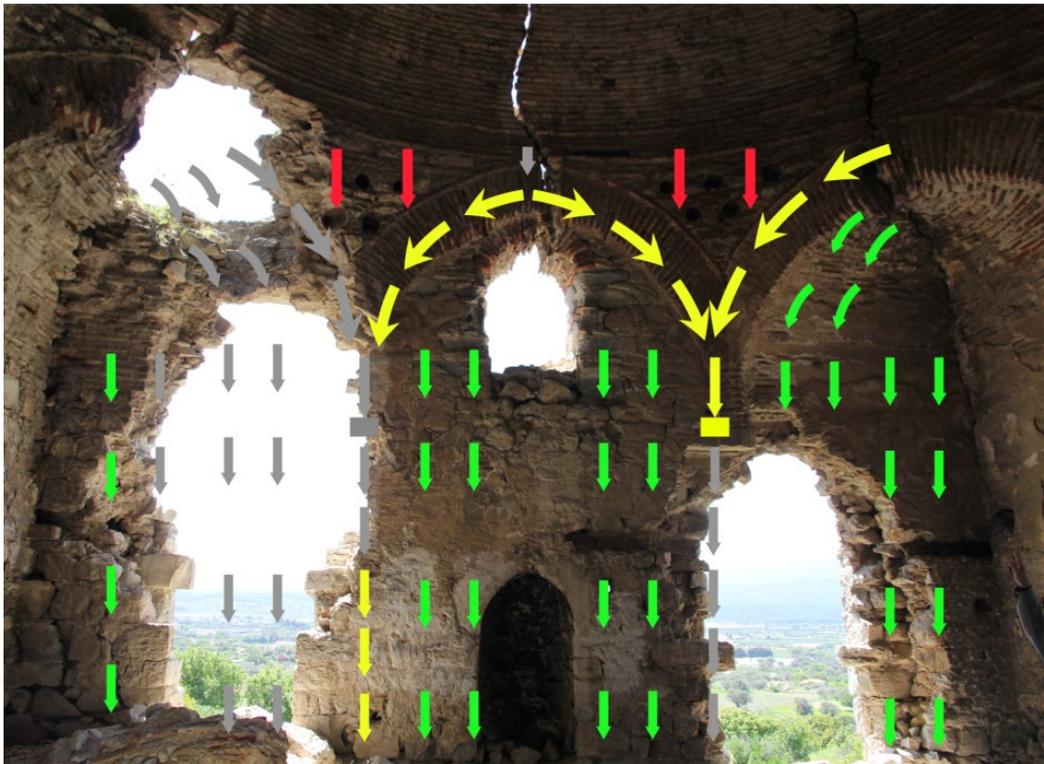
The question of how to model a damaged masonry structure is a really important engineering question for structures like Helvacılar Mosque. The most important engineering inquiry should be to discover the causes of damage in the structure in which the load-bearing system is damaged and the load transfer mechanism is not its original condition (Figure 4.2).

Figure 4.2. Failure mechanism of load bearing system

Because Helvacılar Mosque is a structure that cannot be preserved with its existing damages, the most basic structural need of the structure is to reconstitute its original load-bearing system. Which methods to use in which parts of the structure will be evaluated according to the results of the examination.

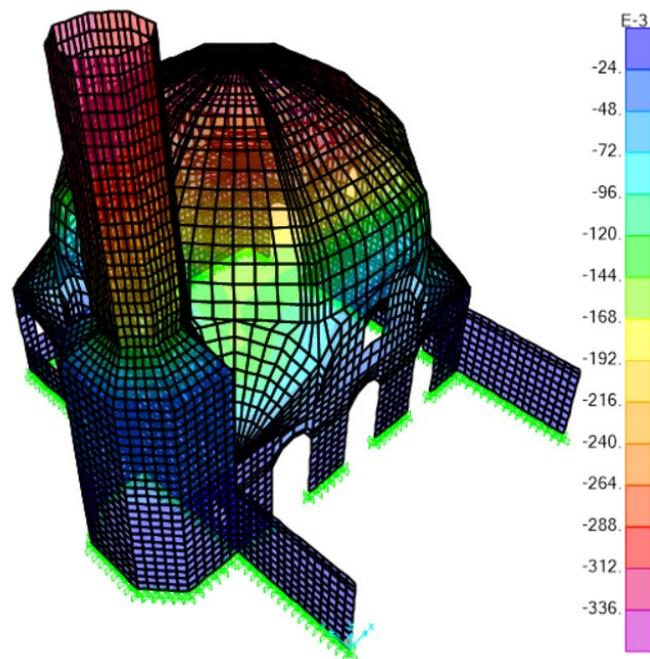
The contour plot of the global z direction displacements (DZ) is given in Figure 4.6. The vertical displacements of the structure under its own weight increase towards the upper levels from the ground, as expected. The maximum vertical displacement is 3 millimeters to the negative Z direction, at the top of the keystone of the dome.

Figure 4.6. DZ (cm) displacement contours of self-weight analysis

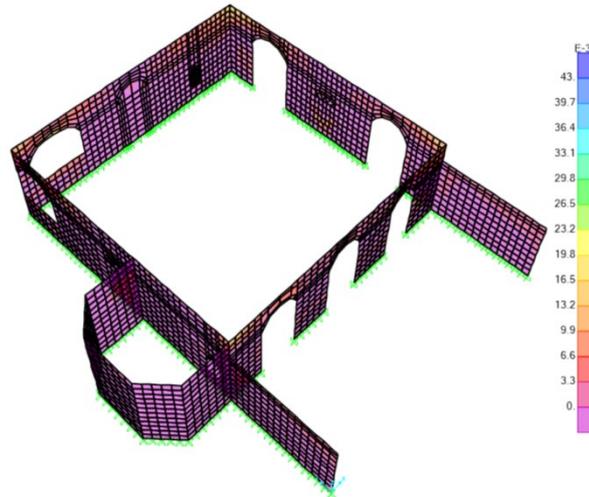
Considering the tensile stresses under the self-weight of the structure, the stresses in the walls are in the wall-squinch joints. The maximum values of tensile stresses are seen at  $0.02 \text{ kN/cm}^2$  (0.2 MPa) in the south-east corner. They are below 1.08 MPa, the maximum tensile stress value for stone masonry structures, and 0.43 MPa, the maximum tensile stress value for brick masonry structures (Figure 4.7)

Figure 4.7. Tensile stress (absolute  $S_{max}$ ) contours of self-weight analysis on walls ( $\text{kN}/\text{cm}^2$ )

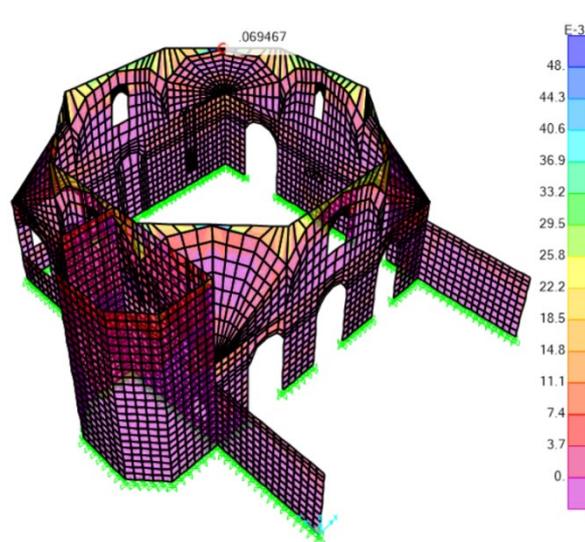
The stresses in the arch, squinch, and pendentive line, which constitutes the transition zone, gradually increase towards the dome drum and the maximum stresses are concentrated on the drum line. The maximum average is  $0.030 \text{ kN}/\text{cm}^2$  ( $0.30 \text{ MPa}$ ) along the drum line, but the highest stress value is  $0.069 \text{ kN}/\text{cm}^2$  ( $0.69 \text{ MPa}$ ) above the south-east squinch. The arch and squinch sections are built of brick masonry and the pendentive sections are built of brick-stone masonry; the values found in the analysis were over the maximum tensile strength of brick masonry ( $0.43 \text{ MPa}$ ) (Figure 4.8). For the dome, tensile stresses are read in the lower sections; however, the maximum values of these stresses are  $0.004 \text{ kN}/\text{cm}^2$  ( $0.04 \text{ MPa}$ ) (Figure 4.9).

Figure 4.8. Tensile stress (absolute  $S_{max}$ ) contours of self-weight analysis on transition zone ( $\text{kN}/\text{cm}^2$ )

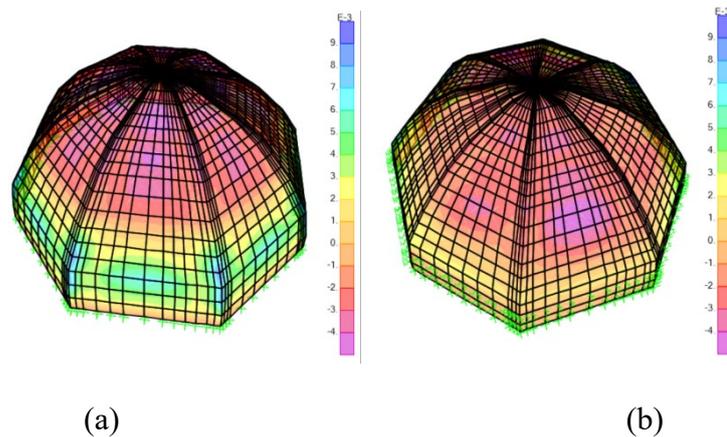
values derived from the equation were applied to the dome. It was found that the low-level tensile stresses at the bottom of the dome approached zero and the dome was completely fulfilling the compression stress due to the rigidity effect of the drum in the dome in which tensile stresses are not above the boundary values even without the drum effect (Figure 4.10).

Figure 4.10. Tensile stress (absolute  $S_{max}$ ) contours of self-weight analysis on dome ( $\text{kN}/\text{cm}^2$ ) a) without drum's frame effect, b) with drum's frame effect

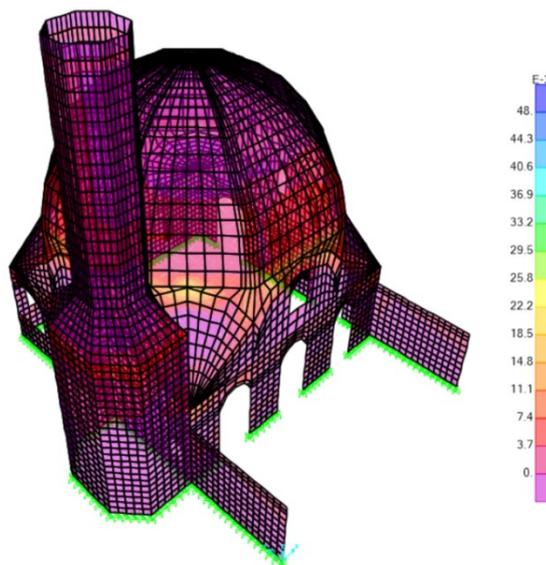
Looking at the entire structure, it is evident that tensile stresses that pose a risk to the masonry structure caused by the effects of geometric forms and window openings on stress variations occurred in the transition to the dome and along the drum line. Therefore, these areas in the mosque should be observed more carefully under possible risks (Figure 4.11).

Figure 4.11. Tensile stress (absolute  $S_{max}$ ) contours of self-weight analysis of the structure ( $\text{kN}/\text{cm}^2$ )

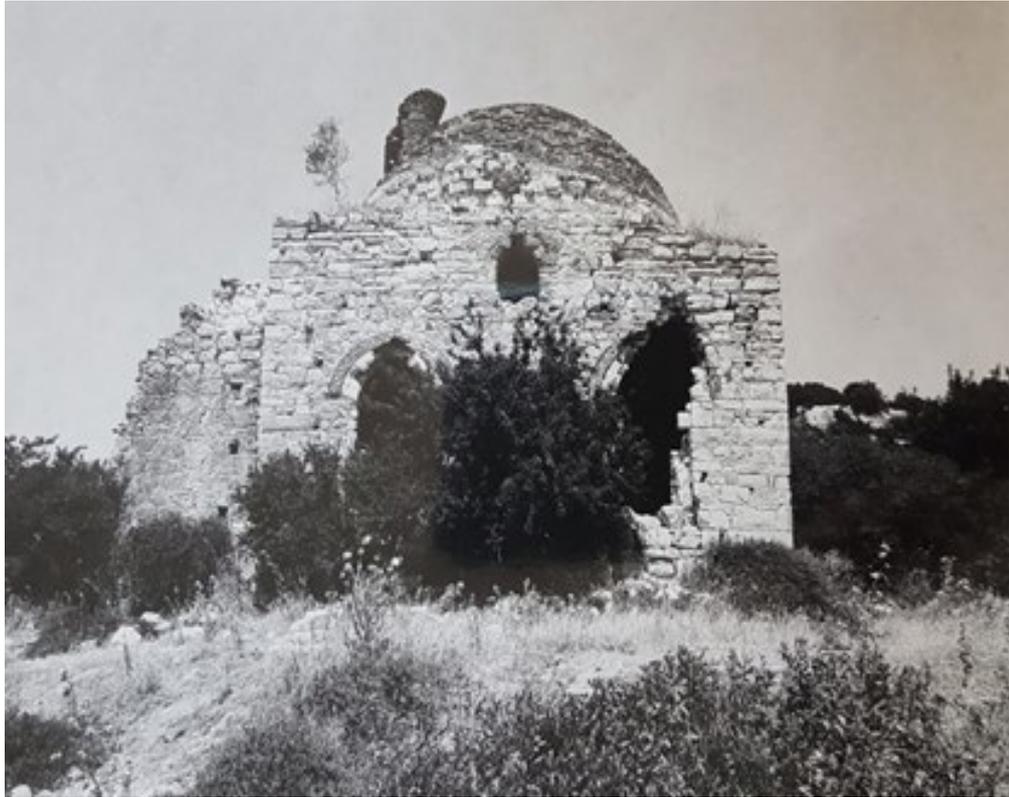
The most critical damage mechanism of the structure is observed in the southern wall and the squinches and dome section in this wall. The structural settlements described in Chapter 3.4 in which structural problems are defined are thought to be the main cause of the damage mechanism in this area. In the light of the documents obtained from Rahmi Hüseyin Ünal's personal archive, similar losses were observed in the southern wall of the building in 1985 and the squinch in this wall had a wide crack along the intersection line with no mass collapse (Figure 4.17, Figure 4.18). According to Ertuğrul (1995), the structure has four corner squinches. In light of this information, when the damage in the wall occurred is unknown; however, but it is clear that the damage grew towards the squinch during the period of nearly twenty years after 1995.

Figure 4.17. South facade (dated on 1985)  
(Source: Rahmi Hüseyin Unal's personal archive)

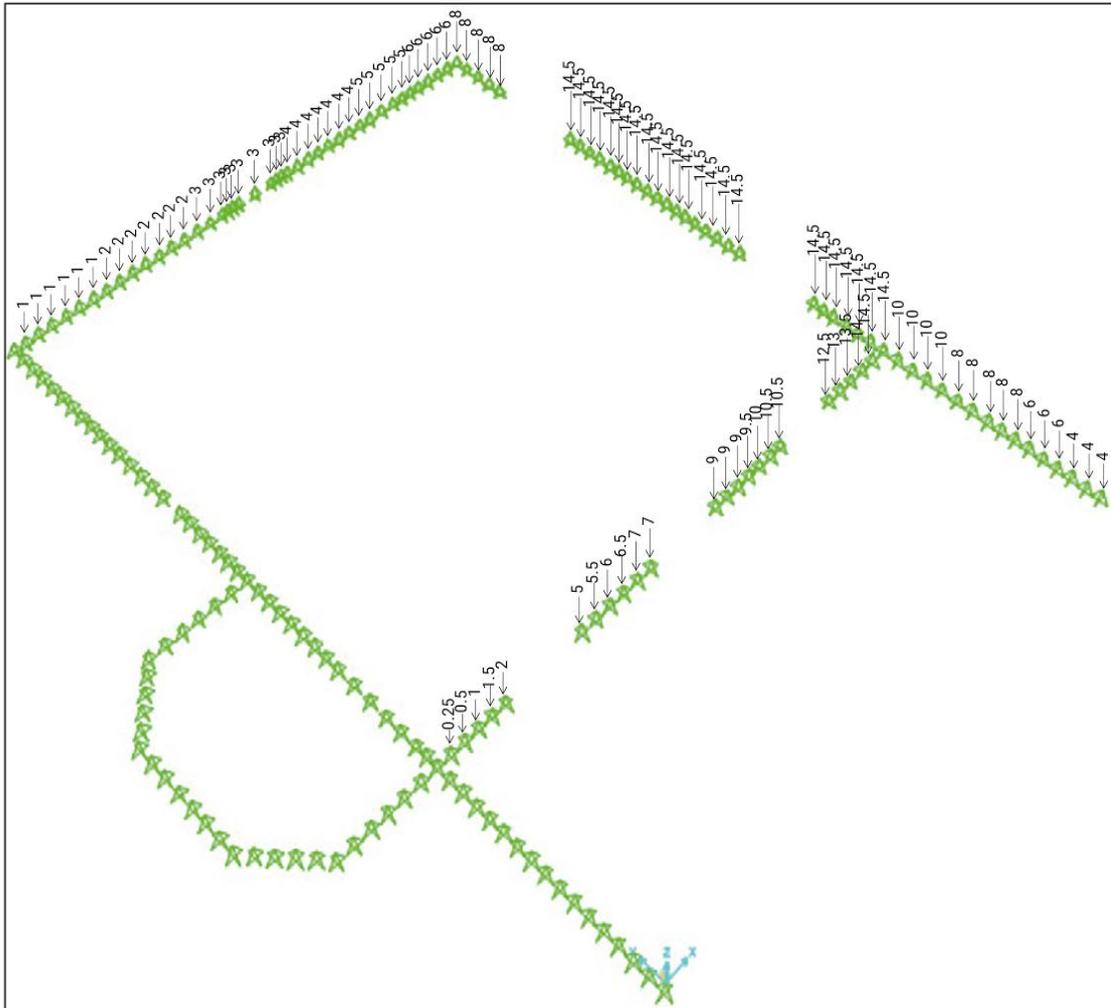
To understand whether or not the cause of the damage in the southern wall of the building was due to the settlement, the manually taken measurements of the building and the values read from the measured drawings were combined and the settlement scenario was constructed. For this scenario, the vertical displacements applied to the structure are shown in Figure 4.19.

Figure 4.19. Displacement scenario for settlement analyses (cm)

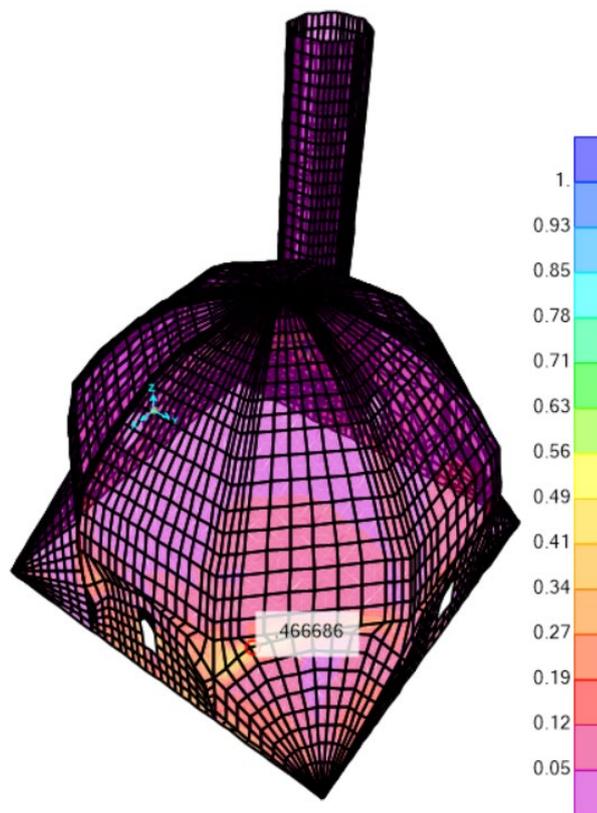
According to the settlement analysis scenario with the vertical displacements, the stress conditions in the southern wall and the southeast squinch are shown in Figure 4.20 and Figure 4.21. The stresses in the walls are greater than the tensile stress boundary value  $0.108 \text{ kN/cm}^2$ . With respect to the southeast squinch, the stresses in the south half of the squinch range from  $0.3$  to  $0.5 \text{ kN/cm}^2$  and are greater than the tensile stress boundary value  $0.043 \text{ kN/cm}^2$ .

This result supports the idea that a settlement caused by ground motion for years in accord with this scenario has led to the damage mechanism in the southern side of the building.

Figure 4.21. Tensile stress (absolute Smax) contours of settlement analysis on southeast squinch of the structure (kN/cm<sup>2</sup>)

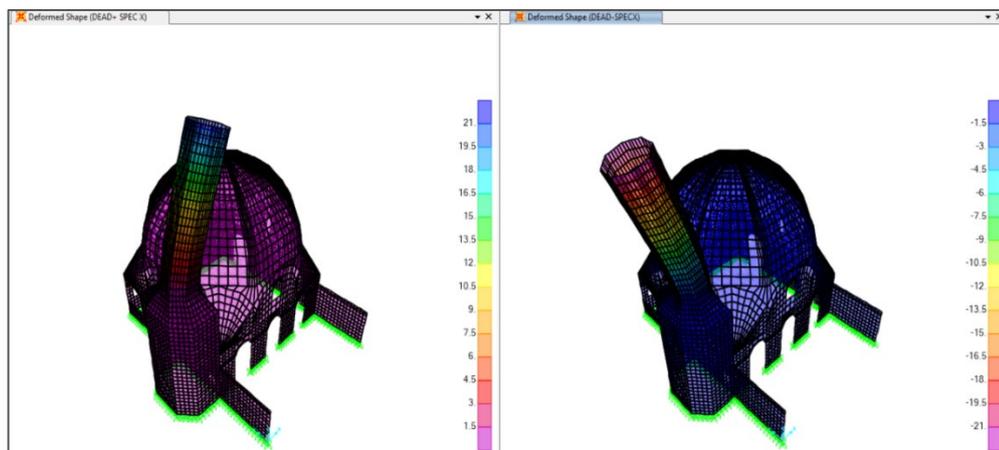
To understand the seismic behavior of Helvacilar Mosque, response spectrum analyses were carried out in both x- and y-direction with the spectrum obtained from the coordinates where the region is located. The analyses investigated parts of the structure in which displacements and in-plane and out-of-plane shear stress occurred. The mass participating ratio of the analysis is 90%. The results of the analysis showed that the displacements observed in the structure are 21 centimeters in the x-direction and 19.6 centimeters in the y-direction in the minaret. The displacement in the main mass does not exceed 1.5 centimeters in the x-direction and y-direction (Figure 4.30, Figure 4.31).

Figure 4.30. Deformation results of response spectrum analyses, a) dead load+ response spectrum x, b) dead load- response spectrum x

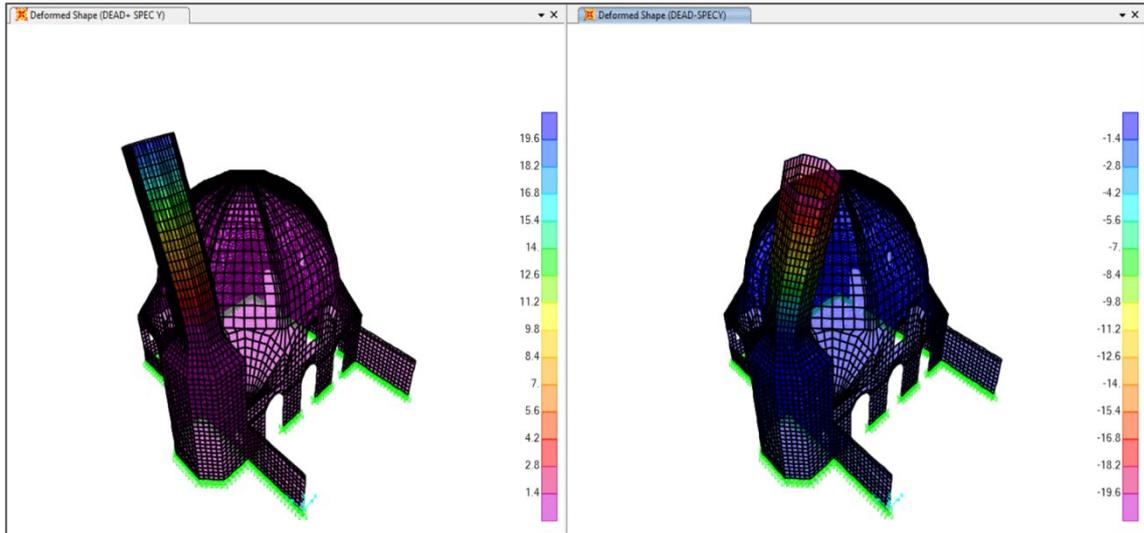
(a) (b)  
 Figure 4.31. Deformation results of response spectrum analyses, a) dead load+ response spectrum y, b) dead load- response spectrum y

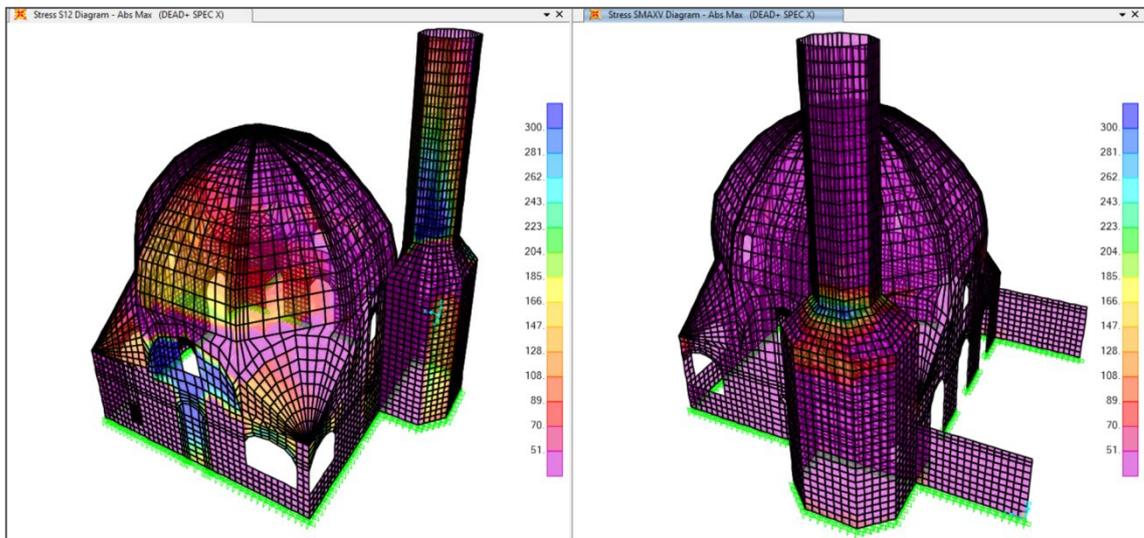
The maximum shear stress for the dead load + spectrum x load combination is observed in the connection of the minaret body and pabuc as (S12) 2120 kPa ( $\text{kN/m}^2$ ) in the in-plane stresses and as (SVmax) 387.7 kPa ( $\text{kN/m}^2$ ) in the out-of-plane stresses. Figure 4.32 shows the in-plane and out-of-plane stress changes for the dead load + spectrum x combination.

Figure 4.32. Shear stress contours of response spectrum analysis ( $\text{kN/cm}^2$ )-1 (result of dead load+ spectrum x, view from east and north), a) in plane (absolute S12), b) out of plane (absolute SVmax)

Given the stress changes detected in the analysis, it is apparent that the in-plane shear stresses occur in different combinations, in different directions, and in similar volumes. The most important sections for the in-plane stresses are the dome drum and the areas that mark changes in the minaret geometry. The out-of-plane shear stresses are mostly observed in the connection of the minaret body and pabuc and at the intersections where the squinches and walls. The in-plane and out-of-plane stresses are above the boundary values both in the walls and the superstructure.

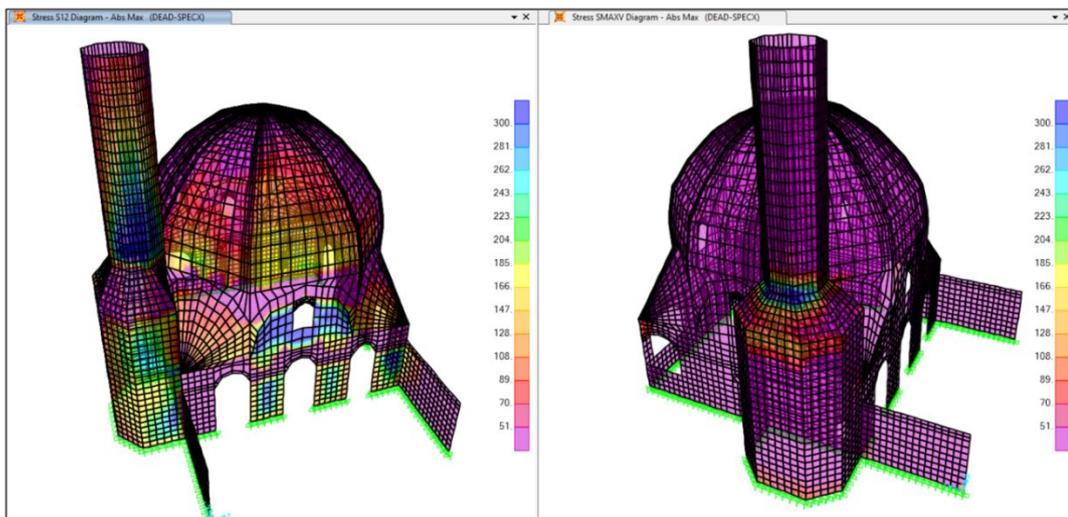
The maximum shear stress for the dead load - spectrum x load combination is observed in the connection of the minaret body and pabuc as (S12) 1900 kPa ( $\text{kN/m}^2$ ) in the in-plane stresses and as (SVmax) 397.9 kPa ( $\text{kN/m}^2$ ) in the out-of-plane stresses. Figure 4.33 shows the in-plane and out-of-plane stress changes for the dead load - spectrum x combination.

Figure 4.33. Shear stress contours of response spectrum analysis ( $\text{kN/cm}^2$ )-2 (result of dead load- spectrum x, view from west and north), a) in plane (absolute S12), b) out of plane (absolute SVmax)

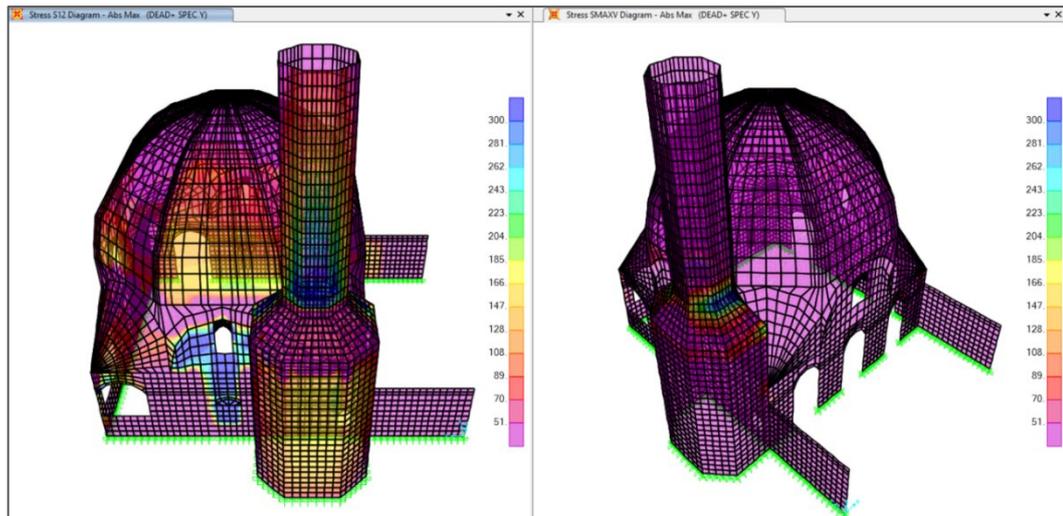
The maximum shear stress for the dead load + spectrum y load combination is observed in the connection of the minaret body and pabuc as (S12) 2448 kPa ( $\text{kN/m}^2$ ) in the in-plane stresses and as (SVmax) 502.5 kPa ( $\text{kN/m}^2$ ) in the out-of-plane stresses. Figure 4.34 shows the in-plane and out-of-plane stress changes for the dead load + spectrum x combination.

(a) (b)  
 Figure 4.34. Shear stress contours of response spectrum analysis ( $\text{kN}/\text{cm}^2$ )-3 (result of dead load+ spectrum y, view from north and west), a) in plane (absolute S12), b) out of plane (absolute SVmax)

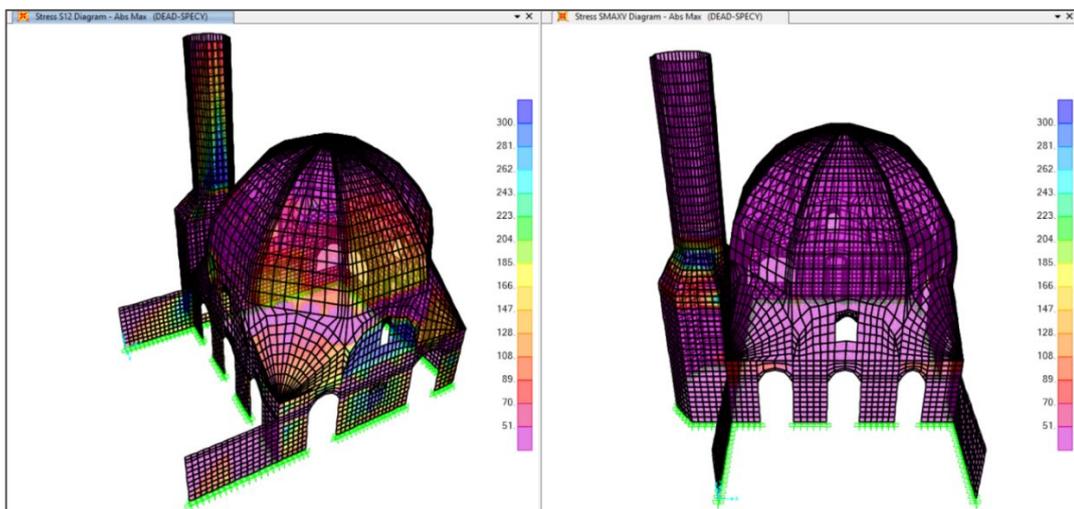
The maximum shear stress for the dead load - spectrum y load combination is observed in the connection of the minaret body and pabuc as (S12) 1585.2 kPa ( $\text{kN/m}^2$ ) in the in-plane stresses and as (SVmax) 509.4 kPa ( $\text{kN/m}^2$ ) in the out-of-plane stresses.

(a) (b)  
 Figure 4.35. Shear stress contours of response spectrum analysis ( $\text{kN}/\text{cm}^2$ )-4 (result of dead load- spectrum y, view from south and west), a) in plane (absolute S12), b) out of plane (absolute SVmax)

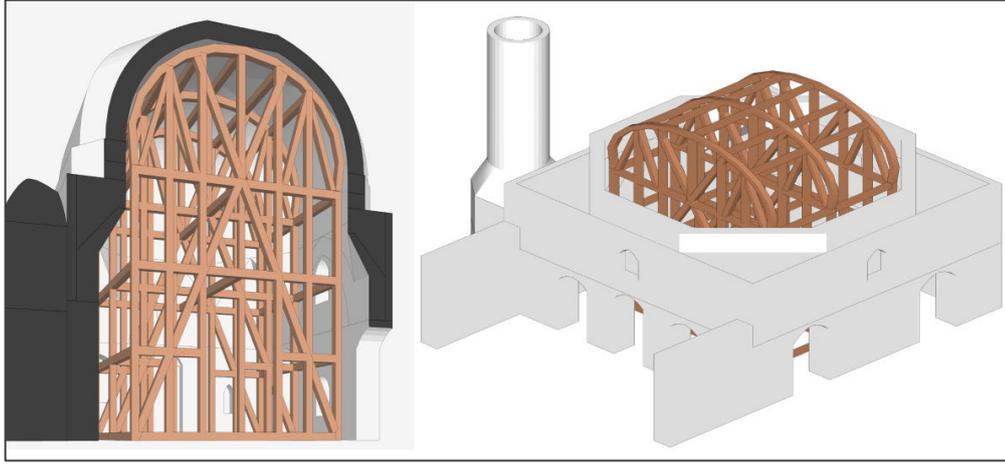
Figure 5.8. Schematic representation of scaffolding system

Among the suspension systems defined in the guideline, the A3 type arch suspension system was adapted to the dome of the structure. In the scaffolding system constructed for the dome, three A3-type suspension structures will be used in the east-west direction. The main entrance gate will be taken as a reference as the central axis and the passage hall will be on this axis. Three parallel suspension systems will be connected to the beams on the spring line (Figure 5.8).

Pillars, beams, and wooden cross-section bracing components used in the suspension system must measure 20 x20 centimeters at the minimum. The connection specifications in Figure 5.9 must also be followed.

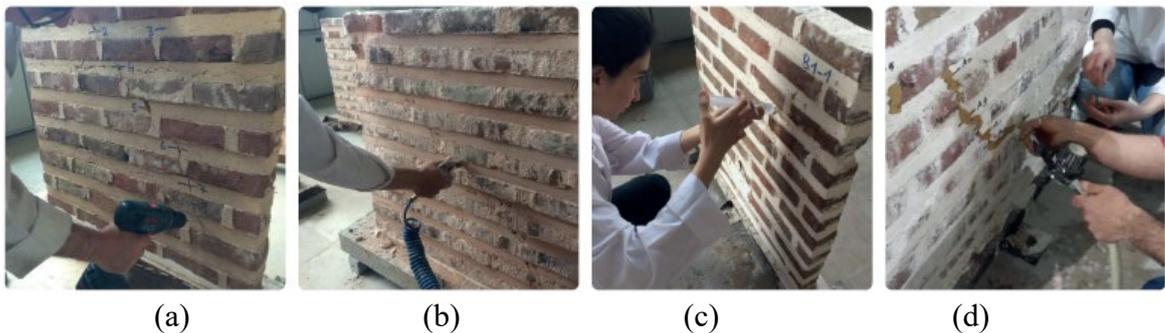
Figure 5.13. Injection application a) drilling holes in the wall, b) cleaning the holes with air, c) wetting application, d) injection application (Source: General Directorate of Foundations' Guideline, 2017)

4. The repair of capillary cracks must be done using lime mortar injection material. According to the guideline, the method is used to restore the integrity of the stone masonry walls with empty joints due to irregular and external effects and of the hollow masonry walls with porous filling material in the inside. The mechanical properties of the wall can be improved by injecting high- binding mortar compatible with the original materials into hollow walls under proper pressure.

The material injection is done with the help of plastic tubes placed in the holes opened. During the application, care is taken to keep the injection pressure constant (approximately 1 bar). The injection process starts in the lower parts of the wall, and the gaps are closed to be cleaned later in order to prevent leakage from cracks throughout the application.

1. To ensure the structural integrity of the dome, brick courses in the cracks in the southern side must be partly removed and reconstructed. Because the width of the cracks decreases when moving upwards through the dome drum, the cracks must be filled with mortar injection as shown in Figure 5.13. After this application, the crack line must be fastened with metal clamps in the injection area.
2. Framing must be made using UPN 240 type steel elements in the stone frame that currently partly encloses the dome. The stone frame that was originally covering the extrados of the dome drum must be rebuilt (Figure 5.17).
3. Joint repairs must be made in the entire.
4. The humidity problem in the northwest side of the dome must be solved. The dome must be insulated.

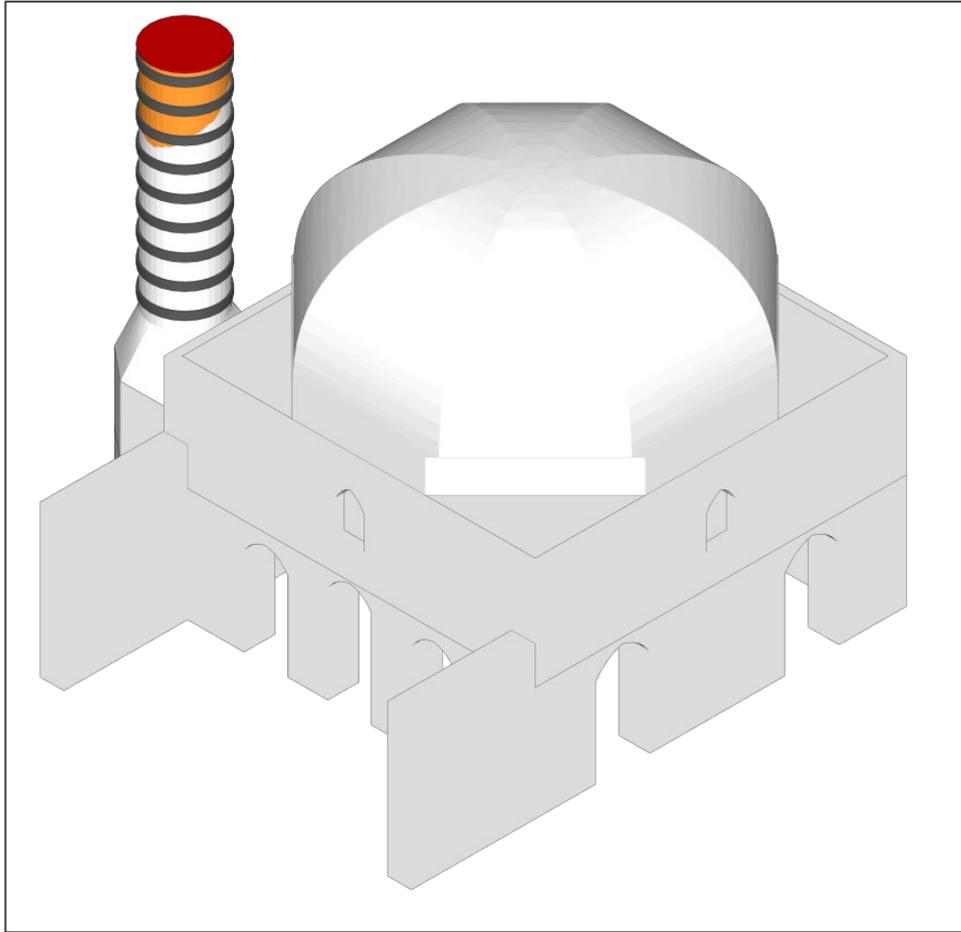
Figure 5.18. Schematic representation of minaret consolidation

Interventions do not vary widely due to the geometry of the minaret. The damage in the minaret is in its body. For this reason, the currently damaged part of the minaret body up to the uppermost level must be rebuilt of brick and mortar in keeping with its original form. The body must also be braced by steel tie from its connection with the minaret base up to the uppermost level. The maximum brace distance must not greater than 50 centimeters. Capping must be installed using lime-based waterproof material in the uppermost level of the minaret to prevent water leakage into the minaret (Figure 5.18).
