**STRUCTURAL MODEL BASED ROOT CAUSE  
INVESTIGATION OF DAMAGE IN URLA  
HELVACILAR MOSQUE AND A PROPOSAL FOR  
STRENGTHENING**

**A Thesis Submitted to  
the Graduate School of Engineering and Sciences of  
İzmir Institute of Technology  
in Partial Fulfillment of the Requirements for the Degree of**

**in Architectural Restoration**

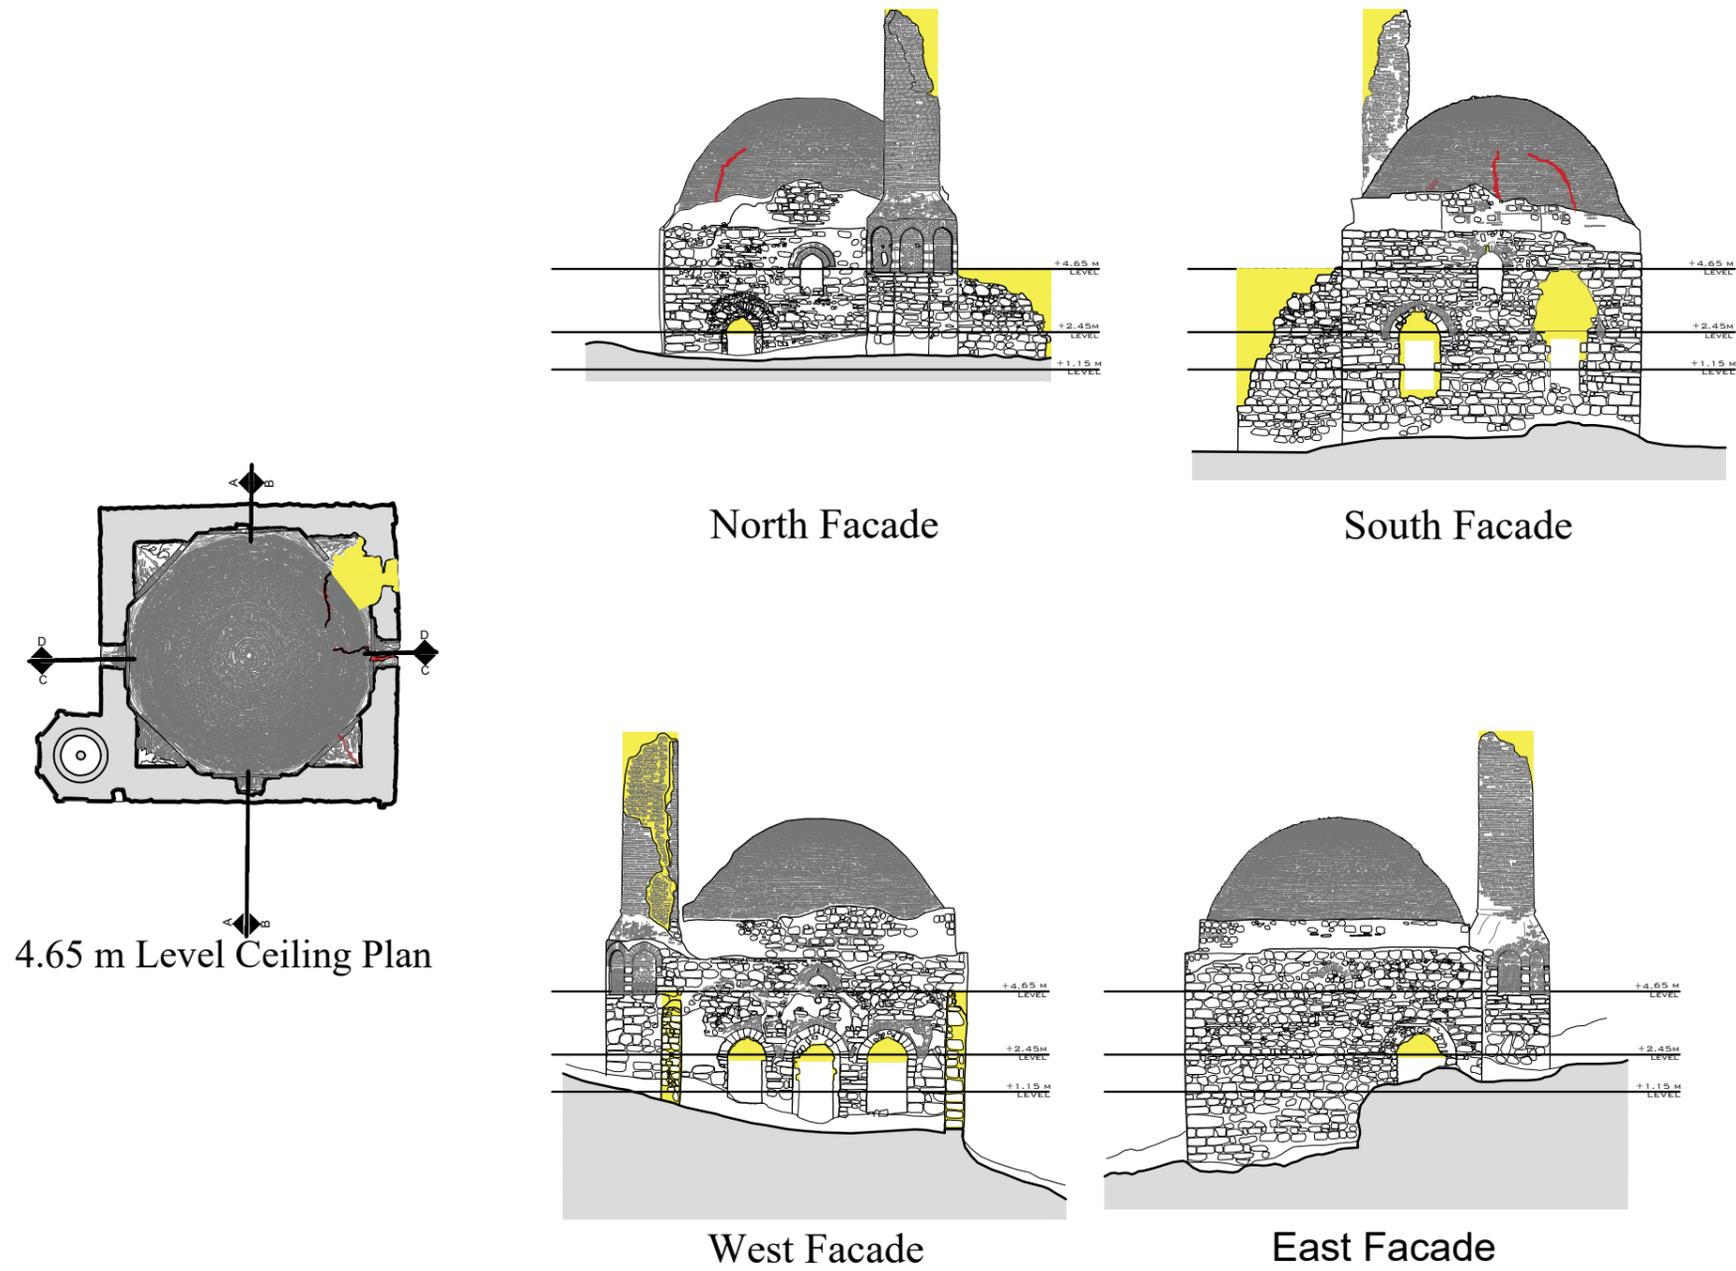
Figure D.2. Structural Failure

STRUCTURAL FAILURE

- MASS COLLAPSE
- CRACK
- LOSS OF TIMBER ELEMENTS
- SETTLEMENT
- TILTING
