## Performance of structures in İzmir after the Samos island earthquake

### Abstract

The October 30, 2020 Earthquake caused unexpectedly significant damage in İzmir considering its distance to the city. This paper evaluates the recorded ground motions, summarizes the performance of structures affected from the earthquake with emphasis on the reasons of damage. A detailed damage assessment was carried out by the Earthquake Engineering Research Center of Middle East Technical University to compile data on the damage of RC and masonry buildings. It was observed that majority of the damage was concentrated in the Bayraklı district due to its peculiar soil properties where many 7–10 story mid-rise RC buildings suffered heavy damage and collapse. The level of amplified ground motions combined with deficiencies of apparently non-code compliant buildings exacerbated the damage. The main reasons of damage were mainly attributed to the presence of soft stories, lack of proper detailing, poor construction quality, presence of heavy overhangs, and hence significant lack of code-compliance in essence. The influence of infill walls on seismic performance of deficient and inadequate buildings w

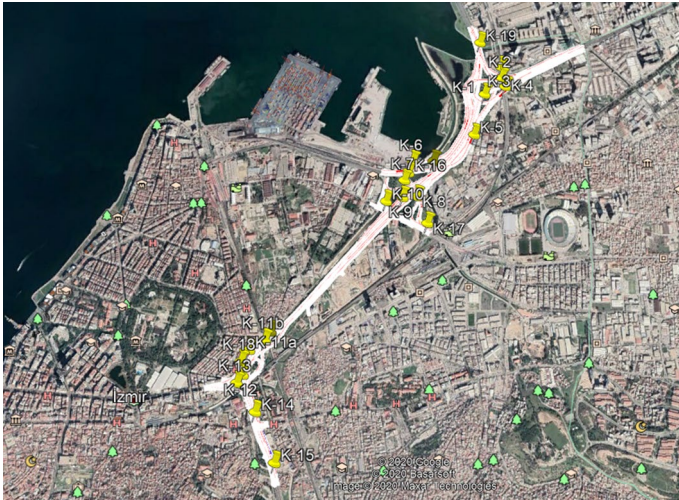
**Fig. 18** The highway line selected and bridges assessed

In addition to buildings, bridges in İzmir were also assessed by METU/EERC teams to investigate their response to the earthquake. The bridges located along Mürselpaşa—Zafer Payzın highway line, shown in Fig. 18, were investigated in detail. All the visited bridges are also marked in Fig. 18. As alluded before, the investigated bridges are approximately 75 km away from the earthquake epicenter. They were observed to perform satisfactorily. These analyzed bridges are in the close vicinity of the Bayraklı region and close to the seismic recording station 3513. Most likely, they have been subjected to spectral accelerations around 0.3 g at their corresponding vibration periods. No permanent movement has been observed in the superstructure beams and supports. The bending and shear capacities of the bridge columns and foundations were exceeded and no visible cracks were observed due to the earthquake. There were no settlements on the foundations mostly located on soft soil. No movement was observed at the bridge expansion joints. No loss of function such as

rupture or fracture was observed in non-structural bridge elements (precast panels, pedestrian railings, lighting poles, etc.). The earthquake performances of longitudinal joints between twin bridges were also satisfactory, and some small concrete pieces not more than 2–3 cm fell on the ground only at some local zones. After the examination of the superstructure and infrastructure of the bridges, no earthquake-related damage was detected. Bridges were available for use right after the earthquake. As a result, it was determined that bridges that performed successfully during the earthquake were serviceable without a need of emergency intervention (Fig. 19).
