A survey of damage observed in Izmir due to 2020 Samos-Izmir earthquake

An earthquake of magnitude 6.9 hit the city of Izmir (Turkey) on 30 October 2020, resulting in 117 deaths (in Turkey) and considerable economic losses. The earthquake also triggered a tsunami. Following the earthquake, field surveys are being conducted in a *Covid-secure* way to study and document the damages caused. The earthquake caused significant damages to residential buildings mainly located in the district of Bayrakli and Bornova. However, no damages were observed in railway and roadway bridges or tunnels and that helped the rescue operations. The damages were mainly structural which included the so-called pancake collapse (where the entire building collapsed) and soft storey type collapse (weak storey characterised with weak columns collapsed), and in some cases, only the ground floor completely collapsed. Due to the proximity of the epicentre and the geology of the area, it seemed that the ground motions were amplified. This technical note provides a summary of the seismological and recorded ground characteristics of the earthquake together with the lessons learnt.

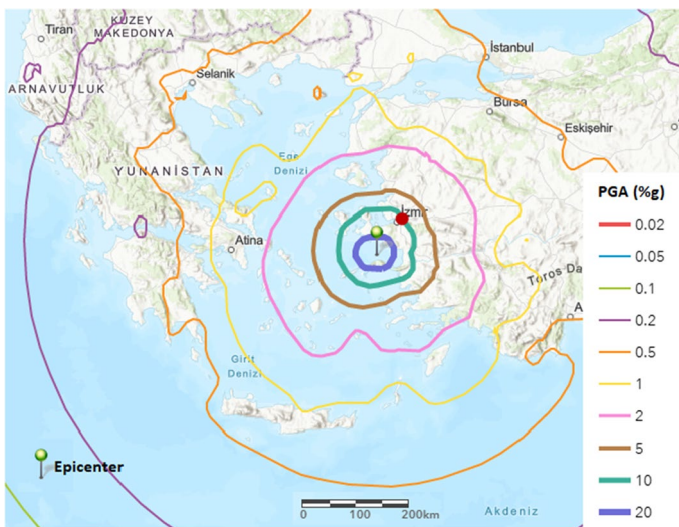
Fig. 3 **a** PGA shake map (%g) for 30 October M_w 6.9 Samos-Izmir Earthquake

Bornova region. The level of PGA at the location of the damaged area is around 10% of the gravitational acceleration (0.1 g) while the magnitude of PGV observed at the damaged area is around 10 cm/s as seen in Figs. 3 and 4. The magnitude of SA (0.3) and SA (1.0) at the damaged area are 20% of the gravitational acceleration (0.2 g) as seen in Figs. 5 and 6.

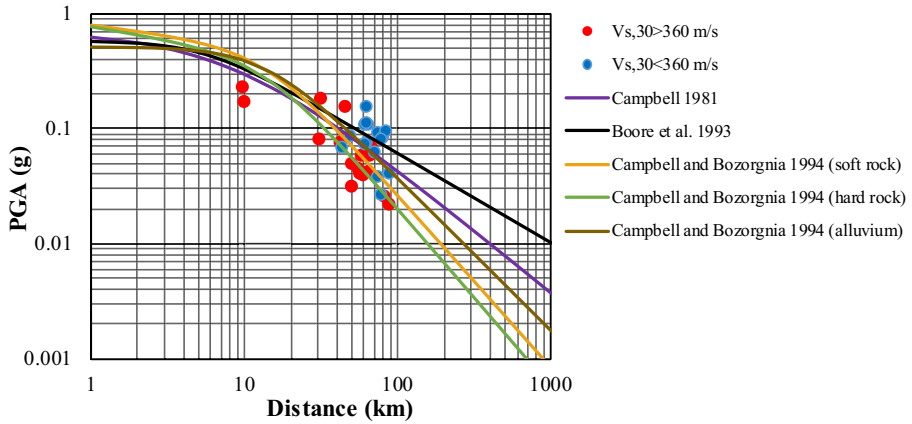
Fig. 9 Comparison of the recorded strong ground motion data for PGA with attenuation prediction models

recorded at accelerometric stations located where the average shear wave velocity of soils in the top 30 m depth (V_{s30}) is greater than 360 m/s while blue points show PGA values recorded at accelerometric stations placed where the value of V_{s30} is smaller than 360 m/s. Solid lines show PGA attenuation relationships suggested by Campbell (1981) [6], Boore et al. (1993) and Campbell and Bozorgnia (1994). The PGA attenuation relationships for soft rock, hard rock and alluvium soils are plotted by using equations proposed by Campbell and Bozorgnia (1994). The information on recorded strong ground motions plotted in the figure is taken from the stations within 100 km epicentral distance. All the attenuation relationships over predict PGA values observed in the earthquake at distances less than 10 km. The acceleration data from the earthquake are generally bound by the minus and plus two standard deviation predictions at distances larger than 10 km.

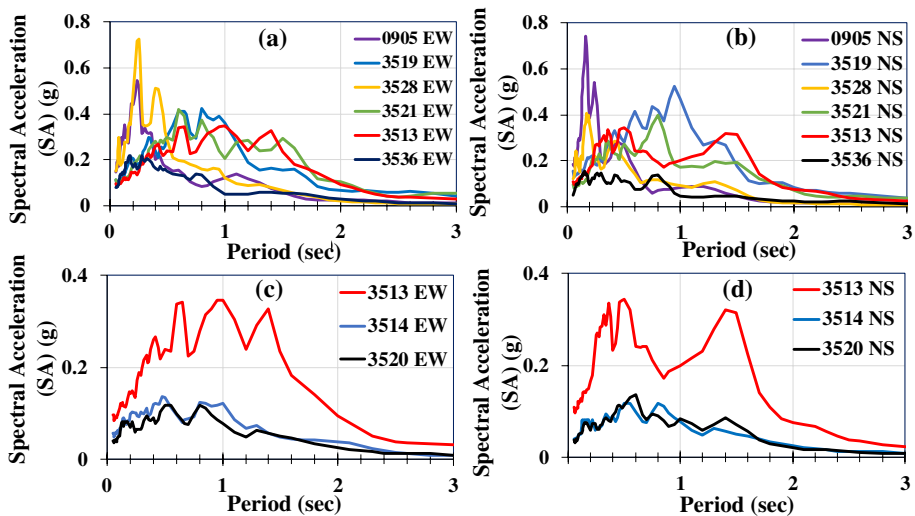
while station numbered 3513 is placed on a weak soil profile. The results for the station numbered 3513 are presented by a solid red line while a blue line is used to present the results for the station numbered 3514. Finally, the results for the station numbered 3520 are presented by black solid lines. The comparison of the response spectra highlights: (i) horizontal ground motions are amplified in both EW and NS directions, (ii) ground motions

Fig. 12. 5% damped elastic acceleration response spectra for records at selected stations (0905, 3519, 3528, 3521, 3513 and 3536): **a** East–West (EW) direction and **b** North–South (NS) direction, 5% damped elastic acceleration response spectra for records at the stations in Bayrakli region (3513, 3514, 3520): **c** East–West (EW) direction and **d** North–South (NS) direction

are amplified by 2.5–3 times between the periods of 0.4 s and 1.5 s, (iii) amplitudes of the response spectra are at around 0.35 g for both EW and NS directions.
