## Dampness Problems in a Historic House in İzmir, Turkey

## DAMPNESS PROBLEMS IN A HISTORIC HOUSE IN İZMİR, TURKEY

*The study, as a preliminary stage of the restoration work of a historic house from Levantine ages of İzmir in the nineteenth century, involves the examination of the dampness basement problems. Moisture contents and temperature of the wall surfaces were monitored by non-destructive techniques, such as direct measurements of electrical conductivity and infrared thermography. The results were evaluated in the light of physical properties, moisture, and soluble salt types and contents in the materials, outdoor, and indoor climatic conditions, layout of the site, and architectural features of the building. In addition to rising damp and lack of sufficient ventilation for years, some faulty details along the intersections with the terraces of the neighbor buildings, and intersection with the asphalt coated street and the basement windows that gave way for rainwater leaks were the other sources of dampness. Some cool but relatively dry parts of the walls were found to be potential zones for dampness problem through condensation between midnight and early mornings, especi

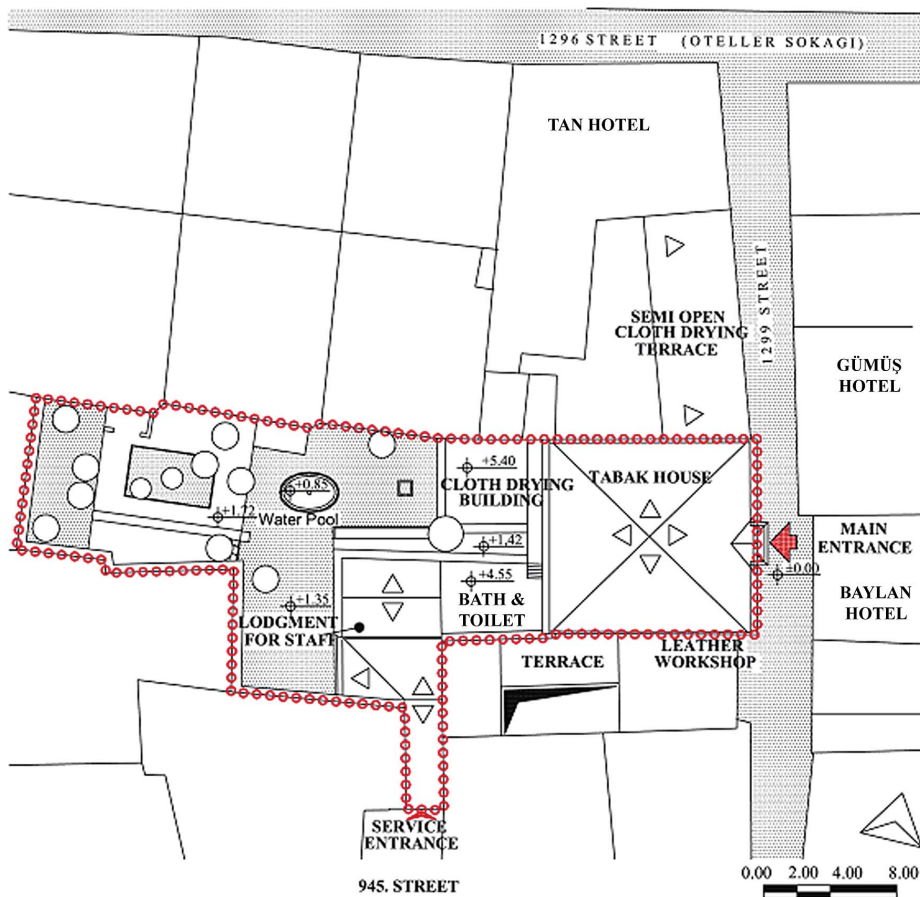
**Figure 3.** Illustration of the location of the Tabak House (modified from the measured drawings provided by the Department of Architectural Restoration, İzmir Institute of Technology, İzmir, Turkey) (figure is provided in color online).

As Figure 9B shows, the strong winds blew from the SW, S, and SSE. The SSE winds were supposed to be effective on the outside drying conditions through the front facade of the house. However, a hilltop, on which the citadel Kadifekale is located approximately 1.5 km towards the SE, formed a topographic obstacle in receiving the dominant winds of the region from SSE (Figures 1B, 1C, and 3). In addition, the taller hotel buildings and other buildings across the very narrow street (not more than 4 m wide) seemed to prevent the basement of the house from receiving the winds from the northeast (NE) and east-northeast (ENE) directions (Figures 3 and 9). The west (W) winds were not also effective on drying due to the attachments of the cloth-drying and bath/toilet buildings built in 1960s blocking the west facade of the basement (Figure 3).

The attachment of the structures such as the toilet and bath building, and the building for cloth drying were the later applications that prevented the basement from drying through its rear facade (Figure 3).

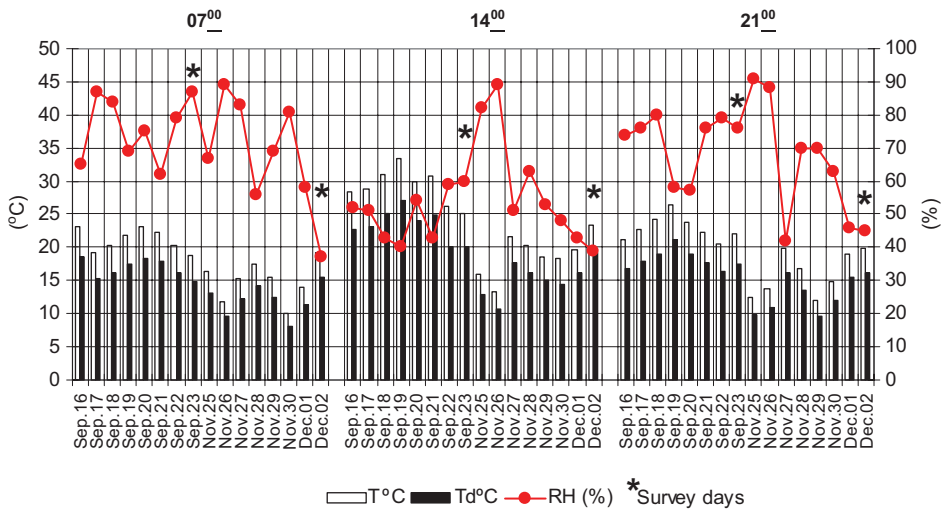
**3.2.1. Outdoor and Indoor Conditions** Outdoor conditions in the 1-week-periods before each survey day proved that condensation did not take place outside since the dew point temperatures were not reached (Figure 11). In both survey days, the relative humidity in the basement (70%–73%) which was higher than the outdoor humidity (39%–60%) (Figure 12). Indicating improper ventilation which provoked the dampness problem, the air movement in the basement was considerably low in both survey days (0.01 m/s) (Figure 12).

**Figure 11.** Graph of the outdoor temperature and humidity conditions during the 1-week period before each survey day in 2005 ( $T^{\circ}\text{C}$ , normal temperature;  $T_d^{\circ}\text{C}$ , dewpoint temperature; RH, relative humidity (data from General Directorate of the State Meteorological Service, İzmir Regional Station, Turkey) (figure is provided in color online).

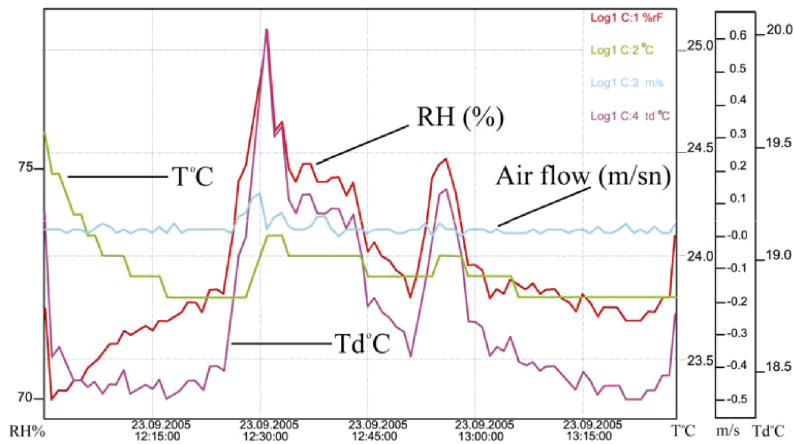
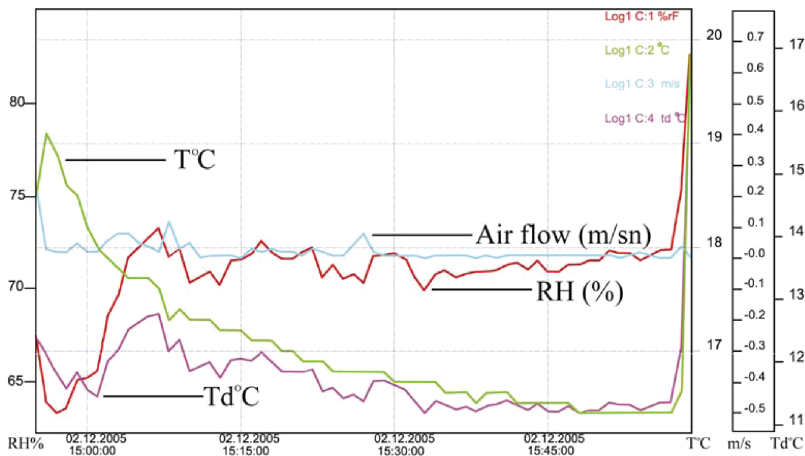
Regarding condensation in the basement, the September 23 survey showed that condensation did not occur since the difference between ambient and dew point temperatures were high enough. However, indoor conditions on the December 2 proved that the condensation was possible (Figure 12).

**Figure 12.** Graph of A) the indoor climate conditions on September 23, 2005 (the sudden jumps in the peaks were the moments when the infrared thermography survey team of three people was passing near by *Testo* equipment); B) and on December 2, 2005 (redrawn from the original *Testo* outputs) (figure is provided in color online).

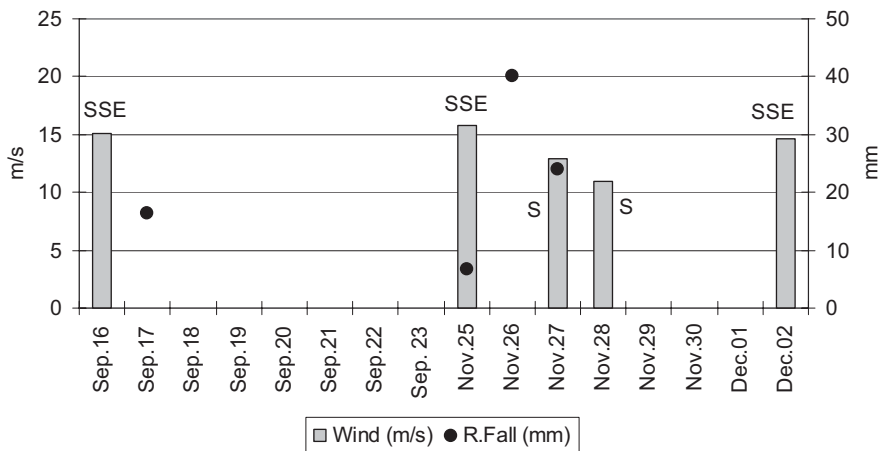
and rainfalls on November 25–27 seemed to affect the dampness that was detected by the survey on December 2 (Figures 15 and 16).

**Figure 15.** Graph of the velocity (m/s) and directions (south and south-southeast) of the winds, and rainfall (mm) during the 1-week-period before each survey day in 2005 (data from General Directorate of the State Meteorological Service, İzmir Regional Station, Turkey).
