**ARCHITECTURAL DESIGN CHARACTERISTICS
OF PROTECTIVE STRUCTURES AT
ARCHAEOLOGICAL SITES AND THEIR IMPACT
ON CONSERVATION OF REMAINS**

**A Thesis Submitted to
the Graduate School of Engineering and Sciences of
İzmir Institute of Technology
in Partial Fulfillment of the Requirements for the Degree of**

DOCTOR OF PHILOSOPHY

**by
Necmiye Funda YAKA ÇETİN**

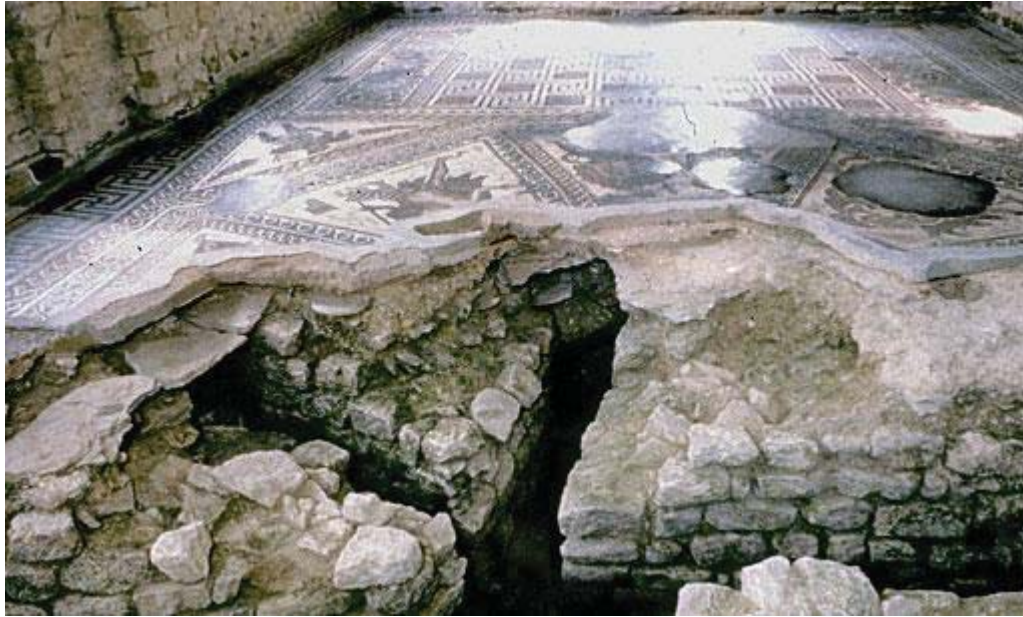
Chedworth Roman Villa at Gloucestershire (UK) consists of remains of a luxuries villa with mosaic pavements (Table 3. 10). Damage is caused by fluctuating relative humidity as repeated cycles of crystallization and hydration in addition the enclosure cannot adequately prevent freeze/thaw action (Figure 3. 17). Although the protective structure was modified before, it did not fulfill the conservation needs therefore a new one was constructed. (National Trust 2009a, National Trust 2009b).

Figure 3. 17. Mosaics at the Chedworth Roman Villa at Gloucestershire (UK). (Source: http://www.getty.edu/conservation/publications_resources/newsletters/21_1/newsletter2.html)
