IDENTIFICATION OF VEZİRAĞA AQUEDUCT IN İZMİR AS A HISTORICAL MONUMENT

**A Thesis Submitted to
the Graduate School of Engineering and Science of
İzmir Institute of Technology
In Partial Fulfillment of the Requirements for the Degree of
MASTER OF SCIENCE
in Architectural Restoration**

**by
Fatma Sezgi MAMAKLI**

**July 2016
İZMİR**

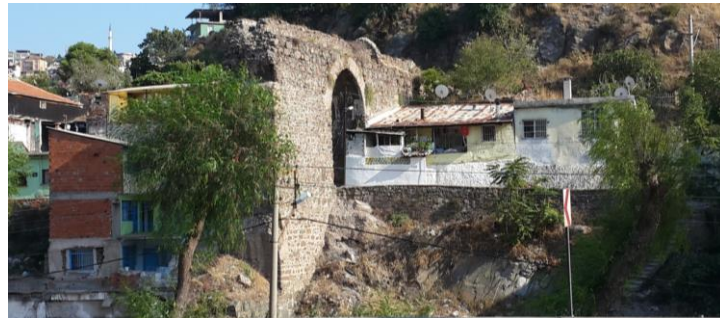
On 10th May of 2007 with the decision numbered 2312, the aqueduct was registered as monument in master plans. This decision included a buffer zone same height with the aqueduct, in order to coordinate the relation of the aqueduct with the housing area at its south. However, the housing units threatening the monument, especially wall portion B, have not been cleaned so far.

Figure 8. Wall portion B with its surrounding

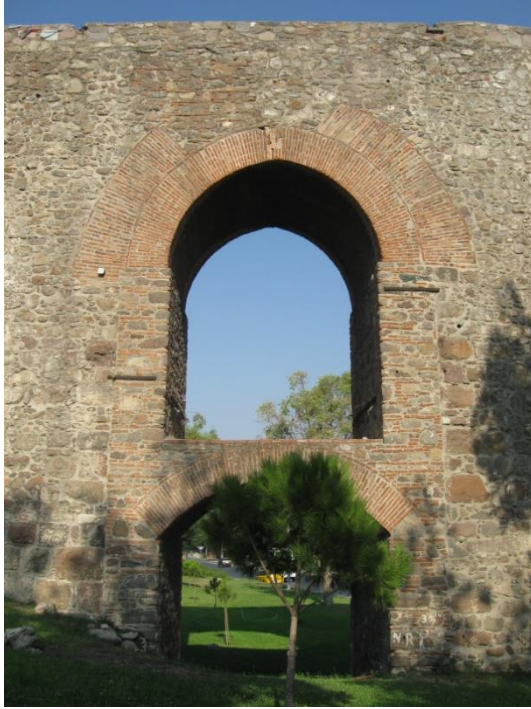
Figure 12. The fourth and fifth arches of wall portion A from the north end.

Stone and brick additional masonry wall system at the south of the wall portion A (85 x 325 x 697 cm) is composed of rubble stones (~ 15 x 35 cm), bricks (~ 4 x 12 cm) and mortar (~2 cm in thickness), and exposed without plastering and paint as the rest of the stone masonry wall (Appendix C2 and Figure 12).

Some structural additions are applied to the wall portion A of the aqueduct to sustain its structural integrity. One of the structural additions is an arch system of wall portion A with two new arches and stone-brick wall under its southern arch (Appendix D2 and Figure 12). The other structural addition is the construction of stone masonry buttresses to the east facade of wall portion A (Appendix D2, Figure 18). Iron

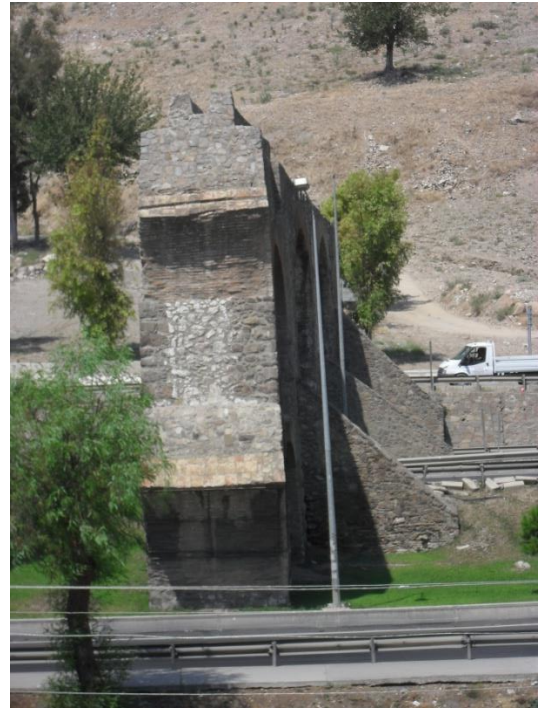
Figure 13. The demolished arches at the south end of wall portion A.

At the end of wall portion A and B, there are the remains of some other original arches, composed of bricks and mortar and exposed without plastering and paint (Appendix C2, Figure 13 and 14).

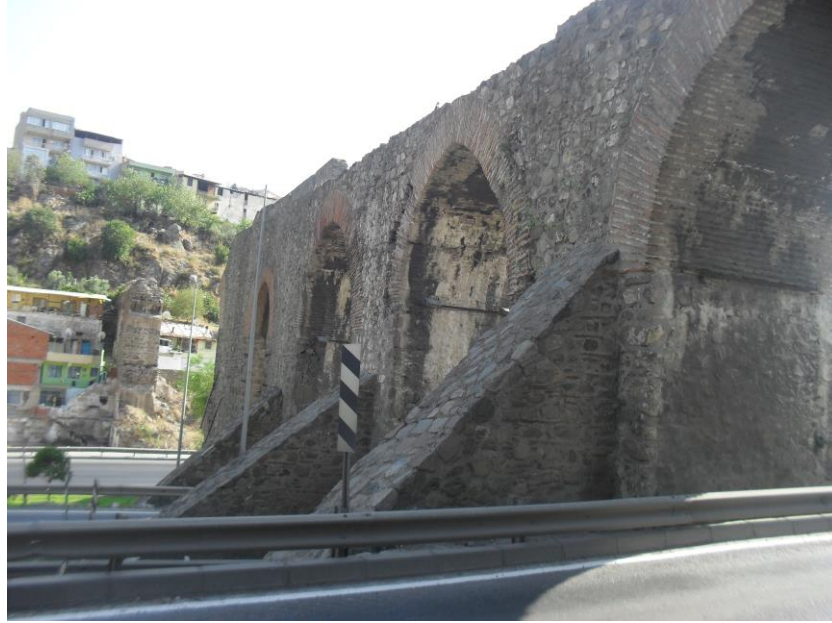
Three stone masonry buttresses (~ 1.4 x 2.8 x 3.3 m) are supporting the wall portion A between its arches at its east elevation (Appendix C2). The buttresses have triangular facades at the north and south and positioned back to back with the stone masonry wall. The buttresses are composed of rubble stones (~ 20 x 50 cm) and mortar (~2 cm in thickness) and exposed without plastering and paint (Figure 18).

Figure 18. Three buttresses on east elevation.

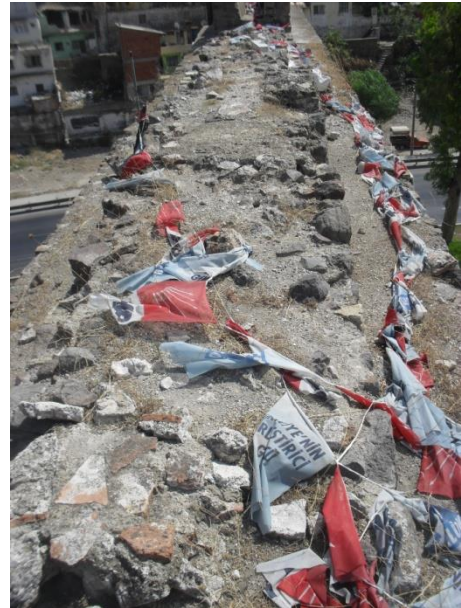
The remain of stone duct (L: 15.11 m) above wall portion A is between incomplete concrete covered stone duct and concrete covered stone duct. The remain is composed of rubble stones and mortar and exposed without plastering and paint (Appendix C2, Figure 21).

Figure 21. The remain of stone duct above wall portion A.

A part of the stone duct on wall portion A, 23 m from north corner and 56 m in length, is lost between incomplete concrete covered stone duct and stone duct (Appendix D2, Figure 21).

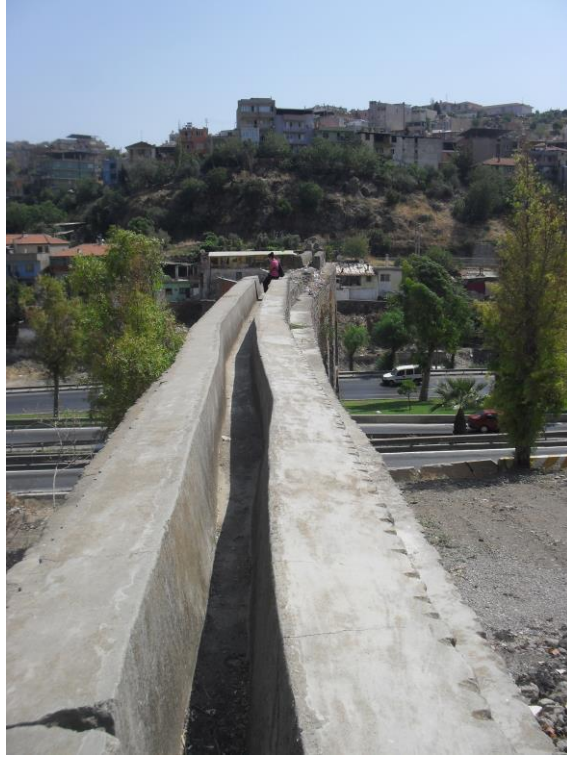
Concrete covered stone duct is composed of two parts (L: 18.90 m / w:172 cm / 60 – 90 cm in depth and L: 13.20 m / w:179 cm / 60 – 90 cm in depth) with U profile is above wall portion A in north west direction. The duct is constructed by stone and covered with concrete from the inside of U profile (Appendix C2 and Figure 22).

Figure 22. Concrete covered stone duct above wall portion A.

The duct of wall portion A is reconstructed with stone and covered with concrete partially (Appendix D2 and Figure 22). However, some part of this concrete covered stone duct is incomplete (Appendix D2 and Figure 23).

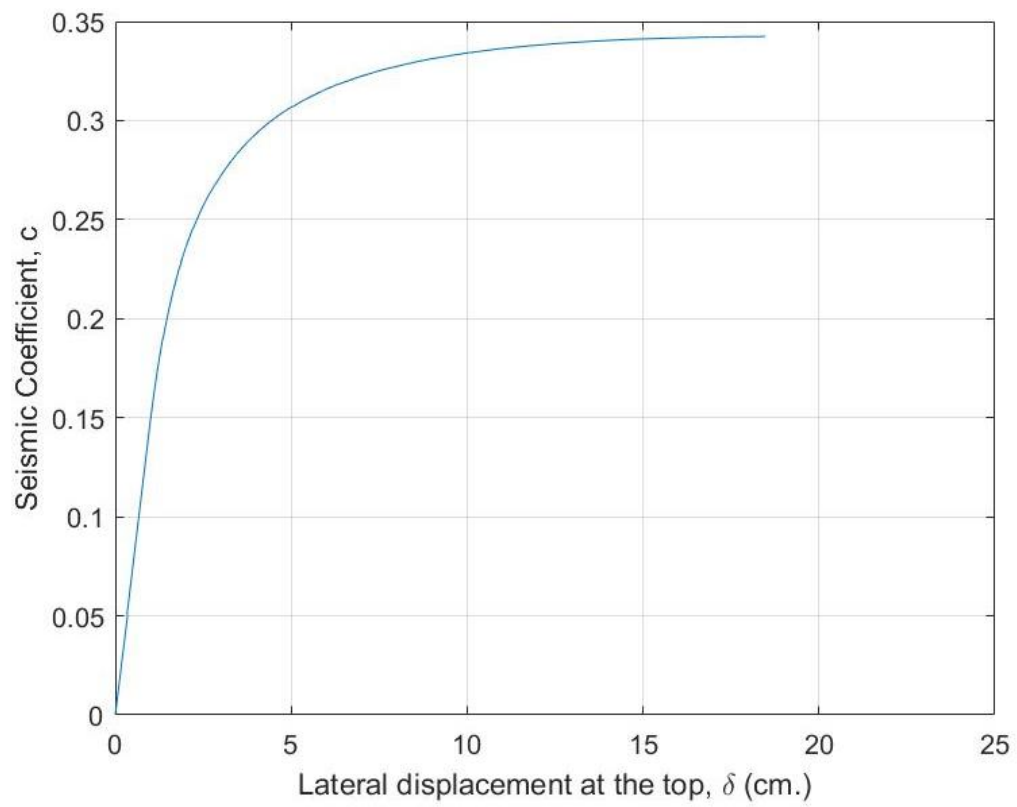
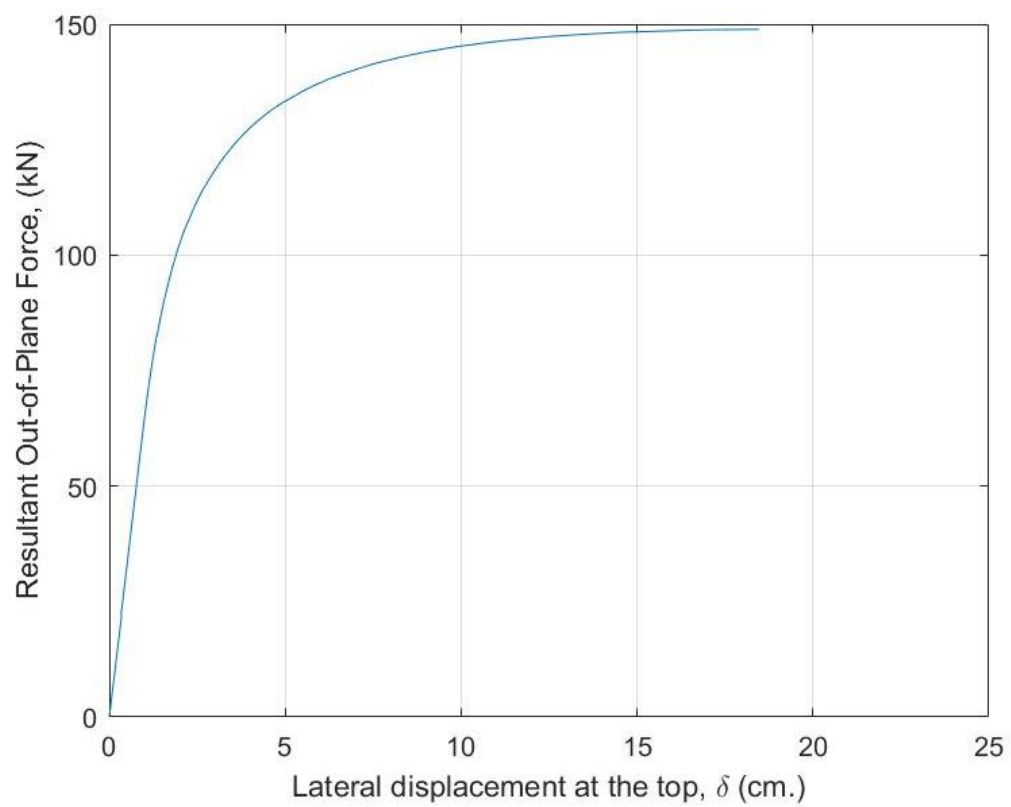
According to the results of analysis (Matlab codes generated to perform analysis can be found in Appendix E4 and E5) and the curves of $c - \delta$ and $F - \delta$ (Figure 33, 34, 35 and 36), the piers stand like a linear-elastic element at first. When the piers meet with the first crack, they behave like a non-linear element until the maximum value of $c_{max_A} = 0.342396$ and $c_{max_B} = 0.20338$. While seismic coefficient has the maximum value, the deflections are $\delta_{max_A} = 18.47 \text{ cm}$ and $\delta_{max_B} = 30.31 \text{ cm}$. The piers reach to their maximum lateral resistance.

Figure 33. The curve of $c - \delta$ for wall portion A.

Figure 34. The curve of $F - \delta$ for wall portion A.

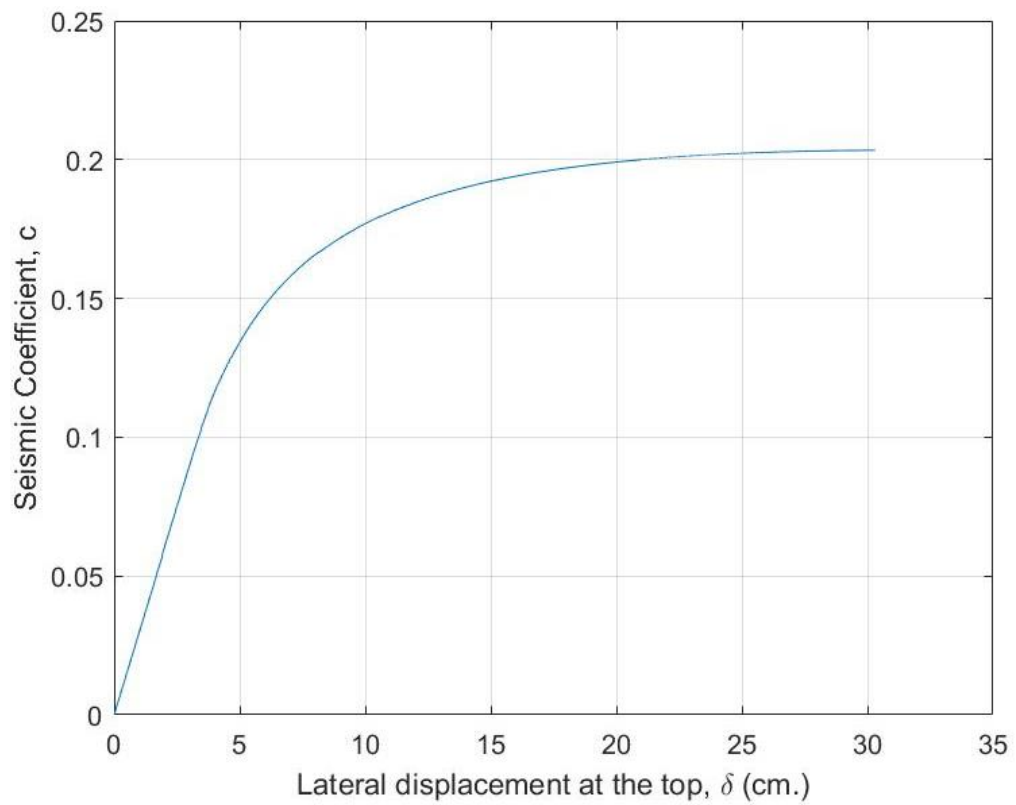
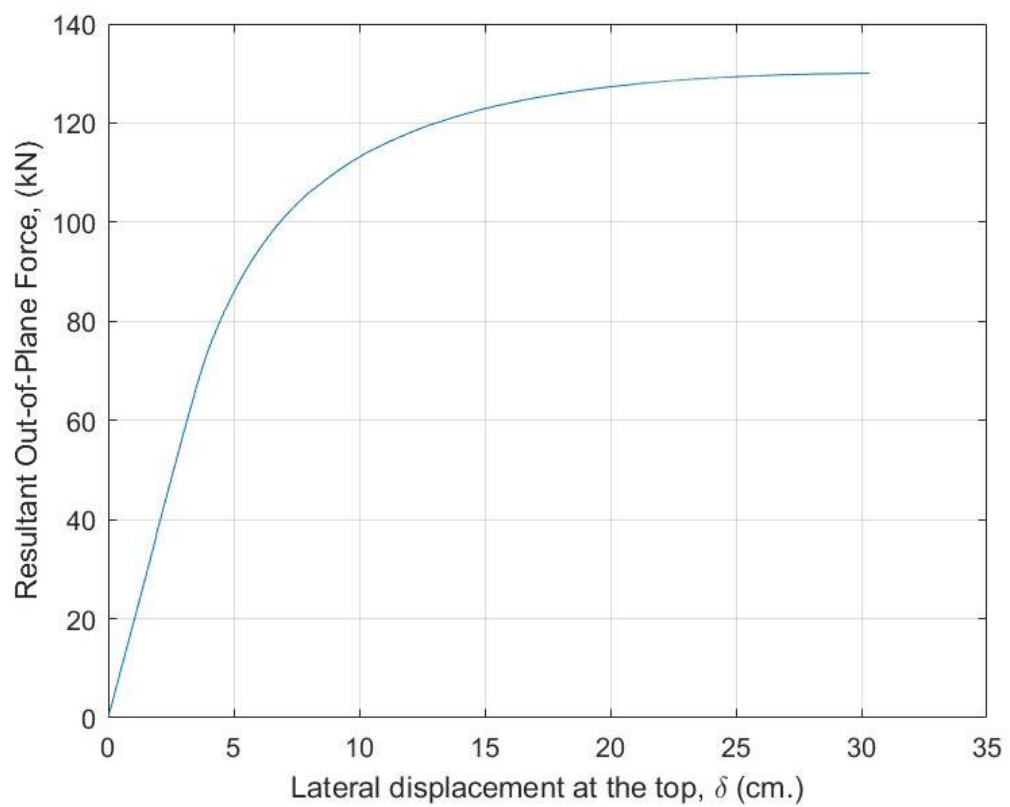
Figure 35. The curve of $c - \delta$ for wall portion B.

Figure 36. The curve of $F - \delta$ for wall portion B.

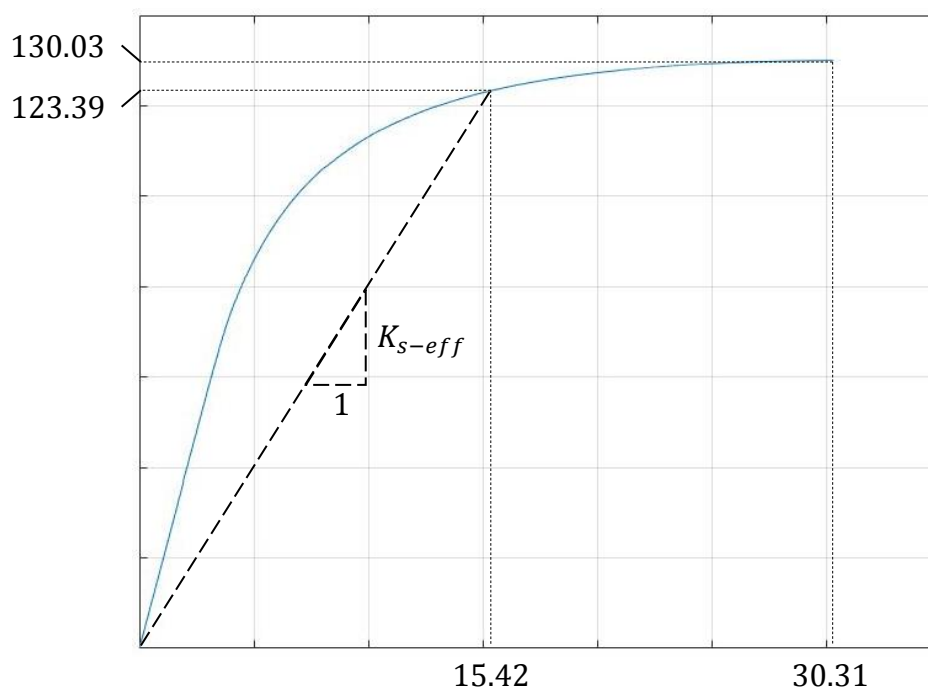
Figure 38. Effective secant stiffness, K_{s-eff} , of substitute structure for wall portion B.

After the calculation of Equation 19 and 20 in order, the effective secant stiffness of the piers are calculated as $K_{s-eff_A} = 1.28$ and $K_{s-eff_B} = 2.17$. The effective natural period of the piers are obtained as $T_{s-eff_A} = 1.28$ s and $T_{s-eff_B} = 2.17$ s.

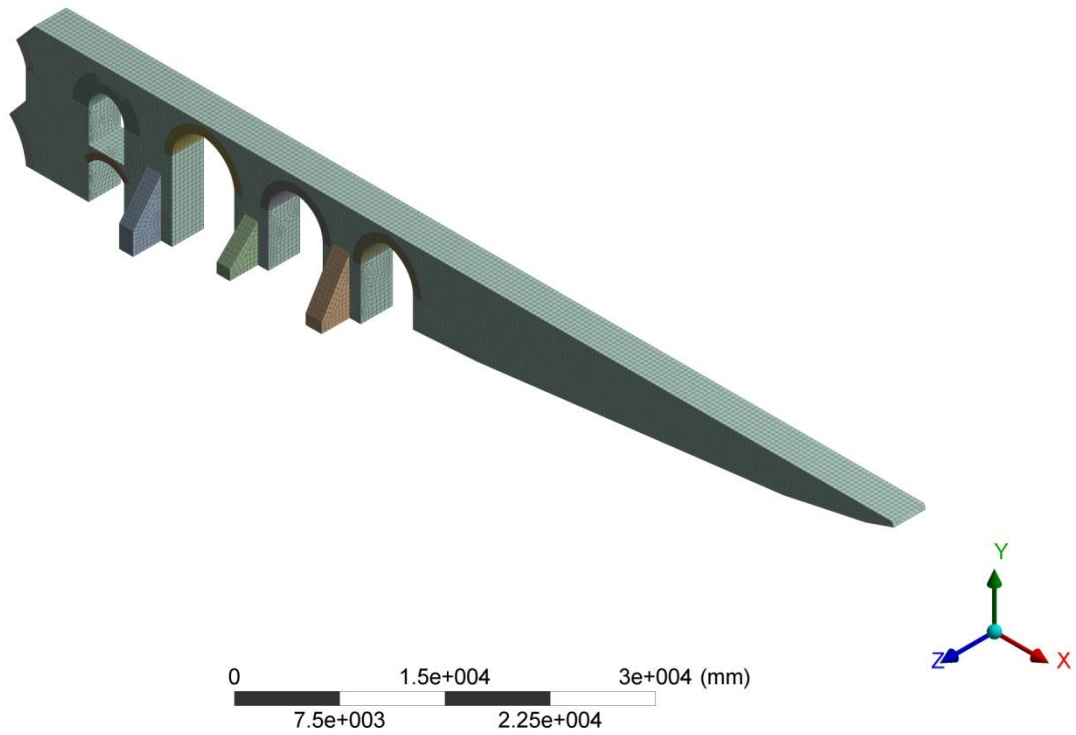
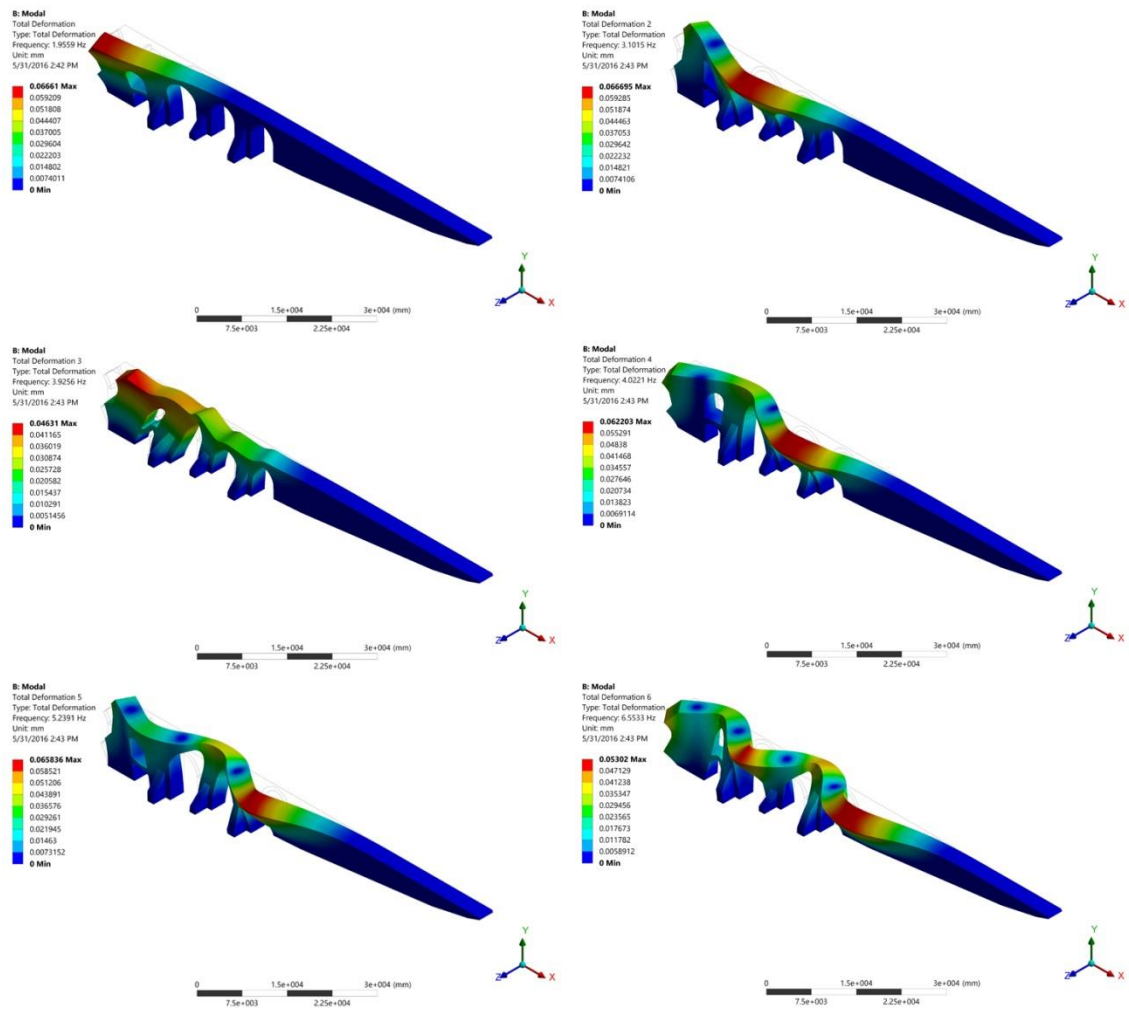
Figure 39. The finite element model of wall portion A.

Wall portion A is modeled with 47355 elements and 176926 nodes. Stone masonry material characteristics are taken from Table 9 which includes the effect of mortar between stones. The finite element model, mode shapes and frequencies of wall portion A are shown below. (Figure 39 and 40, Table 7). The mode shapes are added to Appendix E.

Figure 40. Six mode shapes of wall portion A.

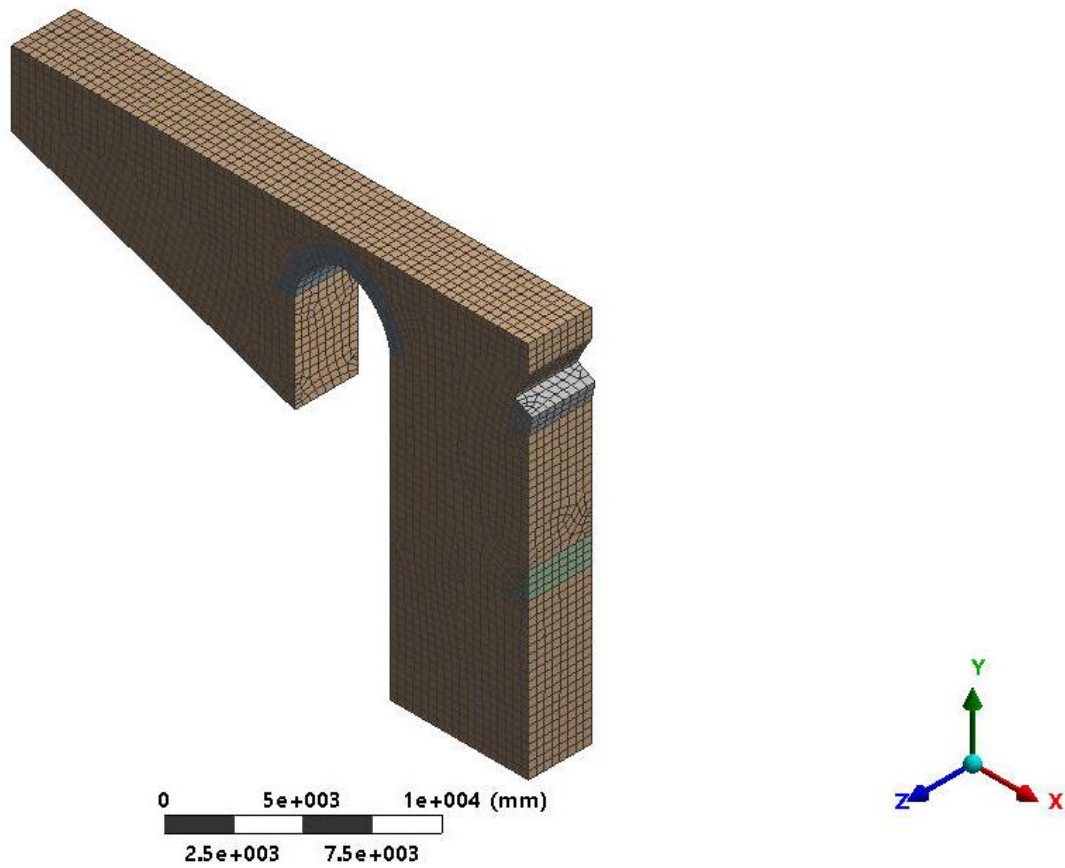
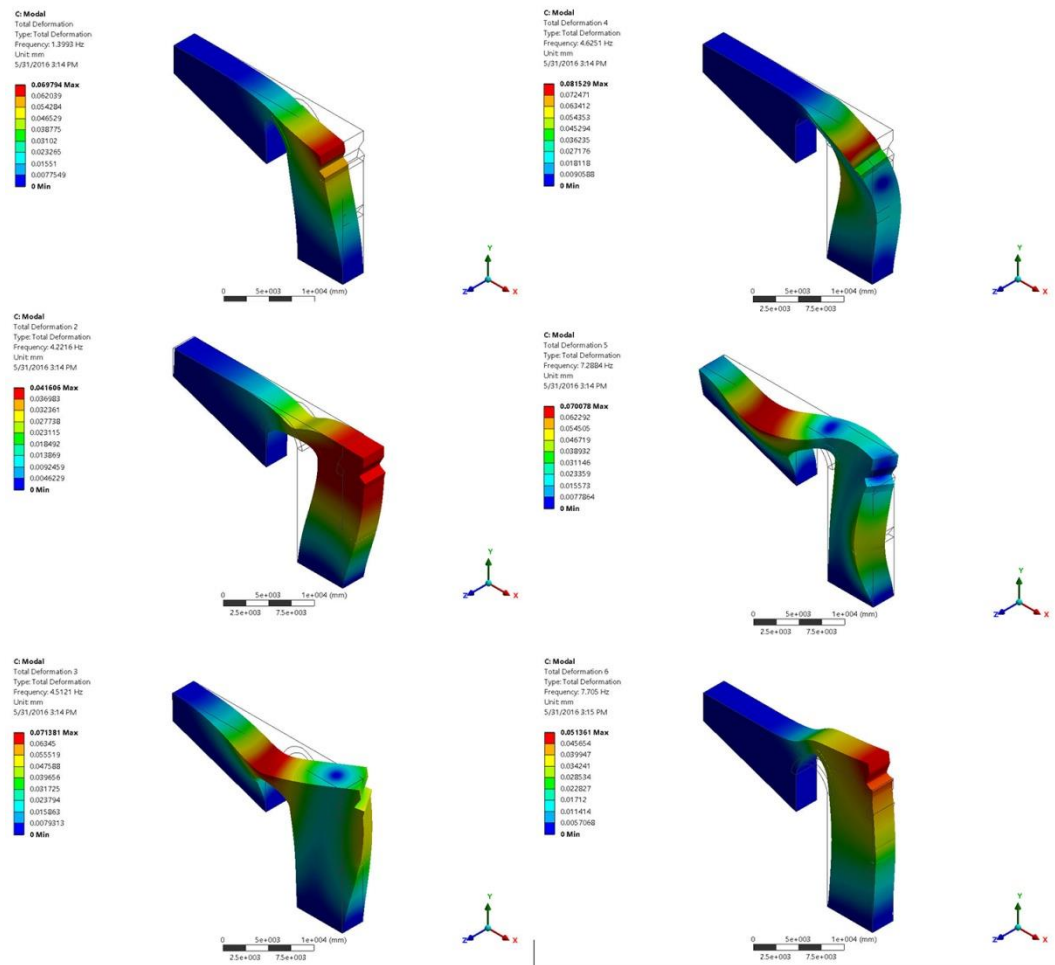
Figure 41. The finite element model of wall portion B.

Wall portion B is modeled with 15512 elements and 64926 nodes. Stone masonry material characteristics are taken from Table 5 which includes the effect of mortar between bricks. The finite element model and frequencies of wall portion B are shown below. (Figure 41 and 42, Table 8).

Figure 42. Six mode shapes of wall portion B.

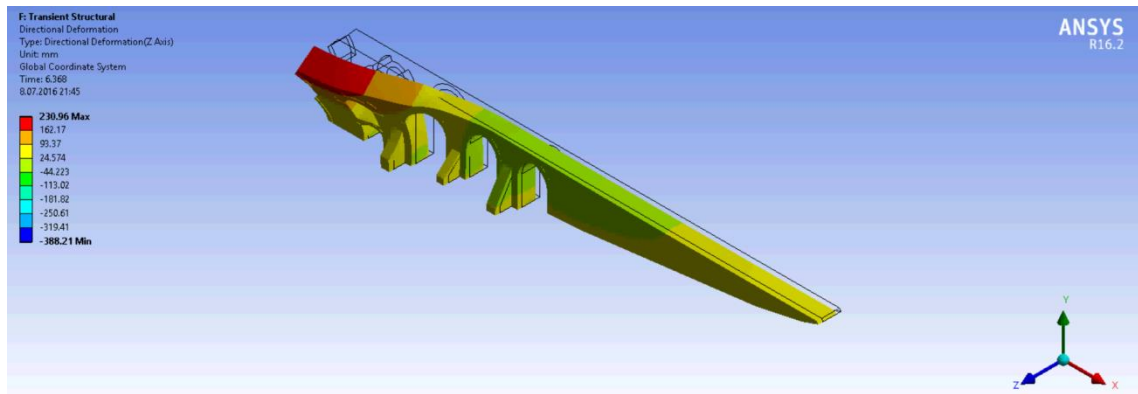
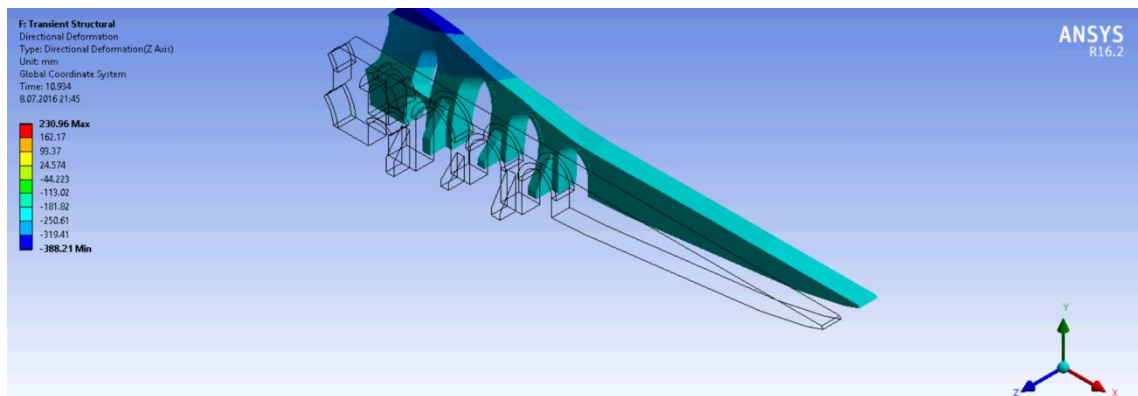
The data of El Centro Earthquake is applied to wall portion A for thirty two seconds. The snapshots of the displacements at different times are show in Figures 44 and 45.

Figure 44. Displacement on plus z direction.

Figure 45. Displacement on minus z direction.

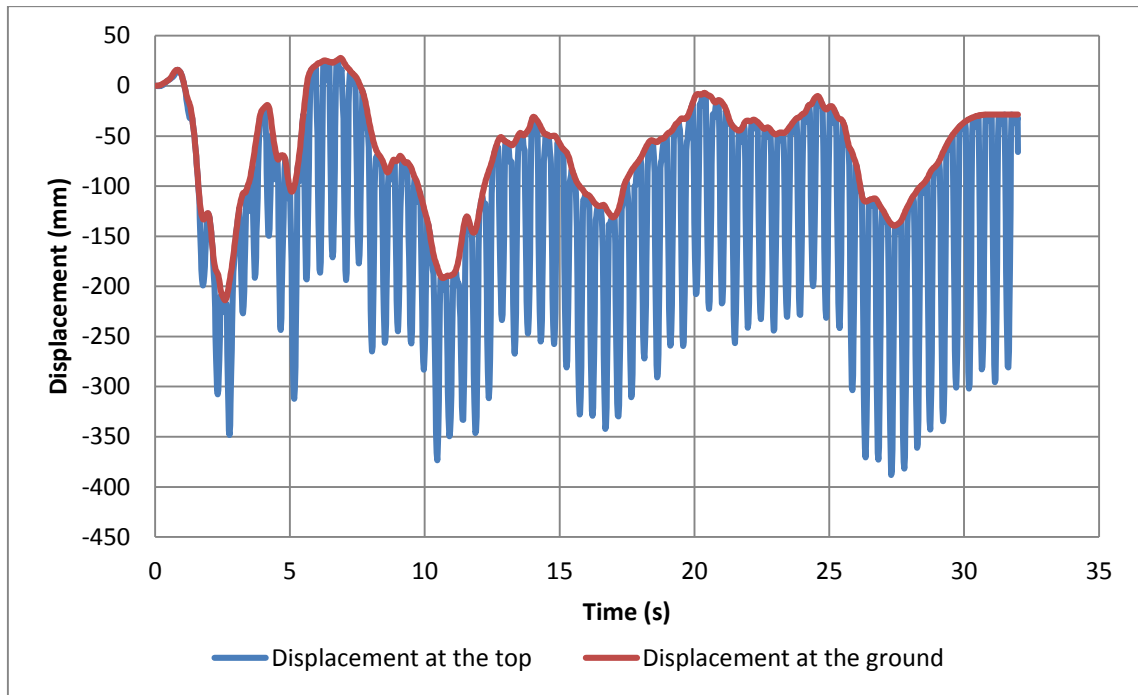
Figure 46. Time-Displacement data at the ground and top for wall portion A.

The maximum displacements are around 213.81 mm at the ground at 2.6 s, 388.21 mm at 27.3 s on plus z direction and 230.96 mm at 6.34 s on minus z direction at the top (Figure 46).

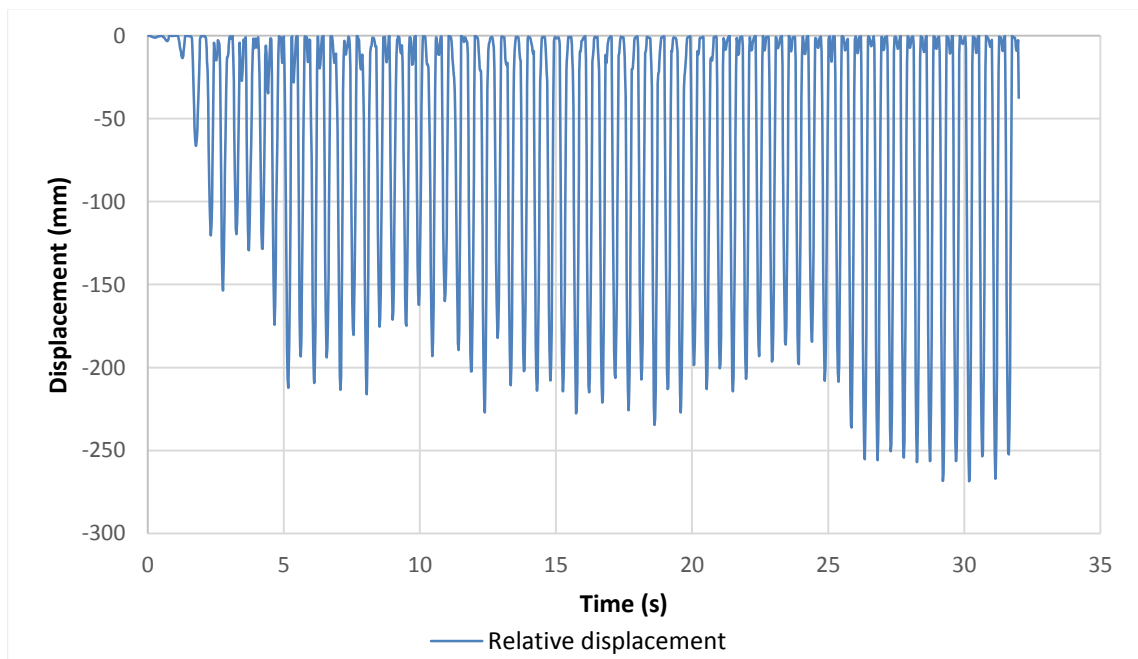
Figure 47. Relative displacement of wall portion A.

The relative displacement defines the difference between top and ground displacements at each second. The maximum relative displacement is 268.55 mm at 30.18 s (Figure 47).

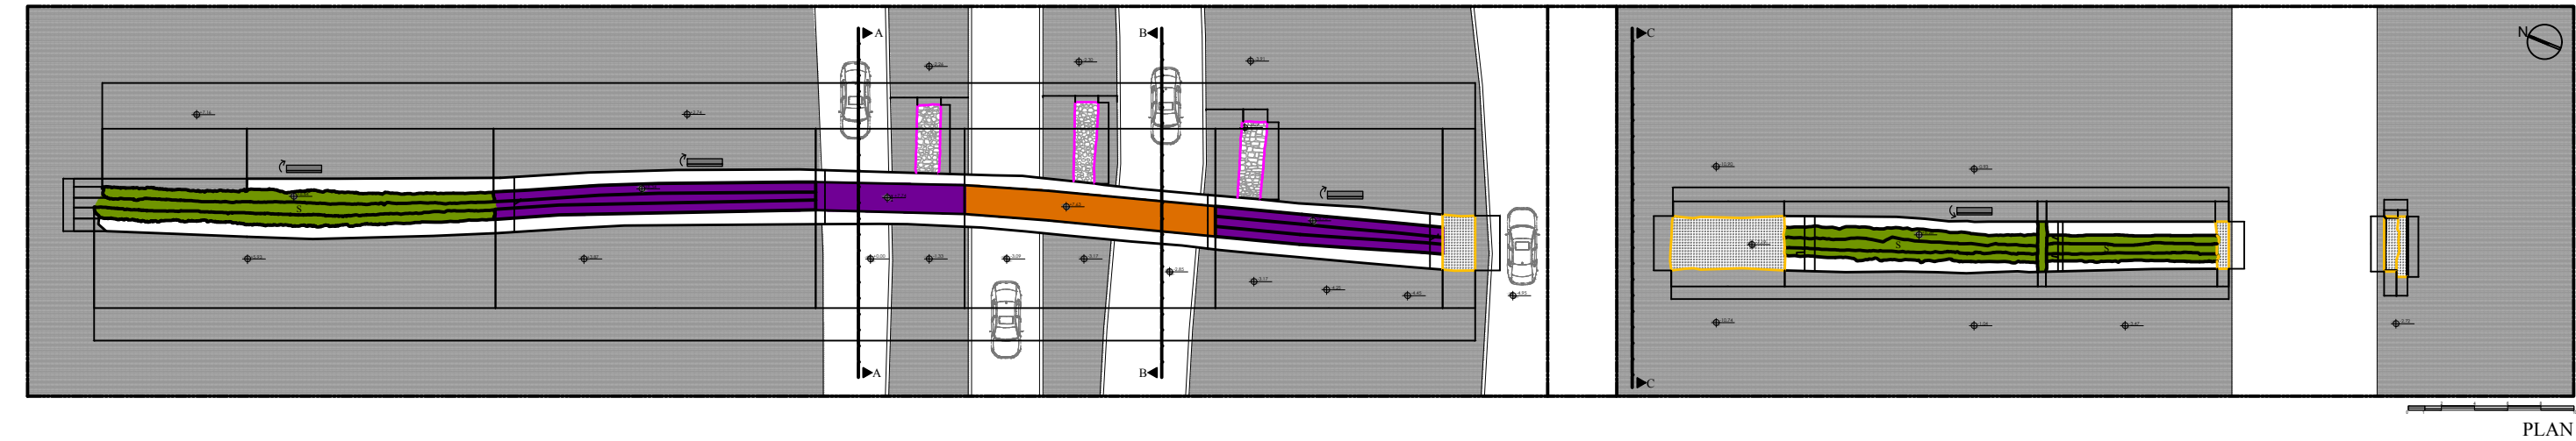
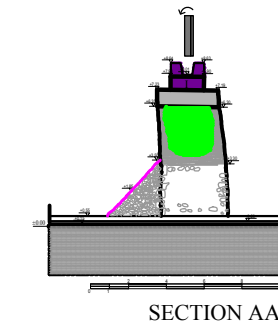
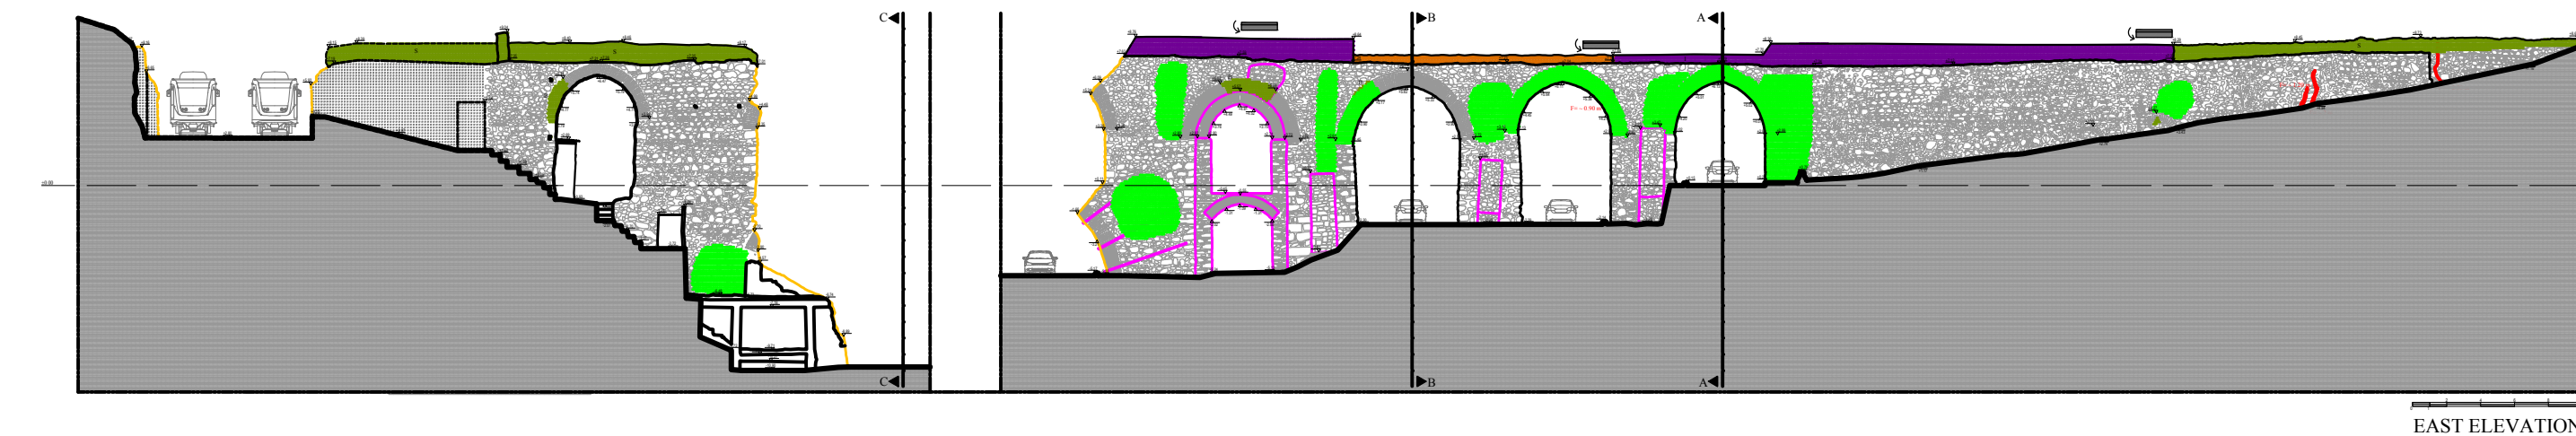
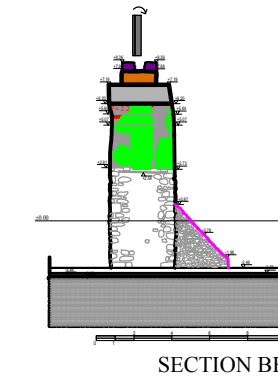
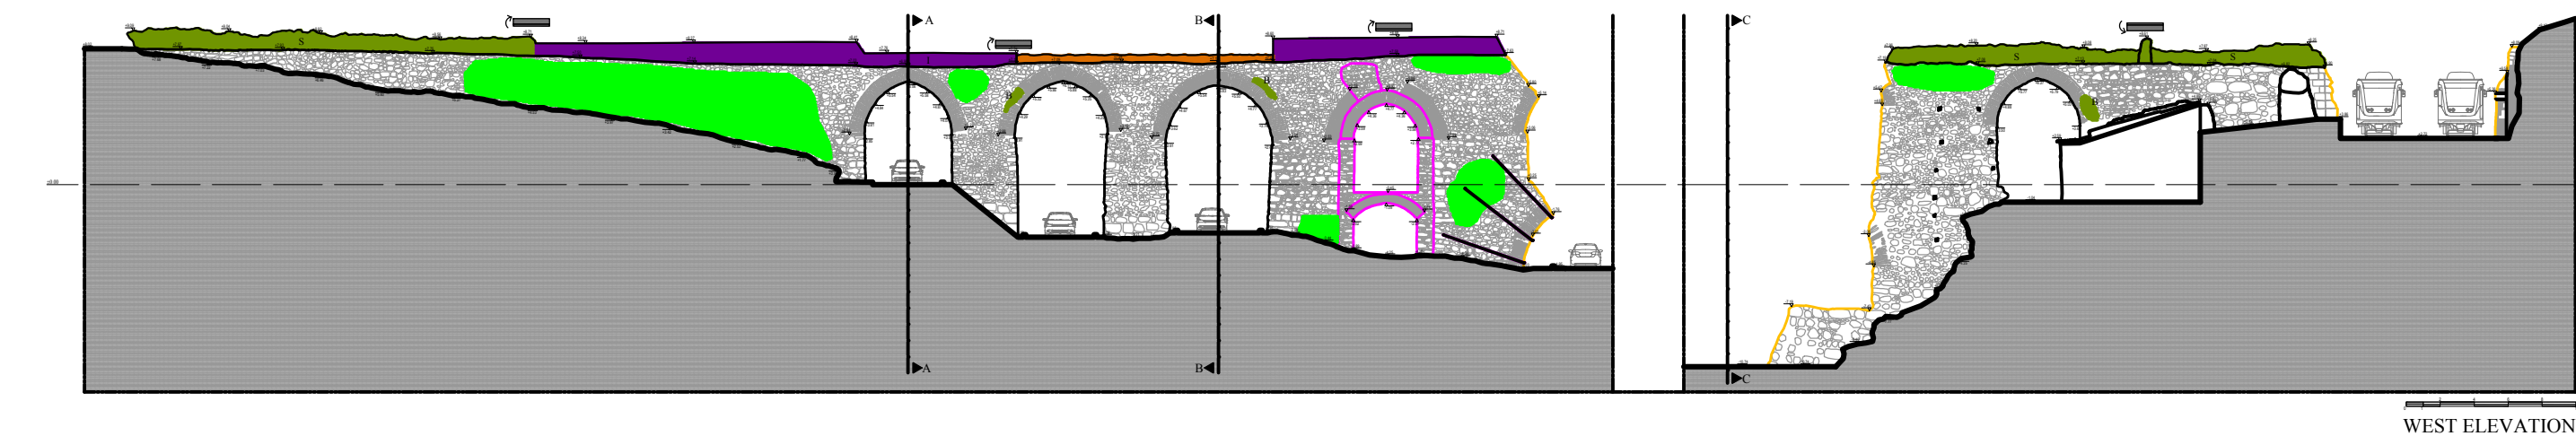
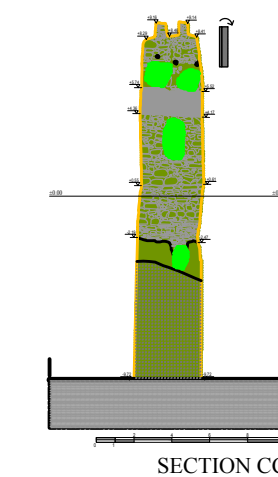
STRUCTURAL FAILURES, MATERIAL DETERIORATIONS AND ALTERATIONS		
STRUCTURAL FAILURES	DEMOLISHMENT Two demolished parts of the stone masonry wall on the main road and on the railway, jeopardizes the stability of the wall and causes loss of structural integrity

FRACTURE Horizontal fractures along arch-wall connections in east-west direction Vertical fractures on the walls continuing from top to bottom Diagonal fractures within the arches

F - Fracture Length
MATERIAL DETERIORATIONS	LOSS OF MATERIALS Loss of brick materials on the arches Loss of stone materials on duct

I - Incomplete
	LOSSES	
	ARCHITECTURAL ELEMENT LOSS Partial loss of stone duct on wall portion A
