**CURRENT CONSERVATION STATE OF SOME
ART NOUVEAU HOUSES AND APARTMENT
BUILDINGS IN ISTANBUL**

**A Thesis Submitted to
the Graduate School of Engineering and Sciences of
İzmir Institute of Technology
in Partial Fulfillment of the Requirements for the Degree of**

in Architectural Restoration

**by
Gizem TÜR KARSLAN**

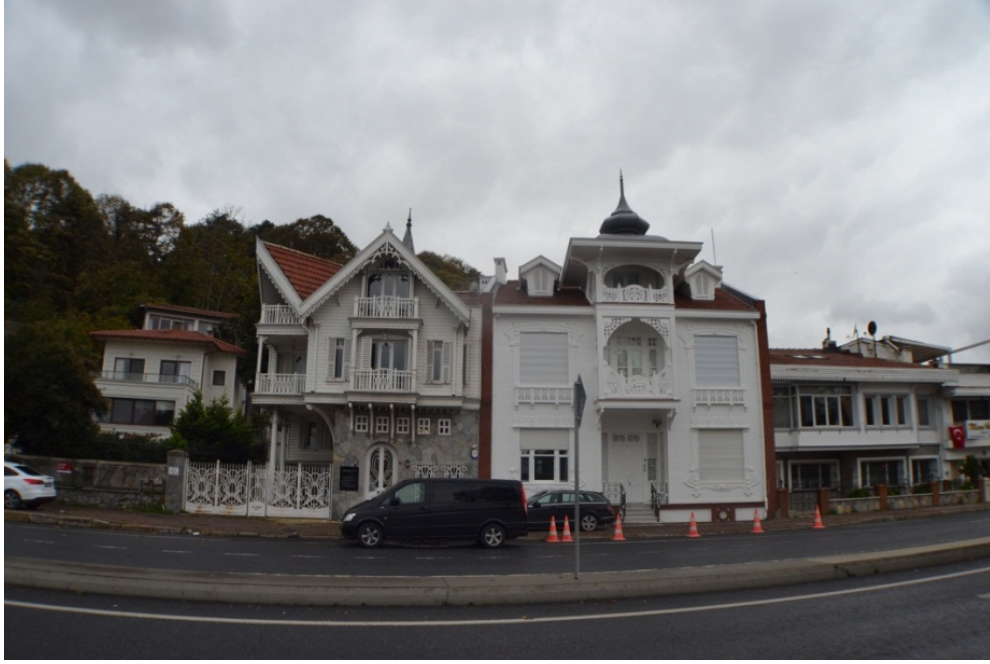
Figure 3.2. Dikranyan *Yalı* and adjoining buildings as viewed from the seaside, 2016.

There are some problems that had occurred through the years in this building and its surroundings. Exterior materials were changed with similar material and this gave way to loss of patina. Along the Kefeliköy Bağlaryolu Street, there are some unqualified mass additions and structures inharmonious with the historical landscape. This caused loss of integrity of the site. The infill parallel to the Bosphorus has reduced the *yalı* characteristics (Appendix J.1.).

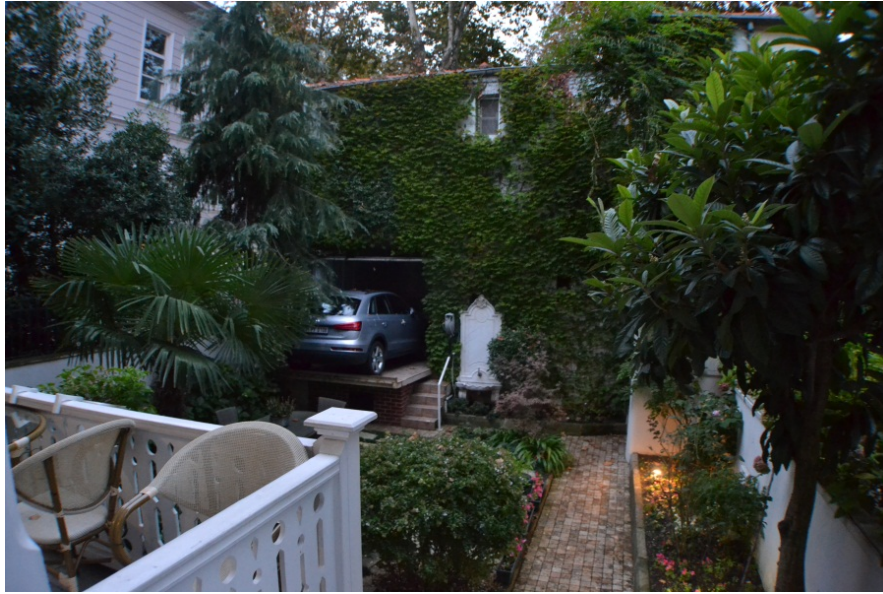
Figure 3.12. The courtyard of Faik Bey *Yalı* and block 316, lot 4 at the left, 2016.

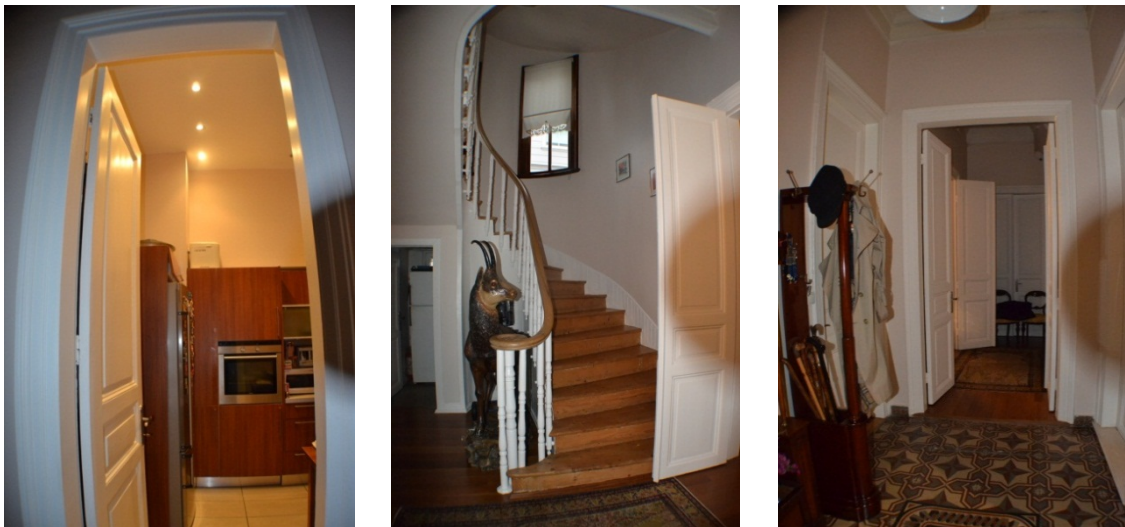
There are several things altered in this building over the years. Just as the other examples, in the buildings, shutters were added to the windows, joinery was renewed. Some shutters are in harmony with the structure, but some of them are green in color. Although there are two symmetrical chimneys in the house, there is another chimney added to the Faik Bey *Yalı* with new materials. At the side facades of the buildings, finishing material is altered with a similar but inharmonious material. Outbuildings were converted into garages and a store. The quay has been used as a balcony. Kitchen floor coverings are changed with the modern ones. Illumination system and cupboards were renewed (Appendix I.2.).

Figure 3.13. Alterations in the kitchen (left), original timber staircase (middle), original floor coverings at the ground floor hall (right), 2016.

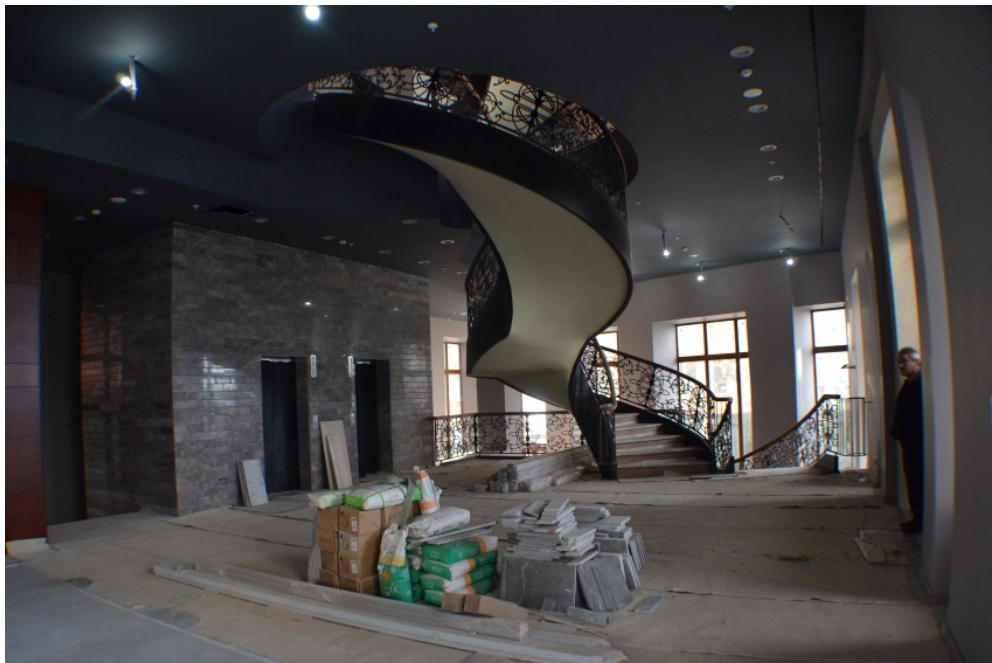
Figure 3.20. The interior of Frej Apartment Building in restoration, 2016.

In 1969 restoration; the interior structural and architectural elements were completely altered. A roof floor was added to the 5 storied structure. Original jack arch floor system was removed (Tanyeli, 2012). Instead, there is reinforced concrete system. Windows were renewed. Deteriorated *Malta* stones at the facades were changed with *Kandira* stones. Original stairs were changed with different types of stairs several times. During the current restoration, a spiral timber staircase with black iron ornamented railings has been added. Ground floor windows were changed with a new timber ones that do not resemble the original ones (Appendix I.3.).

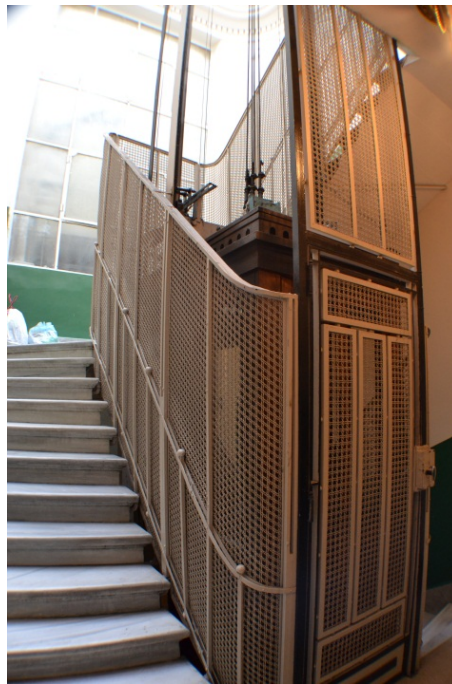
what kind of solution was found and implemented to avoid that problem. In 1939, the building was repaired by the owner, Engineer Yusuf Ziya Demiriz. The concrete balconies were added to the south façade, the heating system and the elevator at the center of the staircase were added. In 1976, materials of the façade started to fall down and repair work was carried out. More detailed repair was carried out in 1994 and all embossments at the façade were renewed and the façade was painted.

Figure 3.27. The elevator and stairs of GümüŖsu Palas, 2016.

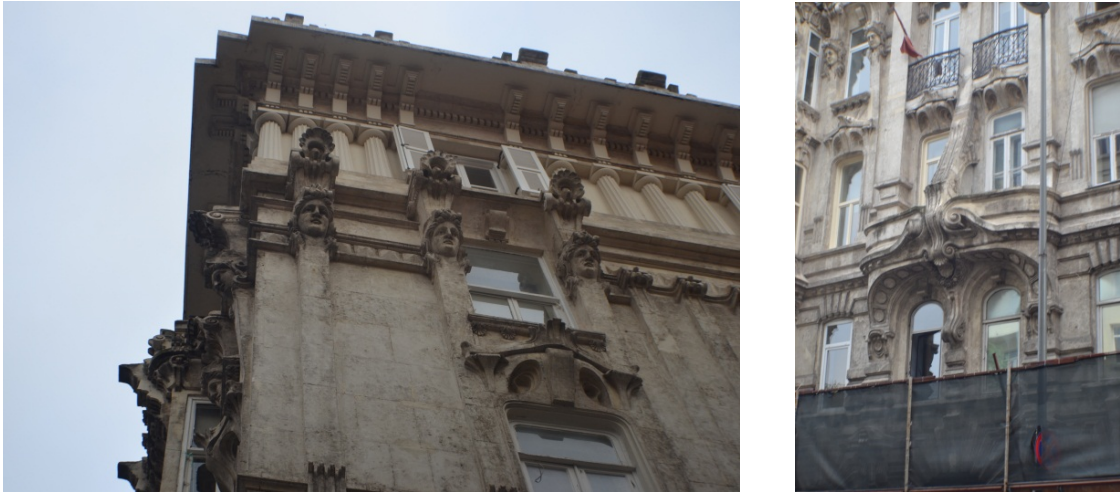
Even though building has experienced several interventions, there is no alteration in façade organization. In 1976, intervention fallen elements and statues were renewed with the copies out of similar material. However, the interiors were altered. Interior walls were removed and created a total space. Residential usage was changed with commercial usage (offices of law firms). In 1939, elevator was added by Yusuf Ziya Demiriz. At the same year, south façade has a new addition, a wide concrete balcony running through all the façade surface (Appendix I.4.).

Figure 3.28. Detail photos of the facade of Gümüşsu Palas, 2016.

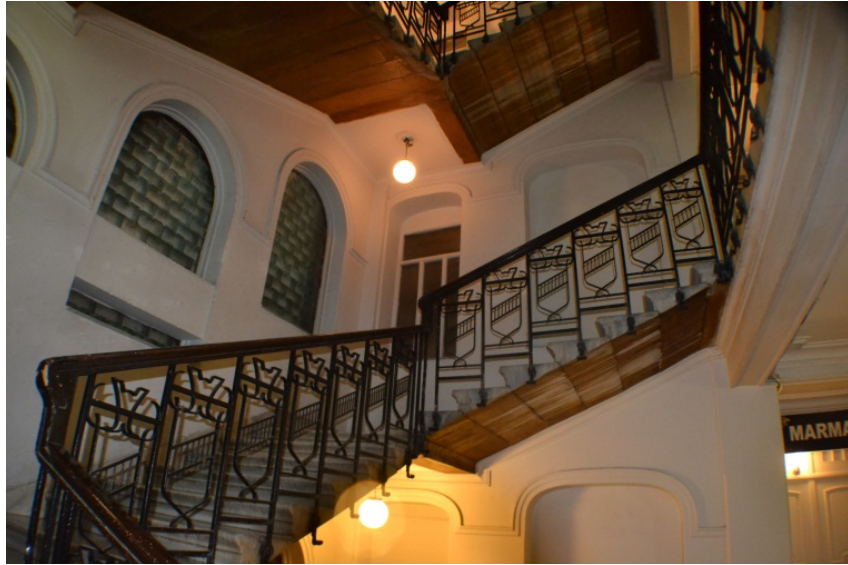
Figure 3.33. The staircase of Mısır Apartment Building, 2016.

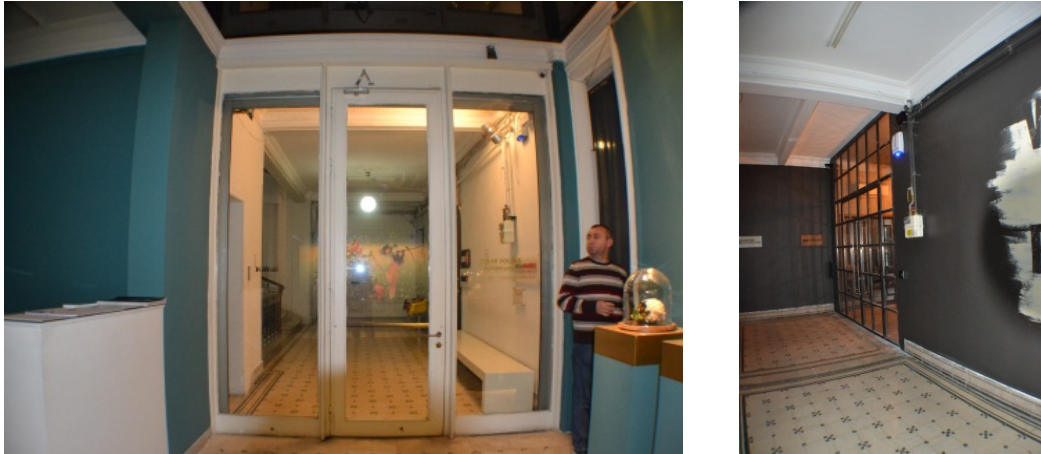
Figure 3.35. Interventions in the circulation spaces of Mısır Apartment Building, 2016.

The function change has given way to alteration of interior organization. . Stone finishing of the façade seems new and ceiling surfaces have been created. The mass addition at the roof is a relatively harmonious intervention since it does not affect the street silhouette (Appendix I.5.).

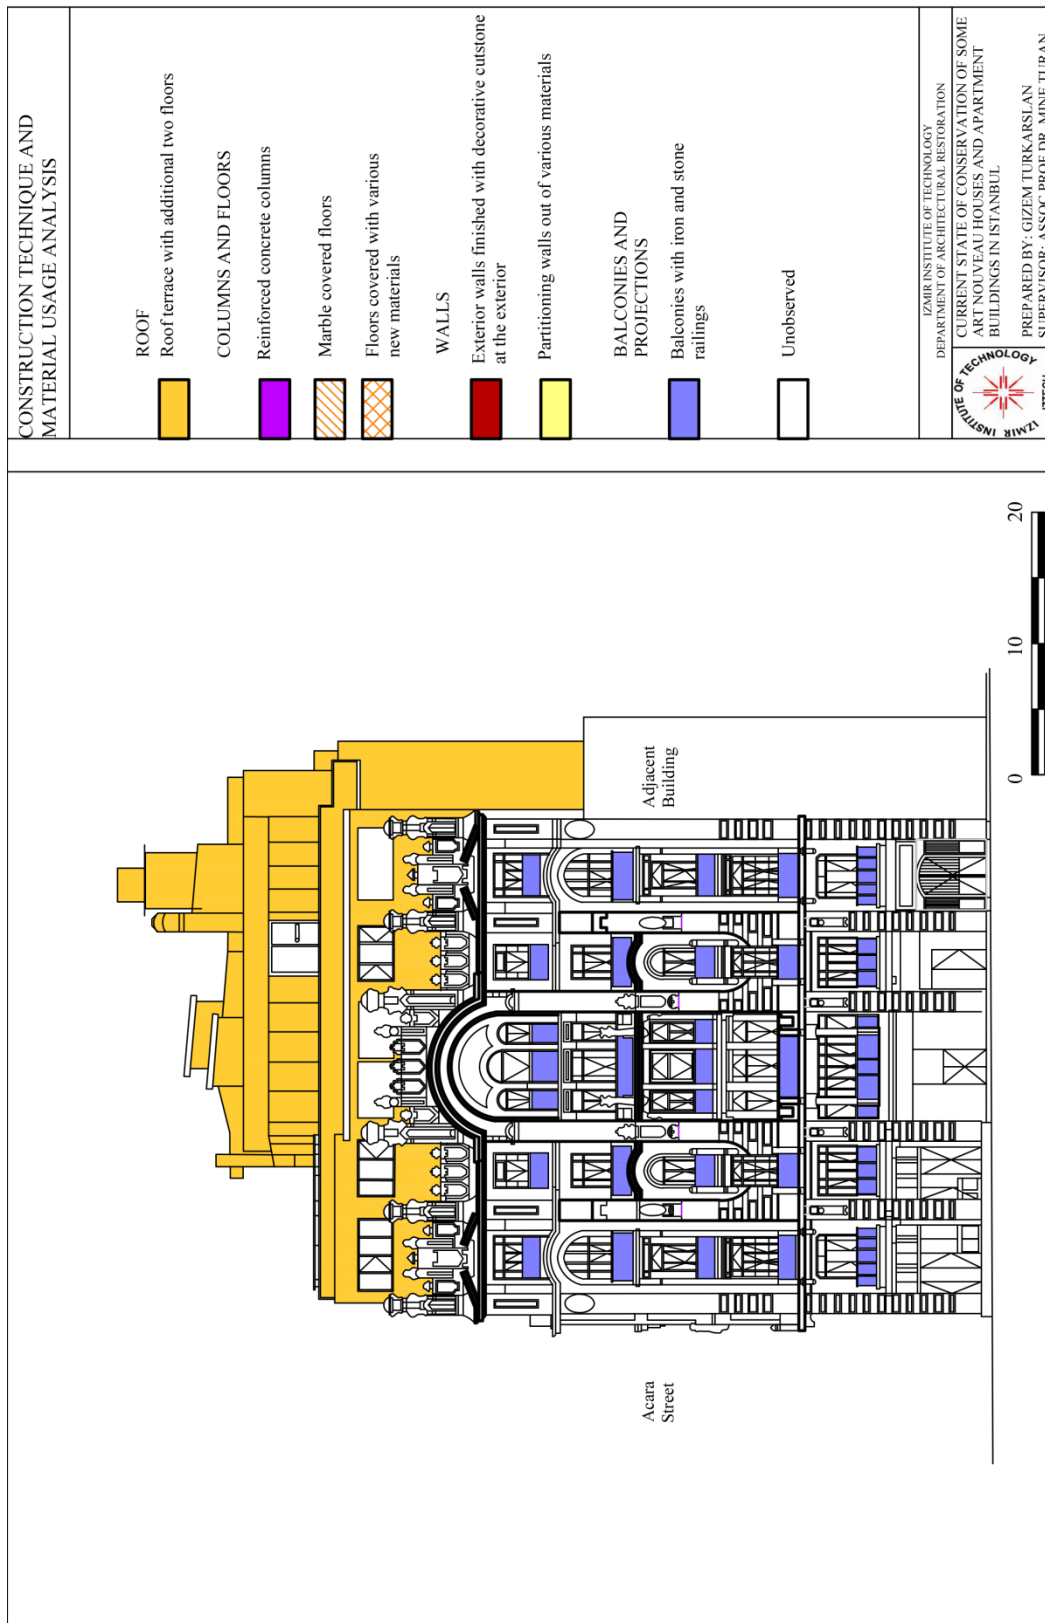
Figure H.5.2. Entrance Façade, Construction Technique and Material Usage Analysis of Misir Apartment Building

The building is supported with a reinforced concrete frame system at present. The mass addition at the terrace is in steel frame system. Blind partitioning walls have been added parallel to the exterior walls to provide necessary vertical boundaries for the present galleries. Decorative cutstone similar to the original is observed at the exterior surfaces of the walls, while the partitioning walls are finished with various new material such as plaster and white wash. The original marble covering is observed at the halls, while the floors of galleries, offices and the restaurant are finished various new materials (Appendix H.5.).

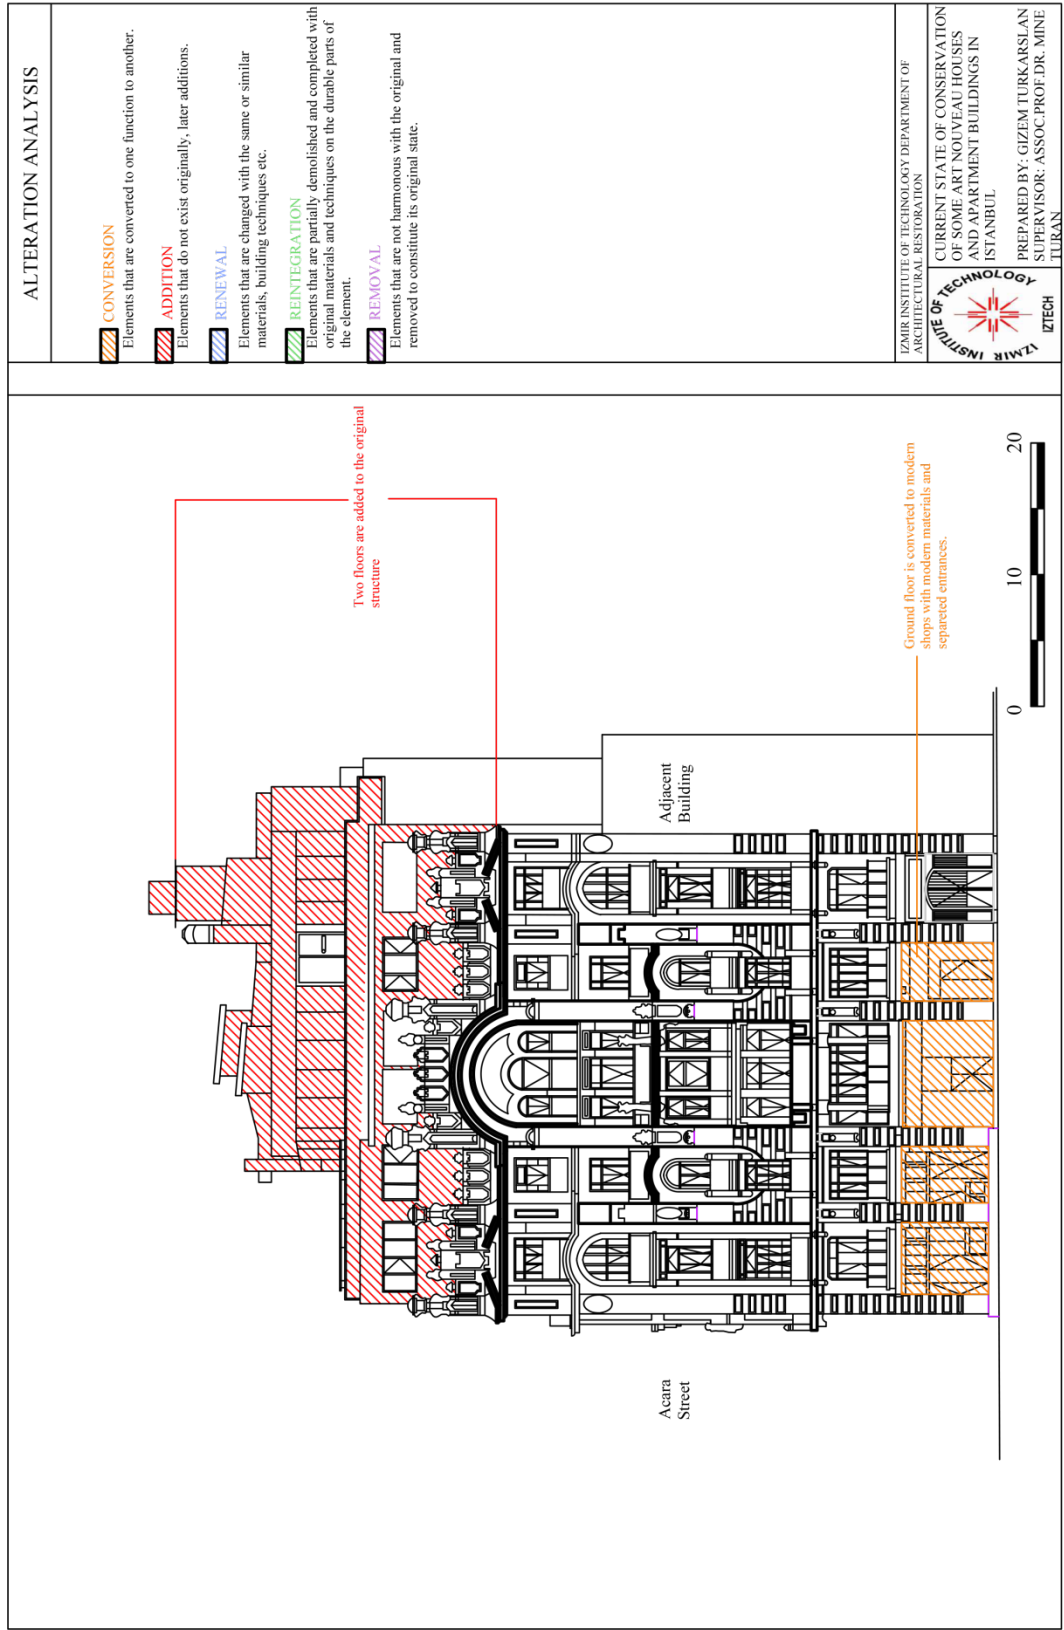
Figure I.5.2. Entrance Façade, Alteration Analysis of Misir Apartment Building

The building contributes to the silhouette of Istiklal Street with its mass characteristics. The additional two stories are inharmonious, but they cannot be easily observed from the street. With its style, it is unique in the close-by environment. The façade order has preserved its authenticity in terms of scale and form, but the material usage and workmanship has been altered. The interior halls with their organization, elements such as stairs, balustrades, windows and floor finishing are authentic. Nevertheless, gallery function dominating the upper stories has given way to radical change in the original apartments. The visual relation of the interior with the surrounding has been hindered. Istanbul panorama can be viewed from the café addition at the roof (Appendix I.5.).
