ASSESSMENT OF İZMİR HALKAPINAR WATER PUMP STATION FOR ITS CONSERVATION AS INDUSTRIAL HERITAGE

A Thesis Submitted to the Graduate School of Engineering and Sciences of İzmir Institute of Technology in Partial Fulfilment of the Requirements for the Degree of

in Architectural Restoration

by İdil Ece ŞENER

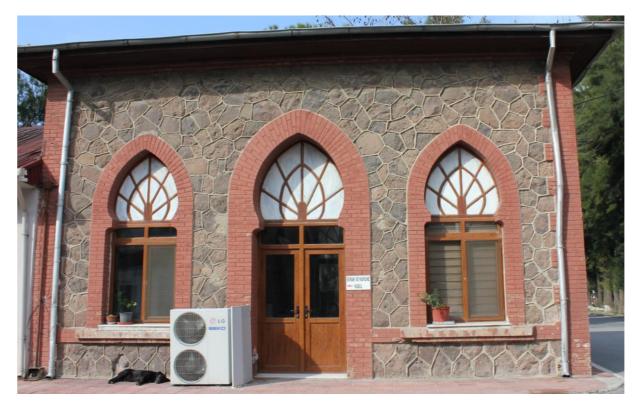
The window openings of the units in the east and west are all original. Windows and brick work frames are pointed extrados and horseshoe profile intrados. Iron bars have been added in facade of the windows of the units in the west in the south facade. The joineries of all windows were replaced with PVC material (Figure 3.46).

Figure 3. 46. Laboratory door and windows

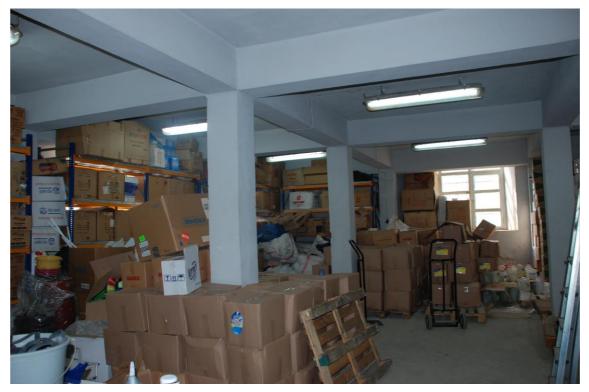
Figure 3. 50. Column beam system and warehouse use added engine room section

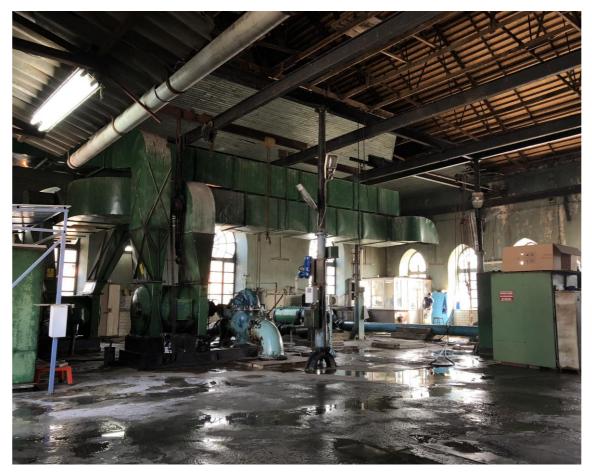
Figure 3. 51. Concrete floor covering of the engine room constructed later

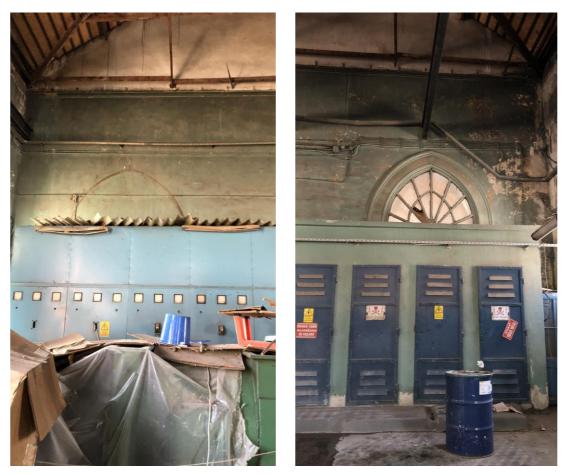
Figure 3. 52. The doors converted into the wall remaining between the two spaces

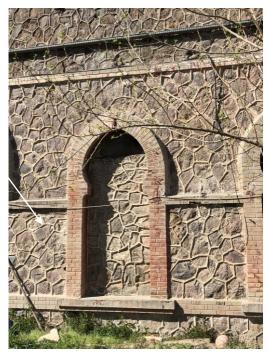
Figure 3. 53. Covered window in the south facade

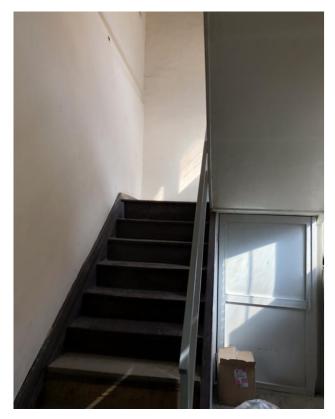
The most important addition in the structure is the unqualified mass addition added later between the two original spaces. In addition to this, mezzanine floor accessed by a steel staircase was added to the original outbuilding structure in the west section. Gutters and window guards in the facades are additions. In the two original spaces, floor, ceiling and wall coverings were added later (Figure 54, Figure 55).

Figure 3. 54. Steel stairs accessing to the mezzanine floor on the outbuilding structure in the west

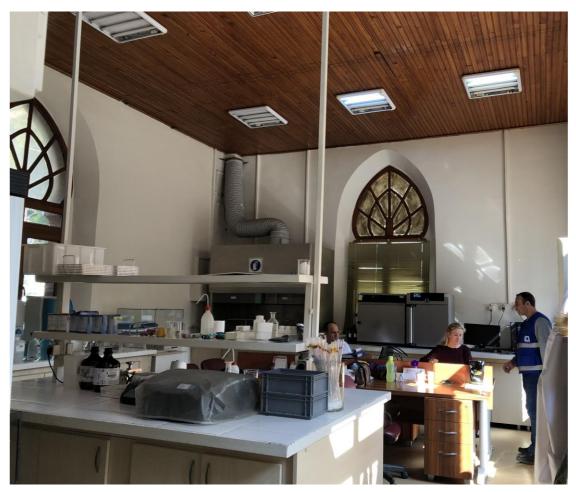
Figure 3. 55. Ceiling covering and wall paint of the outbuilding structure in the east

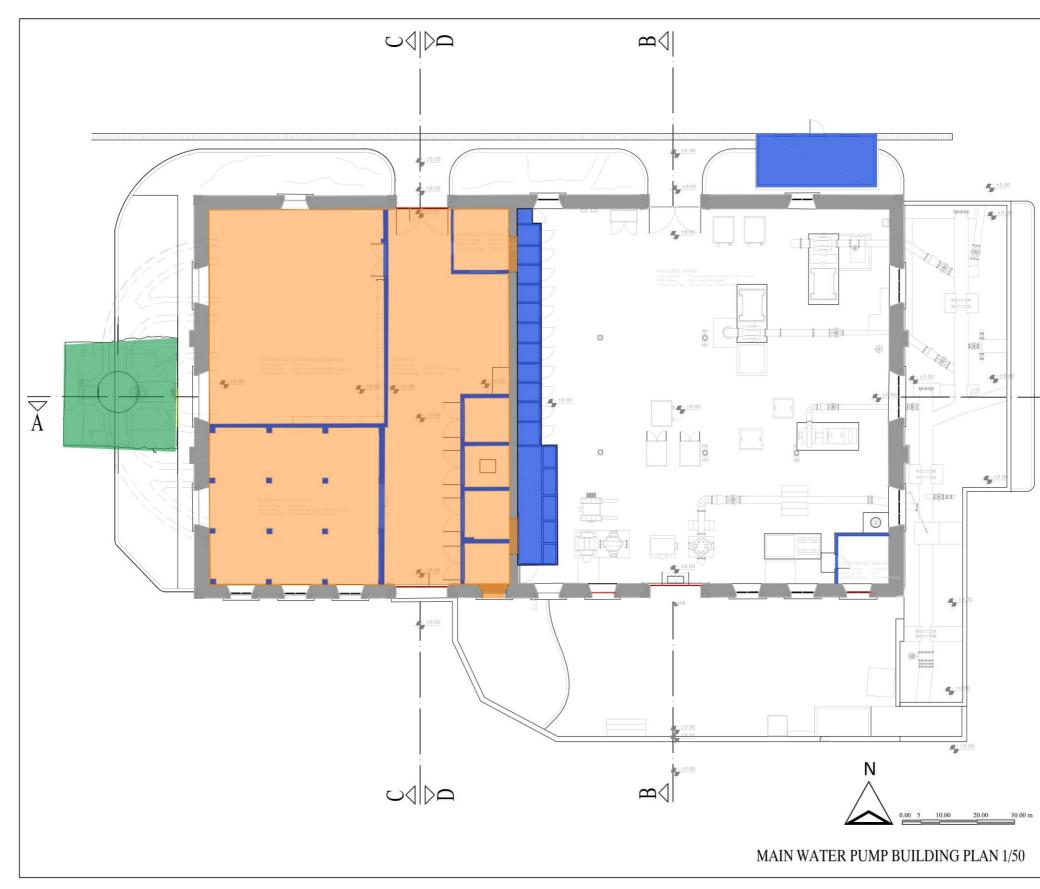
Figure C.4.1. Alterations – Plans redrawn from Semra Emek (Asmira Mimarlık-Restorasyon), İzmir Halkapınar Tarihi Pompa Binası Röleve, Restitüsyon, Restorasyon Projesi, 2012

ANALYSIS	
	ALTERATION	
1.ADDITIONS	PROBABLE CAUSES	S EVIDENCES
1.1. BUILDING ELEM	ENTS	
Partition wall	Improper rearrang	
Reinforced concrete		
Door Transformer	Improper rearrang Improper rearrang	
Window bars	Improper rearrang	
Rain Gutter	Improper rearrang	
Metal chimney	Improper rearrang	ement Location, Mater

1.2. Floor Covering Concrete floor cove	ring Improper repair	Material
1.3. Ceiling Covering		Material
Plywood ceiling cov 1.4. Wall covering		gement Material Material
Plaster 1.5. Roof	Improper repair	Materiai

2. CONVERSION 2.1.Space Function Conversions	ig of roof Improper repair IS	Material
Conversion- of or boilers room to st 2.2. Architectural El Conversions	orage	gement Material
Conversion of do a wall by bonding		gement Material
Conversion of wir opening to a wall		gement Material

3.REMOVAL		T
Chimney	Improper rearrang	and a second sec
Technical eqiupm boiler room	ent of Improper rearrang	gement Material
4.REPLACEMEN	ITS	
Door- window join	eries Improper rearrang	gement Material
	IZMIR INSTITUTE OF DUATE SCHOOL OF ENGI LASTER THESIS IN ARCHITE	NEERING AND SCIENC
	DUATE SCHOOL OF ENGI ASTER THESIS IN ARCHITE HALKAPINAR WATER	R PUMP STATION

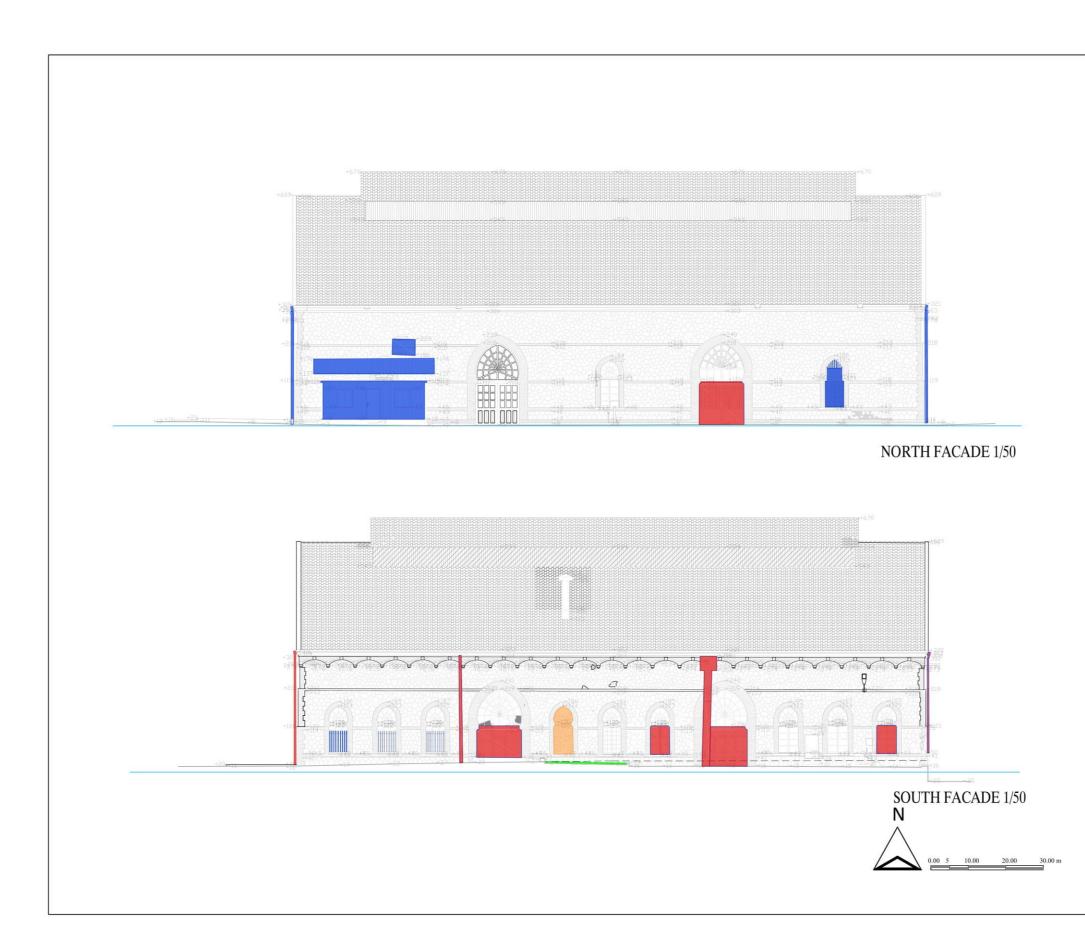
Figure C.4.5. Alterations – Elevations redrawn from Semra Emek (Asmira Mimarlık-Restorasyon), İzmir Halkapınar Tarihi Pompa Binası Röleve, Restitüsyon, Restorasyon Projesi, 2012

A	PINAR WATER PUMP IS INDUSTRIAL HERIT INALYSIS TERATION	
	AL	TERATION	
1.ADDITIONS 1.1. BUILDING ELER		ROBABLE CAUSES	EVIDENCE
Partition wall	IEN IS	Improper rearrangement	Material
Reinforced concre	te column	Improper rearrangement	Material
Door		Improper rearrangement	
Transformer Window bars		Improper rearrangement Improper rearrangement	
Rain Gutter		Improper rearrangement	
Metal chimney		Improper rearrangement

1.2. Floor Covering Concrete floor cov	erina	Improper repair	Material
1.3. Ceiling Covering			Material
Plywood ceiling co 1.4. Wall covering	wenng	Improper rearrangement	Material
Plaster 1.5. Roof

Sheet metal cover lantern 2. CONVERSIO 2.1.Space Functio Conversions	NS	Improper repair	Material
Conversion- of o boilers room to s 2.2. Architectural I Conversions	storage Elements	Improper rearrangement	Material
Conversion of d a wall by bondin		Improper rearrangement	Material
Conversion of w opening to a wa		Improper rearrangement	Material

3.REMOVAL			
Chimney		Improper rearrangement	Traces
Technical eqiup boiler room	ment of	Improper rearrangement	Material
4.REPLACEME Door- window jo		Improper rearrangement	Material
CERECH 250 BLOCK: 1460	ADUATE SCH MASTER THE HA REGISTIRAT DATE:	INSTITUTE OF TECHI HOOL OF ENGINEERI SIS IN ARCHITECTUR IN IZMIR TON DECISION: TON DECISION:	NG AND SC AL RESTOR

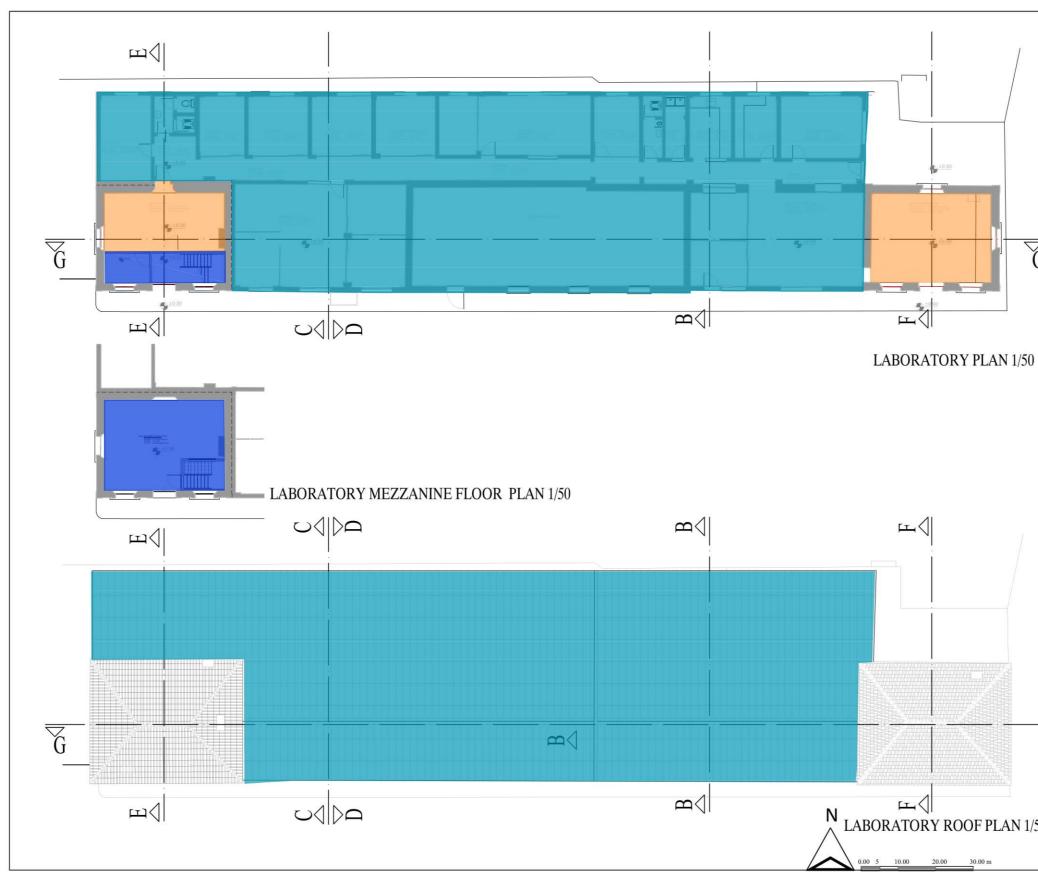
Figure C.4.7. Alterations – Outbuilding Plans redrawn from Semra Emek (Asmira Mimarlık-Restorasyon), İzmir Halkapınar Tarihi Pompa Binası Röleve, Restitüsyon, Restorasyon Projesi, 2012

ANALYSIS ALTERATION	
	PROBABLE CAUSES	S EVIDENCES
1.ADDITIONS 1.1. MASS ADD	ITIONS	
Rooms Half storey 1.2. BUILDING	Improper rearrangem Improper rearrangem	
Partition walls	Improper rearrangem	ent Material
Stair Rain Gutter	Improper rearrangem	ent Material
Window bar	Improper rearrangem Improper rearrangem

1.3. Floor Cover PVC floor cove 1.4. Ceiling Cov	r Improper repair	Material
Wood ceiling o False ceiling	overing Improper repair Improper repair	Material Material

1.5. Wall Coveri Paint	ing Improper repair	Material
2. CONVER 2.1.Space Function	1	
Conversions Service spaces office rooms	Improper rearrangem turn into	ent

2.2. Architectural E Conversions		
Conversion of o opening to a do		nent Material, Size
Conversion of t fireplace to a w	he Improper rearrangem	nent Material

3.REMOVAI	all	
West wall and fireplace of eas place		nent Traces
4.REPLACE Door- window ju	moroper rearrangem	nent Material
Dool window j		
	GRADUATE SCHOOL OF E	e of Technology Ingineering and Sciences Chitectural Restoration

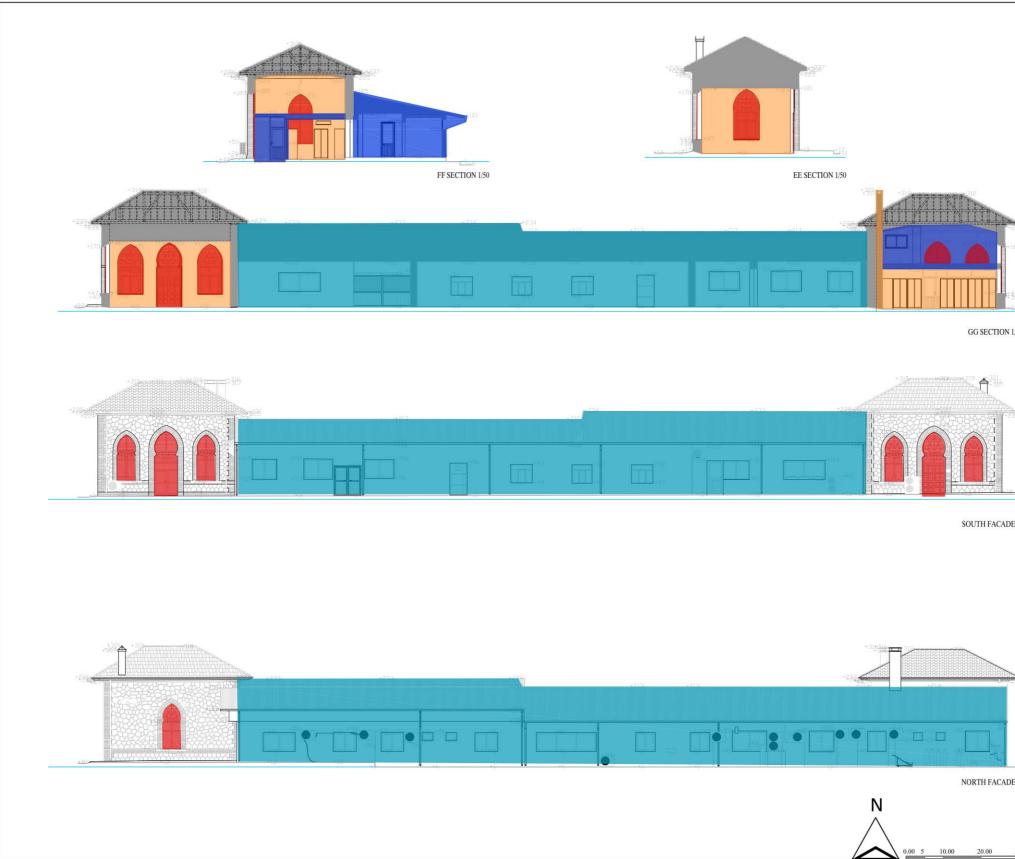
Figure C.4.8. Alterations – Outbuilding Elevations & Sections redrawn from Semra Emek (Asmira Mimarlık-Restorasyon), İzmir Halkapınar Tarihi Pompa Binası Röleve, Restitüsyon, Restorasyon Projesi, 2012

CONSER	VATION AS INDUSTRIAL	HERITAGE
		ANALYSIS	
		PROBABLE CAUSES	EVIDENCES
	1.ADDITIONS 1.1. MASS ADDITIONS	2	
	Rooms Half storey 1.2. BUILDING ELEMEN	Improper rearrangement Improper rearrangement ITS	Form, Construction techniqu Form, Construction techniqu
	Partition walls Stair	Improper rearrangement Improper rearrangement	Material Material
	Rain Gutter Window bar	Improper rearrangement Improper rearrangement	Material Material

1.3. Floor Covering PVC floor cover 1.4. Ceiling Covering	Improper repair	Material
	Wood ceiling covering False ceiling	Improper repair Improper repair	Material Material

1.5. Wall Covering Paint	Improper repair	Material
	2. CONVERSIONS 2.1.Space Function		
\$ 696	Conversions Service spaces turn into	Improper rearrangement	
	office rooms 2.2. Architectural Elements Conversions		
	Conversion of original w opening to a door partly		Material, Size
	Conversion of the fireplace to a wall	Improper rearrangement	Material
-£	3.REMOVALS West wall and west fireplace of east service	Improper rearrangement	Traces
0	place 4.REPLACEMENT	s	Material
0	Door- window joineries	Improper rearrangement	Matenai
181			
1/50			
1677			
25			
	STUTE OF AS	IZMIR INSTITUTE OF	TECHNOLOCY
	🦉 🔰 🦉 GRAD	UATE SCHOOL OF ENGI	NEERING AND SCIENCES
1/50		HALKAPINAR WATE IN IZI	
	BLOCK: 1460	REGISTIRATION DECISION: DATE: 30 JANURARY 2	
	LOT: 8 FIELD SURVEY DATE:	NO: 9731 PREPARED BY: SU	PERVISOR:
			OF DR BASAK IPEKOČU
