**INVESTIGATION OF THE EFFECT OF
STRUCTURAL GRID DISCONTINUITY ON THE
EARTHQUAKE BEHAVIOR OF MIDRISE RC
MOMENT FRAMES**

**A Thesis Submitted to
the Graduate School of Engineering and Sciences of
İzmir Institute of Technology
in Partial Fulfillment of the Requirements for the Degree of**

in Civil Engineering

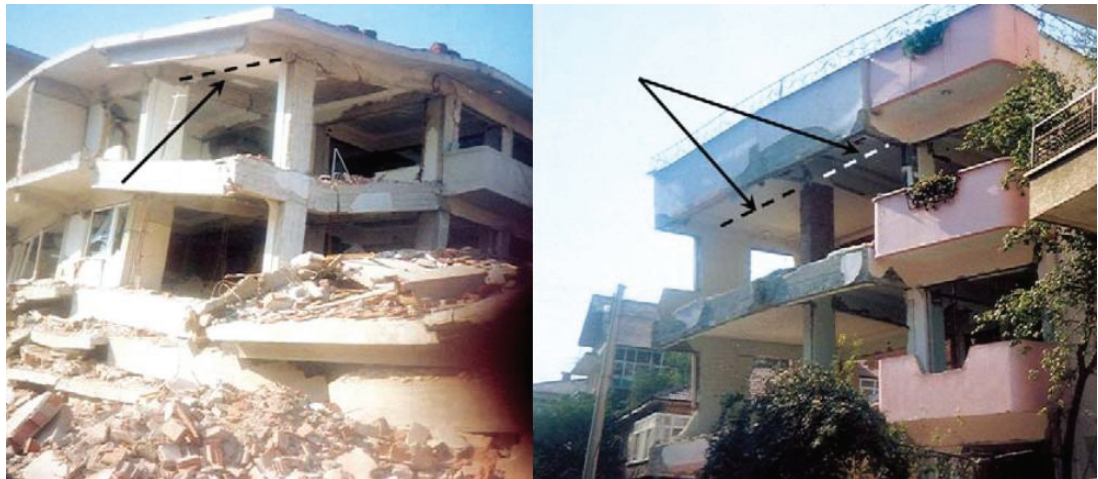
Figure 1.2. Damages related to frame discontinuity
(Source: Bal & Ozdemir, 2006)

Bal and Ozdemir (2006) investigated the behavior of reinforced concrete frames which have frame discontinuities along the perimeter frames. This perimeter frame discontinuity is caused by architectural concerns and constitutes slab bands instead of beams (Figure 1.1). Structural damages related to frame discontinuities are seen in Figure 1.2. For this study, 12 buildings which were designed in accordance with 1975 and 1997 Turkish Earthquake Regulation were chosen and seismic analyses were conducted for 5 different conditions. It is reported that nearly 40% reduction on ultimate strength of existing structures has been observed due to the perimeter frame discontinuity. The authors stated that beam discontinuity issue and column-slab connections control has to be considered in the earthquake specifications.

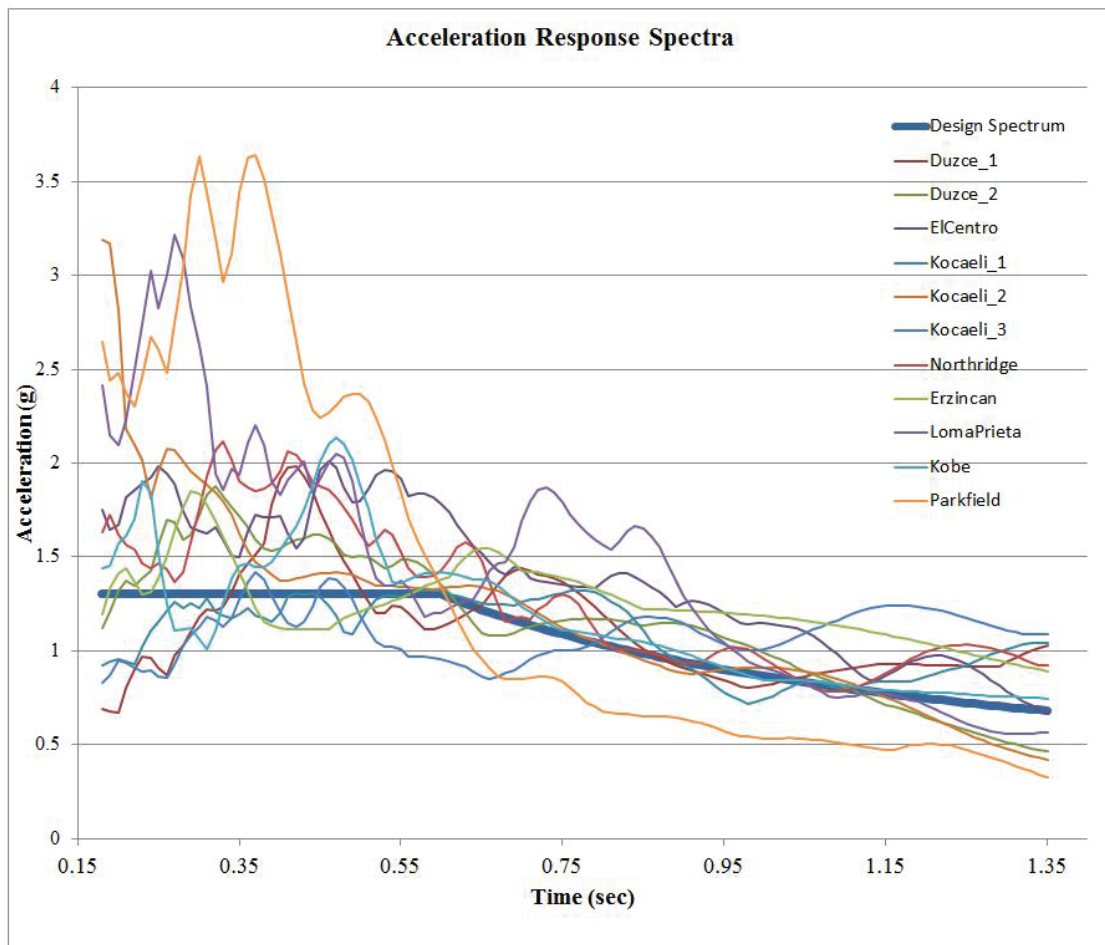
Figure 2.15. Response spectra of ground motion pairs (SRSS)

Response spectra and the average response spectra of scaled ground motions are seen in Figure 2.15 and 2.16, respectively. As it can be seen from the Figures, the values of average response spectrum are larger than the specified design spectrum corresponding to Z3 soil type.

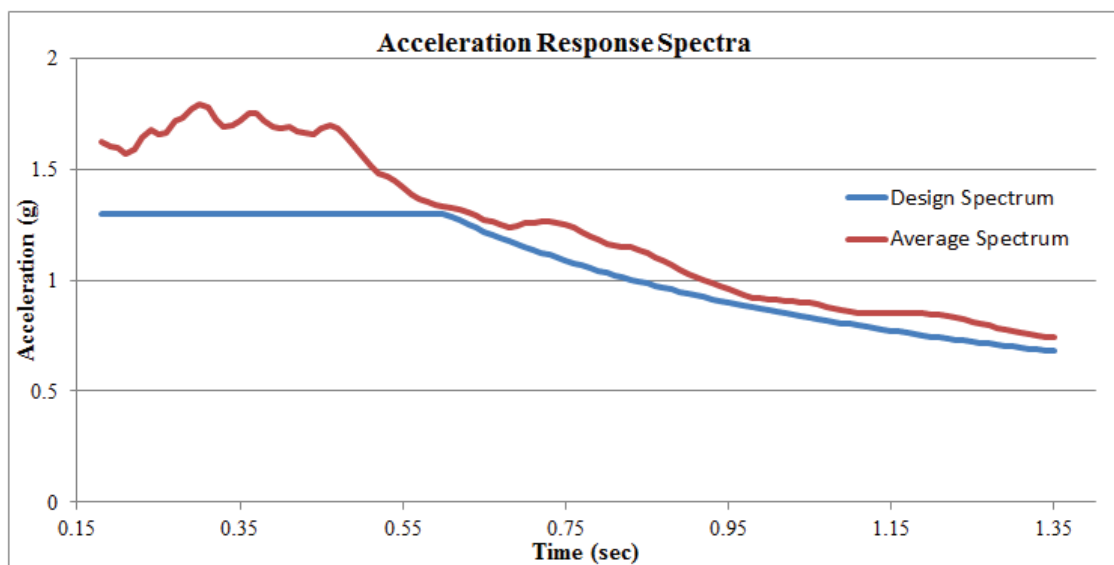
Figure 2.16. Average response spectra of ground motions

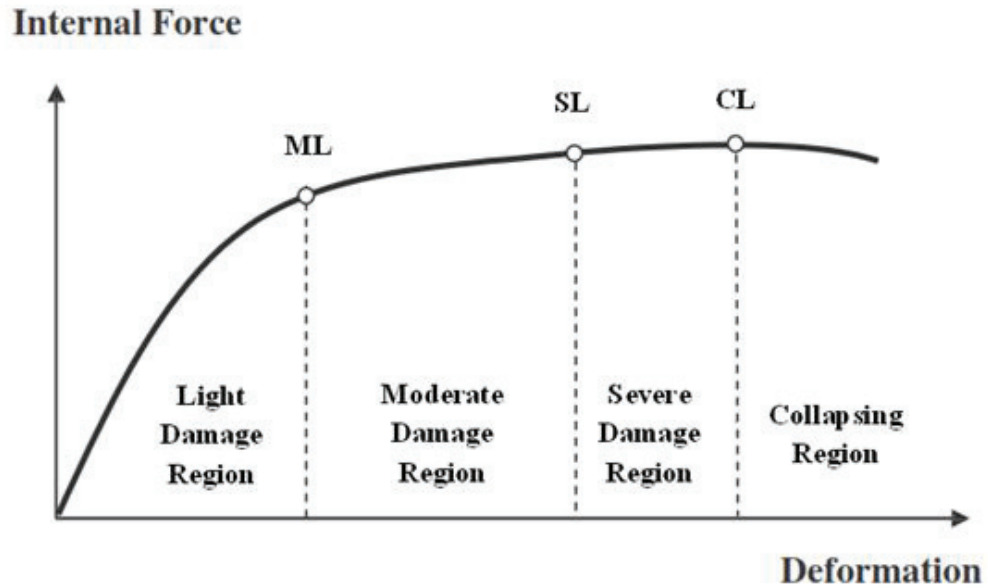
Figure 2.17. Cross-sectional damage levels
(Source: TER 2007)

According to the TER 2007, three limit conditions have been defined for ductile elements based on cross-sections of them. These are Minimum Damage Limit (ML), Safety Limit (SL) and Collapsing Limit (CL), respectively. Minimum damage limit defines the onset of the beyond-elastic behavior, safety limit defines the limit of the beyond-elastic behavior of the cross-section with safely providing its strength and collapsing limit defines the limit of pre-collapse behavior of the cross-section. As shown in Figure 2.1, the cross-sections deformations of which before ML are in the Light Damage Region, deformations of which between ML and SL are in the Moderate

Damage Region, deformations of which between SL and CL are in the Severe Damage Region and deformations of which beyond CL are in the Collapsing Region.

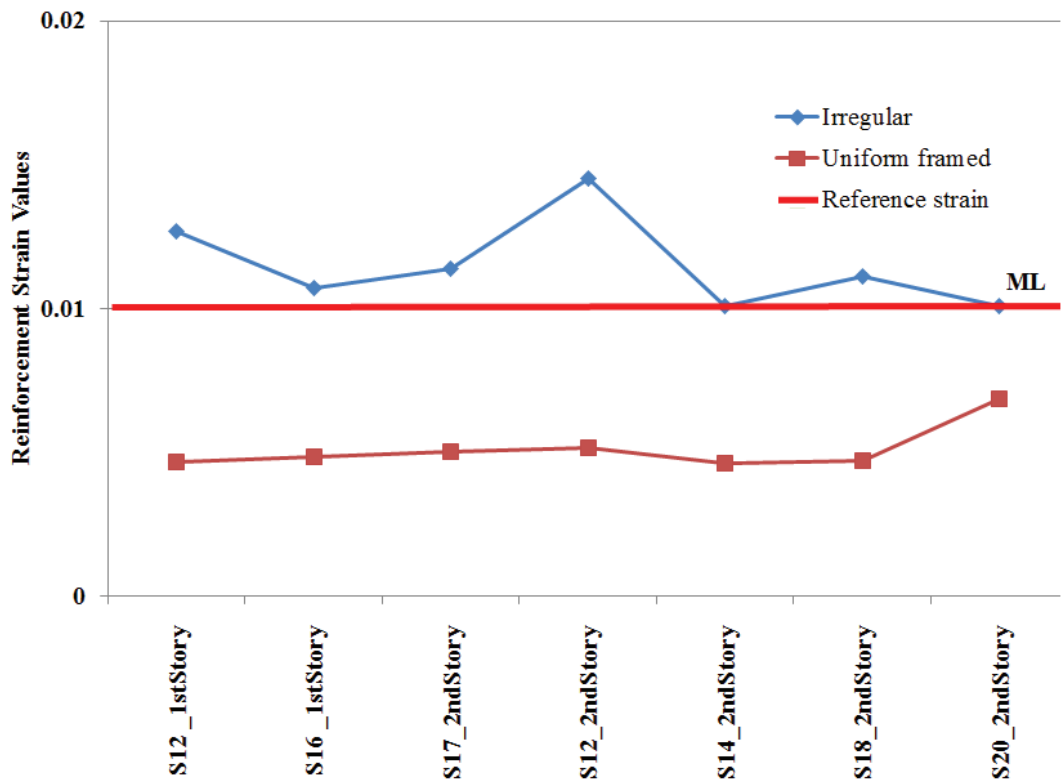
Figure 3.5. Comparison of Column Damage States

As mentioned previously the irregular structure has moderately damaged beams and columns while all members of the uniform framed structure are only in the light damage region. Two columns in the first story and 5 columns in the second story have moderate damages for the case study building 1 (irregular structure) according to the time history analysis made by using 11 earthquake sets. The severity of the column damages is determined by the strain values related to reinforcing steel as the analysis mentioned above. The Figure 3.5 demonstrates the comparison of column damage states between case study building 1 and case study building 2 (uniform framed structure). The comparison is done for the 7 columns which have moderate damages at the irregular frame. The limiting line (Minimum Damage Limit (ML) = 0.01) in Figure 3.5 shows the limit strain value in terms of reinforcing steel and the columns having larger strain values than 0.01 are in moderate damage region while having smaller than 0.01 are in light damage region. As it is seen in the Figure 3.5 the so-called columns for the uniform framed structure have strain values below the limiting line and therefore they are in light damage region.
