Experimental Study of the Evolution of the Breach and the Discharge through the Breach Resulting from Piping due to Seepage at the Earth-Fill Dam Bottom

Keywords: Earth-fill dam, Piping, Breach geometry, Breach development, Discharge through breach

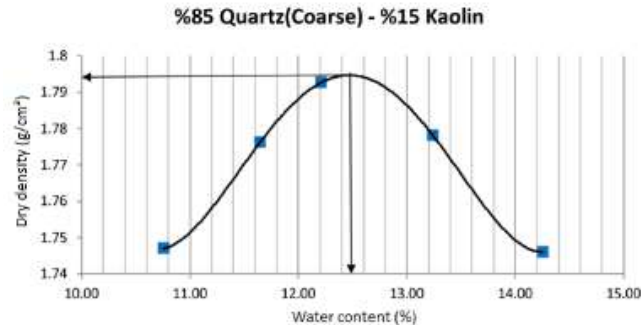
In order to specify the water content, the standard proctor test (ASTM-698) was executed by applying 13 drops and the the so obtained curve is plotted in Figure 3. The reason of applying reduced energy by 50% (13 drops instead of 25) was to increase the probability of the piping occurrence. The maximum dry density and optimum water content were obtained as $\gamma_{drymax} = 1.794 \text{ g/cm}^3$ and $w_{opt} = 12.5 \%$. The void ratio (e) was calculated as 0.469.

Fig. 3: Dry density – water content relationship

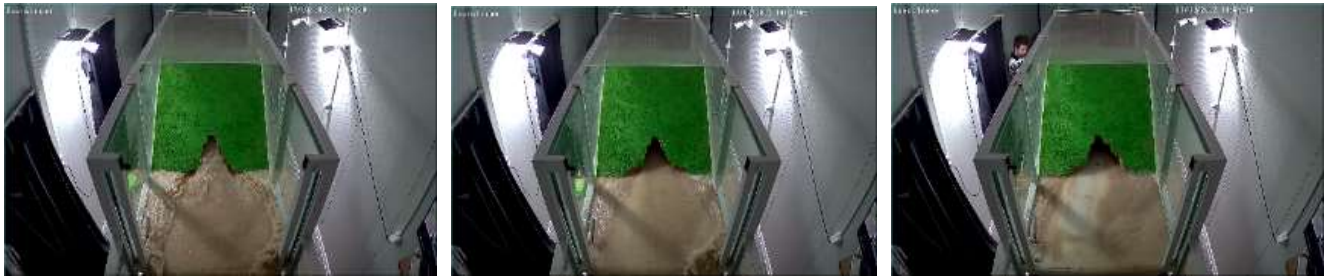
The temporal development of the breach at the downstream and upstream parts are given in Fig. 8 and Fig. 9, respectively. The time $t=0$ corresponds to the time at which the breach appeared at upstream face.

Fig. 8: The temporal development of the breach at the downstream (a) $t=0\text{ s}$, (b) $t=5\text{ s}$, (c) $t=15\text{ s}$

(d) (e) (f)
 Fig.8 (continued): The temporal development of the breach at the downstream (d) 25 s, (e) 60 s, (f) 315 s

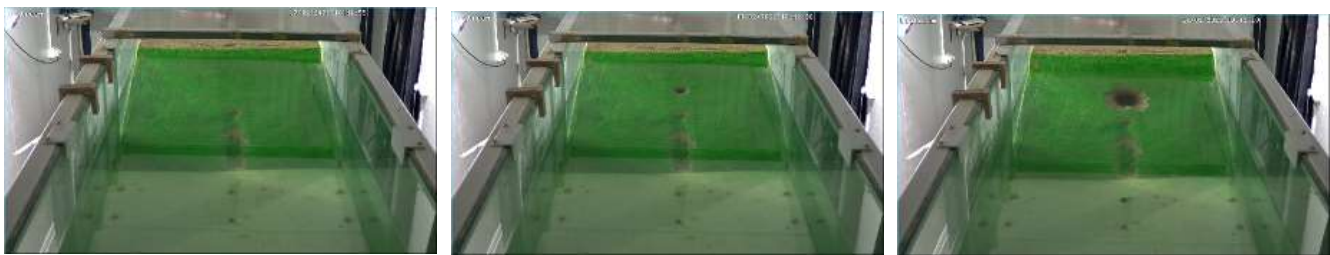
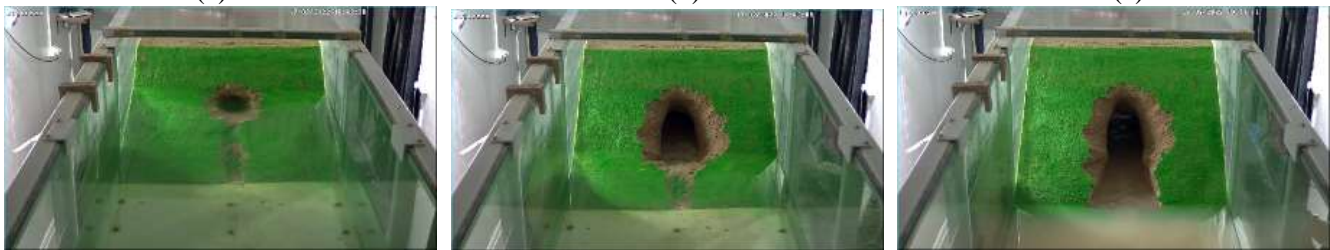
(a) (b) (c) (d) (e) (f)
 Fig. 9: The temporal development of the breach at the upstream (a) $t=0$ s, (b) $t=5$ s, (c) 15 s, (d) 25 s, (e) 60 s, (f) 315 s
