# High arsenic levels in groundwater resources of Gediz Graben, Western Turkey

**SUMMARY:** Gediz Graben situated in western Turkey is an area containing extensional structures with active tectonics and geothermal systems that serves as a suitable environment for the presence of high levels of arsenic in groundwater. The results of a comprehensive monitoring program in the basin revealed that the maximum arsenic concentration detected during the monitoring program was 3086 ppb and the average value was calculated to be 23.63 ppb. In addition, arsenic levels in 28% of the water samples were above the 10 ppb limit value making them unsuitable for drinking water supply. These high arsenic concentrations in the basin was mostly associated with long detention times of water in altered rocks located along detachment faults, strong water–rock interaction processes in the alteration zones and anthropogenic influences made within the geothermal fluid reservoir.

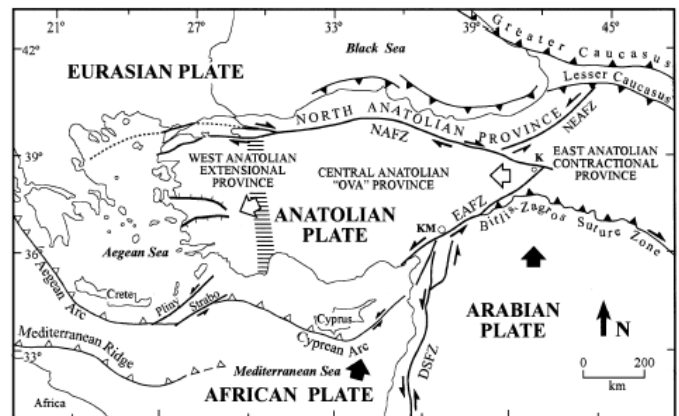
Fig. 1. Simplified tectonic map of Turkey showing major neotectonic structures and neotectonic provinces (from Barka, 1992; Bozkurt, 2001).

The Gediz Graben is 140 km long and 3–40 km wide and has a WNW–ESE trending structure bounded by active normal faults (Fig. 1). The Gediz detachment fault is one of several crustal-scale detachment faults that forms the southern margin of the Gediz Graben (Sözbilir 2001; Sözbilir, 2002).

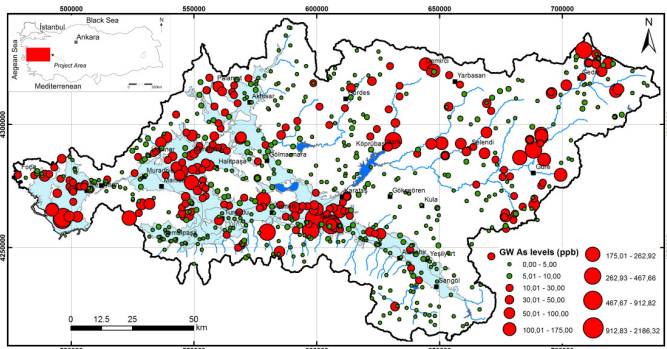
Fig. 2. Distribution of groundwater arsenic in Gediz River Basin

Arsenic in the basin was found to be above the 10 ppb limit value in 28% of the water samples. High concentrations of arsenic were observed in all parts of the basin but particularly in deep wells in the central portions of the graben area (Figure 2). These locations are located around the geothermal fields and within alteration zones. The maximum arsenic concentration detected during the monitoring program was 3086 ppb whereas the average value was calculated to be 23.6 ppb with a standard deviation value of 131.5 ppb.
