**ASSESSMENT OF THE INTERVENTIONS
REGARDING SOME HISTORICAL MOSQUES IN
MANİSA WITHIN THE FRAME OF
CONSERVATION VALUES**

**A Thesis Submitted to
the Graduate School of Engineering and Sciences of
İzmir Institute of Technology
in Partial Fulfillment of the Requirements for the Degree of**

in Architectural Restoration

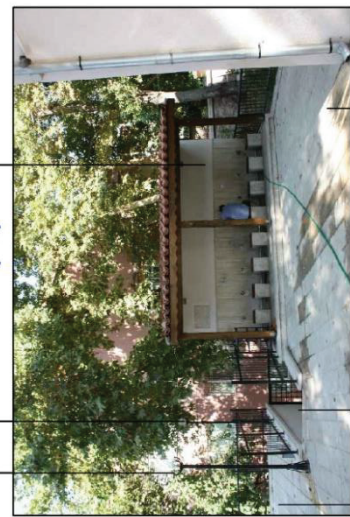
Lighting Element Addition (Ad6)

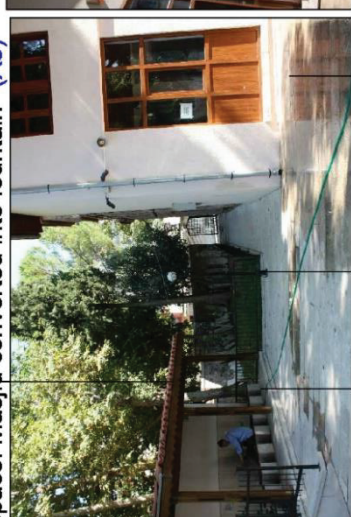
Alteration of space: Masjid converted into fountain (A5)

Alteration of floor covering (A10)

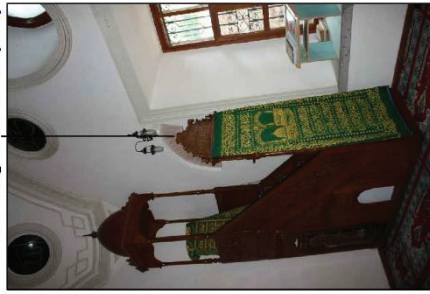
Cleaning of plaster covering addition (C1)

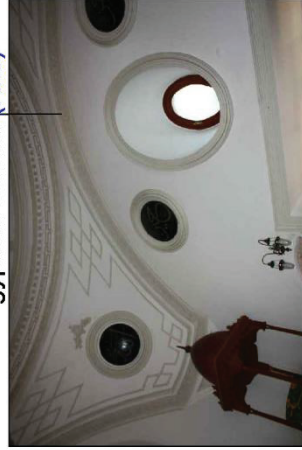
Reintegration of gypsum cornice (Rn3)

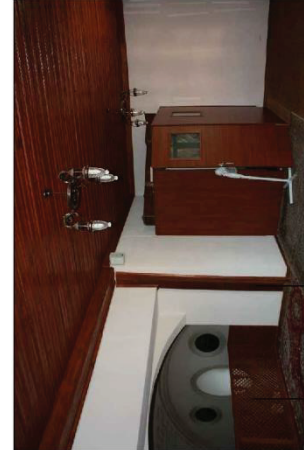
Cleaning of timber covering addition (C4)
Reintegration of gypsum lath (Rn4)
Renewal of repair plaster and paint (Re11)

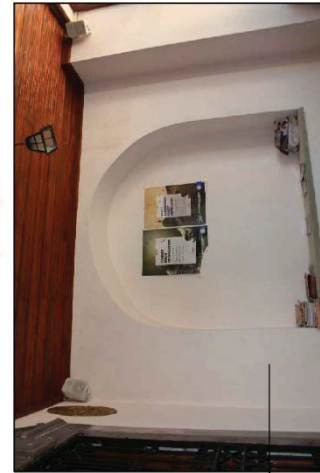
Renewal of repair plaster & paint (Re10)
Renewal of timber balustrades (Re6)
Renewal of timber post and lintel (Re8)

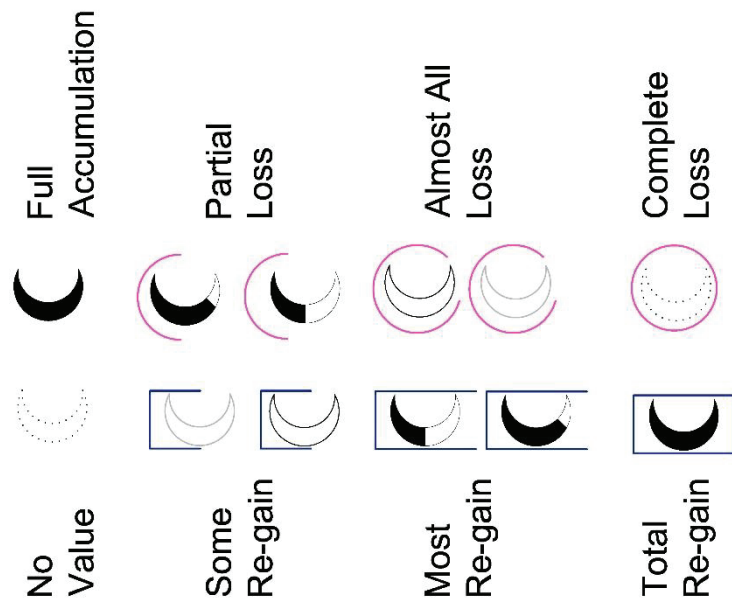
Figure 1.5. Variation of spiritual value.

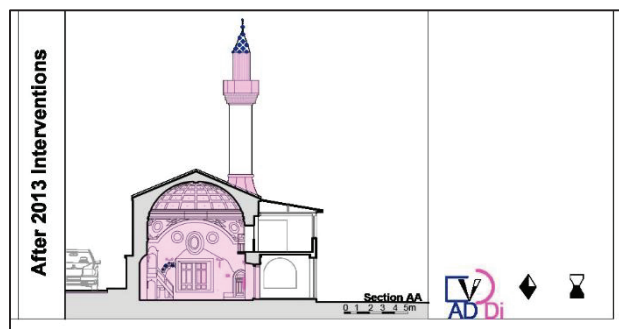
Figure 1.6. Drawing showing appropriateness of the interventions at after 2013 interventions period of Göktaşlı Mosque.

Periods in which interventions/changes occur at the building and its site are drawn on silhouette sections for site scale, and on longitudinal section for building scale. Changes and values for each period are mapped separately on these drawings. Values are shown with solid symbols in accordance with intervention/change differences with which the mass or element faced. State of these values are displayed with from fully solid hatch to without hatch drawn with dotted line (Table 1.5) from full accumulation grade to no accumulation grade, respectively. Loss or re-establishment of the values are shown with hollow symbols put around value symbols (Figure 1.5). Losses can be complete, almost all or partial. No change symbol around the value symbol means sustaining of value. Re-establishment of a value can be some, most or complete. If there is not any trace/remains contributing to a value anymore, there is complete loss of value; if there is slight or partial loss in trace/remain in comparison with the previous period, there is partial loss; if there is more than partial loss in trace/remain in comparison with the previous period, there is almost all loss; if no changes/intervention at the trace/remain in relation with a value, there is sustaining of value; if there was a value at the building before and it was in any amount of lost at the previous period, and it became complete again at the period evaluated, there is re-establishment/re-gain of value; and if it is partially complete again, there is re-establishment to some extent. Cause/basis of these changes are shown with the initial letters written at the right bottom of the value and state of value symbol combination. These causes/basis are appropriate design (AD), appropriate workmanship (AW), design insufficiency (Di), transmission of data insufficiency (TDi) and physical sustainability insufficiency (PSi). Changes affecting value negatively are mapped with pink solid hatch and the ones affecting positively are mapped with dark blue dotted hatch (Figure 1.6).

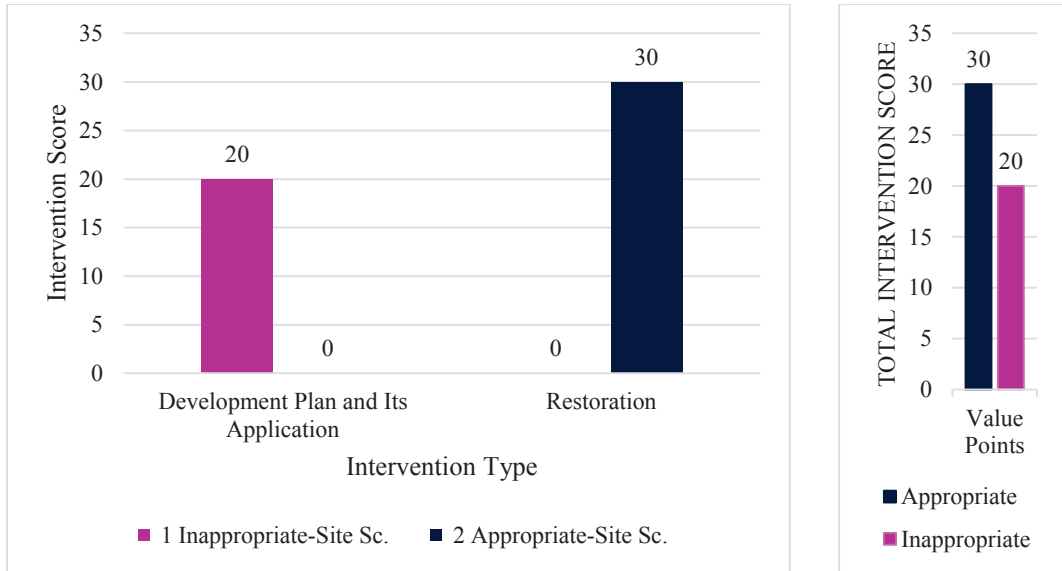
Figure. 1.8. Intervention scores for the neighborhood of Kabasakal Mosque.

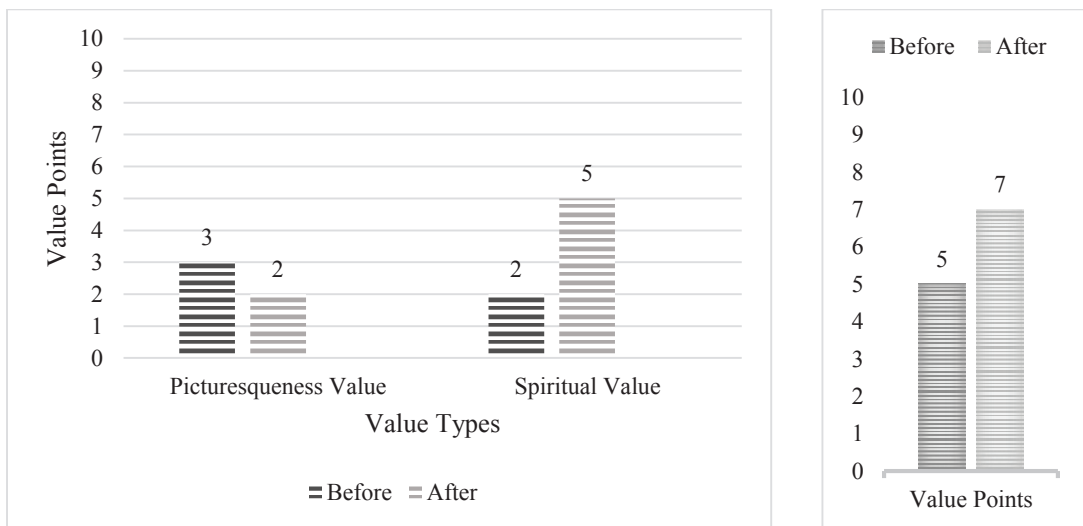
Figure 1.9. Site scale value points for each value type (left), and total site scale value points (right) before and after the latest urban interventions, Kabasakal Mosque.

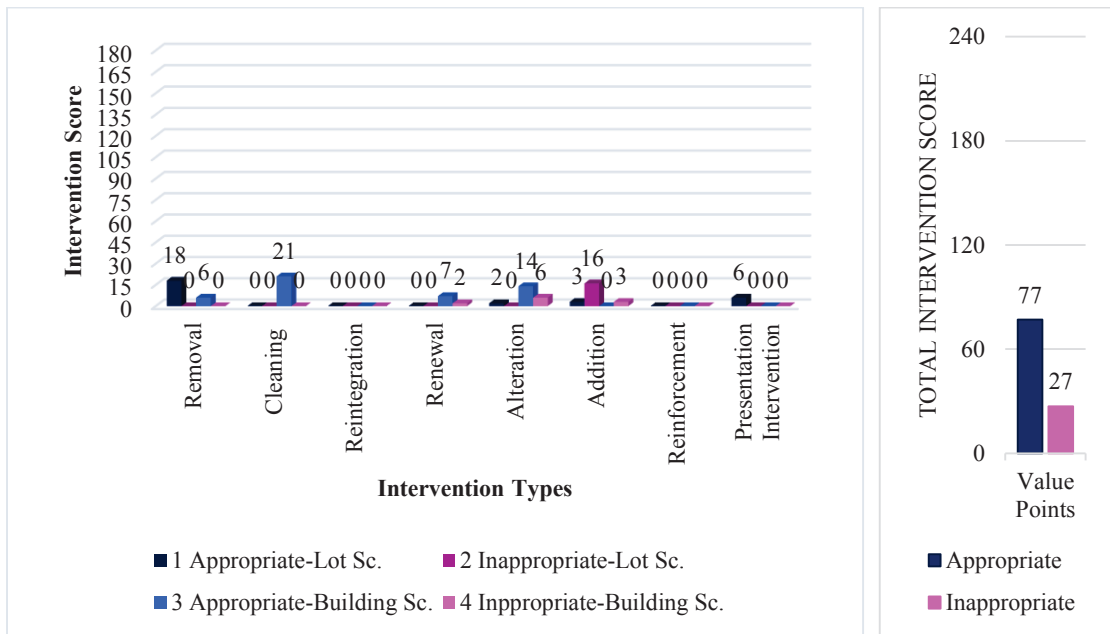
Figure 1.10. Intervention scores for each intervention type, Kabasakal Mosque and its lot.

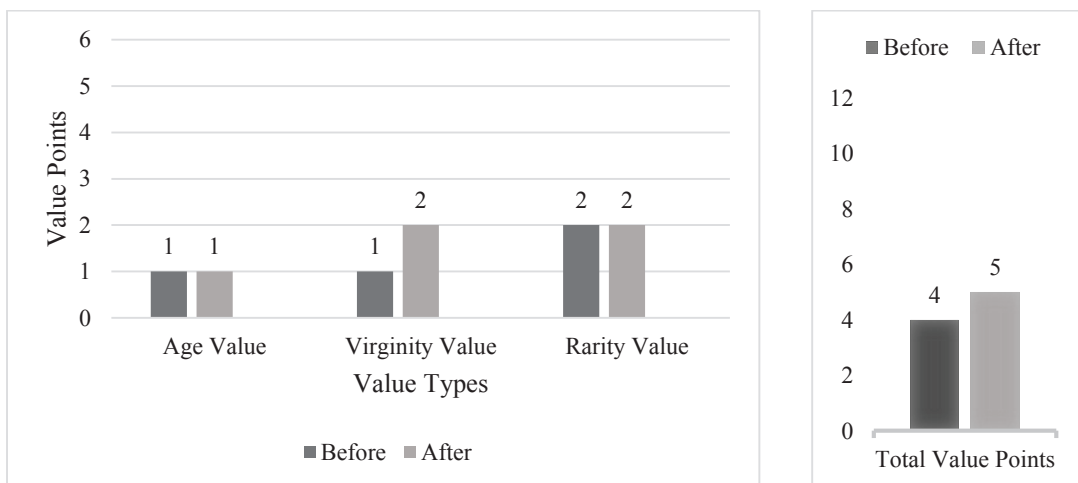
Figure 1.11. Building scale value points for each value type (left), and total building scale value points (right) before and after the current interventions, Kabasakal Mosque.

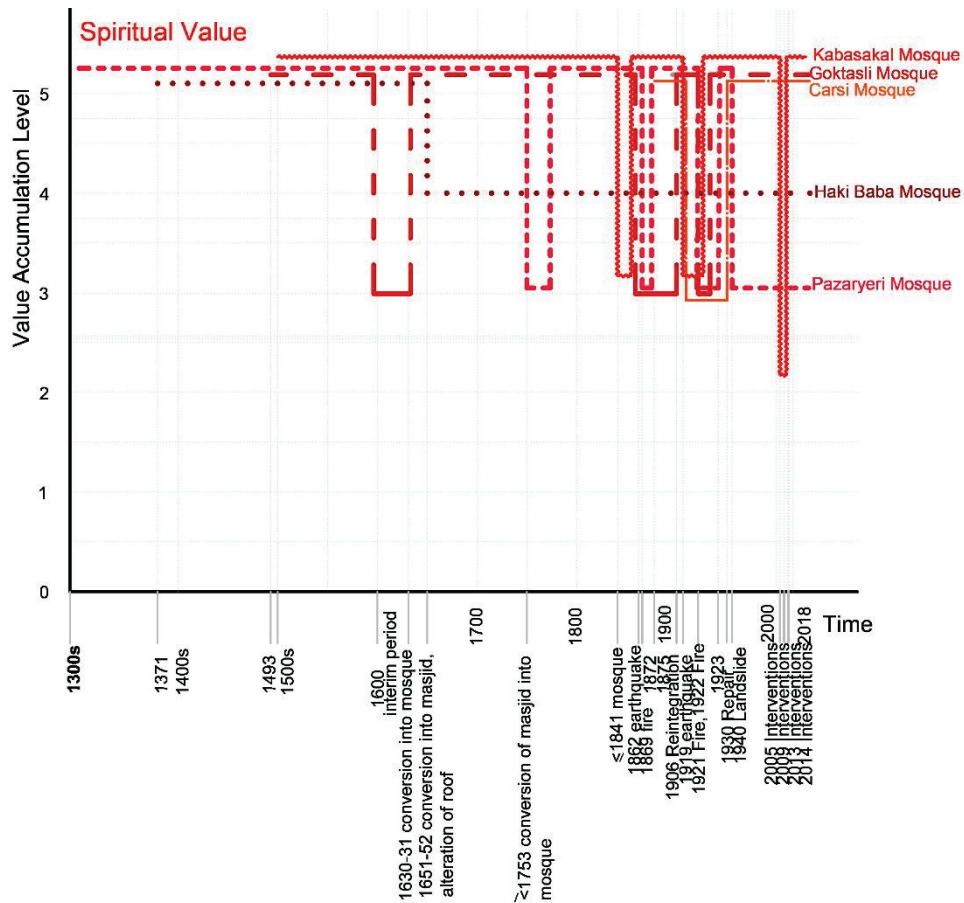
Figure 1.12. Graphic indicating comparison of changes in spiritual values of case study mosques.

In the first part of discussion, comparison is realized to understand the value changes of the different mosques in the same period. Value graphics showing the changes at the same value of different mosques are prepared for each value type to understand the common intervention approaches of the same periods (Figure 1.12). Different line types are attributed to different mosques.

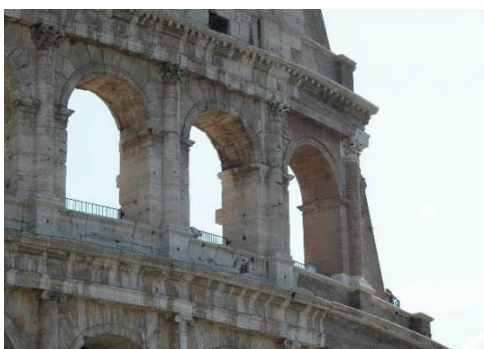
Reintegration is completion (Croci 1998, 90; Ahunbay 2009, 96) or reinstating of elements or masses that have lost their integrity. Reintegration means making something whole again. Reintegration may be applied to a building element, structural system or part of a building (Zakar and Eyüpgiller 2015, 38). Structural elements are very important to hold the building up. Their partially demolished or lost parts may cause the building's collapse (Croci 1998). Reintegration of these parts in terms of structural conservation may be required. Reintegration of a part of a structural system or even a structural element may help the conservation of the building's structural integrity. However, reintegrated part should not be eye catching as in the covered bazaar in Kayseri (Figure 2.5). Consolidation may be a kind of reintegration as seen in the Colloseo, Rome (Figure 2.4) (Zakar and Eyüpgiller 2015, 38).

Figure 2.4. Historic consolidation work in Colloseo, Rome, Italy.
(Source: Hamamcıoğlu-Turan 2018)

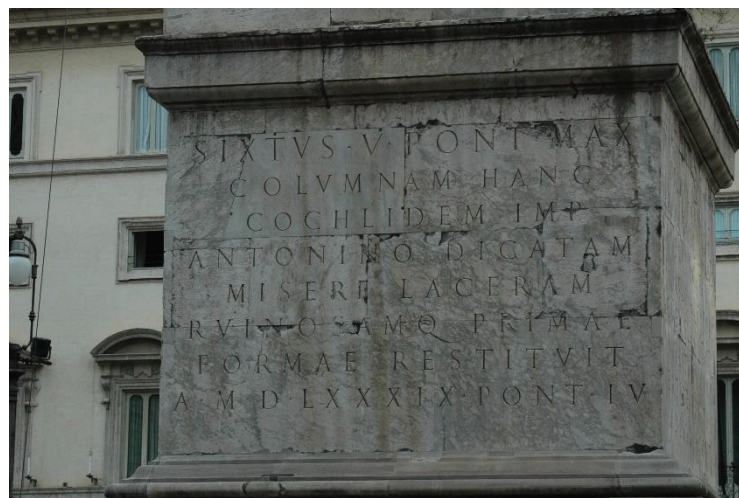
Lacunae or gaps in the building composition can be treated with reintegration as in the obelisk of Pope Sixtus V, Rome (Figure 2.6). Intervention to lacunae should not decrease the architectural characteristics of a building or its elements. Feilden (1994) emphasizes assessing differentiation of colour, texture and relative recession of surfaces in the lacunae treatments. However, visual unity of the reintegrated element should be sustained. Reintegration with an appropriate material but with a different form may damage compositional unity. Thus, this reintegration is not fully efficient. Information gathered from the documentation and literature review phases provides the information of the restitution phases of the building. Credible information is a must for reintegration. Otherwise, conjecture occurs and it is against to the conservation principles. Simplification of the details may be applied at the reintegration of an authentic element if there is not a definite information. However, reintegration of an unqualified element can not be acceptable.

Figure 2.6. Reintegration in the base of the obelisk of Pope Sixtus V, Rome.
(Source: Hamamcıoğlu-Turan 2018)

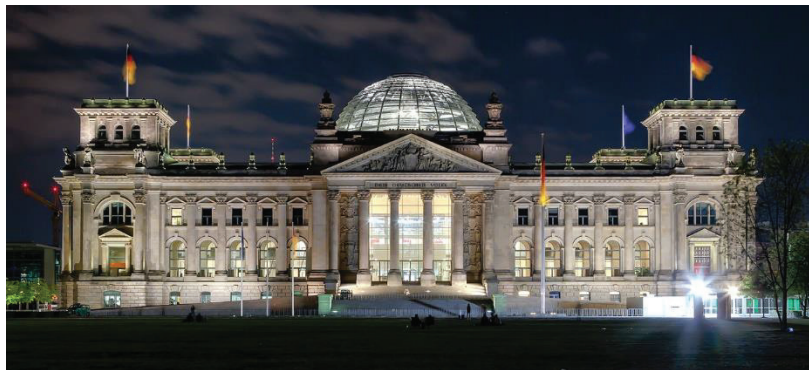
Changing present material, form and/or construction technique of an element with a different one or changing the element (ICOMOS 1999, Article 9-10) or the space with a completely different one as seen at the dome of the Reichstag building in Berlin is alteration intervention (Figure 2.7). If the building’s authentic material can not provide enough bearing capacity or information on this structural/architectural system part or architectural or structural element, alteration of these portions’ construction technique or material may be realized. However, instead of damaging the authentic form, material or construction technique of an element for increasing its load bearing capacity by altering it, different intervention alternatives such as its reinforcement with additional supports can be thought. Alteration of an authentic element hinders its cultural asset values.

Figure 2.7. Dome alteration at the Reichstag building, Berlin.
(Source: Wikipedia A n.d.)

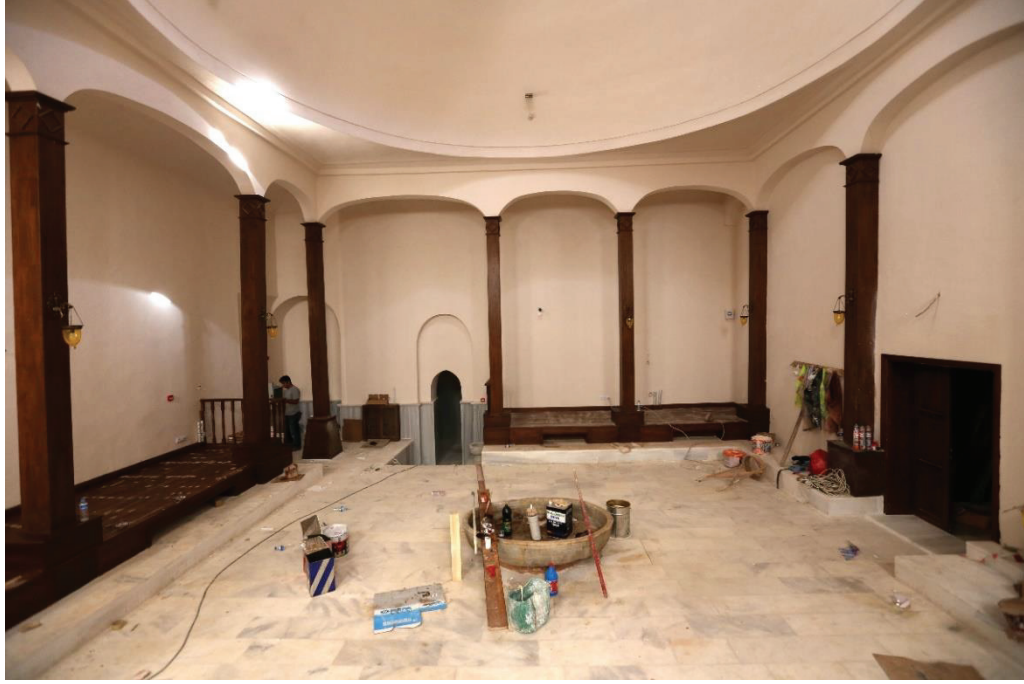
columns of Reyhanpaşa Bath in Bursa (Figure 2.8). Especially timber material may require renewal intervention as seen in the Japanese tradition (Orbaşlı 2008, 149). In Western approach, partial renewal of an element or help of the other intervention types can be preferred to conserve timber. However, their complete renewal unnecessarily prevents physical sustainability of authentic elements. Stone is much more durable than timber. Renewal of a stone element can be preferred in case of its total collapse or at the state in which the stone has lost its bearing capacity. Material and technique similar with the historical one is used in renewal. Renewal causes loss of patina, and reduction in authenticity. Thus, it is not an intervention type preferred frequently and with peace of mind. Sustainability of the monument is essential and renewal decisions can be taken in case of the threats to sustainability of the monument such as loss of load bearing capacity of a structural monument, loss of integrity of the material of a structural element, etc. Besides them, renewal applications for preventing possible damages such as renewal of a protective material such as roof tiles can be preferred. Renewal of paint can be accepted since it is a part of maintenance program of a historic building. Additional unqualified covering materials on the authentic elements should not be confused with their authentic covering materials. Their renewals instead of their cleaning is not an appropriate intervention.

Figure 2.8. Renewal of columns in Bursa, Reyhanpaşa Bath.
(Source: Bursa Municipality n.d.)

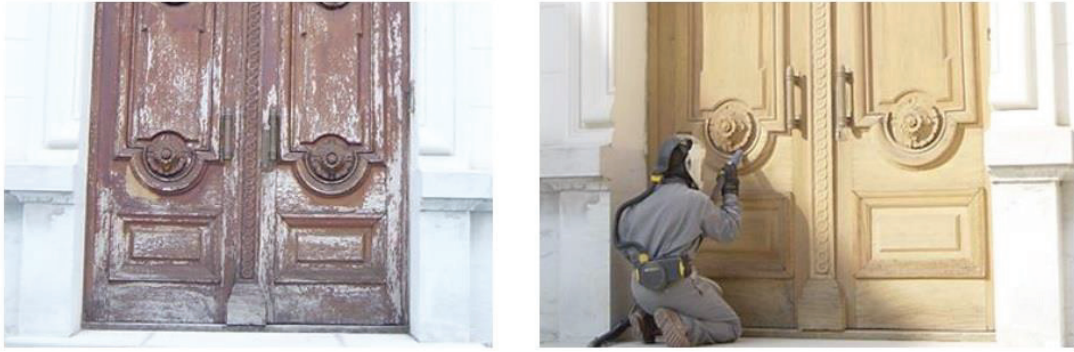
Cleaning is scraping the unqualified layers on the surface of the historical assets (Crocì 1998, 94) such as cleaning of paint at the surface of a historical door (Figure 2.9). Encrustations, dust, microbiological formation, etc. may affect the historical buildings in terms of color changes, undesirable stains or material decay (Crocì 1998). Cleaning of the unqualified materials from the surface of the authentic building elements enhance the heritage values; it stops decay and reveals the heritage characteristics. It should not damage understanding of the building's or an element's proportions, materials, textures, construction detail, etc. actually values. Cleaning should be sensitive/gentle in order to prevent possible damages caused by the loss of the authentic material (SIS 2017, 32).

Figure 2.9. Cleaning of the surface of a historical door.
(Source: Kesik et al. 2015, 1105)

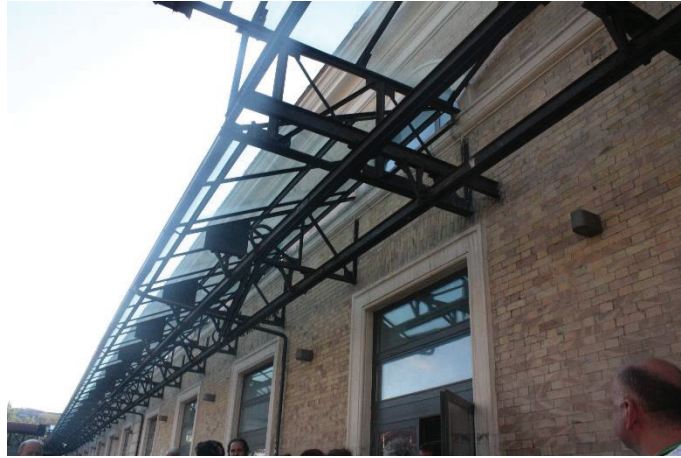
Figure 2.10. Eave addition to historic mansion converted into auditorium, Faculty of Architecture, Roma Tre University, Rome.
(Source: Hamamcioğlu-Turan 2018)

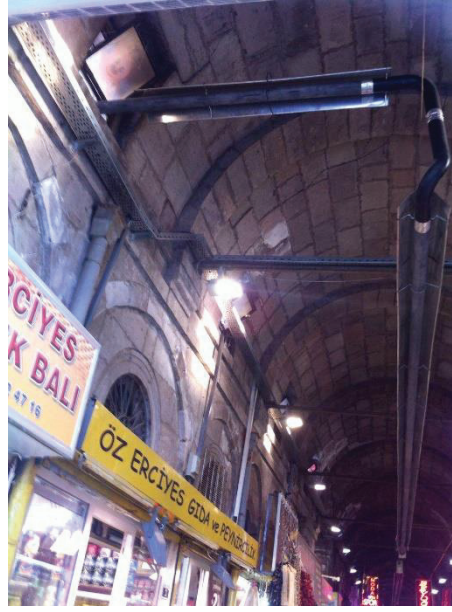
Reinforcement is a kind of physical addition such as iron reinforcement at the covered bazaar, Kayseri (Figure 2.11) or usage of adhesive or supportive materials for helping to keep the structural integrity and durability of the heritage building (Feilden 1994). Reinforcement is the repair with contemporary construction technique detail and material (Zakar and Eyüpgiller 2015, 38). Injection of some chemicals, widening of the foundation, anchorage, etc. may be given as samples for reinforcement applications. If any structural element can not continue its strength with the present material, reinforcement is applied to hold straight the building (Feilden 1994). So that the bearing capacity of the building reaches a better state than the bearing capacity of the authentic state.

Figure 2.11. Iron reinforcement in arch form, covered bazaar, Kayseri.
(Source: Büyükkılıç-Koşun 2017)

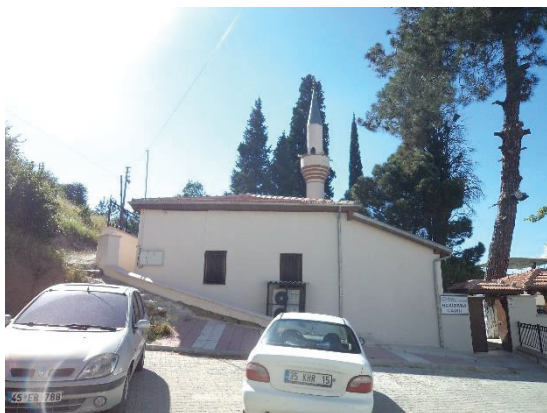
The prayer hall and women's section is spanned with a hipped (*kırma*) roof. Last comers' hall is covered with a lean-to roof. The walls of the prayer hall are out of timber skeleton filled with adobe mud bricks (*kerpiç*) (Figure 3.7) and covered with plaster (Figure 3.5). Almost all of the minaret elements; *kaide*, transition element, body, cornice of *şerefe*,

Figure 3.5. Haki Baba Mosque.

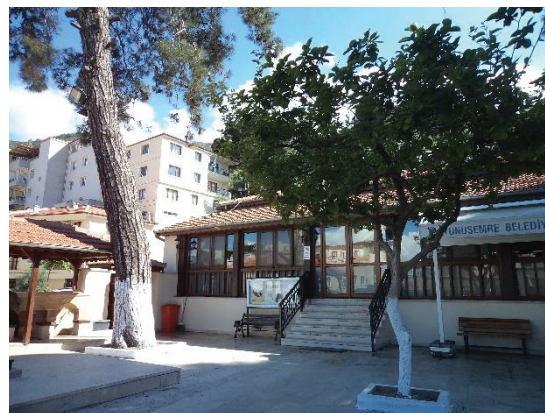
The Mosque building (Figure 3.6) is surrounded by a courtyard on its two sides: western and northern sides. The courtyard is entered from the east and south. The mosque mass is elevated from the courtyard's level and it is reached with a stair with seven steps (Figure 3.6). There is a graveyard composed of gravestones bordered by concrete curbs at the western side of the courtyard. A tomb/grave elevated approximately 80 cm from the ground is located at the northwestern part of the courtyard as separate from the graveyard. It is rumoured that this tomb without any writing on its gravestone is of Haki Baba¹. There is a new *şadırvan* at the north of the eastern entrance of the courtyard. The *şadırvan* and the entrance of the toilet at the underground are covered by a protective shelter. A *musalla* stone is placed in front of the Mosque building. There are also trees, new lighting elements, benches in the courtyard.

Figure 3.6. Mosque building elevated from the courtyard ground level.

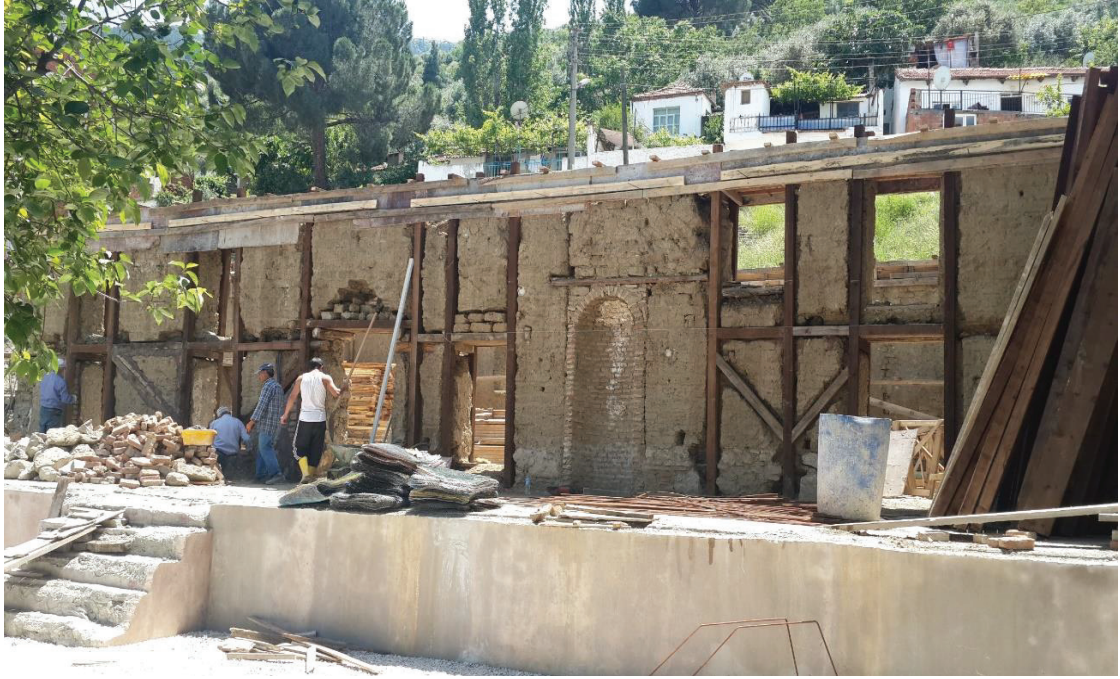
Figure 3.7. Northern wall of the prayer hall as viewed in the restoration of 2014, Haki Baba Mosque.
(Source: Erturan 2012)

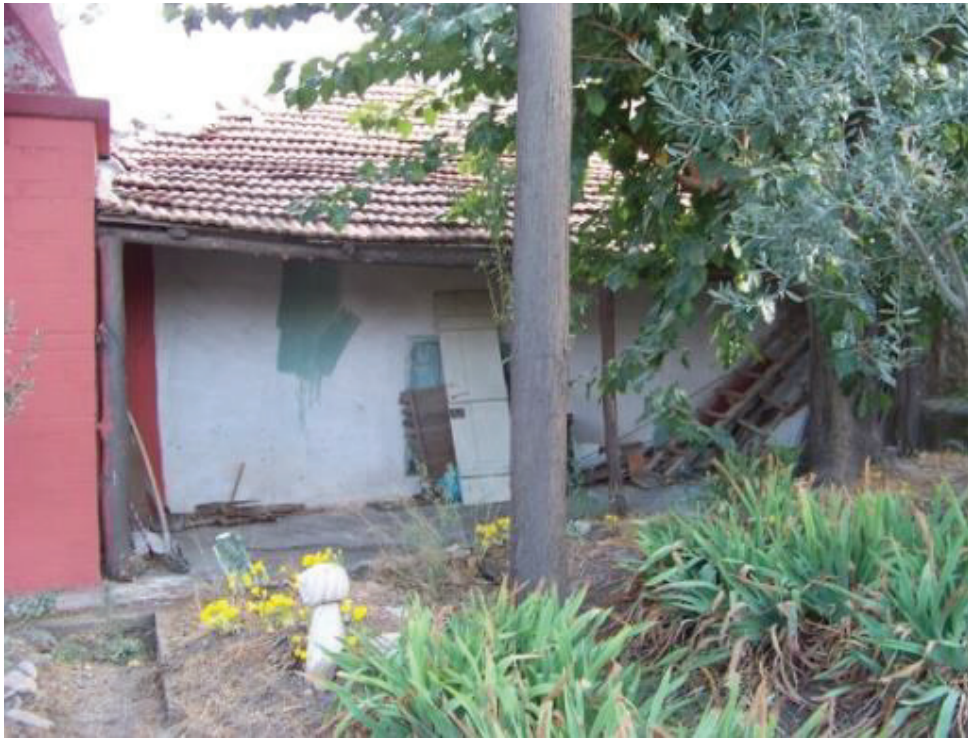
Figure 3.8. Post remains carrying the eave at the Haki Baba Mosque
(Source: RDPF 2012)

Following this, comparative study was detailed to solve the restitution problems of the building detected; roof system, wall system, floor system, organisation of voids, space organisation and presence of *seki*. Adobe masonry walls of Haki Baba *Zaviye* is not appropriate to carry a vault or dome. Earthen flat roof is often applied to the one storied adobe masonry buildings (Tuztaşı and Çobancaoğlu 2006, 97) such as houses in between Malatya and Maraş, in Malatya and Iğdır (Table 3.4). Their roofs are constructed with three layers from down to up: timber lintels, reeds and branches, and earth. It is seen that the eaves of the house are supported with timber posts in between Maraş and Malatya. This system is similar to the post remains carrying the eave at the west of the Haki Baba Mosque (Figure 3.8). Haki Baba should have had earthen roof at its first construction period. Adobe masonry wall system includes timber lintels as in the traditional houses in the Table 3.4 and in the Haki Baba Mosque. They are covered with mud plaster.

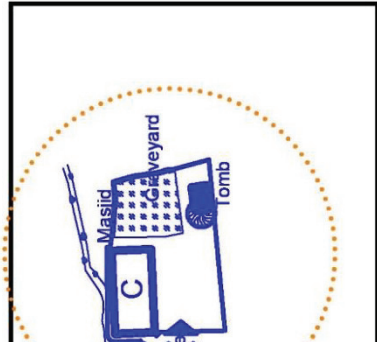
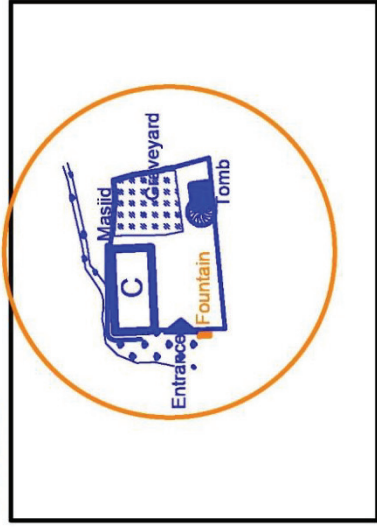
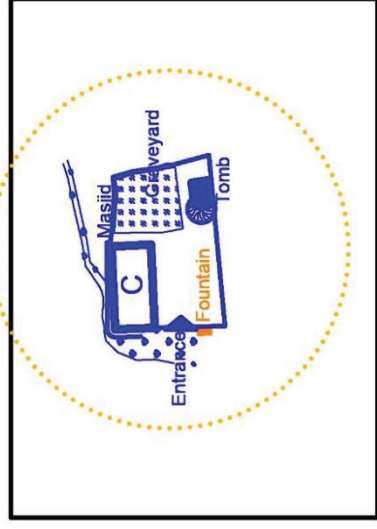
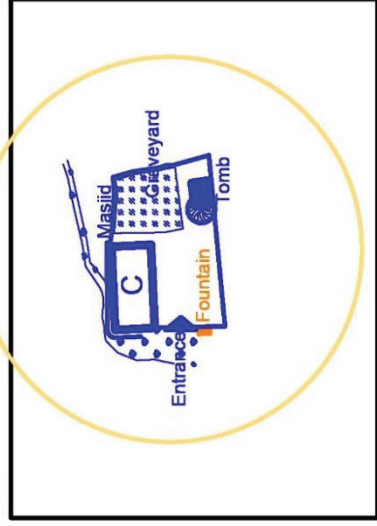
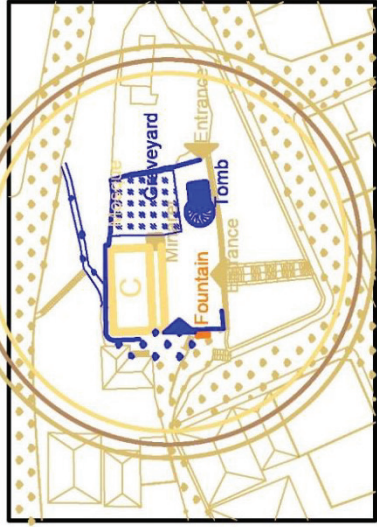
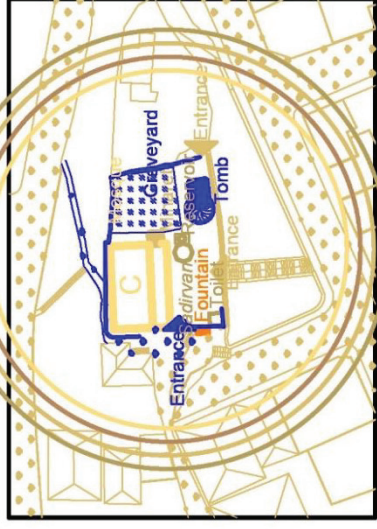
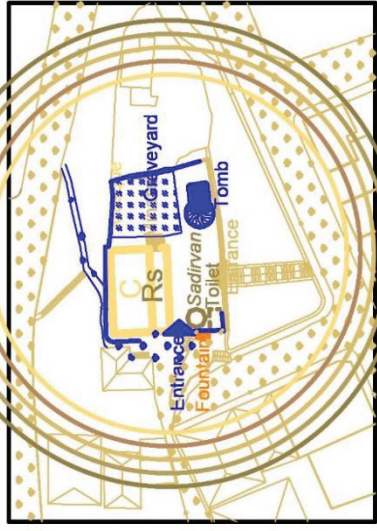
Figure 3.9. Development of Kaynak Neighborhood.

(Uluğay 1940)
1871 Fountain

(Emecen 2003)
After 1922 Fire

(Uluğay 1940)
1940

(Development Plan 1962; Karaoğuz 1977)
Second Half of the 20th Century

(RDPF 2016)
<2012 Measured Survey

(Site Survey 2017)
After 2014 Interventions

The fire dated 1922 damaged most of the city of Manisa (Emecen 2003, 579). Residential area around the *masjid* was burnt (Figure 3.9g).

Uluçay (1940, 89) states that there was a last comers' hall (*sayfiye*) carried by quadrilateral (*dört köşe*) planned timber posts and covered by a roof covered with roof tiles (Figure 3.9h). Its floor was covered with quadrilateral (*dört köşe*) bricks in 1940. There was a *mihrab* niche and *imam* room in this space. Addition of last comers' hall caused to the removal of the timber posts at the north of the building. A simple *mihrab* with carved wardrobes on its both sides was in the prayer hall.

RDPF completed the restoration application in 2014 (Figure 3.9l). The above mentioned new *şadırvan* and toilet were altered and relocated. *Şadırvan* was built to the north of the eastern courtyard entrance. Toilet was built to the underground of the northeastern corner of the courtyard. Reservoir was removed. Collapsed courtyard wall was repaired and thus the western entrance was closed. The roofs of the prayer hall and last comers' hall were altered as two independent roofs: hipped and a lean to, respectively. The last comers' hall was converted into a semi-open space and then it was converted into as a closed space by the community by collecting charity for the mosque. The *imam*

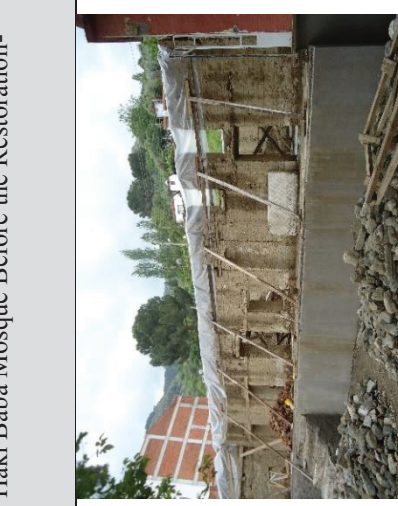
<p>Hacı Baba Mosque Before the Restoration-Adobe Brick</p>

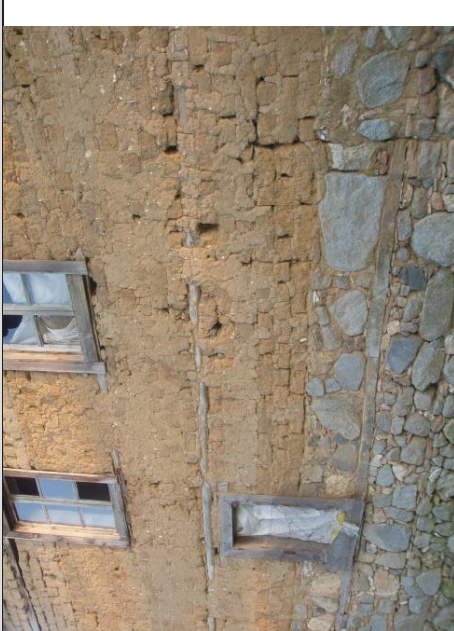
<p>Kabasakal Mosque</p>	<p>Haki Baba Mosque Before the Restoration (Erturan 2012)</p>

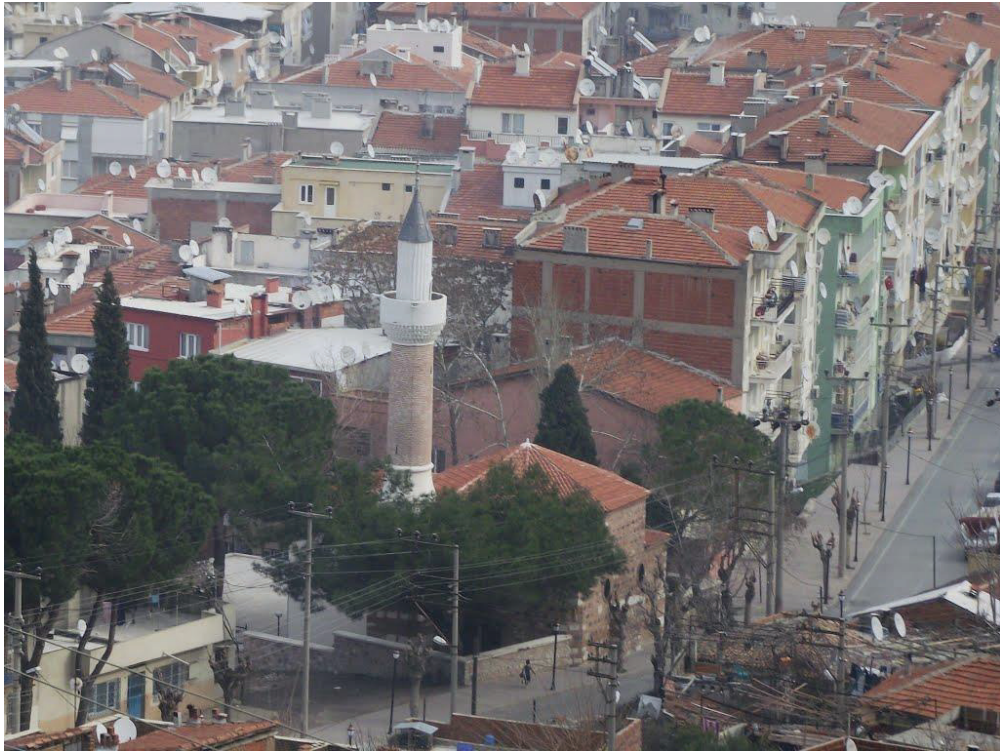
Figure 3.10. Ulutepe Street, Göktaşlı Mosque and organized planned area.
(Source: Panaromio A n.d.)

Göktaşlı Mosque is located in Şehzadeler District, in Manisa. It is on Ulutepe Street constructed after 1962 Development Plan. The building is on an inclined topography. The area is mostly composed of four-five storied apartment blocks (Figure 3.10) dated to 1960s-2000s. The area organized according to 1962 Development Plan has a gridal layout. The mosque and its courtyard is bordered by lots from its northern and western side, and by roads from its southern and eastern sides.

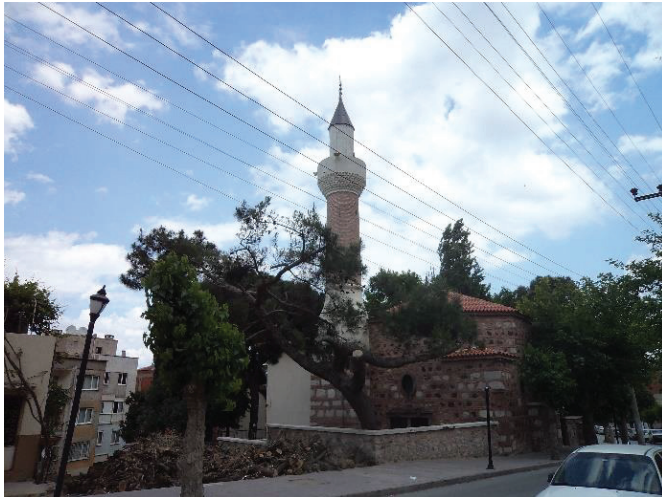
Figure 3.11. Göktaşlı Mosque.

The Mosque building (Figure 3.11) is surrounded by a courtyard on its three sides: eastern, western and northern sides. There is a graveyard composed of unordered gravestones put leaned on the courtyard wall at the eastern side. There is a new fountain juxtaposing the graveyard at its north. There are also trees, new lighting elements, benches, trash bins in the courtyard. Symmetrical planned mosque is composed of square planned prayer hall, rectangular planned additional last comers' hall with a *mahfil* for women on it, and a minaret. Minaret is at the northwestern corner of the prayer hall. Roof of the prayer hall is covered with new over and under tiles. There is a chamfered corner at the southwestern corner of the prayer hall (Figure 3.12). Two oval middle windows

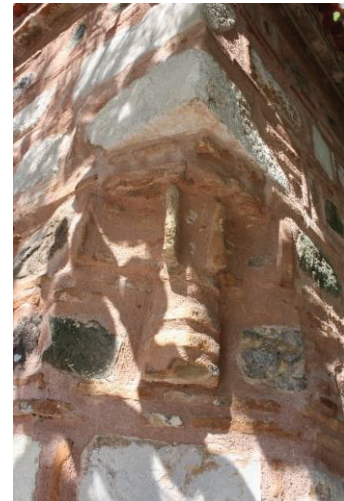
Figure 3.12. Chamfered corner of the Göktaşlı Mosque.

The masjid was rebuilt as a mosque in 1630-1631 (Figure 3.14c). The chamfered corner at the southwest of the mosque (Figure 3.12), the plan displaying the surrounding environment of the mosque taken from the RDPF (Figure 3.2) and Gökçen's sketch (Figure 3.13) put forward that Göktaşlı Mosque was a corner building in its authentic context. The courtyard walls of the Mosque starting from the minaret followed the line of this route. Gülfem Hatun Fountain on this route was adjacent to the western wall of the courtyard of the mosque. There was an entrance to the courtyard on the right of this fountain.

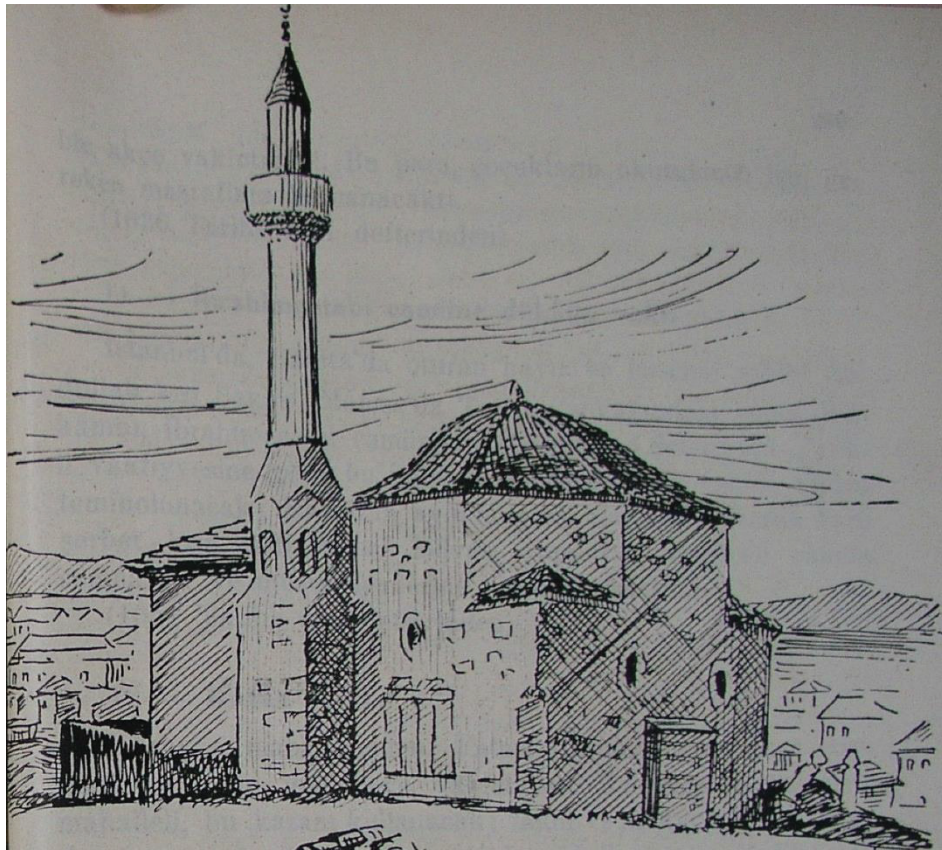
Figure 3.13. Sketch of the Göktaşlı Mosque drawn by İbrahim Gökçen.
(Source: Gökçen 1946, 297)

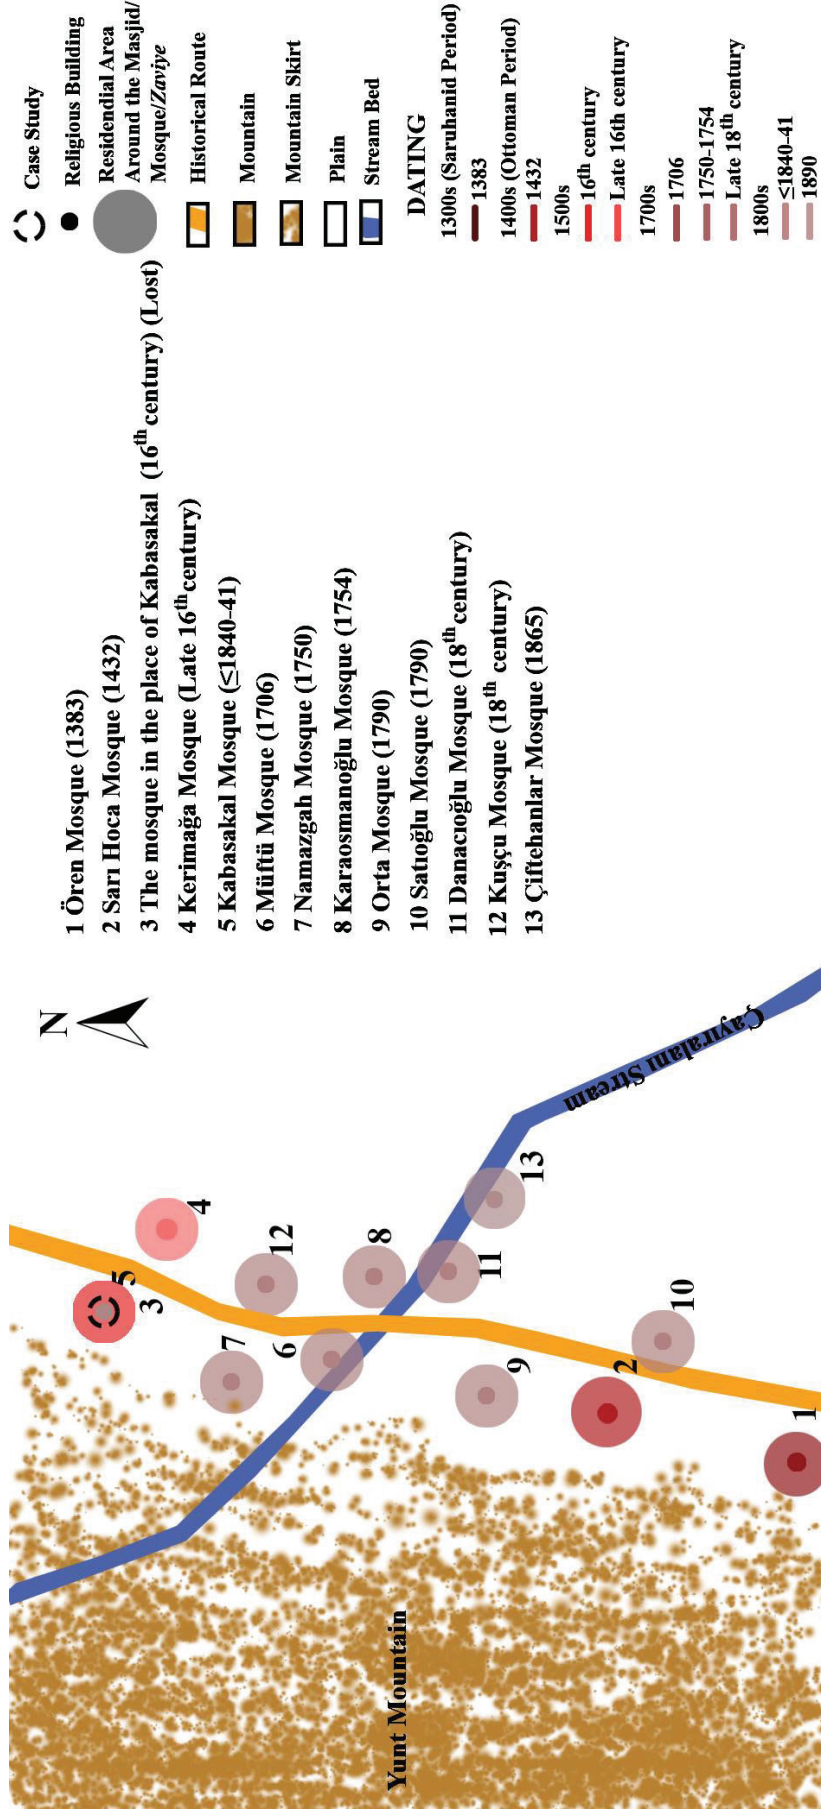
Figure 3.15. Urban development around masjids/mosques in Kırkağaç Centre.

Kırkağaç is a district of Manisa City. It is placed at the northeast of Manisa City centre and hill skirts of Yunt Mountain (Figure 3.15).

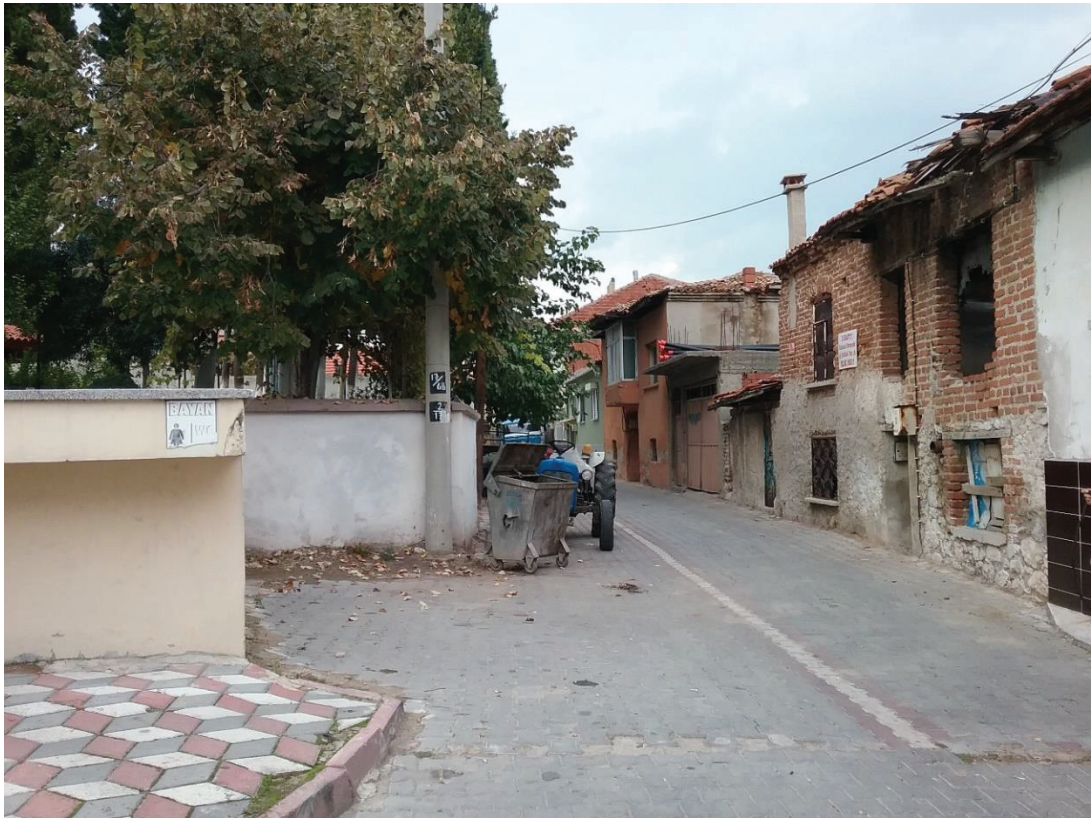
Figure 3.16. View of Kabasakal Mosque's courtyard wall's southeastern corner and wall of underground toilet in front of it, 79/B street and houses at the east.

Kabasakal Mosque is located in Sarı Ağa Neighborhood, Kırkağaç, Manisa. It is on the Edip Bayat Street. The area is mostly composed of a few storied residential buildings. They date to 1800s-2000s. The area developed in gridal layout since 18th century was organized officially according to 1968 Development Plan. While roads border the case study lot from its three sides, houses border it from its northern side (Figure 3.16).

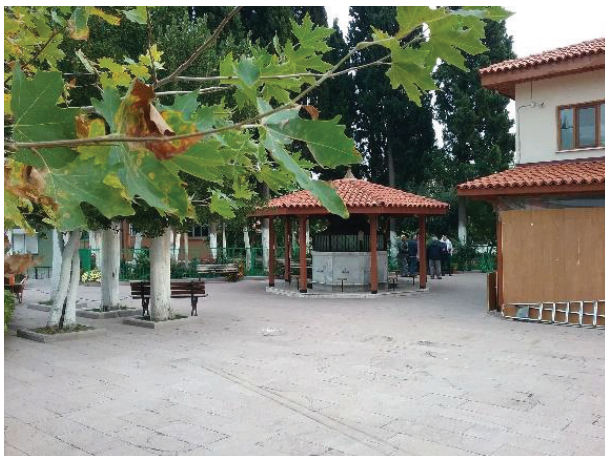
Figure 3.17. View of Kabasakal Mosque's courtyard from the northwestern corner.

The Mosque building (Figure 3.17 and 3.18) is surrounded by a courtyard on its three sides: southern, northern and eastern. The courtyard is entered from the south and east. Courtyard walls are out of stone masonry covered by plaster. The prayer hall is reached from the last comers' hall (Figure 3.19). There is an unqualified *şadırvan* dated to 1985 in the middle of the eastern part of the courtyard (Figure 3.17). There are two forested areas in the courtyard: at the east and at the north.

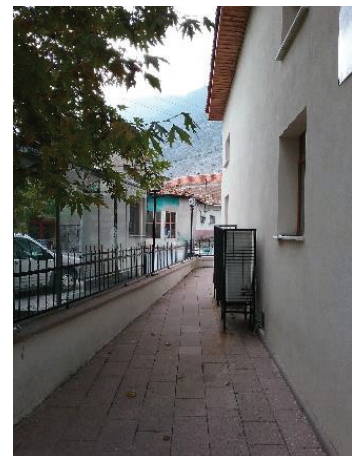
Figure 3.18. Relationship of Kabasakal Mosque and the courtyard's southern part.

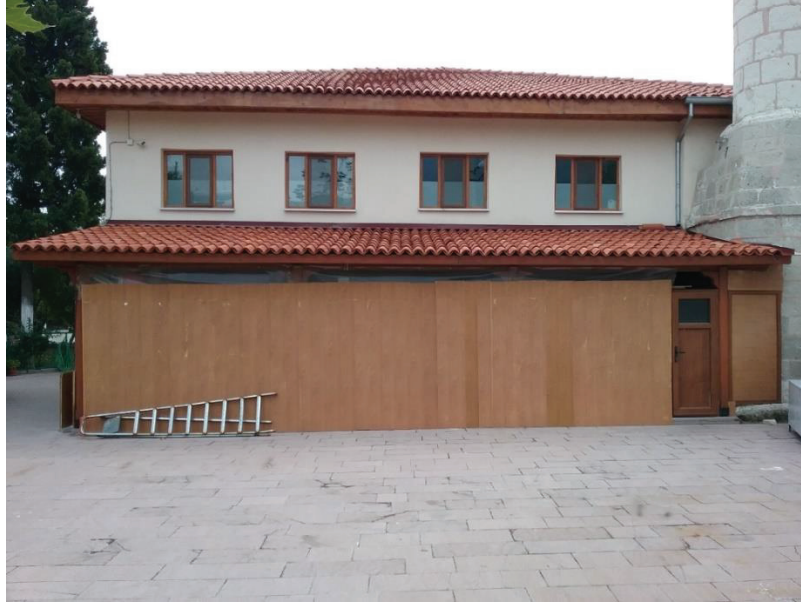
Figure 3.19. View of unqualified last comers' hall mass adjacent to the Mosque mass at its north.

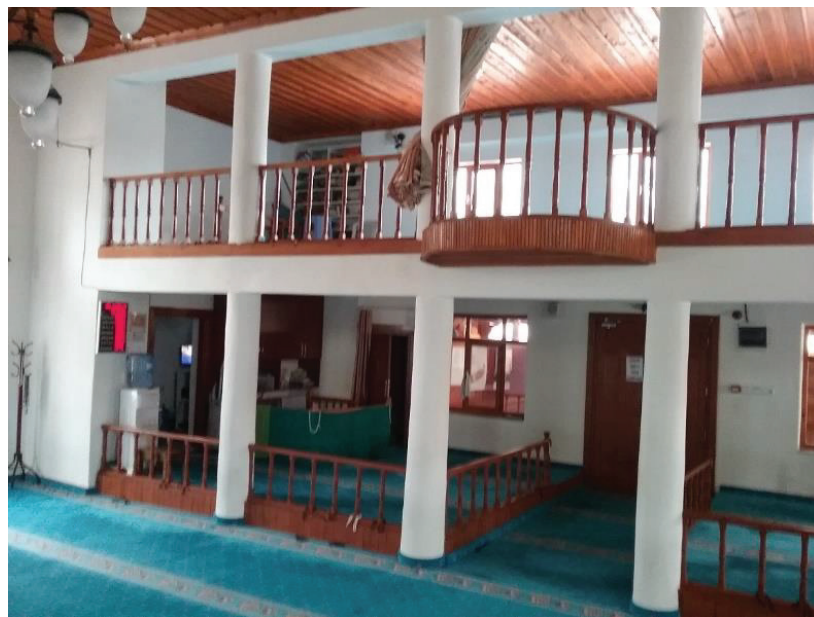
Figure 3.20. Spaces and elements at the northern part of the prayer hall.

The symmetrical planned mosque is composed of rectangular planned prayer hall (~10 x 7.8 m) flanked by the colonnaded space with a gallery floor for women; rectangular planned *mahfil* for women (Figure 3.20). Colonnaded space with a gallery

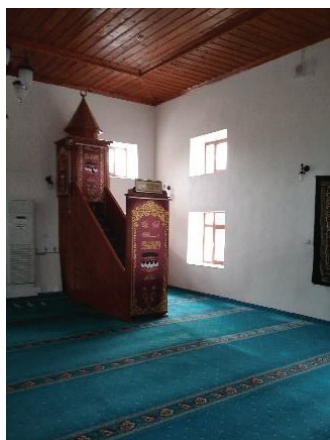
Figure 3.21. New timber *minber*.

Prayer hall is entered from the additional mass, and *imam* room and stair well is entered from prayer hall. Minaret is reached from the stairwell. Stairwell is also related with the last comers' hall; a door placed at their shared diagonal wall. The prayer hall, women's section and last comers' hall are covered with a flat timber ceiling, and their hipped roof with new over and under tiles. Fenestration of the eastern, southern and western walls is composed of upper and lower registers. They are new and slightly widened: upper is ~120 x 75 cm and lower is ~120 x 130 cm. Window numbers at the western and eastern walls are not equal. There are two western and one eastern timber *mahfils* for *müezzin* at the colonnaded space of the prayer hall. In addition to them, the *mihrab* (Figure 3.22) renewed with marble at the southern wall; platform, a timber *minber* (Figure 3.21), and a timber sermon chair in front of southern wall; and an authentic wall
