**ASSESSMENT OF THE INTERVENTIONS
REGARDING SOME HISTORICAL MOSQUES IN
MANİSA WITHIN THE FRAME OF
CONSERVATION VALUES**

**A Thesis Submitted to
the Graduate School of Engineering and Sciences of
İzmir Institute of Technology
in Partial Fulfillment of the Requirements for the Degree of**

in Architectural Restoration

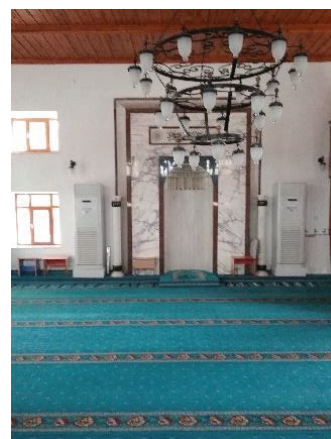
Figure 3.22. New *mihrab* niche and air conditioners on both sides.

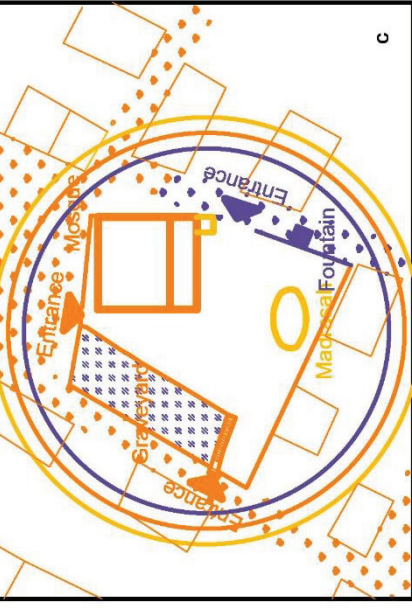
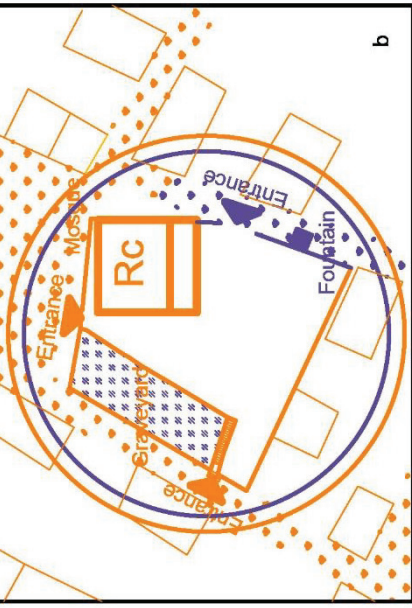
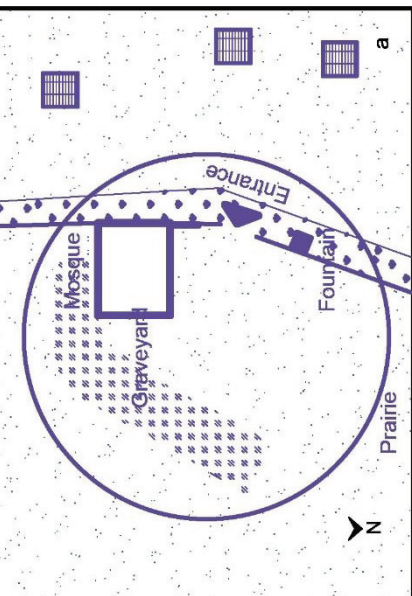
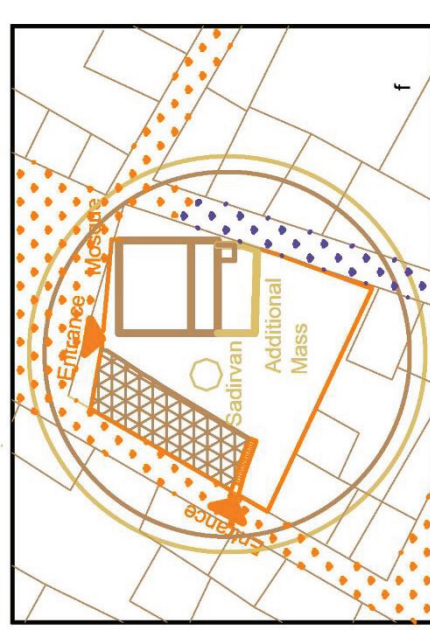
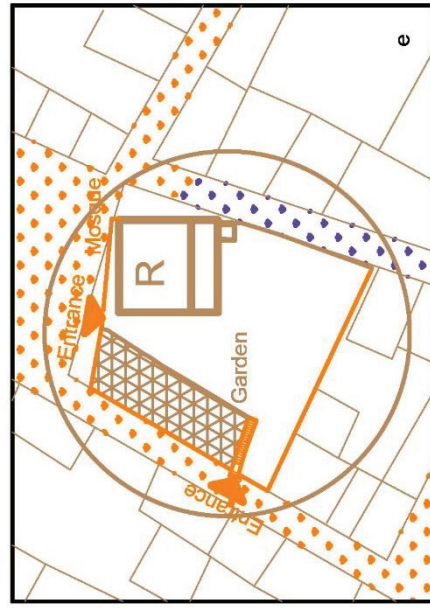
- 1500s
- 1800s
- 1900s
- 1919
- 1968
- 1986
- 2005
- After 2014

Soma earthquake dated to 18th of November 1919 caused damages to the mosque mass and its minaret, madrasah rooms, graveyard and the residential area around the mosque (BUKOERIRETMC n.d.) (Figure 3.23d). Madrasah rooms, graveyard and *kalemişi* on the interior parts of the walls should had been lost in this period. The mosque was repaired after the earthquake; hipped roof, horizontal or squarish windows and western courtyard wall without an entrance were applied.

Development plan was prepared in 1968 (Figure 23e).

In the following process, *şadırvan* dated to 1985 and a service mass at the north of the mosque were added (RDPF 1986) (Figure 23f).

In 2005, the additional service mass at the north was altered with additional unqualified huge ablution space, a dining hall and an *imam*'s house (RDPF 2005) (Figure 23g). Authentic last comers' hall space was included into the praying hall for the enlargement of the closed space of the mosque (Figure 23g). Additional *mahfils* for *müezzins* were provided in this enlarged part and from now on, authentic *mahfil* for women was started to be carried by concrete columns. Stairs reaching to the *mahfil* for women were replaced and was placed at the northwestern part of the prayer hall and in a stairwell. An *imam* room and an additional door was added under the stairs. Marble

Application of restoration project of RDPF is dated to 2009 (Figure 23h). The additional unqualified mass was removed. Prayer hall was sustained as enlarged. Removal of additional unqualified masses, unqualified gypsum interior casings, ornamentations on the walls and concrete balustrades at the courtyard; addition of over and under roof tiles to *şadırvan*, addition of the stone capping on the western courtyard wall, addition of brick infill to the north of the *mahfil* for women, addition of four windows to the north of the *mahfil* for women, addition of plastering on the authentic part of the western courtyard wall, addition of the unqualified last comers' hall mass, addition of daily life objects such as plastic tabourets, air conditioner, tapestry, lighting elements, benches, etc., and addition of the iron balustrades to the courtyard; alteration of marble *minber* and sermon chair with timber, alteration of PVC joinery with timber joinery, alteration of lighting elements by hiding their cables, alteration of concrete parts of the *şadırvan* with timber, alteration of ceramic floor covering at the courtyard with andesite covering, alteration of concrete stair reaching to the *mahfil* for women with timber stair, alteration of ceiling covering: gypsum board panel with timber ceiling covering, alteration of the walls between the concrete columns with timber balustrades, alteration of the concrete eave of the roof with timber eave and alteration of the location of the northern wall of the prayer hall applied as proposed, alteration of ceramic floor covering with andesite at the courtyard, alteration of form of the garden, alteration of the material of the top of the *mihrab* (*kavsara*): marble with plastering, and alteration of additional two windows with brick wall infill at the eastern wall of *mahfil* for women and *müezzin mahfili* not realized, and alteration of organisation of the elements of the roof of the prayer hall with unobserved application state; cleaning of marble sill, cleaning of the timber coverings and marble coverings on the walls, cleaning of ceramic tile floor covering at the entrance of the prayer hall, cleaning of the plastering at the *kaide*, *pabuç* and body of the minaret, cleaning of the travertine coverings on the façades and cleaning of the plastering at the cornice of *şerefe*, *şerefe* and *petek* of the minaret applied as proposed, and cleaning of the plastering at the authentic part of the courtyard wall adjacent to the minaret not applied; renewal of the plastering at the walls, renewal of the altered timber coverings on the floor, renewal of the additional timber baseboards, renewal of the deteriorated timber main entrance door, renewal of the lead covering *külâh* of the minaret, renewal of the door for *şerefe* realized as proposed, and renewal of the drainage system

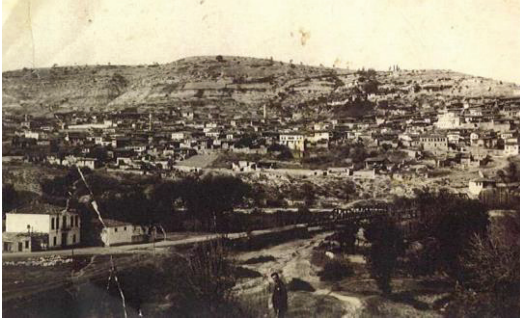
Figure 3.24. Old Gördes, unknown date.

The city faced various disasters during its history. Greek Neighborhood was burnt in 1817 (Bayram 2008, 31). The second great fire dated 1868 affected the whole city; all of the religious buildings, public buildings, houses, etc. were burnt and they were reconstructed after the fire (Figure 3.24). The third fire was realized in 1921; old Gördes was burnt totally by Greeks as the first city in Western Anatolia (İlker et al. 1999, 32). As a result of disasters and the Turkish War of Independence, people were poor and could not rebuild their buildings strong (İlker et al. 1999, 266). The Roman canal system became clogged after the disasters and could not be cleaned out. Rain water could not be taken away and landslide occurred in the old Gördes in 1940. Houses started to collapse at different time intervals. The city was moved to north, a 100-150 m highest point in

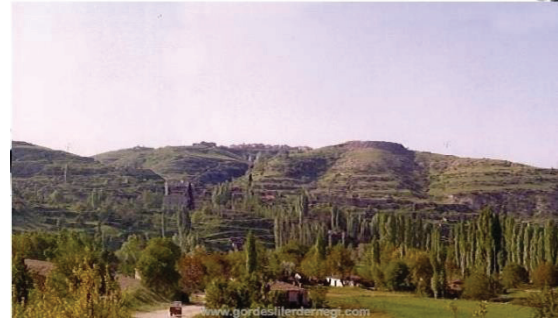
Figure 3.25. Old Gördes after abandonment.

between 1948-1966. This made the city abandoned and dilapidated. There are no archaeological excavations in the old city. Ruins are disappearing gradually. Only Pazar Mosque was restored and reintegrated in 2013. Except from the house at the east of the mosque, there are no old Gördes buildings used by the people today (Figure 3.25).

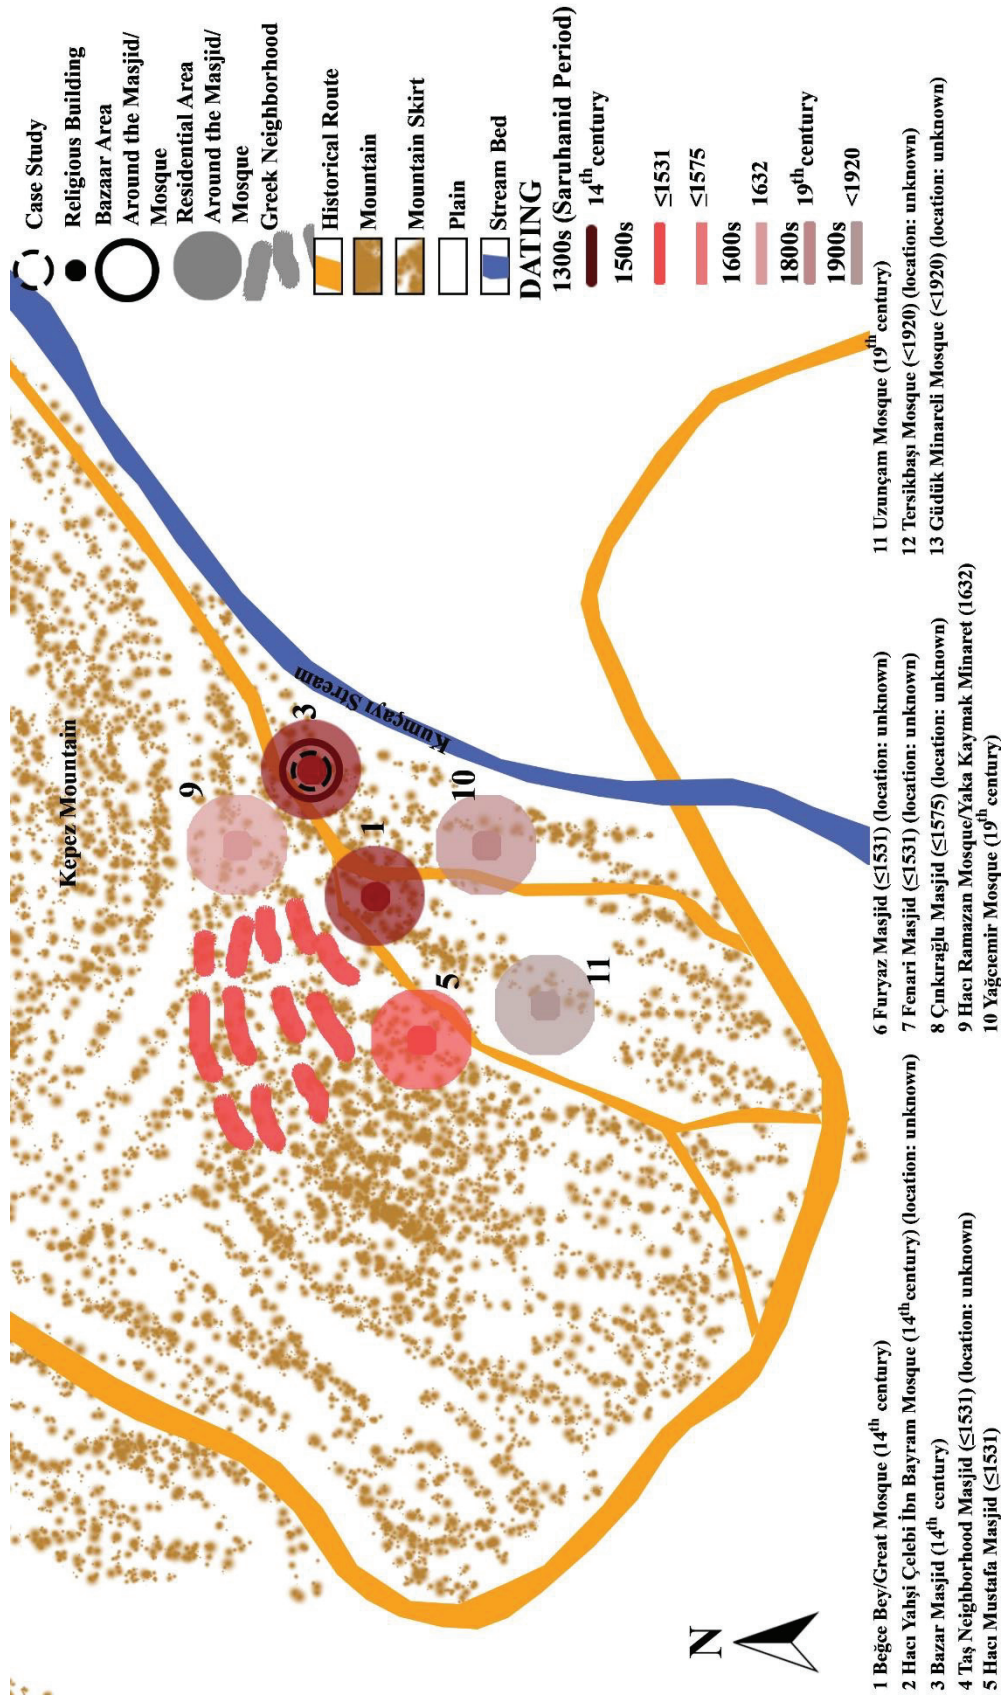
Figure 3.26. Urban development around masjids/mosques in Gördes centre.

Gördes is a district of Manisa City. It is placed at the northeast of Manisa city centre, and eastern hill skirts of Kepez (Tekke) Mountain today. Old Gördes was placed at the 2.5 km far from this area towards south (İlker et al. 1999, 274) and by stream side of Kumçayı (Figure 3.26).

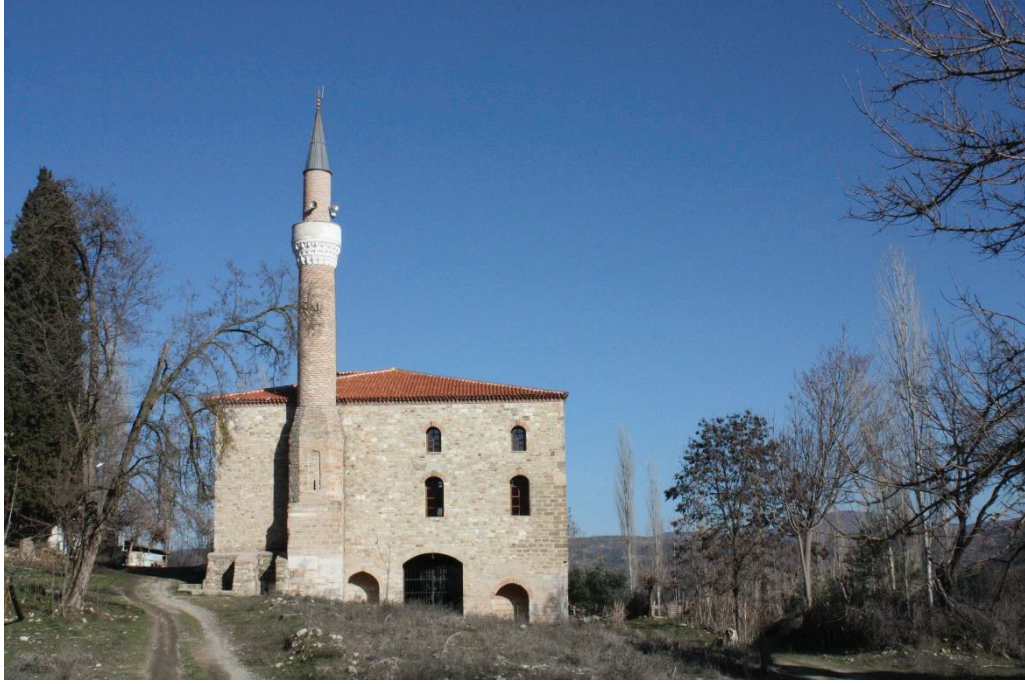
Figure 3.27. View of Pazaryeri Mosque and the surrounding site from the west.
(Source: Büyükkılıç-Koşun 2018)

Pazaryeri Mosque is located in Atatürk Neighborhood, Gördes District, in Manisa. It is placed in an abandoned area, between two routes branching out of the same route. The site is composed of building ruins in a forested area. Almost all of the buildings date to 1900s. The layout of the area is illegible. The mosque is bordered by roads from its southern and northern sides, by a house from its eastern side, and by an empty area from its western side (Figure 3.27).

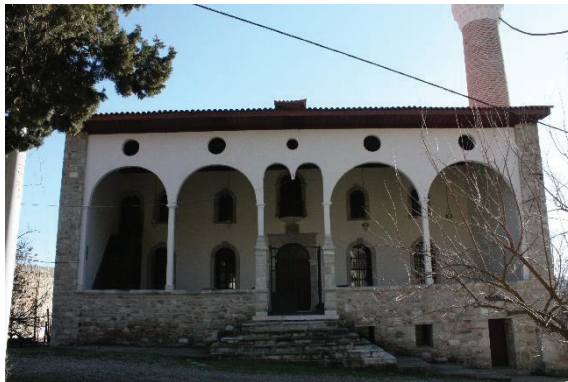
Figure 3.28. View of Pazaryeri Mosque's last comers' hall at its north.

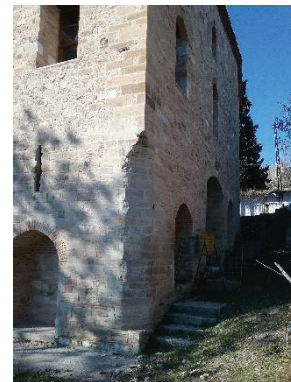
Figure 3.29. View of Pazaryeri Mosque's eastern façade.

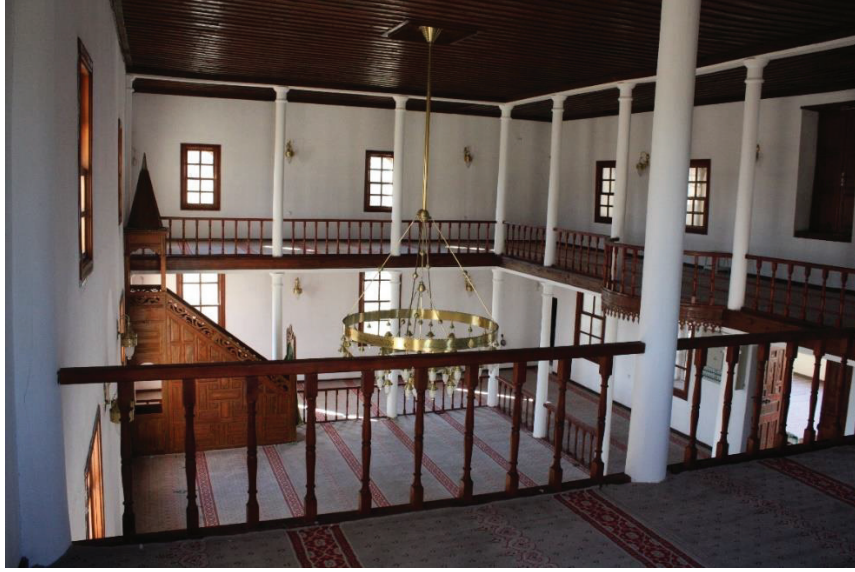
Figure 3.30. Interior space of the prayer hall and *mahfil* for women mass of Pazaryeri Mosque.

The symmetrical planned mosque is composed of longitudinal planned rectangular prayer hall and U shaped gallery floor placed at the eastern, western and southern sides (Figure 3.30). This is the *mahfil* for women. A rectangular planned last comers' hall mass at the north and a minaret is adjacent to both of the northwestern corner of prayer hall and southwest corner of the last comers' hall. The elevated prayer hall is reached from the last comers' hall (Figure 3.28) and the minaret is entered from the prayer hall. A timber staircase at the last comers' hall provides access to the *mahfil* for women and it is entered by a timber door. Last comers' hall is reached by stone steps at its north and it is entered by an iron door.

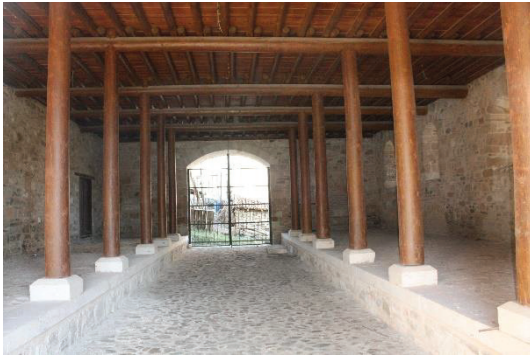
Figure 3.31. Colonnaded passage of Pazaryeri Mosque.

The mosque has other spaces under these spaces: colonnaded semi-open passage space placed east-west axis (Figure 3.31) and entered by the doors with iron balustrades, and the space at its north entered by two doors at the passage space, and a door at the north, under the last comers' hall's floor level. The prayer hall, women's section and last comers's hall are covered with a flat timber ceiling with a centrepiece ornamentation, and their hipped roof with new over and under tiles. Colonnaded passage is covered with the

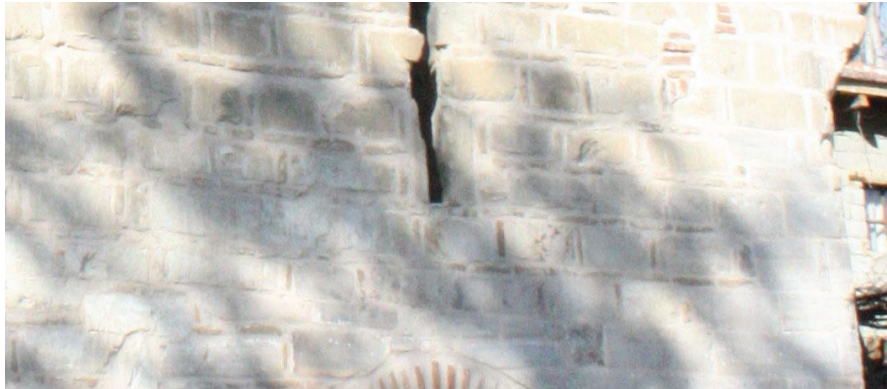
Figure 3.33. A detail from the southern façade showing a row of brick alternating with a cut stone row with a vertical brick between the stones in masonry technique.

Pazaryeri Mosque was built in the bazaar area (Figure 3.35b), in Nakıp Ağa Neighborhood whose former name was Mescid-i Bazar Neighborhood, in the place of Bazar Masjid (14th century) (Figure 3.35a). The mosque should had been constructed before 1753, when the Çarşıbaşı Fountain was built. It should have had a *şadırvan*. In this period, the building was built out of a row of brick alternating with a cut stone row with a vertical brick between the stones in masonry technique (Figure 3.33). Function of the

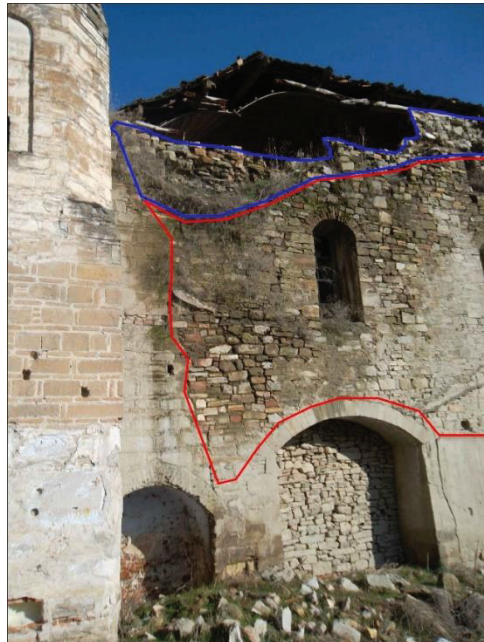
Figure 3.34. Rough stone masonry (blue) and rough cut stone masonry (red) parts of the western wall of Pazaryeri Mosque.

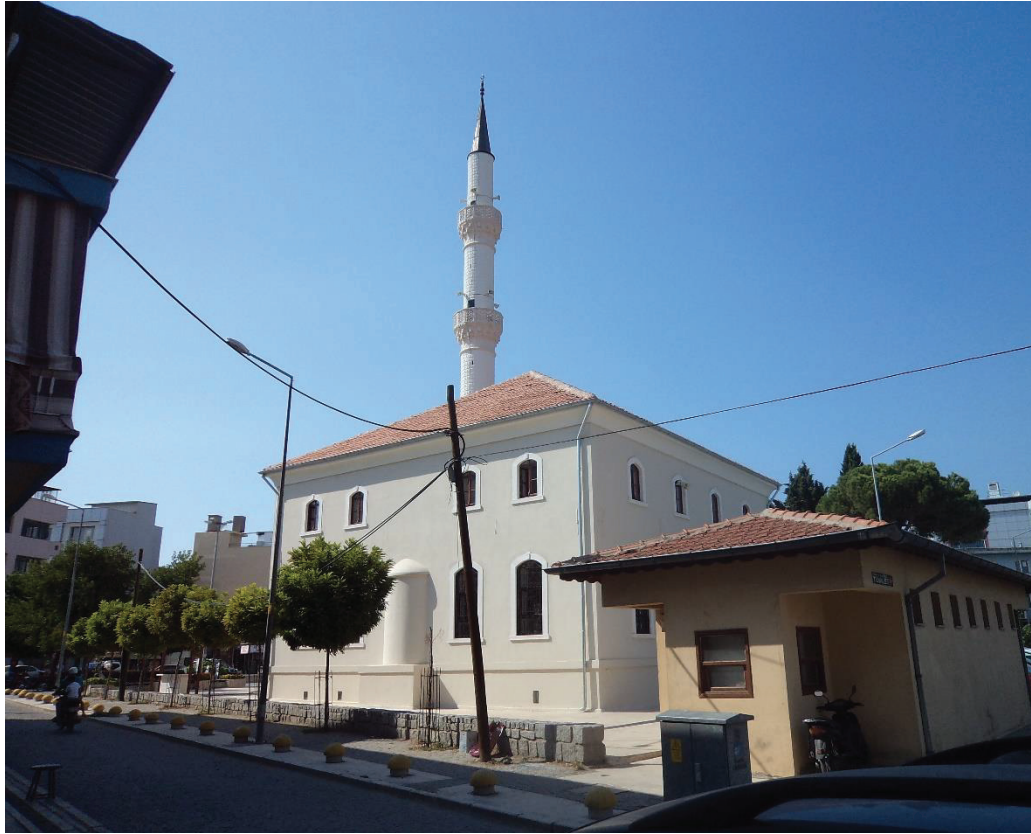
Figure 3.37. View of Çarşı Mosque from the southeast.
(Source: Büyükkılıç-Koşun 2017)

Çarşı Mosque is located in Eski Cami Neighborhood, Salihli District, in Manisa. It is on the Mithatpaşa Street. The area is mostly composed of three to seven storied buildings, which are mostly residential buildings with shops on their ground floors. They date to 1960s-2000s. The area has a gridal layout organized according to 1987 Development Plan. The mosque and its courtyard are bordered by road from its northern, western and southern sides, and by a parking area and a single storied toilet building from its eastern side (Figure 3.37).

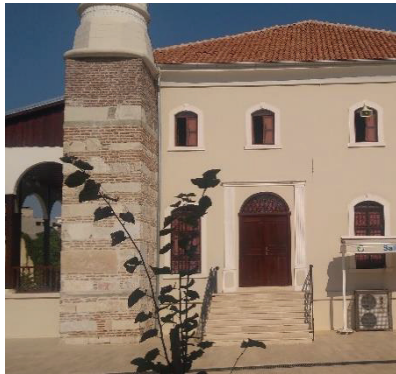
Figure 3.38. Çarşı Mosque as viewed from west.

stone masonry. Mosque mass is elevated from the courtyard's ground level with a basement floor. The prayer hall and the last comers' hall are reached with stairs (Figure 3.38; Figure 3.39). There is an unqualified *şadırvan* repaired in 2011 at the north of the eastern corner of the courtyard. *Musalla* stone is placed at the southwestern corner of the courtyard. There are also trees at the boundaries of the courtyard.

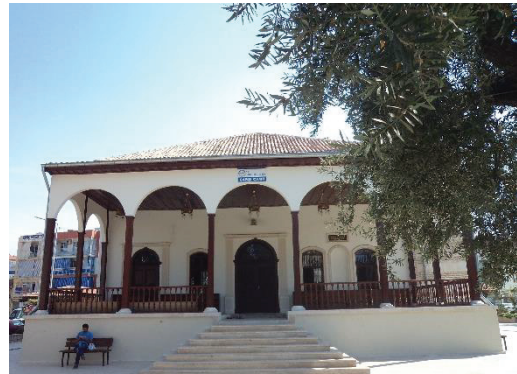
Figure 3.39. Çarşı Mosque as viewed from north.

The Mosque building (Figure 3.39) is surrounded by a courtyard on its all sides. The courtyard is entered from its three sides: eastern, northern and western. However, low height (approximately 40 cm) of the courtyard wall makes entering to the courtyard from everywhere possible. Eastern, northern and western parts of the courtyard wall are composed of benches and flowers in the pots. The southern courtyard wall is made out of

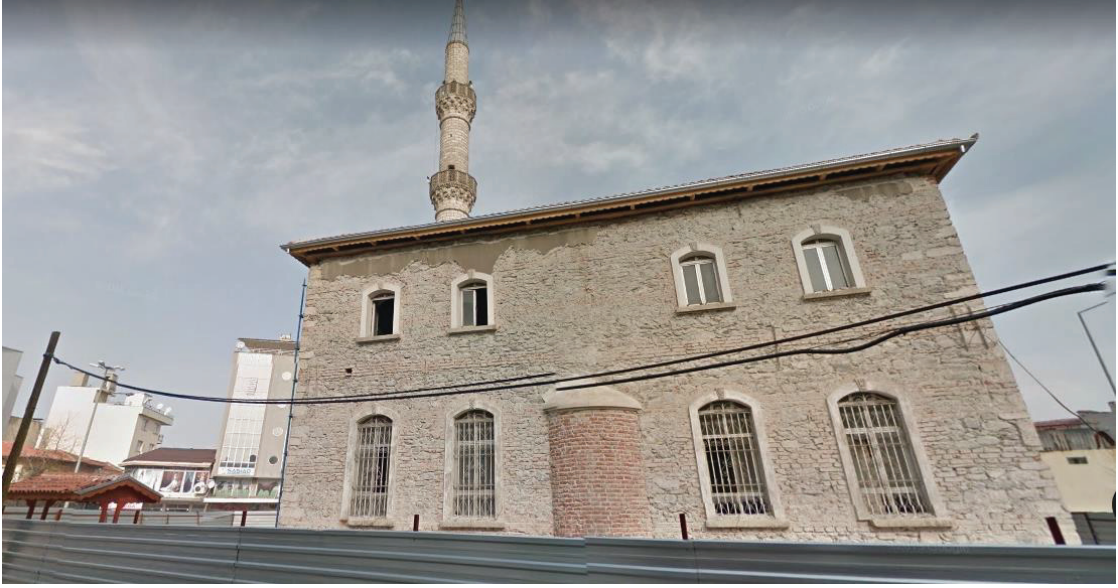
Figure 3.41. Construction technique of the wall, Çarşı Mosque.
(Source: Google Maps 2015)

Prayer hall and *mahfil* for women is covered with a hipped roof. Last comers' hall is covered by a lean-to roof. The walls of the prayer hall are out of rough stone in masonry technique approximately 110 cm alternating with four rows of brick (Figure 3.41) and covered with plaster at the interior. The dome, columns, arches and floors at the prayer hall and last comers' hall are made out of timber (Figure 3.40). The ones at the prayer hall are plastered also. Minaret elements are plastered and painted except the *alem*, *külâh* and *kaide*. *Külâh* is covered with a new metal sheet and *alem* is made out of metal.

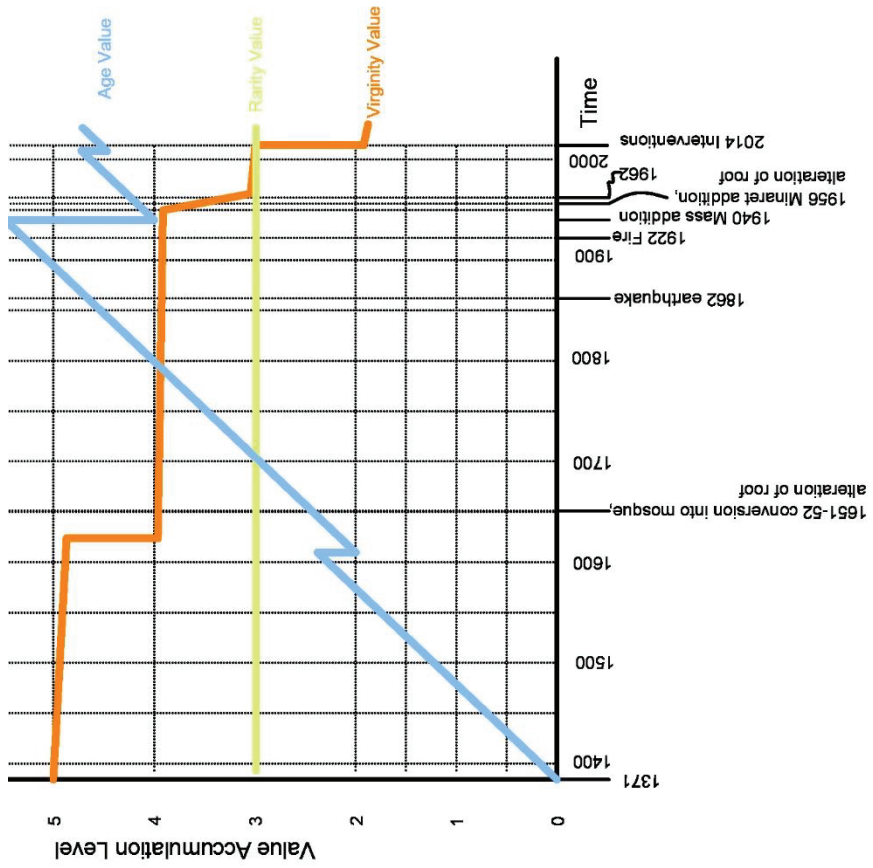
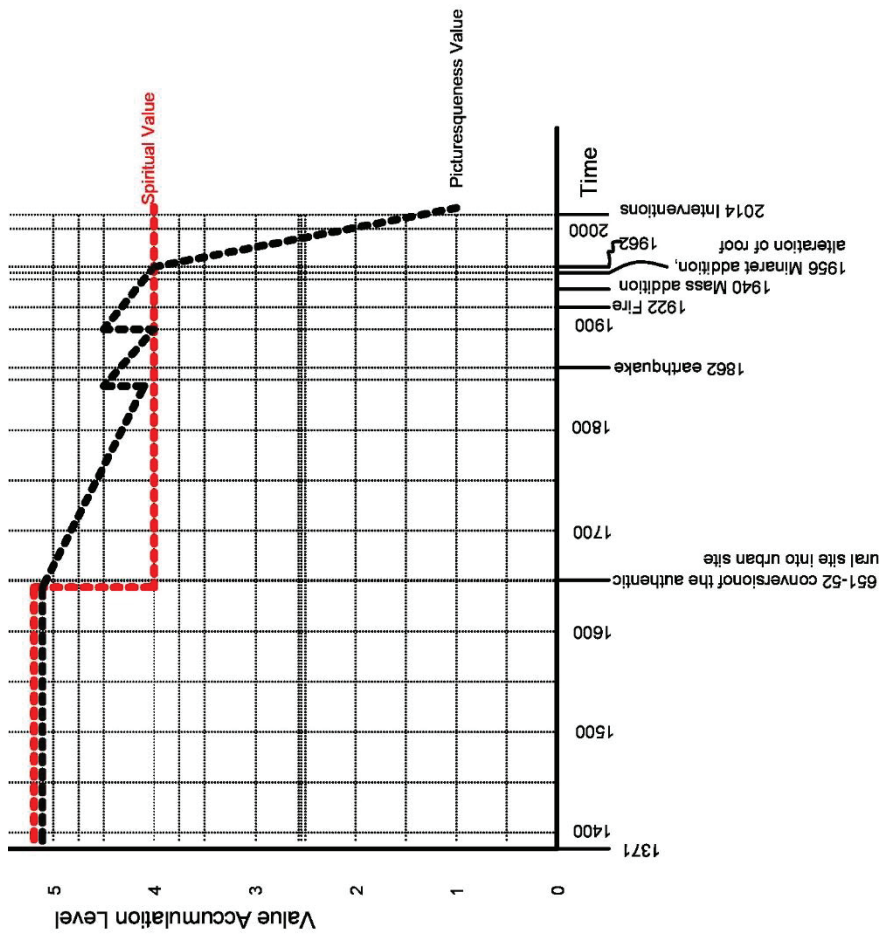
Figure 4.11. Value accumulation levels in site (left) and building (right) scales of Haki Baba Mosque.

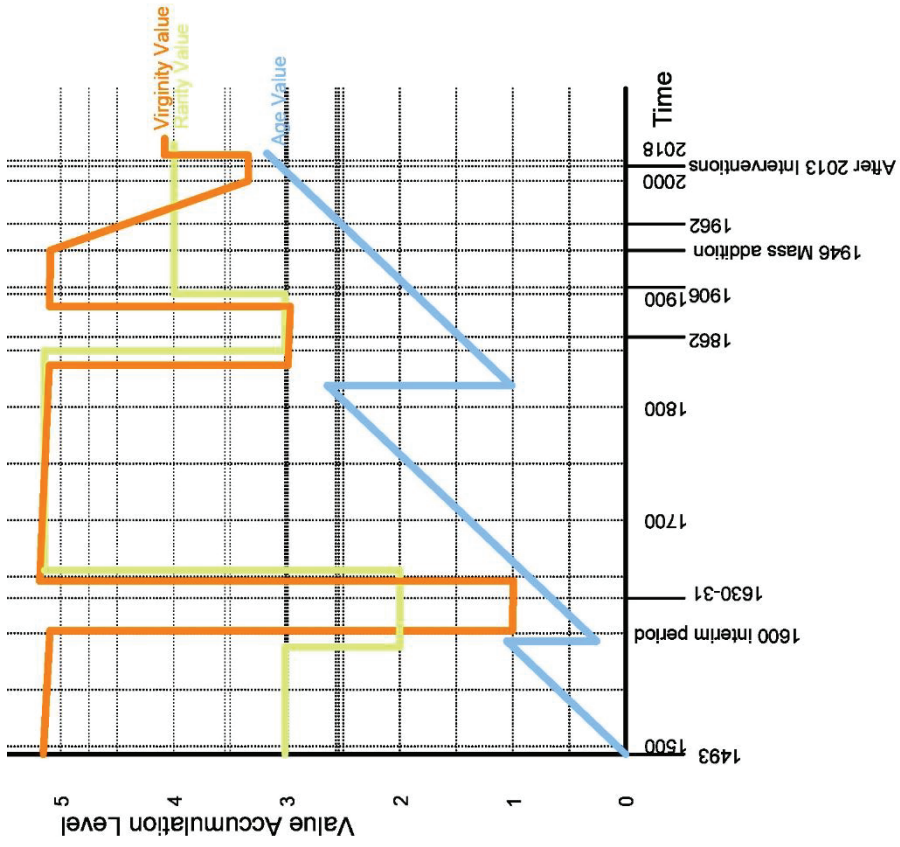
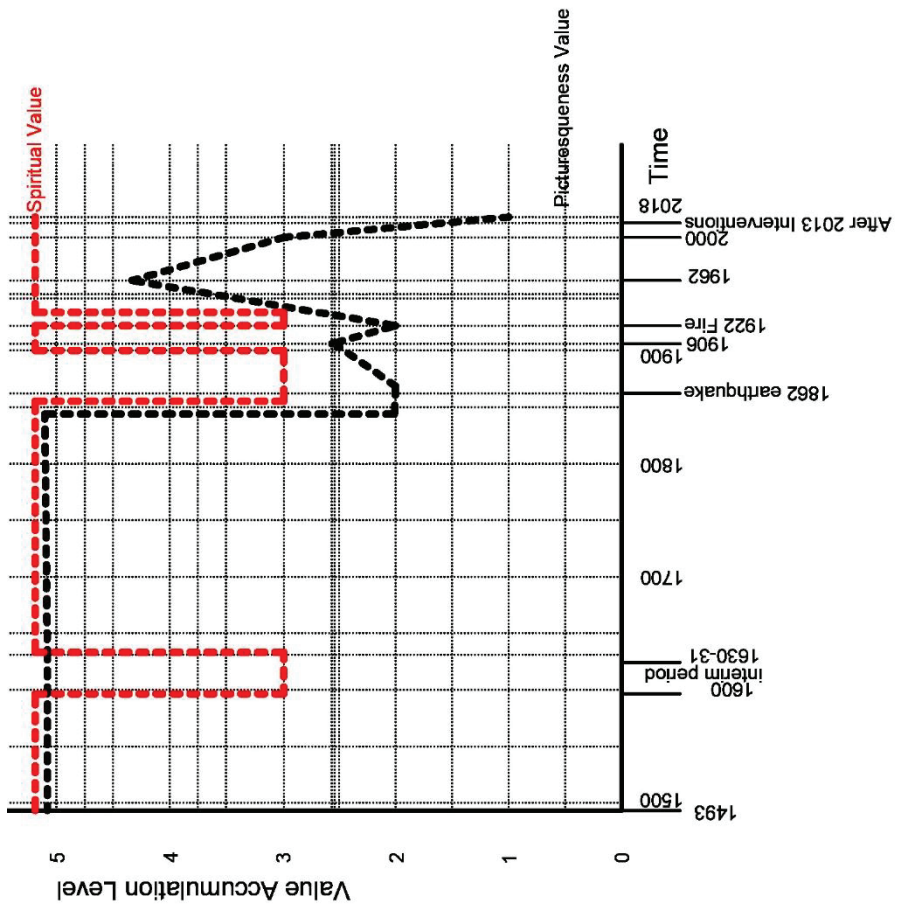
Figure 4.12. Value accumulation levels in site (left) and building (right) scales of Göktaşlı Mosque.

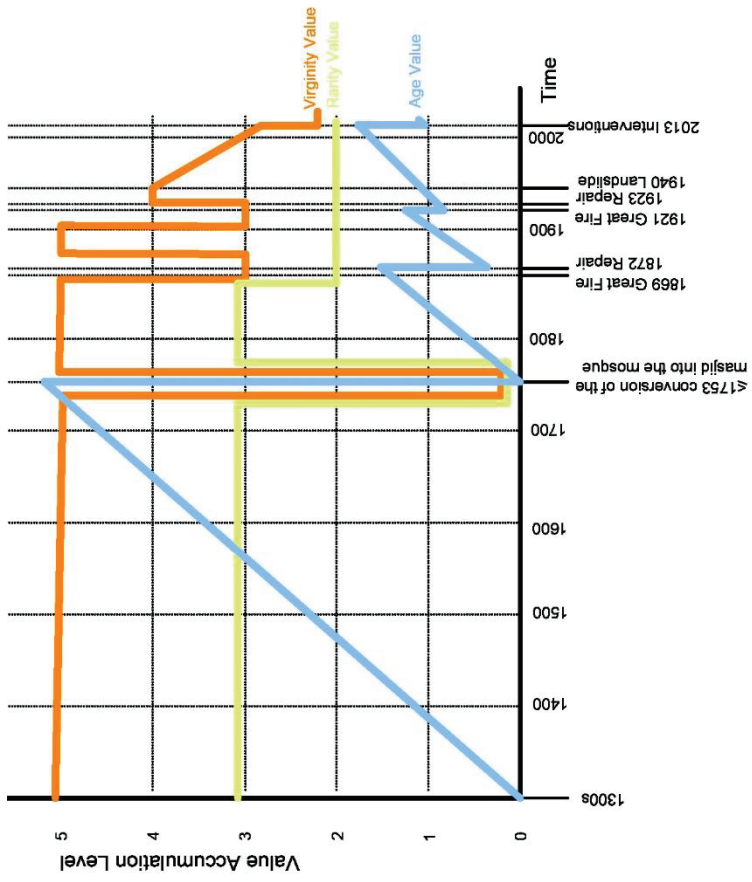
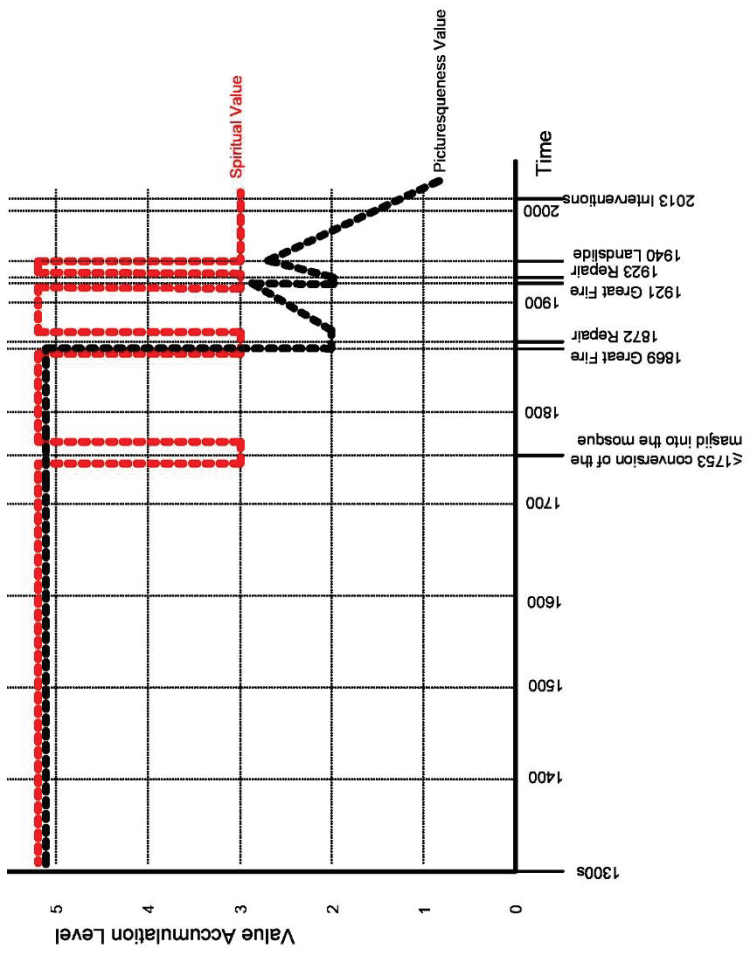
Figure 4.14. Value accumulation levels in site (left) and building (right) scales of Pazaryeri Mosque.

Building scale values of Pazaryeri Mosque were re-established except for age value at the conversion of 14th century masjid into 18th century mosque (Figure 4.14). Overall building scale values were hindered again by 1869 fire, and then by 1921 fire (excluding rarity value), respectively. Virginity value was re-established after 1869 fire and the following reintegration according to the taste of intervention period. Qualified interventions according to taste of 1870s were realized: an elevated mosque with semi-open arched last comers' hall and with U shaped *mahfil* for women carried by timber posts. Pazaryeri Mosque was reintegrated in 1923 as mostly appropriate to its state in 1872; stone masonry walls were added to its eastern and western sides, and a cap was added to its roof as unqualified additions only. Thus, virginity value could be re-established to some extent.

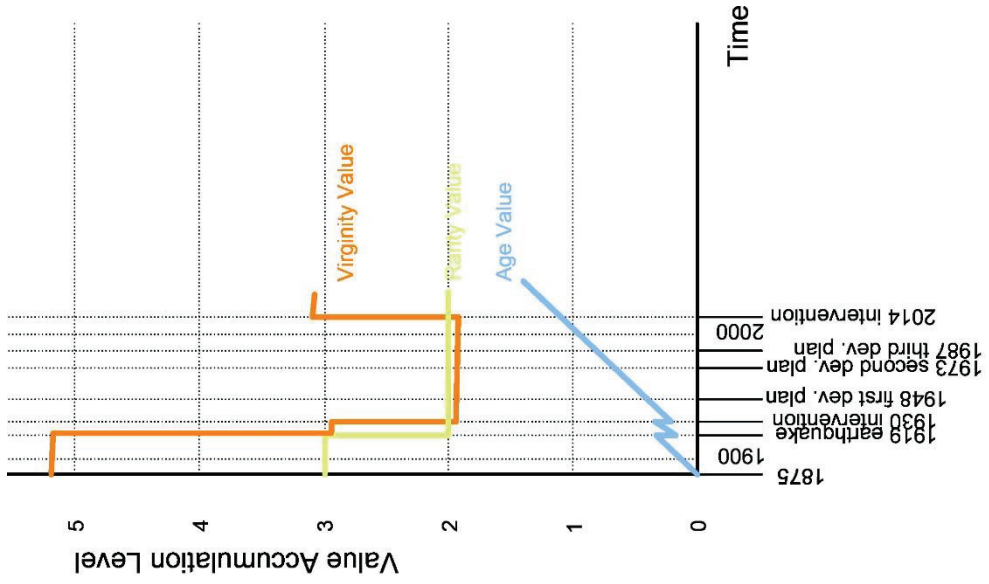
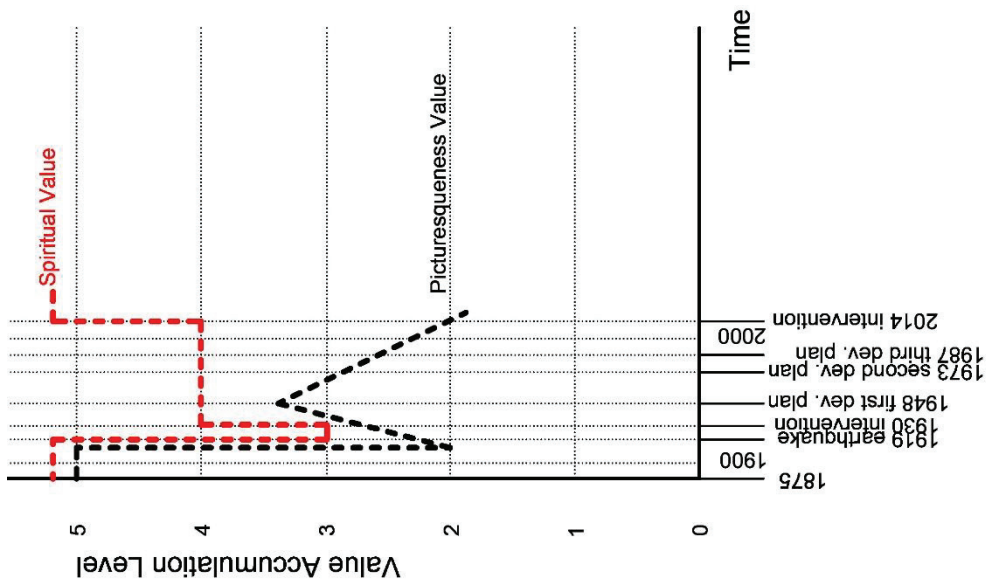
Figure 4.15. Value accumulation levels in site (left) and building (right) scales of Çarşı Mosque.

As a result of period by period evaluation of Çarşı Mosque (Figure 4.15), it is understood that its site values were mostly affected by a disaster; an earthquake. Decrease in its spiritual and picturesqueness values are seen at this period; in 1919. The mosque respected as a veneration object throughout its life span was started to be used after 1930 interventions following the destruction in 1919. However, its reduced spiritual value could not be re-established completely caused by additional functions until 2014 interventions removing them. The process of application of development plans that started in 1948 was the deathblow for picturesqueness value; they changed the site irreversibly.

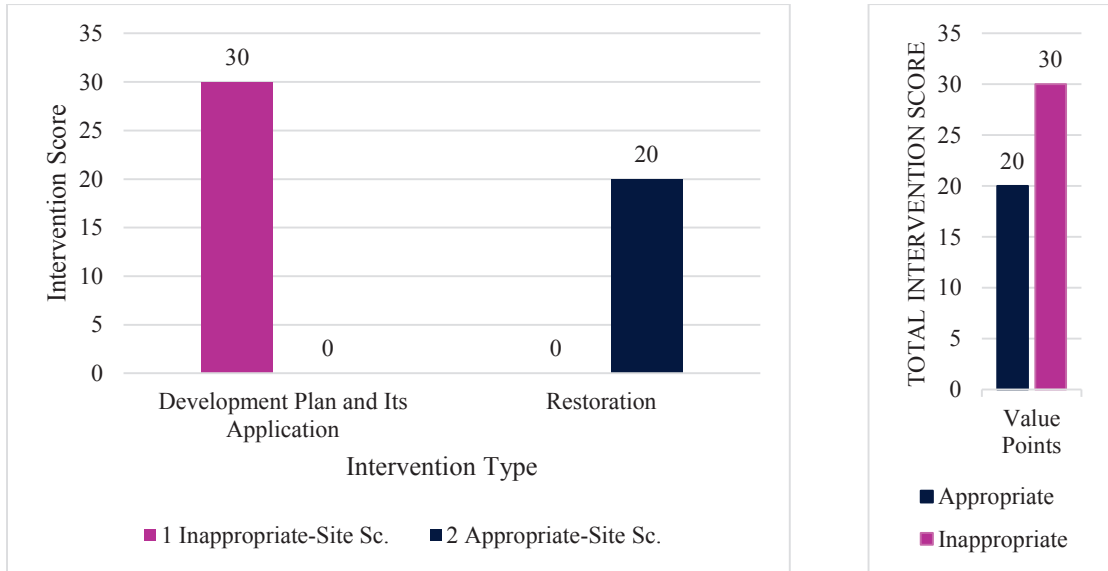
Figure. 4.16. Intervention scores for the neighborhood of Haki Baba Mosque.

The majority of site scale interventions' (Table 4.1) impact on Haki Baba Mosque are inappropriate (-30 points) (Figure 4.16), in turn, they have reduced the overall site scale value points 2 grade (Figure 4.17). Inappropriate planning giving way to urban development on the historic site resulted in the conversion of the traditional site into a dense urban site. This irreversible intervention caused 2 grades reduction in the picturesqueness value points (Figure 4.17). The restoration design of Haki Baba Mosque in terms of presentation of its courtyard as an urban void for spiritual relaxation was appropriate (+20 points). However, sustaining of its unqualified last comers' hall mass filling the courtyard made it inconsistent. Maintenance of the building contributed to the

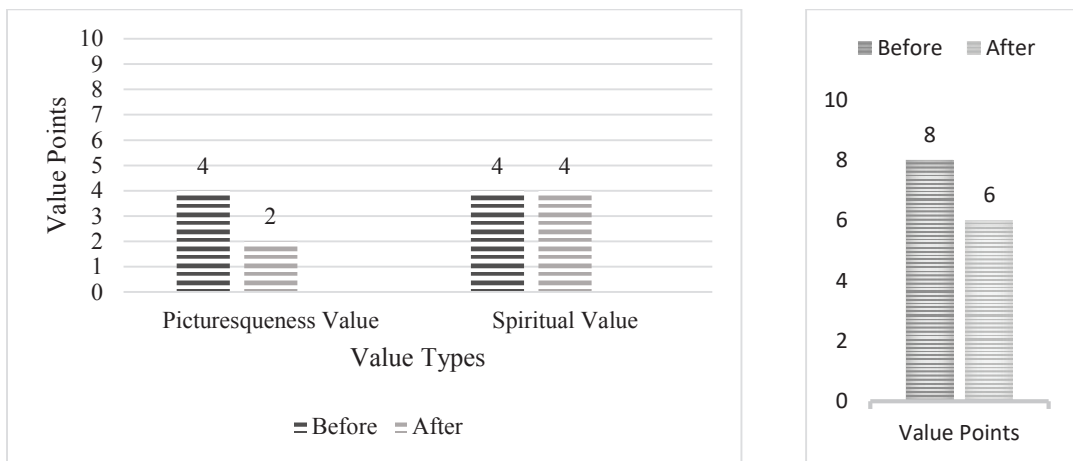
Figure 4.17. Site scale value points for each value type (left), and total site scale value points (right) before and after the latest urban interventions, Haki Baba Mosque.

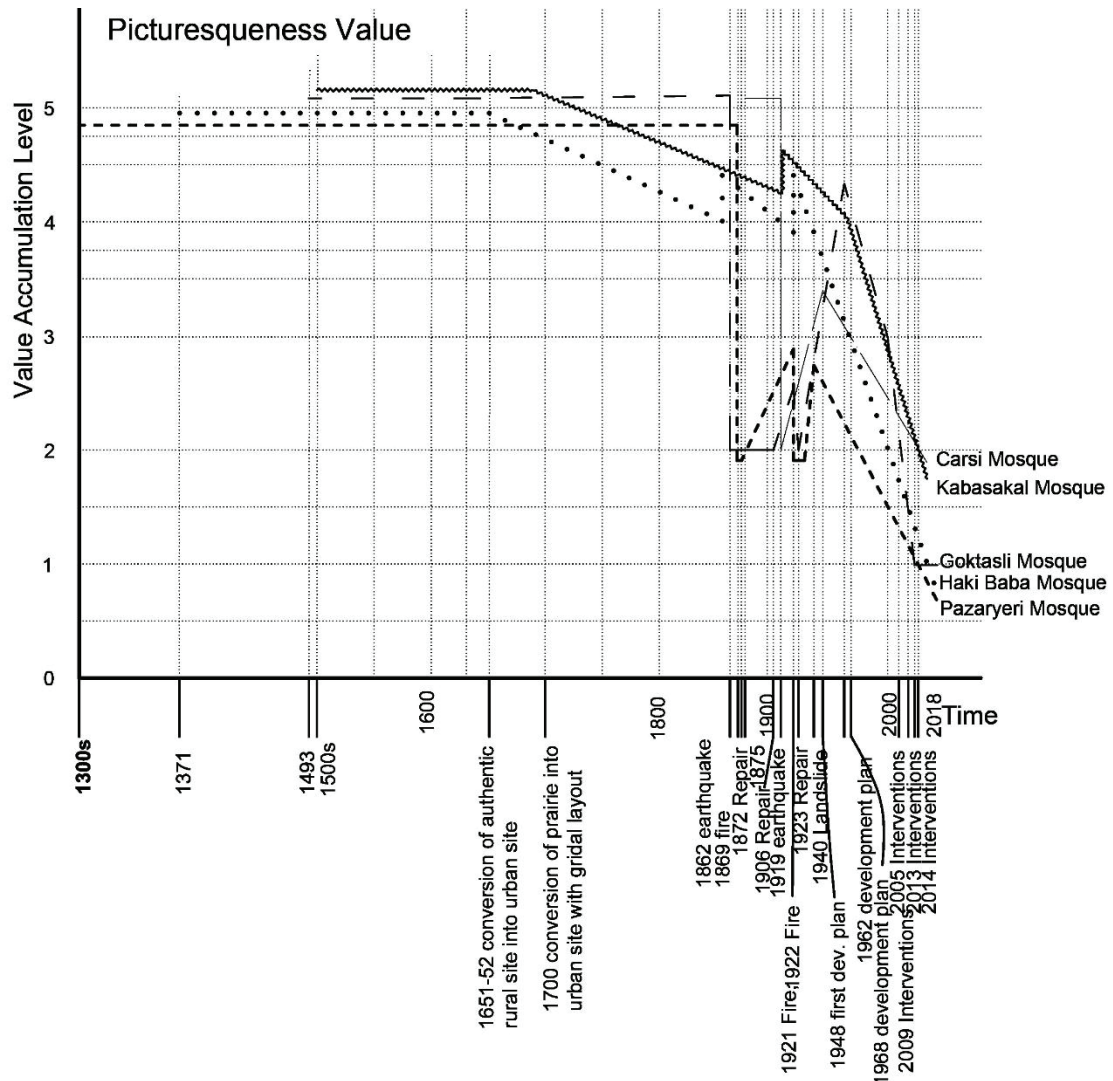
Figure 5.1. Comparison of the accumulation of the picturesqueness values.

If the picturesqueness value accumulations of the case study mosques are investigated (Figure 5.1), it is seen that the mosques sustained their picturesque environments for centuries until the modernisation. One alteration type in this traditional period is conversion of rural sites of mosques into urban ones (2/5; Haki Baba and Kabasakal Mosques). The second alteration type of the traditional period is partial demolition caused by disasters. Earthquakes (4/5; excluding Haki Baba Mosque) and fires (3/5; excluding Çarşı and Kabasakal Mosques) gave way to losses in the aesthetic qualities of the sites, but the sites were repaired and maintained in order to re-establish their qualities in the later years. Nevertheless, the development plans of the modern era gave way to irreversible loss of the picturesque sites (4/5; excluding Pazaryeri Mosque and its site which was abandoned). The growing population in Manisa and its hinterland was settled on the traditional urban land, instead of defining new settlement zones (Karakuyu 2005, 96).

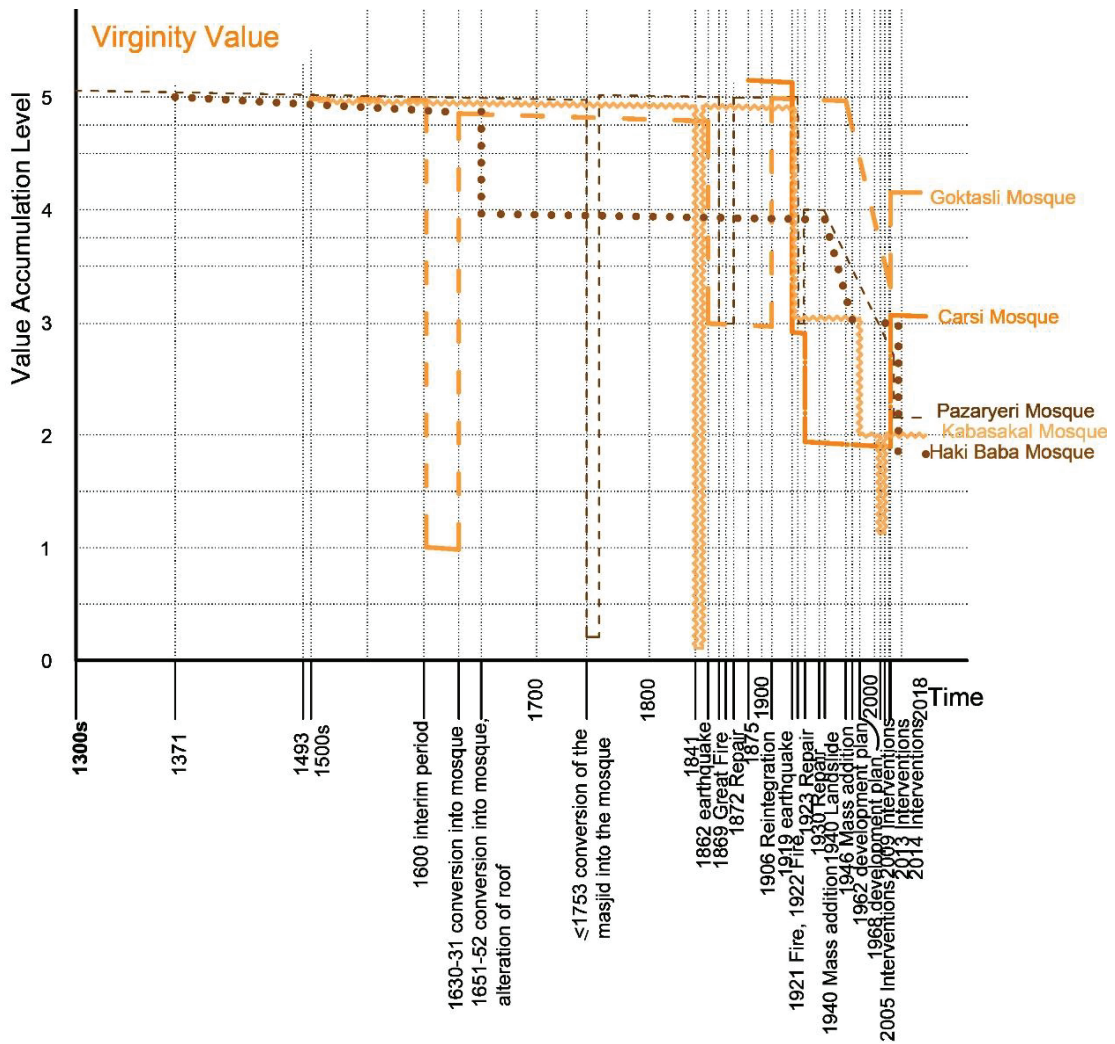
Figure 5.3. Comparison of the accumulation of the virginity values.

Conversion as seen at the Göktaşlı, Pazaryeri and Kabasakal Mosques (3/5) by establishing a new, qualified holy space with the taste of time caused these monuments to continue their new lives with fully accumulated virginity values (Figure 5.3). Disasters (4/5; excluding Haki Baba Mosque) and unqualified contributions such as a blind mass at the entrance façade of Kabasakal Mosque at 2005 interventions damaged the virginity values of the mosques, qualified contributions such as 1906 reintegration of Göktaşlı Mosque and 1872 reintegration of Pazaryeri Mosque (2/5) can re-establish virginity value. In order to fulfill the needs of the growing population, mass additions were made to the lots of the mosques (4/5; excluding Pazaryeri). Current waqf restorations either sustained these additions (2/5; Göktaşlı and Haki Baba) or the additions were removed (2/5; Kabasakal and Çarşı). However, addition of a new mass was also realized after restoration by the community in an illegal way (1/5; Kabasakal). Göktaşlı Mosque is the most virgin case exhibiting its artistic qualities from the fifteenth century onwards. The current mass addition at its entrance and unpresentation of sampling excavation results are the major causes of reduction of its virginity. In the other examples, interventions had been more radical such as addition of huge masses on both sides of Çarşı Mosque, and inappropriate alteration of its last comers' hall and original façade characteristics; Çarşı and Kabasakal Mosques had slightly regained their virgin mass qualities after current restorations. Haki Baba Mosque had further lost its virgin constructional qualities while Pazaryeri Mosque's unqualified additions such as opening at the roof and walls at its last comers' hall have been sustained besides loss of its patina of age completely. Thus, Haki Baba could not re-establish its virginity value in spite of the interventions altering the unqualified additional masses in the lot for an appropriate presentation of lacunae of the courtyard.
