**ASSESSMENT OF THE INTERVENTIONS
REGARDING SOME HISTORICAL MOSQUES IN
MANİSA WITHIN THE FRAME OF
CONSERVATION VALUES**

**A Thesis Submitted to
the Graduate School of Engineering and Sciences of
İzmir Institute of Technology
in Partial Fulfillment of the Requirements for the Degree of**

in Architectural Restoration

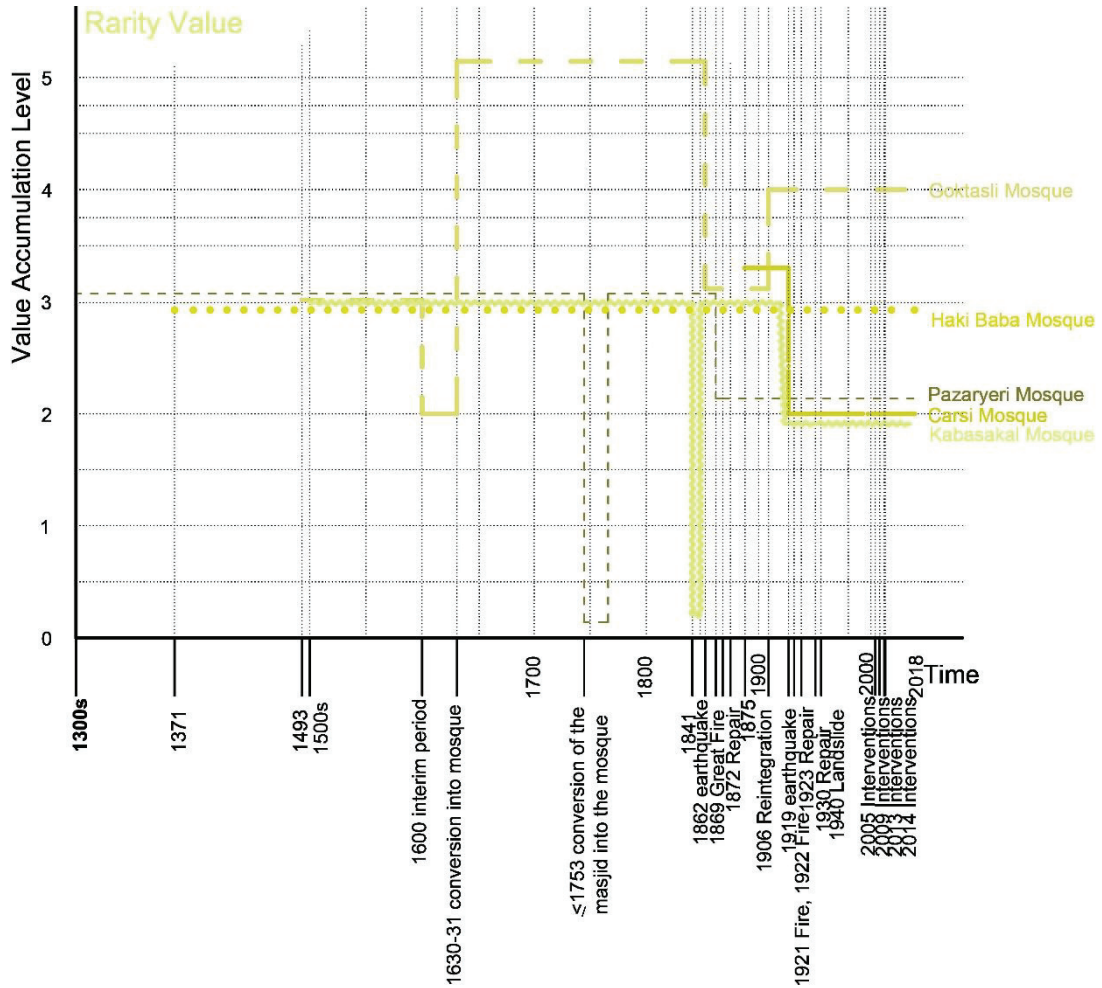
Figure 5.4. Comparison of the accumulation of the rarity values.

The case study mosques have rarity values at average level (5/5) at their first construction period. Rarity value comparison graphic shows that disasters or abandoned state after a disaster resulting in the loss of the third dimension of the mosques cause to decrease in their rarity values (Figure 5.4). The mosques which have

regained their rarity value at average level after the temporary diminishment at their conversions (2/5; Pazaryeri and Kabasakal Mosques), Göktaşlı Mosque which have become with fully accumulated rarity value after the temporary diminishment at its conversion, and Çarşı Mosque faced to disasters; their rarity values become decreased; and could not be fully re-established throughout their lives. Haki Baba Mosque sustained its rarity value without any diminishment.

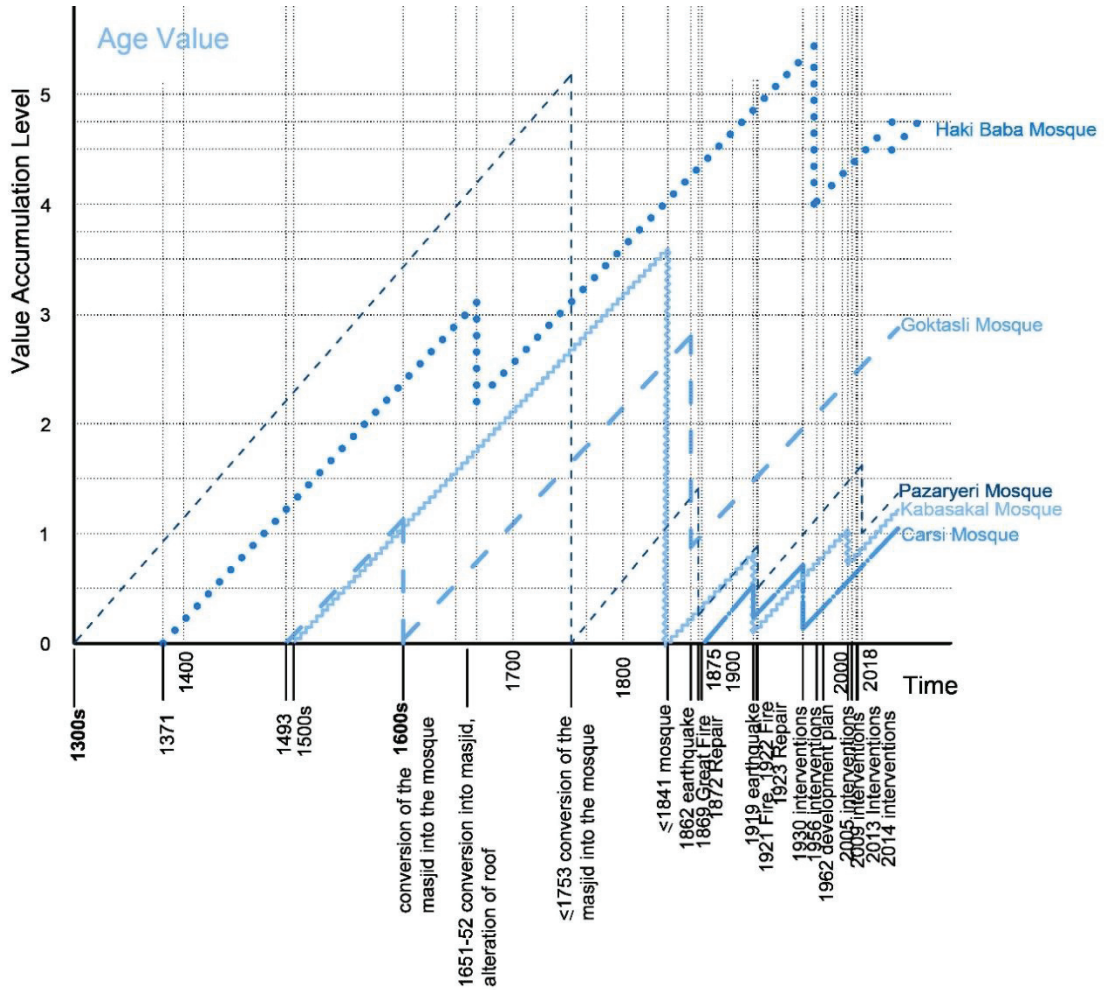
Figure 5.5. Comparison of the accumulation of the age values.

Age value is established with the passage of time. Conversion of the monuments, disasters and interventions causing the loss of the aged parts; trace of the longness of the mosques' life spans such as renewal of the *külâh* of the Göktaşlı Mosque, removal of

authentic posts carrying the eaves of Haki Baba Mosque, alteration of the earthen flat roofs of Haki Baba and Kabasakal Mosque with timber hipped roofs, etc. result in the loss of age value (Figure 5.5).

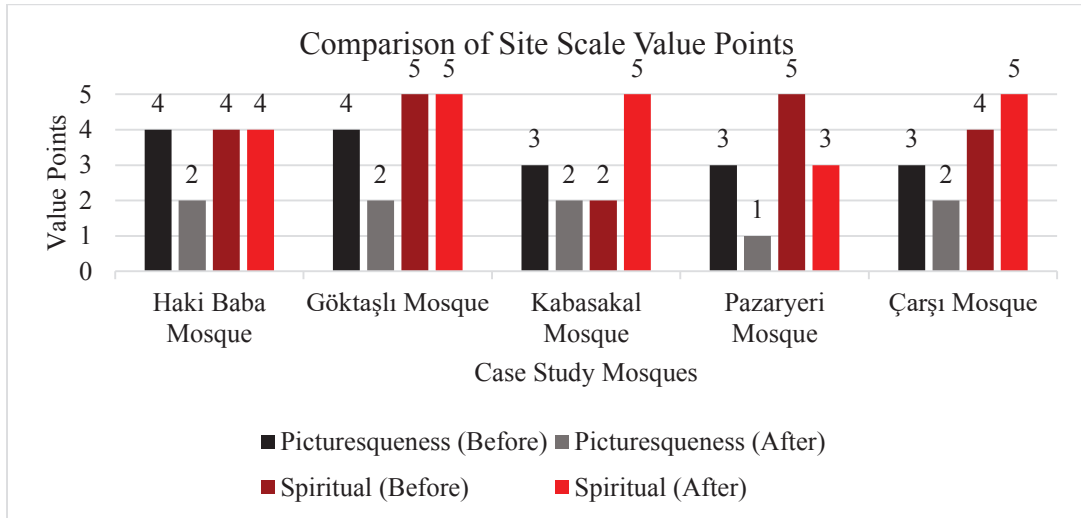
Figure 5.7. Comparison of site scale values before and after the latest urban interventions.

Current site scale interventions are application of development plan, abandonment following the declaration as landslide zone and restoration. Intervention scores of latest urban interventions are compared and their effects on site scale values of the case studies (Figure 5.7) are discussed in this section.

Development plans not taking into account the authentic contextual relations of the mosques affected their picturesqueness value negatively (4/5; excluding Pazaryeri Mosque) (Figure 5.8). High increase in urban density, change in context elements and/or topography occurred. The application of 1962 development plan of Manisa City centre was relatively faster than the ones in small settlements; Salihli and Kırkağaç: 2 grade loss of picturesqueness value is observed at the Göktaşlı Mosque and Haki Baba Mosques in city centre, while 1 grade loss of picturesqueness value is observed at the Çarşı Mosque and Kabasakal Mosques (Figure 5.7).

Declaration of a landslide zone is observed at the neighborhood of Pazaryeri Mosque (Figure 5.9). Materials of the buildings were taken away by the citizens throughout the abandonment process and in turn, the buildings were lost even faster than their possible deterioration with the passage of time (Figure 5.7). Thus, picturesqueness value and spiritual value decreased 2 grades.

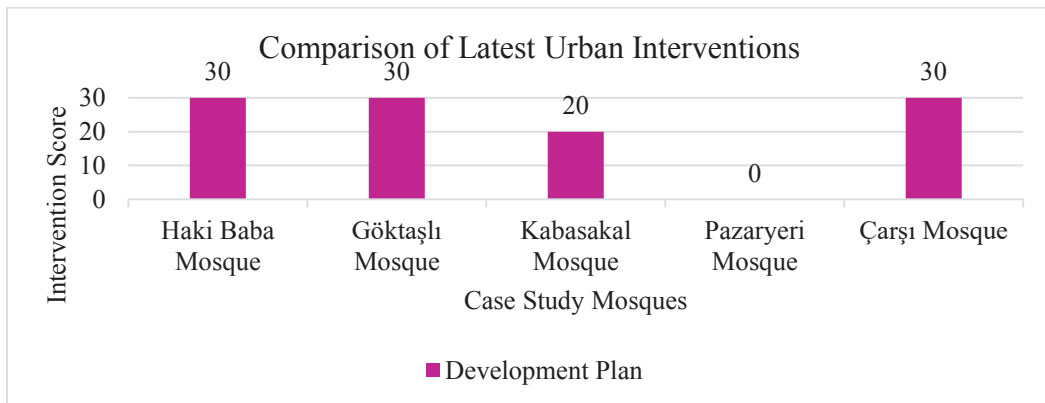
Figure 5.8. Comparison of impact of development plans.

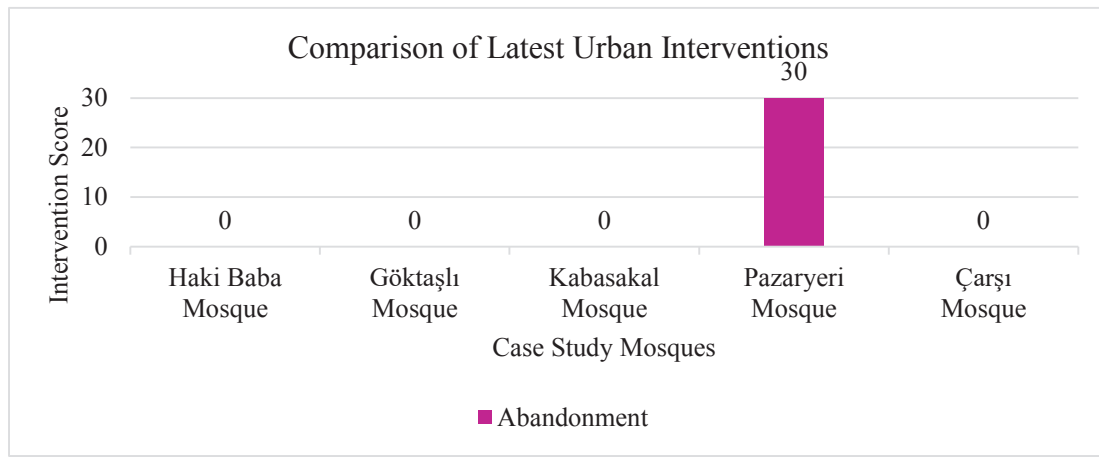
Figure 5.9. Comparison of impact of abandonments.

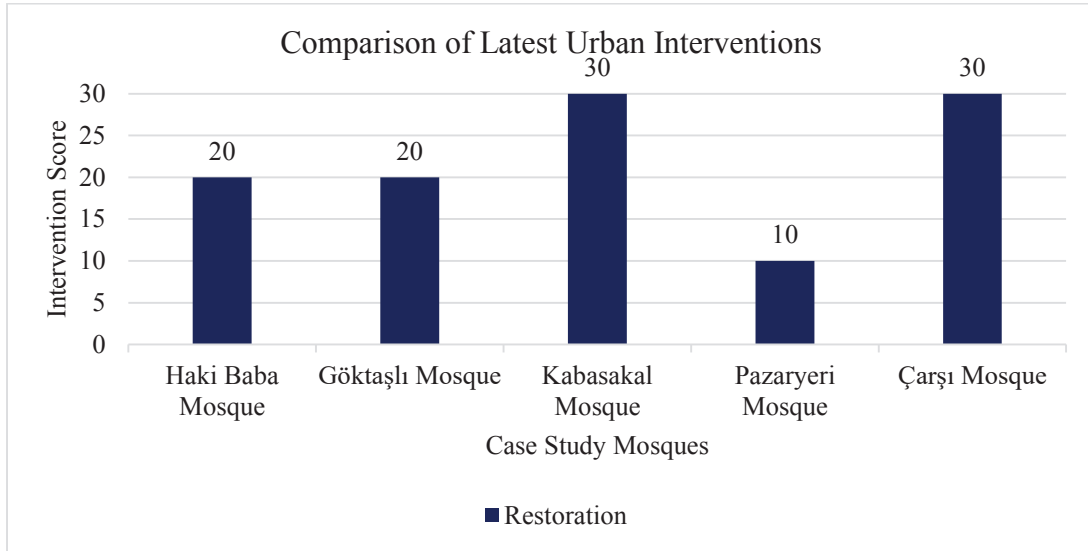
Figure 5.10. Comparison of impact of restorations.

If the intervention scores of current restorations of the mosques are compared, two of them have +30 points (2/5; Kabasakal Mosque and Çarşı Mosque), two of them have +20 points (2/5; Göktaşlı Mosque and Haki Baba Mosque) and one of them has +10 points (1/5; Pazaryeri Mosque) (Figure 5.10). All of the mosques were maintained with the help of their restorations. However, appropriate restoration approaches are observed at four of the mosques (4/5; excluding Pazaryeri Mosque). Reintegration of Pazaryeri Mosque placed in an archaeological site was inappropriate thus appropriateness of the restoration was minimum all along (Figure 5.7). In terms of success in urban context, positive impact of restorations of Kabasakal Mosque and Çarşı Mosque were relatively more compared to Göktaşlı and Haki Baba Mosque. Removal of unqualified mass additions at Kabasakal

and Çarşı Mosques while the ones at Göktaşlı and Haki Baba Mosques are sustained made their solid-void relationship appropriate to their authentic state.

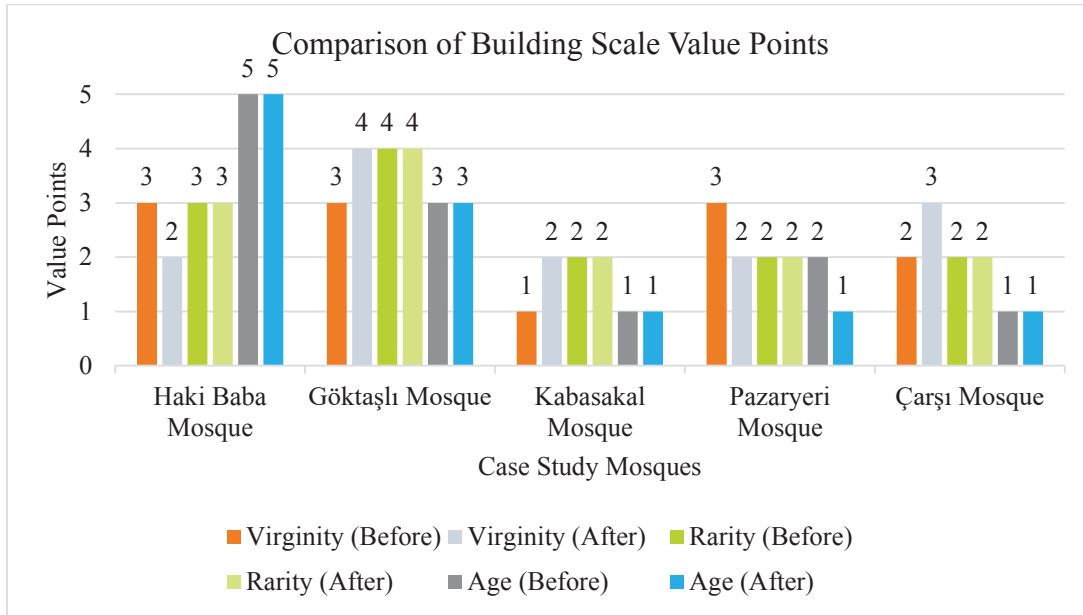
Figure 5.11. Comparison of building scale values before and after the current interventions.

virginitiy value increased 1 grade excluding Haki Baba Mosque (Figure 5.11) which had undergone other inappropriate interventions (Section 4.3.1.).

At lot scale, reintegration is observed only at Haki Baba Mosque (1/5) and it is appropriate (Figure 5.13). Reintegration of its collapsed courtyard wall (+9 points) as appropriate to its authentic state re-established its courtyard's integrity. Thus, it contributed to its virginitiy and rarity values (Figure 5.11). However, this contribution was minor; under the 15 points level.

At lot scale, renewal is observed only at Göktaşlı Mosque (1/5) and it is inappropriate (Figure 5.14). Renewal of the iron door of courtyard (-2 points) is an unnecessary application preventing re-establishment of virginitiy value at a minor level (Figure 5.11).

At building scale, reinforcement is only observed at Haki Baba Mosque (1/5) (Figure 5.24). They are inappropriate reinforcements (-36 points). Reinforcements at Haki Baba Mosque recalling the building techniques of the late 19th century realized by damaging the authentic construction technique of its adobe mud brick walls resulted in the loss of original construction technique of the mosque; its virginity value became decreased 1 grade (Figure 5.11).

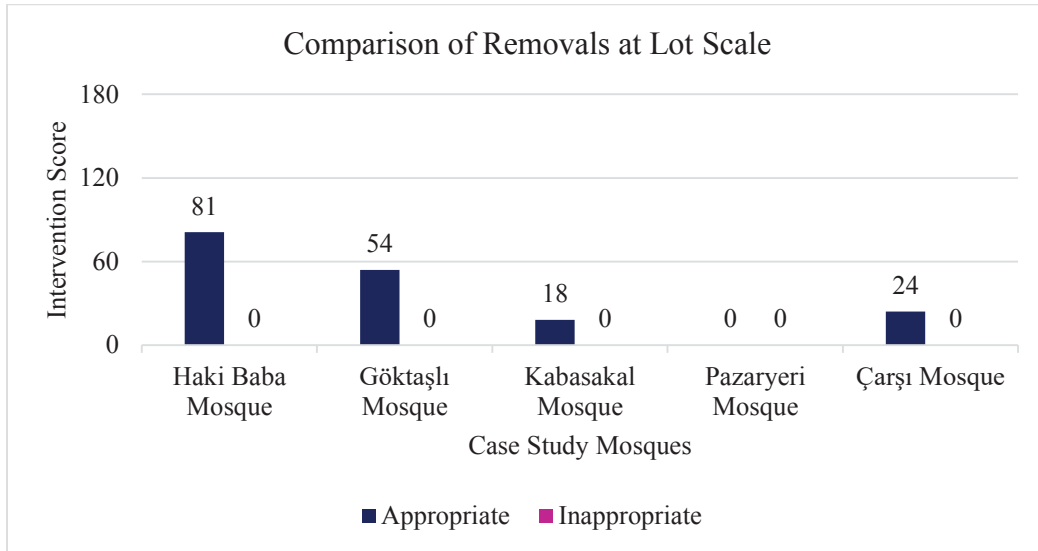
Figure 5.12. Comparison of impact of removals at lot scale.

Removal of inconsiderate mass additions (4/5; excluding Pazaryeri Mosque) re-established the spirit of courtyards. At lot scale, all of the removals were appropriate and at eminent level; +81 points at Haki Baba Mosque, +54 points at Göktaşlı Mosque, +18 points at Kabasakal Mosque and +24 points at Çarşı Mosque (Figure 5.12). Removal of the unqualified additional masses and balustrades in their courtyards made legible its original artistic characteristics, and contributed their virginity value. Their

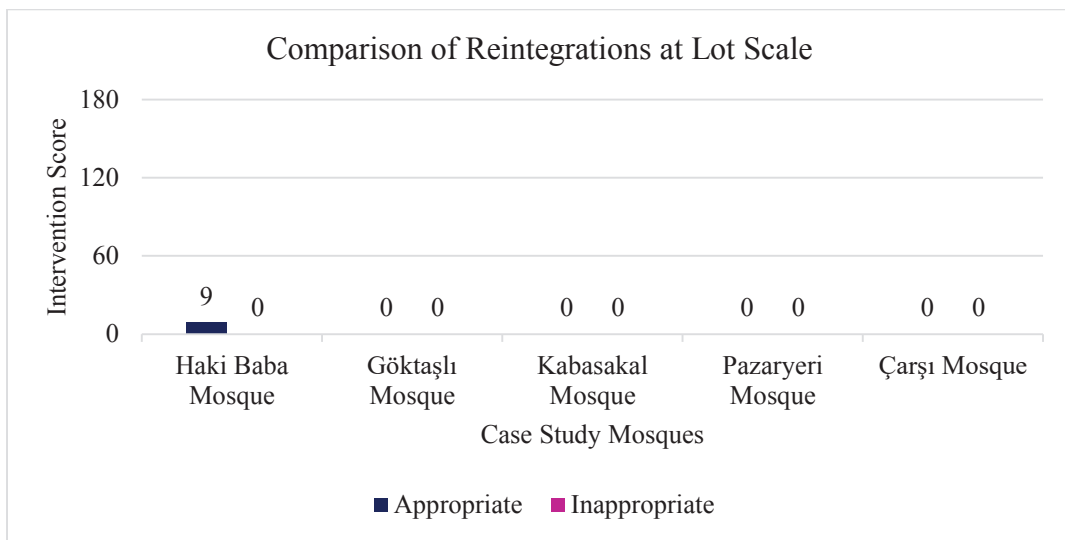
Figure 5.13. Comparison of impact of reintegrations at lot scale.

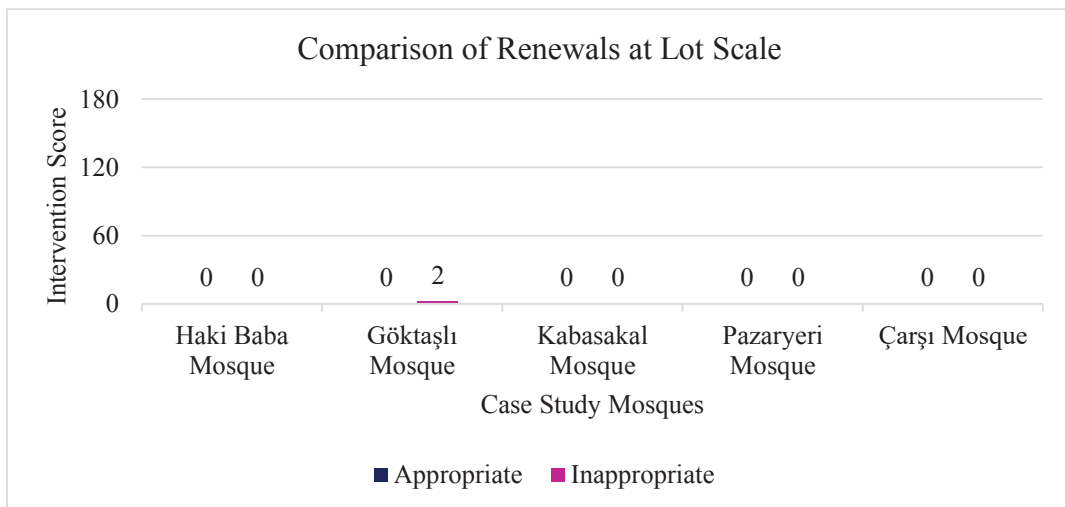
Figure 5.14. Comparison of impact of renewals at lot scale.

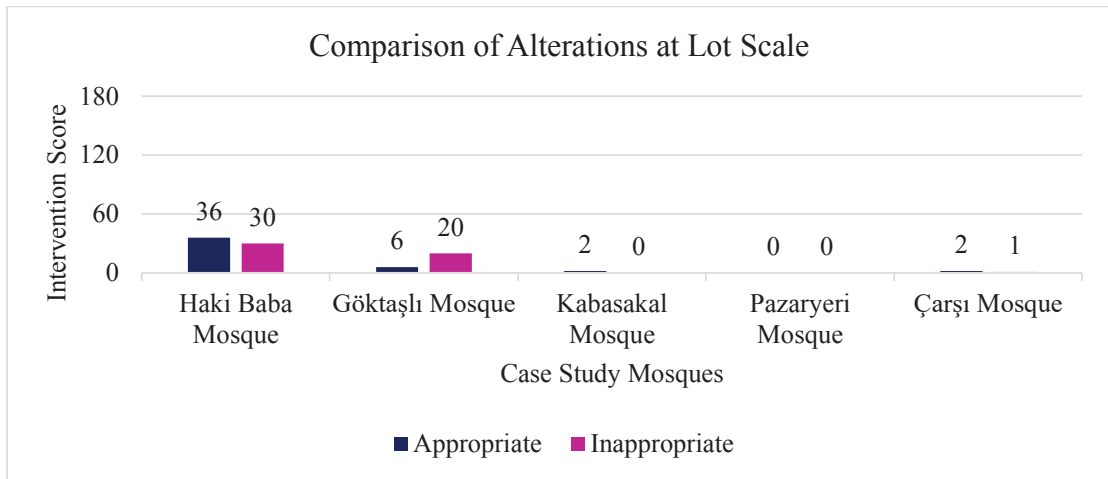
Figure 5.15. Comparison of impact of alterations at lot scale.

Alteration in lots of the mosques are only eye-catching in Göktaşlı and Haki Baba. In Haki Baba Mosque, appropriate alterations (+30 points) such as placement of the toilets underneath the courtyard level, and correction of the location and form of the *şadırvan* have been significant contributions of the current waqf restoration (Figure 5.15). However, alteration of some other courtyard elements such as retaining wall, paint at the balustrades of stairs, floor covering, curb, etc. present design insufficiencies or they are simply unnecessary, because the element itself is an unqualified addition (-24 points). Similarly, in Göktaşlı Mosque, there are unnecessary alterations of inconsiderate additions such as floor covering, roof, windows and wall of last comers' hall mass, and alterations with design insufficiency such as floor covering of courtyard. Alteration of the masjid on authentic *şadırvan* remains with a fountain requires very severe criticism with its negative impact on virginity (-16 points) (Figure 5.11).

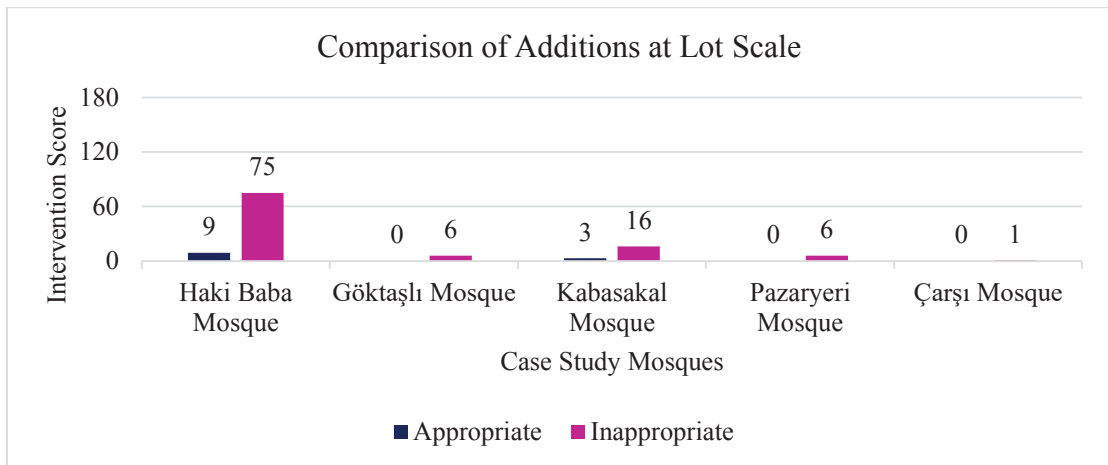
Figure 5.16. Comparison of impact of additions at lot scale.

At lot scale, additions are observed at all of the mosques (5/5). Appropriate additions are observed at two of them (2/5) while inappropriate ones are seen at all of them (5/5) (Figure 5.16). All of the appropriate interventions have minor effects on

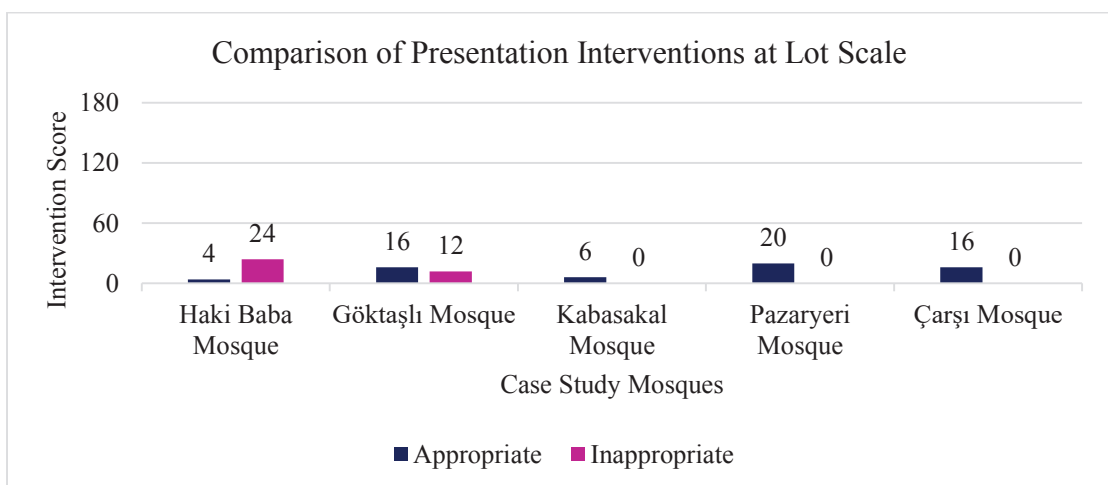
Figure 5.17. Comparison of impact of presentation interventions at lot scale.

The presentation of courtyard and/or mosque mass of Çarşı, Göktaşlı and Pazaryeri Mosques has improved by removal of unqualified additions; with some deficiencies such as sustaining of the last comers' hall in Göktaşlı. Appropriate interventions at Çarşı Mosque (+16 points), Göktaşlı Mosque (+16 points) and Pazaryeri Mosque (+20 points) (Figure 5.17) have eminent effects on virginity values of the mosques (Figure 5.11). The multi-layered qualities of Göktaşlı Mosque are not presented in coordination with a scientific excavation (-12 points). Haki Mosque's presentation is criticised in terms of absence of enough reference to the original silhouette and solid-void pattern (-24 points): no reference to the earthen roof, unqualified last comers' hall and proportionless minaret additions sustained. Problems of presentation limited the increase of virginity value in Göktaşlı, while Haki Baba lost 1 grade.

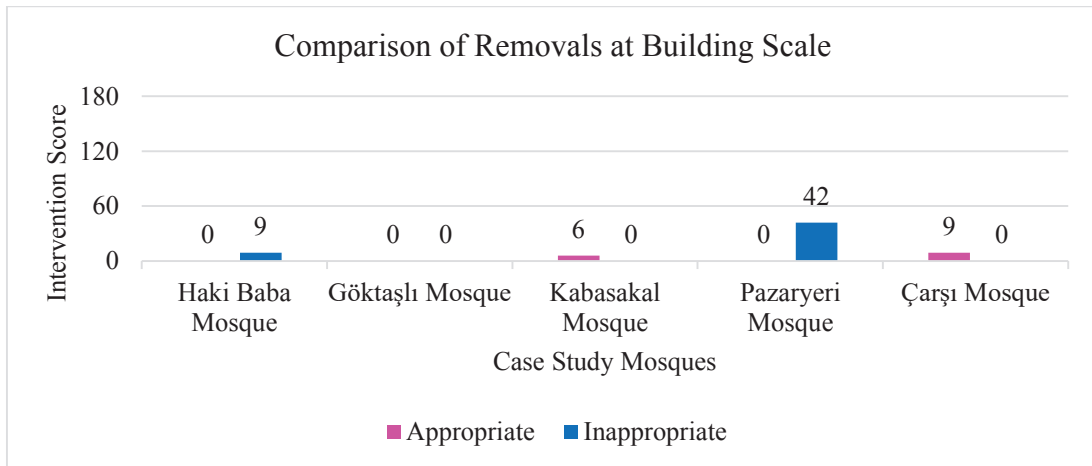
Figure 5.18. Comparison of impact of removals at building scale.

Building scale removals are observed at four of the mosques (4/5; excluding Göktaşlı Mosque) (Figure 5.18). Appropriate interventions at Pazaryeri Mosques (+42 points) are at eminent level. Removal of unqualified architectural elements affecting the mosque's spatial organisation such as iron balustrades at the eastern passage entrance, timber separator at the last comers' hall of Pazaryeri Mosque, etc. contributed to its virginity value (Figure 5.11).

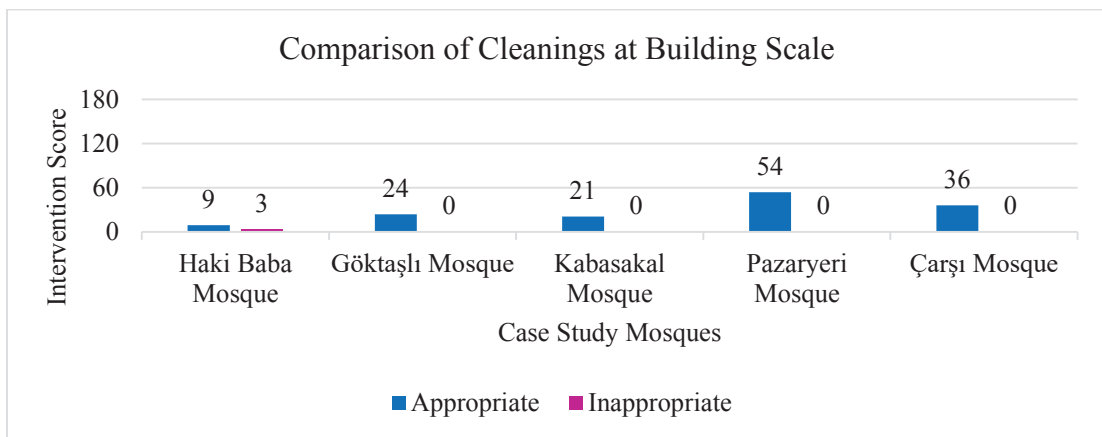
Figure 5.19. Comparison of impact of cleanings at building scale.

Building scale cleanings are observed at all of the mosques (5/5) (Figure 5.19). Cleaning interventions are only appropriate at four of the mosques (excluding Haki Baba Mosque). Their effects are at eminent level; +24 points, +21 points, +54 points and +36 points at Göktaşlı Mosque, Kabasakal Mosque, Pazaryeri Mosque, and Çarşı Mosque, respectively. Cleaning of additional unqualified finishings or elements made the patina of these mosques legible; they affected virginity values positively. Virginity values of Göktaşlı Mosque, Kabasakal Mosque and Çarşı Mosque increased 1 grade (Figure 5.11). However, virginity value of Pazaryeri Mosque decreased only 1 grade, in relation with the effects of other inappropriate interventions.

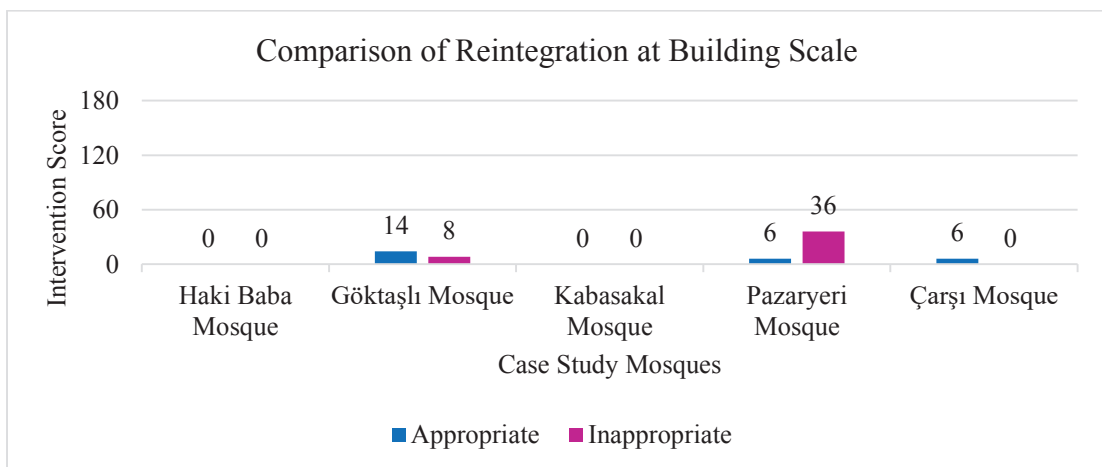
Figure 5.20. Comparison of impact of reintegrations at building scale.

Building scale reintegrations are observed at three of the mosques (3/5; excluding Haki Baba Mosque and Kabasakal Mosque) (Figure 5.20). Appropriate reintegrations are seen at all of these three mosques while inappropriate ones are observed at Göktaşlı Mosque and Pazaryeri Mosque. However, appropriate reintegrations are at minor level. Inappropriate reintegrations are seen at Göktaşlı Mosque (-8 points) and Pazaryeri Mosque (-36 points). Their effects are at eminent level only at Pazaryeri Mosque. In

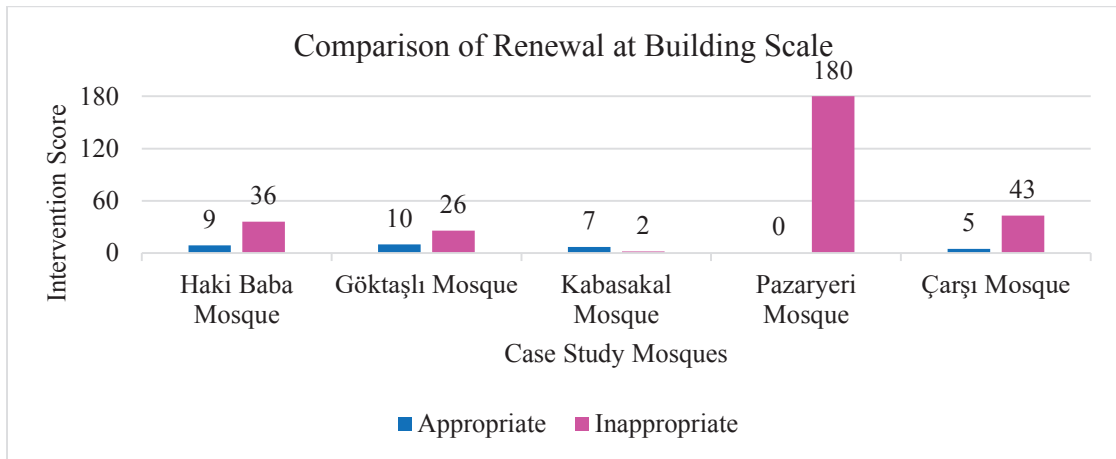
Figure 5.21. Comparison of impact of renewals at building scale.

Building scale renewals are observed at all of the mosques (5/5) (Figure 5.21). Appropriate renewals are seen at four of them (4/5; excluding Pazaryeri Mosque). Appropriate renewals are at minor level. Excluding Kabasakal Mosque, which presents very limited renewal, all of the mosques were extensively renewed giving way to eminent reduction in their virginity (Figure 5.11). Renewal of the elements of inconsiderate additions such as the last comers' hall and *mahfil* for women in Göktaşlı Mosque was evaluated as unnecessary. Renewal of unqualified finishings or elements that should be cleaned or removed as in posts carrying the additional last comers' hall of Haki Baba Mosque, repair plaster and paint at the last comers' hall of Göktaşlı Mosque, etc.; renewal of the authentic elements that have not deteriorated as in floor and ceiling coverings of prayer hall of Çarşı Mosque and Haki Baba Mosque; renewal of the altered elements as appropriate to its altered state such as stone parapets of *şerefe* of Çarşı Mosque; and renewal of the elements which received the age in line with inappropriate restoration approach such as timber joineries of the doors of the passage and timber columns of the prayer hall of Pazaryeri Mosque were inappropriate. So, current waqf restorations are unsatisfactory in terms of virginity.

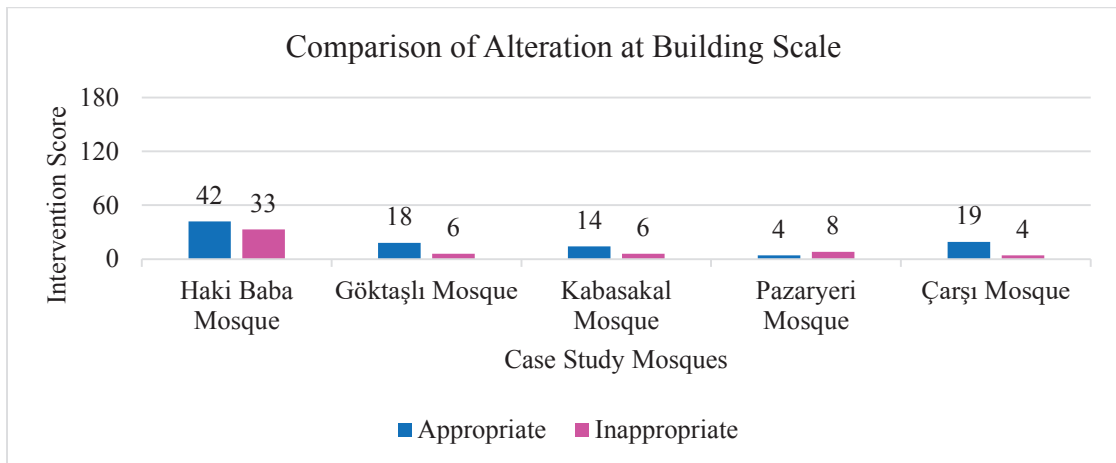
Figure 5.22. Comparison of impact of alterations at building scale.

Building scale alterations are observed at all of the mosques (5/5) as appropriate and inappropriate (Figure 5.22). Appropriate alterations of Haki Baba Mosque (+48 points), Göktaşlı (+18 points) and Çarşı Mosque (+19 points) are at eminent level (3/5). Re-establishment of authentic details of architectural elements such as wooden joinery, *minber*, etc. in all examples; correction of spatial borders such as separator wall in Haki Baba Mosque and location of architectural elements such as stairs in Çarşı were appropriate alterations. Virginity was positively affected. However, some authentic

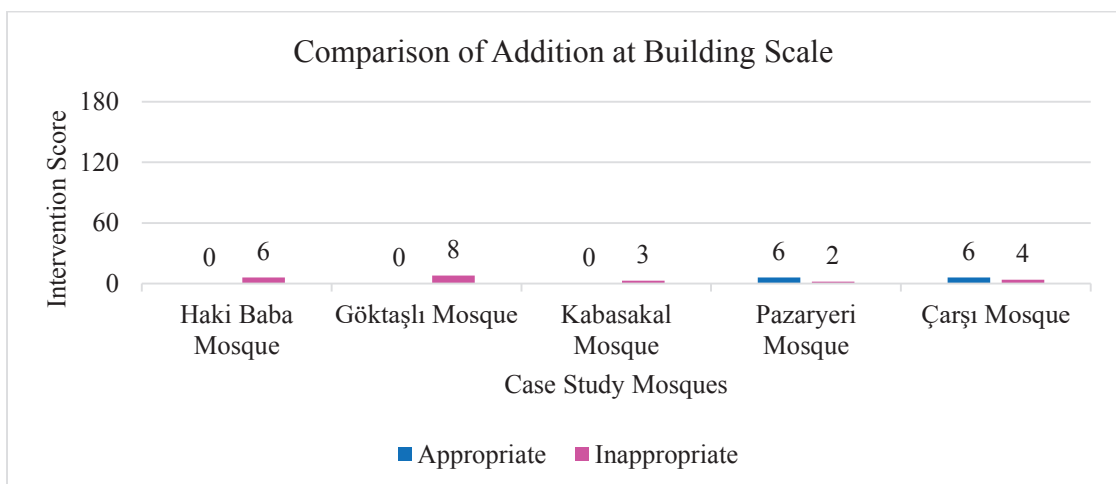
Figure 5.23. Comparison of impact of additions at building scale.

Building scale additions are observed at all of the mosques (5/5) (Figure 5.23). Appropriate and inappropriate building scale additions are at minor level.

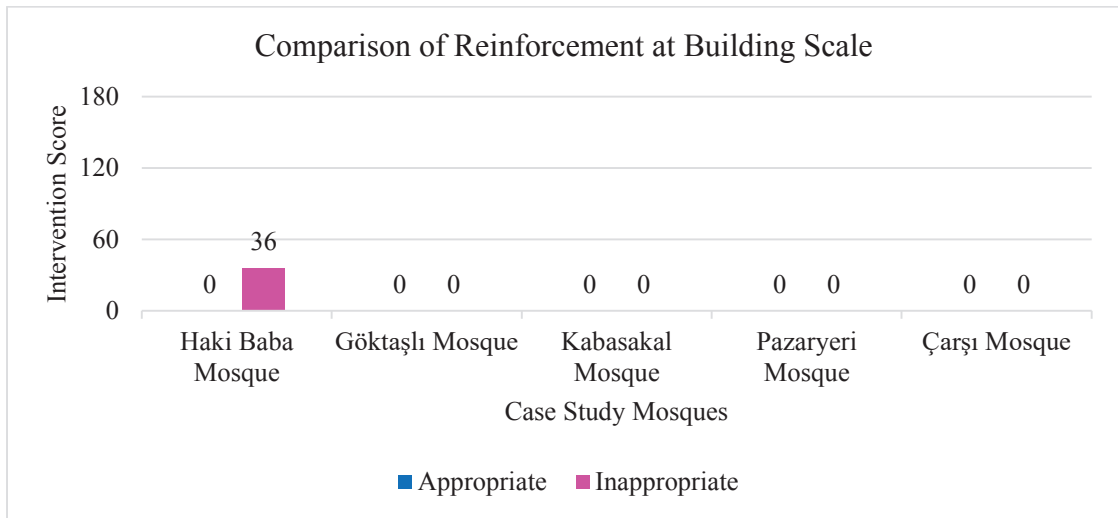
Figure 5.24. Comparison of impact of reinforcements at building scale.

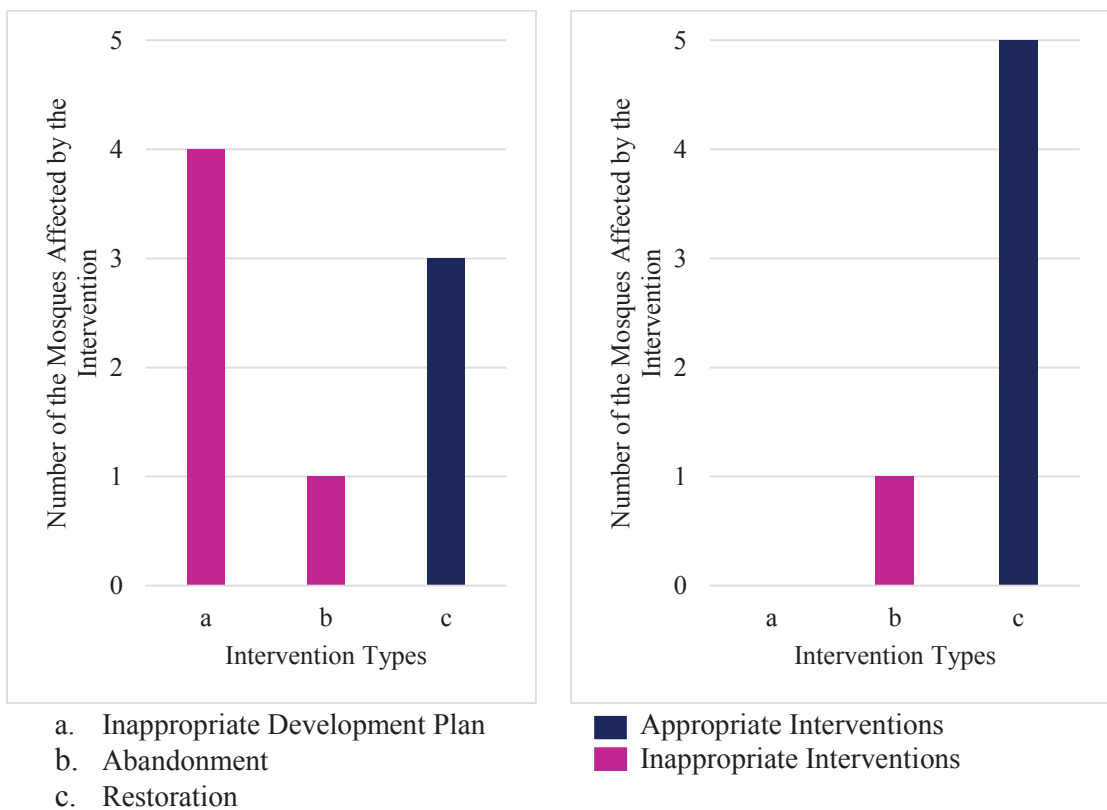
Figure 5.25. Extensiveness of latest appropriate and inappropriate urban interventions affecting picturesqueness (left) and spiritual (right) values.

It is seen that, legibility of historical layers of the cities is achieved by taking into account the historical processes of both the historical buildings and their site. Interventions in different scales can not be considered as independent from each other. GDPF should be stakeholder in the design process of the development plan, which plays role in the change of urban scape in the closed by environment of the waqf originated historical monuments (Figure5.25). Waqf restorations requires this consideration for their appropriate contribution in urban context.

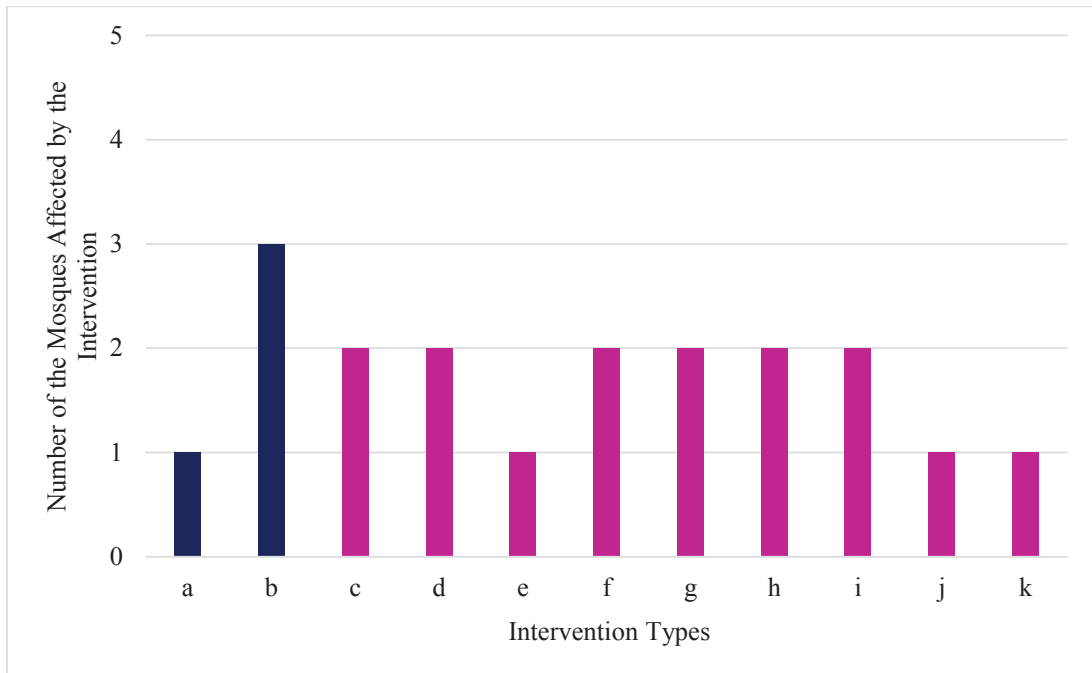
| a. | Alteration of unqualified masses | g. | Addition more than necessary |
| f. | Unqualified element addition | | |

Figure 5.26. Extensiveness of current appropriate and inappropriate lot scale interventions affecting virginity value.

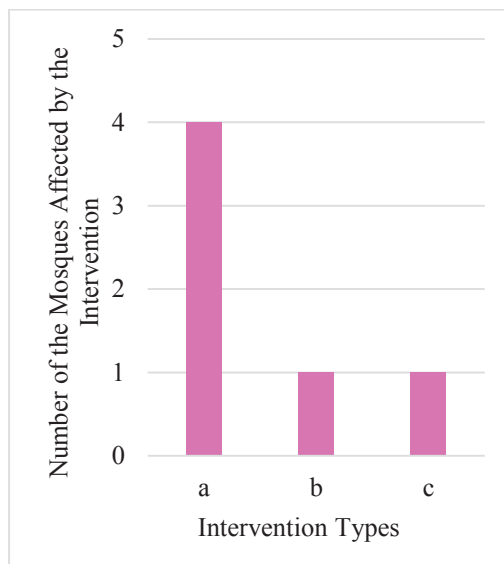
- a. Renewal of undamaged authentic elements
- b. Renewal of authentic elements that gained age
- c. Alteration of authentic element

Figure 5.27. Extensiveness of current inappropriate building scale interventions affecting age values.
