**PLASTER CHARACTERISTICS OF HISTORIC  
*ESKİ HAMAM* IN AYDIN**

**A Thesis Submitted to  
the Graduate School of Engineering and Sciences of  
İzmir Institute of Technology  
in Partial Fulfillment of the Requirements for the Degree of**

**in Architectural Restoration**

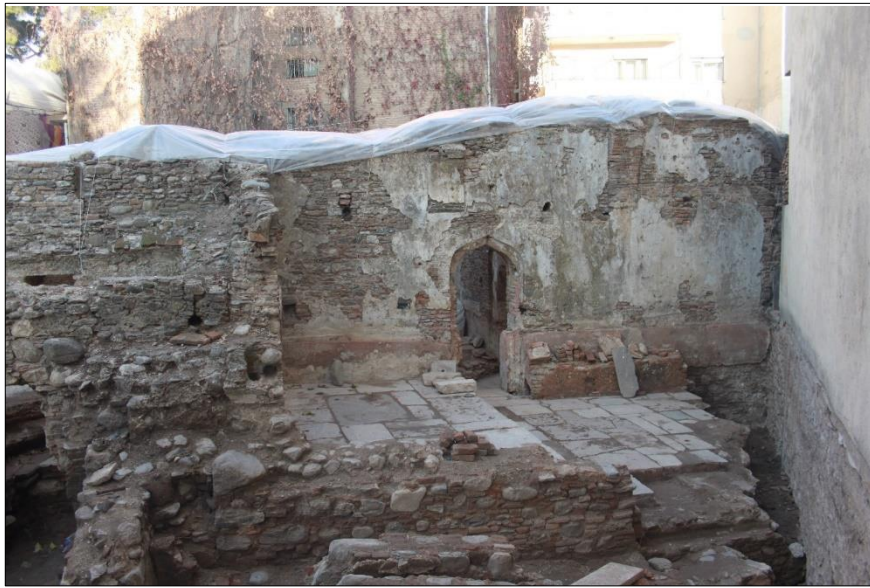
Figure 2.10. *Eski Hamam G01 Soyunmalık-Ilıklık*

The *soyunmalık-ilıklık* was the first space from the entrance into the bath. It hosts a *seki* used for dressing (Figure 2.10). The corners of the walls and the arch remains suggest its spatial dimensions and indicate that the vaults were used as the superstructure. The remains of the southern corner have been lost with the reinforced concrete building erected in the 1970s. However, the horizontal rectangular plan scheme and the vaults can be observed in some 14<sup>th</sup>, 15<sup>th</sup> and 16<sup>th</sup> century baths (Kürüm 2017).

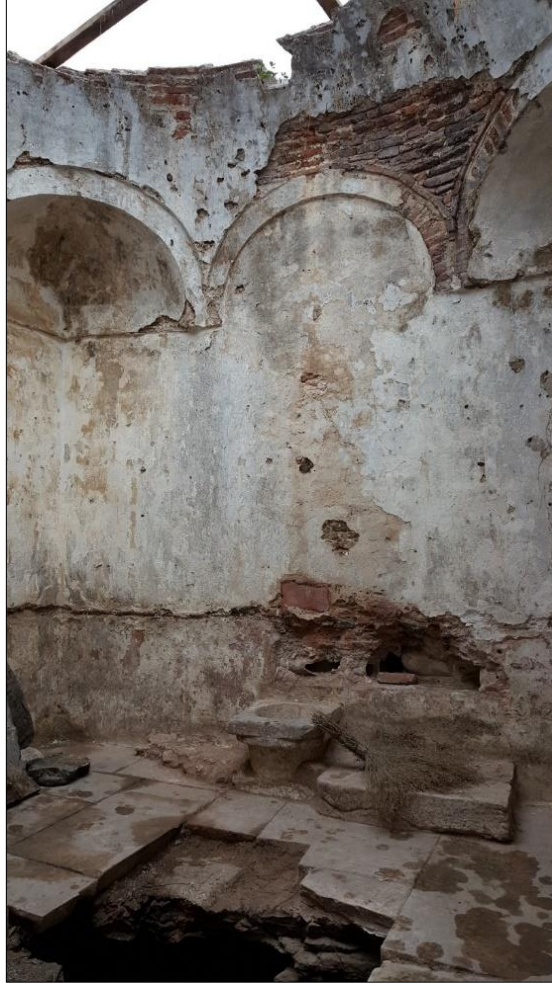
Figure 2.11. *Eski Hamam G02 Sıcaklık*  
(Source: Fatma Gürhan, December 2016)

The G02 *Sıcaklık* was a space that *kurnas* and *sekis* and was used for bathing (Figure 2.11). This space was accessed through another *sıcaklık* that could be reached from the *soyunmalık-ılıkılık*. This opening has two wide concentric pointed arches and a circular addition (Kürüm 2017). The arrangement of the arches reveal that the width of the opening was narrowed later on.

The G02 *Sıcaklık* has one *kurna* and one *seki*. The positions of other *kurnas* and *sekis* can be deduced from their remains. There are no window openings on the walls and the dome has seven pentagonal oculi openings. The midsection of the dome has collapsed but the remaining parts host the best-preserved interior plastering. The squinches end in plaster motifs with curved tips. The damaged sections of the walls allow the determination of the location and the material of the terracotta pipes and *tüteklik*s. The opening of the damaged floor provides a view of the *cehennemlik* underneath. The *cehennemlik* piers were lain with brick and stone and linked with a depressed arch (Kürüm 2017). The floor is made up of slate stones carried by the piers.

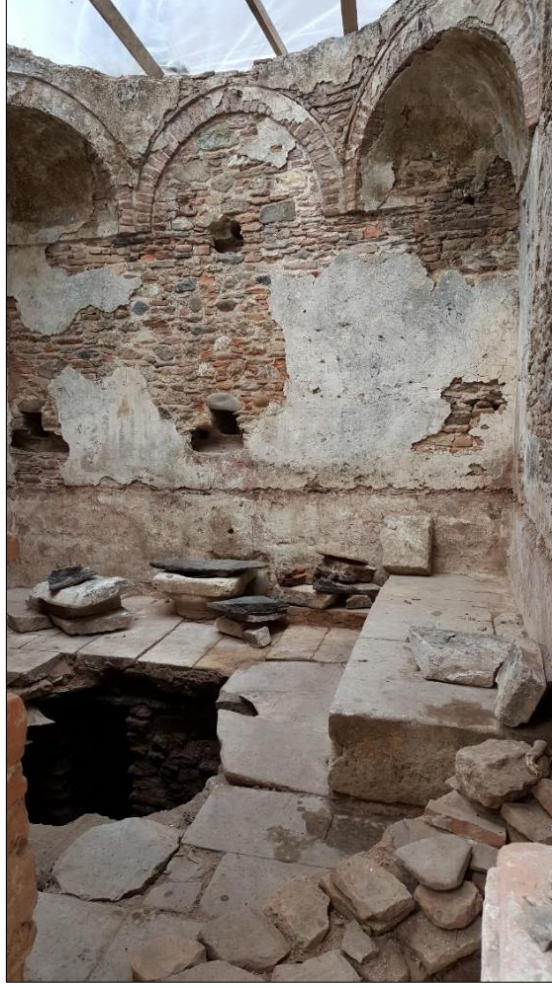
Figure 2.12. *Eski Hamam G03 Sıcaklık*  
(Source: Fatma Gürhan, December 2016)

The G03 *Sıcaklık* was one of the bathing spaces which hosted *kurnas* and *sekis* (Figure 2.12) and had similar characteristics with the G02 *Sıcaklık*. These similarities are the blind walls, the structure and the spatial arrangement of *kurnas* and *sekis*, terracotta pipe and *tüteklik* levels, and plaster and material characteristics. The *cehennemlik* below the space continued in the same manner as the G02 *Sıcaklık*. An opening emphasized with two wide concentric pointed arches led from the *soyunmalık-ılıklik* into the space. The top of the arch accommodates a ventilation hole (Kürüm 2017). The G03 *Sıcaklık* provides access to the other two *sıcaklıks* (Figure A.61-68).

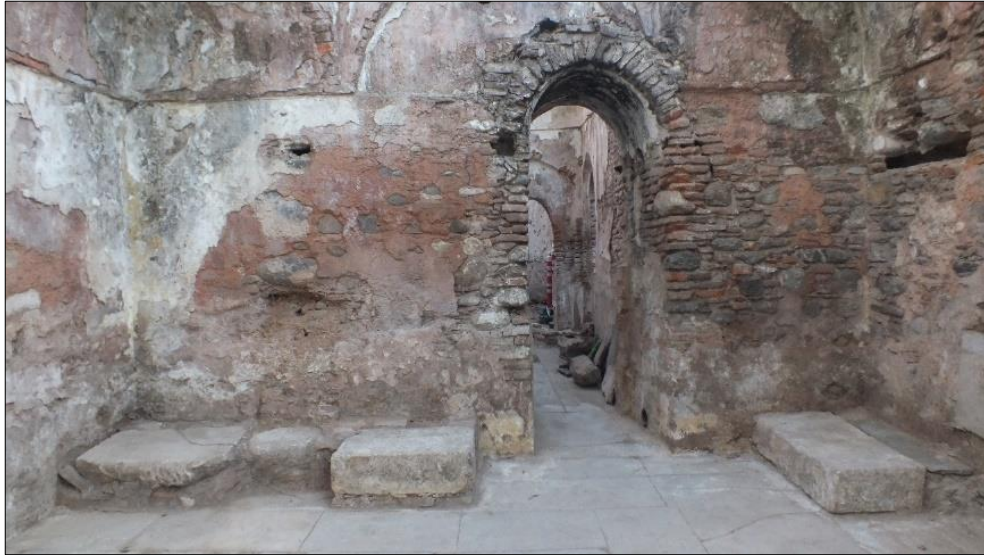
Figure 2.13. *Eski Hamam G04 Sıcaklık*

Passage from the G03 *Sıcaklık* to the G04 *Sıcaklık* was through an arched opening. Arch arrangements indicate that the opening to the G04 *Sıcaklık* was opened later on. The junction line on the wall, the bond type and thickness of the wall and the interrupted

terracotta pipes support the notion that the G04 *Sıcaklık* was a later addition. The excavation revealed that this opening was deliberately filled in. The fill was removed during excavation. This suggests a timeframe during which the opening was disused (Kürüm 2017). This opening is believed to have been sealed for a time and used as a niche (Kürüm 2017) (Figure 2.13).

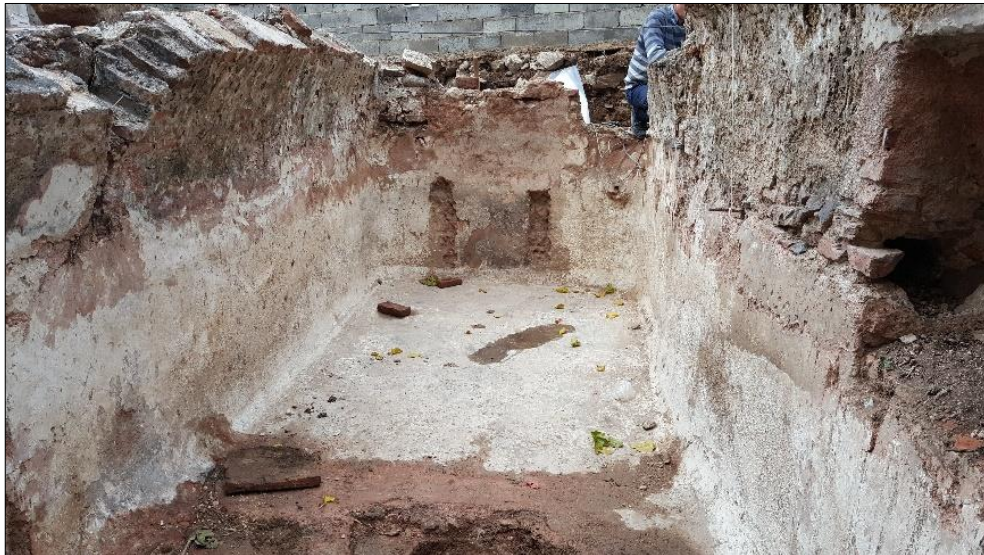
Figure 2.14. *Eski Hamam G05* Hot Water Reservoir  
(Source: Fatma Gürhan, December 2016)

the interior space was coated, and the corners of the walls were rounded on the inside with plaster (Figure 2.14).

The space was constructed adjacent to the *sıcaklık* wall that was added at a later date and the other wall of the space was adjacent to the *soyunmalık-ılıkık* wall. The junction line shows that the water reservoir was constructed later. On the outside of the wall, there was a second adjacent supporting wall. The remains reveal that the superstructure of the water reservoir was a barrel vault. However, the inclination of the vault and the pattern of plastering change near the north end, indicating that the space was expanded later on. The supporting wall continued outside the expanded section as well.

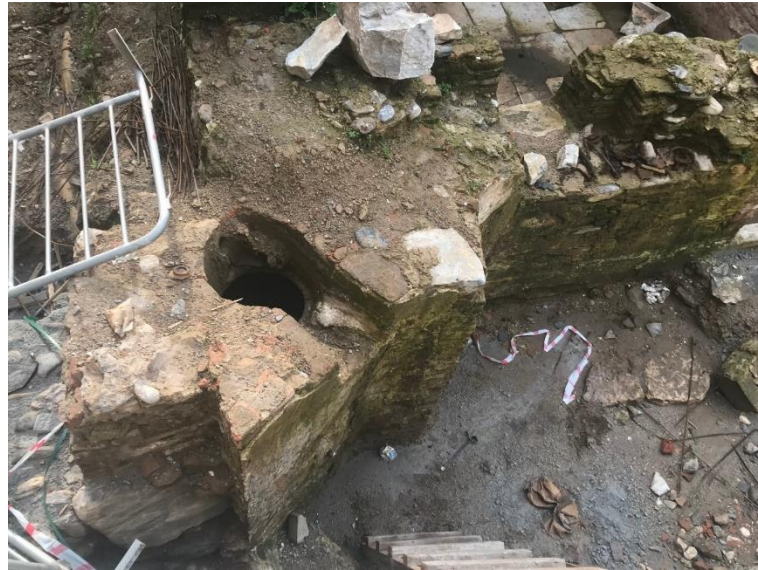
Figure 2.15. The fountain

The fountain was located at the northern corner of the bath. Water carried by the pipes from the northeast of the bath was stored in a terracotta jar inside the fountain (Figure 2.15). The bath initially constructed as a small structure was later expanded into a bath with a fountain (Kürüm 2017), which is demonstrative of the increasing social

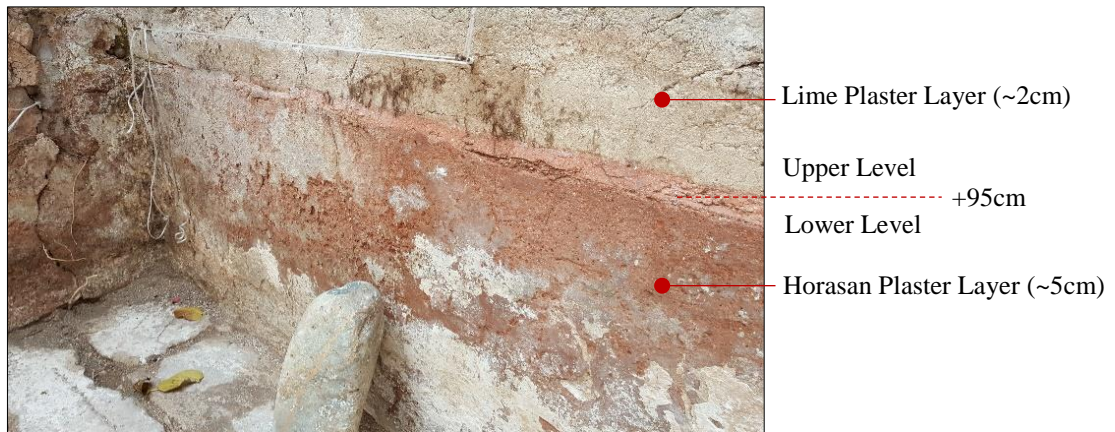
Figure 2.24. Plaster layers of the wall adjacent to the *sıcaklık* in the *soyunmalık-ılıkık* (15<sup>th</sup>-16<sup>th</sup> centuries)

The walls of the *soyunmalık-ılıkık* had two different plasterings. The wall between the *soyunmalık-ılıkık* and the *sıcaklık* was coated with one horasan plaster layer on the lower levels and one lime plaster layer on the upper levels (Figure 2.24). The wall between the *soyunmalık-ılıkık* and the hot water reservoir had a single layer of horasan plaster (Figure 2.25), while the other walls in the space were destroyed.

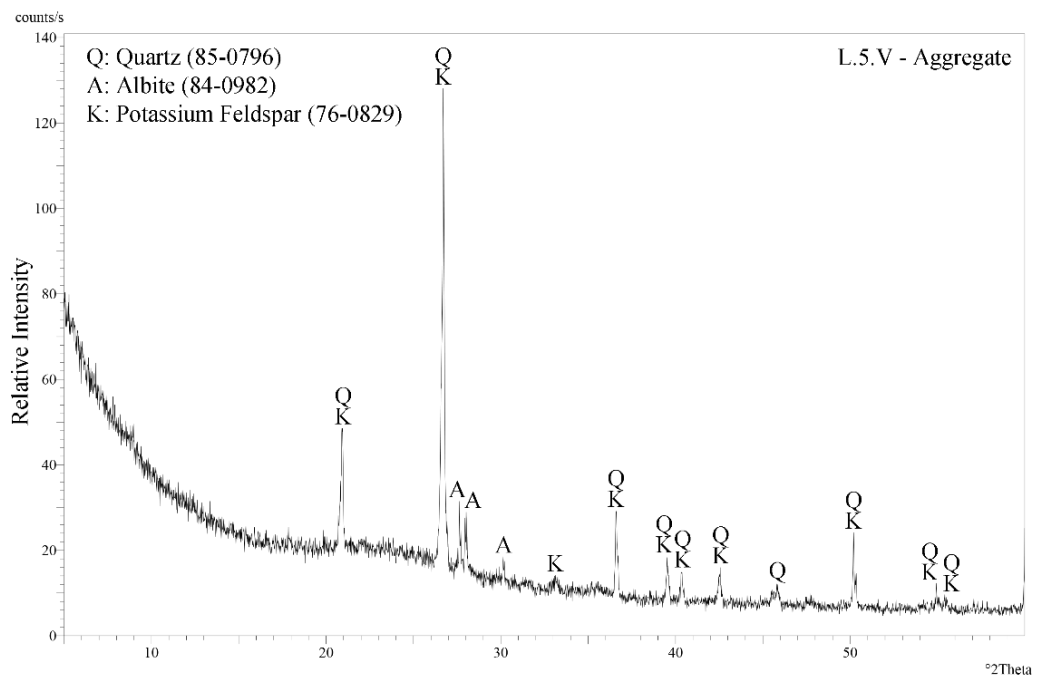
Figure 4.20. XRD patterns of natural aggregates of L.5.V in 16<sup>th</sup>-17<sup>th</sup> centuries

XRD patterns of natural aggregates of the lime plasters are similar with these of horasan plasters. Quartz, albite and muscovite minerals were observed in the natural aggregates of the lime plasters (Figure 4.16-4.20).

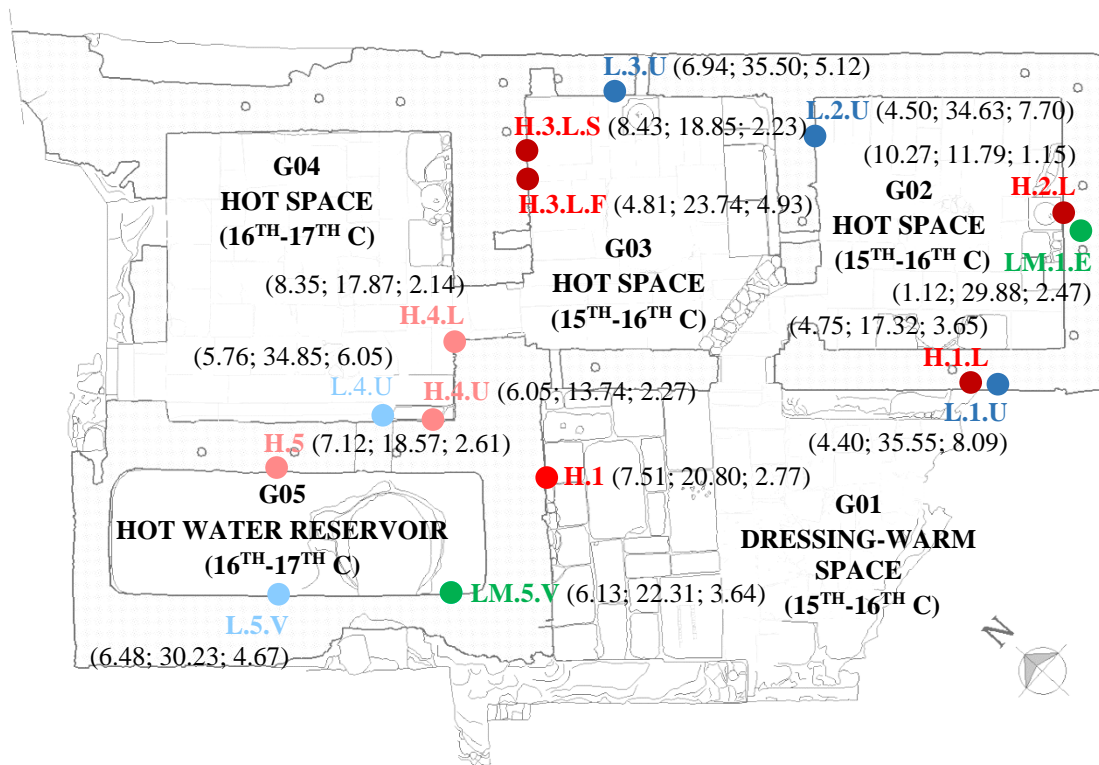
Figure 4.40. Plan of *Eski Hamam* showing hydraulicity of plasters and mortars (H<sub>2</sub>O; CO<sub>2</sub>; H<sub>2</sub>O/CO<sub>2</sub>)

The results of the analysis were given in the following table and on the plan of *Eski Hamam* (Figure 4.40 and Table 4.11).

According to the analysis result, the CO<sub>2</sub>/H<sub>2</sub>O ratios of the horasan plasters used in 15<sup>th</sup>-16<sup>th</sup> and 16<sup>th</sup>-17<sup>th</sup> centuries were lower than 10, ranging between 1.15-4.93 % and 2.14-2.61 % respectively (Figure 4.40 and Table 4.11). The ratios of the CO<sub>2</sub>/H<sub>2</sub>O in lime plasters belonging to 15<sup>th</sup>-16<sup>th</sup> and 16<sup>th</sup>-17<sup>th</sup> centuries were lower than 10, ranging between 5.12-8.09 % and 4.67-6.05 % respectively (Figure 4.40 and Table 4.11). In addition, the CO<sub>2</sub>/H<sub>2</sub>O ratios of the joint mortar collected between terracotta pipes and between the building bricks were lower than 10, which is 2.47 % and 3.64 % respectively due to use of pozzolanic aggregates (Figure 4.40 and Table 4.11).

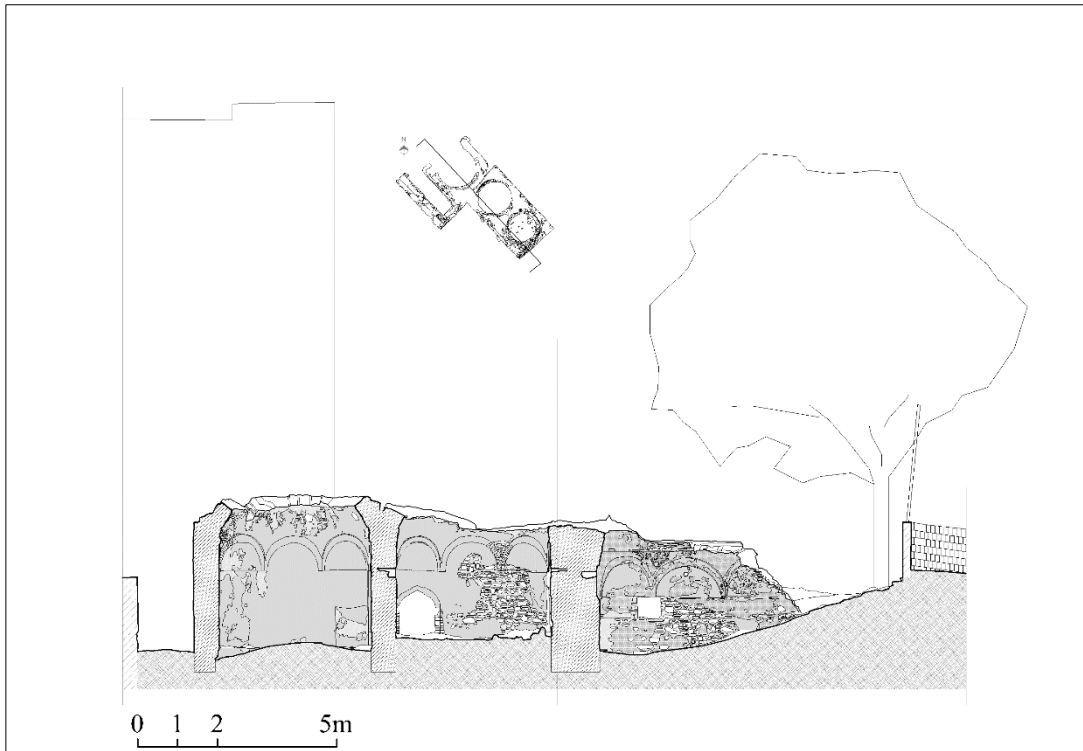
Figure A.10. Section-6 of the primary measured survey  
(Drawn by: Fatma Gürhan, 2017, ANKA Architecture and Restoration Office)

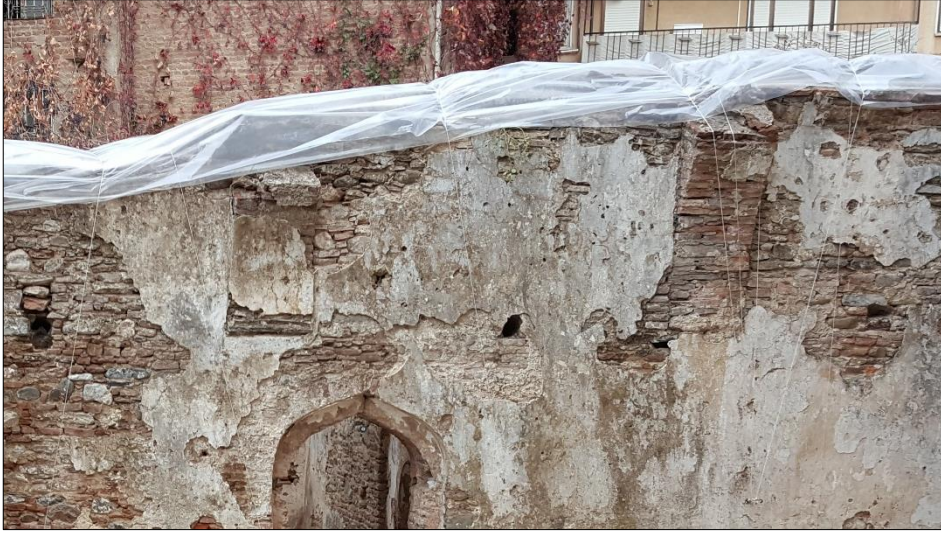
Figure A.37. The arch remains  
(Source: Fatma Gürhan, October 2016)

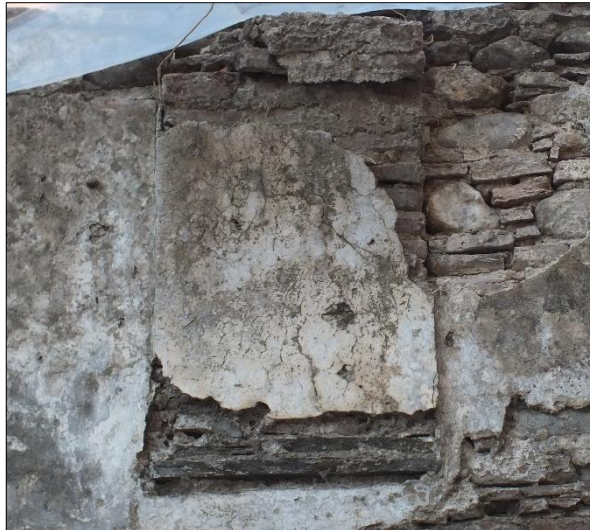
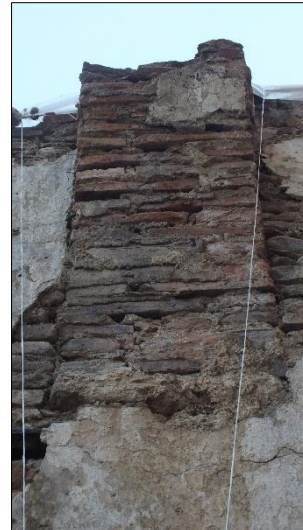
Figure A.38. The left arch remain (a) and the right arch remain (b)  
(Source: ANKA Architecture and Restoration Office archive, October 2016)

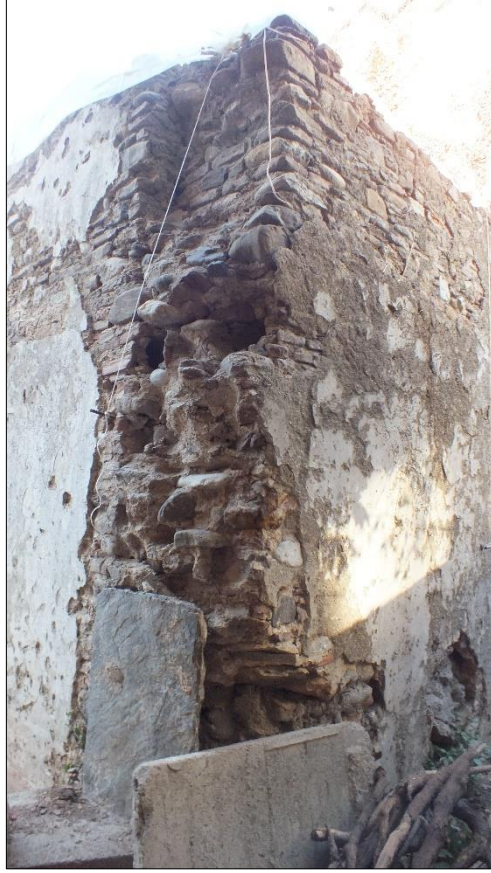
Figure A.39. The southern corner of the *soyunmalık-ılık* space  
(Source: ANKA Architecture and Restoration Office archive, November 2016)

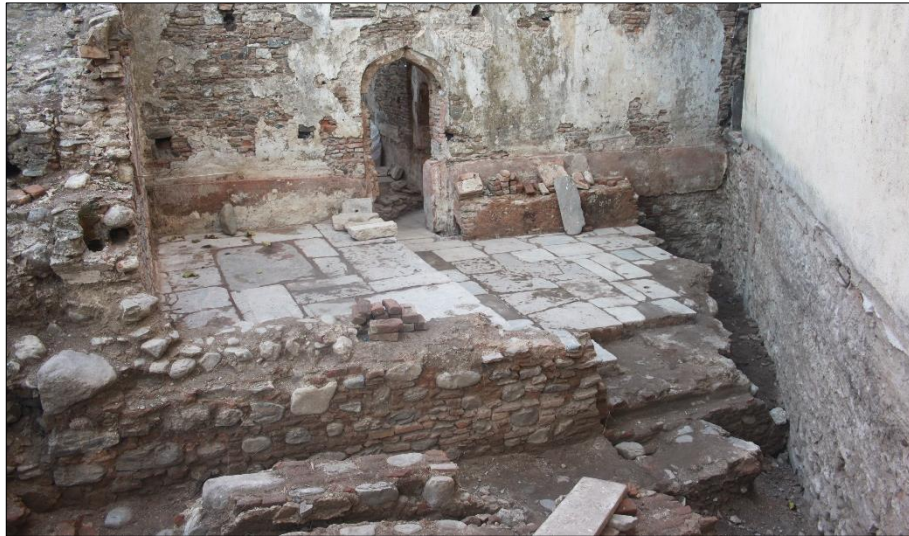
Figure A.40. The floor covering of the *soyunmalık-ılık* space  
(Source: ANKA Architecture and Restoration Office archive, December 2016)

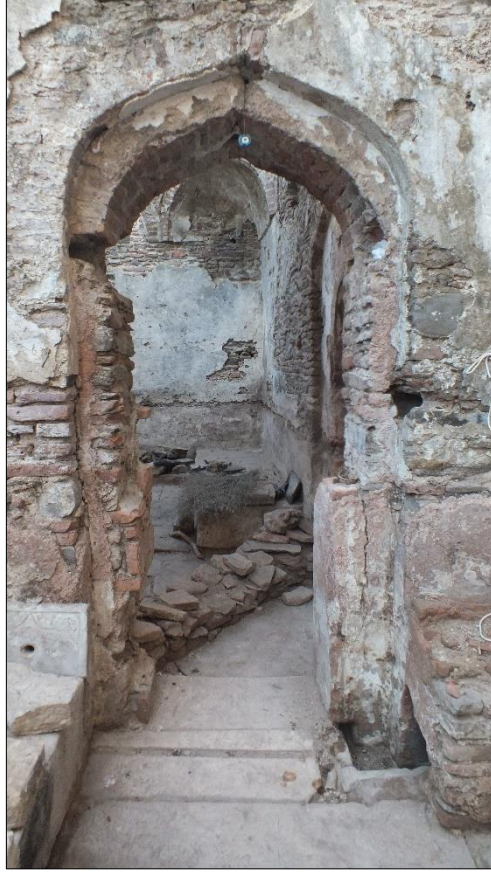
Figure A.41. Transition from the *soyunmalık-ılıklik* to the *sıcaklık* space  
(Source: ANKA Architecture and Restoration Office archive, November 2016)

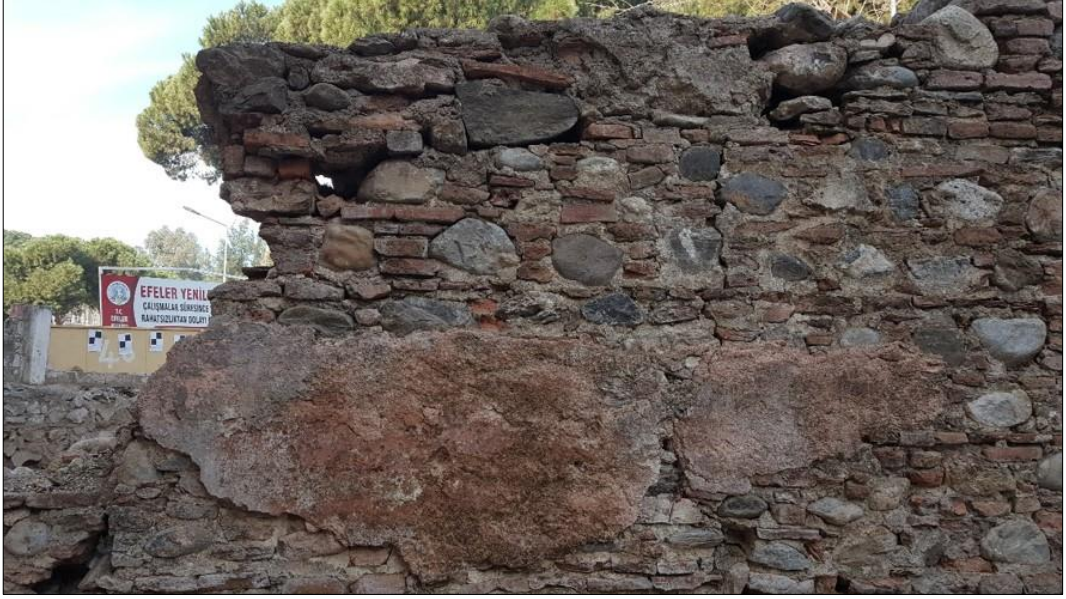
Figure A.43. The wall of the hot water reservoir & *soyunmalık-ılıklik*  
(Source: Fatma Gürhan, December 2016)

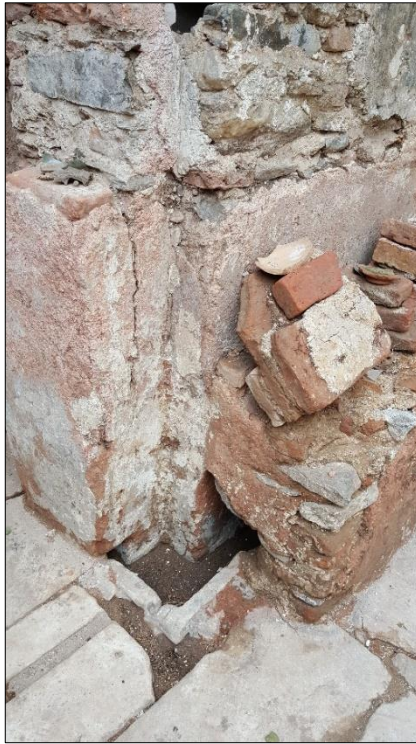
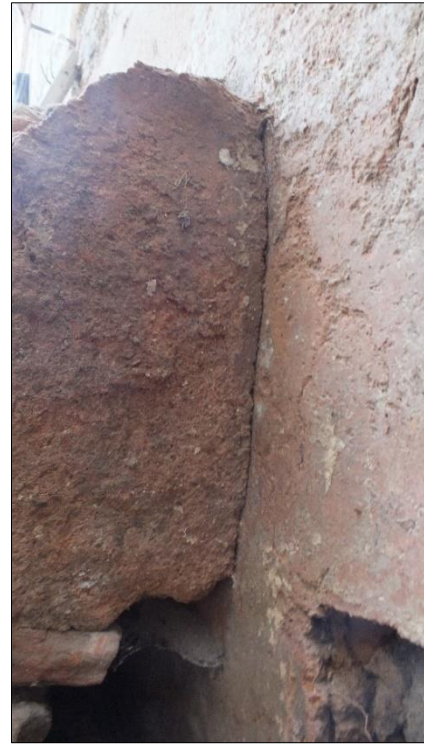
Figure A.44. The left (a) and the right (b) junction line of the *seki* on the *soyunmalık-ılıklik* & *sıcaklık* wall (Source: Fatma Gürhan, December 2016)

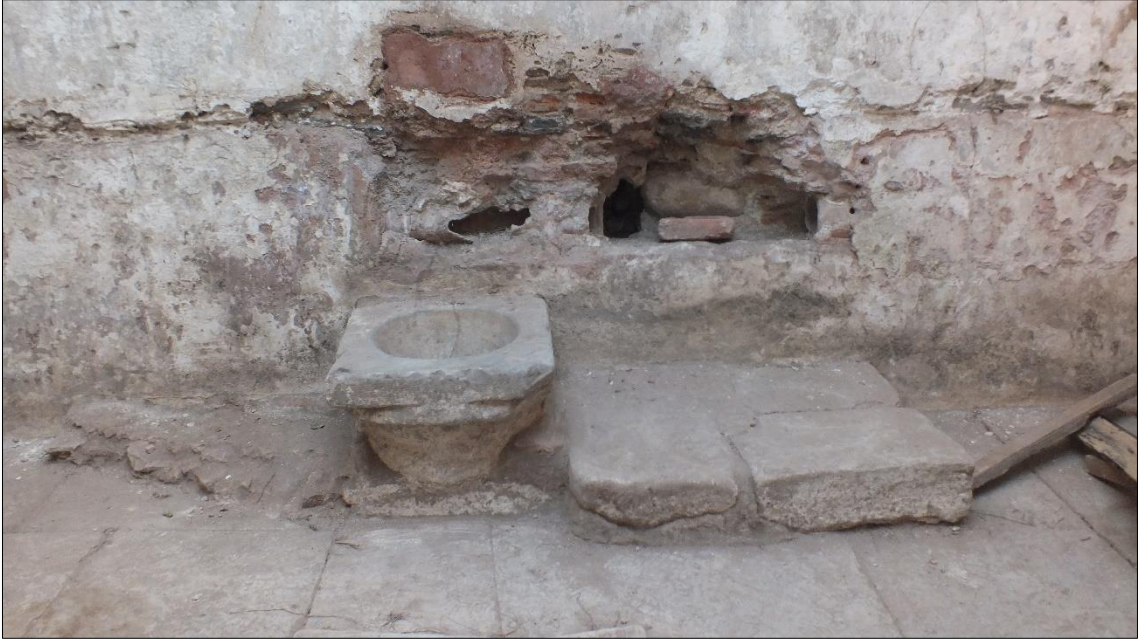
Figure A.45. *Kurna and seki*

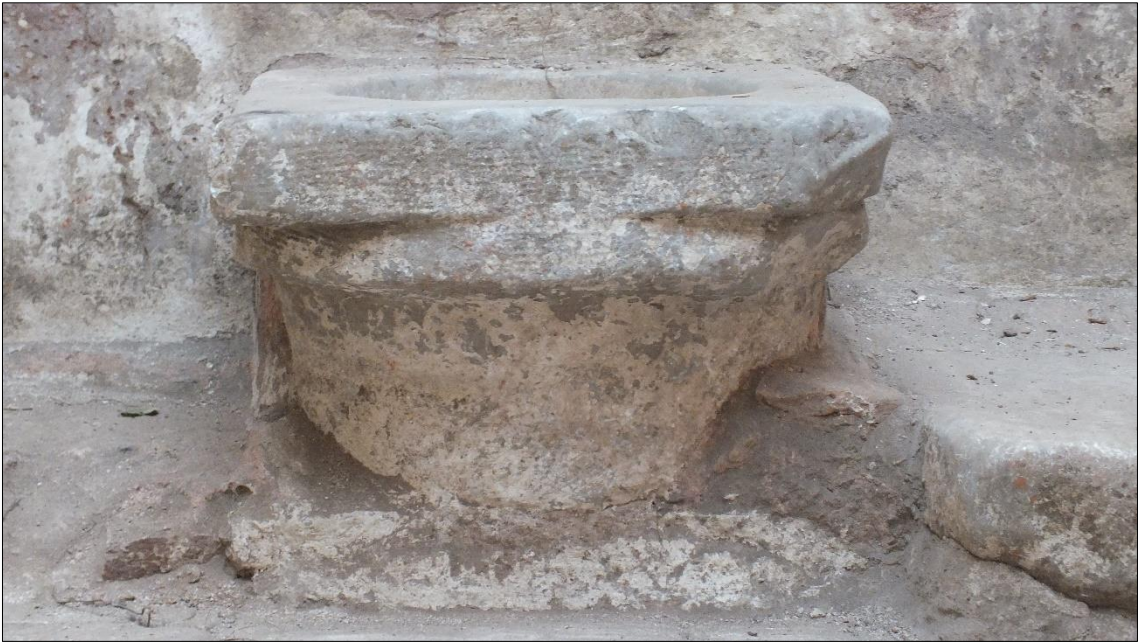
Figure A.46. *Kurna*

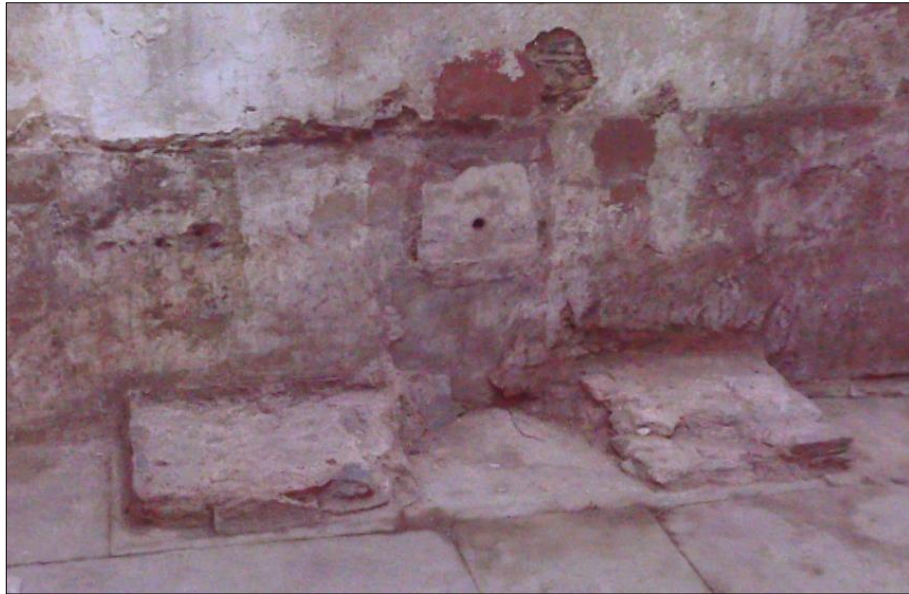
Figure A.47. Traces of the *kurna* and *seki*  
(Source: ANKA Architecture and Restoration Office archive, February 2017)

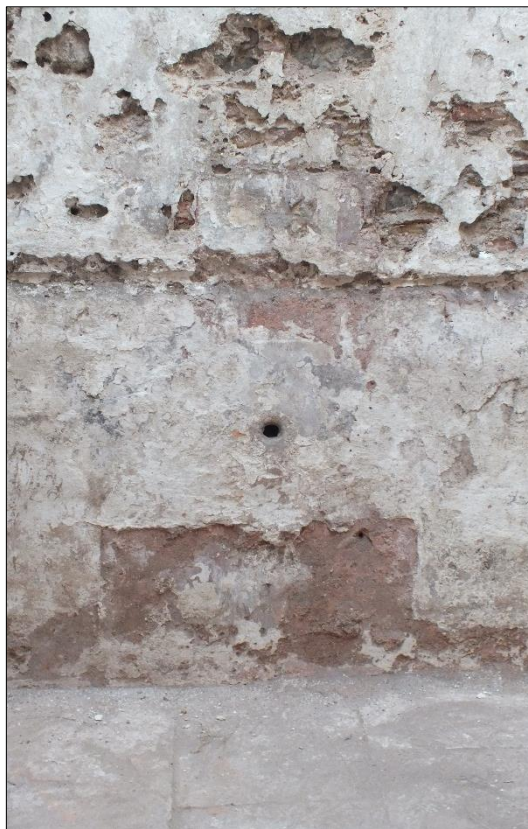
Figure A.48. Traces of the *kurna* and *seki*  
(Source: ANKA Architecture and Restoration Office archive, February 2017)

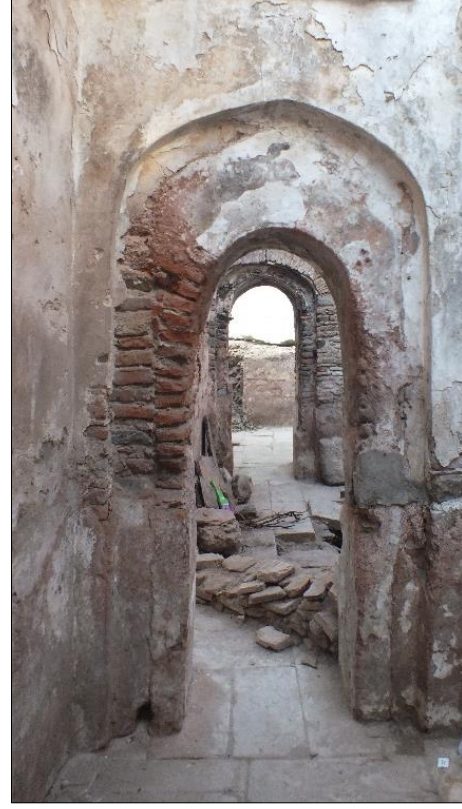
Figure A.49. External (a) and internal (b) view of the entrance of G02 *Sıcaklık*  
(Source: ANKA Architecture and Restoration Office archive, November 2016)

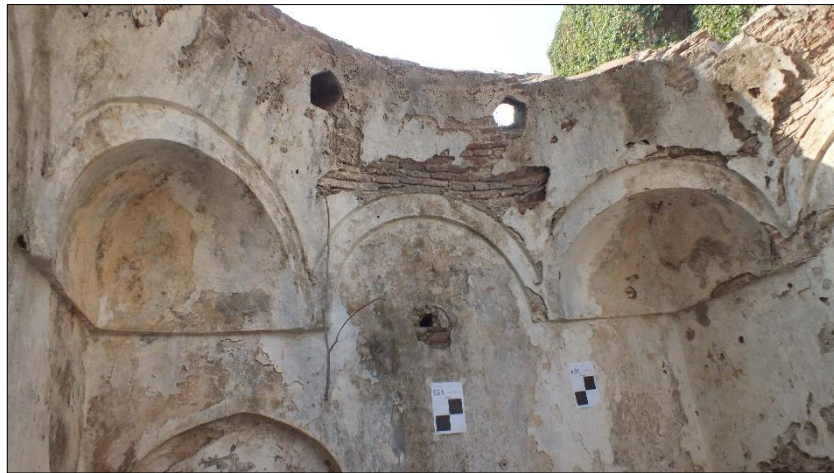
Figure A.50. The squinches and the pentagonal oculises  
(Source: Fatma Gürhan, July 2016)

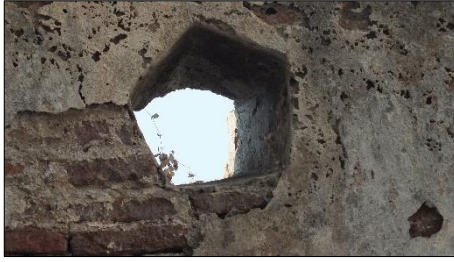
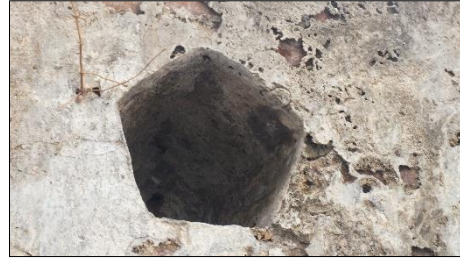
Figure A.51. The pentagonal oculises (a, b)

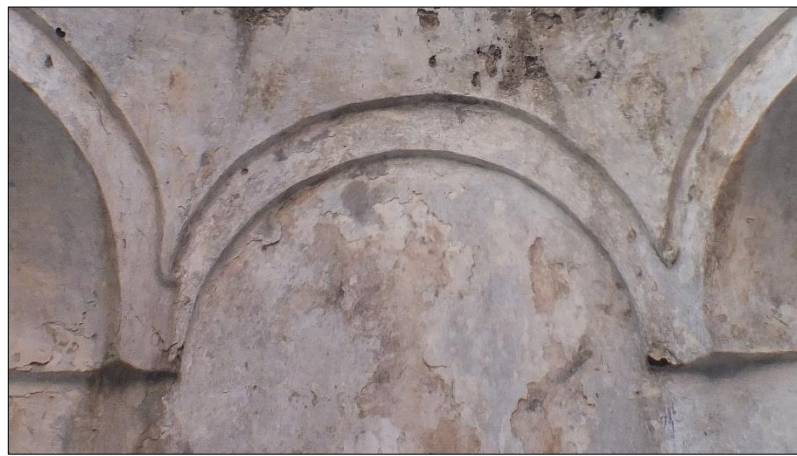
Figure A.52. The plaster motifs at the squinch finishes

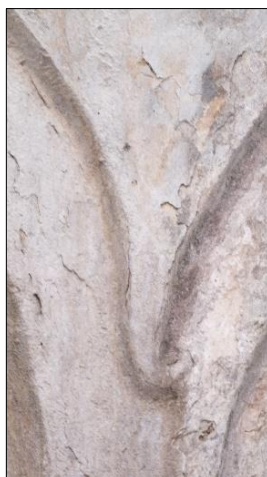
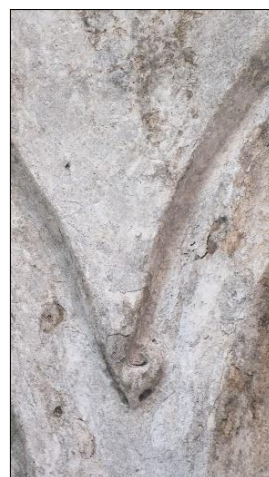
Figure A.53. The left (a) and the right (b) plaster motifs with curved tips

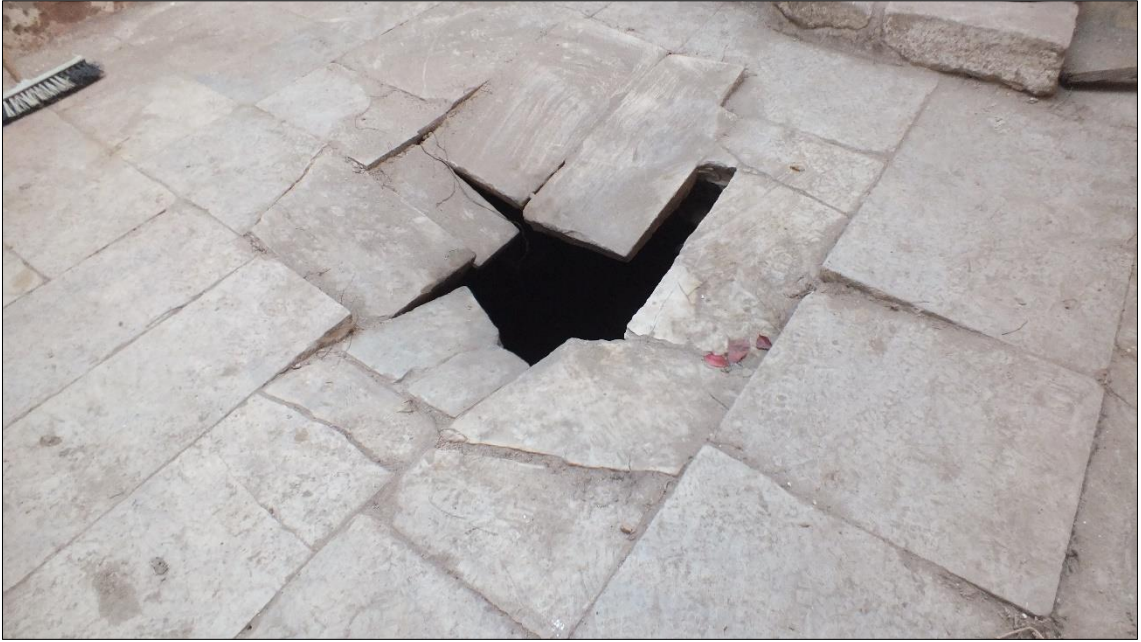
Figure A.54. The floor covering of the G02 *Sıcaklık* space  
(Source: ANKA Architecture and Restoration Office archive, November 2016)

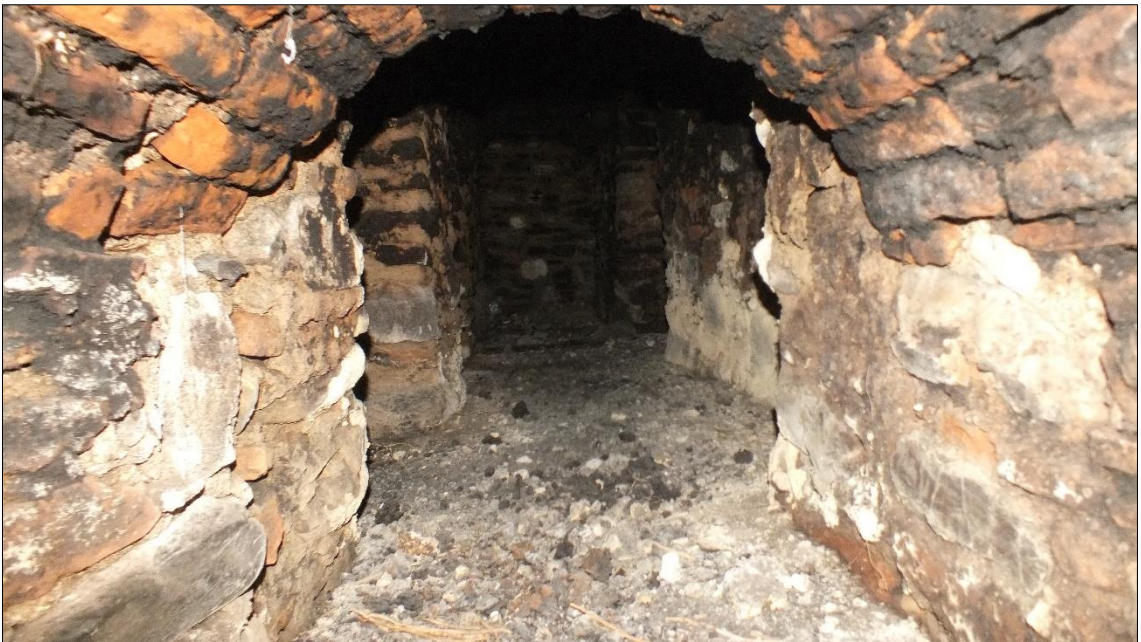
Figure A.55. *Cehennemlik*  
(Source: ANKA Architecture and Restoration Office archive, November 2016)

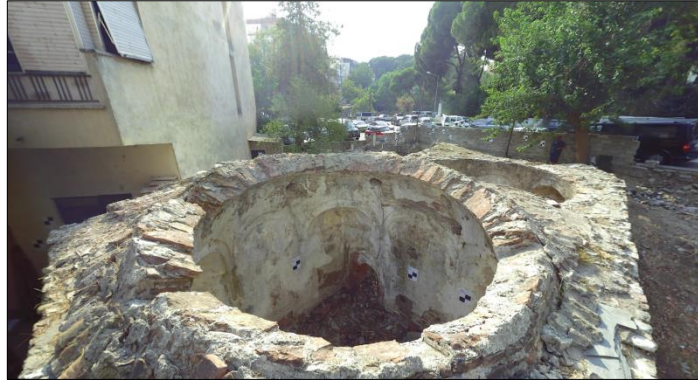
Figure A.56. The dome remain of G02 *Sıcaklık*  
(Source: ANKA Architecture and Restoration Office archive, July 2016)

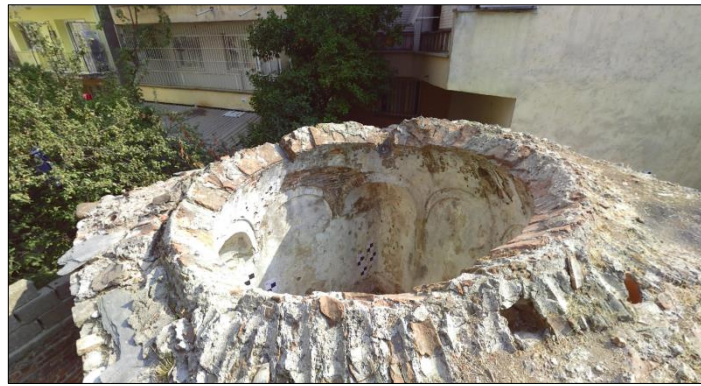
Figure A.57. The dome remain of G02 *Sıcaklık*  
(Source: ANKA Architecture and Restoration Office archive, July 2016)

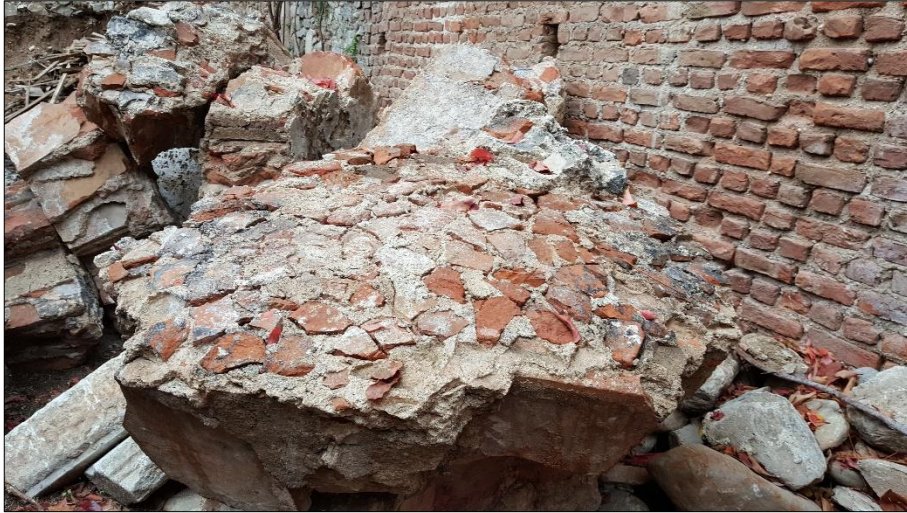
Figure A.59. The dome ruins and horasan plaster layer with crushed bricks  
(Source: Fatma Gürhan, December 2016)

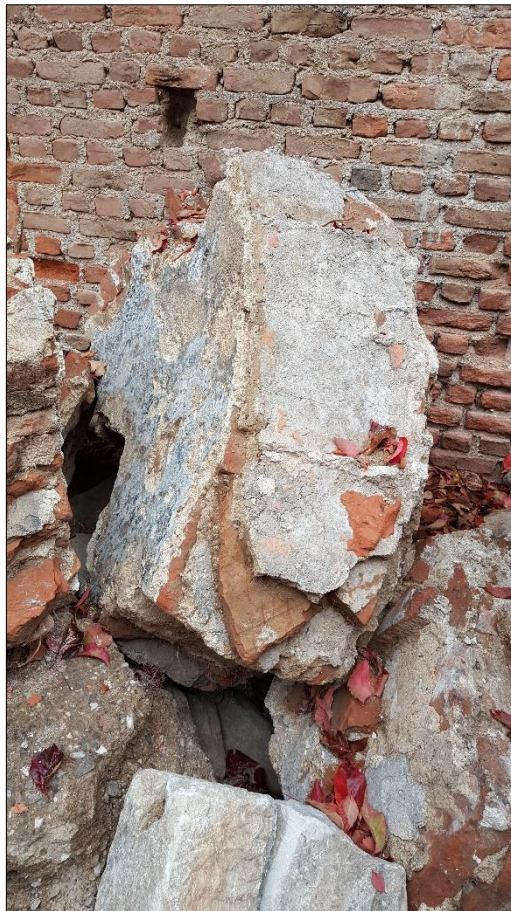
Figure A.60. The dome ruins and horasan plaster layer with crushed bricks  
(Source: Fatma Gürhan, December 2016)

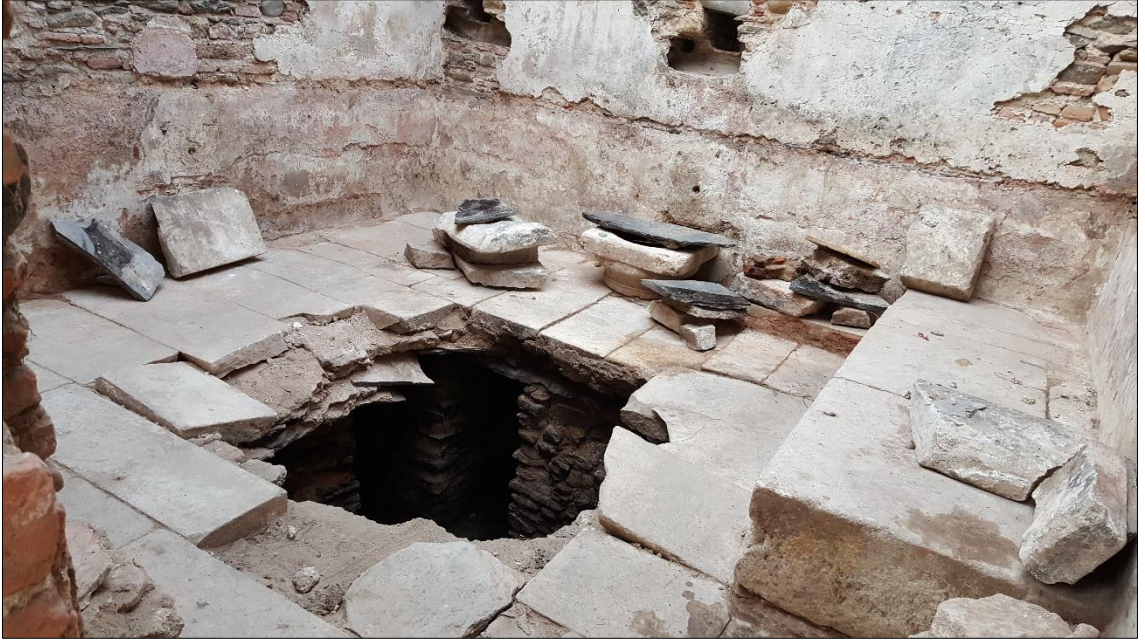
Figure A.61. *Kurna*, *kurna* remains and *seki* used as a navel stone  
(Source: Fatma Gürhan, July 2016)

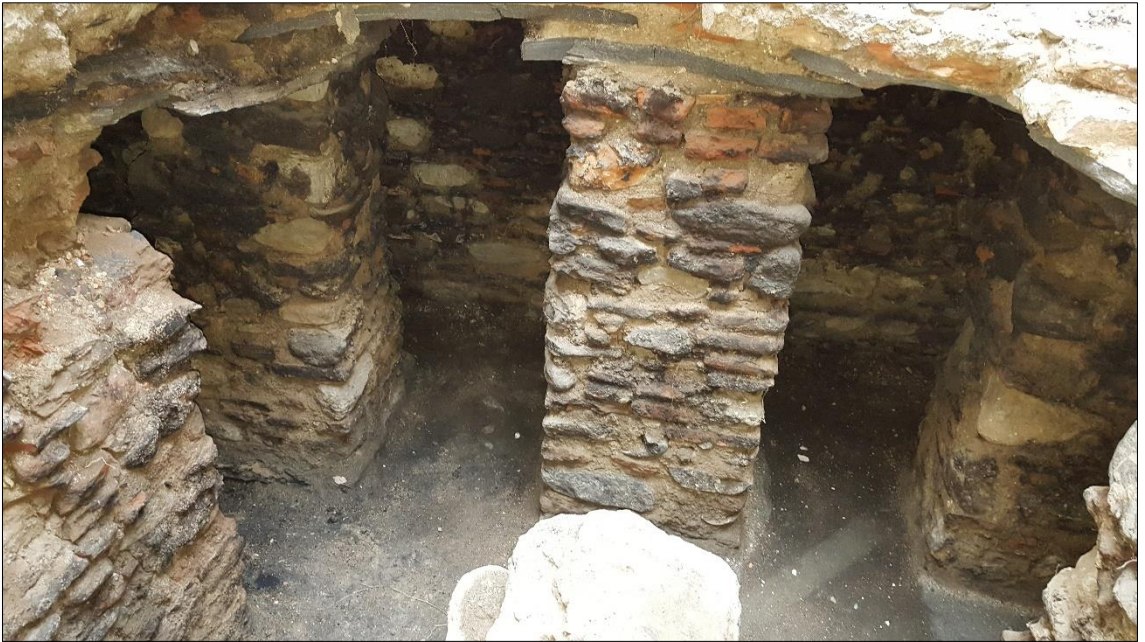
Figure A.62. *Cehennemlik* piers and the floor section  
(Source: Fatma Gürhan, July 2016)

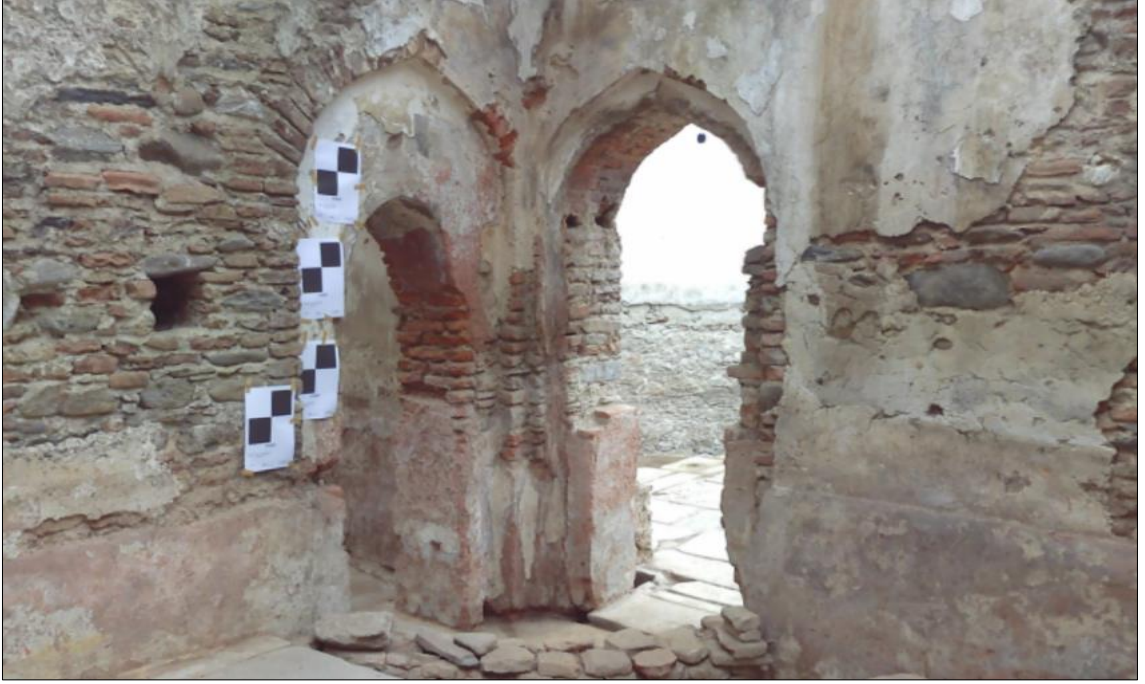
Figure A.63. Transition in the left to G02 *Sıcaklık* space and the entrance in the right from the G01 *Soyunmalık-Ilıklık* space (Source: ANKA Architecture and Restoration Office archive, February 2017)

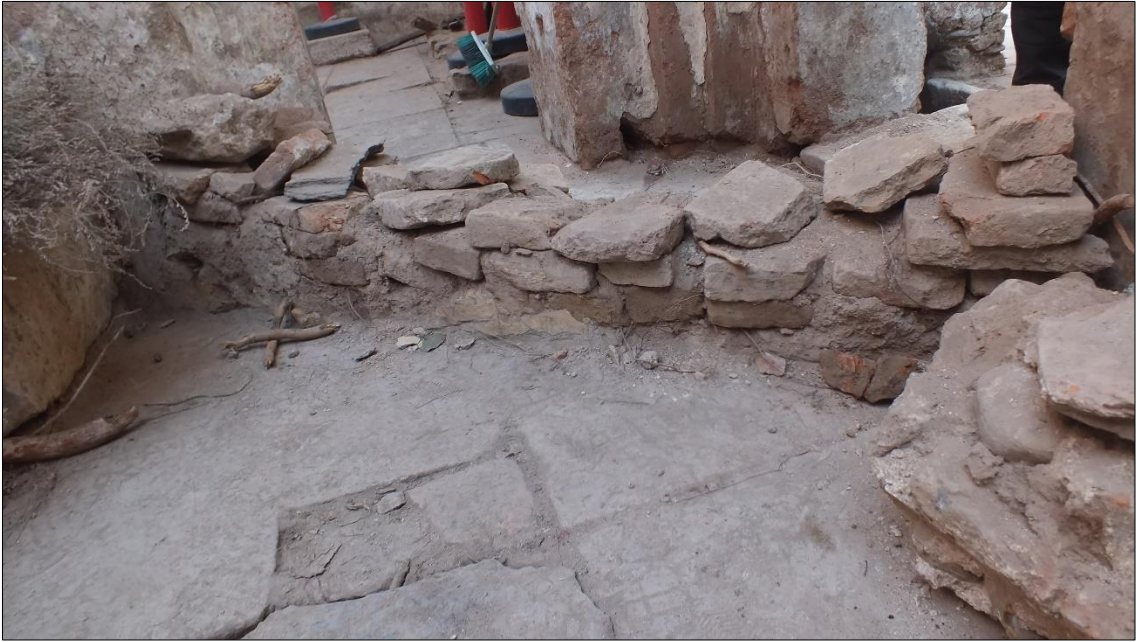
Figure A.64. The waste water channel formed with bricks between G02 *Sıcaklık* and G03 *Sıcaklık* (Source: Fatma Gürhan, November 2016)

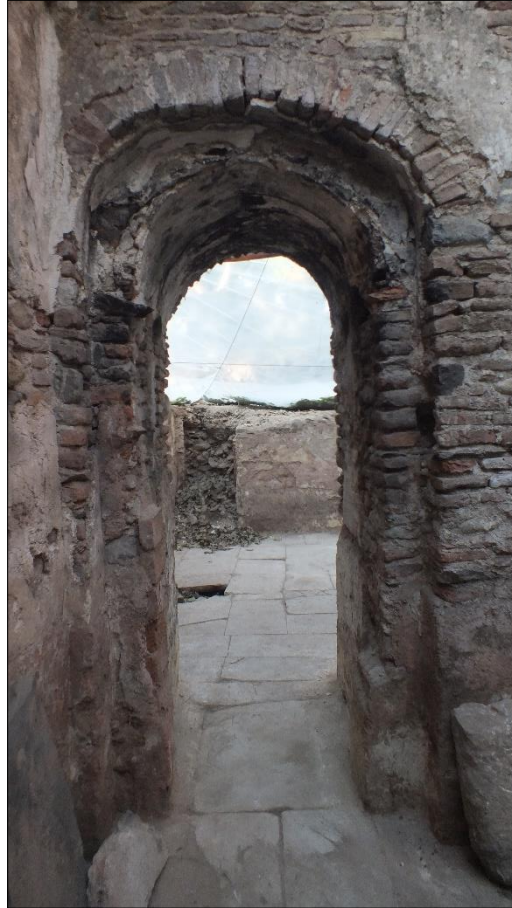
Figure A.65. Transition from G03 *Sıcaklık* to G04 *Sıcaklık*  
(Source: ANKA Architecture and Restoration Office archive, November 2016)
