**PLASTER CHARACTERISTICS OF HISTORIC  
*ESKİ HAMAM* IN AYDIN**

**A Thesis Submitted to  
the Graduate School of Engineering and Sciences of  
İzmir Institute of Technology  
in Partial Fulfillment of the Requirements for the Degree of**

**in Architectural Restoration**

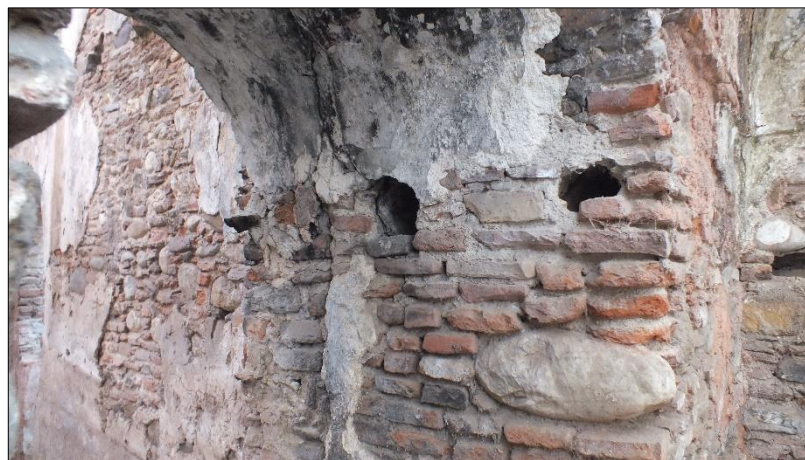
Figure A.66. The junction line between G03 *Sıcaklık* and G04 *Sıcaklık* and the interrupted terracotta pipes (Source: Mükerrerem Kürüm archive, May 2017)

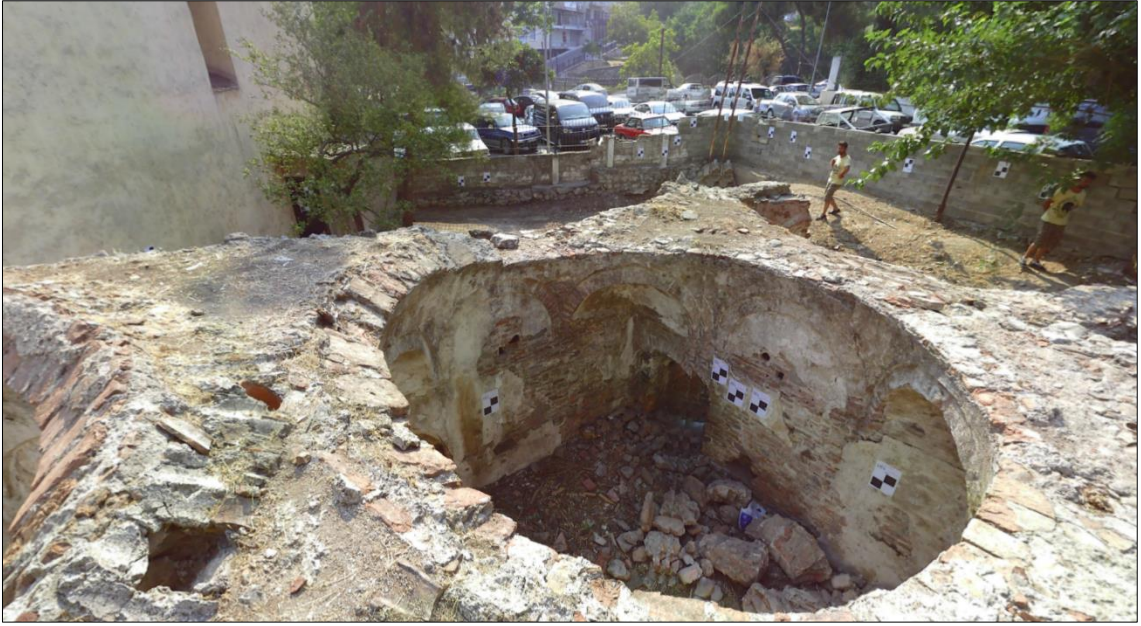
Figure A.67. The dome remain of the G03 *Sıcaklık*  
(Source: ANKA Architecture and Restoration Office archive, July 2016)

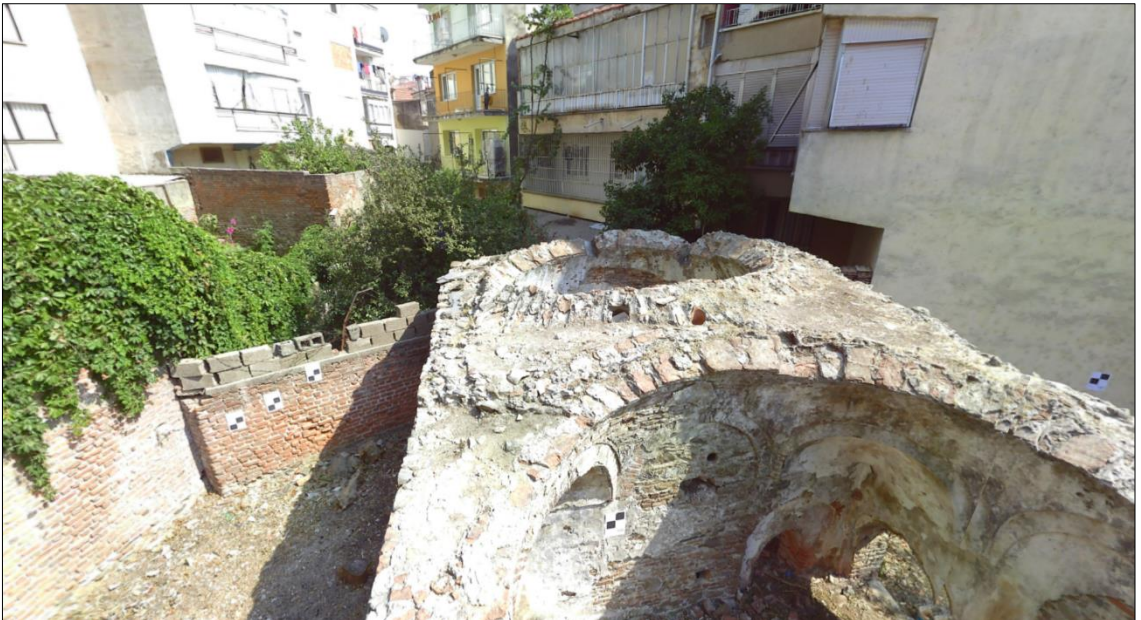
Figure A.68. The dome remain of the G03 *Sıcaklık*  
(Source: ANKA Architecture and Restoration Office archive, July 2016)

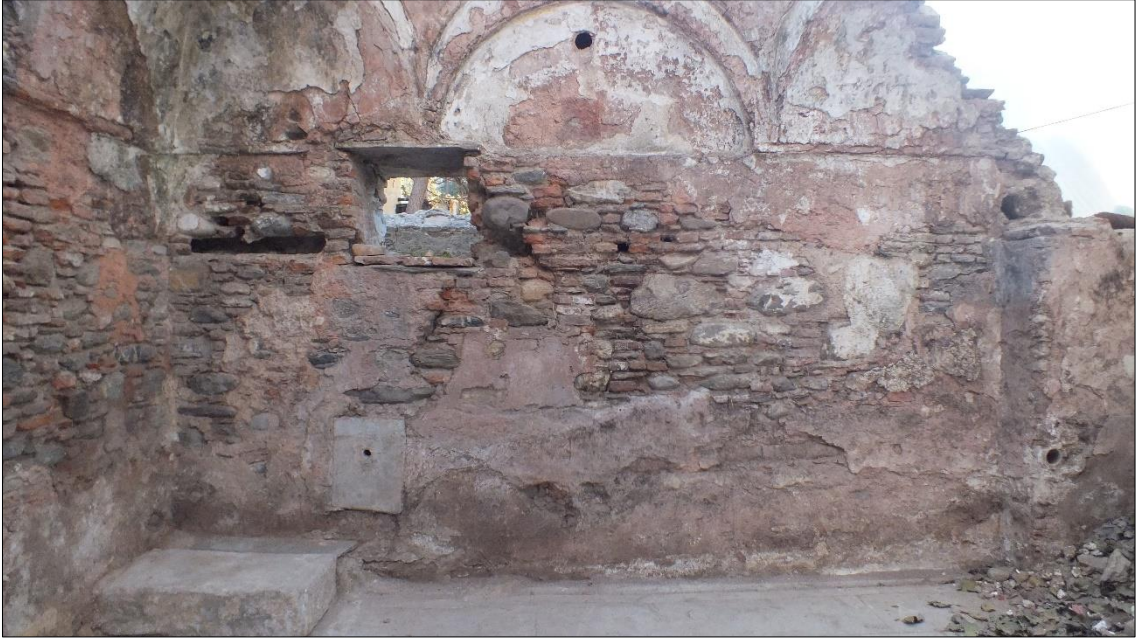
Figure A.69. *Kurna* remain and *seki*  
(Source: Mükerrerem Kürüm archive, May 2017)

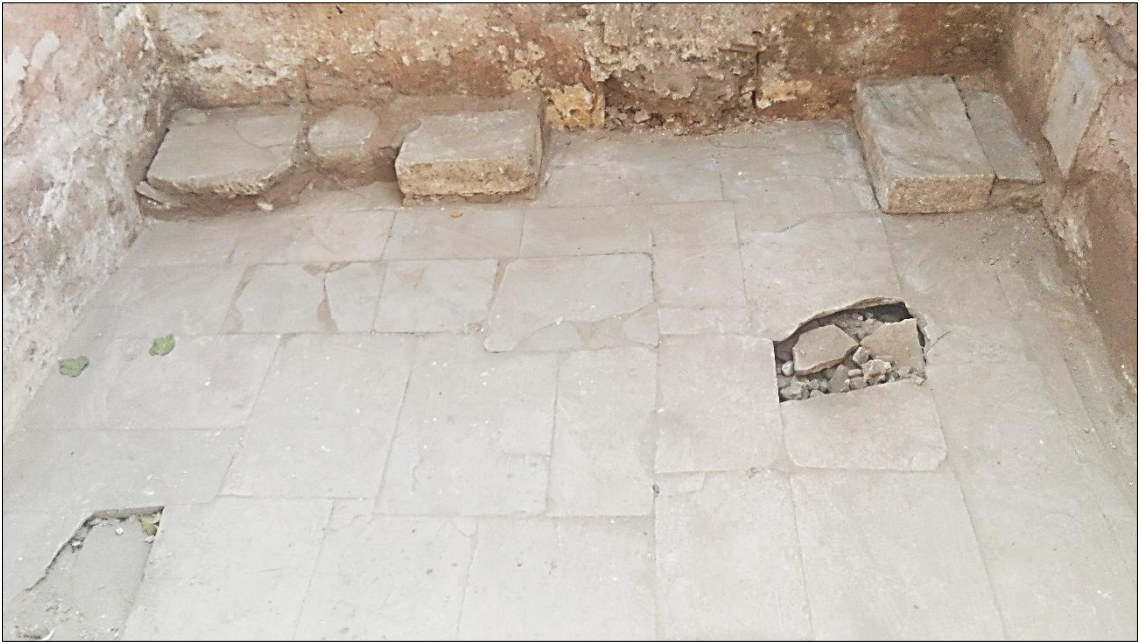
Figure A.70. *Kurna* remains and *sekis*  
(Source: ANKA Architecture and Restoration Office archive, October 2016)

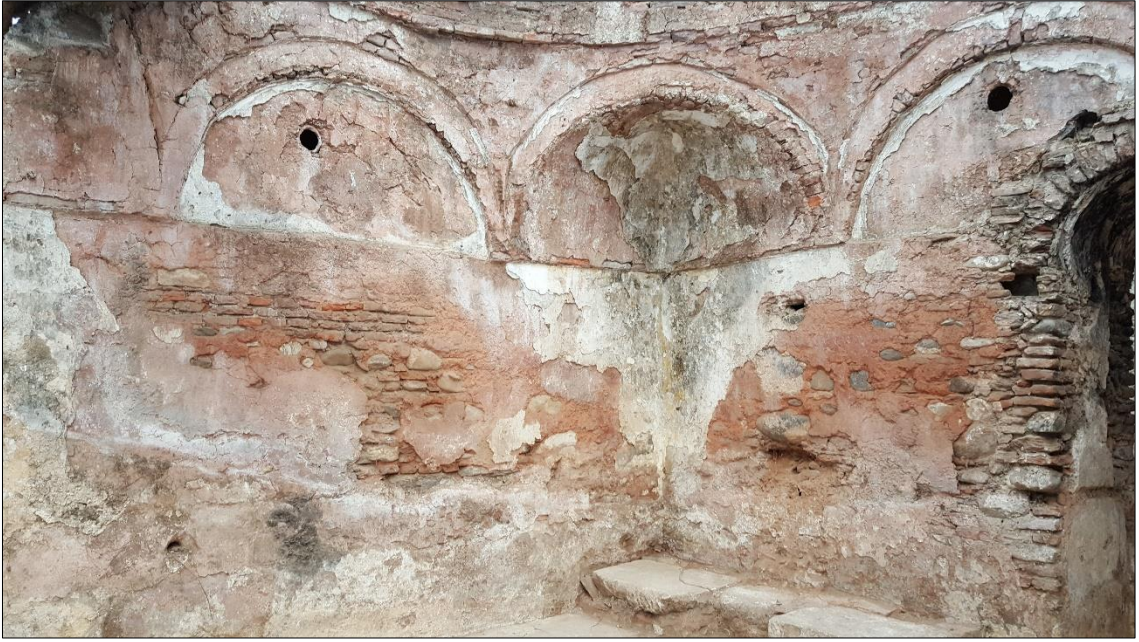
Figure A.71. The interior plasters of the G04 *Sıcaklık*  
(Source: Fatma Gürhan, December 2016)

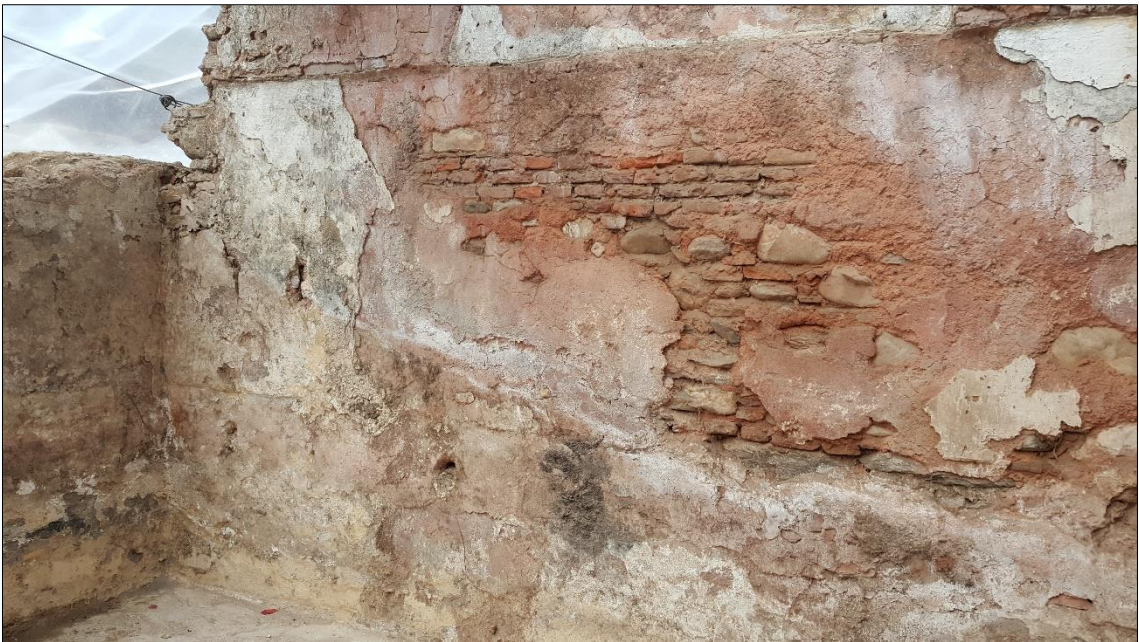
Figure A.72. The interior plasters of the G04 *Sıcaklık*  
(Source: Fatma Gürhan, December 2016)

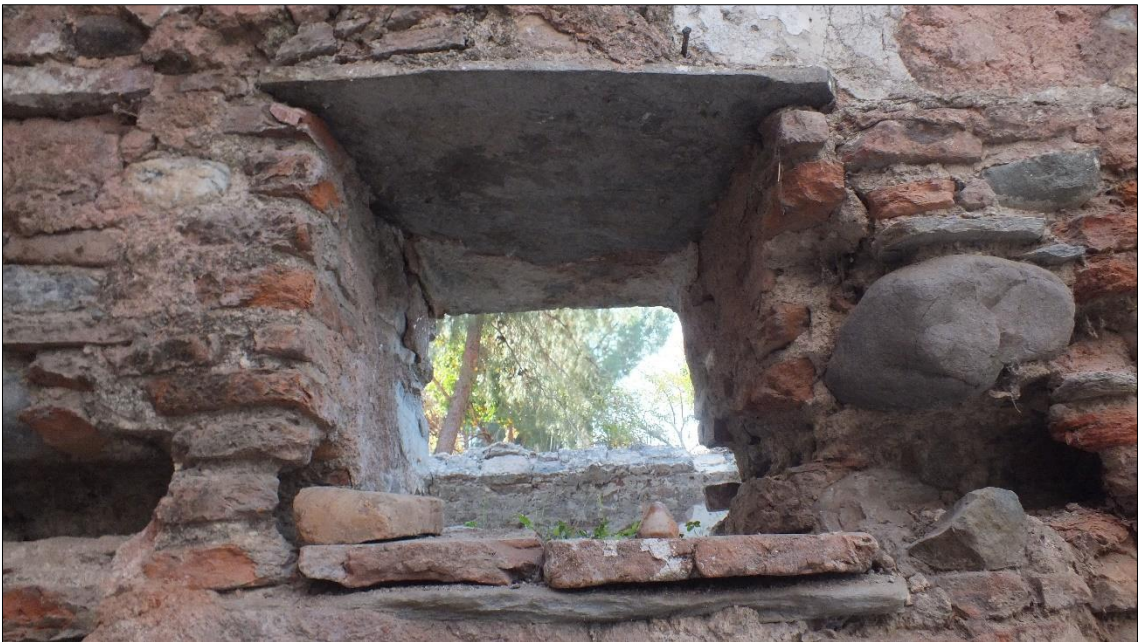
Figure A.74. The control window at the wall of G04 *Sıcaklık*  
(Source: ANKA Architecture and Restoration Office archive, November 2016)

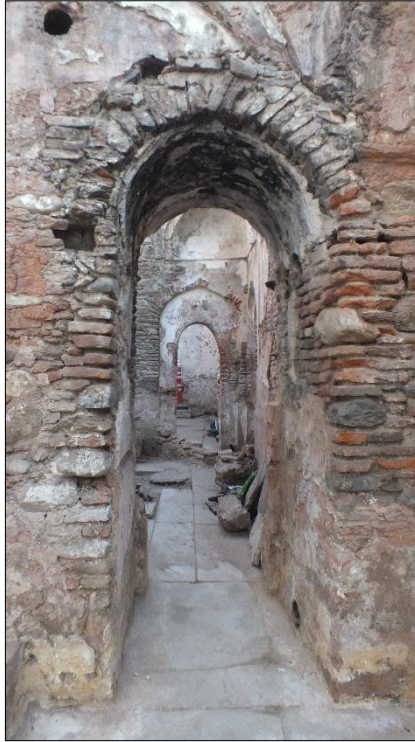
Figure A.75. The entrance of the G04 *Sıcaklık* from the G03 *Sıcaklık*  
(Source: ANKA Architecture and Restoration Office archive, November 2016)

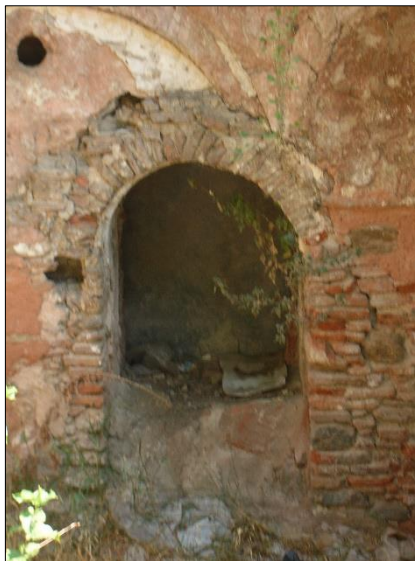
Figure A.76. The brick set at the transition between G03 *Sıcaklık* and G04 *Sıcaklık*  
(Source: Mükerrerem Kürüm archive, May 2017)

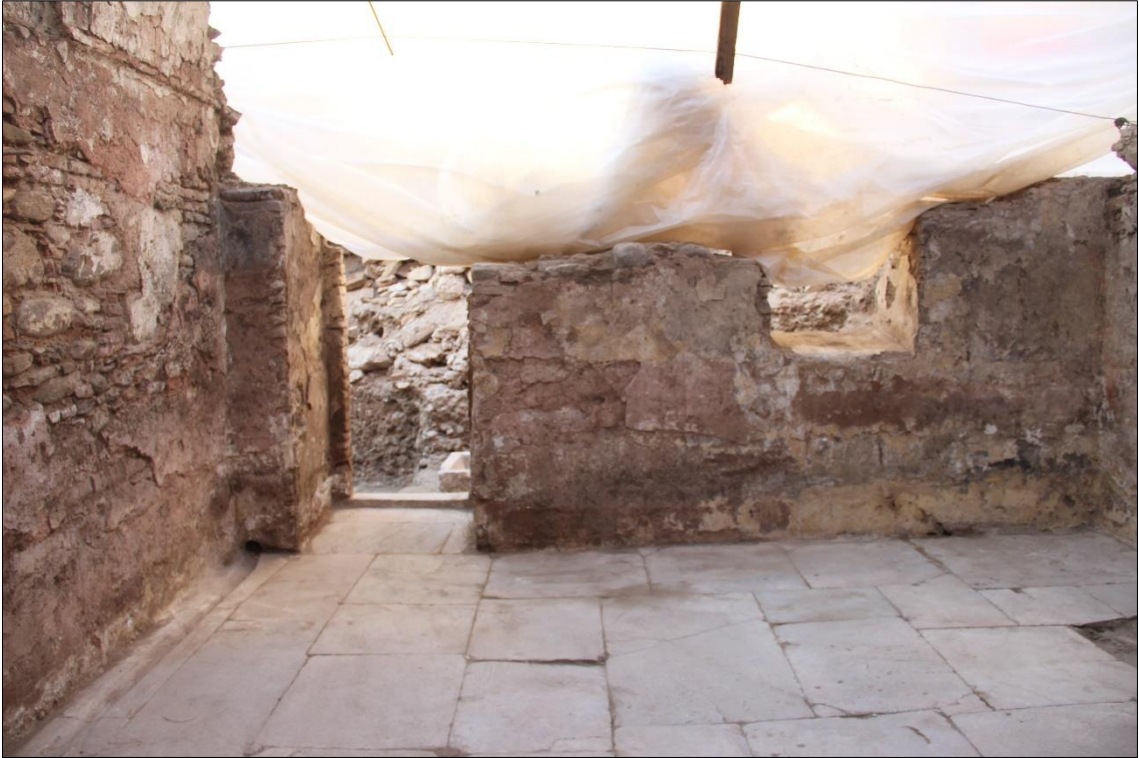
Figure A.77. The opening and a niche on the northwest wall  
(Source: Mükerrerem Kürüm archive, May 2017)

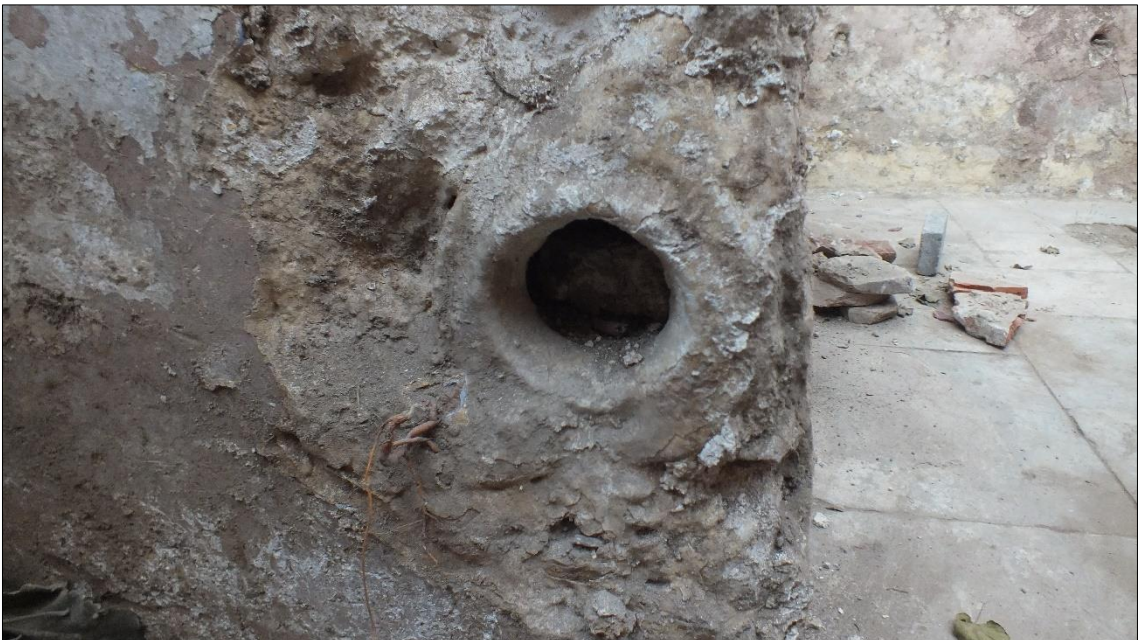
Figure A.78. The interrupted terracotta pipe in the opening on the northwest wall  
(Source: Mükerrerem Kürüm archive, May 2017)

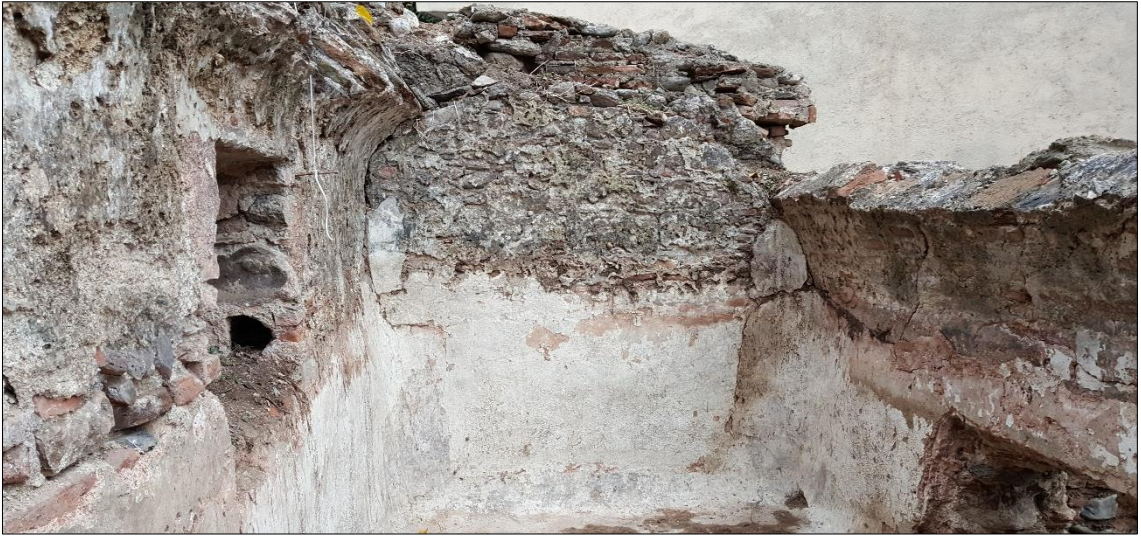
Figure A.79. The control window and the barrel vault remain  
(Source: Fatma Gürhan, December 2016)

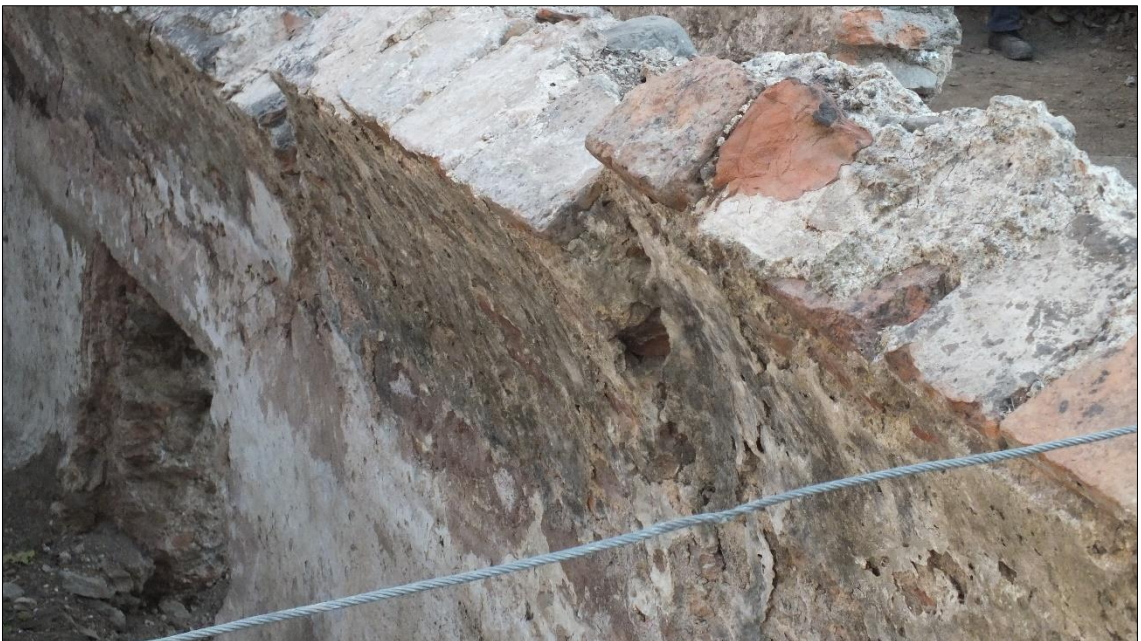
Figure A.80. The junction line between the vaults with different pitches  
(Source: ANKA Architecture and Restoration Office archive, November 2016)

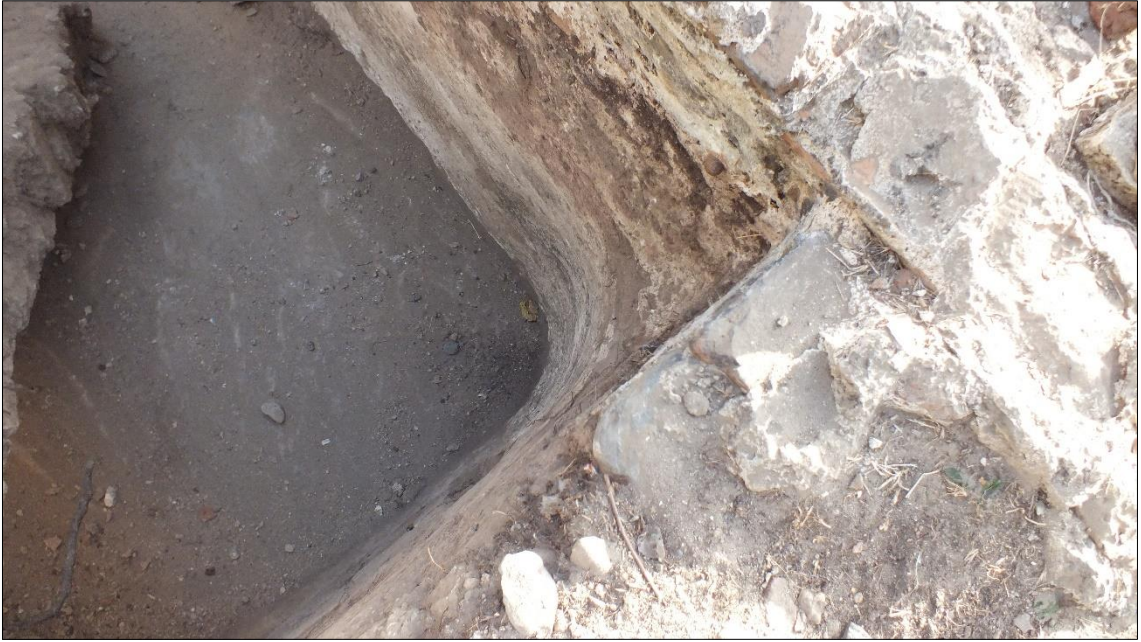
Figure A.81. Example of rounded corner with plaster  
(Source: ANKA Architecture and Restoration Office archive, October 2016)

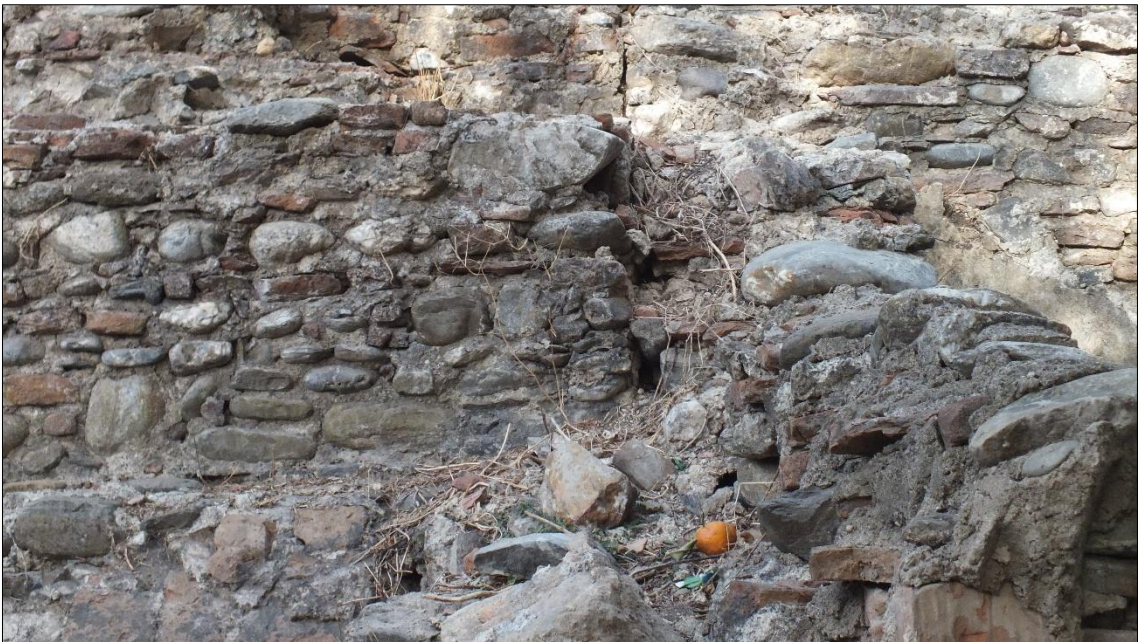
Figure A.82. The junction line between the hot water reservoir and *soyunmalık-ılıkık* wall (Source: ANKA Architecture and Restoration Office archive, October 2016)

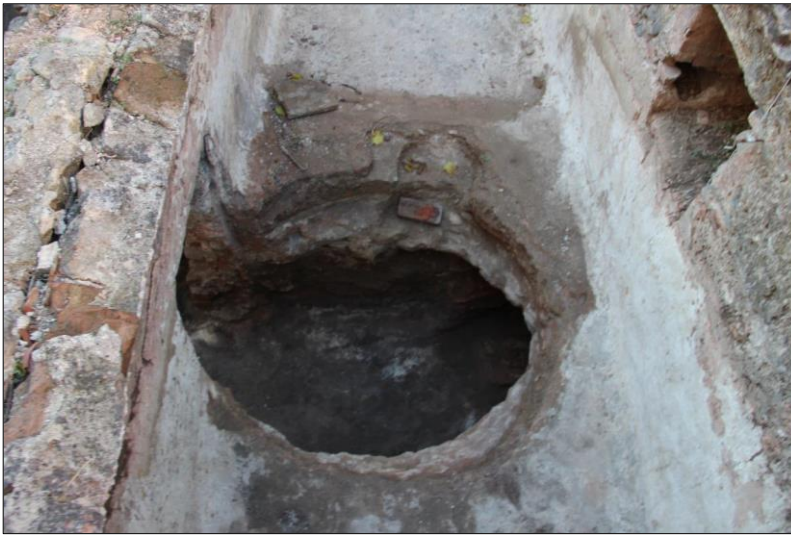
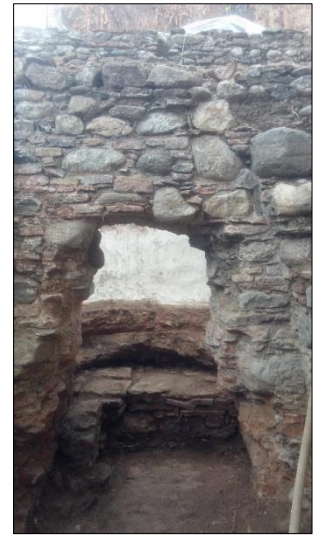
Figure A.83. The water boiler location in water reservoir (a) and *küllhan* (b)  
(Source: ANKA Architecture and Restoration Office archive, December 2016)

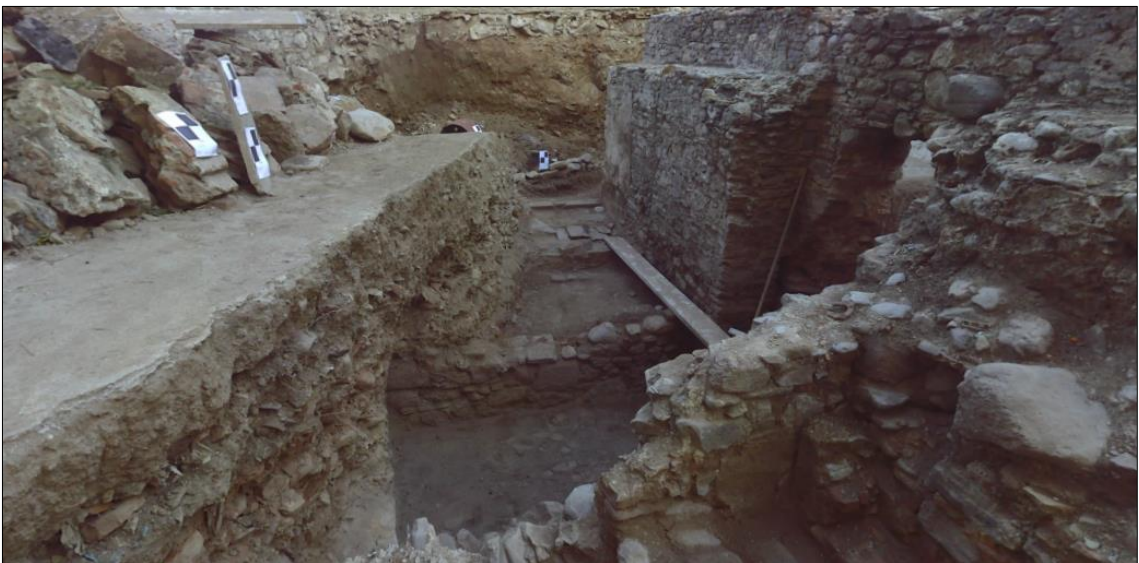
Figure A.84. The woodshed in the left and the supporting wall in the right  
(Source: ANKA Architecture and Restoration Office archive, November 2016)

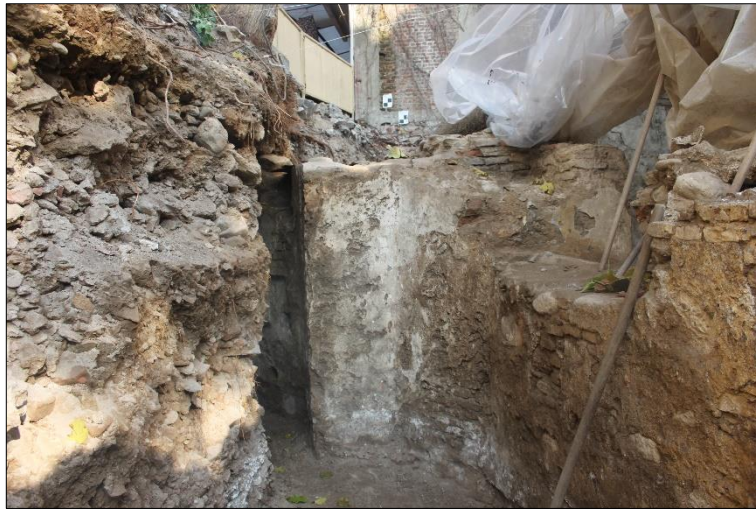
Figure A.85. The fountain in the north of the bath  
(Source: ANKA Architecture and Restoration Office archive, December 2016)

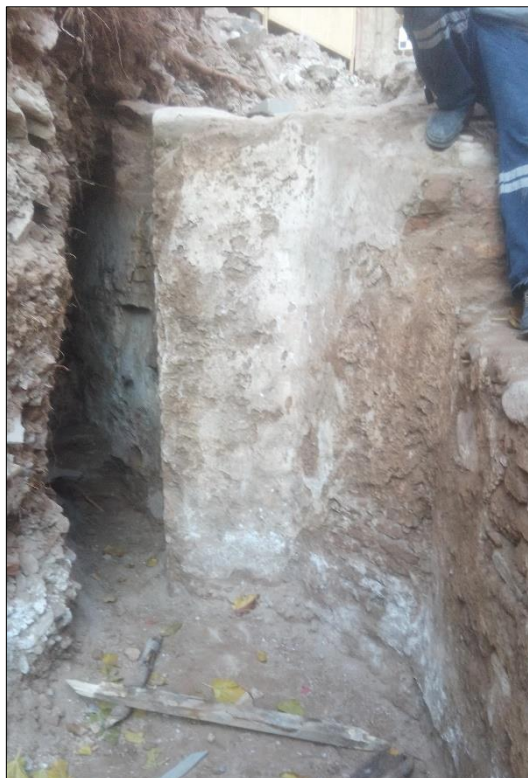
Figure A.86. The fountain of the bath  
(Source: ANKA Architecture and Restoration Office archive, December 2016)

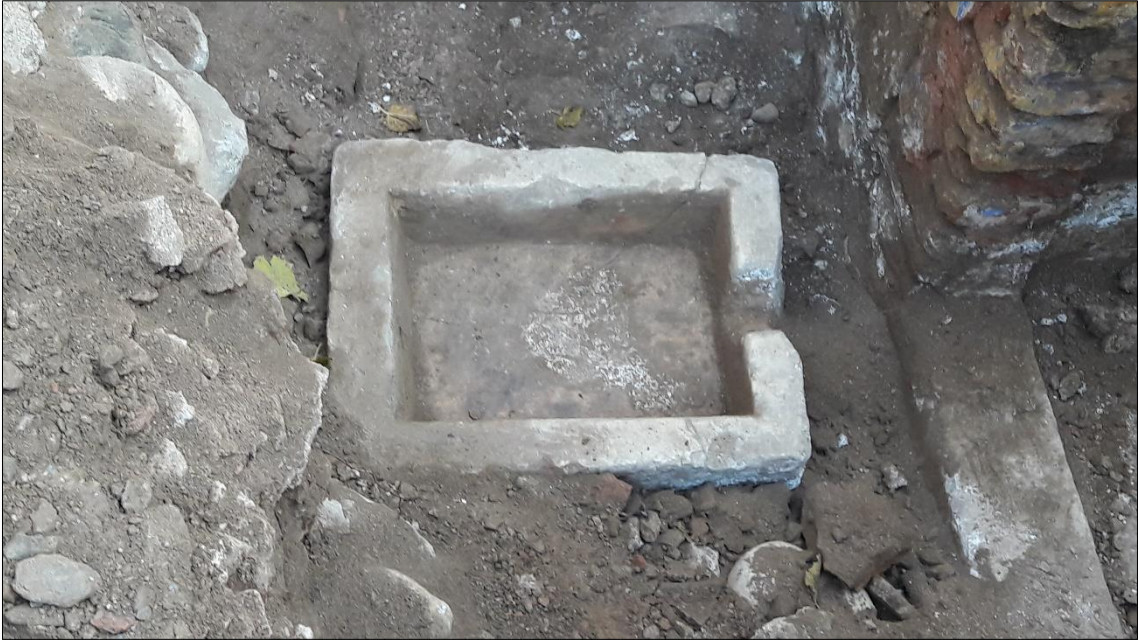
Figure A.87. The trough of the fountain  
(Source: ANKA Architecture and Restoration Office archive, December 2016)

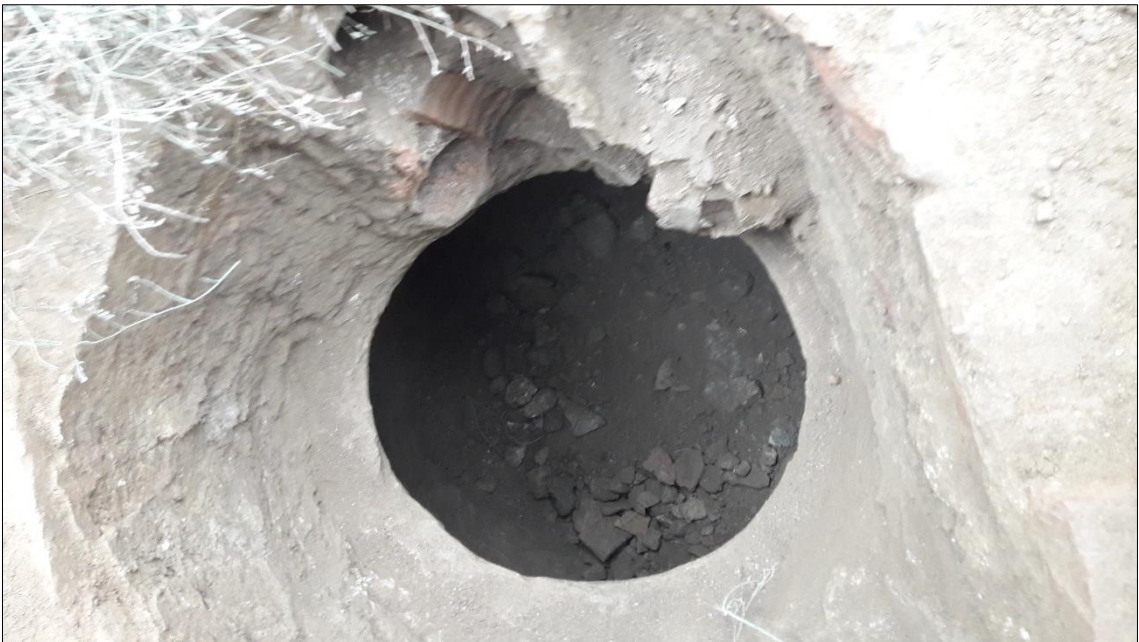
Figure A.88. The water reservoir of the fountain  
(Source: ANKA Architecture and Restoration Office archive, December 2016)

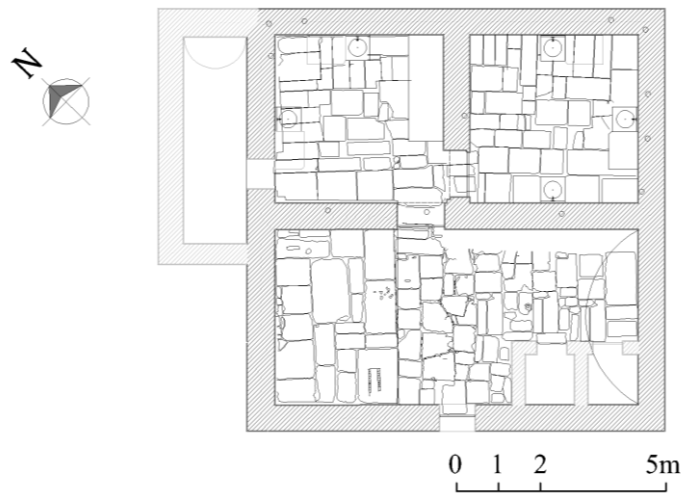
Figure B.1. Floor covering plan of the first period  
(Drawn by: N. Nur Kocasoy Bağıcı, 2017, ANKA Architecture and Restoration Office)

Data pertaining to the original condition of *Eski Hamam* as it was initially constructed was mostly based on the structure itself and the remains uncovered with the excavation. In this respect, the bath can be evaluated as to have a *soyunmalık-ılıklik*, two *sıcaklıks* and a water reservoir in the 15<sup>th</sup>-16<sup>th</sup> centuries (Kürüm, 2017) (Figure 2.18).

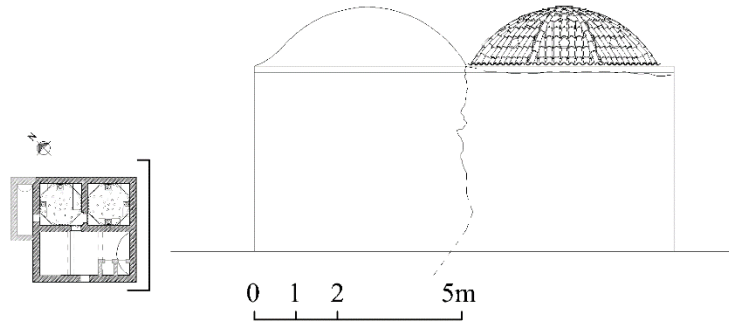
Figure B.12. Southeast elevation of the first period  
 (Drawn by: N. Nur Kocasoy Bağcı, 2017, ANKA Architecture and Restoration Office)

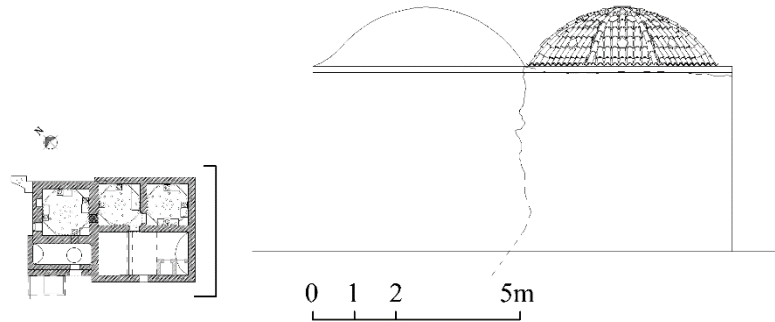
Figure B.51. Southeast elevation of the fourth period  
 (Drawn by: N. Nur Kocasoy Bağcı, 2017, ANKA Architecture and Restoration Office)
