**CONSTRUCTION TECHNIQUES
OF TRADITIONAL HOUSES
IN KARABURUN VILLAGES**

**A Thesis Submitted to
the Graduate School of Engineering and Sciences of
İzmir Institute of Technology
in Partial Fulfillment of the Requirements for the Degree of**

in Architectural Restoration

**by
Burçin GÖRÜR**

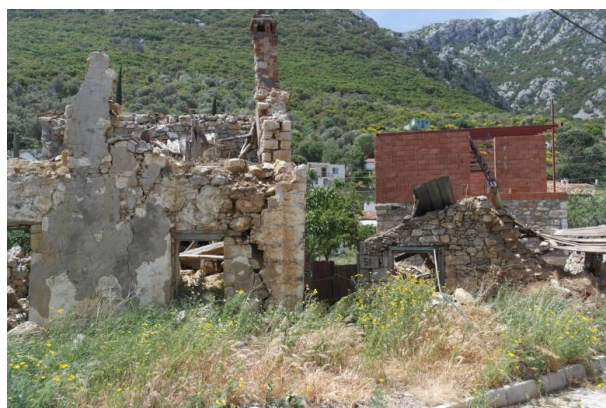
Figure 1.1. Disappearing structures in Ambarseki (May 2017).

Karaburun peninsula which has been inhabited since the prehistoric times has many rural settlements that still represent rural architectural characteristics of 19th century with a high level of preservation. Main reason of the high preservation level depends on poor accessibility possibilities to the region. However, this splendidly preserved condition and the peninsula is subject to major alterations in recent years (Figure 1.1, 1.2, 1.3).

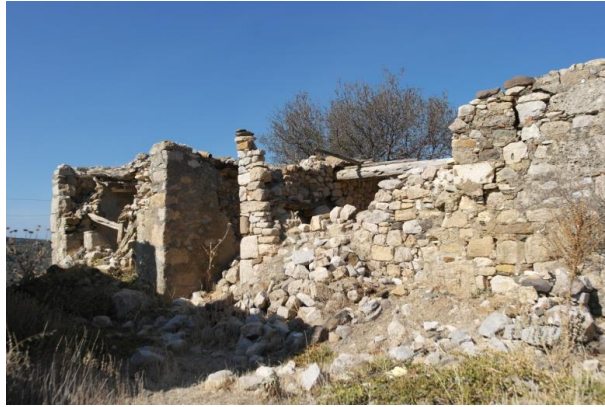
Figure 1.2. Disappearing structures in Bozköy (October 2016).

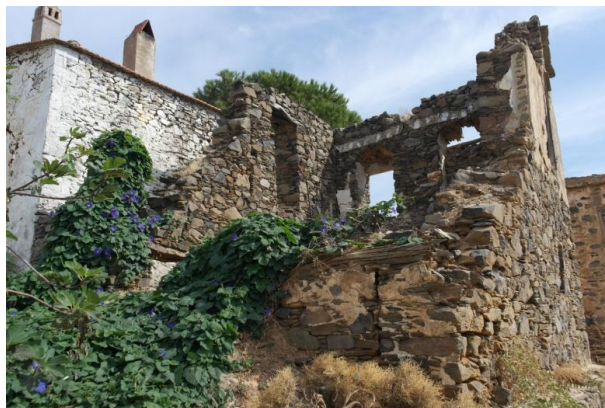
Figure 1.3. Disappearing structures in Salman (October 2016).

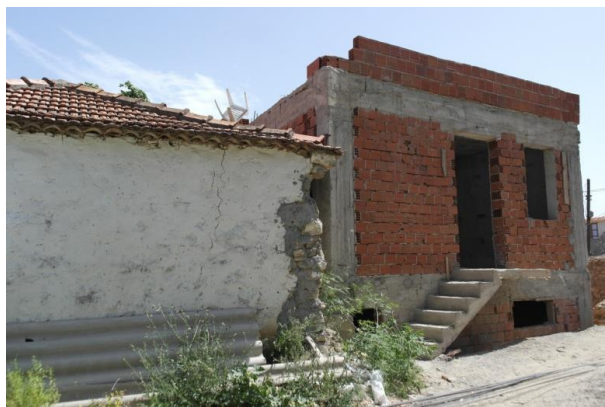
Figure 1.4. Old and new structure relation in Ambarseki (May 2017).

On the other hand, the migration to the peninsula also gained momentum in recent years. The new highway construction which aims to link all the Karaburun settlements to the main transportation network ease access to the peninsula. Thus, urbanite looking for natural life alternatives discovered untouched villages of the peninsula. Unfortunately, these new comers dramatically changed the physical environment to meet their needs. This process also introduced changes to the social structure (Figure 1.4, 1.5).

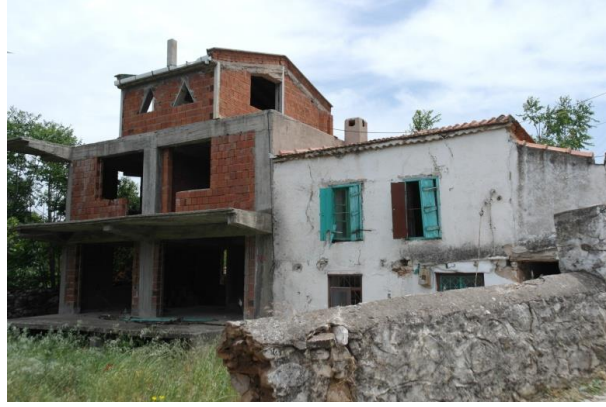
Figure 1.5. Old and new structure relation in Saip (May 2017).

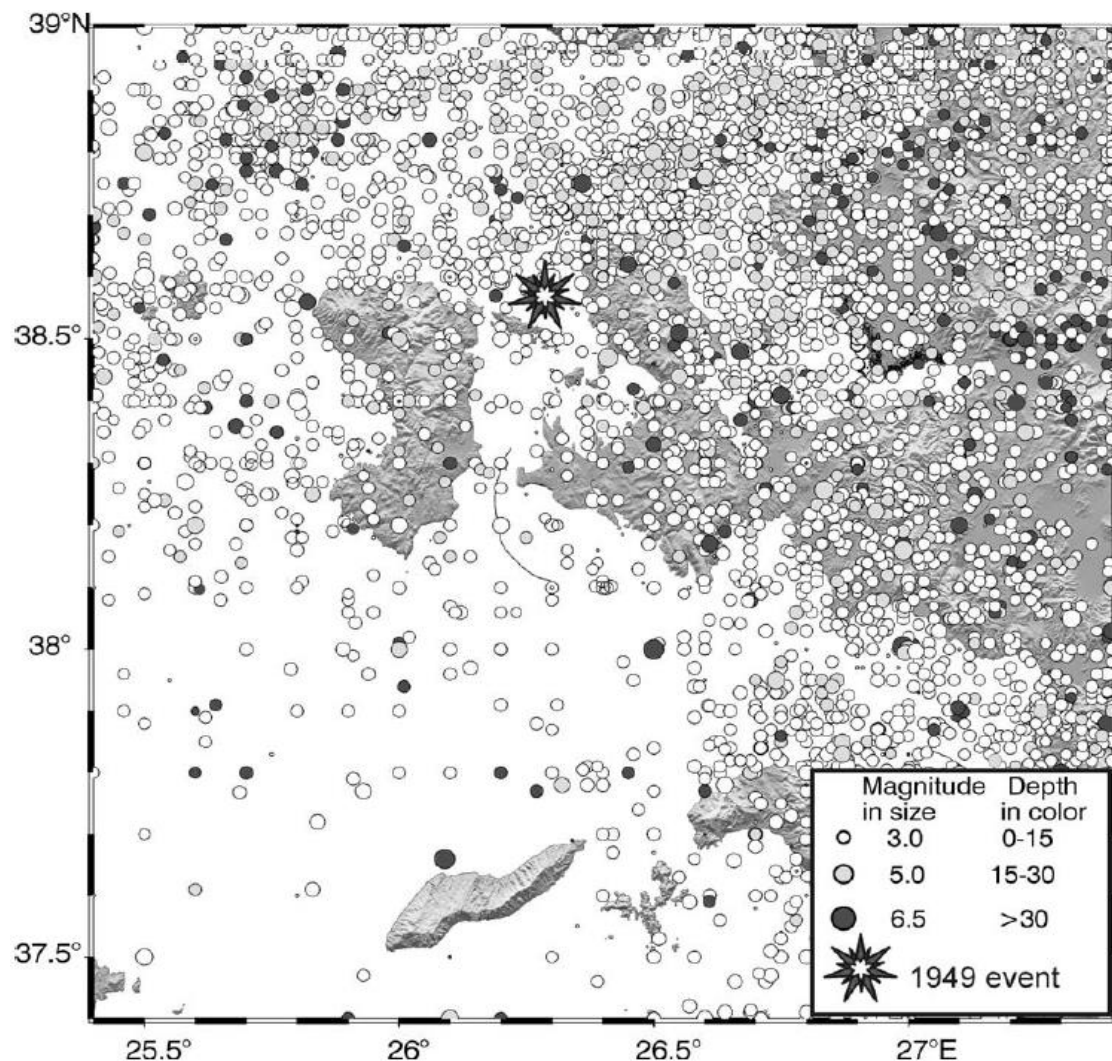
Map 2.11. Instrumental earthquakes occurred between 1900 and 2005. Data is provided from the web page of Kandilli Observatory. Circle size represents the magnitude of the earthquake, and ranges from 0 to 6.8. (Source: Y. Altinok, B. Alpar, N. Ozer, C. Gazioglu., 2005).

İzmir is one of the seismically dynamic part of the Aegean Plate. The seismic movements hold on the Aegean Sea are seen mostly in İzmir Bay, Chios Islands and Karaburun Peninsula. The region suffered from twenty important earthquakes from 496 BC to 1949 (Y. Altinok, B. Alpar, N. Ozer, C. Gazioglu., 2005) (Map 2.11). These earthquakes were so severe that is possible to find the impact and the precautions taken afterwards both in Ottoman and Turkish archive sources.

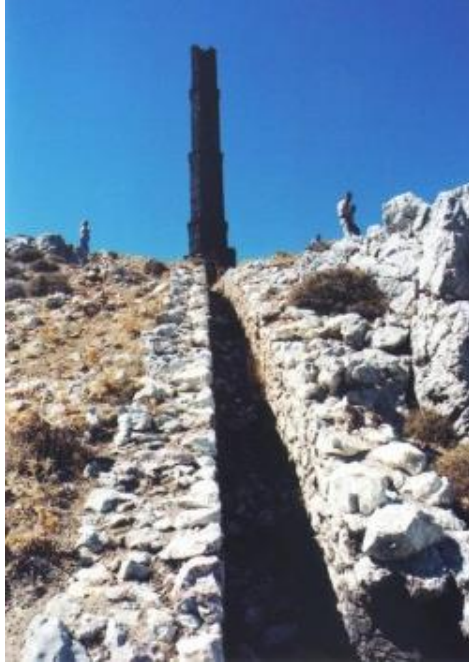
Figure 2.1. Mercury Mine in Karaburun Peninsula (by Cavit Kürnek, 1997).
(Source: <http://www.karaburunkentkonseyi.org/civa-maden-ocagi/>)

Another business on the peninsula is mining (Figure 2.1). By 1929, there were three mercury mines in Karaburun. It is understood from the statistics that there were mines in Yayla in 1931, Denizgiren and Karareis villages and in Çullu village in 1933 (Işık, 2002). Another common mine in the peninsula is quarries. They still exist in the peninsula. There are different quarries where stone, marble (Figure 2.2) and clay (Figure 2.3) are processed.

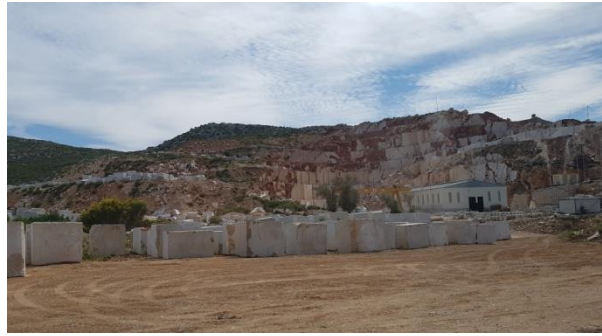
Figure 2.2. Marble Quarry in Karaburun Peninsula (May 2017).

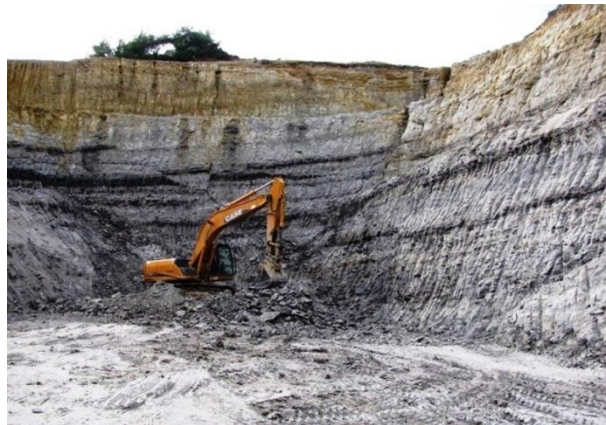
Figure 2.3. Clay Pit in Karaburun Peninsula.
(Source: <http://www.polatmaden.com/sayfa.asp?id=153>)

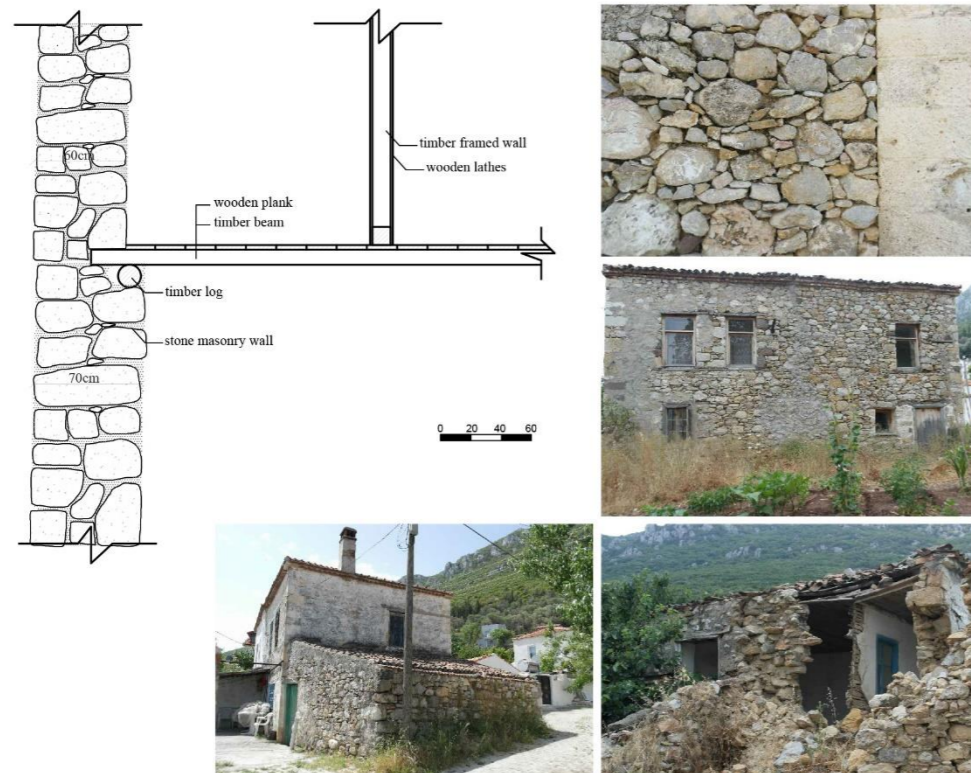
WALL SYSTEM

The traditional houses are generally one or two story buildings. They are constructed with hybrid system in which the walls of the ground floor and the exterior walls of the upper floor are stone masonry; and the inner walls of the upper floor is timber frame without infill (bağdadi). The thickness of masonry walls change between 60-80cm at the ground floor and 50-60 cm at the upper floor. The main material of the masonry walls is rubble stone. The rubble stones are yellowish-white color. The binding material is mud mortar. Large gaps between different sizes of rubble stones are filled with small stones, brick and tile pieces. The corners of the walls are reinforced with relatively larger and shaped rubble stones. Mud mortar is used for the binding material. Timber tie beams are observed in some masonry walls at different intervals. Timber lintels are used in masonry walls to span door and window openings. Some masonry walls are plastered with mud mortar and washed with lime wash.

The thickness of timber frame walls is 15 cm. In this system, firstly a frame is installed with posts (5x10 cm) and wooden lathes on both sides are nailed in horizontal directions. The laths are at closed intervals approximately 3 cm. The space between the surfaces left empty. The surfaces are covered with plaster that is composed of mud and straw. Thickness of the plaster is approximately 2-3 cm. This type of timber walls is called as 'bağdadi' in Turkish.

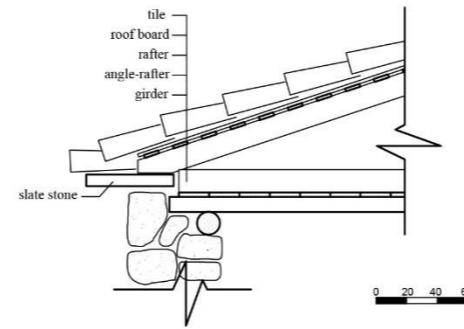
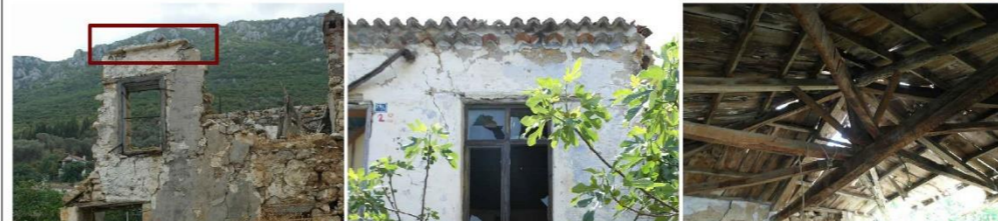
FLOOR SYSTEM

Timber frame floor system is observed on the upper floor. In this system floor beams are laid on a main girder, which is usually placed in the middle of the room, in the opposite direction of the floor beams. Floor beams are placed with approximately 40-50cm spacing. Finally, floor beams are covered with the timber flooring boards in perpendicular direction.

Hipped and pitched timber roofs are observed in the village. Hipped and pitched roofs are covered with tiles. Alaturka type tile is original roof covering material. Marsilya type tiles are observed in altered roofs. Roofs have eave. There are observed mostly tiles or slate stones. Brick has been observed for only one example at the end of the masonry wall, between wall and the roof.

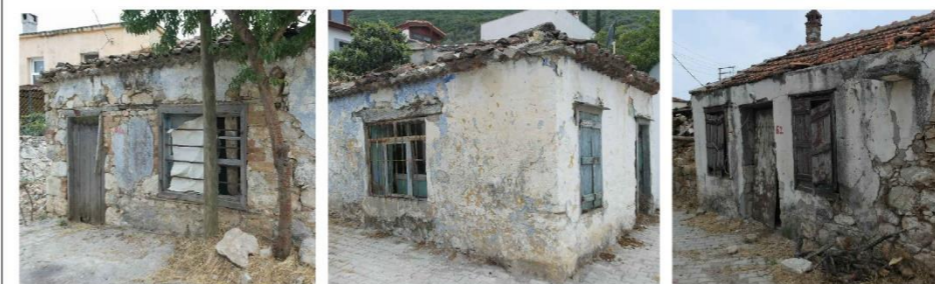
Door Door openings are spanned with timber lintel. The single winged timber doors sit on the outer edge of the door opening so their size depend on the size of the opening.

Window & Shutter Window openings are spanned with timber lintel. They are timber and double winged. The wooden shutters are parts of windows. They sit on the outer edge of a window opening.

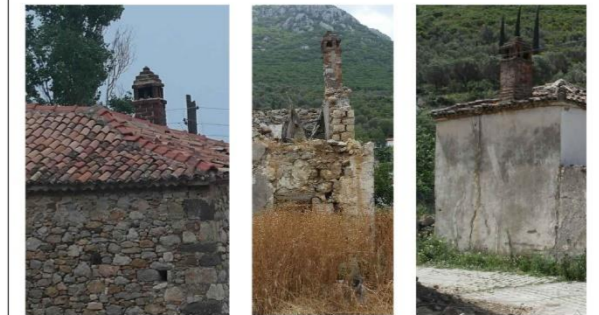
Fireplace & Chimney Fireplace is one of the main elements in the houses. They are generally located at the first floor. The wall that has the fireplace has no opening. All chimneys that could be observed were made of brick.

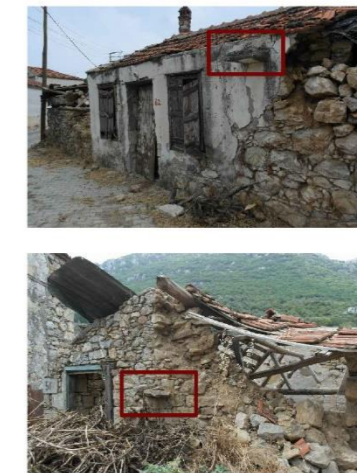
Luminaire There are stone projections next to the entrance door. They were probably used for the luminaire shelf.

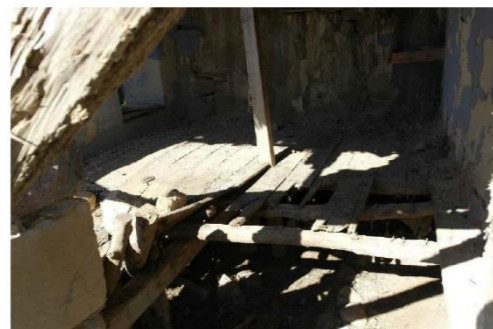
FLOOR SYSTEM

Timber frame floor system is observed on the upper floor. In this system floor beams are laid on a main girder, which is usually placed in the middle of the room, in the opposite direction of the floor beams. Floor beams are placed with approximately 40-50cm spacing. Finally, floor beams are covered with the timber flooring boards in perpendicular direction.

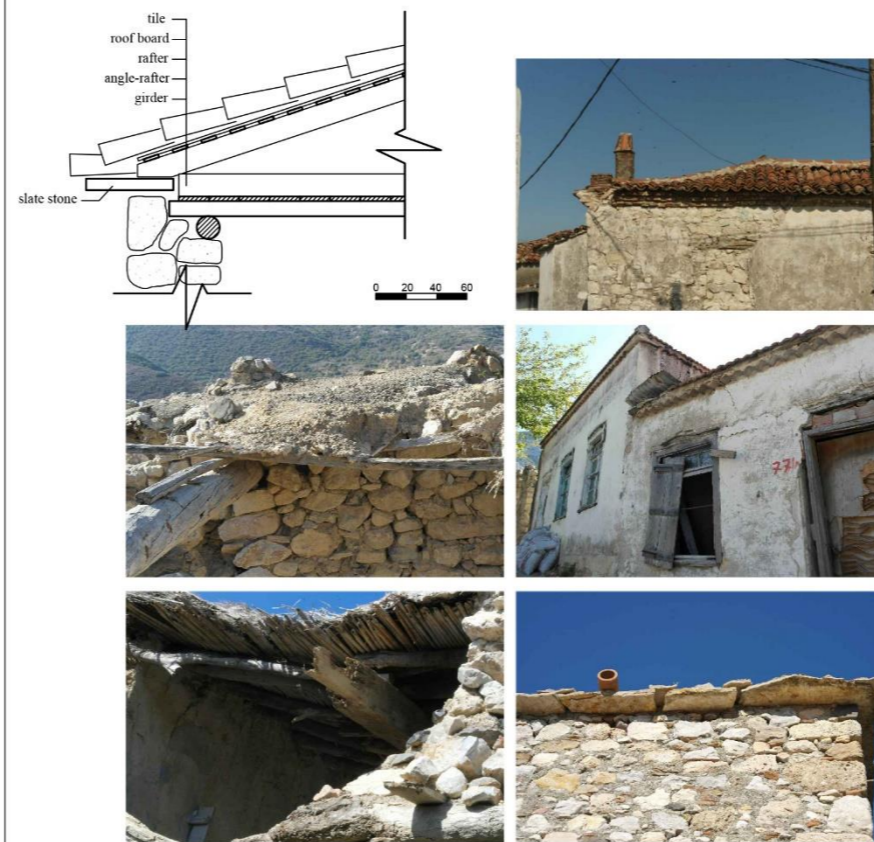
ROOF SYSTEM

Hipped and pitched timber roofs are observed in the village. Hipped and pitched roofs are covered with tiles. Alaturka type tile is original roof covering material. Marsilya type tiles are observed in altered roofs. Flat roofs are also observed in Bozköy. In this system, the main beams are placed firstly for spanning. Then they are covered with timber boards vertically to the direction of the beams and timber boards are covered with firstly reed or small wooden lathes then earth. The earth composed of dried straw and earth. In Bozköy, main beams have been covered with directly reed then they have been covered with earth.

Roofs have cave. There are observed as tile, slate stone or brick between wall and the roof.

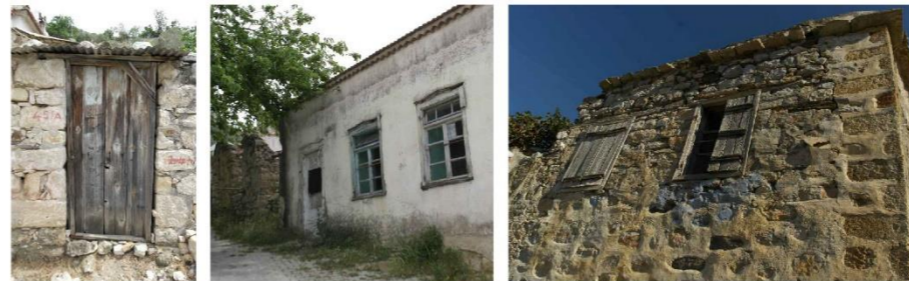
Door Doors are generally one winged and they sit on the outer edge of the door opening.

Window & Shutter Windows are timber and double winged. The wooden shutters are parts of windows. They sit on the outer edge of a window opening.

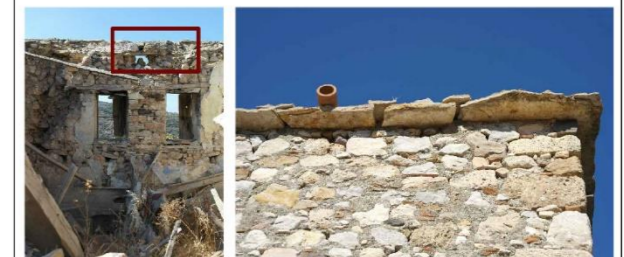
Waterspout Waterspouts have been observed in the houses that have flat roof. They are made of terracotta.

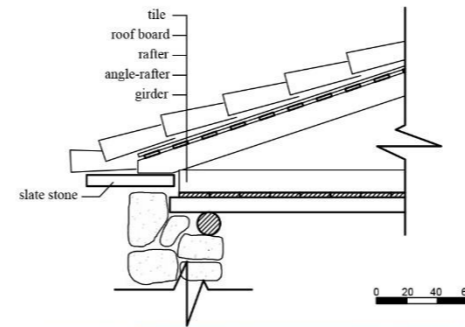
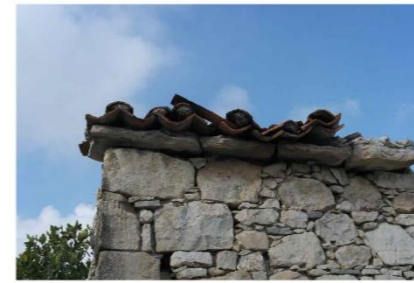
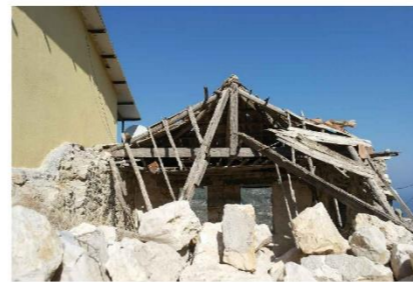
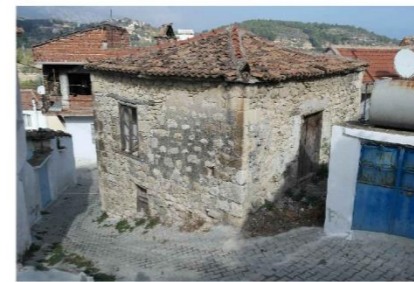
ROOF SYSTEM

Hipped and pitched timber roofs are observed in the village. Hipped and pitched roofs are covered with tiles. Alaturka type tile is original roof covering material. Marsilya type tiles are observed in altered roofs. Roofs have eave. There are observed mostly tiles, slate stones or brick for only one example at the end of the masonry wall, between wall and the roof.

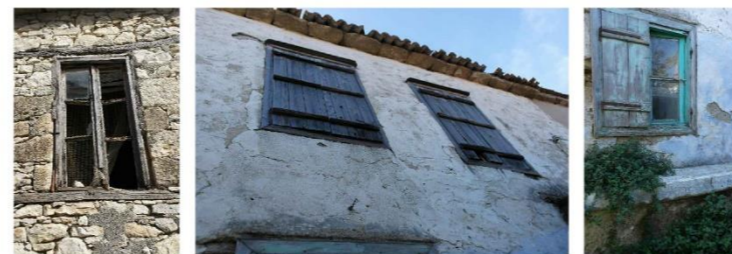
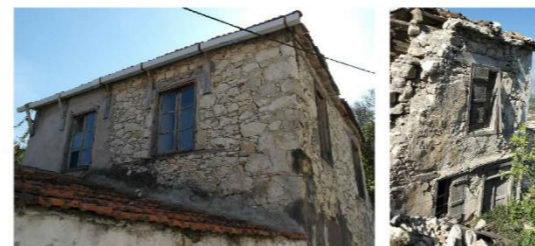
Door Doors are generally one winged and they sit on the outer edge of the door opening.

Window & Shutter Windows are timber and double winged. The wooden shutters are parts of windows. They sit on the outer edge of a window opening.

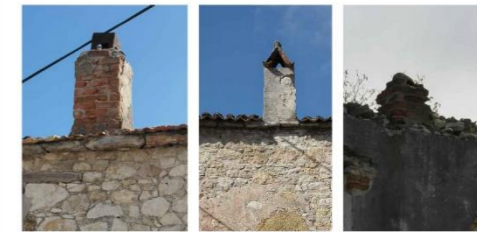
Fireplace & Chimney Only one fireplace is observed in one house and it has been made of stone. The chimneys that could be observed are made of brick.

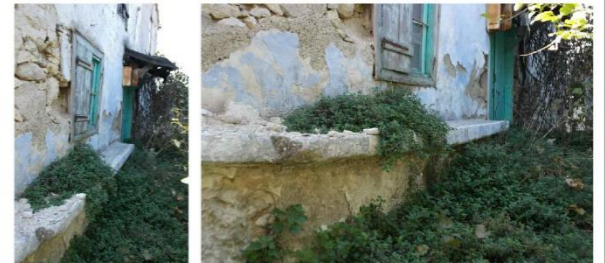
Bench A kind of stone bench in front of the front facade of house has been observed.

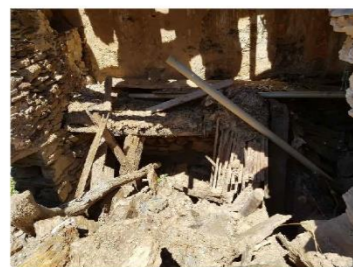
FLOOR SYSTEM

The ground floor system cannot be observed because of debris layers on floors.

Timber frame floor system is observed on the upper floor. In this system floor beams are laid on a main girder, which is usually placed in the middle of the room, in the opposite direction of the floor beams. Floor beams are placed with approximately 40-50cm spacing. Finally, floor beams are covered with the timber flooring boards in perpendicular direction.

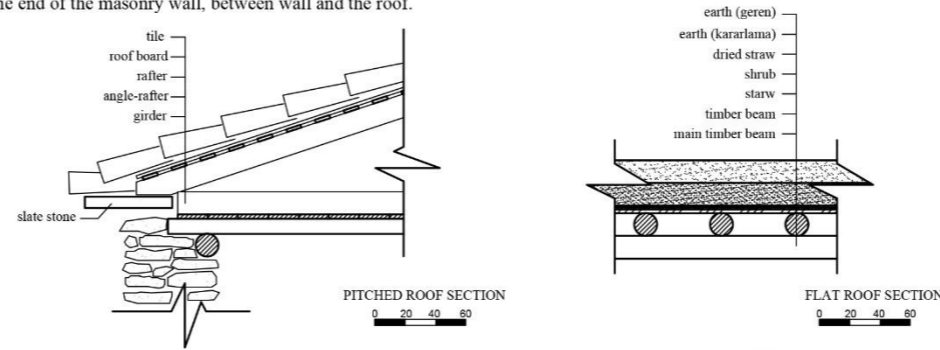
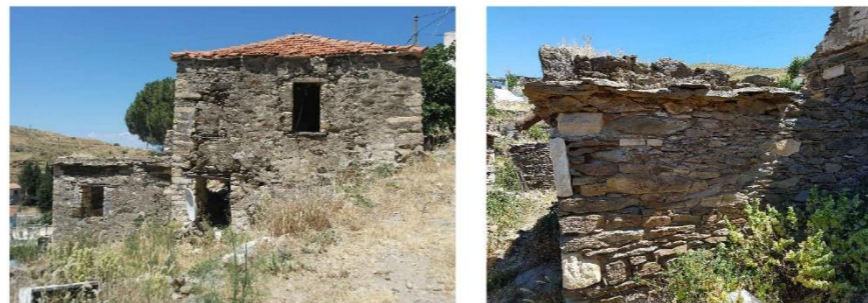
ROOF SYSTEM

Hipped and pitched timber roofs are observed in the village. Hipped and pitched roofs are covered with tiles. Alaturka type tile is original roof covering material. Marsilya type tiles are observed in altered roofs. Flat roofs are also observed in the village. The flat roofs are applied on thick wooden beams have round section and the beams are covered with pieces of thick shrub (kalin çalı), then thin shrub (ince çalı) and compressed by laying 30-40 cm clayed soil on them. On the soil, the clay is formed by the mixture of soil, water and straw, which has higher clay content and is called "geren". Geren is the specific name given to clay dense soils in the region. When it rains, this soil is waterproof due to its oily structure. Lastly, the soil is compressed by moving a cylindrical stone called 'loğ taşı' in Turkish. Roofs have eave. There are observed mostly tiles, slate stones or brick for only one example at the end of the masonry wall, between wall and the roof.

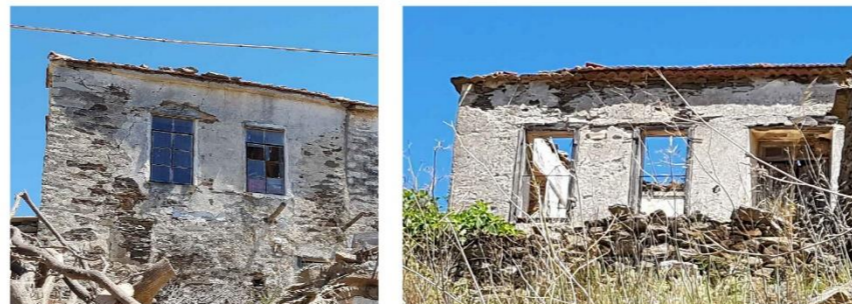
Door Doors are generally one winged and they sit on the outer edge of the door opening.

Window & Shutter Windows are timber and single or double winged. The wooden shutters are parts of windows. They sit on the outer edge of a window opening.

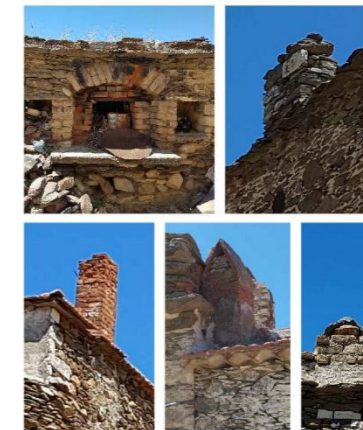
Fireplace & Chimney Only one fireplace is observed in one house and it has been made of brick. The chimneys that could be observed were made of brick or stone.

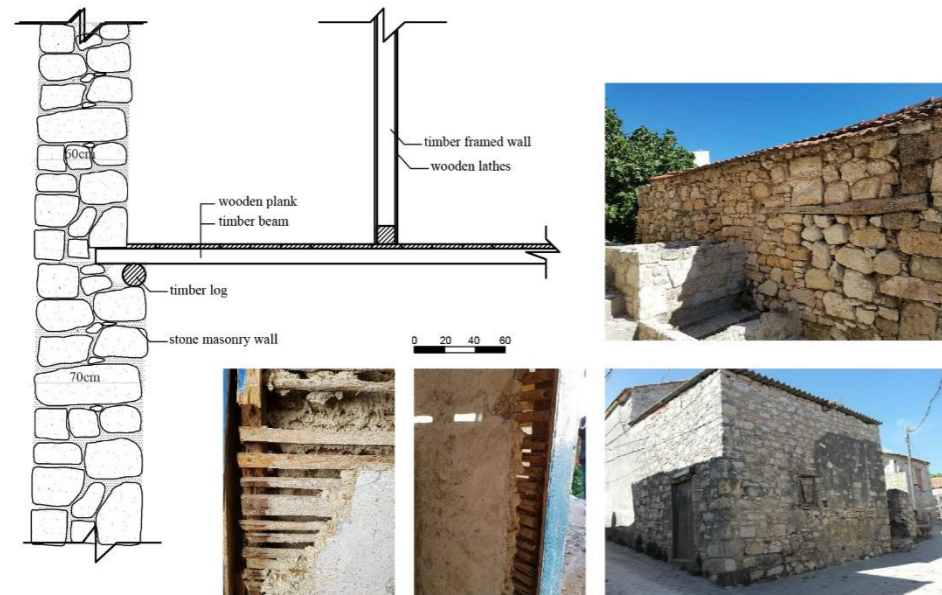
WALL SYSTEM

The traditional houses are generally one or two story buildings. They are constructed with hybrid system in which the walls of the ground floor and the exterior walls of the upper floor are stone masonry; and the inner walls of the upper floor is timber frame without infill (bağdadi). The thickness of masonry walls change between 60-80cm at the ground floor and 50-60 cm at the upper floor. The main material of the masonry walls is rubble stone. The rubble stones are yellowish-white colour. The binding material is mud mortar. Large gaps between different sizes of rubble stones are filled with small stones, brick and tile pieces. The corners of the walls are reinforced with relatively larger and shaped rubble stones. Mud mortar is used for the binding material. Timber tie beams are observed in some masonry walls at different intervals. Timber lintels are used in masonry walls to span door and window openings. Some masonry walls are plastered with mud mortar and washed with lime wash.

The thickness of timber frame wall is 15 cm. In this system, firstly a frame is installed with posts (5x10 cm) and wooden lathes on both sides are nailed in horizontal directions. The laths are at closed intervals approximately 3 cm. The space between the surfaces left empty. The surfaces are covered with plaster that is composed of mud and straw. Thickness of the plaster is approximately 2-3 cm. This type of timber walls is called as 'bağdadi' in Turkish.

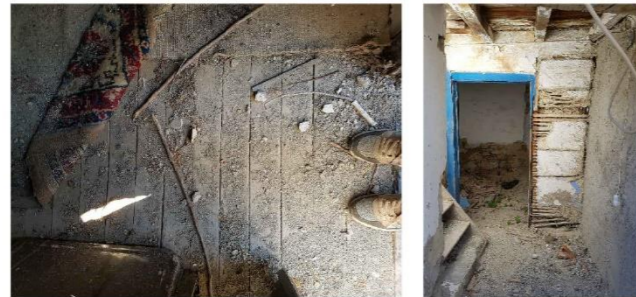
FLOOR SYSTEM

The ground floor system couldn't be observed in all the houses however it is seen that raised timber floor system in one house and compacted soil is seen in one house. Timber frame floor system is observed on the upper floor. In this system floor beams are laid on a main girder, which is usually placed in the middle of the room, in the opposite direction of the floor beams. Floor beams are placed with approximately 40-50cm spacing. Finally, floor beams are covered with the timber flooring boards in perpendicular direction.

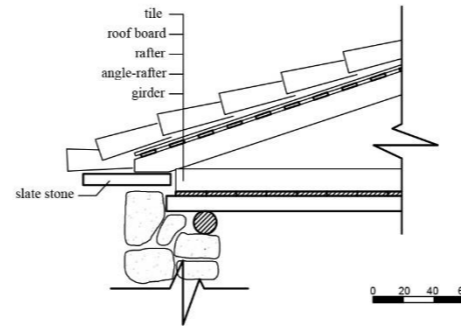
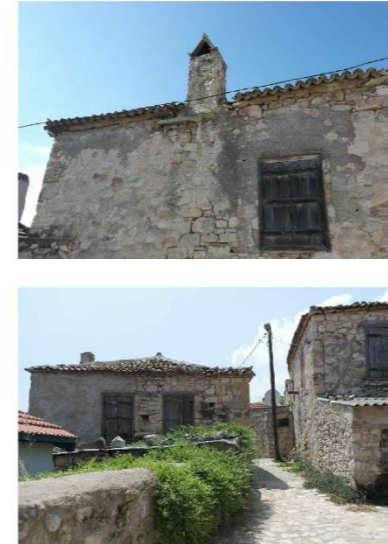
ROOF SYSTEM

Hipped and pitched timber roofs are observed in the village. Hipped and pitched roofs are covered with tiles. Alaturka type tile is original roof covering material. Marsilya type tiles are observed in altered roofs. Roofs have eave. There are observed slate stones as an eave between wall and the roof.

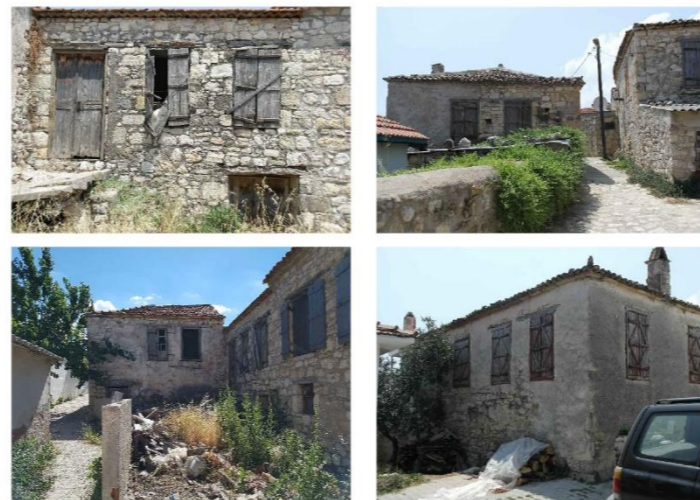
Door Doors are generally one winged and they sit on the outer edge of the door opening.

Window & Shutter Windows are timber and double winged. The wooden shutters are parts of windows. They sit on the outer edge of a window opening.

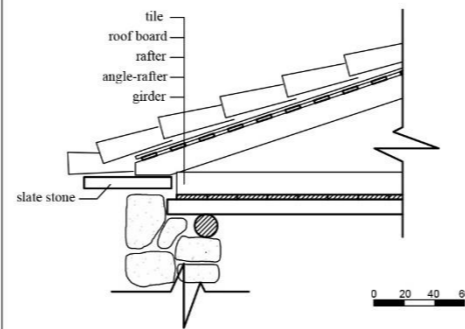
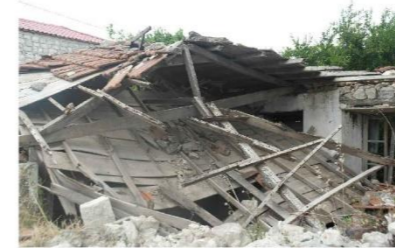
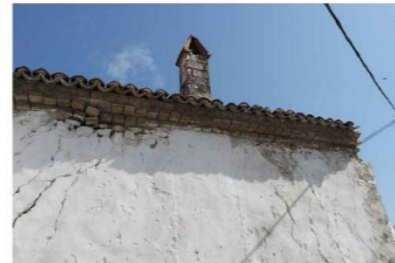
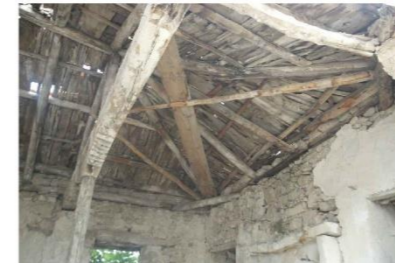
ROOF SYSTEM

Hipped and pitched timber roofs are observed in the village. Hipped and pitched roofs are covered with tiles. Alaturka type tile is original roof covering material. Marsilya type tiles are observed in altered roofs. Roofs have eave. There are observed mostly tiles, slate stones or brick for only one example at the end of the masonry wall, between wall and the roof.

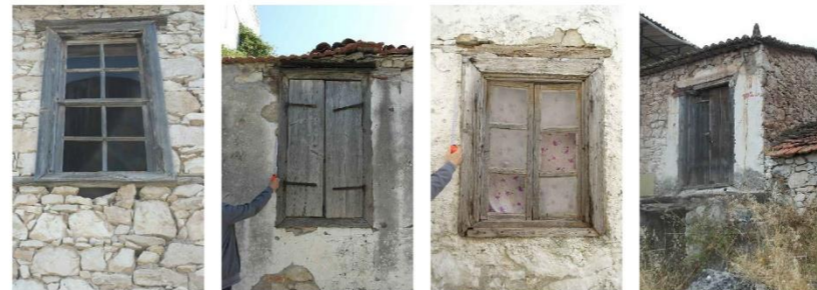
Door Doors are generally one winged and they sit on the outer edge of the door opening.

Window & Shutter Windows are timber and double winged. The wooden shutters are parts of windows. They sit on the outer edge of a window opening.

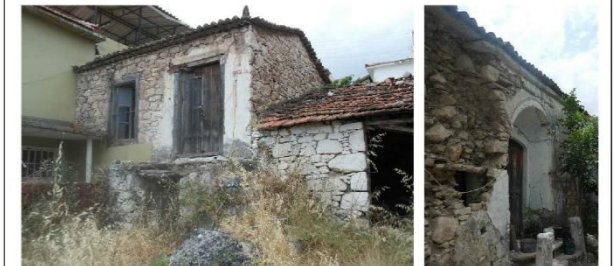
Staircase Timber stairs are used in two storey houses in which first floor are accessed through an entrance door in the ground floor. Use of stone is seen at the outside of two storey houses where an entrance to the house at the second storey is.

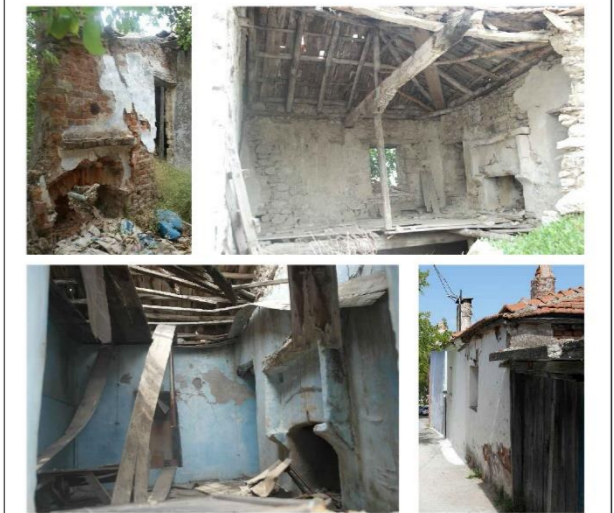
Fireplace & Chimney Fireplace is one of the main elements in the houses. They are generally located at the firsts floor. The wall that has the fireplace has no opening. All chimneys that could be observed were made of brick.

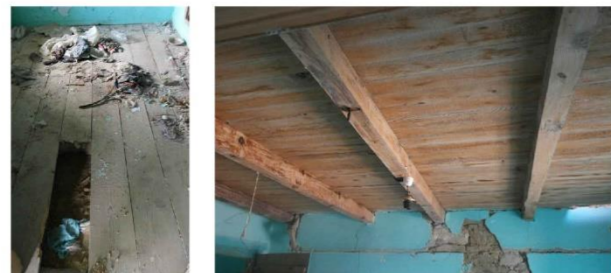
FLOOR SYSTEM

The ground floor system cannot be observed because of debris layers on floors.

Timber frame floor system is observed on the upper floor. In this system floor beams are laid on a main girder, which is usually placed in the middle of the room, in the opposite direction of the floor beams. Floor beams are placed with approximately 40-50cm spacing. Finally, floor beams are covered with the timber flooring boards in perpendicular direction.

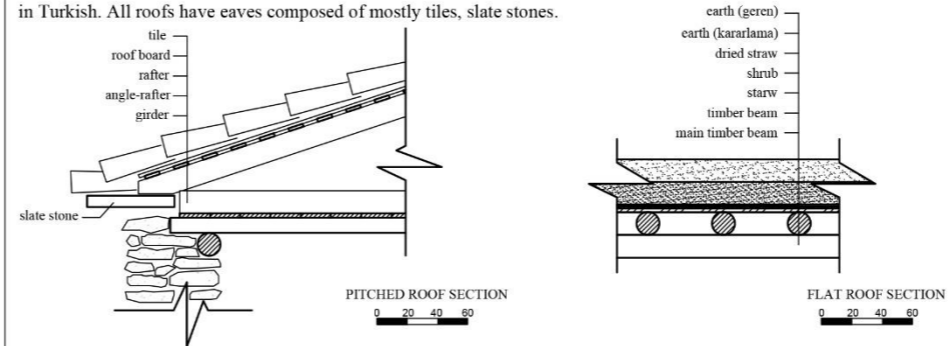
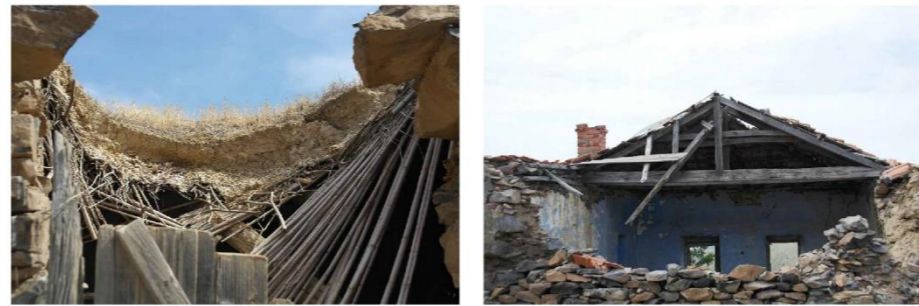
ROOF SYSTEM

Hipped and pitched timber roofs are observed in the village. Roofs are covered with tiles. Over and under type tile is original roof covering material. Marsilya type tiles are observed in altered roofs. Flat roofs are also observed in the village. The flat roofs are applied on thick wooden beams have round section and the beams are covered with pieces of thick shrub (kalın çalı), then thin shrub (ince çalı) and compressed by laying 30-40 cm clayed soil on them. On the soil, the clay is formed by the mixture of soil, water and straw, which has higher clay content and is called "geren". Geren is the specific name given to clay dense soils in the region. When it rains, this soil is waterproof due to its oily structure. Lastly, the soil is compressed by moving a cylindrical stone called 'loğ taş' in Turkish. All roofs have eaves composed of mostly tiles, slate stones.

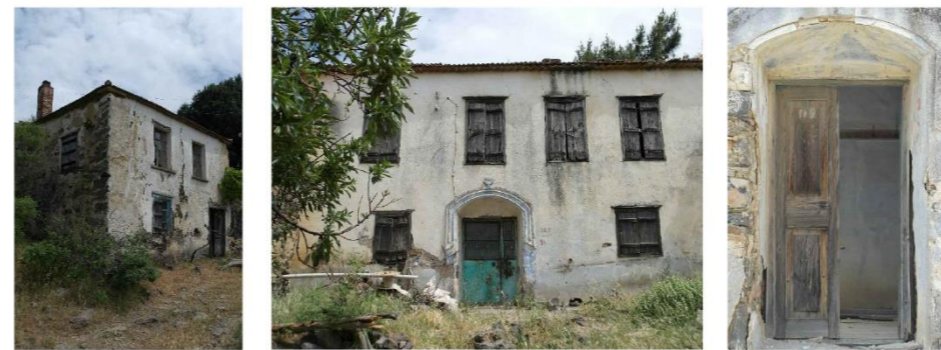
Door Doors are generally one winged timber doors and they sit on the outer edge of the door opening.

Window & Shutter Windows are timber and double winged. The wooden shutters are parts of windows. They sit on the outer edge of a window opening.

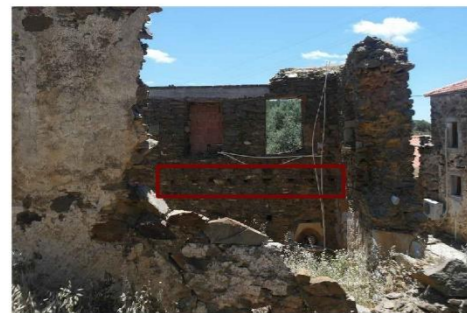
FLOOR SYSTEM

The floor system cannot be observed because of debris layers on ground floors and to be collapsed of first floors. However, the traces of the beams belonging to the flooring system were observed on the wall.

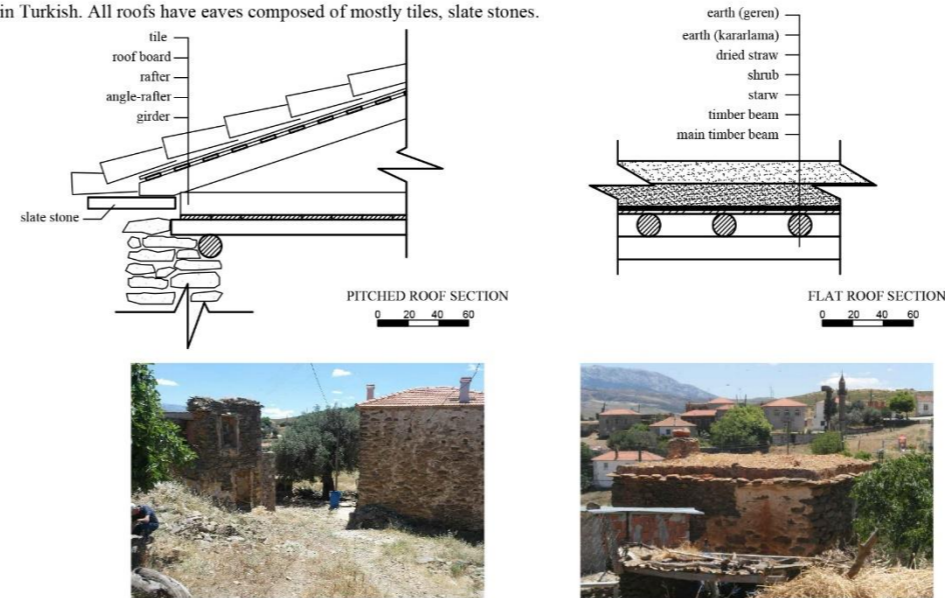
ROOF SYSTEM

Hipped and pitched timber roofs are observed in the village. Roofs are covered with tiles. Over and under type tile is original roof covering material. Marsilya type tiles are observed in altered roofs. Flat roofs are also observed in the village. The flat roofs are applied on thick wooden beams have round section and the beams are covered with pieces of thick shrub (kalın çalı), then thin shrub (ince çalı) and compressed by laying 30-40 cm clayed soil on them. On the soil, the clay is formed by the mixture of soil, water and straw, which has higher clay content and is called "geren". Geren is the specific name given to clay dense soils in the region. When it rains, this soil is waterproof due to its oily structure. Lastly, the soil is compressed by moving a cylindrical stone called 'loğ taş' in Turkish. All roofs have eaves composed of mostly tiles, slate stones.

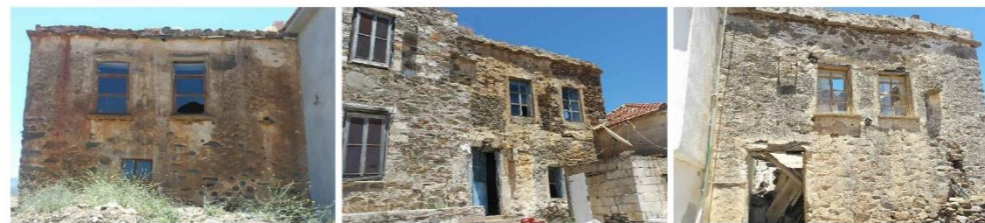
Door Doors are generally one winged timber doors and they sit on the outer edge of the door opening.

Window & Shutter Windows are timber and double winged. The wooden shutters are parts of windows. They sit on the outer edge of a window opening.

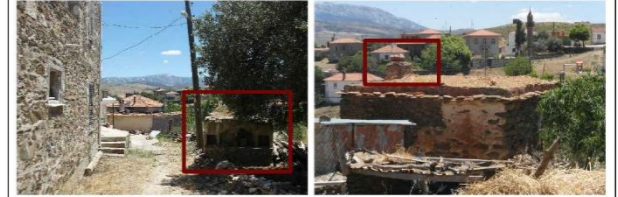
Fireplace & Chimney Only one example has been observed in the village and it has been repaired with contemporary materials. Chimneys that could be observed were made of stone.

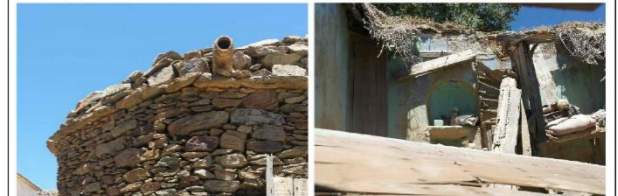
Waterspout Only one waterspout could be observed in the village. It is made with terracotta.

Niche & Cupboard Niches are observed next to the Fireplace. Observed cupboard is simple timber skeletons in rectangular prism shape where two vertical sides of it on edged either by wall or wooden plates.

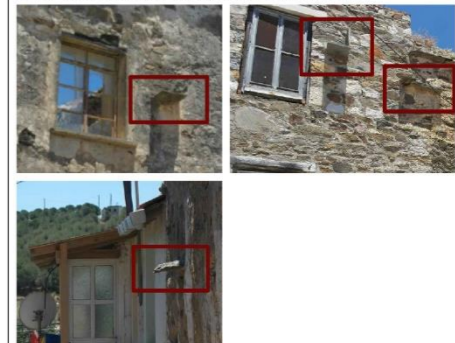
Luminare There are stone projections next to the windows in some houses. They were probably used as luminare shelf.

Niches are observed next to the fireplace. Observed cupboard is simple timber skeletons in rectangular prism shape where two vertical sides of it on edged either by wall or wooden plates. There are stone projections next to the windows in some houses. They were probably used as luminaire shelve. (Figure 3.16)

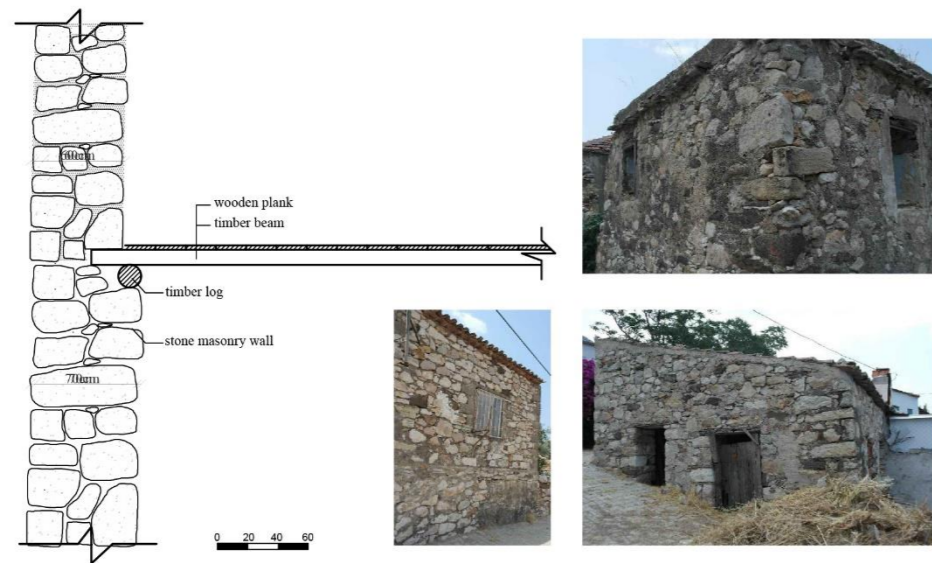
WALL SYSTEM

The traditional houses are generally one- or two-storey buildings. The exterior walls of the buildings are stone masonry. The main material of the masonry walls is flat stone. The flat stones are grey-black color. The binding material is mud mortar. Large gaps between different sizes of slate stones are filled with small stones and tile pieces. The corners of the walls are reinforced with relatively larger and shaped slate stones. Mud mortar is used for the binding material. Timber lintels are used in masonry walls to span door and window openings. Some masonry walls are plastered with mud mortar and washed with lime wash. The corners of the walls are reinforced with relatively larger stones. Mud mortar is used for the binding material. Timber tie beams are observed in some masonry walls at different intervals. Timber lintels are used in masonry walls to span door and window openings. Some masonry walls are plastered with mud mortar and washed with lime wash. Inner walls couldn't be observed.

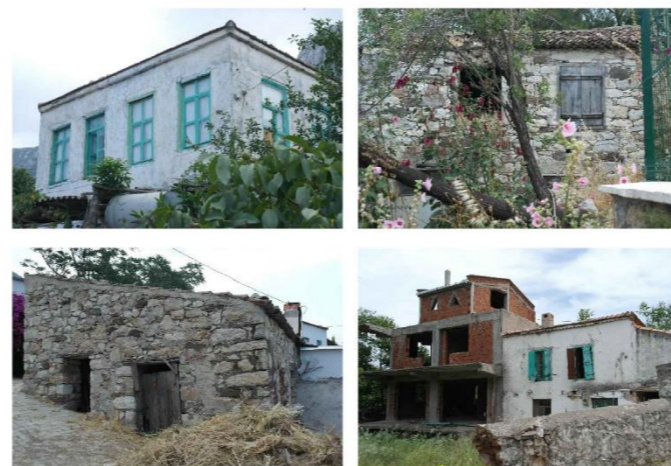
Door Doors are generally one winged timber doors and they sit on the outer edge of the door opening.

Window & Shutter Windows are timber and double winged. The wooden shutters are parts of windows. They sit on the outer edge of a window opening.

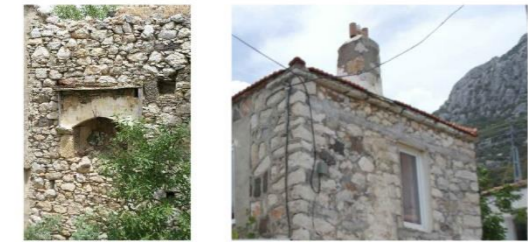
Fireplace & Chimney Only one stone fireplace and chimney could be observed in the village.

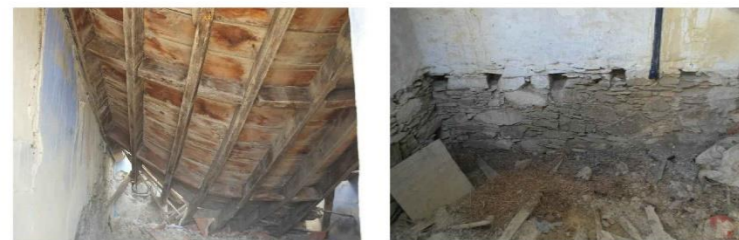
FLOOR SYSTEM

The ground floor system cannot be observed because of debris layers on floors.

Timber frame floor system is observed on the upper floor. In this system floor beams are laid on a main girder, which is usually placed in the middle of the room, in the opposite direction of the floor beams. Floor beams are placed with approximately 40-50cm spacing. Finally, timber flooring boards are nailed to the beams in perpendicular direction.

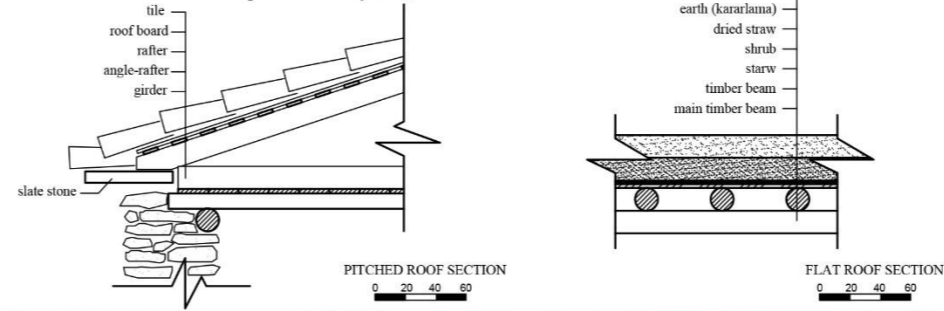
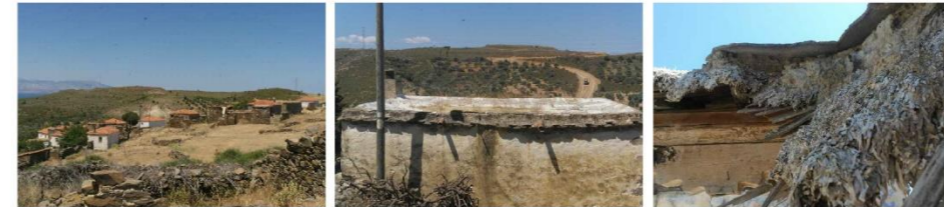
ROOF SYSTEM

Hipped and pitched timber roofs are observed in the village. Roofs are covered with tiles. Over and under type tile is original roof covering material. Marsilya type tiles are observed in altered roofs. Flat roofs are also observed in the village. The flat roofs are applied on thick wooden beams have round section and the beams are covered with pieces of thick shrub (kalın çalı), then thin shrub (ince çalı) and compressed by laying 30-40 cm clayed soil on them. On the soil, the clay is formed by the mixture of soil, water and straw, which has higher clay content and is called "geren". Geren is the specific name given to clay dense soils in the region. When it rains, this soil is waterproof due to its oily structure. Lastly, the soil is compressed by moving a cylindrical stone called 'loğ taş' in Turkish. All roofs have eaves composed of mostly tiles, slate stones.

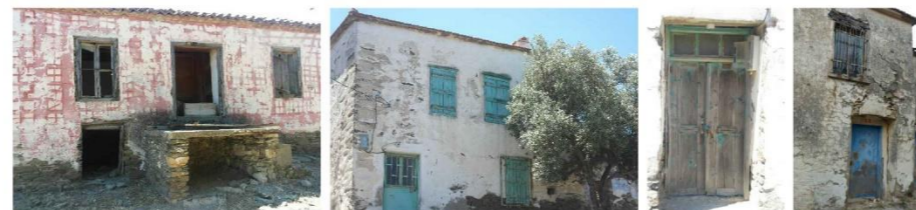
Door Doors are generally one winged timber doors and they sit on the outer edge of the door opening.
Window & Shutter Windows are timber and double winged. The wooden shutters are parts of windows. They sit on the outer edge of a window opening.

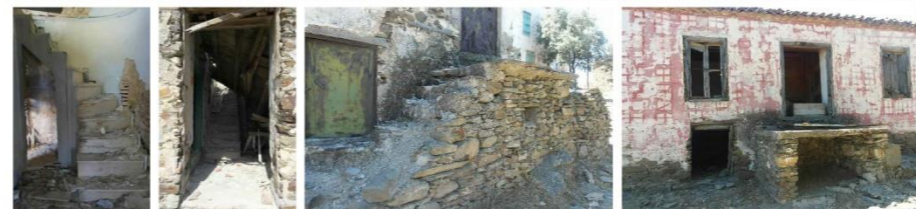
Staircase Timber stairs are used in two story houses in which first floor is accessed through an entrance door in the ground floor. Use of stone is seen at the outside of two-storey houses where an entrance to the house at the second story is.

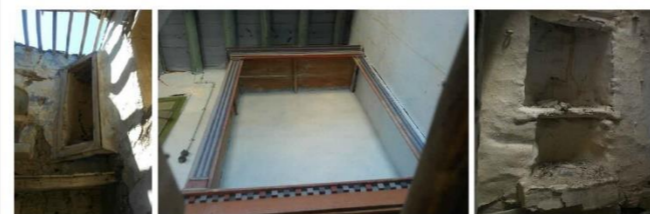
Cupboard & Niche Cupboards are simple timber skeletons in rectangular prism shape where two vertical sides of it on edged either by wall or wooden plates.

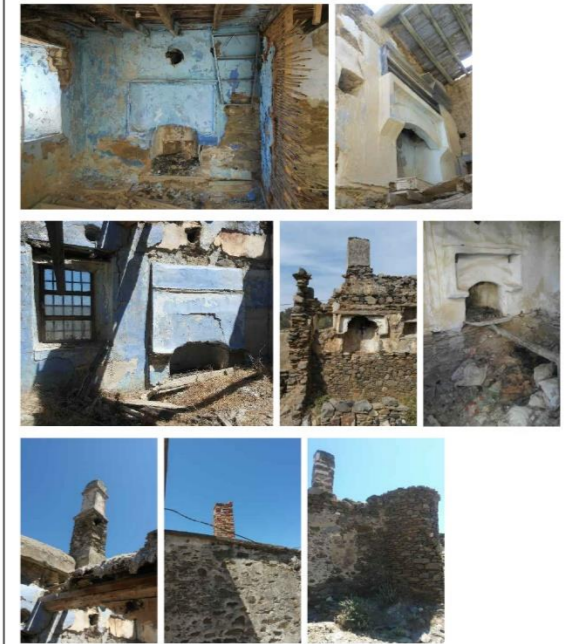
Fireplace & Chimney Fireplace is one of the main elements in the houses. They are generally located at the first floor. The wall that has the Fireplace has no opening. Chimneys that could be observed were made of brick or stone.

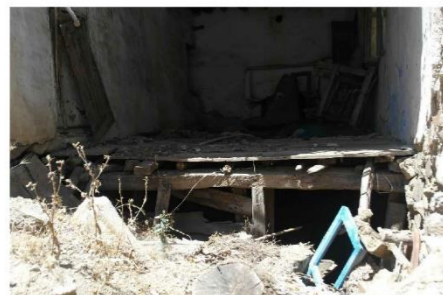
FLOOR SYSTEM

The ground floor system cannot be observed because of debris layers on floors.

Timber frame floor system is observed on the upper floor. In this system floor beams are laid on a main girder, which is usually placed in the middle of the room, in the opposite direction of the floor beams. Floor beams are placed with approximately 40-50cm spacing. Finally, floor beams are covered with the timber flooring boards in perpendicular direction.
