**CONSTRUCTION TECHNIQUES
OF TRADITIONAL HOUSES
IN KARABURUN VILLAGES**

**A Thesis Submitted to
the Graduate School of Engineering and Sciences of
İzmir Institute of Technology
in Partial Fulfillment of the Requirements for the Degree of**

in Architectural Restoration

**by
Burçin GÖRÜR**

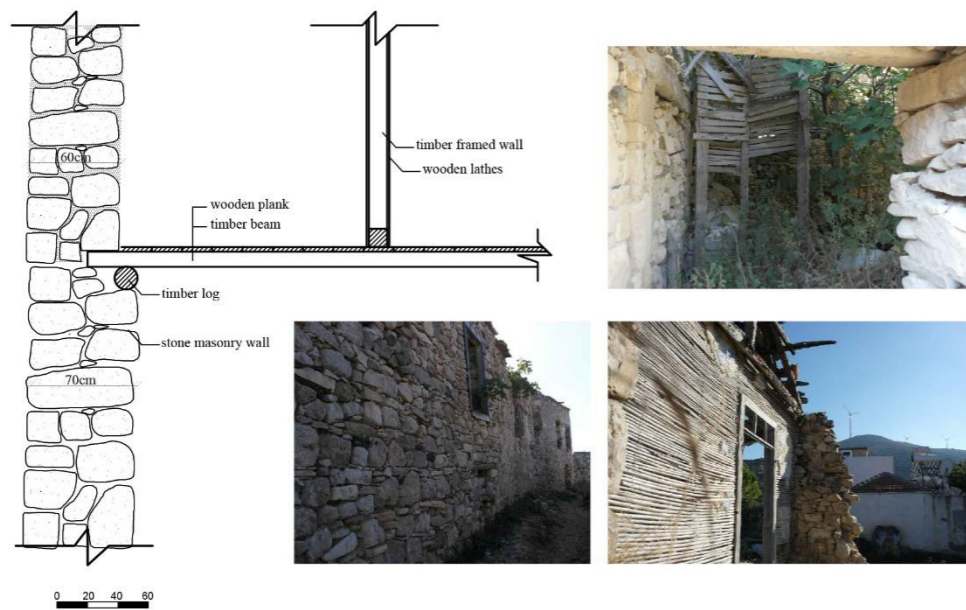
The traditional houses are generally one- or two-storey buildings. They are constructed with hybrid system in which the walls of the ground floor and the exterior walls of the upper floor are stone masonry; and the inner walls of the upper floor is timber frame without infill (bağdadi). The thickness of masonry walls changes between 60-80cm at the ground floor and 50-60 cm at the upper floor. The main material of the masonry walls is rubble stone. The rubble stones are yellowish-white color. The binding material is mud mortar. Large gaps between different sizes of rubble stones are filled with small stones, brick and tile pieces. The corners of the walls are reinforced with relatively larger and shaped rubble stones. Mud mortar is used for the binding material. Timber tie beams are observed in some masonry walls at different intervals. Timber lintels are used in masonry walls to span door and window openings. Some masonry walls are plastered with mud mortar and washed with lime wash.

The thickness of timber frame walls is 15 cm. In this system, firstly a frame is installed with posts (5x10 cm) and wooden lathes on both sides are nailed in horizontal directions. The laths are at closed intervals approximately 3 cm. The space between the surfaces left empty. The surfaces are covered with plaster that is composed of mud and straw. Thickness of the plaster is approximately 2-3 cm.

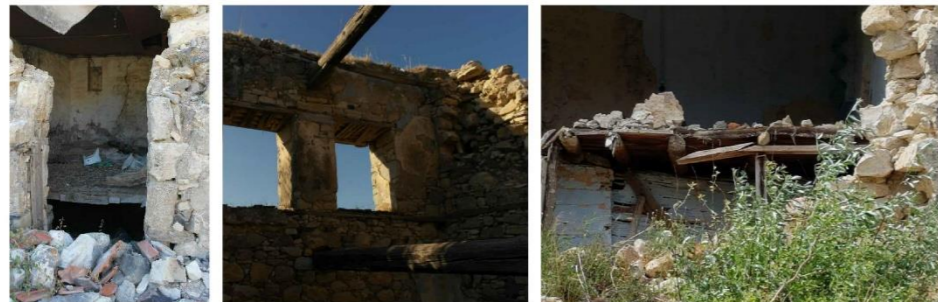
Timber frame floor system is observed on the upper floor. In this system floor beams are laid on a main girder, which is usually placed in the middle of the room, in the opposite direction of the floor beams. Floor beams are placed with approximately 40-50cm spacing. Finally, floor beams are covered with the timber flooring boards in perpendicular direction.

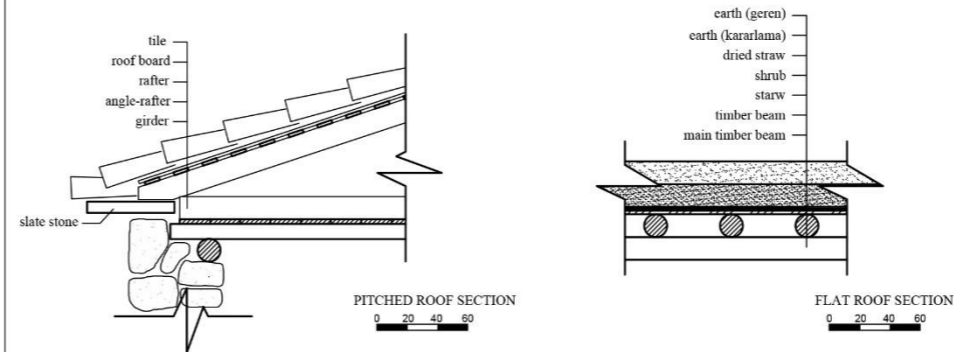
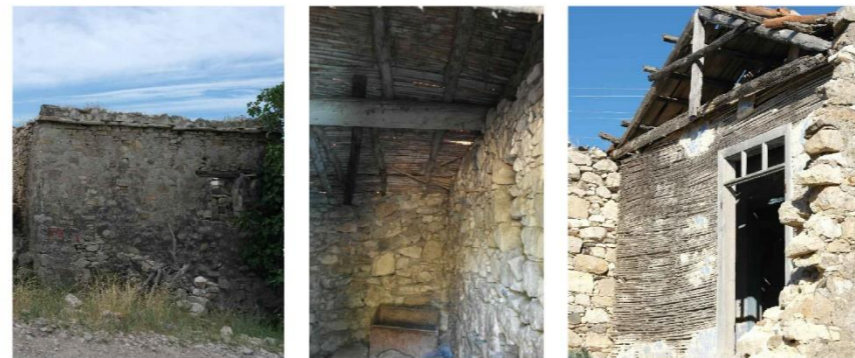
Hipped and pitched timber roofs are observed in the village. They are covered with tiles. Over and under type tile is original roof covering material. Marsilya type tiles are observed in altered roofs. Flat roofs are also observed in Bozköy. In this system, the main beams are placed firstly for spanning. Then they are covered with timber boards vertically to the direction of the beams and timber boards are covered with firstly reed or small wooden lathes then earth. The earth composed of dried straw and earth. In Bozköy, main beams have been covered with directly reed then they have been covered with earth. All roofs have eaves composed of tiles, slate stones or bricks.

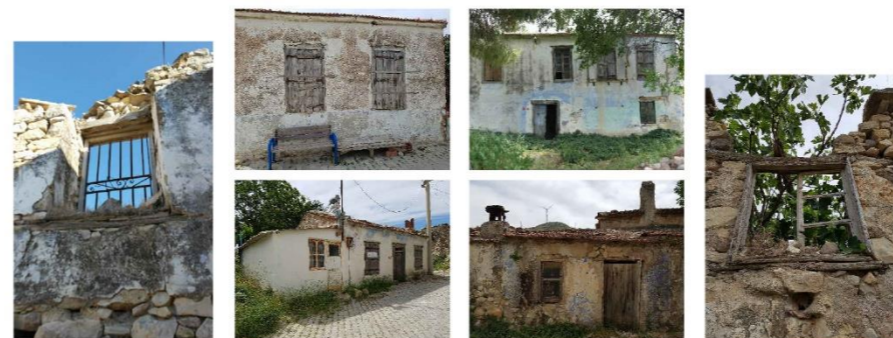
Door Doors are generally one winged and they sit on the outer edge of the door opening.

Window & Shutter Windows are timber and double winged. The wooden shutters are parts of windows. They sit on the outer edge of a window opening.

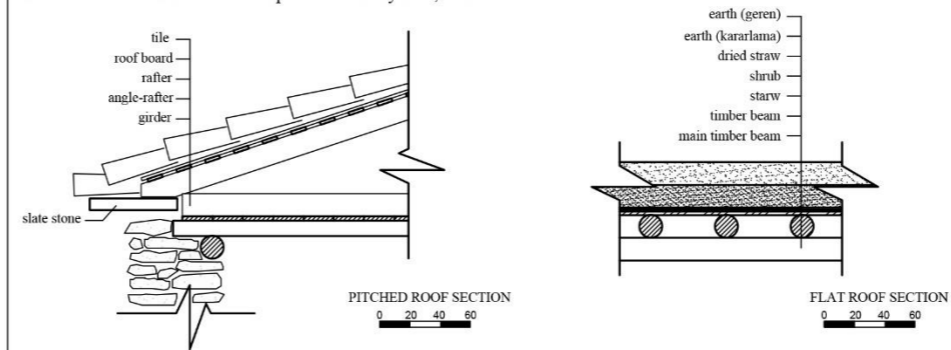
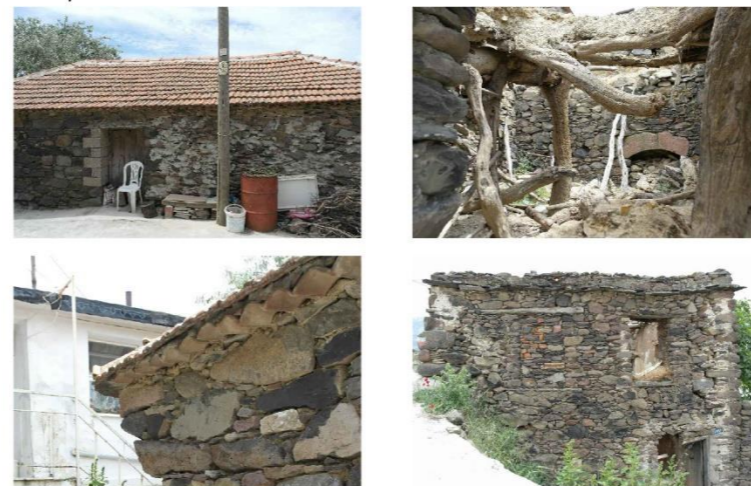
Hipped and pitched timber roofs are observed in the village. Roofs are covered with tiles. Over and under type tile is original roof covering material. Marsilya type tiles are observed in altered roofs. Flat roofs are also observed in the village. The flat roofs are applied on thick wooden beams have round section and the beams are covered with pieces of thick shrub (kalın çalı), then thin shrub (ince çalı) and compressed by laying 30-40 cm clayed soil on them. On the soil, the clay is formed by the mixture of soil, water and straw, which has higher clay content and is called "geren". Geren is the specific name given to clay dense soils in the region. When it rains, this soil is waterproof due to its oily structure. Lastly, the soil is compressed by moving a cylindrical stone called 'loğ taş' in Turkish. All roofs have eaves composed of mostly tiles, slate stones.

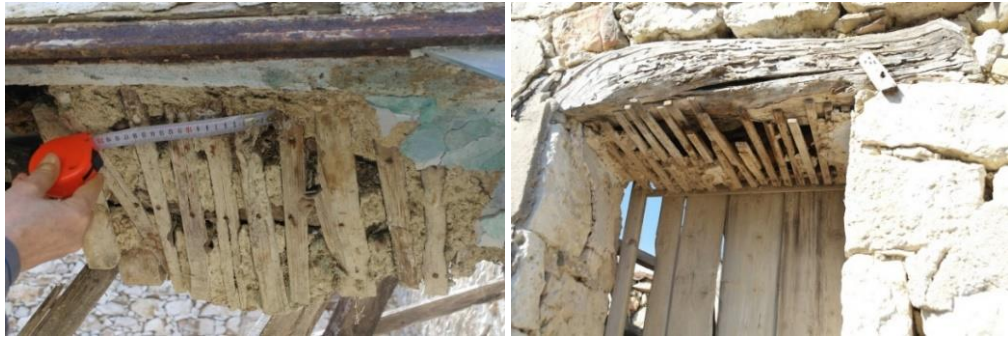
Figure 4.20. Spanning Openings in Eğlenhoca (March 2017).

In Eğlenhoca, another treatment is observed to obtain clean-cut openings. Irregular shaped wooden lintels are covered with wooden laths of 2 cm thickness (Figure 4.20). These lathes are nailed to the lintels and plastered and washed. Thus, clean perpendicular openings could be obtained. Lath usage for the openings is also observed in Küçükbahçe and Salman with same technique.

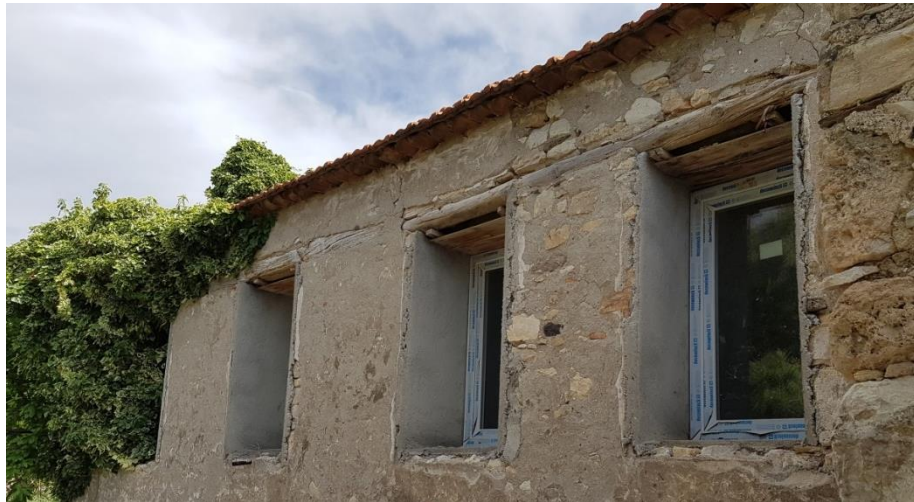
Figure 4.21. Spanning Openings in Tepeboz (April 2017).

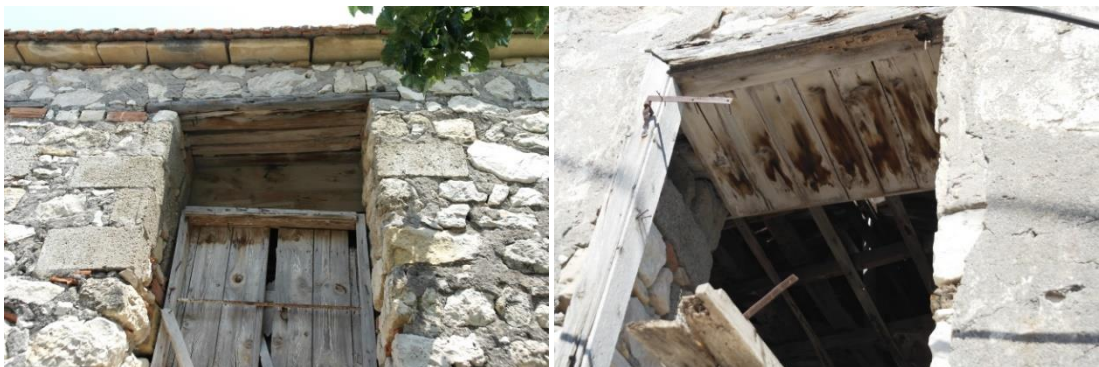
Figure 4.22. Spanning Openings in İncelik (April 2017).

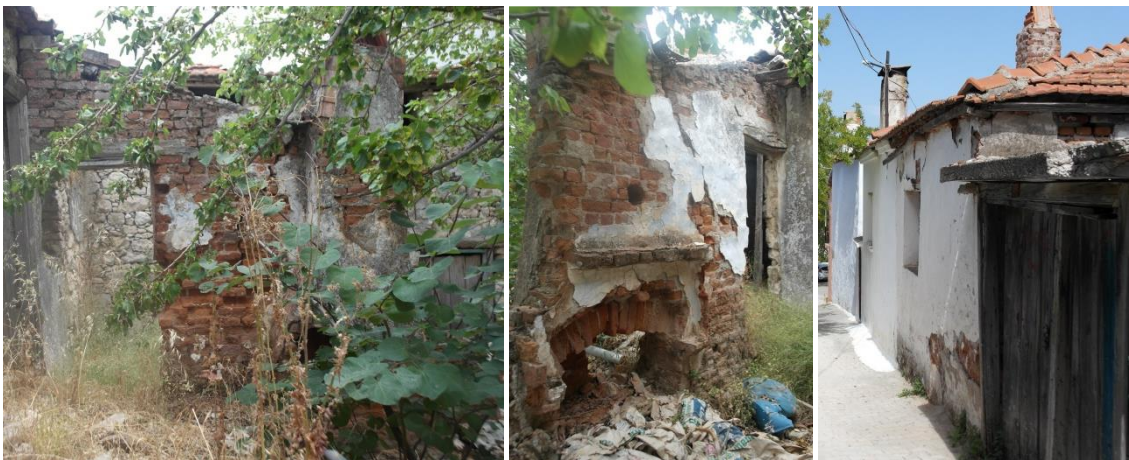
Figure 4.23. Brick Usage in Kösedere (June 2016).

Beside the rubble stone, brick usage is also observed in the villages. In one house in Kösedere, brick is the only material of the vertical structural elements and architectural elements such as fireplaces and chimneys (Figure 4.23). Brick walls are thinner than stone masonry, but the other features are similar. Bricks are 5x19 cm in size. Brick masonry walls are not only observed in exterior walls but also as interior walls. Mud mortar is also used for binding and it is plastered and washed with white lime. Brick is also used for obtaining clean-cut openings corners in both villages; window openings, corners of railing walls of stone stairs. And niches are constructed out of brick for obtaining fine shaped architectural elements (Figure 4.24, 4.25).

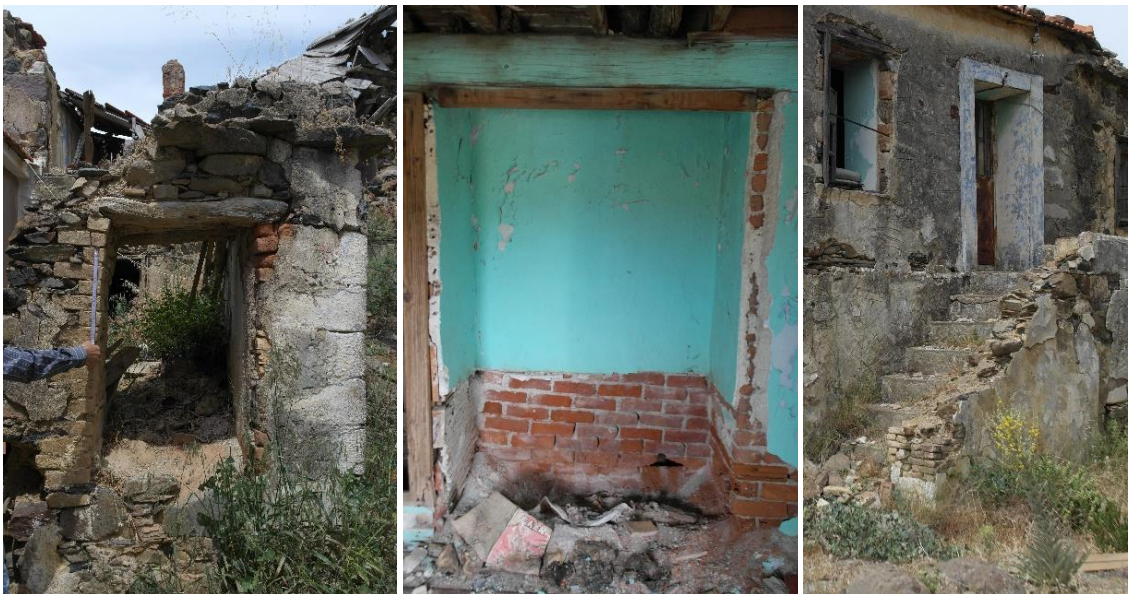
Figure 4.24. Brick usage examples in Küçükbahçe (April 2017).

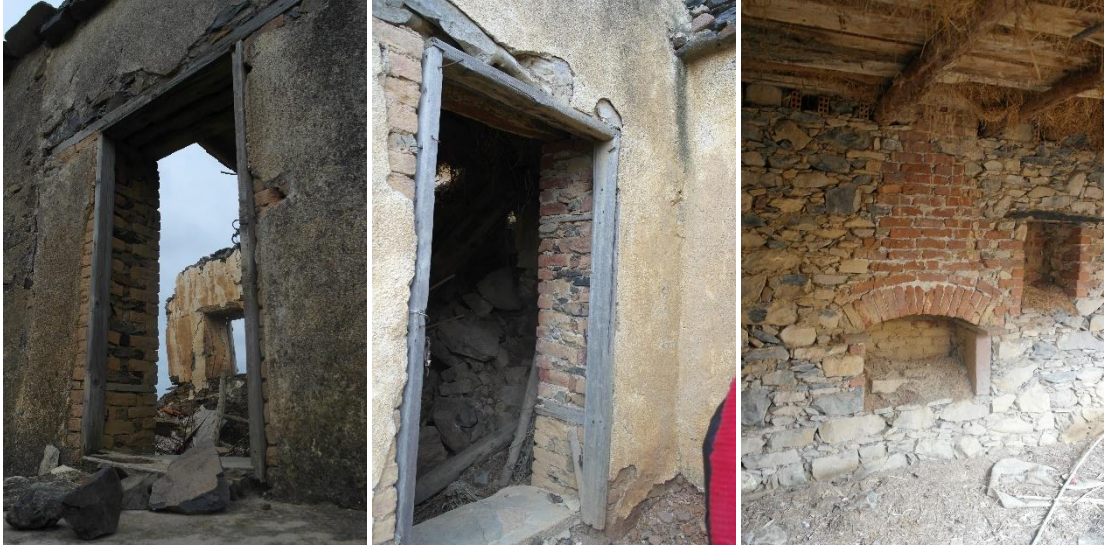
Figure 4.25. Brick usage examples in Küçükbahçe (November 2014).

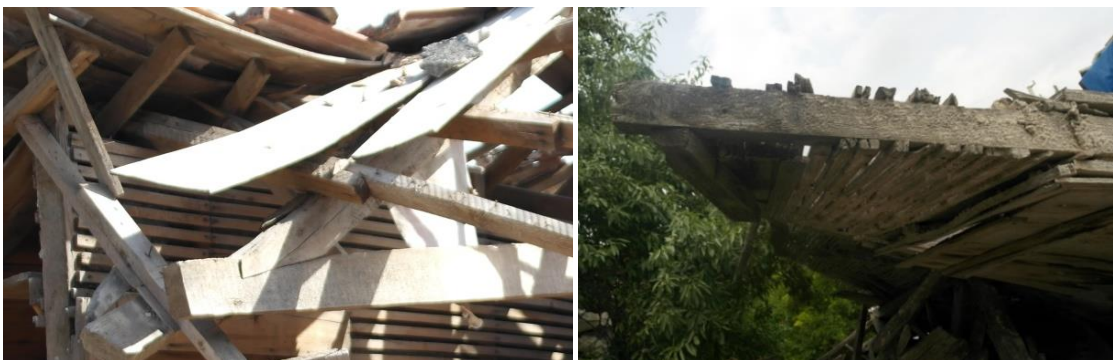
Figure 4.26. Timber Framed Wall Examples in Kösedere (June 2016).

Inner walls of upper floors are constructed with timber frame system. In this system, firstly a frame is installed with posts (5x10 cm) and wooden lathes on both sides are nailed to these posts in horizontal directions. The laths are at closed intervals approximately 3 cm. The space between two lath surfaces are left empty. The surfaces are covered with plaster that is composed of mud and straw. Thickness of the plaster is approximately 2-3 cm. This type of timber walls is called as '*bağdadi*' in Turkish. Reeds usage have been observed besides the use of lathes in Küçükbahçe.(Figure 4.26, 4.27, 4.28, 4.29, 4.30) (Drawing 4.3, 4.4)

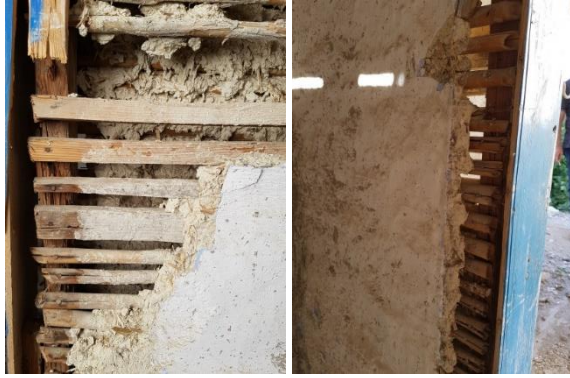
Figure 4.27. Timber Framed Wall Example in İncik (June 2017).

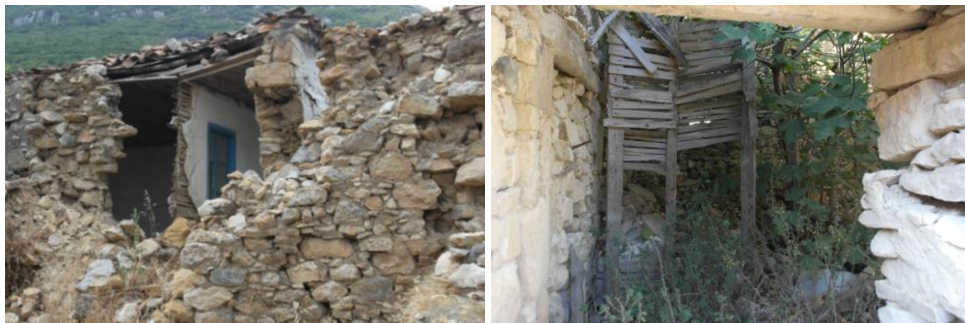
Figure 4.28. Timber Frame Wall in (a) Ambarseki (b) Tepeboz (June 2016).

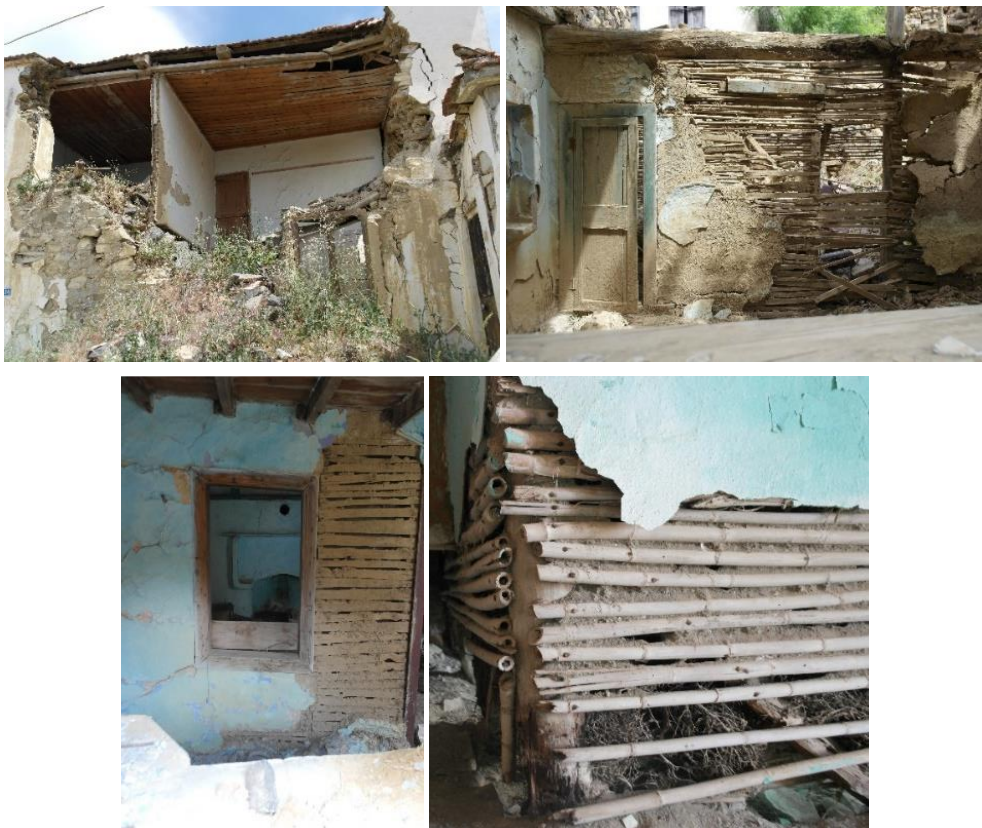
Figure 4.29. Timber Framed Wall Examples in Küçükbahçe (April 2017).

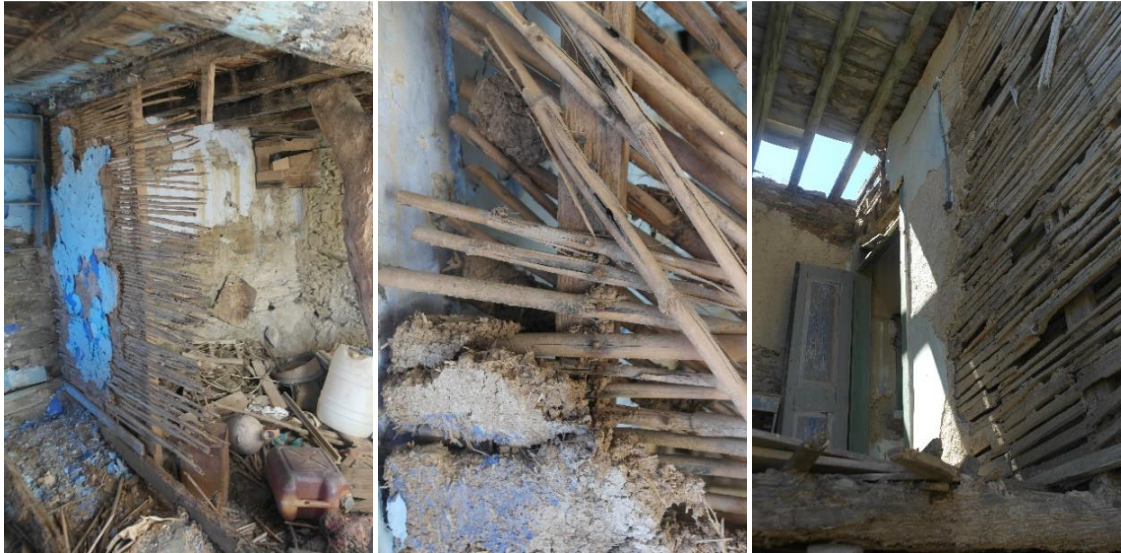
Figure 4.30. Timber Framed Wall Examples in Salman (May 2017).

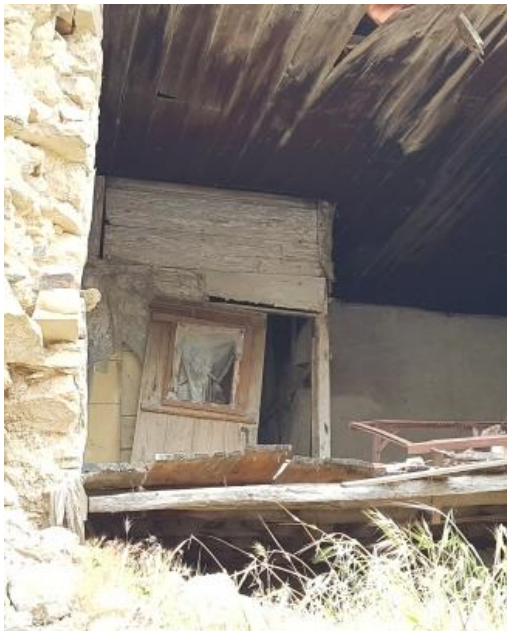
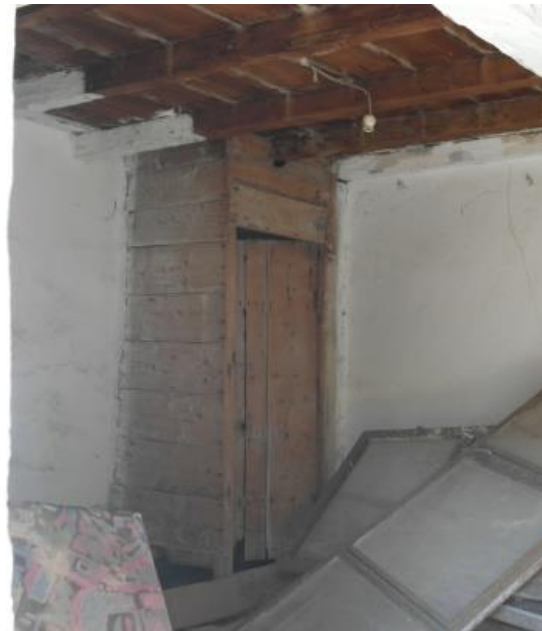
Figure 4.31. Wooden Panel Partitions (a) Tepeboz (b) İncik (June 2016).

Except for the timber framed wall, wooden panel partition walls have been observed in İncik and Tepeboz (Figure 4.31). In this system, firstly posts (5x10 cm) are placed and then wooden panels are nailed to posts in horizontal directions on one side. The surfaces of wooden panels have been left empty; there is no any plaster on them.

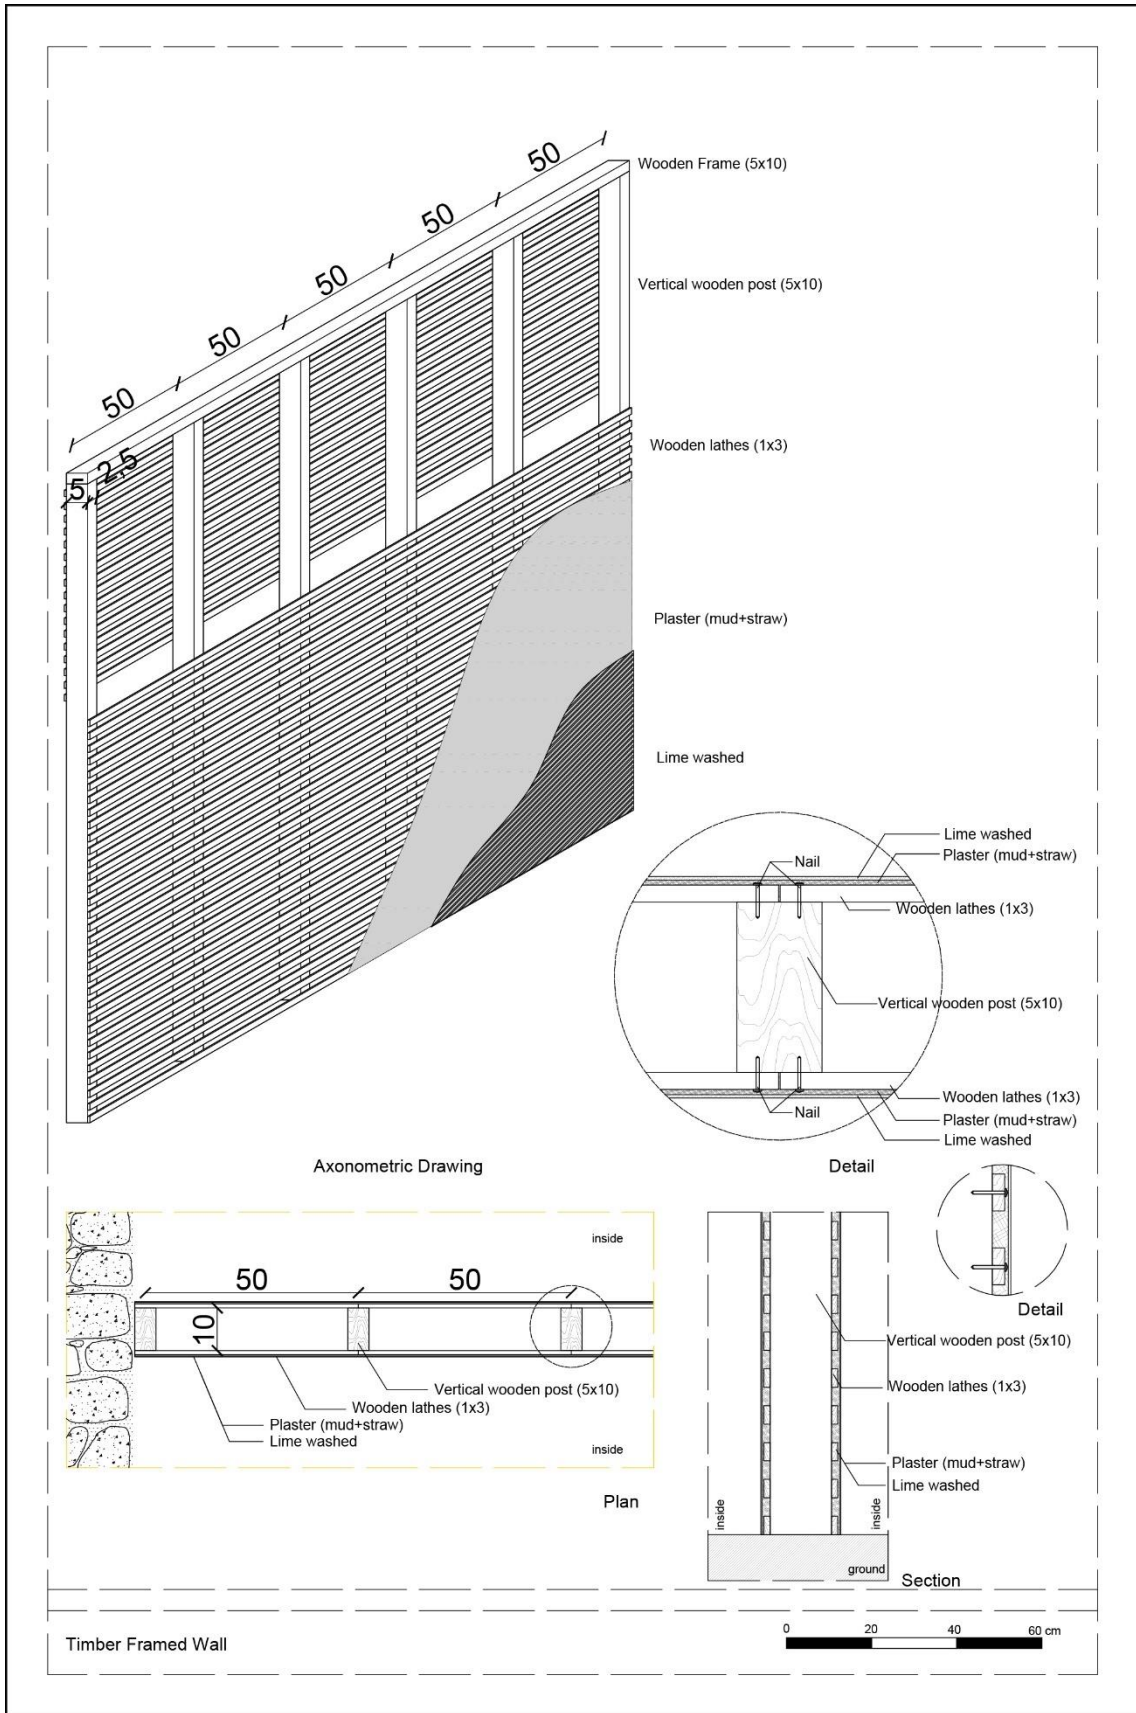
Drawing 4.3. Timber Framed Wall with Lathes Drawings.

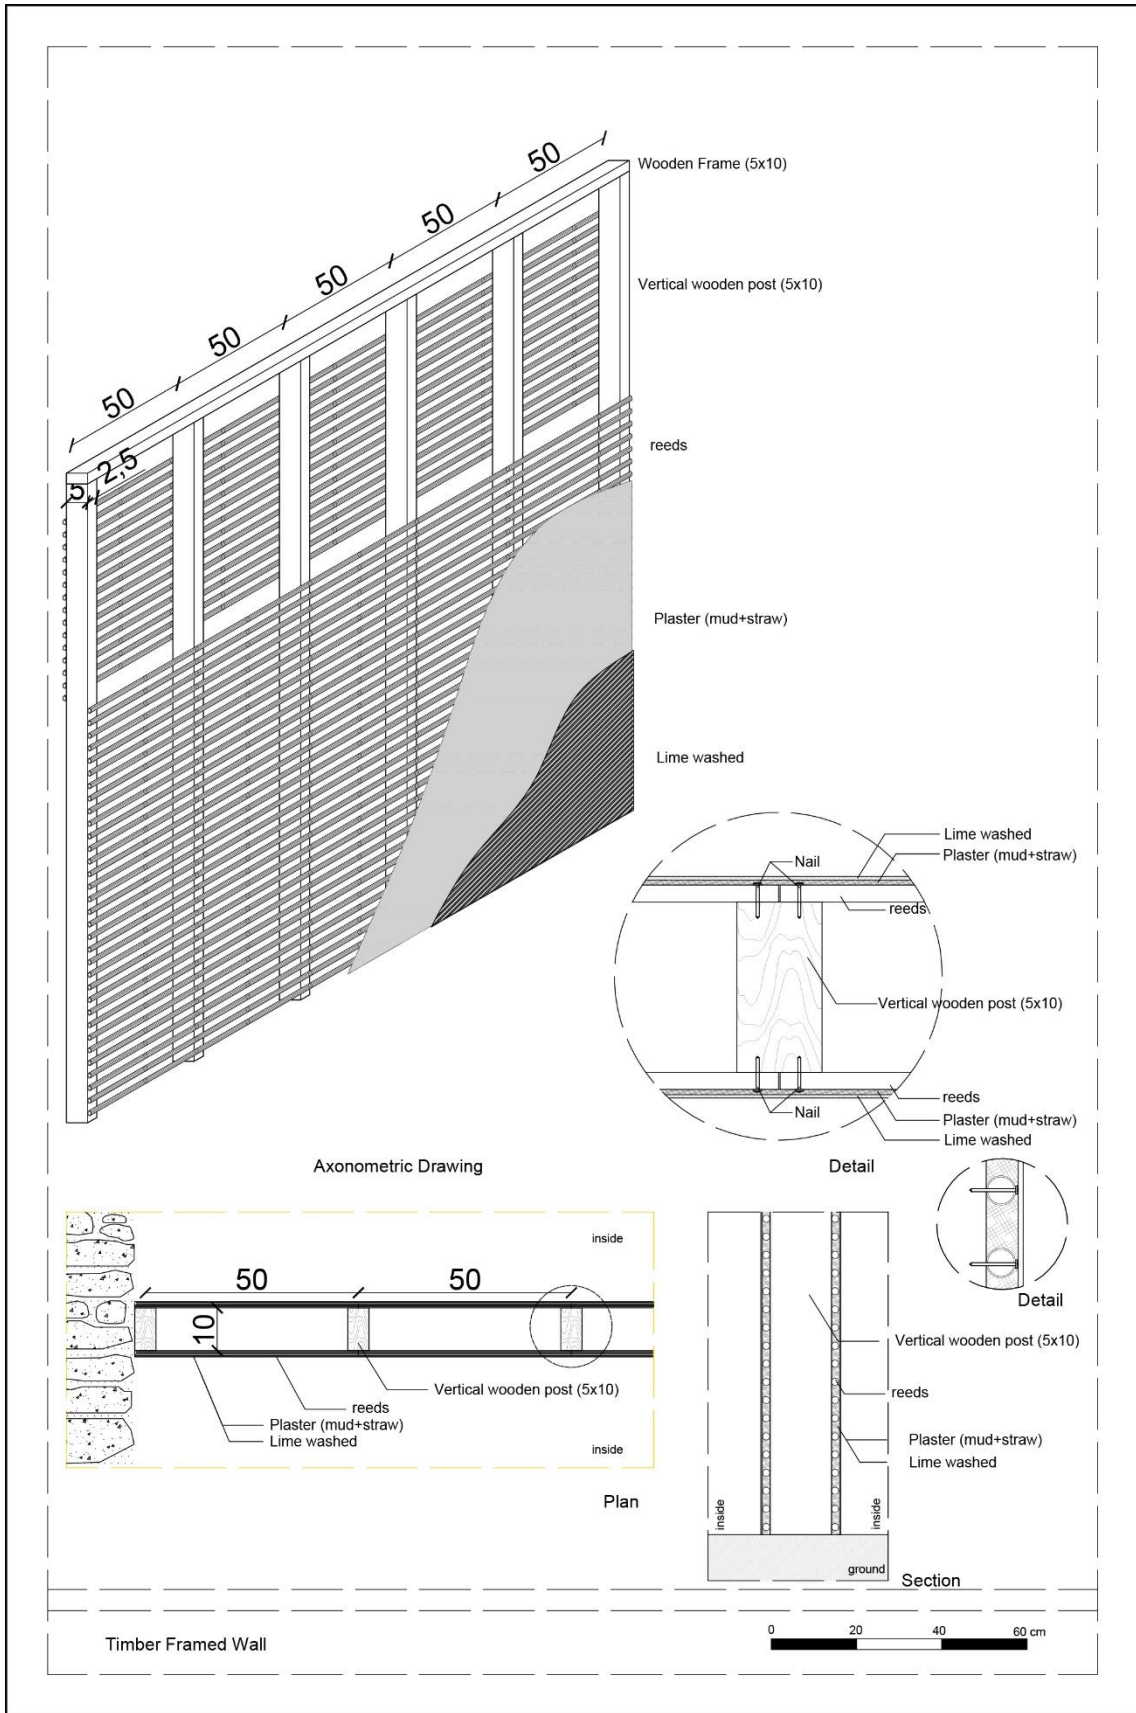
Drawing 4.4. Timber Framed Wall with Reeds Drawings.

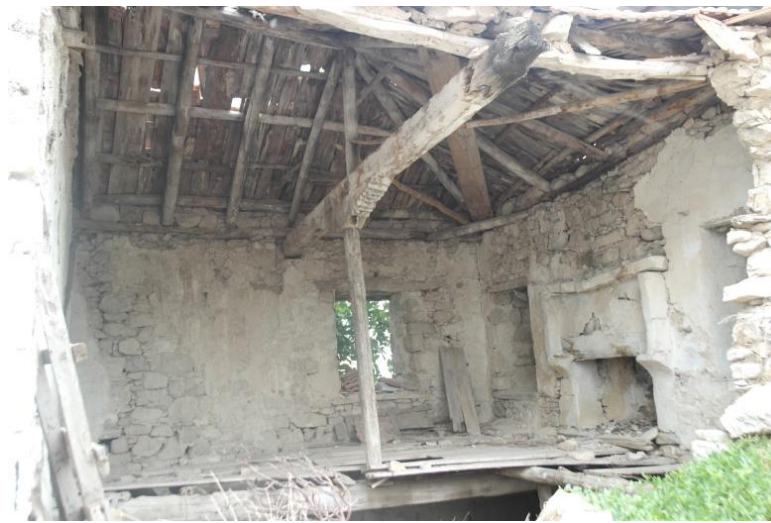
Figure 4.32. Wooden Post Carrying the Main Beam of the Roof in Kösedere (2016).

In Kösedere, a wooden post is observed in one house (Figure 4.32). Timber post is vertical load-bearing element that is used for the transfer of loads to the ground. It has been used in both ground and first floors. It has been used at the first floor for carrying the main beam of the roof structure in Kösedere. It has rectangular cross-section and ornamented heading. The head part's section is wider to get more loads. The post has been observed in Saip and Bozköy also (Figure 4.33). The post has been used at first floor has also wider head however the post has been used at the ground floor is simple. Most of the structures have it at ground floor. One of the structures has it at first floor. The post is simple in this example.

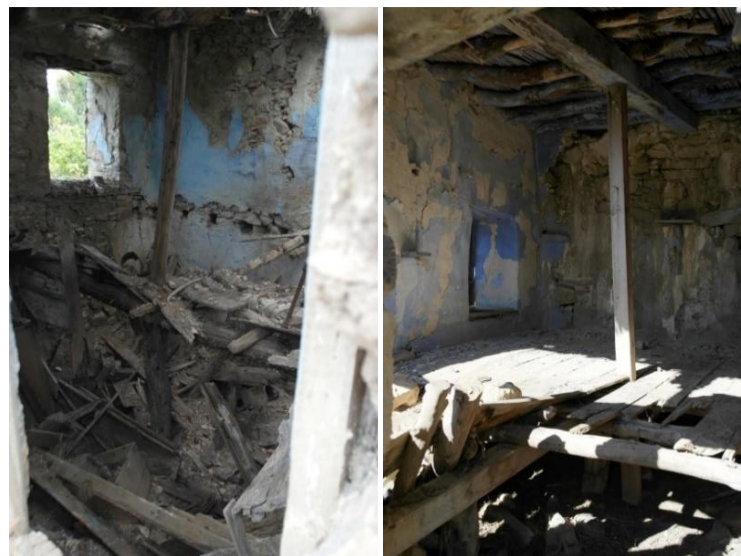
Figure 4.33. Wooden Post in (a) Saip (b) Bozköy (April 2017).

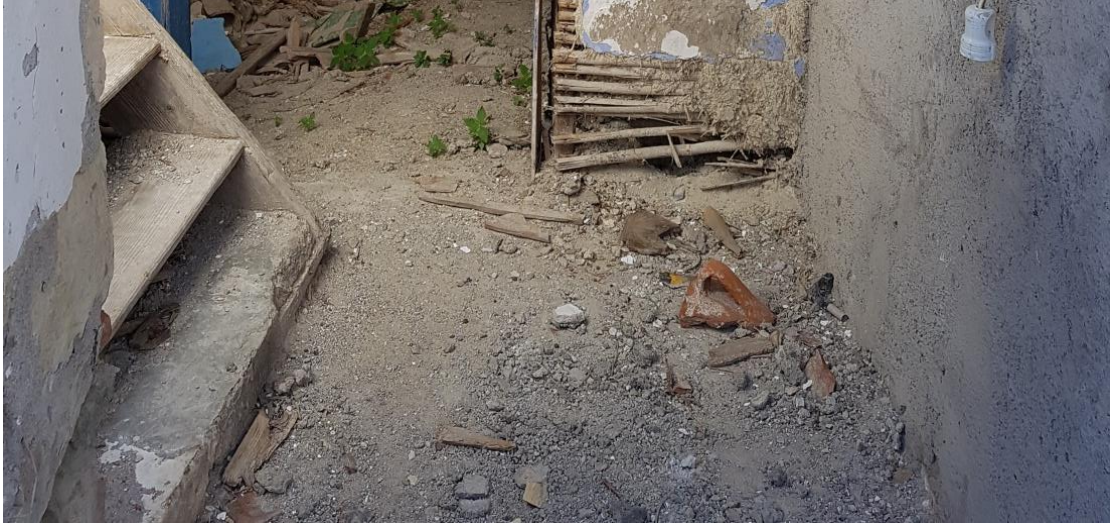
Figure 4.34. Pressed Earth Floor Pavement Example on Ground Floor in İncik (June 2017).

The ground floor system cannot be observed because of debris layers on floors in Kösedere. However, the floor pavement of the ground floors is covered with pressed earth in nearby east villages like İncik (Figure 4.34) and wooden floor covering has been observed on ground floor in some examples in these villages (Figure 4.35). (Drawing 4.5)

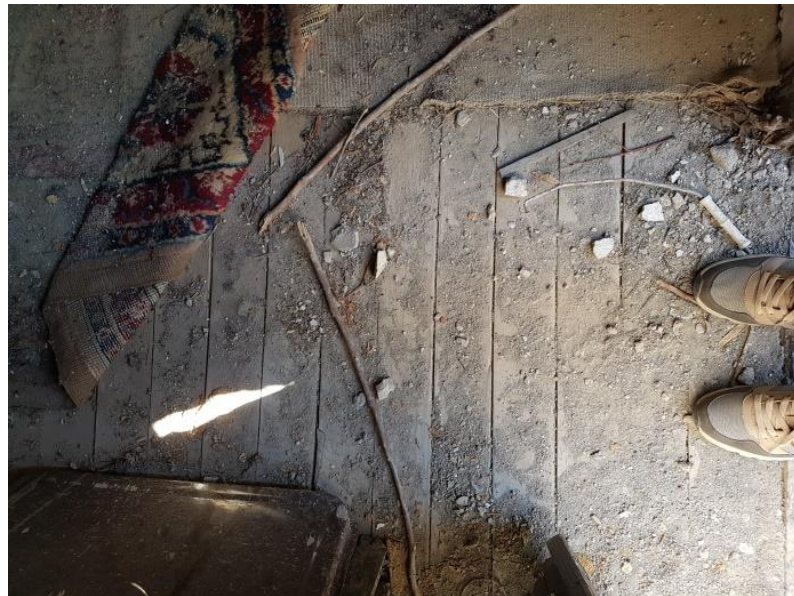
Figure 4.35. Wood Panel Covering Example on Ground Floor in İncik (June 2017).

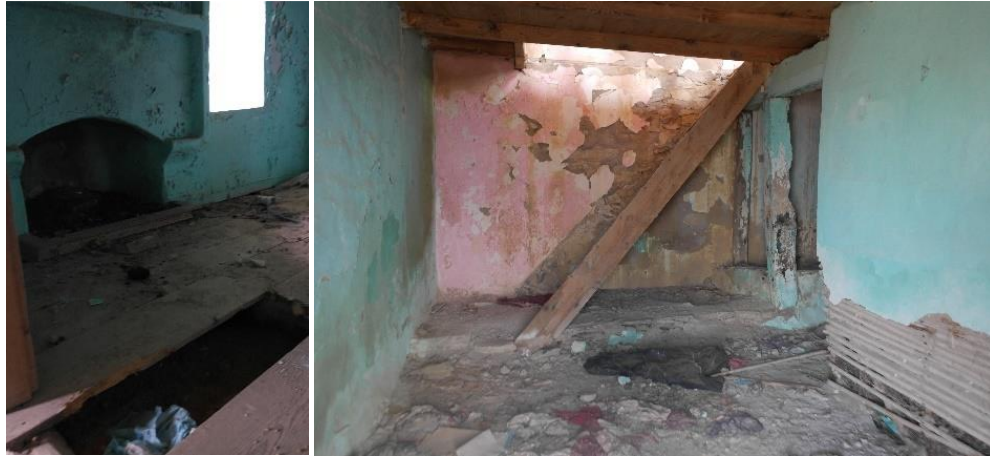
Figure 4.36. Ground Floor Coverings in Küçükbahçe (April 2017).

The ground is covered with pressed earth and there is also raised floor system example from ground level in Küçükbahçe (Figure 4.36, 4.37). The system is covered with wooden boards. In this system, a space of 50 - 100 cm is left between ground level and wooden coverings for ventilation.

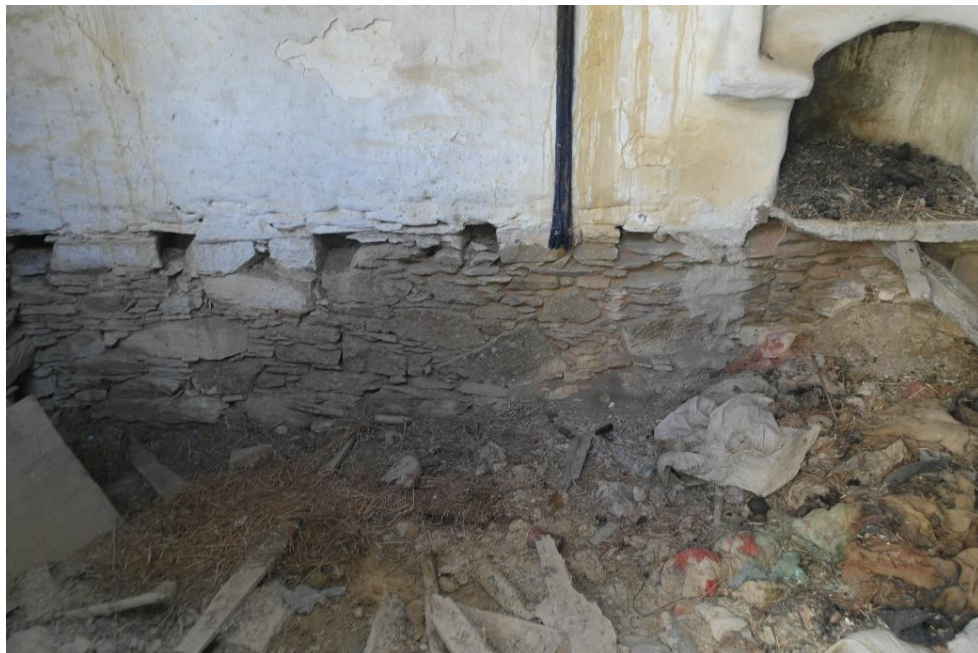
Figure 4.37. Raised Ground Flooring System Trace in Salman (May 2017).

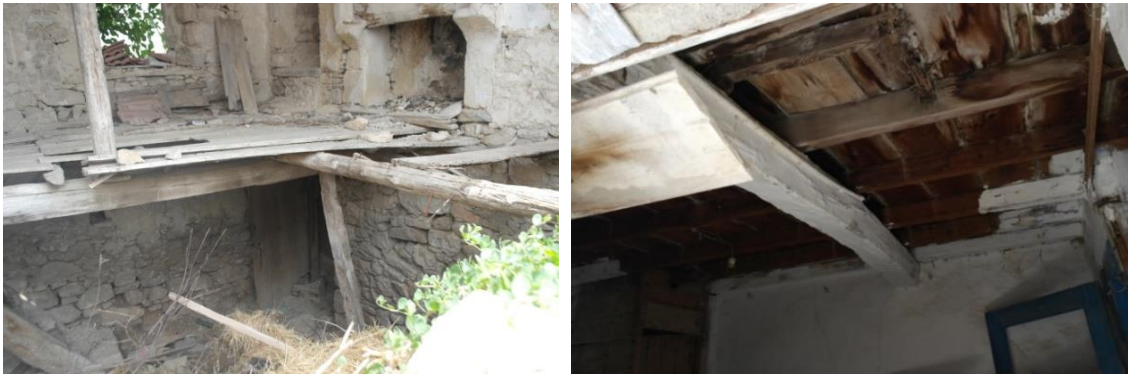
Figure 4.38. Floor Construction (a) Kösedere (June 2016) (b) İncecik (November 2016)

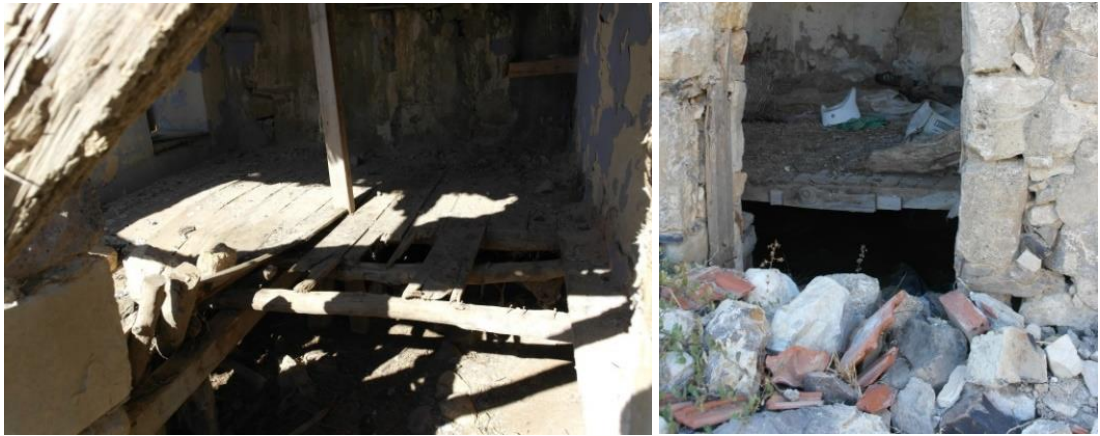
Figure 4.39. Floor Construction (a) Bozköy (b) Tepeboz (June 2016)

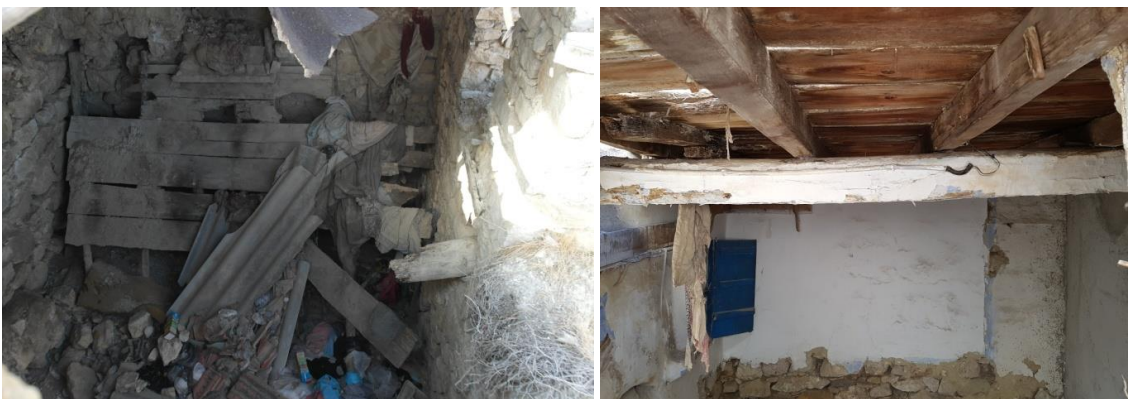
Figure 4.40. Floor Construction example (a) Eğlenhoca (b) İncecik (June 2017)

Timber floor system is used for the first floor in Kösedere and Küçükbahçe. Floor beams are laid on a main girder, which is usually placed in the middle of the room, in the opposite direction of the floor beams. The cross section of this main girder can be 18 / 18-20 / 20cm size. These main beams are often roughly processed or not processed at all. Floor beams are wooden elements with a smaller cross-section (6 / 12-8 / 12-8 / 15cm cross section depending on the width of the openings and the work piece), which are placed with approximately 40-50cm spacing. The floor beams are usually placed between two floors with the wooden wall plate being seated on the beam element. Finally, floor beams are covered with the timber flooring boards in perpendicular manner. Their sizes are almost 2x20 or 2x30 cm. (Figure 4.40, 4.41, 4.42, 4.43, 4.44) (Drawing 4.5)

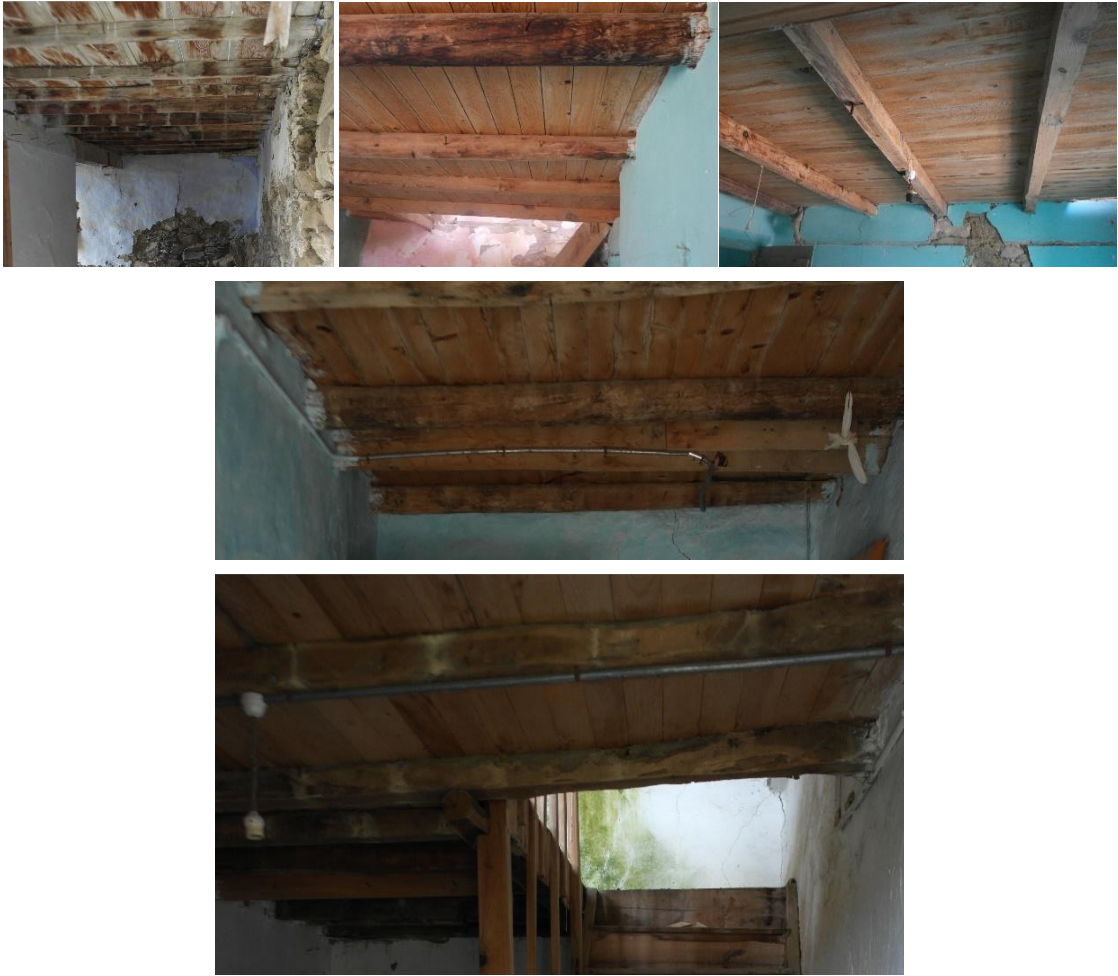
Figure 4.41. Floor Construction in Küçükbahçe (April 2017).

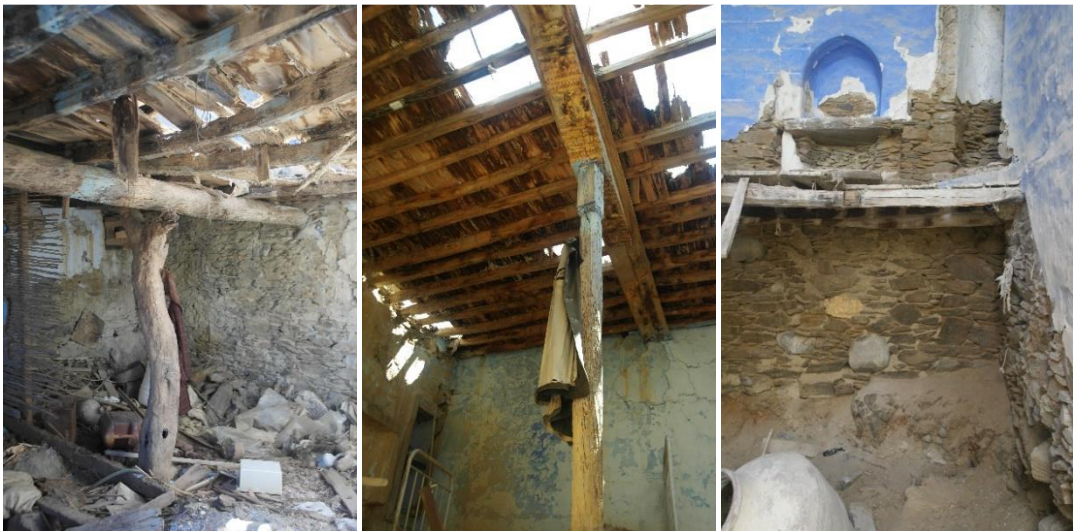
Figure 4.42. Floor Construction in Salman (May 2017).

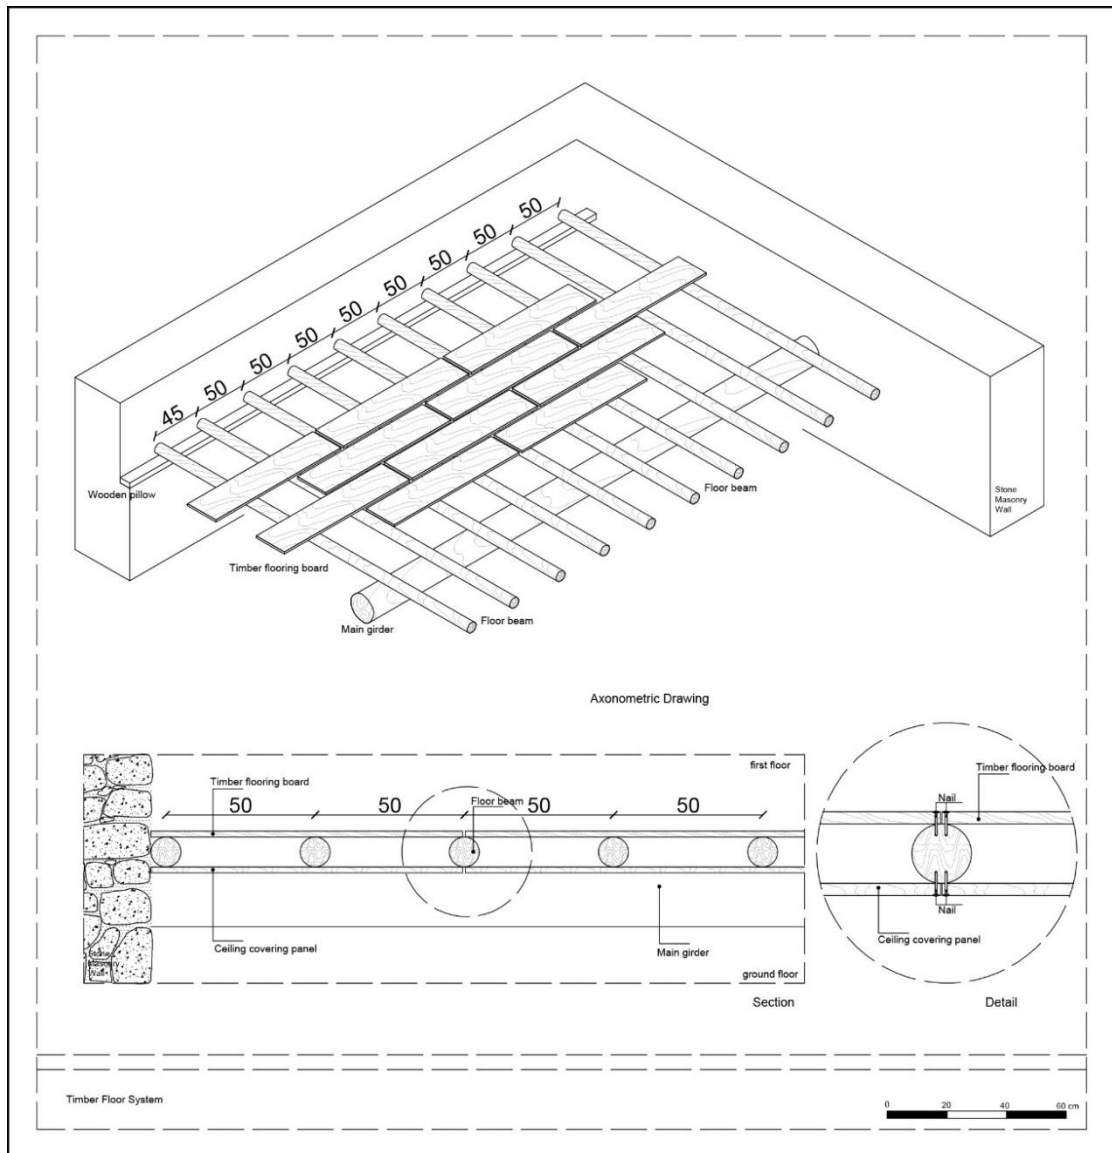
Drawing 4.6. Timber Floor System Drawings.
