**CONSTRUCTION TECHNIQUES
OF TRADITIONAL HOUSES
IN KARABURUN VILLAGES**

**A Thesis Submitted to
the Graduate School of Engineering and Sciences of
İzmir Institute of Technology
in Partial Fulfillment of the Requirements for the Degree of**

in Architectural Restoration

**by
Burçin GÖRÜR**

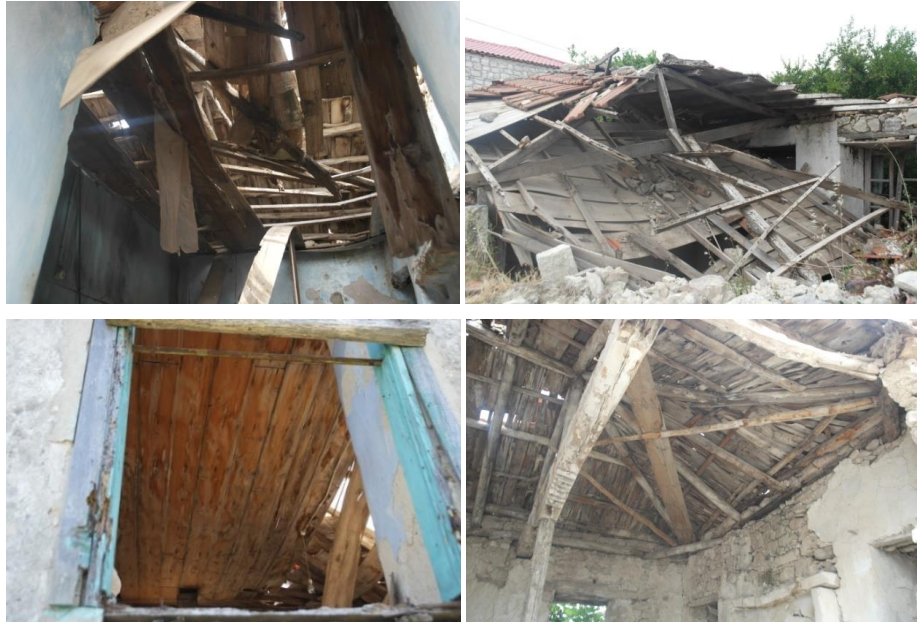
Figure 4.43. Ceiling Structure Examples in Kösedere (June 2016).

It is observed that the ceilings of the ground floors are not covered in Kösedere and Küçükbahçe. In these spaces, the floor girders of the upper floor are left open. In the first floor, some of the ceilings are covered with wooden panels and some of them are also left open like ground floor ceiling. In these examples, roof structures can be seen. 15 cm wide ceiling boards with rectangular cross-section are set next to each other and nailed on floor girders in perpendicular direction for covering ceiling. (Figure 4.43, 4.44, 4.45) (Drawing 4.7)

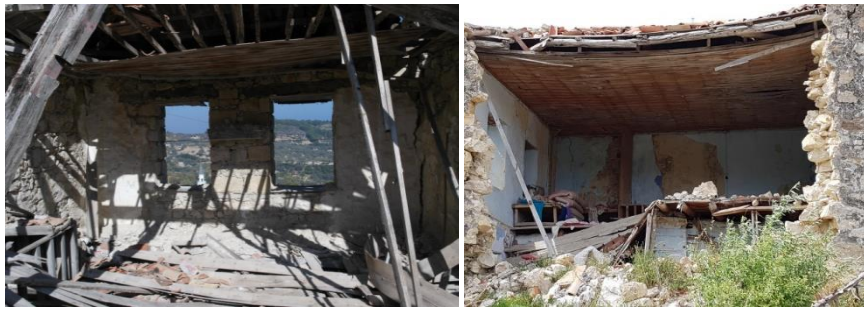
Figure 4.44. Ceiling Structure Examples (a) Eğlenhoca (June 2016) (b) Tepeboz (June 2017).

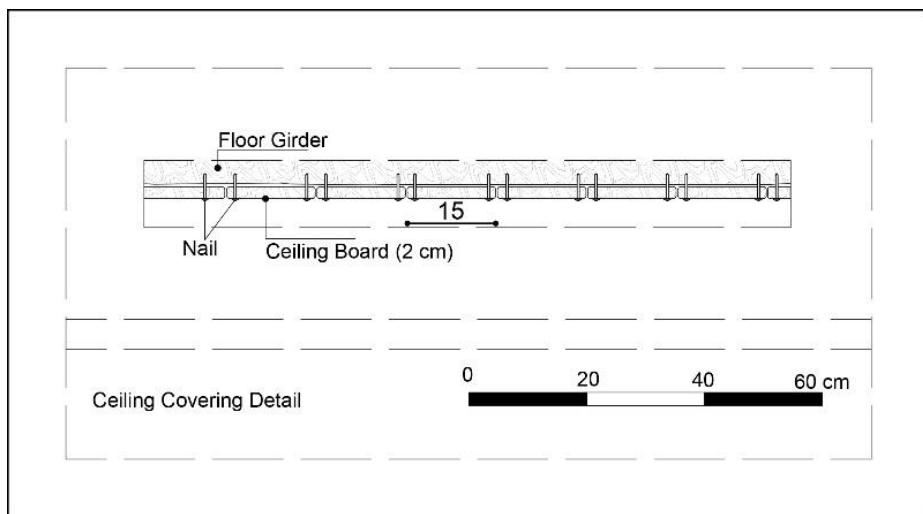
Drawing 4.7. Ceiling Covering Detail Drawing.

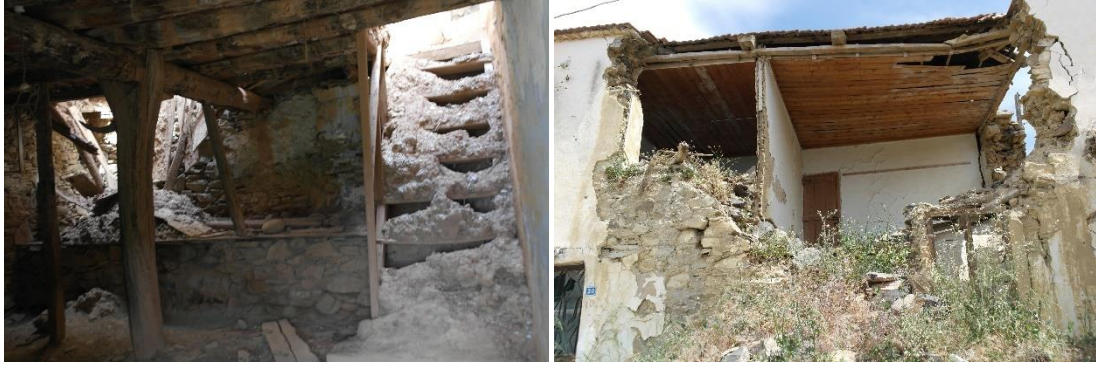
Figure 4.45. Ground Floor and First Floor Ceiling Structures in Küçükbahçe (April 2017).

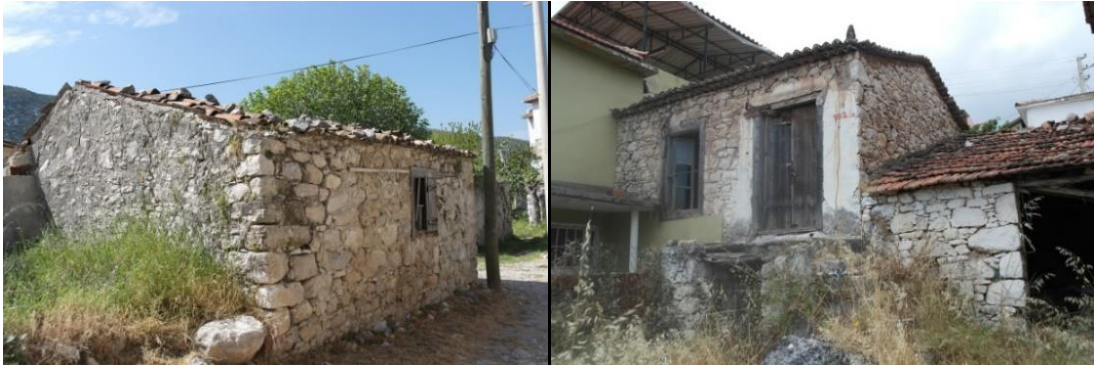
Figure 4.46. Examples of Pitched Roofs in Kösedere (June 2016).

Hipped and pitched timber roofs are observed in the Kösedere (Figure 4.46, 4.47). Flat roof hasn't observed in this village. Hipped, pitched and flat roof types are observed in Küçükbahçe (Figure 4.48, 4.49). Structures of hipped and pitched roofs are similar to each other. Pitched roofs are formed with two surfaces sloped towards to opposite directions and the purlin which is usually presents at the central axis of the plan. These two surfaces sloped through the longitudinal edges of the roof and gable walls took place at the shorter edges. Hipped roofs are formed with three or four surfaces sloped; it changes according to the location of house; if the house stands alone, the hipped roof is formed with four surfaces; if it stands next to another house, the hipped roof is formed with three surfaces. The roof system is composed of posts, purlin, angle rafters, collar beams, angle braces, and rafters (Figure 4.50, 4.51) (Drawing 4.8). Timber posts are placed in every 100 cm, on the girders, placed between roof and upper floor. Posts transfer the load through to the girder to lower stories. Their thickness changes between 10-15 cm. Posts are supported by angle braces. The dimension is 5-10 cm in rectangular cross-sections and 8-8 cm if it has circular cross-section. Angle rafters are placed on the posts. They transfer the load to posts and girders. The thickness is change between 8 -15 cm. Purlins are placed between the angle rafters in the perpendicular direction to the roof slope. Purlins transfer the load to posts. The size of these elements is approximately 10 cm x 2-2.5 cm. The purlin placed at the top point of the roof, on the line where the roof slope changes is called ridge purlin; and the farthestmost one placed directly on the girder is called end purlin. Rafters are placed on purlin in perpendicular way, one in every 50-70 cm. The cross-sections of these purlins are approximately 5-10 cm. Roof boards are placed on purlin in perpendicular way. These boards are 2 cm thick, 10-15 cm wide. The

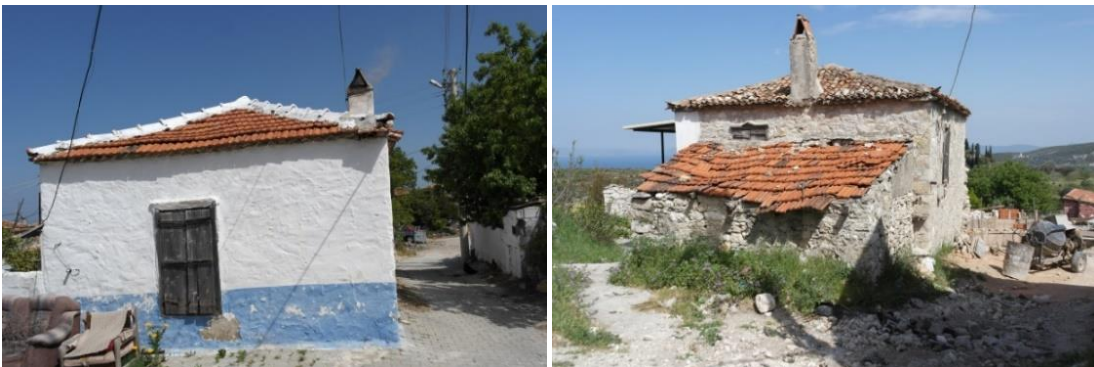
Figure 4.47. Examples of Hipped Roofs in Kösedere (June 2016).

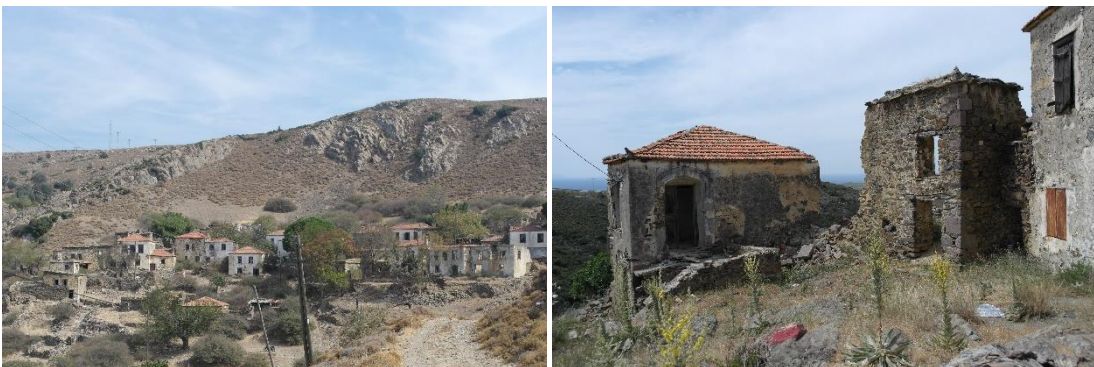
Figure 4.48. Hipped and Pitched Roof Examples in Küçükbahçe (April 2017)

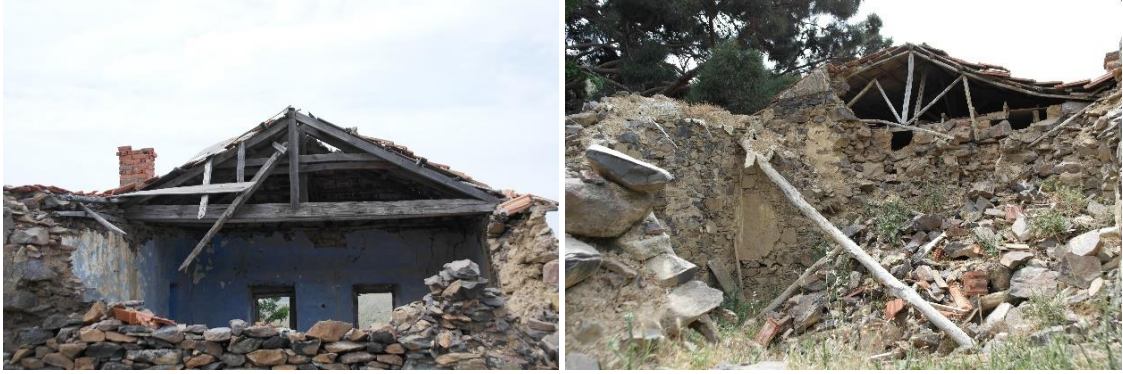
Figure 4.49. Hipped and Pitched Roof Examples in Küçükbahçe (April 2017).

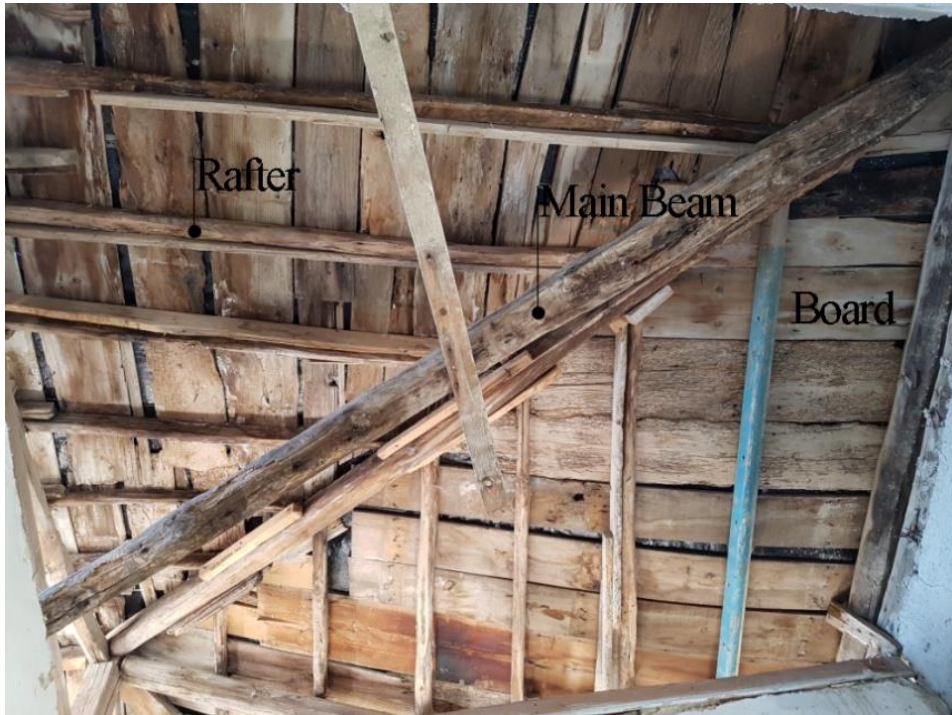
Figure 4.50. Hipped Roof Components in İncelik (June 2017).

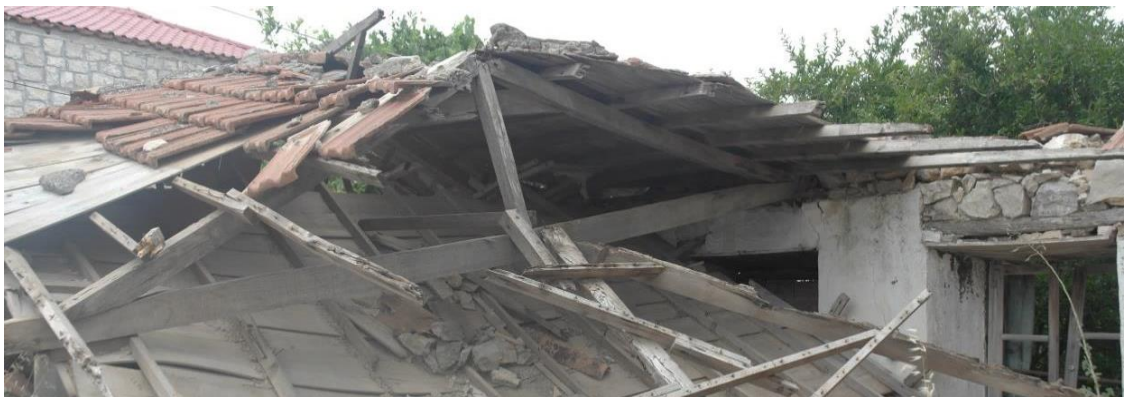
Figure 4.51. Rafters, Boards and Roof Tiles Relation in Kösedere (June 2016).

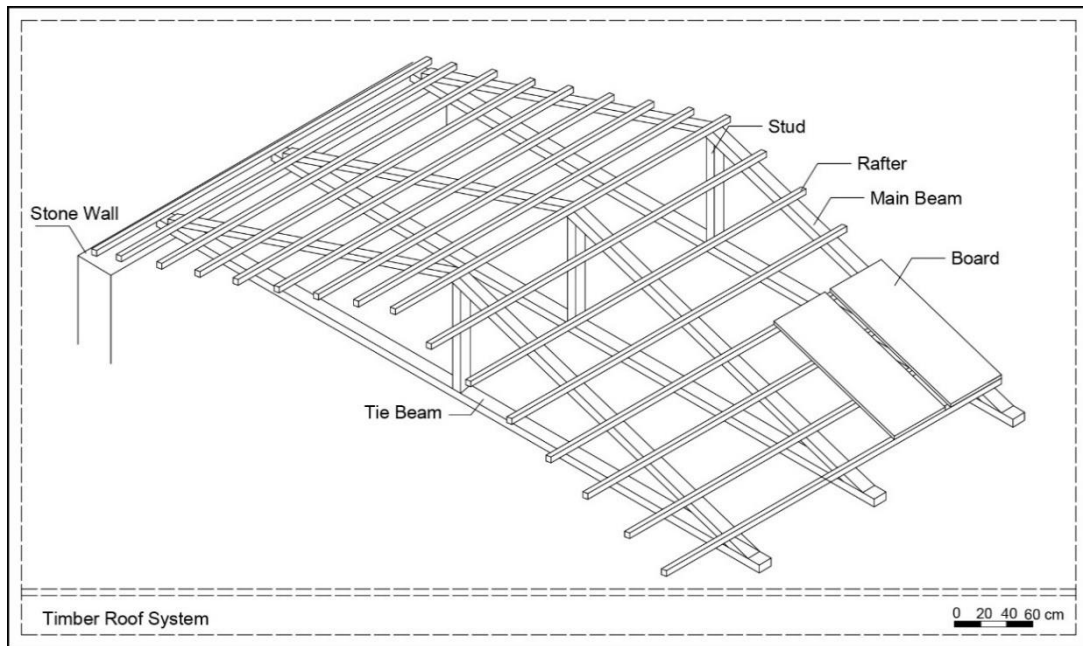
Drawing 4.8. Components of Timber Roof Structures.

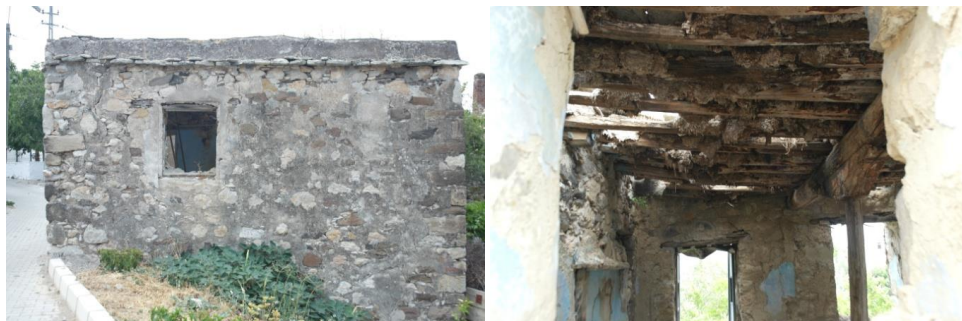
Figure 4.52. Flat roof examples in Saip (June 2016).

In the eastern zone of the Peninsula, flat roof examples are observed in Saip, Tepeboz and Bozköy (Figure 4.52, 4.53). These examples represent the very original roof type of the whole buildings in the villages. This original roof type is converted into hipped or pitched types due to difficulties in taking care and maintenance. In this very original flat roof type; firstly, the main beams are placed for spanning. These beams have circular cross-sections with approximately 20cm diameters. Then they are covered with timber boards to the vertical direction of the beams and timber boards are covered with a bottom layer of reed or small wooden lathes and top layer of earth and dried straw mixture. In Bozköy, on the other hand, main beams are covered with reed and then with earth and dried straw mixture.

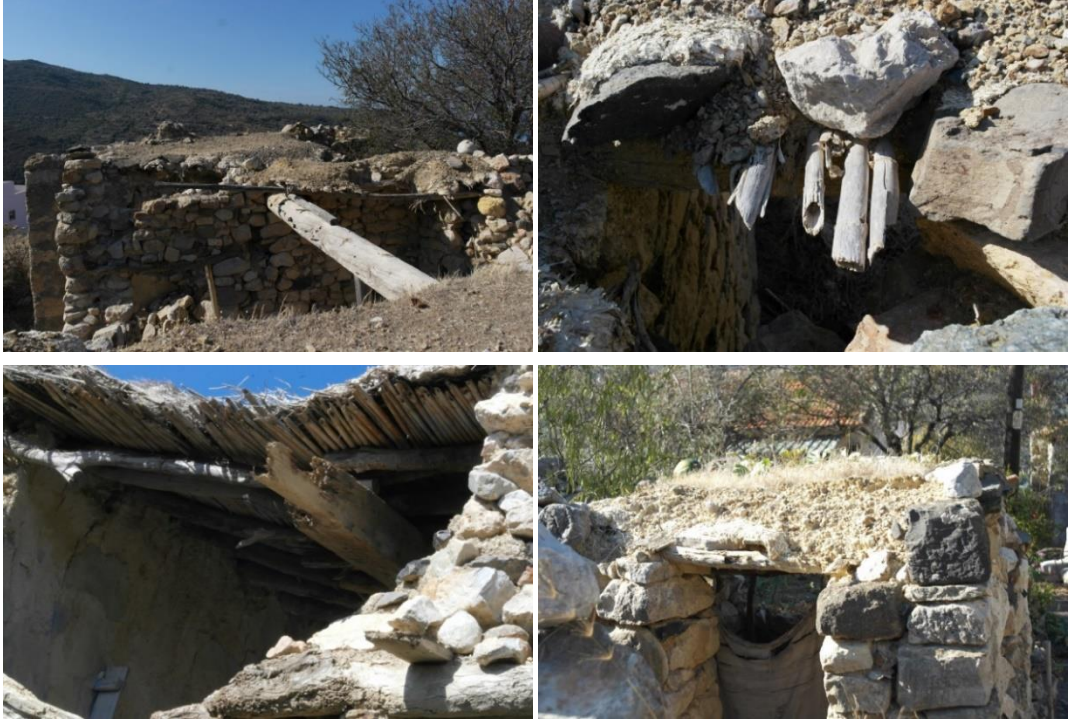
Figure 4.53. Fat roof examples in Bozköy (June 2016).

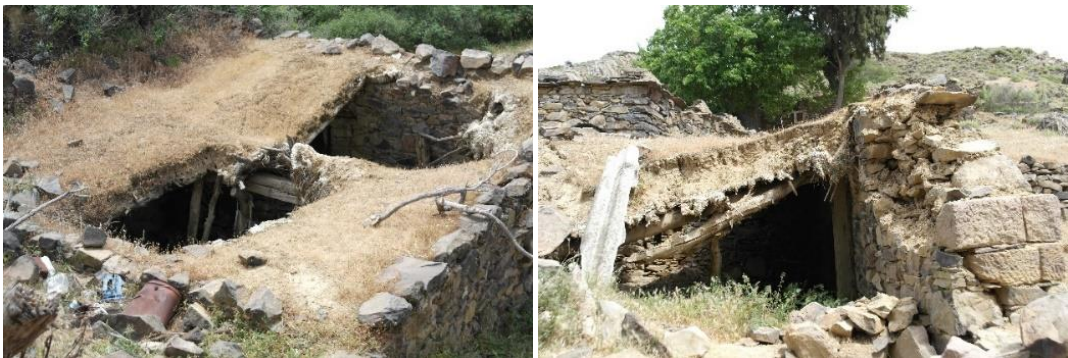
Figure 4.54. Flat Roof Examples in Küçükbahçe (April 2017).

Minor differences are observed on flat roofs between two zones. In Küçükbahçe, round sectioned wooden beams are covered with two layers of shrub. The bottom layer is composed of thick sectioned shrubs whereas the top layer is composed of thinner sectioned shrubs. Finally, a 30-40 cm thick earth layer is applied. This layer is composed of a mixture of soil, water and straw which has high clay content and called “geren” by the locals (Figure 4.54, 4.55) (Drawing 4.9). Every year, this soil is feeded if necessary. The soil mixture is pressed with a cylindrical stone called ‘*loğ taşı*’ to increase its water-proof capacity. The flat roofs have slate stone eaves projecting about 10-15cm from the masonry walls.

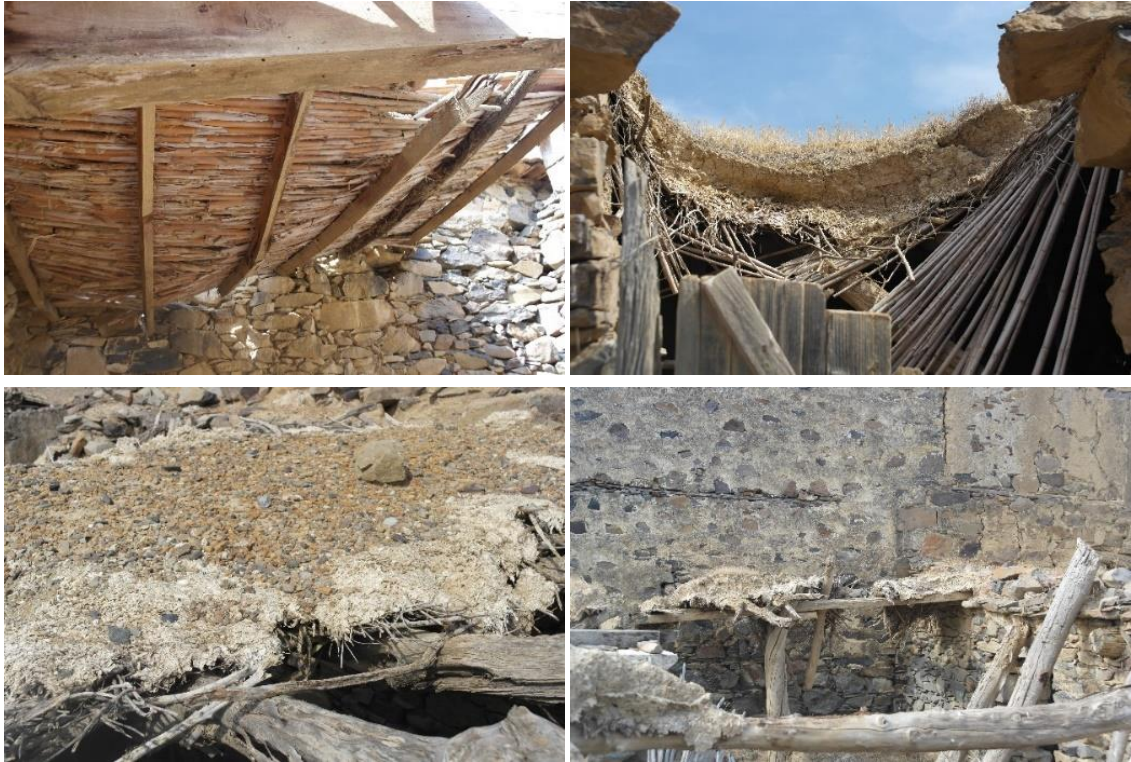
Figure 4.55. Flat Roof Examples in Küçükbahçe (April 2017).

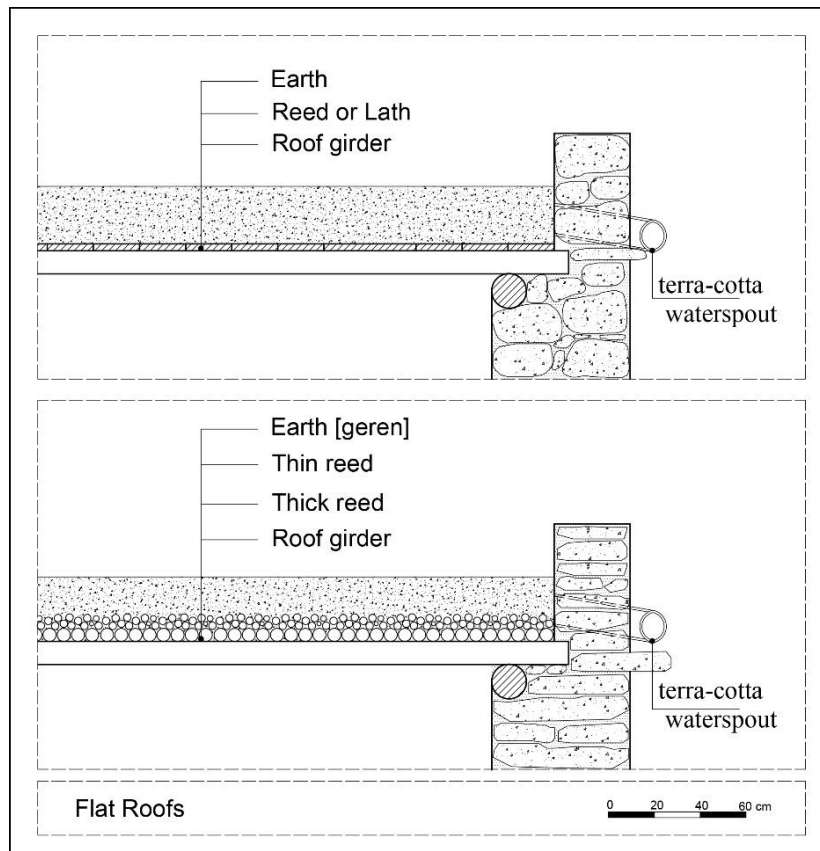
Drawing 4.9. Flat Roof Drawings.

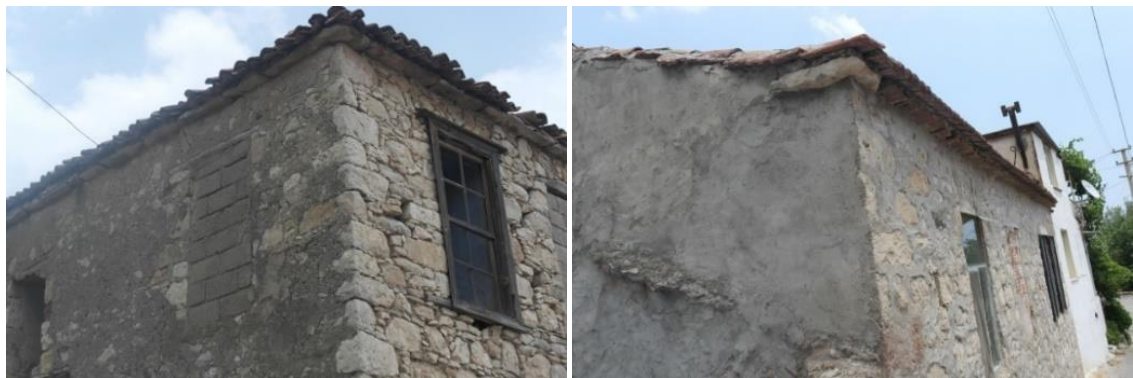
Figure 4.56. Examples of Eave Types in Kösedere (June 2016).

All roofs have eave composed of mostly over and under type tiles and slate stones in hipped or pitched roofs and slate stone in flat roofs. Brick is also used for the eave in Kösedere. Beside these eaves, one of the houses in Kösedere has gypsum sill under its eave. (Drawing 4.10) (Figure 4.56, 4.57, 4.58)

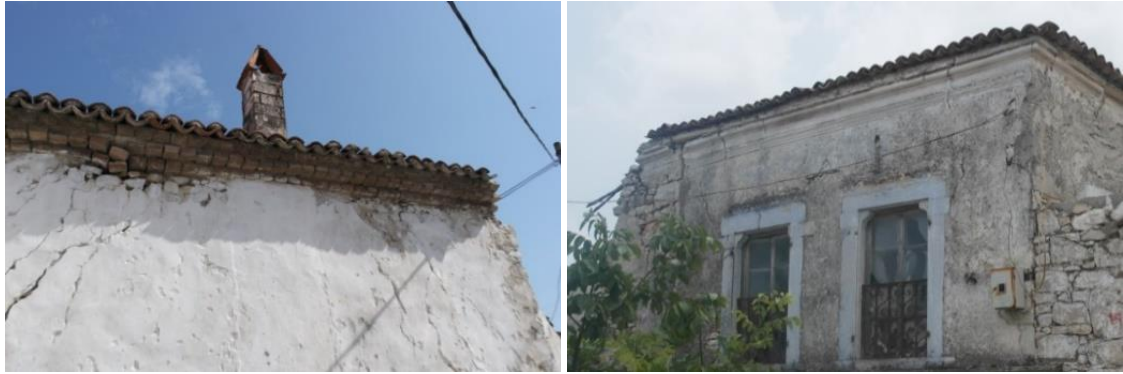
Figure 4.57. Examples of Eave Types in Kösedere (June 2016).

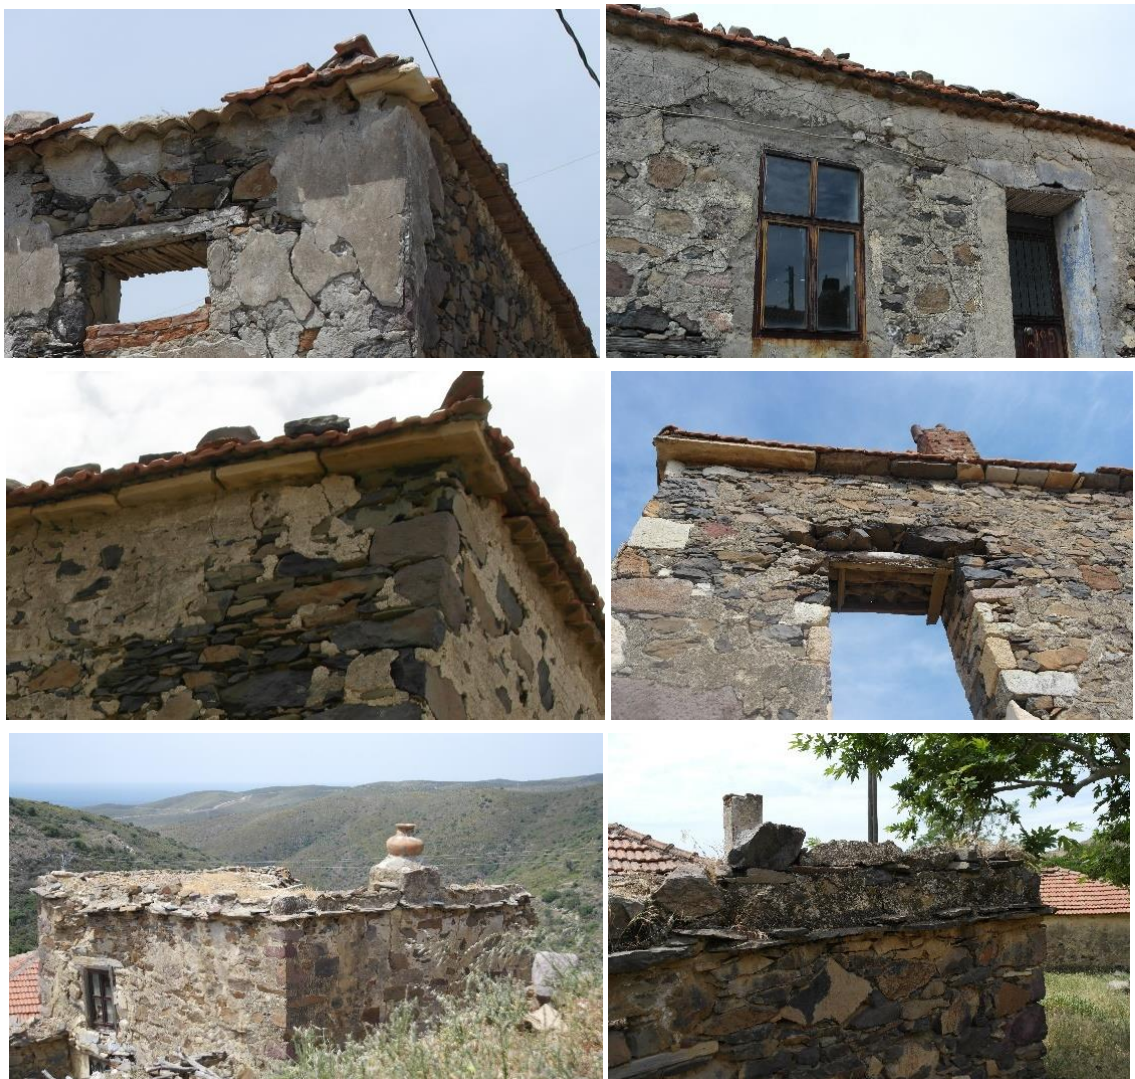
Figure 4.58. Tile and Stone Eave examples in Küçükbahçe (April 2017).

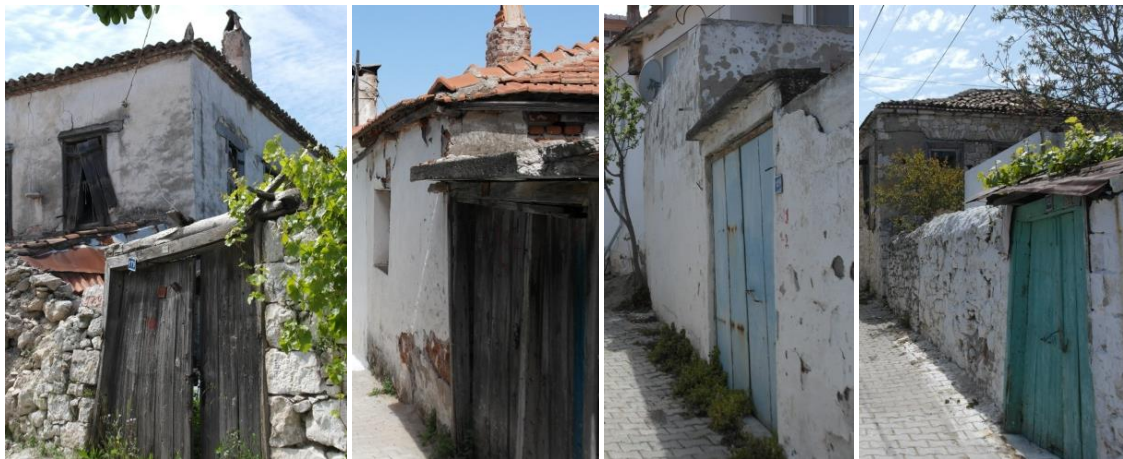
Figure 4.59. Courtyard Doors in Kösedere (June 2016).

Doors can be grouped according to their place; on exterior and interior walls. Exterior doors can be grouped into two as courtyard doors and main entrance doors. It is understood that most of the houses had courtyards in the past in Kösedere; however, their walls had been partly or totally collapsed today. However, some of the original courtyard doors could be observed and they are two-wing wooden panel doors (Figure 4.59). Most of the houses in Kösedere have courtyard but they are new structure and their doors are made by iron. Dimensions of courtyard doors are approximately 220x215 cm. The door opening is spanned by flat timber beam in one example, and concrete lintels at the others. It is obvious that the original timber lintels are replaced with concrete. However, the original wooden doors are kept. They are placed on the outer edge of the door opening of the courtyard wall. The wooden door wings are made up of vertical wood pieces 20-25 cm wide and they are nailed to horizontal backing panels at the back side of the doors. (Drawing 4.11)

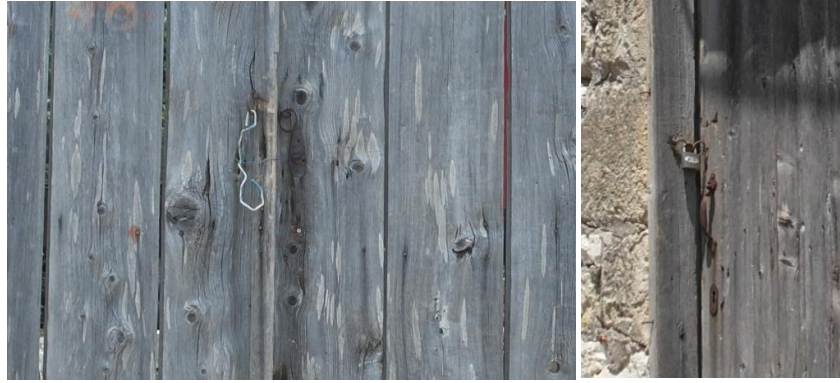
Figure 4.60. Metal Element (a) Saip (b) İncecik (June 2016).

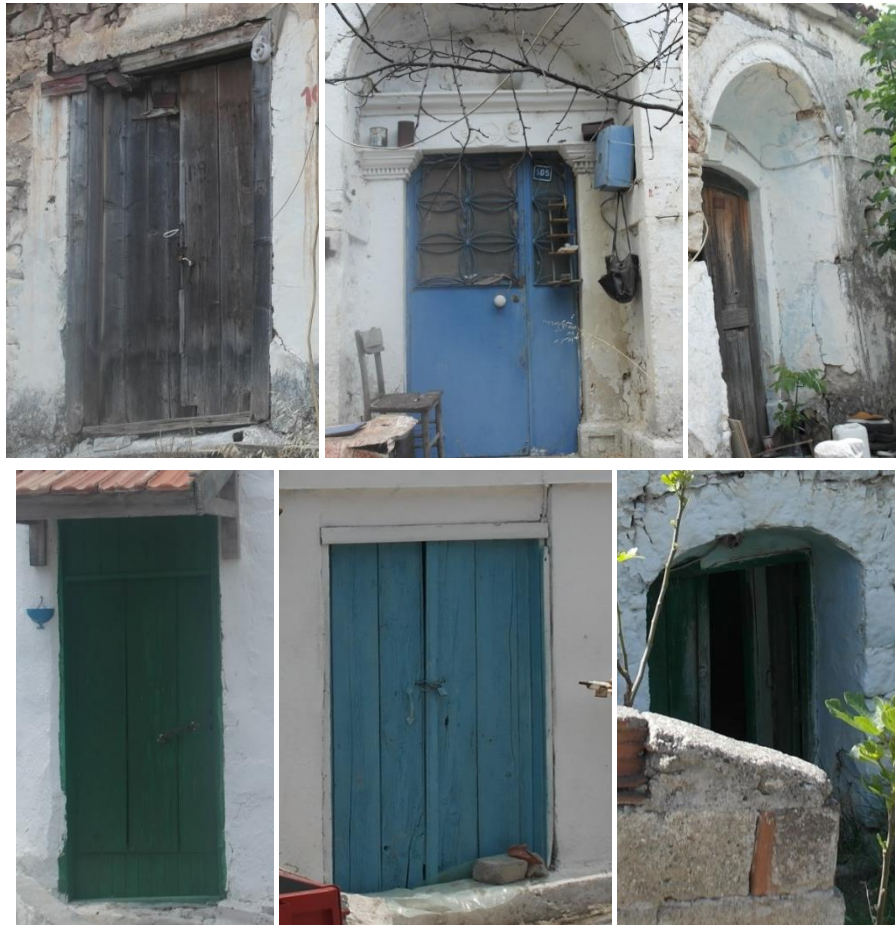
Figure 4.61. Exterior Door Examples in Kösedere (June 2017).

The main doors are located between house and courtyard or between house and street. The main doors are generally two-wing panel doors in both villages (Figure 4.61, 4.62, 4.63). Dimensions of the two-wing doors change 200x220cm to 220x250cm. For spanning door openings not only flat lintels, but also semi-circle arches and depressed arches are used. In two examples, door wings fit in these arches with circular shaped, but at the others, the doors are rectangular shaped in these spanning. These doors are made from pieces of solid timber panels and their place in the masonry wall is various; some of

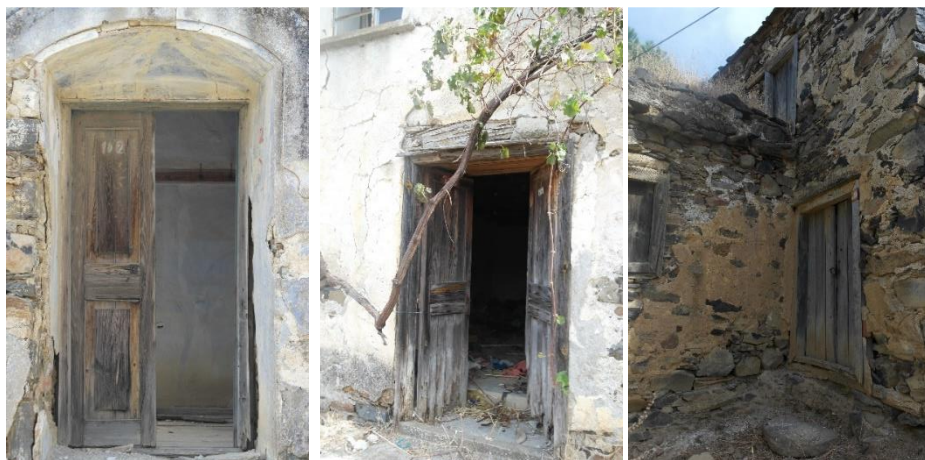
Figure 4.62. Entrance Doors Examples in Küçükbahçe (April 2017).

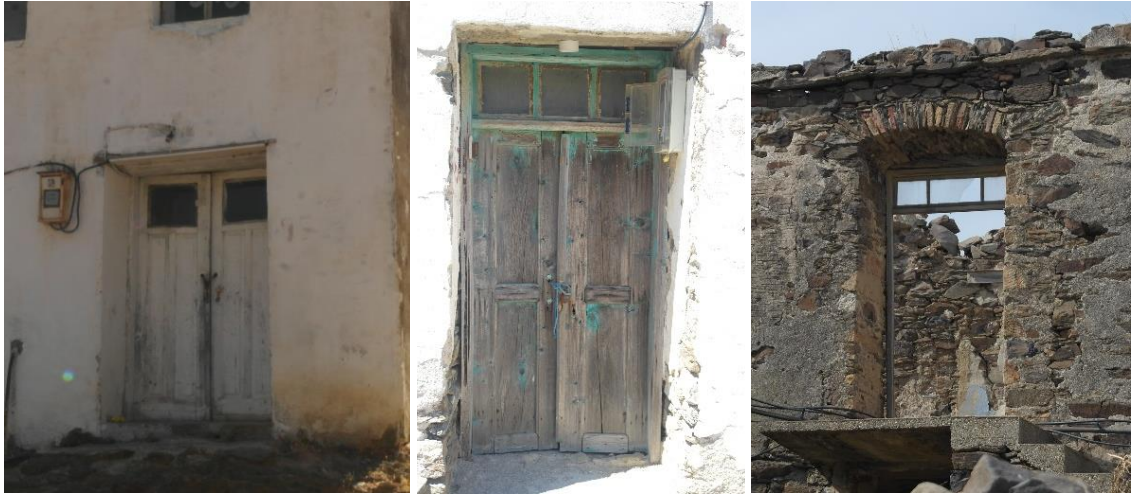
Figure 4.63. Entrance Doors Examples in Salman (May 2017).

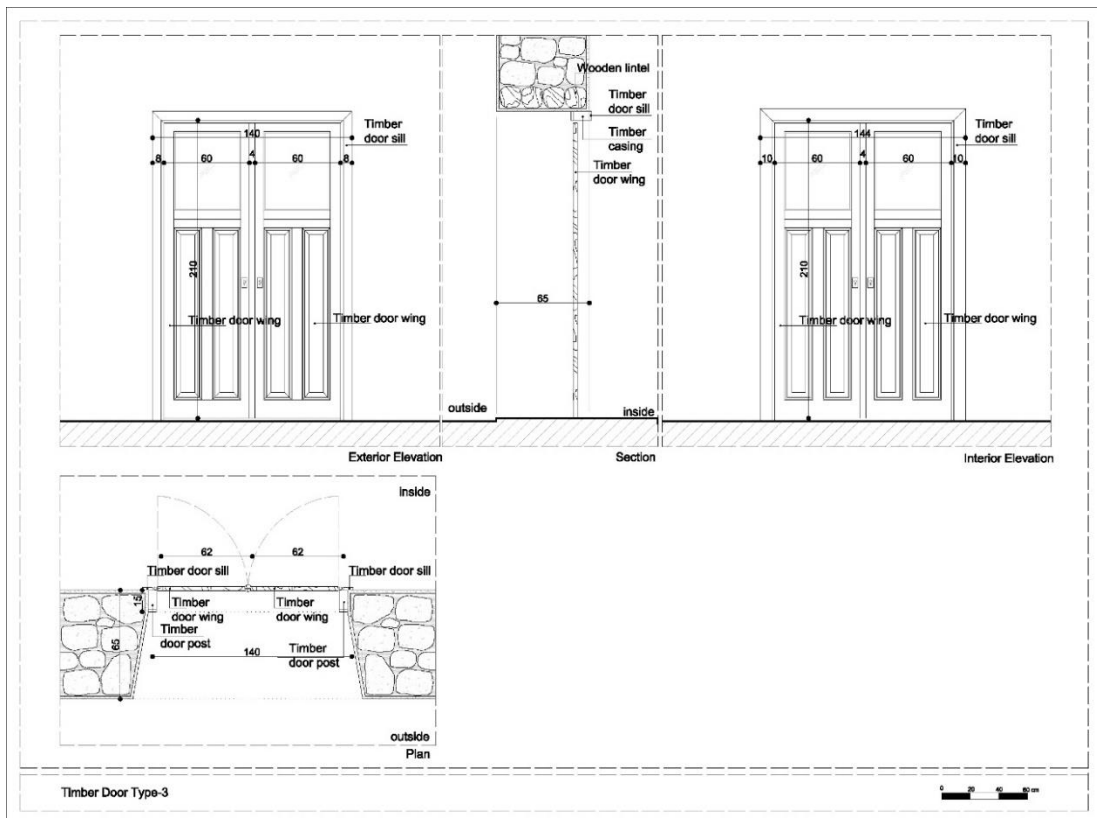
Drawing 4.14. Timber Door Type-2 Drawing.

them sit on the inner edge of the opening and some of them sit in the middle and some of them sit on the outer edge of the wall. (Drawing 4.12, 4.13, 4.14)

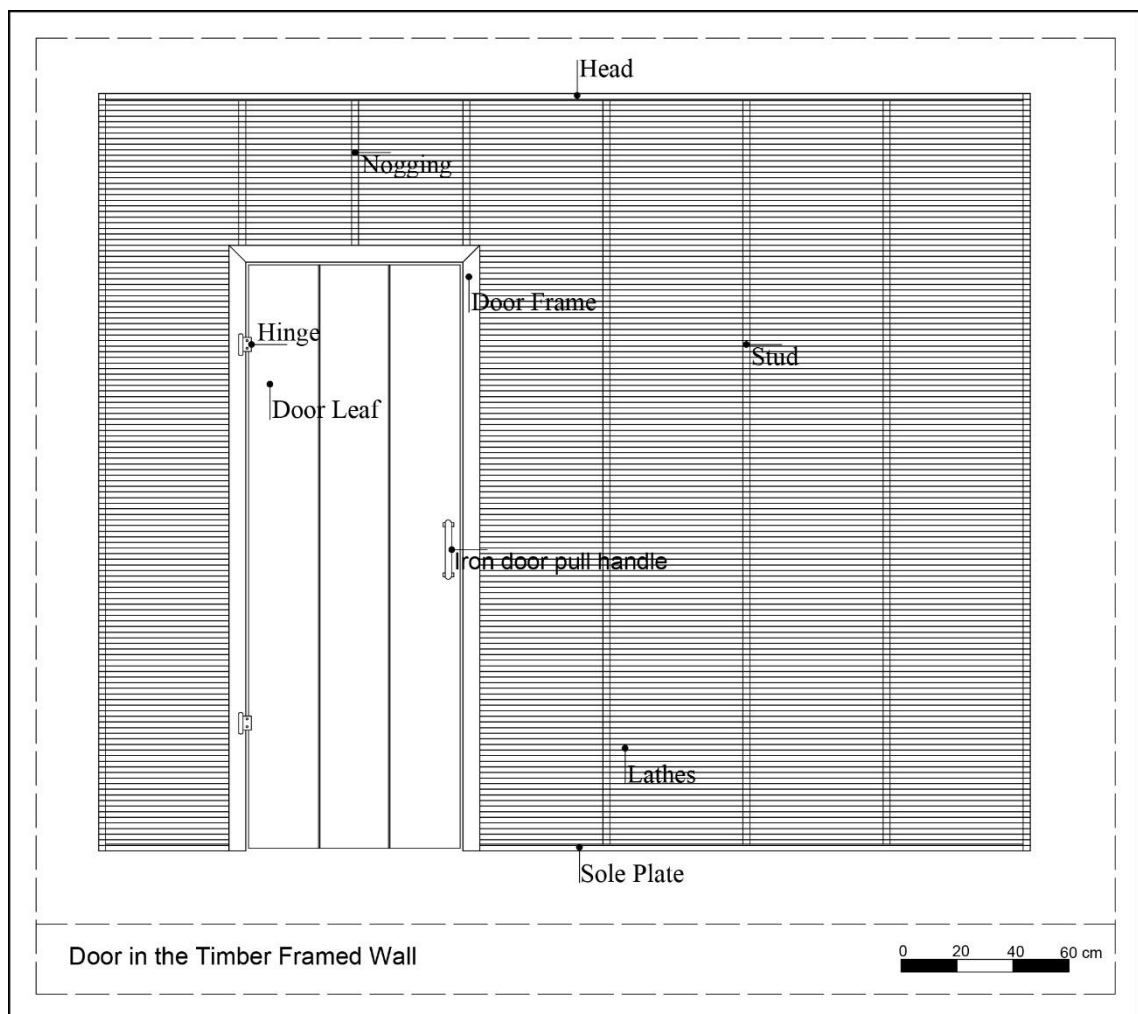
Drawing 4.15. Door in the Timber Framed Wall.

Inner doors are placed on inner timber framed walls. They are generally one-wing panel doors (Drawing 4.15). Firstly, the studs are placed according to the door opening width. Horizontal timber beams are placed between door studs. Noggins are placed on this timber beam. The door leaf made from pieces of solid timber panels. The door casings are 5-15 cm wide and composed of 2 timber posts with rectangular cross-sections. Nailing and lapping technique are used in door leaves. Timber thresholds placed in some doors between door posts on the ground and they are 5-10 cm high and 5-15 cm wide. (Figure 4.64, 4.65, 4.66, 4.67)

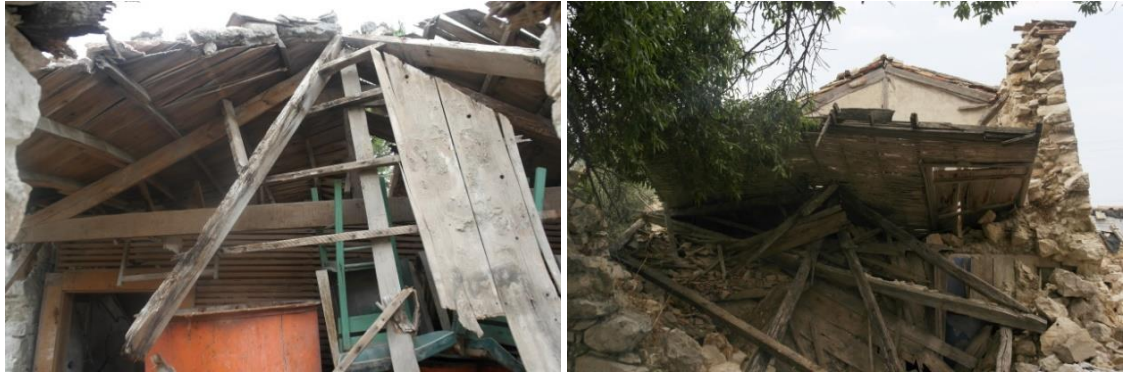
Figure 4.64. Doors in Timber Framed Wall in Kösedere (June 2016).

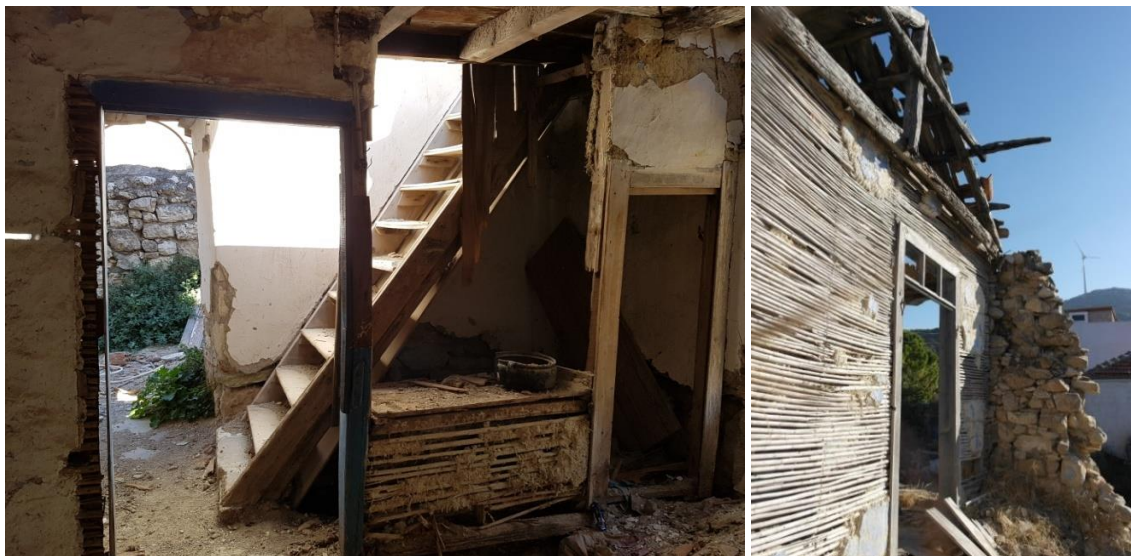
Figure 4.65. Doors in Timber Framed Wall (a) İncecik (b) Tepeboz (June 2016).

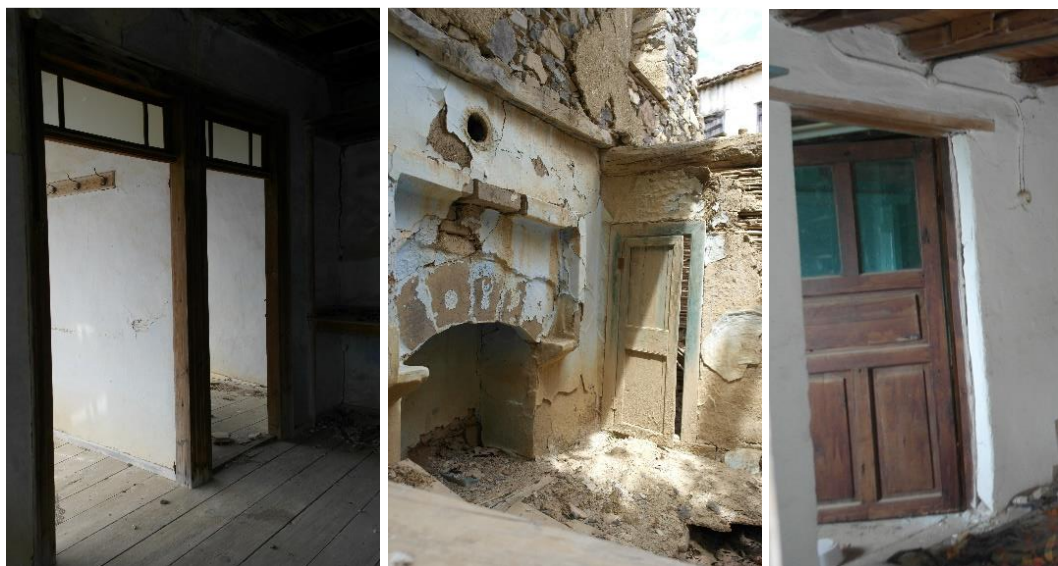
Figure 4.66. Inner Door Examples in Küçükbahçe (April 2017).

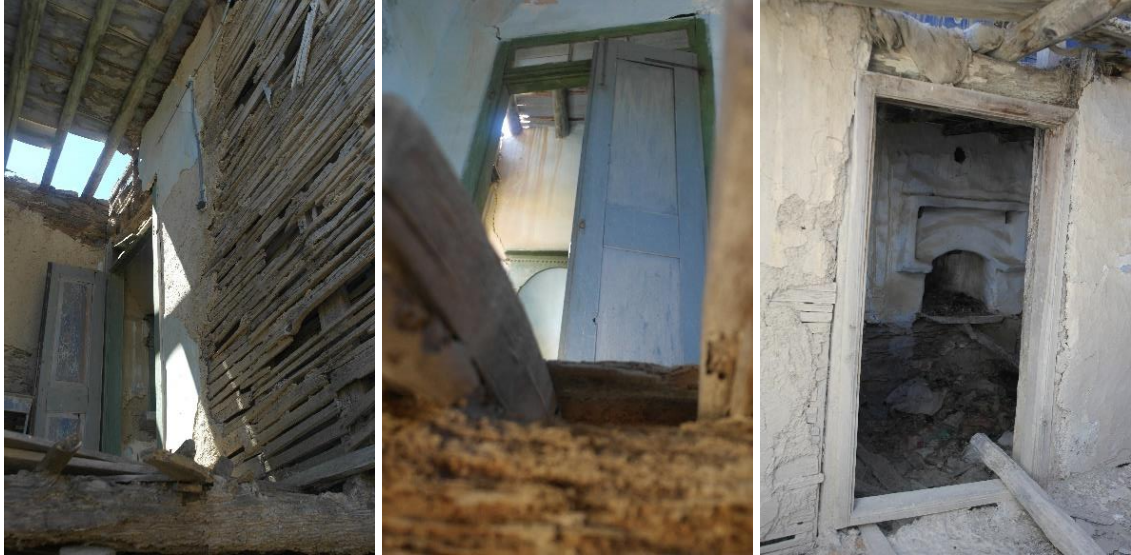
Figure 4.67. Inner Door Examples in Salman (May 2017).

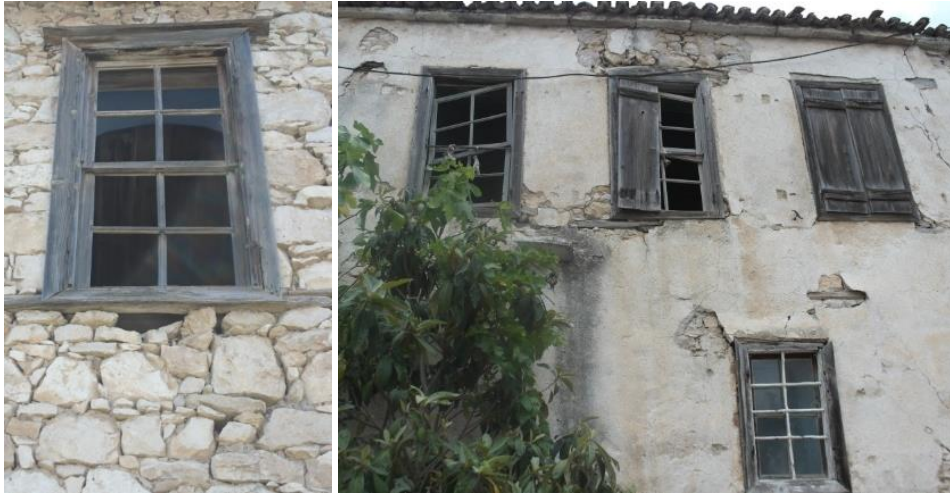
Figure 4.68. Sash Window Examples in Kösedere (June 2016).

Sash windows have been observed in both villages (Figure 4.68). They have one movable panel at the bottom and one fixed panel at the top. Panels are sub-divide horizontally and vertically with transoms. The panels fit to the wooden frame with hinges. It is seen that there are wooden window sills at the outside of the window. The windows have wooden shutters. (Drawing 4.16)

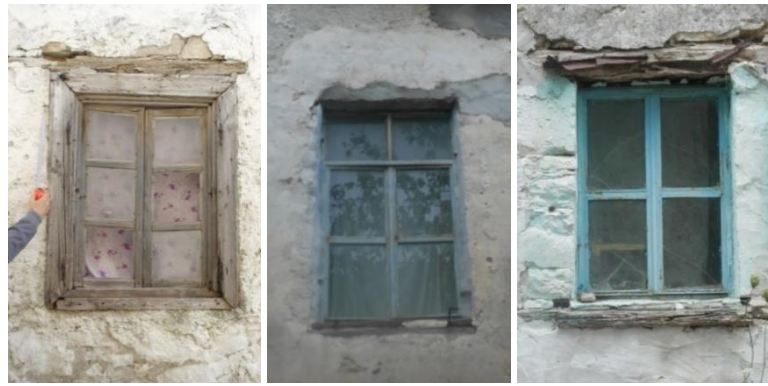
Figure 4.69. Double Casement Window Examples in Kösedere (June 2016).

Another window type is double casement window (Figure 4.69, 4.70). This is the most common type observed. They are inward opening type wood or metal windows. One of the examples has fixed glass top; the others have only two wings. Casements subdivide horizontally with transoms and they fit the frames with hinges. Windows located on the ground floor have balustrade and one of them in Kösedere has been more ornamented. Also, that window opening has fine cut stone window casing. Wooden windows have no color, but metal ones have painted blue in the village. (Drawing 4.17, 4.18, 4.19, 4.20)

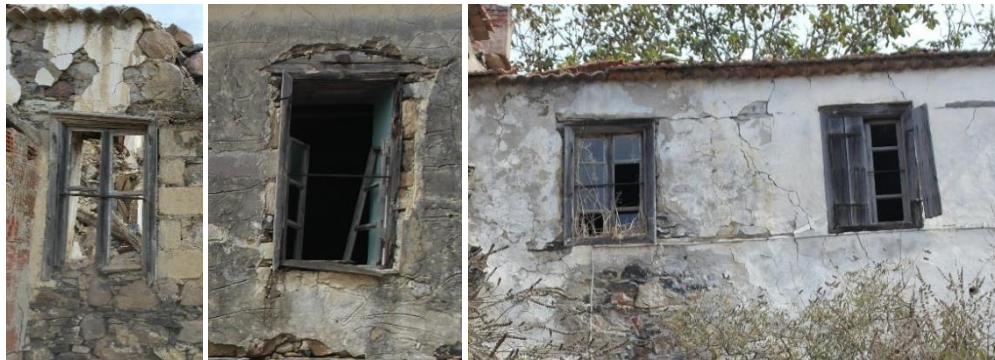
Figure 4.70. Double Casement Window Examples in Küçükbahçe (October 2016).

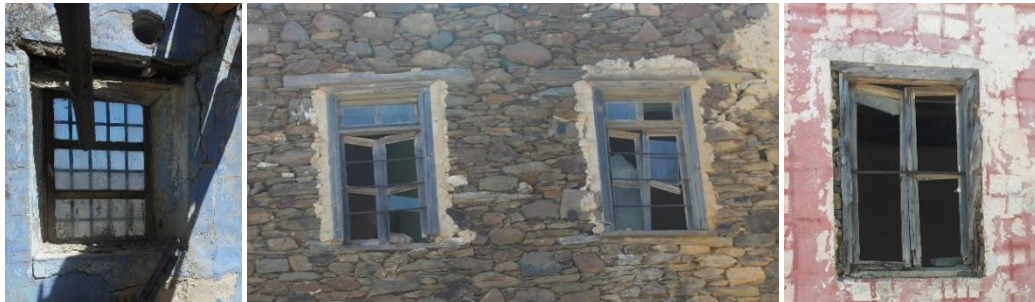
Figure 4.71. Window Examples in Salman (May 2017).

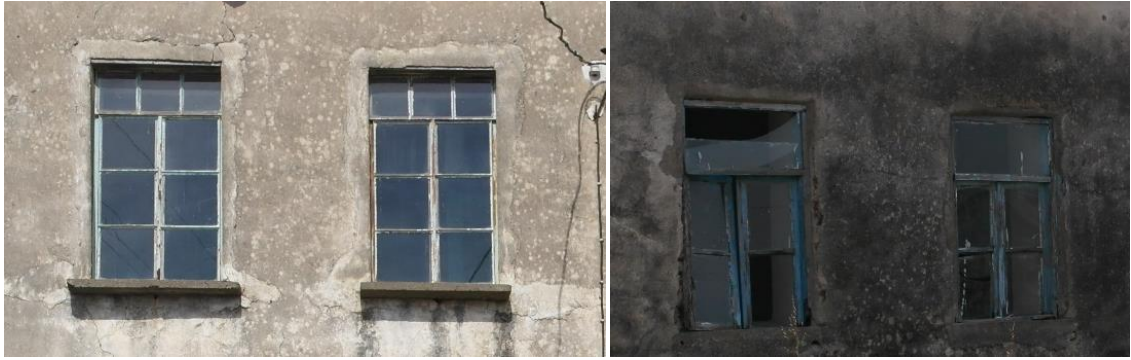
Figure 4.72. Window Examples in Salman (October 2016).
