**CONSTRUCTION TECHNIQUES
OF TRADITIONAL HOUSES
IN KARABURUN VILLAGES**

**A Thesis Submitted to
the Graduate School of Engineering and Sciences of
İzmir Institute of Technology
in Partial Fulfillment of the Requirements for the Degree of**

in Architectural Restoration

**by
Burçin GÖRÜR**

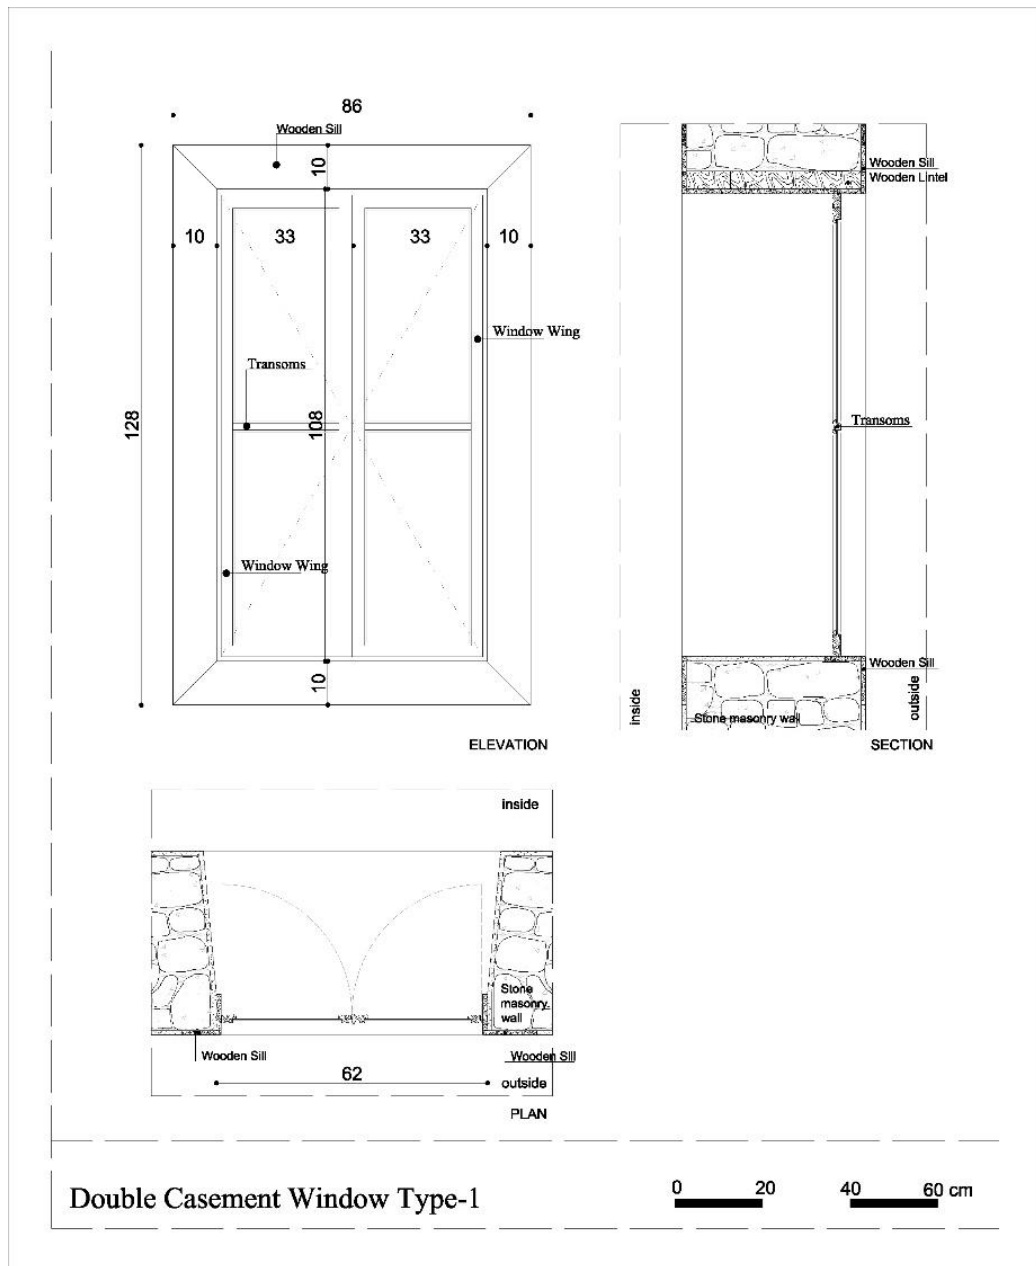
Drawing 4.17. Double Casement Window Type-1 Drawing.

Another window type is double casement window (Figure 4.69, 4.70). This is the most common type observed. They are inward opening type wood or metal windows. One of the examples has fixed glass top; the others have only two wings. Casements subdivide horizontally with transoms and they fit the frames with hinges. Windows located on the ground floor have balustrade and one of them in Kösedere has been more ornamented. Also, that window opening has fine cut stone window casing. Wooden windows have no color, but metal ones have painted blue in the village. (Drawing 4.17, 4.18, 4.19, 4.20)

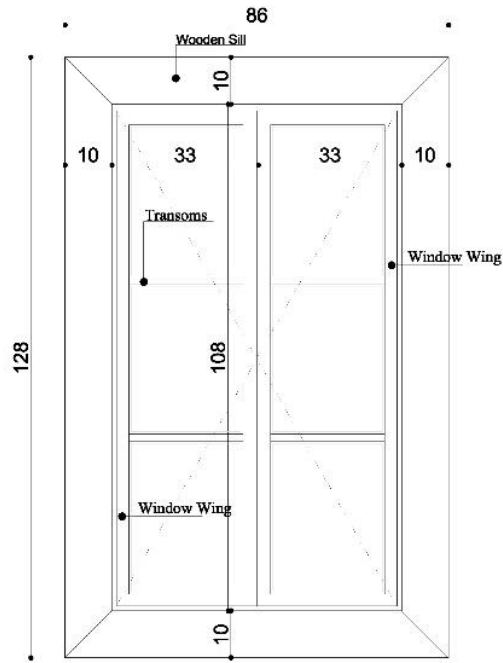
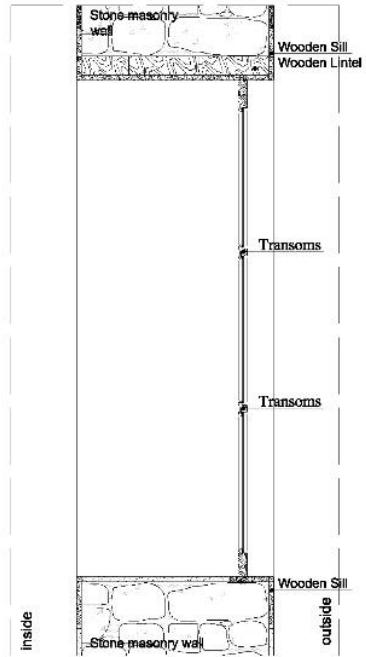
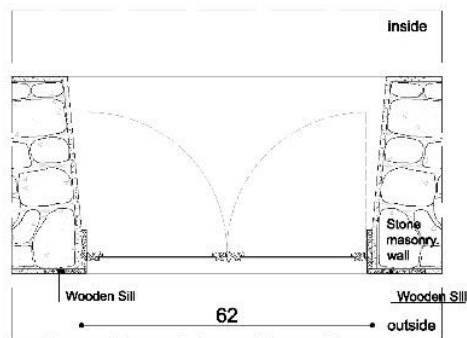
Double Casement Window Type-2

Drawing 4.18. Double Casement Window Type-2 Drawing.

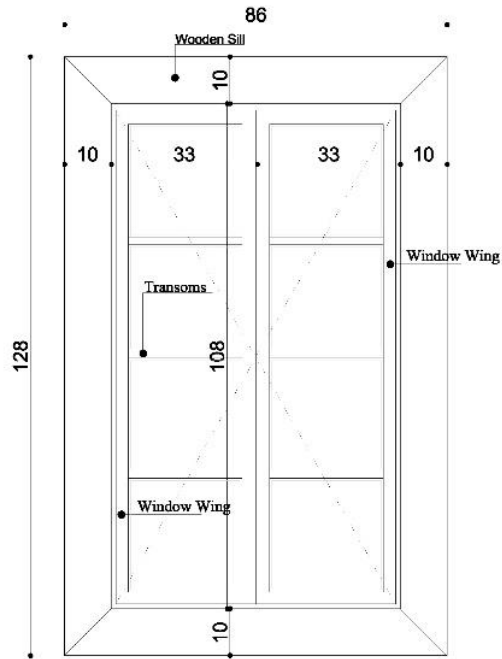
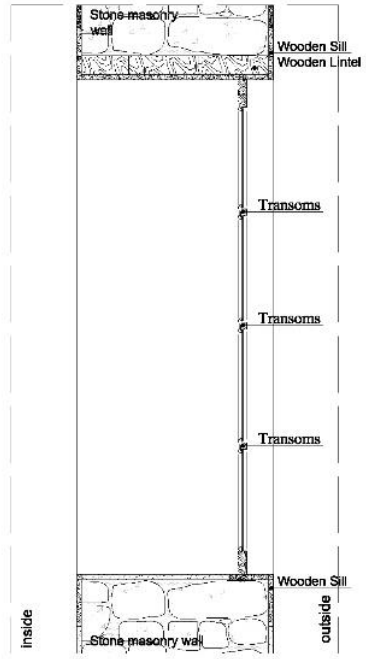
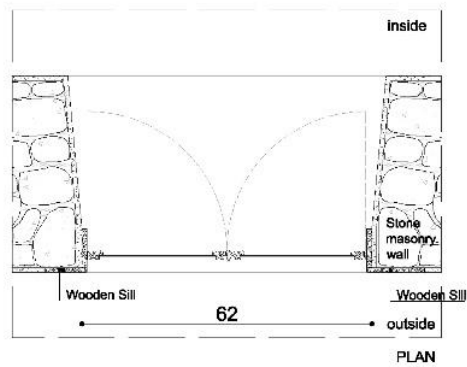
Double Casement Window Type-3

Drawing 4.19. Double Casement Window Type-3 Drawing.

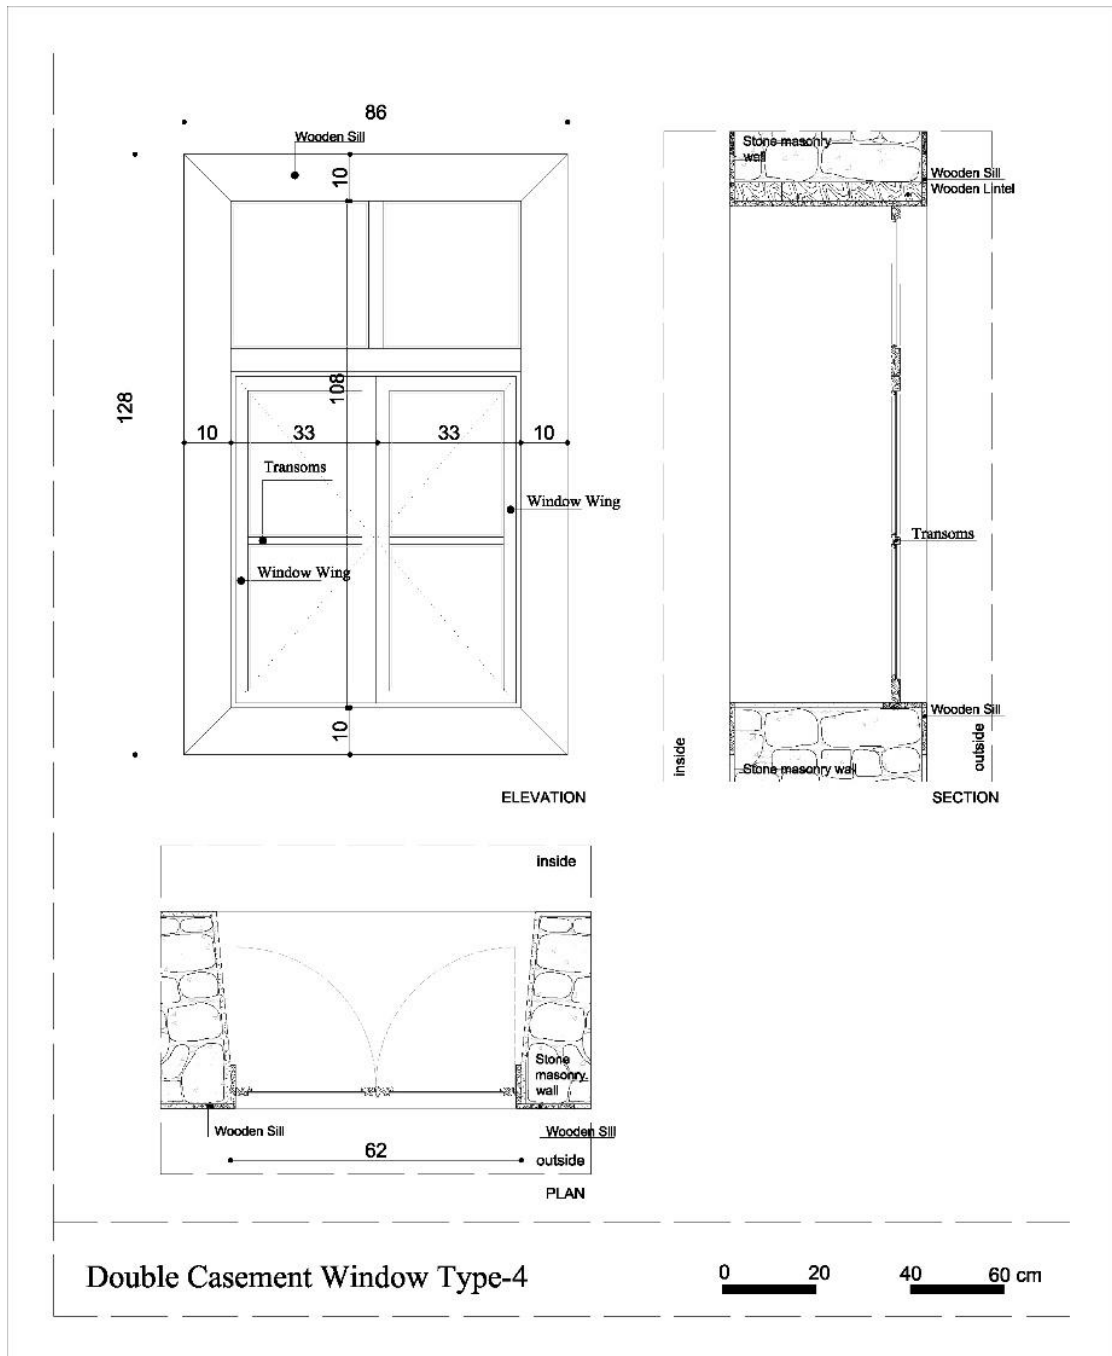
Drawing 4.20. Double Casement Window Type-4 Drawing.

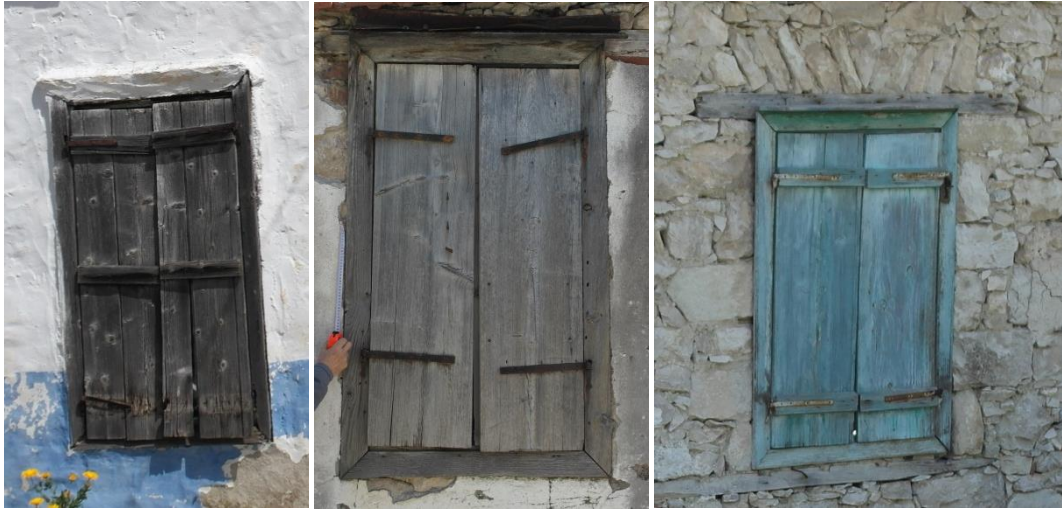
Figure 4.73. Shutters in Kösedere (June 2016).

The shutters are observed in both villages (Figure 4.73, 4.74). Their wings are made of 2- 2.5 cm wide timber elements. Then they nailed to 2 cm wide timber boards at the back side of the shutters and they hinged to the sills or they hold together by iron elements and directly hinged to sills. They are outward openings shutters. A few houses in İncelik and one house in Küçükbahçe have ornamented shutters (Figure 4.75, 4.76).

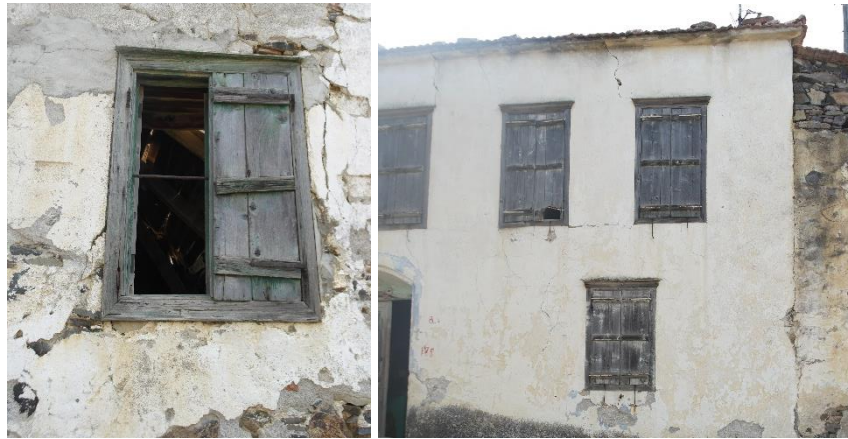
Figure 4.74. Shutter Examples in Küçükbahçe (October 2016).

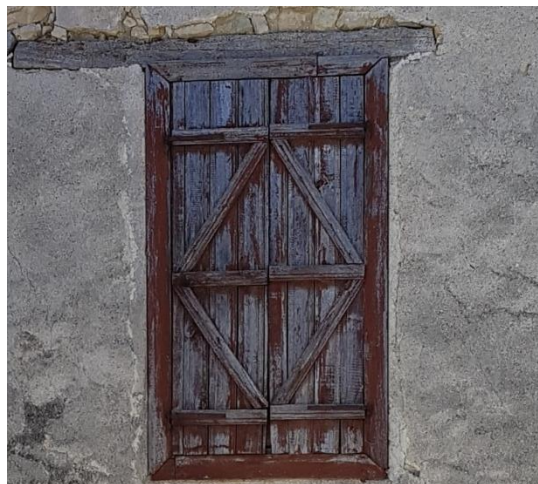
Figure 4.75. Shutters in İncecik (June 2016).

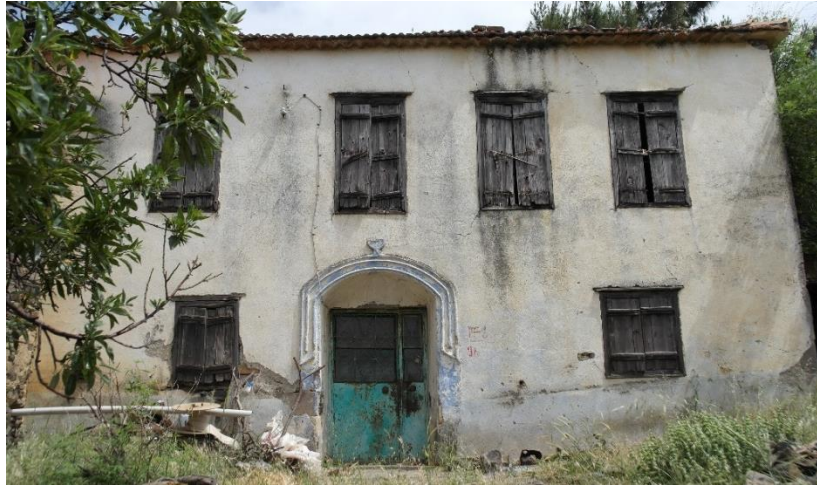
Figure 4.76. Shutter Examples in Küçükbahçe (April 2017).

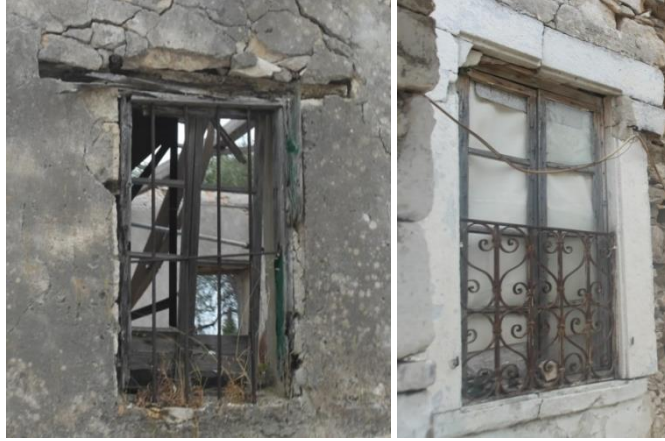
Windows located on the ground floor in Kösedere have balustrades and one of them has been more ornamented. Also, that window opening has shapely stone window casing (Figure 4.77). Wooden windows have no color, but metal ones have painted blue in the village.

Figure 4.77. Balustrades in Kösedere (June 2016).

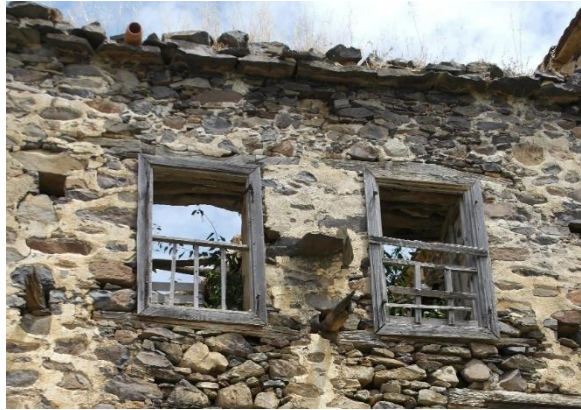
There is observed wooden balustrade in only one structure in Küçükbahçe (Figure 4.78). Its height is half of the window height. They composed of horizontal guardrail and vertical studs stick to guardrail. They have rectangular cross-section. Wooden balustrades have been also observed in İncik among east zone (Figure 4.79).

Figure 4.78. Wooden balustrade example in Küçükbahçe (April 2017).

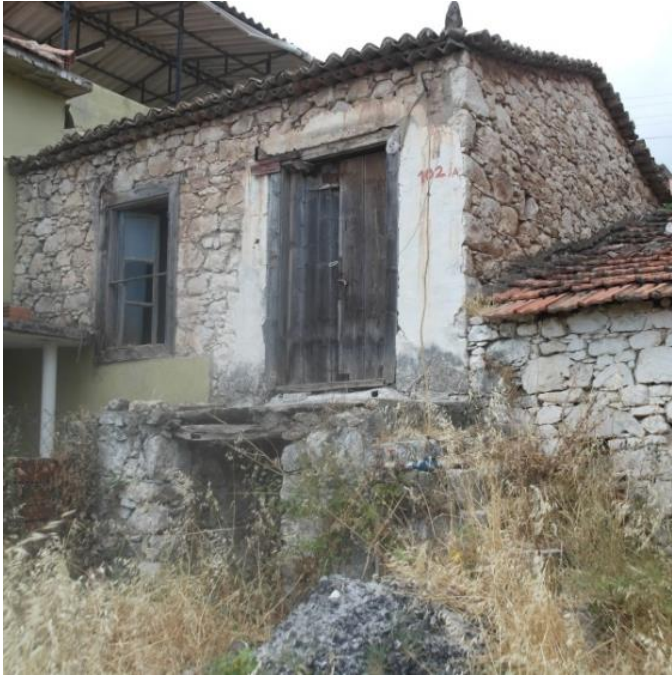
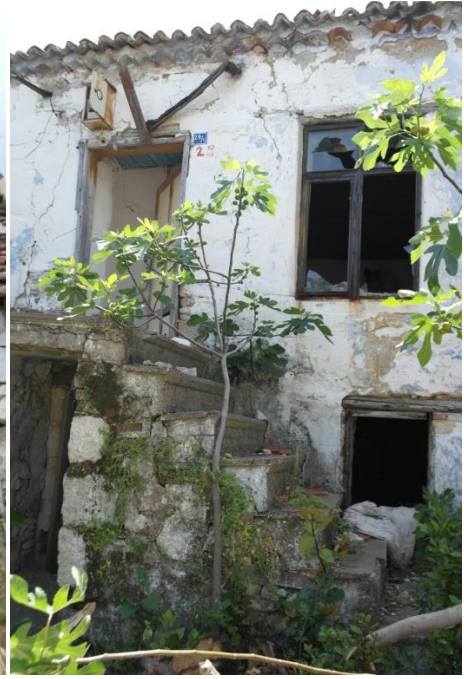
Figure 4.80. Stone Stair in Kösedere (a) (June 2016) in Ambarseki (b) (May 2017).

In the stone masonry stairs, rounded rubble stones and mud mortar are used in Kösedere (Figure 4.80) and thin, flat and gray-black color stones and mud mortar are used in Küçükbahçe (Figure 4.81, 4.82, 4.83). The stairs width generally changes between 80 and 140 cm, the width of steps between 25 and 50 cm, height of the step risers between 17 and 25 cm. (Drawing 4.23)

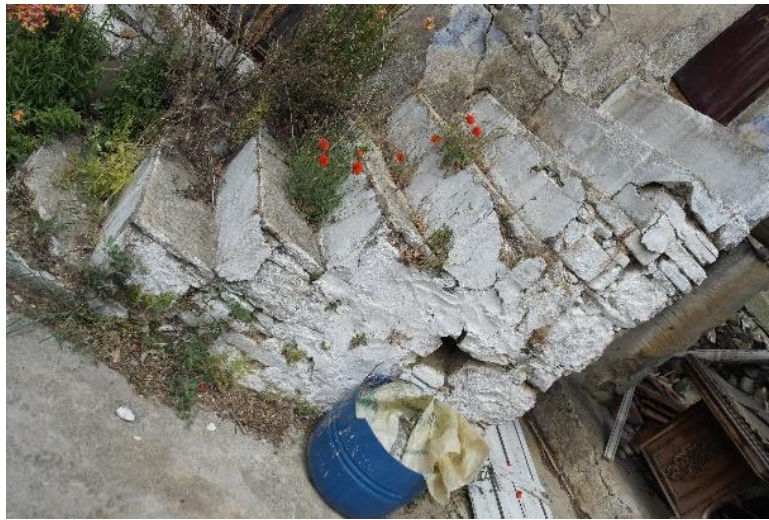
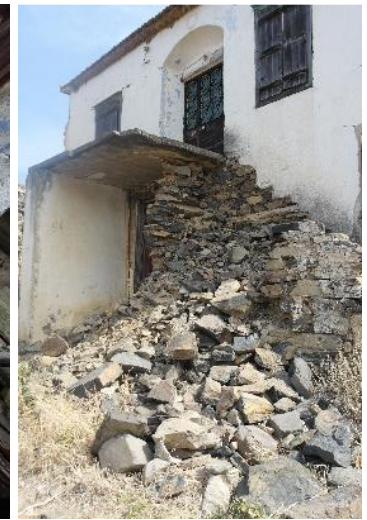
Figure 4.81. Stone Stair Examples in Küçükbahçe (April 2017).

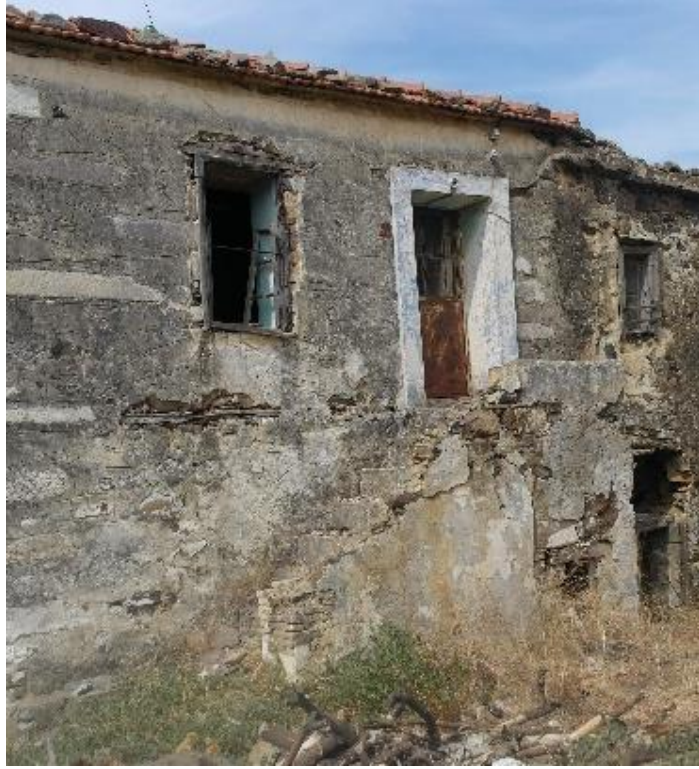
Figure 4.82. Stone Stair Parapet Wall Example in Küçükbahçe (April 2017).

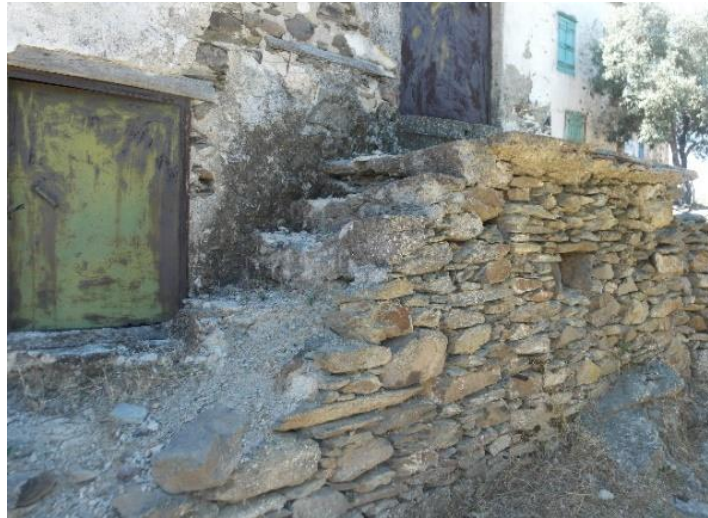
Figure 4.83. Stone Stair Examples in Salman (May 2017).

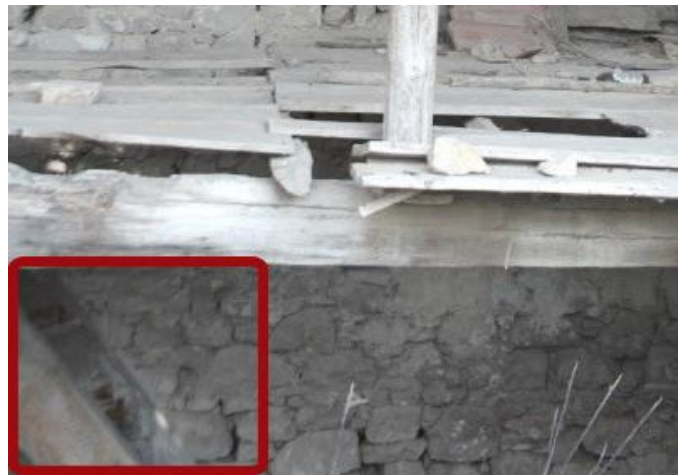
Figure 4.84. The Only Timber Stair Observed in Kösedere (June 2016).

Only one timber stair observed in Kösedere (Figure 4.84). However the other villages have timber stair examples around the peninsula (Figure 4.85, 4.86, 4.87, 4.88) The stairs width changes between 70 and 100 cm, the width of steps between 20 and 27 cm, height of risers between 15 and 26 cm. Stairs have been constructed using solid timber

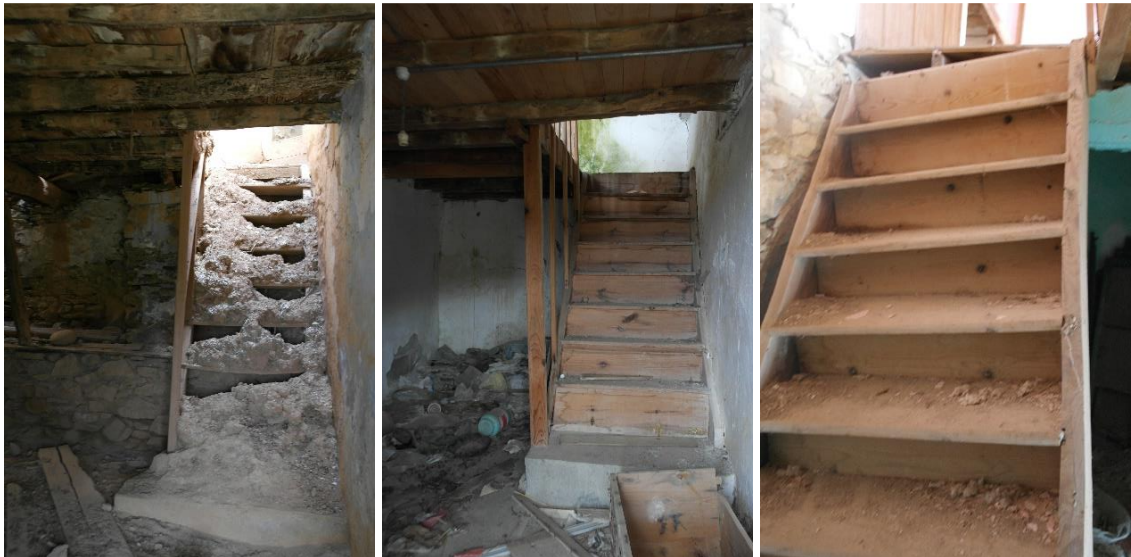
Figure 4.85. Timber Stair Examples in Küçükbahçe (June 2017).

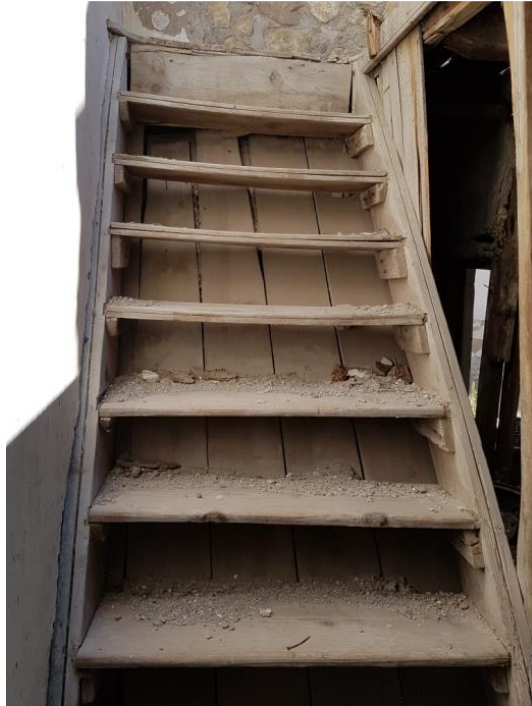
Figure 4.86. Timber Stair Example in İncik (June 2017)

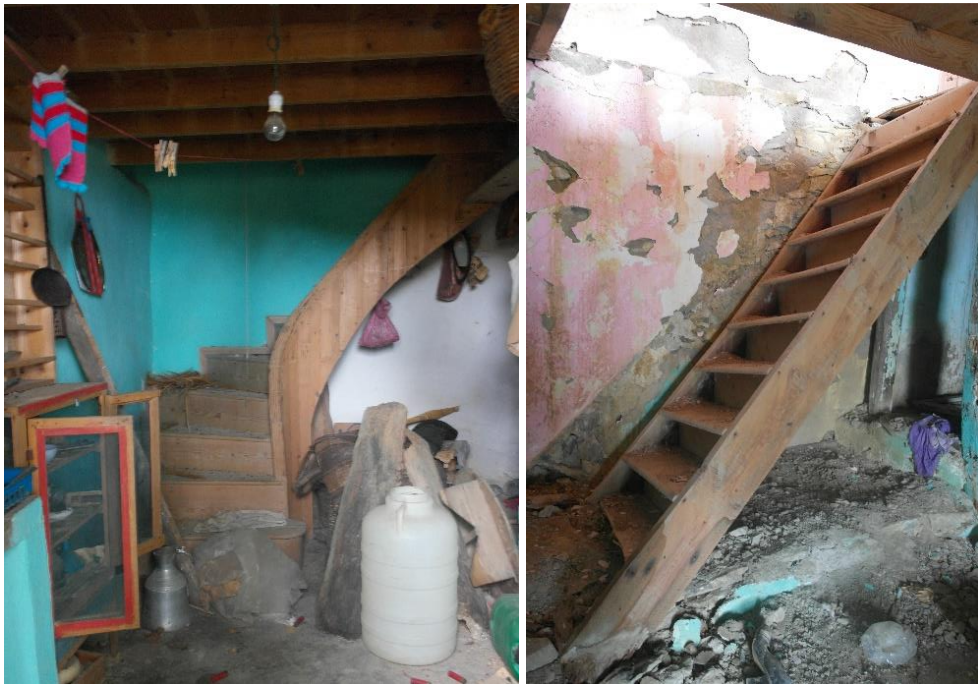
Figure 4.87. Timber Stair Examples in Küçükbahçe (November 2014)

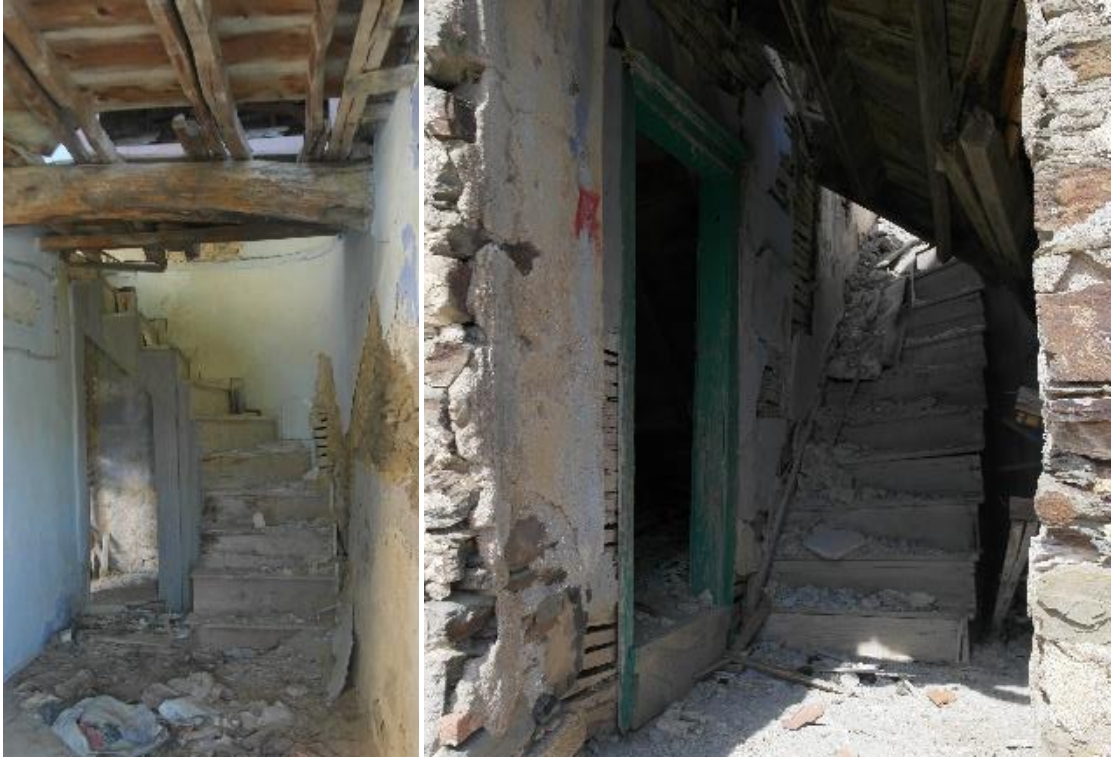
Figure 4.88. Timber Stair Examples in Salman (May 2017).

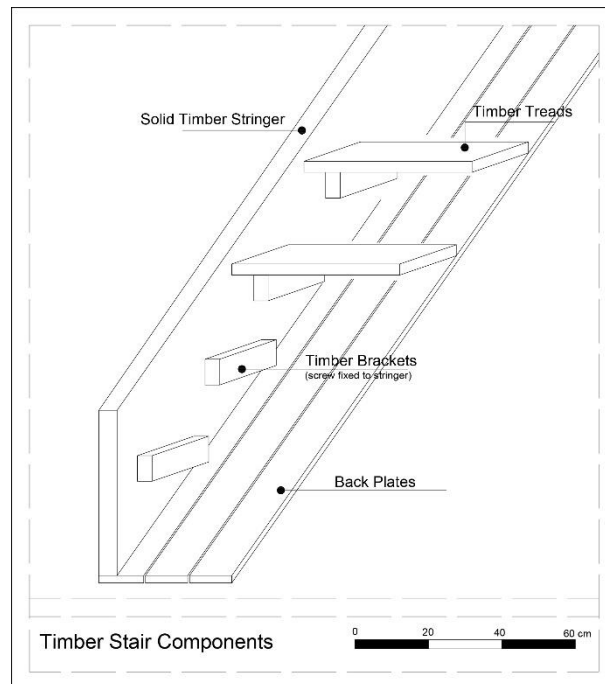
Drawing 4.24. Timber Stair Components.

stringers as support for the treads and risers. The treads are placed on the stringer and held in place by wedges. If the stair has been built between wall and stringer, in this case the stringer is attached to the wall and transfers the stair load directly to the wall. Handrails have square or rectangular cross-section of 3-6 cm, have been placed and nailed on balusters and between newels. Handrail height changes between 60 and 80 cm. In the cases where one side of the staircase is adjacent to the wall, newels and balusters are used on one side only. (Drawing 4.24, 4.25)

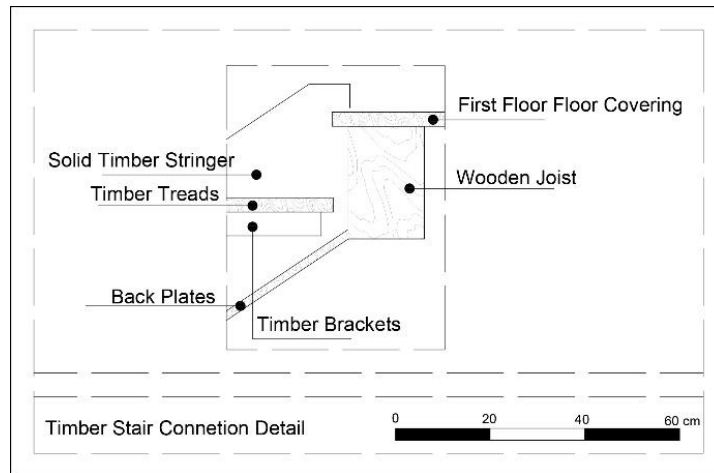
Drawing 4.25. Timber Stair Connection Detail to the Upper Floor.

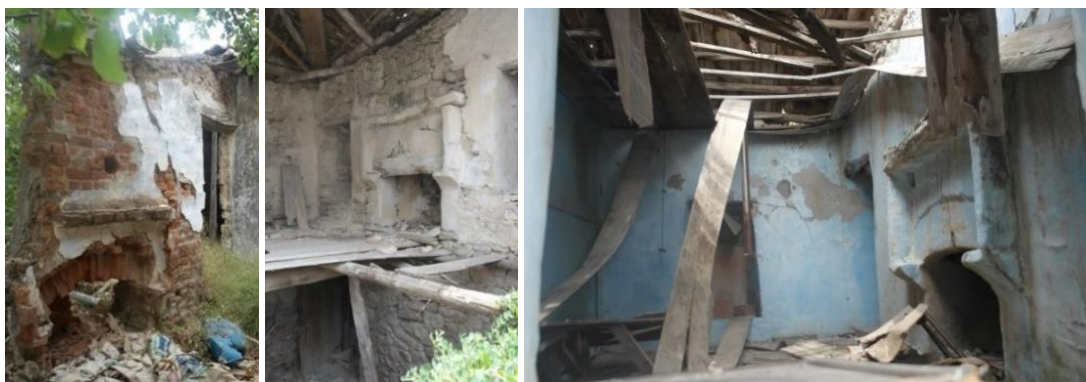
Figure 4.89 Fireplace Examples in Kösedere (June 2016).

Fireplaces have been composed of two parts where the fire is placed, and smoke is discharged. First part is the main area where fire is found inside the wall. The niche is rounded or has rectangular surfaces. It is observed that depressed arch or flat wooden lintels have been used for spanning the opening. The interior faces of this space have been covered by mud mortar. In the examples, lime plaster traces have been observed. (Figure 4.89, 4.90, 4.91, 4.92, 4.93)

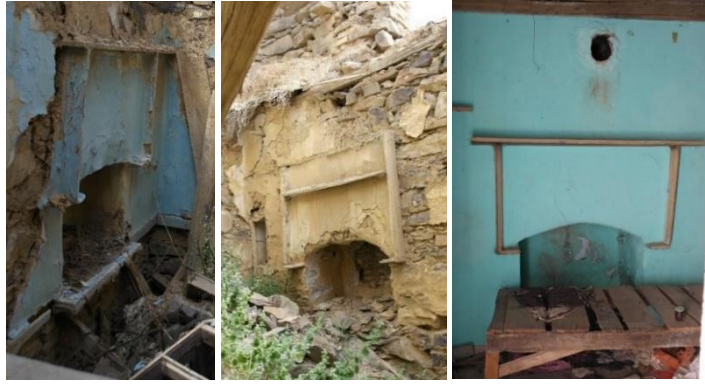
Figure 4.90. Fireplace Examples in Küçükbahçe (April 2017).

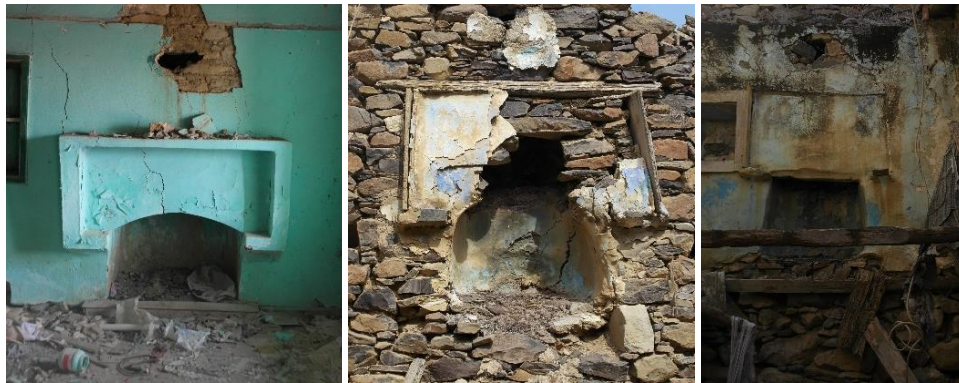
Figure 4.91. Fireplace Examples in Küçükbahçe (October 2016).

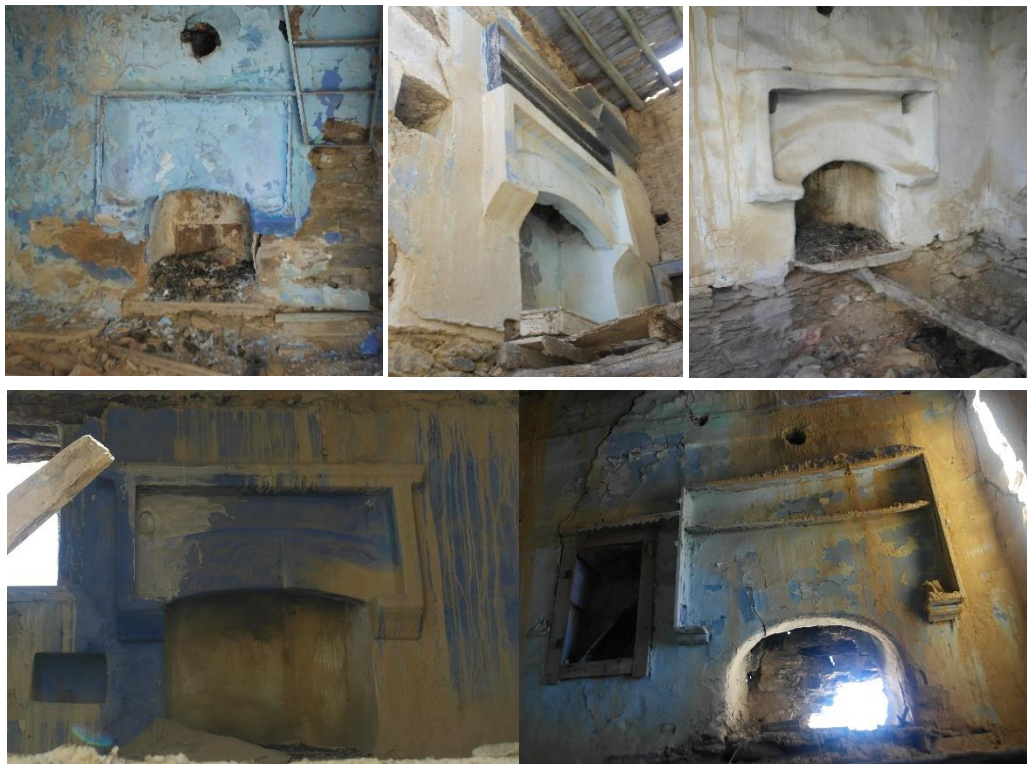
Figure 4.92. Fireplace Examples in Salman (May 2017).

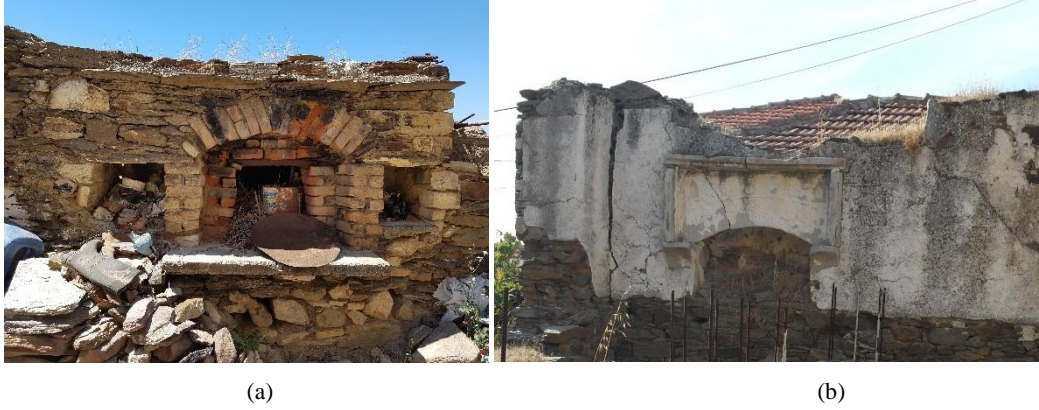
Figure 4.93. Fireplace Examples in (a) Haseki (June 2017), (b) Sarpıncık (October 2016).

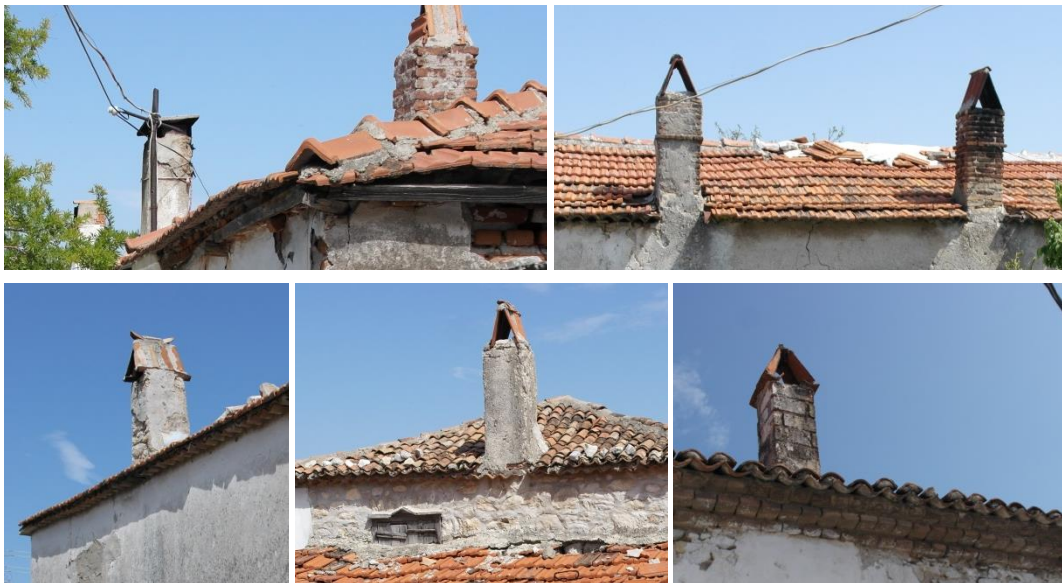
Figure 4.94. Chimney Examples in Kösedere (June 2016).

The other part is used for the collection and discharge of smoke. This system has a section, narrowing from the smoke collection area to the discharge point. The upper part of the system projected from the roof level; almost 40-50 cm. It is observed that they have been built by stone or brick. It is known that the interior faces of these parts are unplastered, and the main structure can be read. Chimneys have been covered by tiles in two directions on the top as cap. It is good for protection against heavy rainfalls in the region and wind blow from different directions. In some examples, there are different application on chimney as a capping for protection against heavy rainfalls in the region and wind blow from different directions in Küçükbağçe. (Figure 4.94, 4.95, 4.96, 4.97)

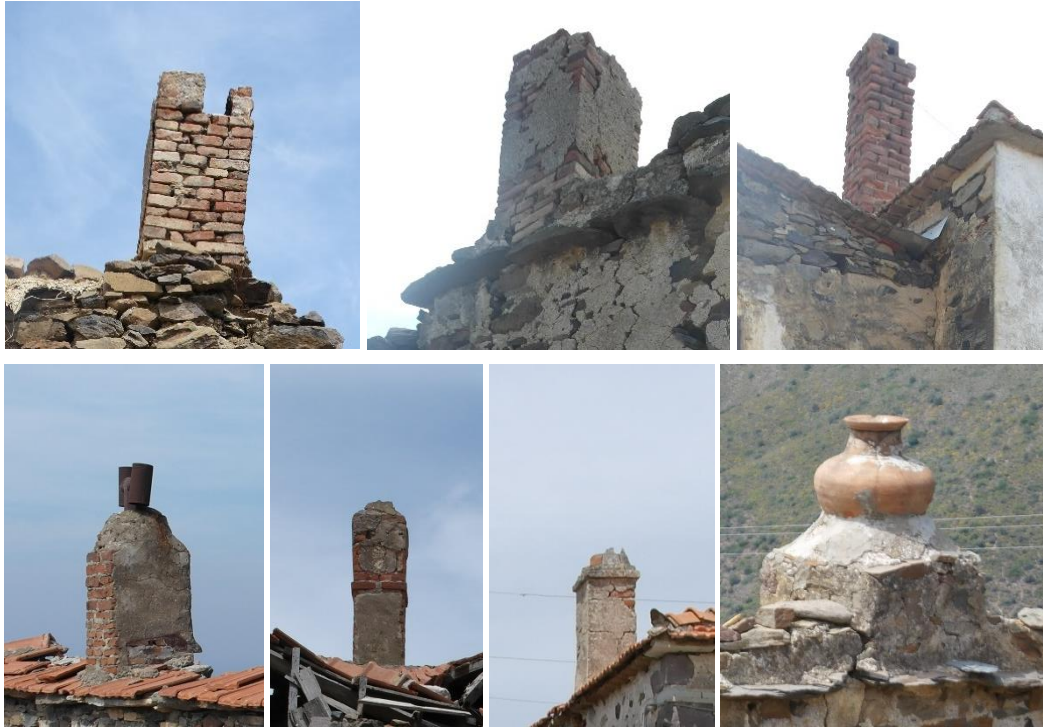
Figure 4.95. Chimney Examples in Küçükbahçe (April 2017).

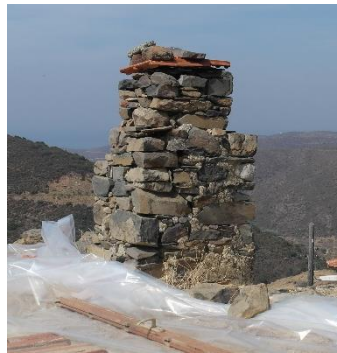
Figure 4.96. Chimney Examples in Küçükbahçe (October 2016).

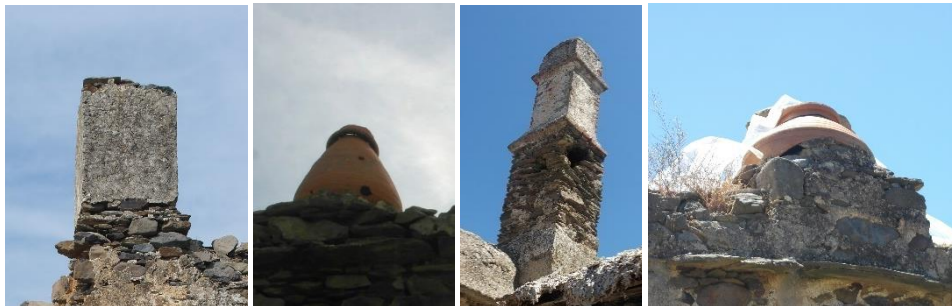
Figure 4.97. Chimney Examples in Salman (May 2017).

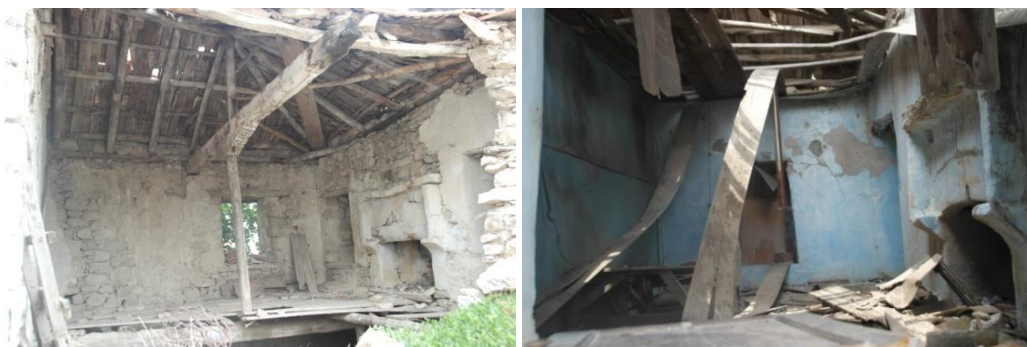
Figure 4.98. Niche Examples in Kösedere (June 2016).

Niches usually exist in the walls where the fireplace takes place. Similar to the door or window openings in stone masonry walls; the openings of niches are formed by using wooden lintels. Their sizes are almost same with window openings; they change between 60 to 90 cm horizontally and 50 to 100 or 100 to 160 cm vertically. Some of the niches have a shelf in the middle; and some of them have wooden shutters. The interior surface of the niches is plastered and painted or covered by timber boards. (Figure 4.98, 4.99, 4.100, 4.101) (Drawing 4.27, 4.28)

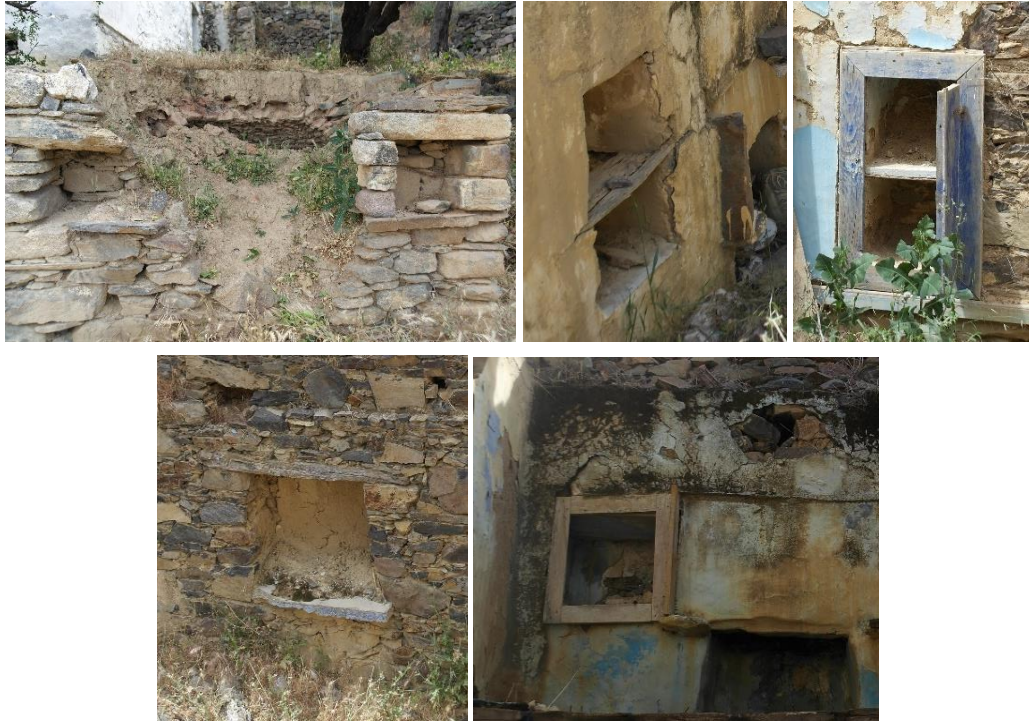
Figure 4.99. Niche Examples in Küçükbahçe (April 2017).

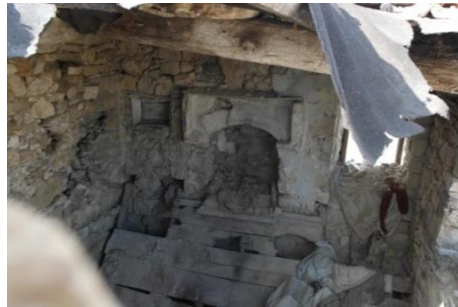
Figure 4.100. Niche Example in Eğlenhoca (October 2016).

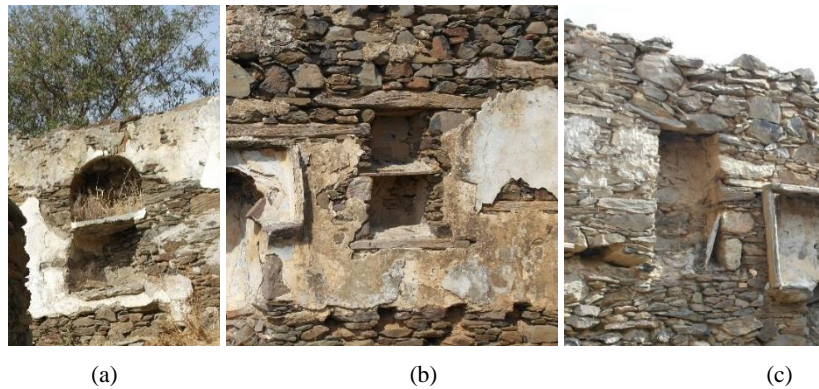
Figure 4.101. Niche Examples in (a) Sarpıncık (October 2016), (b-c) Salman (October 2016).

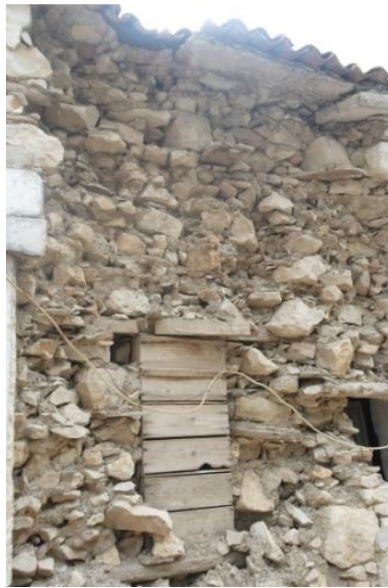
Figure 4.102. Example of Cupboard Placed in a Niche; View of Back Side (June 2016).

Cupboards are placed on both the ground and the upper floor walls. They are formed by using wooden panels. They are shaped rectangular prism that has two vertical sides and horizontal wooden plates. Shelves are altered about 60 to 90 centimeters. The width of the horizontal plate is mostly around 40 to 60 centimeters. The height changes between 40-120 centimeters when the cupboards are placed on the wall; the height is equal to the dimensions of the niches when they are in the niches. They have 35-40 centimeters depth. (Figure 4.102, 4.103, 4.104, 4.105, 4.106)

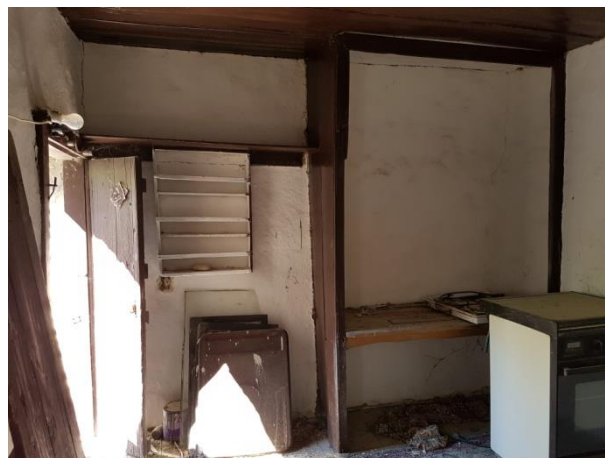
Figure 4.103. Example of Cupboard in İncelik; (June 2017).

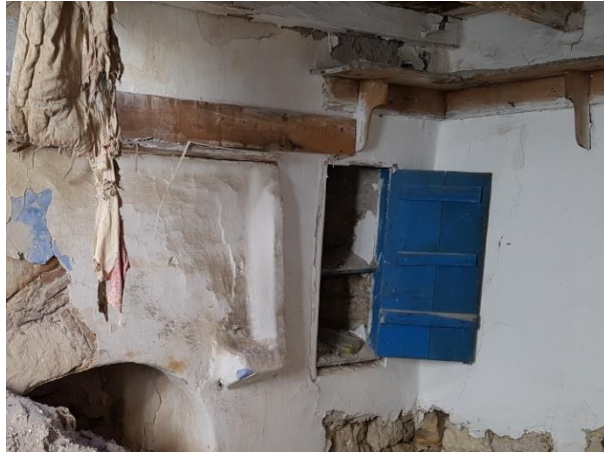
Figure 4.104. Cupboard example in İncik (June 2017).

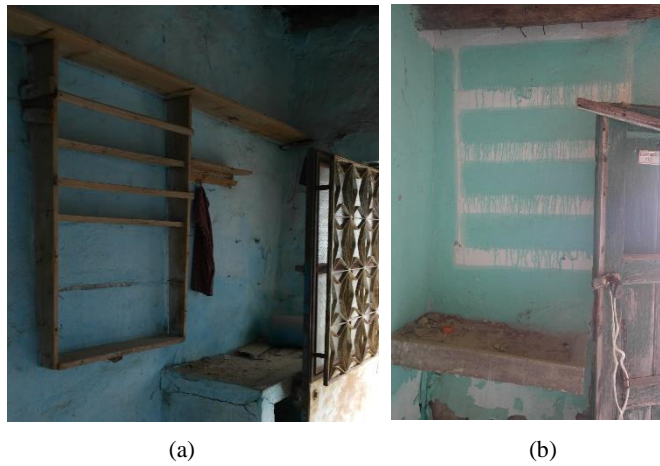
Figure 4.105. Cupboard example in (a) Küçükbahçe (April 2017), (b) Cupboard trace in Küçükbahçe (October 2016).

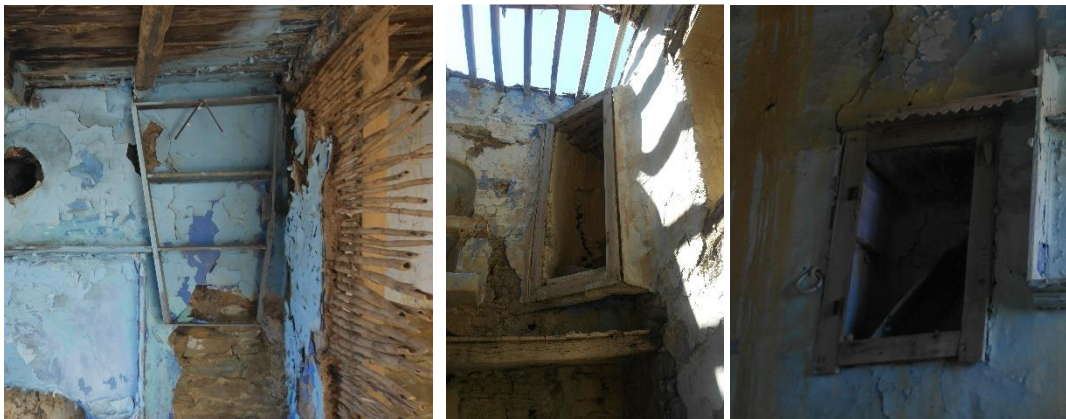
Figure 4.106. Cupboard Examples in Salman (May 2017).

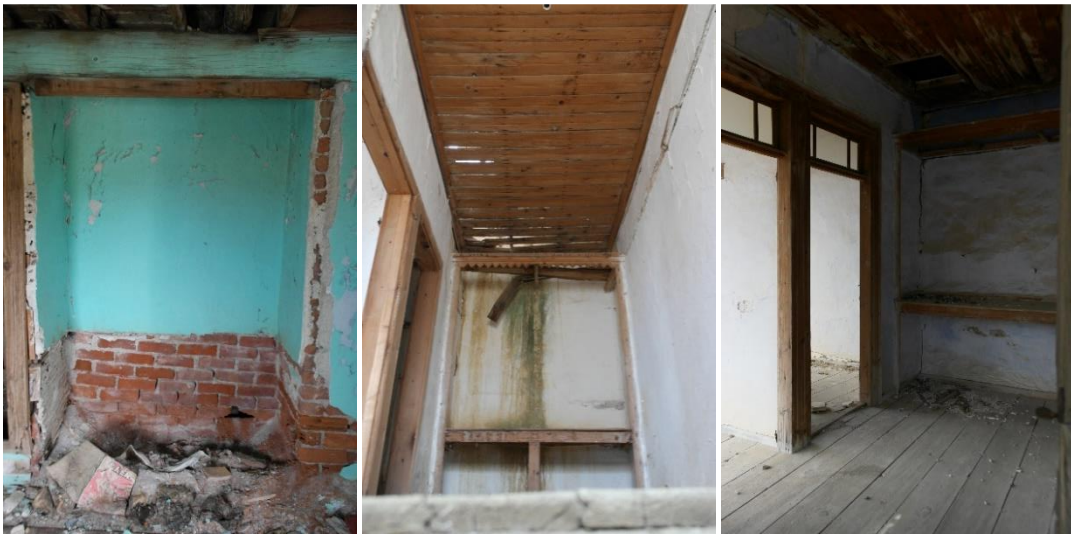
Figure 4.107. Closet Examples in Küçükbahçe (April 2017).

Three closets have been observed in Küçükbahçe (Figure 4.107). One of them is located in the ground floor, and the others are located in the first floor. Their depth changes between 65 and 75 cm. The closet where is located in the ground floor is built by brick. It has timber sill around it and the surfaces are covered with mud-mortar and lime-washed. Other two closets are located in the corridor in the first floor and they use for the storage for mostly bedding staffs. They have timber board elevated almost 70 cm from the ground. It is called as 'yükçük' in Turkish.

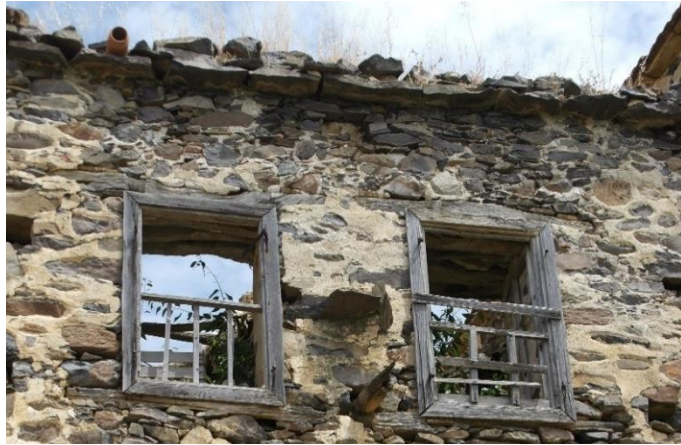
Figure 4.108. The only luminary in Küçükbahçe (April 2017)

They were used for the lightening the roads; when there was no electricity in the village. Because of that, they are located on the street facades of the houses. Luminaries are formed by flat stones extending from the masonry walls. Locations of the luminaries on the masonry wall diversify. Most of them are located between ground and first floors. One of them is located bottom sides of the wall; close to the ground and one of them located at the middle of the first-floor level. It is important that they are easily accessible in any cases. (Figure 4.108, 4.109, 4.110) (Drawing 4.29)
