**CONSTRUCTION TECHNIQUES
OF TRADITIONAL HOUSES
IN KARABURUN VILLAGES**

**A Thesis Submitted to
the Graduate School of Engineering and Sciences of
İzmir Institute of Technology
in Partial Fulfillment of the Requirements for the Degree of**

in Architectural Restoration

**by
Burçin GÖRÜR**

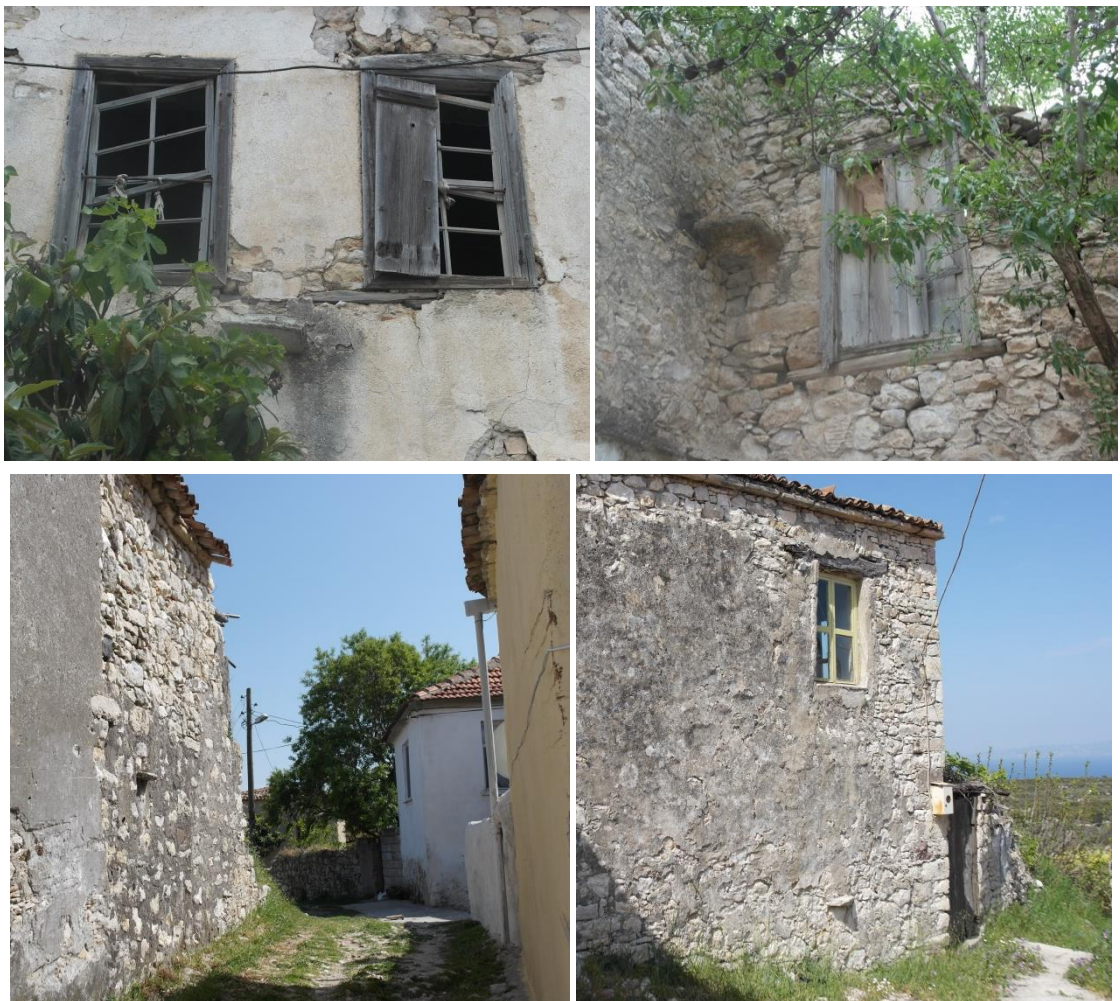
Figure 4.109. Luminaries in Kösedere (June 2016)

They were used for the lightening the roads; when there was no electricity in the village. Because of that, they are located on the street facades of the houses. Luminaries are formed by flat stones extending from the masonry walls. Locations of the luminaries on the masonry wall diversify. Most of them are located between ground and first floors. One of them is located bottom sides of the wall; close to the ground and one of them located at the middle of the first-floor level. It is important that they are easily accessible in any cases. (Figure 4.108, 4.109, 4.110) (Drawing 4.29)

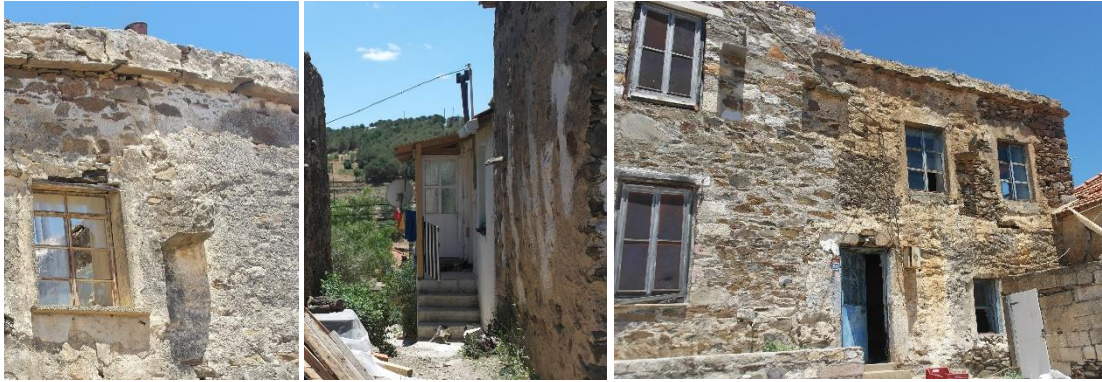
Figure 4.110. Luminary Examples in Parlak (May 2017).

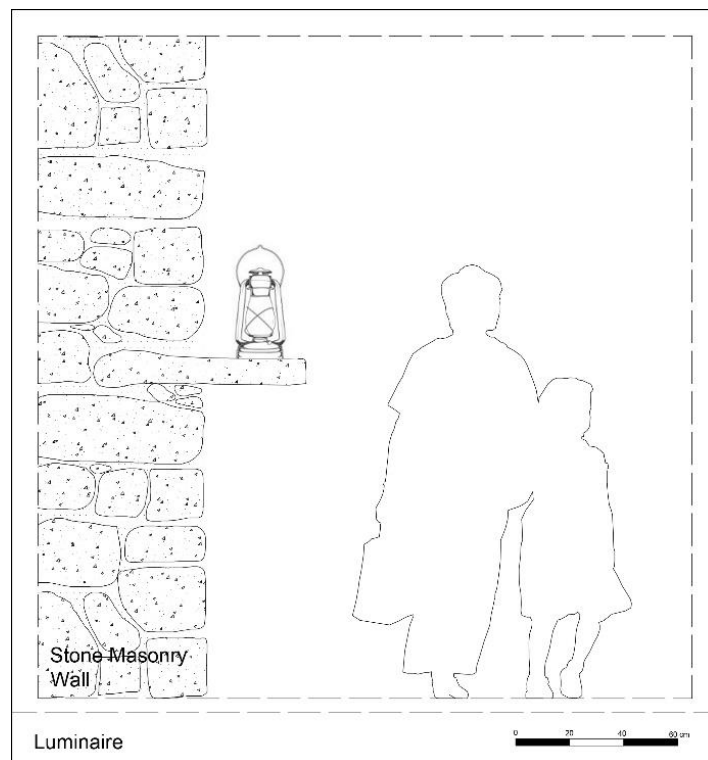
Drawing 4.29. Drawing of the Luminaire.

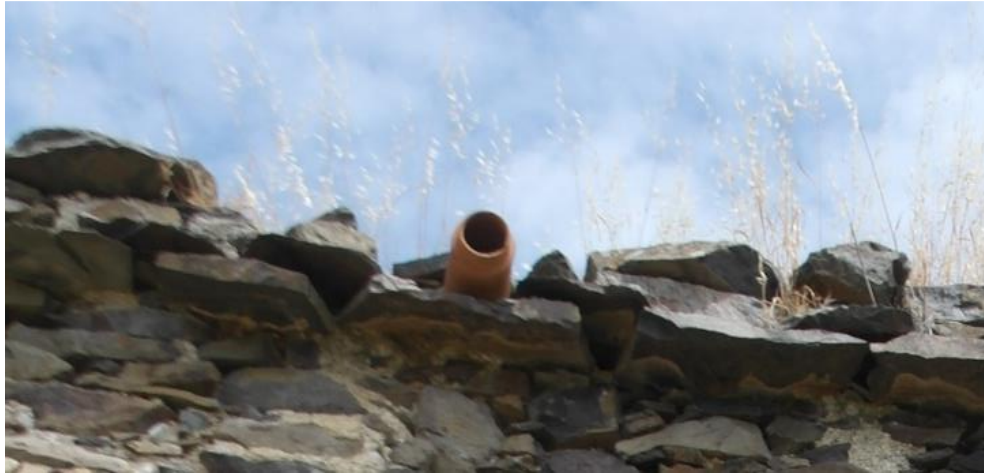
Figure 4.111. Waterspout in Küçükbahçe (April 2017).

Waterspouts are observed in west zone villages. Only one waterspout is observed in Küçükbahçe (Figure 4.111). They are used for removing rain water from flat roof to prevent penetrate water to walls. It is made by terra-cotta. They have circular-section. (Figure 4.112, 4.113, 4.114) (Drawing 4.30)

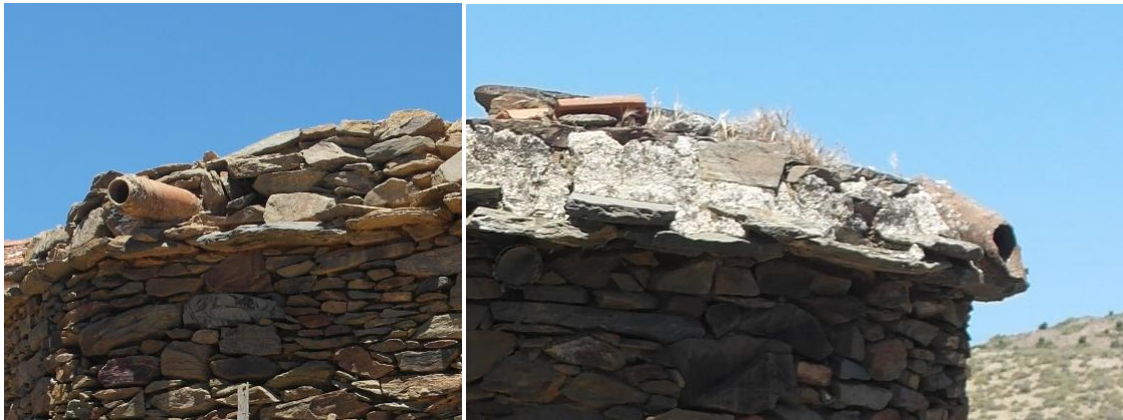
Figure 4.112. Waterspout Examples in Parlak (May 2017).

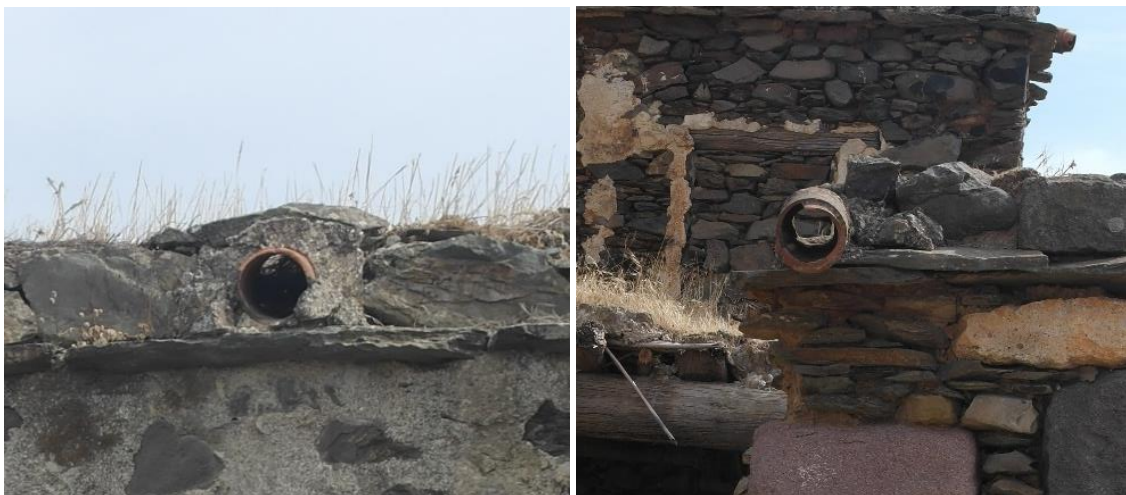
Figure 4.113. Waterspout Examples in Salman (October 2016).

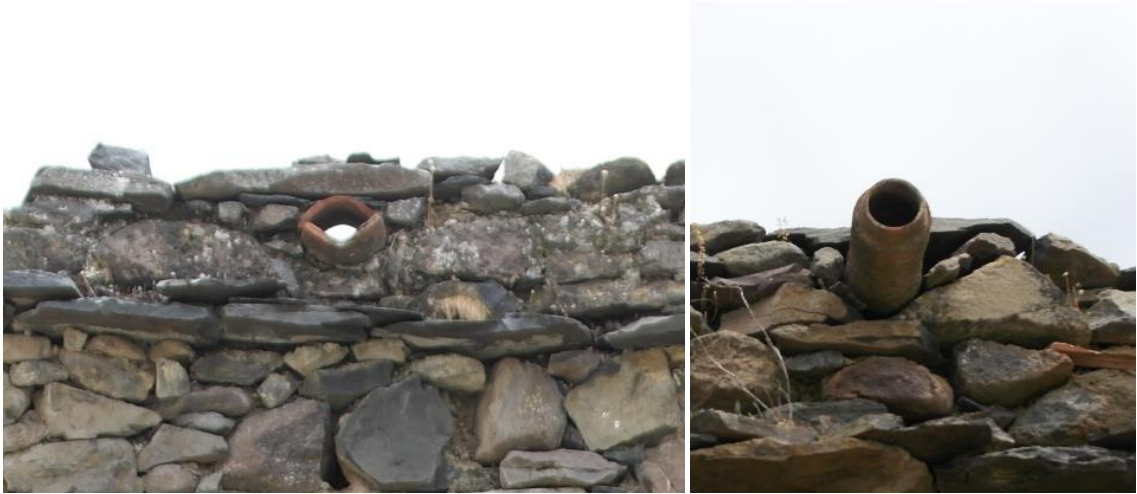
Figure 4.114. Waterspout Examples in Yayla (April 2017).

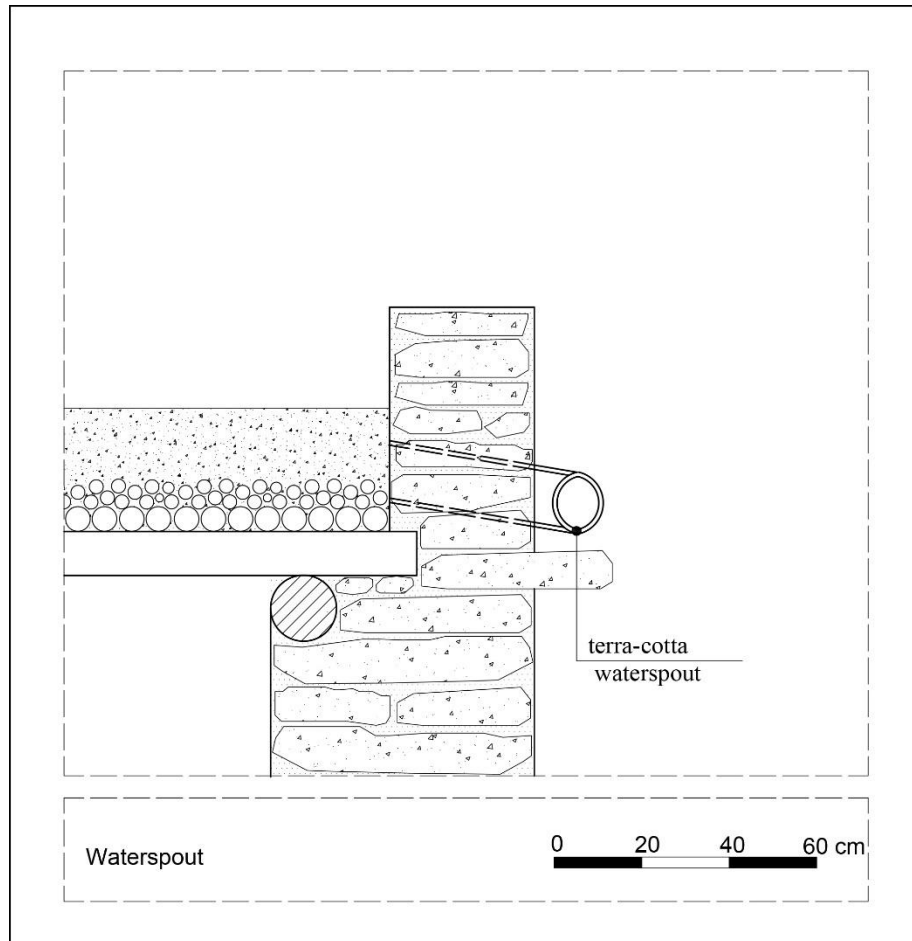
Drawing 4.30. Waterspout Drawing.
