**ARCHIVING OF THE CONSERVATION DATA OF  
IMMOVABLE CULTURAL ASSETS DATING TO  
1300-1600 IN URLA CENTER USING GIS**

**A Thesis Submitted to  
the Graduate School of Engineering and Sciences of  
İzmir Institute of Technology  
in Partial Fulfillment of the Requirements for the Degree of**

**in Architectural Restoration**

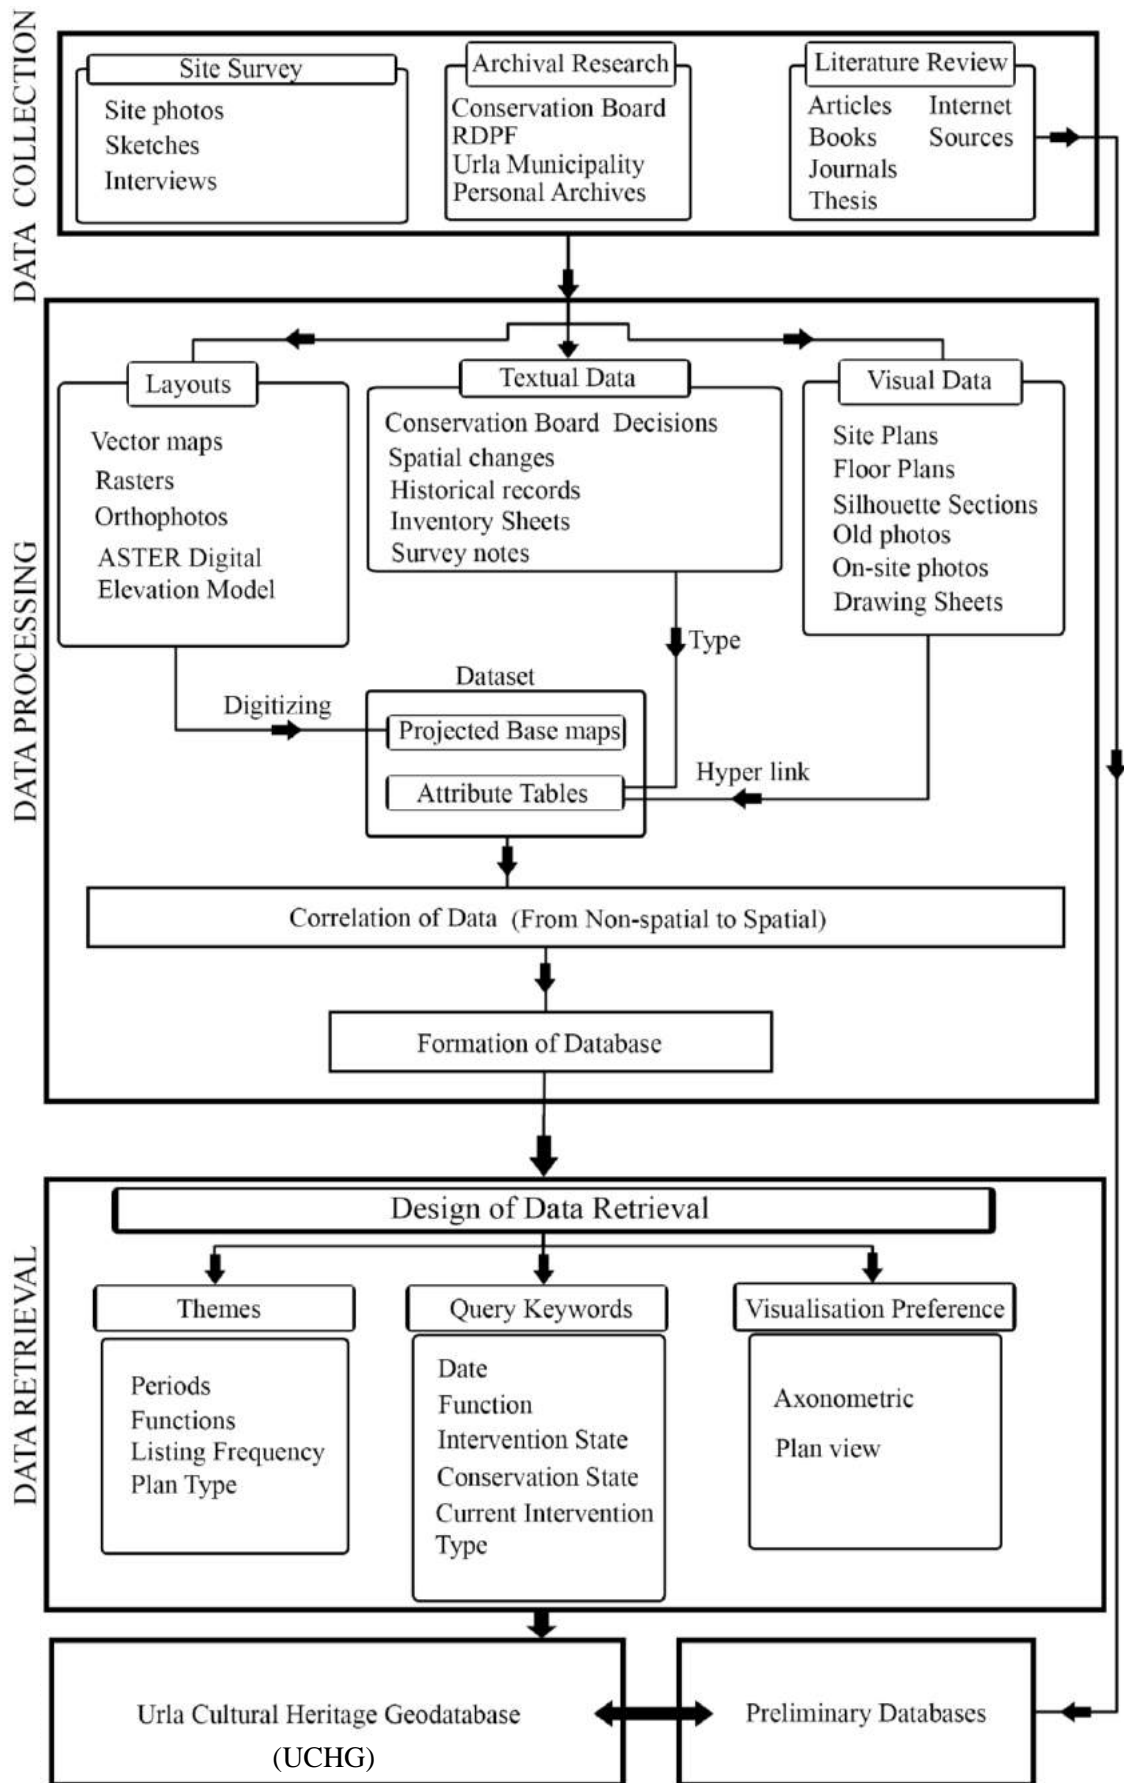
Figure 1.1. Diagram of data collection, processing and retrieval process

All this comprehensive data comprises of layouts, textual data, and visual data (Figure 1.1). Layouts consist of vector maps, rasters, orthophotos, and ASTER Digital Elevation Model (DEM) (Figure 1.2). Textual data consists of Conservation Board Decisions, spatial changes, historical records (construction date, listing date, and intervention date), inventory sheets, and survey notes. Visual data consists of site plans, floor plans, silhouette sections, old photos, on-site photos, and drawing sheets. Several softwares are required to use for geodatabase construction such as Autodesk AutoCAD, Adobe Photoshop, Microsoft Excel, 3D Map Generator Terrain, Global Mapper, ArcGIS ArcMap, and ArcGIS ArcScene softwares are utilized frequently.

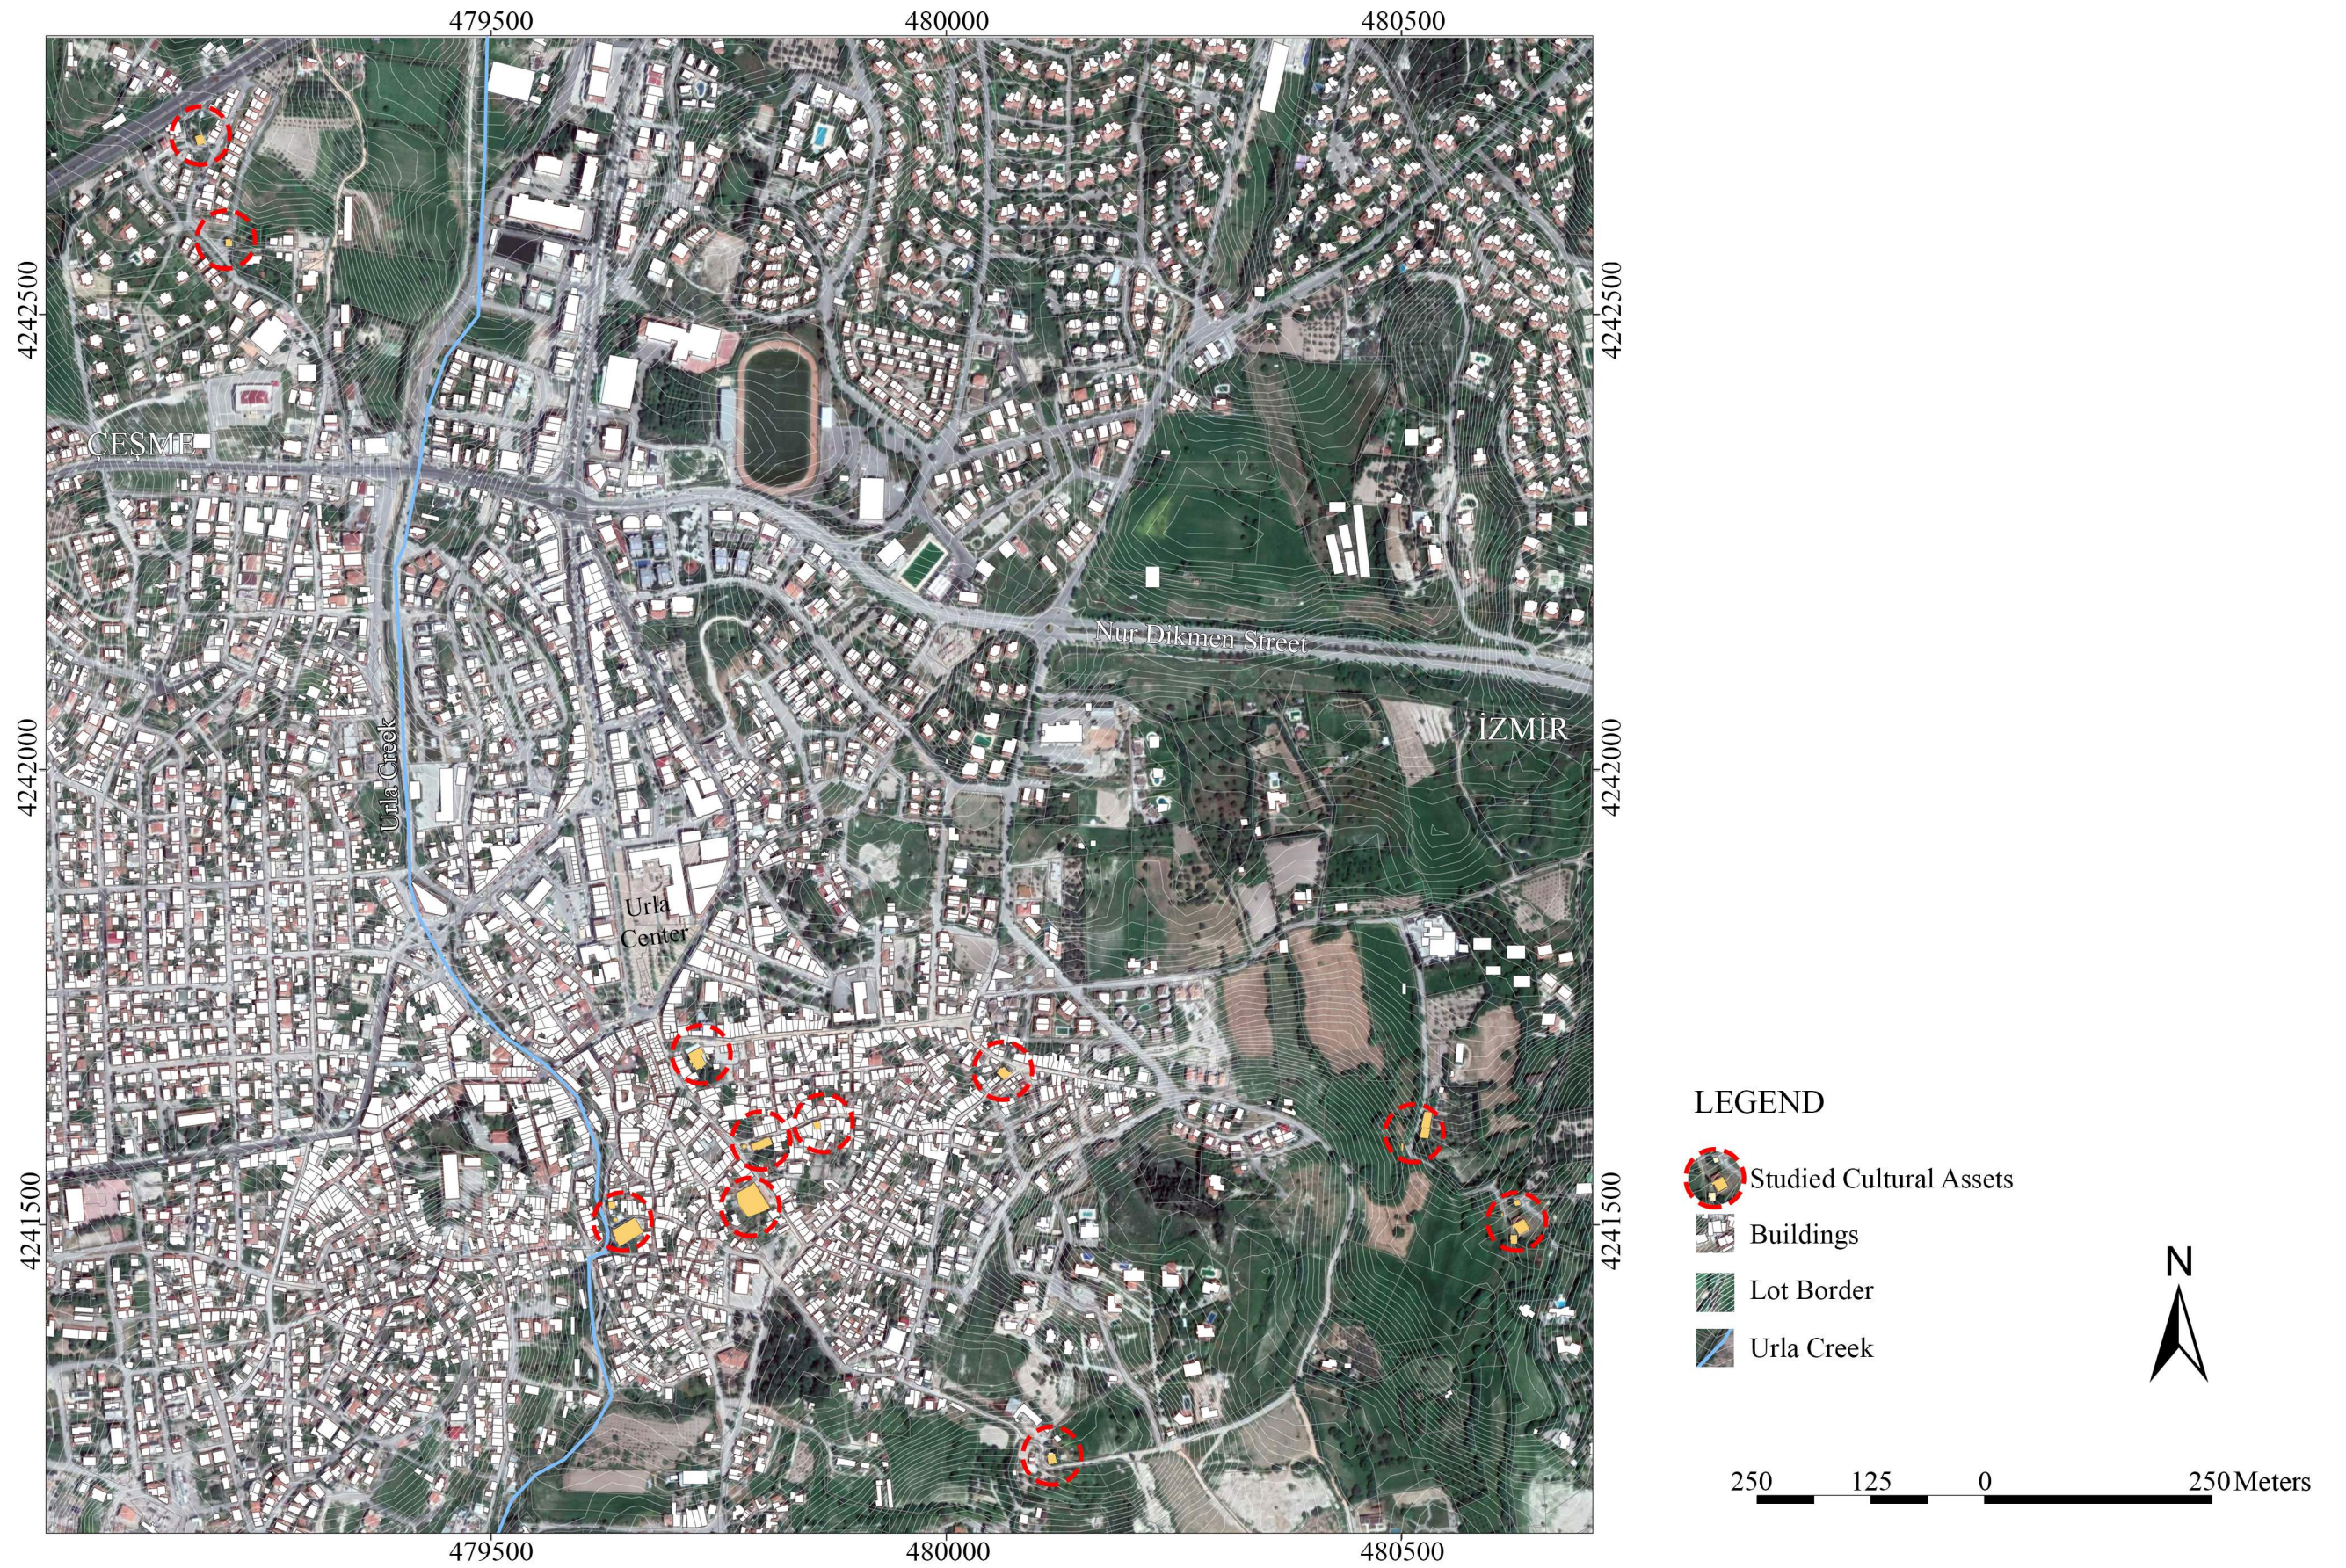
Figure 1.2. Orthophoto of Urla Center

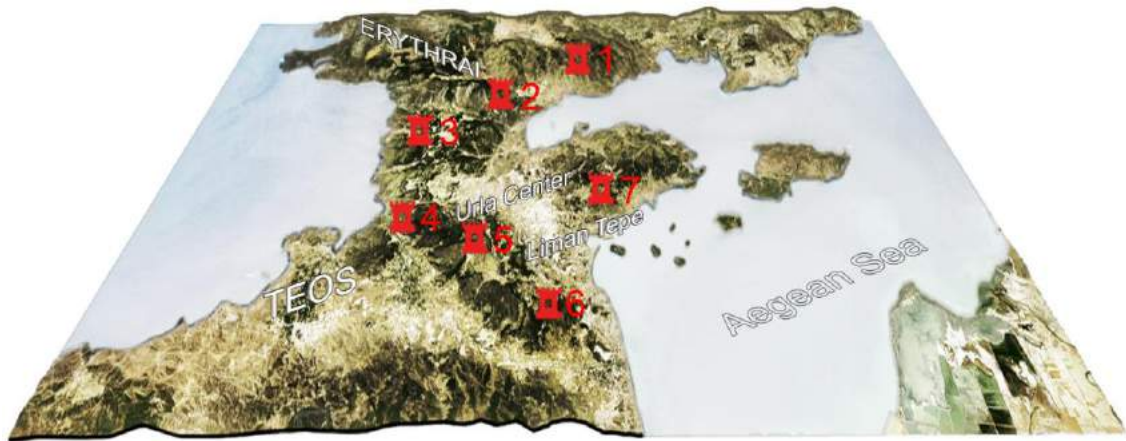
1 Cin Deresi 2 Hacigebeş 3 Yemişliboğaz 4 Akçahisar 5 Yarentepe 6 Sivricetepe 7 Dubatepe

Figure 2.4. 3-D Map of Defense Structures in Klazomenai’s Chora 1800 – 1200 B.C.

There was a building complex representing the central authority at the center of the inner castle and used as the administrative, commercial and religious center of the city (ANKÜSAM n.d.) (Şahoğlu, 2005a: 350). There were seven defense structures in Klazomenai’s chora (Koparal n.d.) (Figure 2.4).

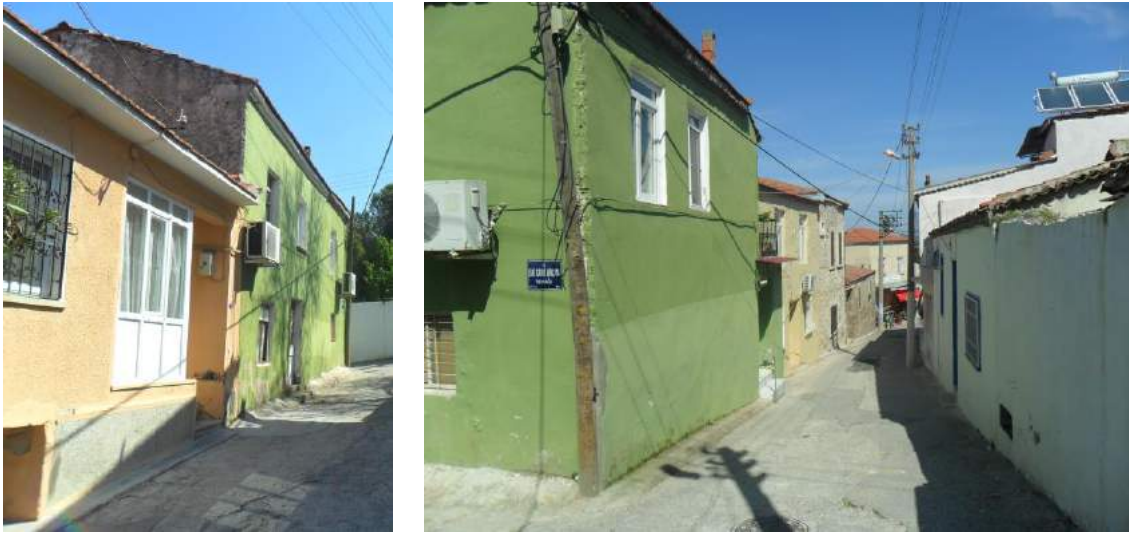
Figure 3.2. Houses adjacent to the Mosque as viewed from the south (left) and east

one storied. According to the Conservation Plan, article 3.1.1, when these historic houses are to be demolished and rebuilt, it is mandatory to prepare a new project by preserving the facade characteristics such as material, color and solid-void ratios (Figure 3.2). The relationship between the mosque and the house at the east corner of the mosque is problematic: masses almost juxtapose each other, threatening the monumentality of the mosque. The organic street pattern is eye-catching within the residential area. Since the widths of the roads vary between 3 meters and 5.5 meters, there are very few sidewalks. Moreover, the street covering is either asphalt or concrete pavement.

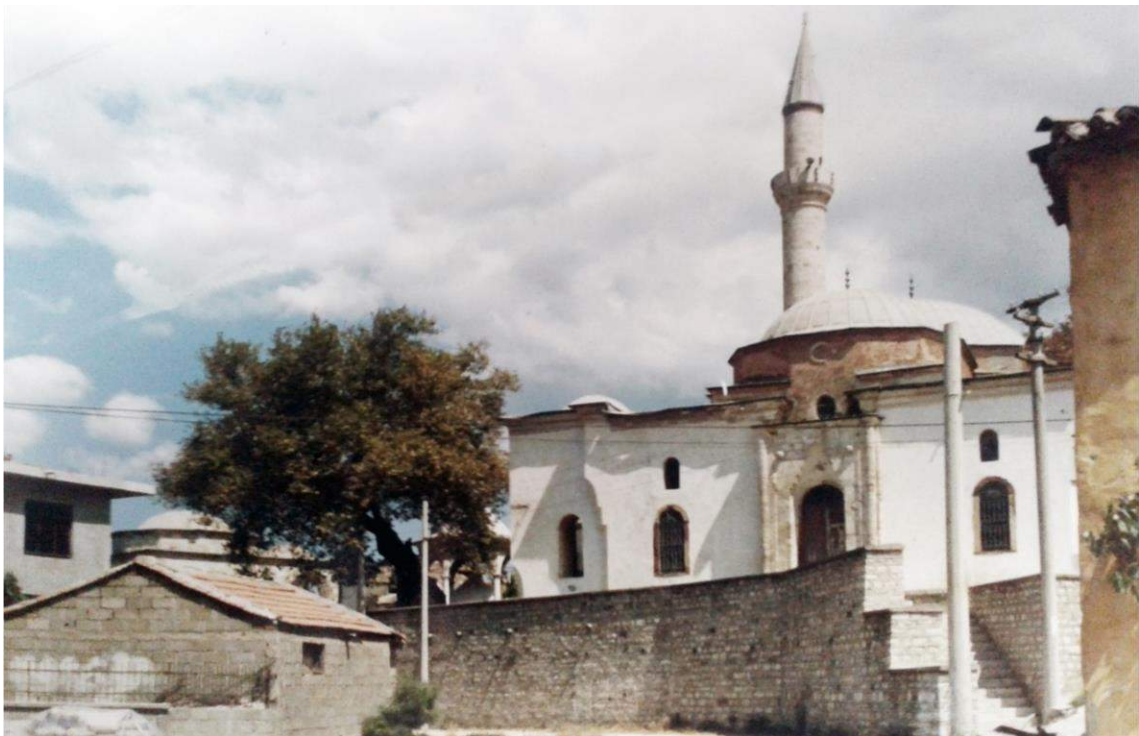
Figure 3.4. The Mosque as viewed from the southwest  
(Source: Conservation Board Archive, 1990)

The mosque mass is dominated by the central dodecagon drum crowned by a dome, and the minaret (Figure 3.4). The building spaces which are relatively low surround the elevated drum and the dome at their northwest, north and northeast. In the northwest facade, the red colour of the drum, the crescent and star pattern are eyecatching.

The eastern facade of the mosque cannot be easily seen from the outside due to the courtyard wall of the adjacent house. There are two semicircular-arched windows which are placed at the middle of this facade. In the south facade, the cubic space in the middle is differentiated by the physical appearance from the east and west parts.

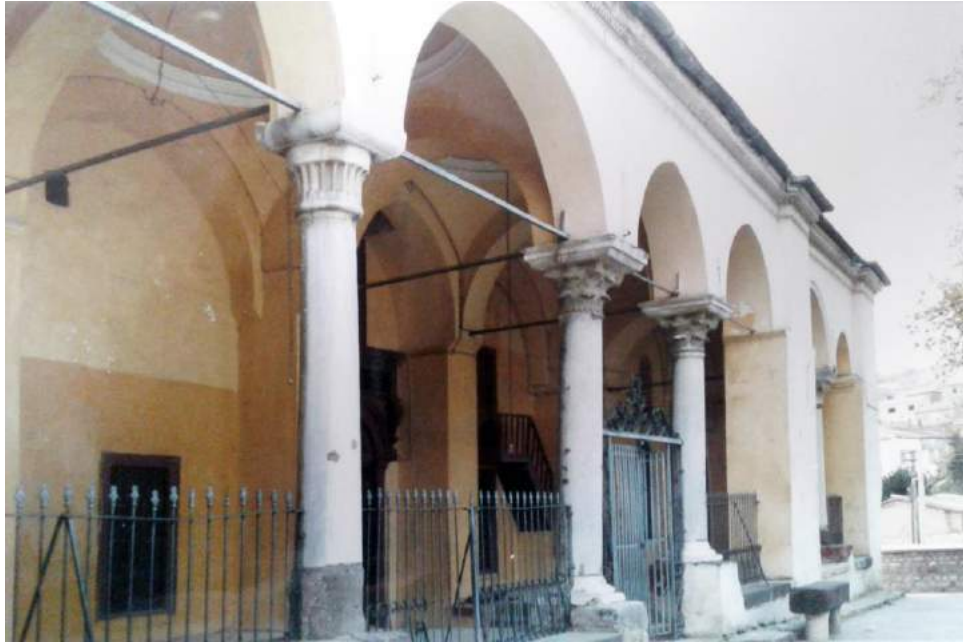
Figure 3.5. The last comers' hall as viewed from the northeast  
(Source: Conservation Board Archive Archive, 1990)

There are seven window openings, five of them are at the bottom and two of them are at the top. The lower windows are semi-circular arched and have stones with alternating colors: light orange and brown. The upper windows are also semi-circular arched. The monumental portal projects out of the western facade. The portal's top portion is decorated. In the north facade, the semi-open last comers' hall is crowned with different sized domes resting on semi-circular arches (Figure 3.5).

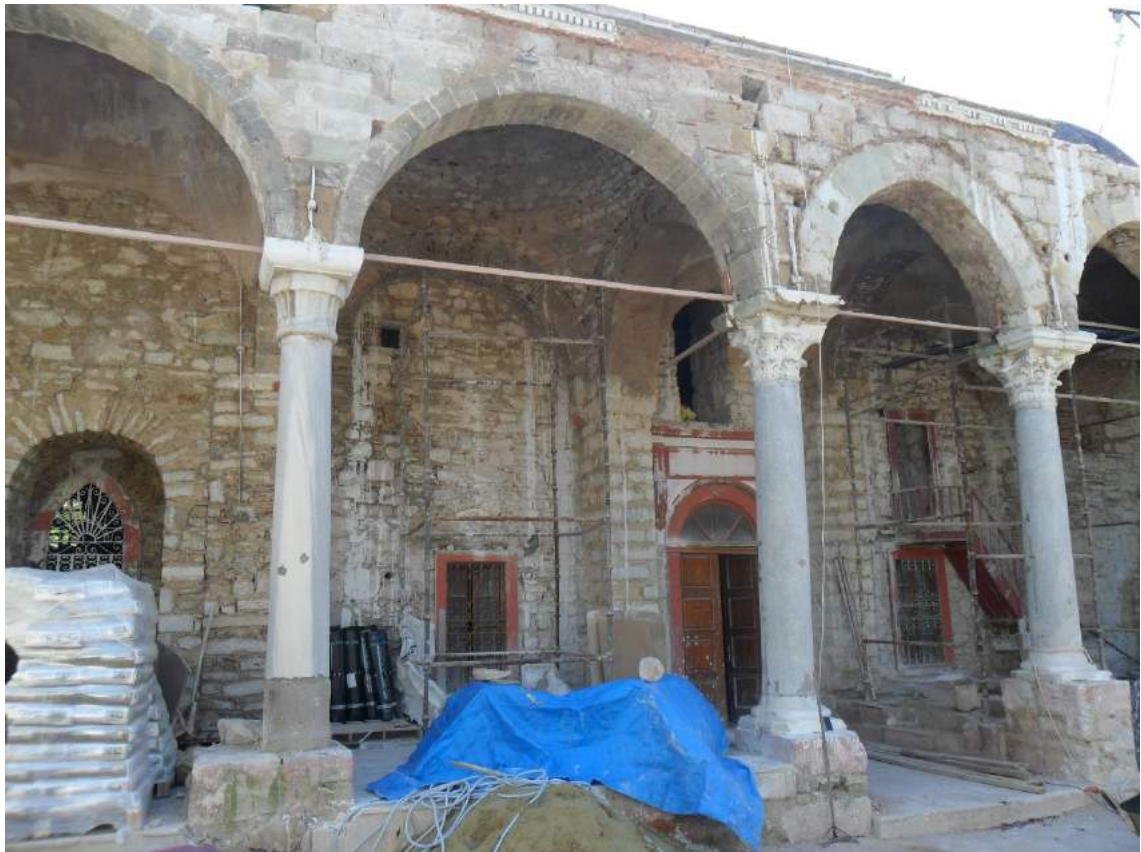
Figure 3.8. The last comers' hall as viewed from the northeast

The collanaded porticoe (4 x 26 m) at the northwest is crowned with seven domes, their radiuses vary in dimensions (Figure 3.8). Semicircular arches resting on reused columns are observed at the northwest, while the narrow sides are walled. There are also walls and columns on the side juxtaposing the praying halls. There is a wooden staircase which is used for accessing the women's section at the west of the main entrance.

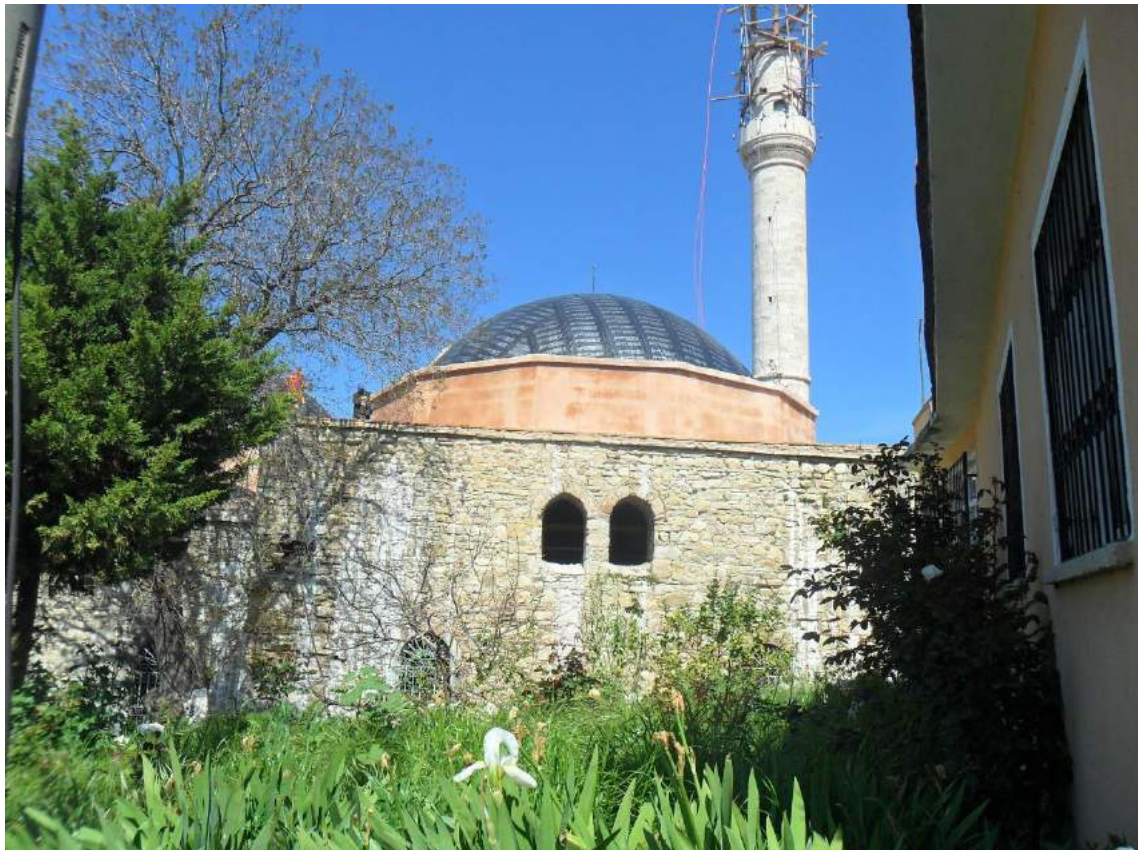
Figure 3.9. The graveyard and the south facade of the mosque as viewed from the south

Also, some minor changes such as partial painting, door and window repairs, and cleaning of the graveyard were realised, but there is no clear information in the records. The restoration has been continuing (Figure 3.9).

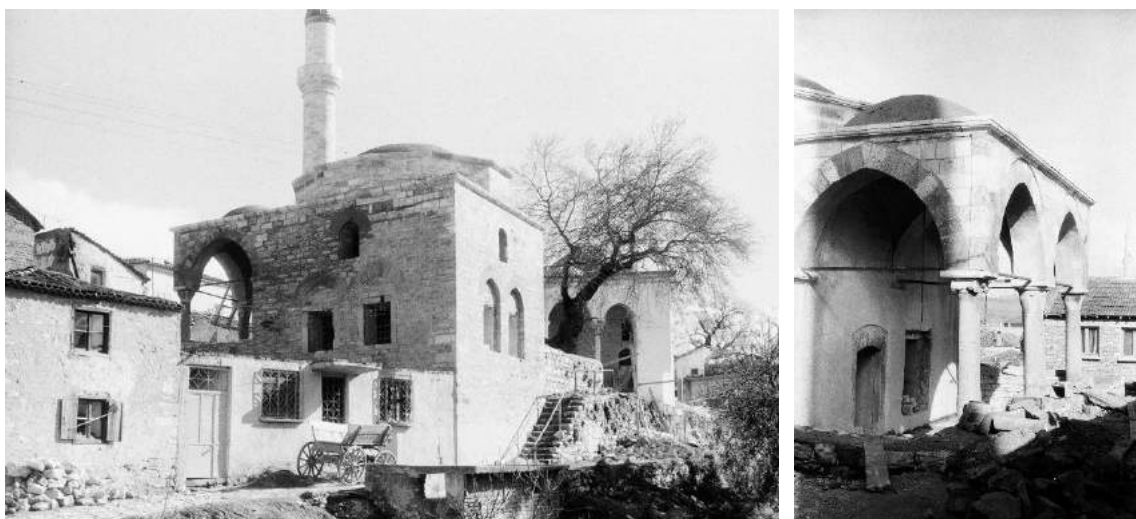
Figure 3.10. The School as viewed from the northeast (left) and collonaded porticoe (Source: RDPF Archive, 1980)

The cubical building crowned with a dome at the northwest corner of the mosque's courtyard is smaller in scale (Figure 3.10). The houses at the north and east of the houses are to be preserved according to the Conservation Plan article 3.1.1. This is controversial, because they have lost their authenticity. The school cannot be easily detected due to the houses and ivy in the east, when entered from İbrahim Algan Street.

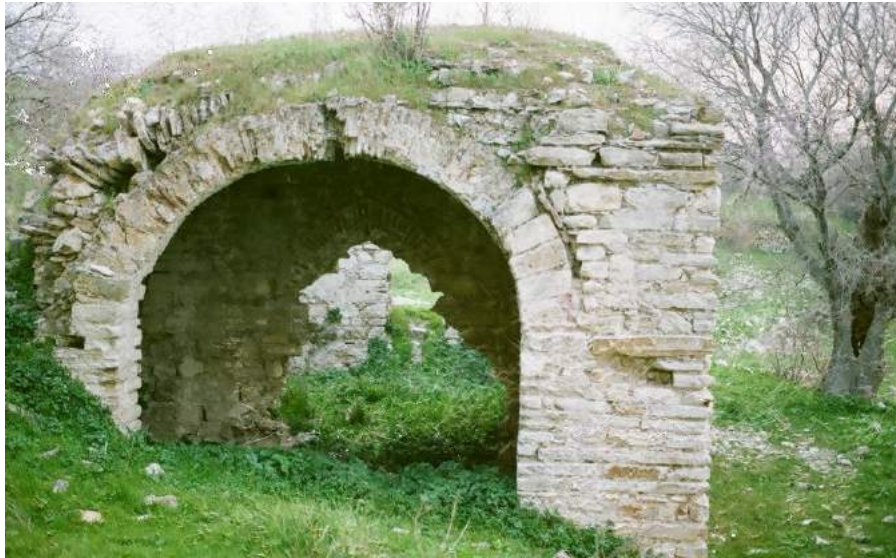
Figure 3.23. Kamanlı Dervish Lodge as viewed from the northwest  
(Source: RDPF Archive, 1990)

The dervish lodge is the element at the very south of the composition. It has some vista of Urla plain, but the privacy of entrance is strengthened with its orientation towards the mosque. It is designed on a slope in the north-south direction and close to the mosque (3 m). It is on a different lot from the mosque. Bayrakal (2009: 203) and Akyıldız (1988: 192) claim that the building was a children's school, but Kütükoğlu (2000: 229) thinks that the structure was a Dervish lodge since there are niches recalling fireplaces. Nevertheless, children's schools may have fireplaces as well. The building is not in good conservation state; plants and other environmental and human factors are threatening the building (Figure 3.23).

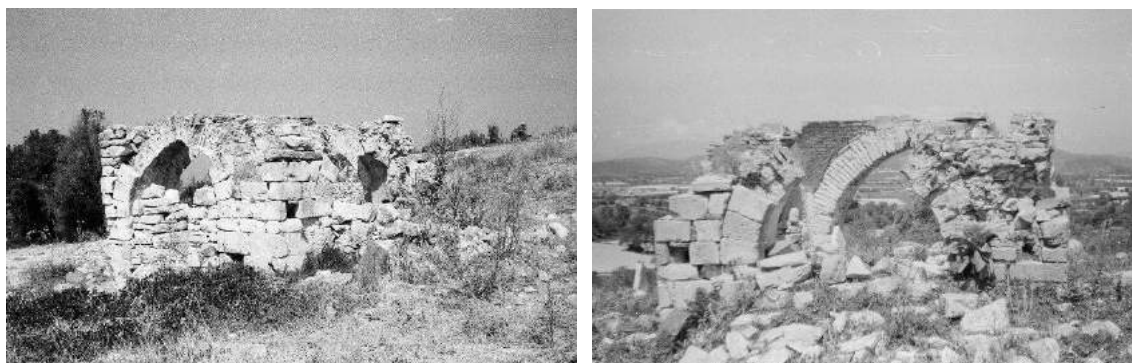
Figure 3.25. Kamanlı Tomb as viewed from the northeast (left) and south (right)  
(Source: RDPF Archive, 1980)

The tomb was designed at the corner of the lot, north of the mosque. It juxtaposes to the garden wall at the north and west. There is a tree next to it. Due to lack of maintenance and weathering, it is nearly demolished: the piers and top of the tomb are not present today. So, the tomb does not have a precise geometry at present. In the southwestern facade, there is a pier ruin which is made of cut stone, it is higher from the others (Figure 3.25). Elevation of southeast and northwest facades is the same and it is nearly the ground elevation. The tomb has a square plan (3.60 x 3.60 m). There are debris

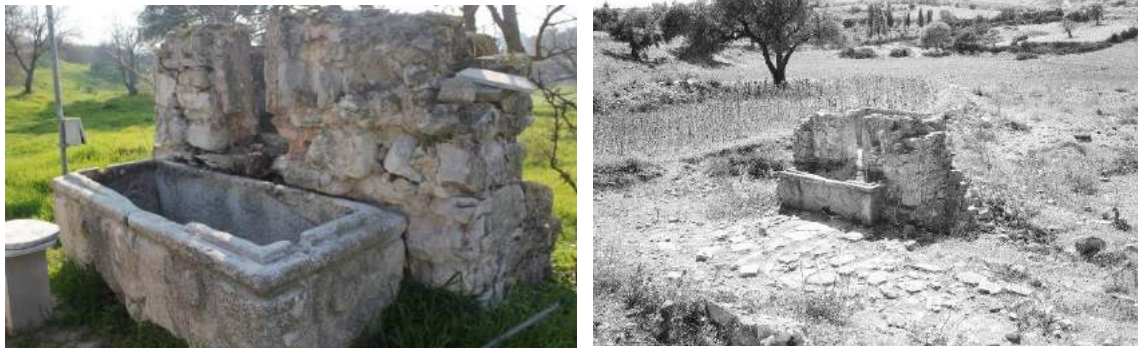
Figure 3.28. Kamanlı Fountain near the Mosque as viewed from the northwest  
(Source: RDPF Archive, 2006 (left) and 1980)

The fountain which was designed outside the western gate of the mosque courtyard has its own lot. There is a path paved with stone remains at its front. Reused cut stone material, coarse and rubble stones were used in its construction (Figure 3.28). It consists of three different elements: water storage, watering trough and two seatings which are contemporary (Figure 3.29).

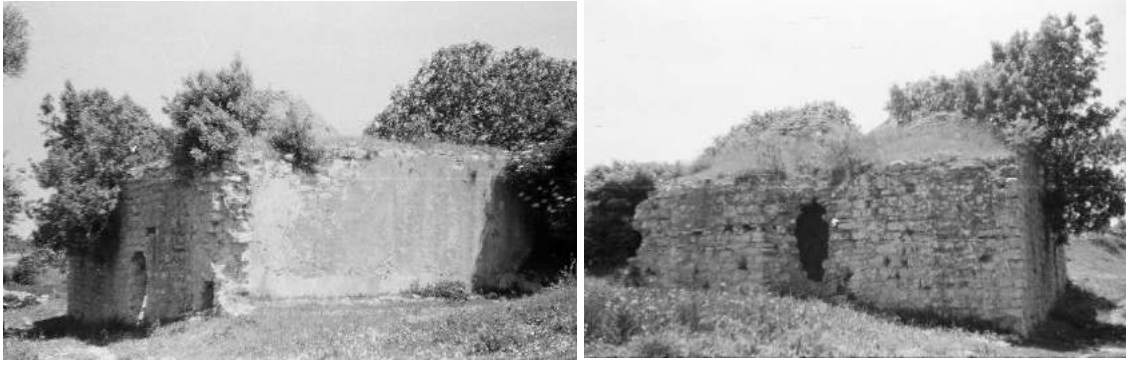
Figure 3.31. Kamanlı Bath as viewed from the southwest (left) and north (right)  
(Source: RDPF Archive, 1980)

The northwest facade is the only facade that interacts with the road because it can be perceived from the street. There is an opening on this facade: present entrance opening with iron bars. Moreover, a lot of gaps and cracks are visible on this surface due to stone losses. At the south of this facade, there is a partially collapsed wall and most of the wall (length nearly 9 m) is not present today (Figure 3.31). The north facade (length: 9.20 m, height: 4.10 m) is covered with plants and ivy.

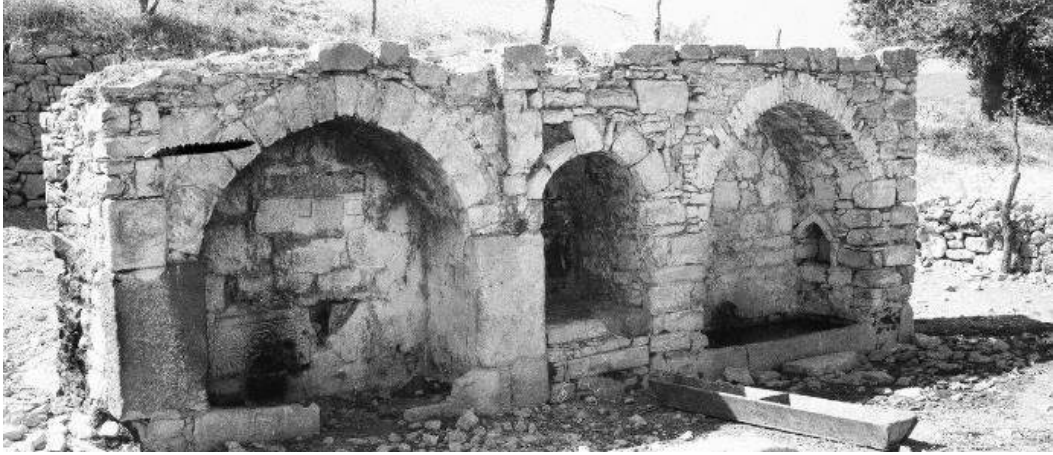
Figure 3.35. Kamanlı Bath Fountain as viewed from southeast  
(Source: RDPF Archive, 1980)

The fountain was constructed in the 15<sup>th</sup> century by Yahşi Bey and it was used to 1970s (Table 3.8) (RDPF Archive, 1965). In 1965, the fountain was first listed. Then, it was in good condition and it was possible to get a drink (RDPF Archive, 1965). In 1975, re-listed and it was not pouring anymore (RDPF Archive, 1975) (Figure 3.35).

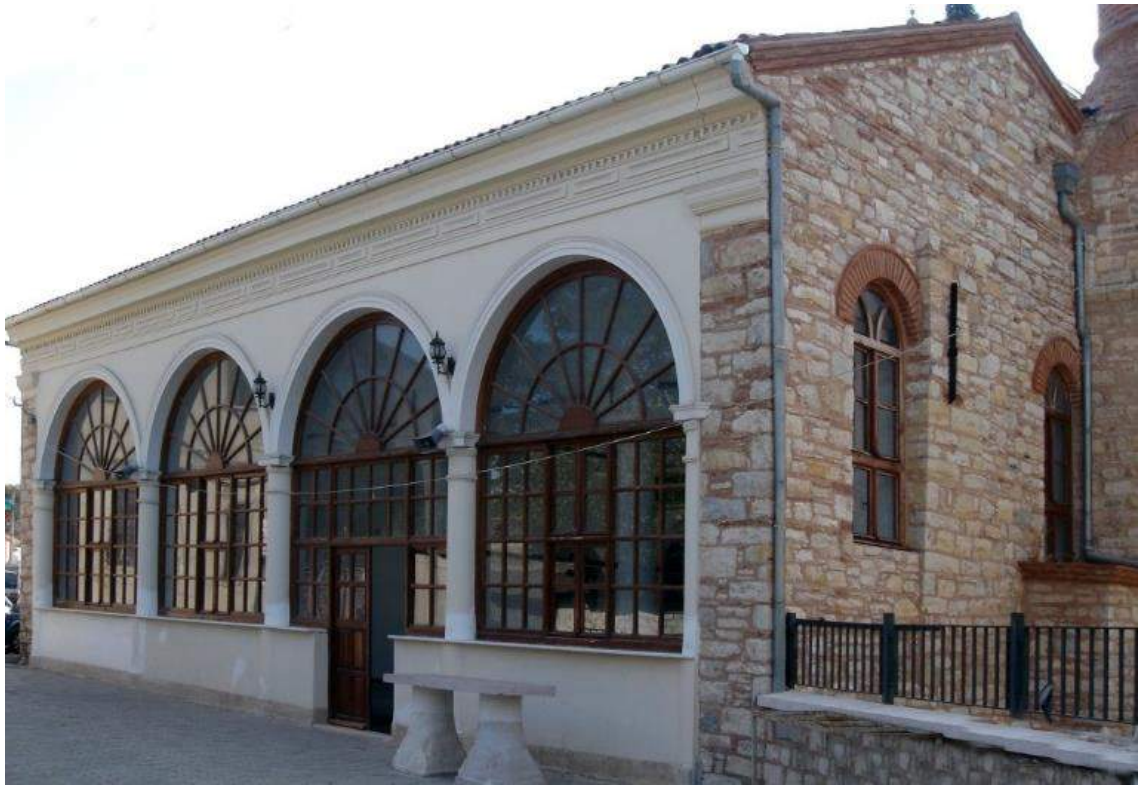
Figure 3.39. Last comers' hall as viewed from north  
(Source: RDPF Archive, 2006)

The mosque mass is dominated by a central octagonal drum crowned by a dome, and a minaret. At present, the mass consists of three units: cubical and domed praying hall, the last comers' hall addition with a pitched roof, and a shed addition with a lean-to-roof at the very north. The last comers' hall projects to the east, creating an open space for funeral praying at the east of the mosque. The northern facade of the mosque cannot be easily seen from Mustafa Kemal Paşa street because of trees and the additional shed (Figure 3.38). At the north facade, four semicircular-arched openings of the last comer's hall are closed with glass panels and joinery (Figure 3.39).

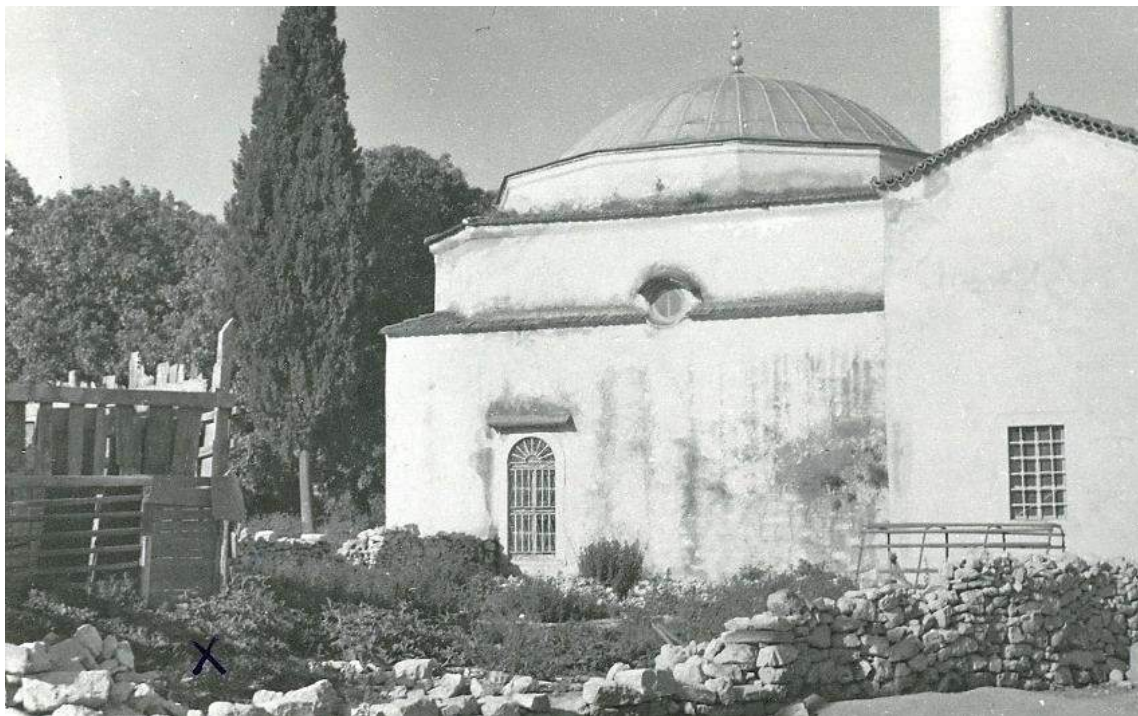
Figure 3.40. Graveyard and surrounding garden wall in front of the east facade as viewed from northeast (Source: RDPF Archive, 1980s)

There are three window openings at the eastern facade: two of them were designed on main praying hall (Figure 3.40). At the south facade of the mosque, there are four window openings and the wall piece at the middle of this facade. At the west facade of the mosque, there are four window openings and the minaret exist here. A wall piece perpendicular to the facade of the mosque at its center is eye-catching. Another wall piece is at the intersection of the minaret and the last comers' hall.

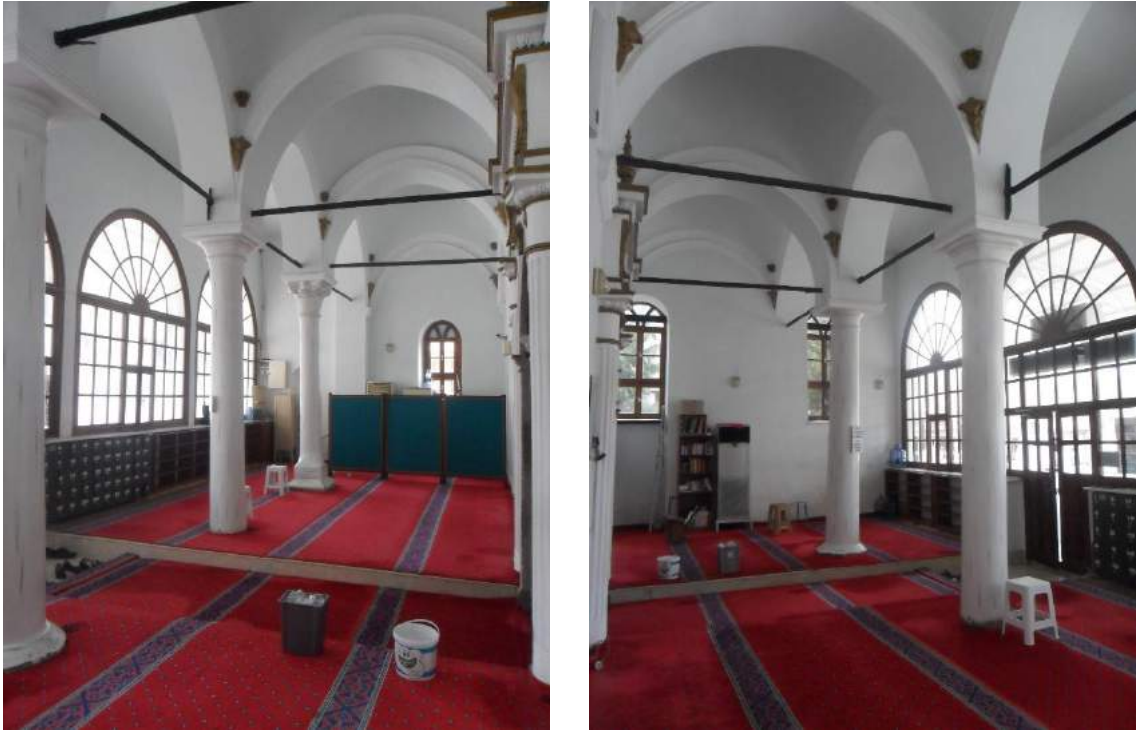
Figure 3.42. Last comers' hall as viewed from the northeast (right) and northwest

Last comers' hall (5.70 x 15.6 m) was designed at the northwest of the main praying hall (Figure 3.41). Its superstructure consists of four domes at the southeast, and single sloped ceiling at the northwest (Figure 3.42). These domes rest on re-used capitals, columns and base plates lined up at the center of the space. The columns are connected to each other by arches. A niche is present at the northeast wall. The entrance to the mosque is juxtaposed by two window openings at its sides at the southeast. From the western corner, the minaret can be entered. Moreover, white plaster was used in this space. The main volume is in square plan (9.2 x 9.2 m). Its superstructure consists of a dome on an octagonal drum supported with four squinches. Furthermore, it is covered with lead. A wooden staircase was designed at the northwest to provide access to the upper praying hall. Upper praying section was constructed with six wooden columns, wooden decks, and wooden columns (Figure 3.43).

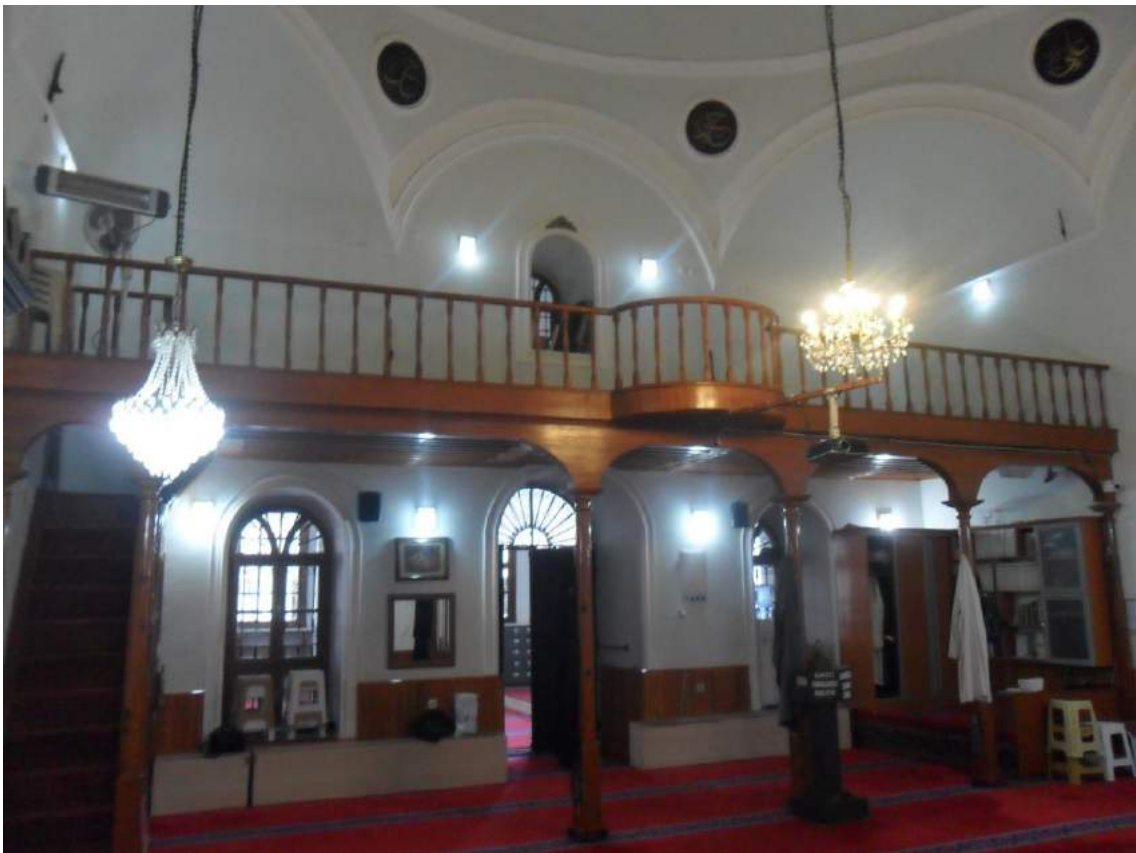
Figure 3.43. Main praying hall and upper section as viewed from the southwest

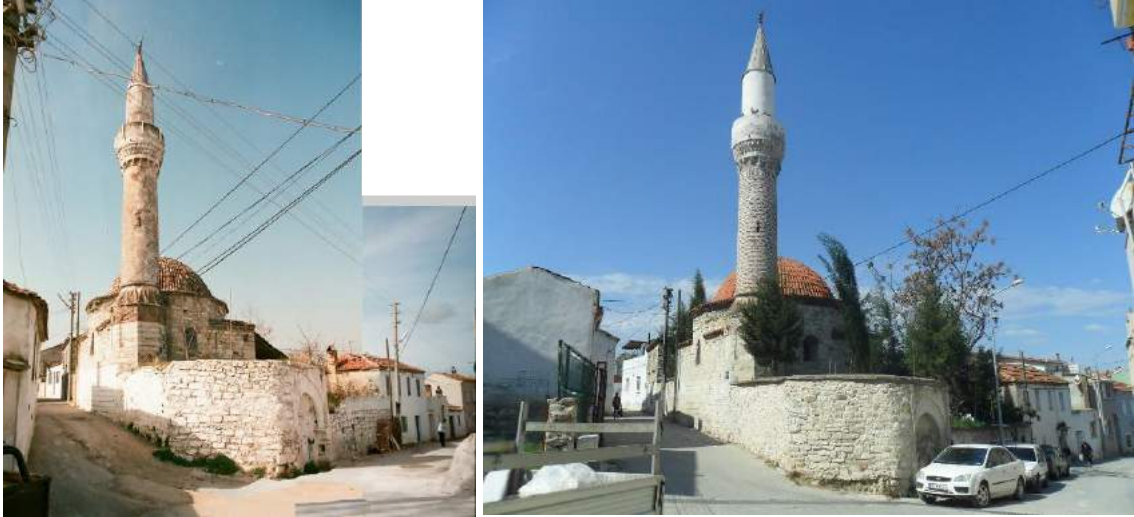
Figure 3.46. The mosque and fountain as viewed from the northeast in 2019 (right) and 1990 (Source: RDPF Archive, 1990)

The width of the streets (4 m) is narrow; so, there are rarely sidewalks. Although the irregular formed lot is 334 m<sup>2</sup>, the mosque mass is only 90 m<sup>2</sup>. A fountain, graveyard, and service units (ablution unit and toilet) are the other elements of the composition. It is surrounded by garden walls which leads to a flight of stairs ascending towards the mosque. The east side of the garden is nearly 4 meters long, so it is a chamfered corner at the intersection of streets. On the northern side of the composition, there is the entrance gate. The fountain is at the intersection of the above-mentioned streets (Figure 3.46). It is still reachable from the streets, but its water is no more running.

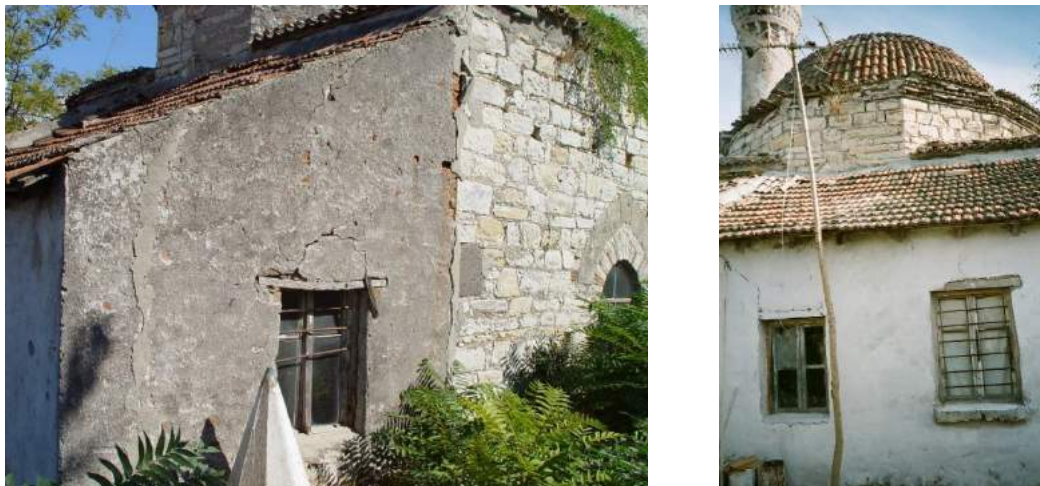
Figure 3.49. Last comers' hall as viewed from southwest (left) and northwest (Source: RDPF Archive, 1990)

In 1988, it was recorded as composed of two units: the entrance hole and the lodging use (Akyıldız, 1988: 93) (Figure 3.48, 3.49). In 1975, it was a single semi-open space used for praying (RDPF Archive, 1975). It is claimed that the last comers' hall was L planned in the original construction and it extended towards the minaret (Ünal and Çağlıtütüncügil, 2016: 65). However, L shaped plan is not suitable because of courtyard's wall position. There are no traces at present so, sampling excavation can be helpful.

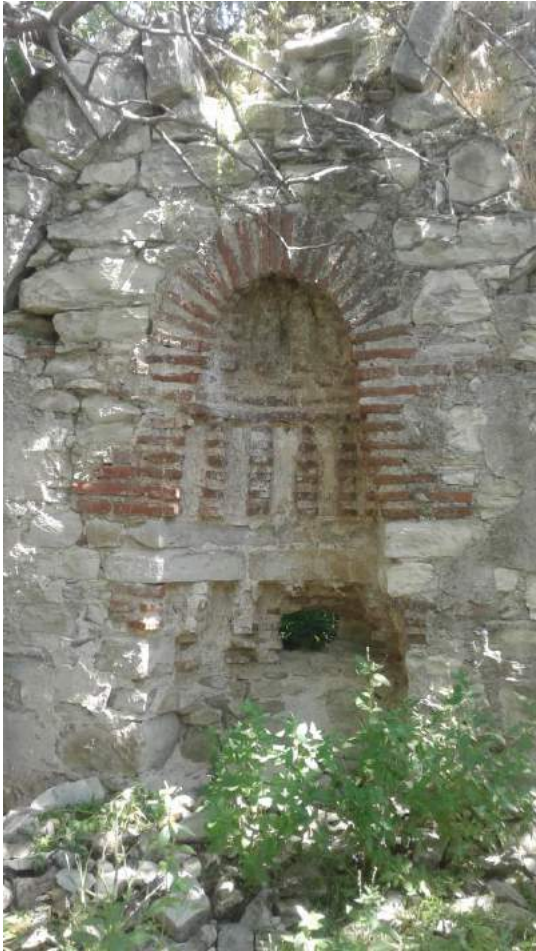
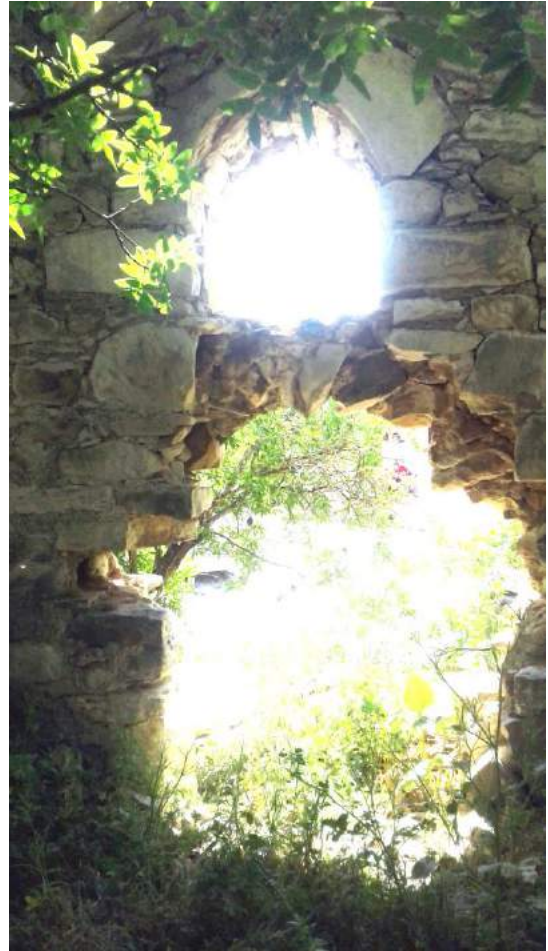
Figure 3.58. Mihrab (left) and an arched window at southwest interior as viewed from the center of the masjid

The southeastern facade has two windows. The ruined bottom window crowned with an arched top one are the elements of the blind southwestern facade. The praying hall is square in plan (5 x 5 m) (Figure 3.57) and spanned with a single dome resting on an octagonal drum. There is an arched mihrab niche at the southeastern wall (Figure 3.58). The ground is covered with debris and tree branches (Figure 3.59).
