**ARCHIVING OF THE CONSERVATION DATA OF  
IMMOVABLE CULTURAL ASSETS DATING TO  
1300-1600 IN URLA CENTER USING GIS**

**A Thesis Submitted to  
the Graduate School of Engineering and Sciences of  
İzmir Institute of Technology  
in Partial Fulfillment of the Requirements for the Degree of**

**in Architectural Restoration**

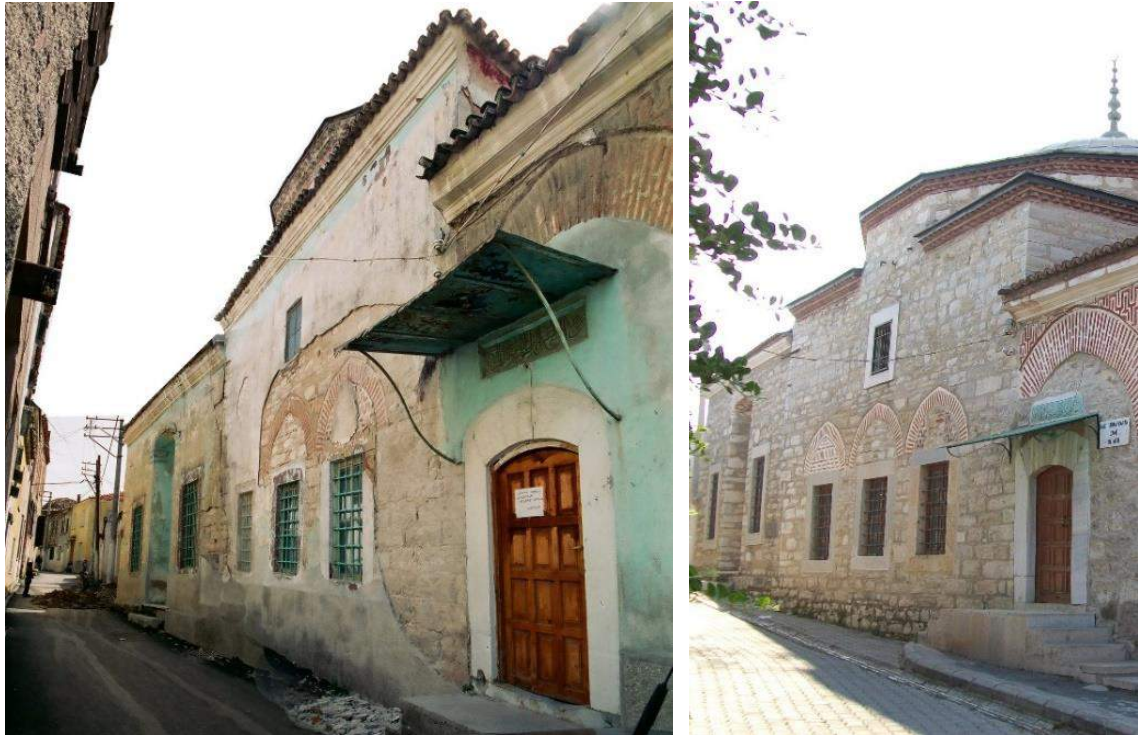
Figure 3.63. The Kapan Mosque before (left) and after restoration implementation as viewed from the west (Source: RDPF Archive, 1990)

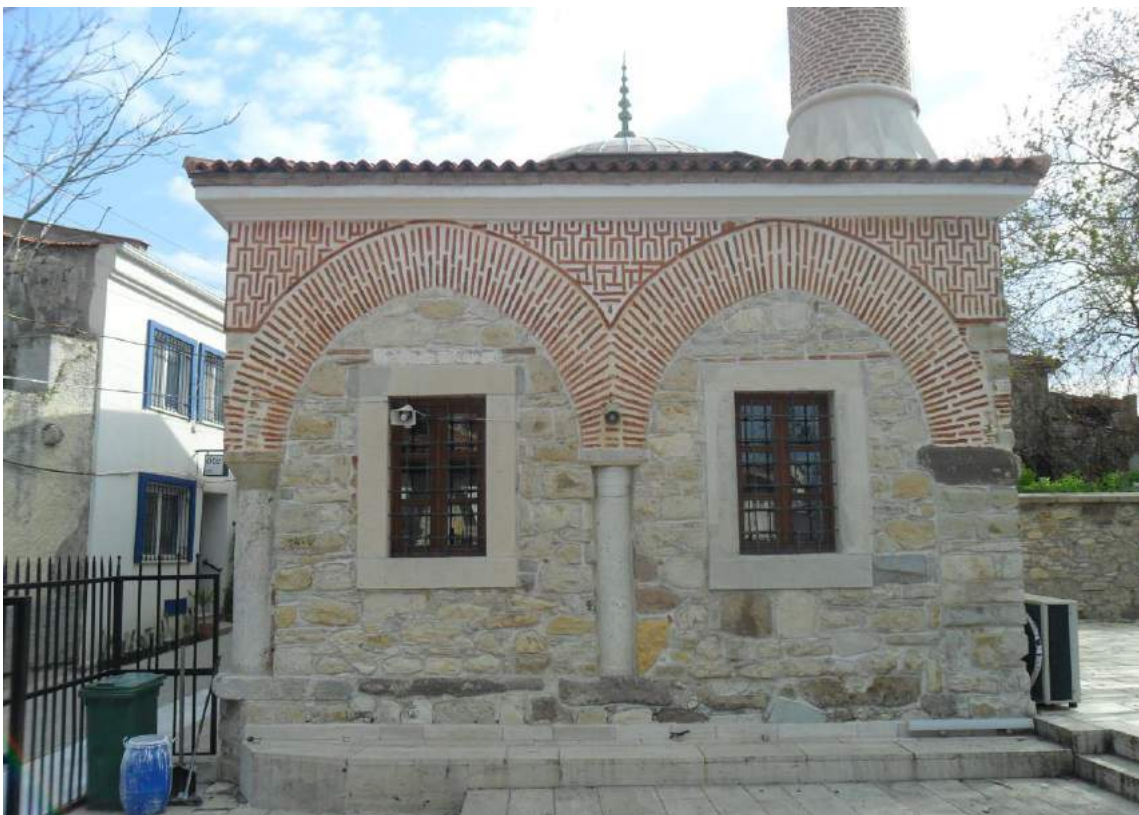
Figure 3.65. After restoration implementation as viewed from the west

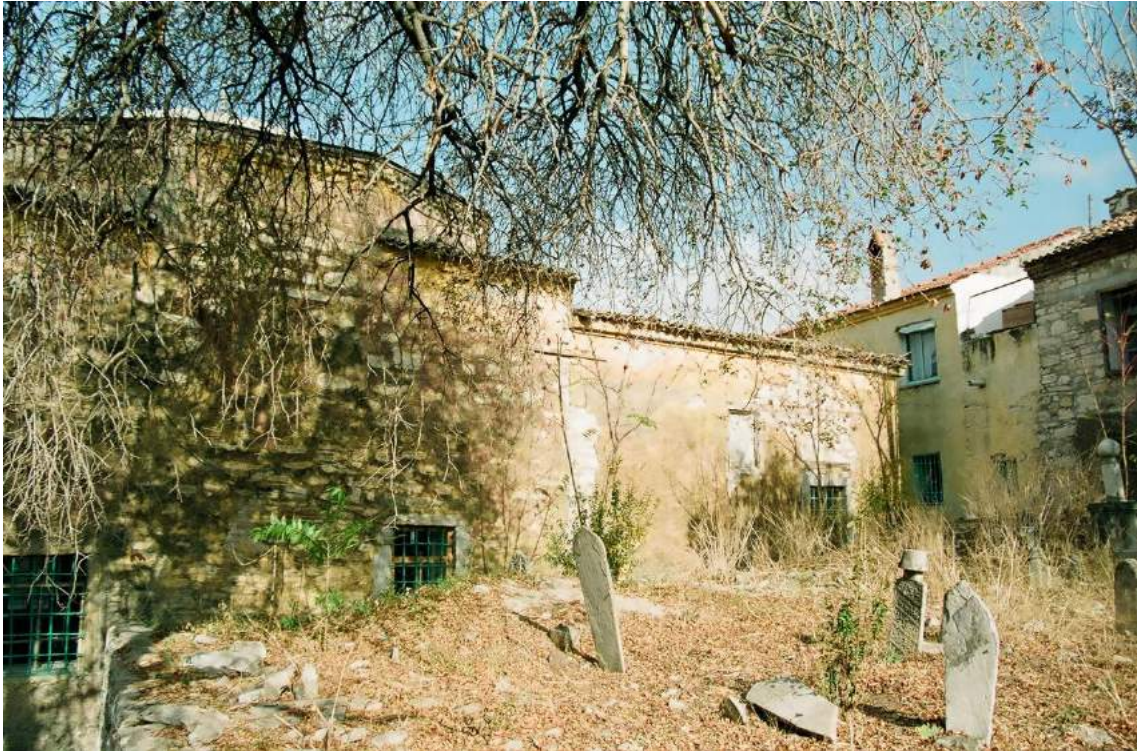
Figure 3.66. The Kapan graveyard before restoration process as viewed from the west  
(Source: RDPF Archive, 1990)

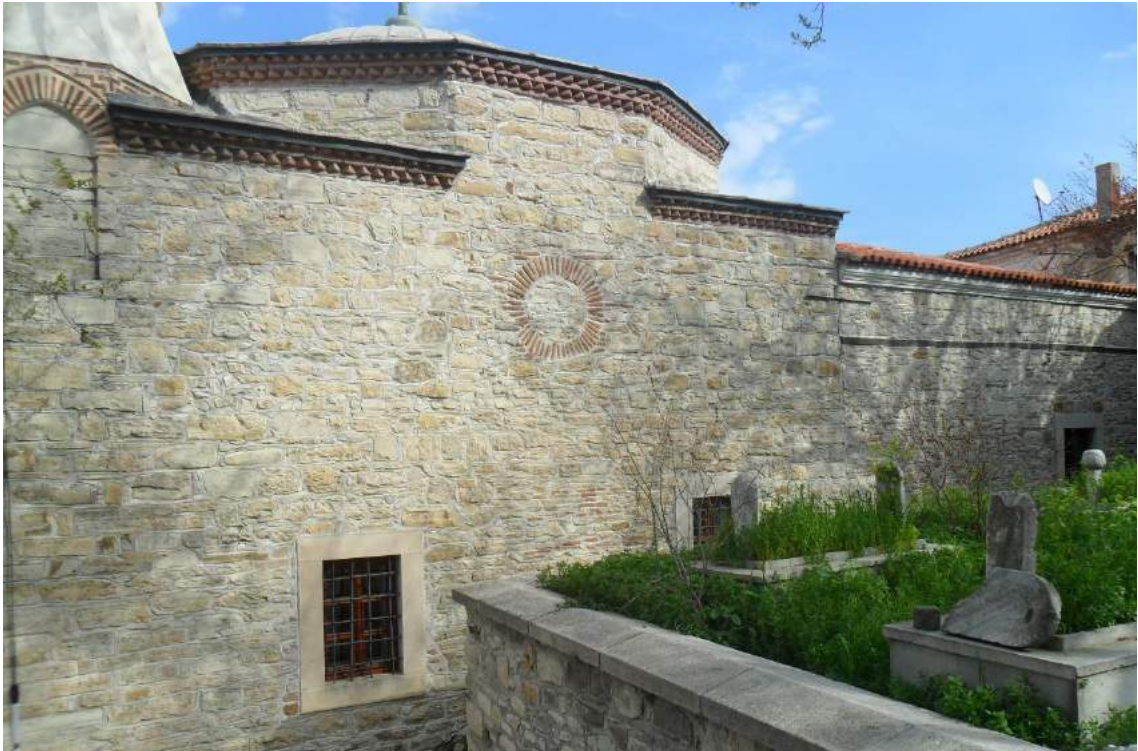
Figure 3.67. The Kapan graveyard after restoration process as viewed from the south

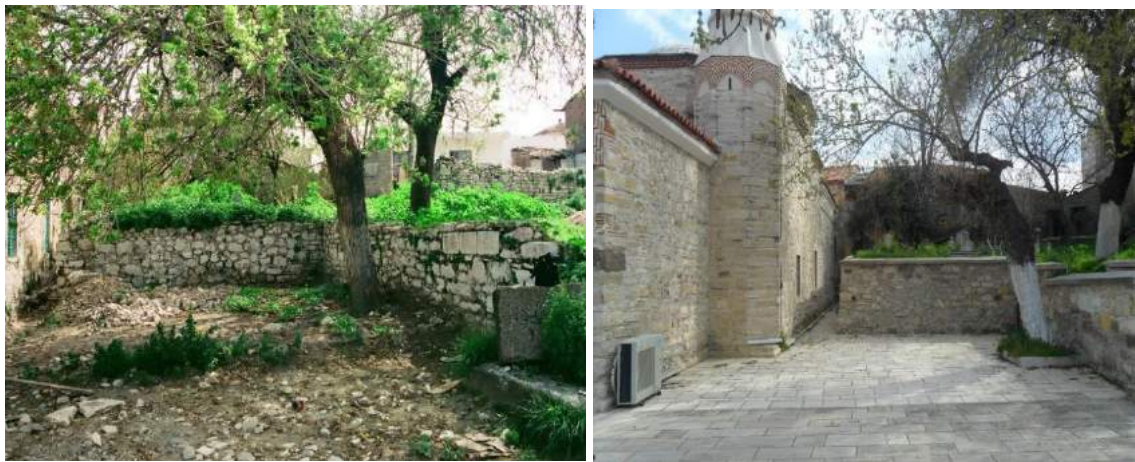
Figure 3.70. The Kapan Mosque courtyard before (left) (Source: RDPF Archive, 1990) and after restoration implementation as viewed from the southwest

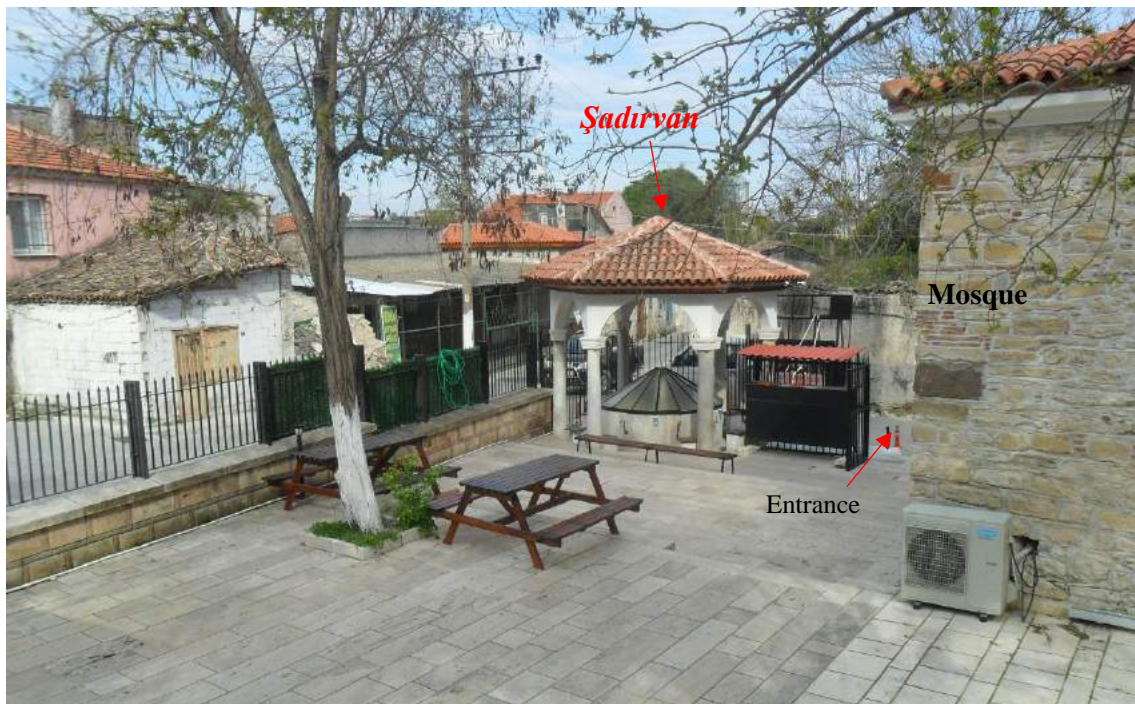
Figure 3.71. Kapan Mosque *Şadırvan* as viewed from the south

it is at the intersection of streets. The toilet mass parallel to Mustafa Kemal Paşa Street is a new addition. The historic graves in the shadow of old trees are still visible at the eastern portion at an elevated position due to natural inclination. The historic terrace walls are still visible, although their capping was altered (Figure 3.70). There are three different elevations in the courtyard; on the lowest level, entrance and *Şadırvan* are present (Figure 3.71, 3.72), the toilet is at the middle level, and at the highest elevation, there is the graveyard.

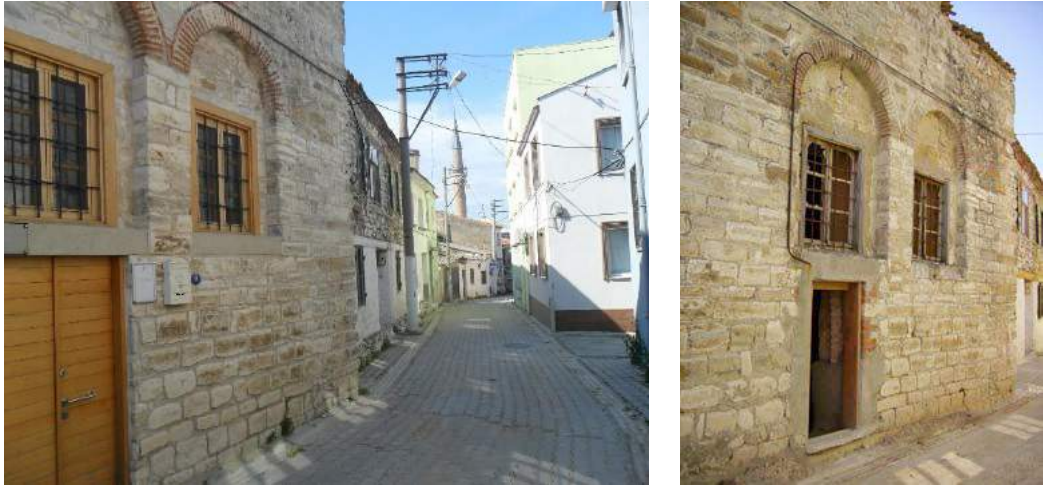
Figure 3.74. The Kapan school after (left) and before (right) restoration implementation as viewed from the northeast (Source: Conservation Board Archive, 2008)

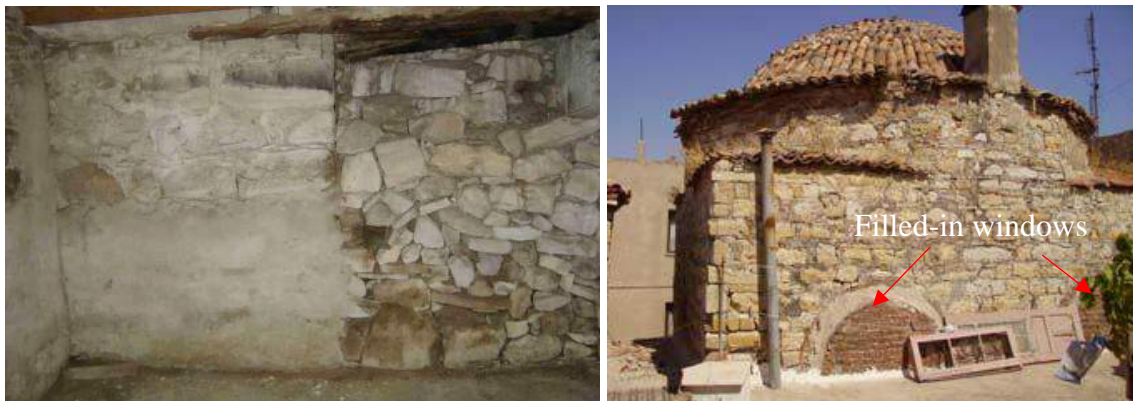
Figure 3.75. Kapan children's school before restoration implementation, interior of southwest wall (left), exterior of southeast wall (Source: Balcioglu, n.d.)

The southeast facade is totally blind and unplastered at present, but there are two filled in windows that are arched and placed symmetrically a chimney and rising above the dome is eye-catching. The arch at the southwest wall and filled in at present points out the location of the original entrance (Figure 3.75). At present, the entrance door is the only source of natural illumination.

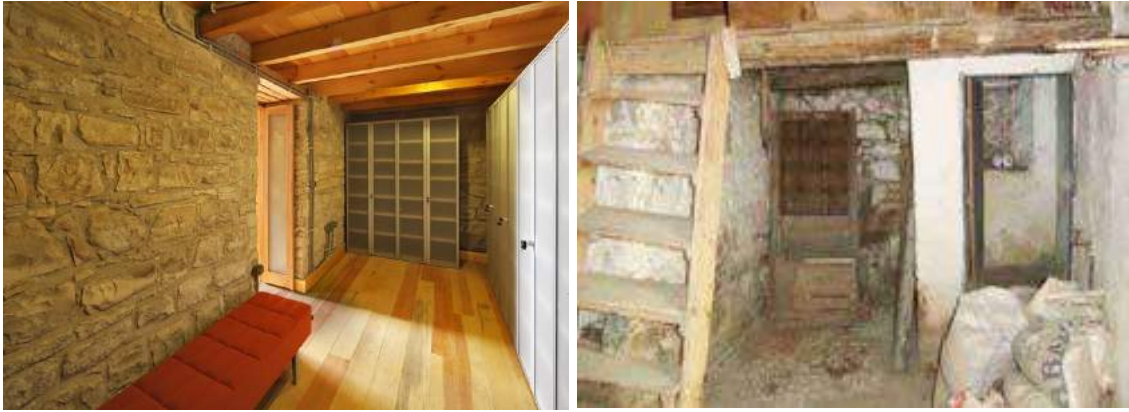
Figure 3.78. As viewed from ground floor after restoration (left) (Source: Serbestiyet, n.d.) and before restoration (Source: Balcioglu, n.d.)

The building has a square plan (7.5 x 7.5 meters) and has two floors (Figure 3.76, 3.77). The ground floor is composed of two rectangular units, parallel to Kapan Camii Street and juxtaposing each other. The modern kitchen and the toilet units at the sides of the entrance are additions of the current restoration. The rear unit reached through a rectangular opening is used as an archive at present (Figure 3.78).

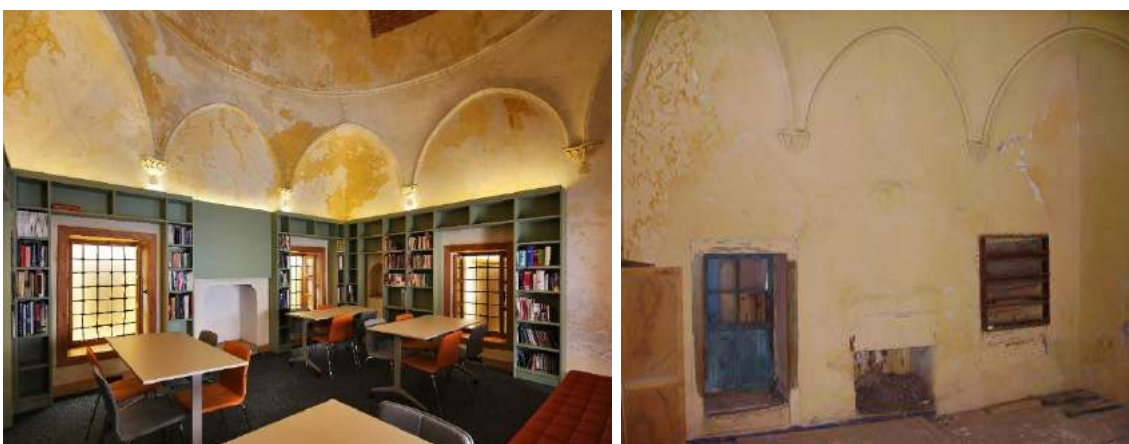
Figure 3.79. As viewed from first floor before restoration (right) (Source: Balcioglu, n.d.) and after restoration (Source: Serbestiyet, n.d.)

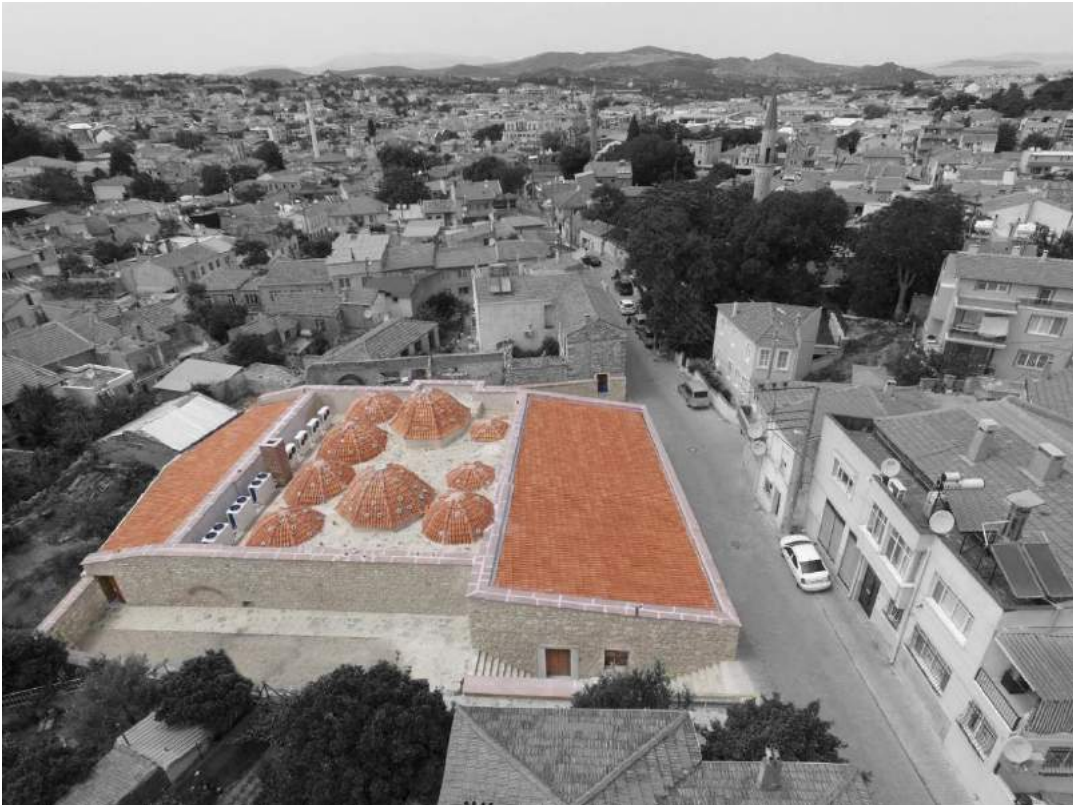
Figure 3.80. Aerial view of Hersekzade Ahmet Paşa Bath as viewed from southwest  
(Source: Urla Municipality Archive, 2016)

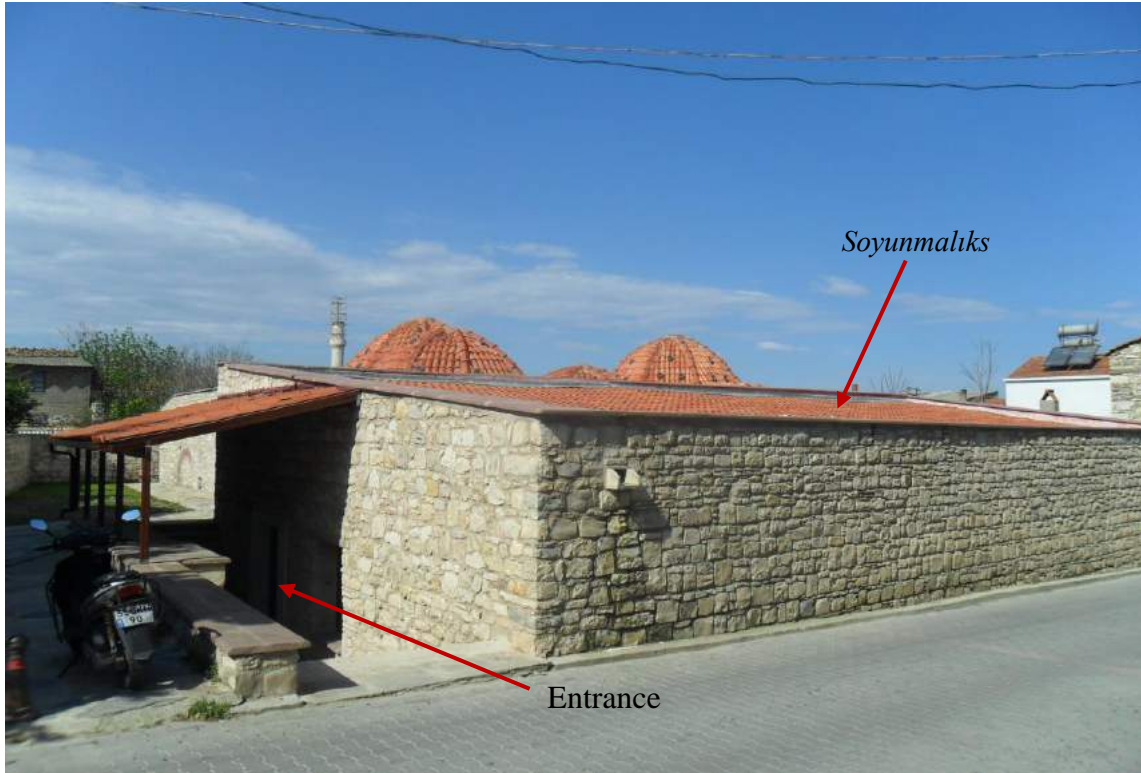
Figure 3.83. After restoration implementation as viewed from the east corner

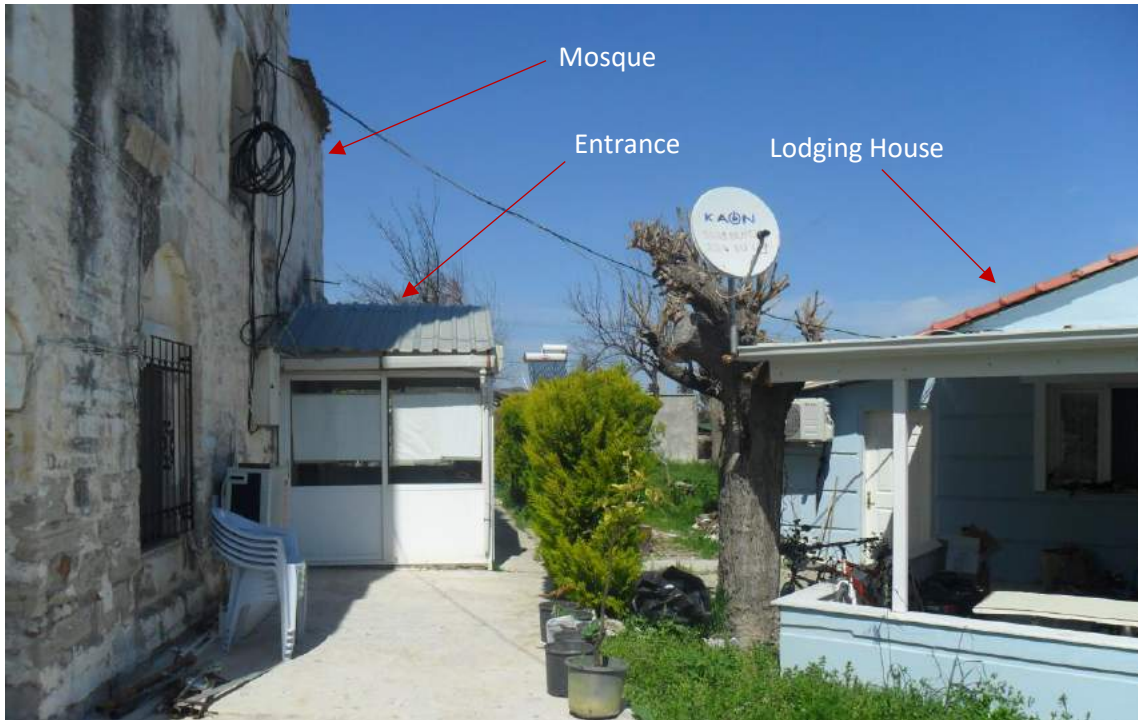
Figure 3.87. Relation between the mosque and lodging house as viewed from the southwest

The mosque is located at Rüstem neighbourhood, 457 block, 4 lot and sheet number is 53. The mosque mass consists of a single cubical mass, crowned with a dome; resting on an octagonal drum and a minaret flanking it. There is an entrance space added to its east. The southwestern corner of the mosque is chamfered, indicating an original relation with the street. The two lodging houses at the east of the mosque threaten the integrity of the historic silhouette (Figure 3.87).

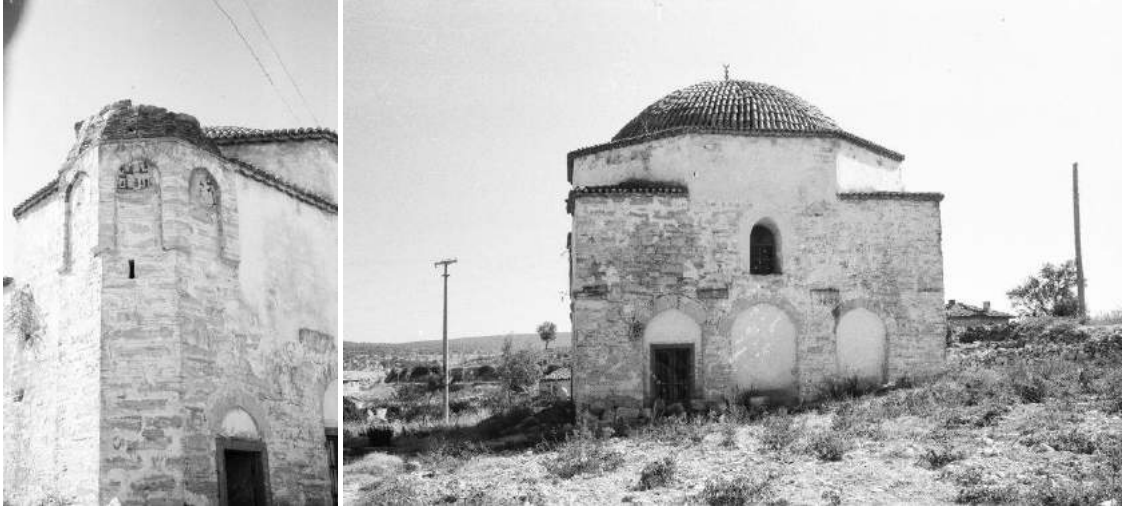
Figure 3.91. Partial minaret (left) as viewed from the southeast and north facade (Source: RDPF Archive, 1980)

The mosque was built at the 16<sup>th</sup> century by Rüstem Paşa who is the grand vizier of the Ottoman Empire. He built hundreds of charitable works in Anatolia and Rumelia (İslam Ansiklopedisi n.d.). In 1893, the minaret was demolished after the Chios earthquake (Figure 3.91) and it was reconstructed at 1985 (RDPF Archive, 1985). In 2016, it was listed, and its restoration was requested (Conservation Board Archive, 2016) (Table 3.14) (Appendix A, Figure A.10).

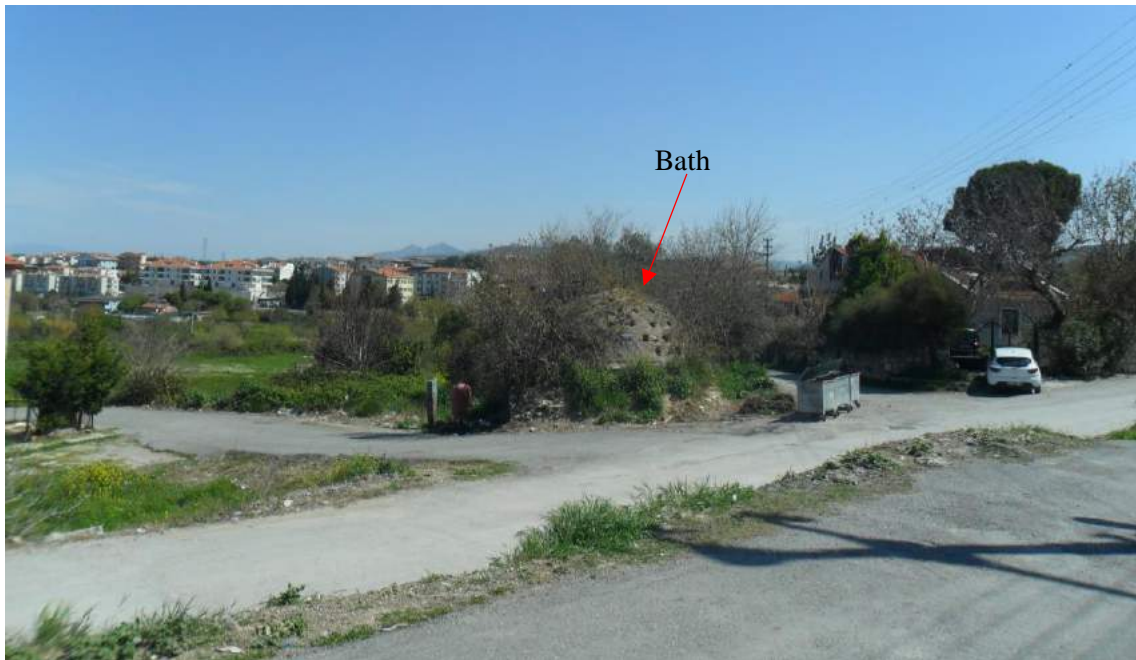
Figure 3.92. Rüstem Paşa Bath current situation as viewed from the northwest

The bath ruin is located at Rüstem neighbourhood, 640 block, 25 lot and sheet number is 53. Three sides of the bath are surrounded with roads, and there is a courtyard at its northeast (Figure 3.92). Due to the dense plants, trees and illegal interventions, the effect of the bath at the third dimension gradually decreased. Only one large cubical mass has reached today. It has a straight facade character consists of solid, blind walls demonstrating without plastering.

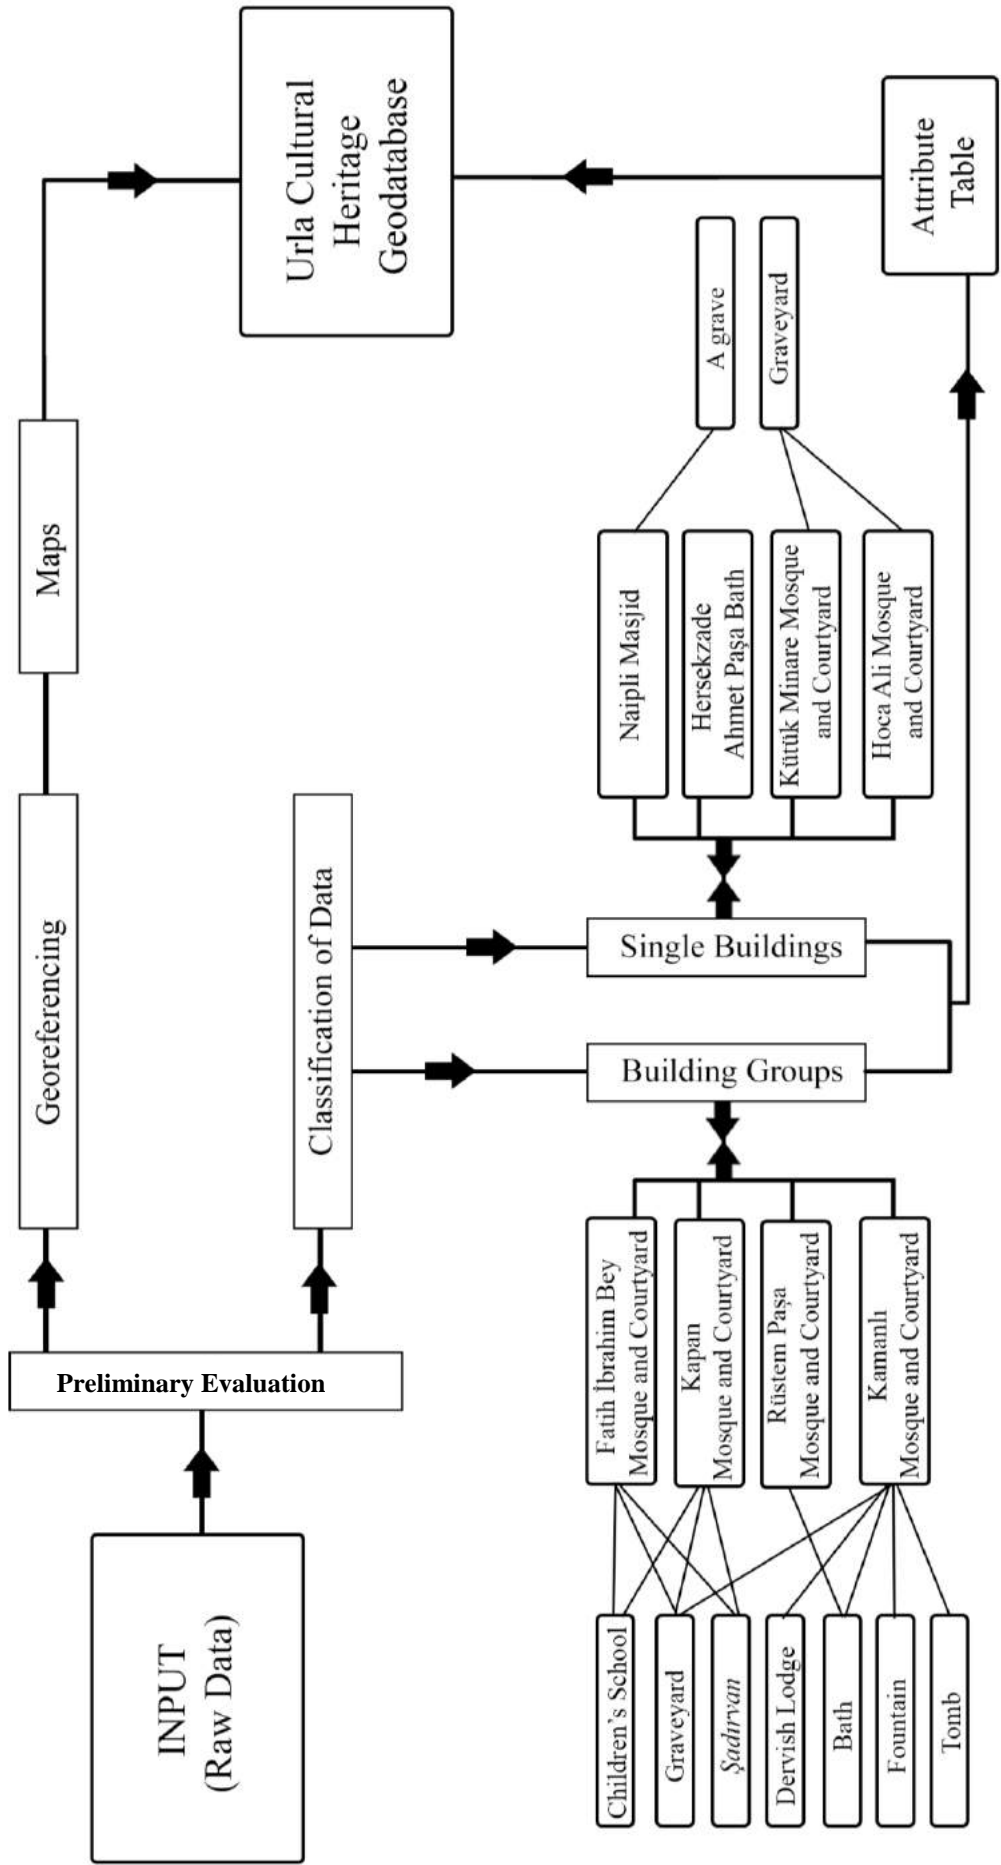
Figure 4.1. Constructing GIS layers and attributes of table

Based on the characteristics of the cultural heritage elements, the classification, separation, and grouping operations are done on a systematic basis by means of the features presented by the database. In order to be a conformant database must be following the specific rules. Raw data consists of visual and textual cumulative information (tables, drawings, photos, etc.) obtained from various sources. Initially, the studied data is divided into “Building Groups” and “Single Building Elements” in order to control easily (Figure 4.1).

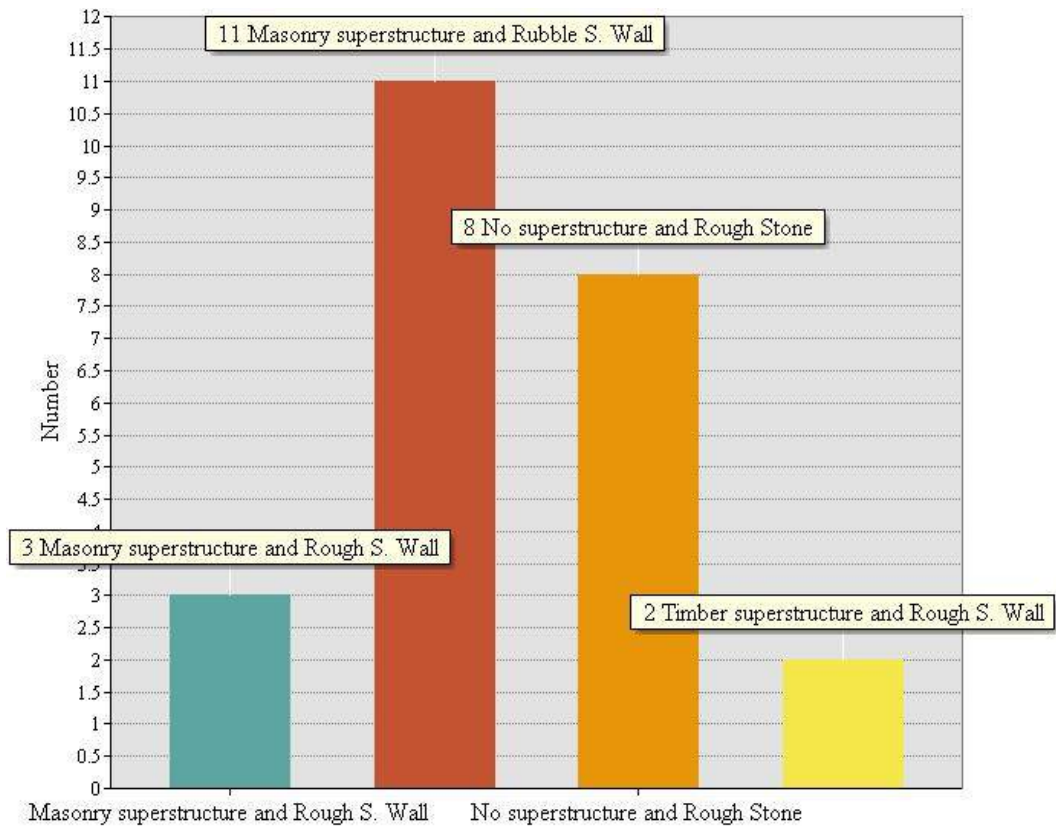
Figure 5.5. Distribution of cultural assets according to their construction technique

When the cultural assets are classified their construction technique; eleven cultural assets have a masonry superstructure and construction technique is a rubble stone wall masonry (Figure 5.5) (Appendix B, Figure B.5). Eight cultural assets' construction technique is a rough stone masonry and they have not a superstructure. Two cultural assets have a timber superstructure and construction technique is rough stone wall masonry. Three cultural assets have masonry superstructure and construction technique is rough stone wall masonry. When the studied assets are classified by conservation activities (Figure 5.6), four of them are in ruins, three of them are under restoration process, thirteen of them have been restored, two of them are in project process and two of them are unmaintained (Appendix B, Figure B.6). When the studied cultural assets are grouped according to their third listing frequency, four of them are listed for once, two of them were listed twice, nine of them were listed three times, and eight of them were listed four times (Figure 5.7) (Appendix B, Figure B.7).
