**CHARACTERIZATION OF HORASAN PLASTERS  
FROM SOME OTTOMAN BATHS IN İZMİR**

**A Thesis Submitted to  
the Graduate School of Engineering and Sciences of  
İzmir Institute of Technology  
in Partial Fulfillment of the Requirements for the Degree of**

**in Architectural Restoration**

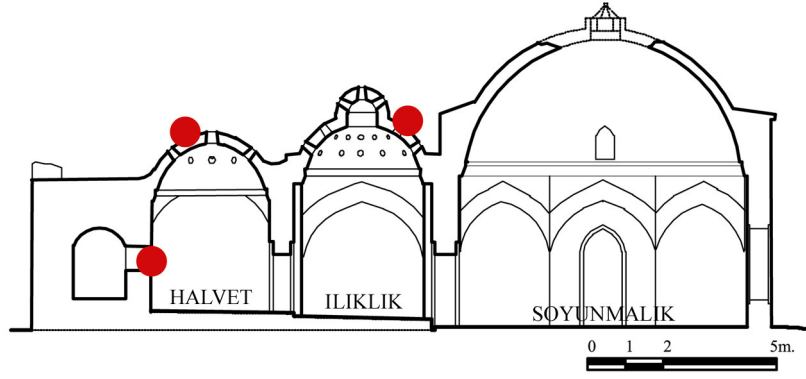
Figure 3.9. Section of Düzce Bath showing where the samples were collected  
(Source: Reyhan 2004)

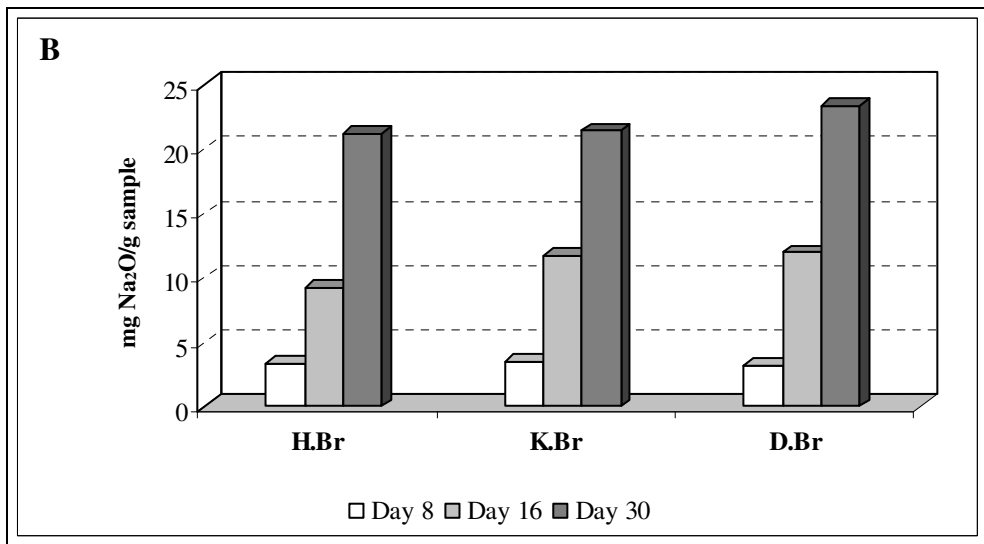
Figure 4.12. The amount of sodium oxide ( $\text{Na}_2\text{O}$ ) released by brick aggregate (A) and building brick (B) powders after 8, 16 and 30 days

The results indicated that amounts of releasing sodium oxide ( $\text{Na}_2\text{O}$ ) and potassium oxide ( $\text{K}_2\text{O}$ ) were higher in the non-pozzolanic bricks. It may explained by the high amounts of feldspar minerals in the composition of non-pozzolanic bricks (Table 4.1, 4.2, 4.3).

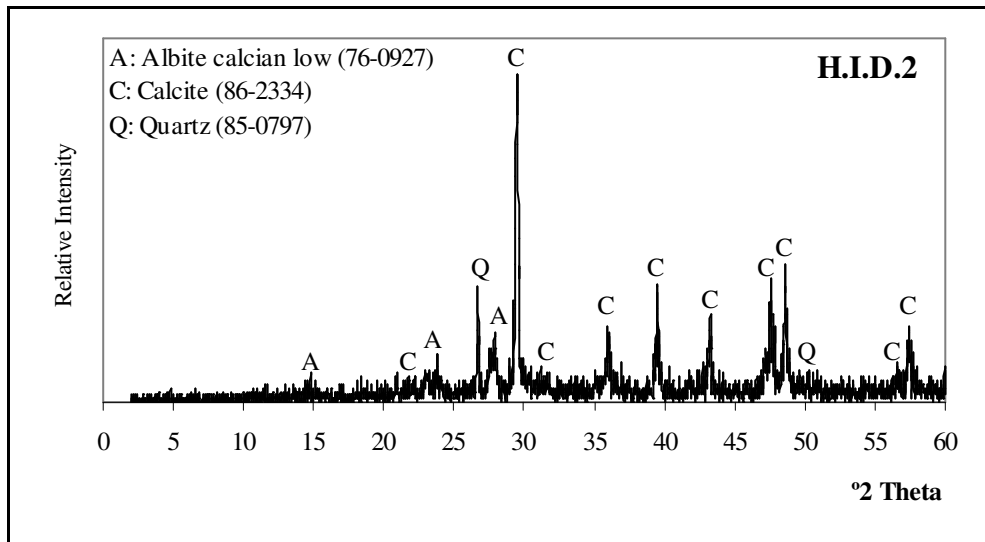
Figure 4.16. XRD patterns of some horasan plaster samples

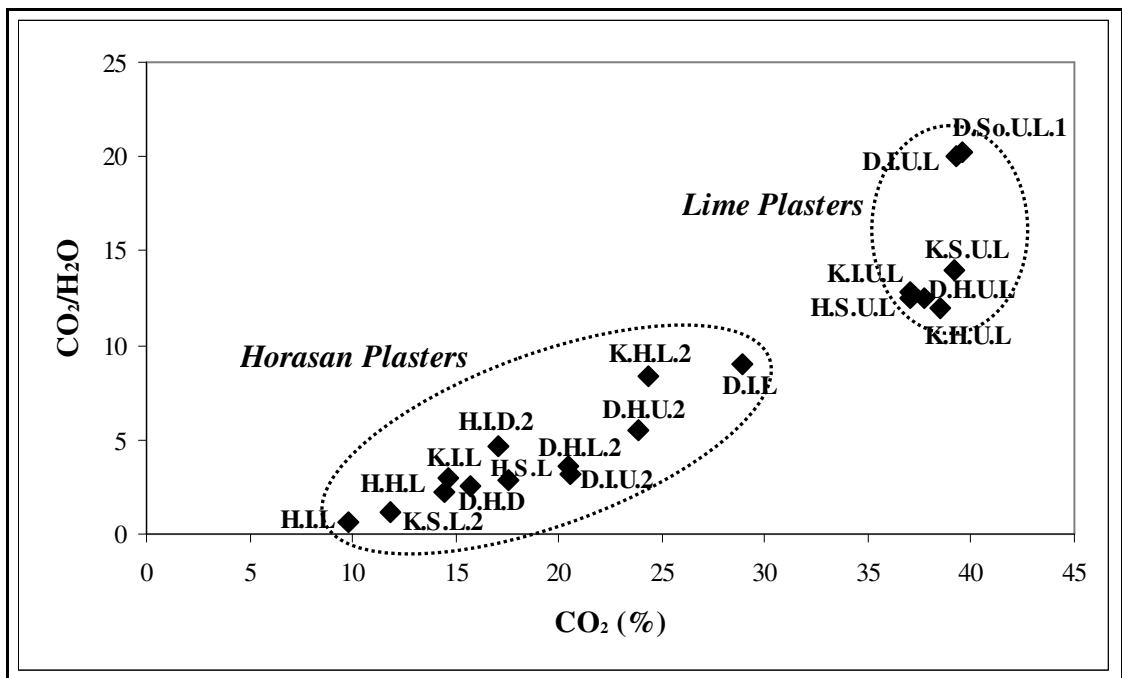
Figure 4.54. Hydraulicity (CO<sub>2</sub>/H<sub>2</sub>O) versus CO<sub>2</sub> % of plasters

Hydraulicity levels of mortars and plasters are usually expressed by a graph on which the ratio of CO<sub>2</sub>/chemically bound water versus CO<sub>2</sub> percent is given (Moropouolu et al. 2000a, Moropoulou et. al. 2000b, Moropoulou et. al. 2002a). When investigated horasan plasters and lime plasters were put on this graph, it was clearly observed that horasan plasters were concentrated at the bottom left part of the graph with their CO<sub>2</sub>/H<sub>2</sub>O ratio less than 10, and lime plasters were concentrated at the upper right part of the graph with their CO<sub>2</sub>/H<sub>2</sub>O ratio greater than 10 (Figure 4.54).
